**SLED IMPACT TESTS
OF WHEELCHAIR TIE-DOWN SYSTEMS
FOR HANDICAPPED DRIVERS**

**FINAL REPORT TO
MASSACHUSETTS REHABILITATION COMMISSION**

MAY 1985

UMTRI The University of Michigan
Transportation Research Institute

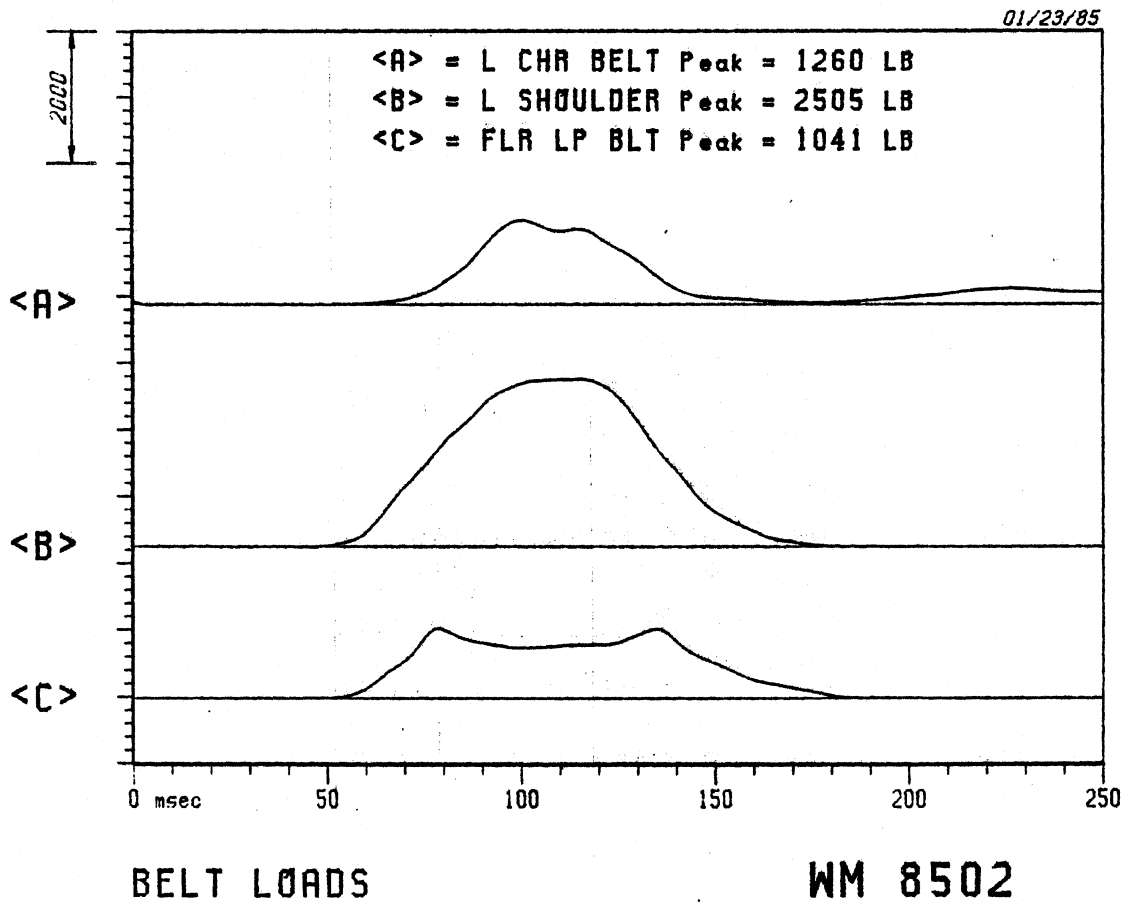
Figure 23. Belt loads versus time.

Figures 21 through 23 show the head accelerations, chest acceleration and belt load time histories. Resultant accelerations and the Head Injury criteria (HIC) are well below existing tolerance levels for the able-bodied population. The high value of peak shoulder belt force indicates that some of the restraint of the wheelchair may have been due to the shoulder belt's acting on the chair through the chest of the dummy.

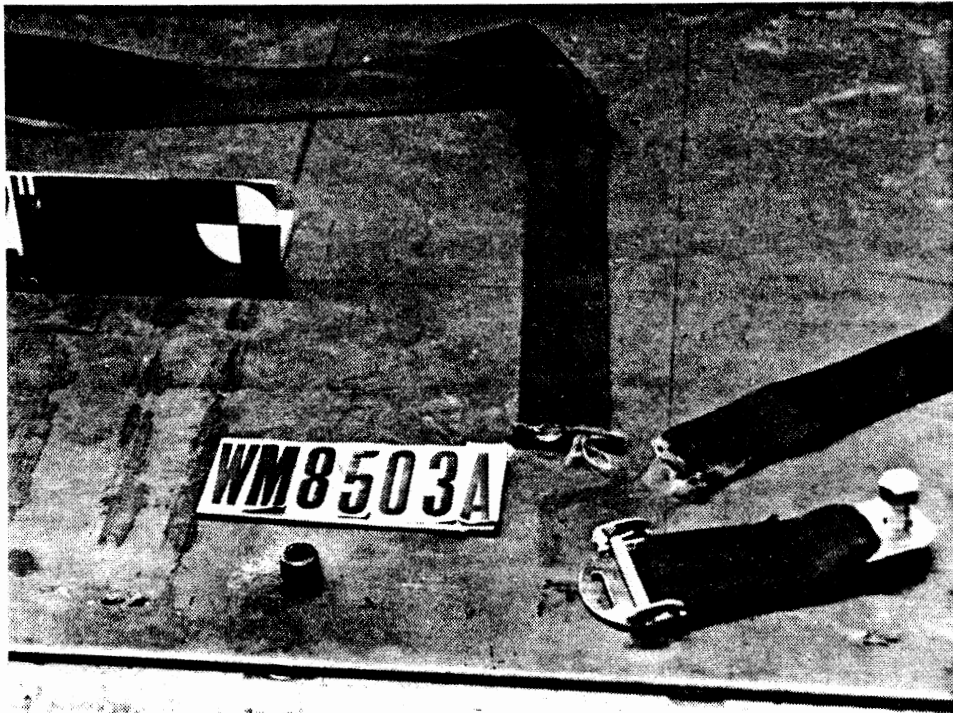
Figure 17. Torn shoulder belt webbing and anchor bracket.

Inspection of the shoulder belt webbing revealed that it had torn at the anchorage point due to abrasion with a knurled locking bar. Inspection of the tie-down hardware revealed no noticeable bending or damage to the cross-bars or floor mounted structure. The rear "U" bolts which attach the tie-down to the wheelchair did show some bending and appear to be a weak point in the tie-down system.

The peak shoulder belt force at failure is greater than it would have been if the wheelchair had not loaded into the restraint. The cause of failure seems to be abrasion or cutting due to the knurled locking bar. FMVSS 209 specifies that "any webbing cut by the hardware during test shall have a breaking strength of ... not less than 2,800 pounds or 1,270 kilograms at a cut in webbing of the upper torso restraint." While the peak force at failure in this test was just greater than 2800 pounds, consideration should be given to another type of adjustment and anchor mechanism that would not be as likely to cut the webbing material. It is also recommended that the "U" bolts used to anchor the "Speedlock" to the wheelchair be made of hardened steel or changed to "U" brackets that would have higher breaking strength.
