IMPACT TESTING OF  
RESTRAINT DEVICES USED  
WITH HANDICAPPED CHILDREN IN  
BUS SEATS AND WHEELCHAIRS

Lawrence W. Schneider  
and  
John W. Melvin

November 1978

1. Report No. UM-HSRI-78-52		2. Government Accession No.		3. Recipient's Catalog No.	
4. Title and Subtitle Impact Testing of Restraint Devices Used With Handicapped Children in Bus Seats and Wheel-chairs				5. Report Date November 8, 1978

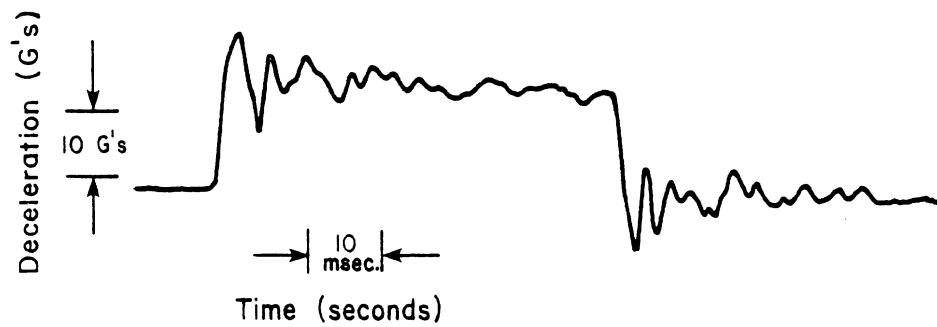
Impact tests were performed at the Highway Safety Research Institute Impact Sled Laboratory. This facility consists of an impact sled (Figure 1) that moves on a 45-foot track into a pneumatic decelerator and can simulate crashes up to 75 m.p.h. and 75 times the force of gravity. The sled itself is a 975-lb. test platform, 6.5-ft. square and is driven by a compressed-gas-powered ram. The sled operates on the principle of rebound, stopping and reversing direction abruptly by impacting the adjustable pneumatic decelerator. In this study, all pressures were set to achieve a 20 m.p.h. velocity differential and 16 G (i.e., 16 times the acceleration of gravity) deceleration pulse. Figure 2 shows a typical sled deceleration pulse for the tests in this study.

Figure 2. Sled Test Deceleration Pulse

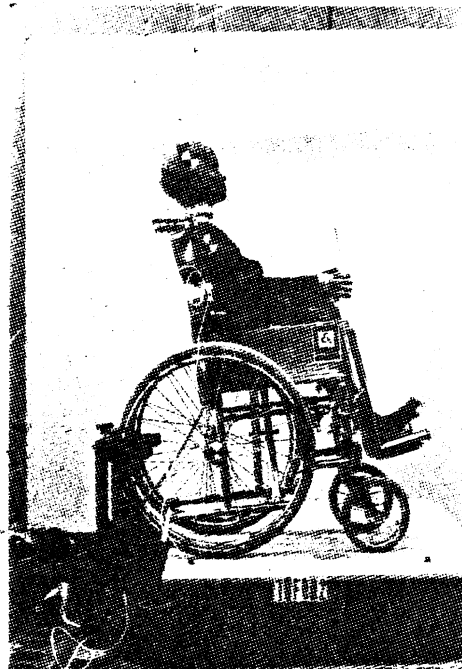
Test No. and Type: 78F002 TINY TOT WHEELCHAIR

The Collins Saf-T-Lock wheelchair tie-downs were bolted rigidly to the sled rails facing forward and the large wheels on the Tiny Tot wheelchair were secured in place by means of the steel pins. The 6 year child dummy was placed in the wheelchair and strapped to the chair back by means of the Collins Saf-T-Straint padded belt. The wheelchair friction brakes on both sides were applied and a load cell was installed to measure the tension in the Saf-T-Straint belt.

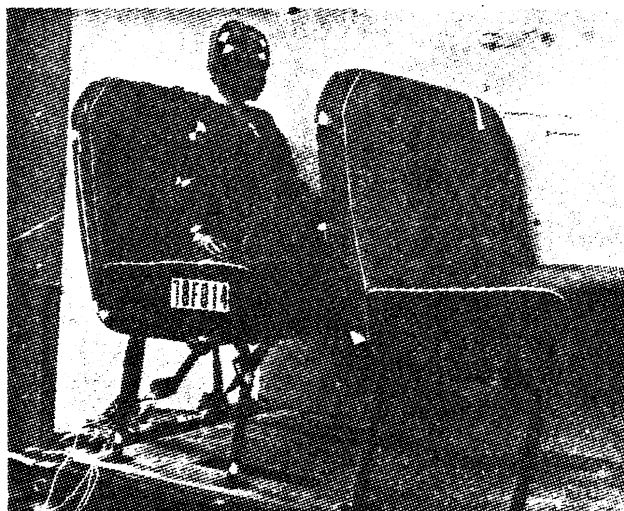
Test No. and Test Type: 78F014 BUS SEAT WITH RUPERT E-Z-ON SAFETY HARNESS

Two school bus seats and pseudo bus wall and floor were bolted to the sled at an angle of 33 degrees to the side of the sled with the horizontal distance from the back of the rear seat to the back of the front seat equal to 27 inches. The Rupert eye bolts were bolted to the sled just behind the rear seat as per the Rupert instructions. The 6 year dummy wearing the Rupert harness with heavy duty "D" rings replacing the original rings was placed in the center of the seat and the belt clips attached to the "D" rings. Belts were adjusted to take up any slack. Four load cells were used to measure the belt tensions in the two upper belts and two lower belts near the belt anchor points.

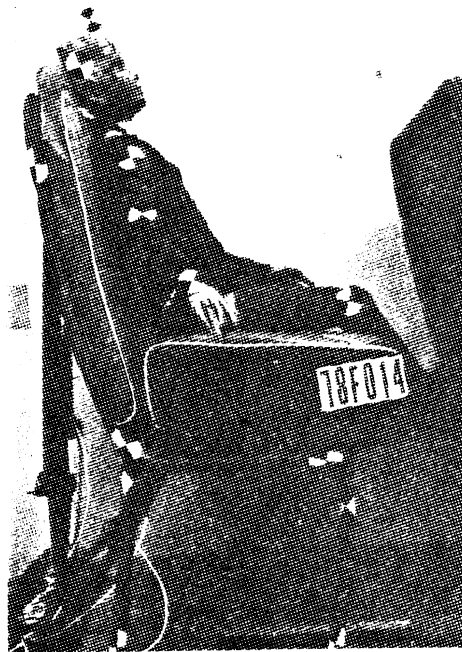
Photograph of Results:

Upon impact the dummy torso moved toward the front of the sled but was quickly restrained by the tension in the four belts. The head flexed forward but did not come close to striking the front seat. The maximum head excursion was 47.5 centimeters (18.7 inches) in the direction of impact. Peak tensions in the belts were 240 and 290 lbf. in the left and right lower belts and 290 and 350 lbf. in the left and right upper belts respectively. At the end of the test the dummy was very near its starting position.

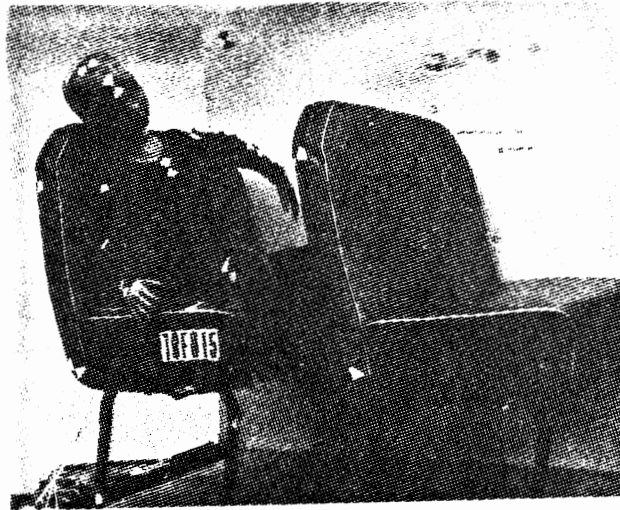
Photograph of Results:

Upon impact, the dummy moved forward on the seat toward the front of the sled with very little torso or neck flexion and with little apparent restraint. Considerable slack was provided by both the belt pad folding in back and by the straightening of the belt as the seat cushion was pulled out. The torso moved about 37.3 centimeters (14.7 inches) before head rotation began. As the torso approached its maximum excursion the head began to flex forward and the forehead struck the top bar of the front seat back near the wall. The dummy then rebounded to near its original position at the end of the test. During the test, the rear seat back was bent forward to a nearly vertical position by the force in the restraining belt. The maximum head excursion was about 69.9 centimeters (27.5 inches) in the direction of impact. Peak belt loads were 260 lbf. in the belt around the dummy and 400 lbf. in the belt around the seat back.

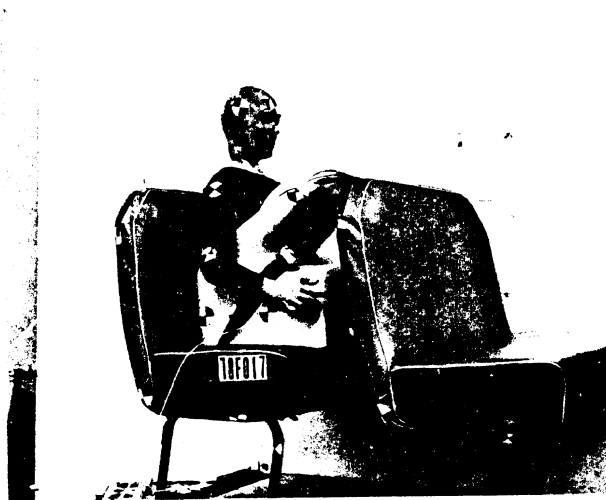
Photograph of Set-Up:

Two bus seats with a pseudo bus wall and floor were bolted to the sled at an angle of 33 degrees to the side of the sled and so that the horizontal distance from the back of the rear seat to the back of the front seat was 27 inches. A Rupert seat belt was bolted to the rear bus seat frame just below and behind the seat cushion and the 5th percentile female dummy was placed on the seat between the two belt anchor points. The Ford Tot Guard without booster seat was placed over the dummy's legs and the belt tightened in position. A load cell was used to measure the tension in the belt.

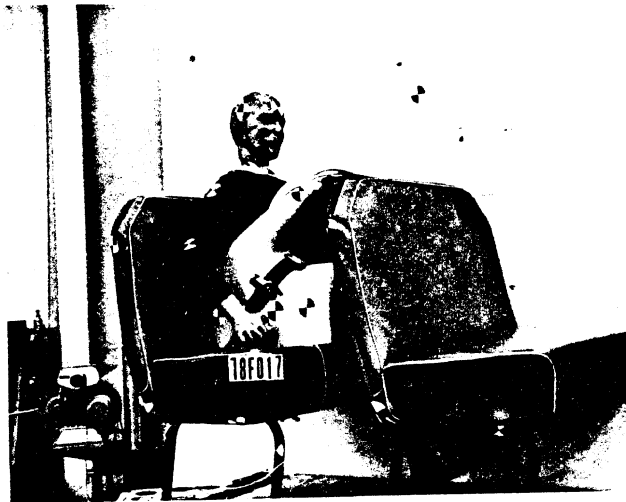
Photograph of Results:

Upon impact, the dummy rotated forward in the Tot Guard pushing the Tot Guard toward the front of the sled and down on the seat cushion. The padded front of the Tot Guard struck into the front seat back below the top of the seat and the dummy's head rotated into the top bar of the seat back impacting just above the eyes near the wall. The dummy's head and torso then rebounded back up and returned to near the original position. The maximum head excursion was 65.3 centimeters (25.7 inches) in the direction of impact. The peak belt load was approximately 950 lbf.
