U.S. Department
of Transportation
**National Highway
Traffic Safety
Administration**

DOT HS 811 060

Commercial Medium Tire Debris Study

Final Report

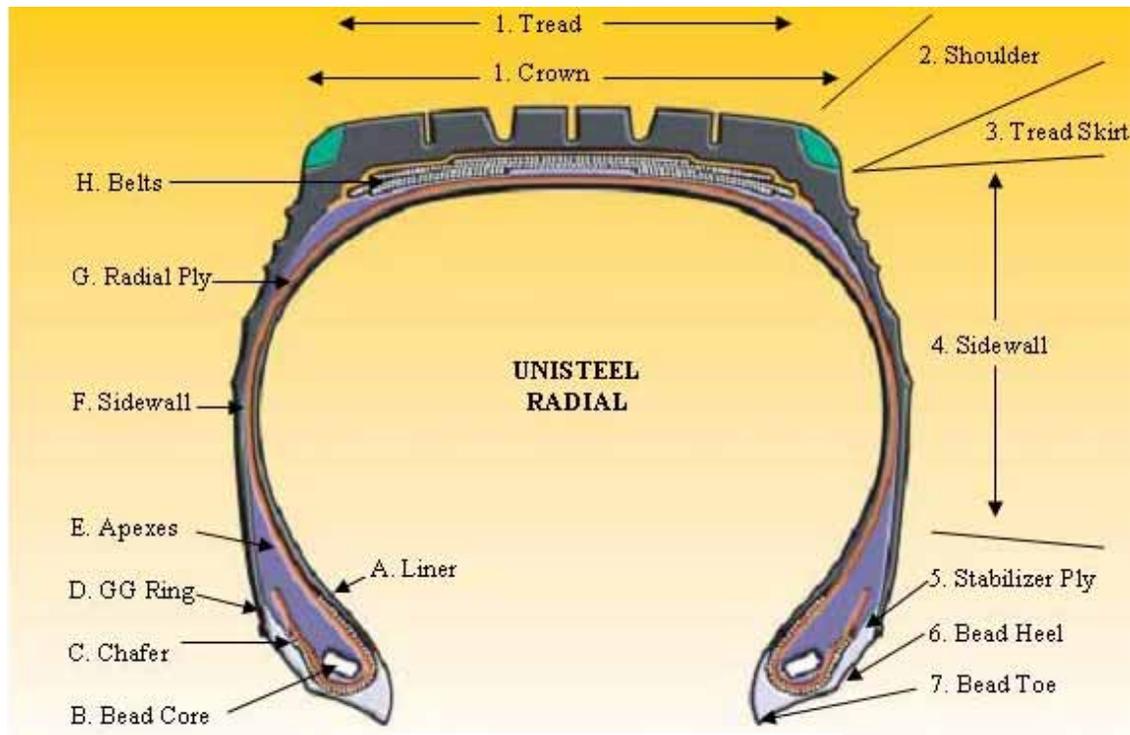
Figure 2.2 – Tire Structure

Figure 2.2 (Goodyear, 2003) presents a cross-sectional view of a typical tire illustrating the various components (e.g., bead core) and specific areas (e.g., sidewalls) that make up the tire structure. A brief explanation of these various components and areas follows (overleaf).

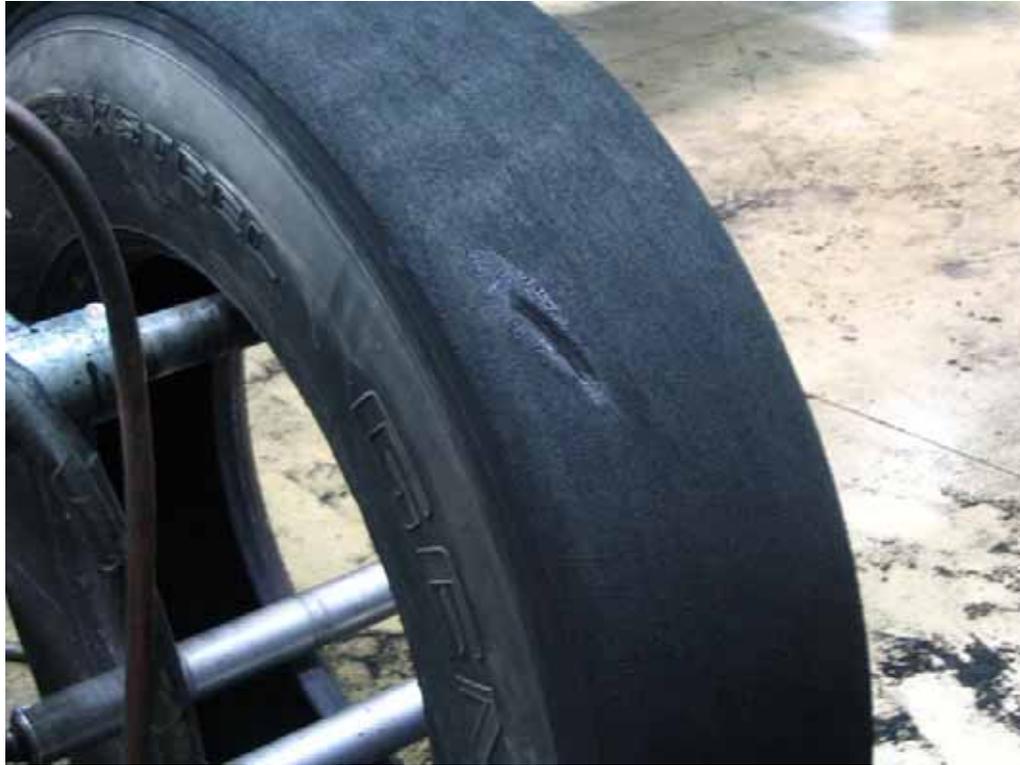
Figure 2.9 – A Buffed Casing Showing Area in Need of Repair

Removal of the old tread may expose minor defects which are then repaired (Figures 2.9 and 2.10). Any injuries identified are determined repairable or nonrepairable. Casings that do not meet the required retread standards (after any attempted repair) at this stage of the process are rejected.

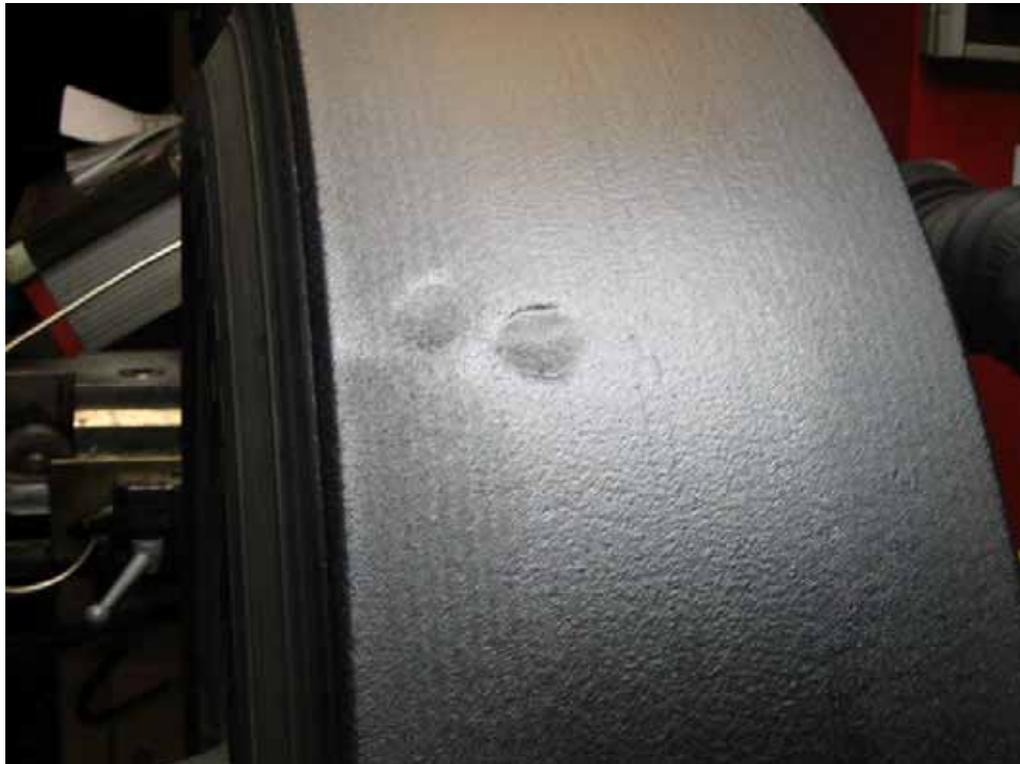
Figure 2.10 – A Buffed Casing After Required Repair

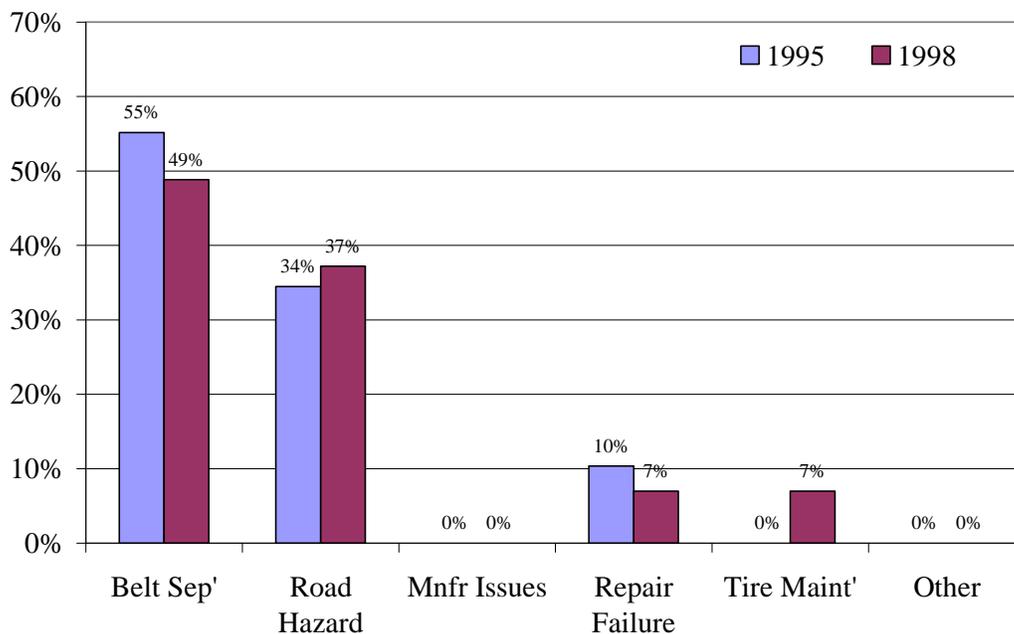
- **Belt separations**
The unraveling or separation of tire belt materials due to excessive flexing of the casing
- **Road hazard**
Stress resulting from road hazards (e.g., nails, potholes, etc.)
- **Manufacturer issues**
Poor quality control in the tire/retread manufacturing process
- **Repair failure**
Inappropriate/poor quality tire repairs
- **Maintenance issues**
Inadequate fleet maintenance (e.g., allowing tires to run on insufficient tread depth)
- **Other**
All other probable causes not defined above

Figure 3.3 – Probable Failure Reasons New Tires TMC Study, 1995 & 1998

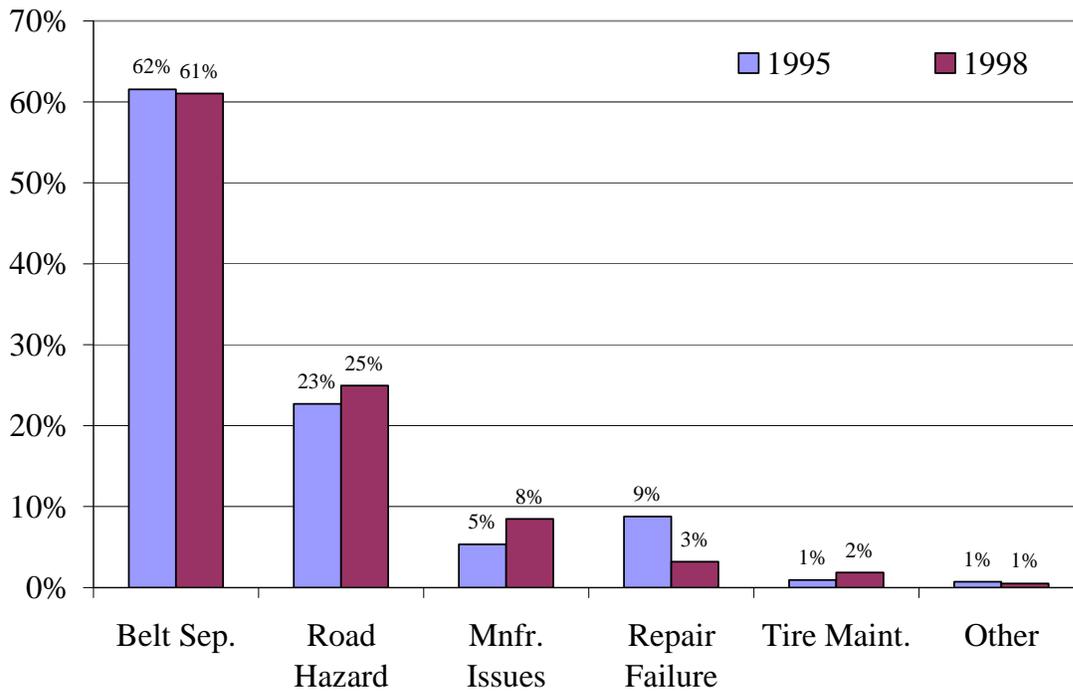
layers. See Chapter 2 for more information on tire structure). No matter how well a tire is constructed, underinflation creates excessive heat that will lead to a premature failure of the casing.

Figure 3.4 – Probable Failure Reasons Retread Tires TMC Study, 1995 & 1998

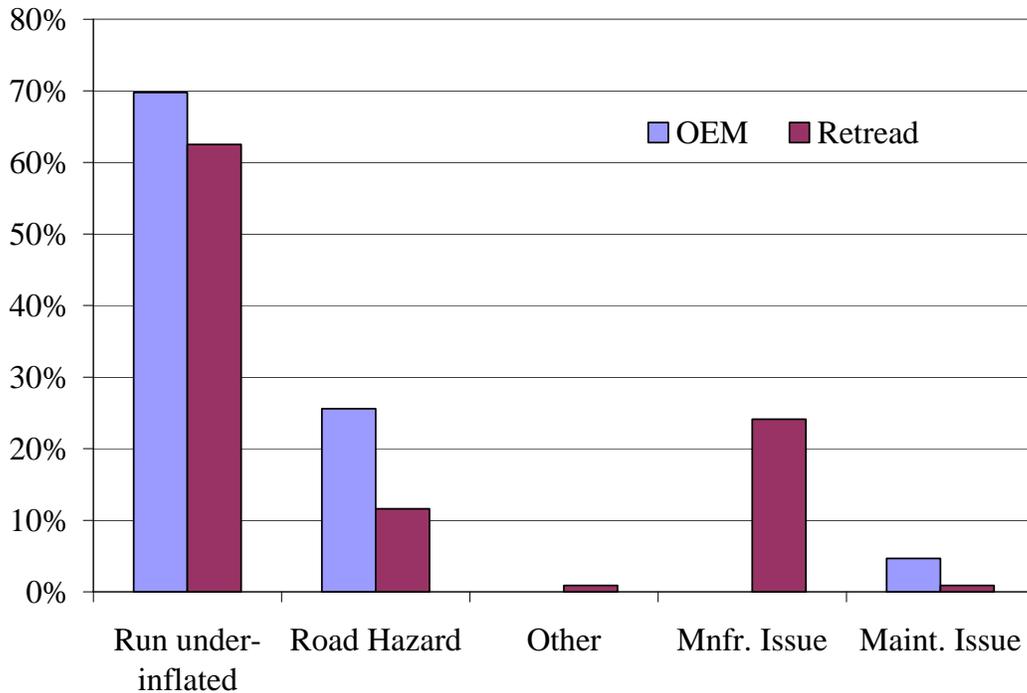
Approximately 155 tires identified (31%) were medium- or wide-base truck tires; 213 were passenger cars (43%), and 127 were light trucks (26%). It should come as no surprise that the percentages of identified tire debris differ from that found in other studies such as the TMC (see section 3.2). However, the extent and type of tire debris found on the Nation’s highways is a function of location, permissible speeds, weather, vehicle mix, etc. Figure 3.5 presents results of the probable causes of failure for the truck tires identified.

Figure 3.5 - Probable Cause of Failure for Truck Tires in Metropolitan Phoenix, 1999

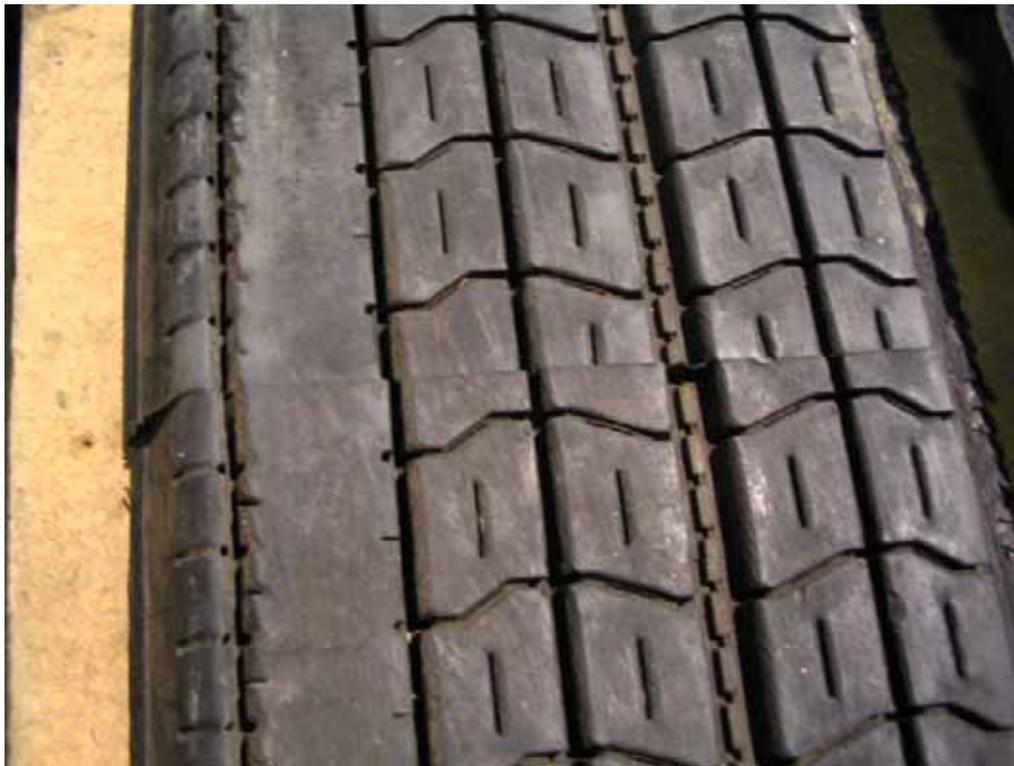
The above problems (though rare) emanating from retread splicing are often used as selling points promoting retread tire processes that do not use splicing (e.g., ring tread or mold cure). Figure 5.4 indicates a misaligned splice on a retread.

Figure 5.4 – Misaligned Splice on a Pre-Cure Retread Casing

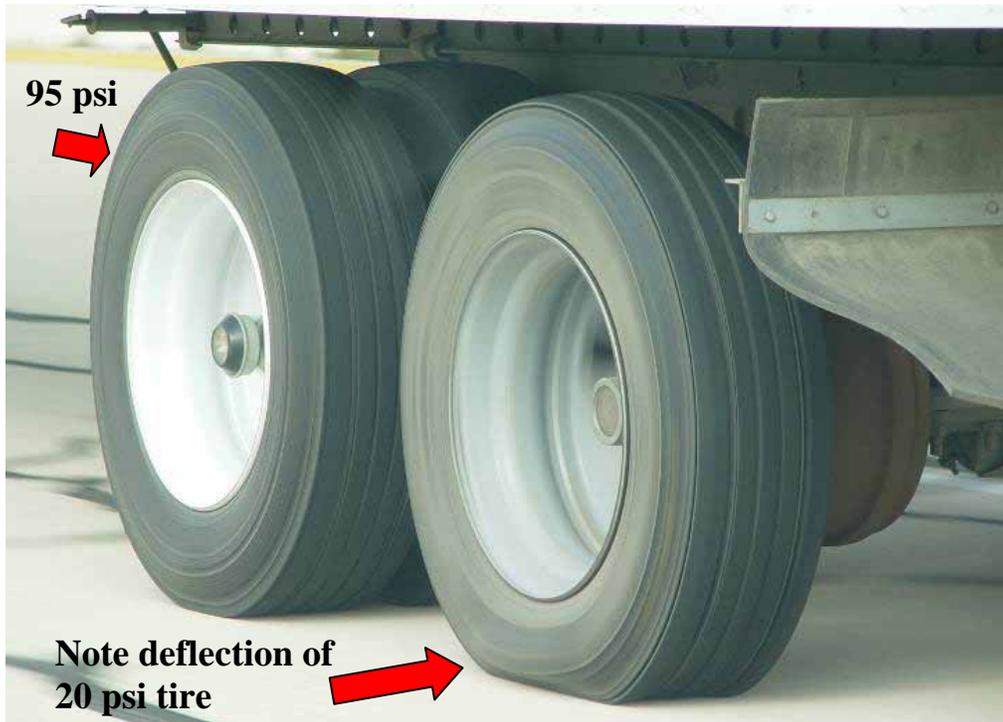
40 percent of the tire's rolling resistance while the tread accounts for 60-70 percent" (Kenworth Truck Company, 2003). Thus, shorter journey times may make a trucking operation more competitive, but they may also have long-term negative impacts increasing tire costs. Figure 5.5 illustrates an underinflated tire operating at high speed. Overdeflection of the underinflated tire is noticeable (when compared to the correctly inflated tire) and the resulting footprint is suboptimal.

Figure 5.5 – Underinflated Tire

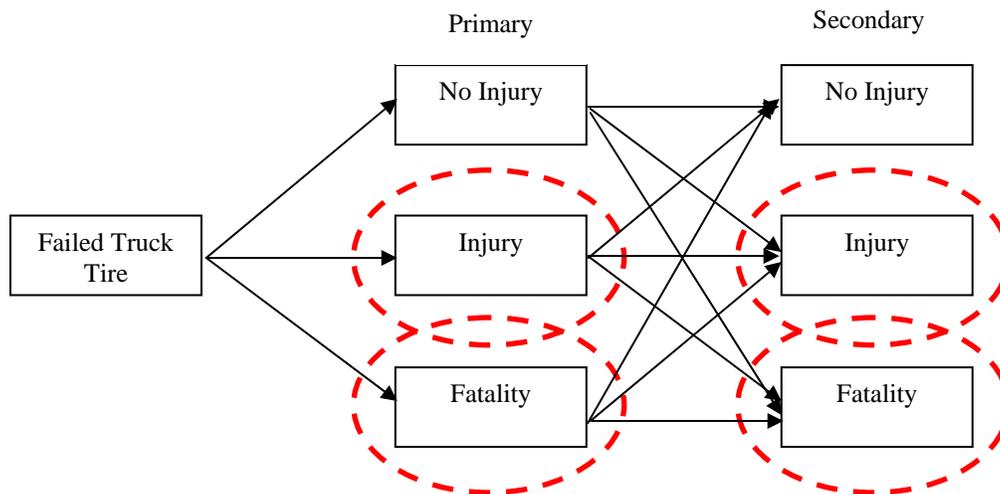
Figure 7.1 depicts potential scenarios that may result from truck tire failure. The highway safety implications of truck tire debris are wide ranging, as not only the vehicle from which the debris originated (i.e., primary incident) may immediately be involved in a crash, but vehicles traveling alongside, traveling immediately behind, or otherwise engaged in a maneuver to avoid the offending debris may also be endangered (i.e., secondary effects). Research has shown that downstream disruptions in the normal flow of traffic due to a traffic crash have a tendency to increase the risk of crashes upstream (Forbes, 2004).

Figure 7.1 – Truck Tire Failure Injury/Crash Scenarios

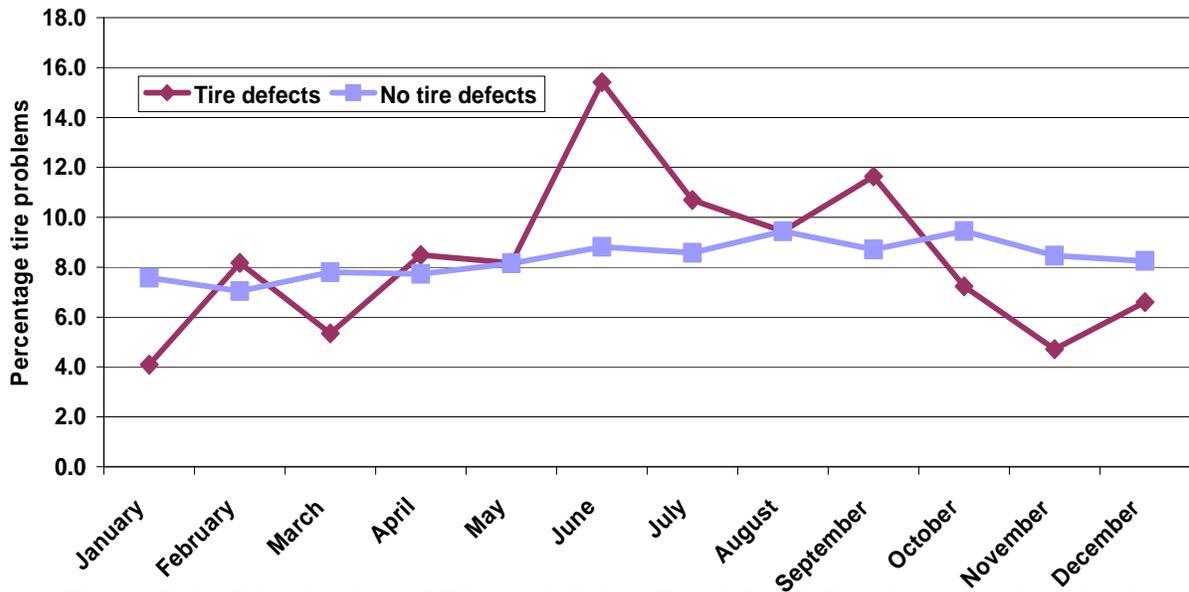
A variety of factors were examined for association with tire defects. This includes the month of the crash, to test if tire defects are more common in the summer months when temperatures are high, or lower in months when temperatures are on average lower. Figure 7.4 shows the distribution of tire defects and other fatal crash involvements by month. The curves are consistent with the higher temperatures of summer months associated with more identified tire defects. The mechanism may be that tires are more likely to fail when operated in hotter temperatures. The ambient temperature is not available directly in the crash data. Month is used as a surrogate. Note that unlike passenger vehicles, commercial trucks are not driven more during the summer months than during the winter months as their patterns of use are roughly the same throughout the year.

Figure 7.4 – Distribution of Tire and Other Fatal Crash Involvements by Month, TIFA 1999-2005

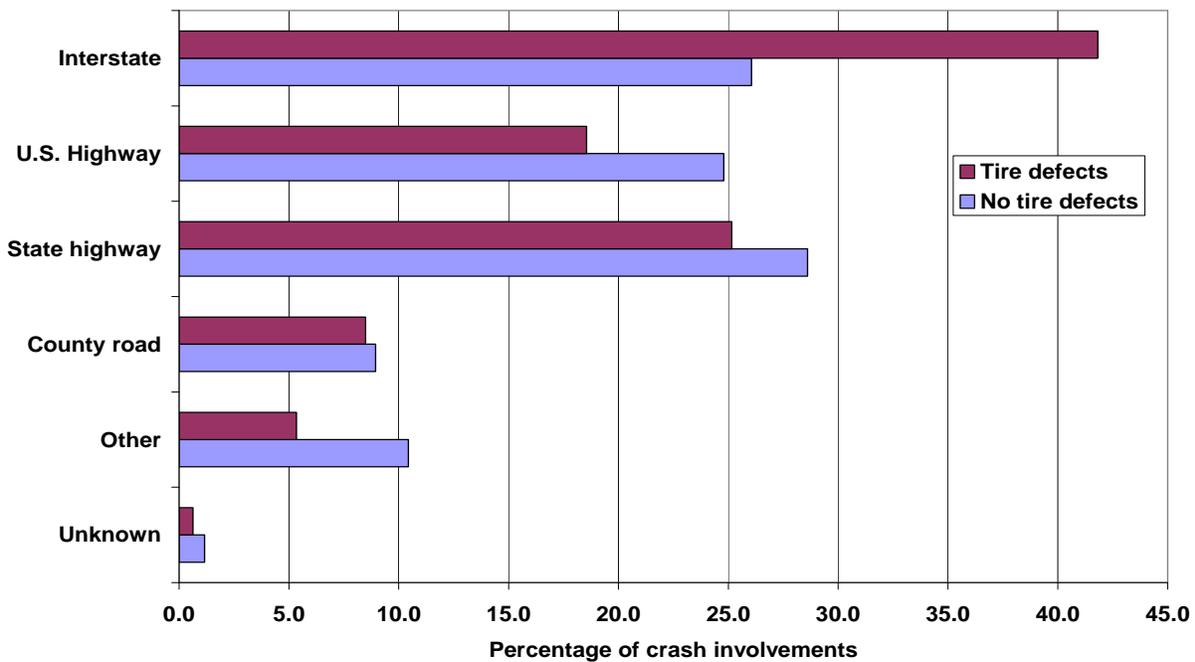
Tire defects are more likely to occur on relatively high-speed roads. Figure 7.5 shows the distribution of cases coded with tire defects by route signing. The distribution of cases with no tire defects is shown for comparison. About 42 percent of tire-defect involvements occurred on interstate-quality highways, compared with only about 26 percent of the involvements that did not have an identified defect.

Figure 7.5 – Distribution of Tire and Other Fatal Crash Involvements by Route Signing, TIFA 1999-2005

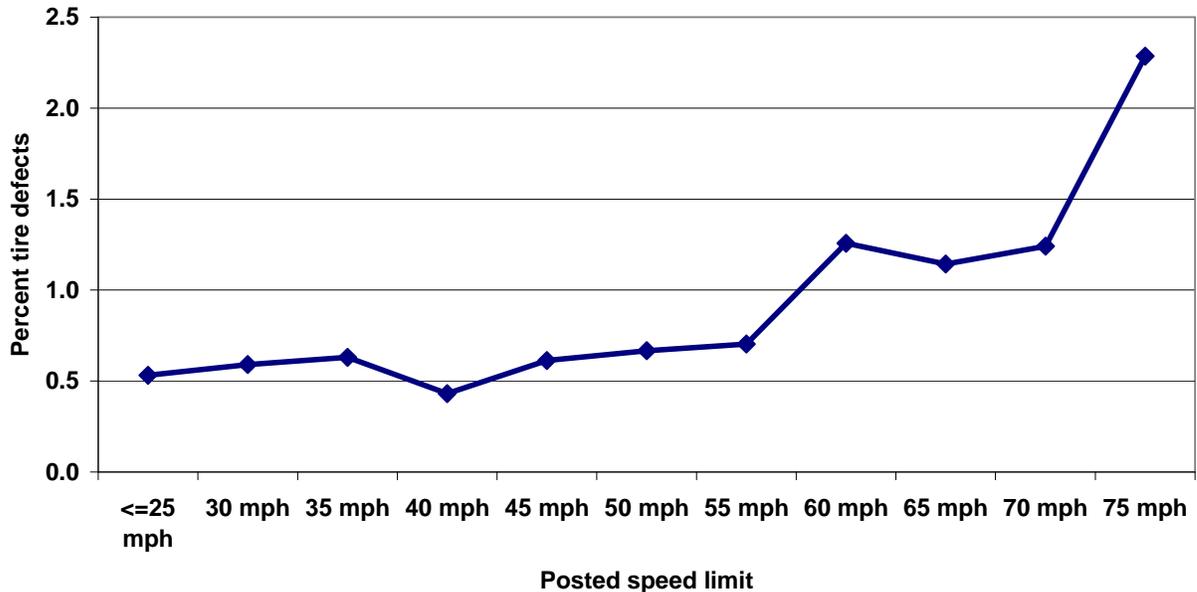
The effect of road speed is more directly shown in Figure 7.6, which shows the percentage of tire defects identified in crashes by the posted speed limit on the road. The incidence of tire defects stays low at around 0.6 percent on roads with posted speed limits up to 55 mph. On roads with speed limits from 60 mph to 70 mph, the percentage essentially doubles to about 1.2 percent, and then doubles again to 2.3 percent on roads with posted speed limits of 75 mph. In combination with the distribution of tire-defect-related fatal truck crashes by route signing, this suggests that high speeds and the related heat generated are associated with the incidence of tire defects.

Figure 7.6 – Incidence of Tire Defects in Fatal Crash Involvements by Posted Speed Limit, TIFA 1999-2005

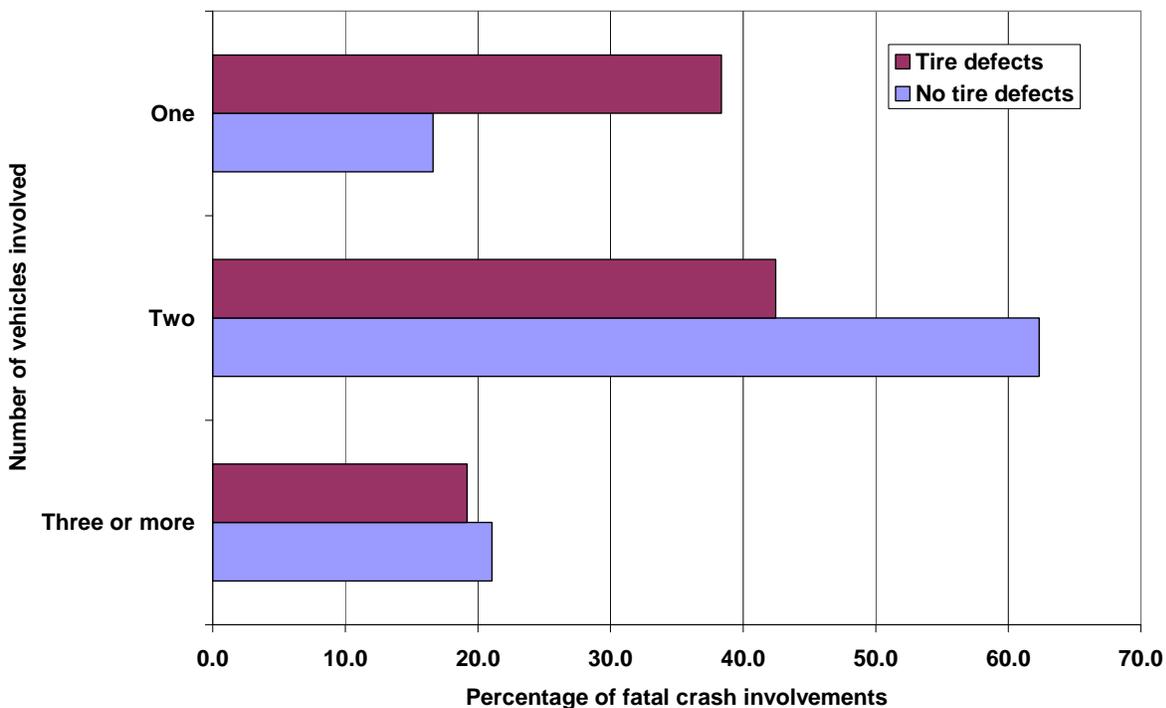
Trucks with tire defects in fatal crashes are much more likely to be involved in single-vehicle crashes than other trucks. Figure 7.7 shows that about 38 percent of fatal crashes involving trucks with tire defects are single-vehicle crashes, compared with only about 17 percent for other trucks. Accordingly, the percentage of two-vehicle crashes is much lower (42.5% compared to 62.3%) for trucks not coded with tire defects, though the percentage of involvements with three or more vehicles is about the same.

Figure 7.7 – Distribution of Tire-Related and Other Fatal Crash Involvements by Number of Vehicles Involved, TIFA 1999-2005

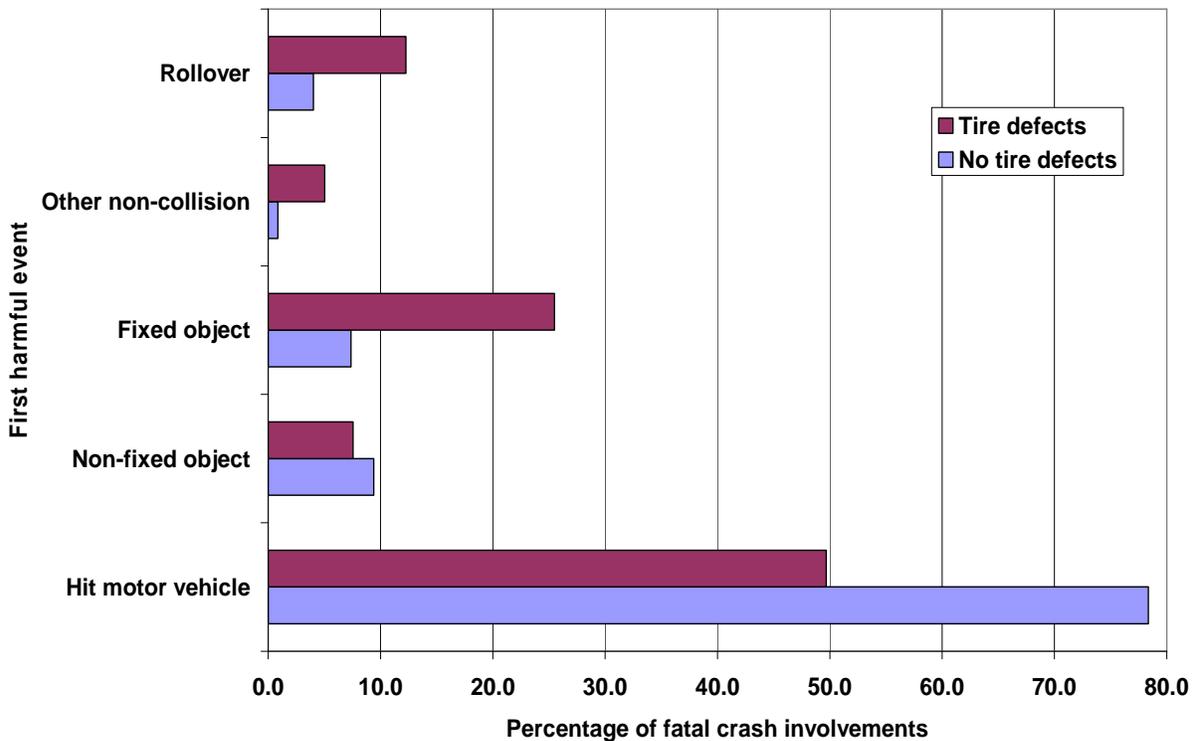
The distribution of first harmful event (Figure 7.8) in the crash is also quite different for trucks coded with tire defects. As expected, the first harmful event in fatal crashes of trucks with tire defects is much more likely to be a collision with a fixed object than other fatal truck crash involvements. In over 25 percent of tire-defect-related crash involvements, the first harmful event was a collision with a fixed object, which implies (generally) that the truck departed the road and collided with a tree, sign, bridge abutment, or some other permanent roadside object. Other loss-of-control type first events are much higher for tire-defect involvements. Over 12 percent of tire-defect involvements include a first-event rollover, compared to about four percent for trucks without tire defects. Other loss-of-control type first events are much higher for tire-defect involvements. Over 12 percent of tire-defect involvements include a first-event rollover, compared to about four percent for trucks without tire defects. The “other non-collision” category is not further specified unfortunately, but may include road departures not involving an overturn or collision with an object. Note that collisions with other motor vehicles are proportionately reduced.

Figure 7.8 – Distribution of First Harmful Event for Tire-Related and Other Fatal Crash Involvements, TIFA 1999-2005

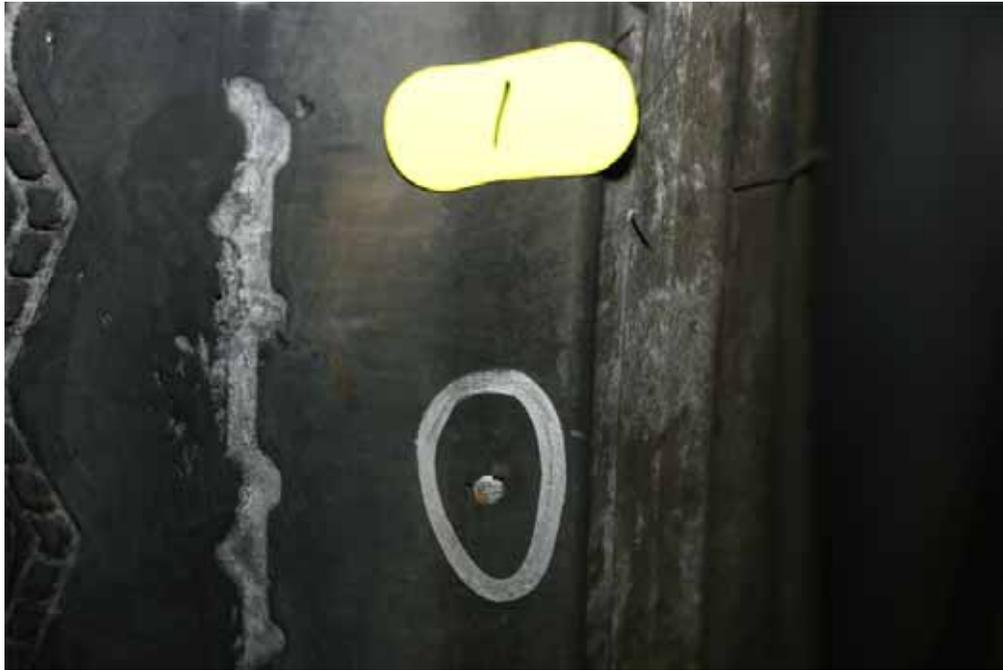
Figure 9.2 - Overdeflected Operation #1 - Apparent nail in outer rib, resulting in slow air loss and flex fatigue damage

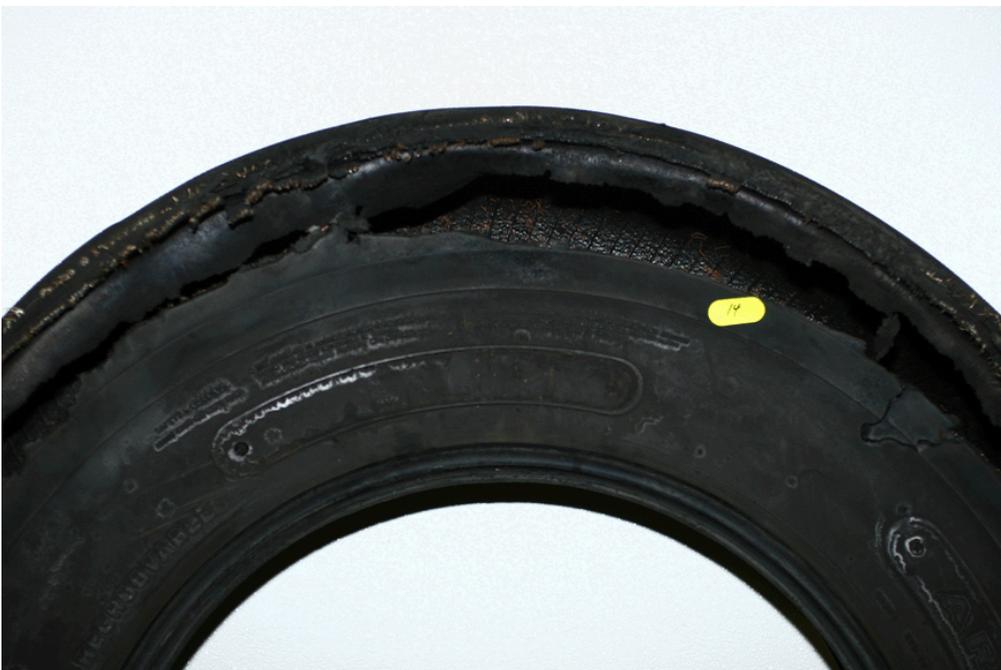
Figure 9.5 - Excessive Heat #2 (Original tread with very significant heat damage (bright bluish discoloration), including localized reversion of rubber)

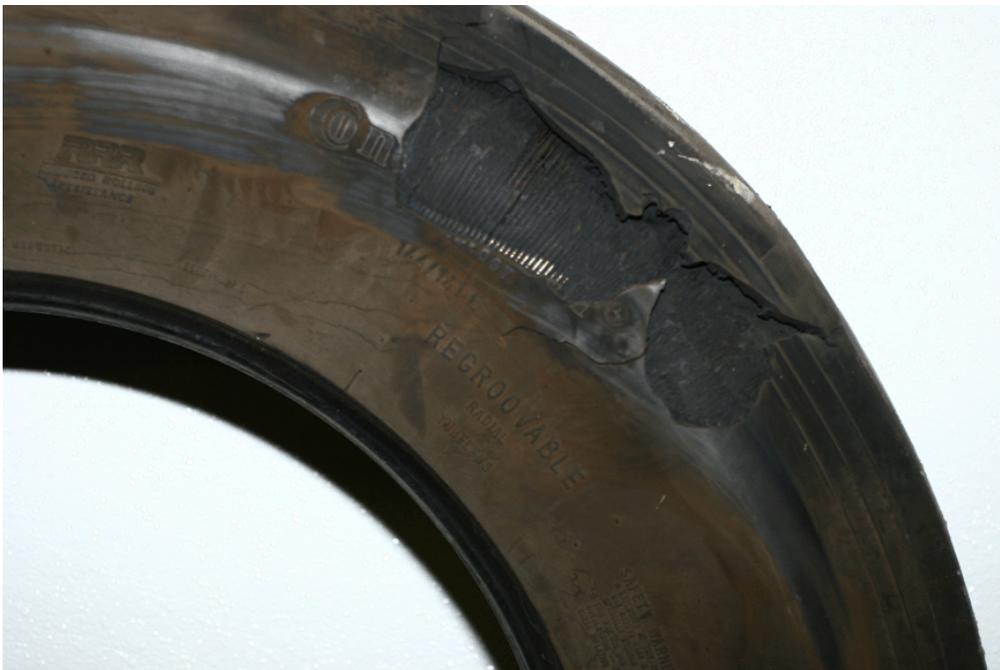
Figure 9.9 - Road Hazard #2 - Pinch shock damage. Sidewall separation resulting from excessive intracarcass pressurization, allowed by the pinch shock injury

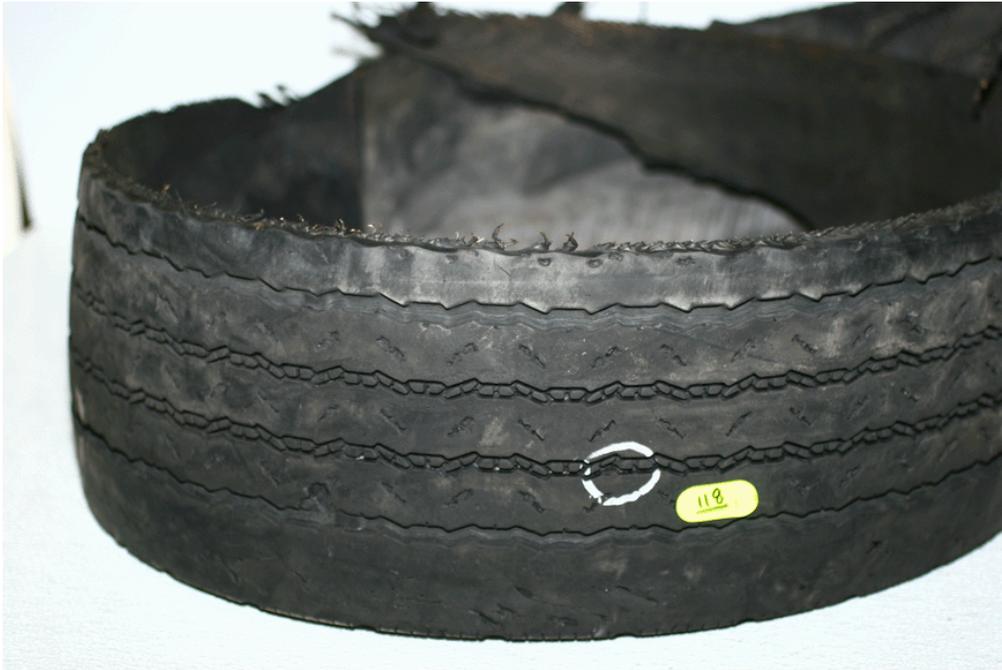
Figure 9.10 - Road Hazard #3 - Unrepaired crown puncture in original tread

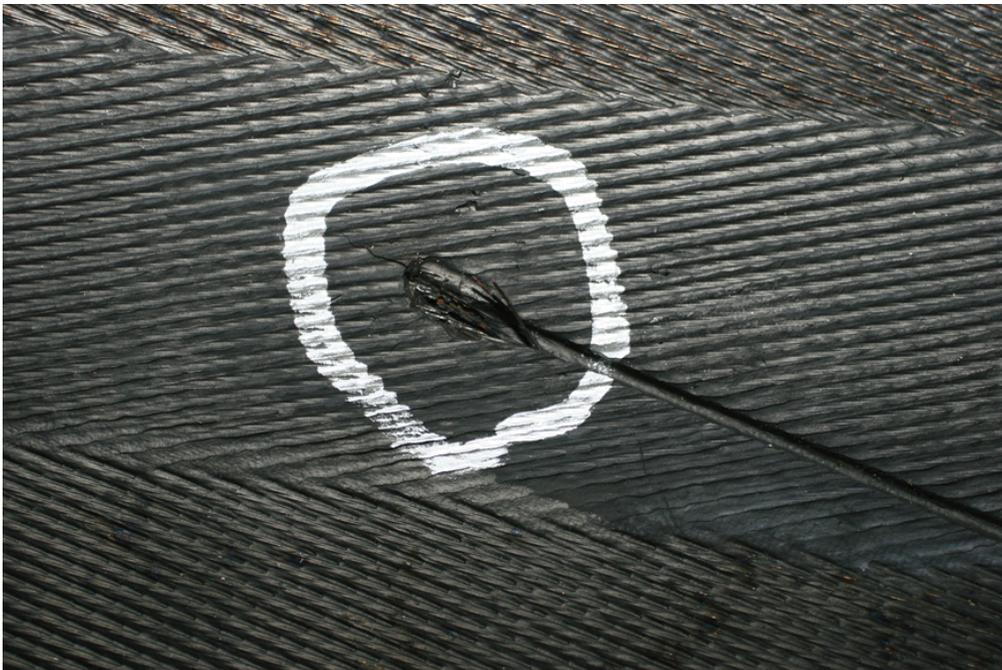
Figure 9.11 - Road Hazard #4 - Unrepaired crown puncture in original tread

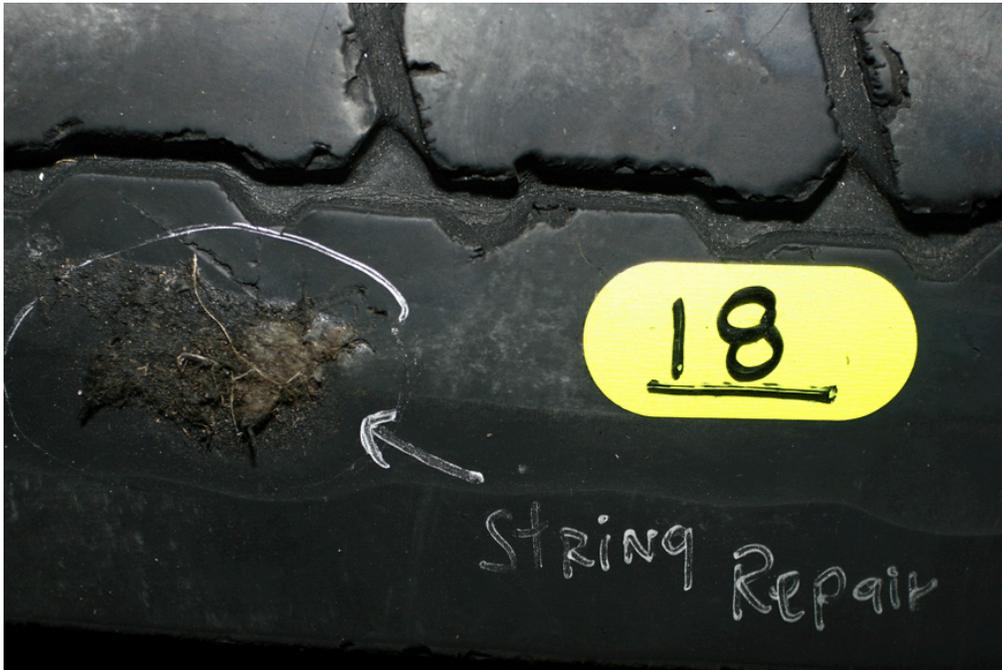
Figure 9.12 – Maintenance/Operational #1 - Use of improper (outside-in string plug) repair. Resulted in excessive intracarcass pressurization, sidewall separation, and tire failure

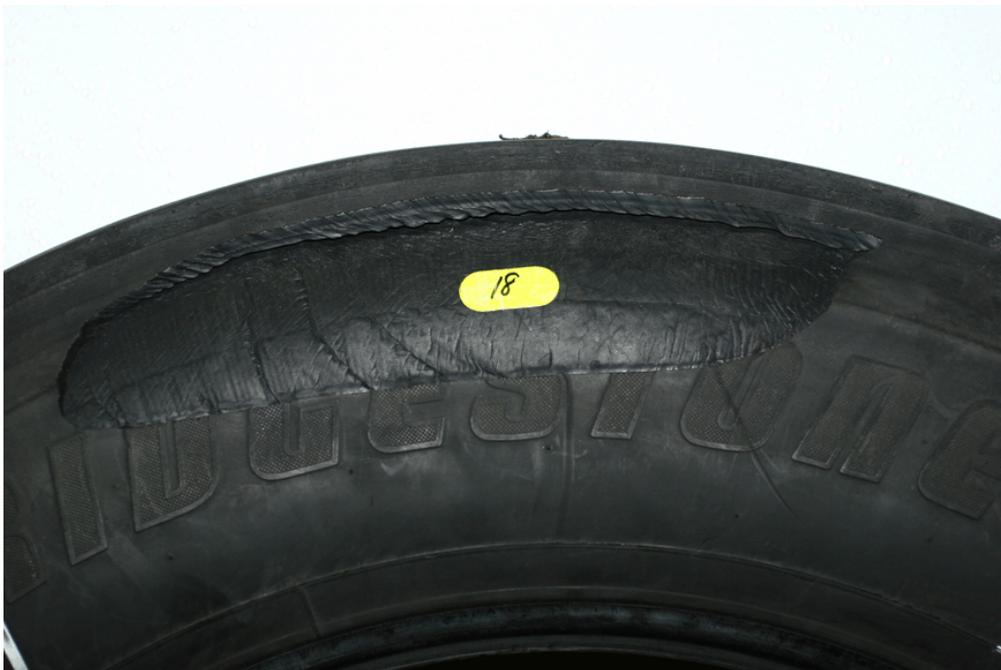
Figure 9.13 – Maintenance/Operational #2 - Use of improper (outside-in string plug) repair. Resulted in excessive intracarcass pressurization, sidewall separation, and tire failure

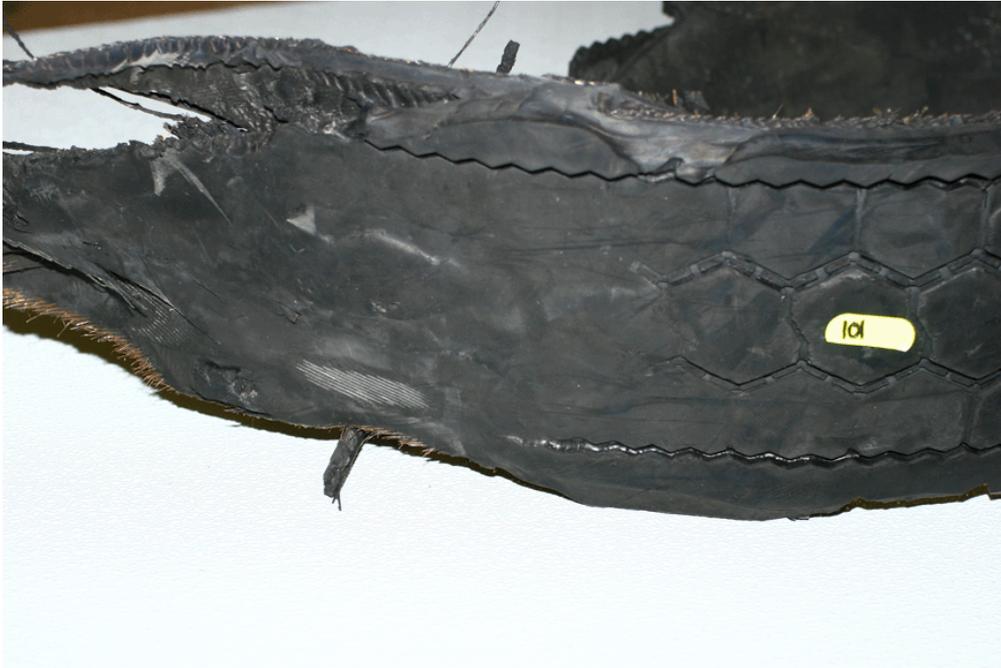
Figure 9.14 – Maintenance/Operational #3 - Example of drive axle tire with localized accelerated wear

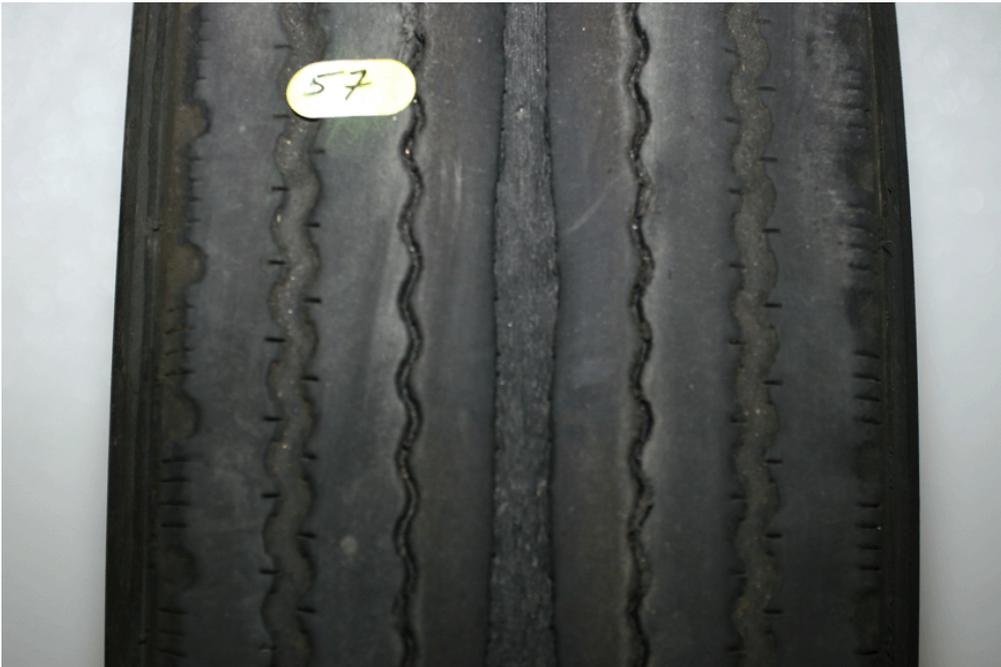
Figure 9.15 - Manufacturing/Process Issues #1 - Retread rubber separated at buff line. This resulted in a "raised" section of the tire's circumference. Localized, accelerated wear (9" in the center of the tread) resulted, extending to the buff line.

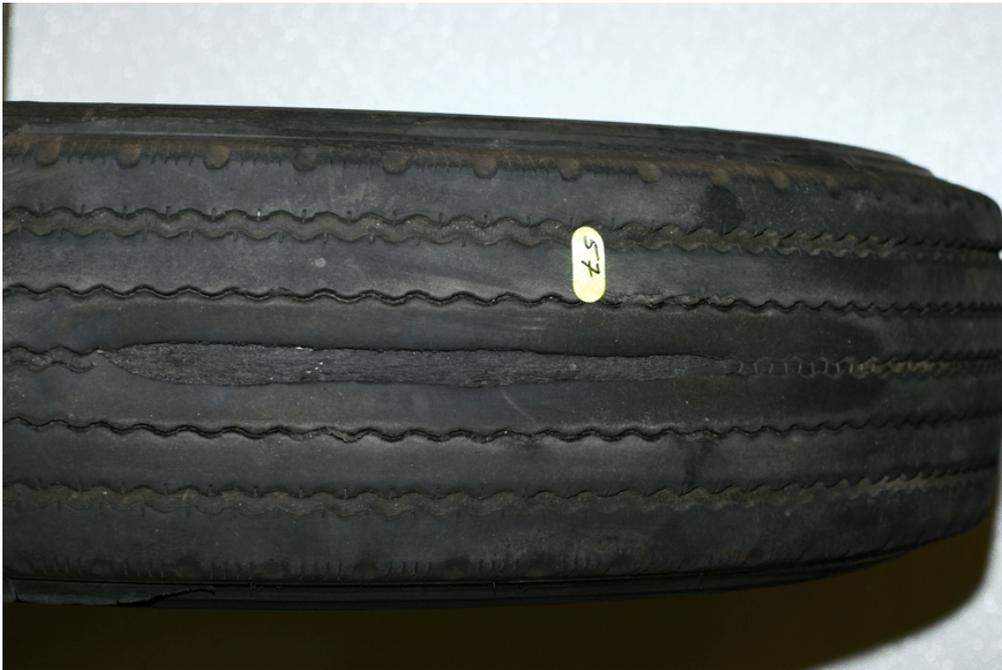
Figure 9.16 - Manufacturing/Process Issues #2 - Retread rubber separated at buff line. This resulted in a "raised" section of the tire's circumference. Localized, accelerated wear (9" in the center of the tread) resulted, extending to the buff line.

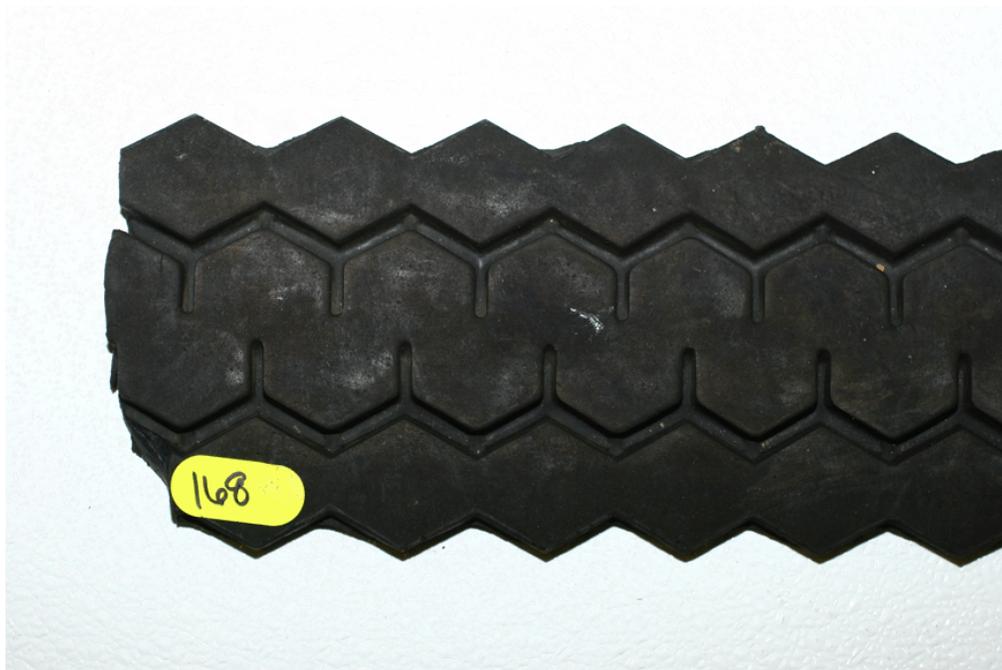
Figure 9.17 - Manufacturing/Process Issues #3 - Bond failure at buff line

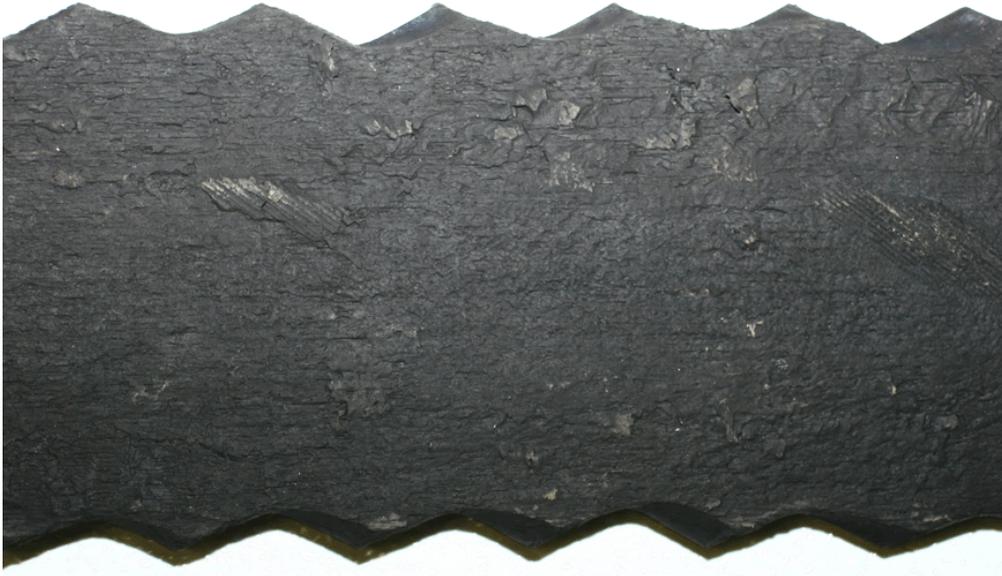
Figure 9.18 - Manufacturing/Process Issues #4 - Bond failure at buff line

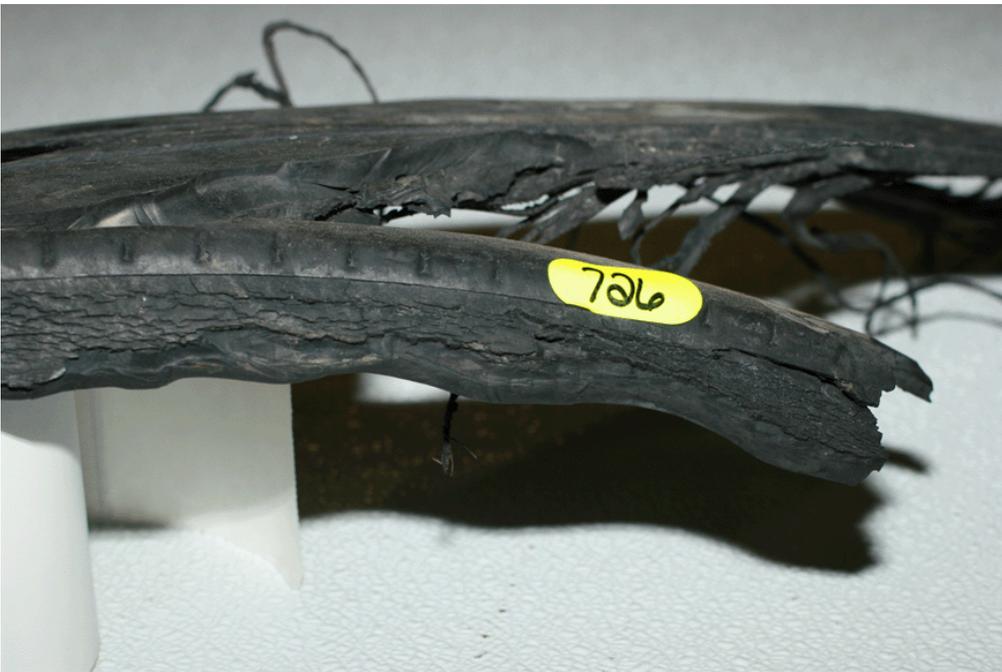
Figure 9.19 - Manufacturing/Process Issues #5 - Tire may have been unsuitable for retreading (severe weather cracking)

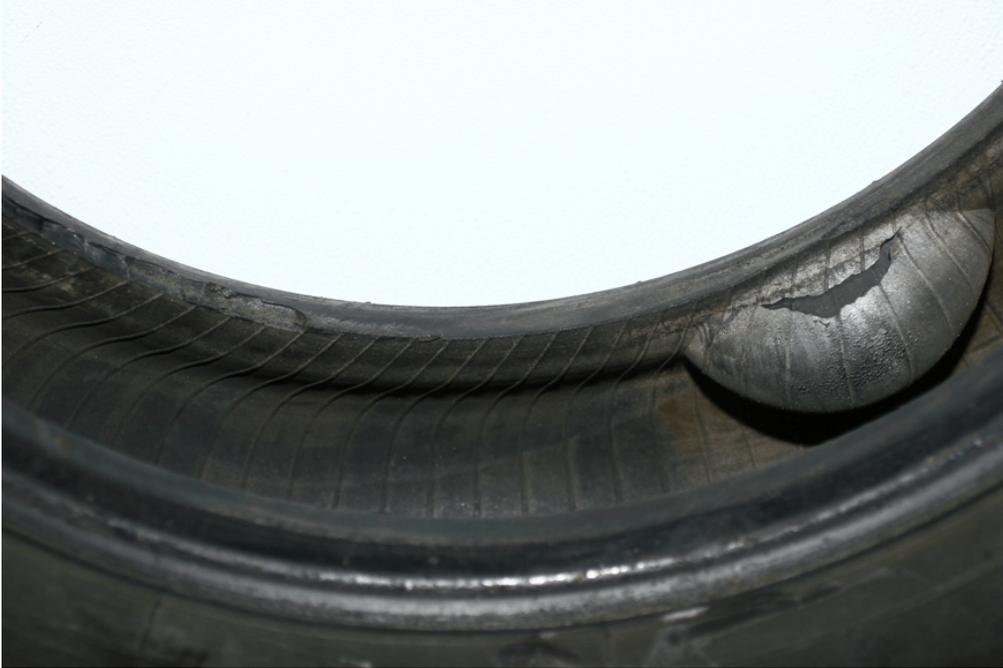
Figure 9.20- Excessive Intra-carcass Pressurization #1 - Separation as a result of excessive intracarcass pressurization
