1. Report No. UMTRI-85-36	2. Government Accession No.	3. Recipient's Catalog No.	
4. Title and Subtitle Biomechanical Accident Investigation Methodology: Second Phase Case Reports and Guidelines for Application.		5. Report Date August 1985

Biomechanical Accident Investigation Methodology:
Second Phase Case Reports and Guidelines for Application

Final Report
August 1985

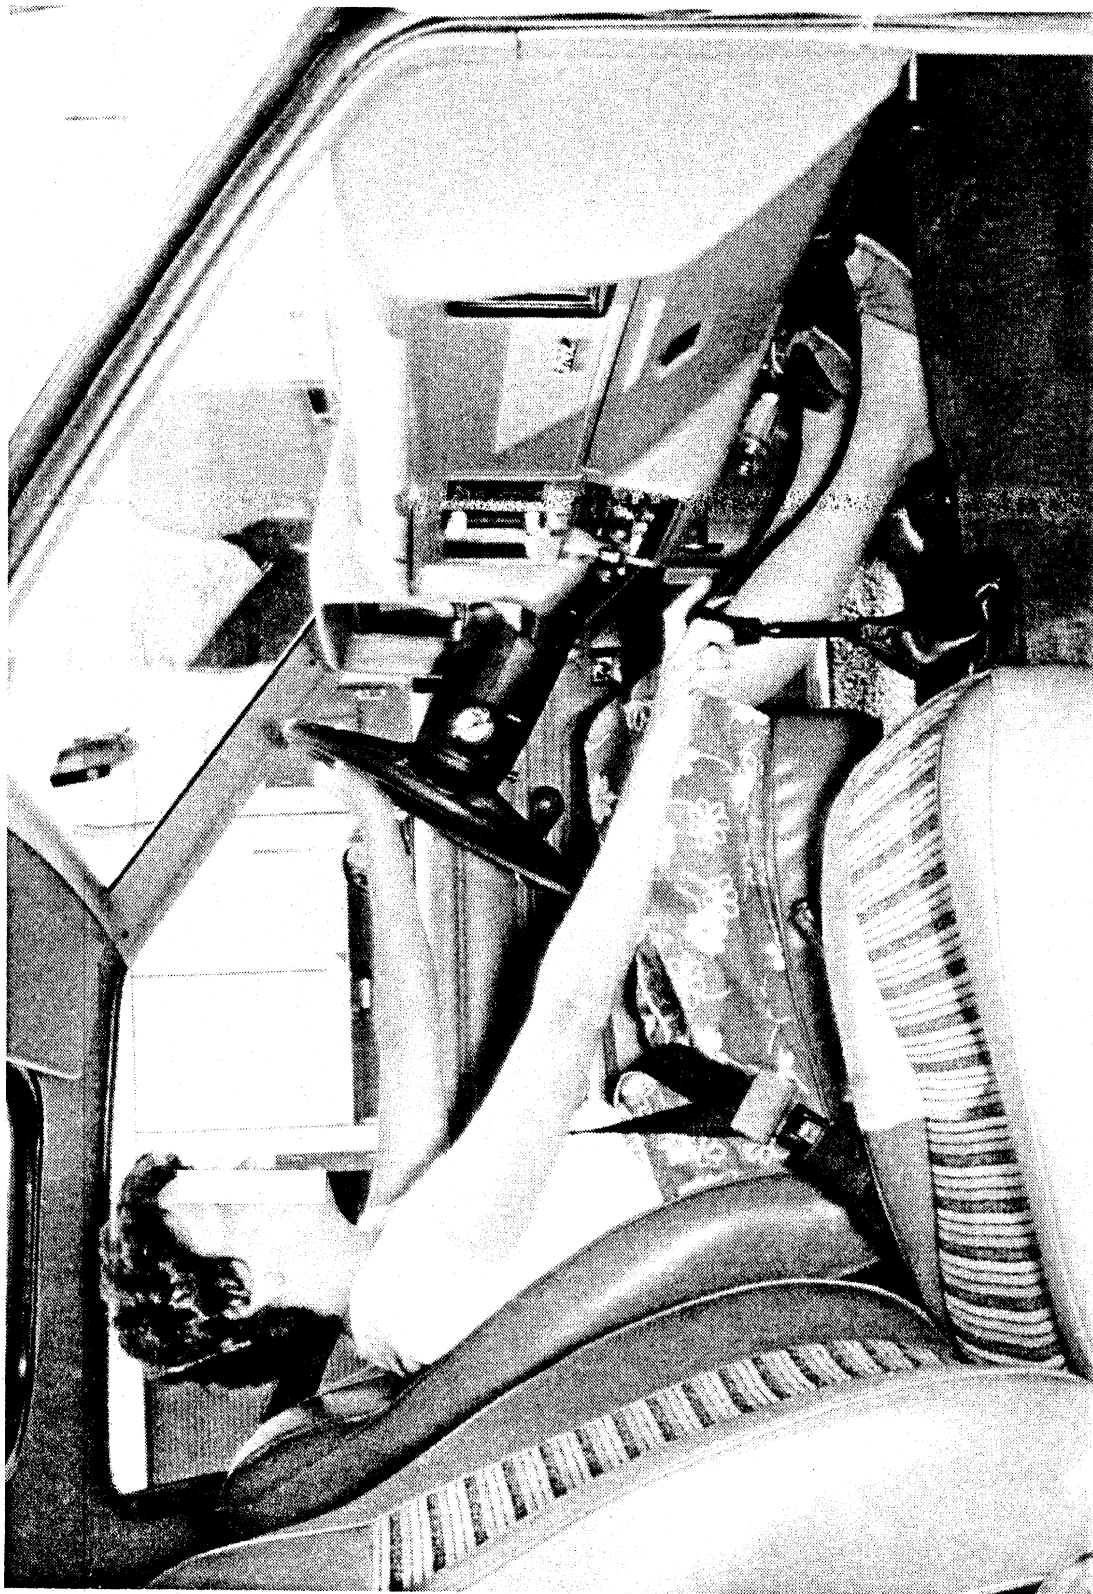
Figure 3. Injuries to the Driver (Case No. 2-6).

The driver sustained a variety of injuries which are illustrated in Figure 3. These include well-defined contusions and abrasions caused by interaction with the well-positioned belt, abrasions and lacerations of the knees, a neck strain and contusions to the back of the head and neck, as well as injuries to the right hand.

A biomechanical review of these results yields a classic case of the effectiveness of properly worn seat belts. The primary crash force was absorbed by the belts and yielded contusions to the regions underneath the belt (left clavicle, surface of chest between breasts, the lower ribs, and the region across the iliac crests and lower abdomen). These loadings (4800N (1078 lb)), although substantial, were within known tolerance estimates based on the work of Kroell et al (6) and used by Robbins et al (2) in the previous study. On one hand this supports the work of Kroell in that injuries were not observed. On the other it provides a data point estimate for human tolerance derived from real crash conditions.

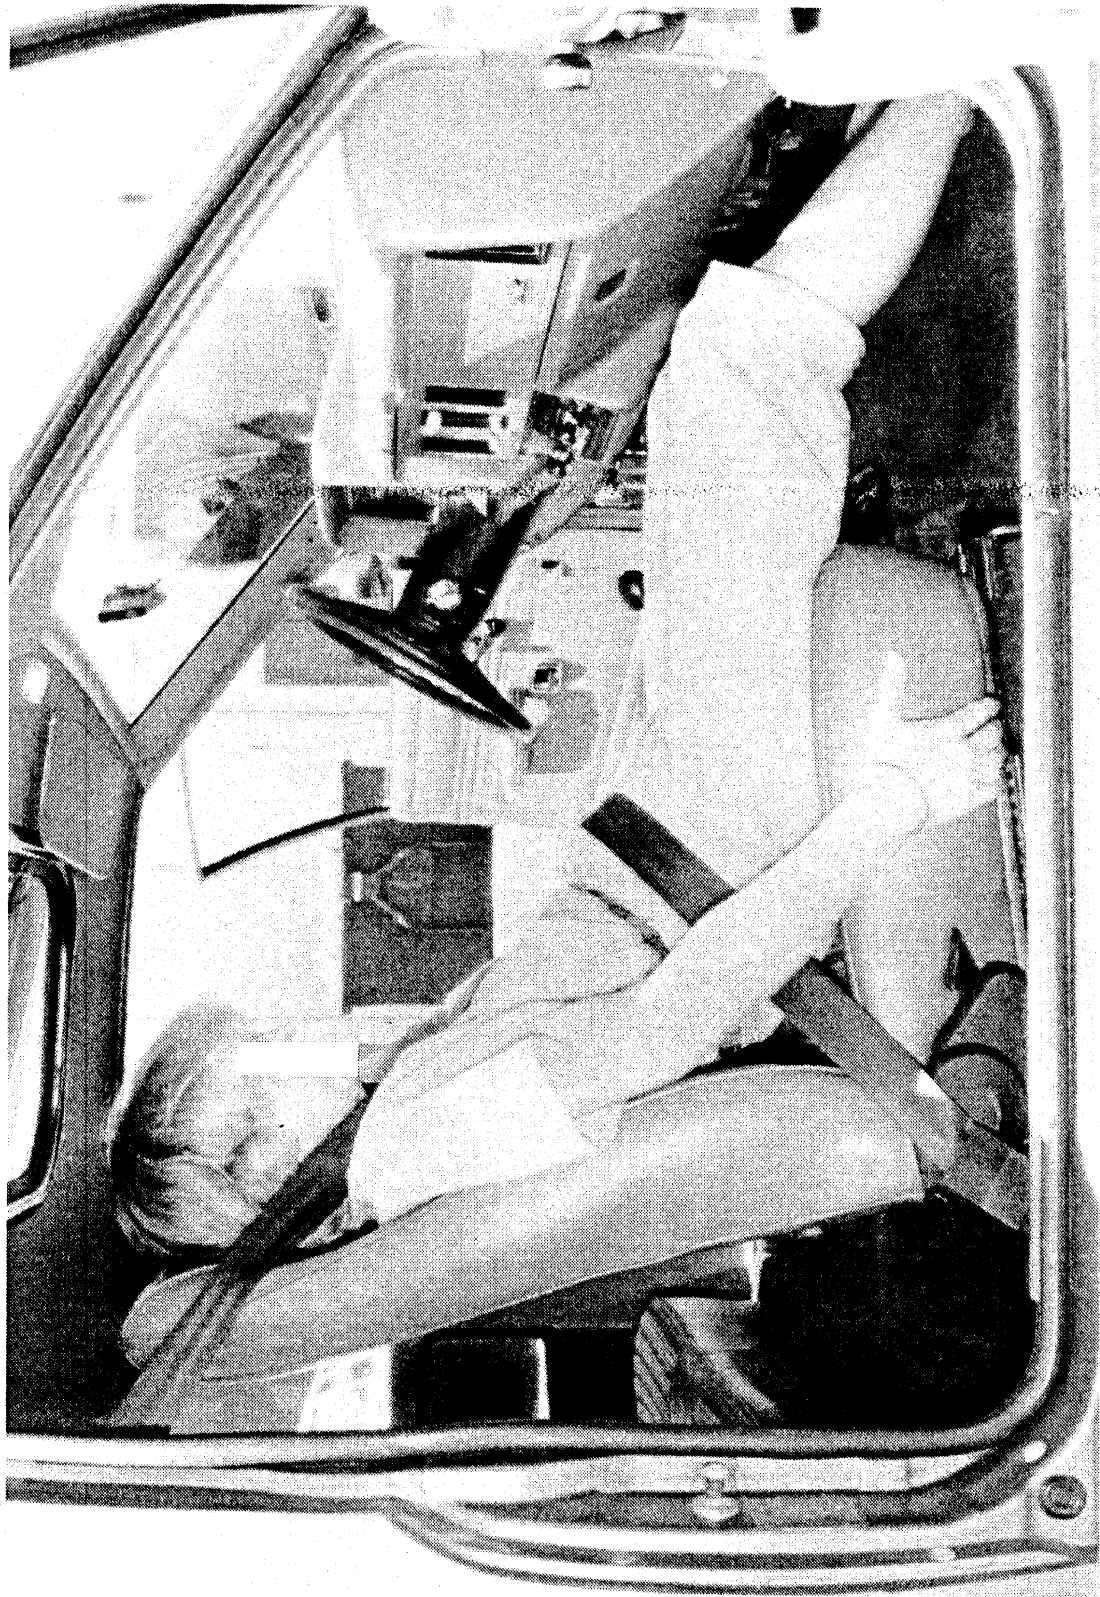
Figure 17. Passenger in Case 2-6 Shown Seated in Similar Vehicle.

In the case of the passenger, she indicated that she slid down in the seat and attempted to grab the lower edges of the seat. The photograph of this posture is included as Figure 17. A schematic of the vehicle interior cross-section was then made for a plane through the centerline of the occupant using vehicle scale drawings as well as some measurements taken directly from the vehicle due to the unusual occupant posture. The photographic slide of the occupant was then projected onto the schematic taking account, as before, of distortions based on camera placement. An outline of the occupant was then sketched onto the schematic. The occupant linkage, mass properties, and collection of contact ellipses were developed using the same procedure described in Section 4.1. Figure 18 is the resulting schematic of the occupant positioned in the vehicle. As in previous cases, engineering estimates and available data were used for the description of the deformability of vehicle interior components. A complete data set used in the simulation is included in Appendix A.
