CHILD SEAT AND RESTRAINT SYSTEMS TEST RESULTS

APPENDIX D

**THE UNIVERSITY OF MICHIGAN
HIGHWAY SAFETY RESEARCH INSTITUTE
HURON PARKWAY AND BAXTER ROAD
ANN ARBOR, MICHIGAN 48105**

Final Report

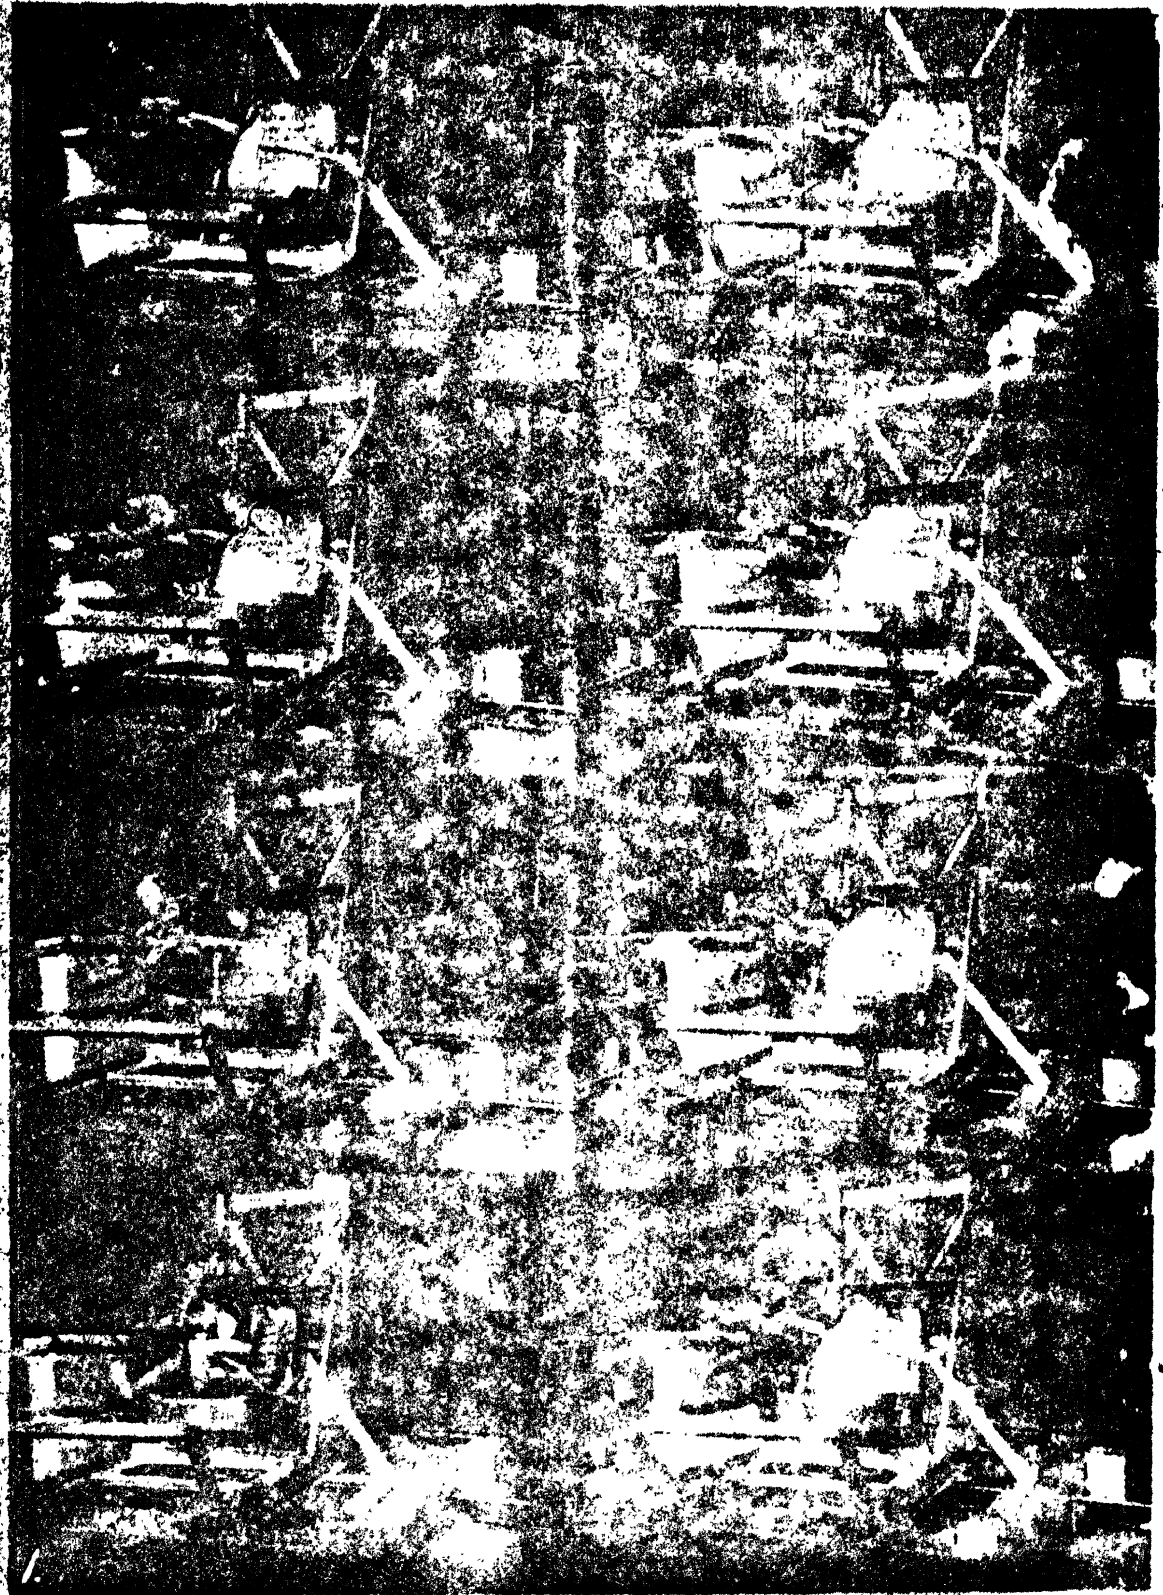
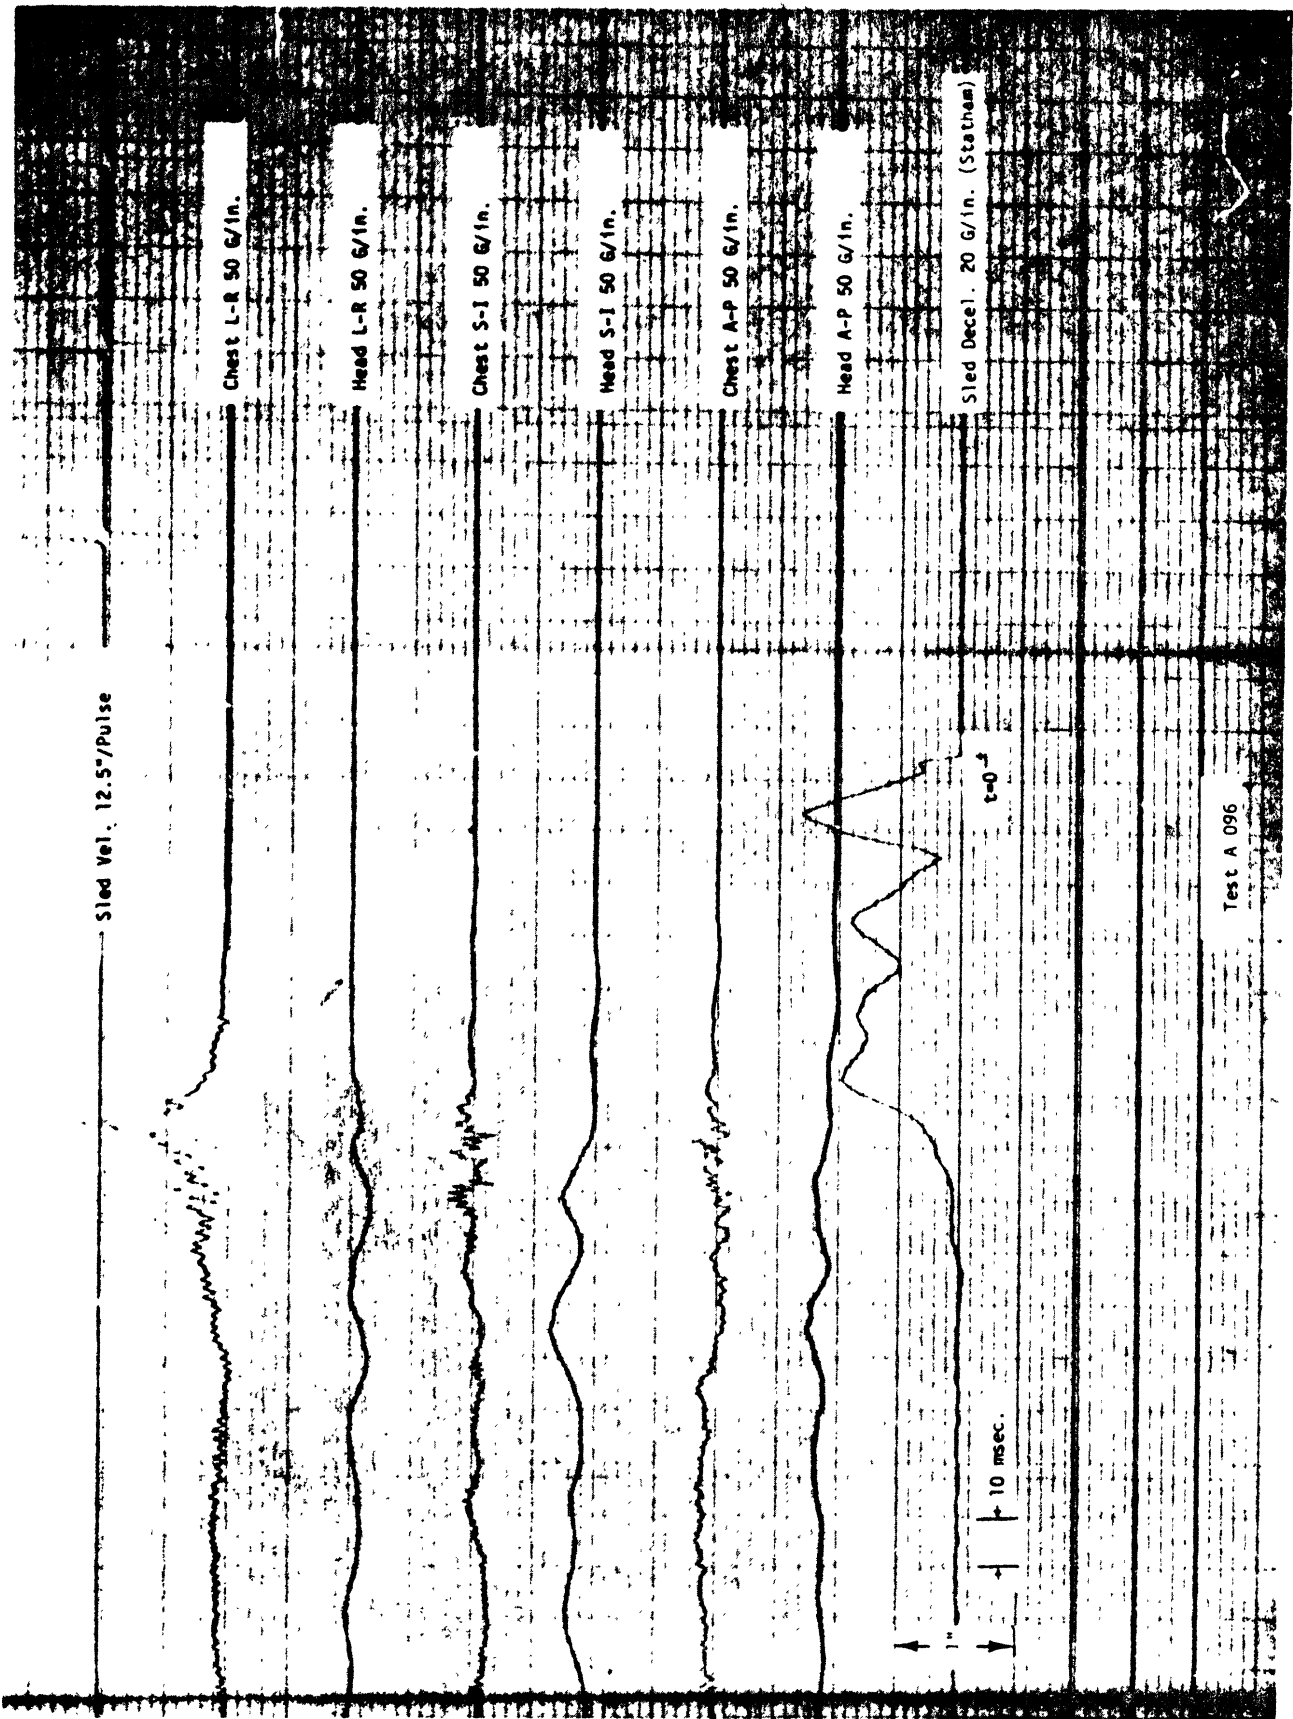
A096

Test No: A-096
Test Date: 11 July 1969
Restraint Code No.: C-7
Restraint Description: Trimble Products Seat No. 821

The dummy and child restraint seat were both ejected in this test. The dummy ended up lying over to the right of the adult seat about 20° from the horizontal. The child seat was destroyed. The right-hand bail pivoted off the adult seat back. The left-hand bail slid along the adult seat back wiping material from the plastic bail and onto the seat back. The bail tore out of the child seat back fracturing the masonite backboard.

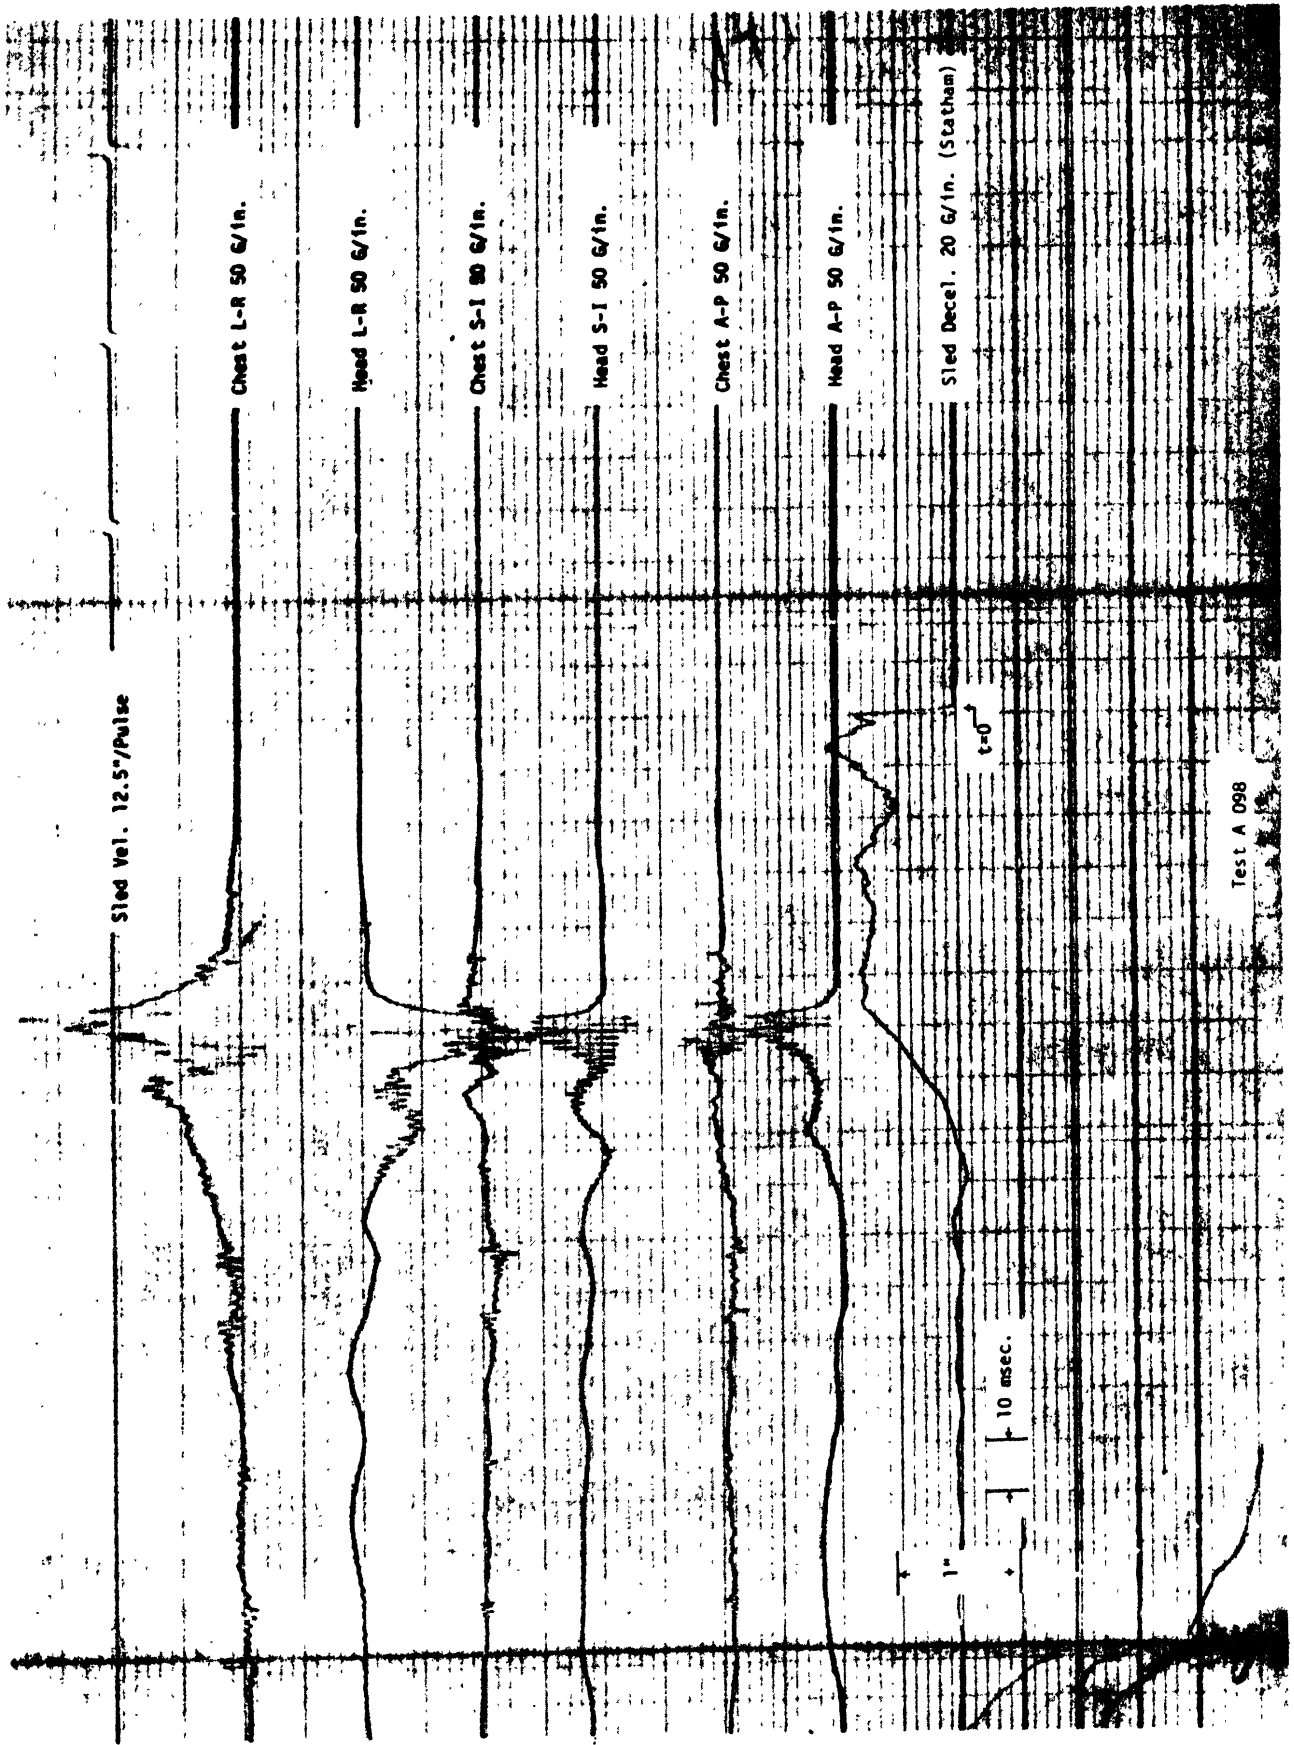
A098

Test No: A-098
Test Date: 15 July 1969
Restraint Code No.: C-23
Restraint Description: Volvo Child Safety Seat

The Volvo seat's integral lap restraint failed in the buckle allowing the belt to slip down. The dummy slid sideways against the side of the seat and was catapulted out of the seat. The backup restraint tether prevented ejection. The Volvo seat has pointed sheet metal screws attaching the integral straps to the side of its shell. The points protrude through the shell towards the inside approximately three-eighths inch. A child's head could be pierced by the points.

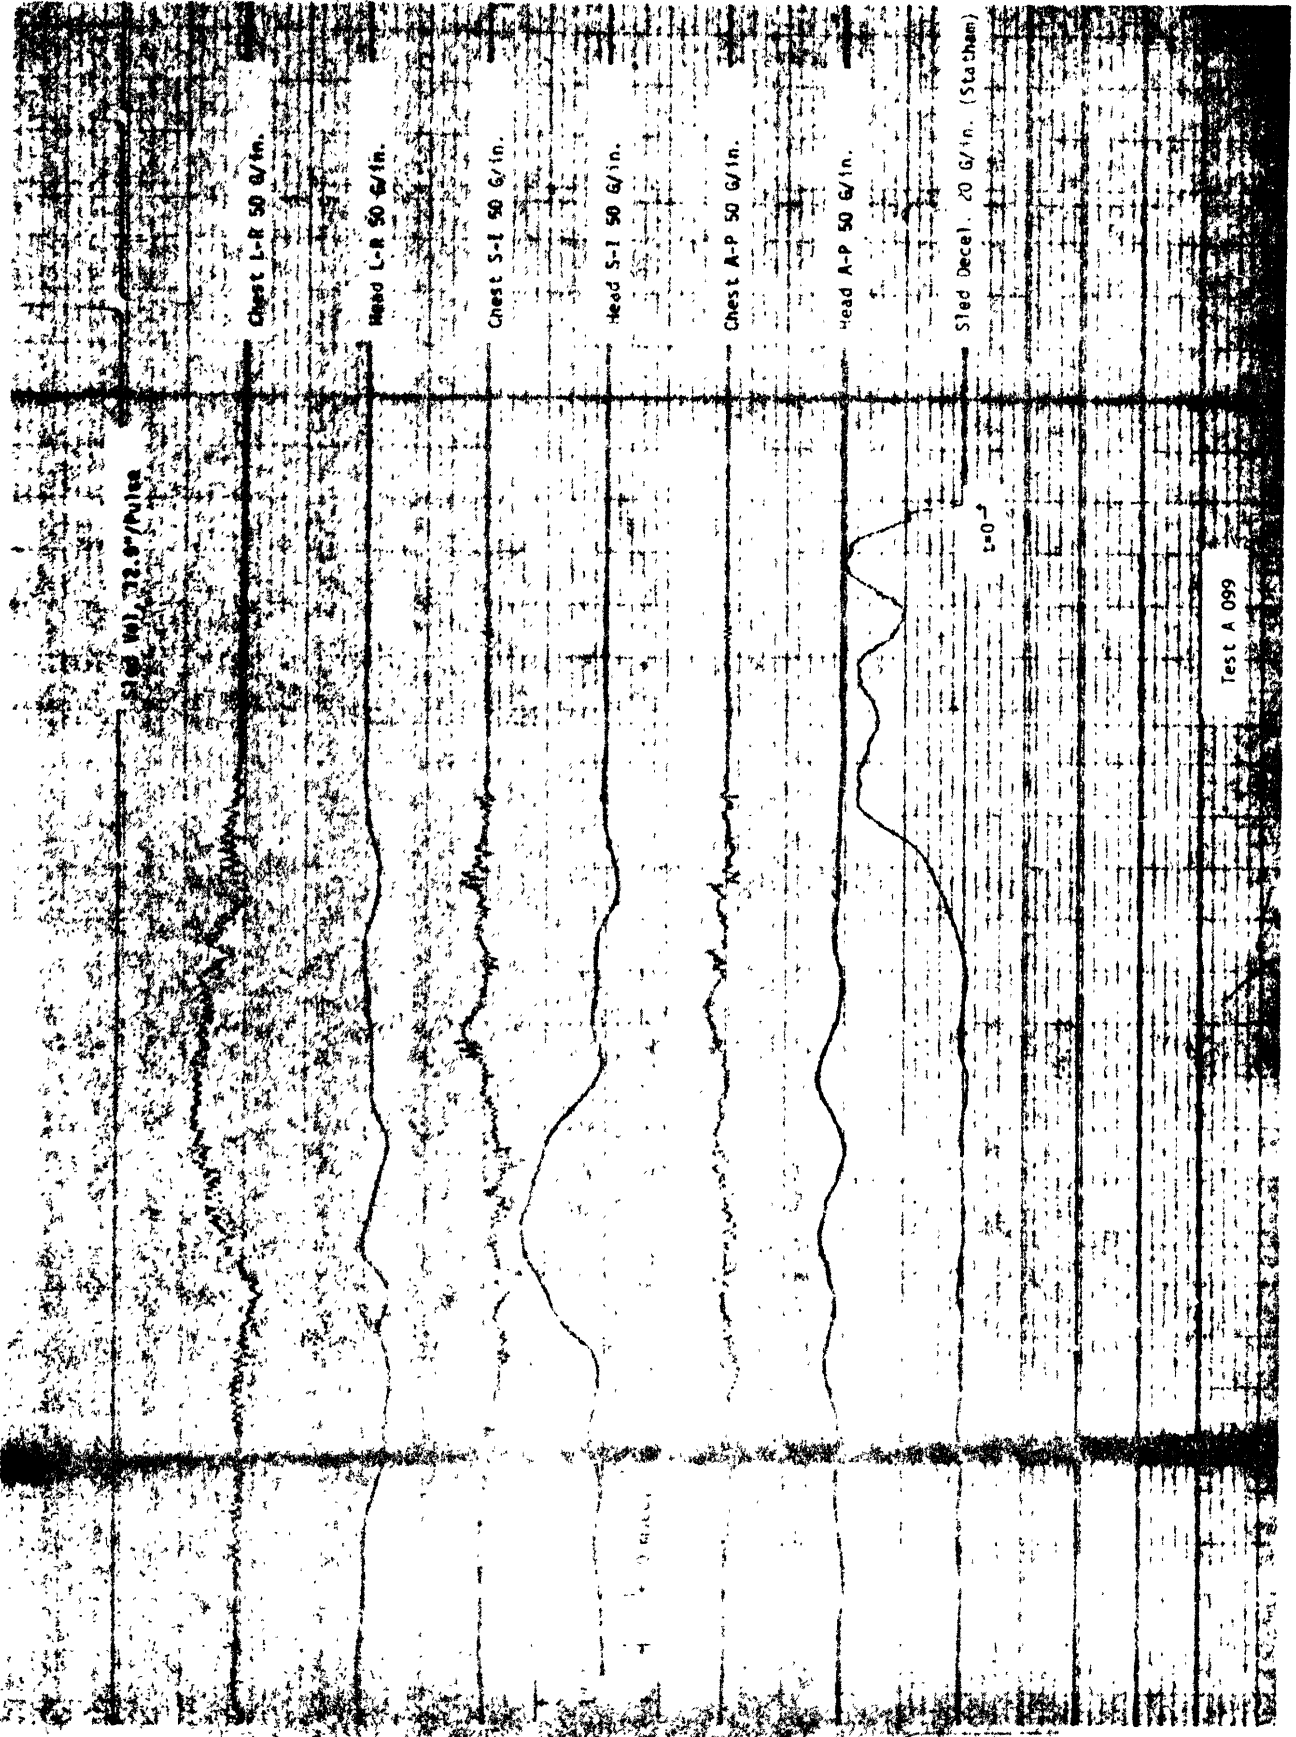
A099

Test No.: A-099
Test Date: 15 July 1969
Restraint Code No.: C-6
Restraint Description: George B. Walker's Safety Seat

The dummy loadings were quite low. However, the excursion of the dummy was large enough to insure violent contact with any adjacent side structures. The gentleness of the ride is due in part to the deformation of the plastic of the left-hand bail hook and hand guard rail.

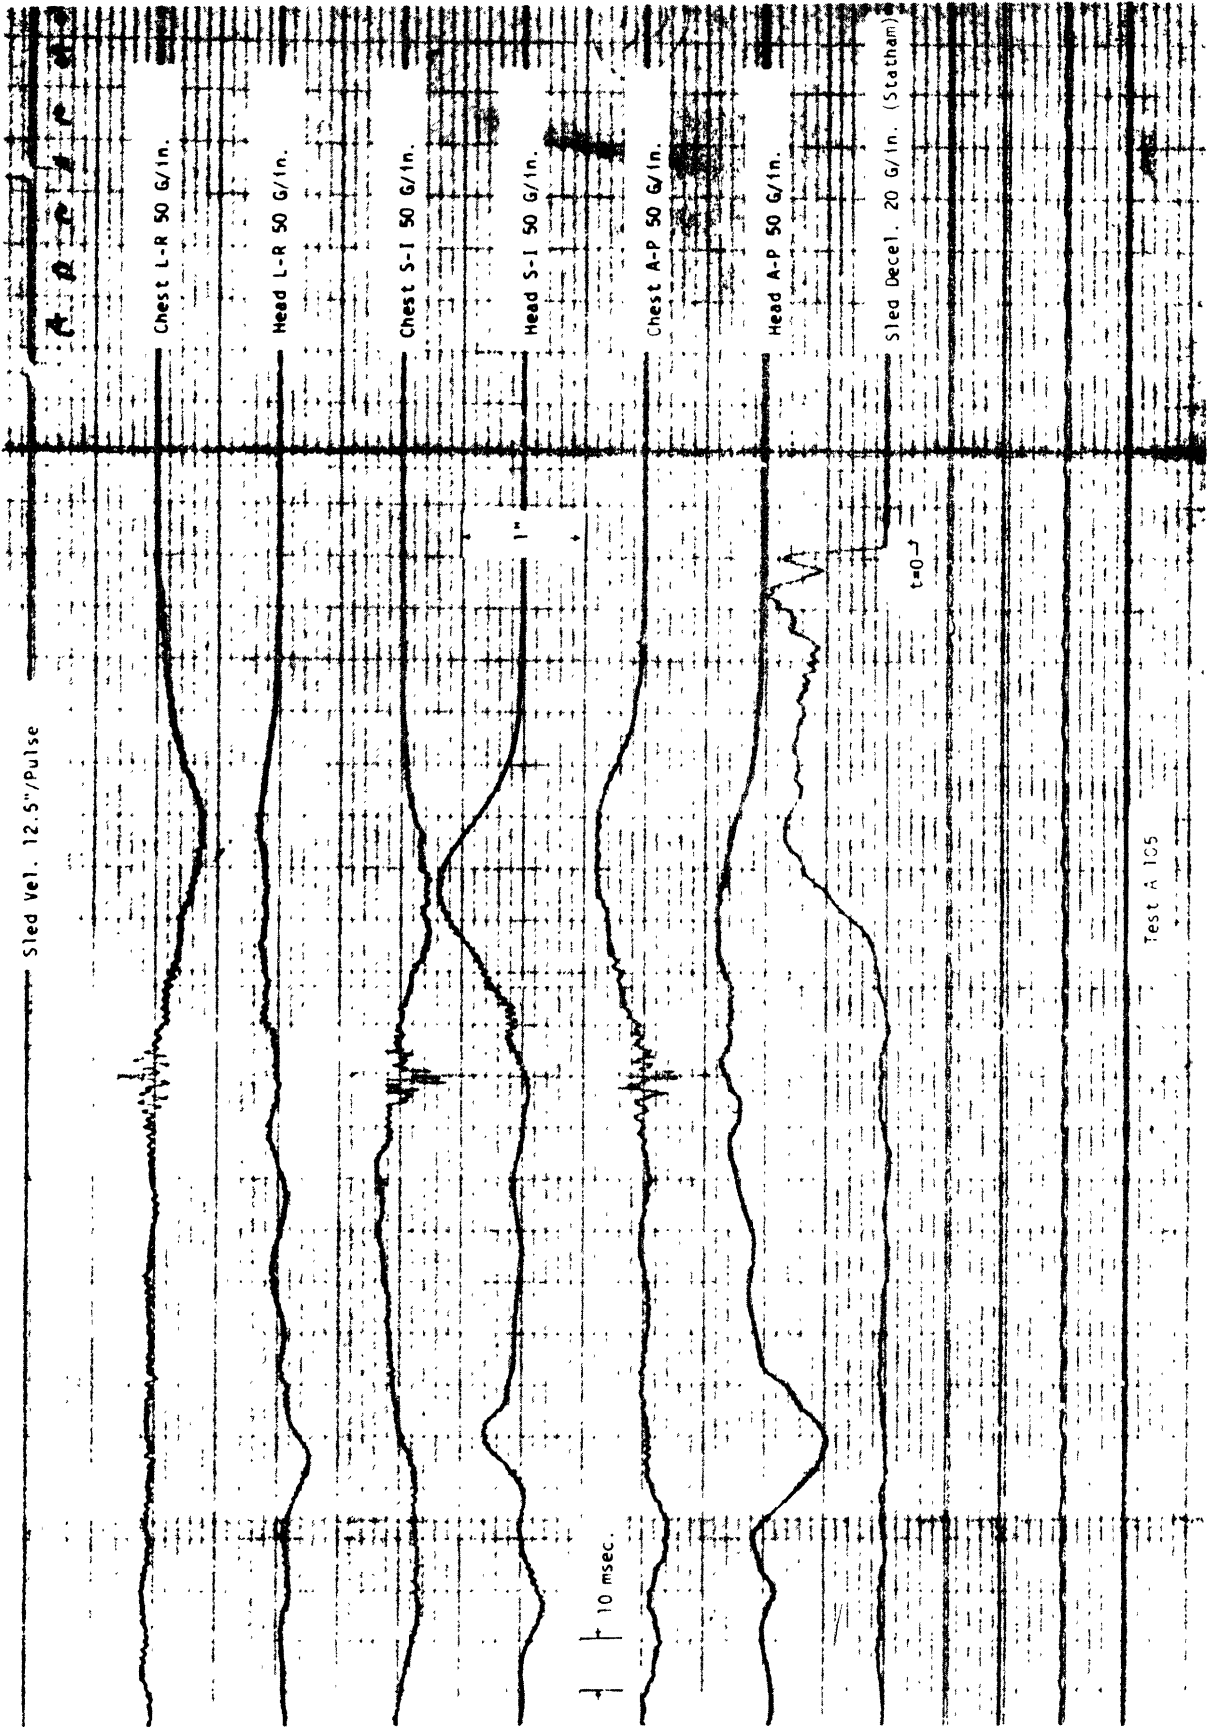
A105

Test No: A-105
Test Date: 21 July 1969
Restraint Code No.: C-31
Restraint Description: Sears Auto Harness, small

Neither the loadings or excursion of the dummy appeared to be severe.

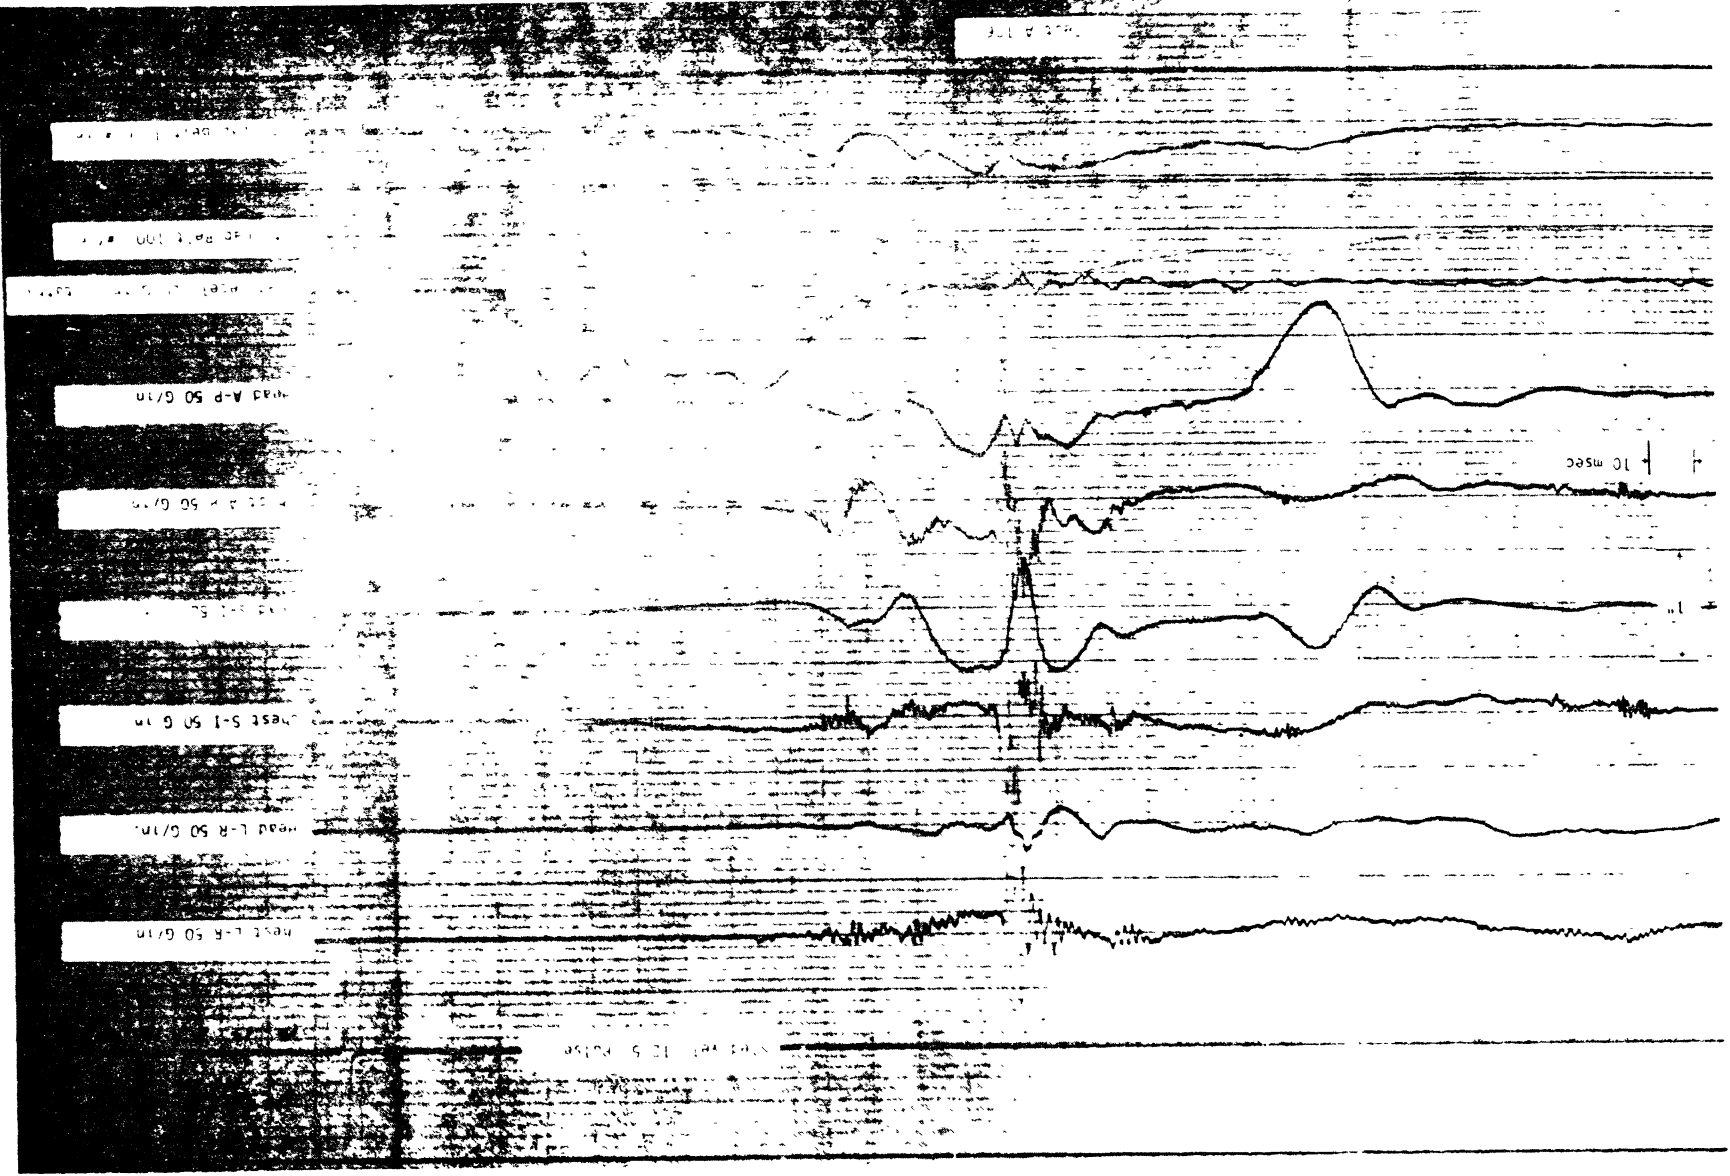
A106

Test No: A-106
Test Date: 22 July 1969
Restraint Code No.: C-34
Restraint Description: Life Auto Babe Nylon Car Harness

The stitching parted at the rear where the belly strap and shoulder joint strap are attached. This allowed the dummy to slide downward until the remaining intact portion of the harness formed a loop and hung the dummy by its chin. The dummy was essentially ejected and hung at the same time.

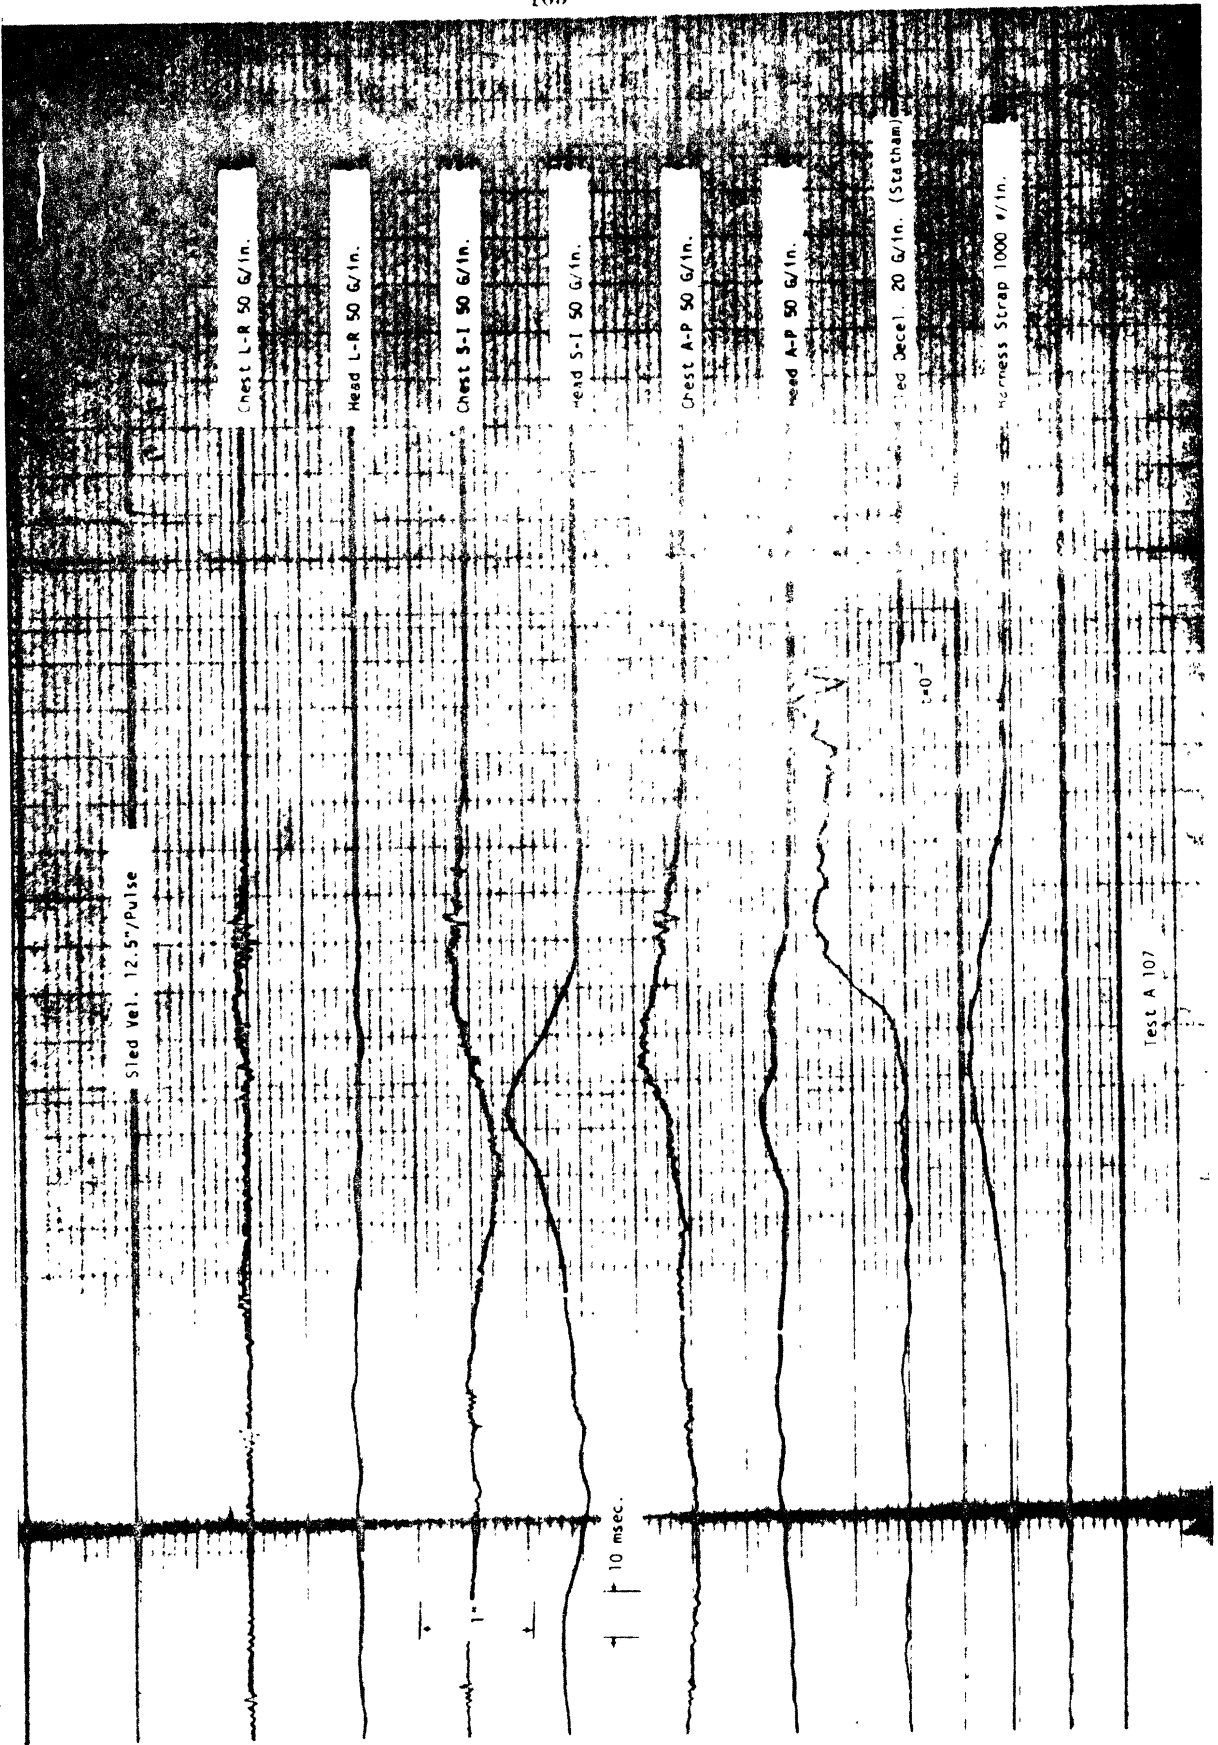
A107

Test No: A-107
Test Date: 22 July 1969
Restraint Code No.: C-36
Restraint Description: Irvin Auto Safety Harness No. CH-102

The loadings experienced by the dummy were moderate. No damage was done to either the dummy or the restraint system. The restraint system seemed to slide down into the abdominal area of the dummy causing apparent high loading in that region of the body.

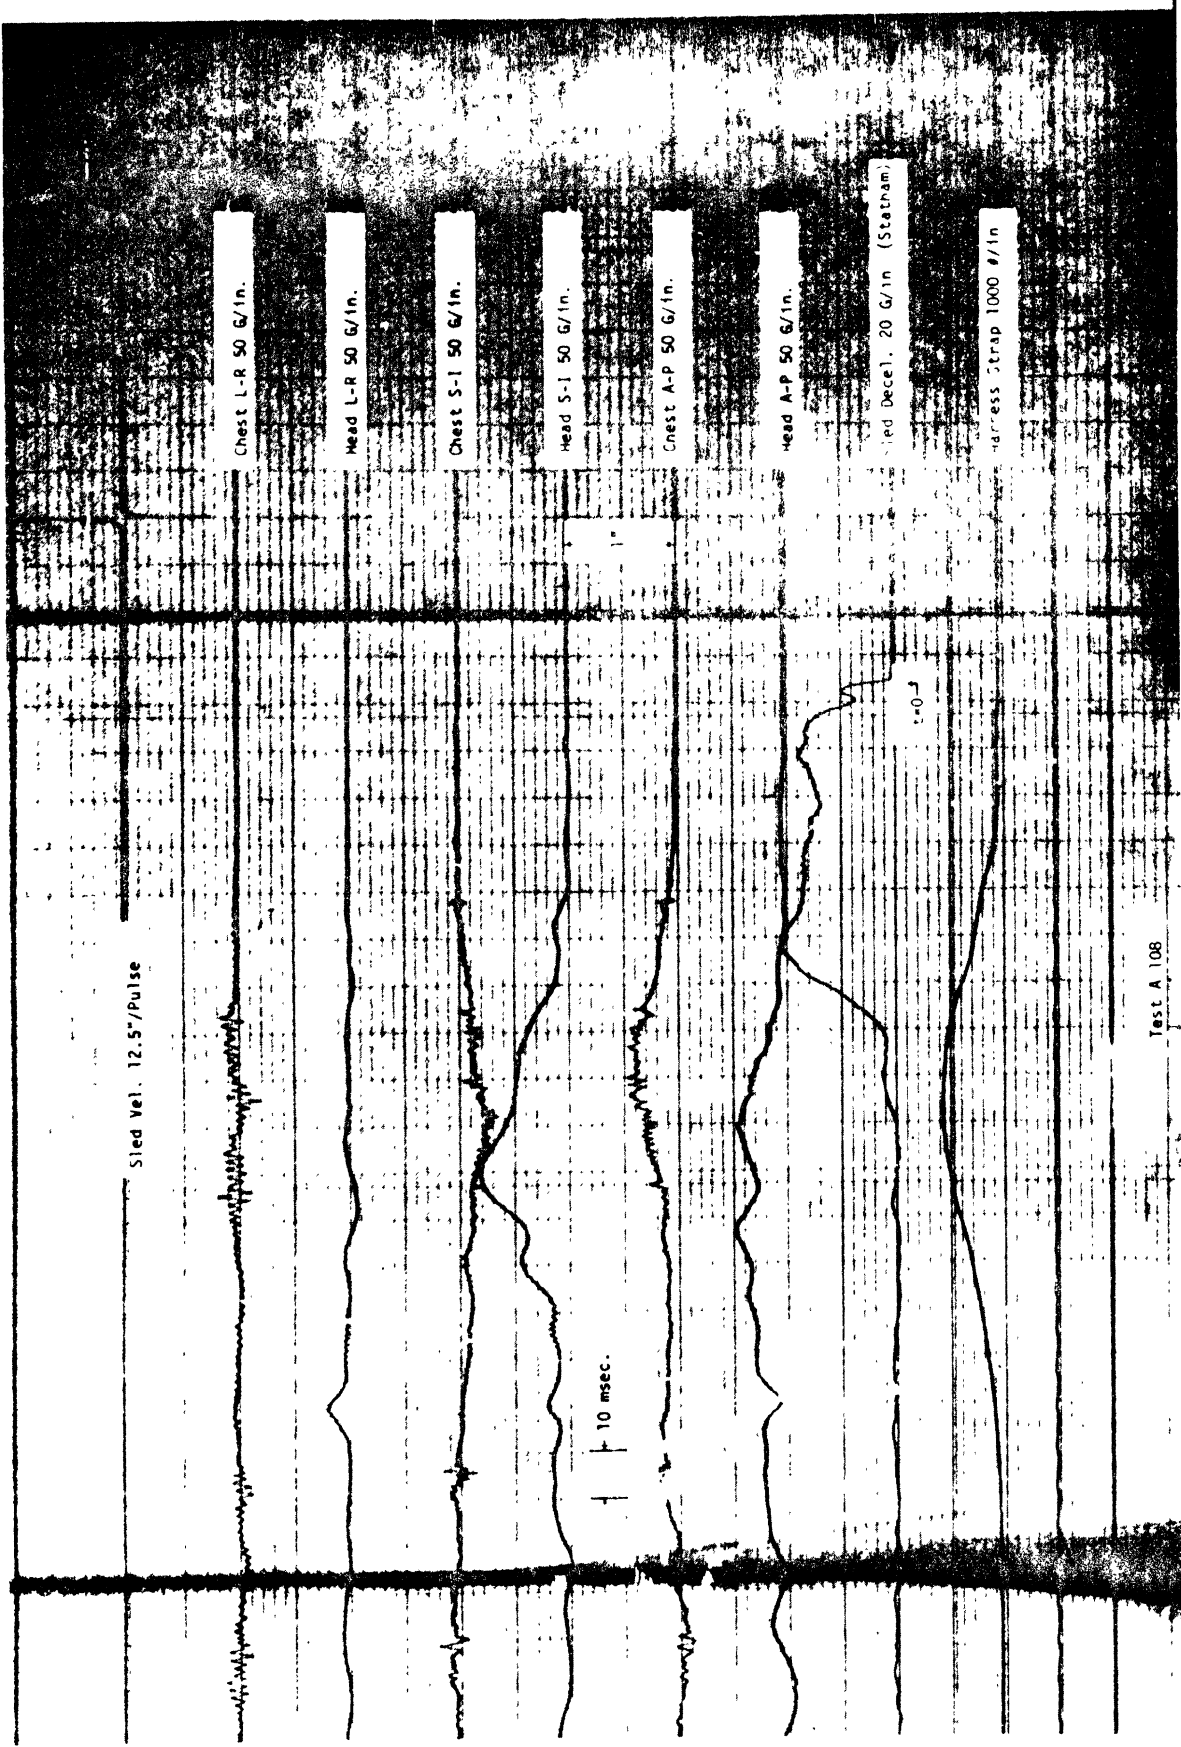
A108

Test No: A-108
Test Date: 22 July 1969
Restraint Code No.: C-36
Restraint Description: Irvin Auto Safety Harness No. CH-102

The system kept the dummy from impacting the instrument panel on the body buck, but the dummy was sharply doubled over about the waist due to the belly strap. He received a peak g loading of approximately 40 g's in the head superior-interior accelerometer. The crotch strap pulled tightly into the crevice between the thigh and the lower torso.

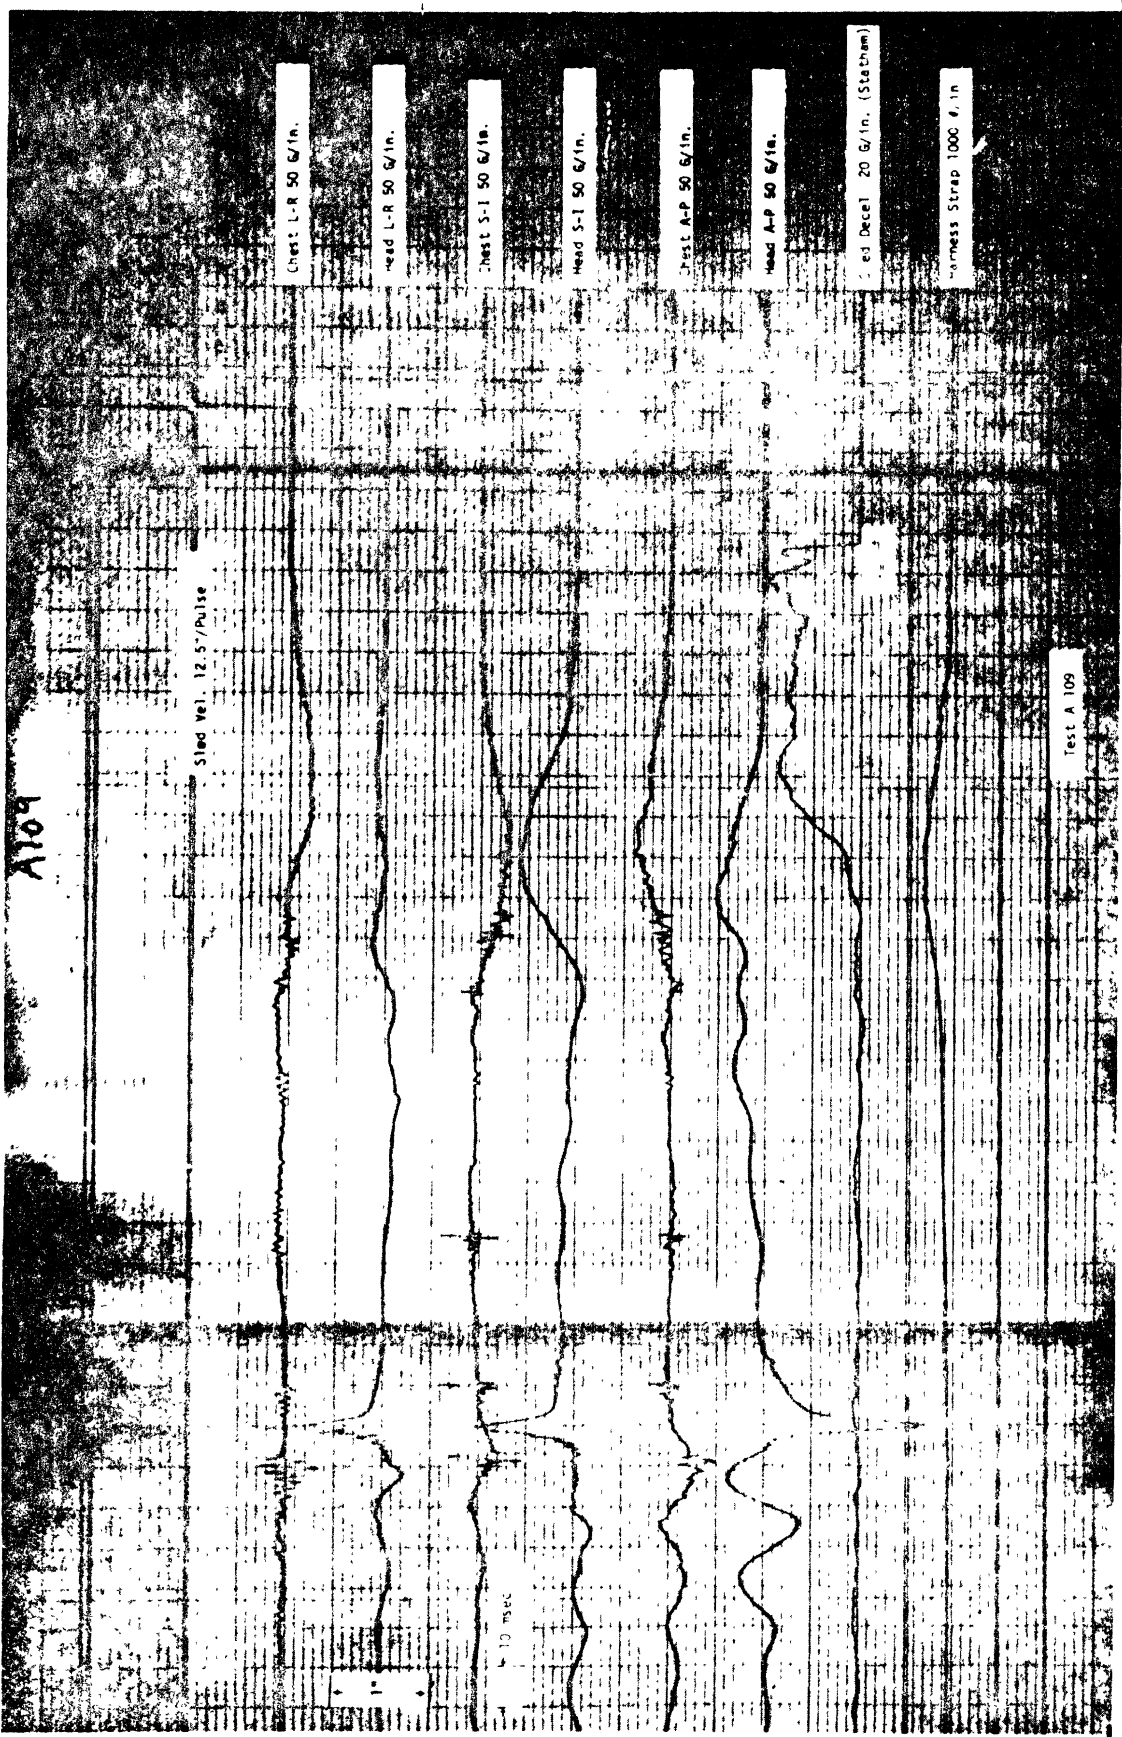
A109

Test No: A-109
Test Date: 22 July 1969
Restraint Code No: C-36
Restraint Description: Irvin Auto Safety Harness No. C-102

The loads and the excursion experienced by the dummy were moderate as it moved forward into the deceleration. However, on the rebound the dummy interacted rather violently with the adult seat structure.

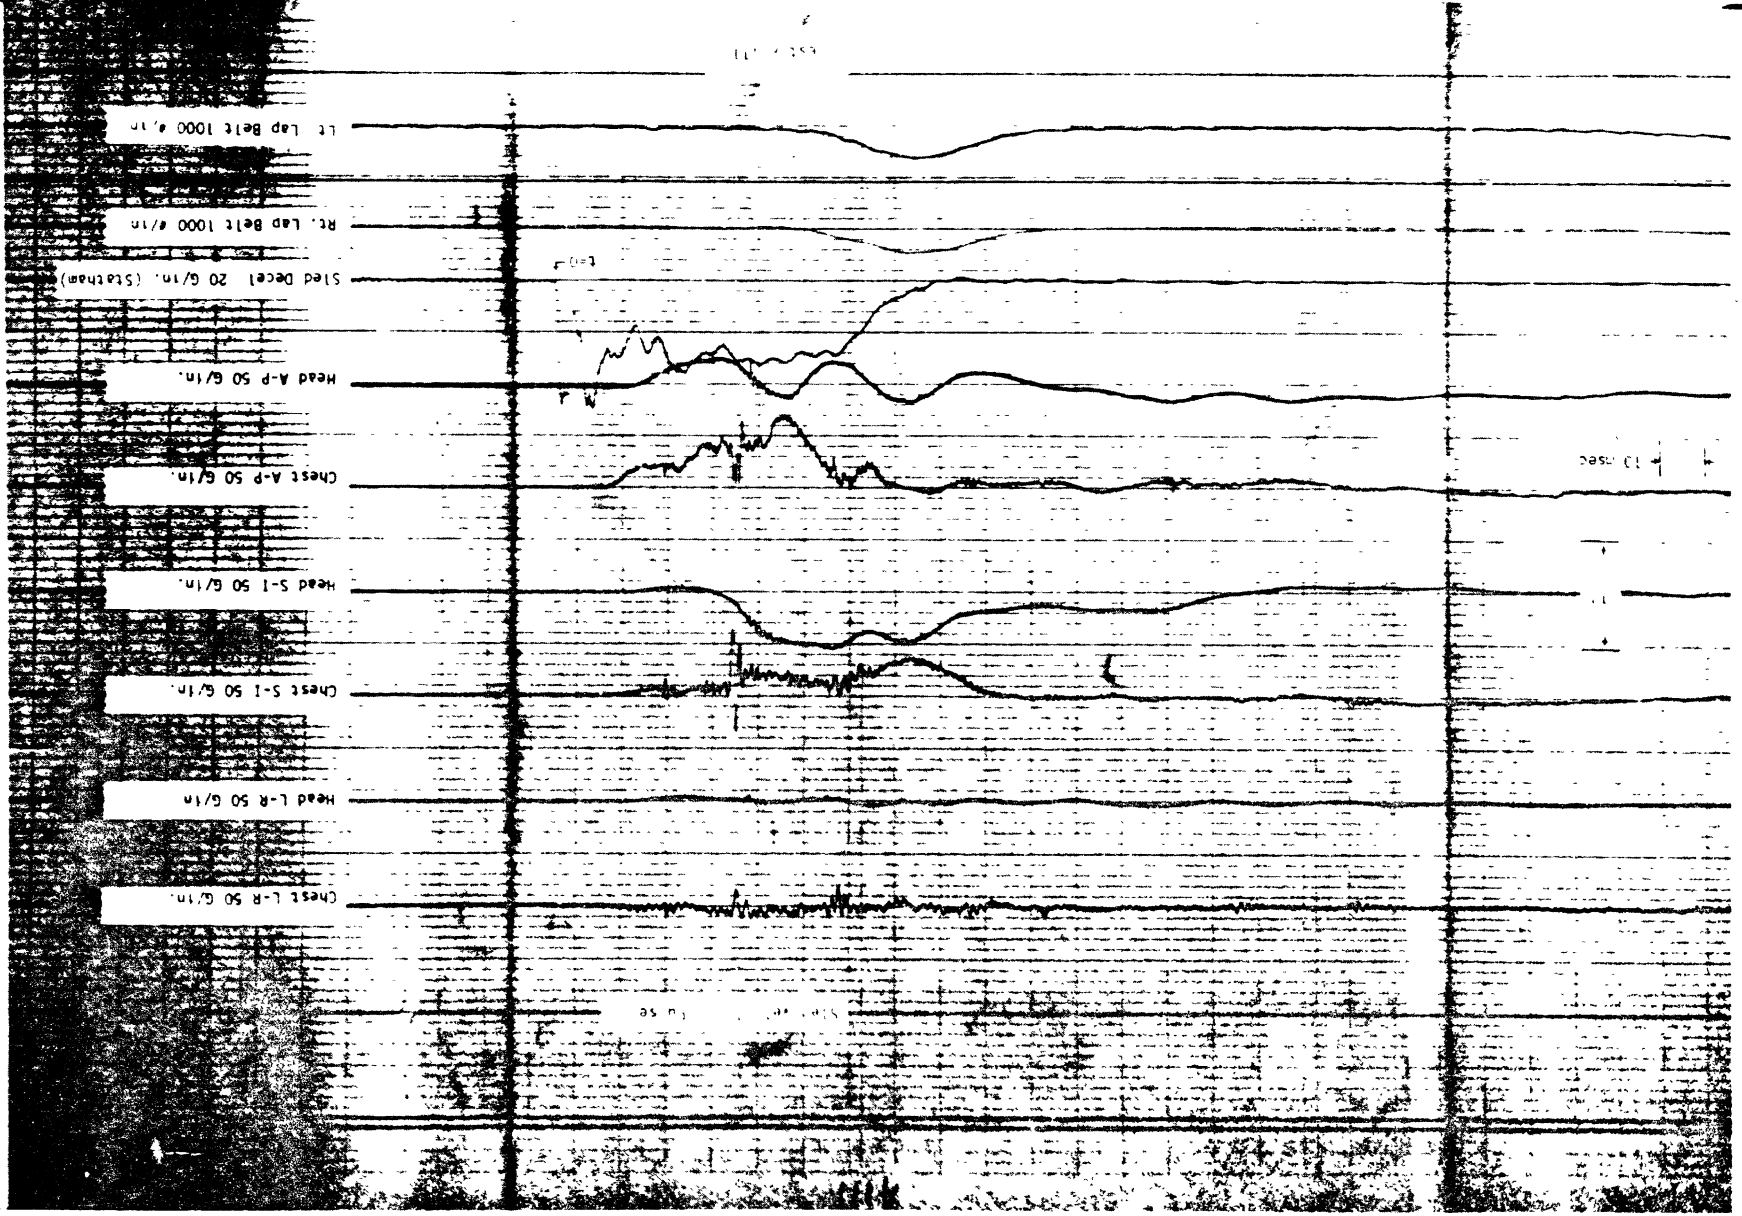
A111

Test No: A-111
Test Date: 28 July 1969
Restraint Code No.: C-3
Restraint Description: General Motors Standard Seat

The loadings experienced by the dummy were quite moderate. However, because of the high seated position of the dummy and the lack of a head-rest on the adult seat, there were substantial whiplash effects due to the relative motion between the dummy head and the chest as the top of the adult seat acted as a pivot point.
