CHILD SEAT AND RESTRAINT SYSTEMS TEST RESULTS

APPENDIX D

**THE UNIVERSITY OF MICHIGAN
HIGHWAY SAFETY RESEARCH INSTITUTE
HURON PARKWAY AND BAXTER ROAD
ANN ARBOR, MICHIGAN 48105**

Final Report

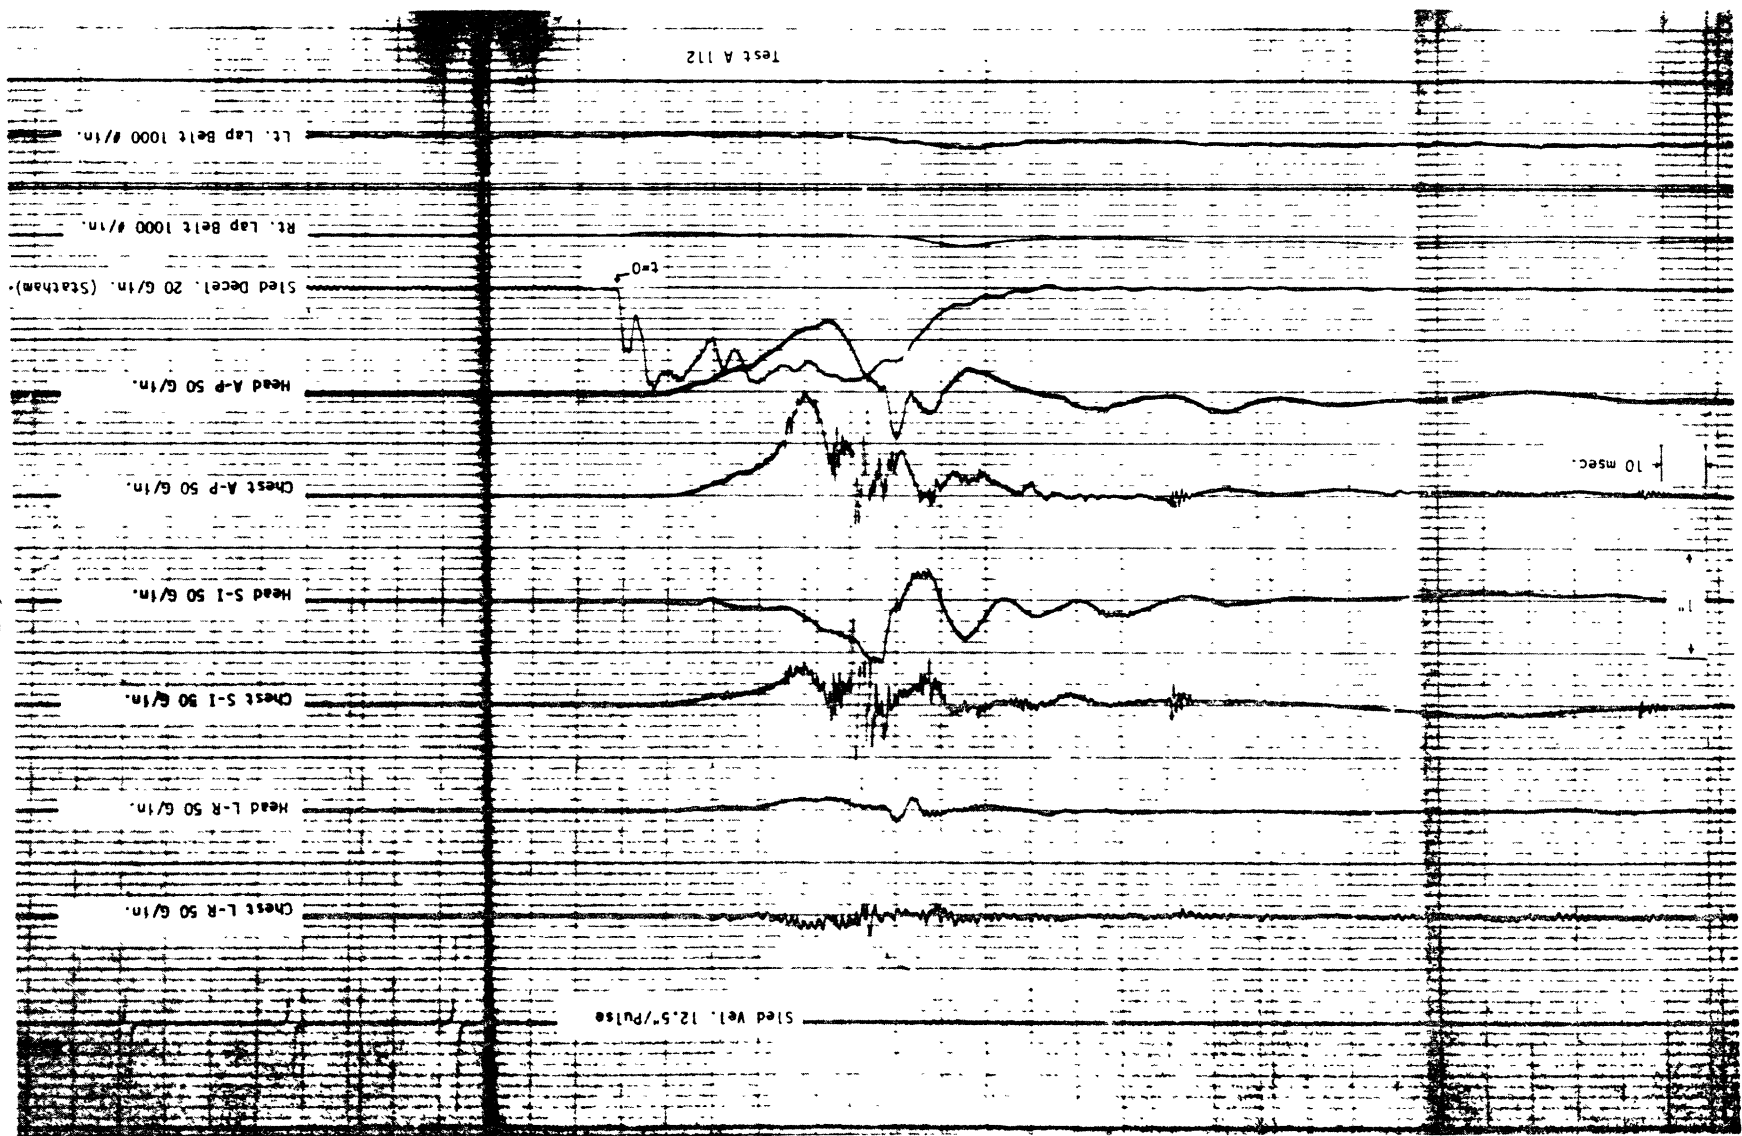
Test A 112

Test No: A-112
Test Date: 28 July 1969
Restraint Code No.: C-1
Restraint Description: Ford Tot-Guard

Neither the g loadings or the excursion of the dummy were severe. However, the upper section of the tot-guard pivoted upward pinning the dummy's head against the back of the adult seat. The dummy's chin on rebound rubbed skin material off onto the cushion of the tot-guard.

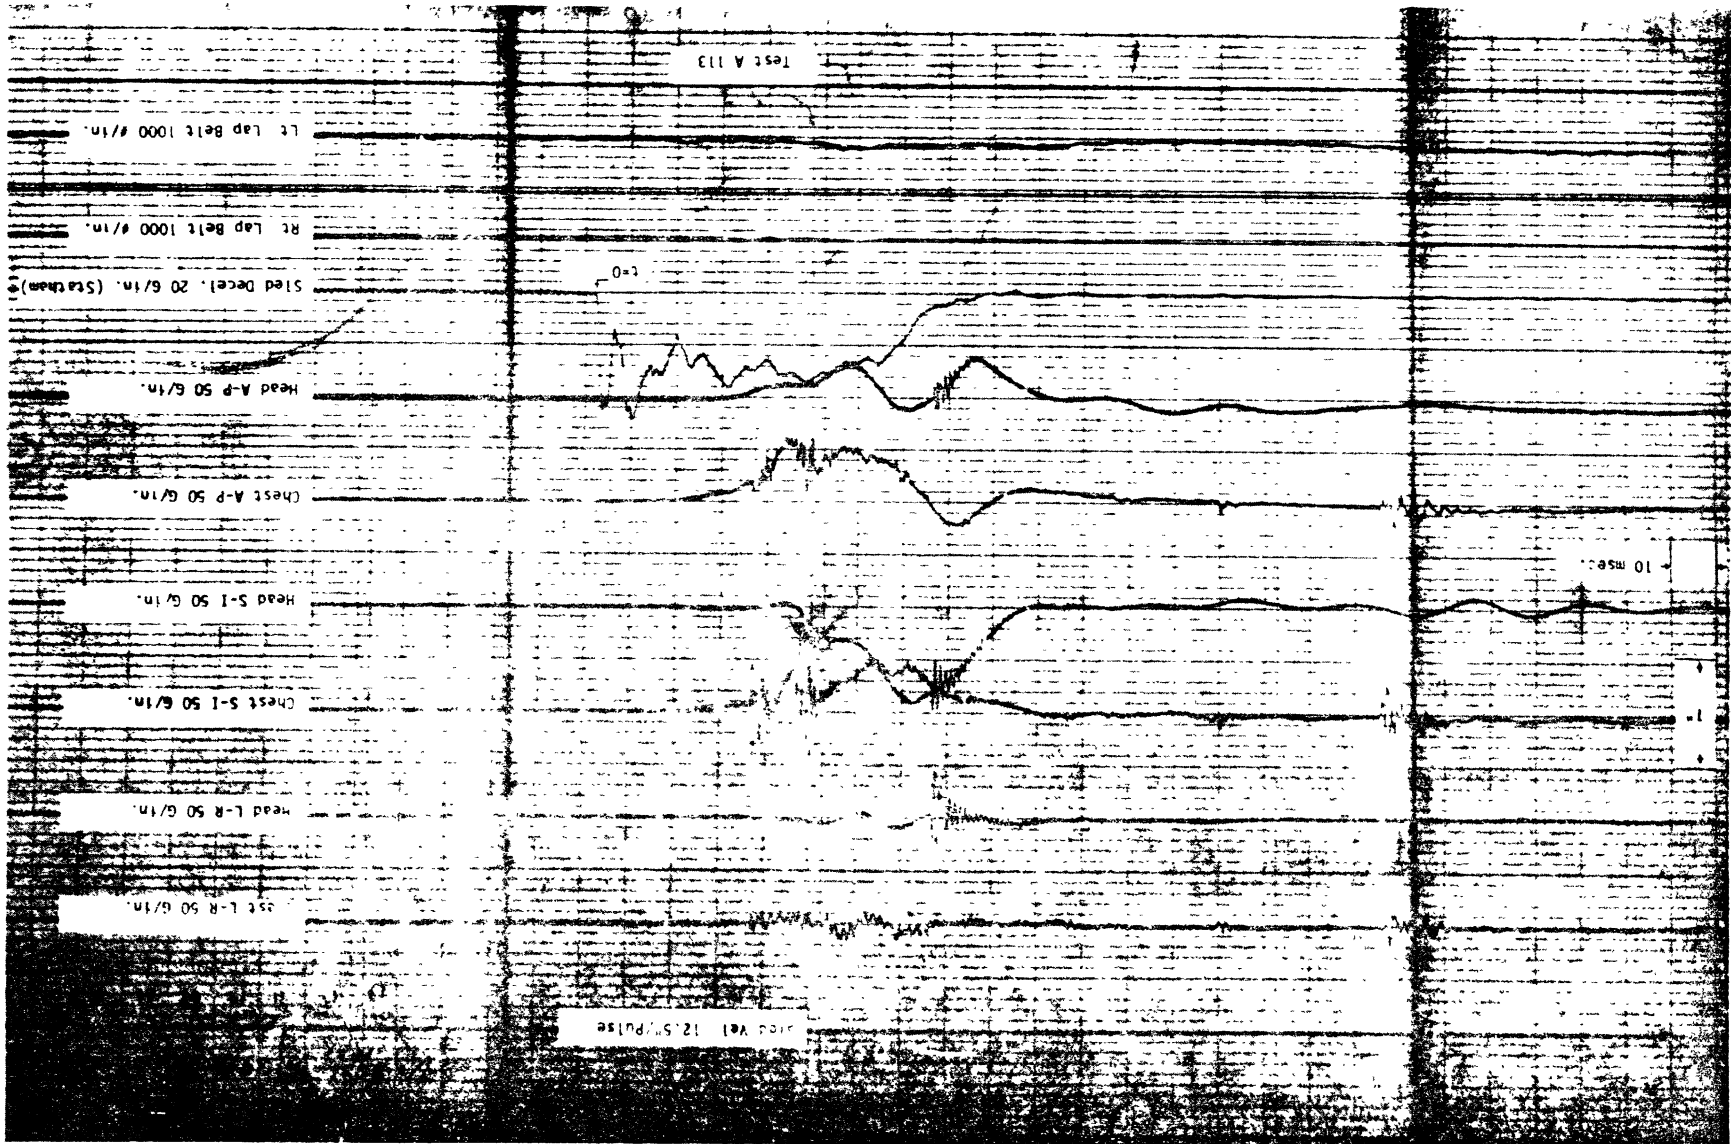
Test A 113

Test No: A-113
Test Date: 28 July 1969
Restraint Code No.: C-19
Restraint Description: Strolee Seat No. 589

No extreme loadings were experienced by the dummy. However, some whiplash was evident as the dummy head interacted with the headrest structure of the Strolee seat bending it backwards.

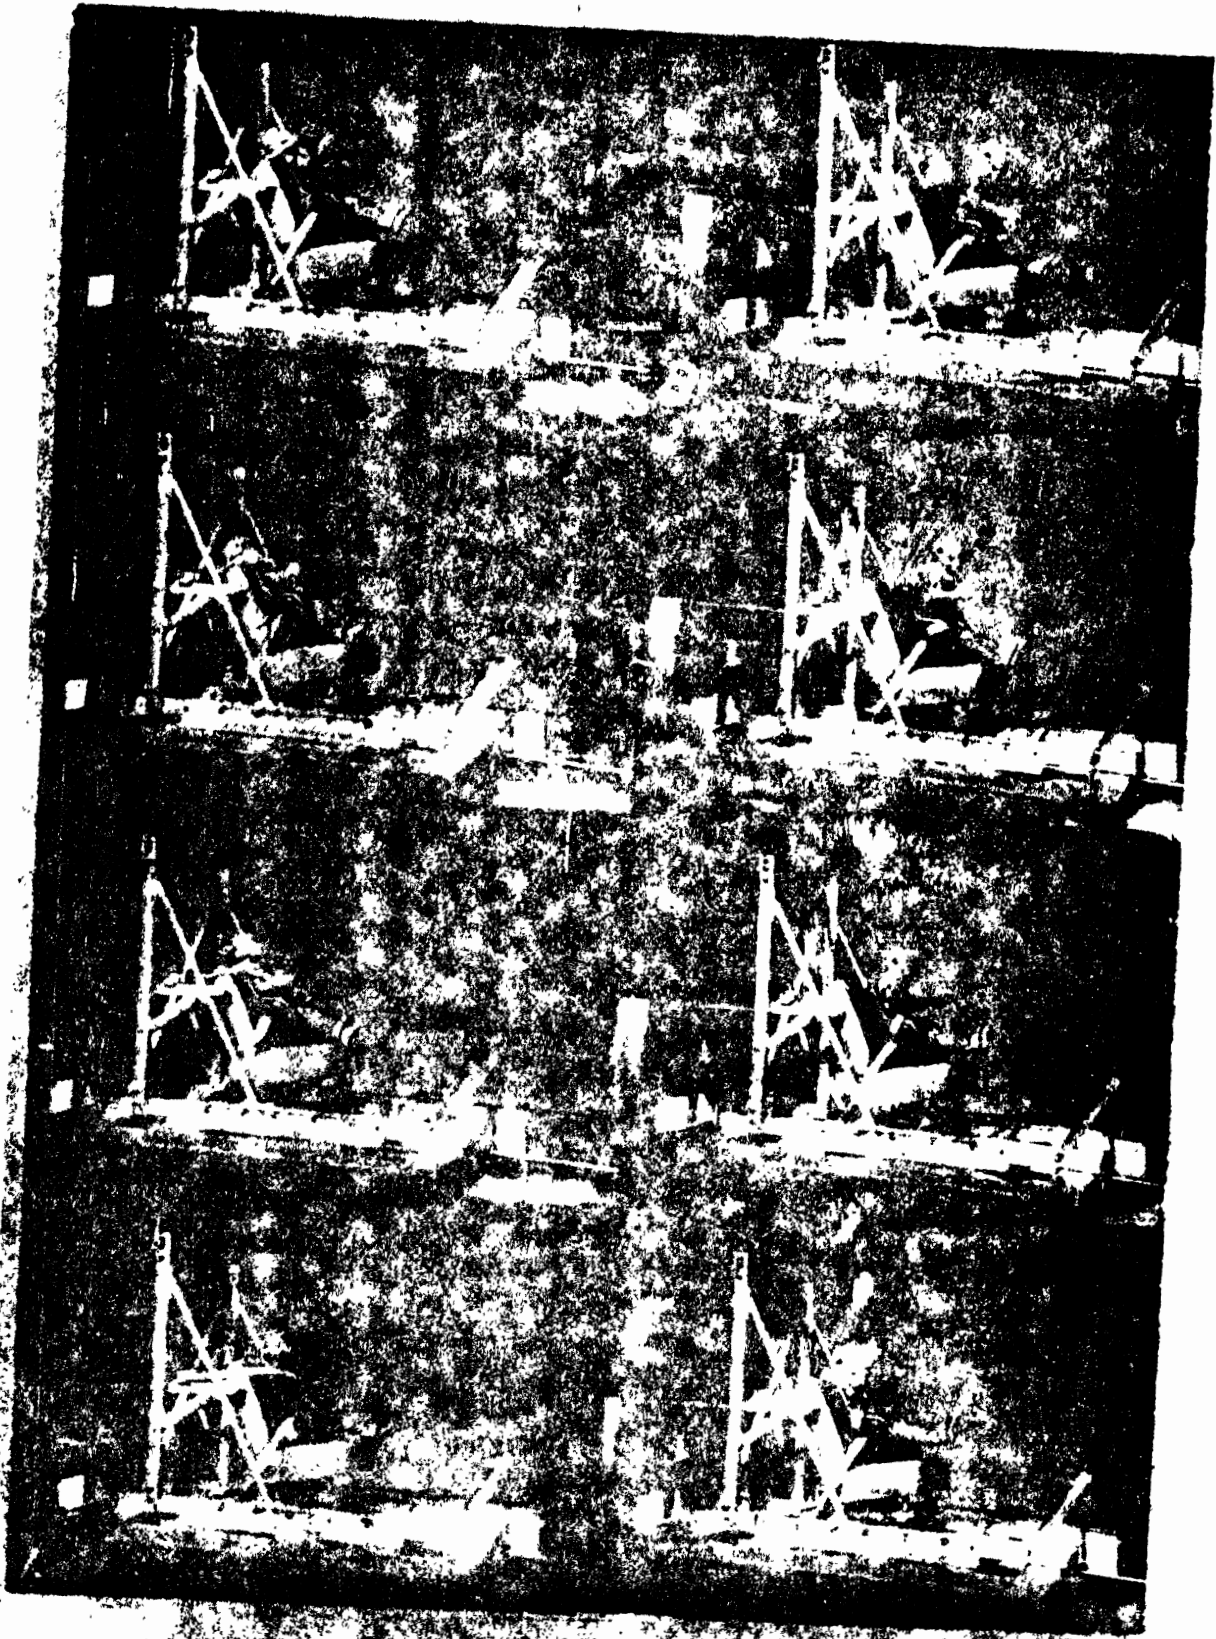
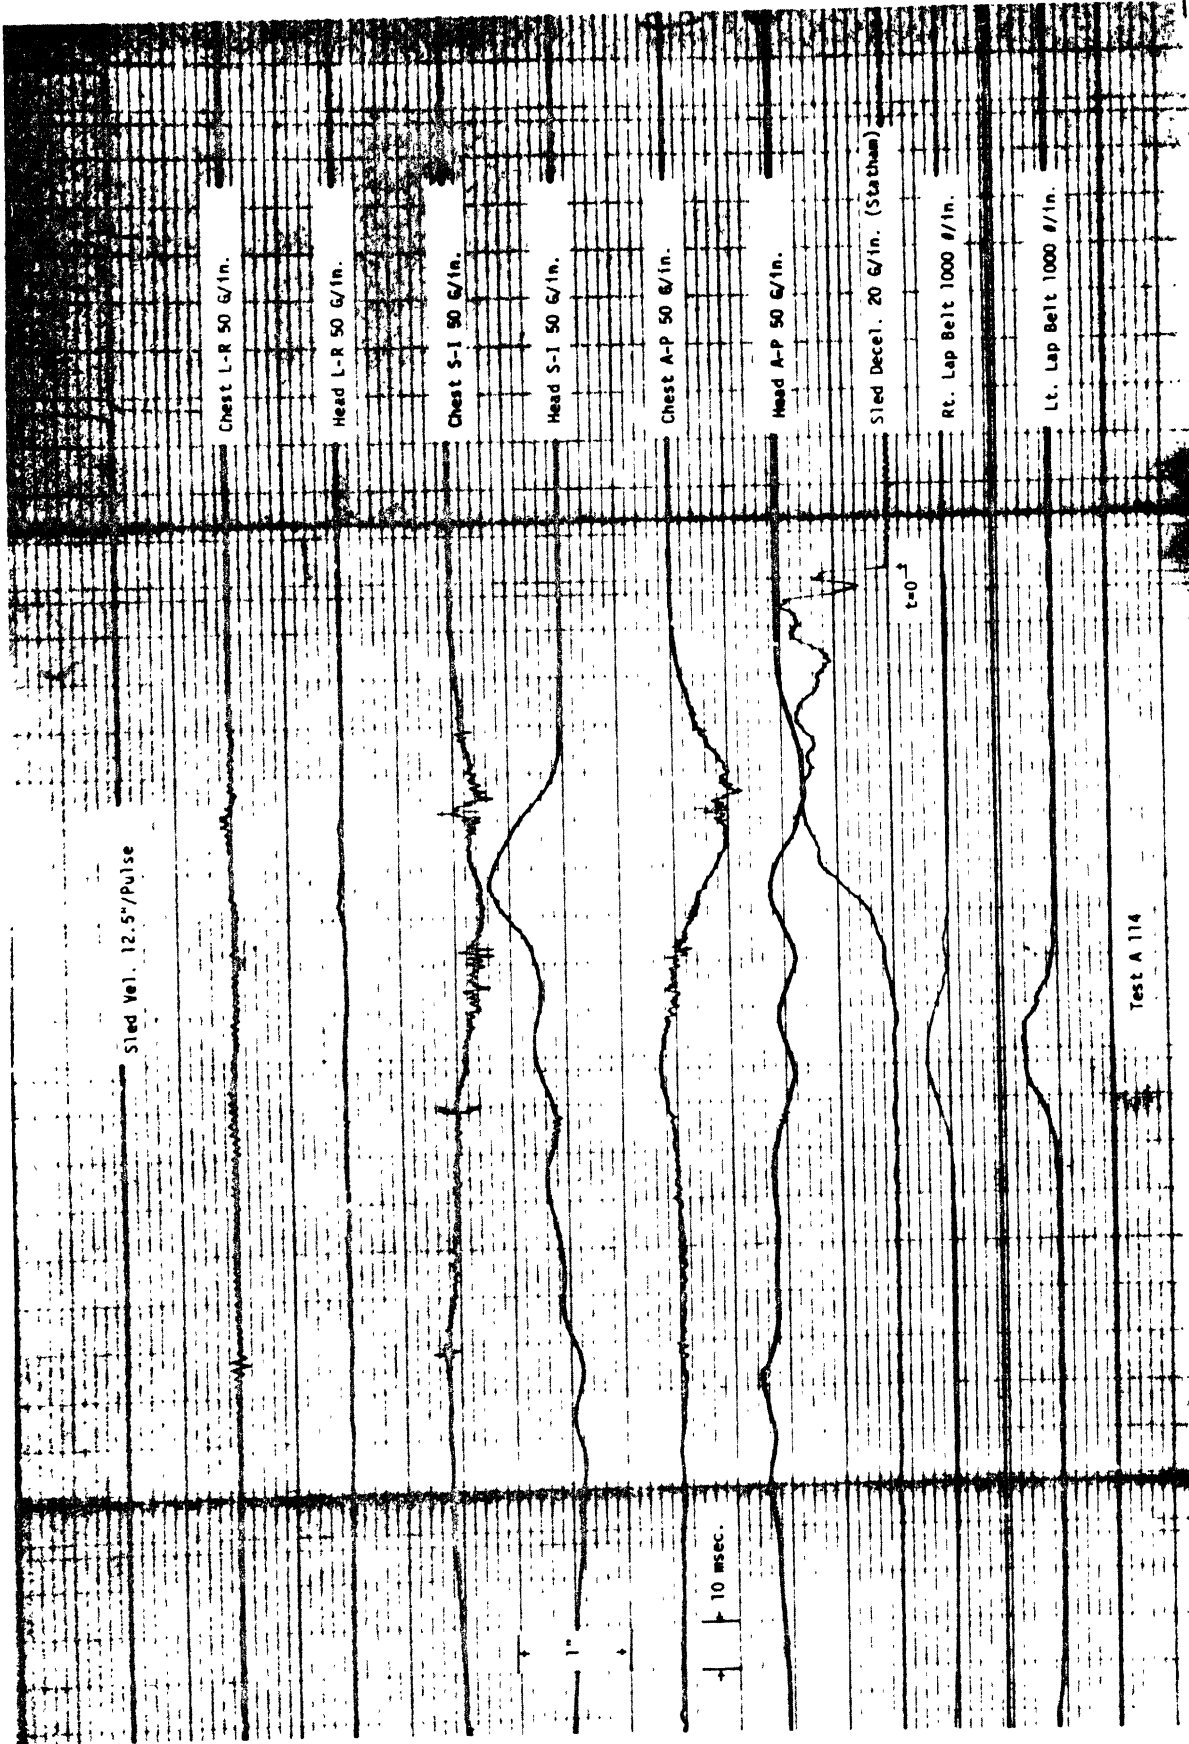
A114

Test No: A-114
Test Date: 29 July 1969
Restraint Code No.: C-5
Restraint Description: Sears Seat No. 5515

No severe loadings were experienced by the dummy. However, the dummy was seated high enough on this pedestal-type seat that whiplash was experienced as the head rotated backwards over the top of the adult seat which did not have a headrest.

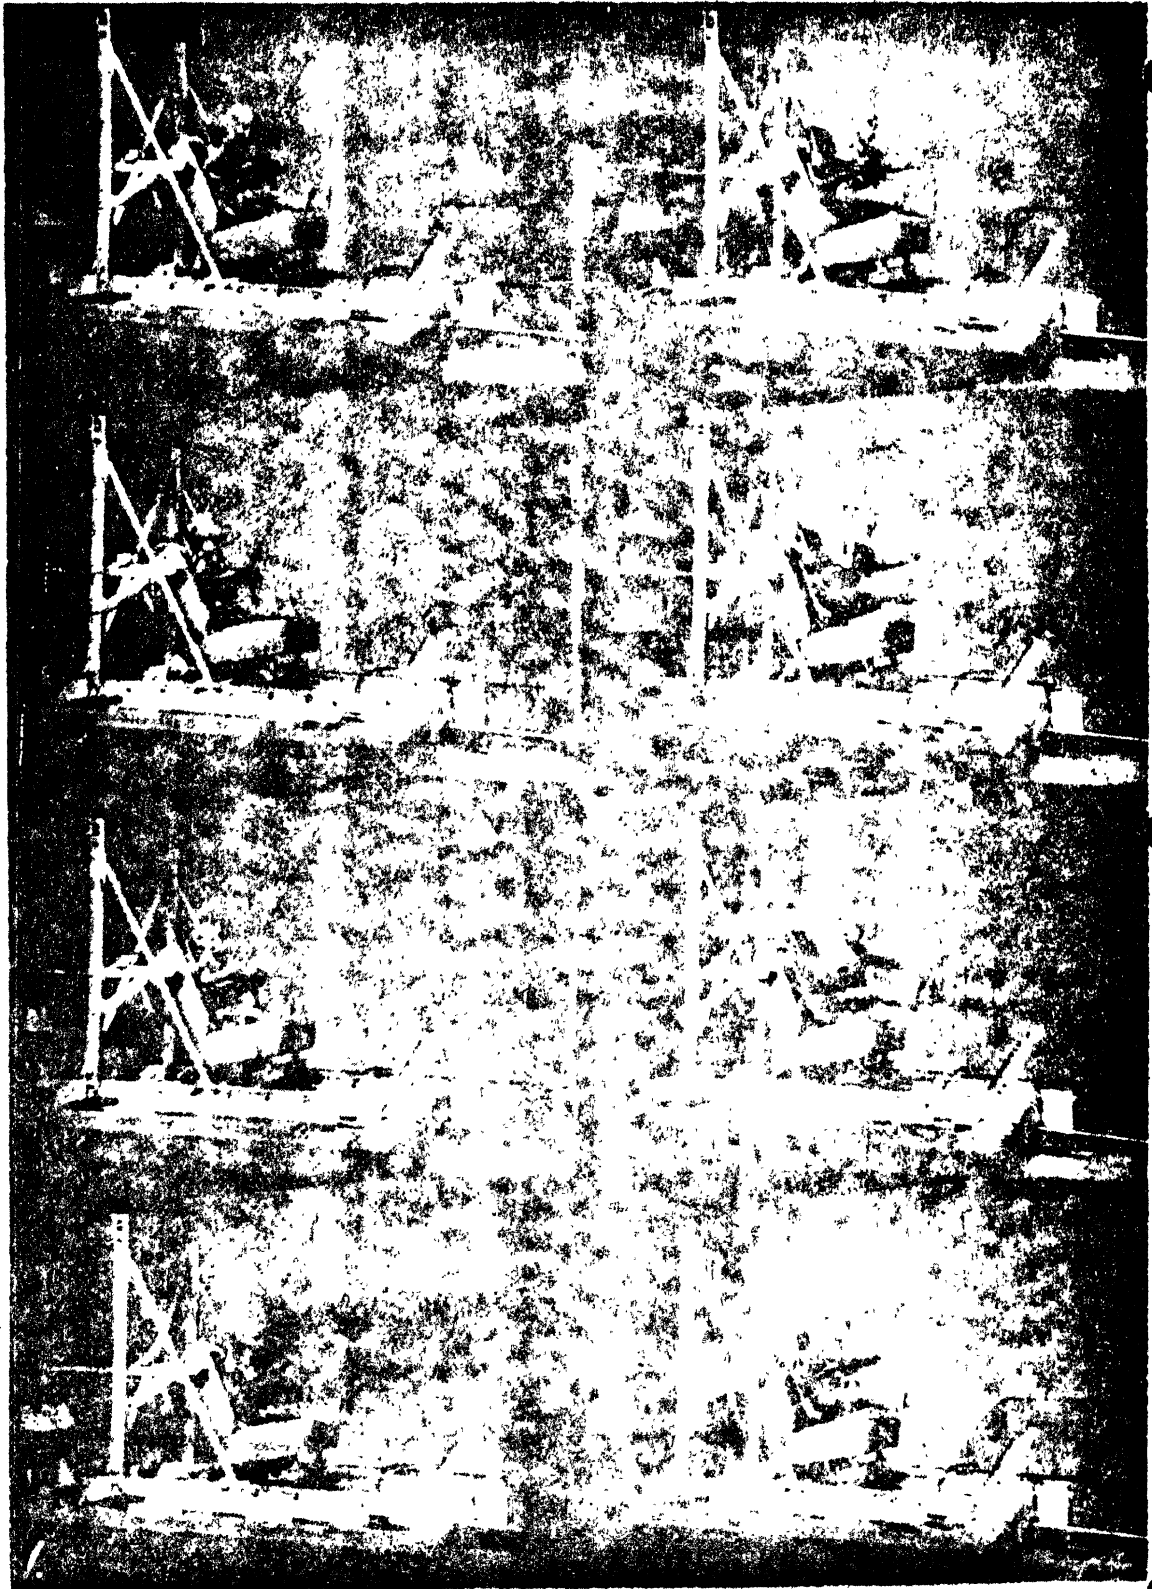
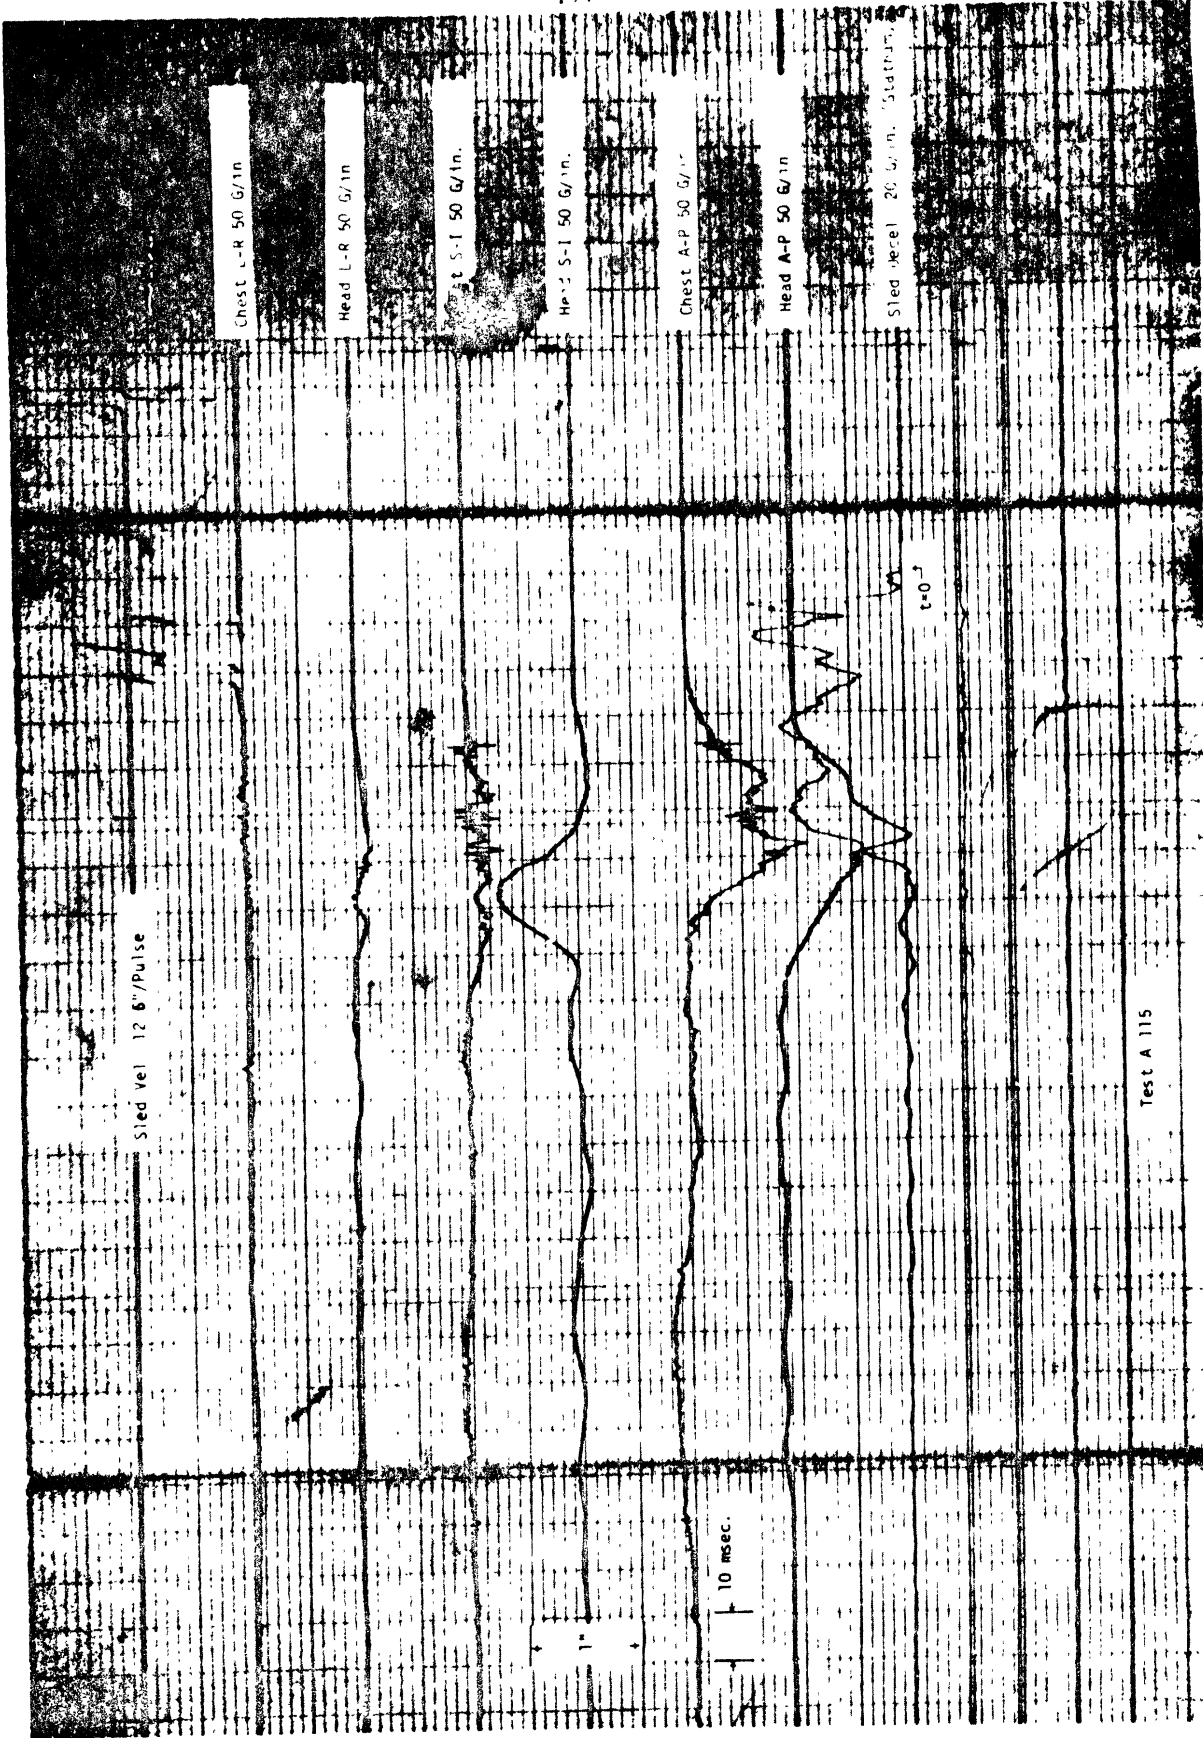
A115

Test No: A-115
Test Date: 29 July 1969
Restraint Code No: C-13
Restraint Description: Peterson Swinger Seat, Model No. 60EC

Head and chest loadings experienced by the dummy were fairly high. The bails bent somewhat and the masonite baseboard on the seat back was fractured by the impact on this child seat. The high seat back on this restraint system prevented any whiplash from occurring.

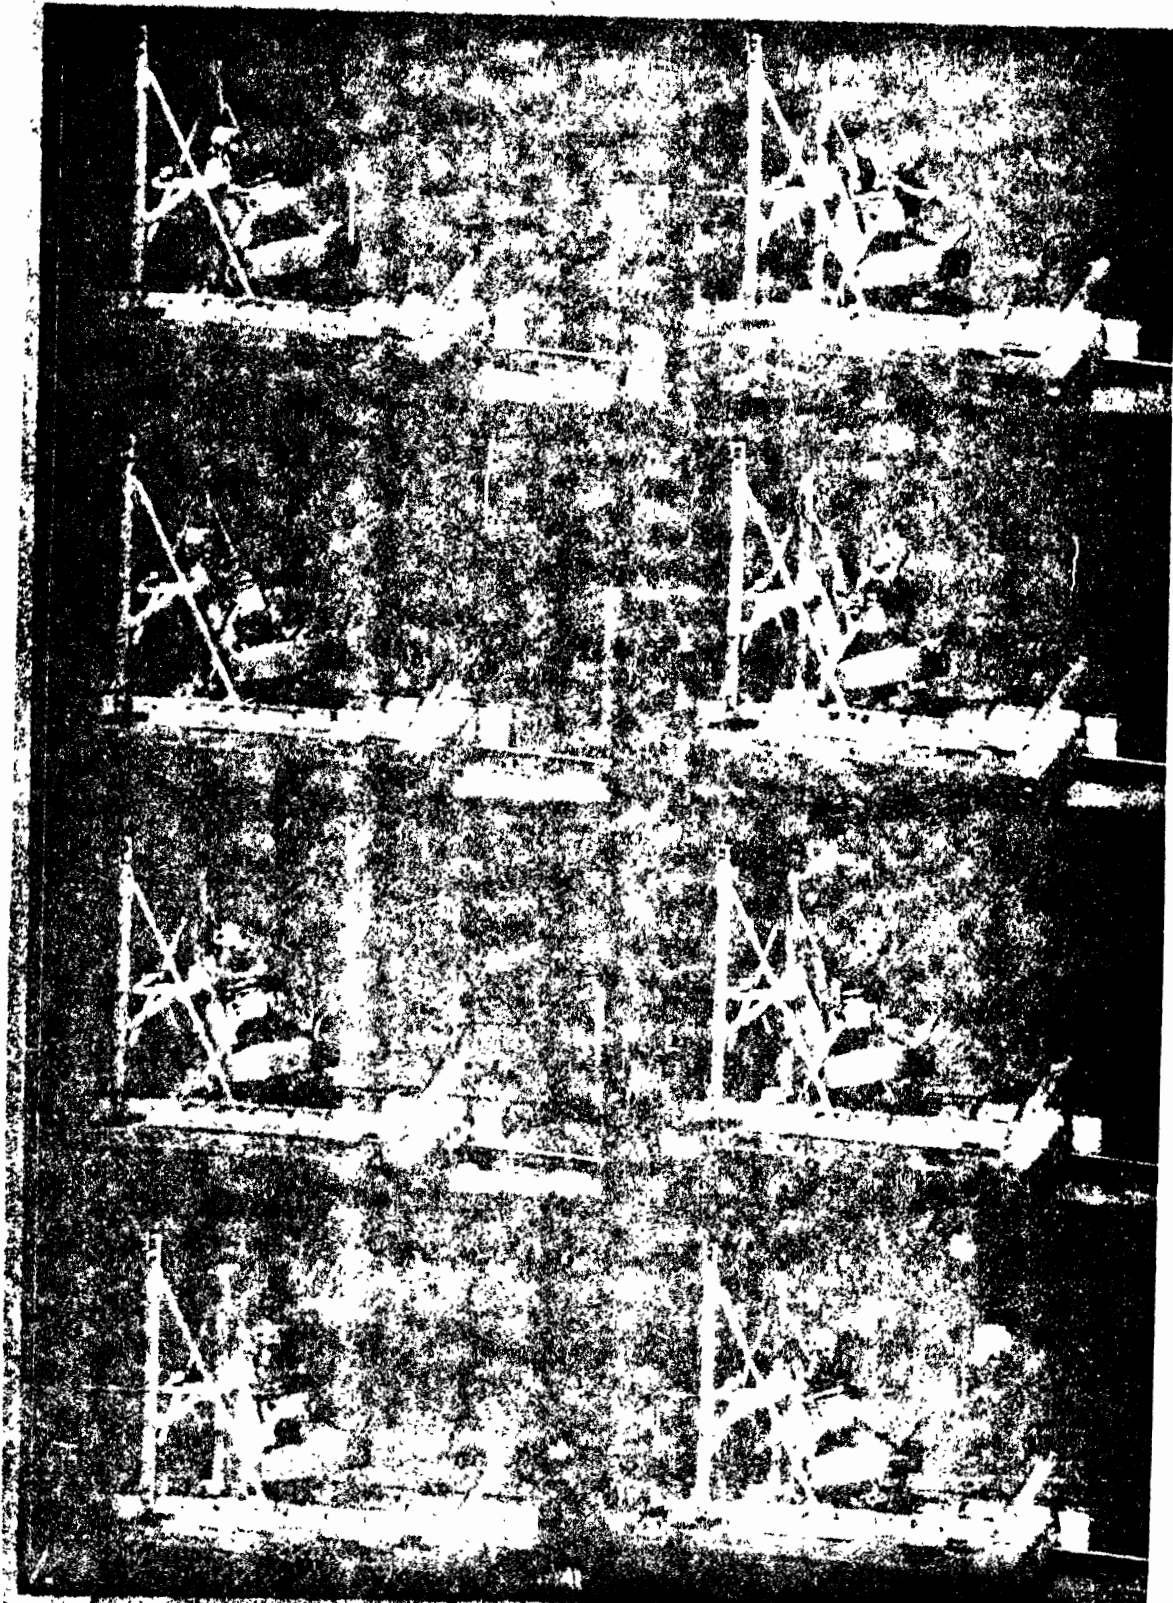
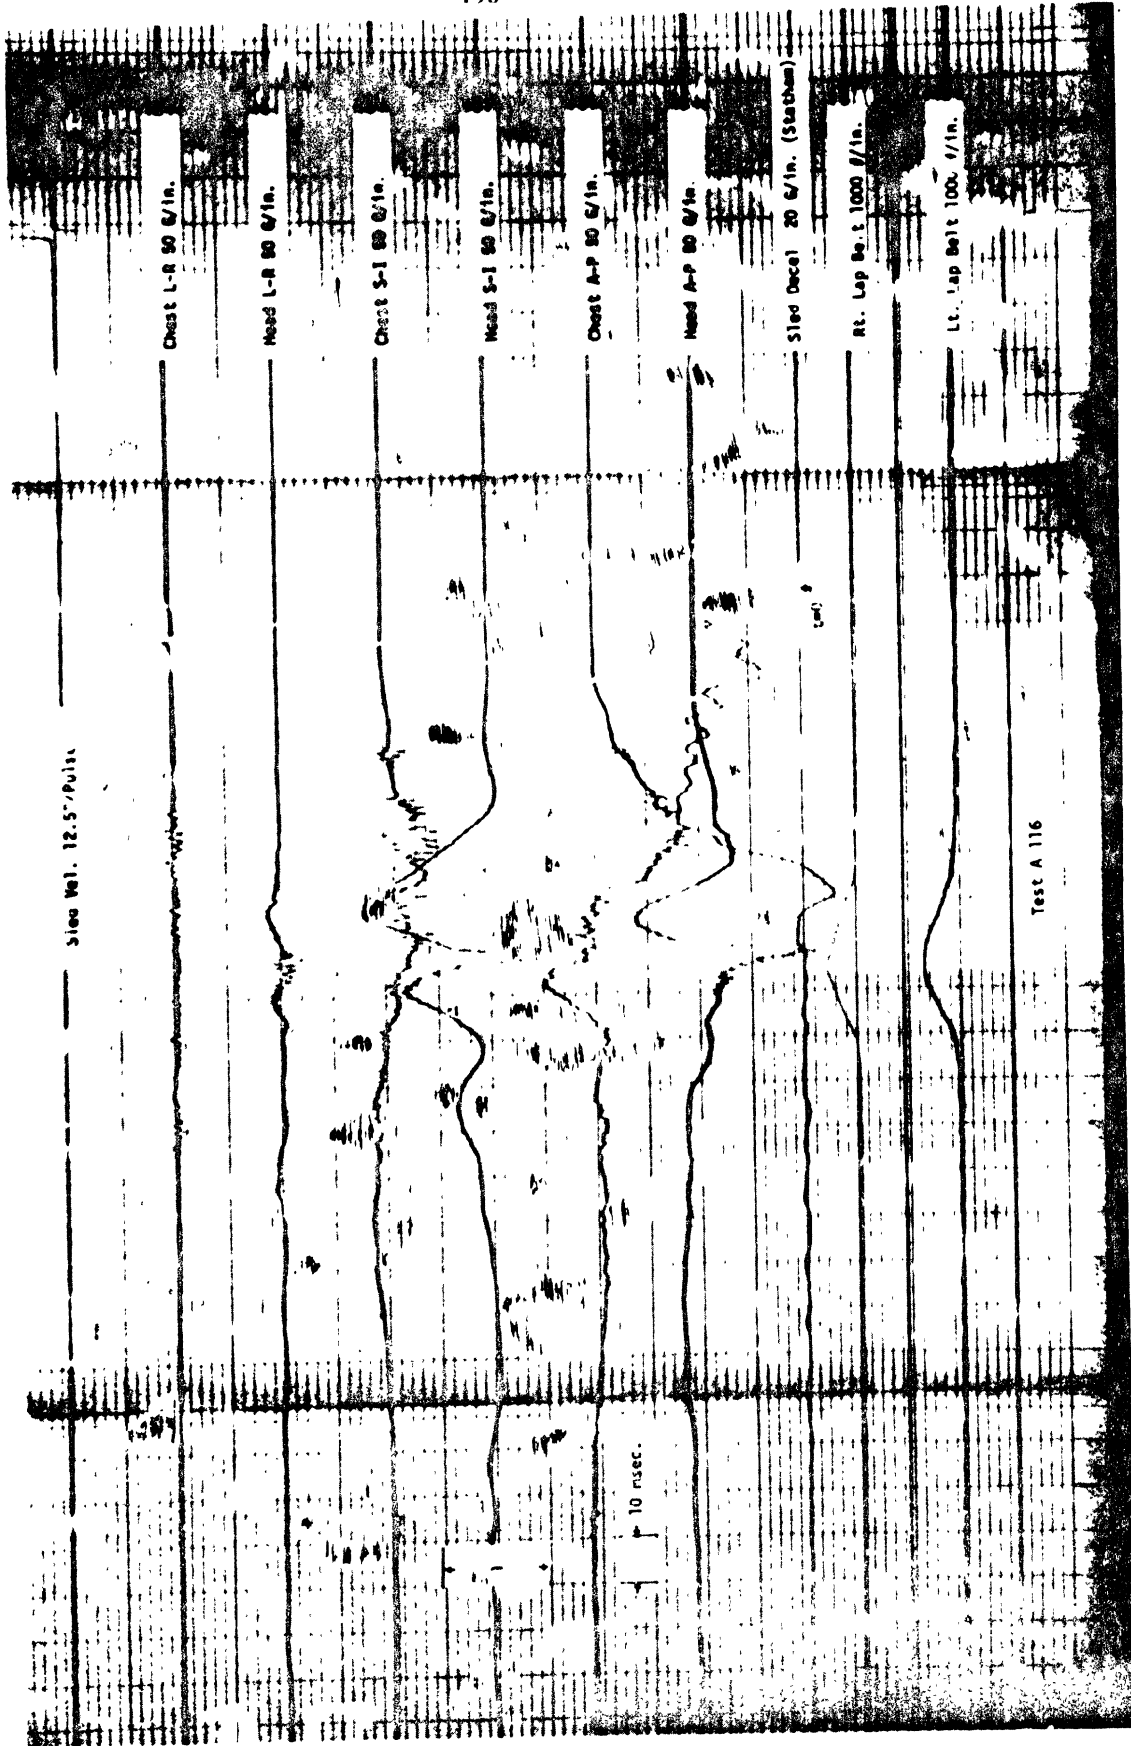
A116

Test No: A-116
Test Date: 29 July 1969
Restraint Code No.: C-14
Restraint Description: International Seat No. 4613

Dummy experienced high anterior-posterior head and chest accelerations. Due to the lack of a headrest on either the child restraint system or on the adult seat, the dummy experienced whiplash.

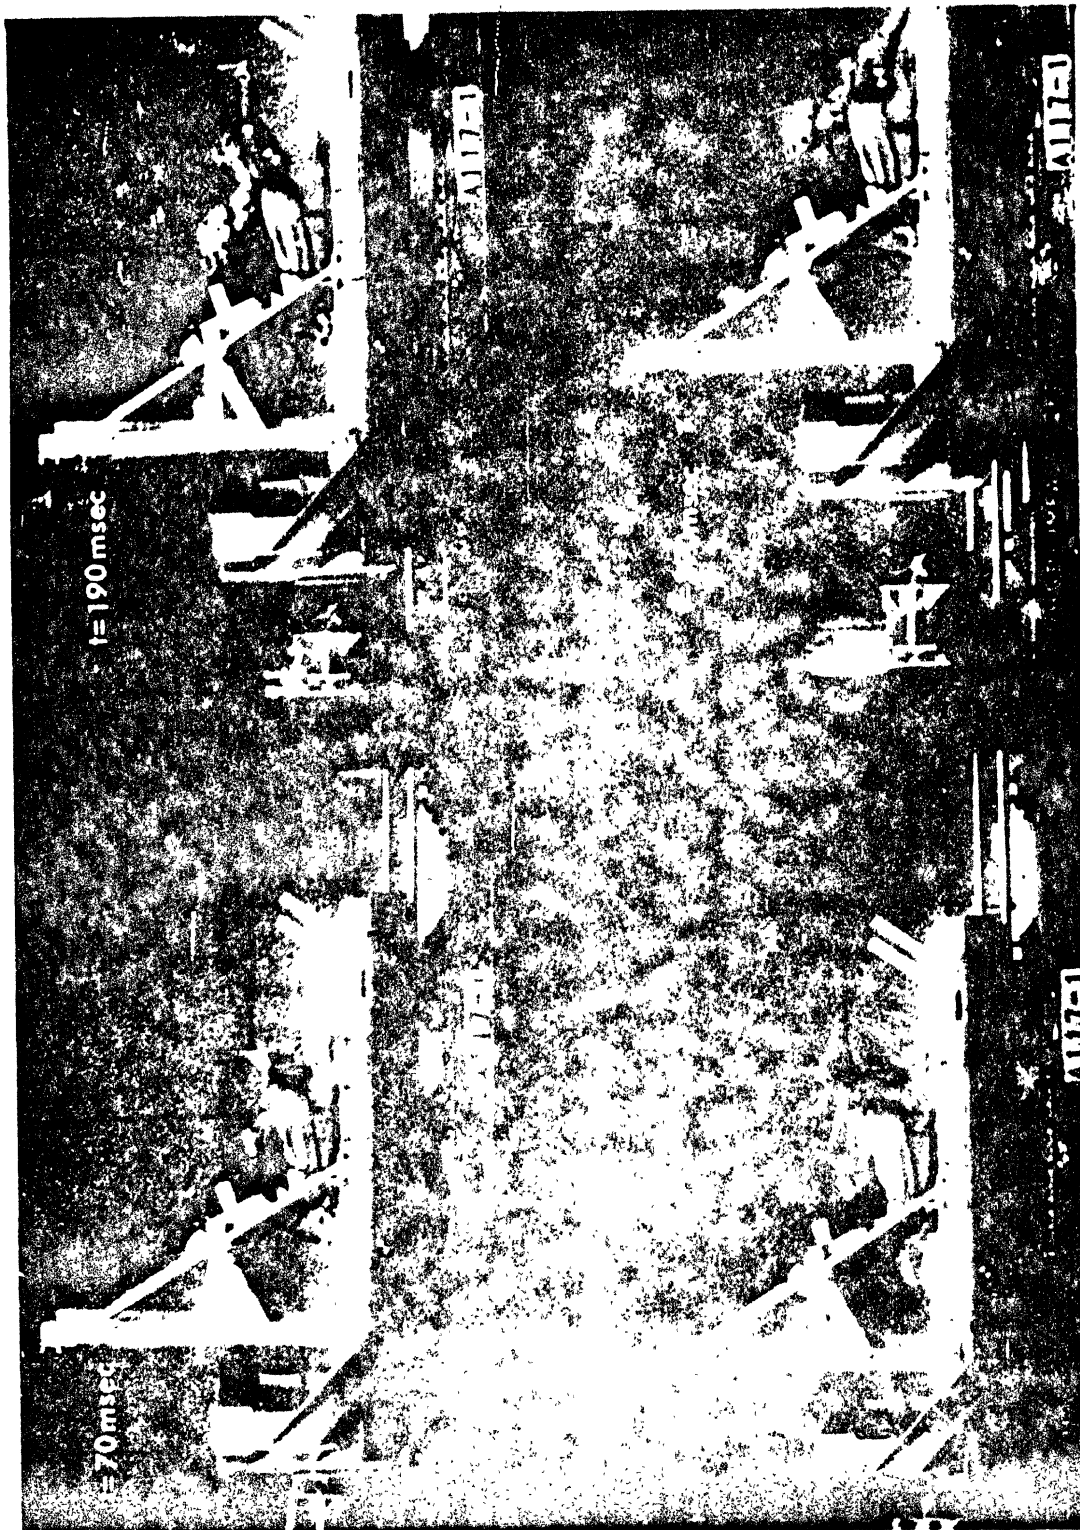
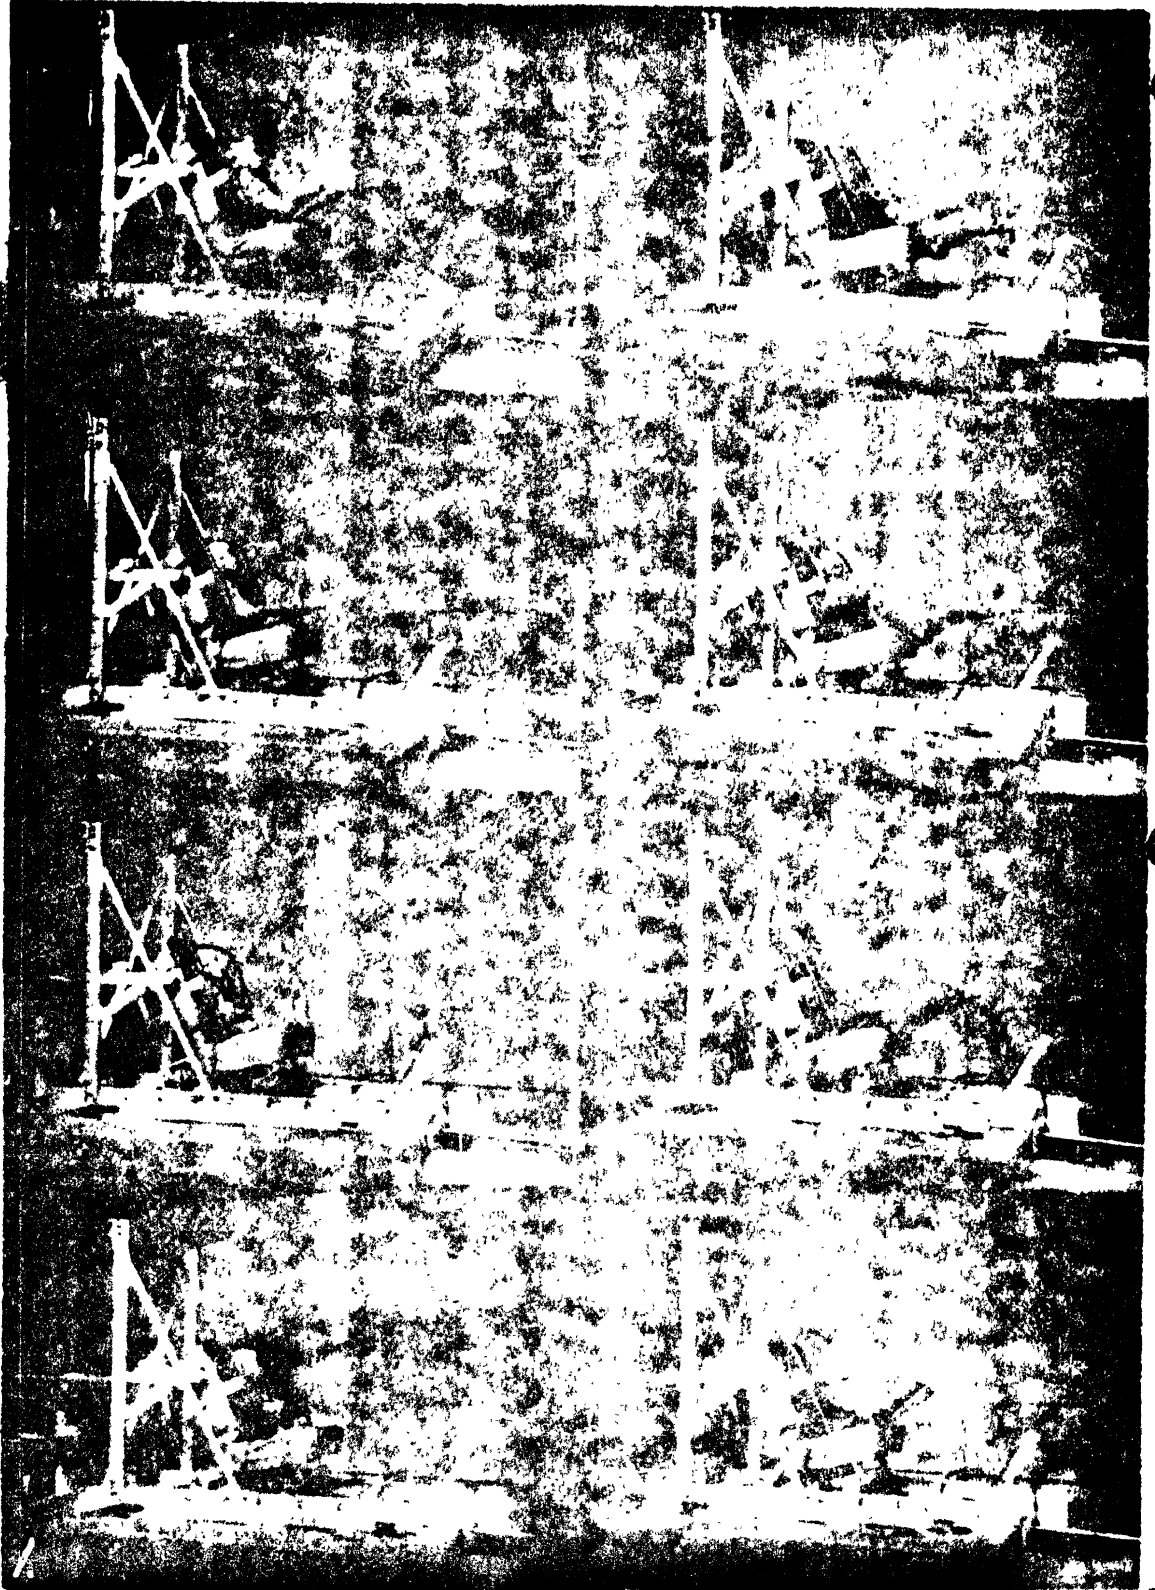
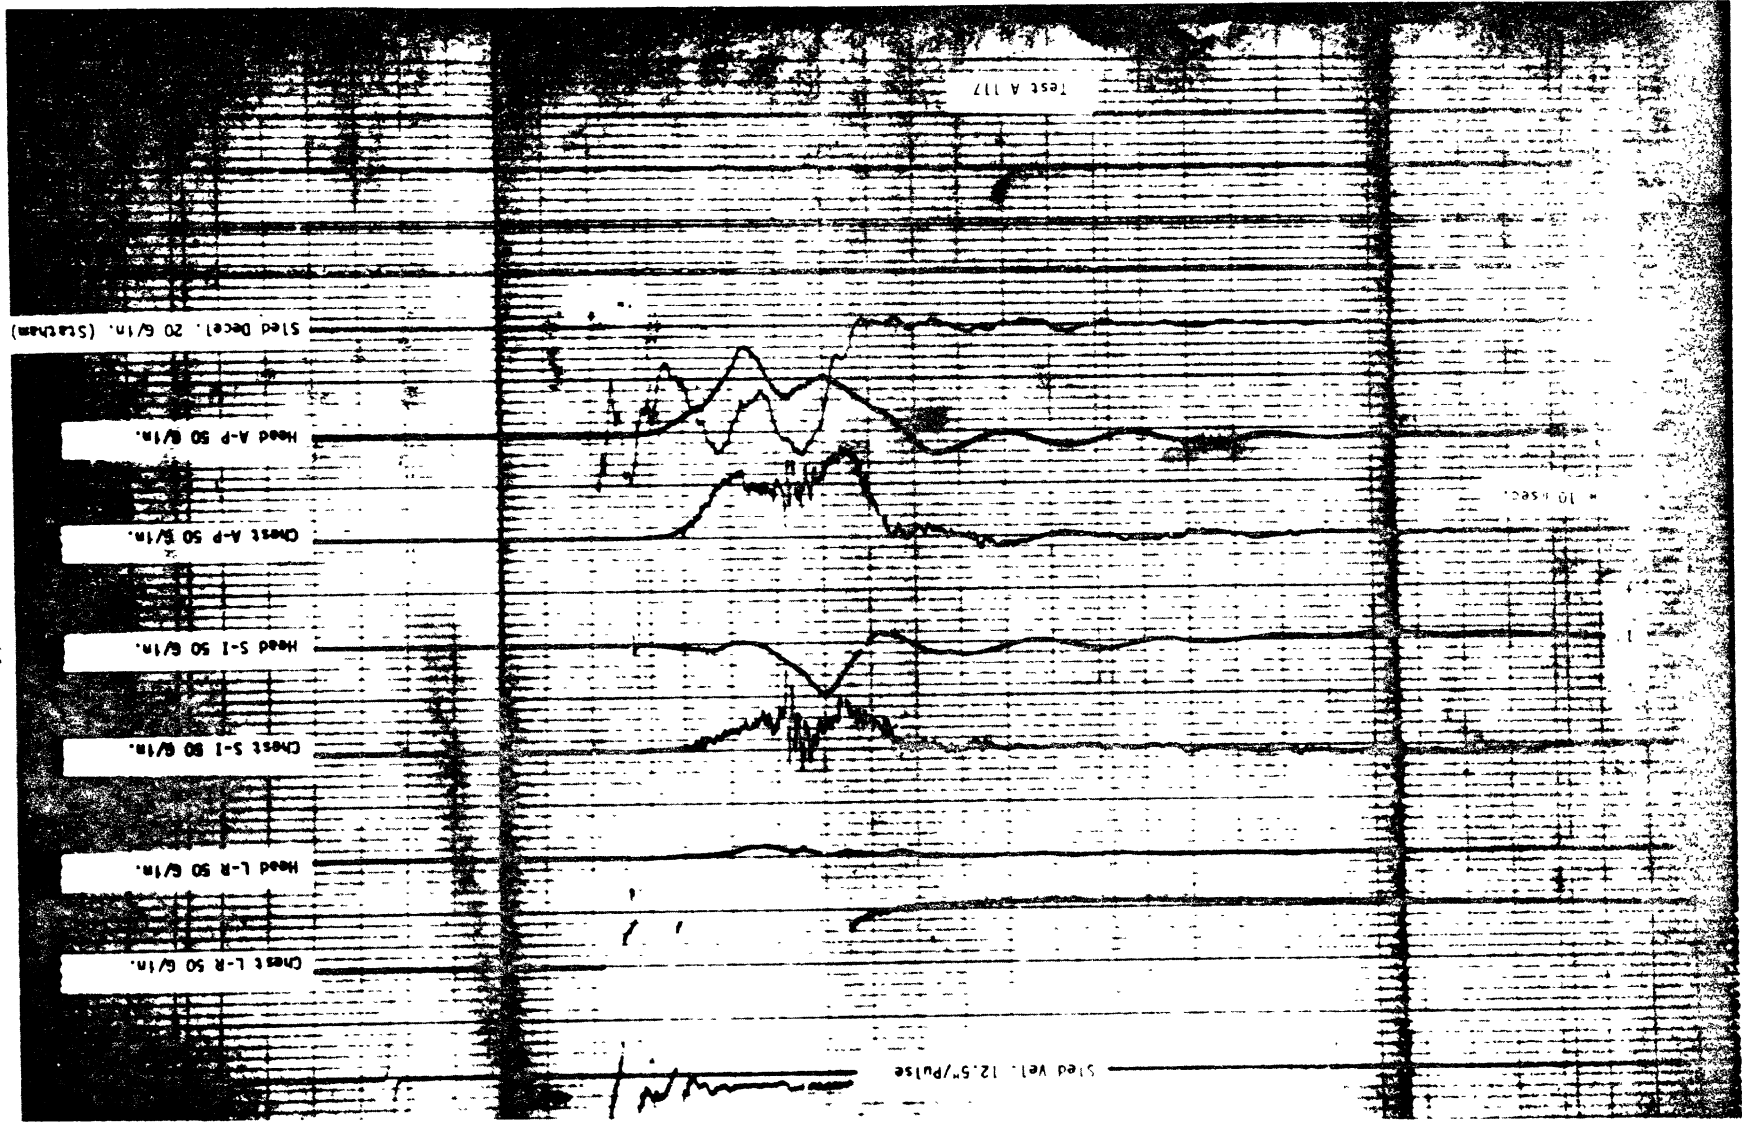
A117

Test No: A-117
Test Date: 30 July 1960
Restraint Code No.: C-23
Restraint Description: Volvo Child Safety Seat

Chest and head g-loadings on the dummy were moderate. There were no gross relative motions between the various body parts. However, on the rebound the lap belt buckle which is integral with the restraint system did not hold. When the dummy rebounded from the seat, these buckles failed and the dummy was catapulted forward out of the adult seat onto the floor of the sled.
