CHILD SEAT AND RESTRAINT SYSTEMS TEST RESULTS

APPENDIX D

**THE UNIVERSITY OF MICHIGAN
HIGHWAY SAFETY RESEARCH INSTITUTE
HURON PARKWAY AND BAXTER ROAD
ANN ARBOR, MICHIGAN 48105**

Final Report

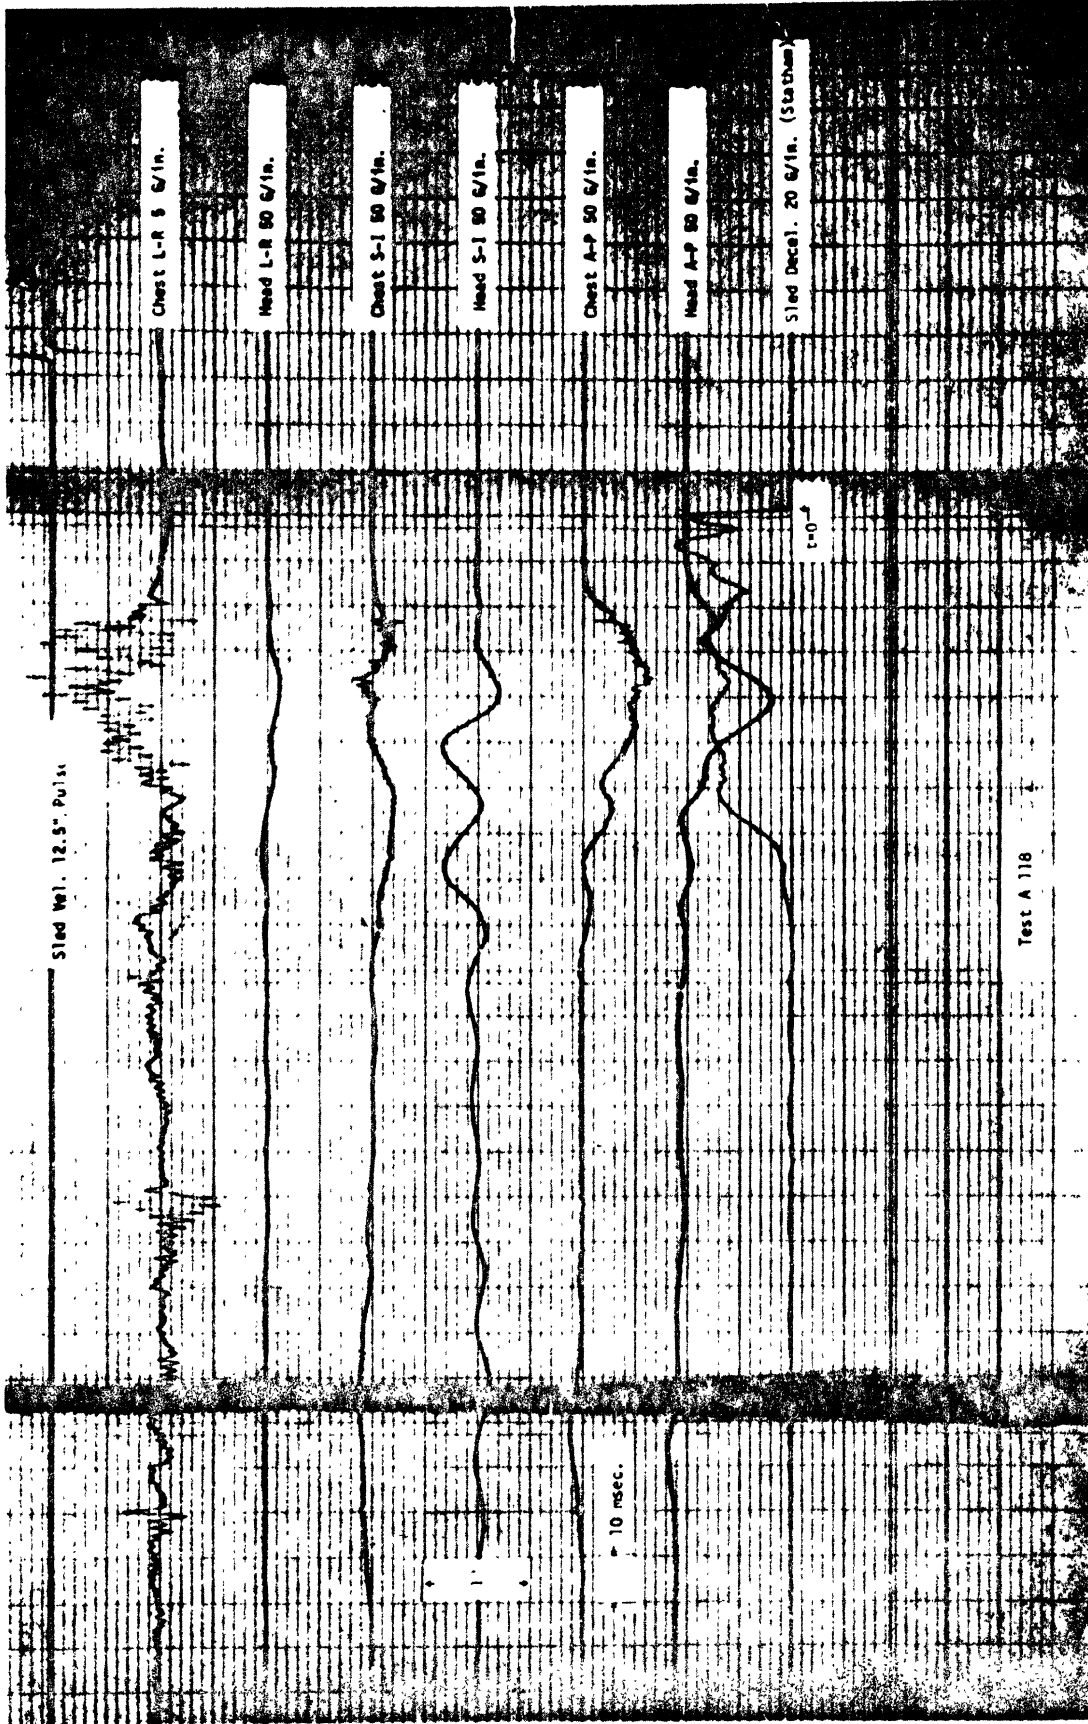
A118

Test No: A-118
Test Date: 30 July 1969
Restraint Code No.: C-16
Restraint Description: Klippan Safety Seat

Decelerations and loadings experienced by the dummy were quite mild. Because of the high seat back on the Klippan seat, no gross relative motions between body parts were recorded.

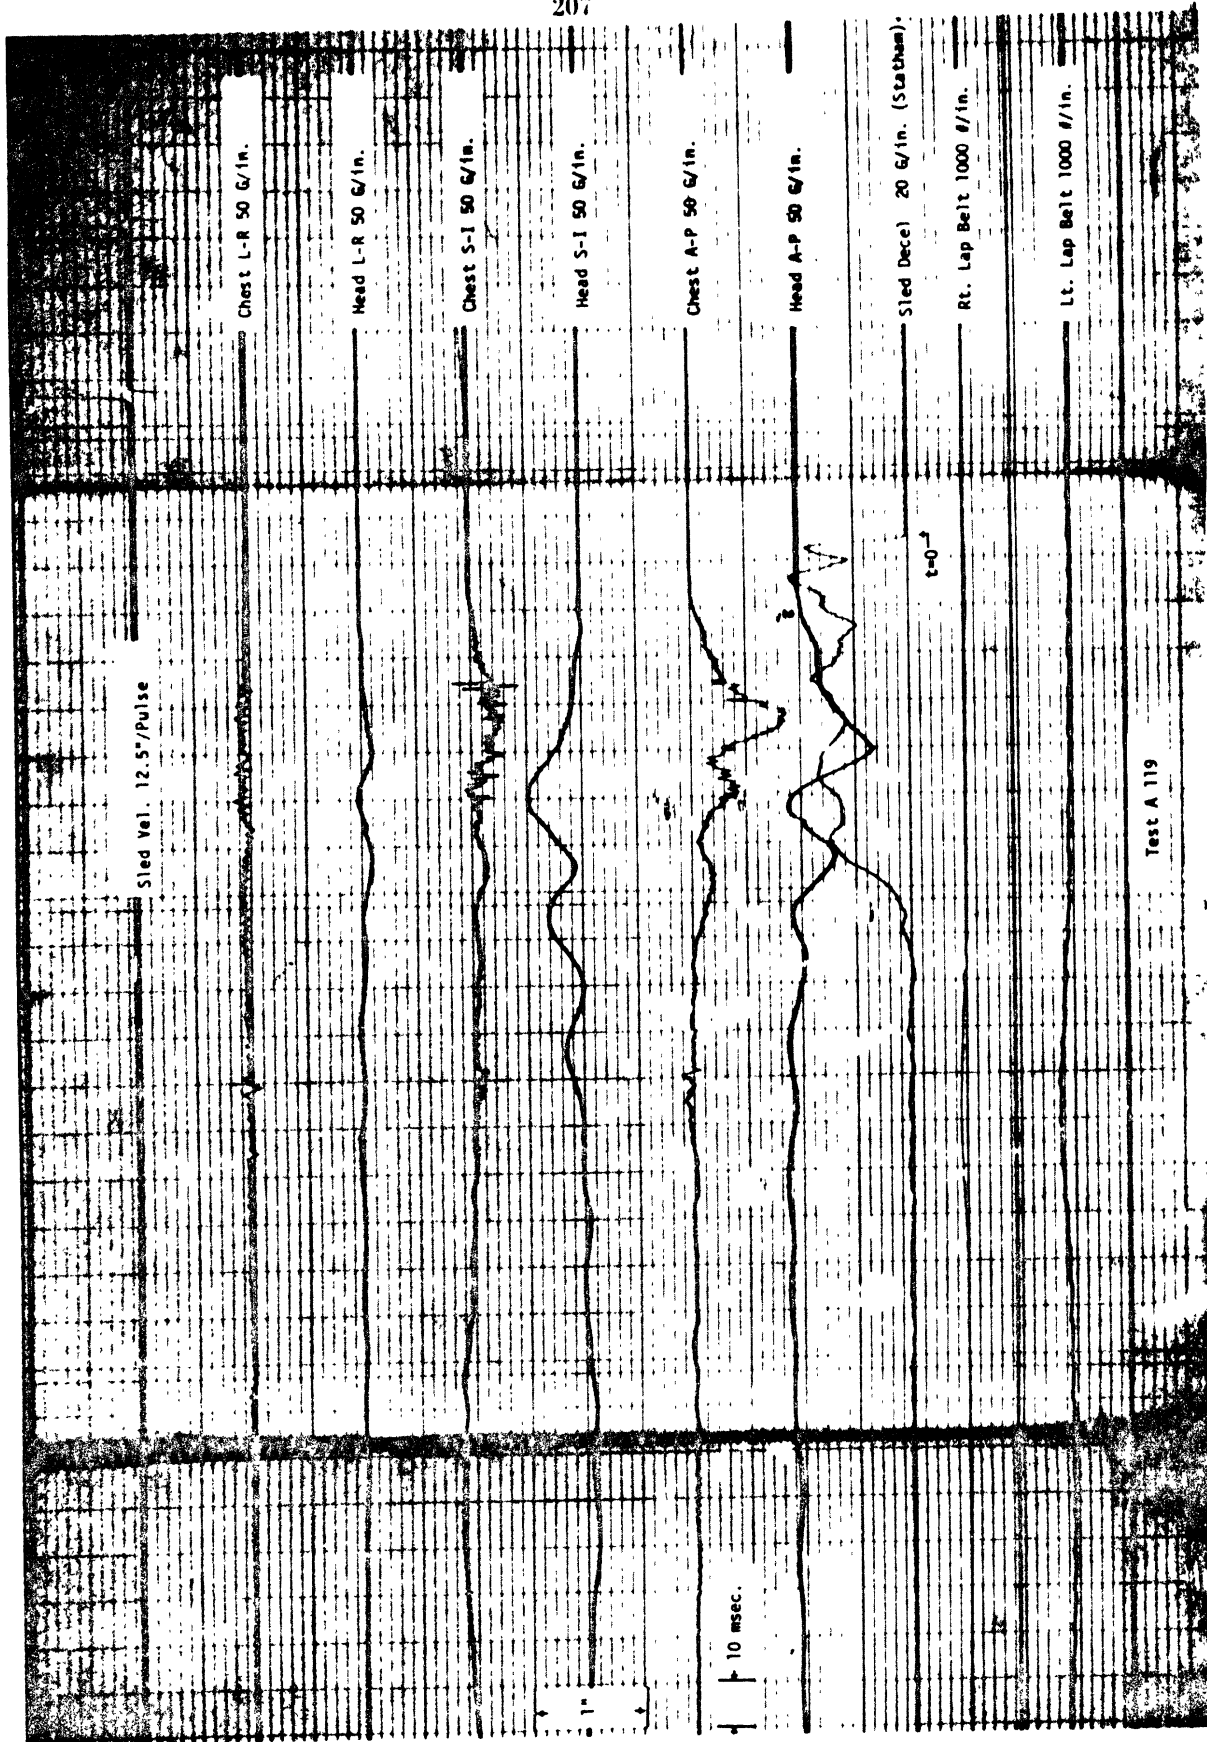
A119

Test No: A-119
Test Date: 31 July 1969
Restraint Code No.: C-28
Restraint Description: Kelly Kiddy Kaddy

The loadings and accelerations experienced by the dummy were quite mild. Although this is a booster seat, the child's head received protection against whiplash from the rear of the adult seat. The height of the seat back is a critical factor in the prevention of whiplash.

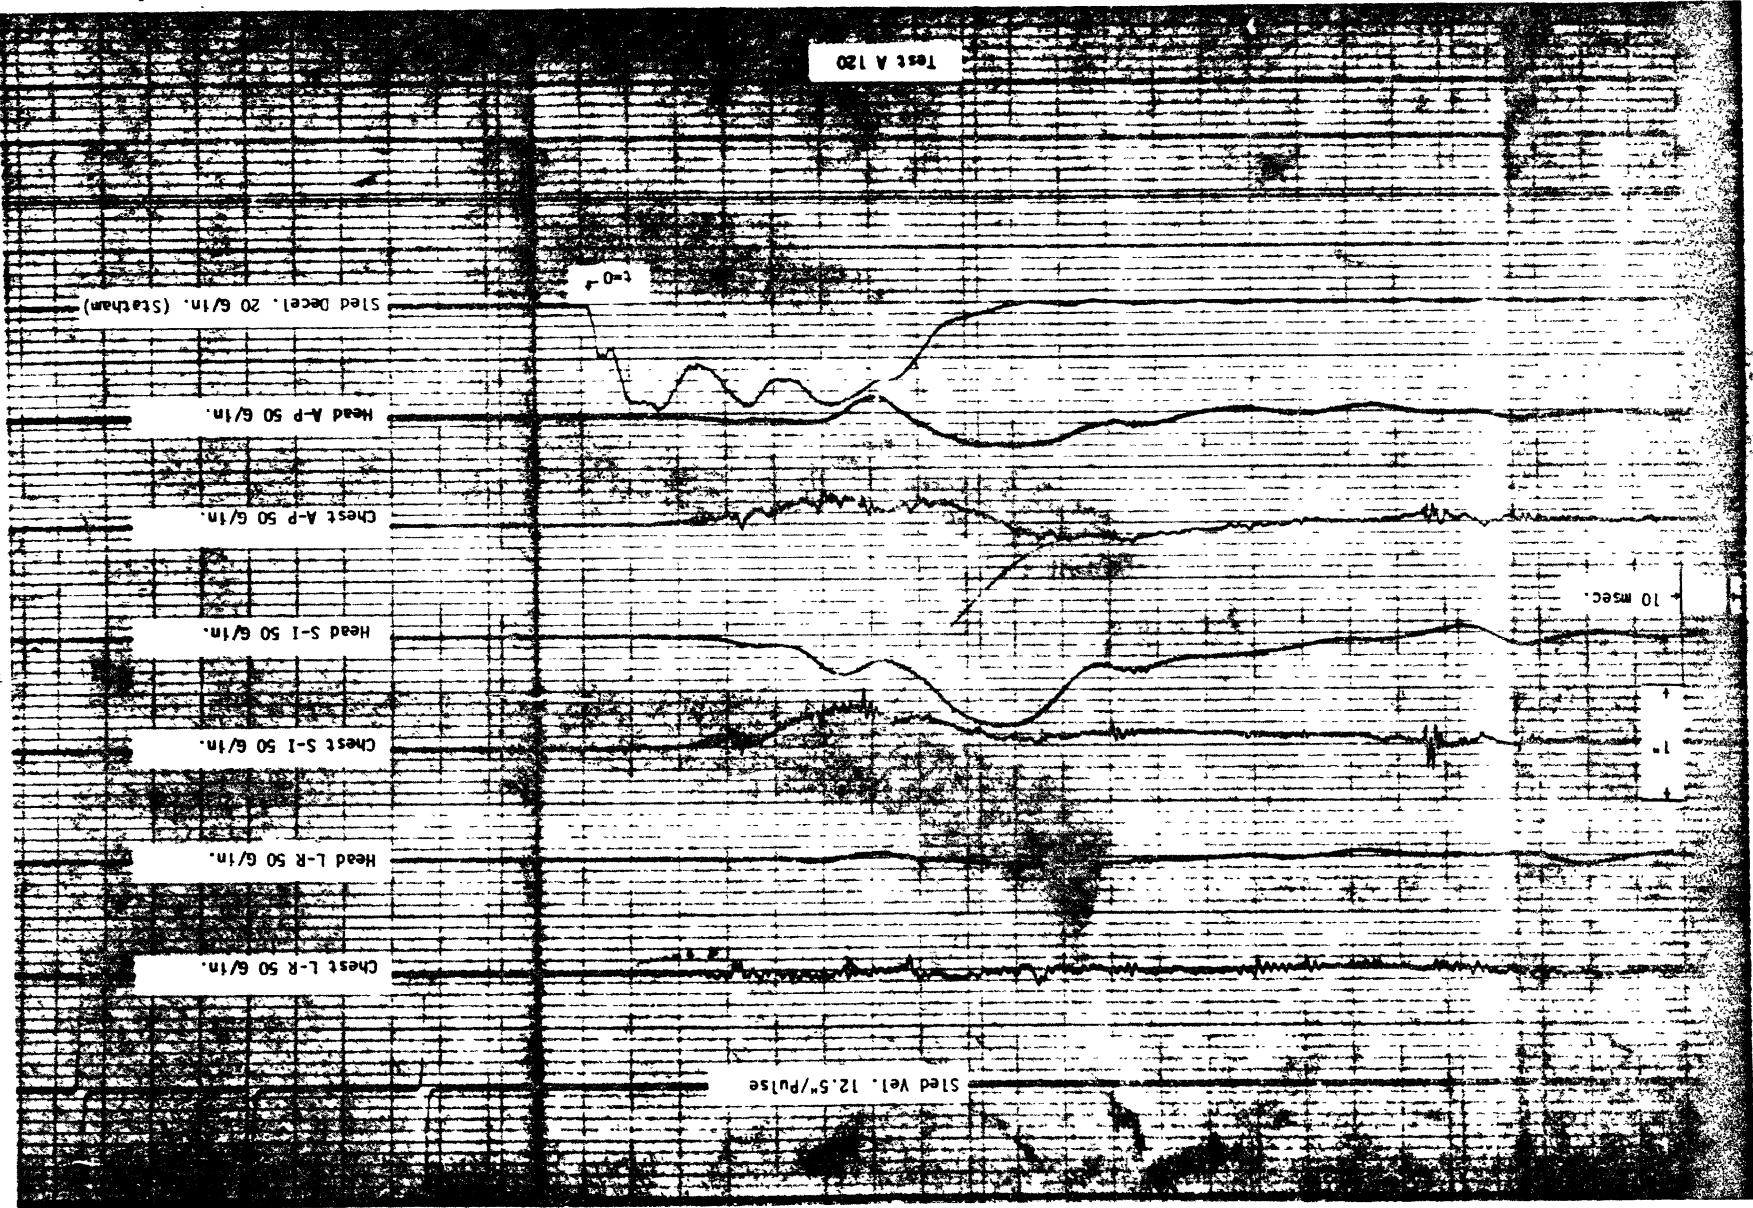
A 120

Test No: A-100
Test Date: 20 July 1960
Restraint Code No: C-31
Restraint Description: Sears Auto Harness, small

Because of the high center of gravity of the dummy standing on the seat, it was pitched backwards over the adult seat back and ended up hanging by the straps of the child harness. This restraint system offered no protection whatsoever in this impact situation.

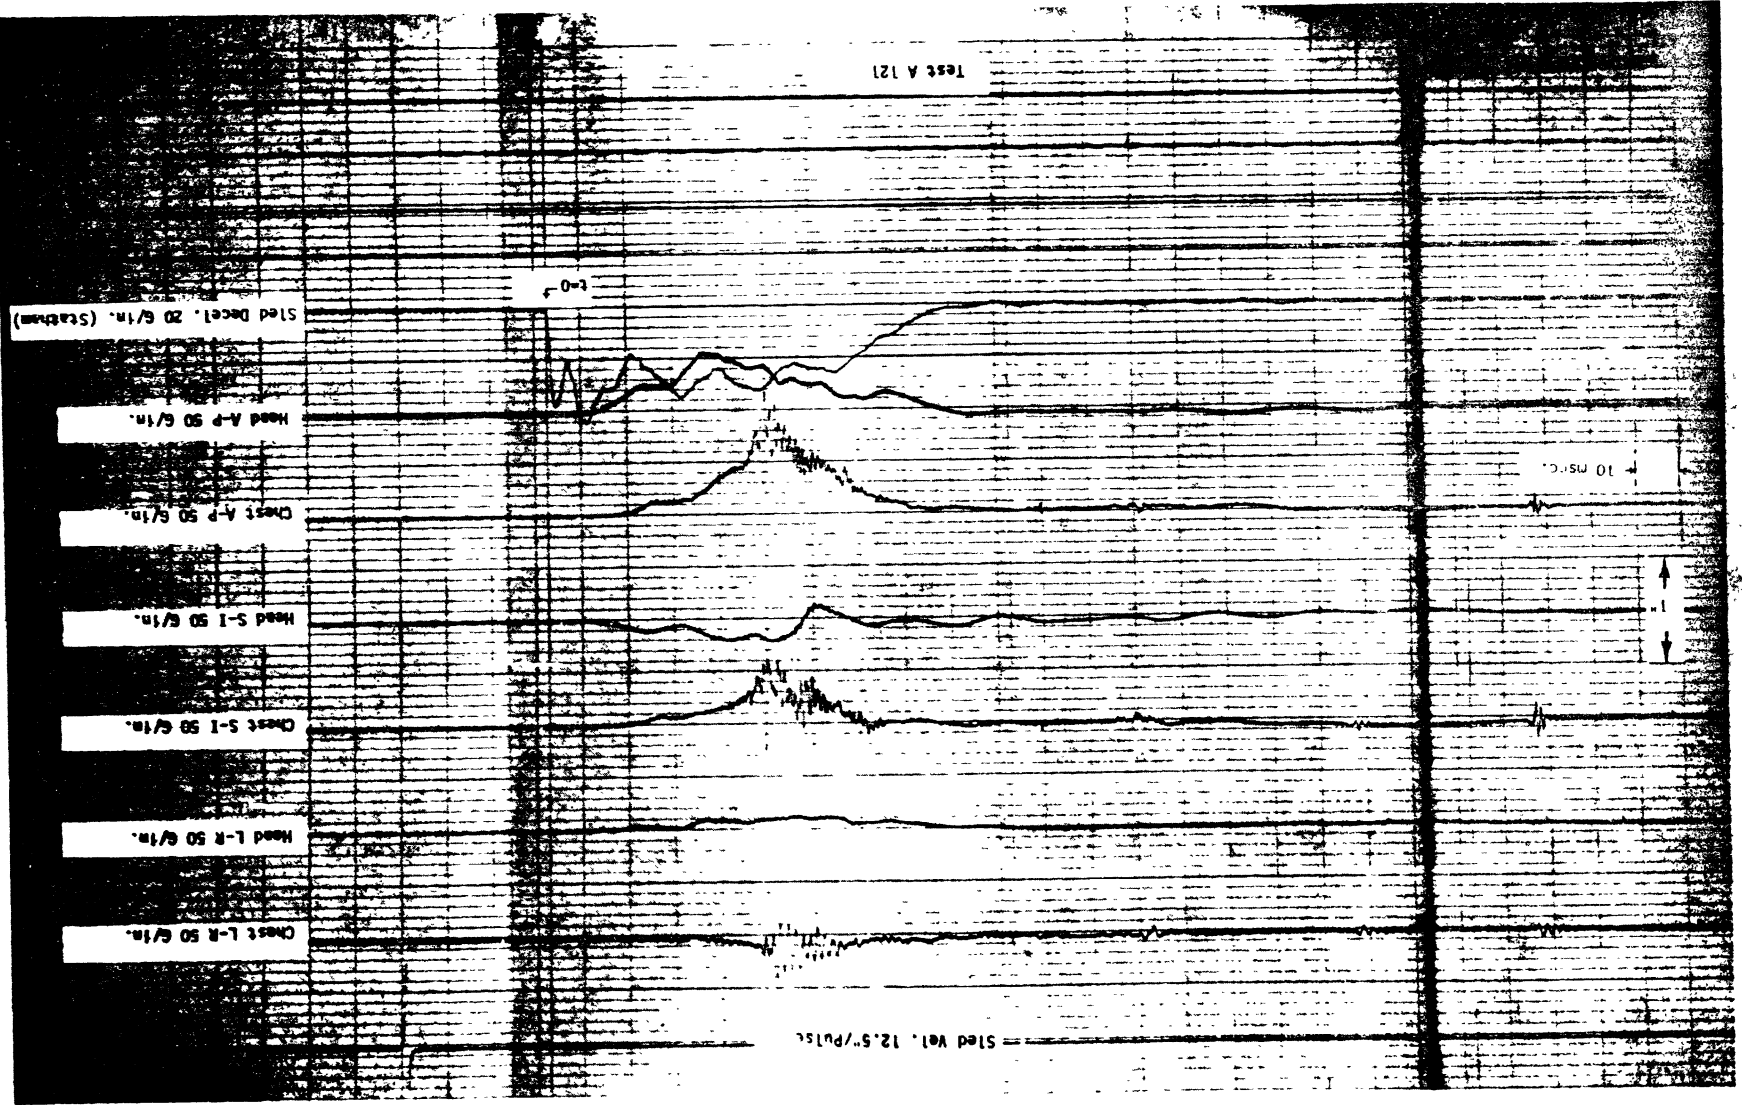
A121

Test No: A-121
Test Date: 1 August 1969
Restraint Code No.: C-31
Restraint Description: Sears Auto Harness, small

The dummy received a very gentle ride. No gross loadings or motions were observed.

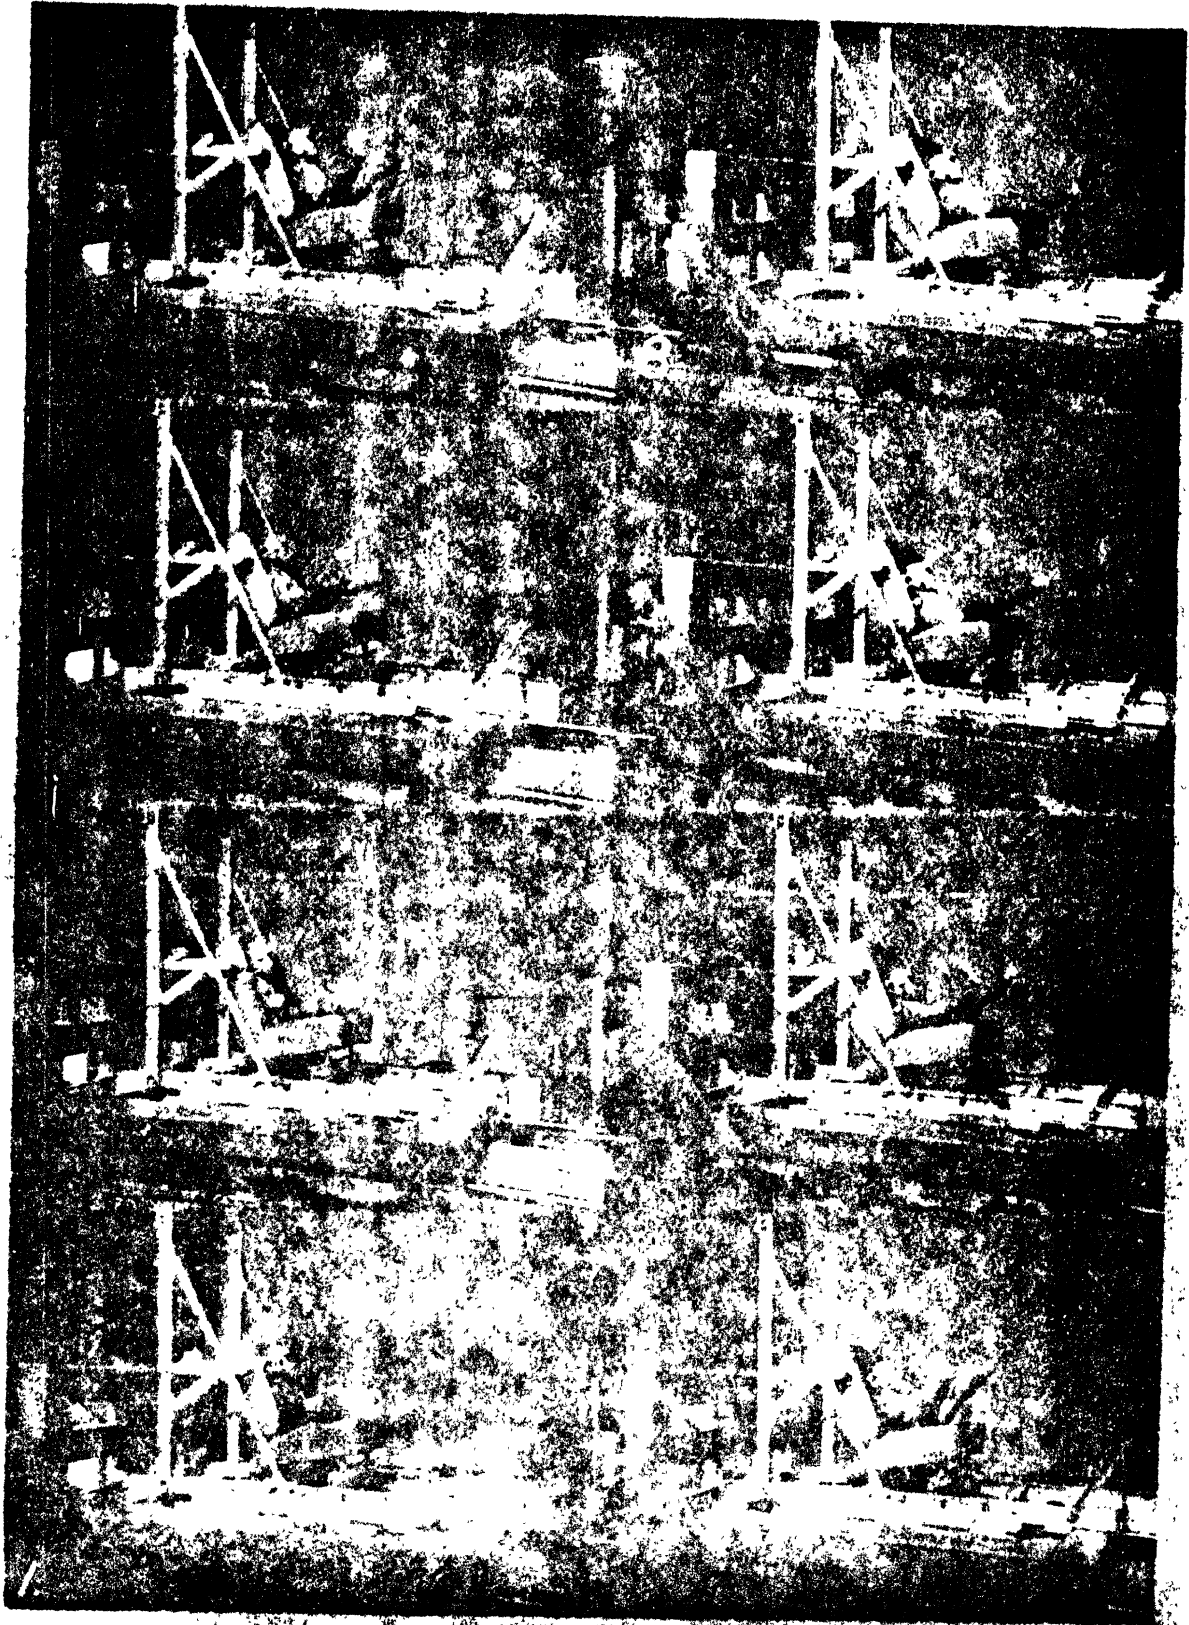
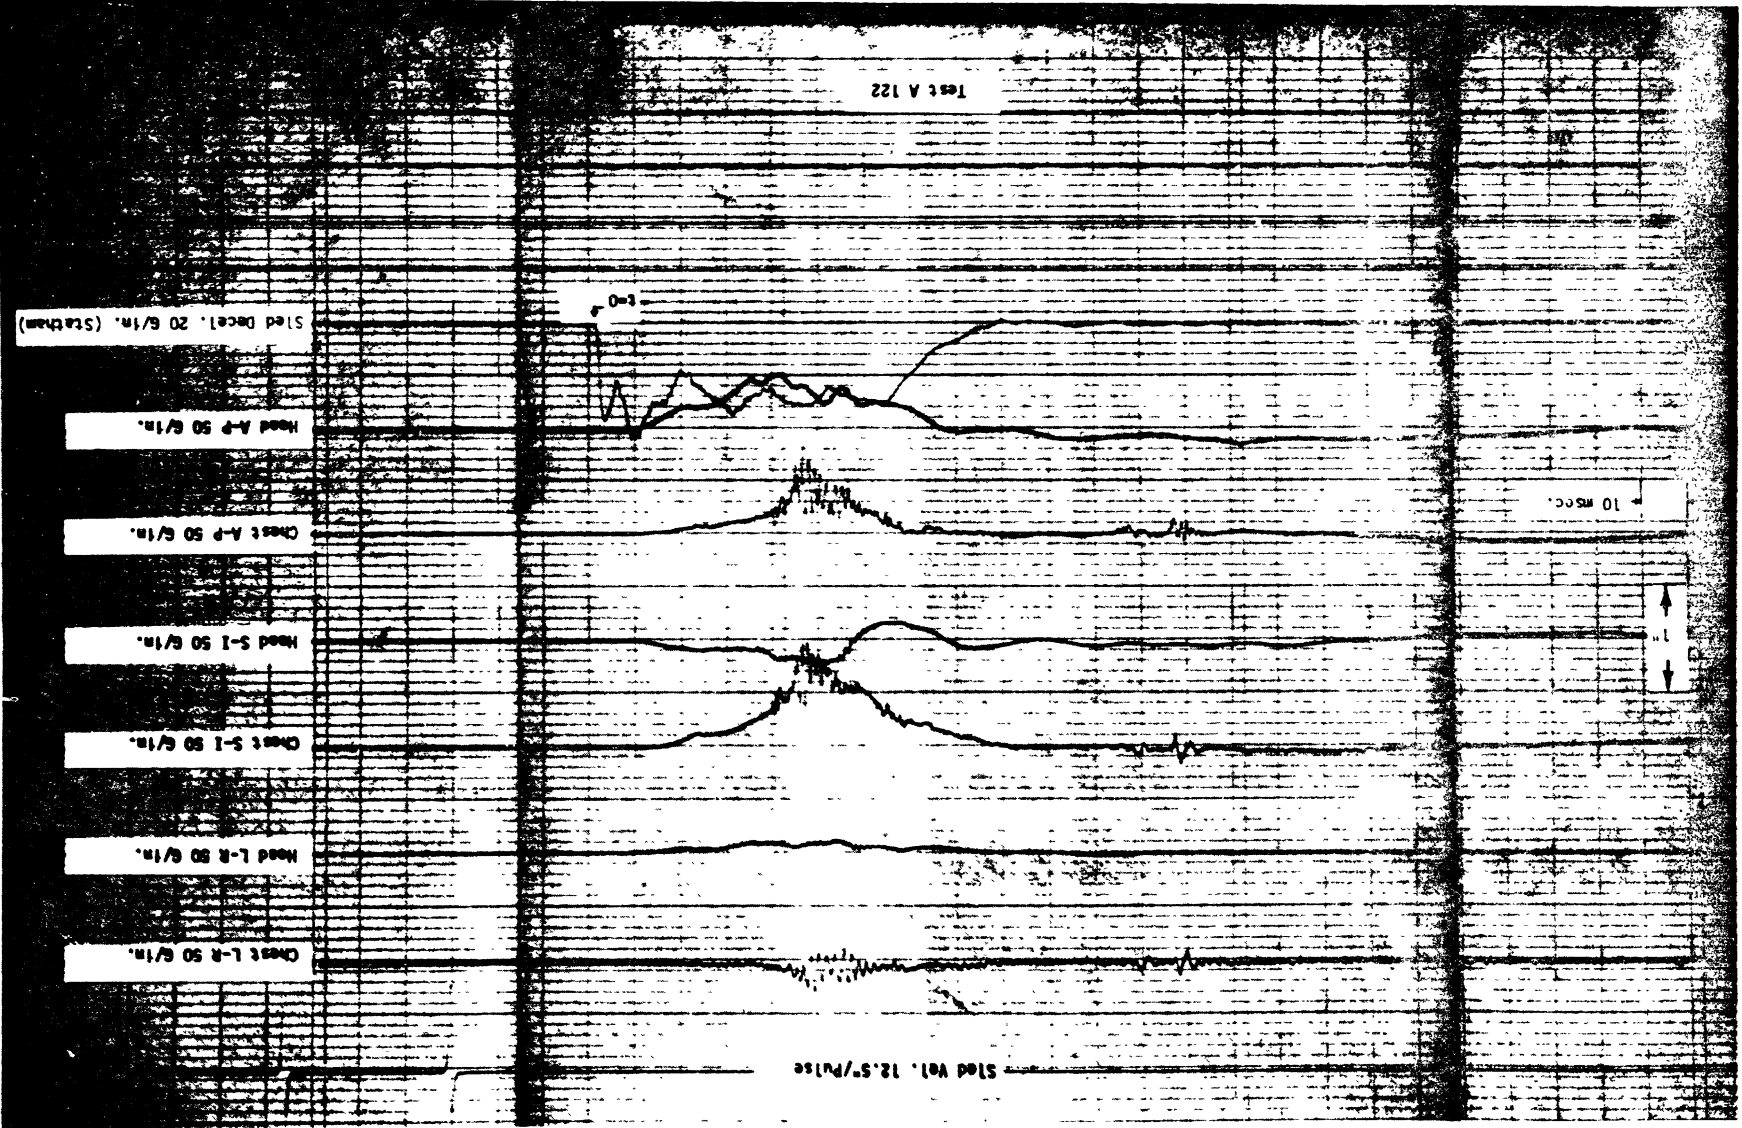
A122

Test No: A-122
Test Date: 1 August 1969
Restraint Code No: C-35
Restraint Description: American Motors Harness No. 8992185

The dummy received a gentle ride and no gross loadings or motions were recorded. The lack of a crotch strap on this harness caused the dummy's lower torso and legs to rebound somewhat farther than the upper torso. This harness is very difficult to install and attach to the dummy.

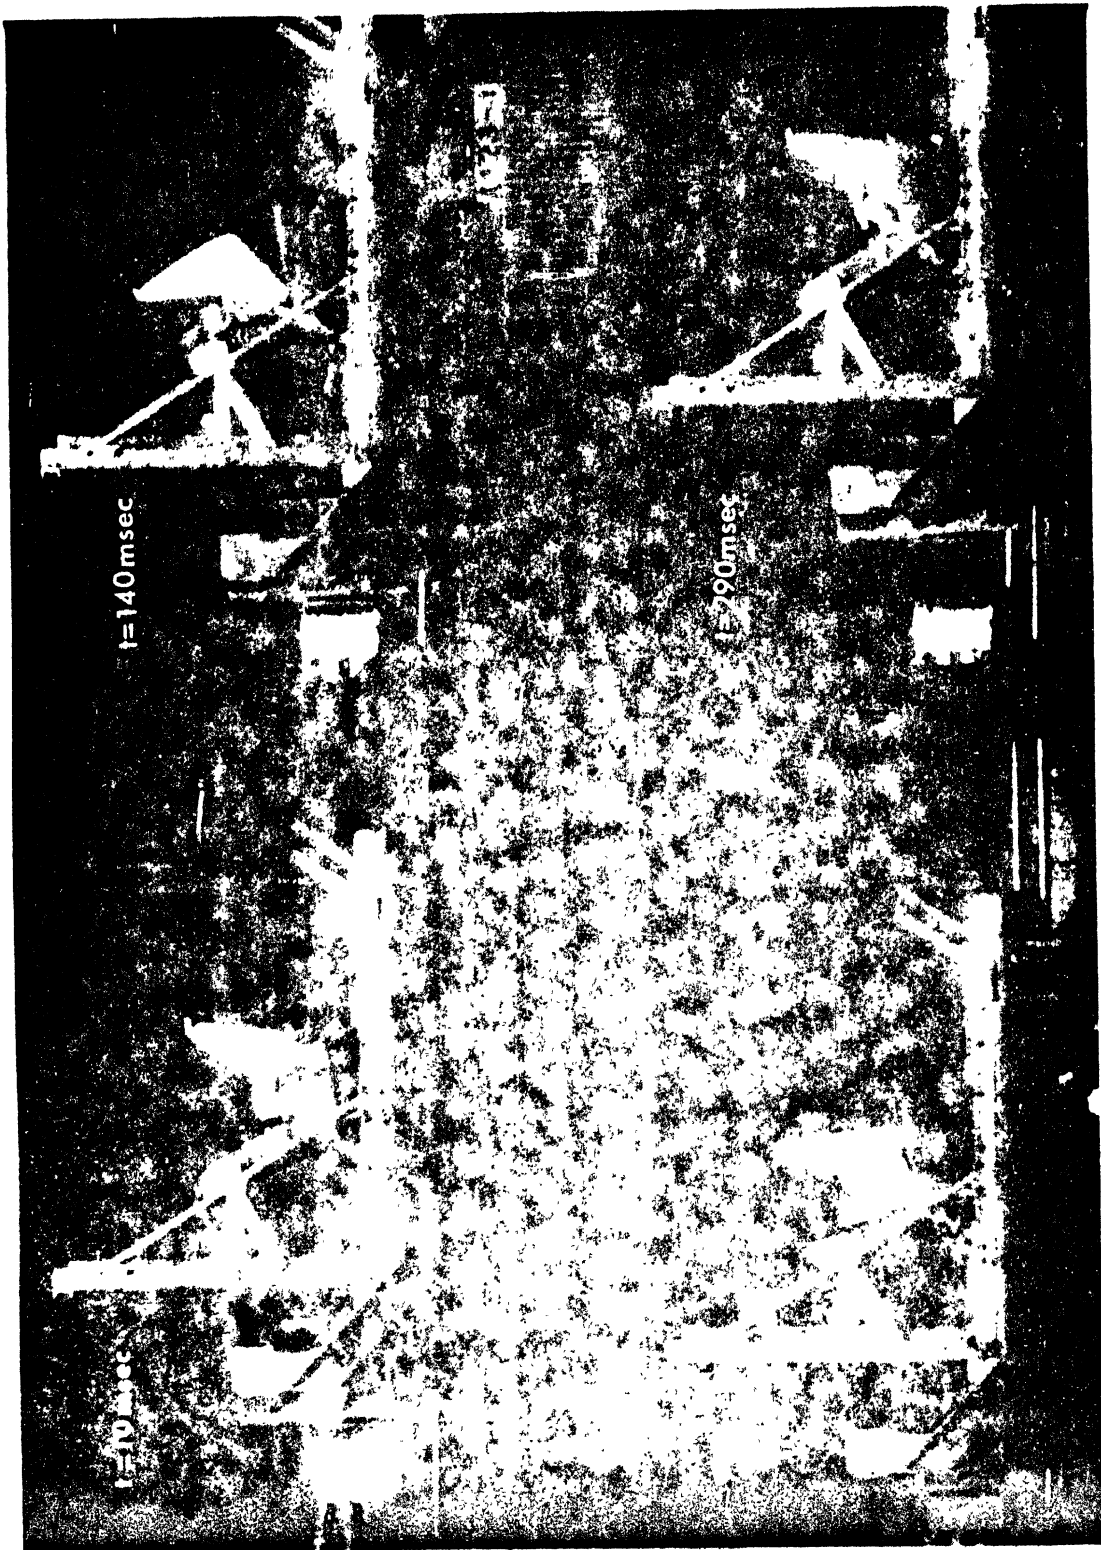
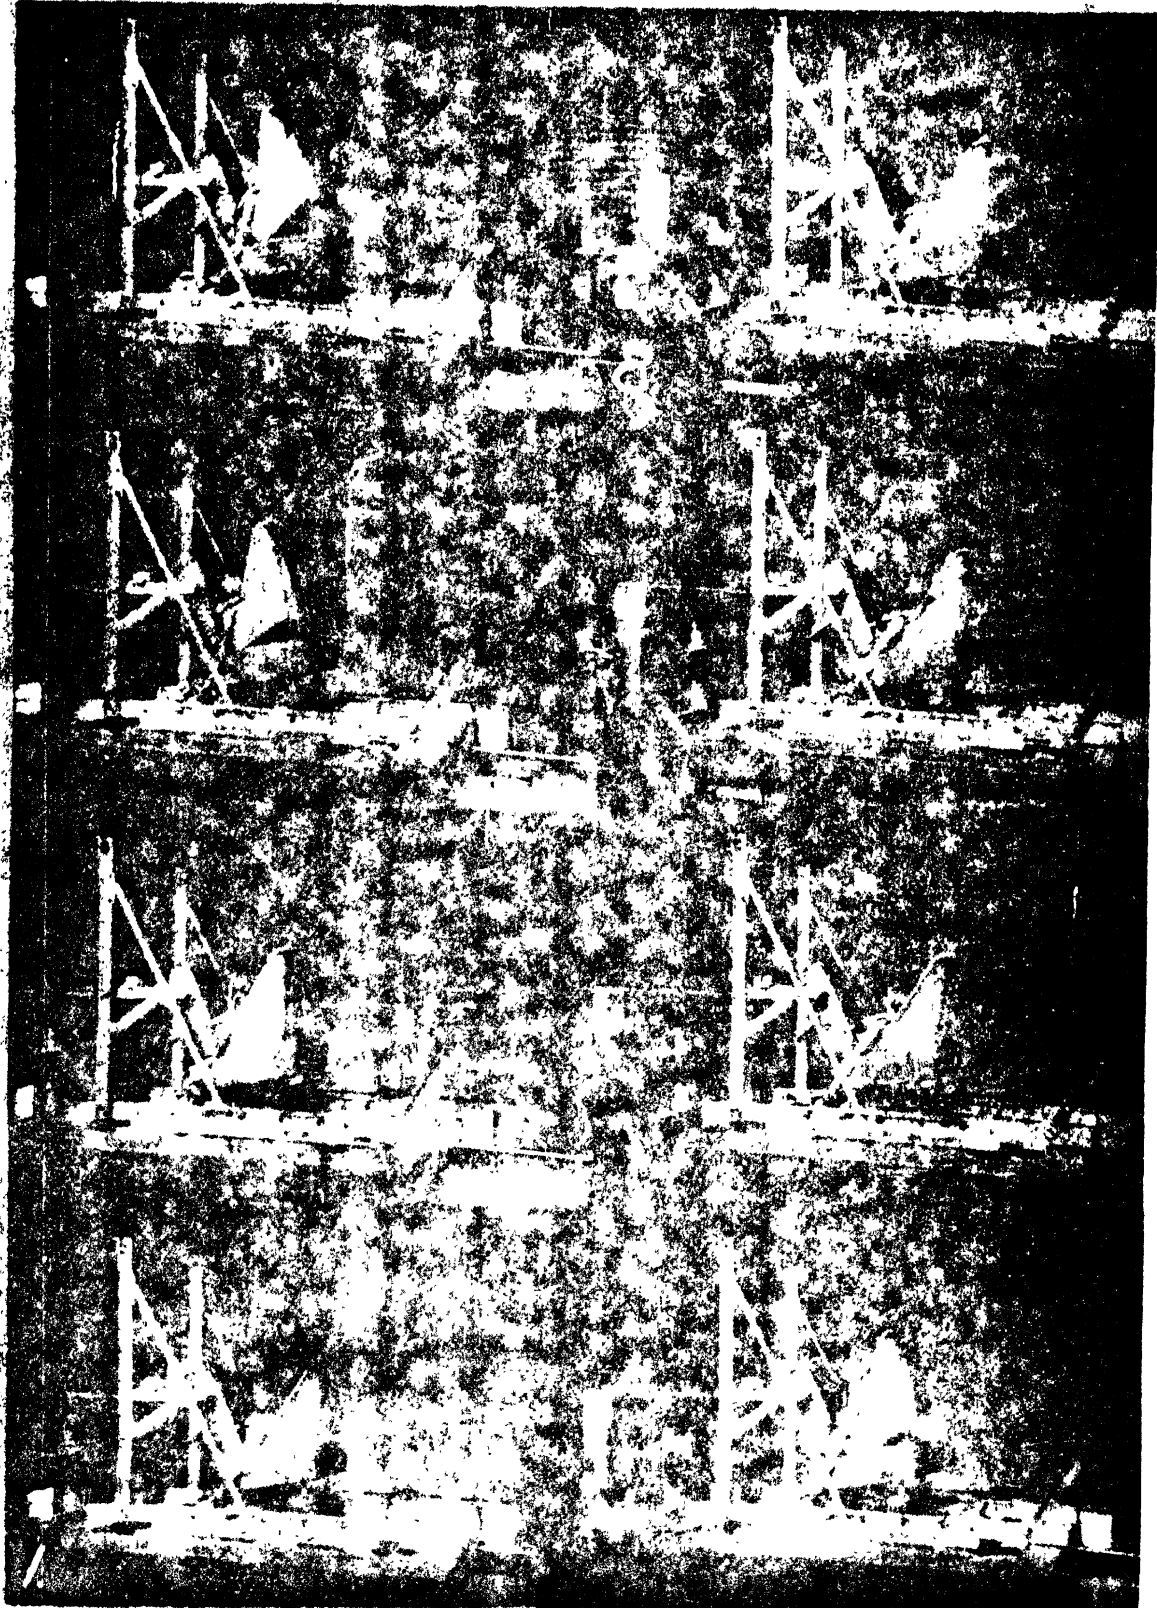
A123

Test No: A-123
Test Date: 4 August 1969
Restraint Code No.: C-25
Restraint Description: General Motors Infant Carrier

The doll appeared to experience a fairly gentle ride. The movies showed that the infant carrier tilted upward toward the adult seat back allowing the doll to impact the seat. No damage was suffered by the dummy except that the face appeared to be flattened somewhat. The small three-quarter-inch cross strap on the infant carrier connecting the two shoulder straps came unsnapped.

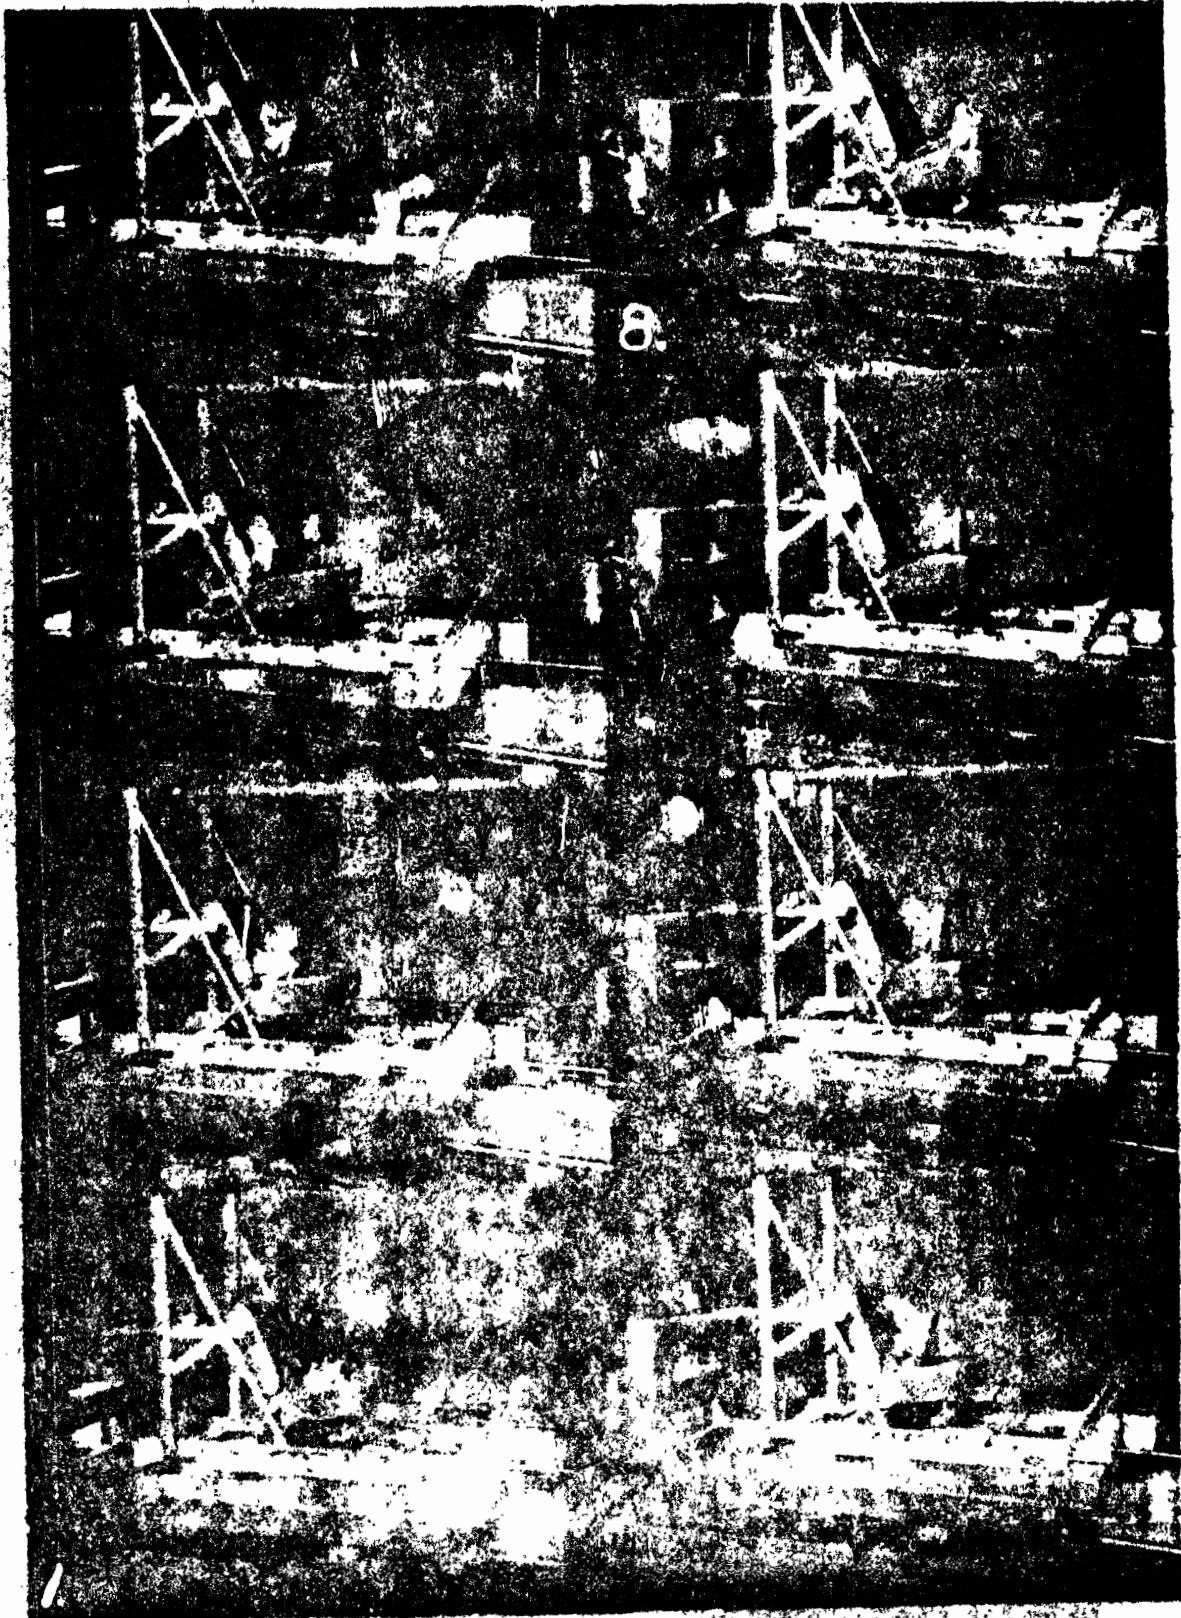
A124

Test No: A-124
Test Date: 4 August 1969
Restraint Code No.: C-41
Restraint Description: Circle-Square Ba-Be Safe Harness

No damage was apparent either to the doll or to the restraint system. The doll pivoted up into contact with the adult seat back during the simulated rear-end collision, then it rebounded violently into an upright sitting position flexed at the waist.
