CHILD SEAT AND RESTRAINT SYSTEMS TEST RESULTS

APPENDIX D

**THE UNIVERSITY OF MICHIGAN
HIGHWAY SAFETY RESEARCH INSTITUTE
HURON PARKWAY AND BAXTER ROAD
ANN ARBOR, MICHIGAN 48105**

Final Report

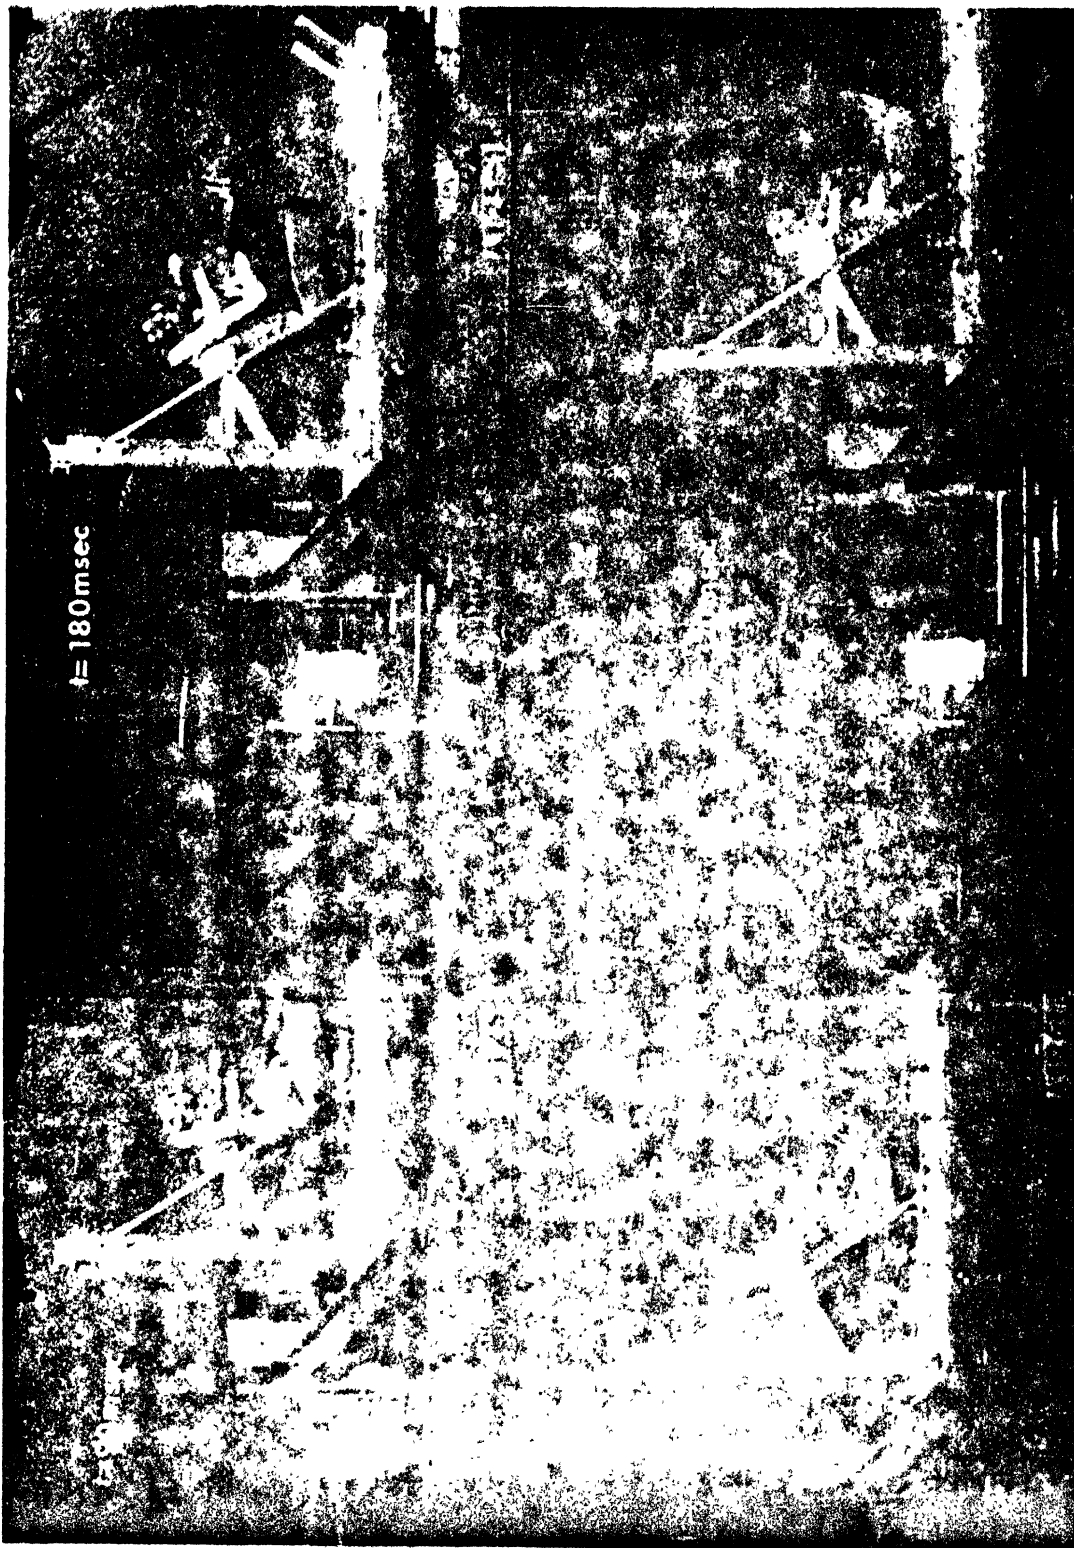
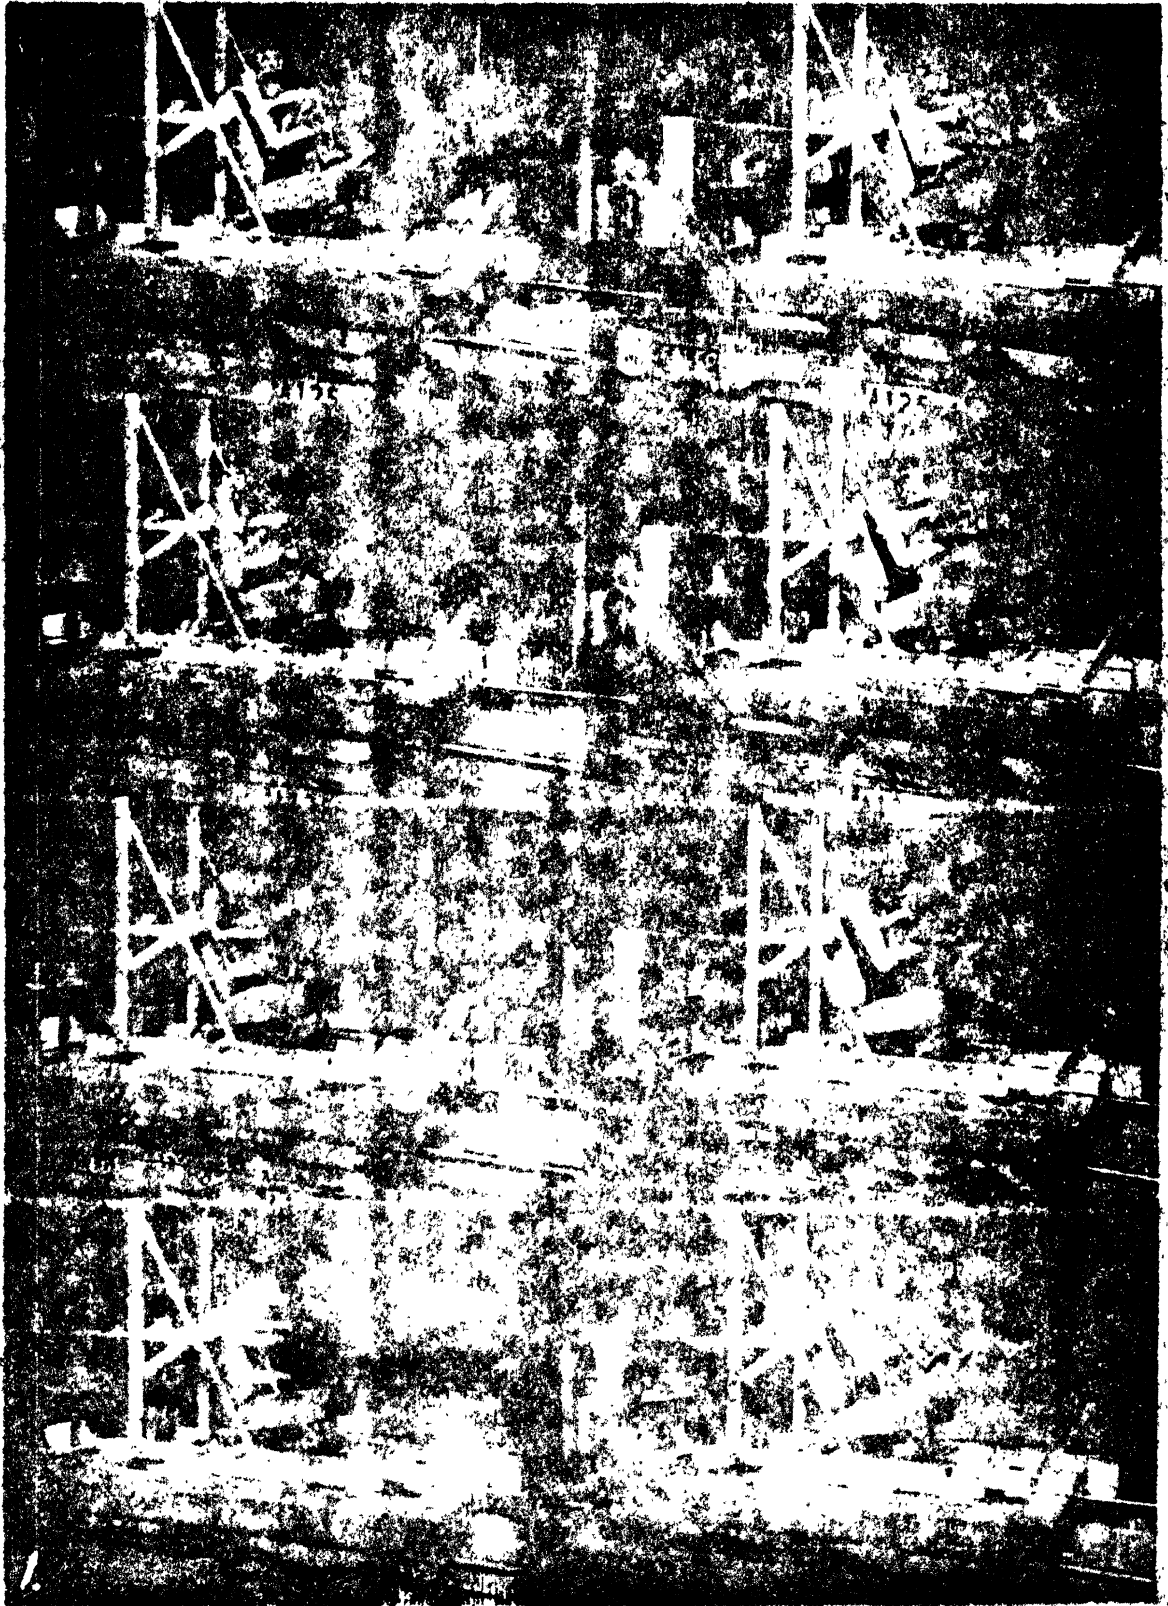
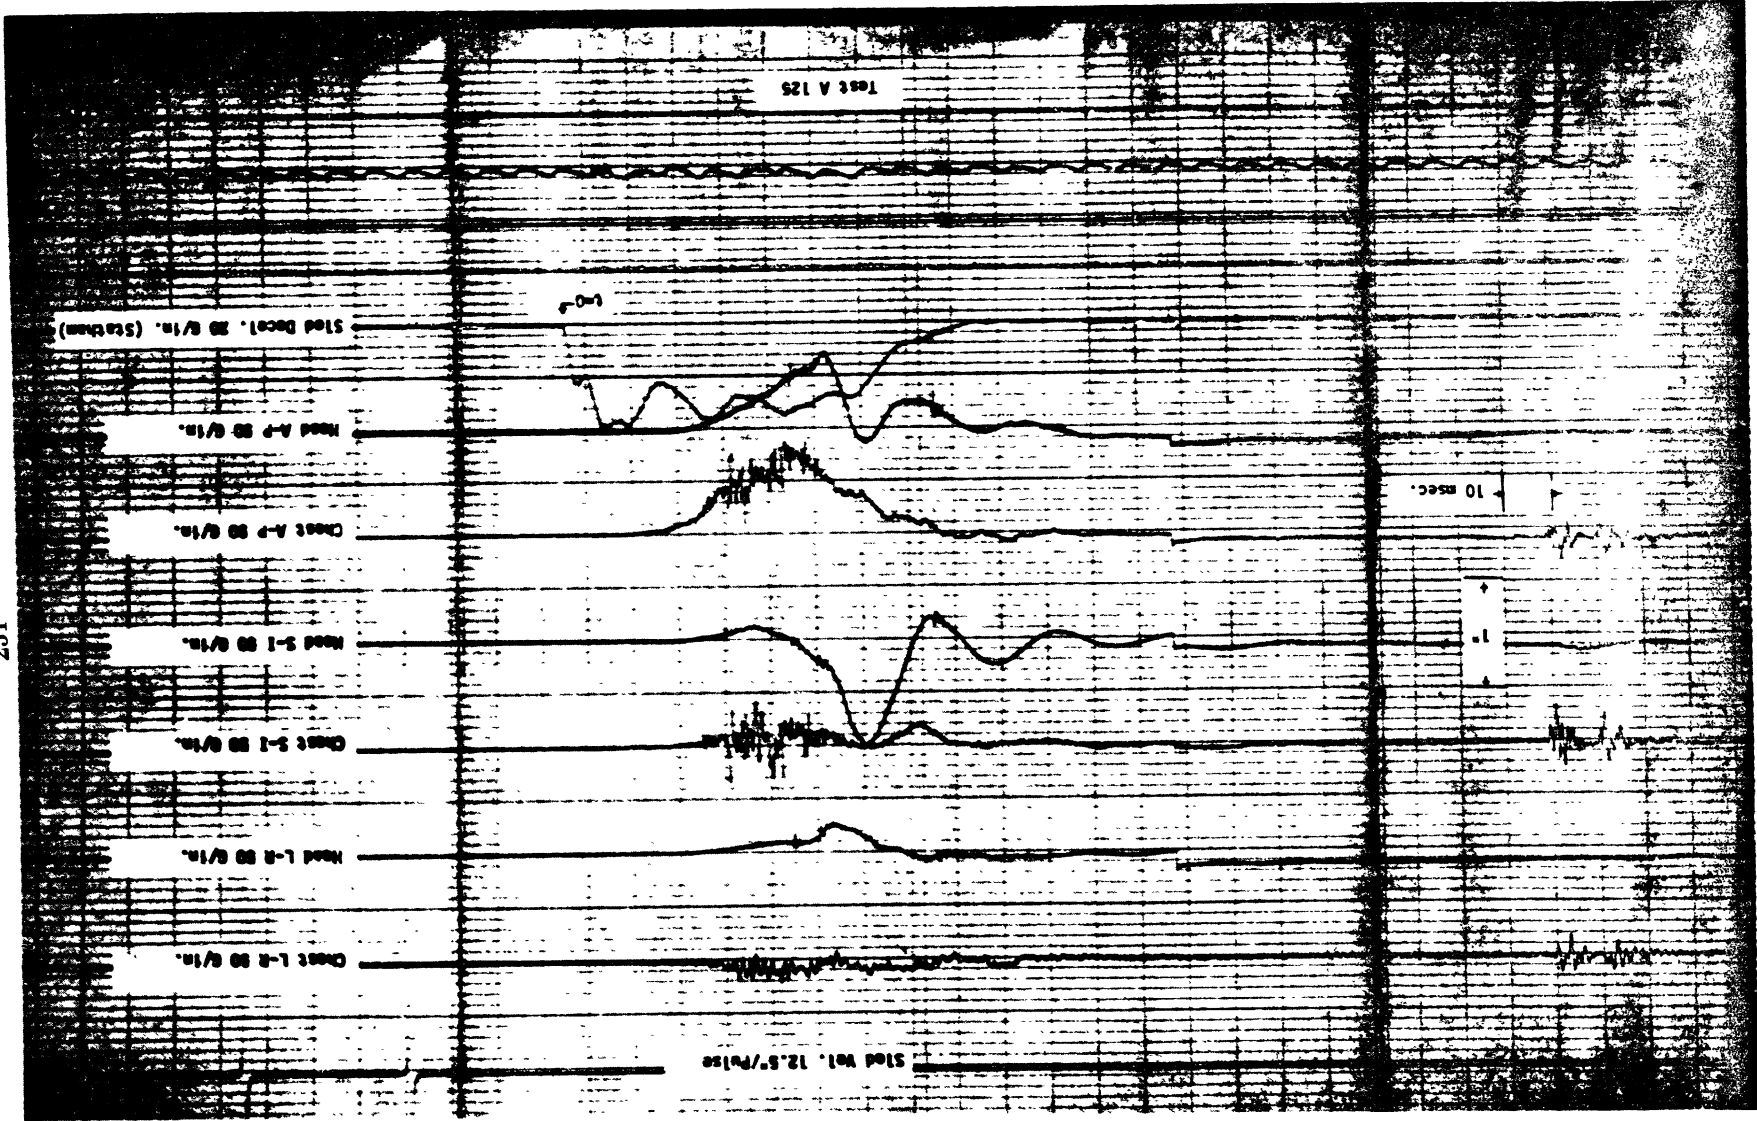
A125

Test No: A-125
Test Date: 4 August 1969
Restraint Code No.: C-6
Restraint Description: George B. Walker Safety Seat

The dummy experienced fairly high g-loadings in this test. Some whiplash was observed as the dummy's head slid sideways off the high seat back. A strong rebound was observed.

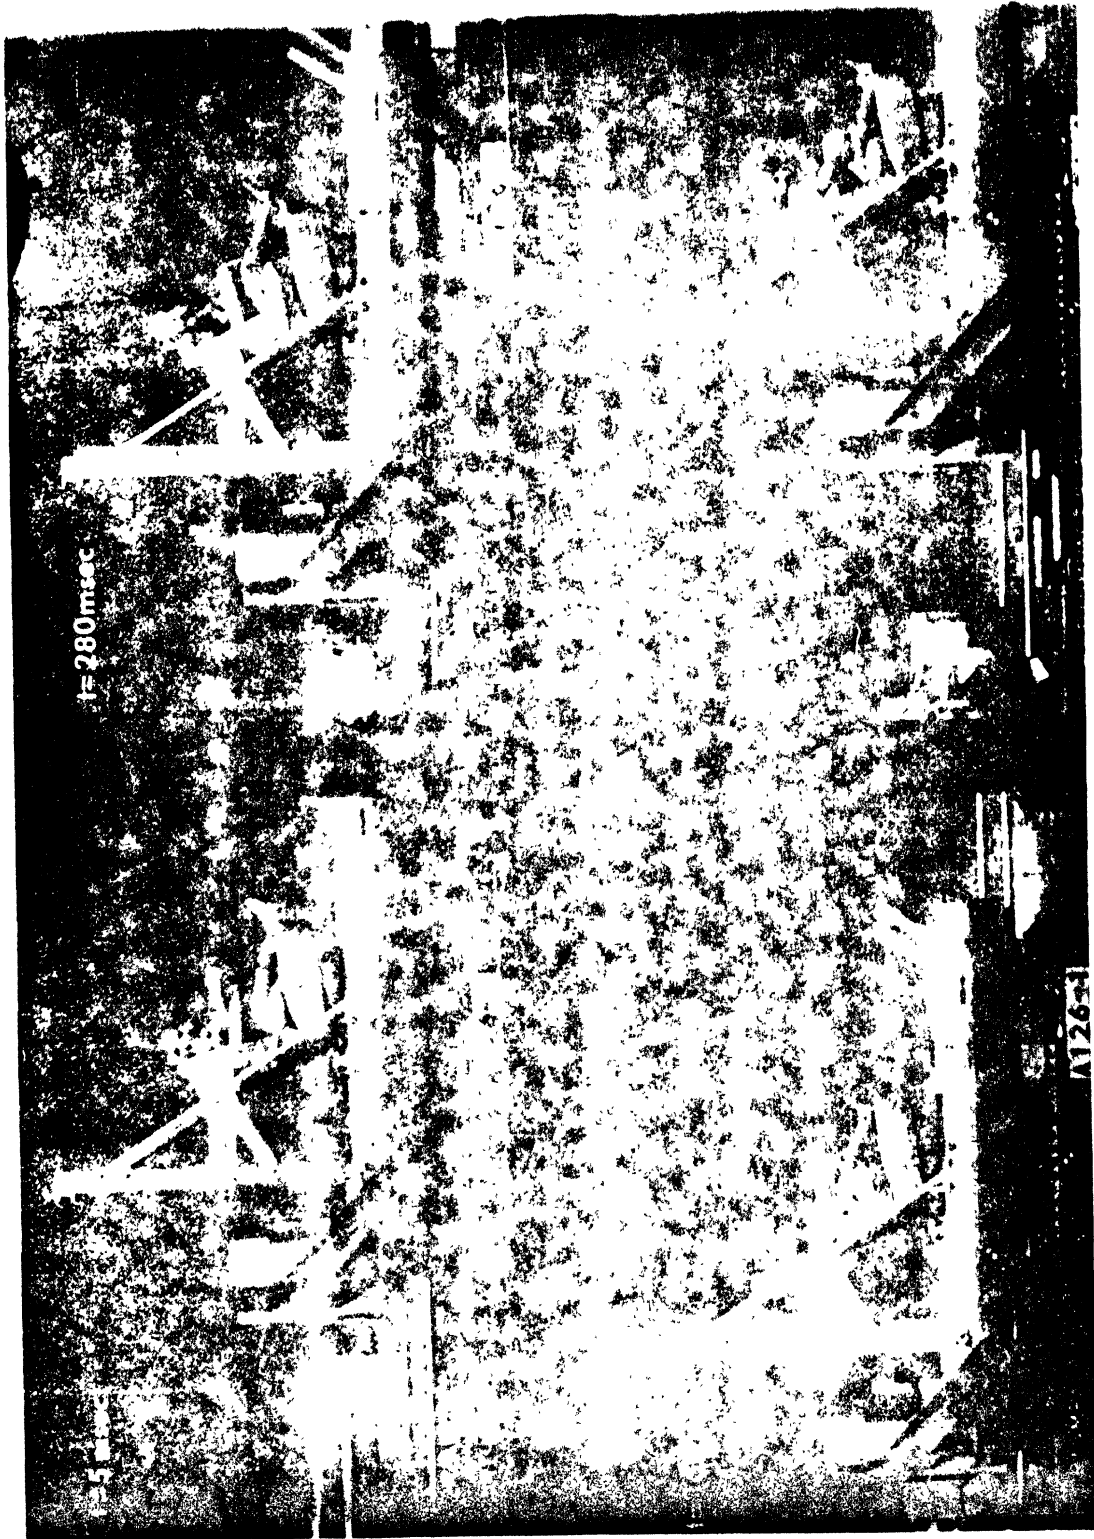
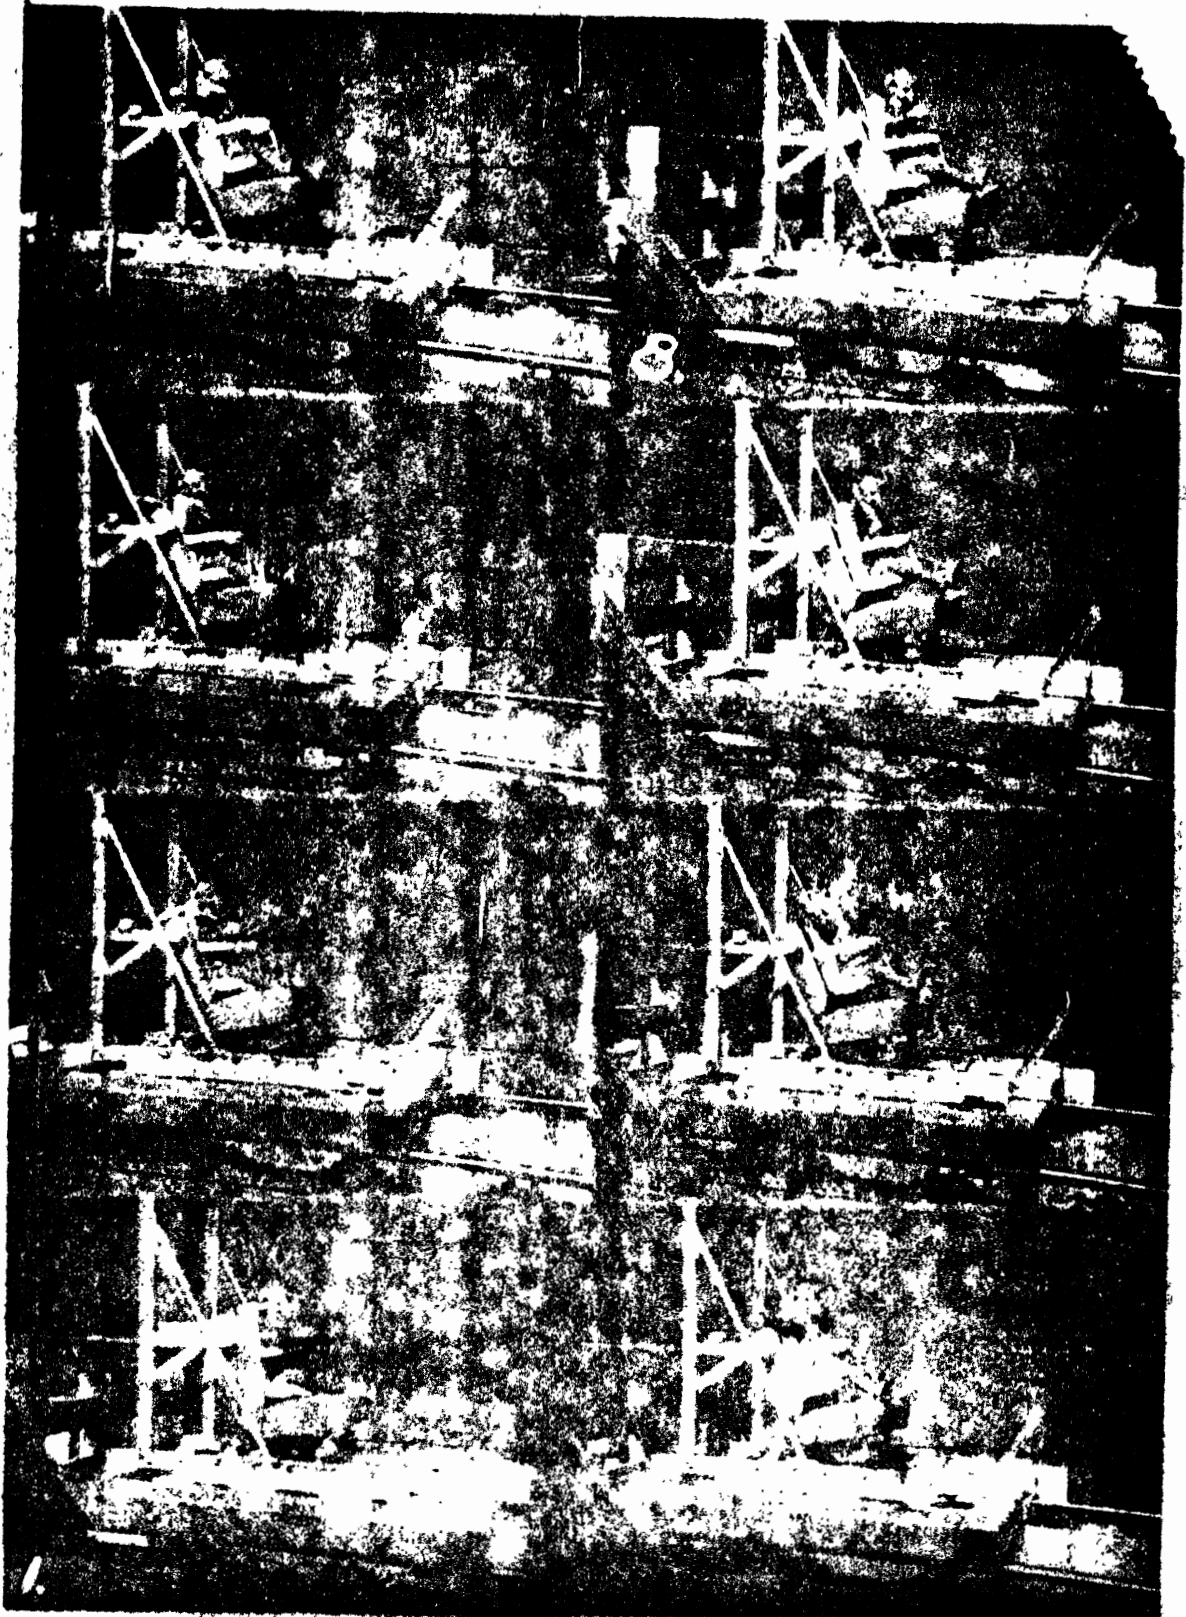
A126

Test No: A-126
Test Date: 4 August 1969
Restraint Code No.: C-6
Restraint Description: George B. Walker Safety Seat

The dummy received a fairly gentle ride in this test. Some straightening of the bail hooks was evidenced on the rebound.

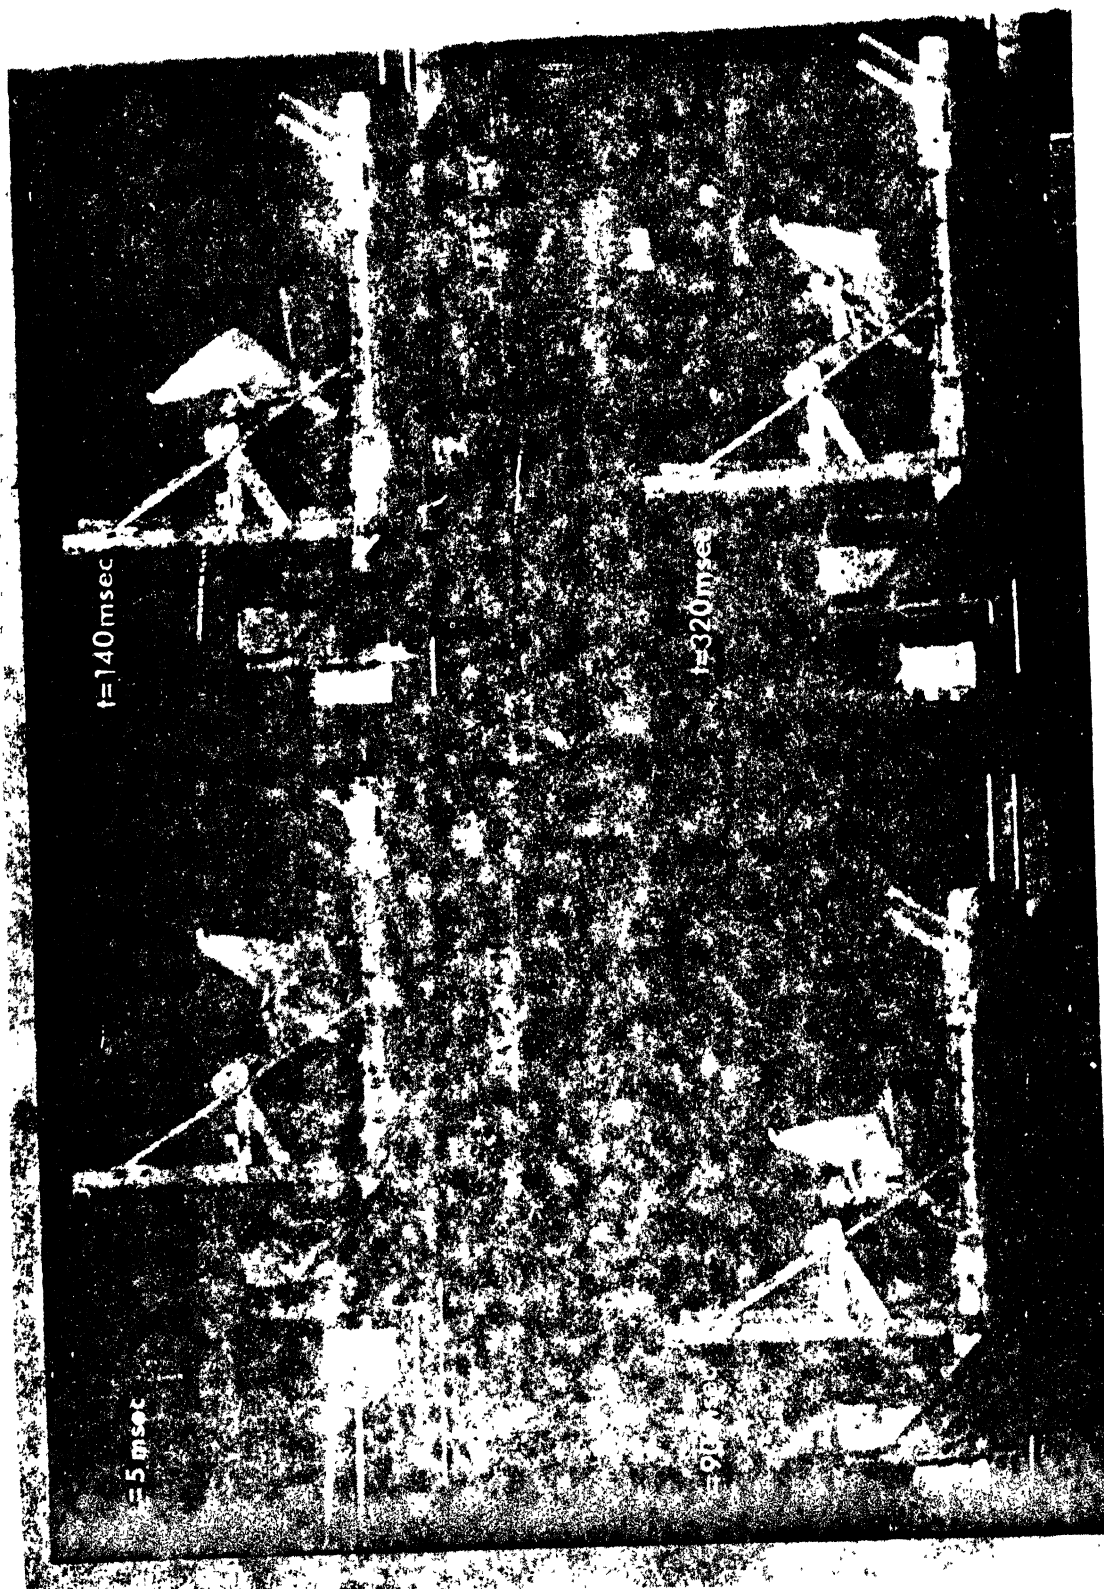
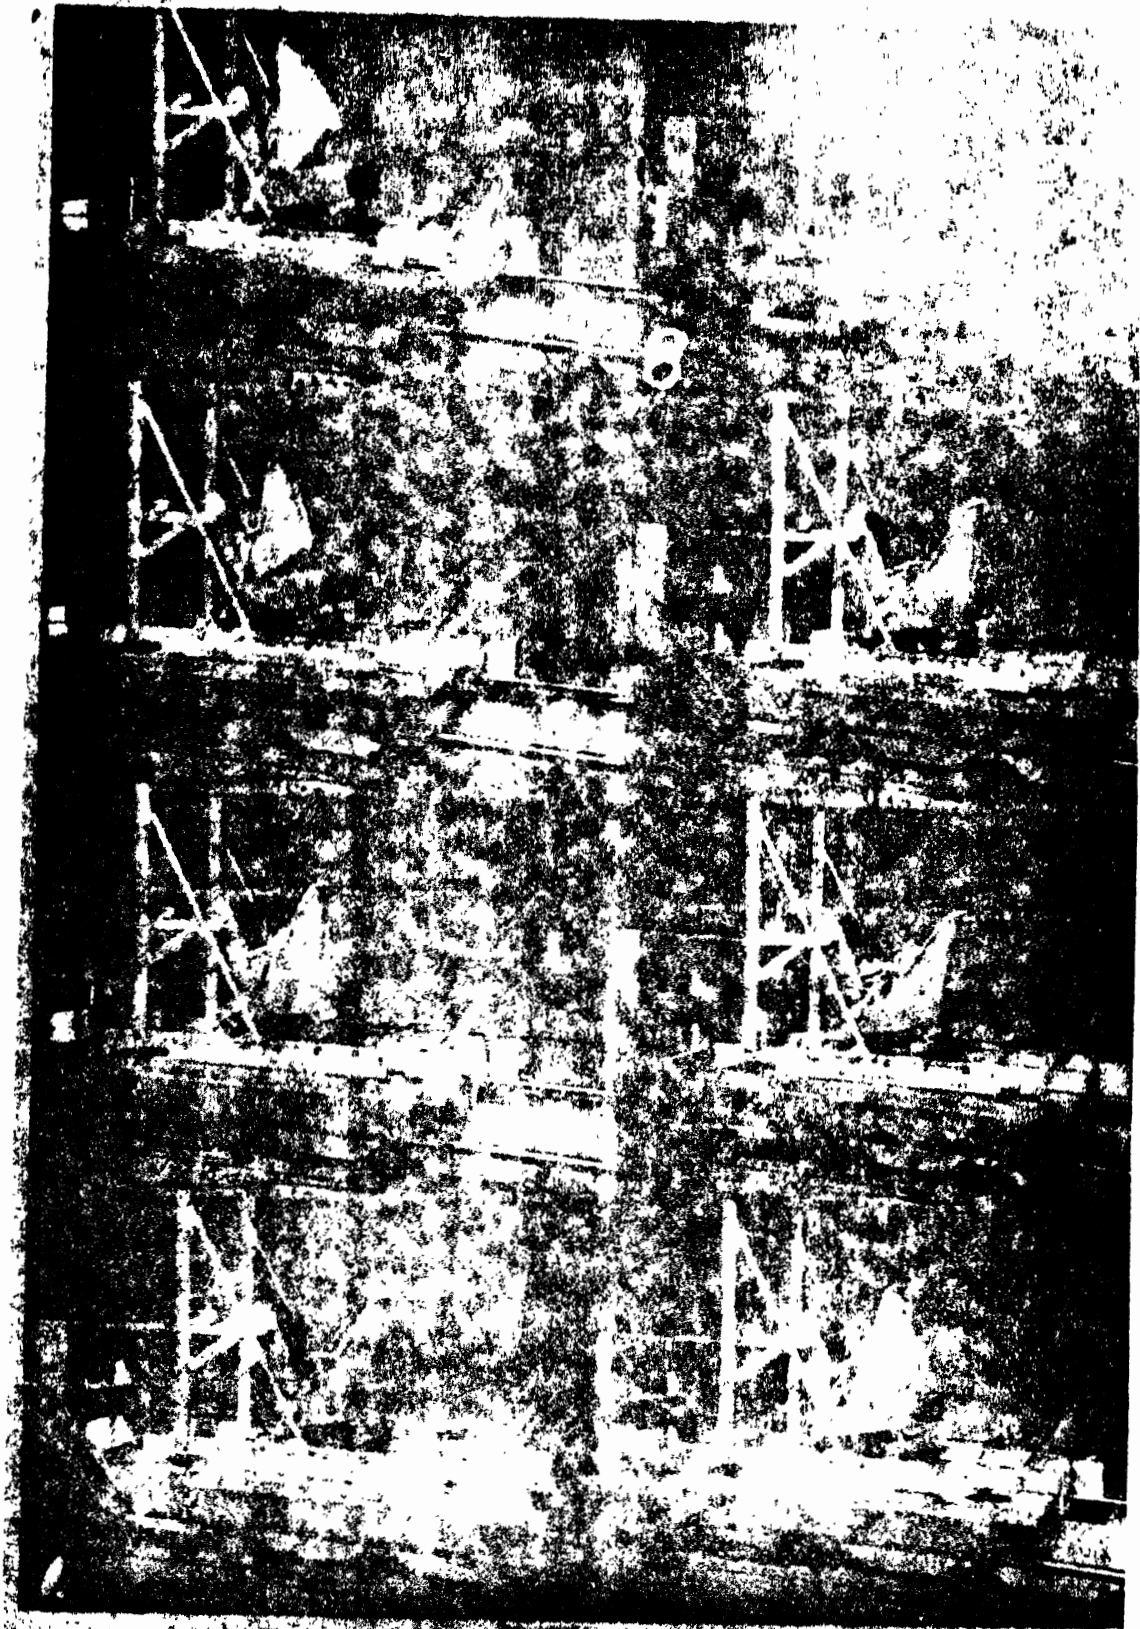
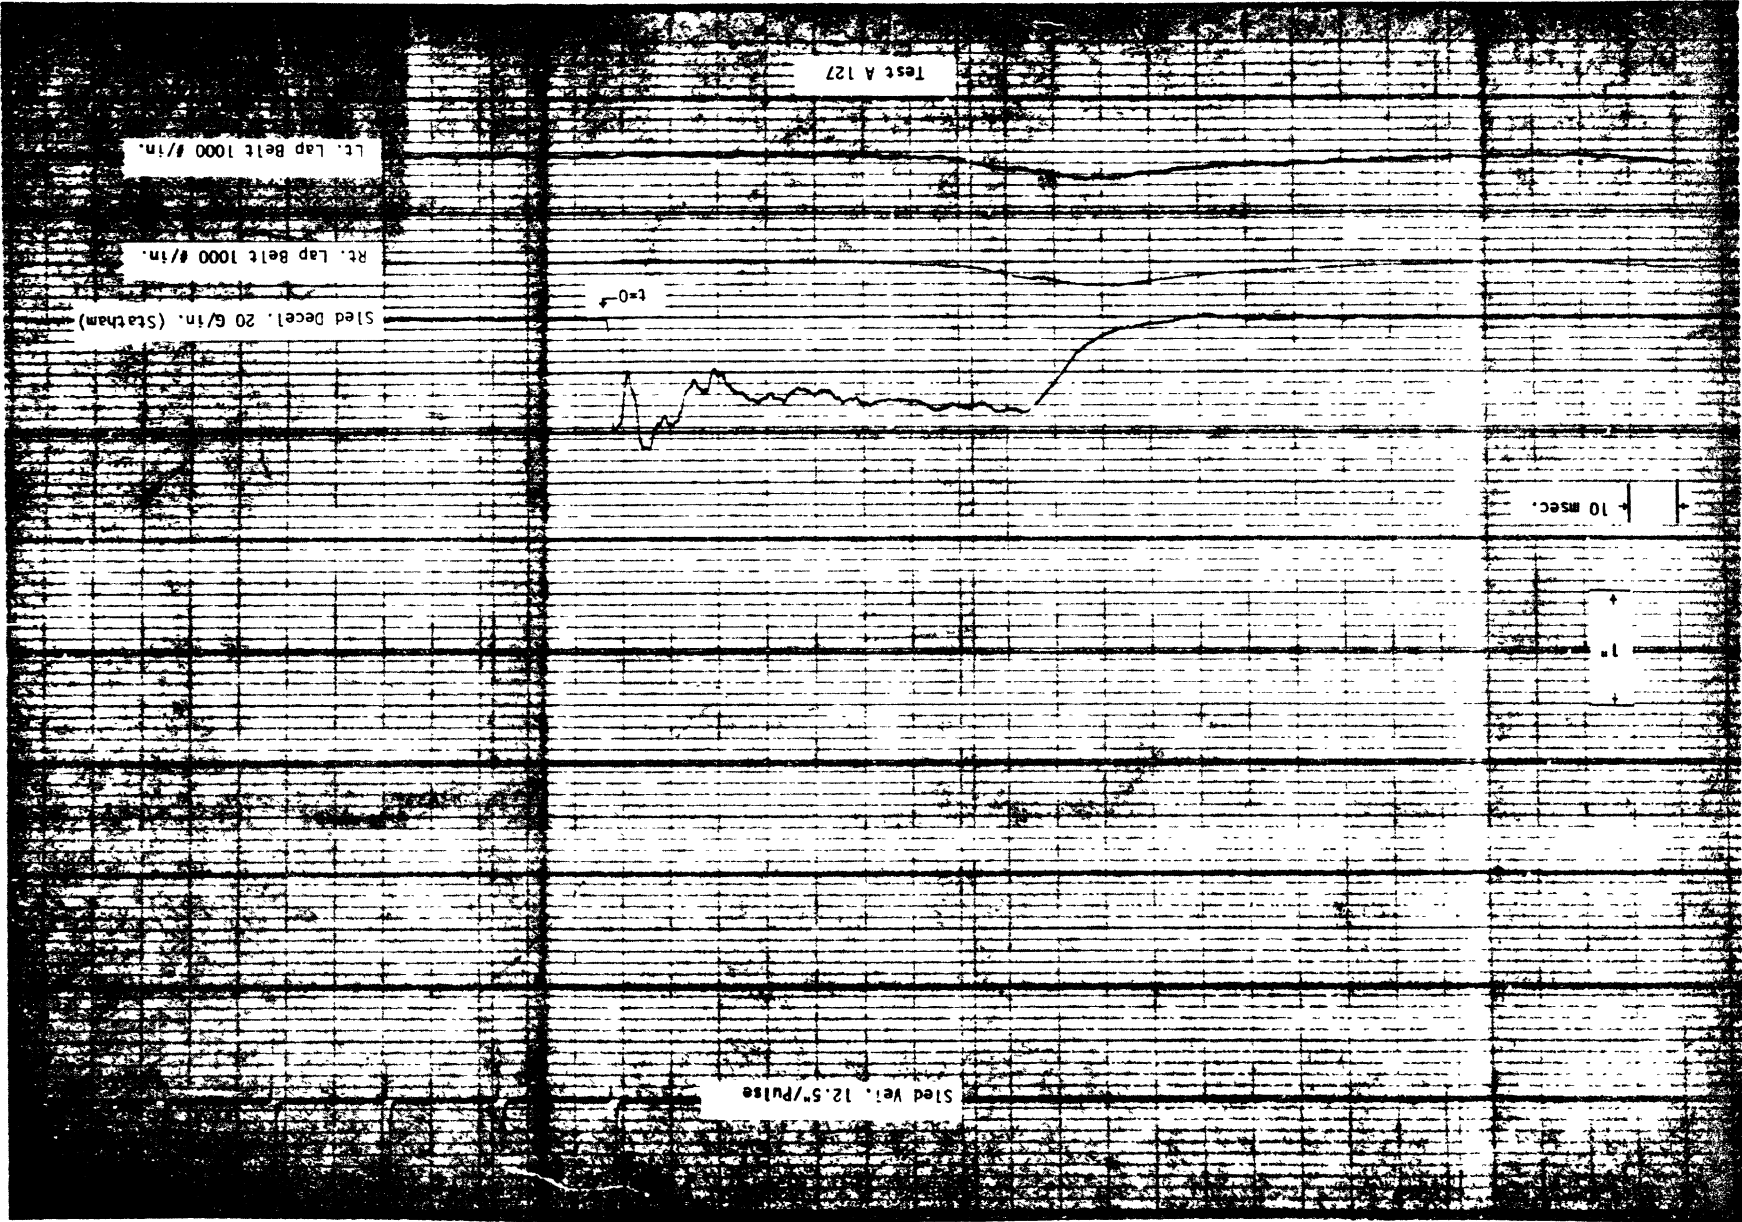
A127

Test No: A-127
Test Date: 5 August 1969
Restraint Code No: C-25
Restraint Description: General Motors Infant Carrier
Dummy: doll
Sled Velocity: 30 mph
Sled G-level: 18
Impact Direction: Rear-end
Dummy Attitude: Semi-reclining

The infant carrier pitched upwards toward the adult seat back causing the doll to contact the seat back. Again the small three-quarter-inch cross strap connecting the shoulder straps came unsnapped.

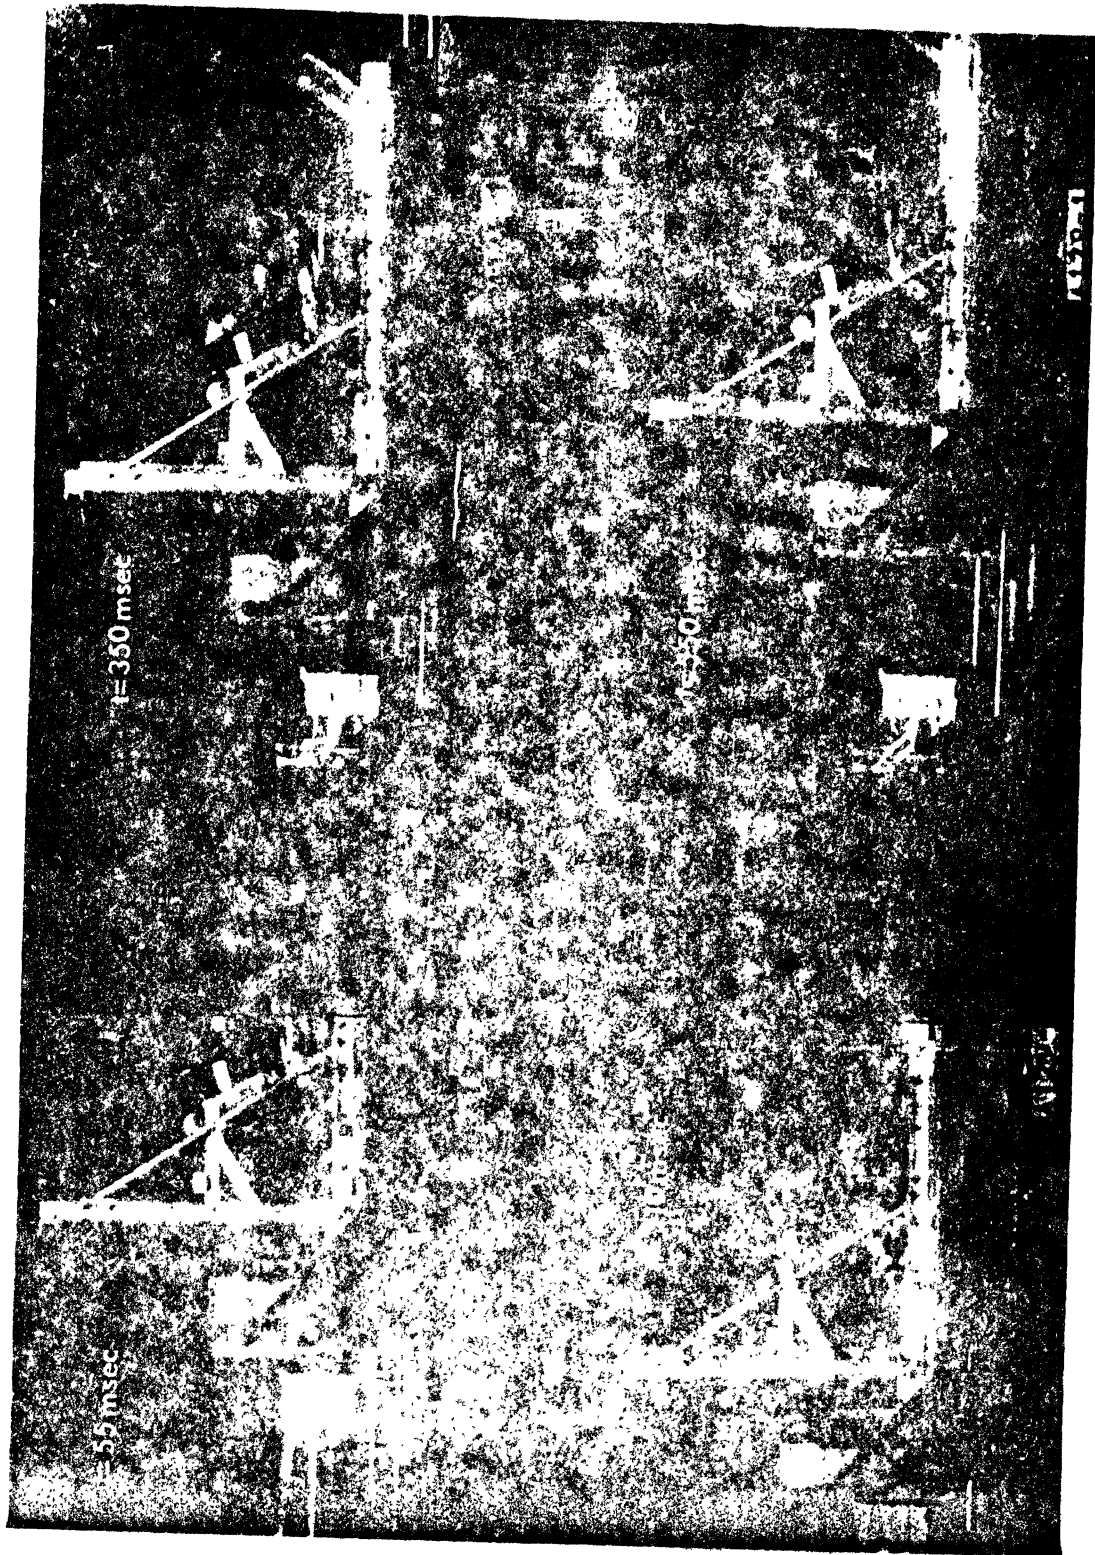
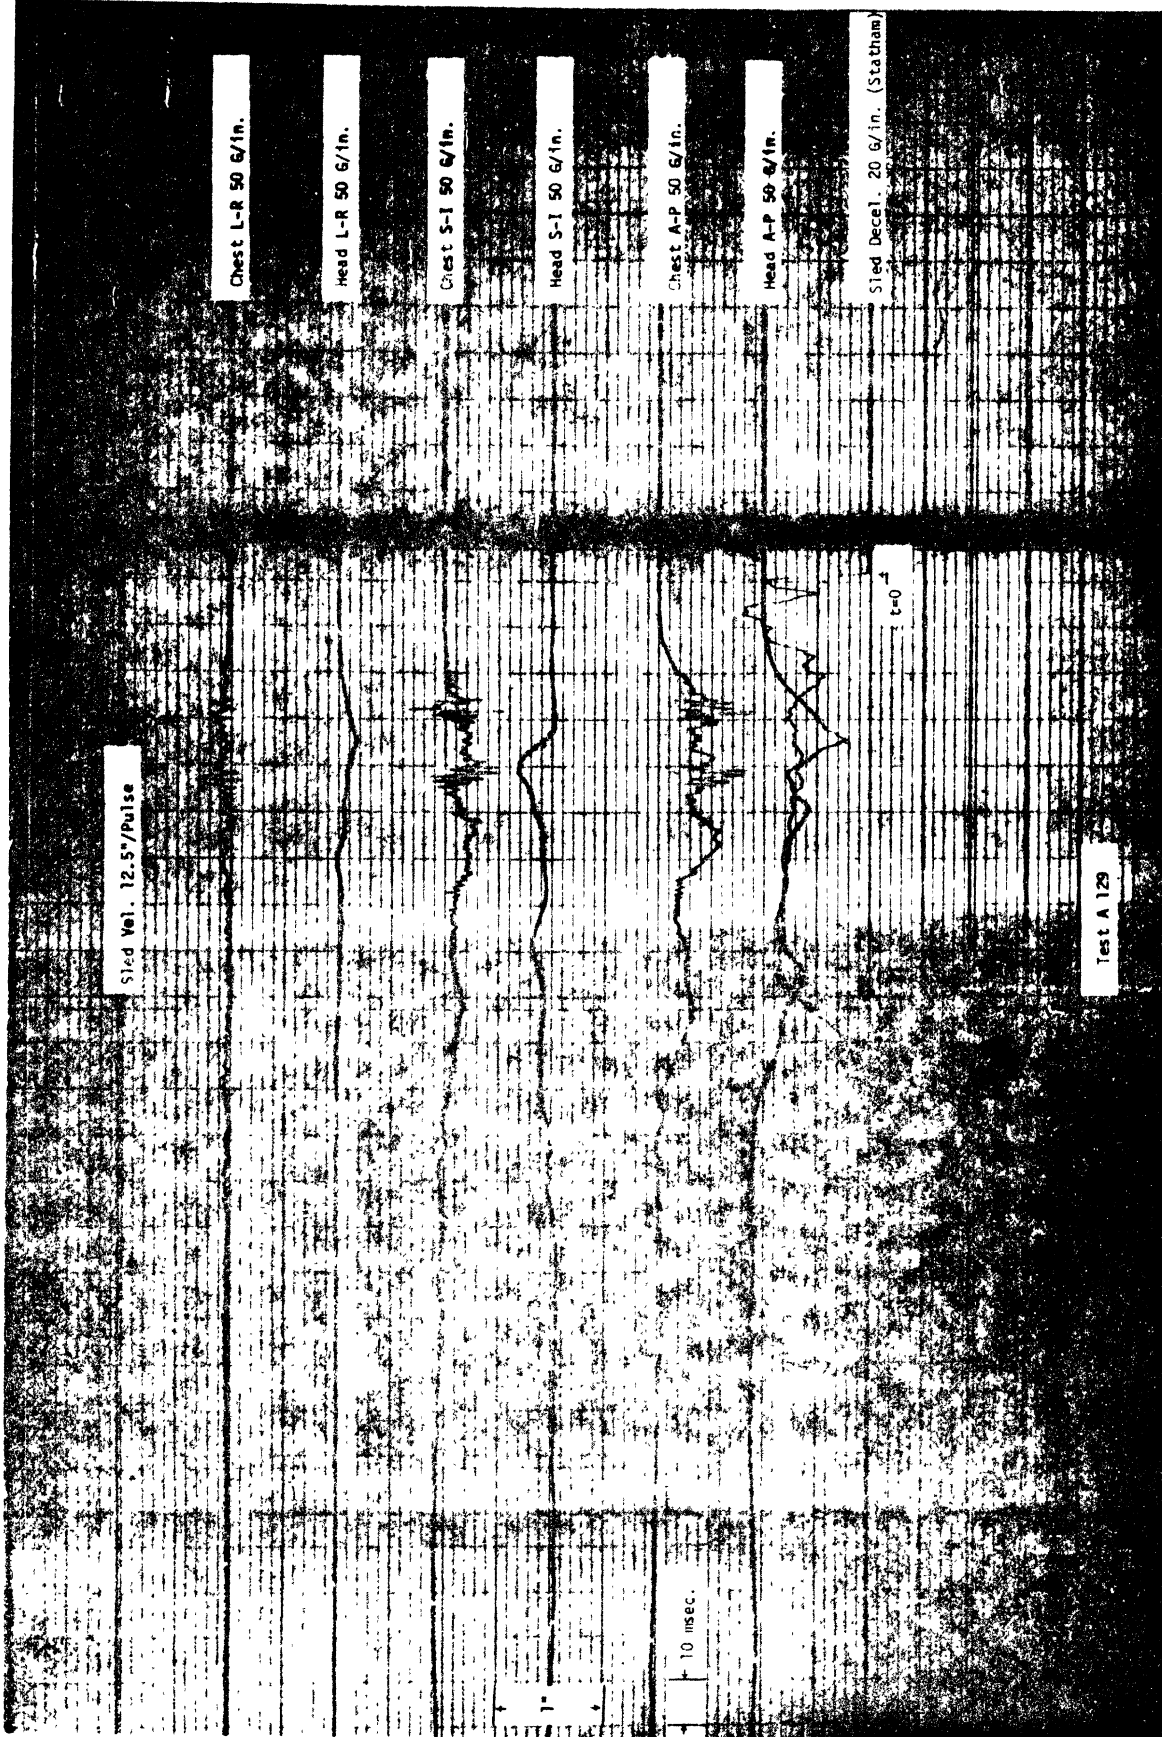
A129

Test No: A-129
Test Date: 5 August 1969
Restraint Code No.: C-23
Restraint Description: Volvo Child Safety Seat

The dummy received a fairly gentle ride in this test. Rebound into the integral strap system seemed quite severe.
