CHILD SEAT AND RESTRAINT SYSTEMS TEST RESULTS

APPENDIX D

Final Report

Volume III of III

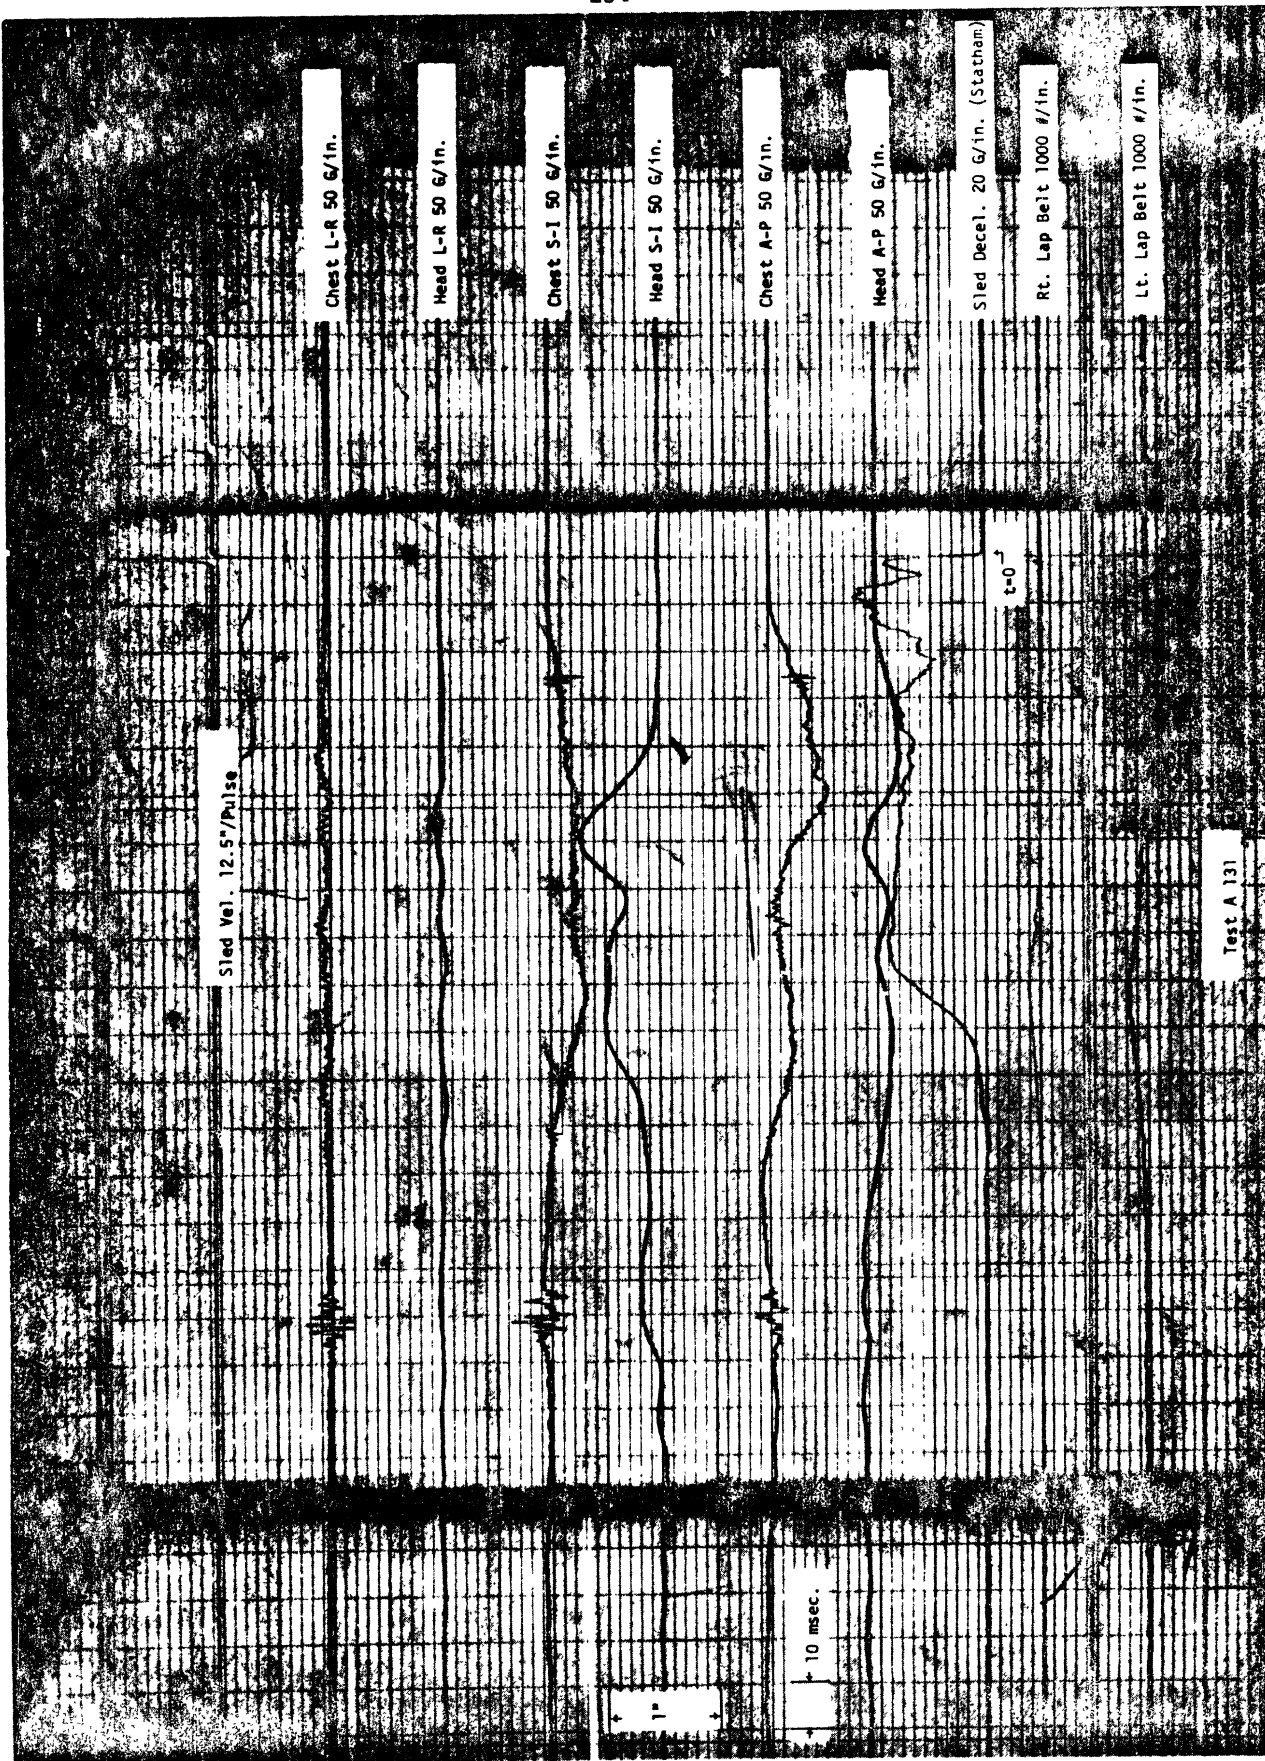
A131

The g-loadings experienced by the dummy were moderate. However, the height of the child seat back coincided exactly with the height of the adult seat back. Because there was no headrest on the adult seat, severe whiplash was encountered by the dummy.

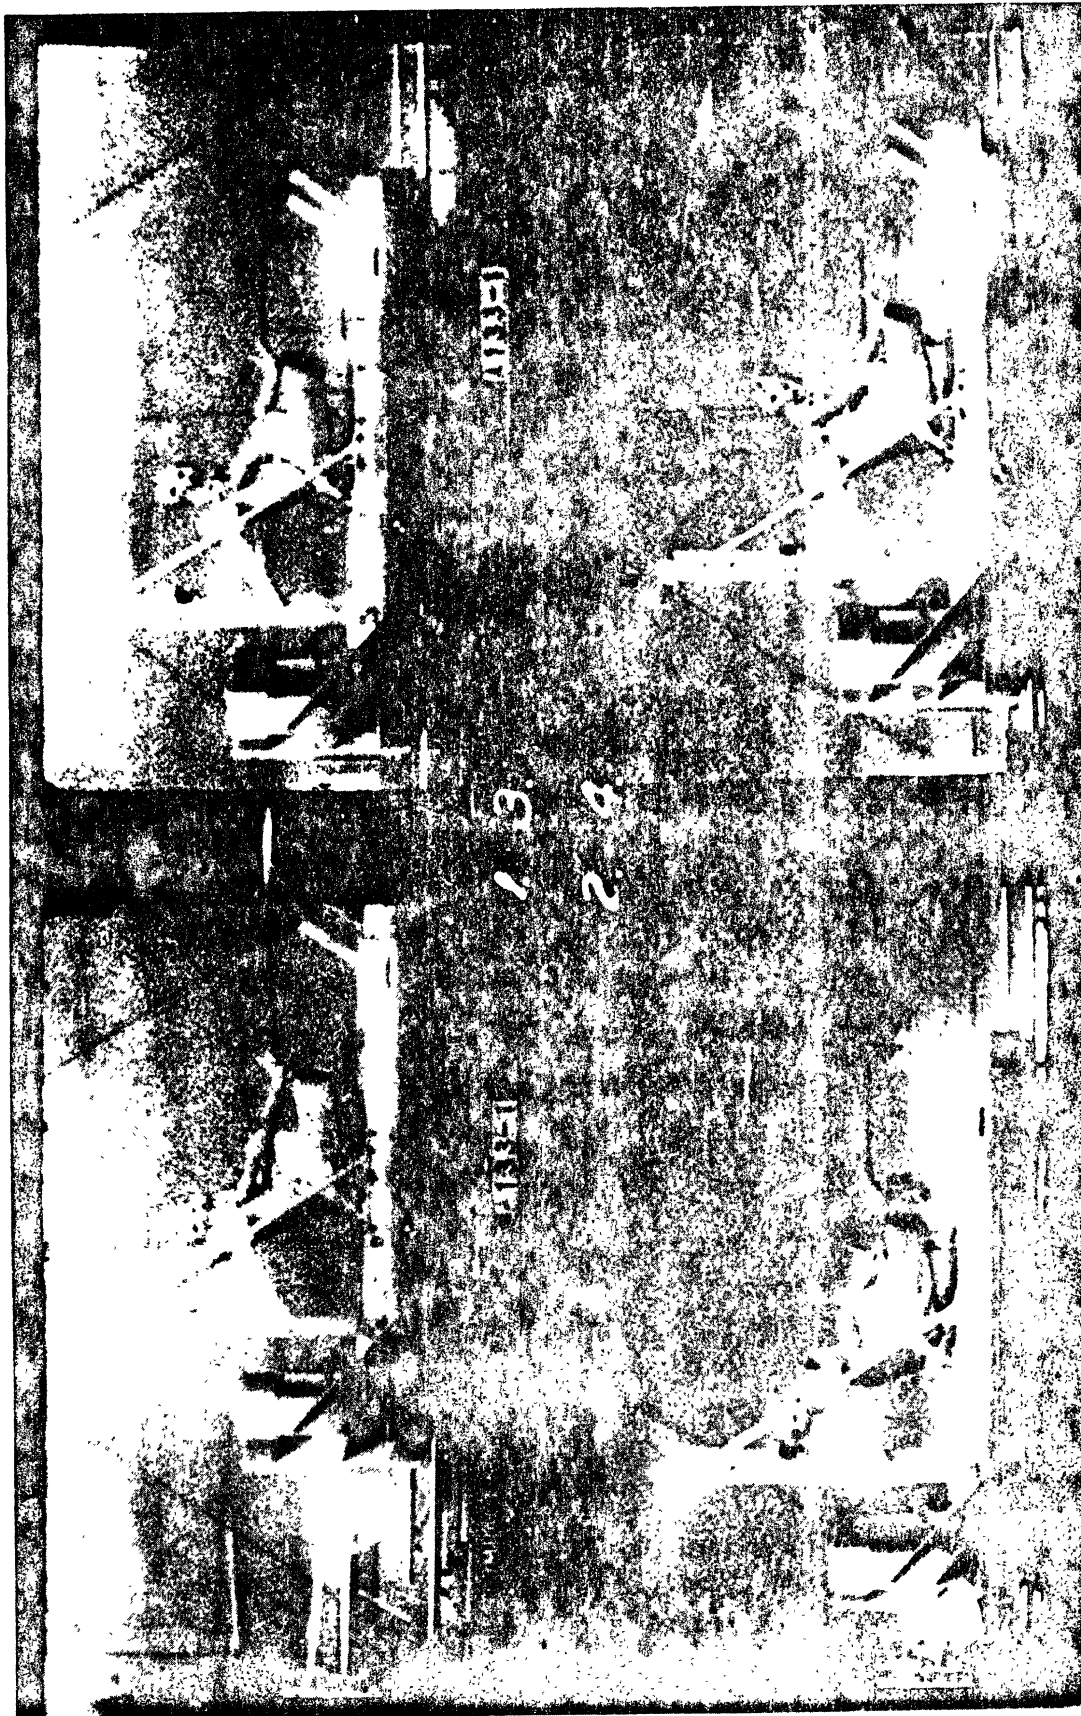
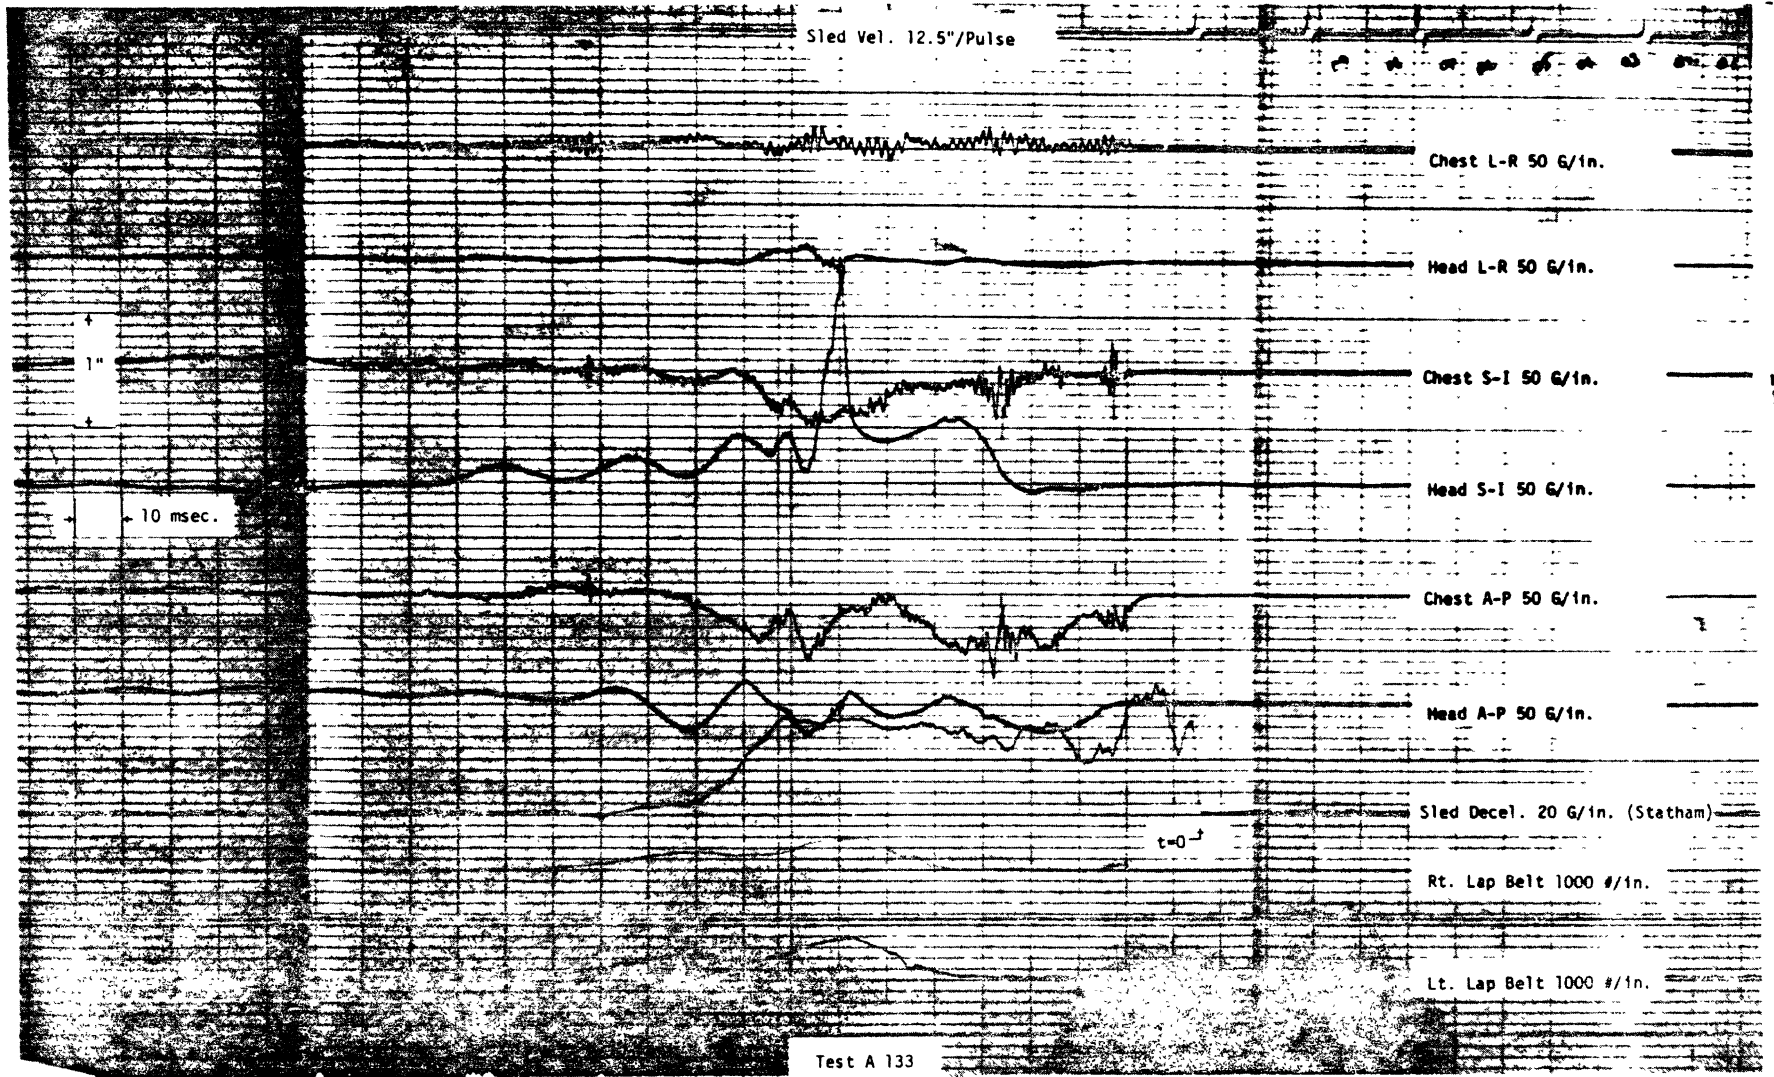
A133

The dummy received quite high loadings especially in the chest superior-inferior accelerometer. Because the height of the child seat and the height of the adult seat were similar the dummy received a very severe whiplash of the neck. Moderate rebound was observed.

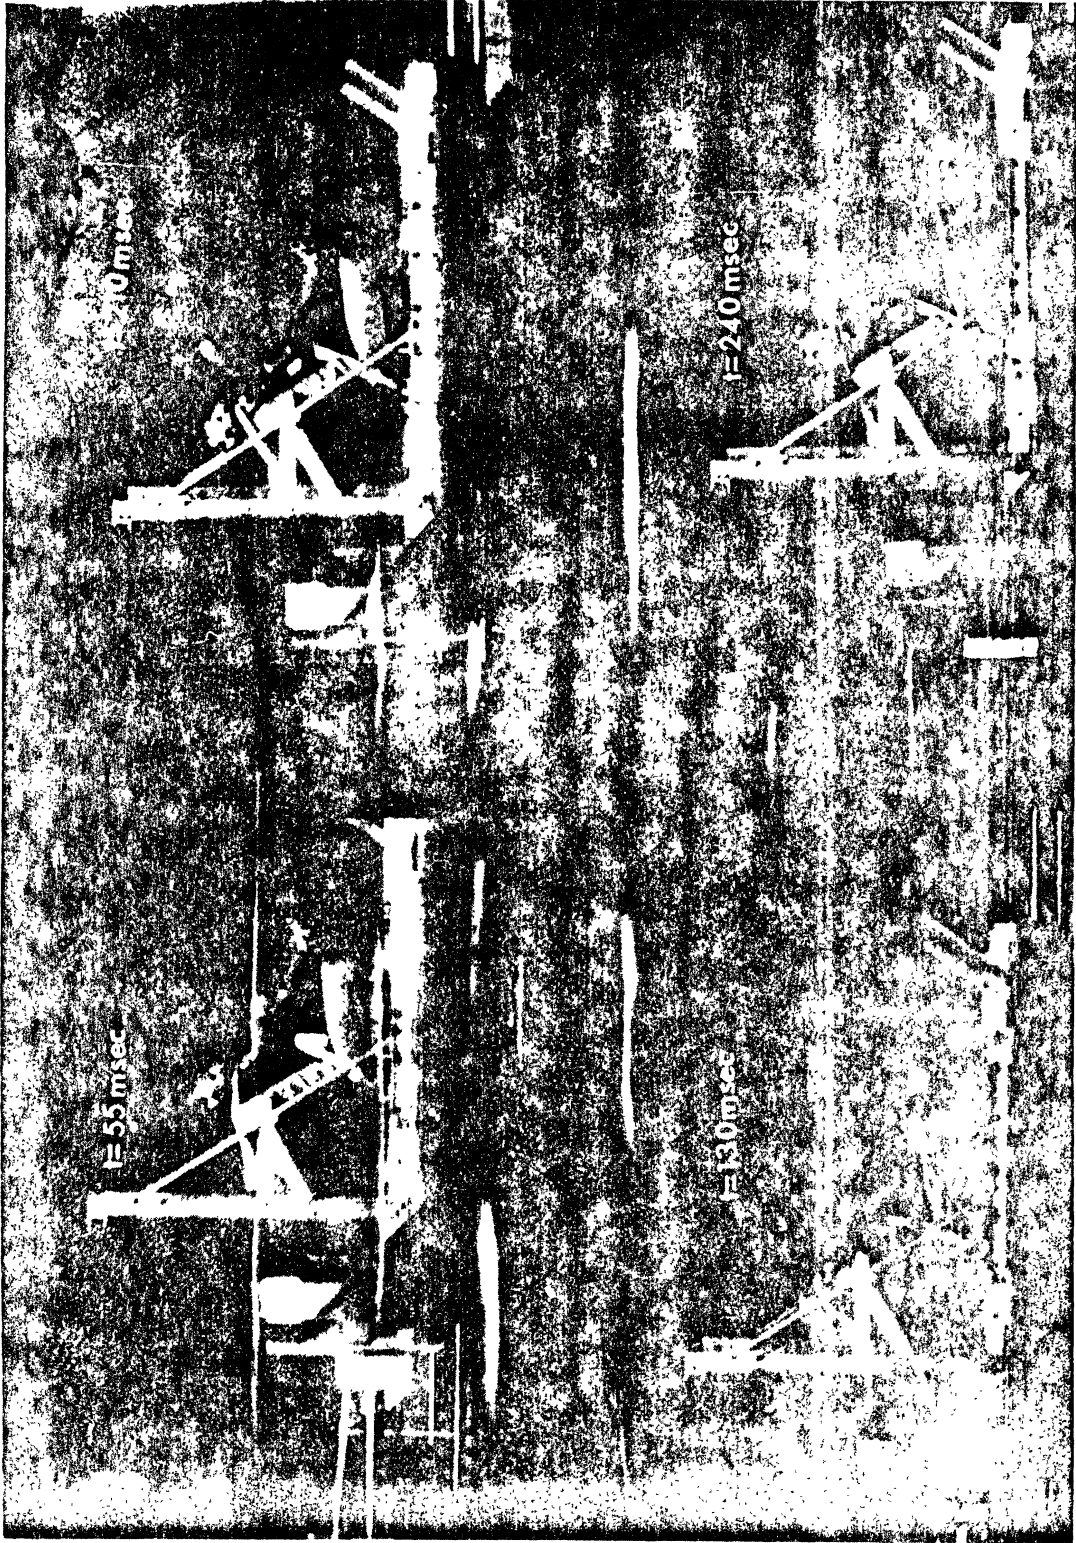
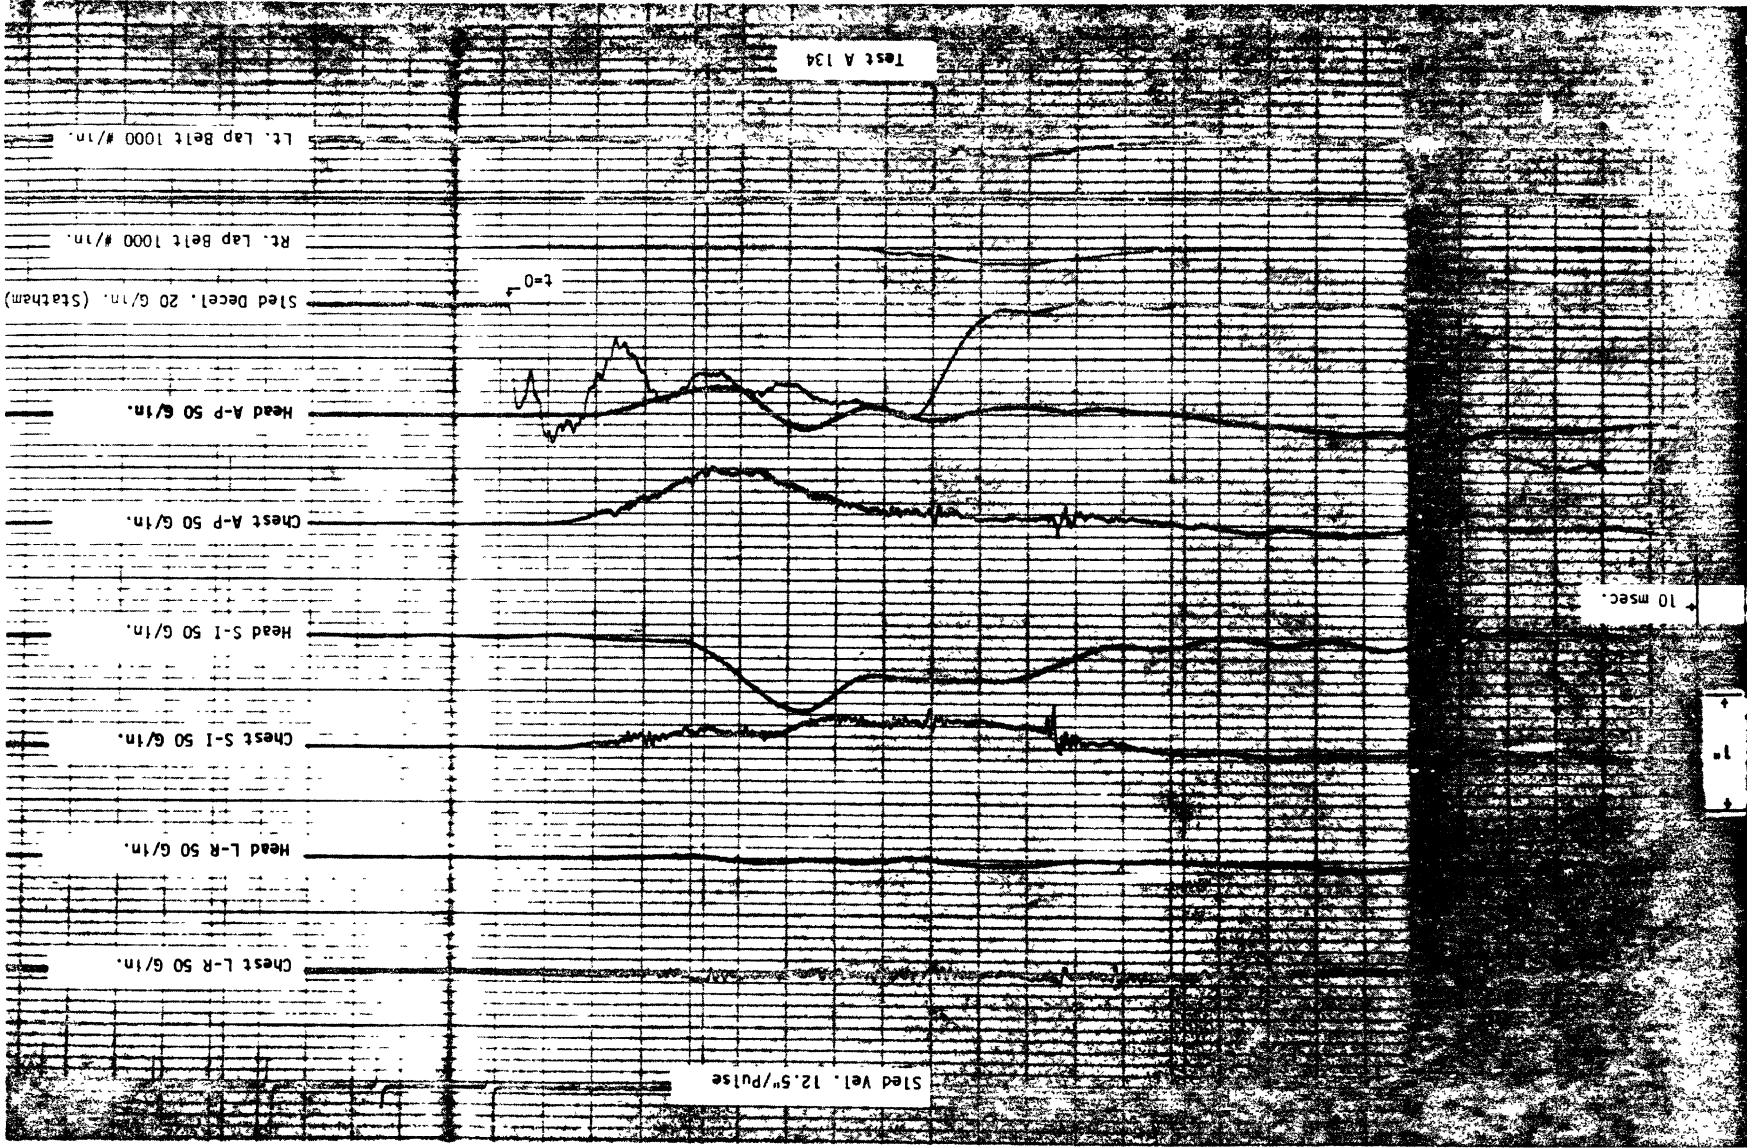
A134

The loadings experienced by the dummy in this test were quite gentle. However, because of the seat height problem severe whiplash was again observed.

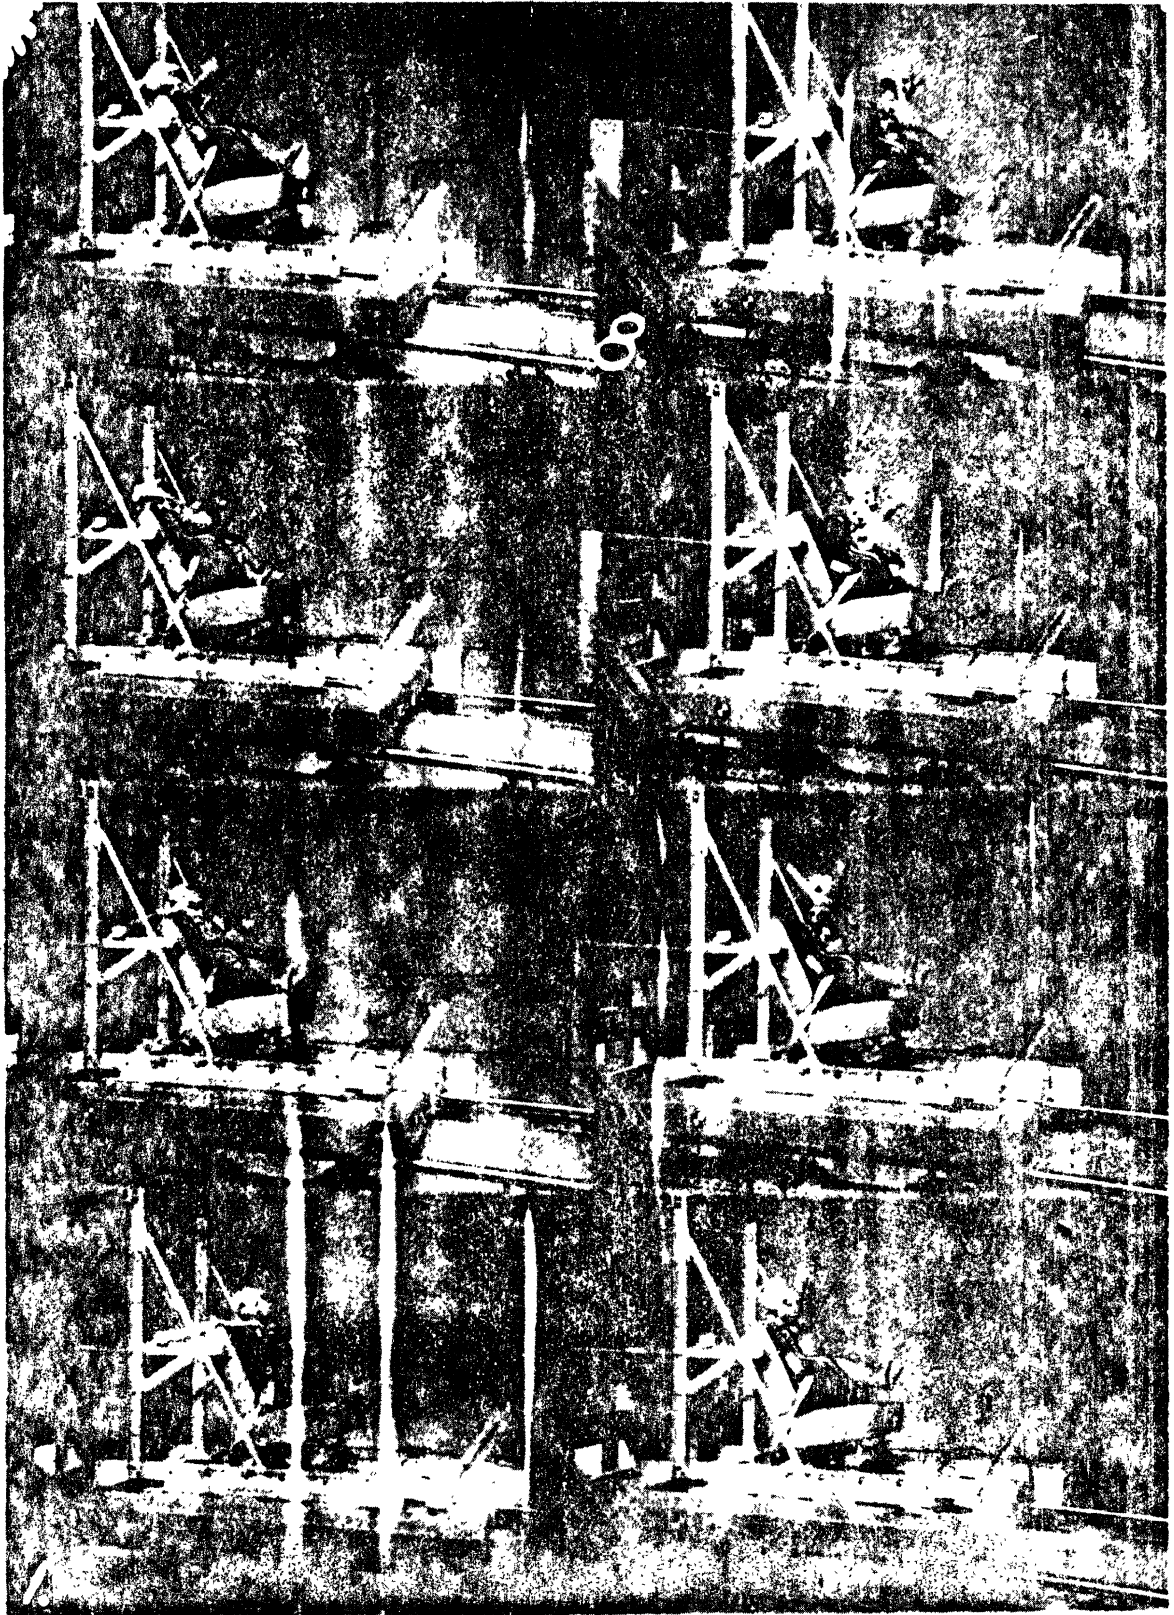
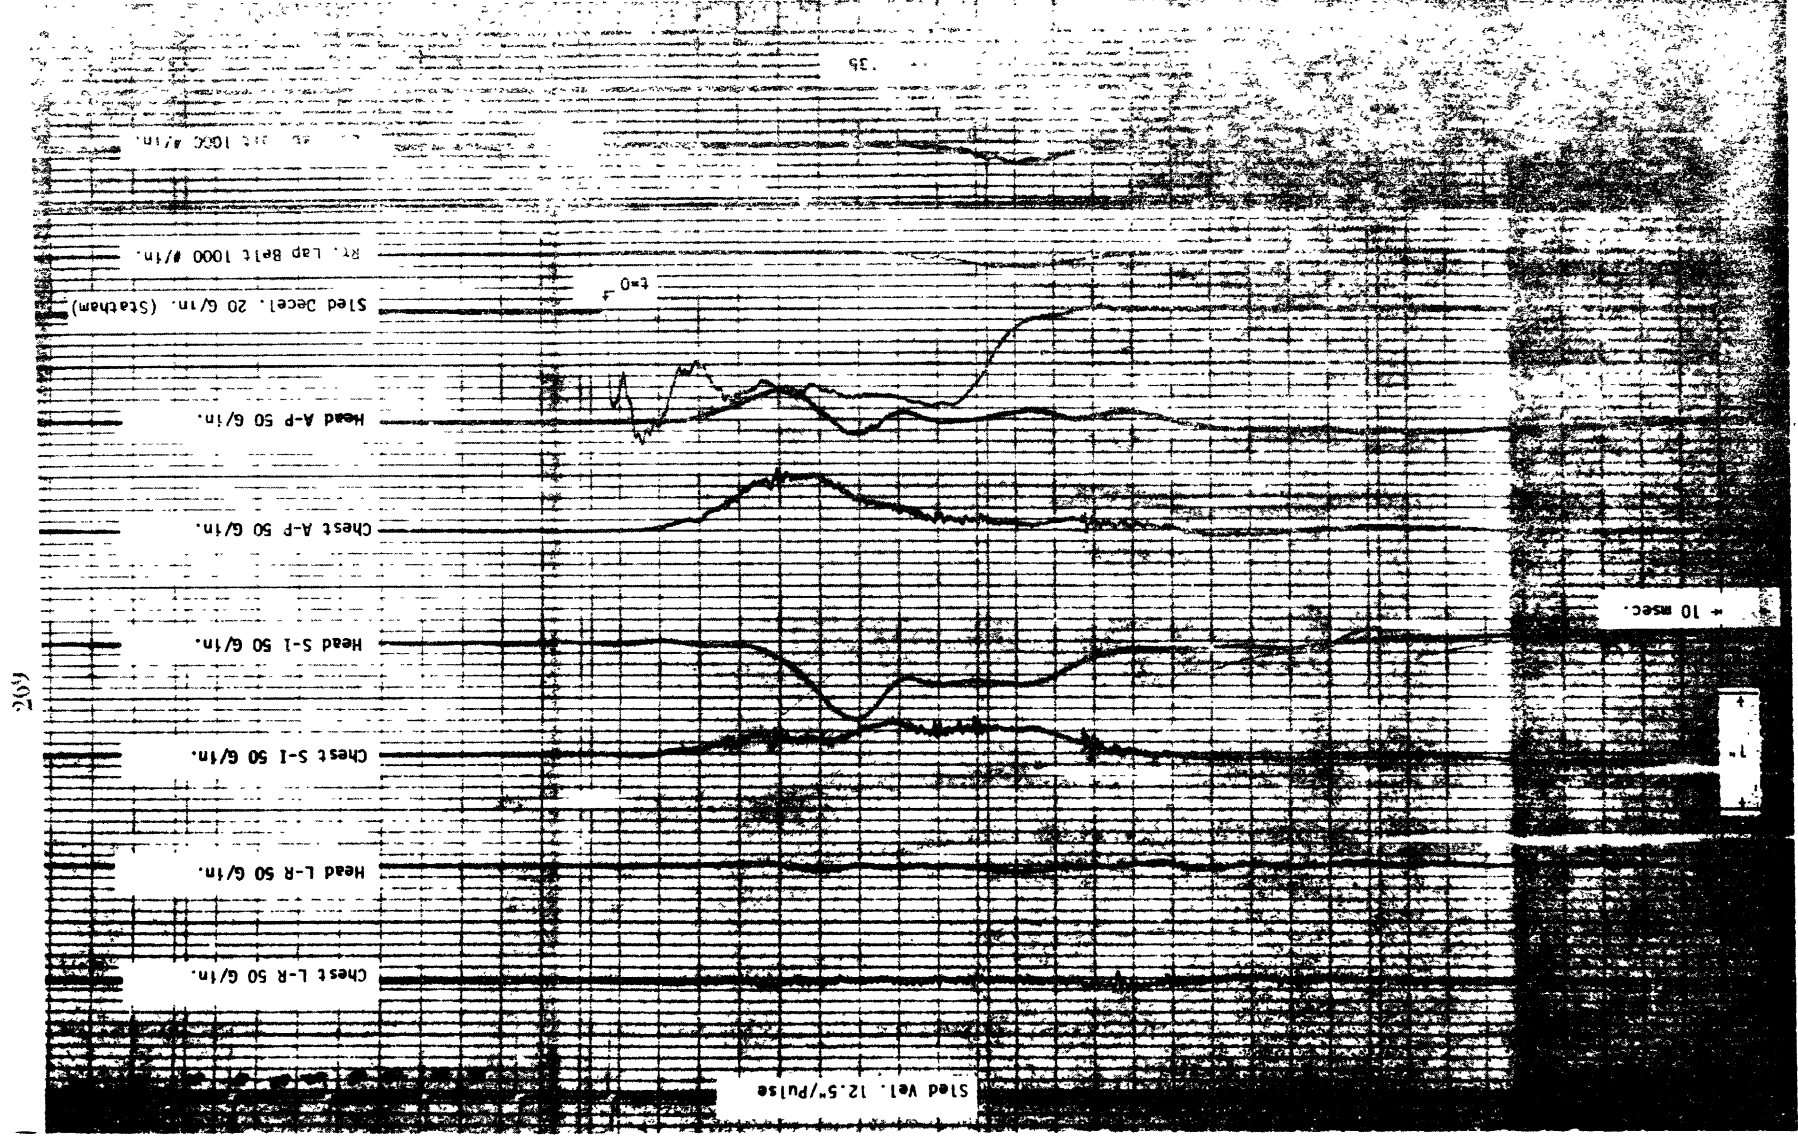
A135

The loadings experienced by the dummy were quite gentle. However, severe whiplash was again observed.

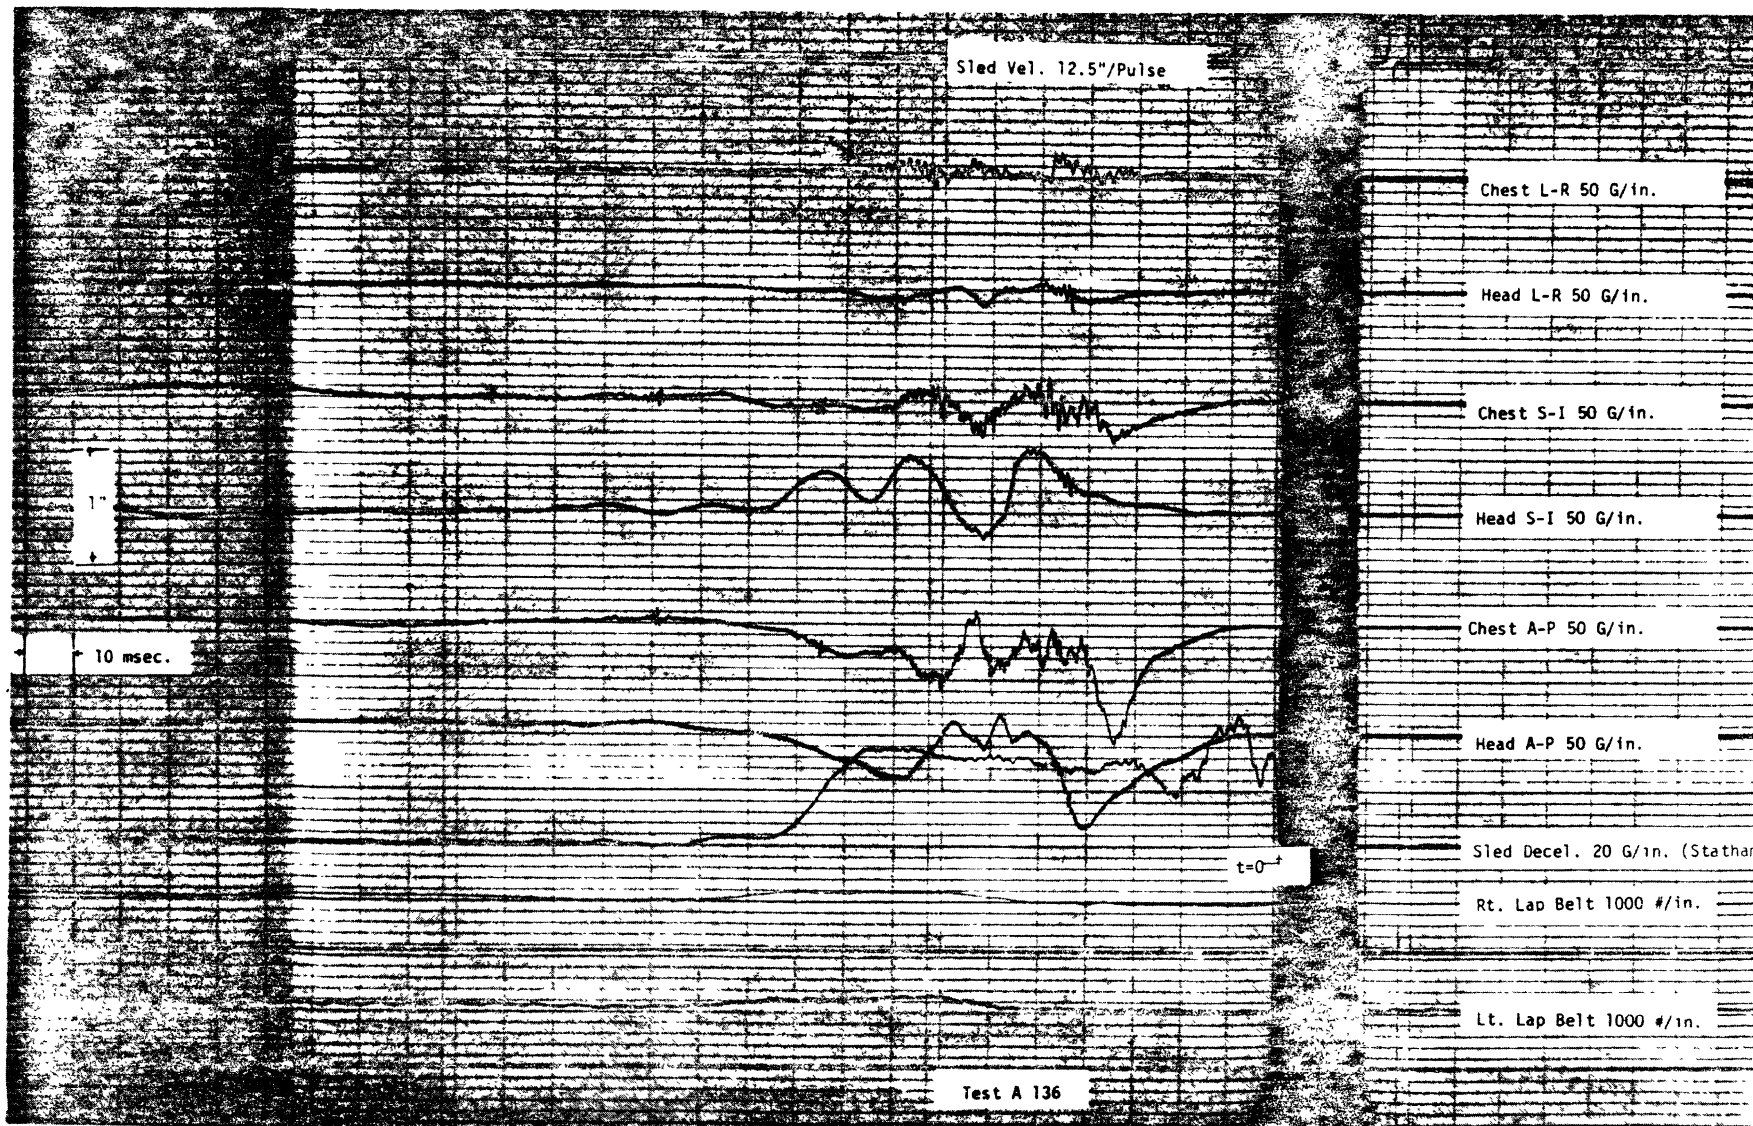
A136

The dummy received moderately high chest and head anterior-posterior accelerations, but the motion experienced was minimum. The upper part of the Tot-Guard appeared to rotate upward during the deceleration pinning the dummy's head between the front piece and the adult seat.

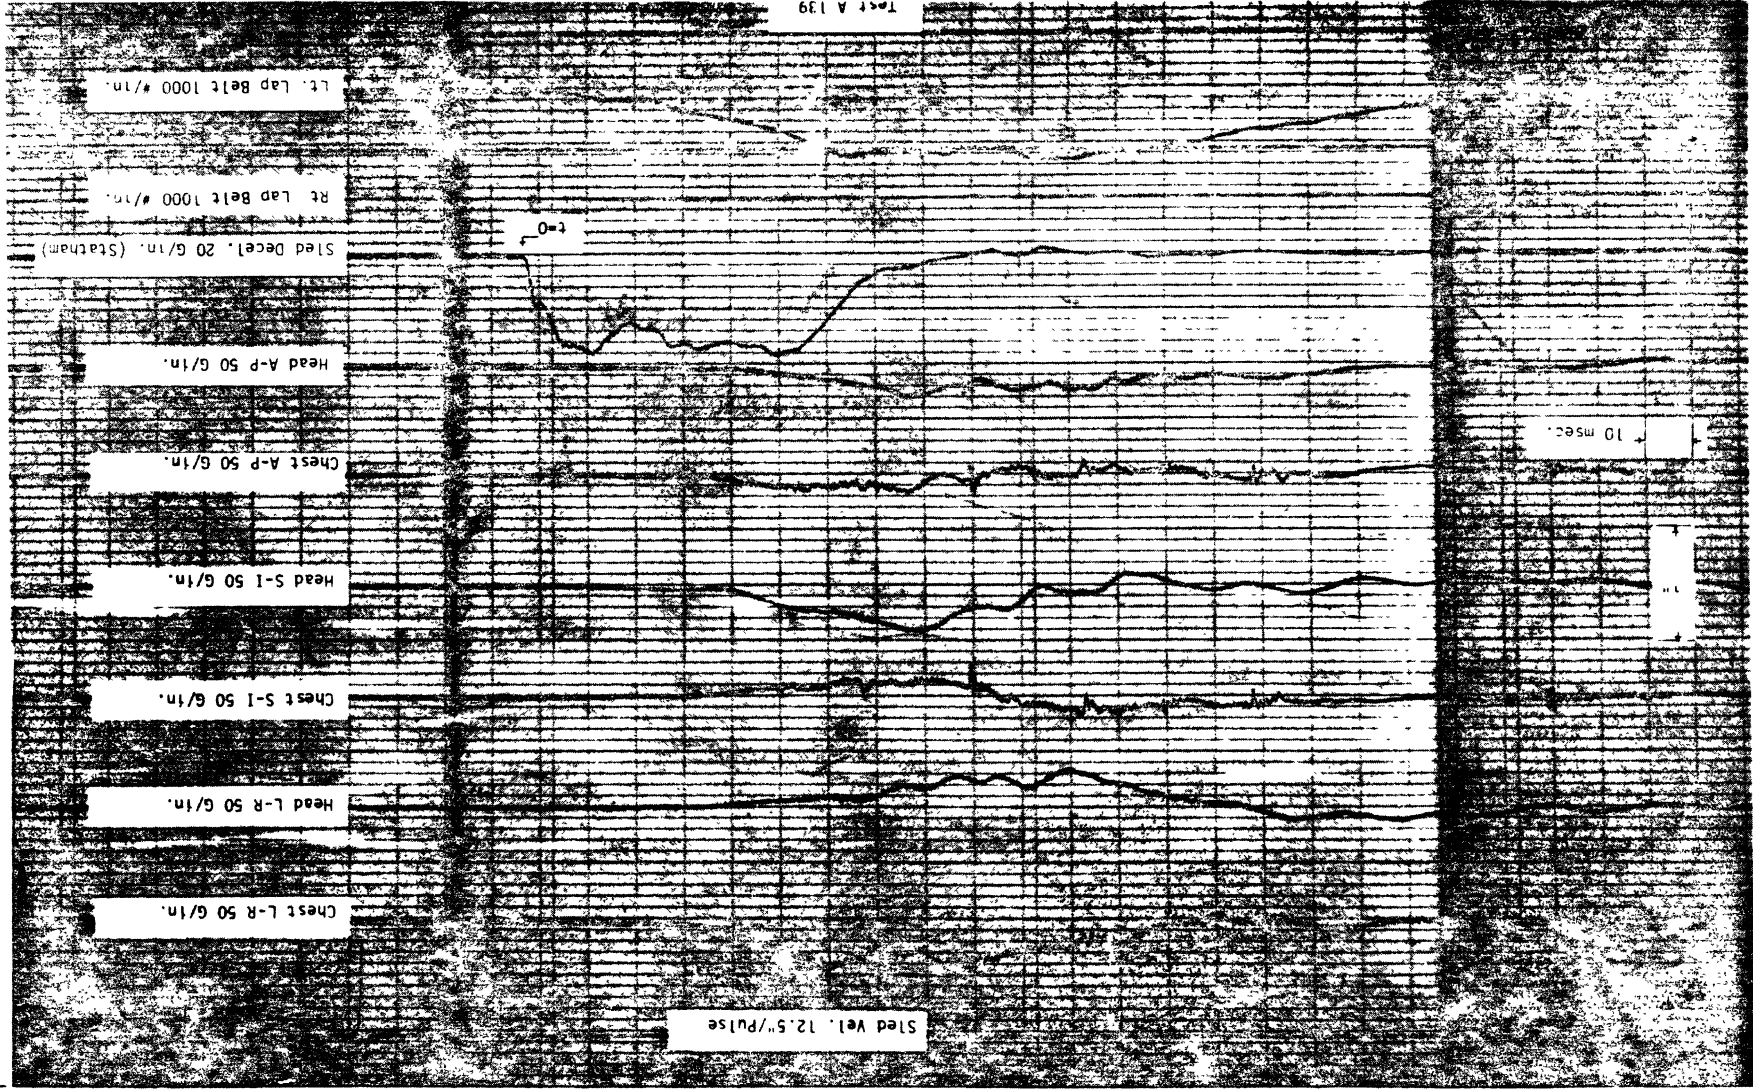
A139

The dummy received a fairly gentle deceleration in this test. However, the excursion was large enough to ensure contact with any side structures which would be present in an automobile interior. The child seat was badly deformed. The tubular frame collapsed sideways and the lower left seat retaining strap tore at the buckle. The headrest jumped out of its sockets.

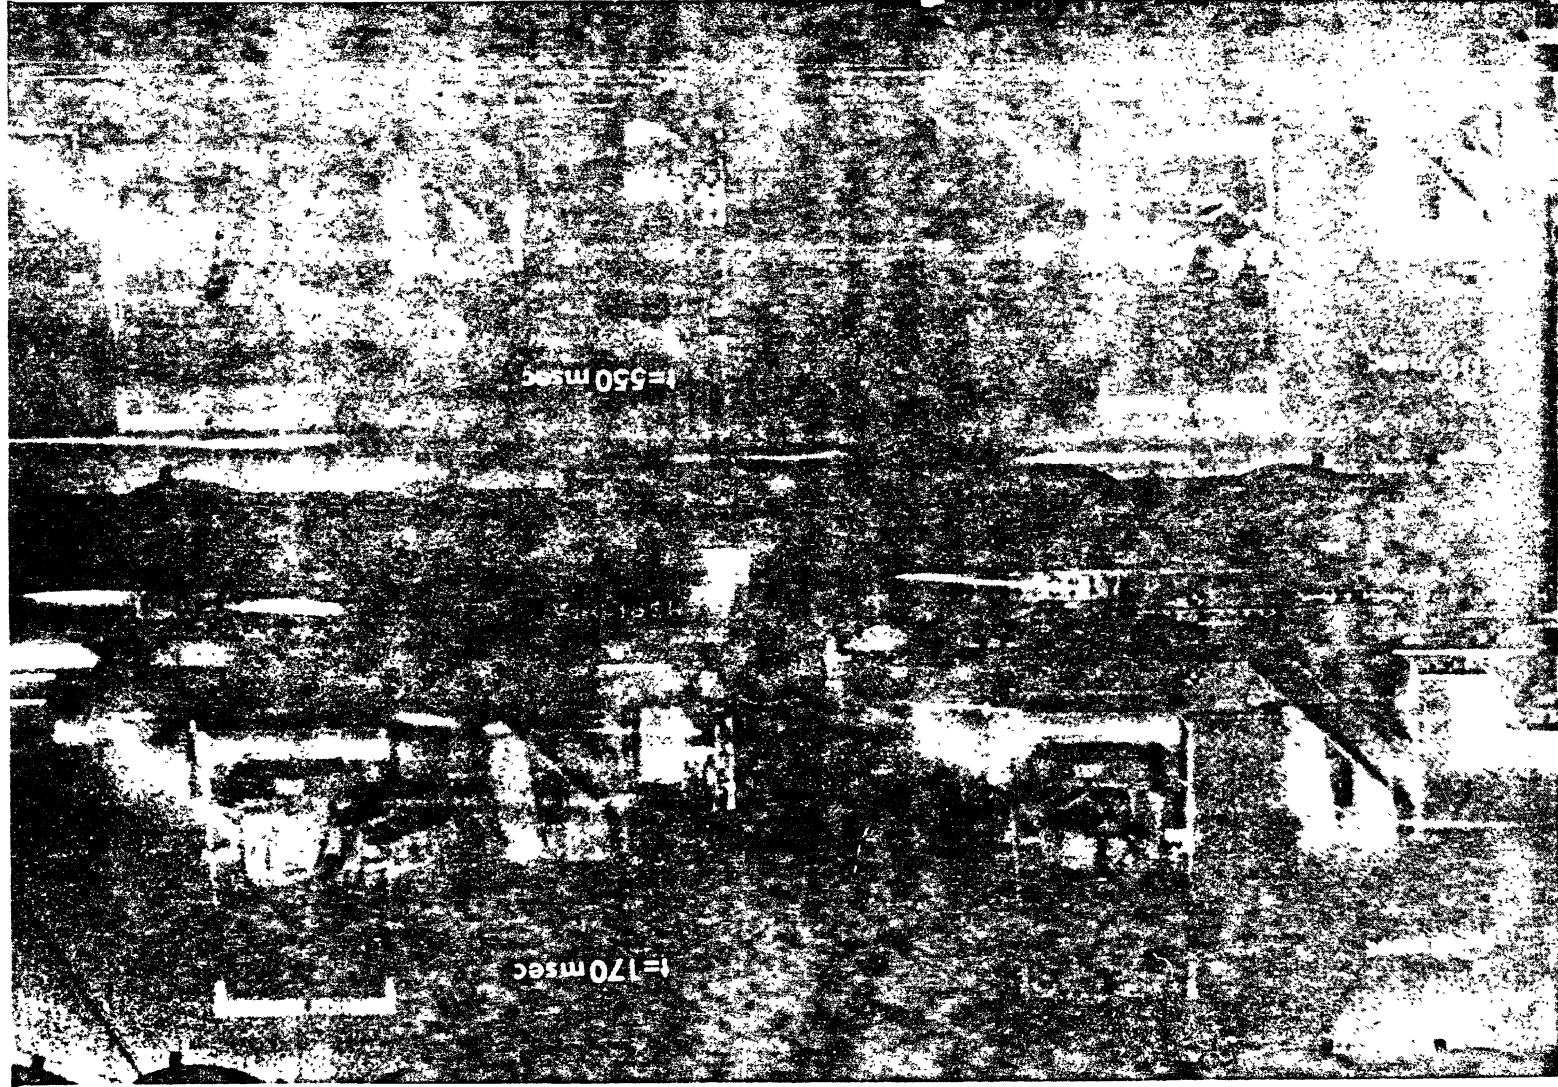
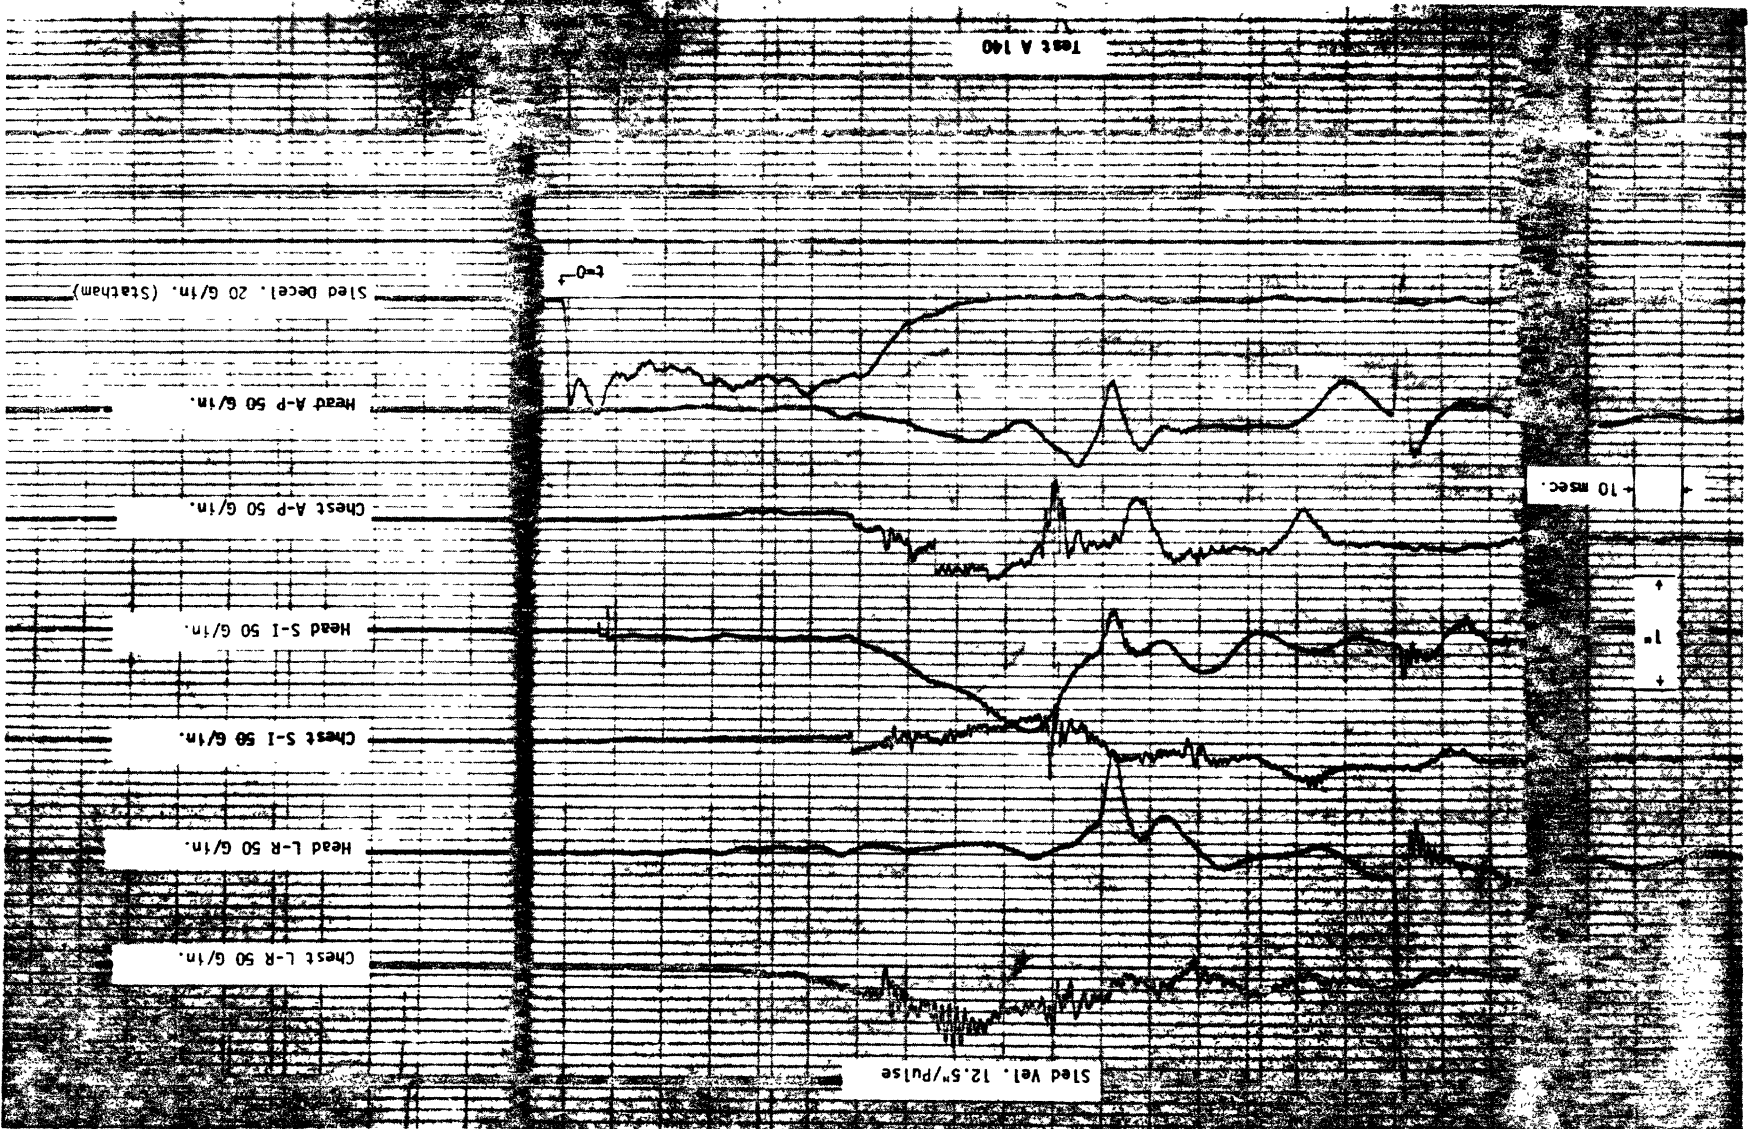
A140

Accelerometer readings were moderate. However, excursion was large enough to ensure contact with any side structures of the vehicle interior. No damage was apparent to the restraint system except that the straps over the shoulders slipped in their buckle.

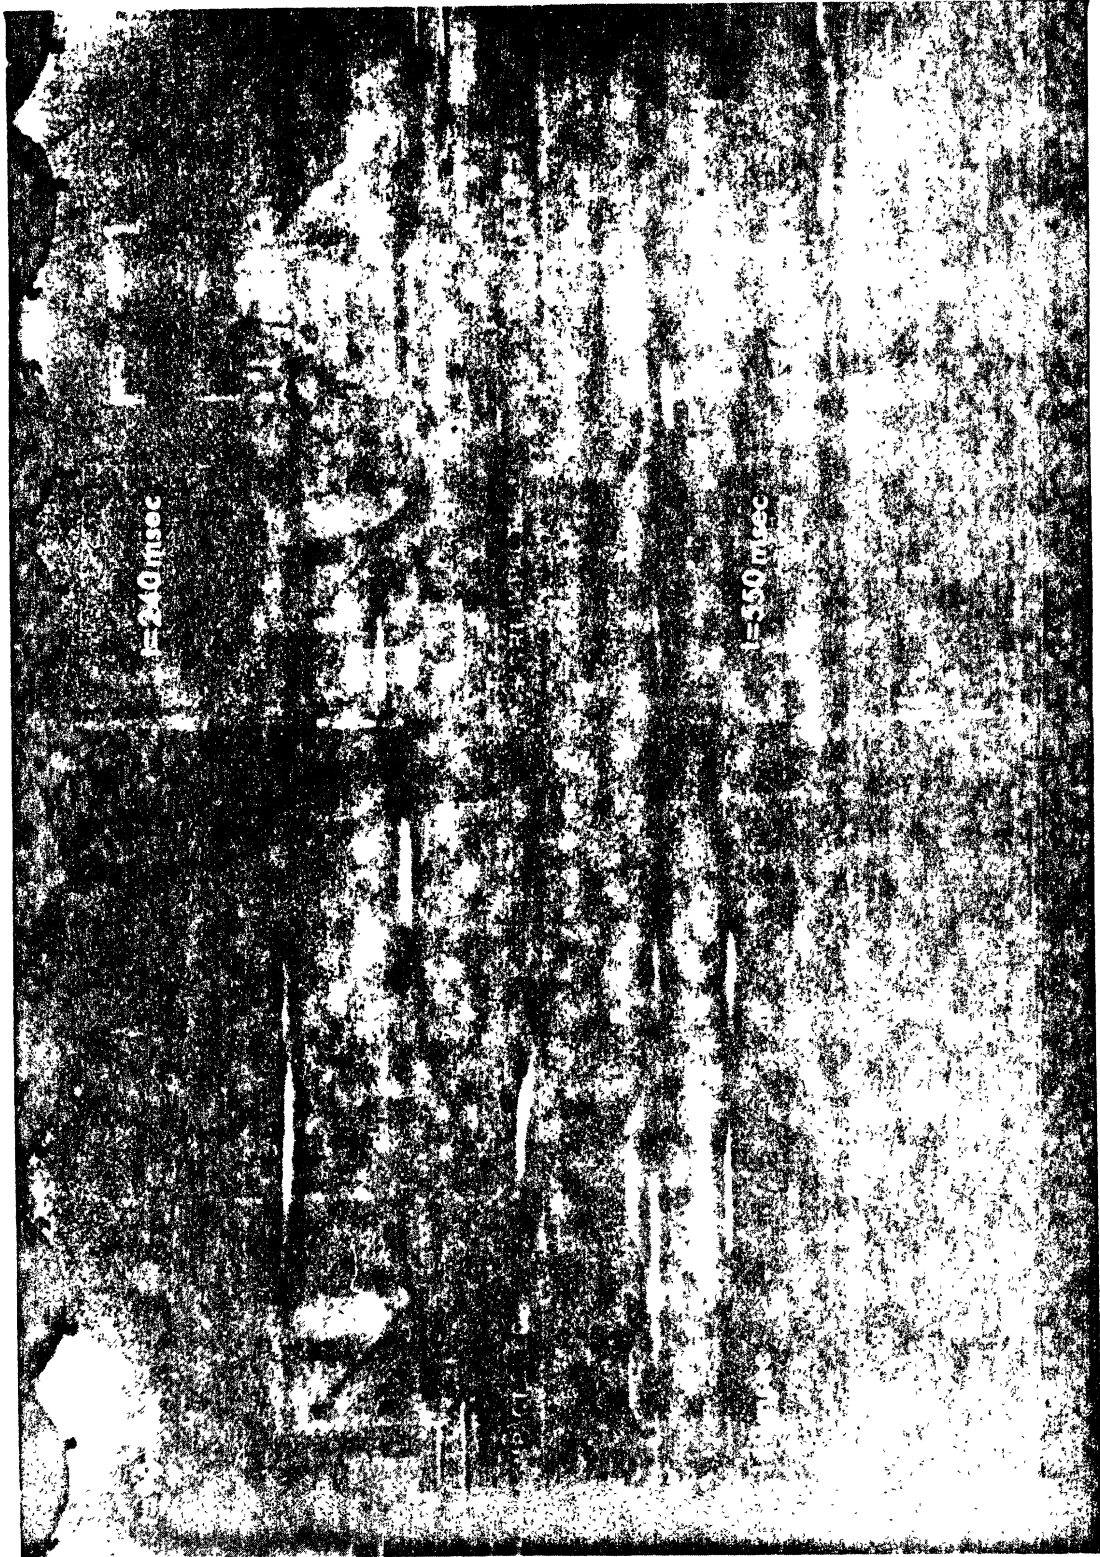
Test Observation:

The dummy received moderate acceleration loadings in this test. The excursion was large enough to ensure contact with any vehicle side structures adjacent to the seat.
