CHILD SEAT AND RESTRAINT SYSTEMS TEST RESULTS

APPENDIX D

Final Report

Volume III of III

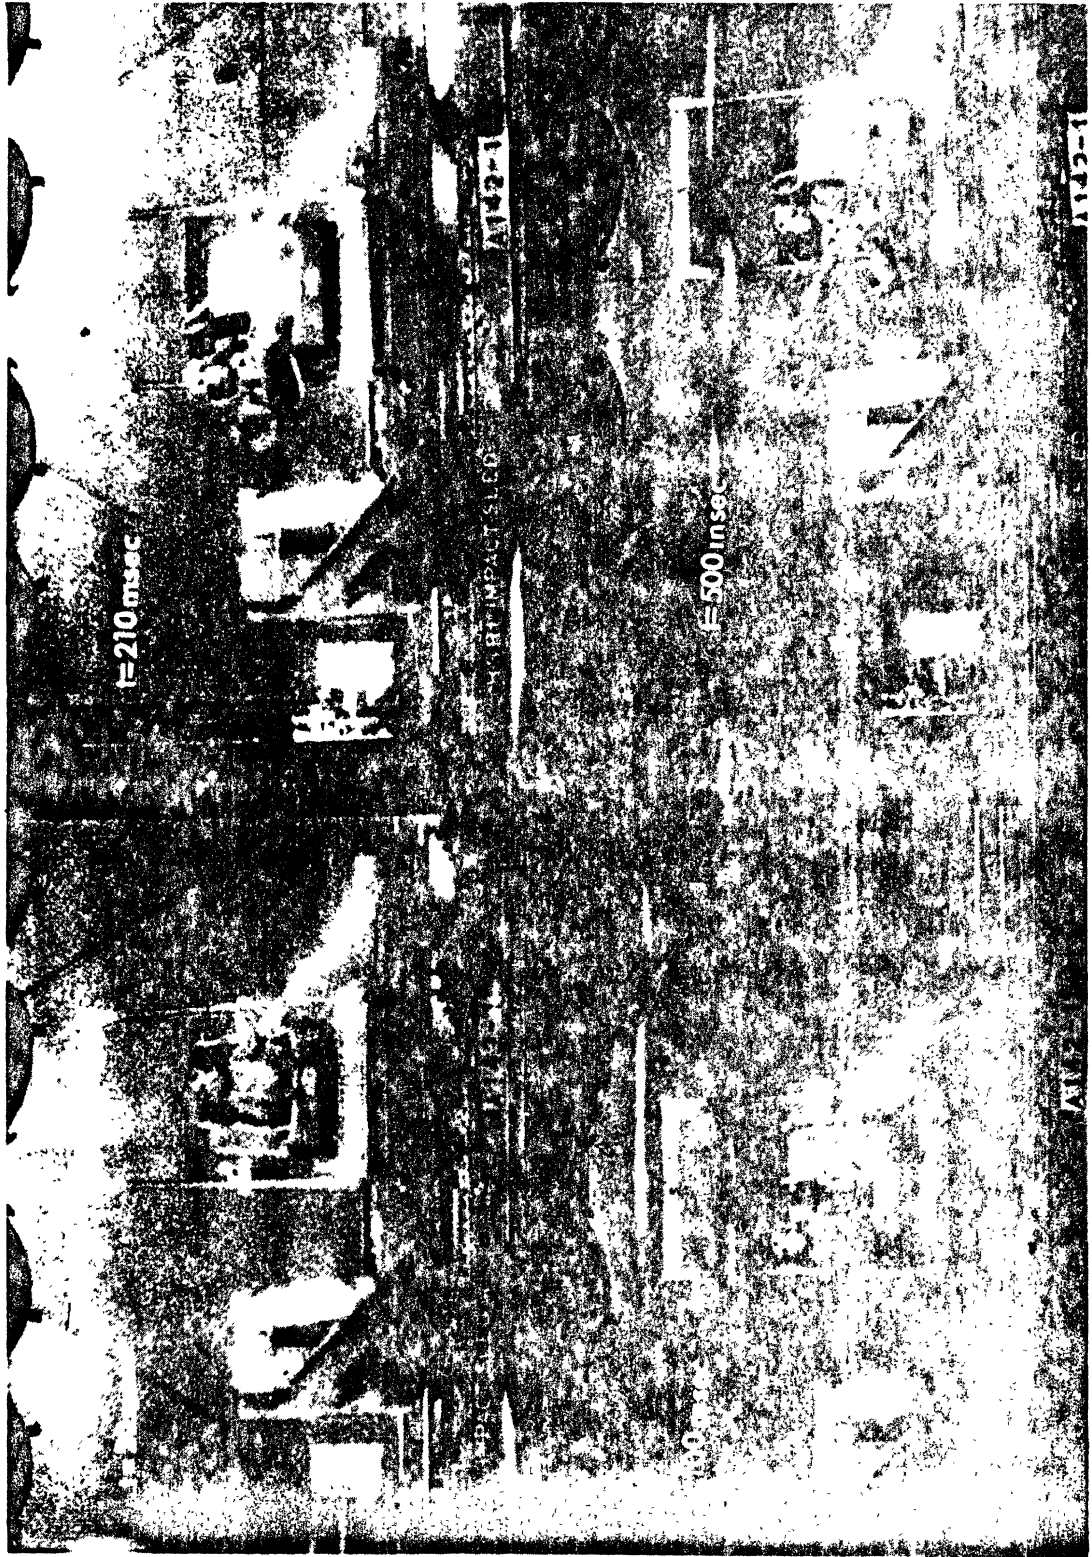
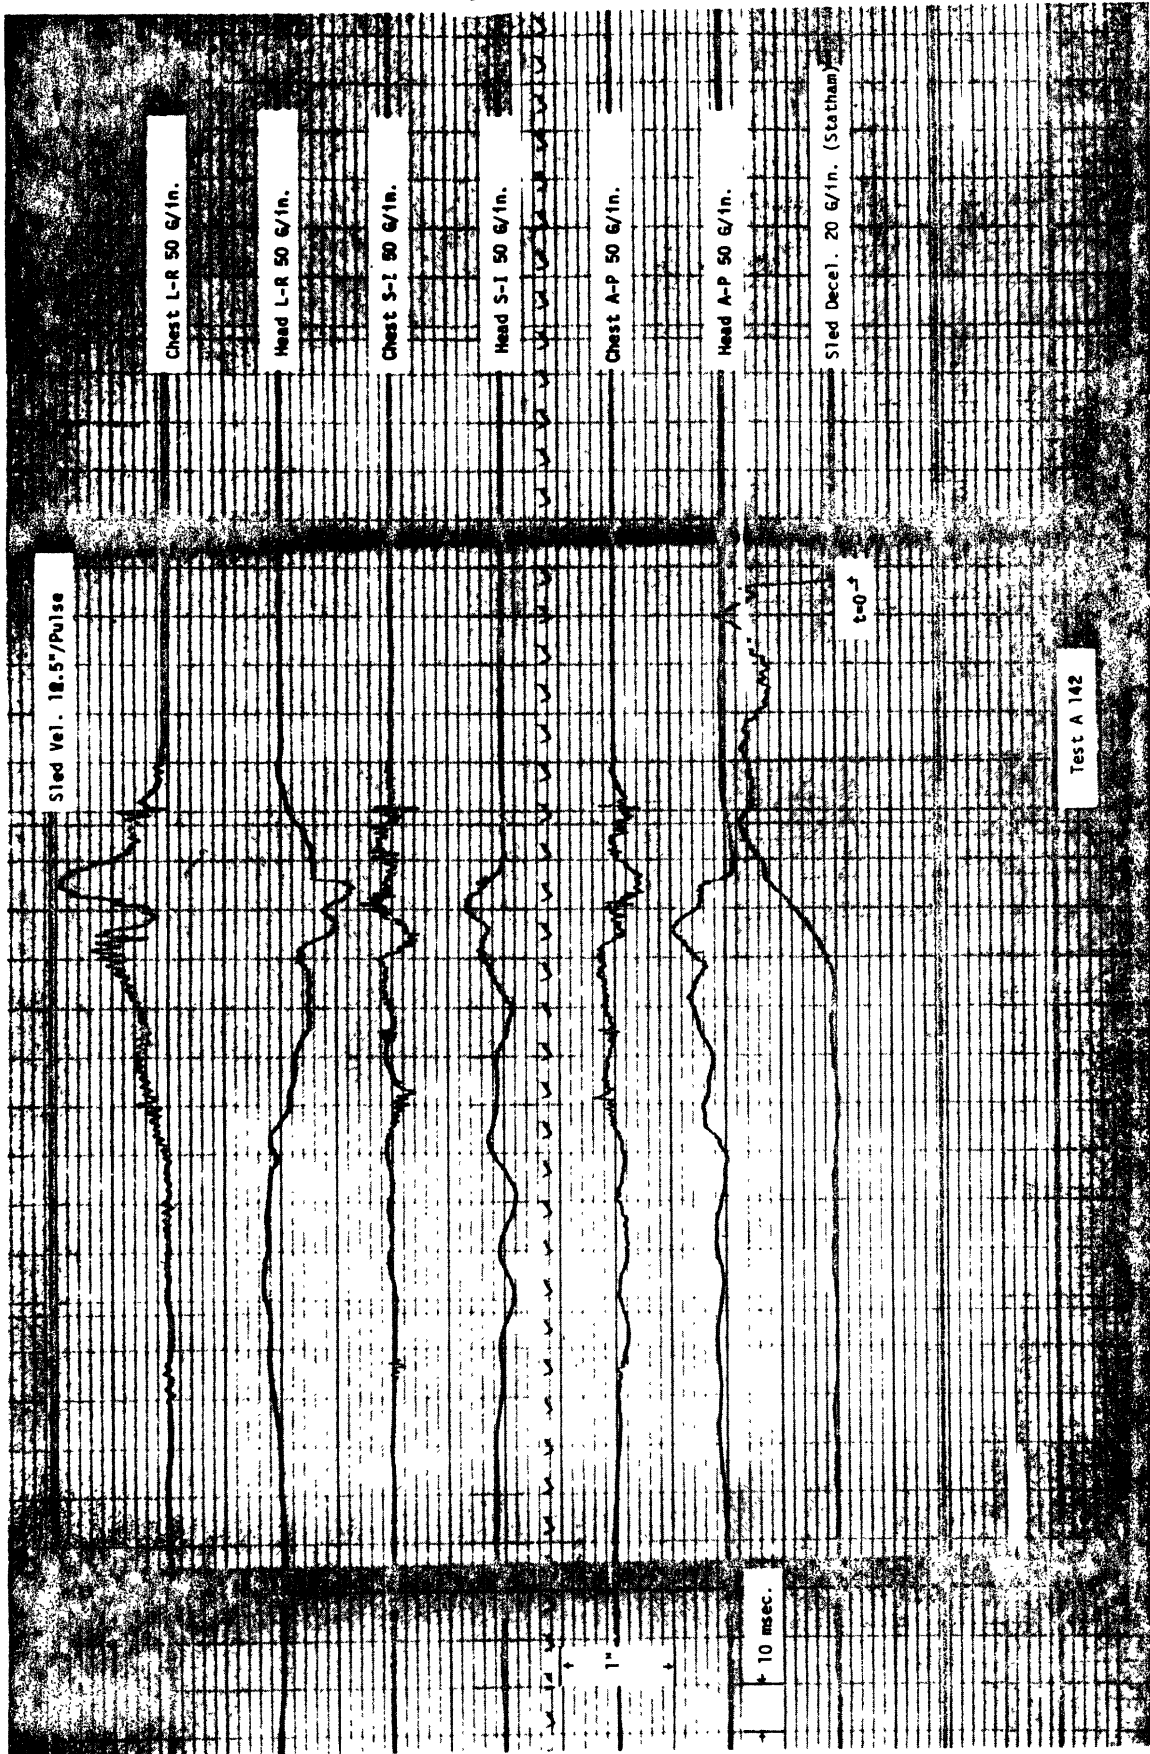
A142

The seat failed, causing both the dummy and the seat to be ejected from the adult seat. The special integral retaining strap on the left side of the Klippan Safety Seat ripped completely out of the shell.

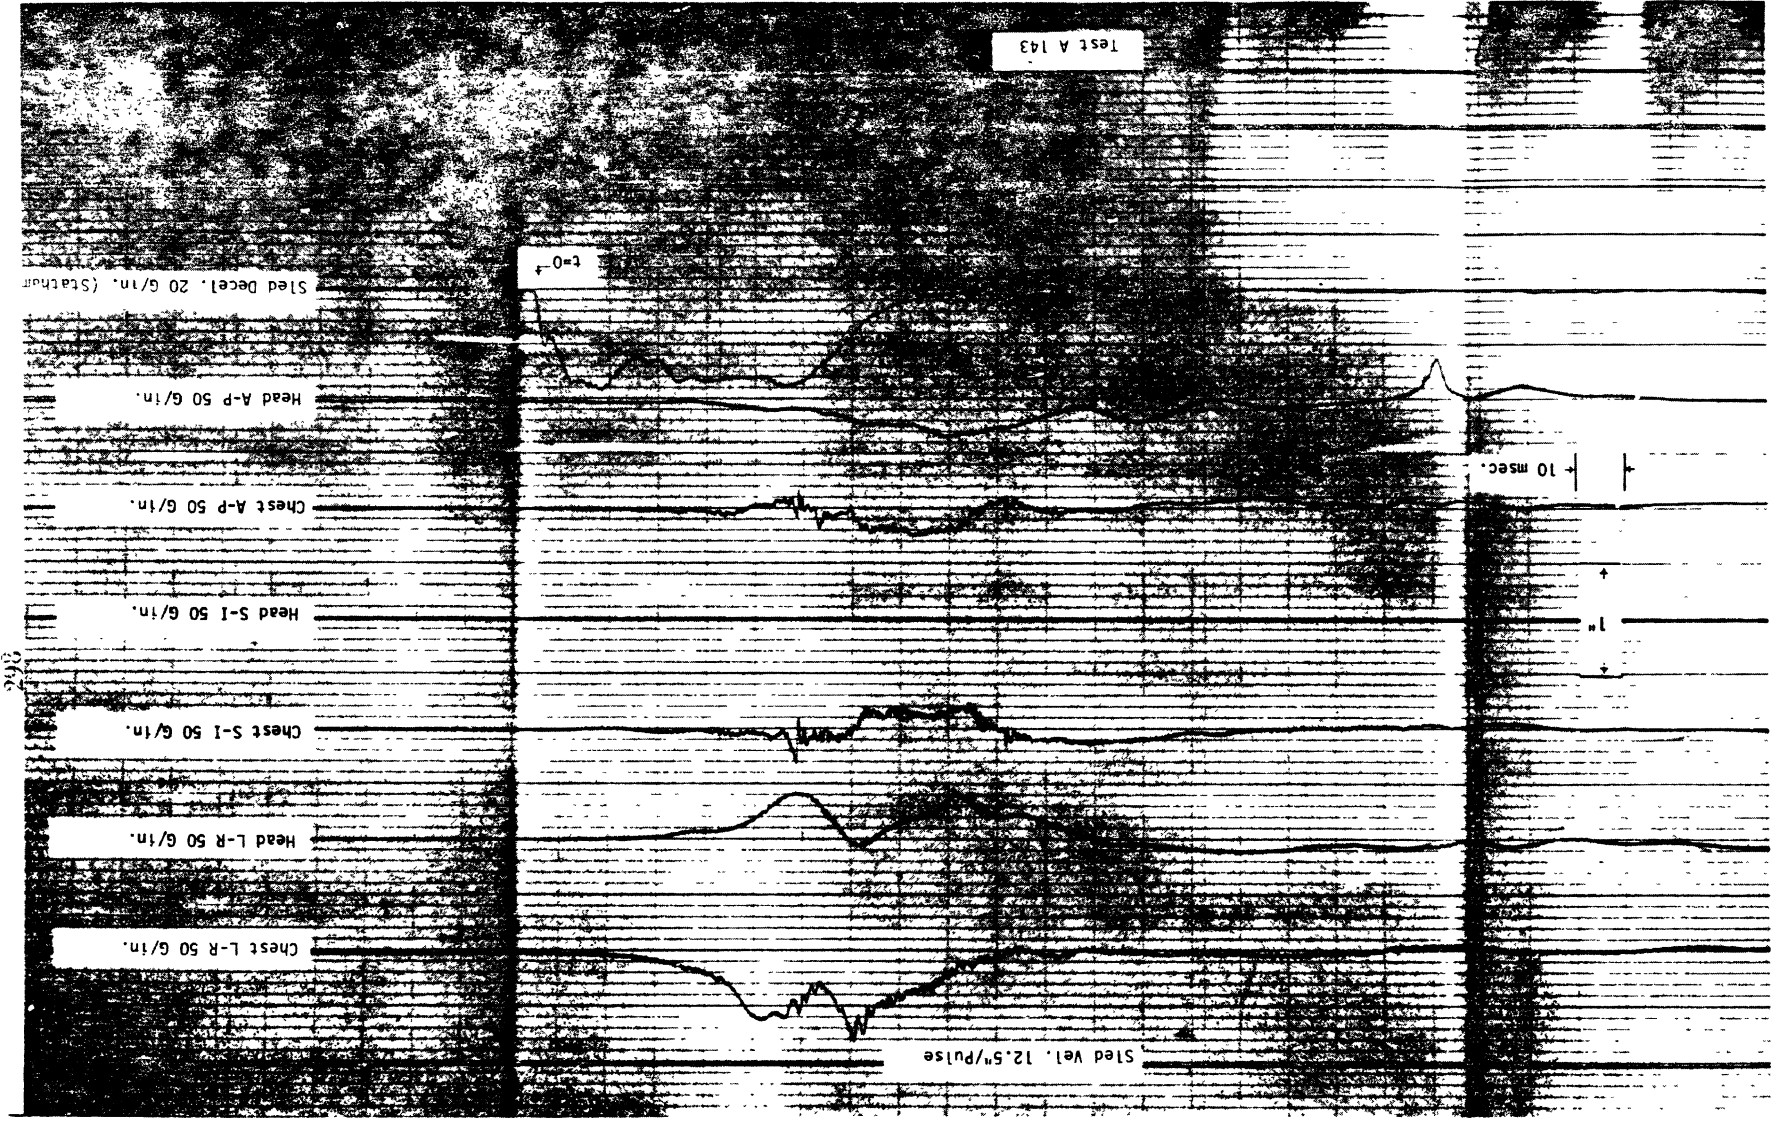
A143

The loadings experienced by the dummy were quite gentle. No excessive excursion was observed, indicating that there was only slight danger of contact with interior structures in the automobile. This seat maintained its integrity in side impact very well.

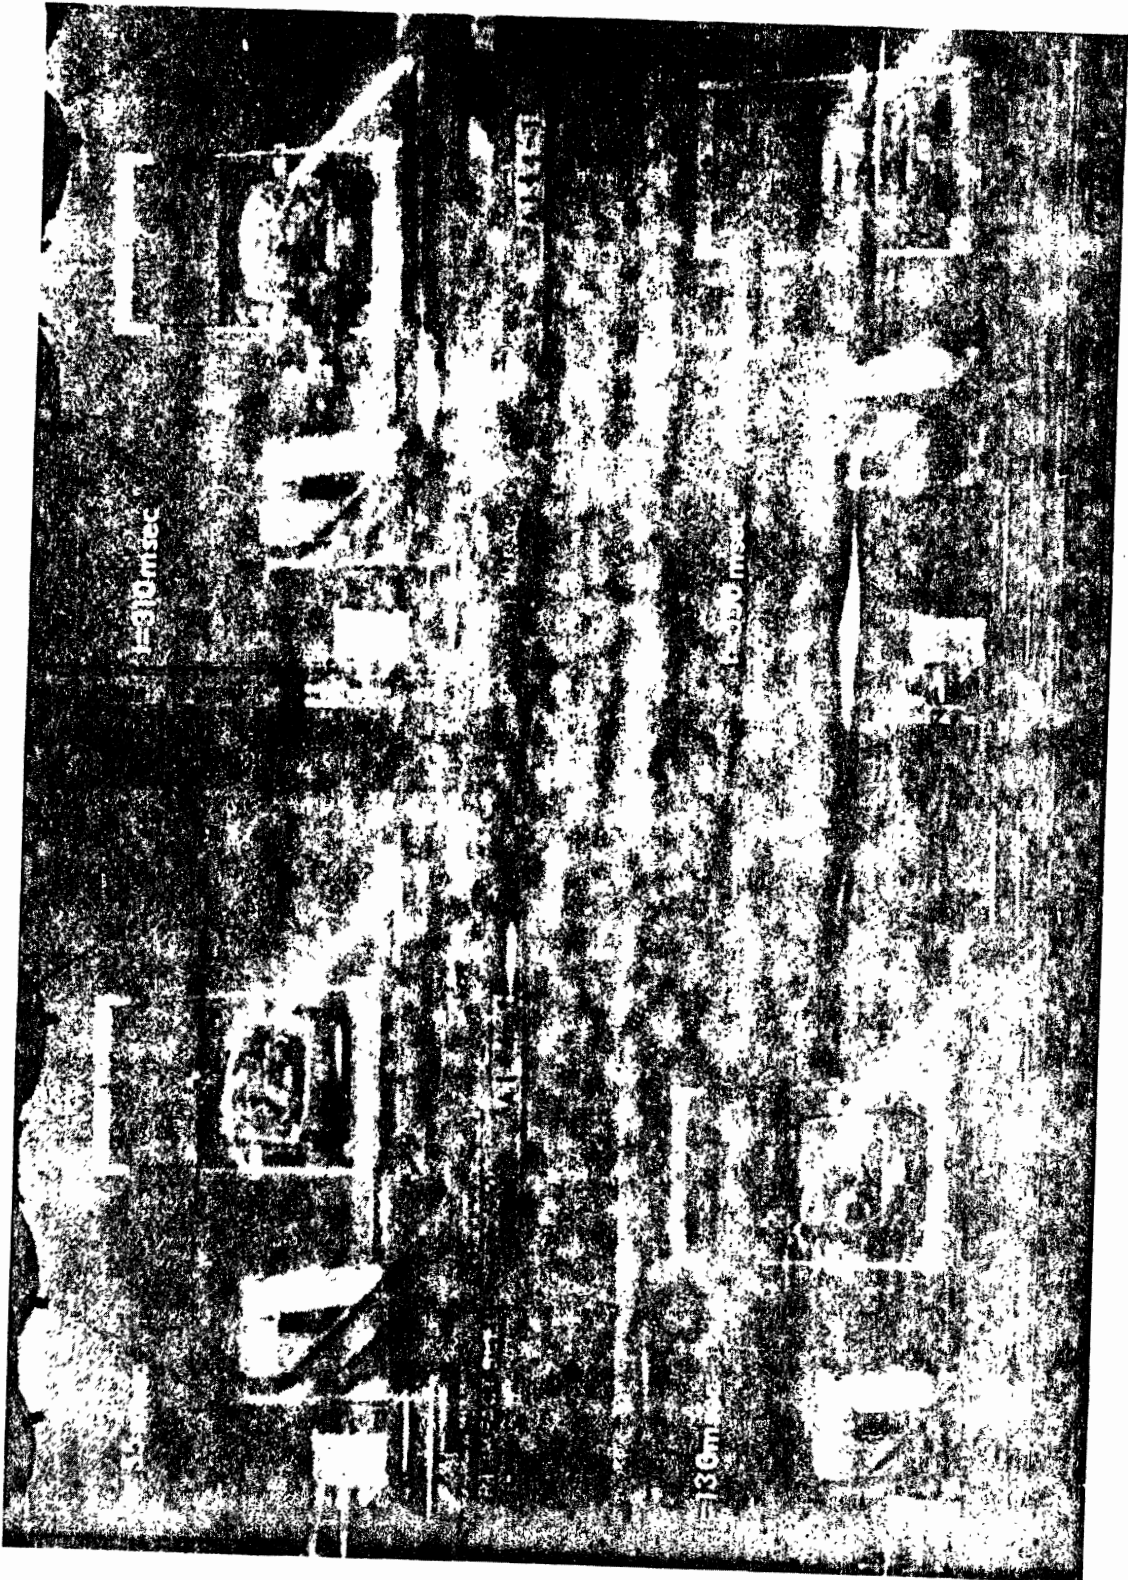
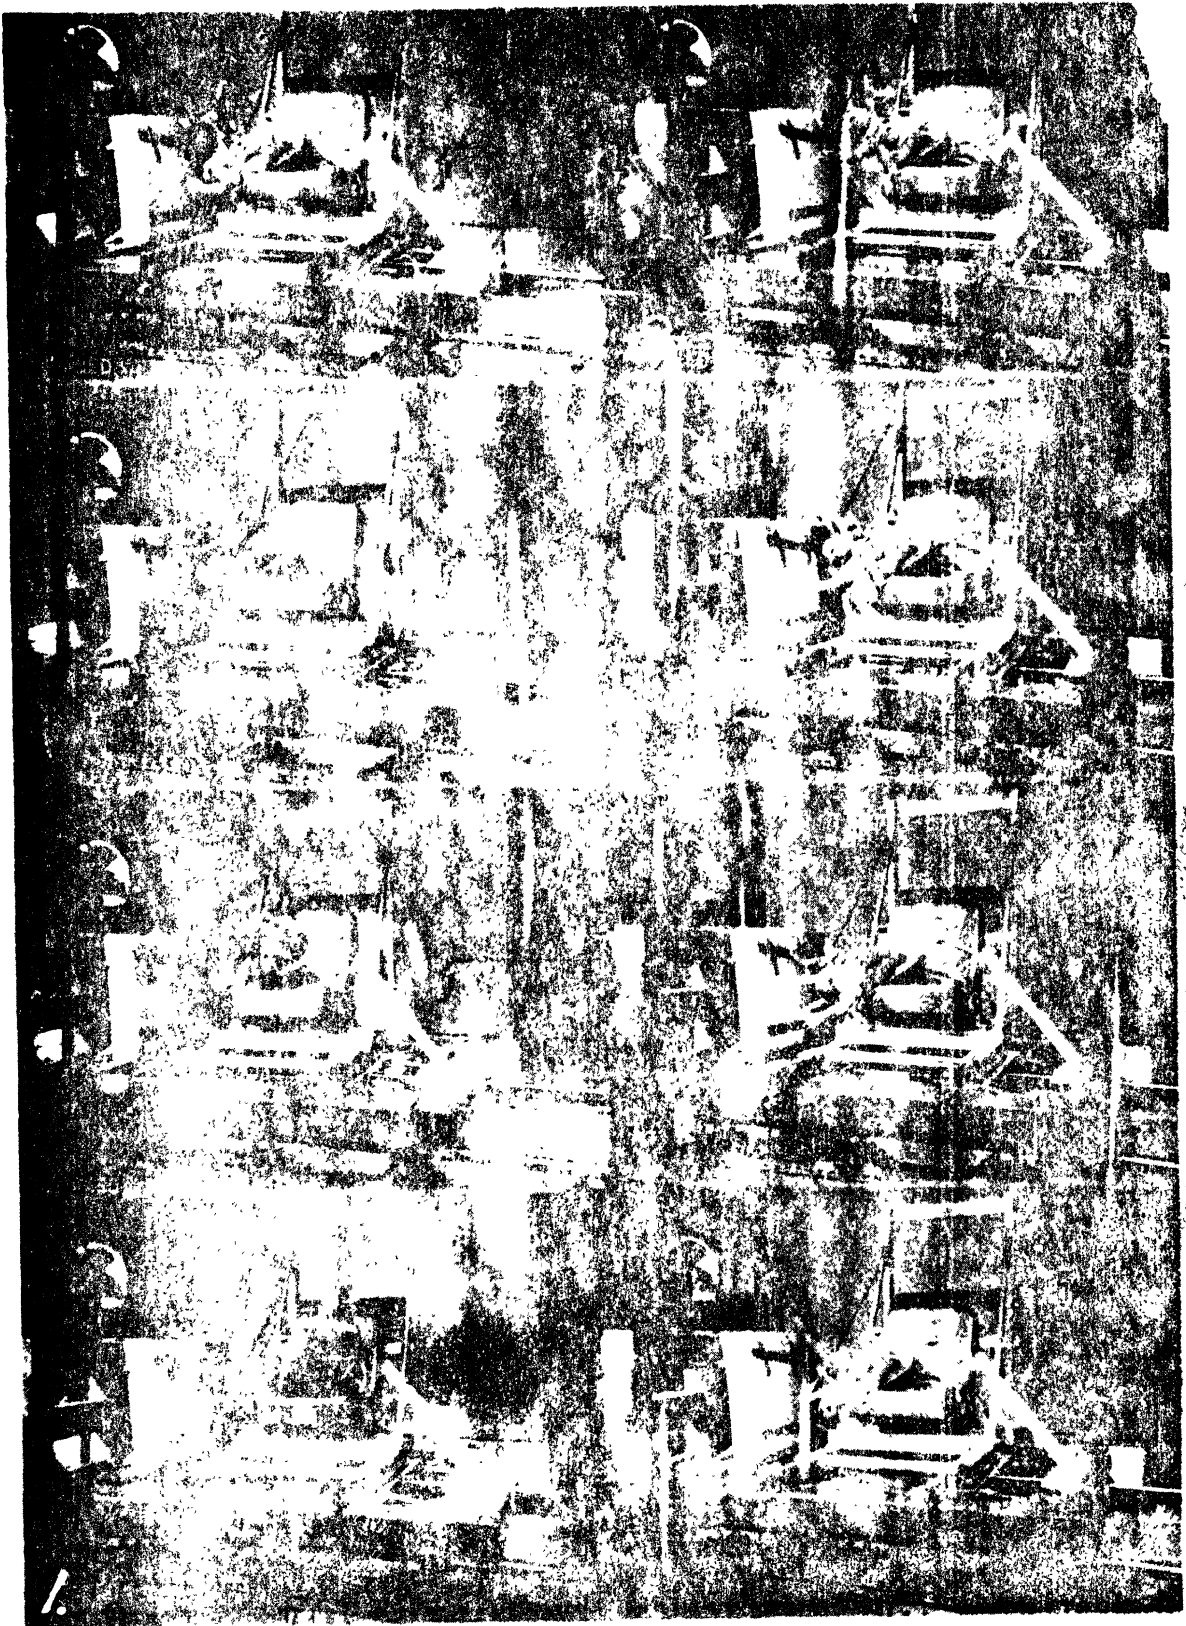
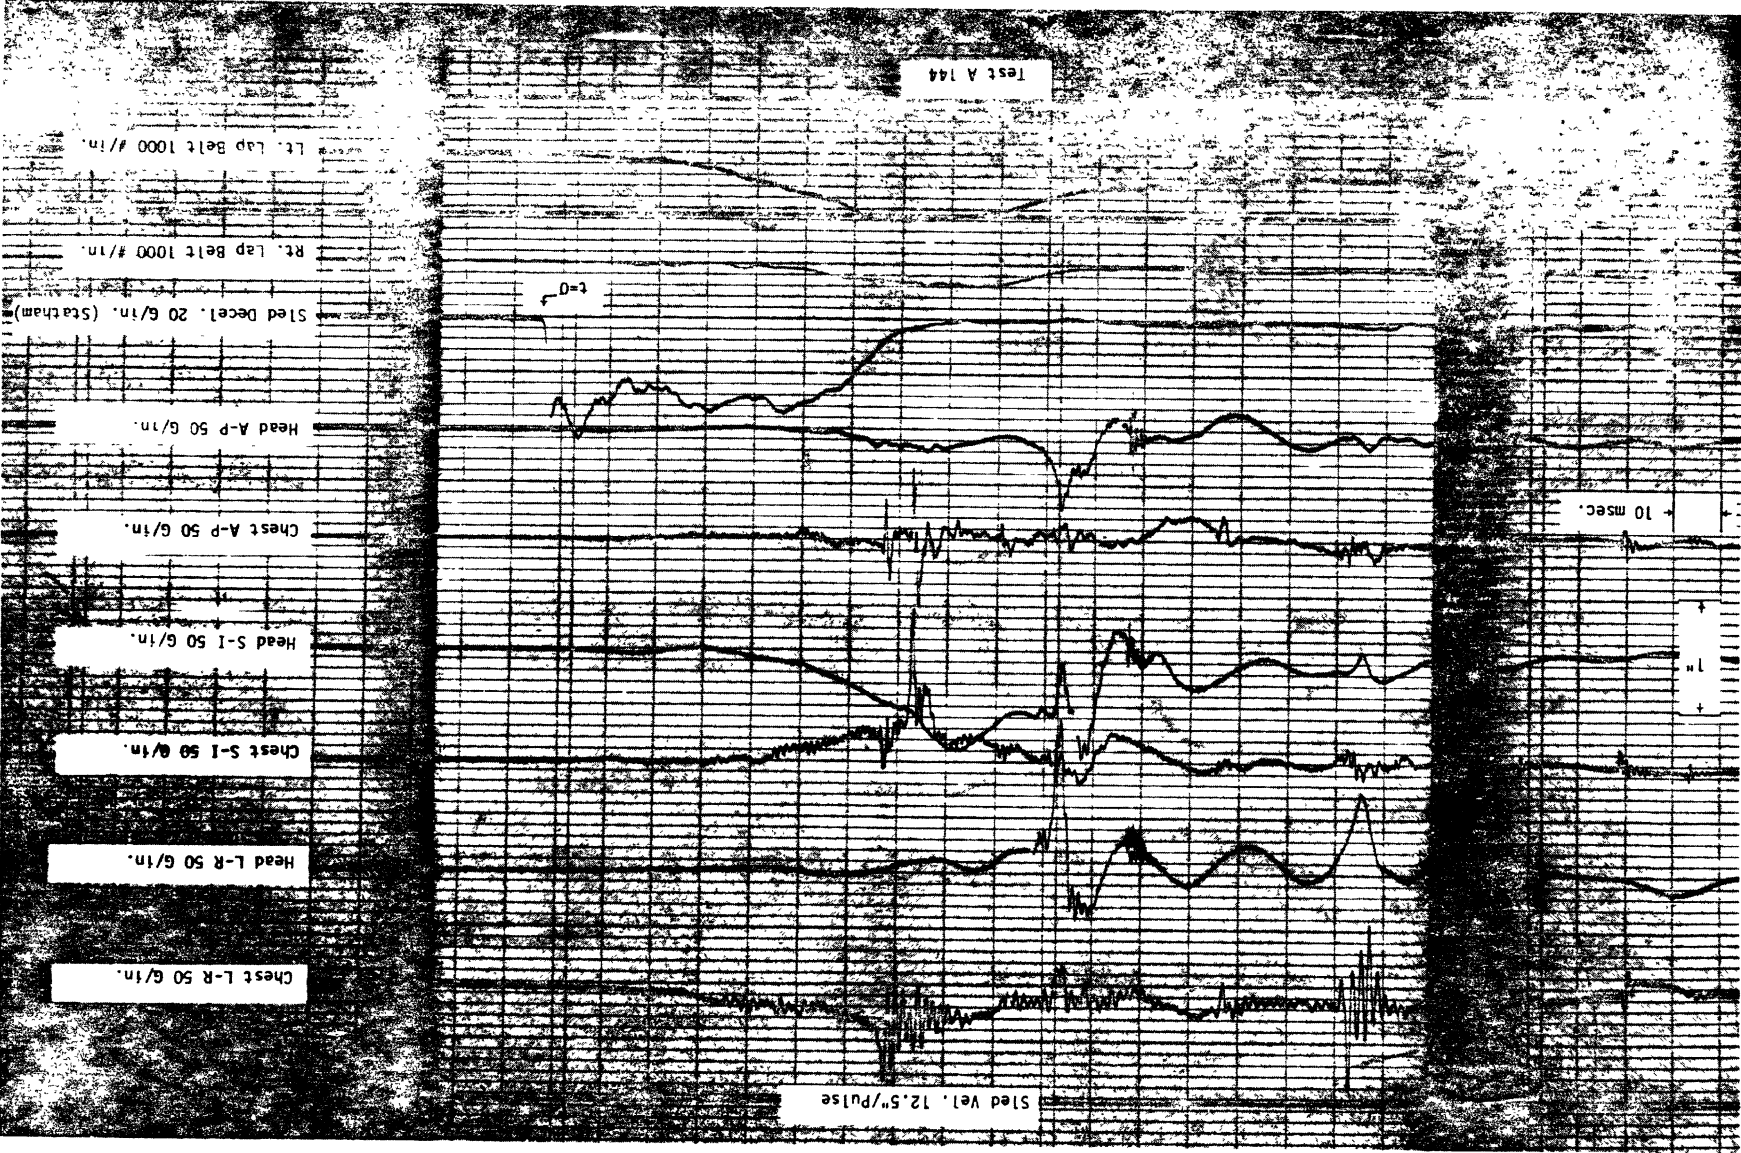
A144

The metal structure supporting this pedestal seat was observed to dig deep into the adult seat cushion, causing the dummy to pitch to the side violently, ensuring contact with any adjacent interior structures. High accelerometer readings were observed.

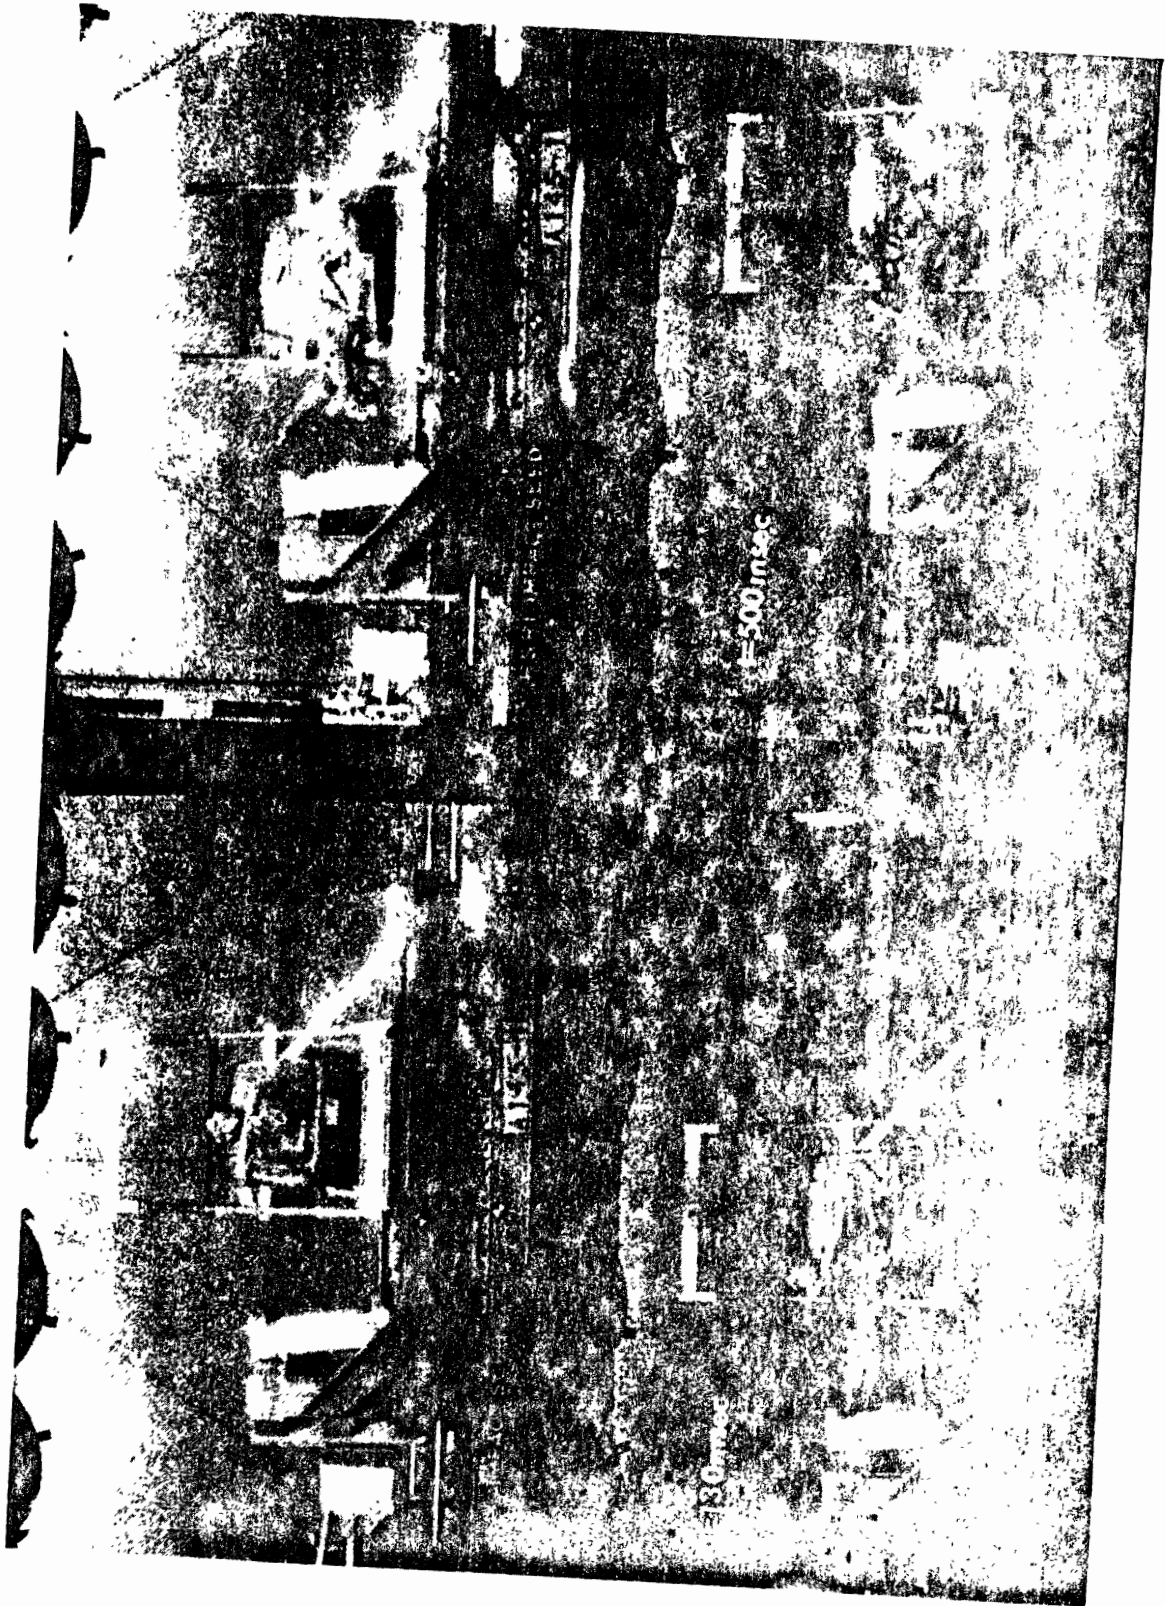
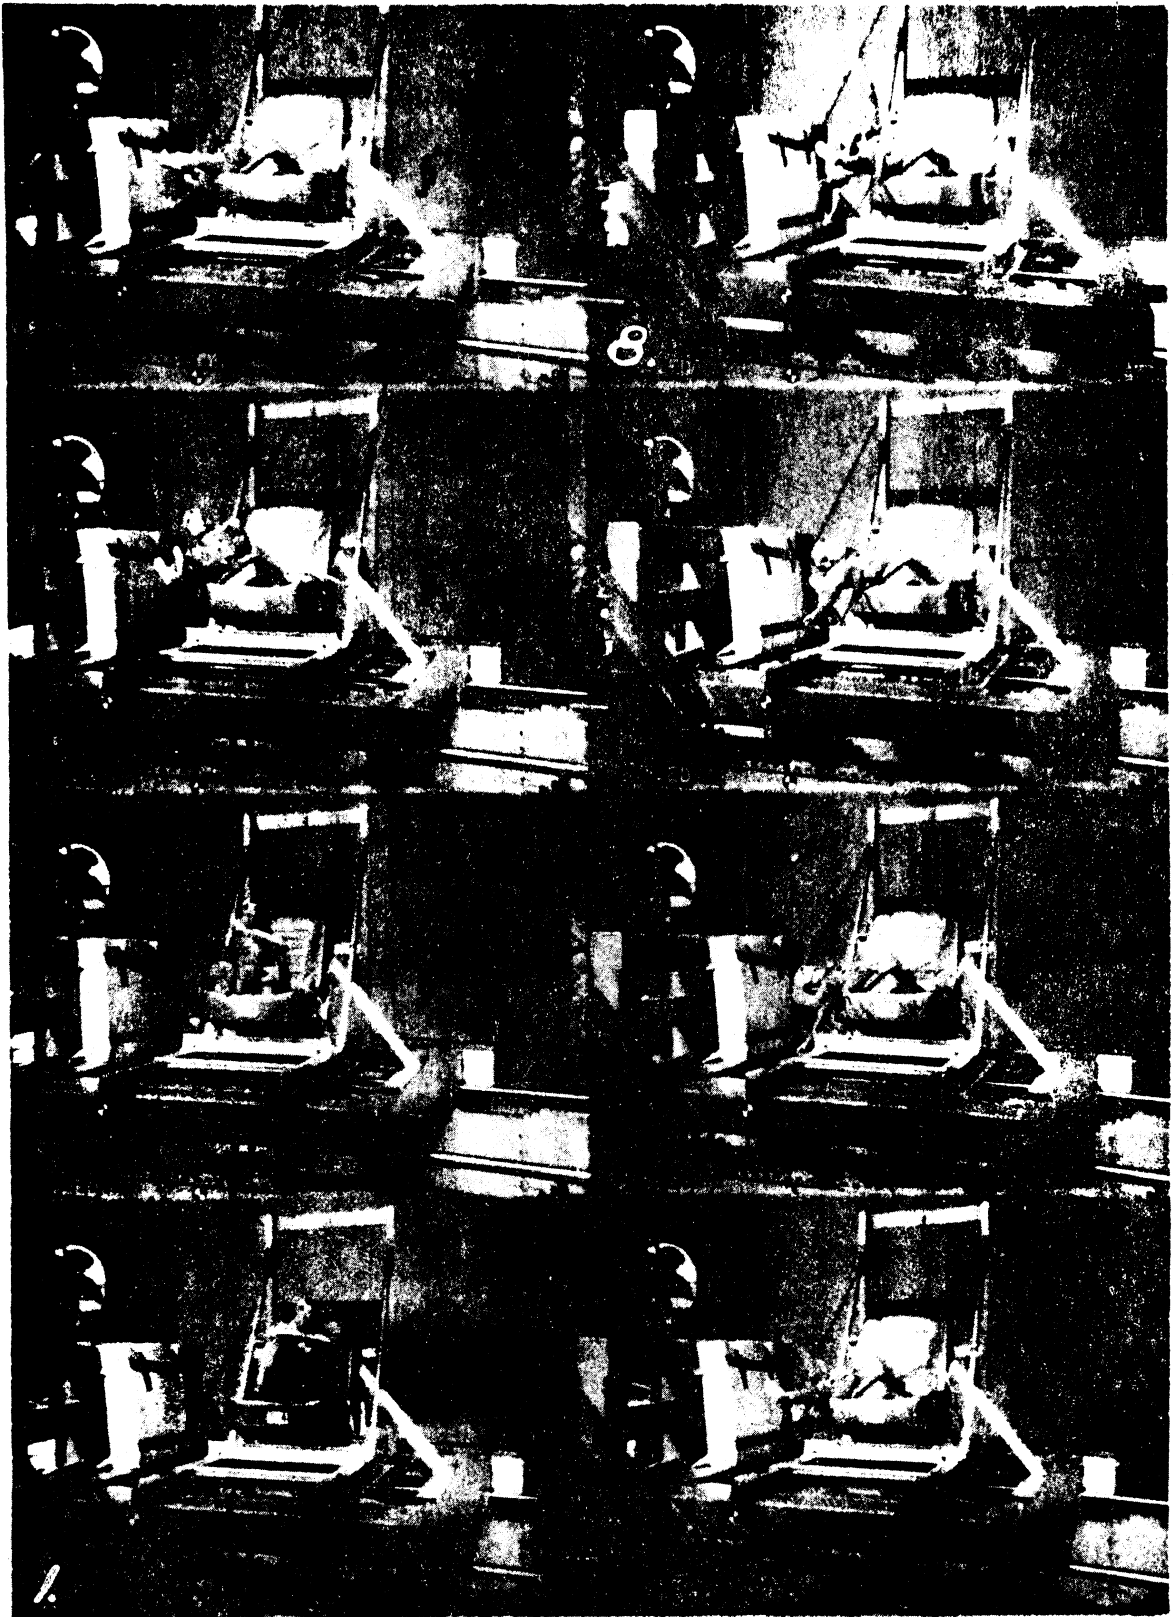
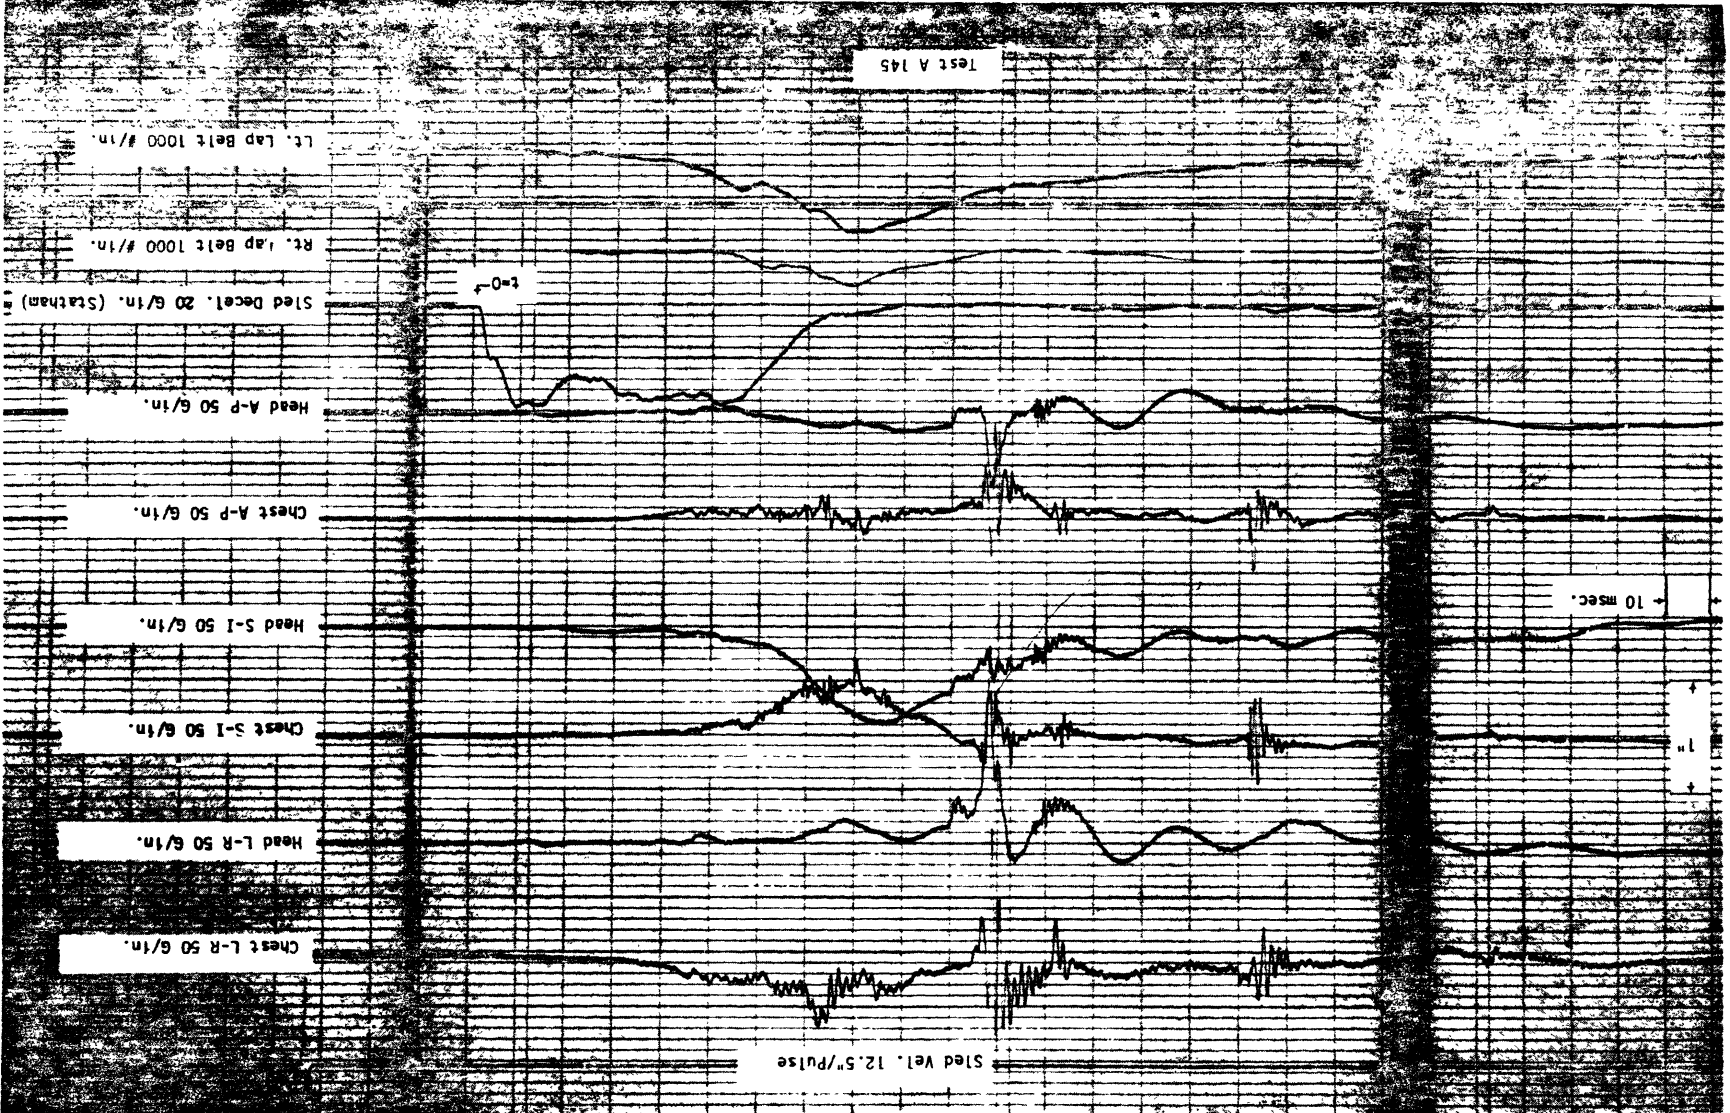
A145

This pedestal type seat was observed to dig deeply into the cushion of the adult seat. This caused the dummy to flex at the waist so severely that the head bent downwards to a level equivalent to the floorboard of the simulated model. Contact with any adjacent interior structures would be ensured.

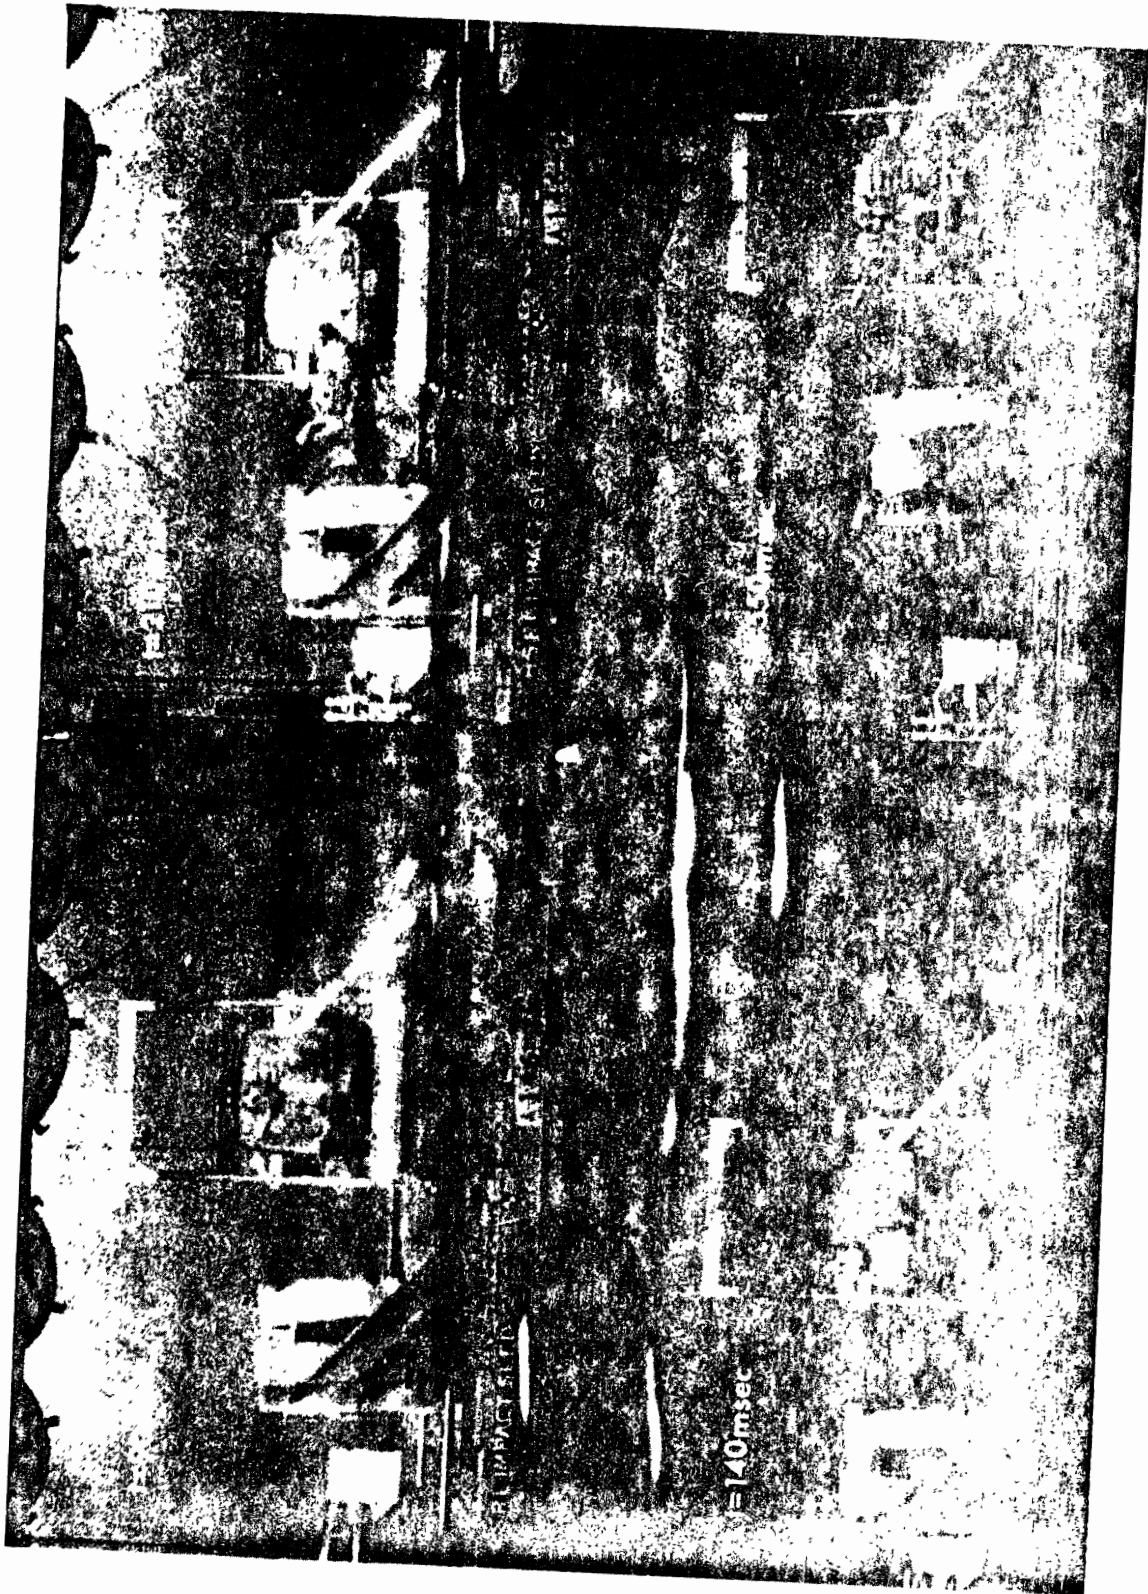
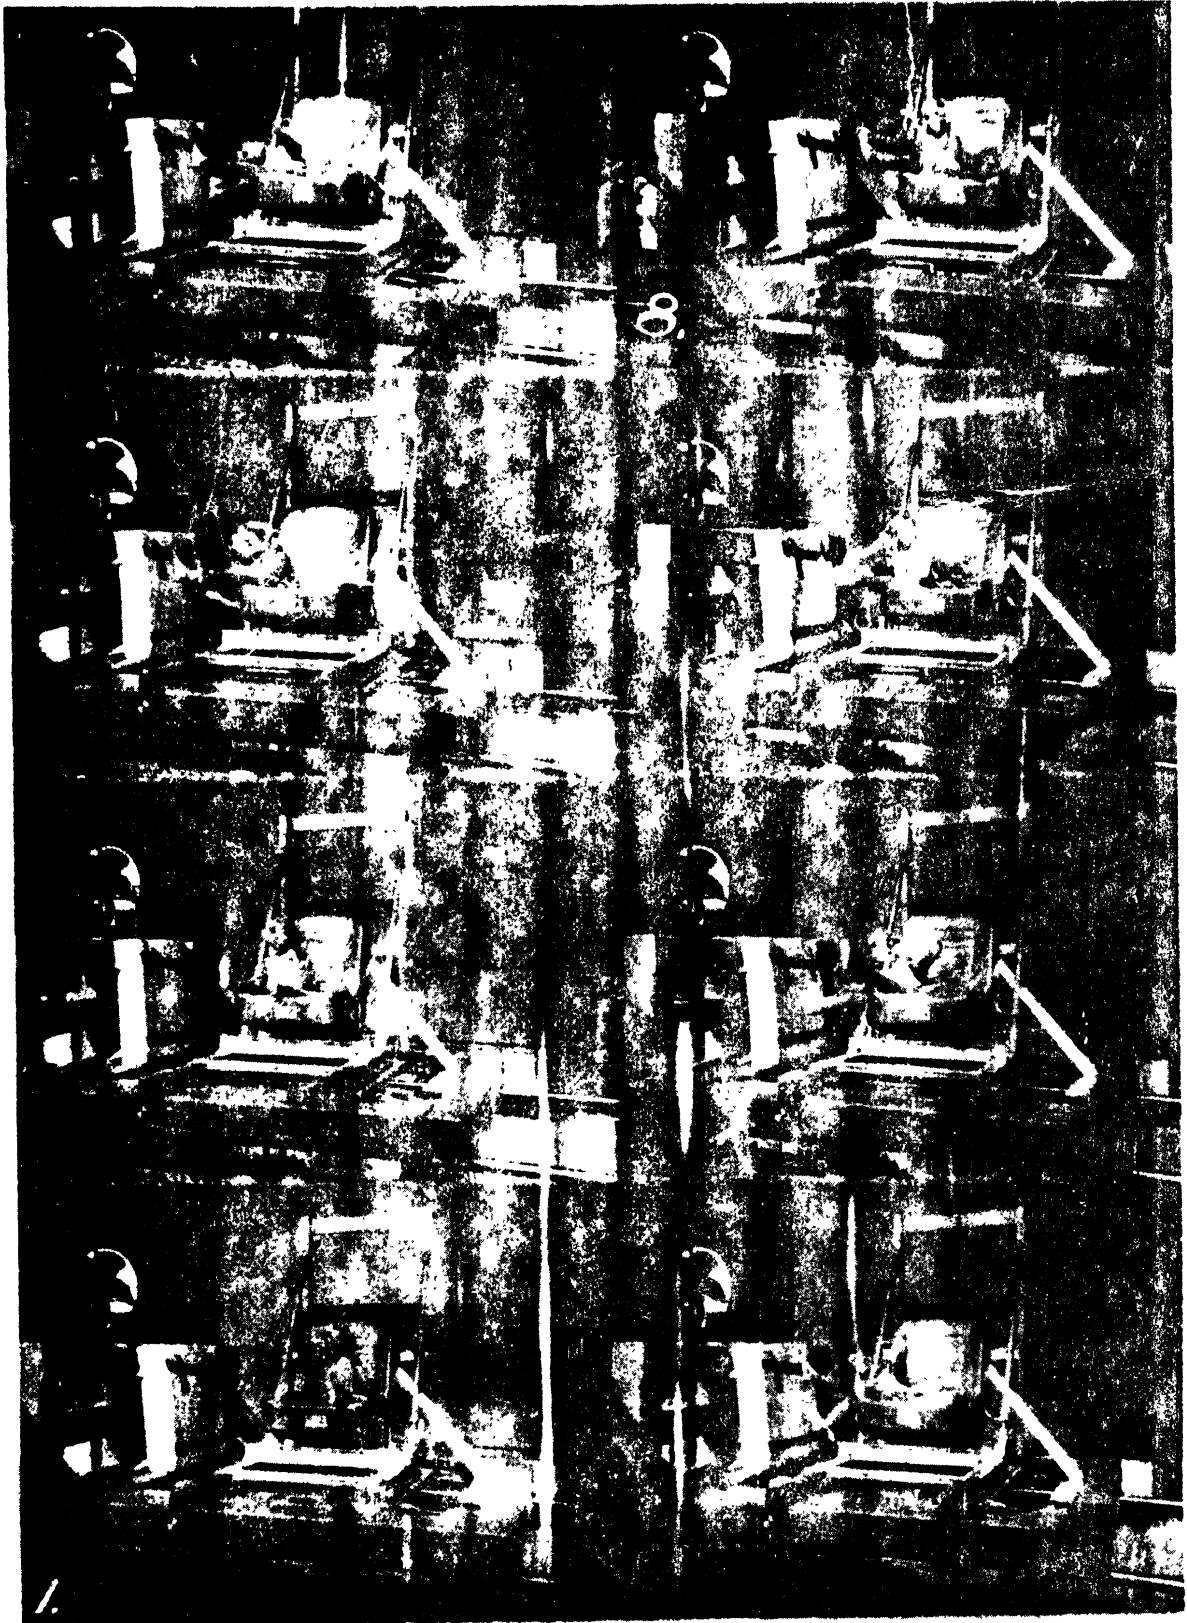
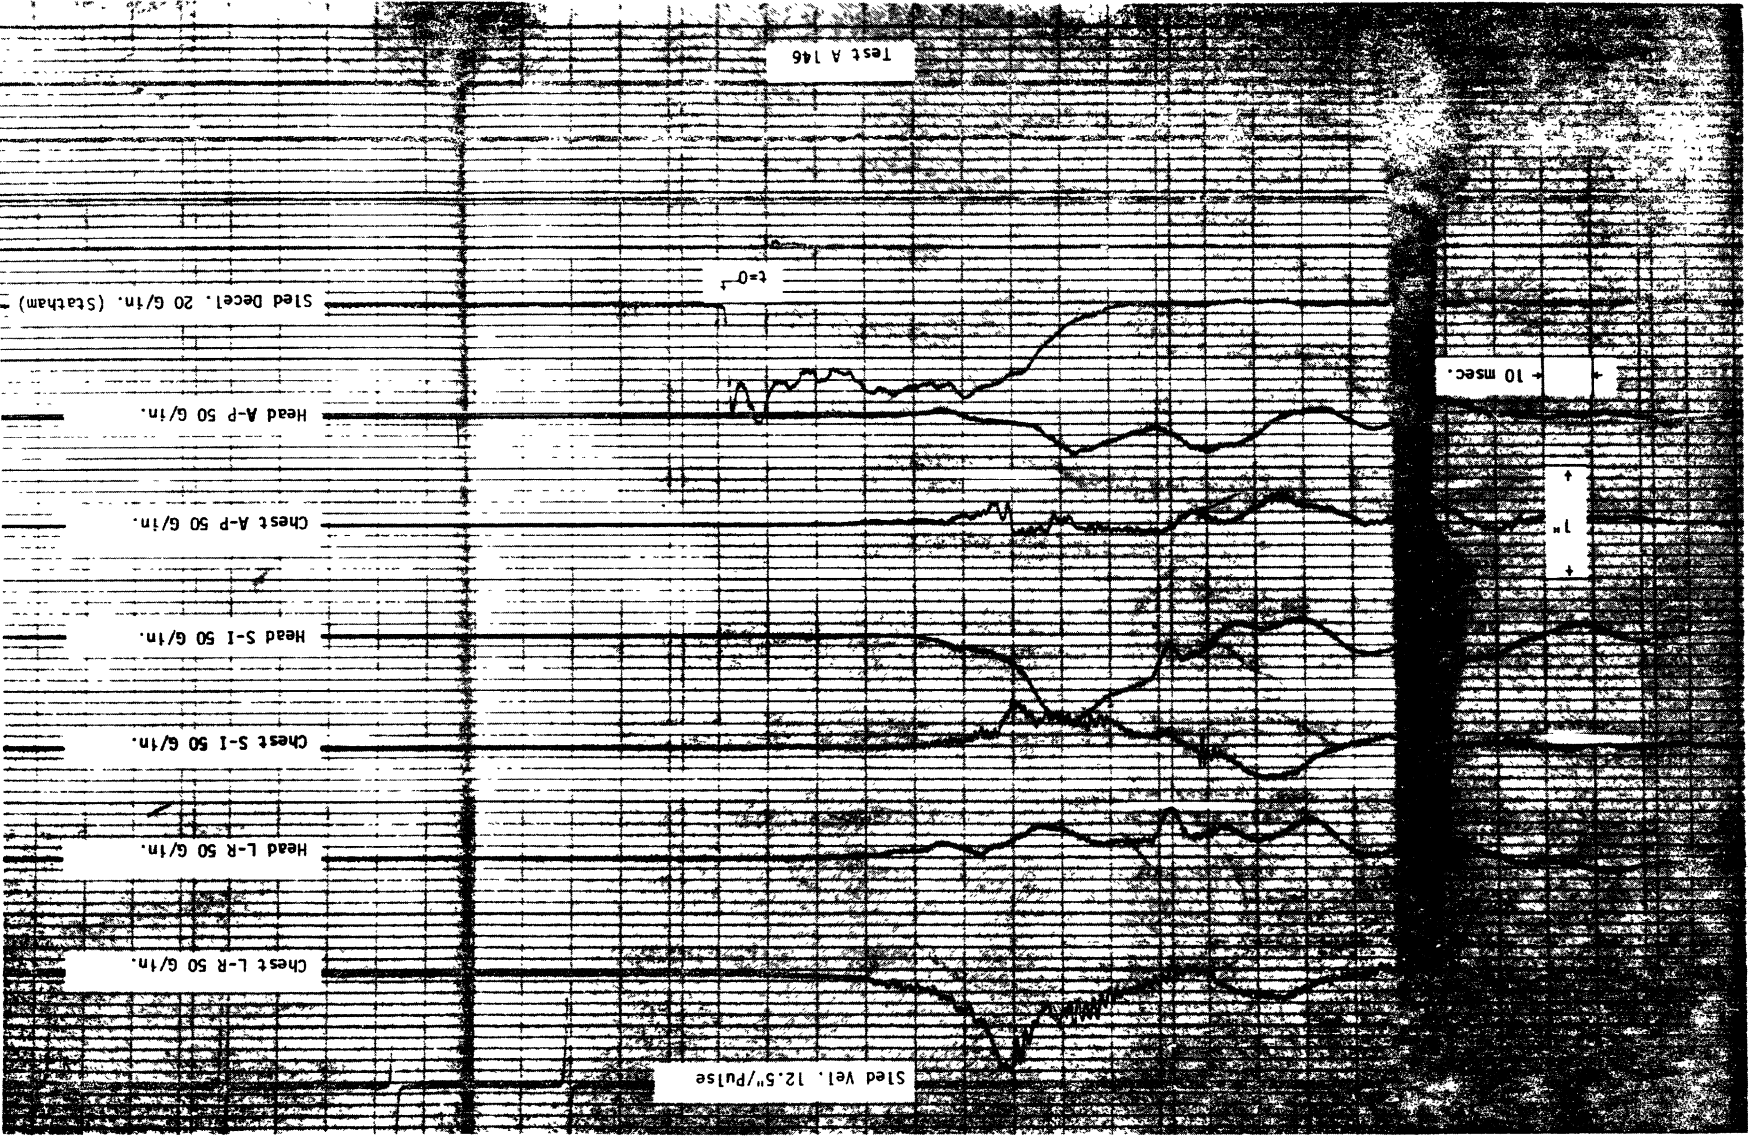
A146.

The loads experienced by the dummy in this test were moderate. However, the restraint system slid sideways allowing the dummy to move sufficiently far to the side to contact any vehicle structures adjacent to the seat location. No damage to the restraint system was observed, but the button snap on the vest strap, which is independent of the harness, came unsnapped.
