CHILD SEAT AND RESTRAINT SYSTEMS TEST RESULTS

APPENDIX D

Final Report

Volume III of III

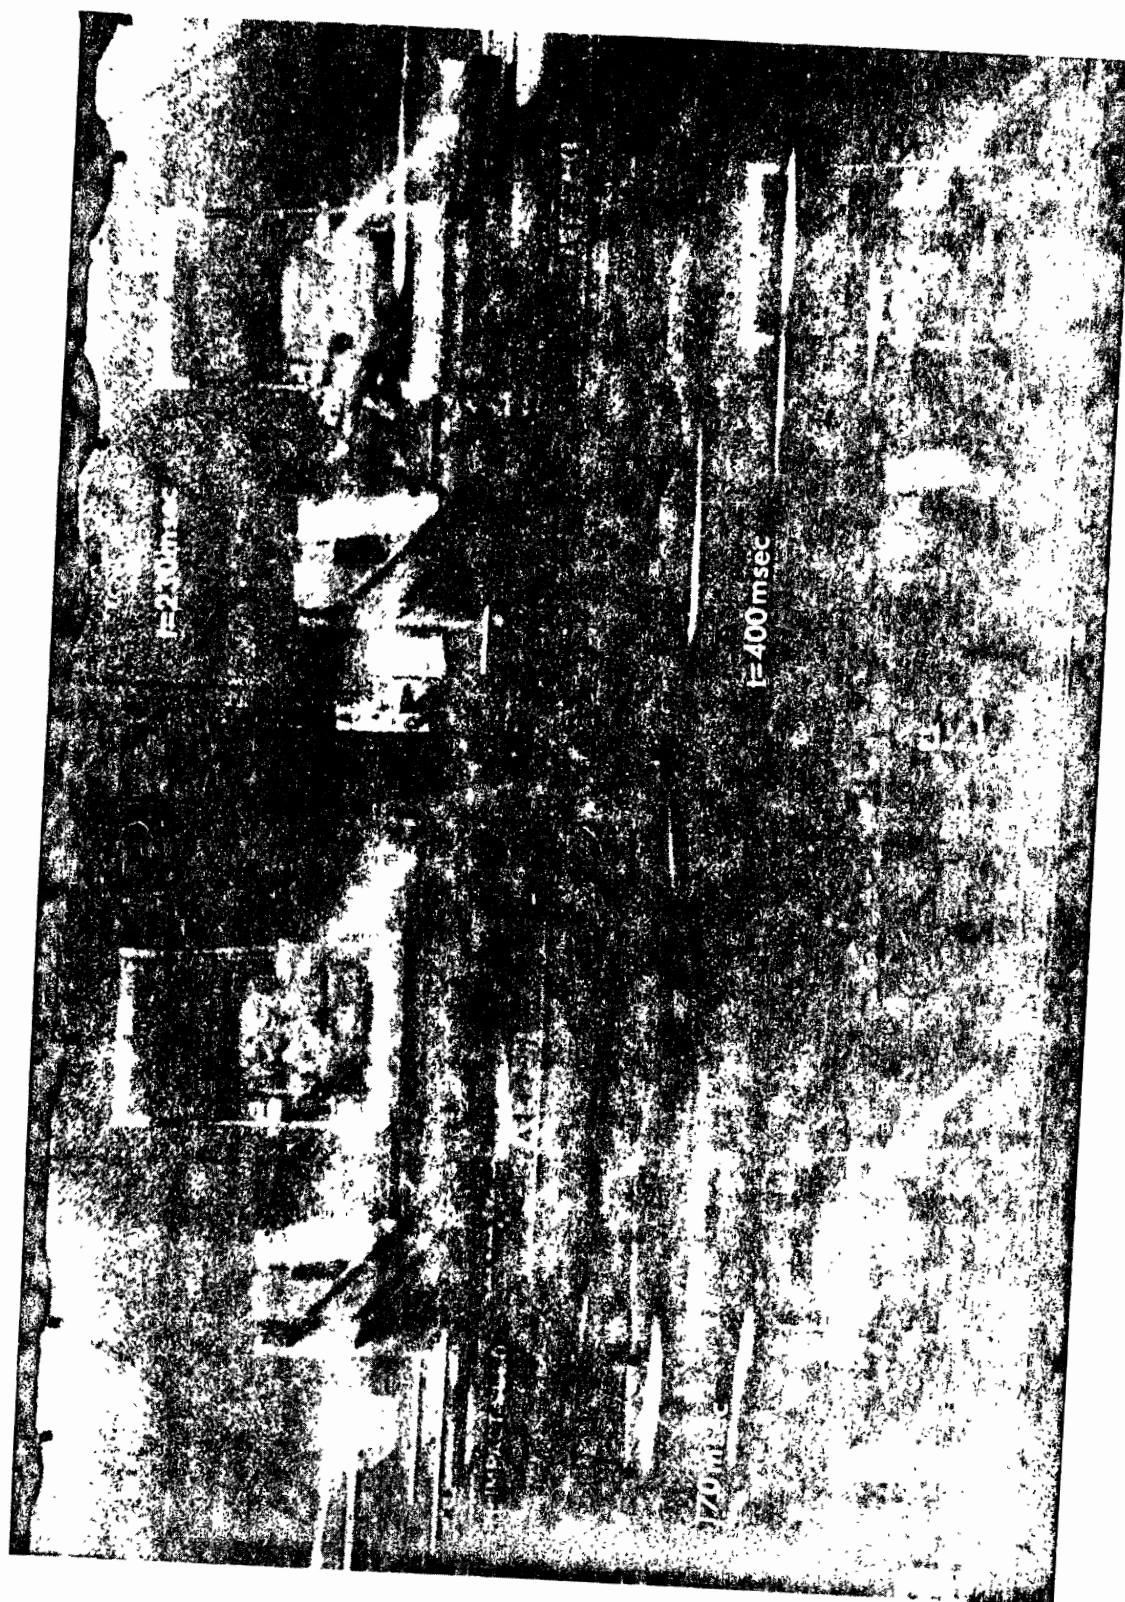
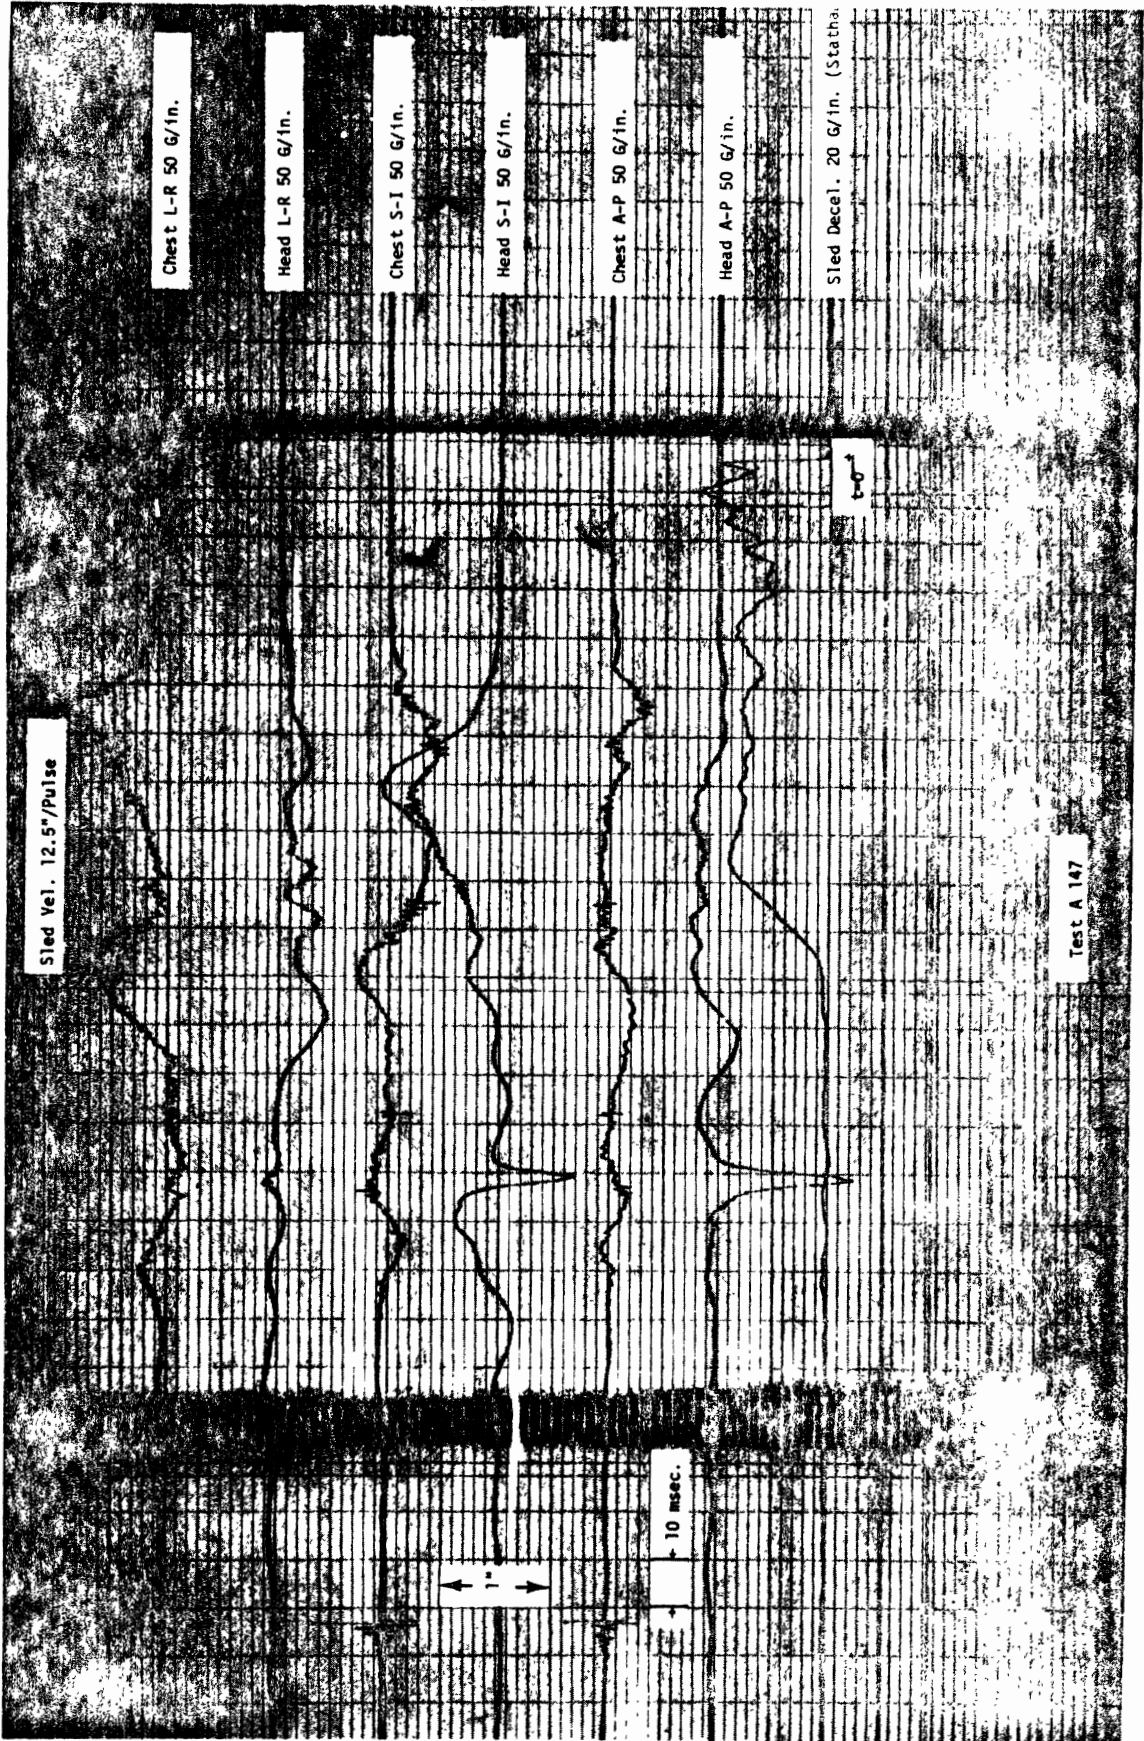
A147

The g-loadings experienced by the dummy were quite high. Sideways motion of the dummy was sufficient enough to cause contact with any adjacent interior structures in a vehicle. The nylon mesh vest was torn where it was sewed to the upper left shoulder strap.

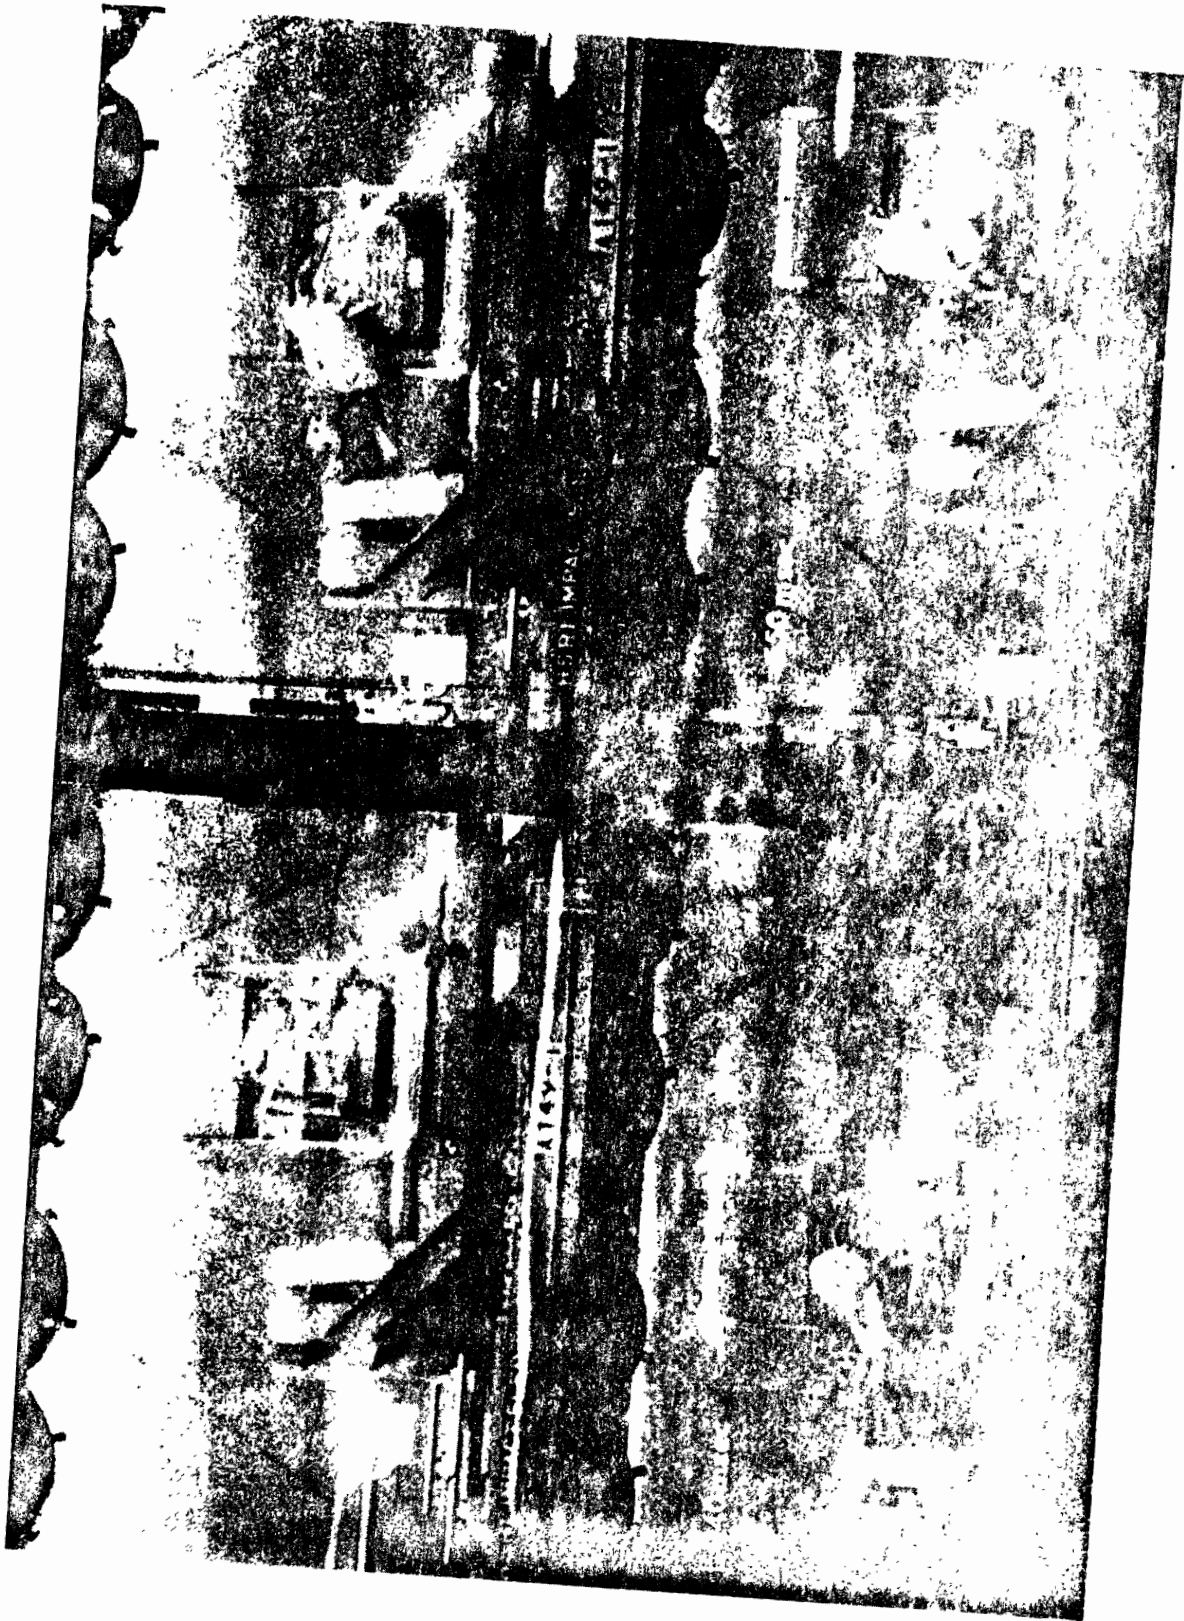
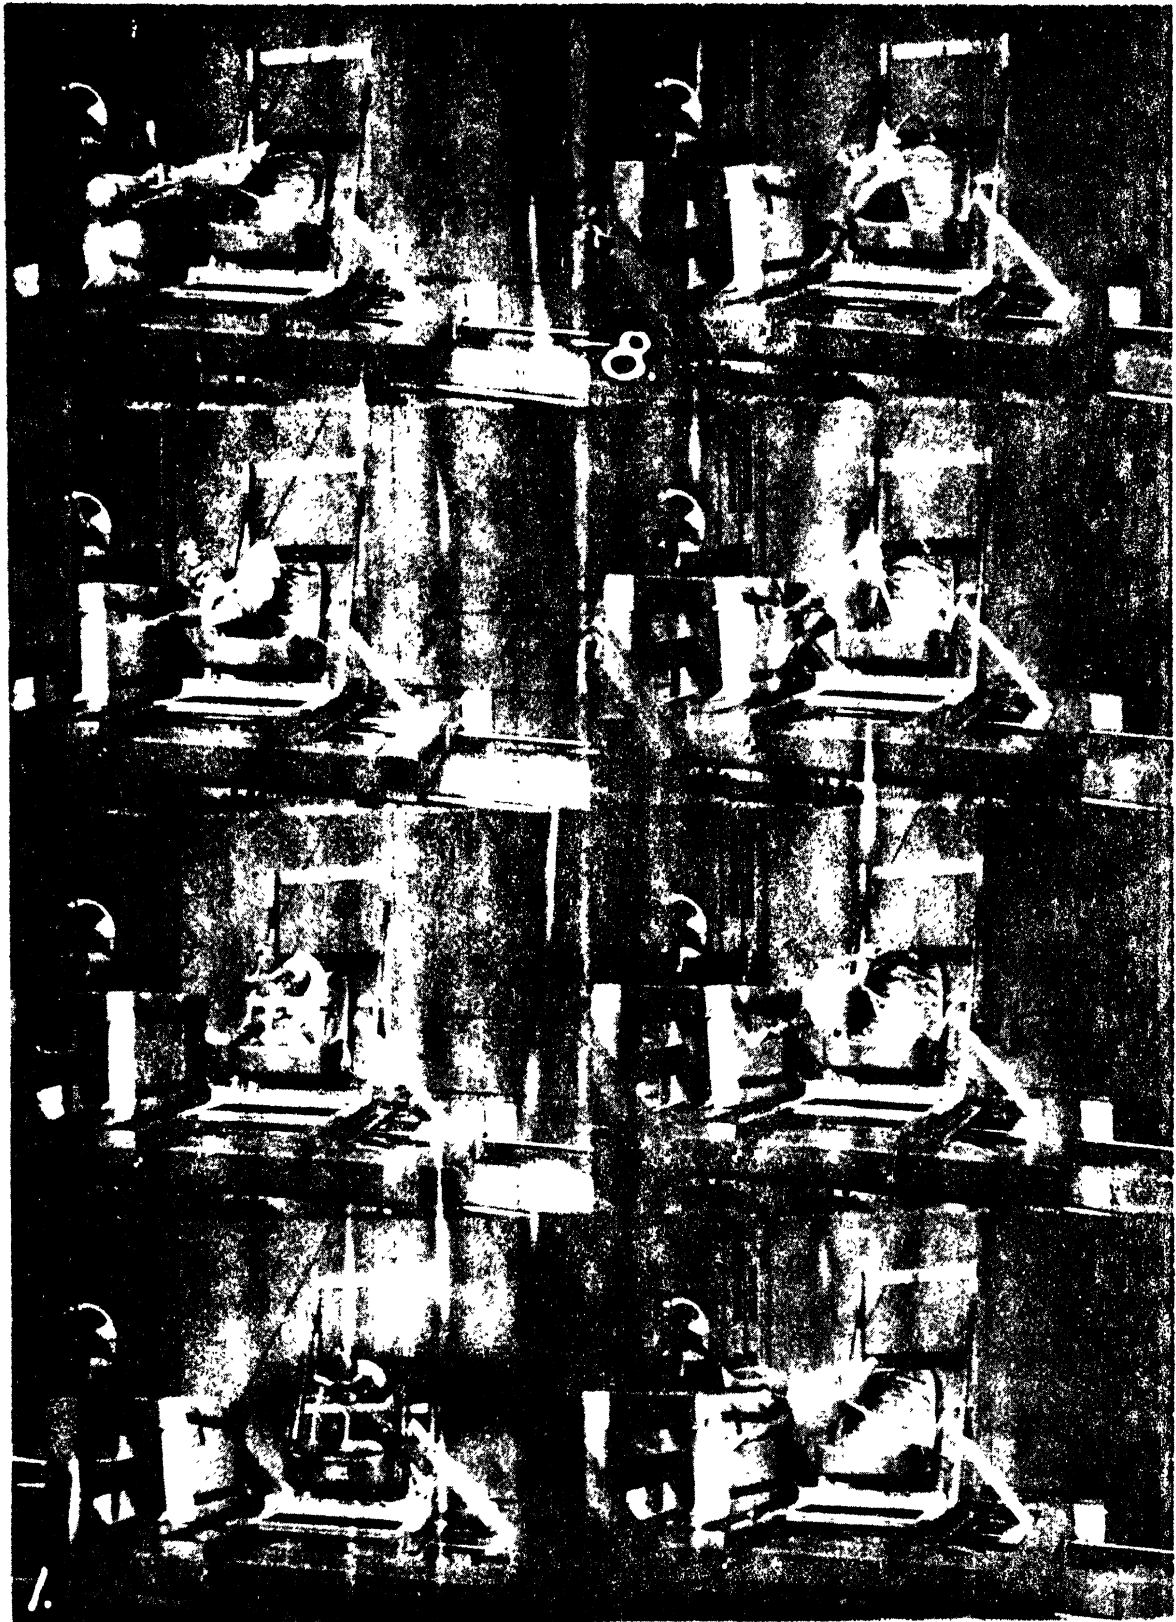
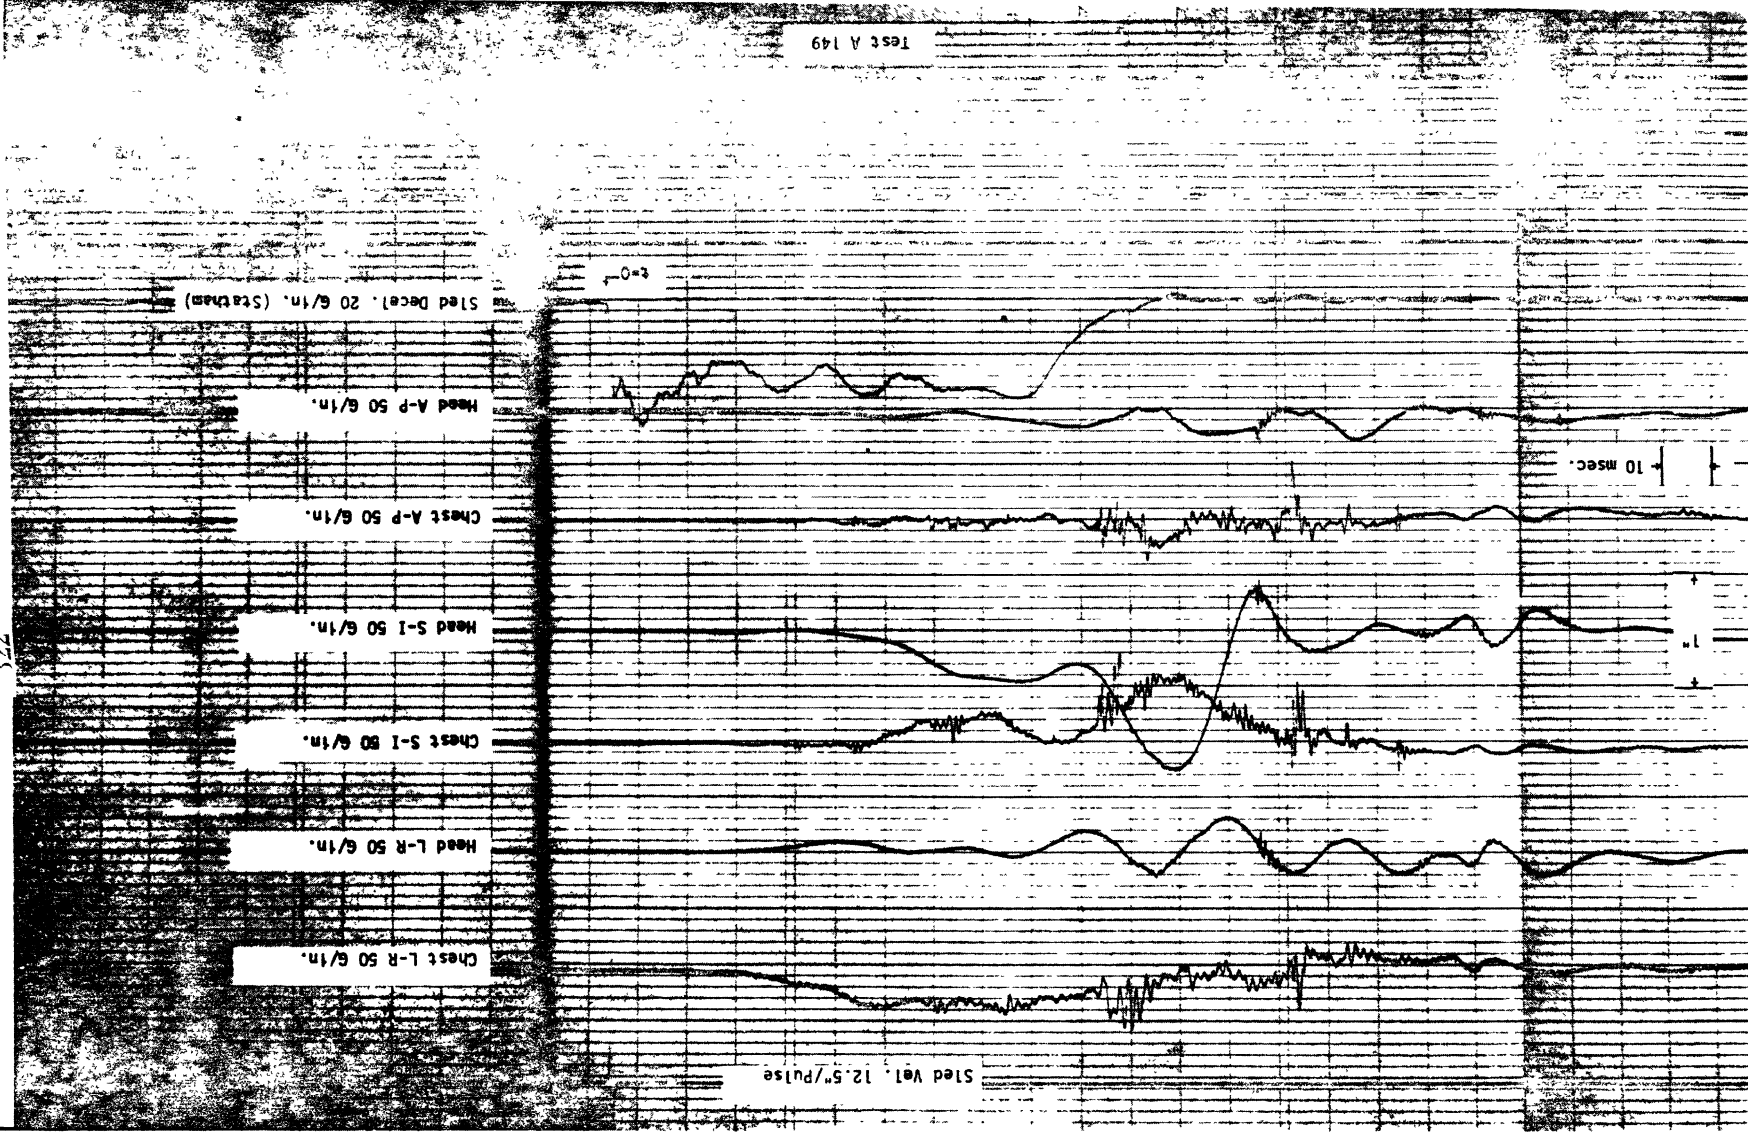
A149

The rear seat retaining strap which anchors the bail hooks to the floor parted at the intersection of the Y. Thus, the dummy and the seat were both ejected from the adult seat. The restraint system would have offered no protection whatsoever in this situation.

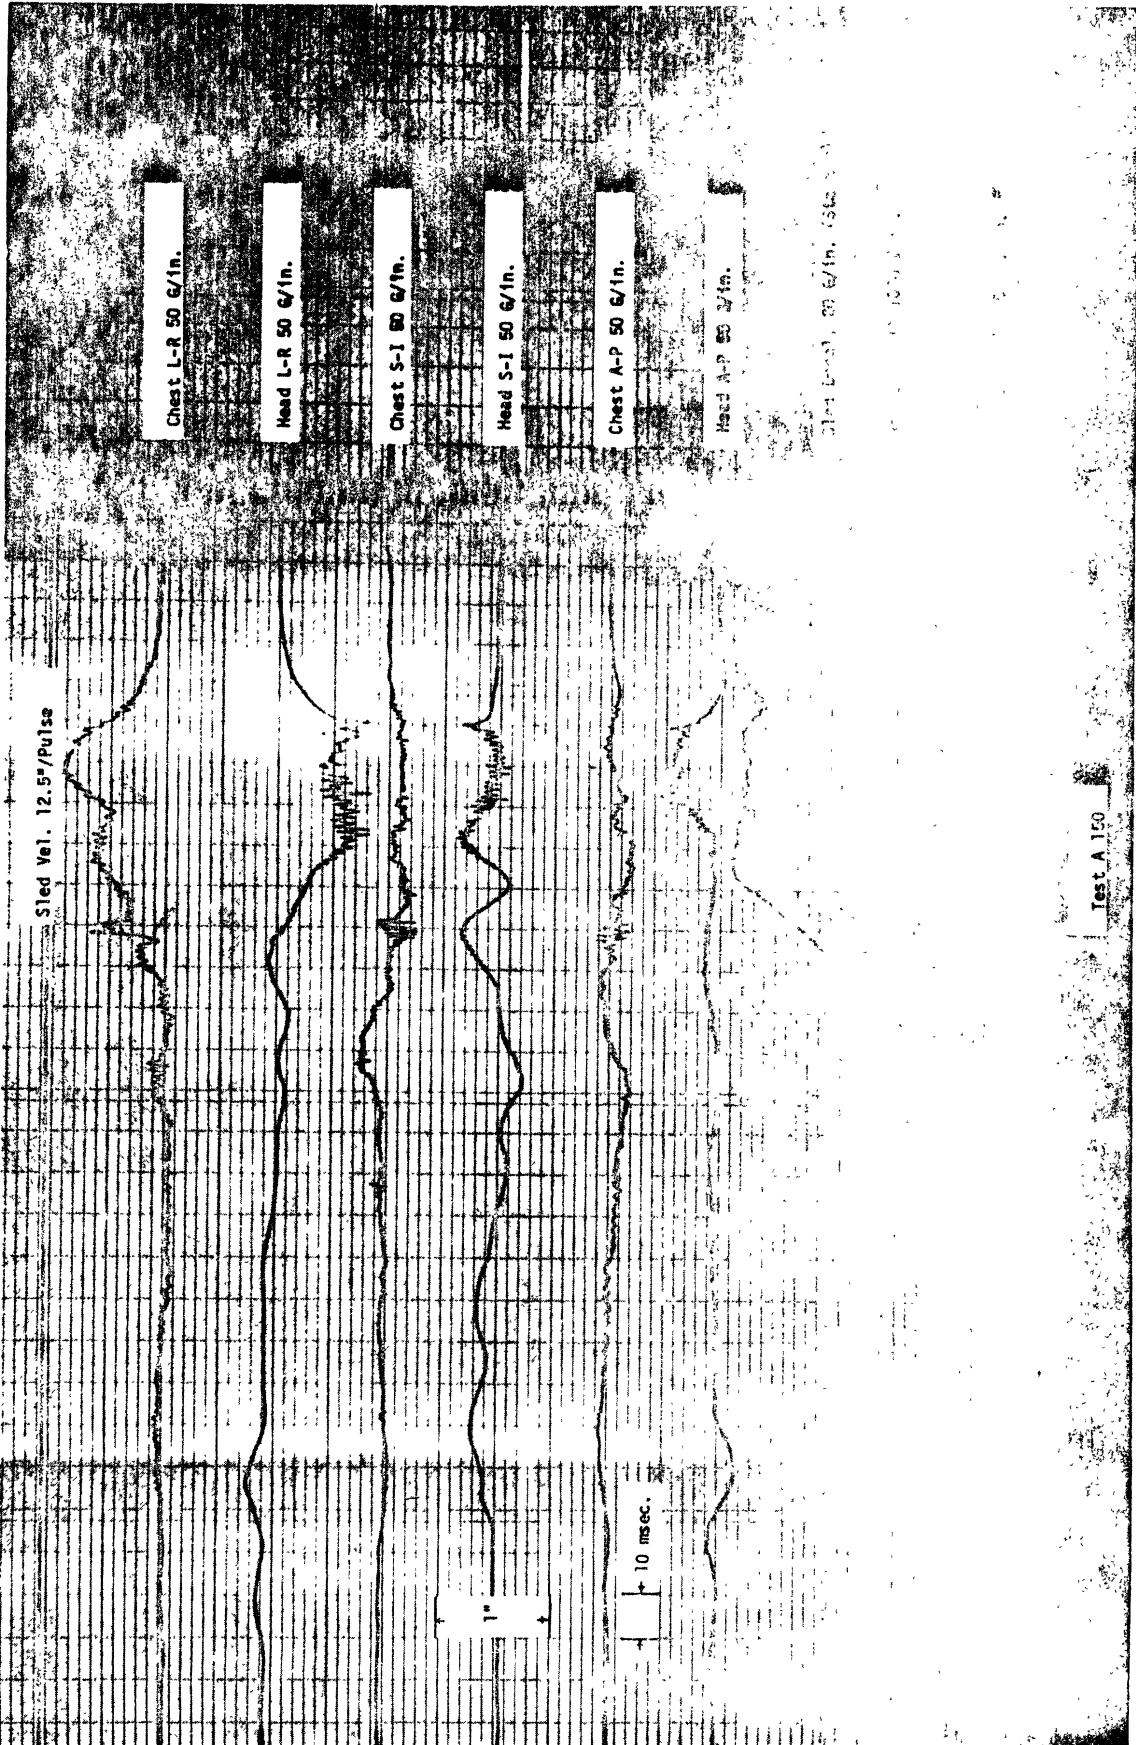
A150

The g-loadings experienced by the dummy in this test were moderate. The side structures of this restraint system would have prevented the dummy from contacting vehicle interior structures. In addition to this, no gross relative motion between the head and the torso took place. The side structure of this seat was somewhat bent outward in this test. This is the only seat observed in this test series which offered a substantial degree of protection in side impact.

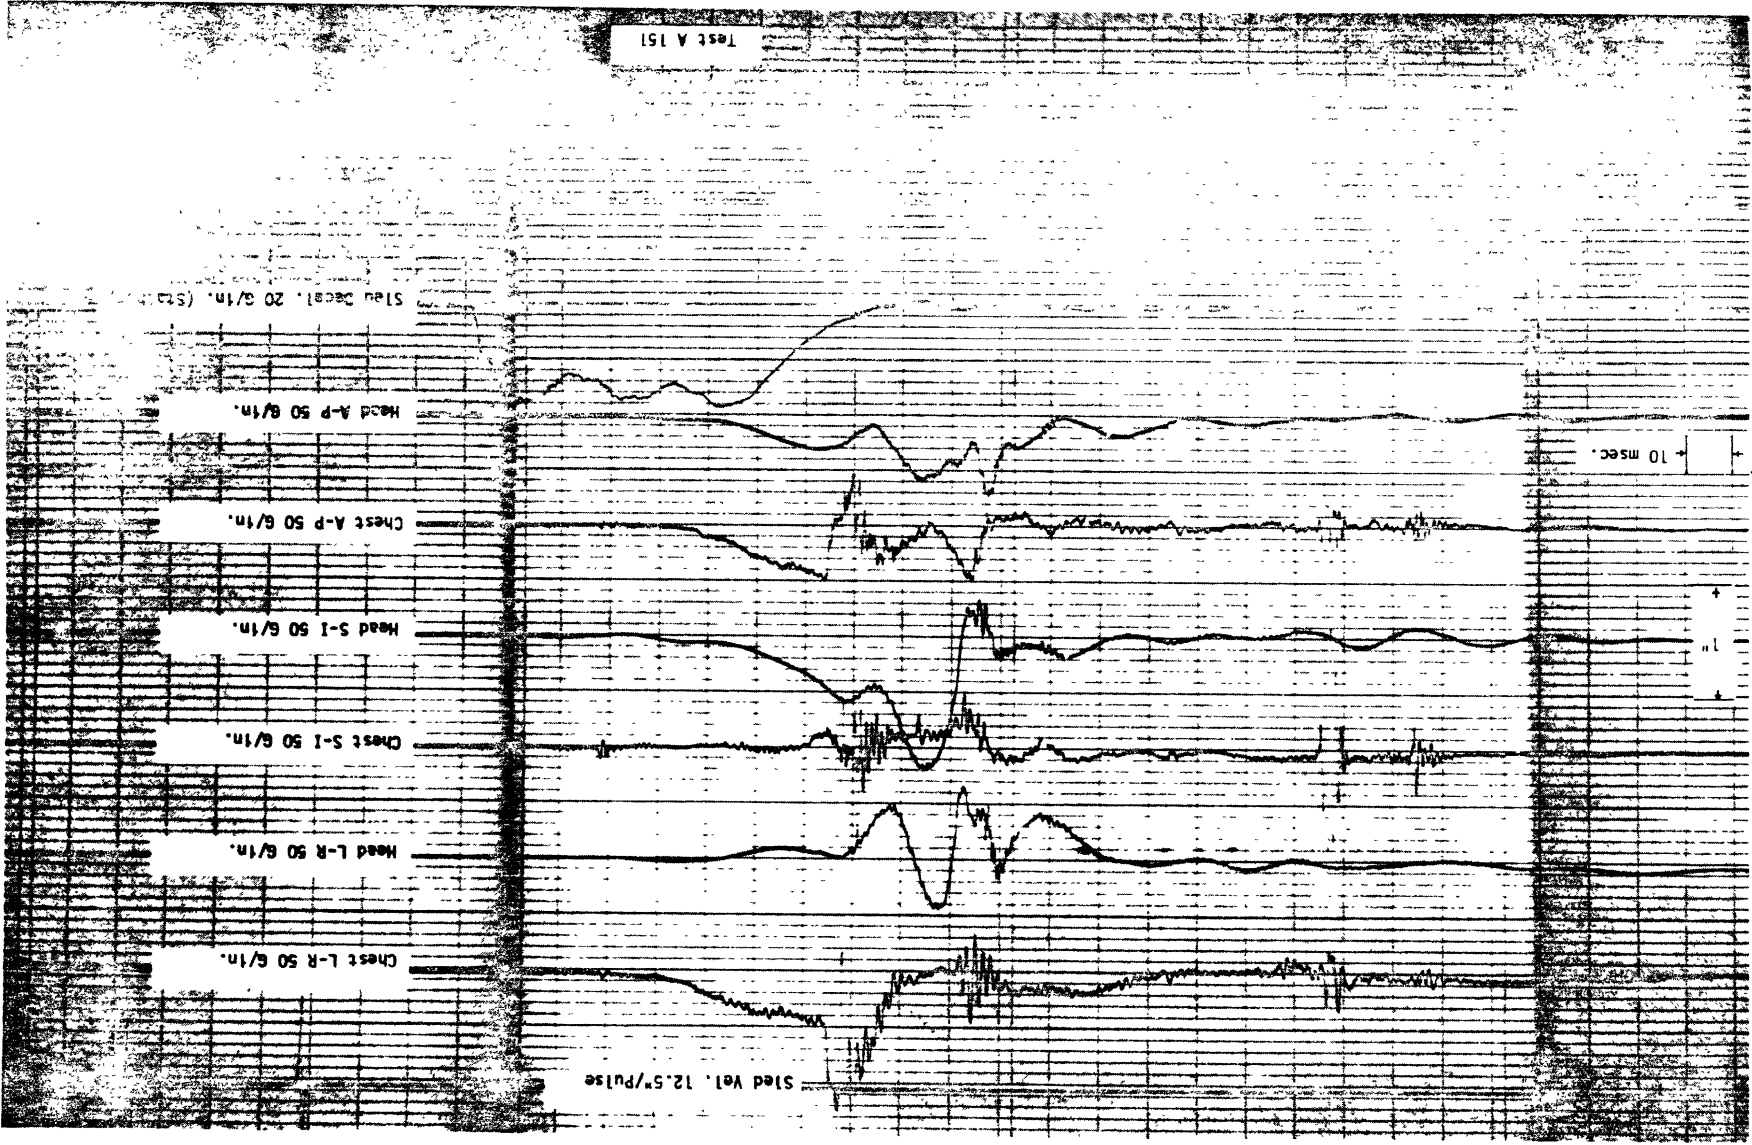
A151

The dummy went through rather wild contortions during this test. The right arm was broken off. Because the restraint system slid to the side, the dummy would have contacted any adjacent vehicle structures.

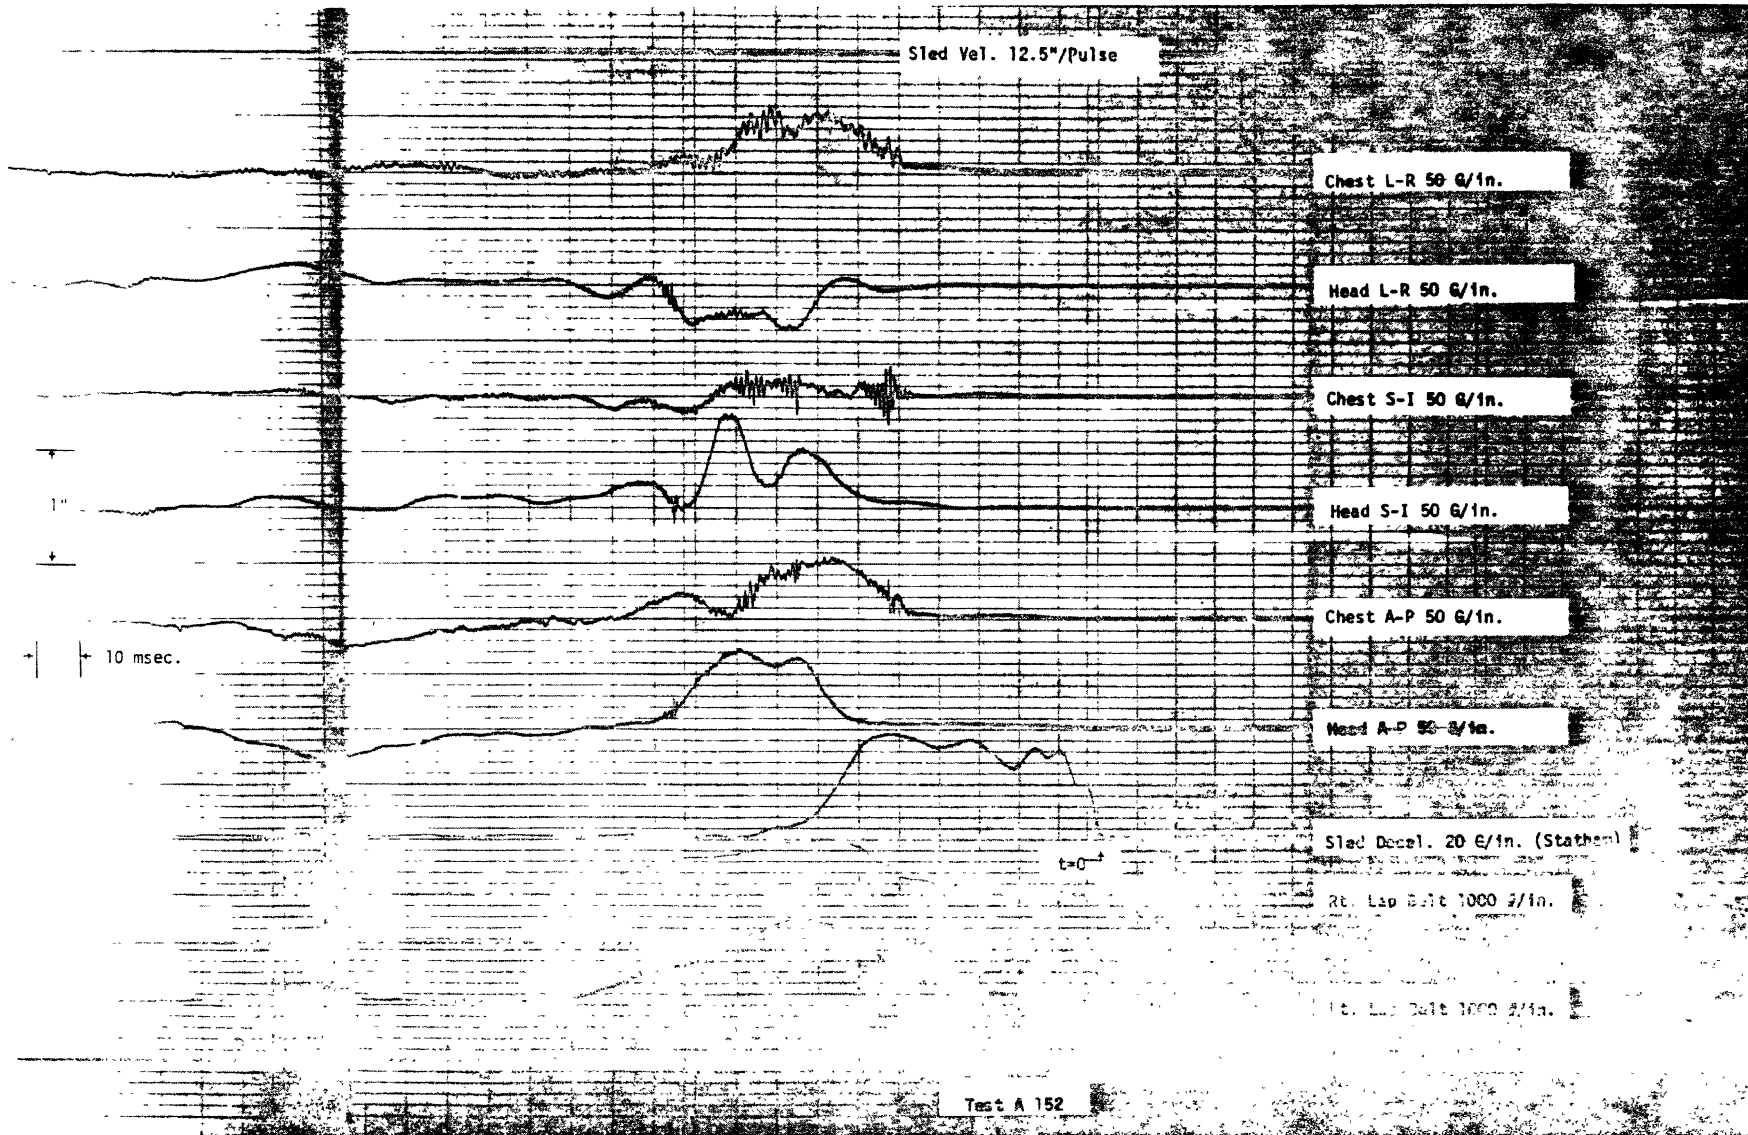
A152

The g-loadings experienced by the dummy were moderate and the motion experienced was minimal. Rebound was quite severe.

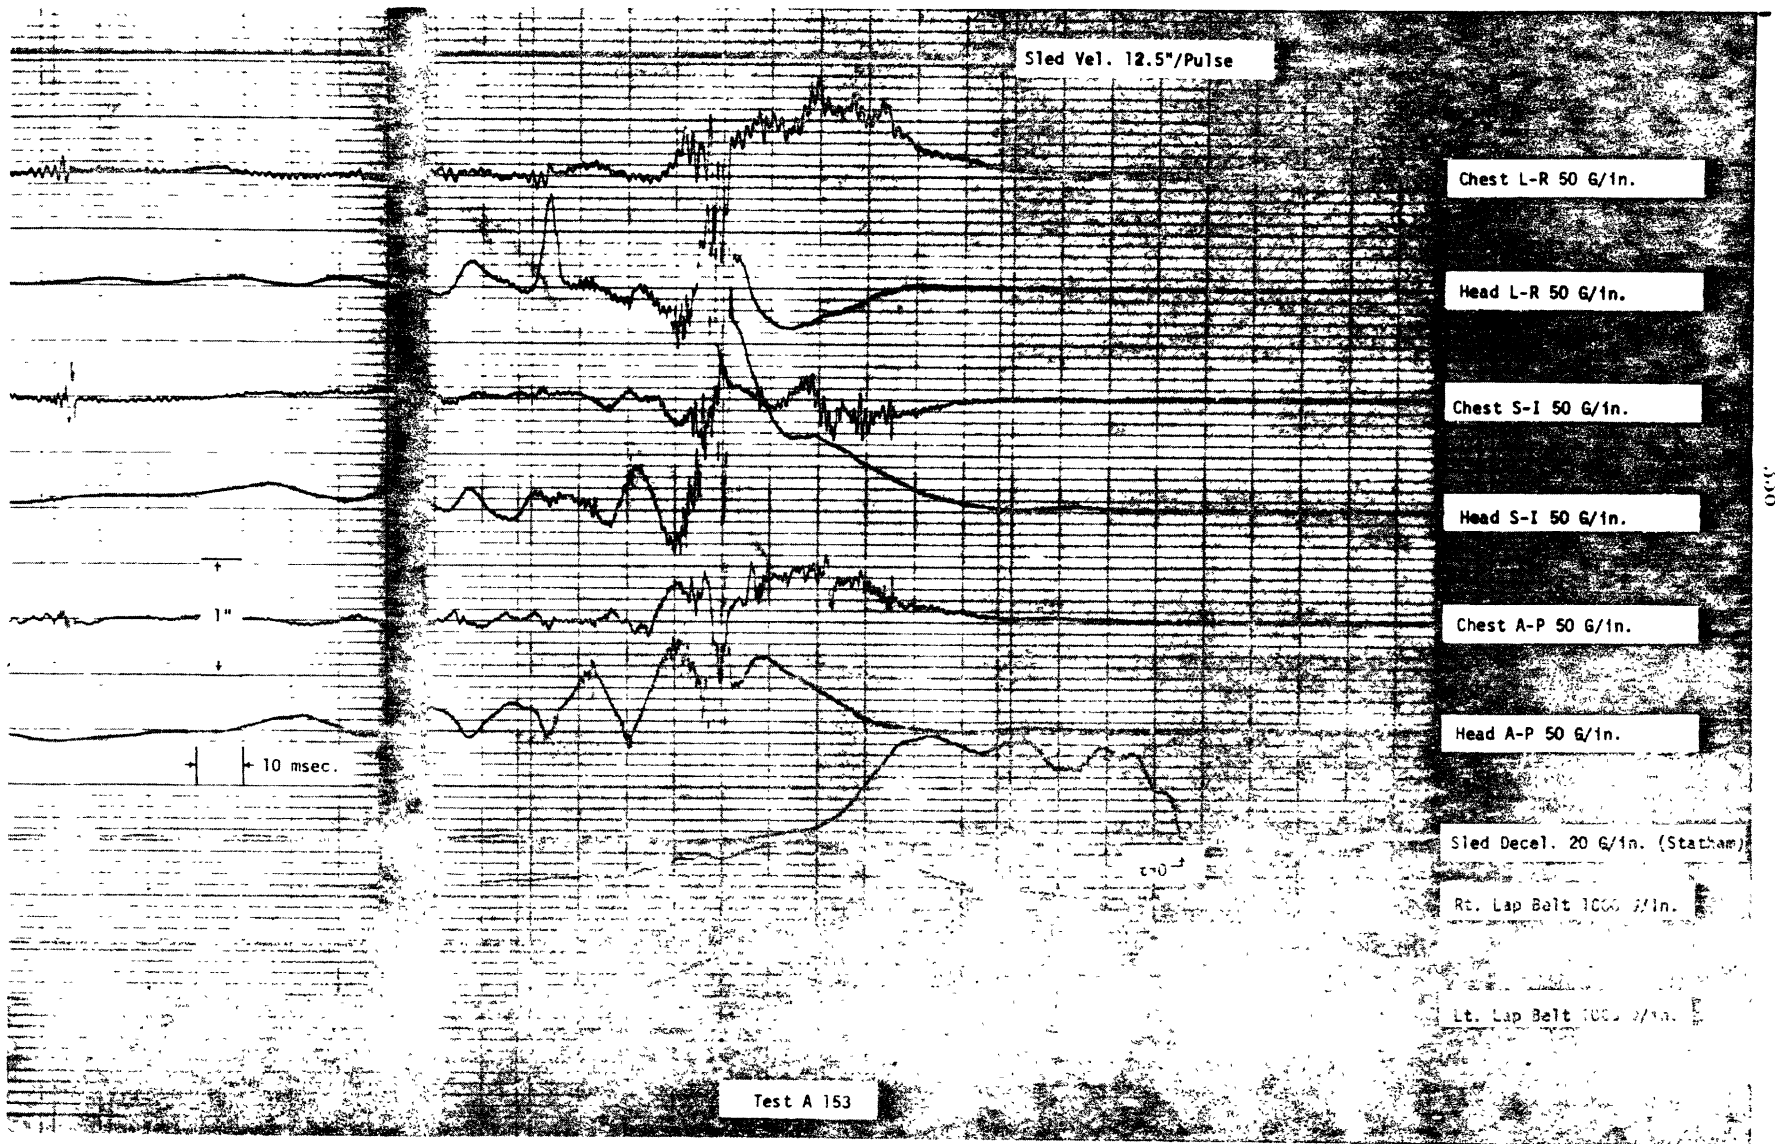
A153

The loadings received by the dummy were quite high, especially in the head superior-inferior accelerometer. As is usual with this pedestal type seat, it was observed to dig into the seat cushion structure of the adult seat. The upper part of the upper torso of the dummy and the head pitched forward over the chest restraining strap.

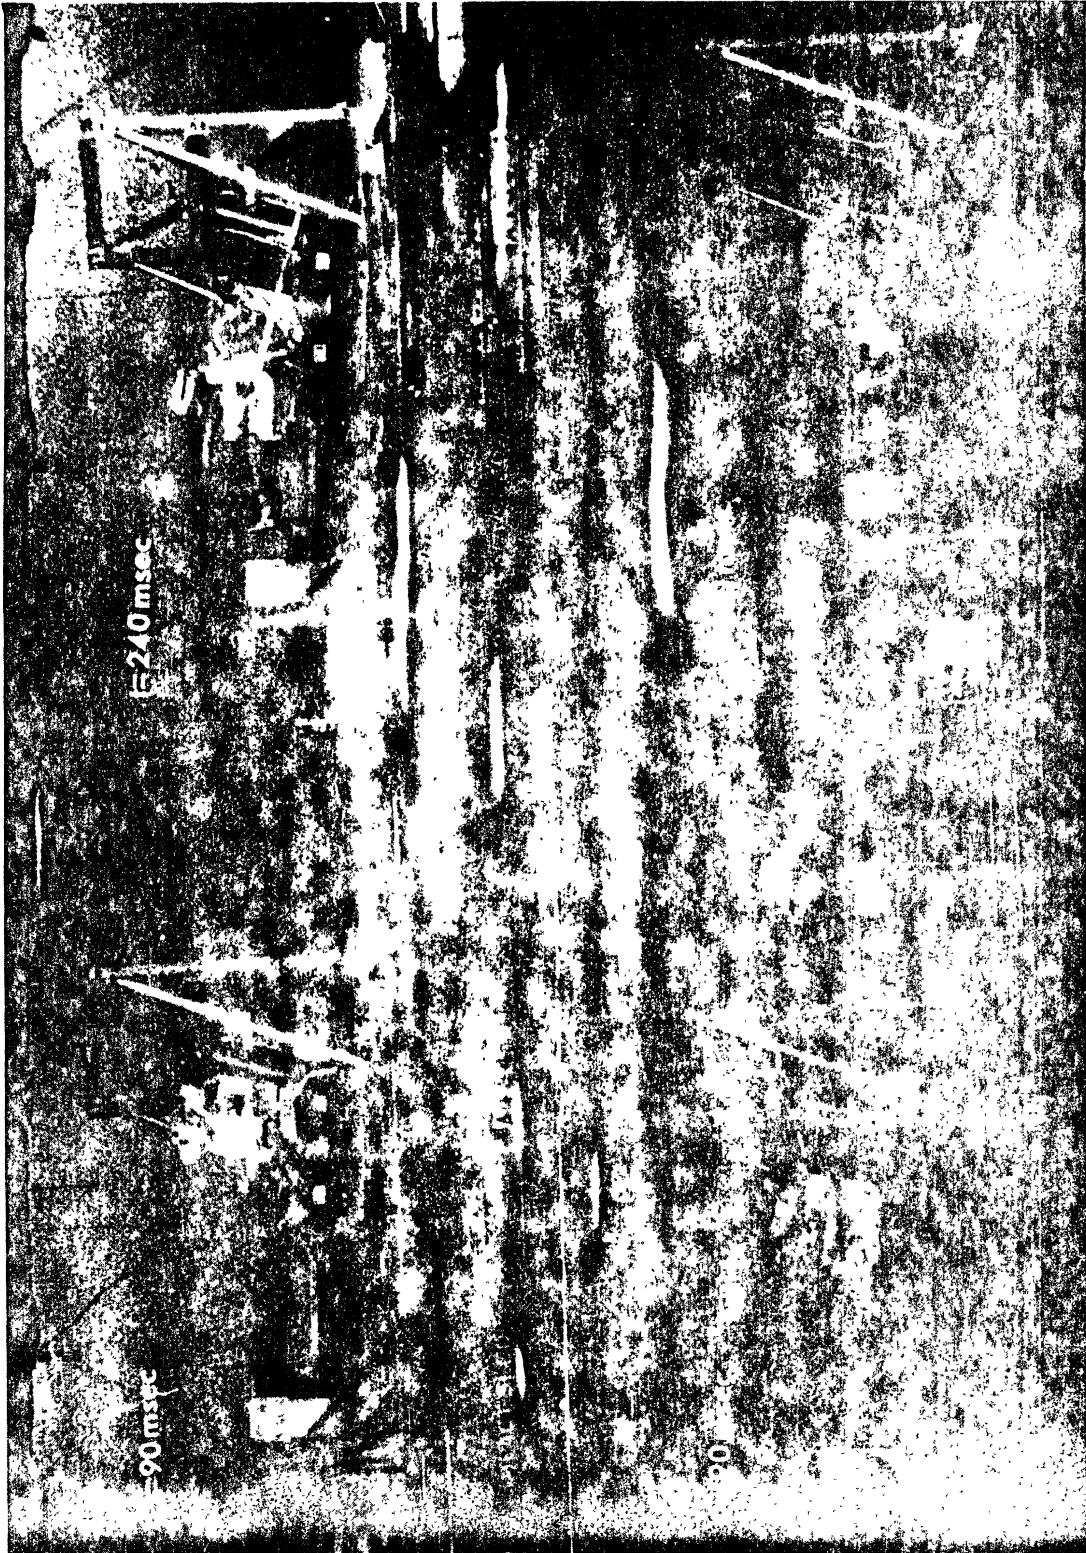
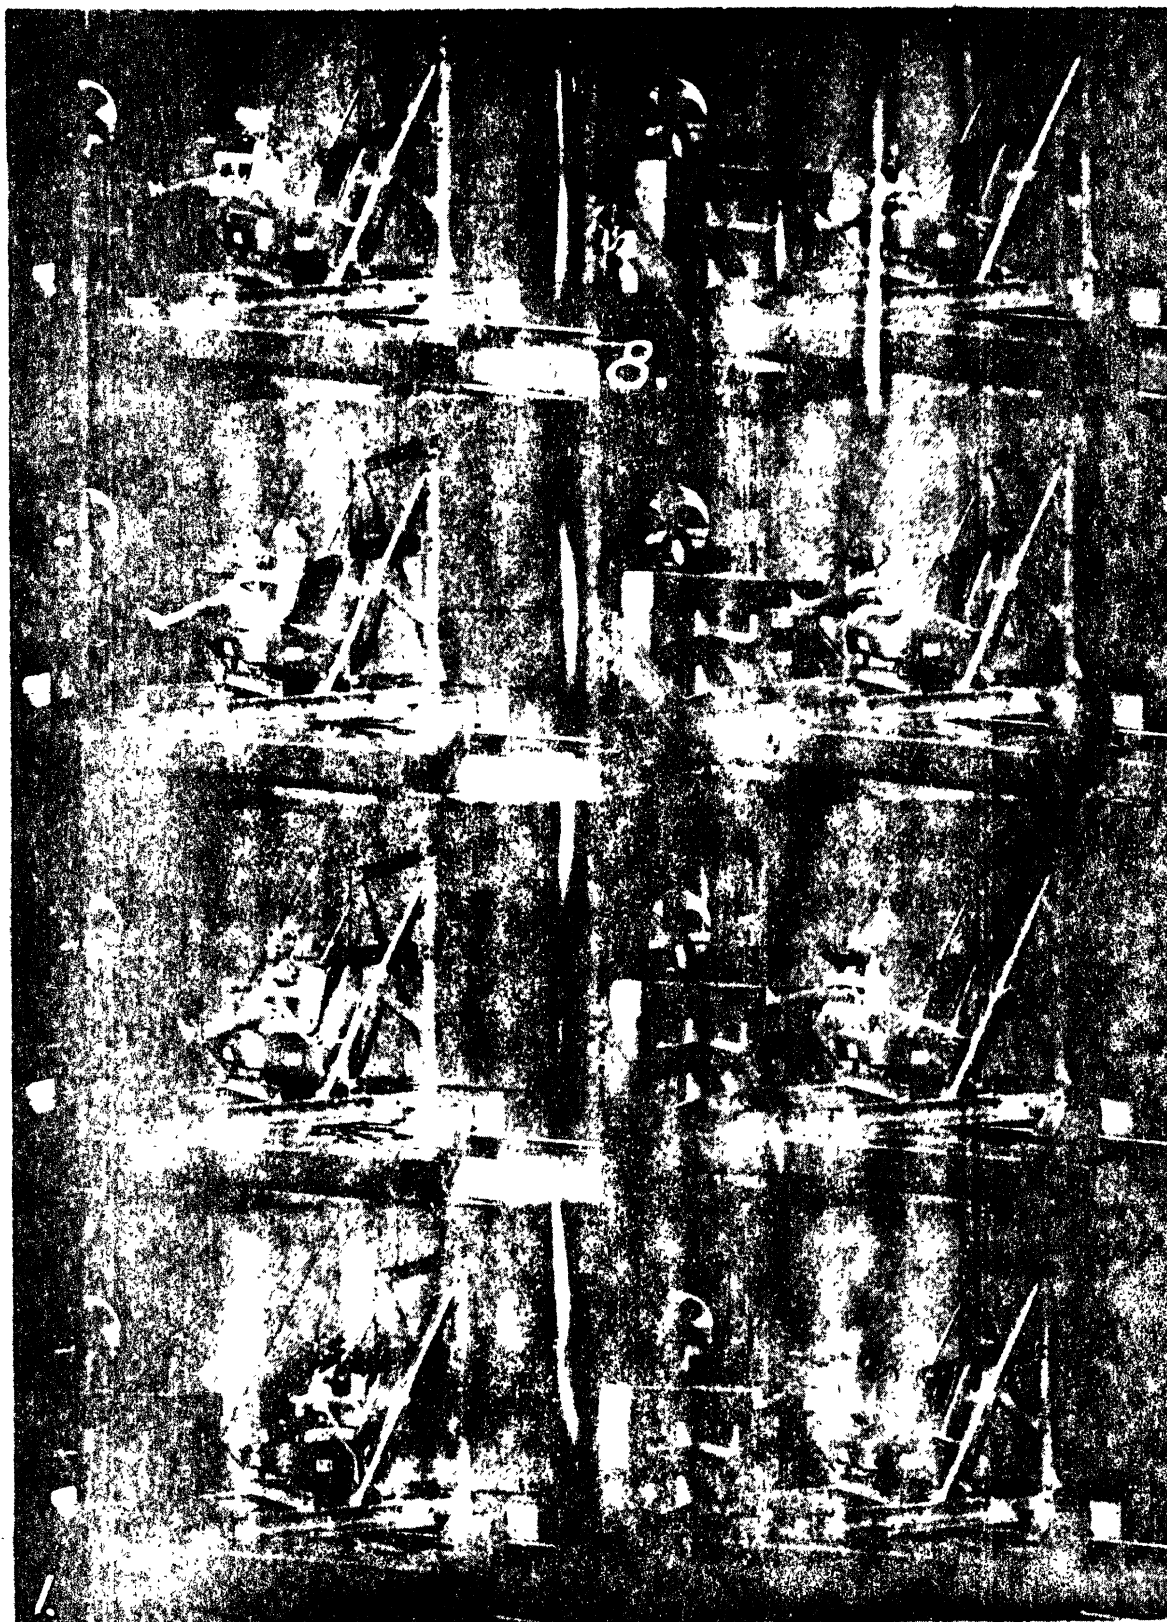
A154

The failure of the left ball hook allowed the dummy and the child seat to cartwheel sideways off the adult seat. This would have resulted in impacting the inside of the car. NOTE: Instructions with the seat recommended use of the adult lap belt across the seat behind the dummy's buttock to help restrain the seat. This was not done in this test.
