CHILD SEAT AND RESTRAINT SYSTEMS TEST RESULTS

APPENDIX D

Final Report

Volume III of III

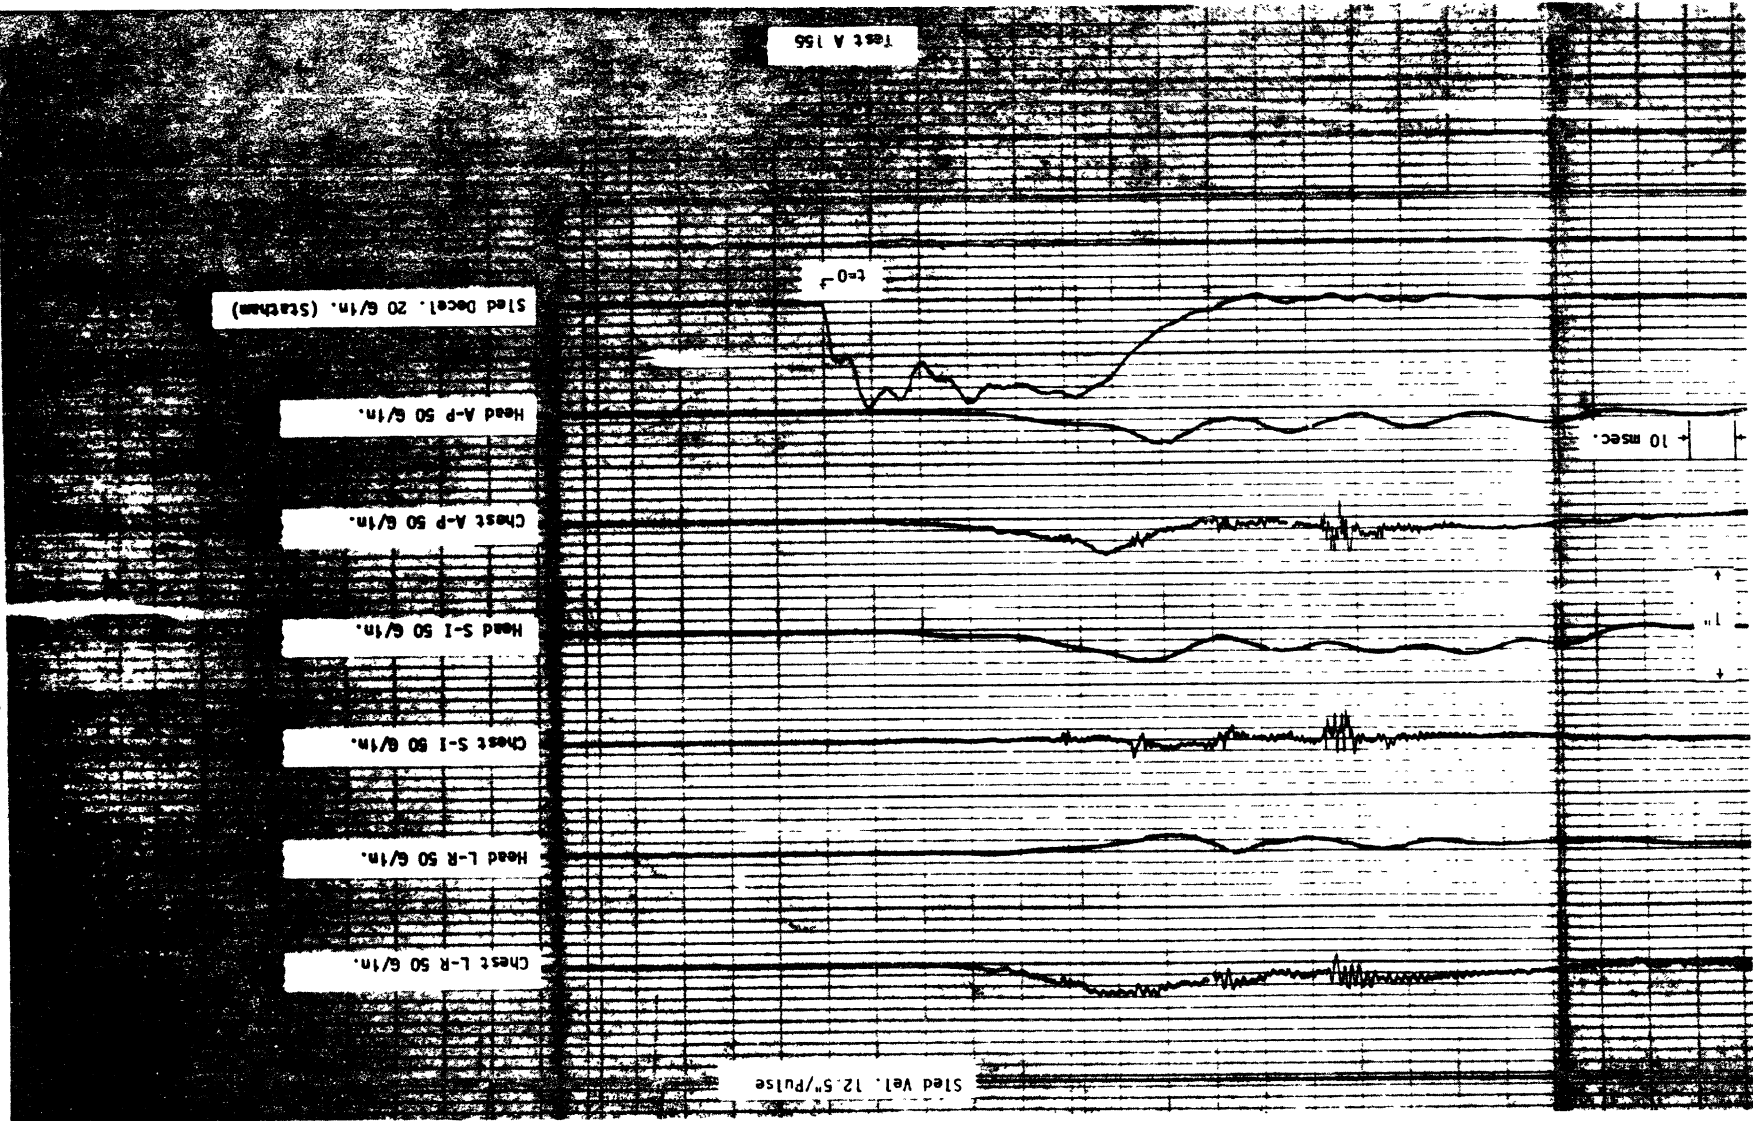
A155

The dummy experienced very low g-levels, apparently due to the gradual collapse of the seat. The tubular frame structure of the seat collapsed completely. The seat and dummy were partially off the seat after the test. The excursions appeared to be very large.

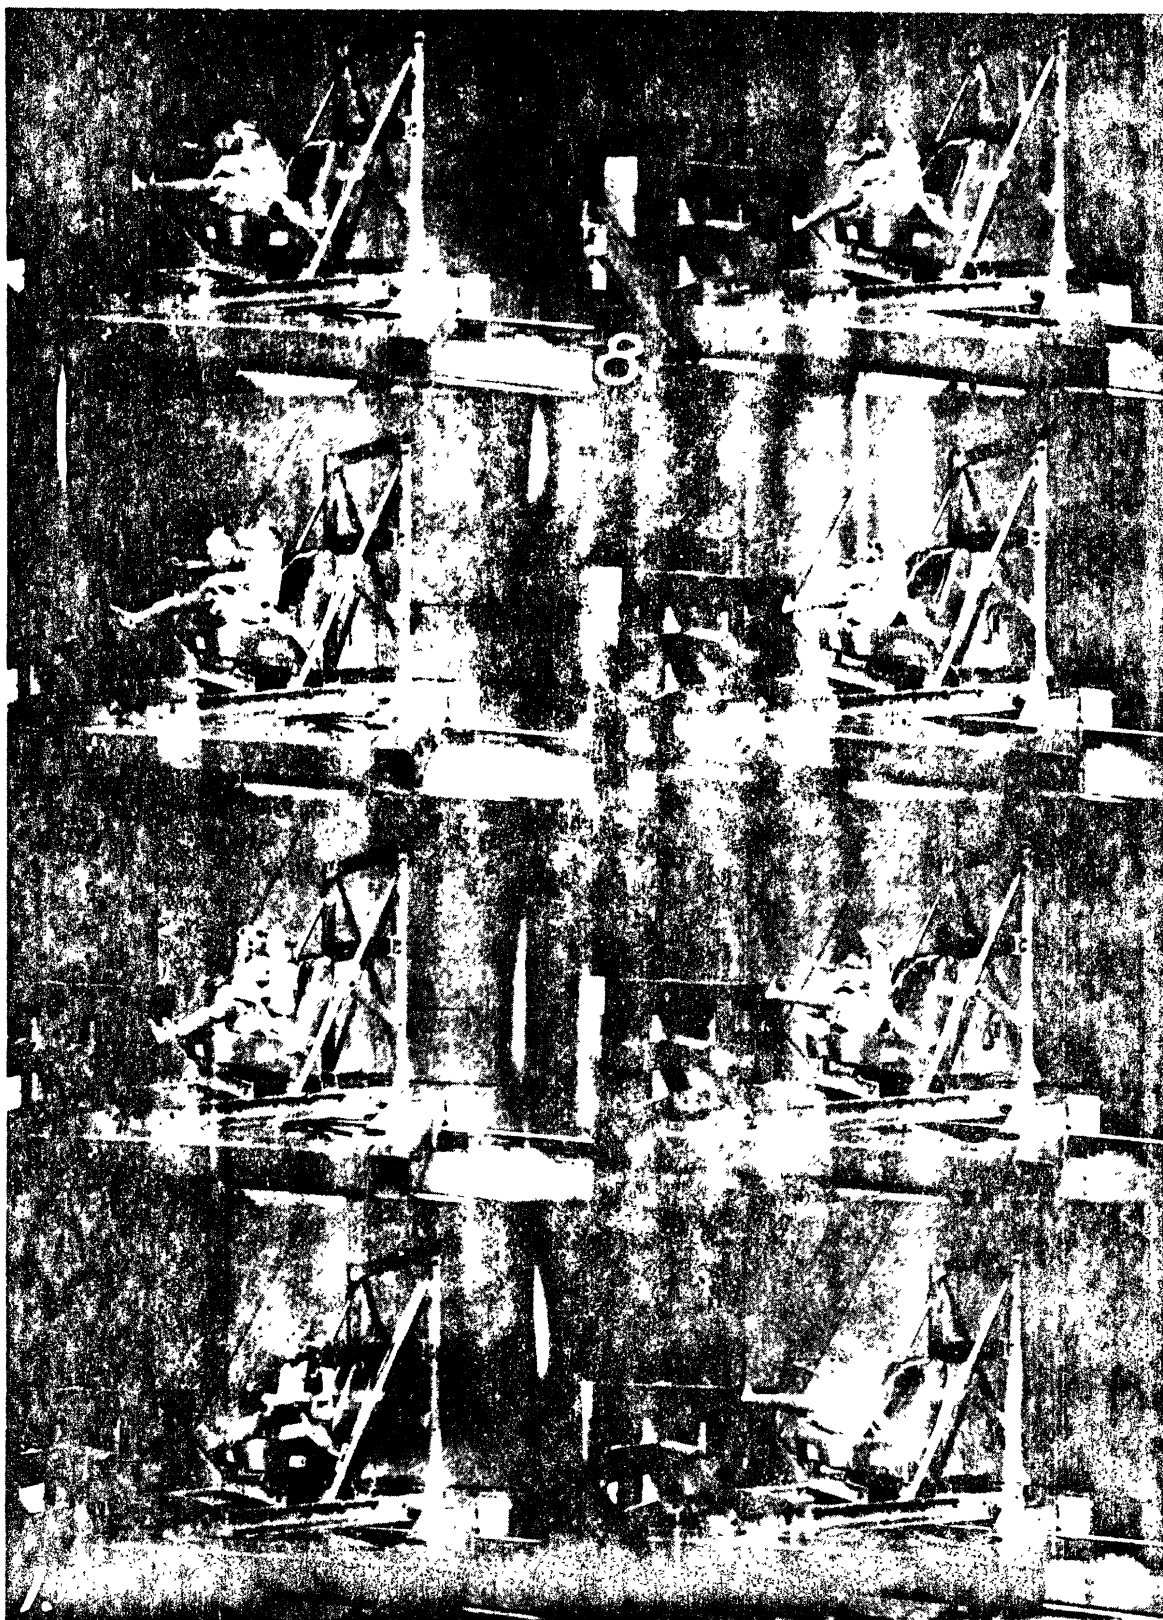
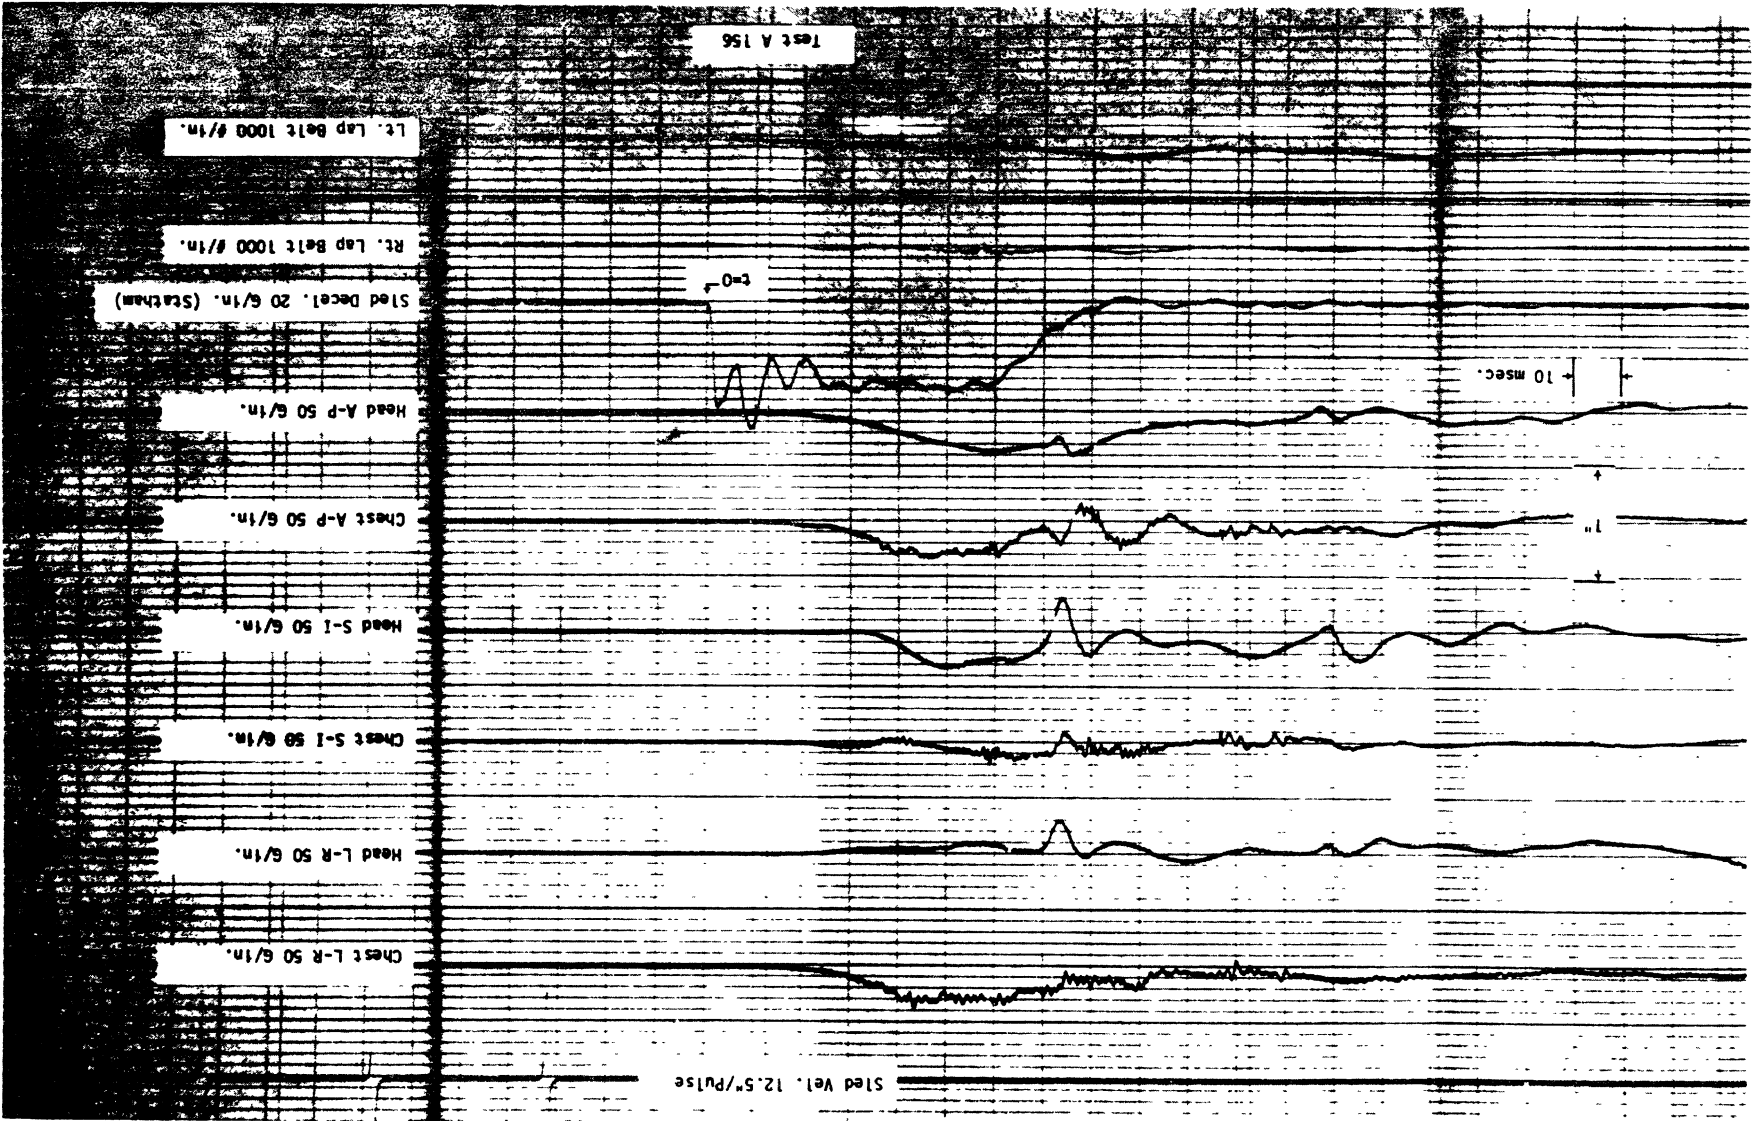
A156

The failure of the left bail hook allowed the seat and the dummy to cart-wheel sideways until the motion was arrested by the adult lap belt. Acceleration loadings of the dummy were moderate. Extreme excursions were experienced by the upper torso and head of the dummy. The left bail hook was bent nearly straight, the main vertical side tube was fractured and bent, and the crotch strap was torn between the dummy's legs.

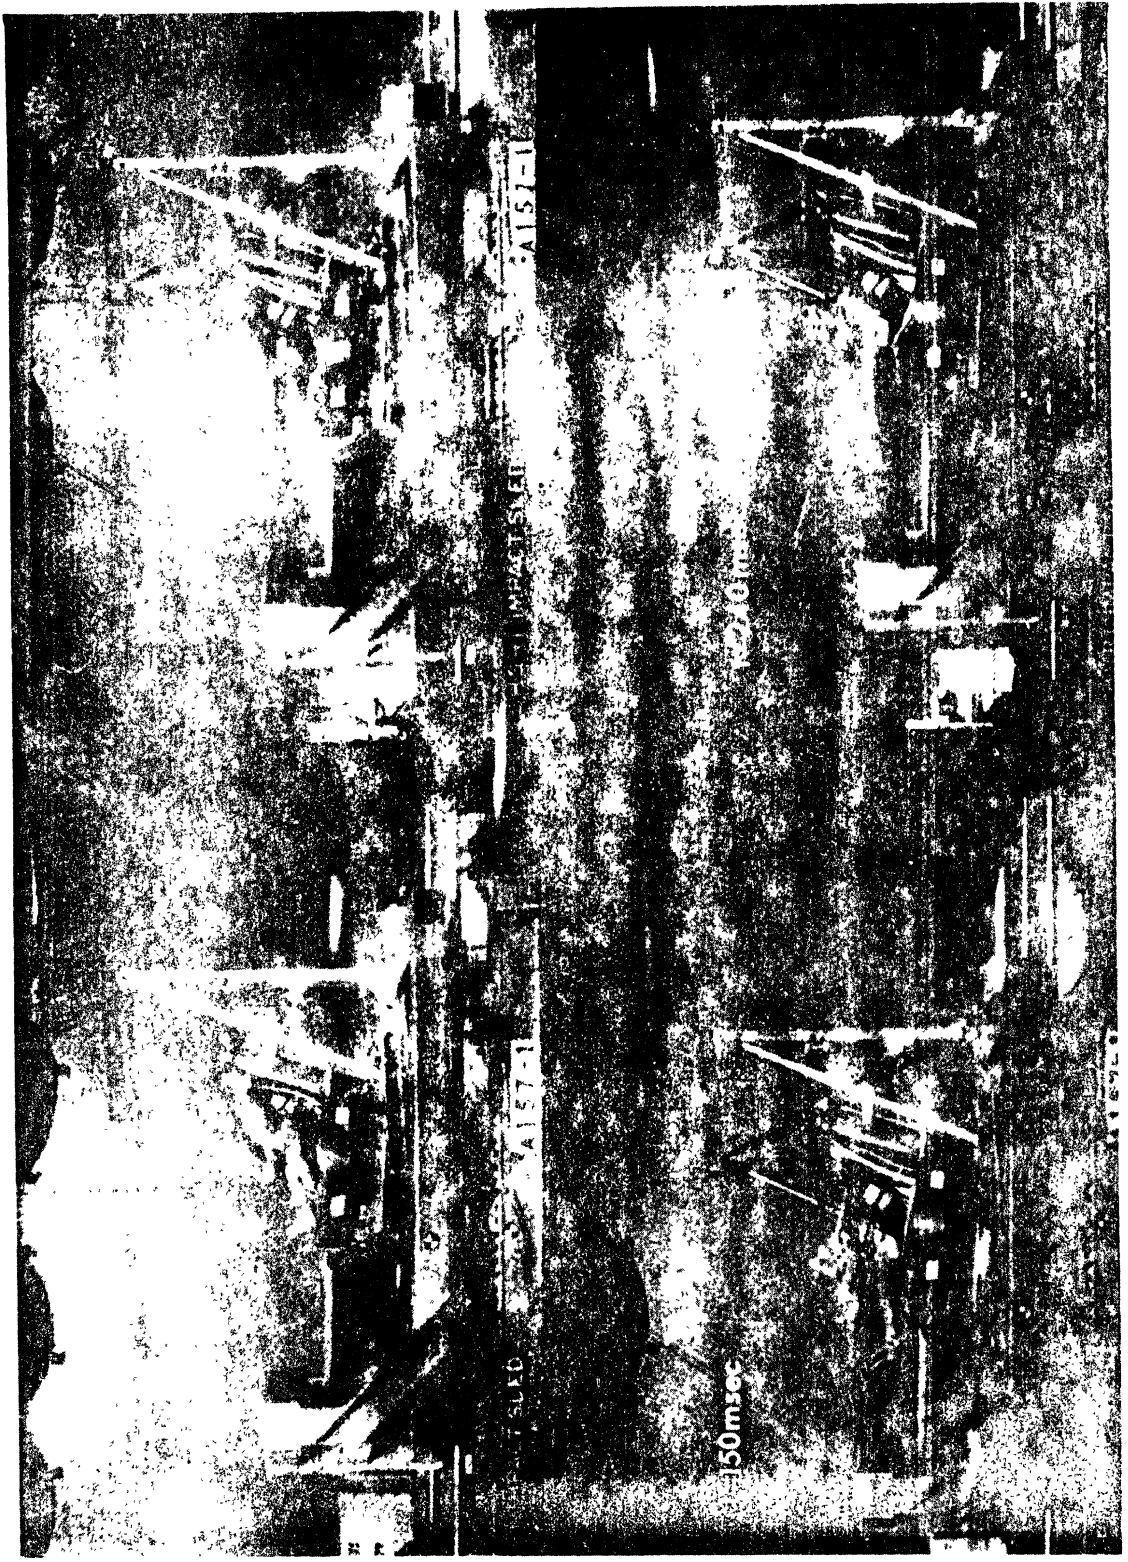
A157

The acceleration loadings experienced by the dummy were moderate. The seat appeared to be too narrow for the dummy's shoulders. The seat held up well and retained its integrity. No undue excursions were observed.

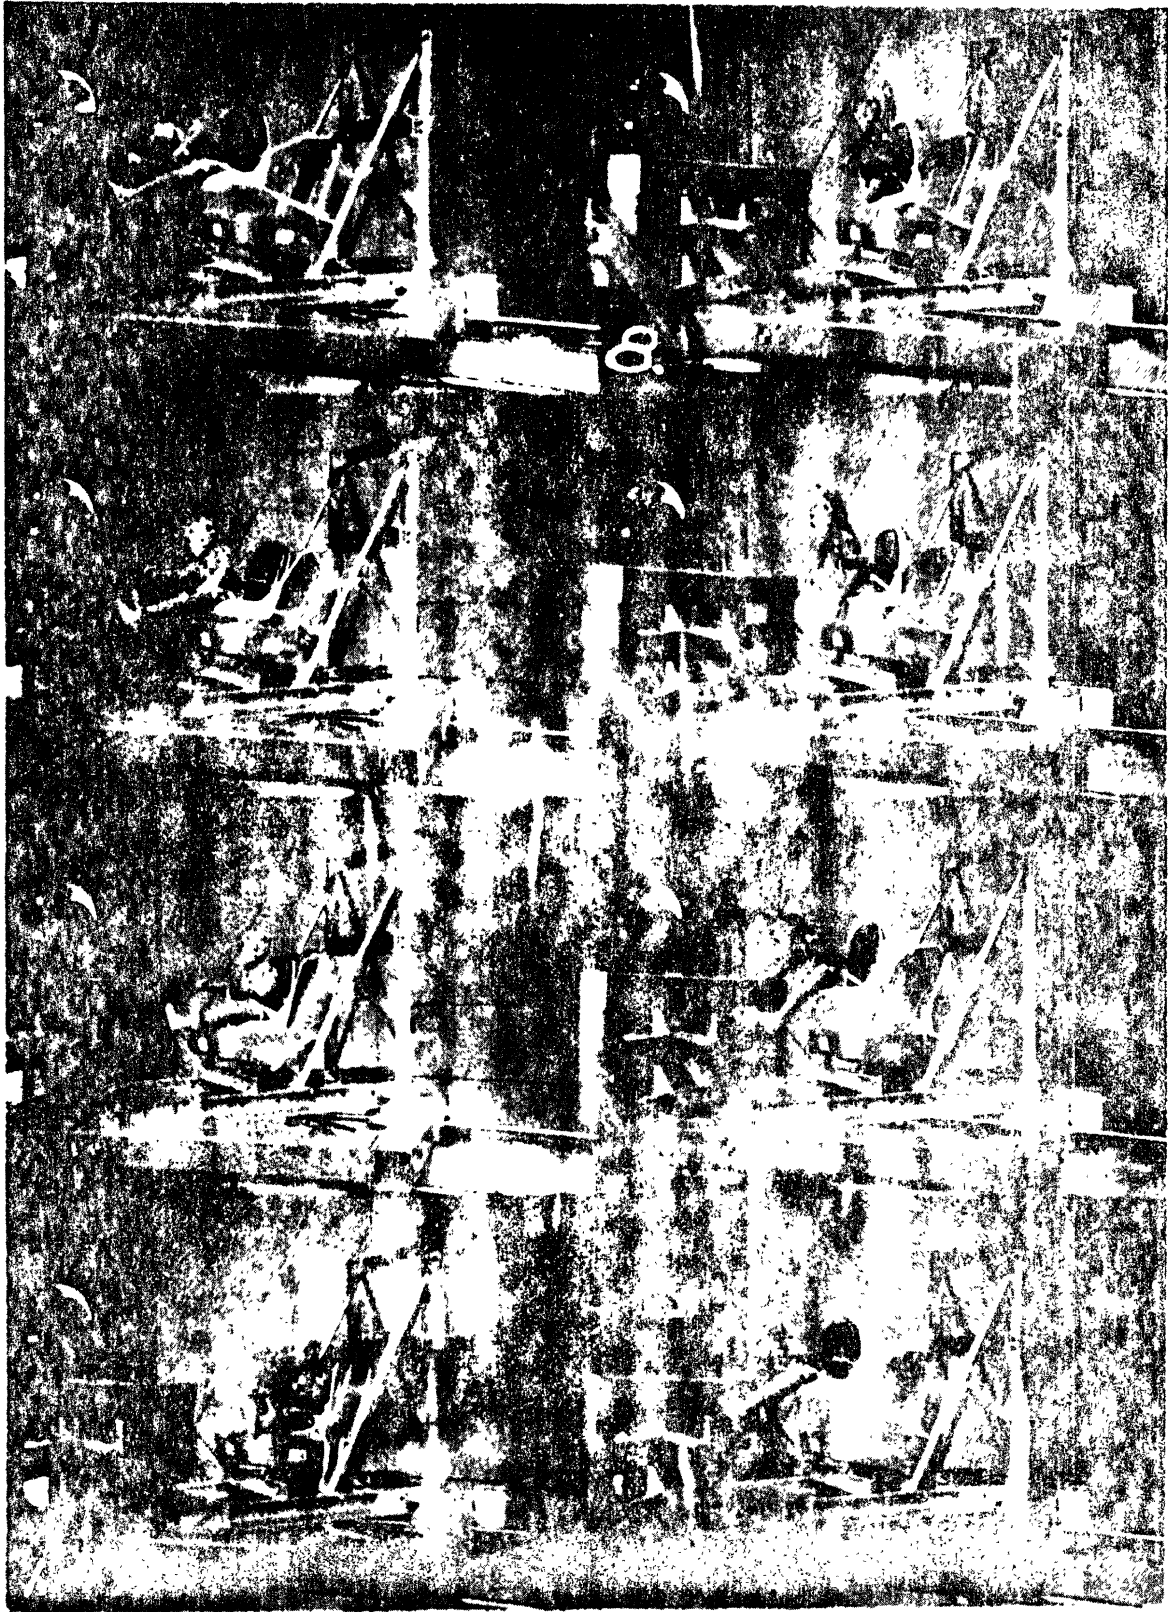
A158

The left bail hook failed because of severe bending, allowing the seat to be ejected from the back of the adult seat. The dummy was also ejected. The bail was bent at the swivel joint where it enters the seat. The belly strap pulled loose from the seat at the left side where it was anchored with staples.

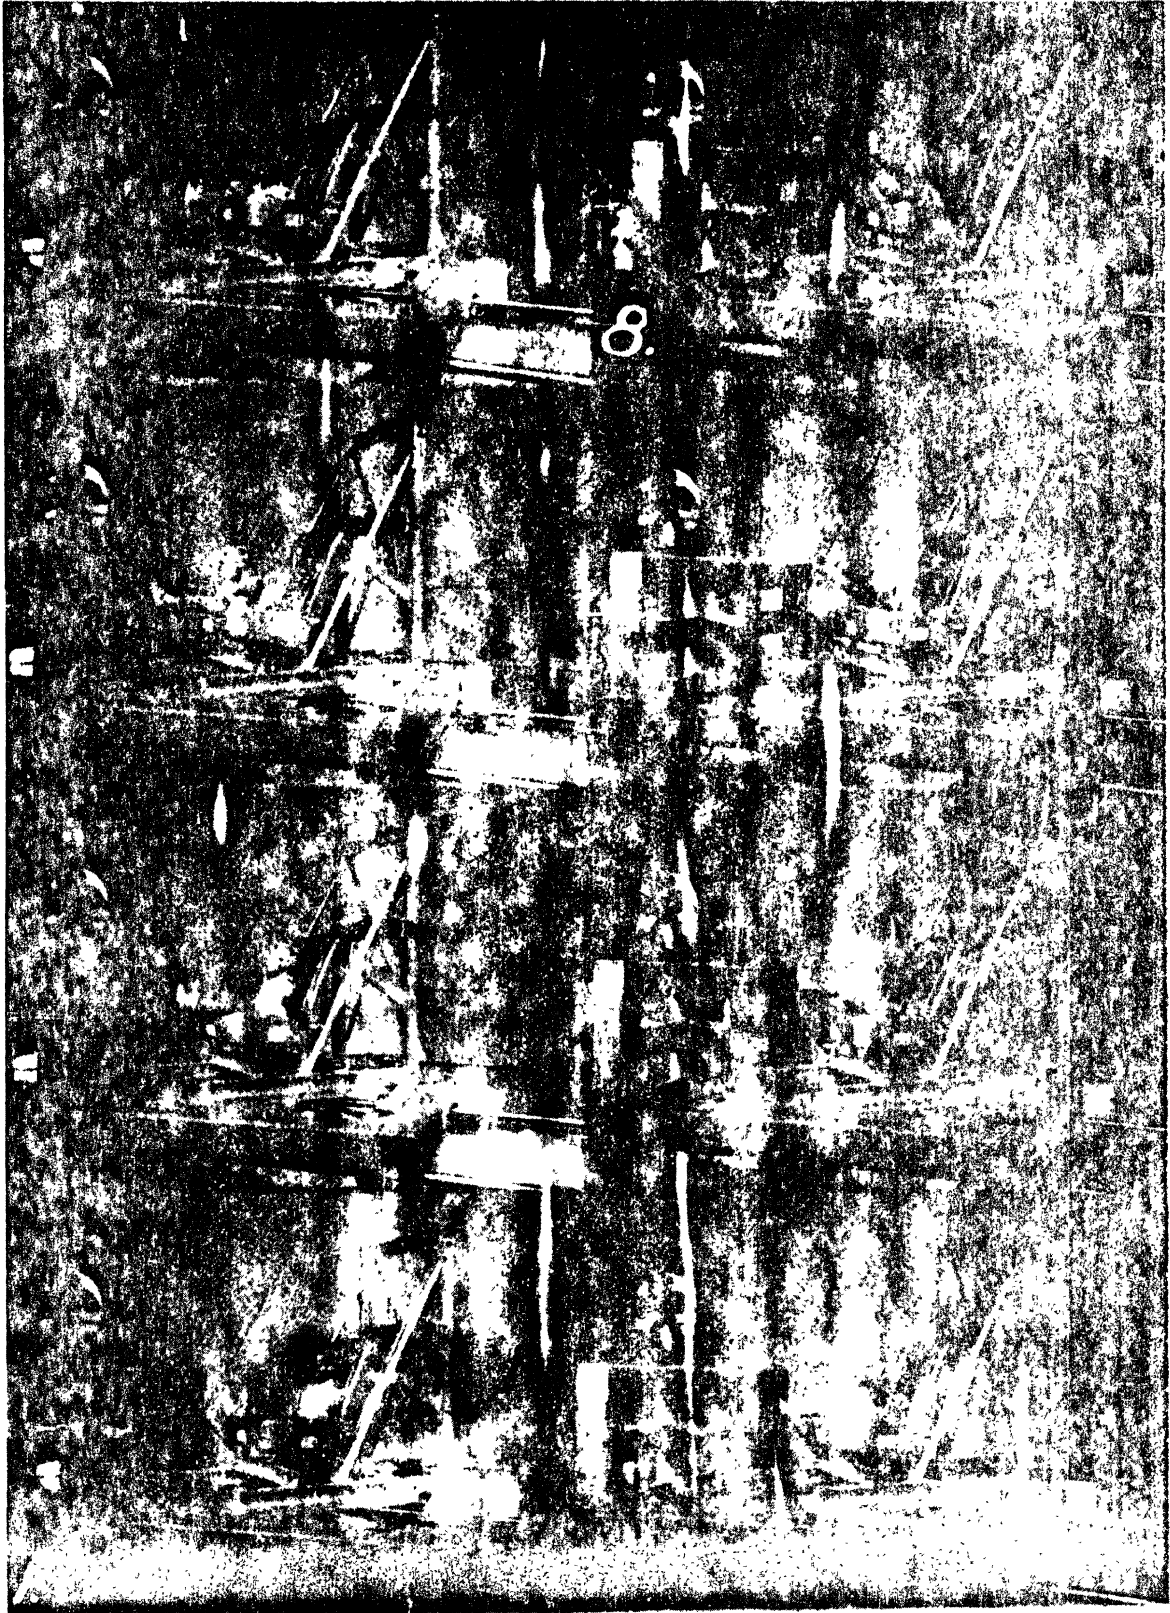
A159

The restraint system slid sideways allowing the dummy to be ejected from the seat. Contact with the vehicle interior adjacent to the adult seat would have been assured.

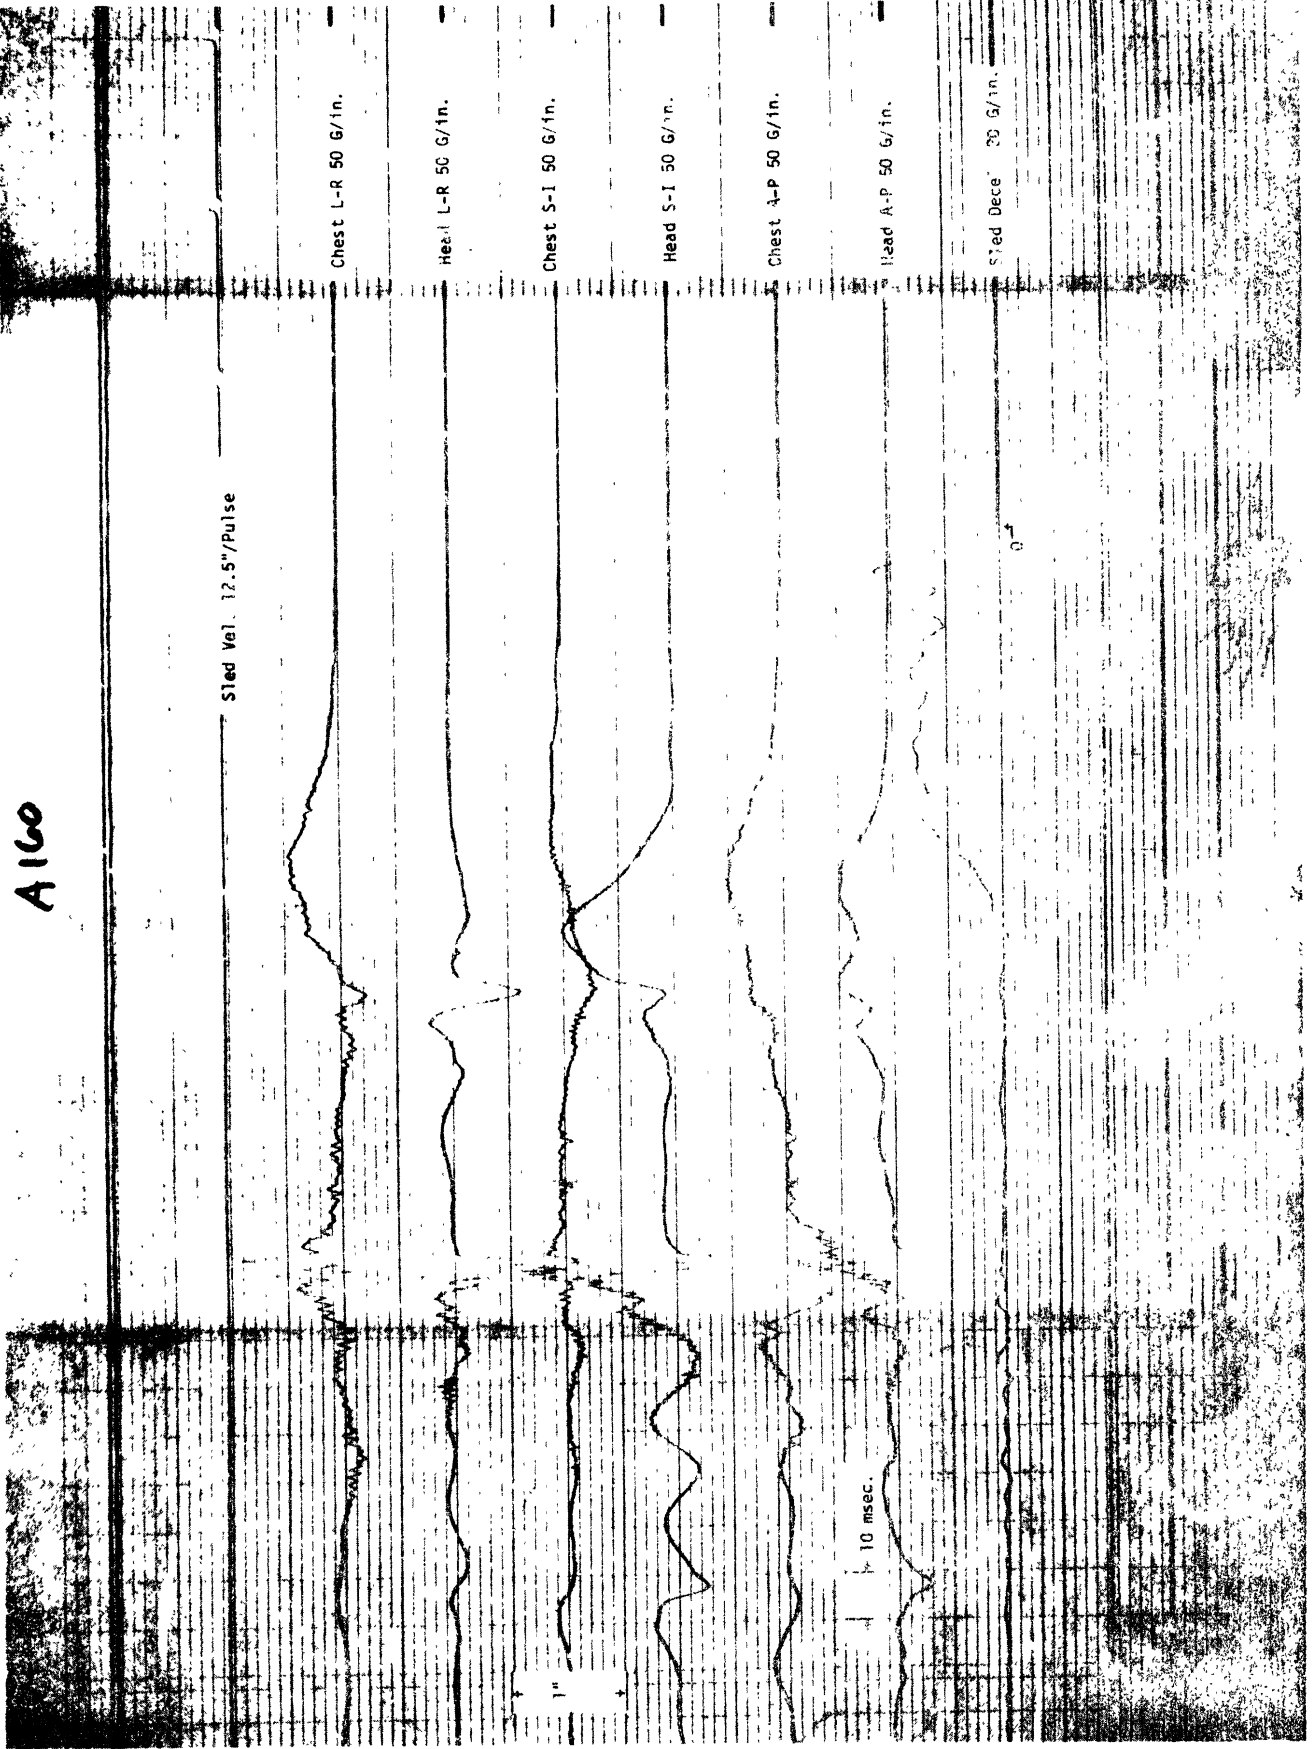
A160

The g-loadings received by the dummy were moderate. The dummy moved to the right front portion of the adult seat on the initial deceleration. Upon rebound the dummy slid from the seat and contacted the sled structure violently.

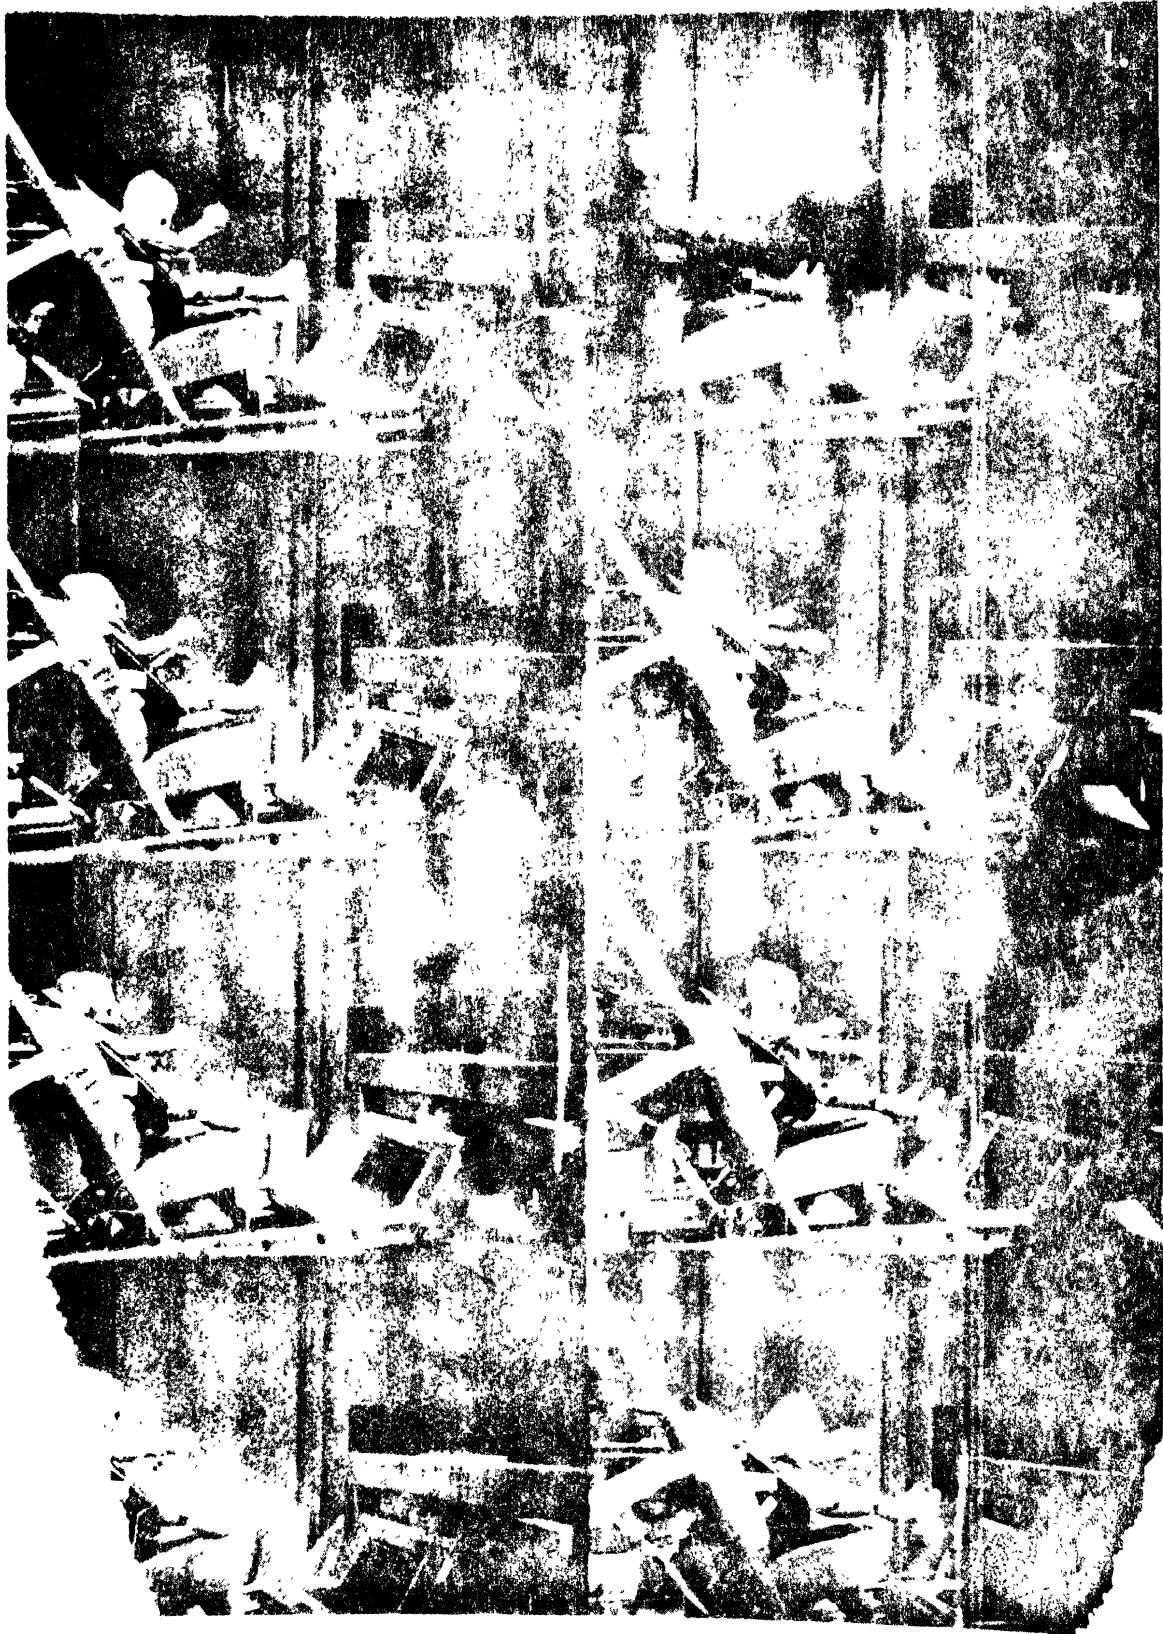
A181

Dummy accelerations were moderate, except for a 48 g head A-P spike which occurred when the dummy rebounded into the seat back. Excursion was acceptable, but there was approximately 80° head flexion with respect to the upper torso.

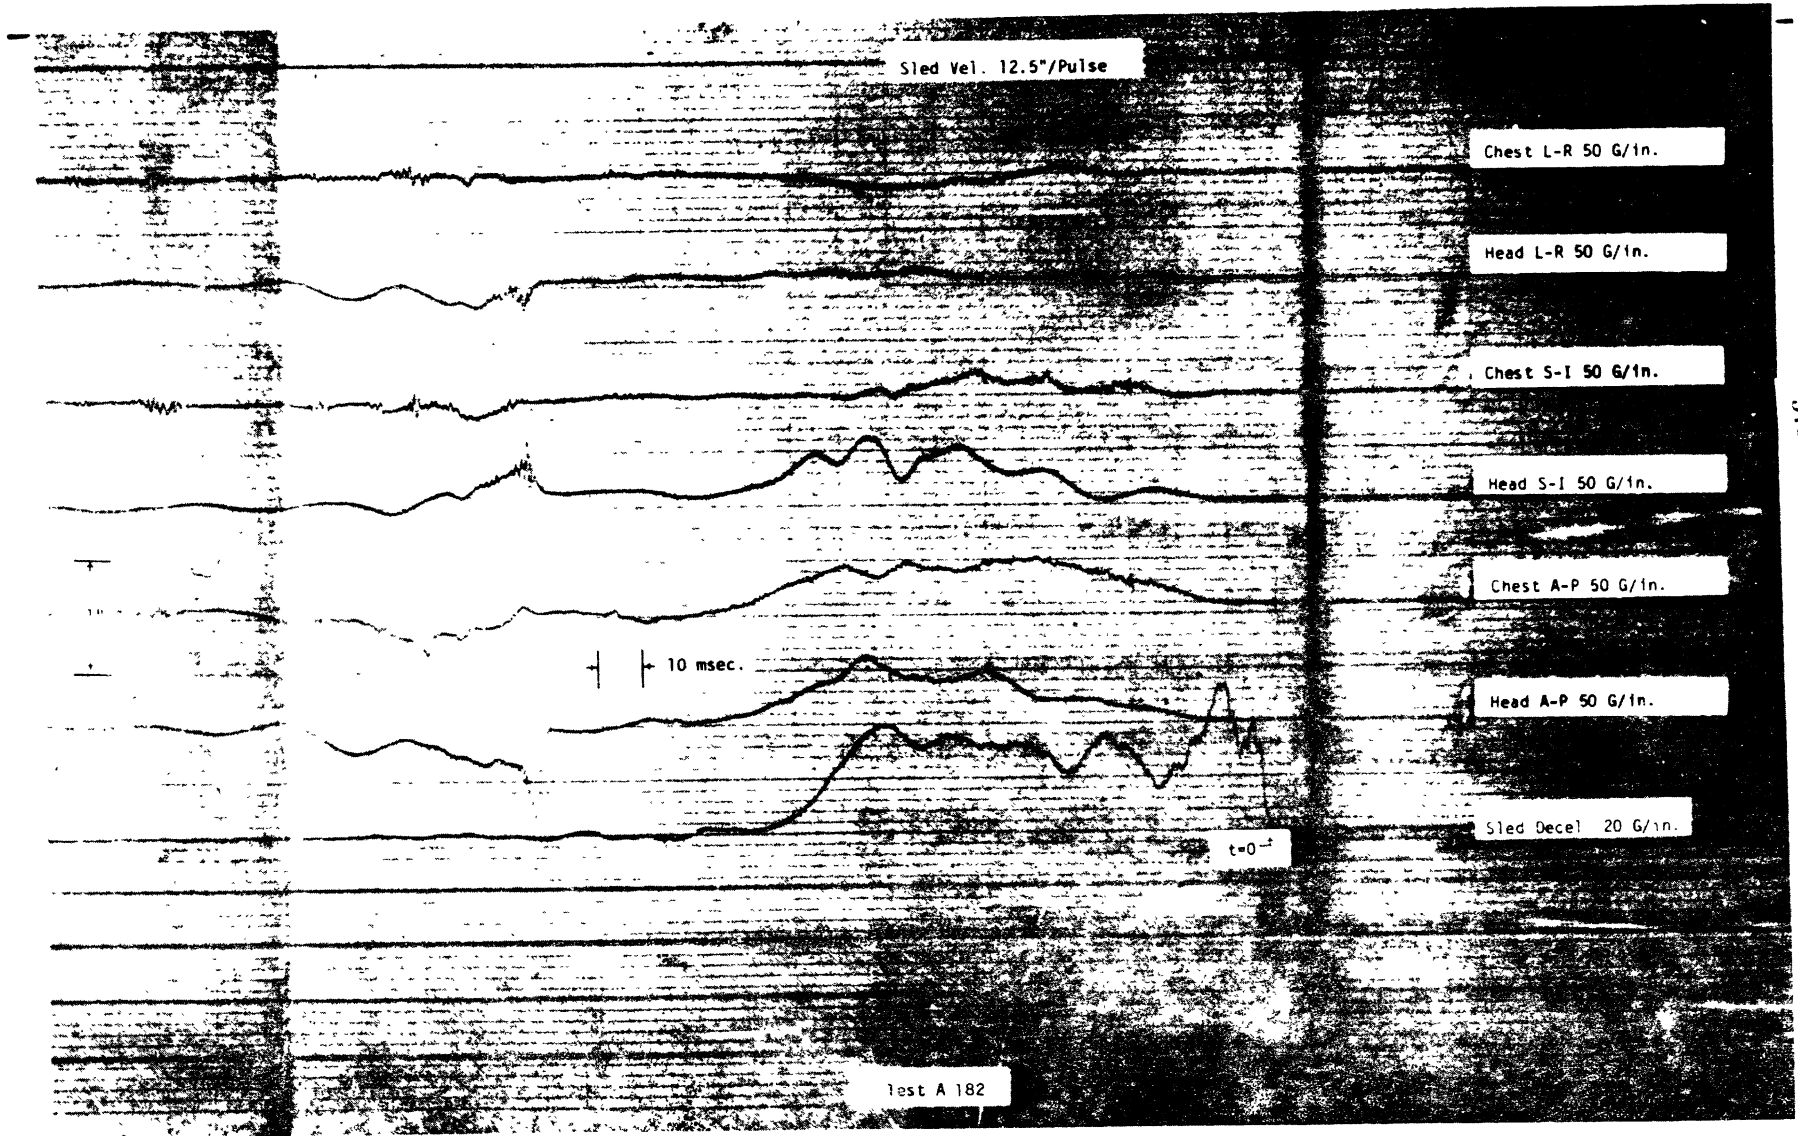
A182

Dummy acceleration levels were moderately low but of longer duration than 20 mph test #A-181. Rebound into the seat resulted in 40 g head A-P spike. Excursion was small, but was accompanied by approximately 80° head flexion with respect to torso. Some deformation of the harness grommets was observed where they were pinned. In addition, the seat shell cracked where the lower seat anchor belt bracket was riveted to the shell.
