# CHILD SEAT AND RESTRAINT SYSTEMS TEST RESULTS

## APPENDIX D

THE UNIVERSITY OF MICHIGAN  
HIGHWAY SAFETY RESEARCH INSTITUTE  
HURON PARKWAY AND BAXTER ROAD  
ANN ARBOR, MICHIGAN 48105

Final Report

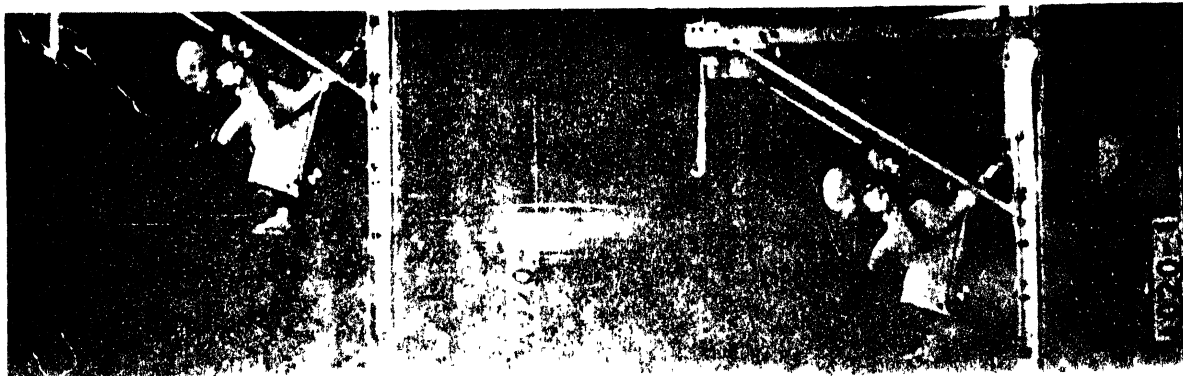
Test A 020

There was no damage observed either to the dummy or to the restraint system. There were no gross motions observed.

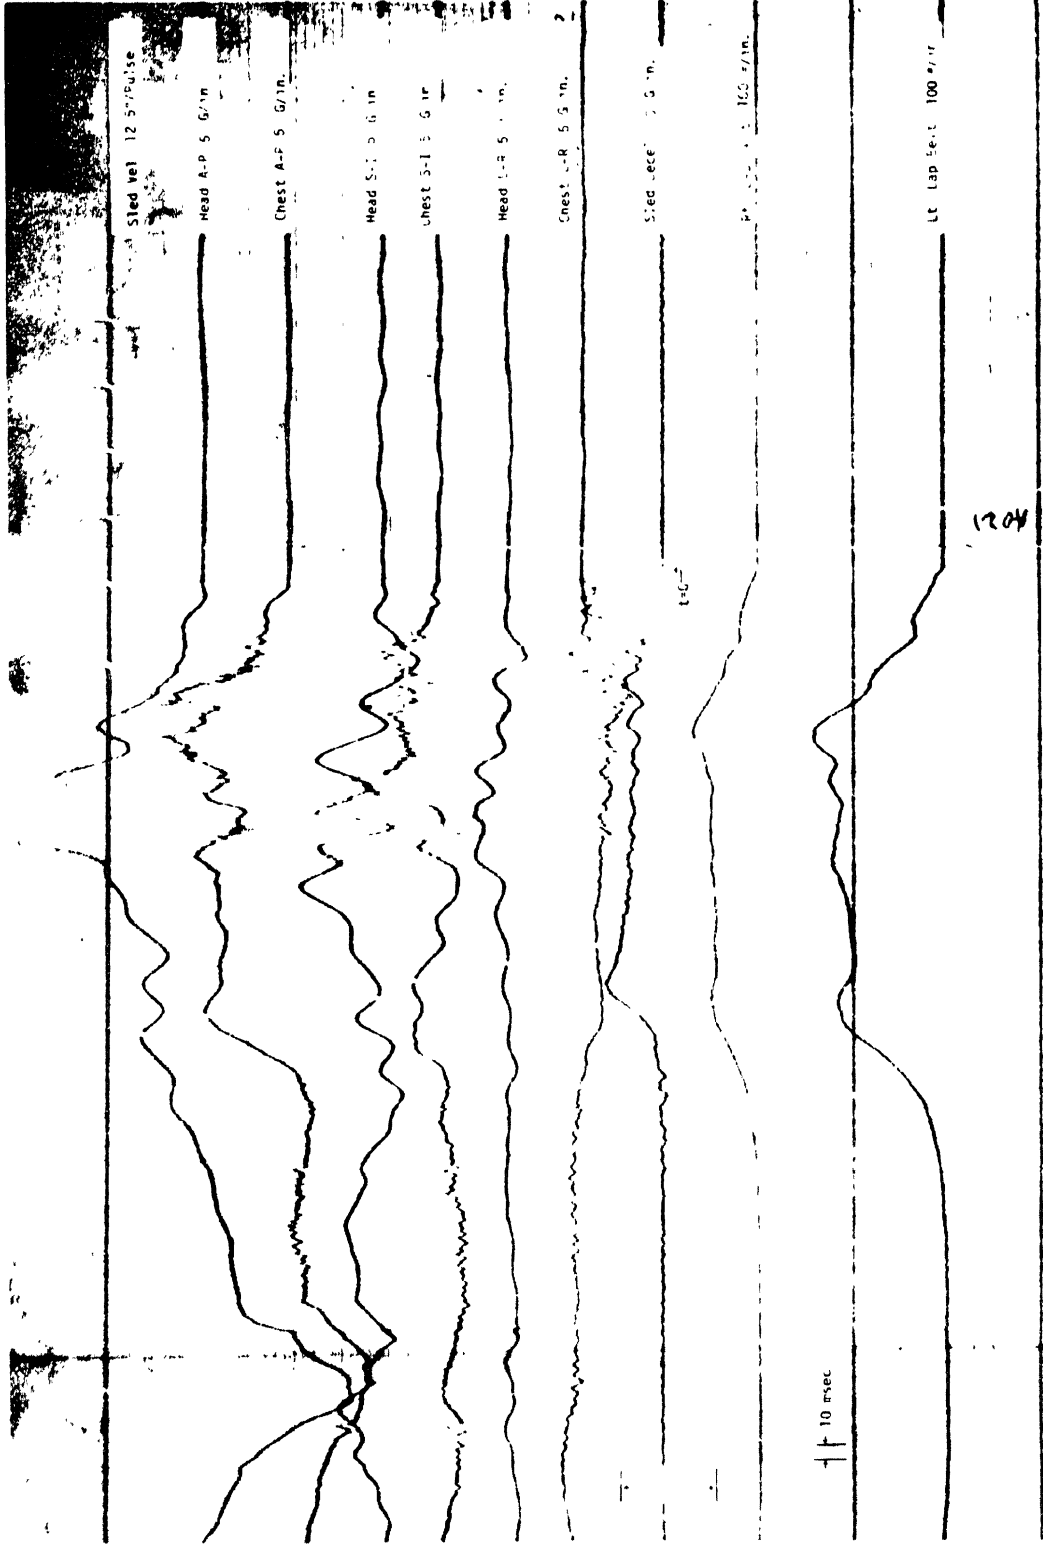
Test A 021

There was no damage observed either to the dummy or to the restraint system. No gross motions were observed.

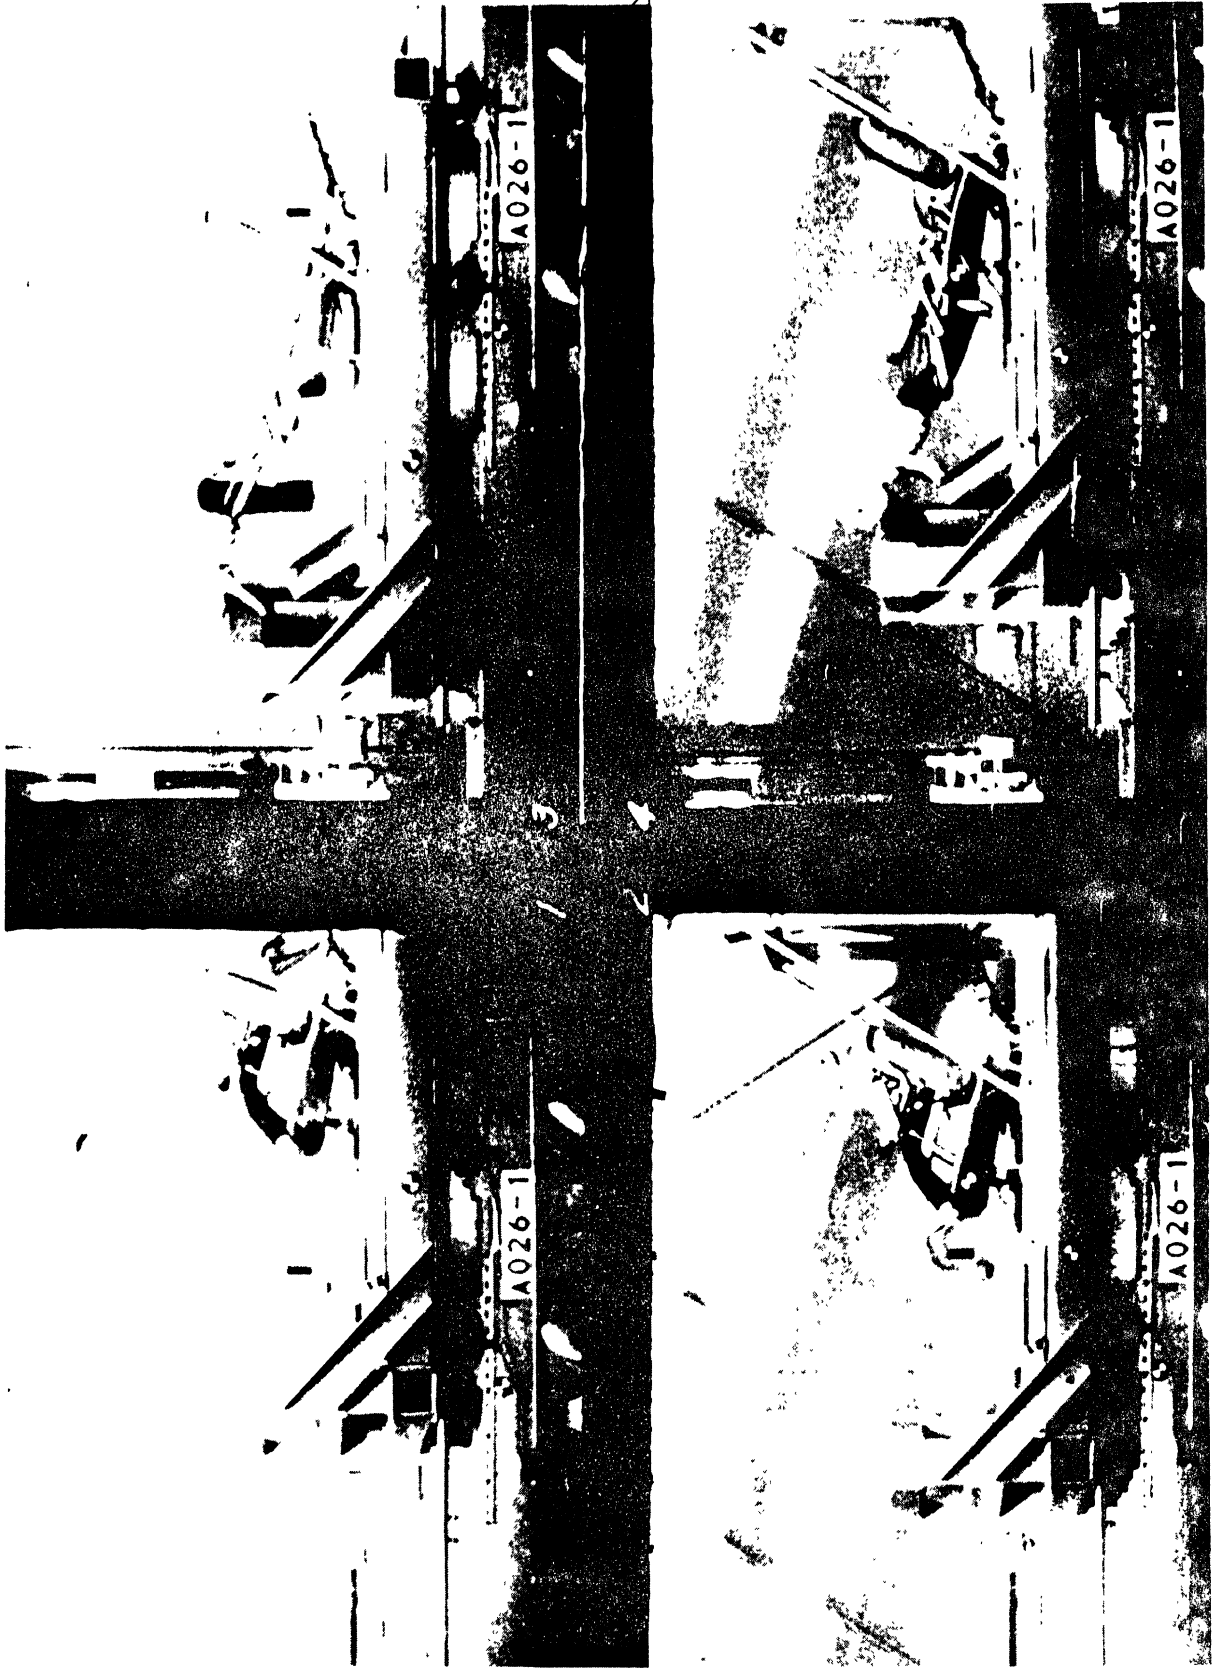
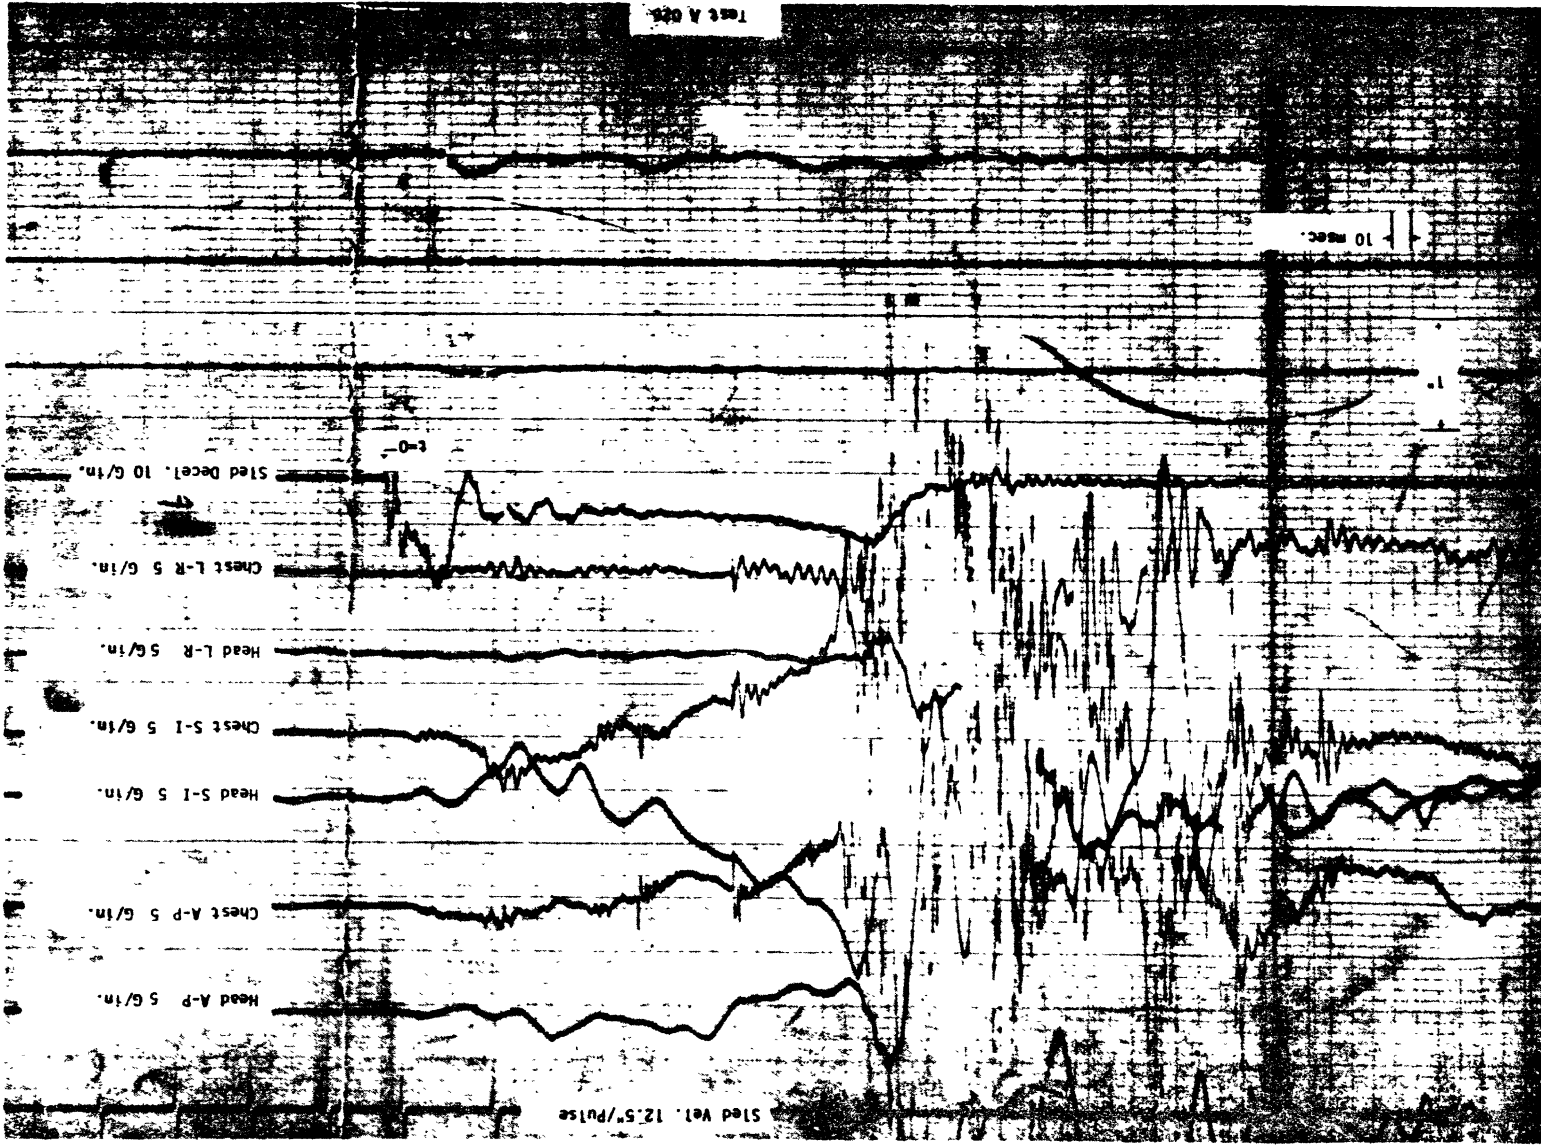
The tubular structure of the seat was observed to fold up as the impact occurred. The dummy was ejected from the seat and violently contacted the sled structure.

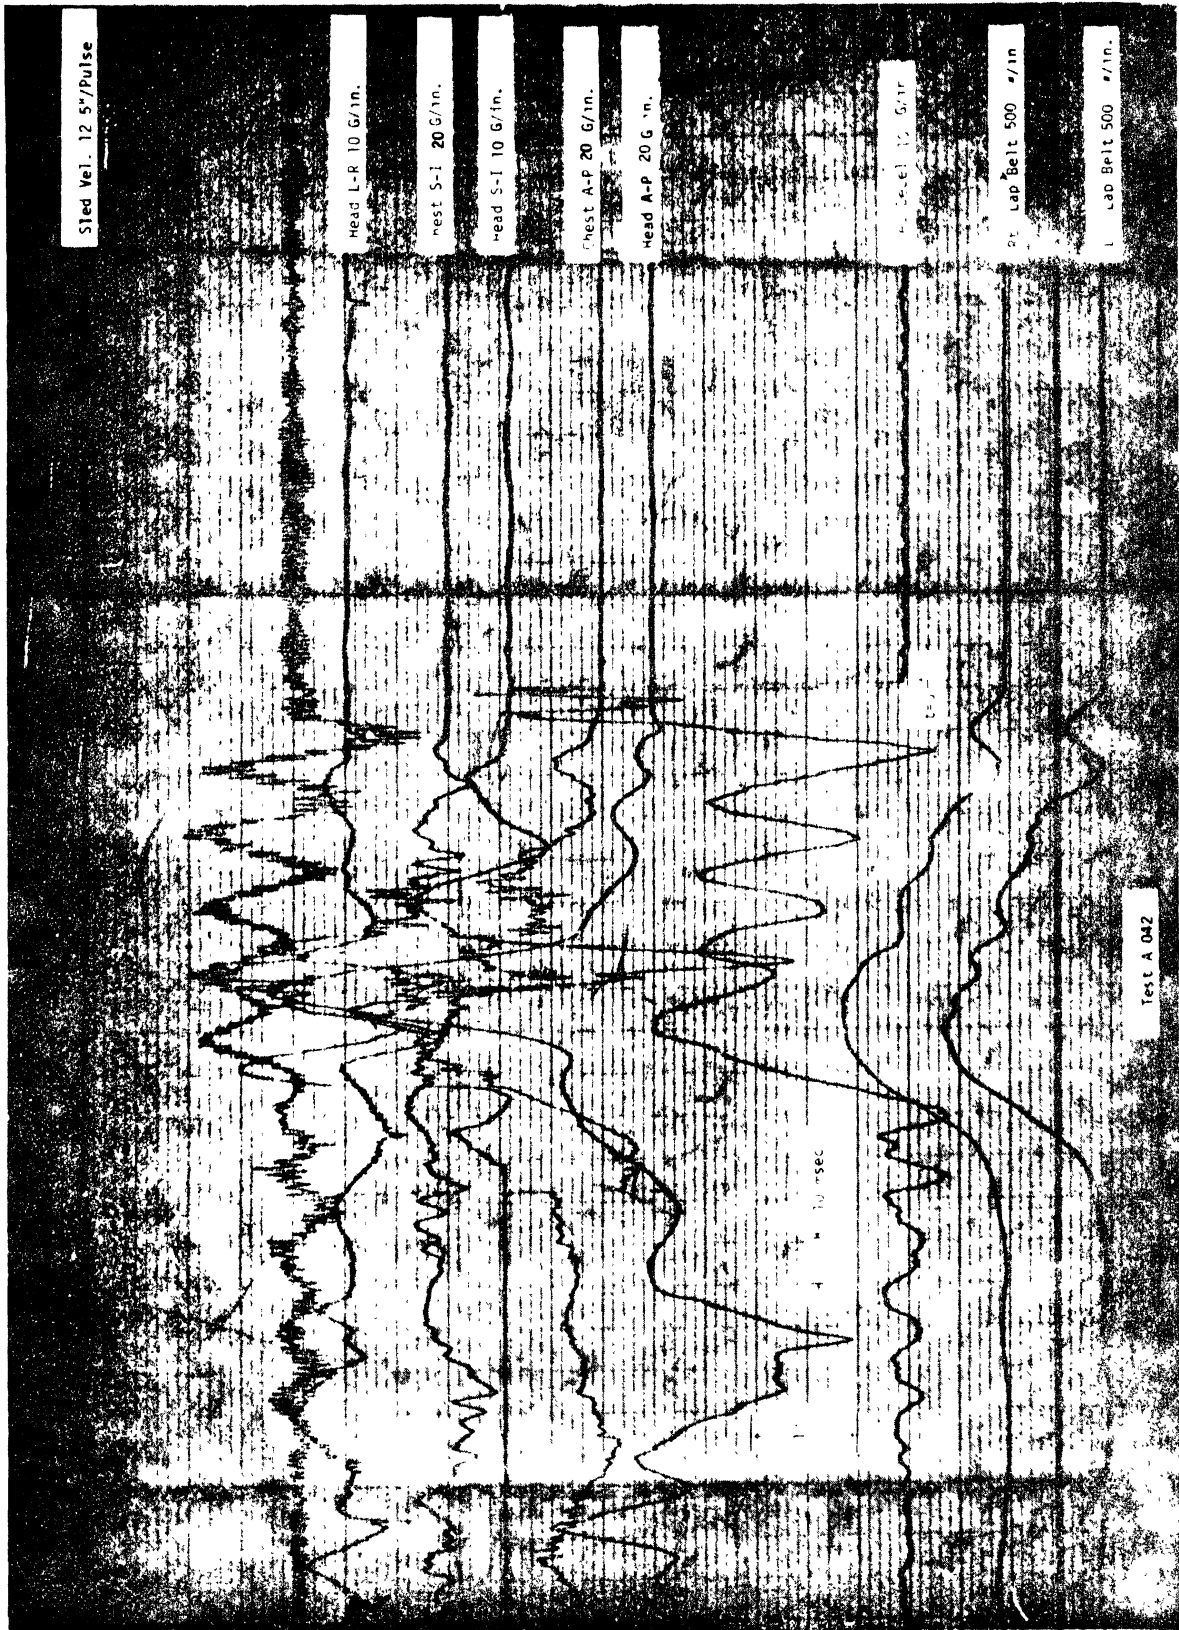
The Tot-Guard was not located properly on the adult seat. Dummy motions were minimal, except that the left leg became detached from the torso of the dummy. Chest and head accelerometer readings were quite high.

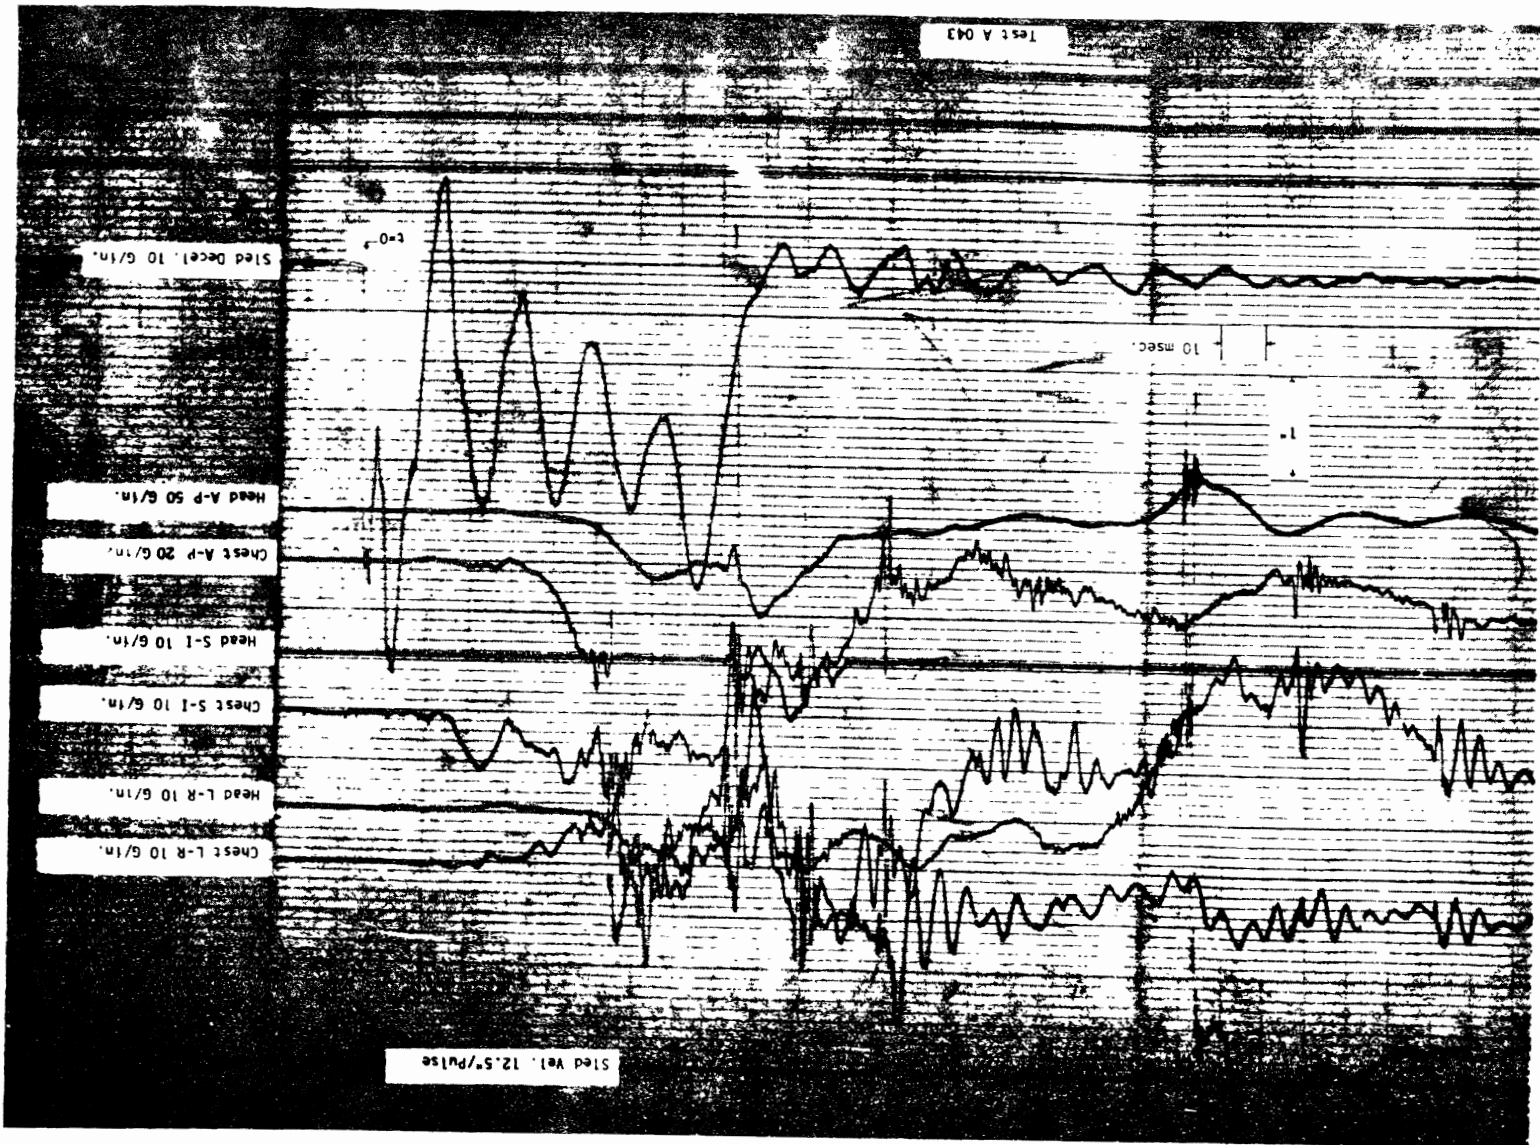
Test A 043

No damage was observed to either the dummy or to the restraint system. However, the adult seat back was bent severely by the harness strap which is looped over it. The excursion experienced by the dummy was probably sufficient to allow contact with a vehicle interior.

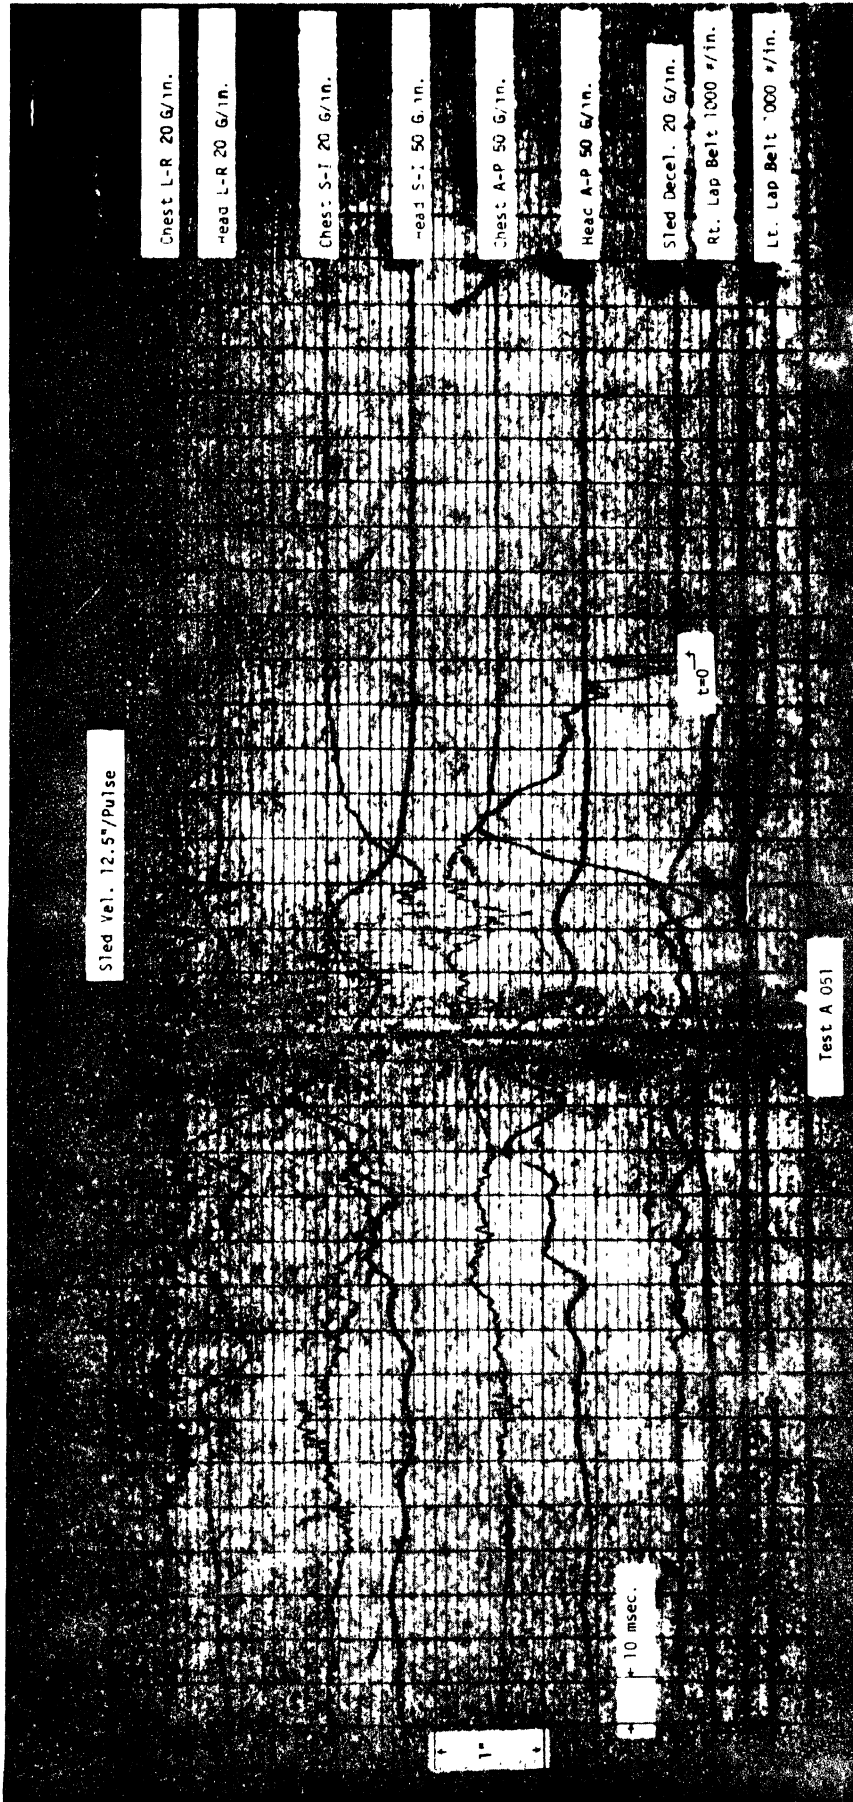
The dummy experienced no damage although the head loads were quite high. The seat was badly damaged in this test. The tubular structure collapsed and was bent severely. The padded rail in front of the dummy was bent. The cross piece to which the seat back was riveted was also bent and the crotch strap snap came loose. The excursion of the dummy was probably sufficient to allow contact with the interior of the vehicle.

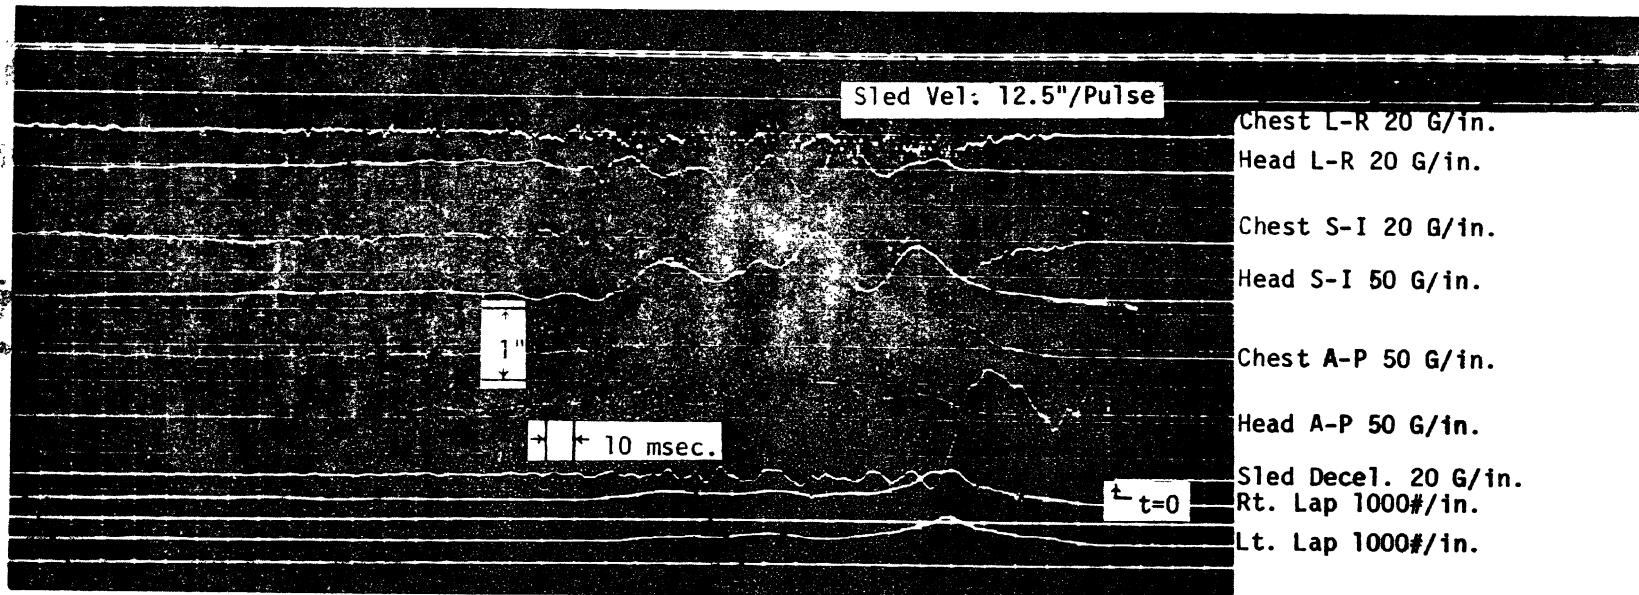
Test A 052

No damage was observed to the dummy, but excursions in this test were probably sufficient to allow contact with the interior of the vehicle. The seat experienced severe damage due to the collapse of the rear support bars at the rivet holes.

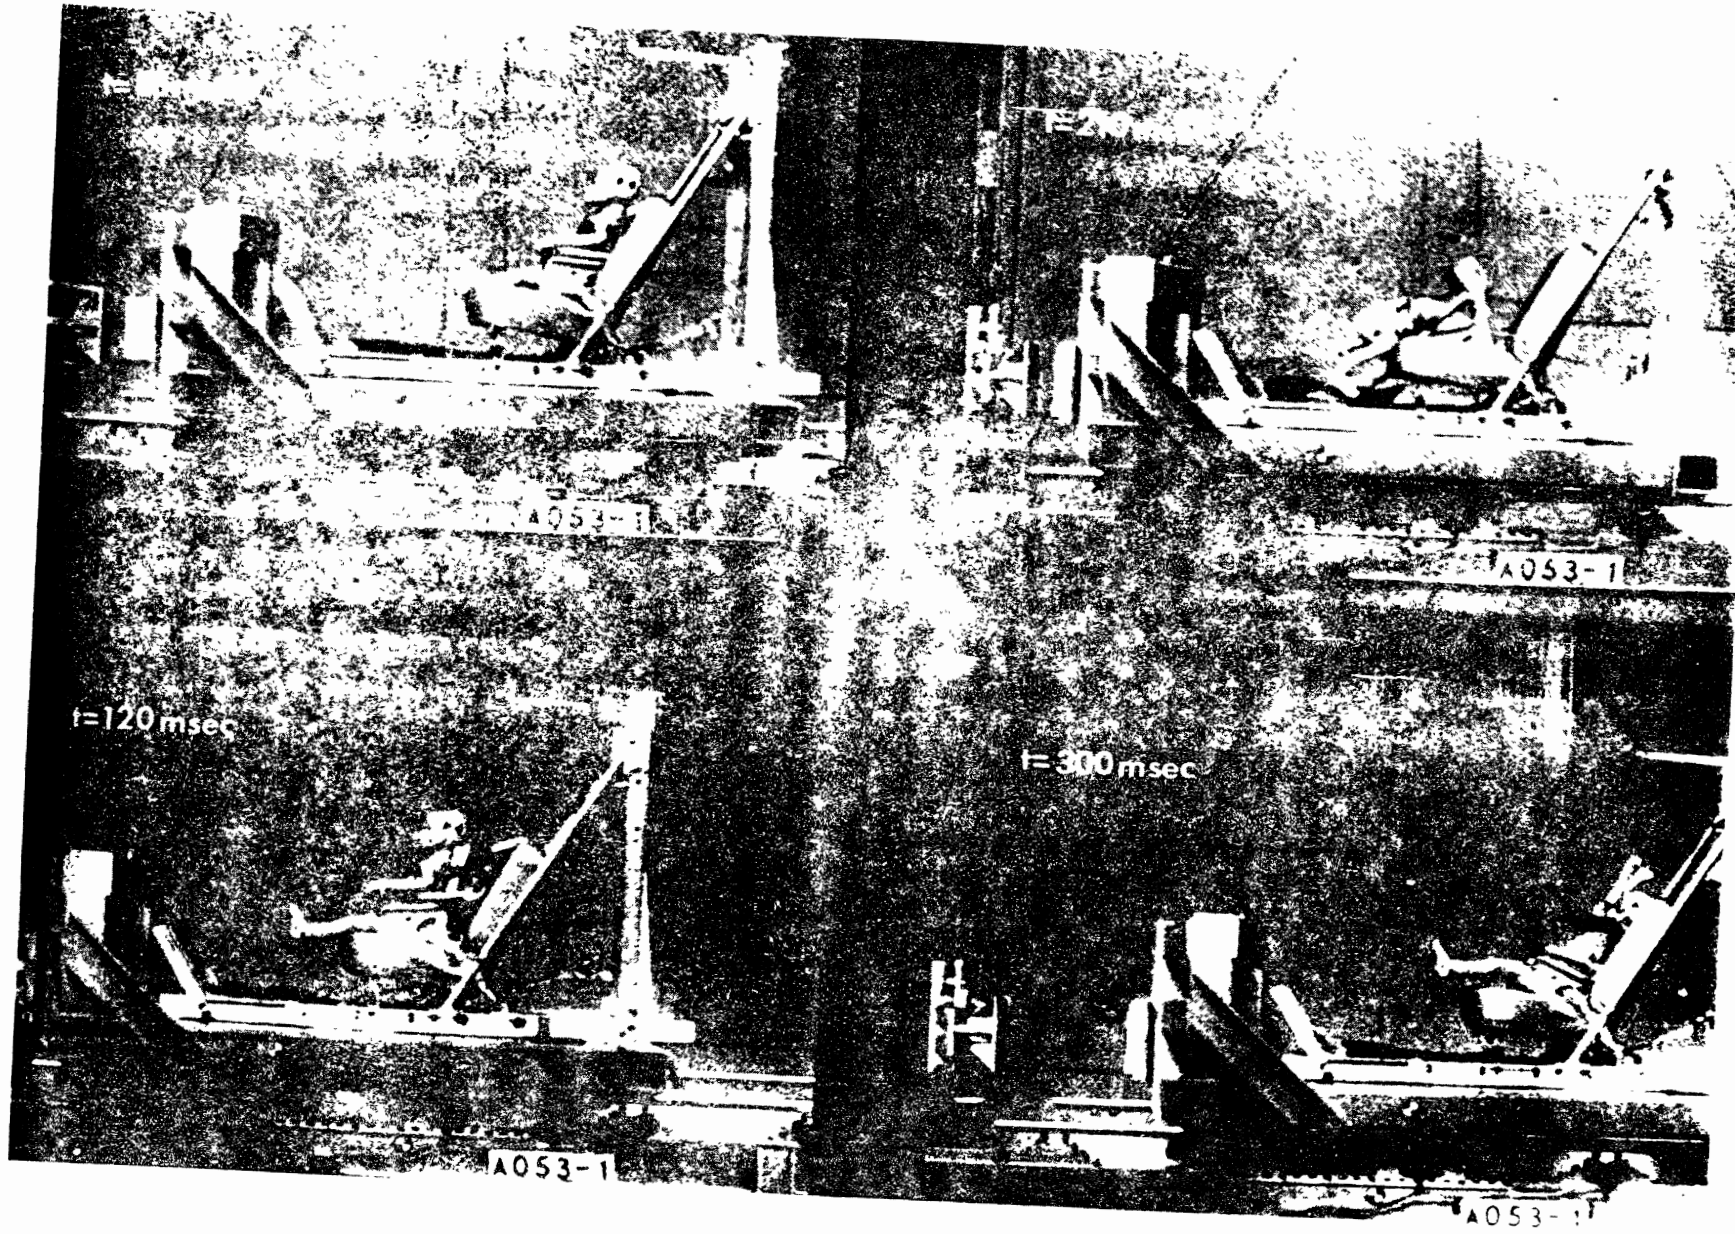
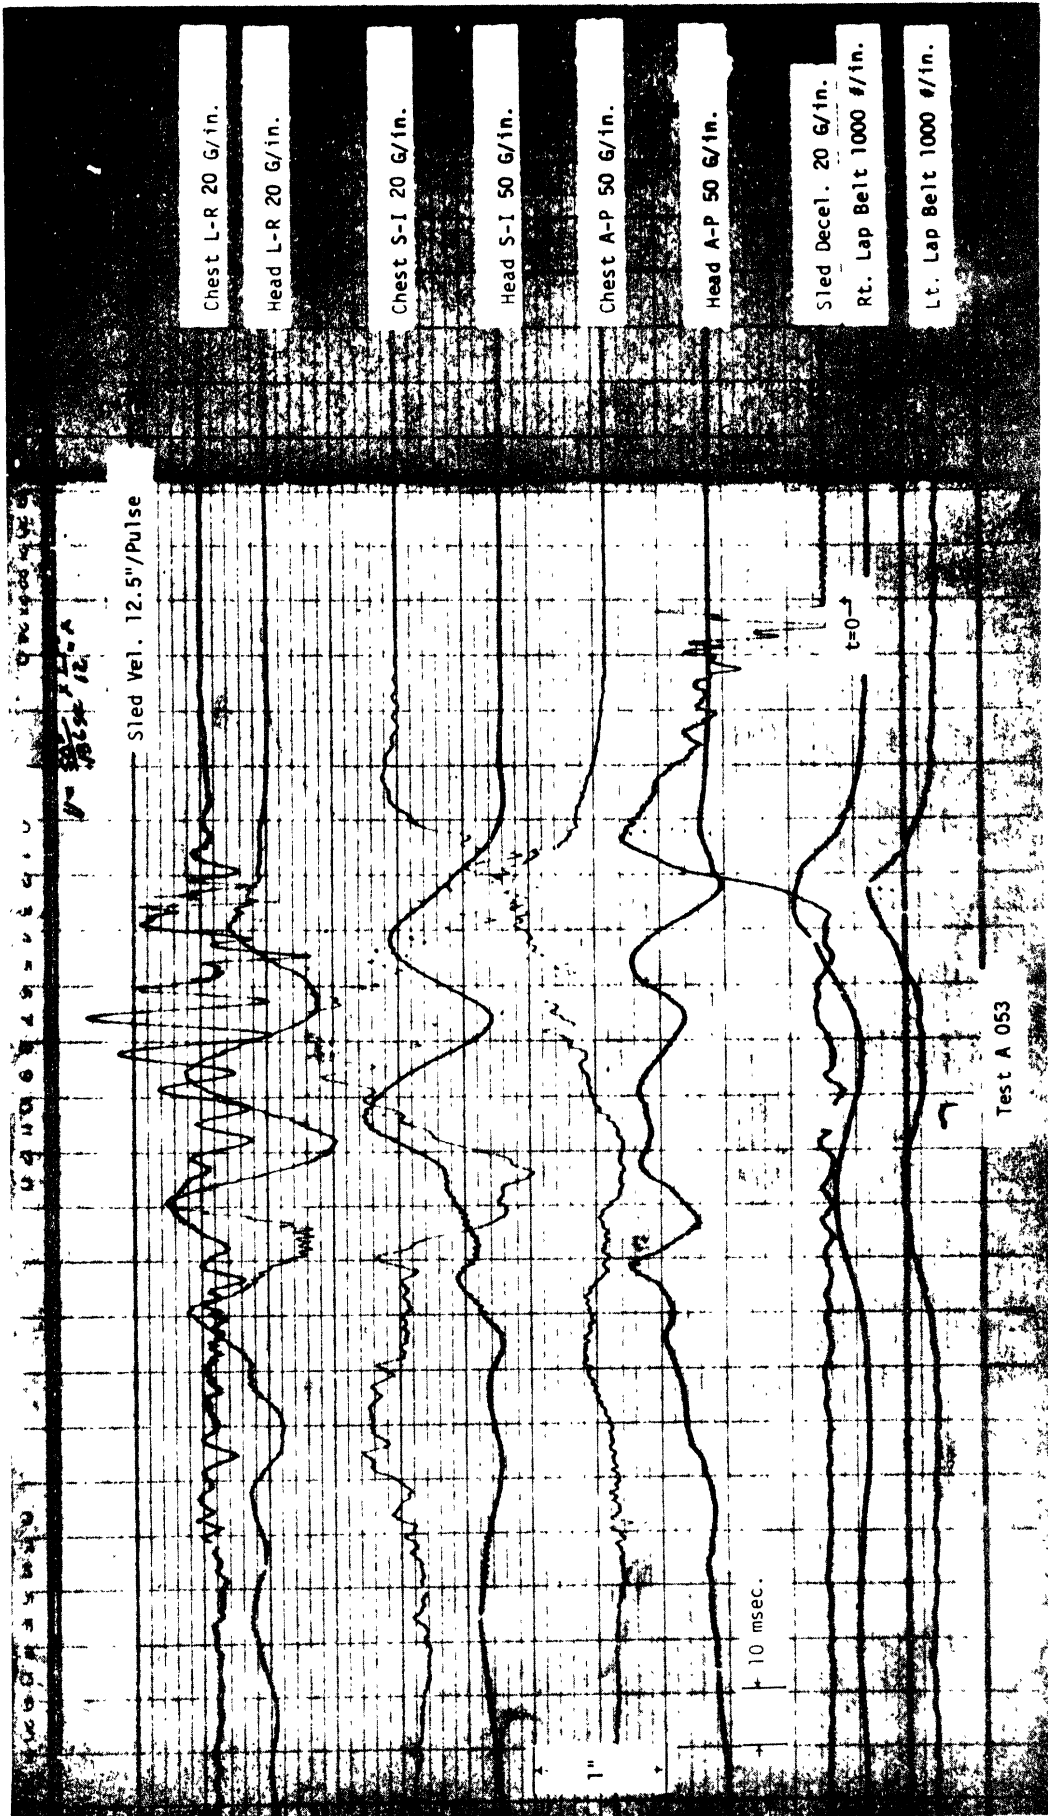
Both bail hooks on this seat were broken and became unattached from the back of the adult seat. The molded back of the child seat flexed allowing the chest belt to slide up and become disengaged. The upper torso and head of the dummy pitched forward over the padded rail at the front of the seat.

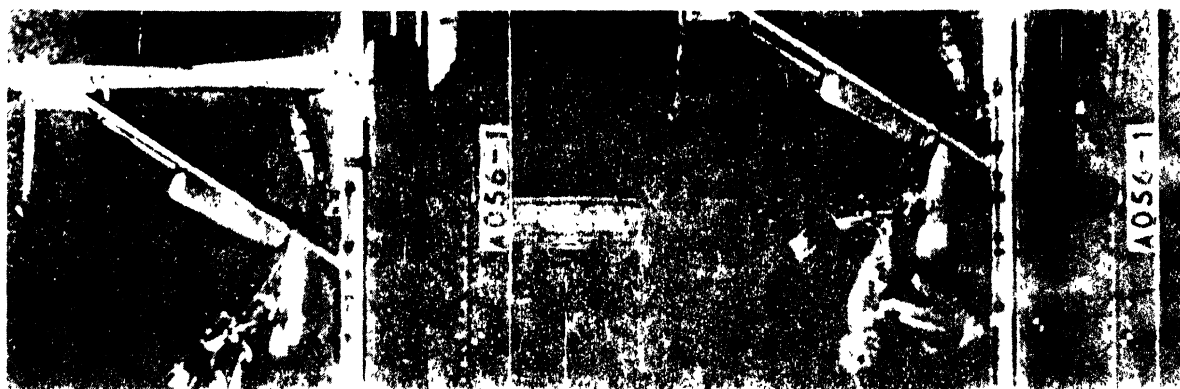
The loadings experienced by the dummy were quite small, however, its excursion was sufficiently large to allow contact with the interior of any vehicle. The seat experienced considerable damage. The belly straps pulled loose at each end because the rivets pulled out. The one-eighth inch by five-eighth inch steel diagonal folding braces supporting the seat back structure collapsed on both sides. The dummy jackknifed and was nearly ejected. The dummy appeared to be restrained by the auxiliary nylon safety straps which are not part of the seat structure.

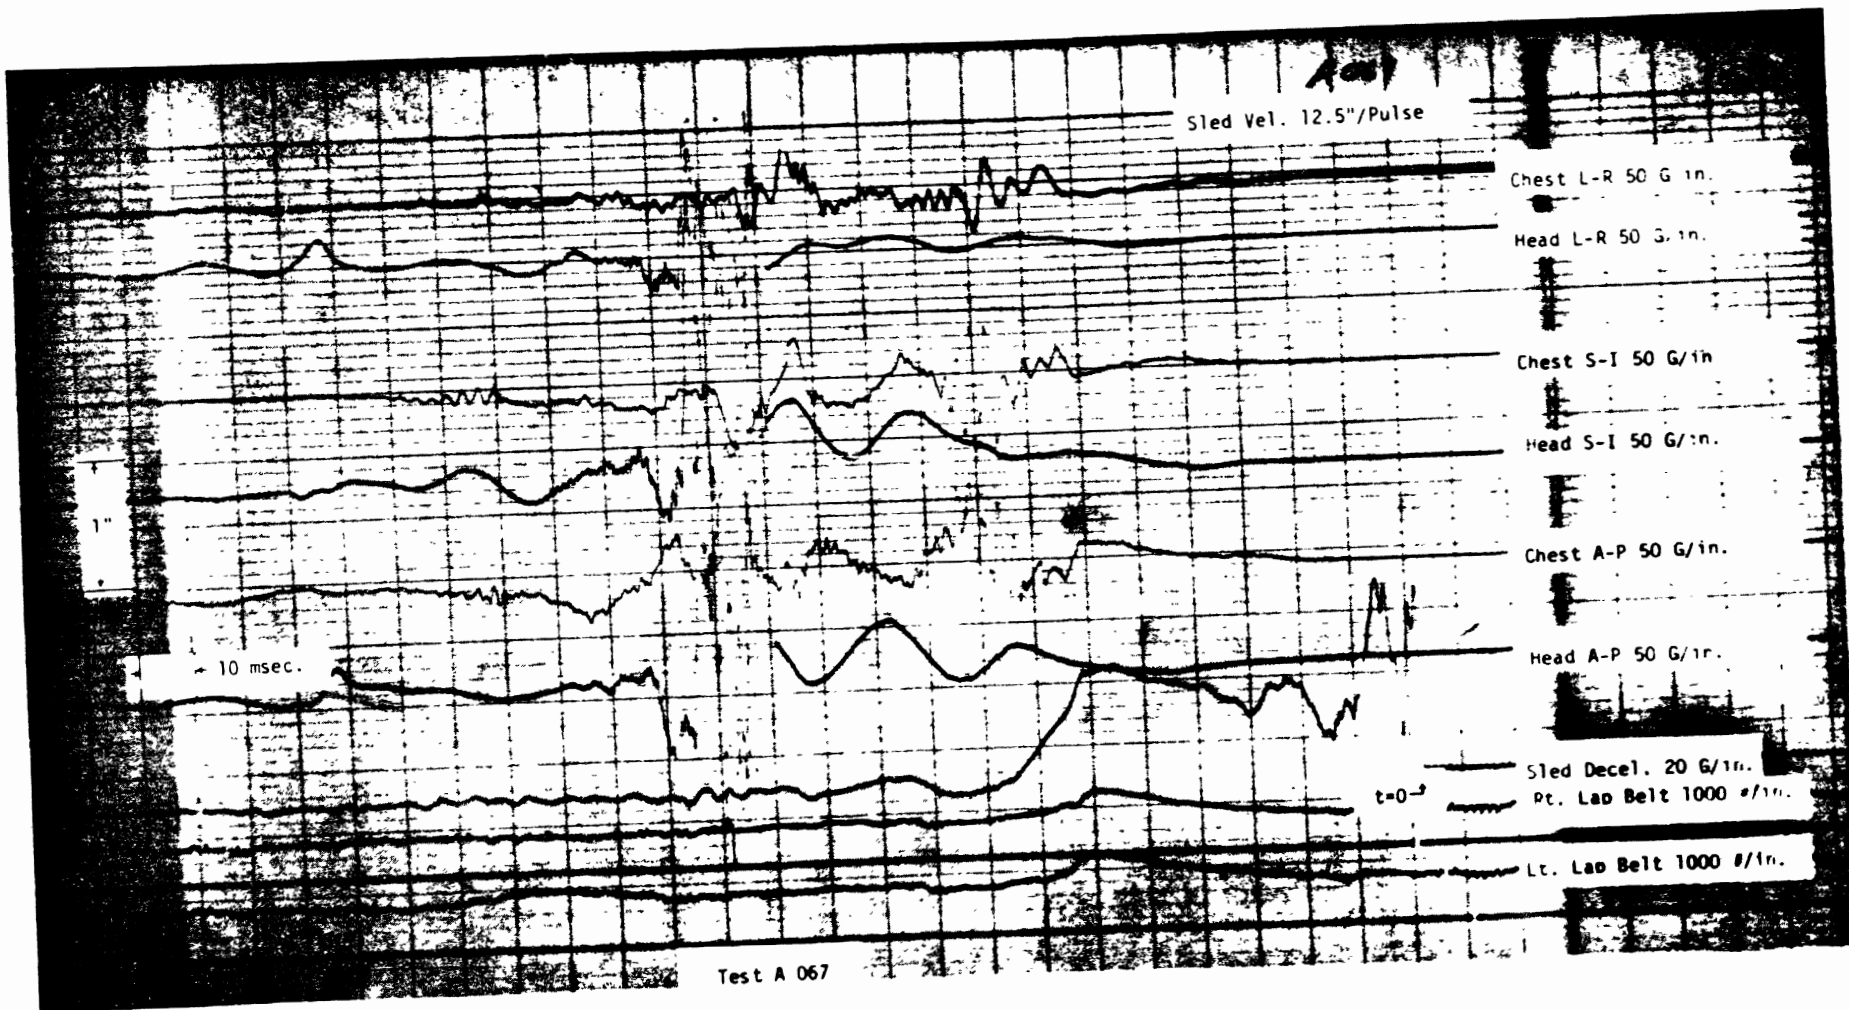
No damage was observed to the dummy. However, due to the structural failure of the seat the dummy was ejected and violently contacted the interior of the body buck which was being used in this test. The under structure collapsed as the main tube on the right side of the seat broke at the rivet holes. The straps holding the child's seat to the adult seat held. The restraining strap hook on the child seat failed as the wire straighten and was lost. The handrail came loose.

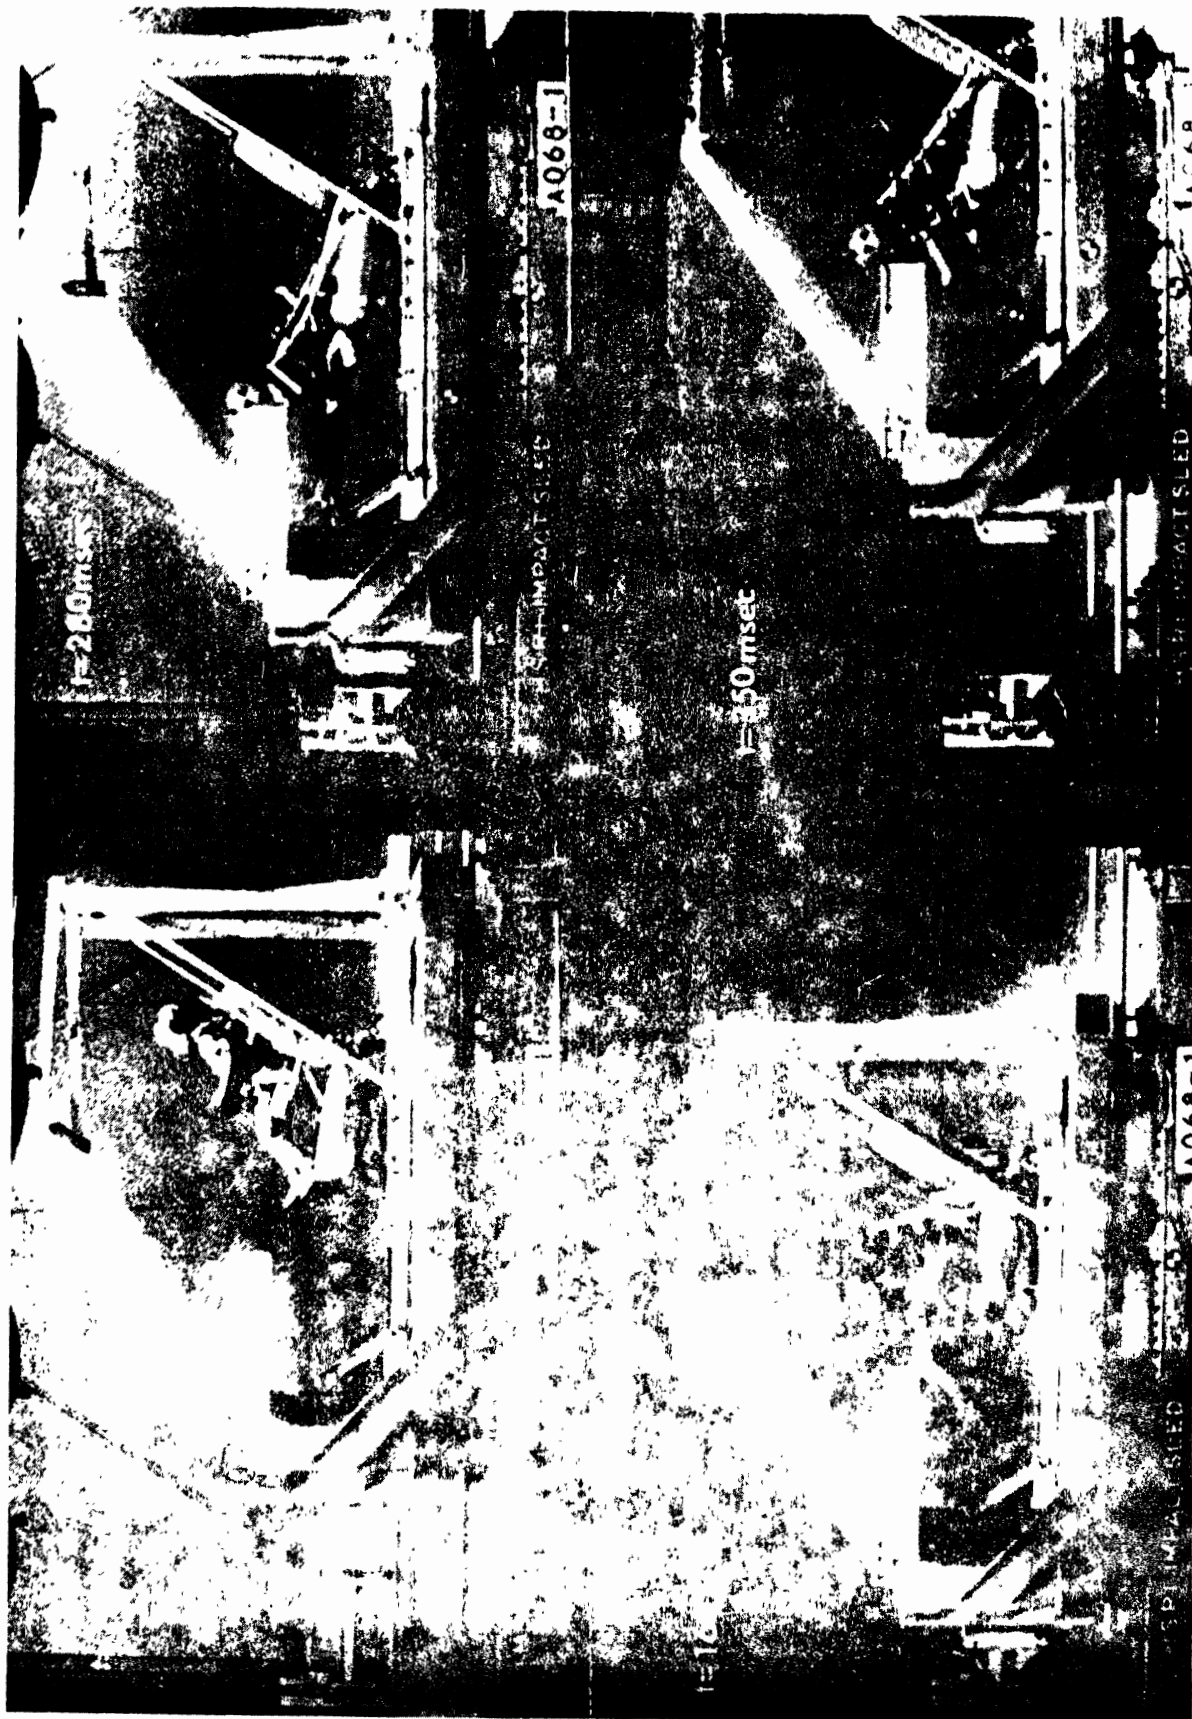
The seat structure collapsed allowing the dummy to move forward and contact the body buck. The tubular structures supporting the seat cushion were completely buckled. The chest harness was torn at the lower right attachment point. The right-hand retaining strap of the child's seat was torn by the teeth of the buckle.
