# CHILD SEAT AND RESTRAINT SYSTEMS TEST RESULTS

## APPENDIX D

THE UNIVERSITY OF MICHIGAN  
HIGHWAY SAFETY RESEARCH INSTITUTE  
HURON PARKWAY AND BAXTER ROAD  
ANN ARBOR, MICHIGAN 48105

Final Report

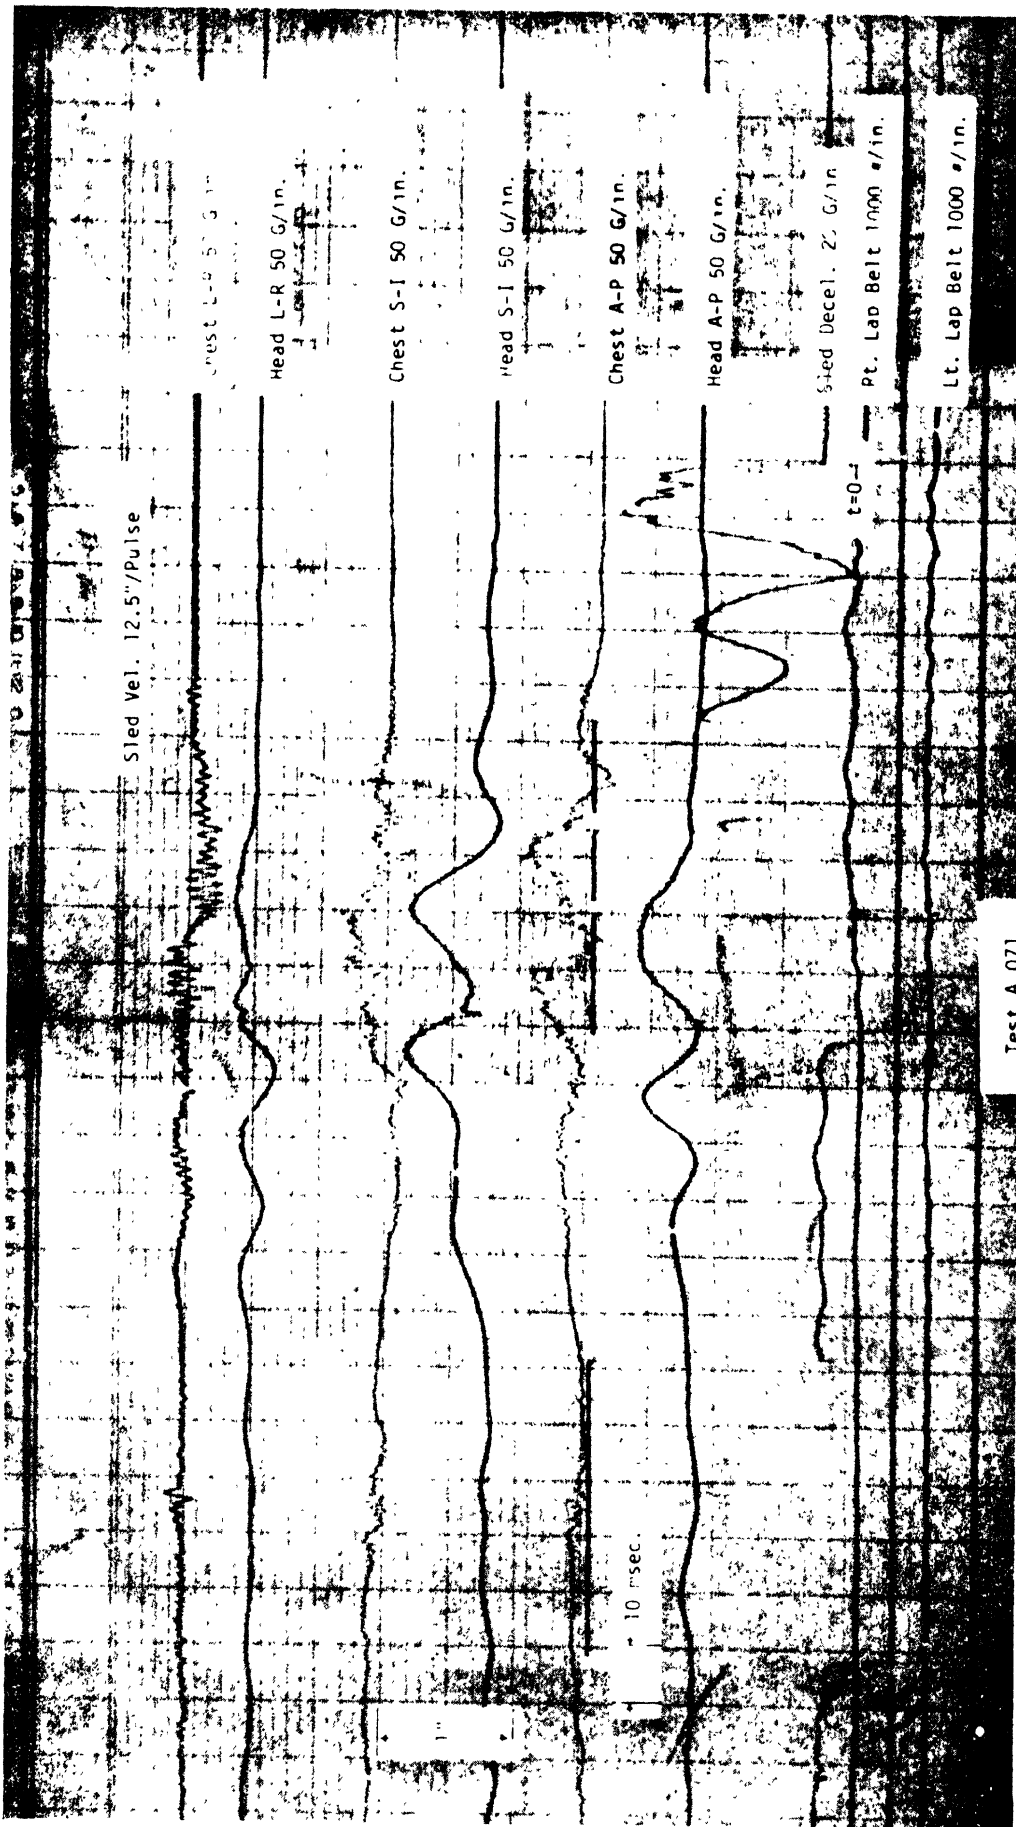
Test A 071

The loadings experienced by the dummy were quite low. However, the seat structure failed leading to very large dummy excursions. The restraint harness failed so that the dummy's energy was absorbed by the handrail which contacted the dummy's abdomen and the upper torso and legs flexed around the handrail. The right-hand bail hook disengaged from the seat back and the under structure support brace on the right-hand side of the seat collapsed.

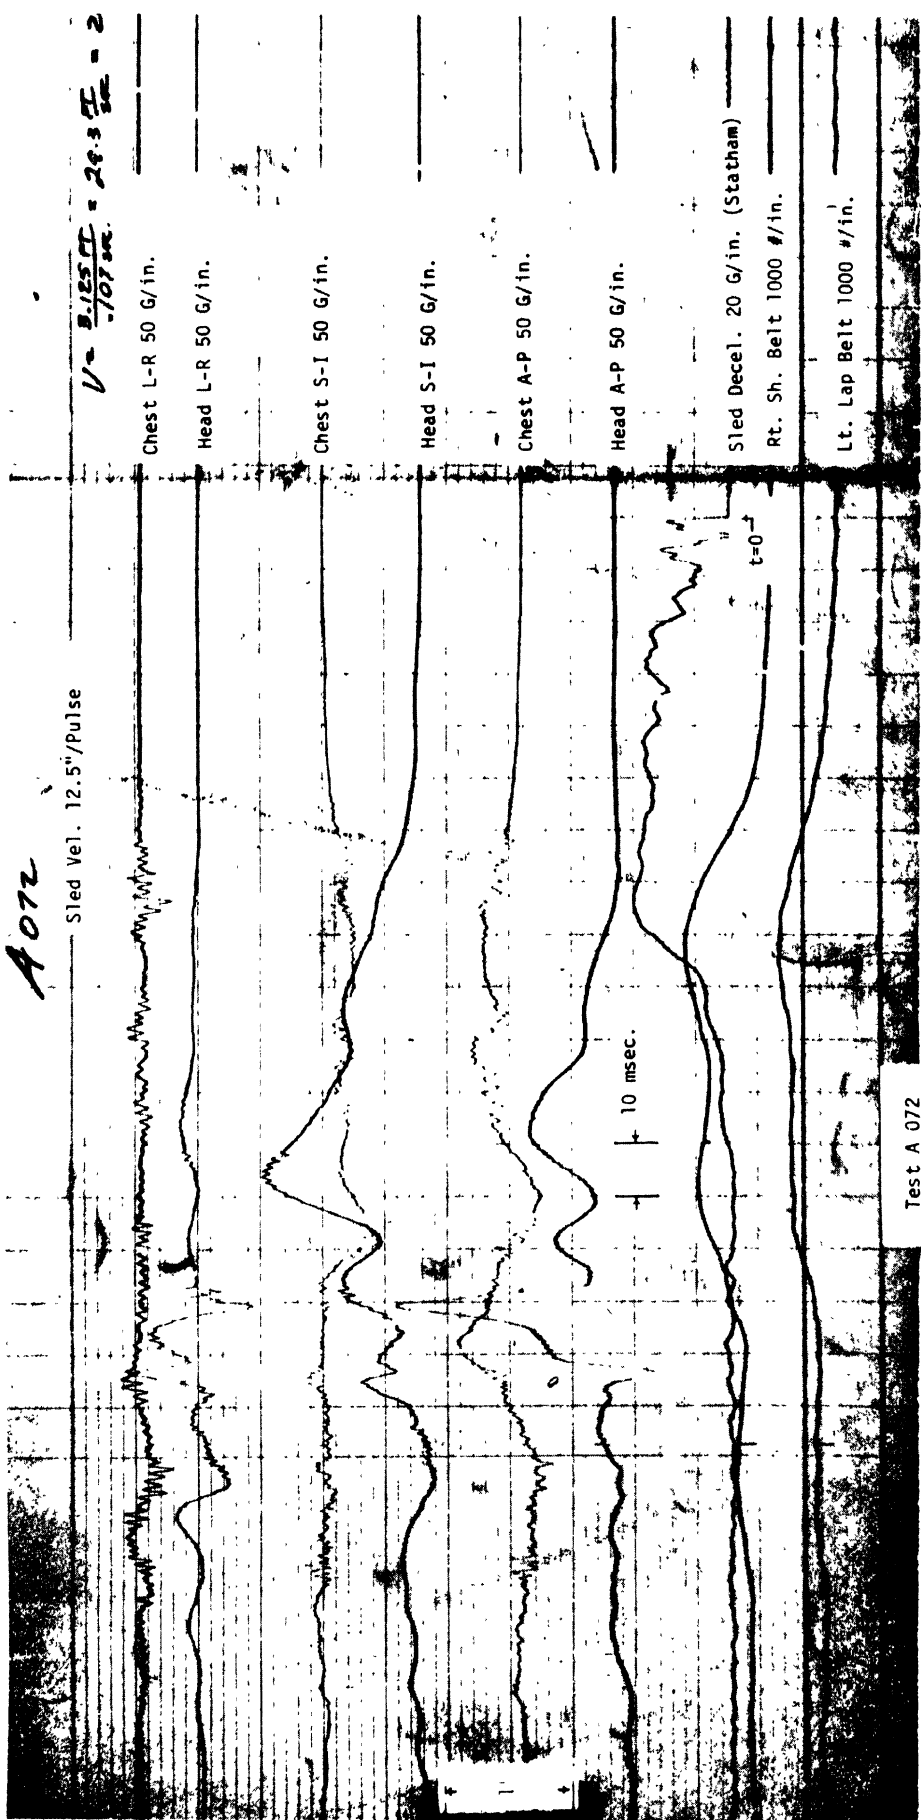
Test A 072

No damage to either the dummy or to the restraint system was observed.  
The dummy experienced a high g loading on the head.

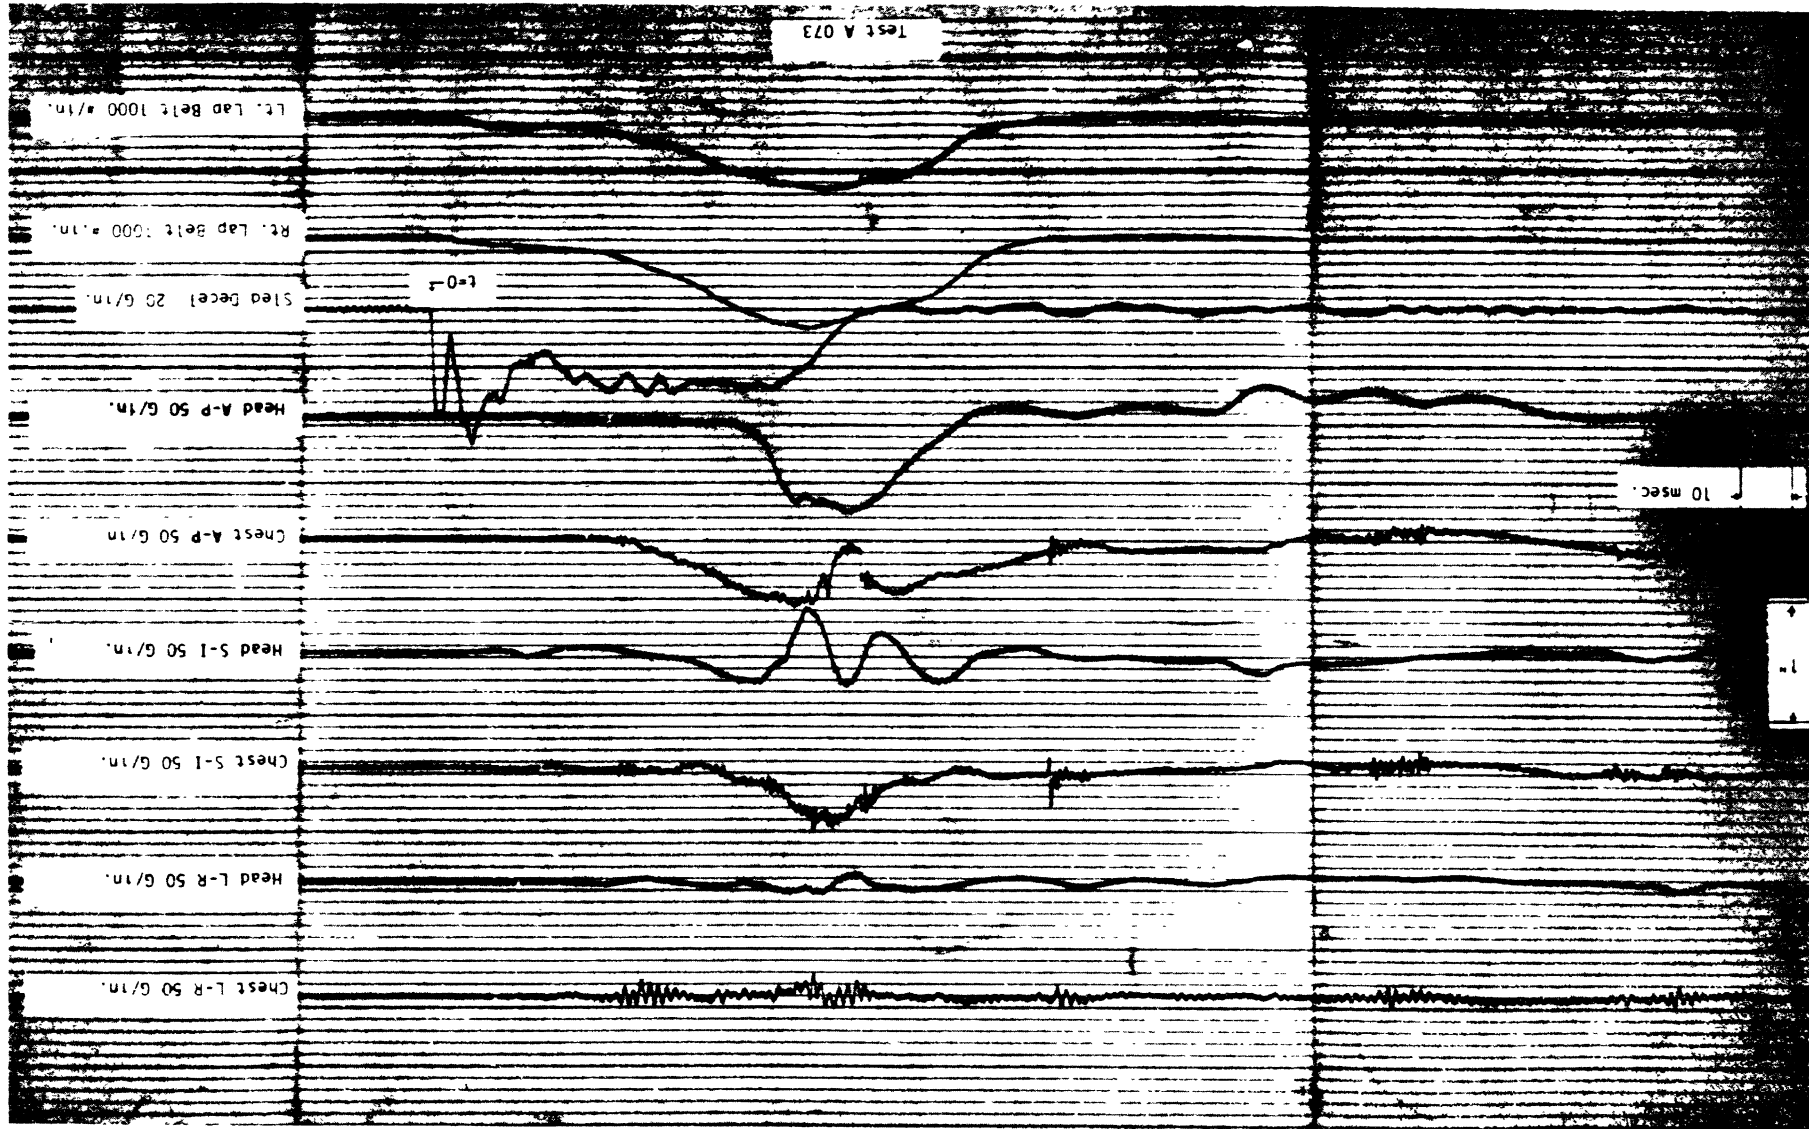
Test A 073

No damage was experienced by either the dummy or the restraint system.  
Seat belt and accelometer readings were quite low.
