The effect of microstructure on wear modes of ceramic materials*

O. O. Ajayi† and K. C. Ludema

Mechanical Engineering Department, The University of Michigan, Ann Arbor, MI 48109 (USA)

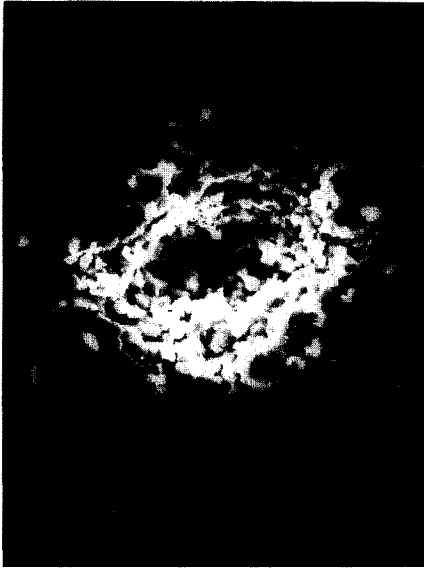
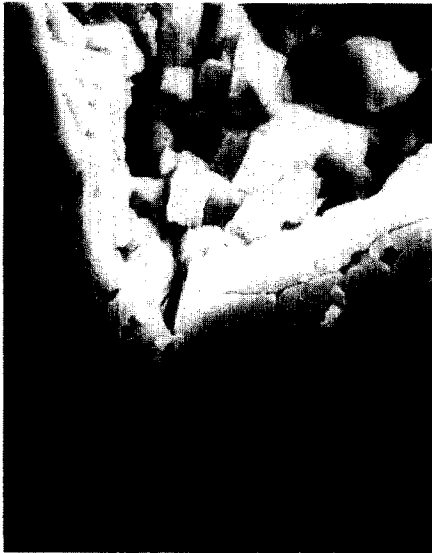
Fig. 3. Indentation damage in the two kinds of SiC materials: (a) hot-pressed SiC; (b) α -sintered SiC; (c) etched α -SiC material showing the transgranular nature of the cracks.

The characteristic radial cracks usually formed at the corners of an indentation were observed in all five materials for all loads used in the present test. The radial cracks in almost all cases propagated well beyond the contact region between the indenter and the material surface. The cracks followed the grain boundary (intergranular) in all the materials, except for SiC-2 (α -sintered SiC) where cracks propagated transgranularly.

In addition to the radial cracks, other kinds of damage occurred at and around the contact area. In general, the two SiC materials showed more fracture and fragmentation and less deformation around the contact area than the Al_2O_3 materials. From the hardnesses of the various materials in Table 1, more deformation is expected in the Al_2O_3 materials than the SiC. Figure 3 shows the major features of the indentation damage in the two SiC materials. In the SiC-1 material, extensive grain boundary failure occurred which resulted in the removal of some material from the contact area. This observation is in agreement with previous studies with this material [13, 14]. In SiC-2, extensive cracking was also observed around the contact area but it was primarily transgranular, as were the radial cracks. Evidence of a limited amount of plastic flow was also observed (Fig. 3(b)). Etching of an indented specimen showed more clearly the transgranular path of cracks in this material (Fig. 3(c)). In addition to the radial cracks, "rim" cracks were also revealed by the etching process.

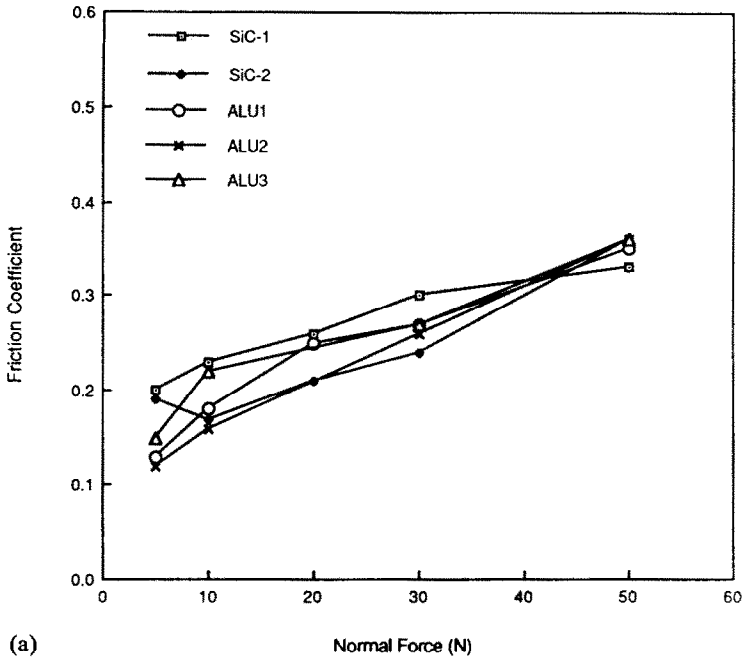
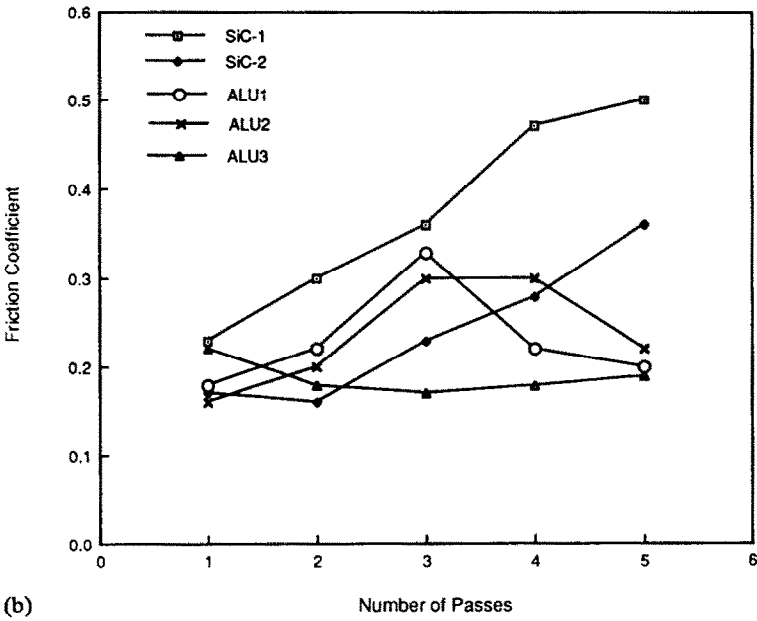
Fig. 5. Friction coefficient for a spherical tip diamond slider on the polished surface of the five different materials: (a) variation with normal force and (b) variation with the number of passes at a normal force of 10 N.

Figure 5 shows the frictional behavior of the five materials when sliding against a diamond indenter. The values plotted are the steady state friction coefficients. In all cases, the friction coefficient was lower than the steady value when sliding began. For all five materials, the friction coefficient appears to show a similar trend of modest increase with increasing load (Fig. 5(a)). Under repeat passes, however, significant differences were seen in the frictional behavior of the various materials. The two SiC materials showed increases in their friction coefficients with each pass; the increase was more pronounced in the SiC-1 material (Fig. 5(b)). The friction in the ALU1 and ALU2 materials increased for the first two passes, reached a peak at the third pass and then decreased thereafter. In the ALU3 material, after the first pass there was a small decrease in the friction coefficient to an almost constant value.

The frictional behavior appears to be connected with the nature of the damage. The materials in which fracture was prominent during contact exhibited an increase in the friction coefficient with repeat passes. The two SiC materials showed this trend. For materials in which both deformation and fracture were significant, only a slight increase in the friction with repeat passes was observed (ALU1 and ALU2). When deformation was the prominent mode of damage, the friction decreased modestly, reaching a constant value with repeat passes (ALU3).

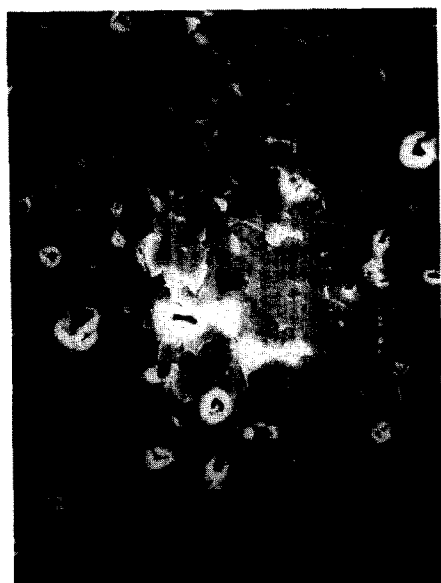
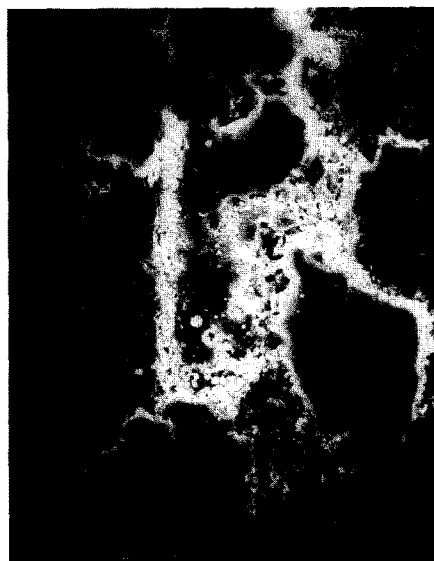
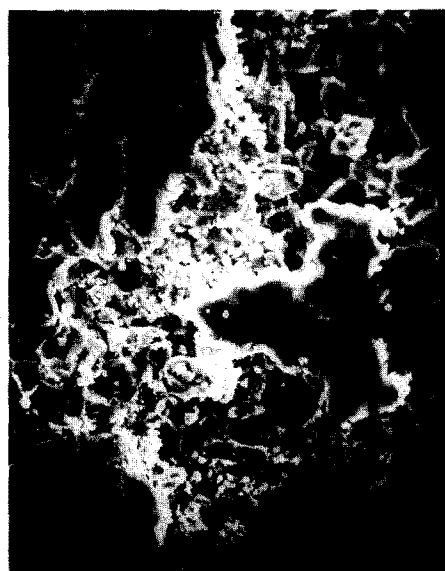
Fig. 8. Sliding indenter damage in the alumina materials: (a) ALU1; (b) ALU1 after five passes; (c) ALU2 after five passes; (d) ALU3.

Figure 8 shows the damage in the alumina materials. ALU1 and ALU2 showed the same type of damage, consisting of some deformation and grain boundary cracking. Under repeated passes, material loss by grain pull-out was observed. The extent of the material removal was greater in ALU2 than ALU1 after five passes, although it started with less wear after a single pass (Fig. 9). The damage in ALU3 consisted primarily of plastic flow (Fig. 8(d)). Even at higher loads, only a limited amount of cracking at the edge of the track was observed.

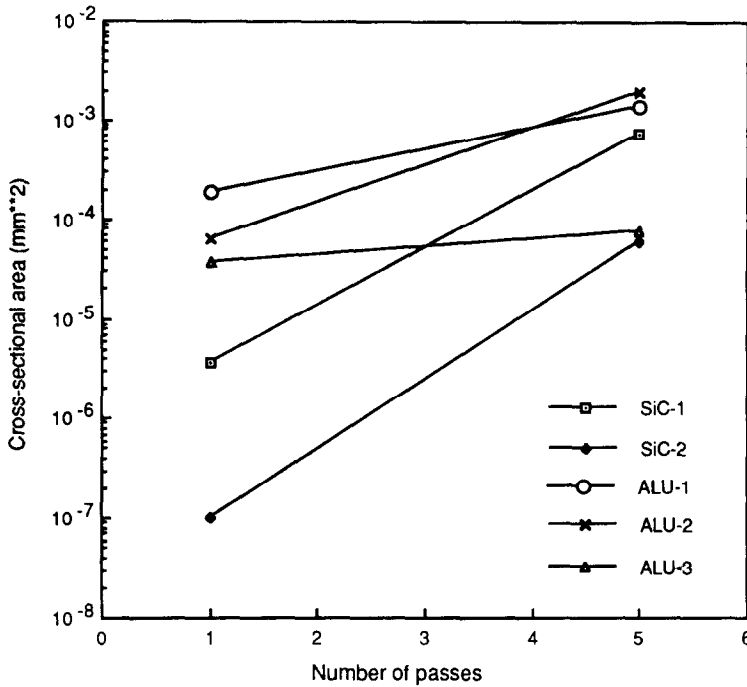
Fig. 9. Wear scar cross-sectional area as a function of the number of passes.

For a better visualization of the comparative amount of wear in the five materials, a plot was made of the track cross-sectional area as a function of the number of passes as shown in Fig. 9. A number of points can be seen in this plot. First, the ranking order of the materials by eqn. (1) is about the same as the results from one-pass tests except for the ALU3 material. However, the equation predicts a total range of 2.6:1, whereas there is about a 1000:1 range in the data. It appears that the slight ductility and strong grain boundaries of the SiC-2 material are influential in its wear resistance. Ductility by itself is not beneficial as indicated by the higher wear of the Al_2O_3 materials in one-pass sliding as compared with the SiC materials.

The ranking order of the materials changes after five passes, reflecting the differences in the rate of progression of damage under cyclic stresses. The size of the increase in the wear over five passes was as follows: SiC-1 — 200 times; SiC-2 — more than 200 times; ALU1 — 7.5 times; ALU2 — 31 times; ALU3 — double. This suggests that the SiC materials are more prone to cyclic stress damage than the more “ductile” Al_2O_3 materials. ALU3 also showed the great influence of the glassy second phase in preventing a large increase in the wear rate after five passes.

SiC-2 to only 2 for ALU3 after five passes (Fig. 9). The more ductile Al_2O_3 materials in general showed lower rates of increase than the more brittle SiC materials.
