FIELD INVESTIGATIONS OF THE PERFORMANCE OF AIR BAG DEPLOYMENTS IN FRONTAL COLLISIONS*

DONALD F. HUELKE and JAMIE L. MOORE

University of Michigan Transportation Research Institute, 2901 Baxter, Ann Arbor, MI 48109, U.S.A.

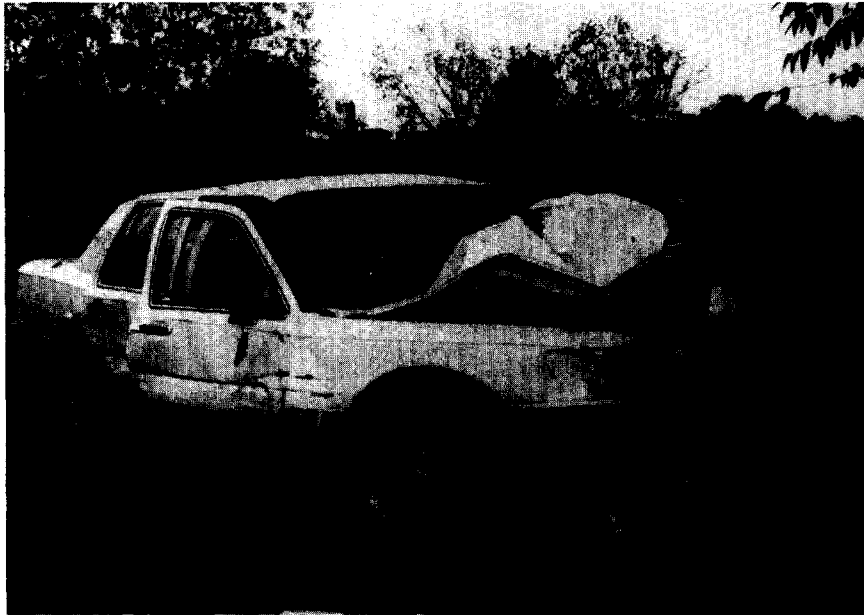
Case 1 (UM-FMA-046). A 1990 Lincoln Town Car driven by a 73-year-old female left the interstate highway for an unknown reason, traveled in the grassy median, and struck a large overhead highway sign support pole. It was estimated the car was traveling at more than 97 kmph when the crash occurred (Fig. 2). Frontal damage extent was 137 cm.

Interior damage was extremely severe with catastrophic compartment crush. The forward movement of the rear occupants loaded the front seats. There were four female occupants in the car, ranging in age from 69 years to 74 years. None of the women

Fig. 2. High speed pole crash. 1990 Lincoln Town Car. All four occupants killed.

was restrained, and all were pronounced dead at the scene. Both the driver- and passenger-side air bags deployed. The occupants sustained numerous fractures, severe internal injuries, and multiple superficial injuries; MAIS 5, MAIS 6.

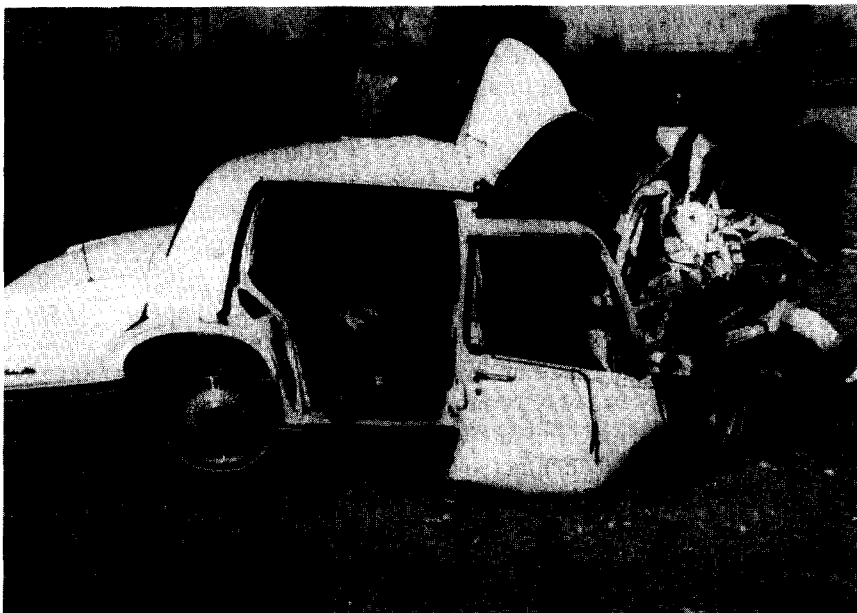
Case 2 (UM-2934-91). In this collision the impact was so severe that the crash was totally unsurvivable for both front seat occupants. This 1991 Cadillac DeVille was traveling on a two-lane roadway when the driver entered the right shoulder in an

attempt to pass a turning vehicle. The driver lost control, crossed the centerline, and struck a 1987 Ford Econoline E-150 Van head-on. There was extensive damage to the front of the Cadillac (132 cm) (Fig. 3). The 79-year-old female driver (161 cm, 45 kg) was wearing the 3-point restraint; the air bag deployed. She sustained the following injuries: complete separation of C1 from the base of the skull (impact force), multiple rib fractures on both sides (shoulder belt, air bag), and fractures of the right

Fig. 3. Severe car to van crash. Elderly female driver died from multiple injuries.

tibia (lower instrument panel) and right humerus (steering wheel, upper instrument panel); MAIS 6. The 81-year-old, right-side male passenger (164 cm, 68 kg) was wearing the 3-point restraint and was also fatally injured; MAIS 5.

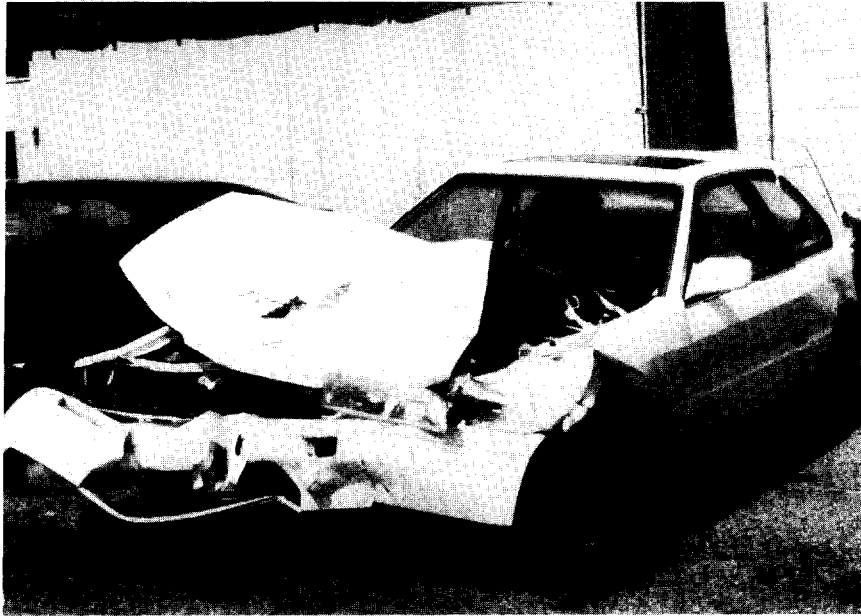
with the 3-point restraint. A 1977 Plymouth Gran Fury attempted a left turn in front of a 1990 Infiniti M30 that was traveling at an estimated speed of about 72 kph. The two cars struck head-on. After impact, both cars rotated and struck again, damaging the left rear quarter panel of the M30 (36 cm of crush). The maximum crush to the front of the M30 was about 64 cm (Fig. 5).

The air bag of the M30 deployed during the first crash sequence. The 3-point restrained male driver (180 cm, 82 kg) sustained the following minor (AIS 1) injuries: cervical and thoracic strain (impact force), contusions across the abdomen and chest (3-point belt), contusion left knee (lower instrument panel), contusion right lower leg (center console trim piece), contusion right anterior forearm and abrasions (air bag), and first-degree thermal burns to the top of the right hand (air bag gas); MAIS 1. The two front seat occupants in the Plymouth were not wearing their safety belts and were seriously injured.

Fig. 5. Multiple minor injuries sustained by a belted driver. Dorsal right hand burn from the air bag gas.

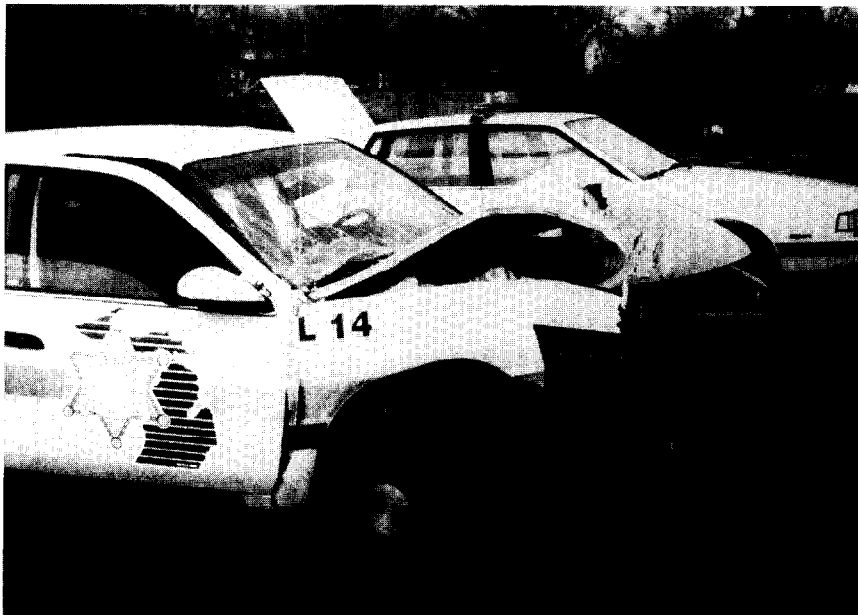
Case 5 (UM-2939-91). This is a severe crash where the driver was protected by the air bag. This 1991 Ford Taurus police car was on an emergency call when the driver failed to negotiate a left curve at the crest of a hill. The car went off the right side of the roadway and struck a large tree. There was extensive damage to the front end (74 cm) (Fig. 6).

The 28-year-old, lap-shoulder belted male driver (180 cm, 91 kg) sustained a hairline fracture of the sternum (shoulder belt), contusions of the left neck, across the abdomen (3-point restraint), of the anterior right forearm (transmission selector), the left forearm (steering wheel), a sprained right ankle (brake pedal), and a tongue laceration (bit down with teeth); MAIS 2.

Fig. 6. Severe frontal crash; air bag deployed and lap shoulder belt worn. Most severe injury was a sprain of the ankle.

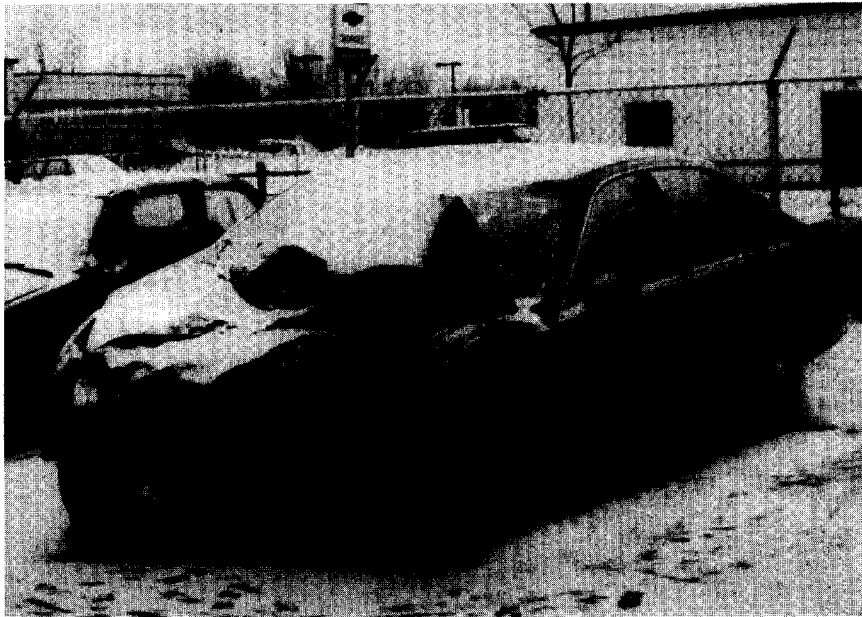
Case 6 (UM-2979-92). In an attempted left turn this 1991 Chevrolet Caprice four-door sedan was struck head-on by a 1984 Chevrolet Blazer traveling at a driver-estimated speed of 72 kph. The front of the Caprice was severely damaged (Fig. 7). The 85-year old, belted male driver (185 cm, 86 kg) sustained a thoracic strain (impact force). No injuries were reported from the air bag; MAIS 1.

Fig. 7. An 85-year-old belted driver sustained minor injuries in this car-to-car crash. No injuries reported from the deployed air bag.

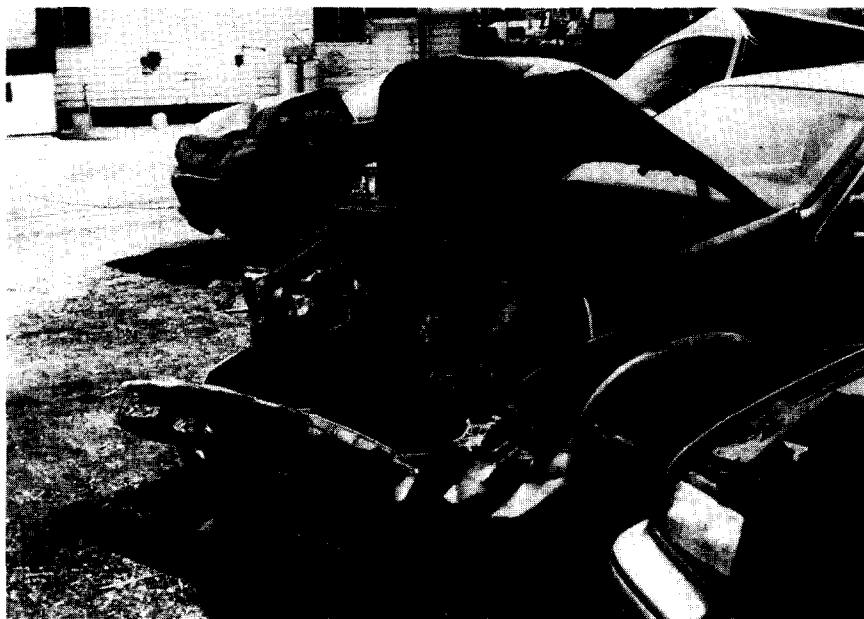
Fig. 9. Severe frontal damage with only minor injuries to the restrained driver. Air bag contact produced a contusion of the nose and a hand abrasion.

Case 8 (UM-2994-92). This severe crash occurred when a 1988 Chrysler LeBaron, traveling at an estimated speed of 100 kph, struck the rear of a 1984 Ford Mustang that had been stopped on the highway due to engine trouble (Fig. 9). The 44-year-

old restrained, male driver (173 cm, 74 kg) sustained a contusion to his nose and an abrasion to the dorsum of the left hand (air bag), and a contusion across his left shoulder (shoulder portion of belt); MAIS 1.

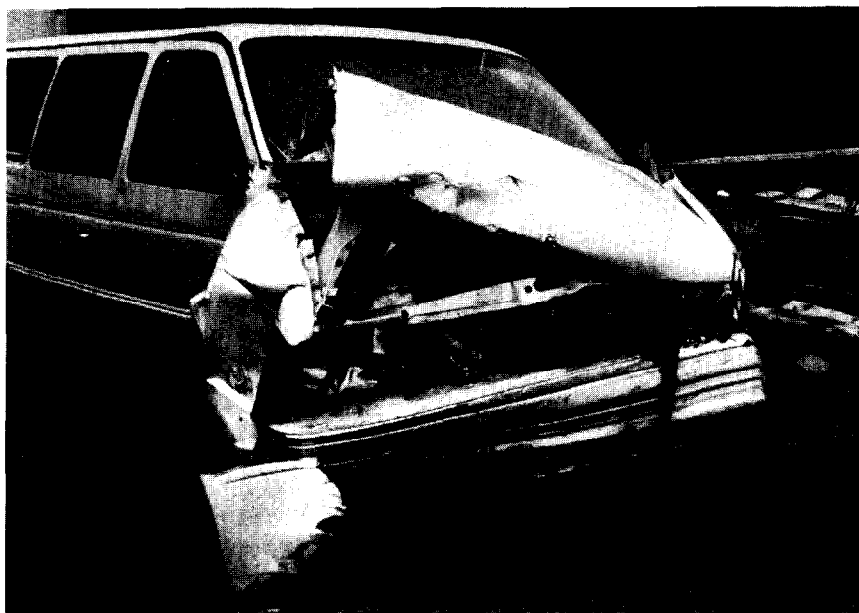
Case 9 (UM-CCA-073). In this crash a 1992 Dodge Caravan crossed the center line and struck a 1979 Oldsmobile Station Wagon head-on. The frontal damage was extremely severe to the front of the Caravan (68 cm) (Fig. 10). The 52-year-old, re-

Fig. 10. Dodge Caravan—head-on crash into an Oldsmobile station wagon. Minor injuries to the restrained driver.

strained male driver (183 cm, 84 kg) sustained multiple lacerations to arms, knees, and ankles. In addition, he sustained some chest muscle strain and contusions (restraint); MAIS 1.

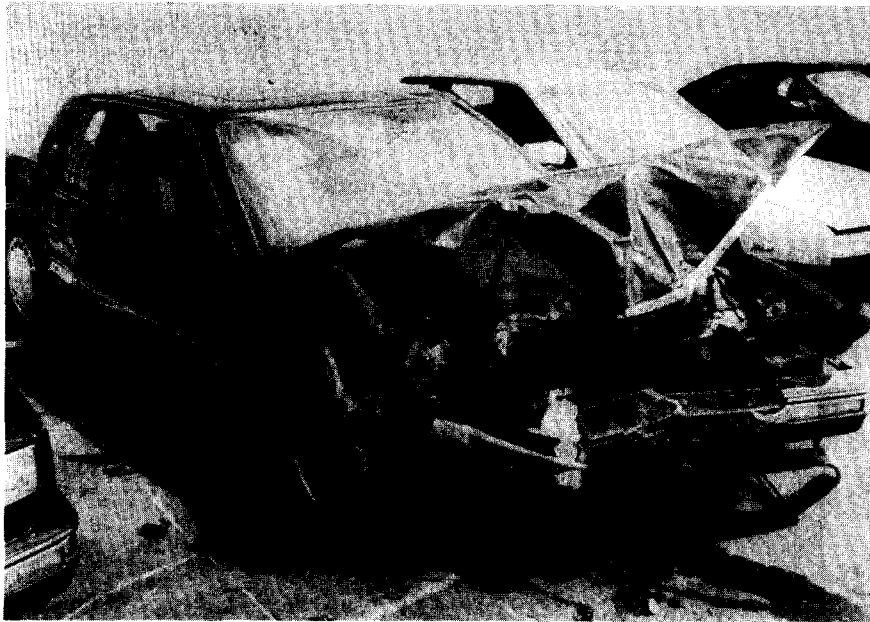
Case 11 (UM-2909-91). This crash occurred when the driver swerved to avoid an oncoming vehicle, went off the road, and impacted two trees. The damage to the front of this 1991 Cadillac Eldorado was 54 cm (Fig. 12). The 30-year-old, unbelted female driver (163 cm, 64 kg) sustained cervical strain (impact force), contusions to both temples (air bag), contusions to both anterior forearms (air bag), and contusions to both knees (lower instrument panel); MAIS 1.

Fig. 12. Head and arm contusions were sustained from the deployed air bag in this car-to-tree crash. All injuries were rated as AIS-1.

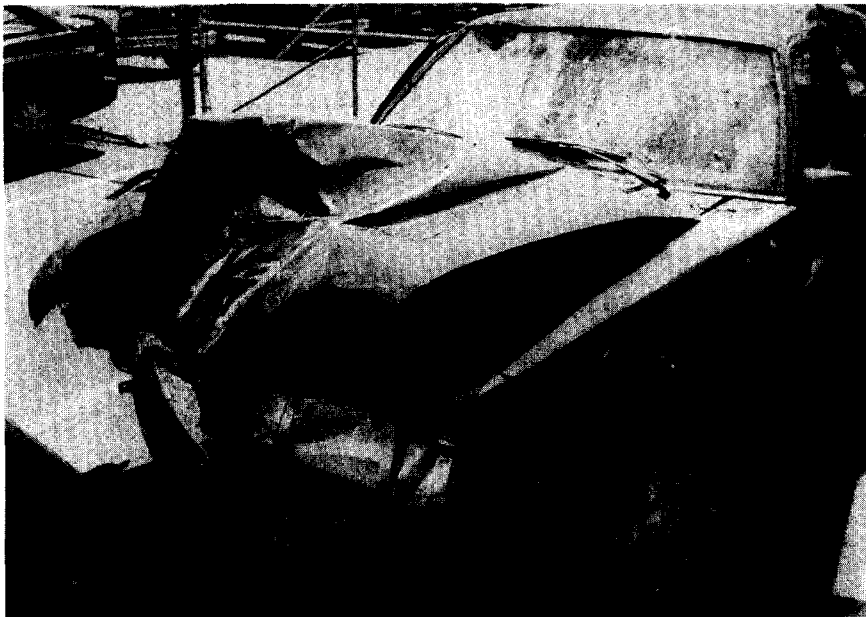
Case 12 (UM-2912-91). A 1991 Ford Mustang went out of control on the wet road, went onto the off-road area, and struck two trees (Fig. 13). The 21-year-old, unbelted male driver (180 cm, 77 kg) sustained a contusion behind his left ear (head rest),

lumbar strain (impact force), and a contusion to his right knee (lower instrument panel); MAIS 1.

Fig. 13. Car-tree crash. Unbelted driver had minor injuries. No injuries were related to the air bag.

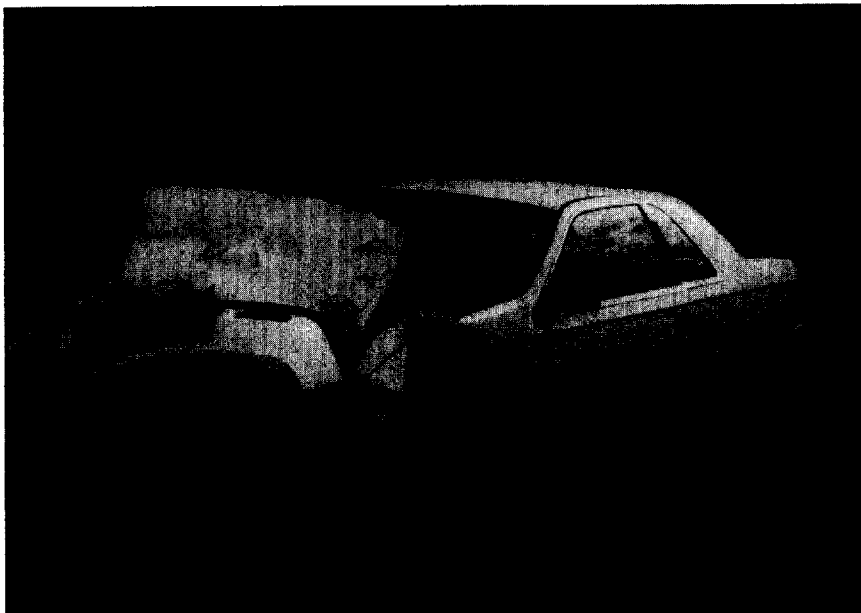
Case 14 (UM-CCA-027). A 1966 White 9564 TD Wrecker was towing a 1974 Freightliner 6 × 4 truck that had stopped to make a left turn. A 1988 Chrysler LeBaron struck the rear of the Freightliner (the towed vehicle). The damage to the front of the LeBaron was 58 cm (Fig. 15). The 47-year-old, unbelted male driver (178 cm, 72 kg) sustained a fractured right femur (lower instrument panel), a chin abrasion and a chest contusion (air bag), and cervical strain (impact force); MAIS 3. The air bag provided excellent protection to his head and torso.

Fig. 15. Chin and chest contusion from air bag contact sustained by an unbelted driver. Fracture of the femur was due to lower instrument panel contact.

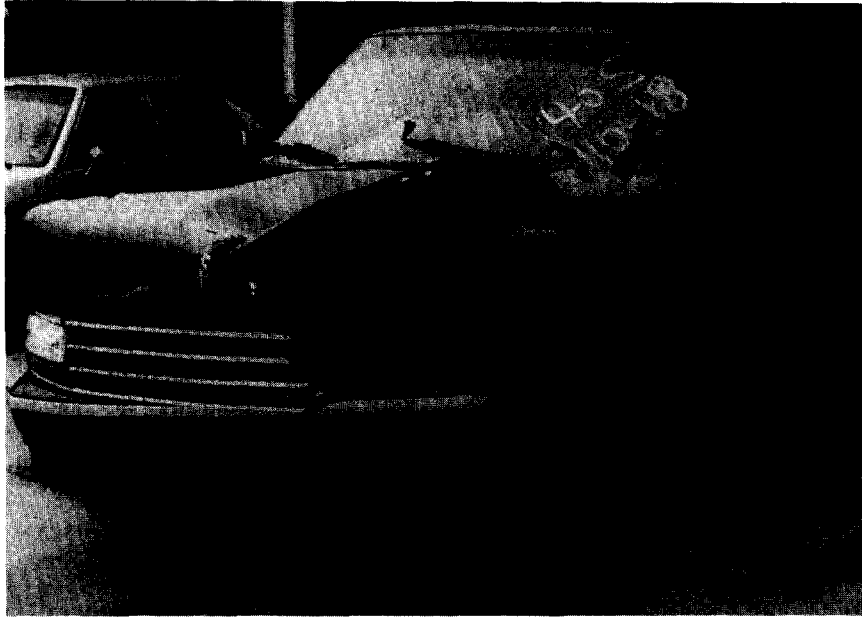
Case 15 (UM-CCA-071). The driver of this 1991 Plymouth Voyager was traveling about 88 kph on the interstate when he struck the rear of a 1989 Ford

F-125 pickup truck that had stopped. The maximum crush to the front of the van was 19 cm (Fig. 16).

The unbelted 23-year-old male driver (193 cm, 89 kg) continued to move forward and rotated upward and over the deployed air bag. His head contacted the top left area of the windshield causing a 6 cm laceration to the left side of his forehead and

a concussion. Small lacerations to both of his hands (flying glass), contusions to both knees (lower instrument panel), and to his left forearm (armrest) were reported along with cervical and thoracic strain (impact force); MAIS 2.

Fig. 16. No air-bag-related injuries to the unbelted driver of this 1990 Plymouth Voyager.
