REINFORCED CONCRETE STRUCTURAL WALLS
WITH STAGGERED OPENING CONFIGURATIONS
UNDER REVERSED CYCLIC LOADING

Aejaz Ali
and
James K. Wight

April 1990 Report No. UMCE 90-05

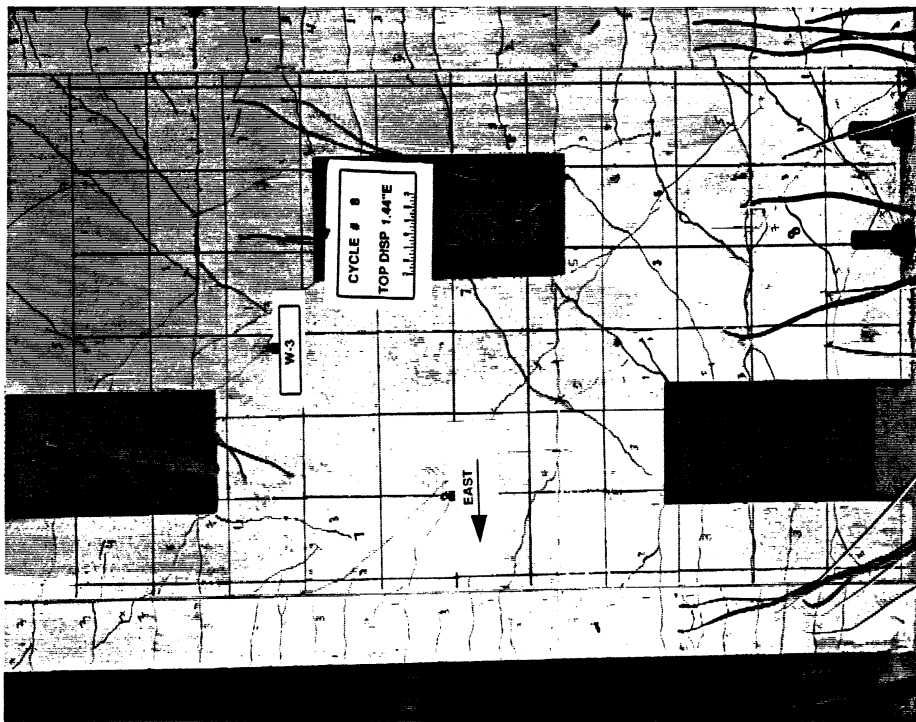
Fig. 4.24 : Crack Pattern in the Upper Half of W-3 during Cycle 8.

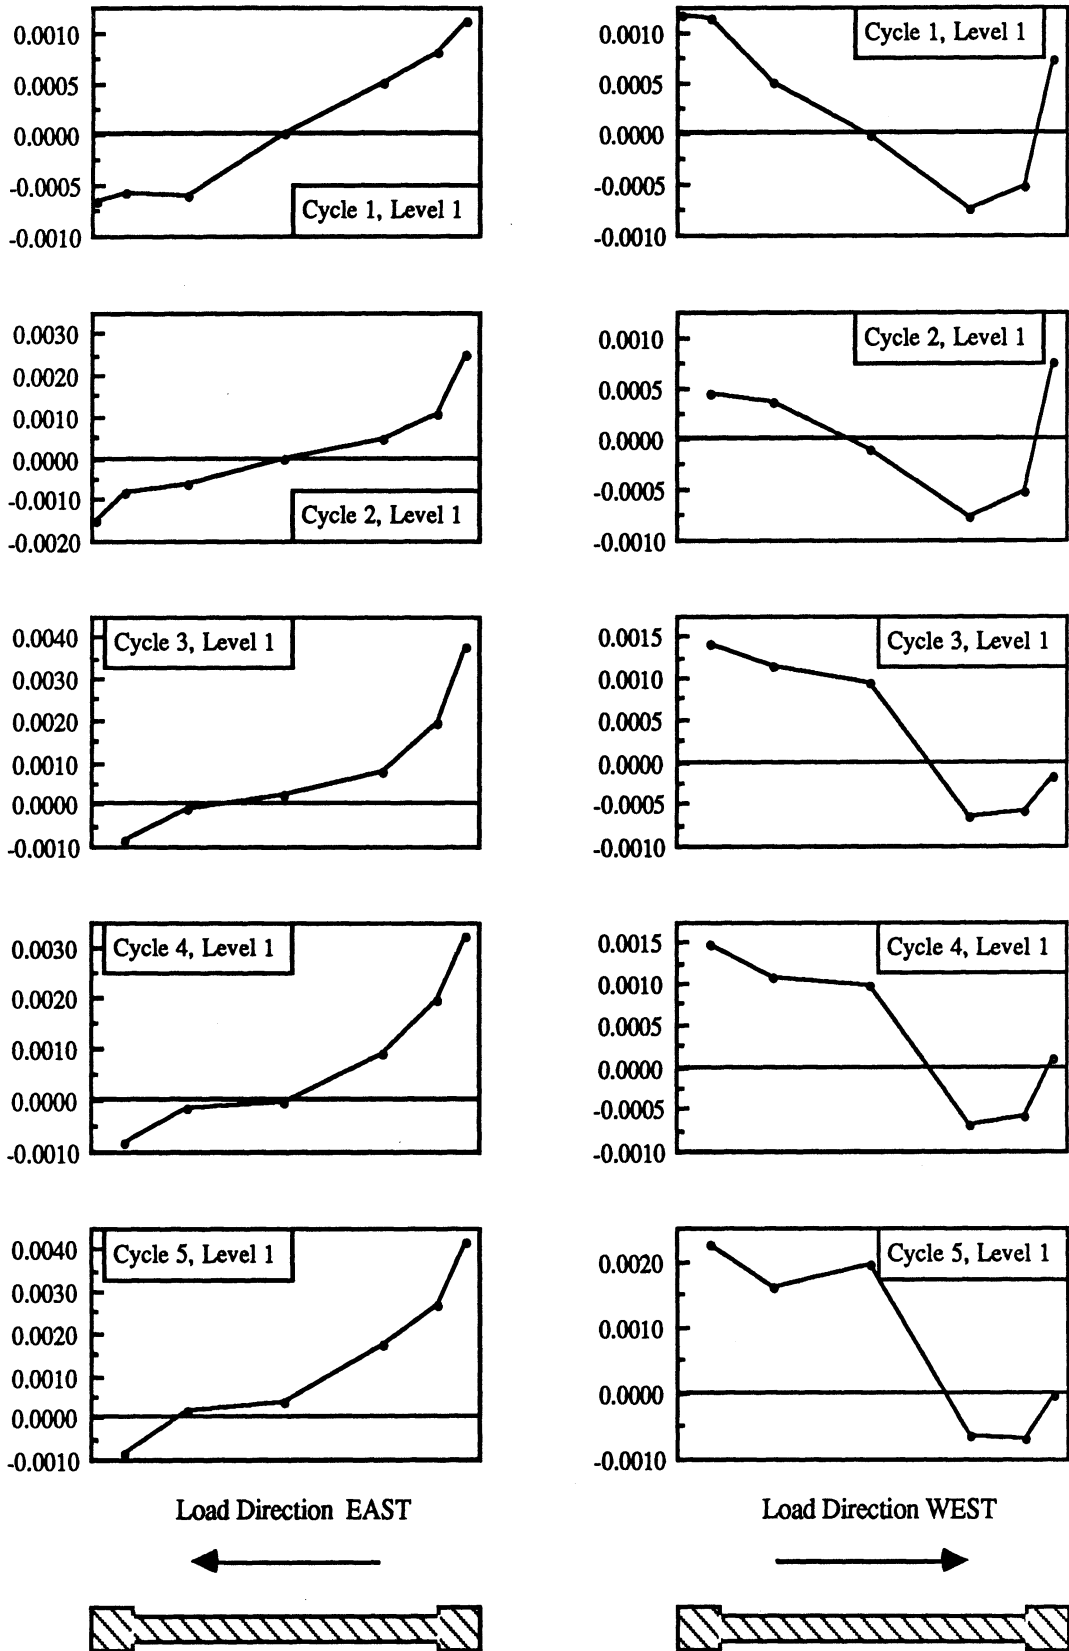
Fig. 4.63 : Strain Profiles for Wall W-1 at Story Level 1.

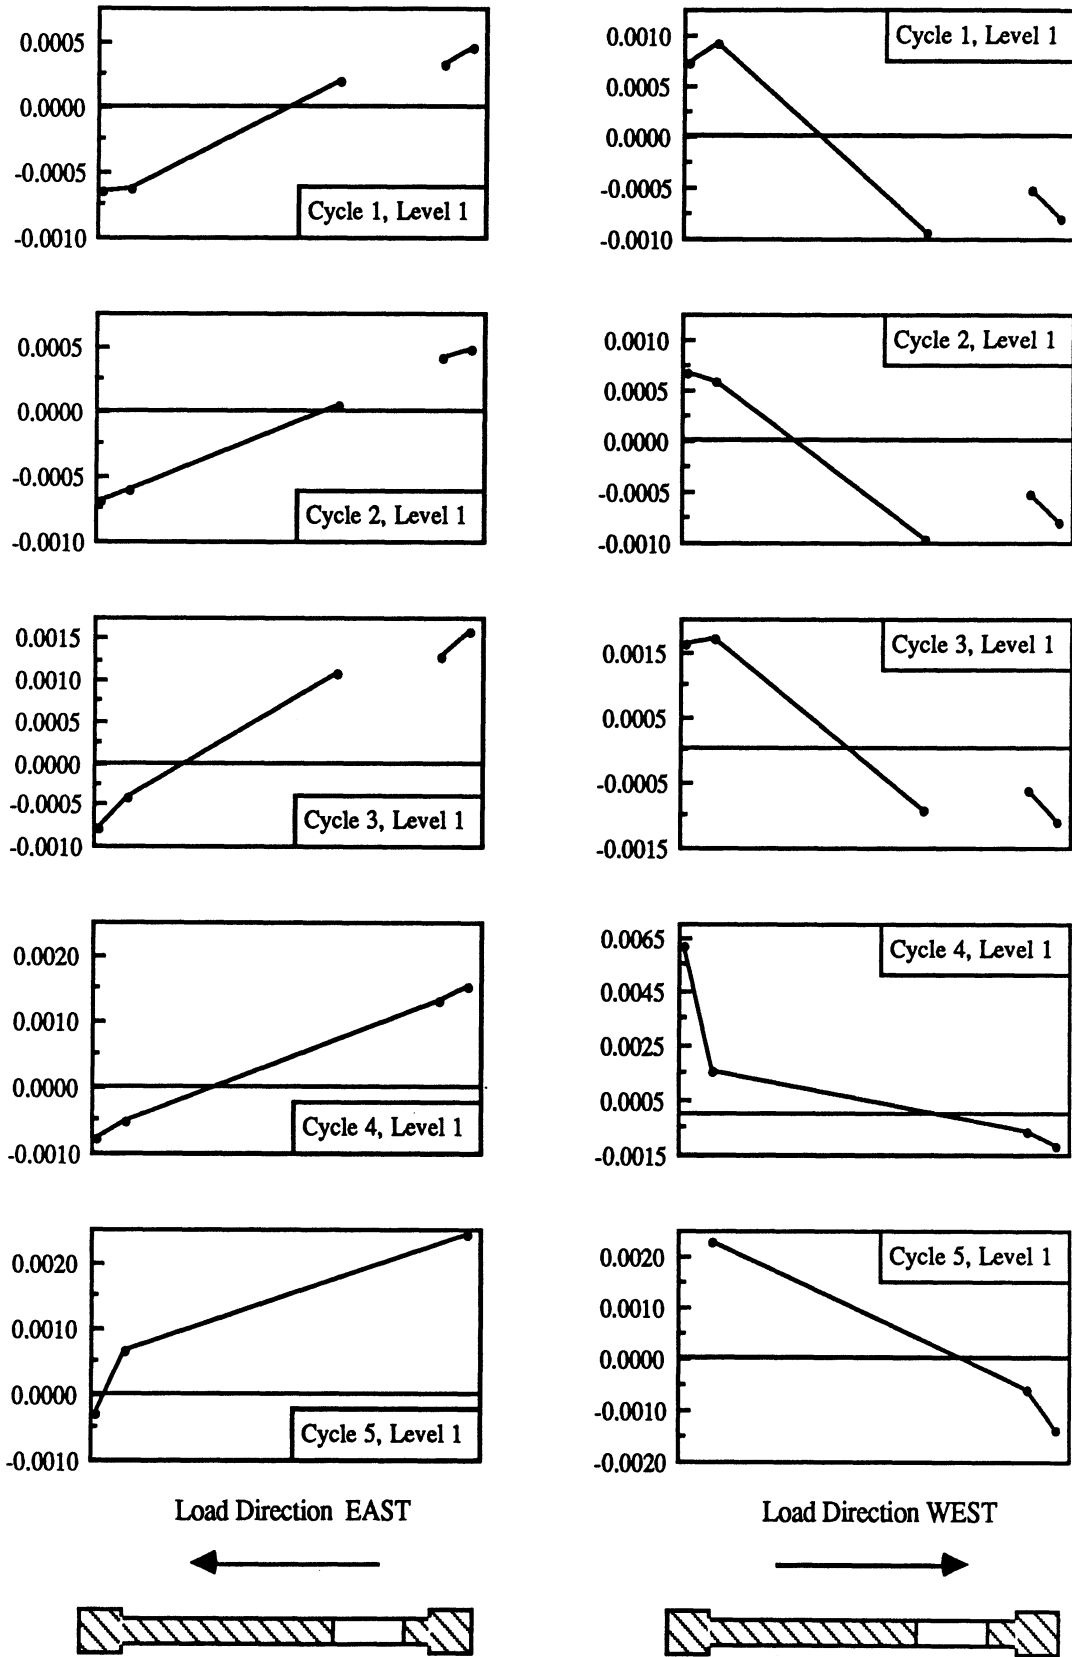
Fig. 4.65 : Strain Profiles for Wall W-2 at Story Level 1.

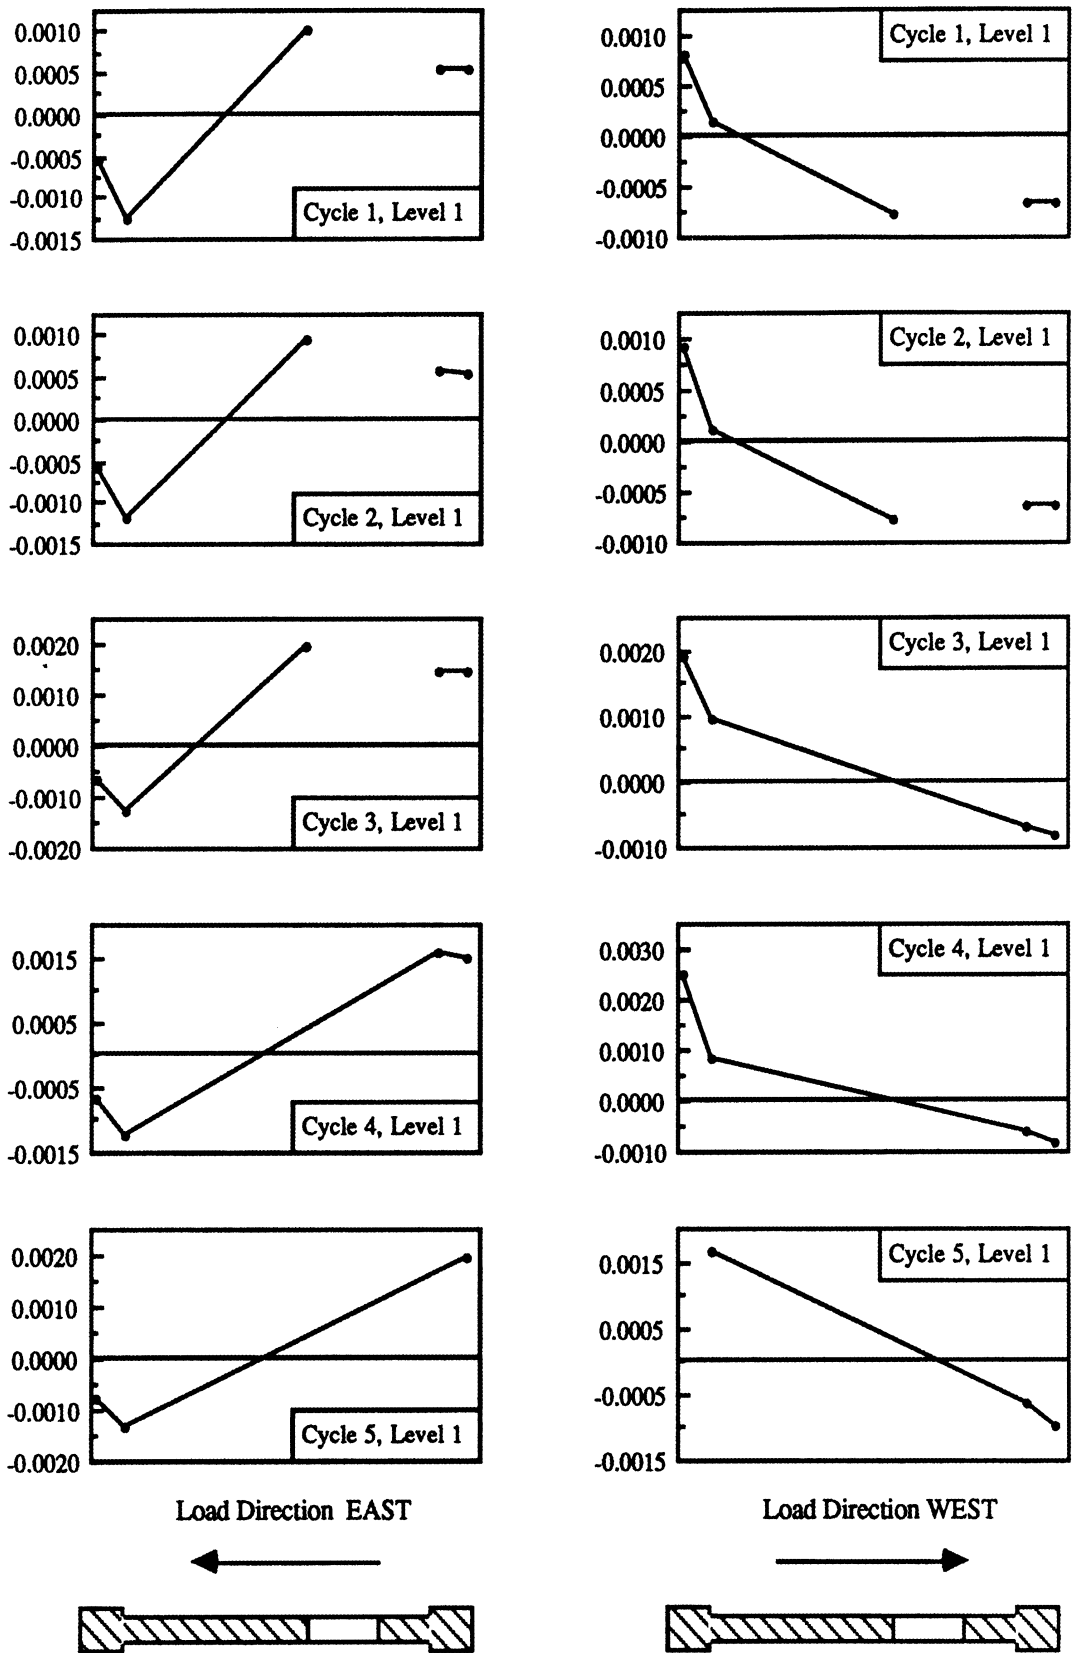
Fig. 4.67 : Strain Profiles for Wall W-3 at Story Level 1.

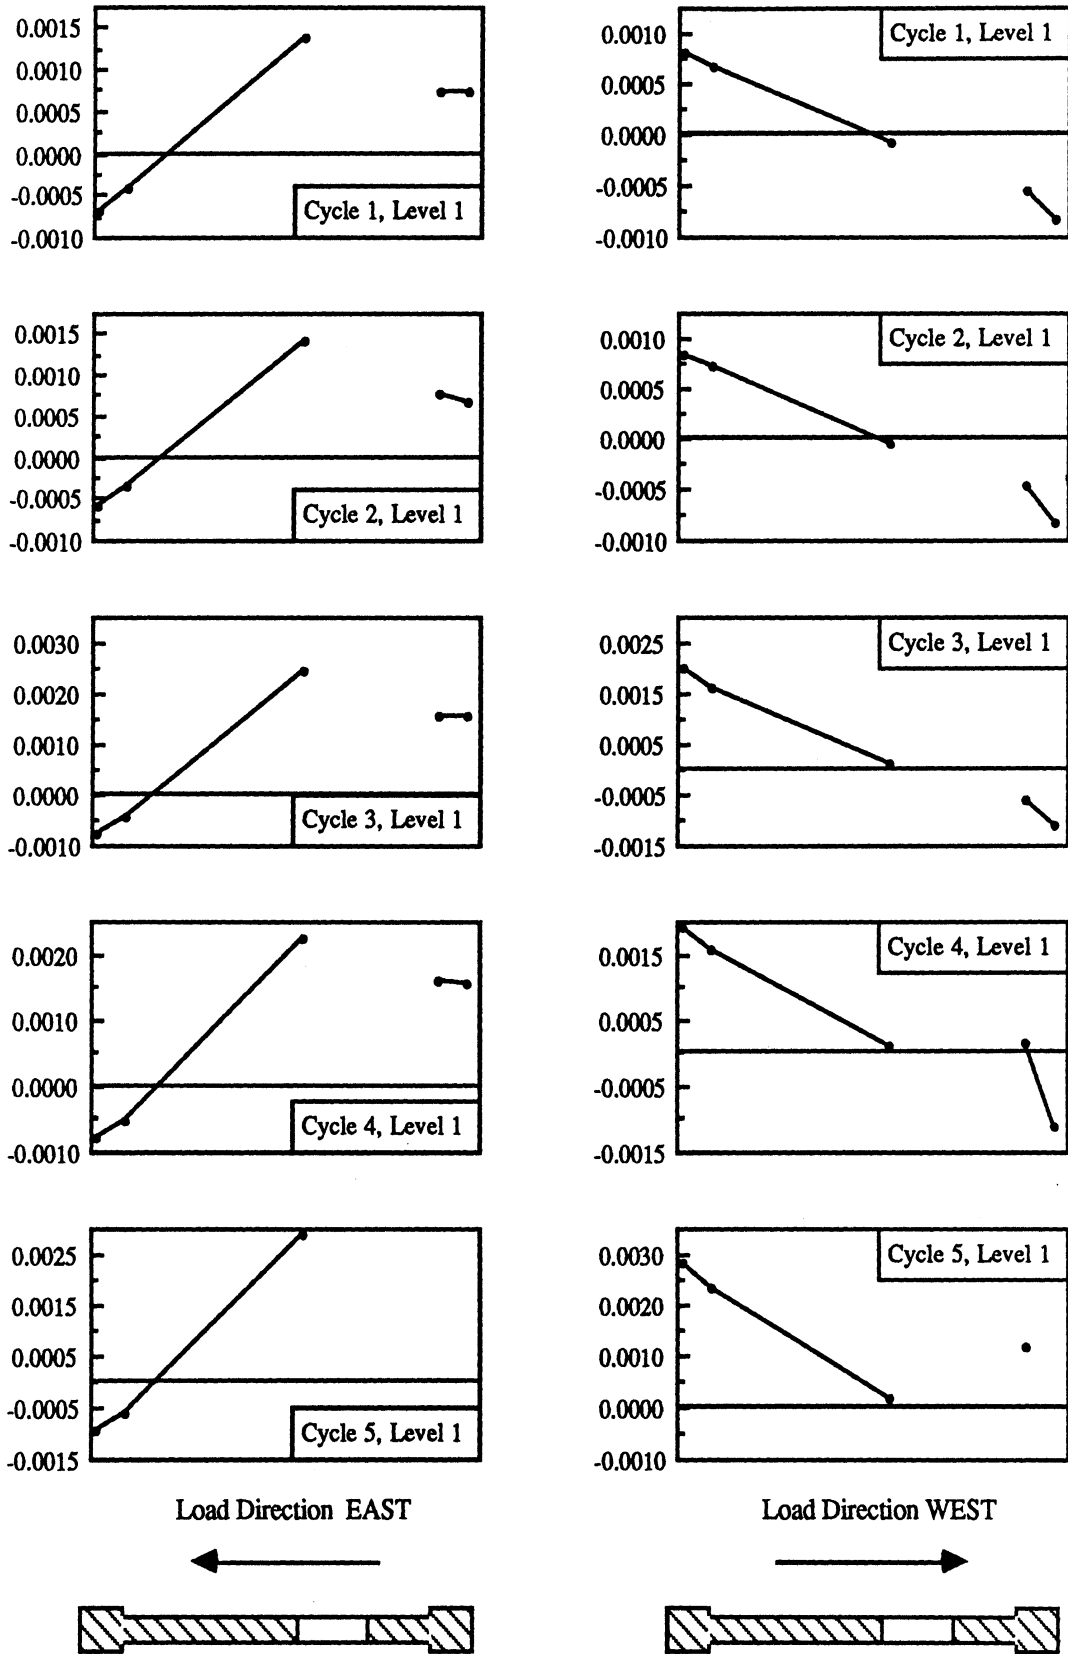
Fig. 4.69 : Strain Profiles for Wall W-4 at Story Level 1.

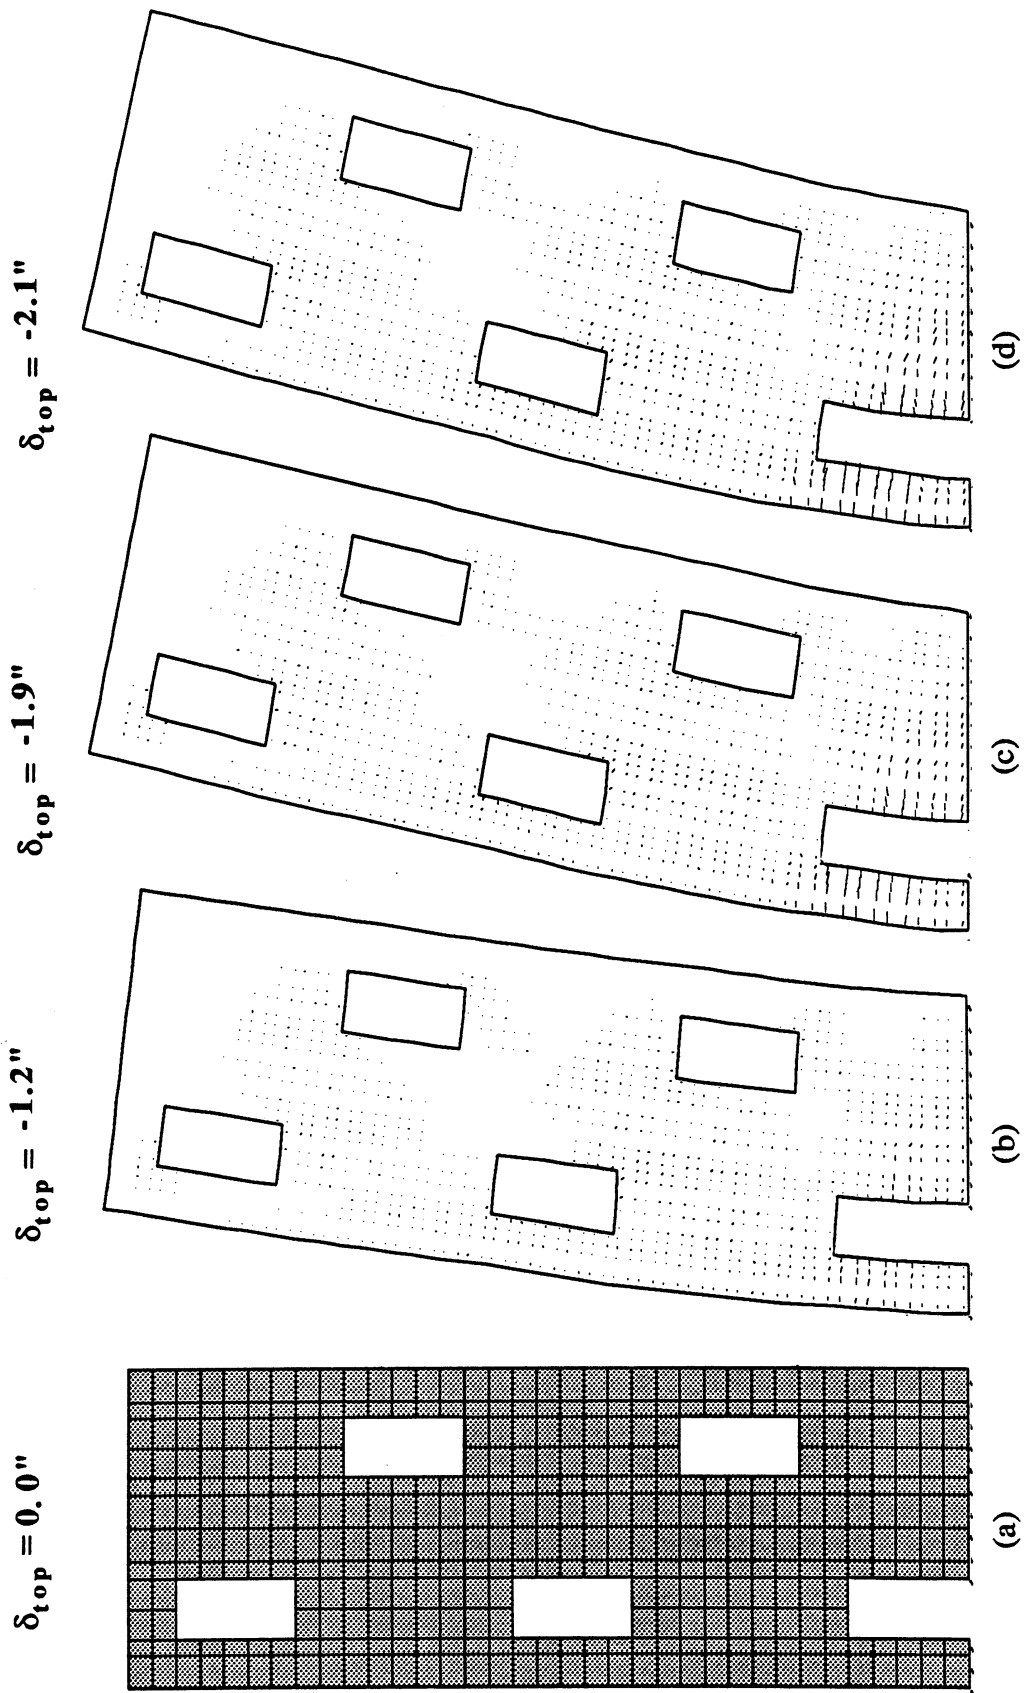
Fig. 5.18 : Undeformed Geometry and Nonlinear Trends in Wall W-2 at Selected Top Displacements.

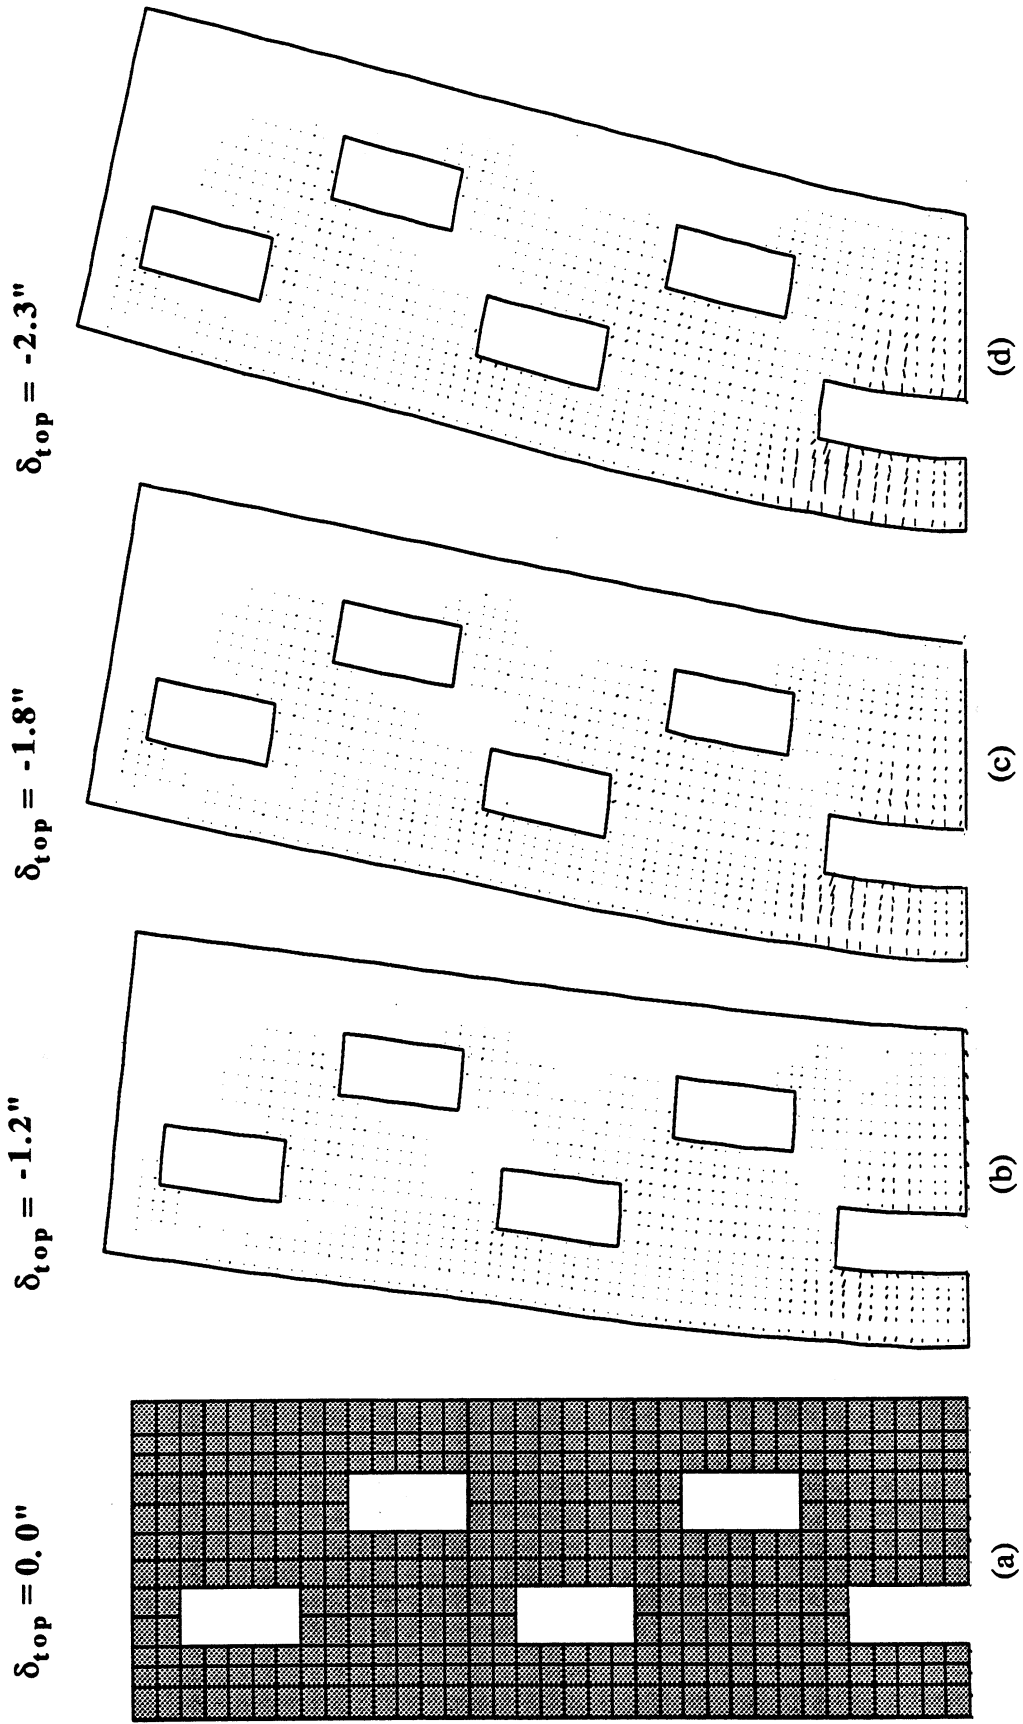
Fig. 5.19 : Undeformed Geometry and Nonlinear Trends in Wall W-3 at Selected Top Displacements.

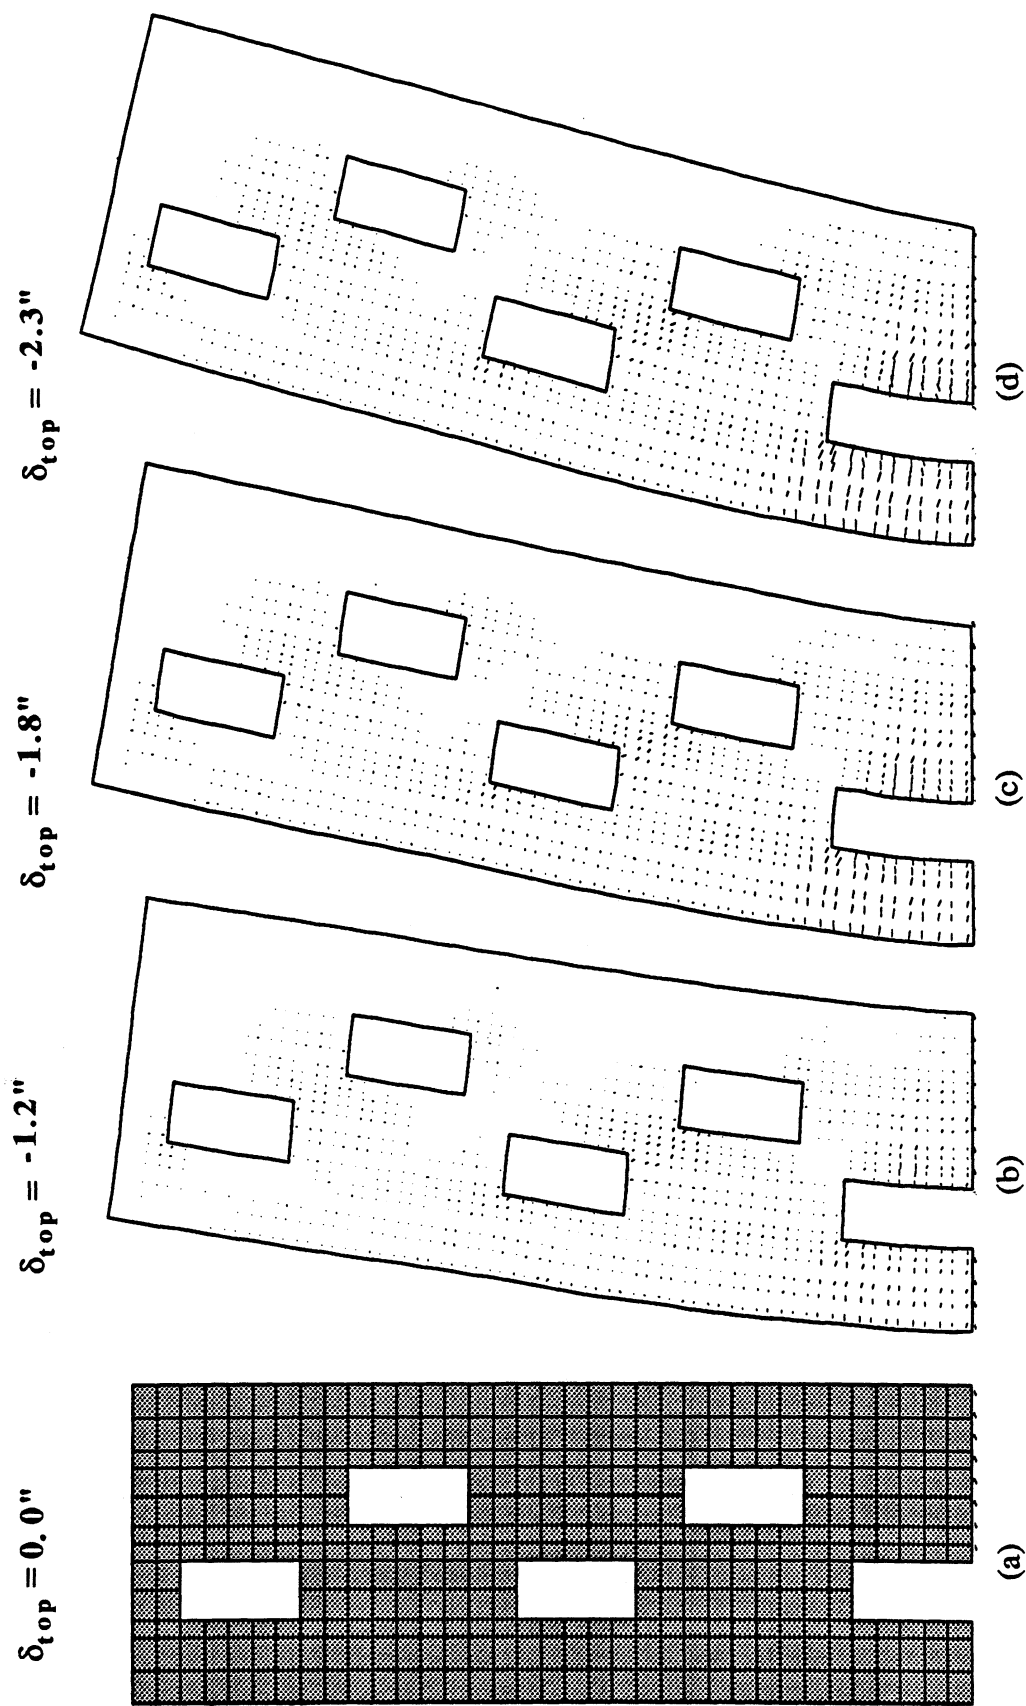
Fig. 5.20 : Undeformed Geometry and Nonlinear Trends in Wall W-4 at Selected Top Displacements.
