Final Report

SHOCK ON ELECTRICAL COMPONENTS  
IN TRACK-LAYING AND WHEELED VEHICLES

Project 2145

DEPARTMENT OF THE ARMY, DETROIT ARSENAL  
CONTRACT NO. DA-20-089-ORD-36543  
CENTER LINE, MICHIGAN

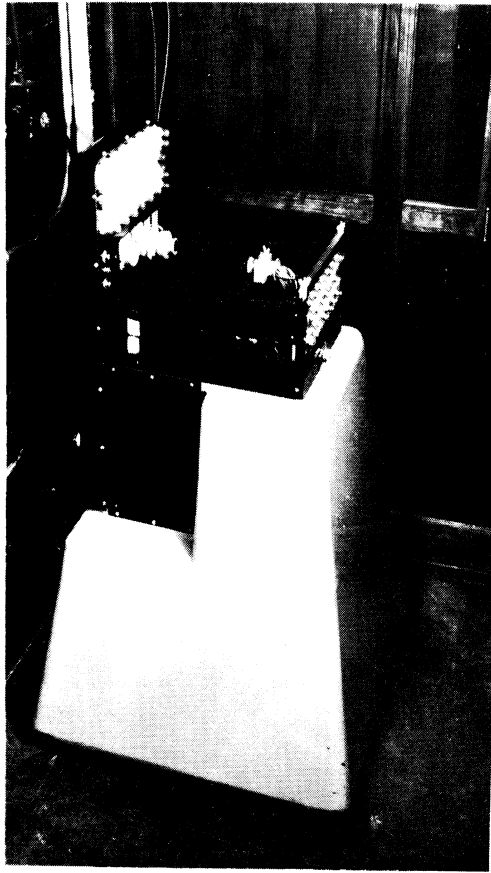
Fig. 1. Ordnance Incandescent Lamp Impact Tester.

In review, for those unfamiliar with the operation of this device, the lamps to be tested are mounted in a frame which is attached to the end of a pivoted truss-like arm. The arm is lifted up on a rotating cam and permitted to drop onto an anvil. The downward motion of the frame is suddenly stopped by the anvil, its motion reversed by elastic bouncing; and the filaments are set in free vibration in a two-noded mode. When this happens often enough, the filament fails in fatigue.

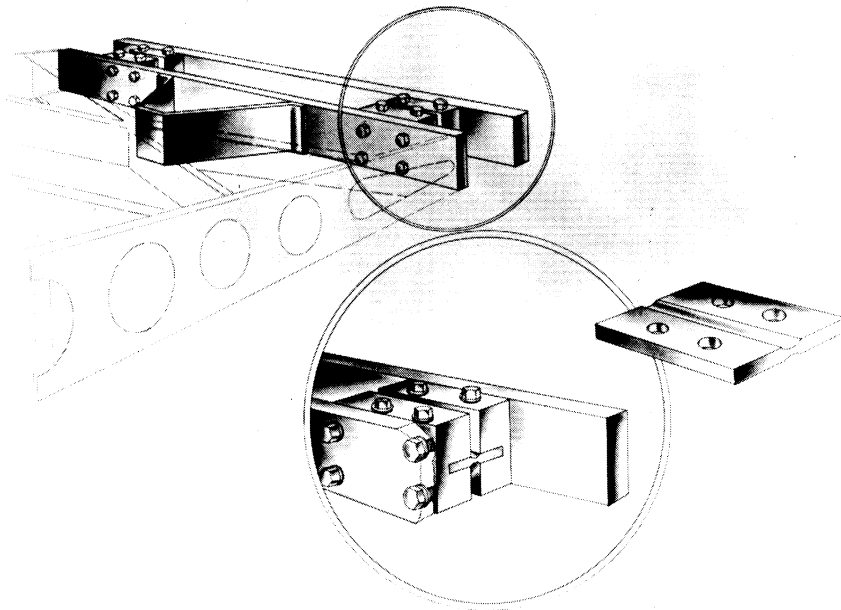
Fig. 2. The modified hinge of the arm for the Ordnance Impact Tester.

The mechanical constants of the movable arm were secured by a series of tests and observations of the Arsenal tester.<sup>13</sup> The assembling of these data led to a more thorough understanding of the machine and later to an important modification of the hinging of the arm, which is shown in Fig. 2.

These mechanical constants were used in a theoretical analysis of the movable arm.<sup>14</sup> This investigation indicated that the upper and lower anvils did not act as short beams in pure compression. It seemed likely that the upper anvil was bent in the vertical plane so that its effective flexibility was due to bending rather than compression. It was calculated that the ef-

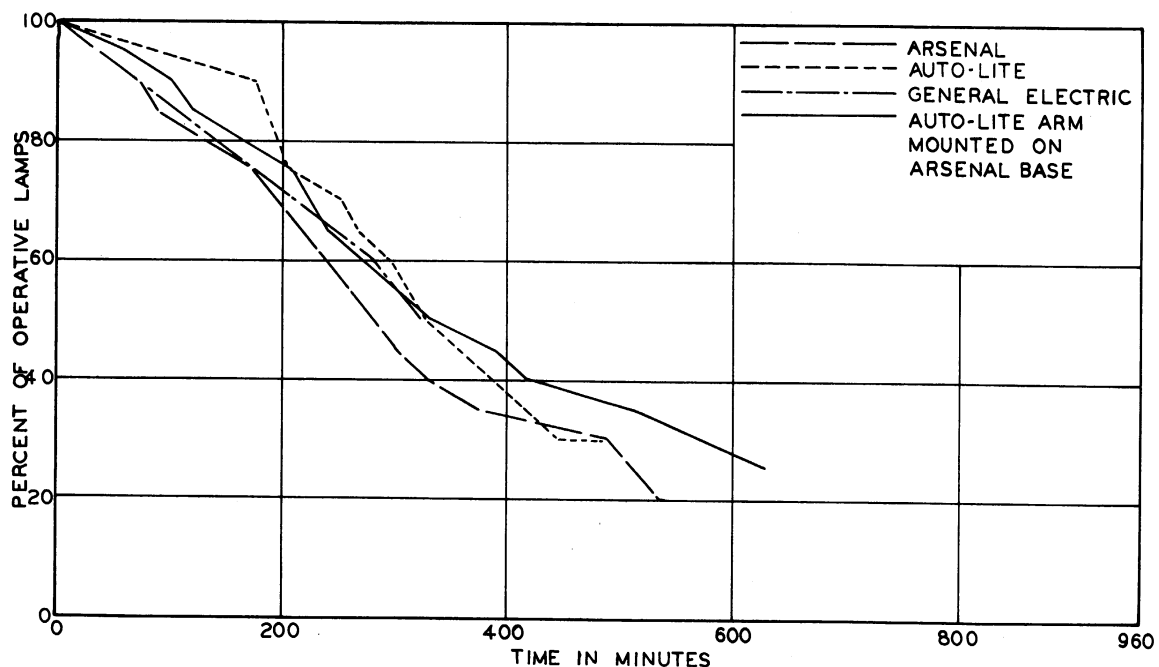
Fig. 3. Comparative mortality curves of the Arsenal, Auto-Lite, and General Electric modified testers.

In the initial effort to obtain evidence as to the comparative performance of the three modified testers, a small quantity of type 1251 lamps, selected from the same manufacturer and the same production lot, was allocated to each tester for a mortality-curve determination. Minor deviations in lamp-voltage regulation and testing procedure undoubtedly existed. Nevertheless the results are close in their agreement, as will be noted in the curves of Fig. 3.

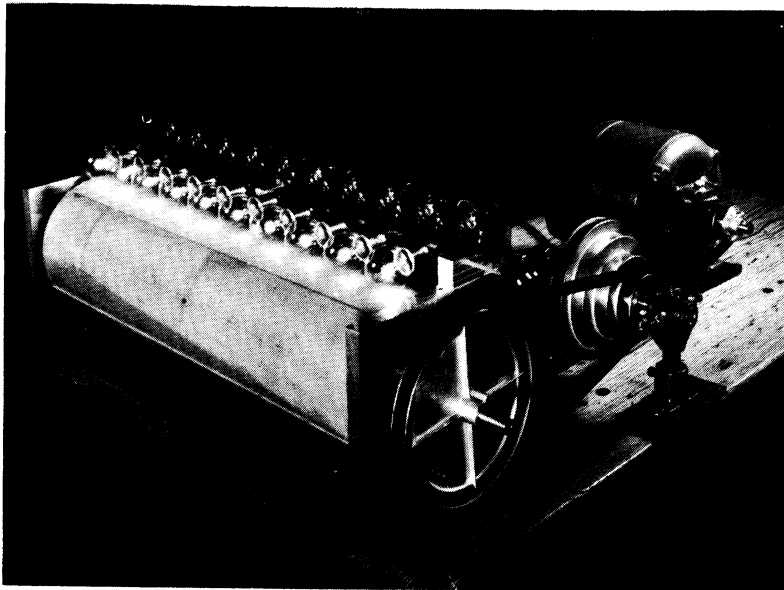
Fig. 4. Principal structural features of the first rotary-drum impact tester.

The present form of the rotary-drum tester has evolved from the pilot model just described. The first enlarged model to embody the essential features of this design is illustrated in Fig. 4. It could accommodate 10 B-12 lamps, but was also designed to test 20 G-6 lamps and proportionate numbers of other sizes. It is interesting to note that the only features of this tester which seemed to require any change after exhaustive tests were the lamp holders.

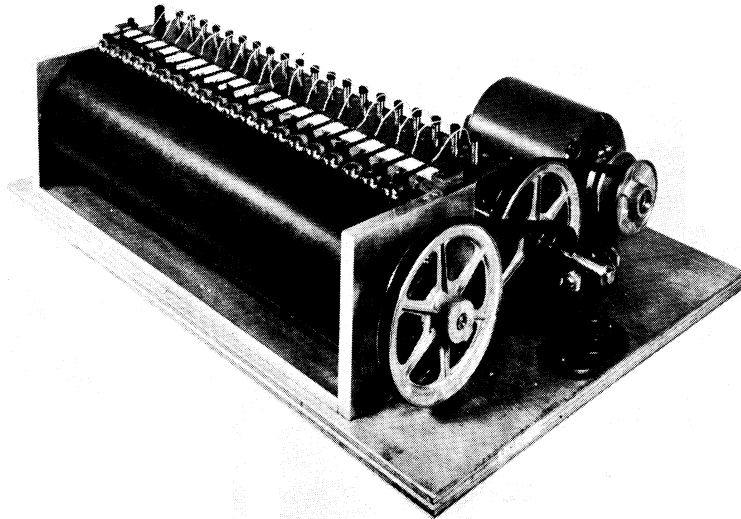
Fig. 5. The modified rotary-drum impact tester with a rack of G-6 lamps mounted for testing.

Figure 5 shows the rotary-drum tester in its present form with a rack of G-6 lamps mounted for testing. It is quite evident from this illustration that the tester components have only been changed slightly to take advantage of design improvements. The machine, which is 30 x 21 inches and weighs 80 pounds, can be easily handled and requires small bench space.

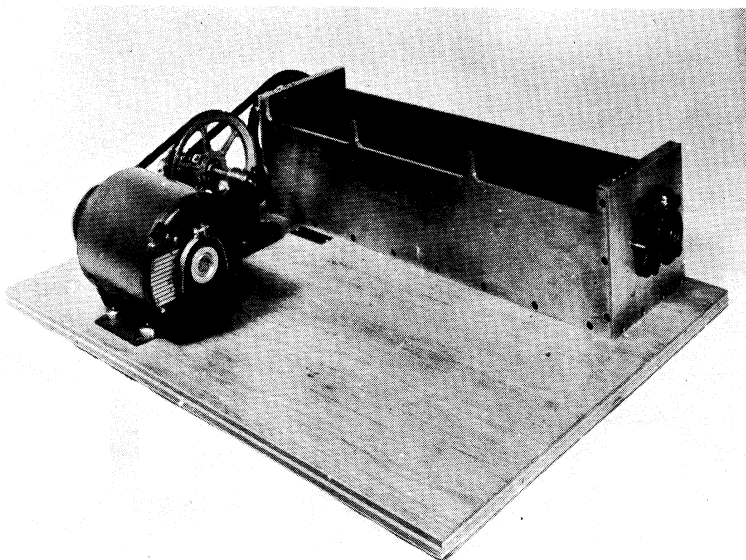
Fig. 6. The basic impact tester showing the drive mechanism, the frame, and the cam.

The basic machine, of which the rear quarter-view is shown in Fig. 6, is composed of three assemblies: the drive mechanism, the frame, and the cam. The purpose of the drive unit and the frame are self-explanatory, but it should be noted that each is composed of materials and parts that can be readily obtained, and can be fabricated with simple basic tools. The dimensional tolerances that are specified for most of the parts are readily obtainable.

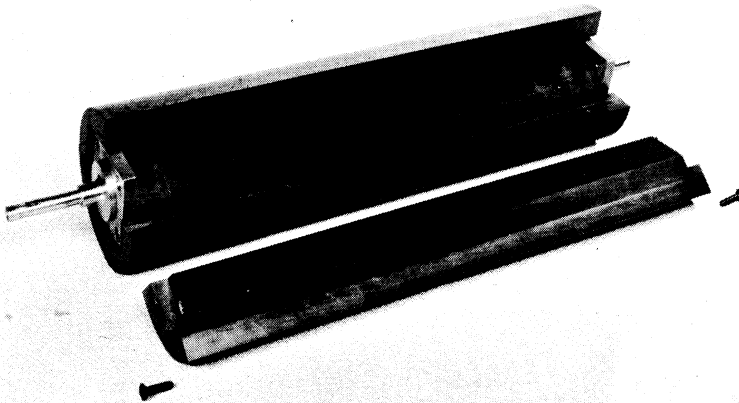
Fig. 7. The cam, partially disassembled, of the impact tester.

The cam, partially disassembled and shown in Fig. 7, has  $21\text{-}13/16$  inches of test length and is unique in that the offset can be adjusted up to approximately  $1/8$  inch by a simple procedure.<sup>23</sup> The length of this cam is adequate to accommodate either 20 G-6 or S-8 lamps and proportionate numbers of larger lamps. The cam material is such that it can be operated in normal environments with little or no dimensional changes due to moisture or heat.

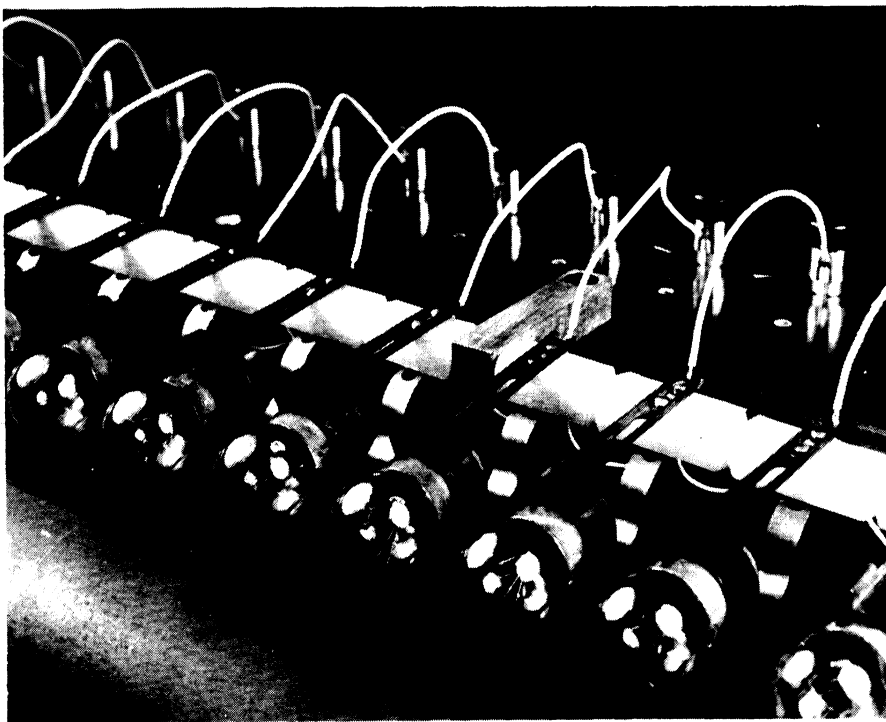
Fig. 8. Method of lamp attachment on the rotary-drum tester.

contact at the rear. Each lamp-holder unit can be removed from the tester frame quickly and easily, which also permits the mounting of different lamp types.

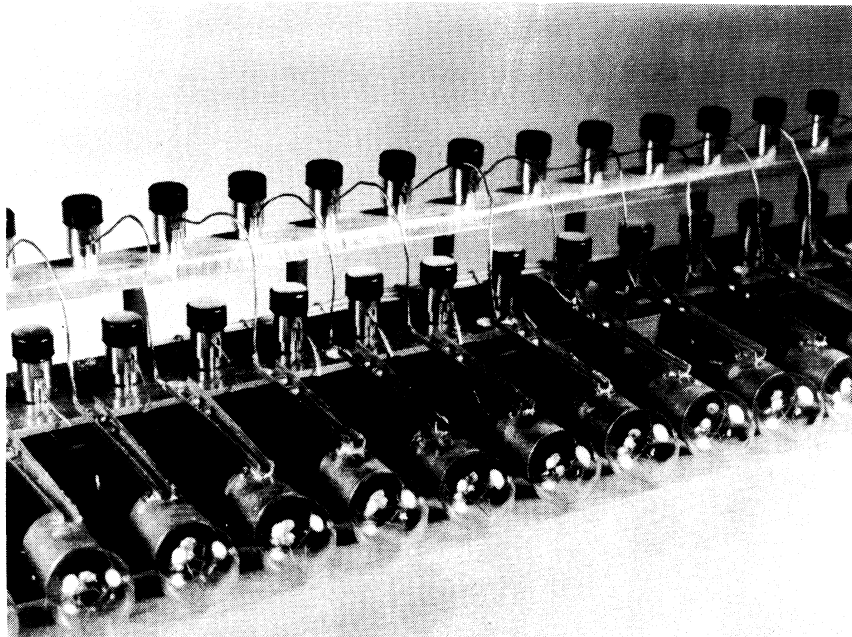
Fig 9. G-6 bulbs soldered to improved lamp holders.

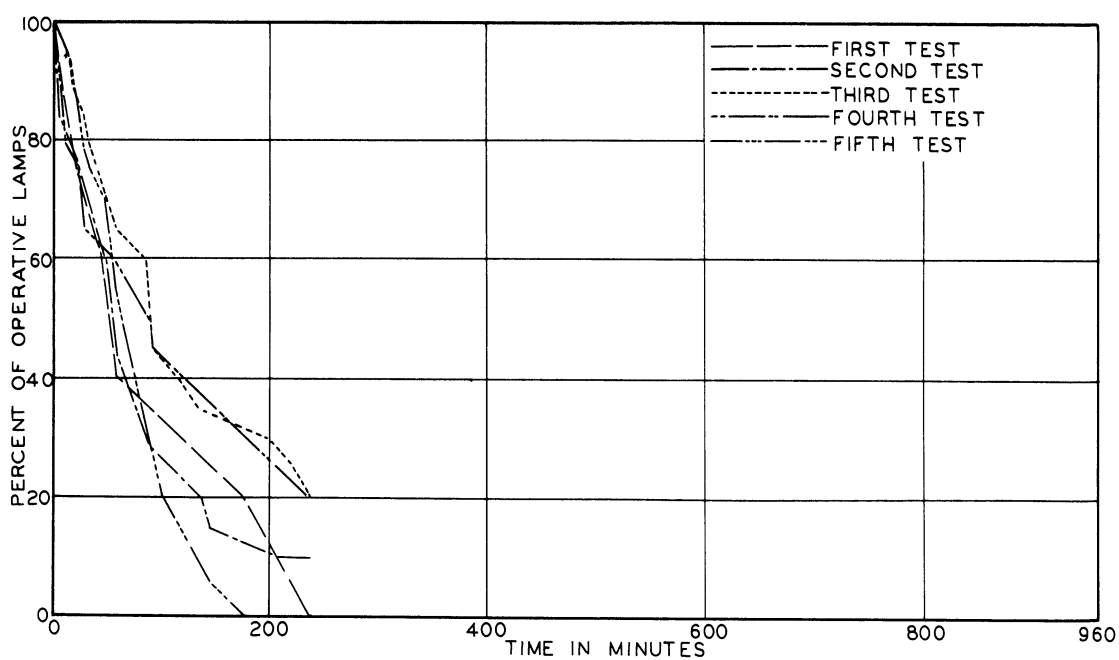
Fig. 10. Five mortality curves of type 1251 lamps tested on the rotary-drum impact tester.

Similar results were experienced with impact tests on a second group of type 1251 lamps obtained from a different manufacturer in which the same test procedure was followed. The spread of the curves was slightly greater, but no marked differences in mortality rate could be observed. In this group, about 25% failed as a result of entangled filament sections, with the rest showing fatigue failure.

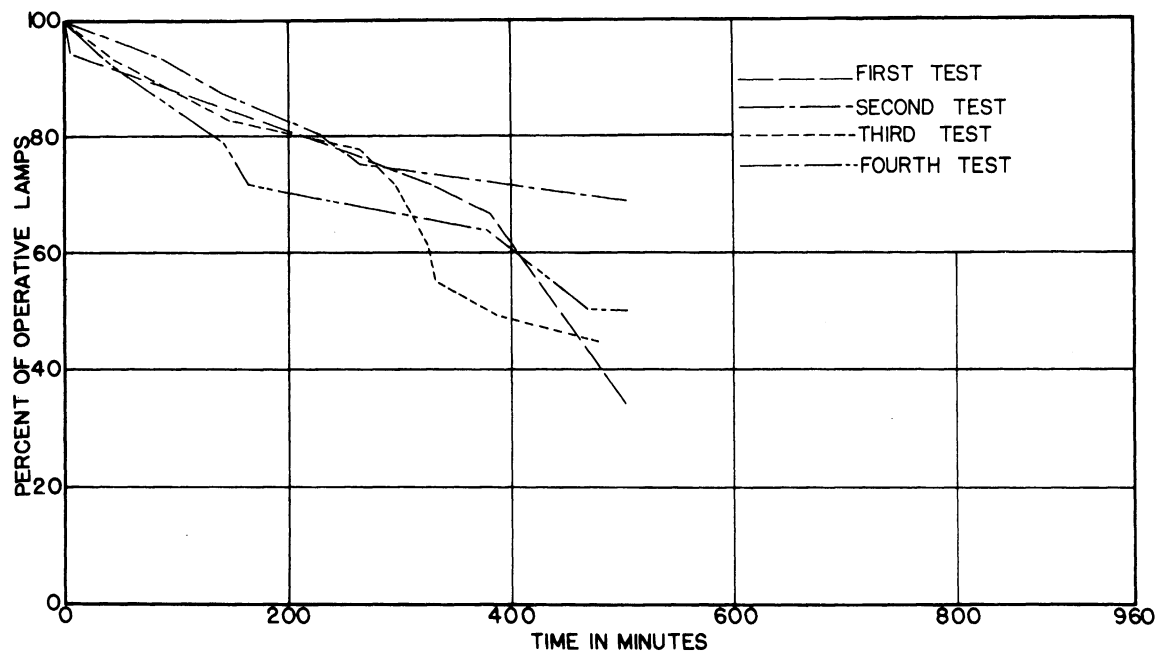
Fig. 11. Four mortality curves of type 1683 lamps of the same origin tested on the rotary-drum impact tester.

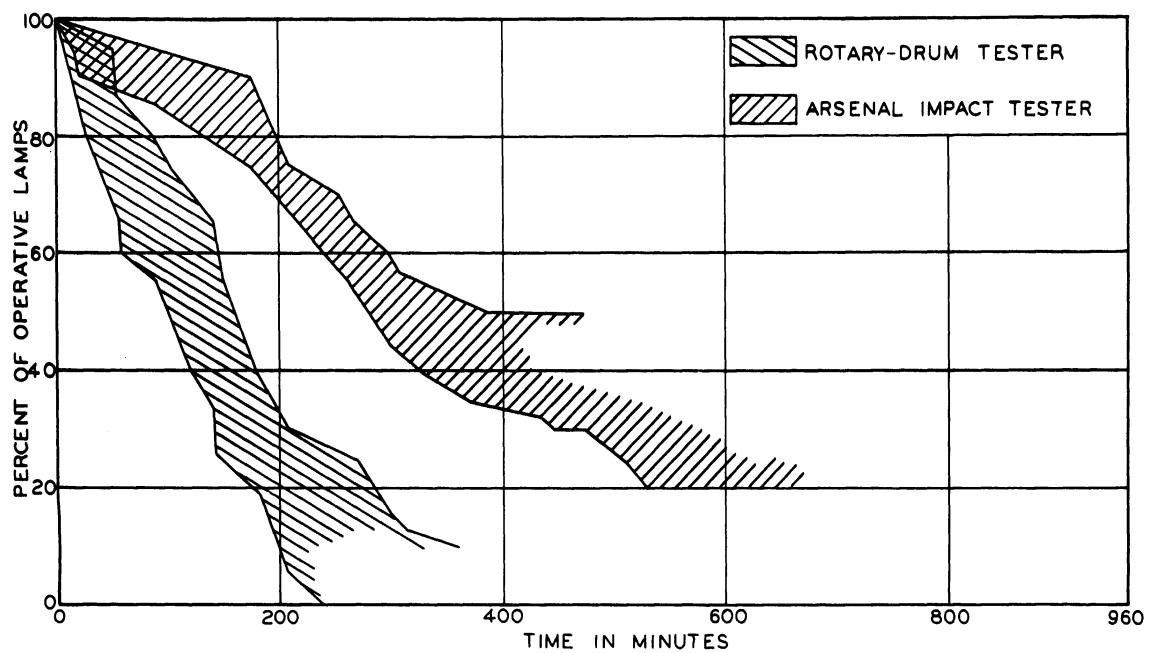
Fig. 12. Comparative ranges of mortality tests completed on the rotary-drum impact tester and the Arsenal impact tester using five racks of type 1251 lamps for each grouping.

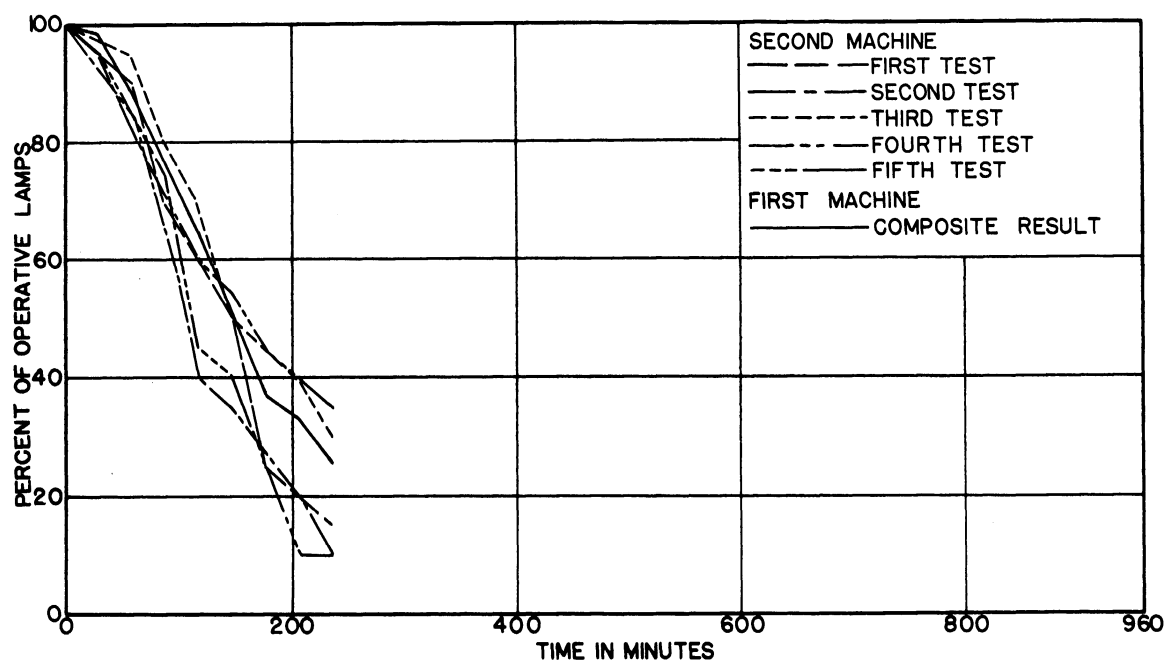
Fig. 13. Mortality results of type 1251 lamps from the second impact tester compared to the composite result of equal tests performed on the original machine.

With the experience of one machine indicating consistent and reliable behavior, it was determined, therefore, to build a second machine for purposes of comparison. The original machine was duplicated except for minor structural changes that increased the available test capacity.<sup>28</sup> After this machine was assembled and inspected, preparations were made for a series of mortality tests to be conducted in accord with past tests. The results of five such tests, using type 1251 lamps, are compared in Fig. 13, with a com-

posite curve obtained from data taken on the original machine. It is quite evident, on the basis of this limited comparison, that consistency and good correlation was secured. When the composite results from both testers were compared, the mortality rate for the new machine was consistently higher by a very slight amount. It is not unrealistic to think that if additional tests were completed, this relationship could easily equalize or reverse.

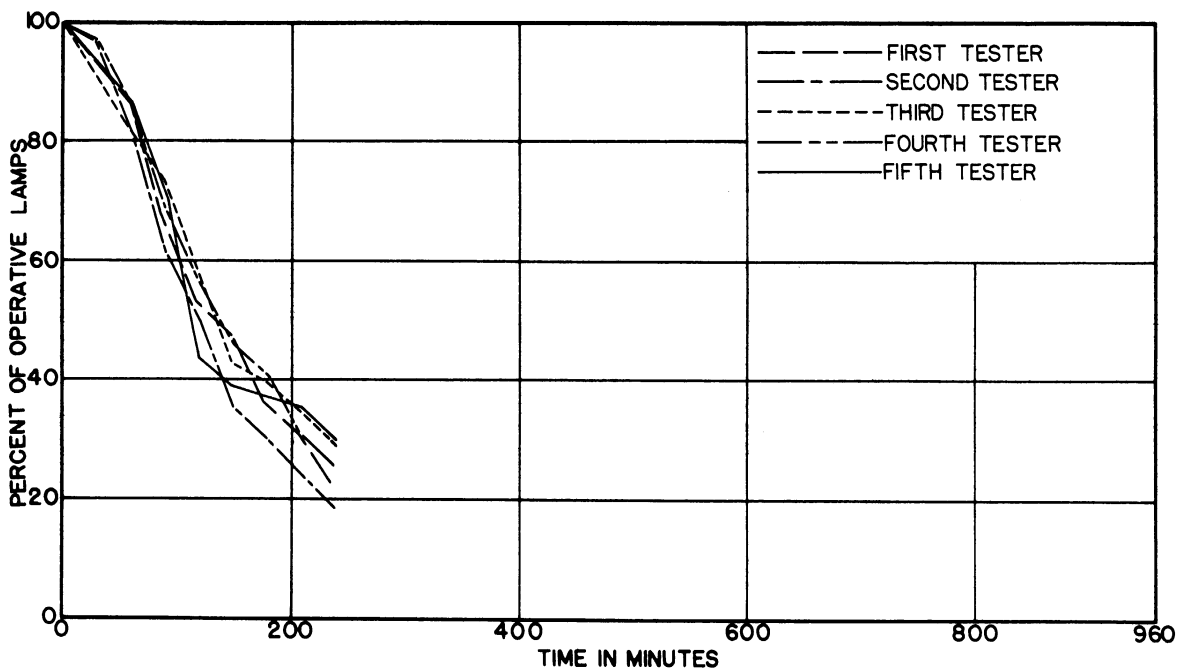
Fig. 14. Comparative mortality results of the five rotary-drum testers evaluated by the project.

Figure 14 shows the cumulative mortality results of each tester. This distribution indicates that all five machines gave very comparable results for the limited number of mortality tests (a total of 12 tests for the five machines).

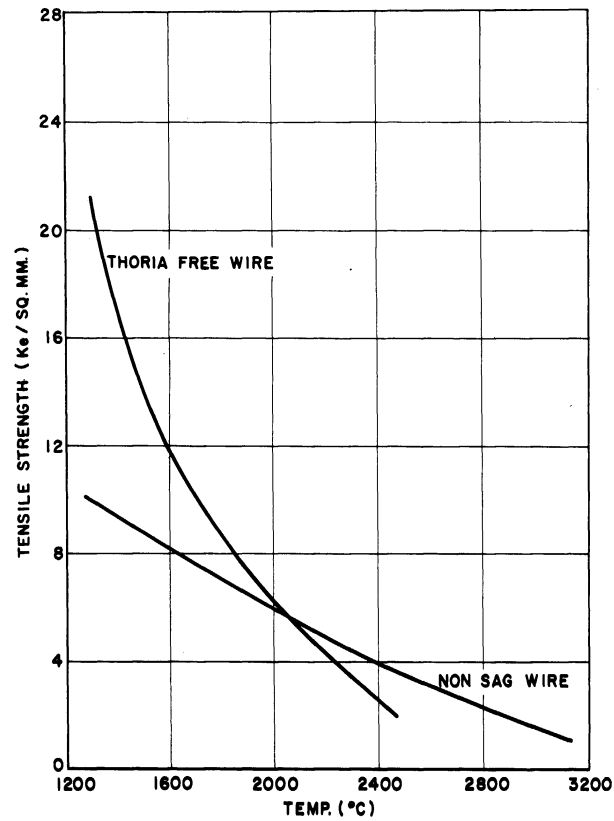
Fig. 15. The tensile strength of thoria free and nonsag tungsten wire as a function of temperature.

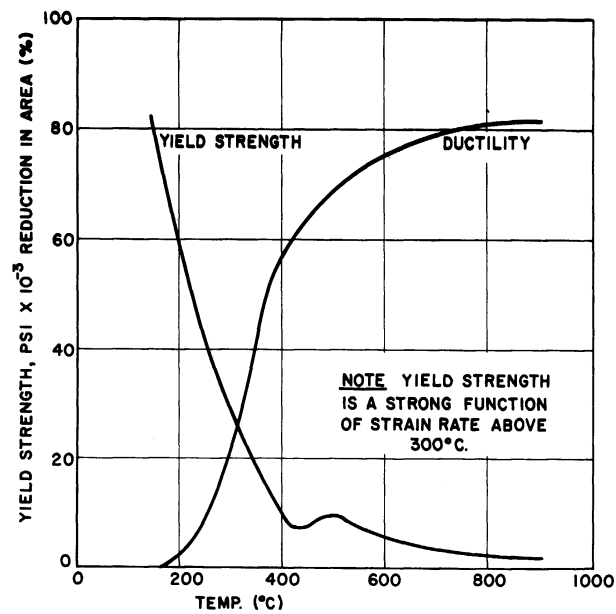
Fig. 16. The yield strength and ductility of tungsten wire as a function of temperature.

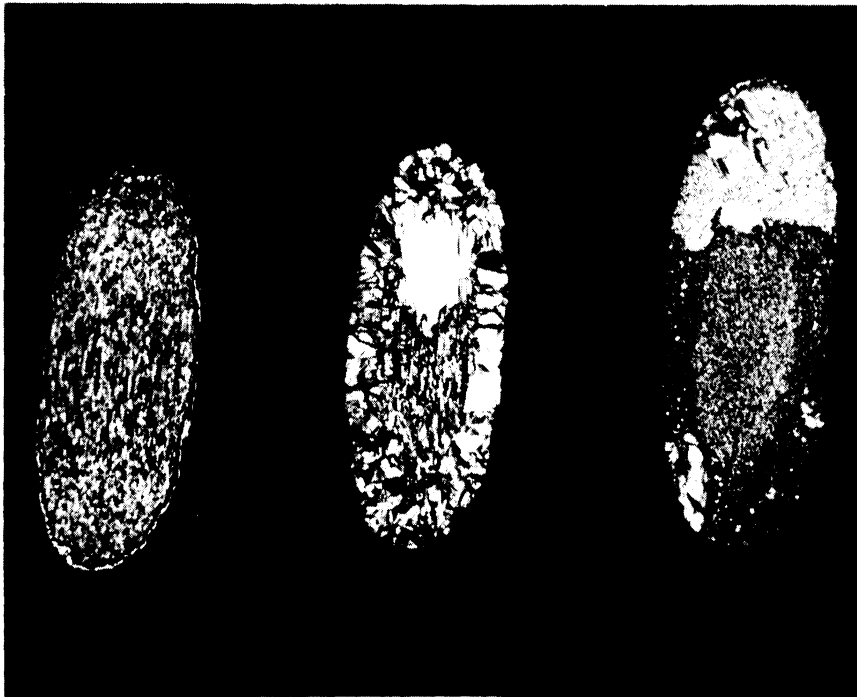
Fig. 17. Three successive turns of a filament showing cold-worked, fine-grained, and coarse-grained structures (250X).

The tungsten in a lamp filament is not structurally homogeneous after it has once been burned. When a current is passed through the filament, there is a temperature distribution set up due to the cooling effect of the leads and/or the leg inserts (spuds). This temperature distribution is reflected by the structures of the various portions of the filament. Figure 17 shows the microstructures that exist near the point of filament attachment of a coiled-coil filament. In this figure the turn nearest the attachment point shows a cold-worked structure, and moving out into the incandescent portion of the filament there is a fine-grained zone followed by a coarse-grained region.

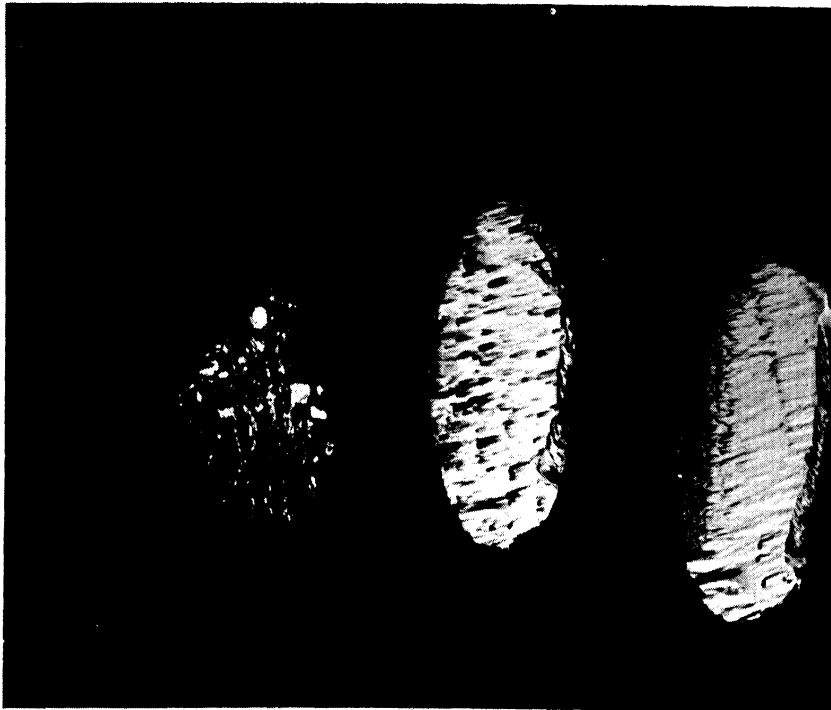
Fig. 18. Fracture in sample 921-2 (250X).

Fractures generally occur during the cooling period just after operation and when the filament is being excited by some physical force. These fractures appear within one or two primary turns of the leg insert in the recrystallized fine-grained structure. An example of such a fracture is shown in Fig. 18.

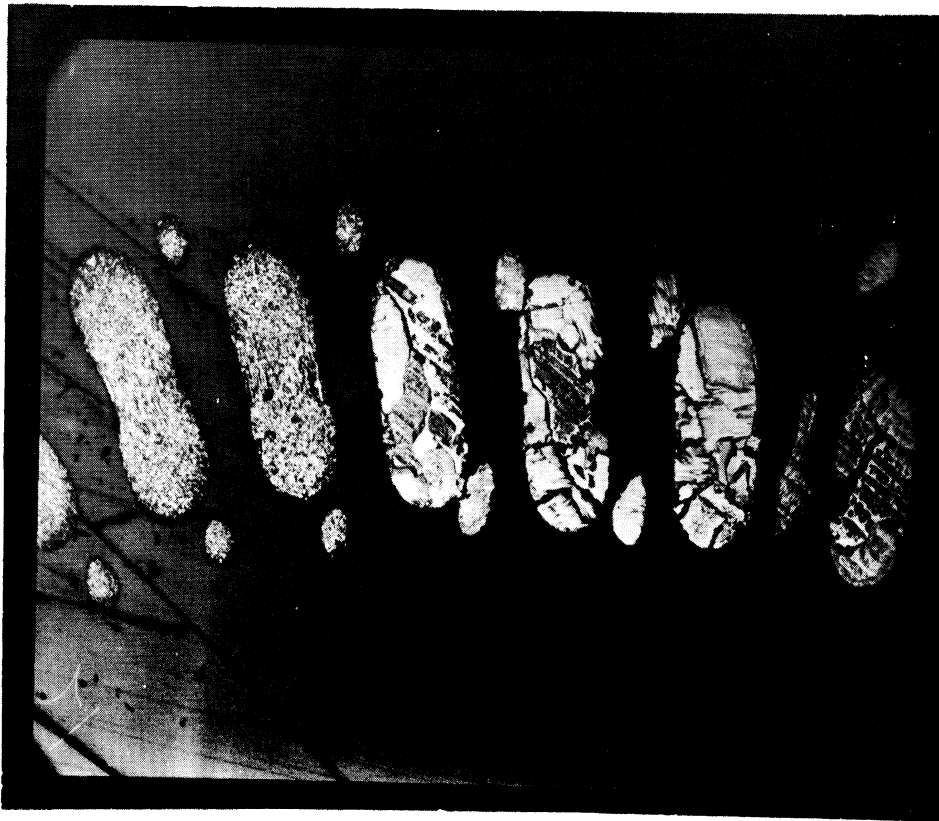
Fig. 19. Primary coil surrounded by an auxiliary coil.

A second group of type 2416 was provided, by another manufacturer, with short auxiliary coils slipped over the primary ends of the filament. Careful examination of these lamps showed that the physical structure of the filaments was apparently identical to the standard production type, except for the addition of slip-on coils. The slip-on coils were composed of

tungsten wire with a diameter of about 75% of the filament-wire diameter, and extending for distances of from 3 to 7 turns beyond the weld at the point of attachment to the leads.

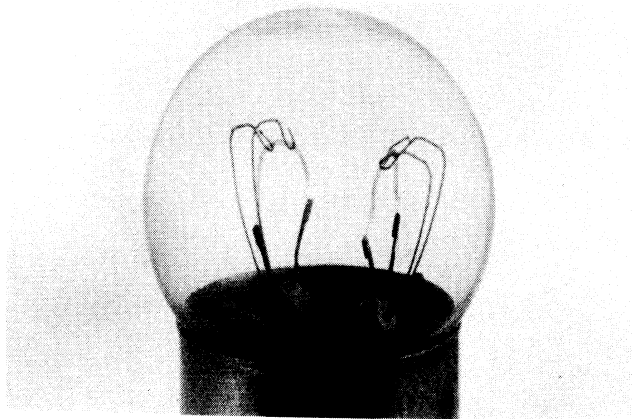
Fig. 20. Modified 1251 lamp with double-anchored filaments.

The lot of lamps was divided into three equal groups for evaluation on a rotary-drum tester. When the mortality curves were compared to a previous range established by a series of tests on a rotary-drum tester using 1251 lamps supplied by the same manufacturer, it was quite evident that the life expectancy of these lamps had been increased by a factor of from 2 to 3.

The failure schedules indicated almost a complete absence of hot failures during these tests. Undoubtedly the two anchors controlled the filaments so effectively that no shorting of the filaments could occur. Although no major entanglements occurred, in many cases the coil was stretched and distorted near the supports so that some individual turns did short. About 75% of the failures occurred at or very near the anchor which suggests a sawing action of the anchor on the filament. The remaining fractures were located centrally on one of the three segments.

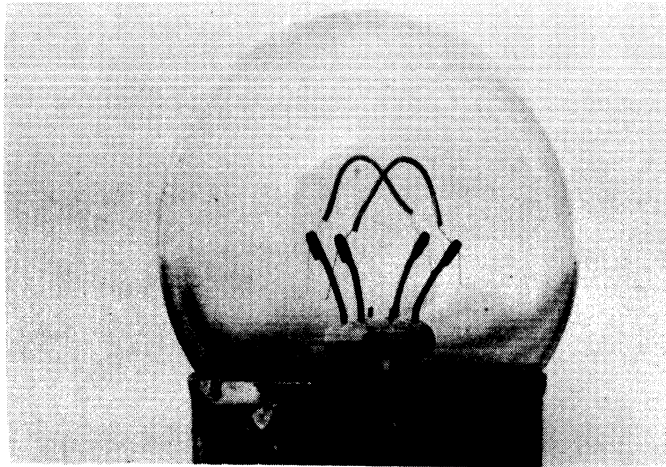
Fig. 21. Modified 1251 lamp with an unsupported filament.

The failure schedules of these four tests revealed some rather inconsistent facts. In the first test, seven of the nine failures occurred during the hot phase of the cycle, while in the third test only one of the eight failures occurred during this period. The filaments of these hot failures had few if any of the characteristics of previous hot failures of the other tests (i.e., filament entanglement and shorts). A typical hot failure had the break at a point between the lead wire and the coil and the average cold failure had the break in the coiled section of the filament.

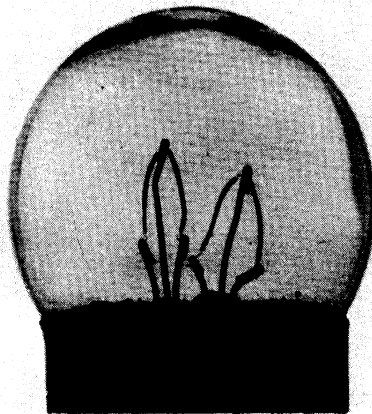
Fig. 22. Modified 1251 lamp with a rigid support clamped to a two-segment gapped filament.

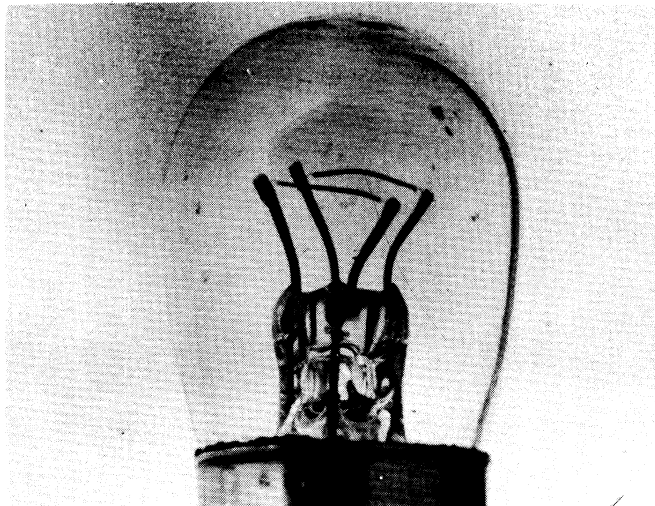
Fig. 23. A lamp with four-wire, flange-stem construction mounted in a B-6 bulb with unsupported 1251 filaments.

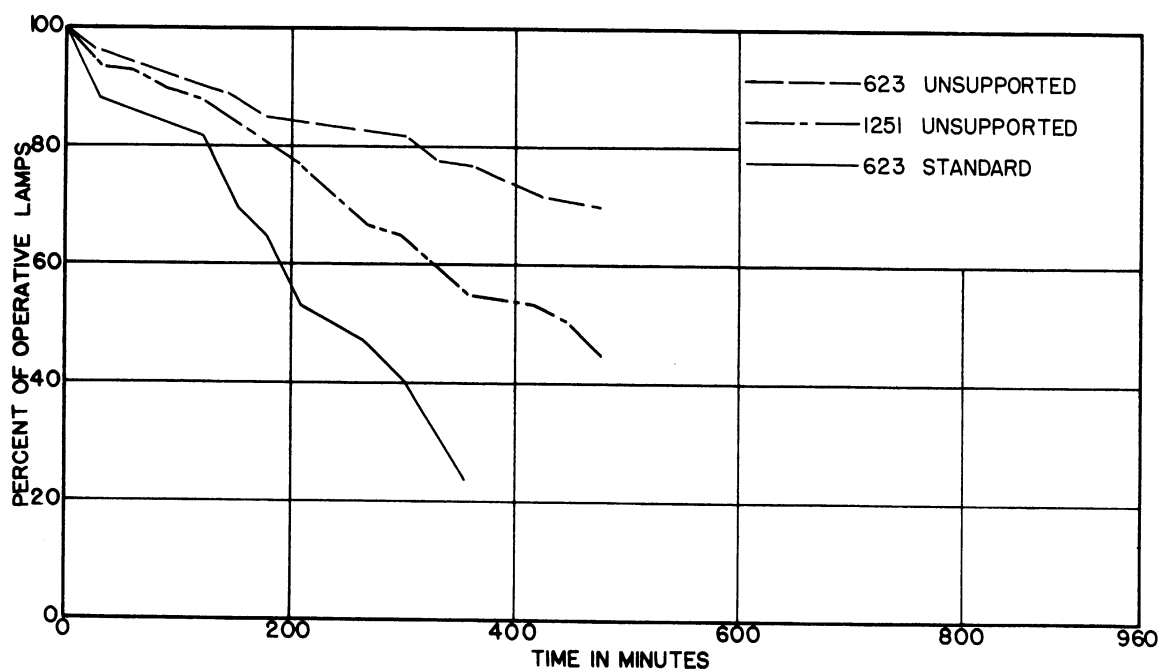
Fig. 24. Comparative mortality results of type 623 and 1251 lamps with unsupported filament and type 623 standard lamps tested equally on the rotary-drum impact tester.

The possibility of substituting this lamp for the regular type 1251 in extremely rough service applications has been suggested.

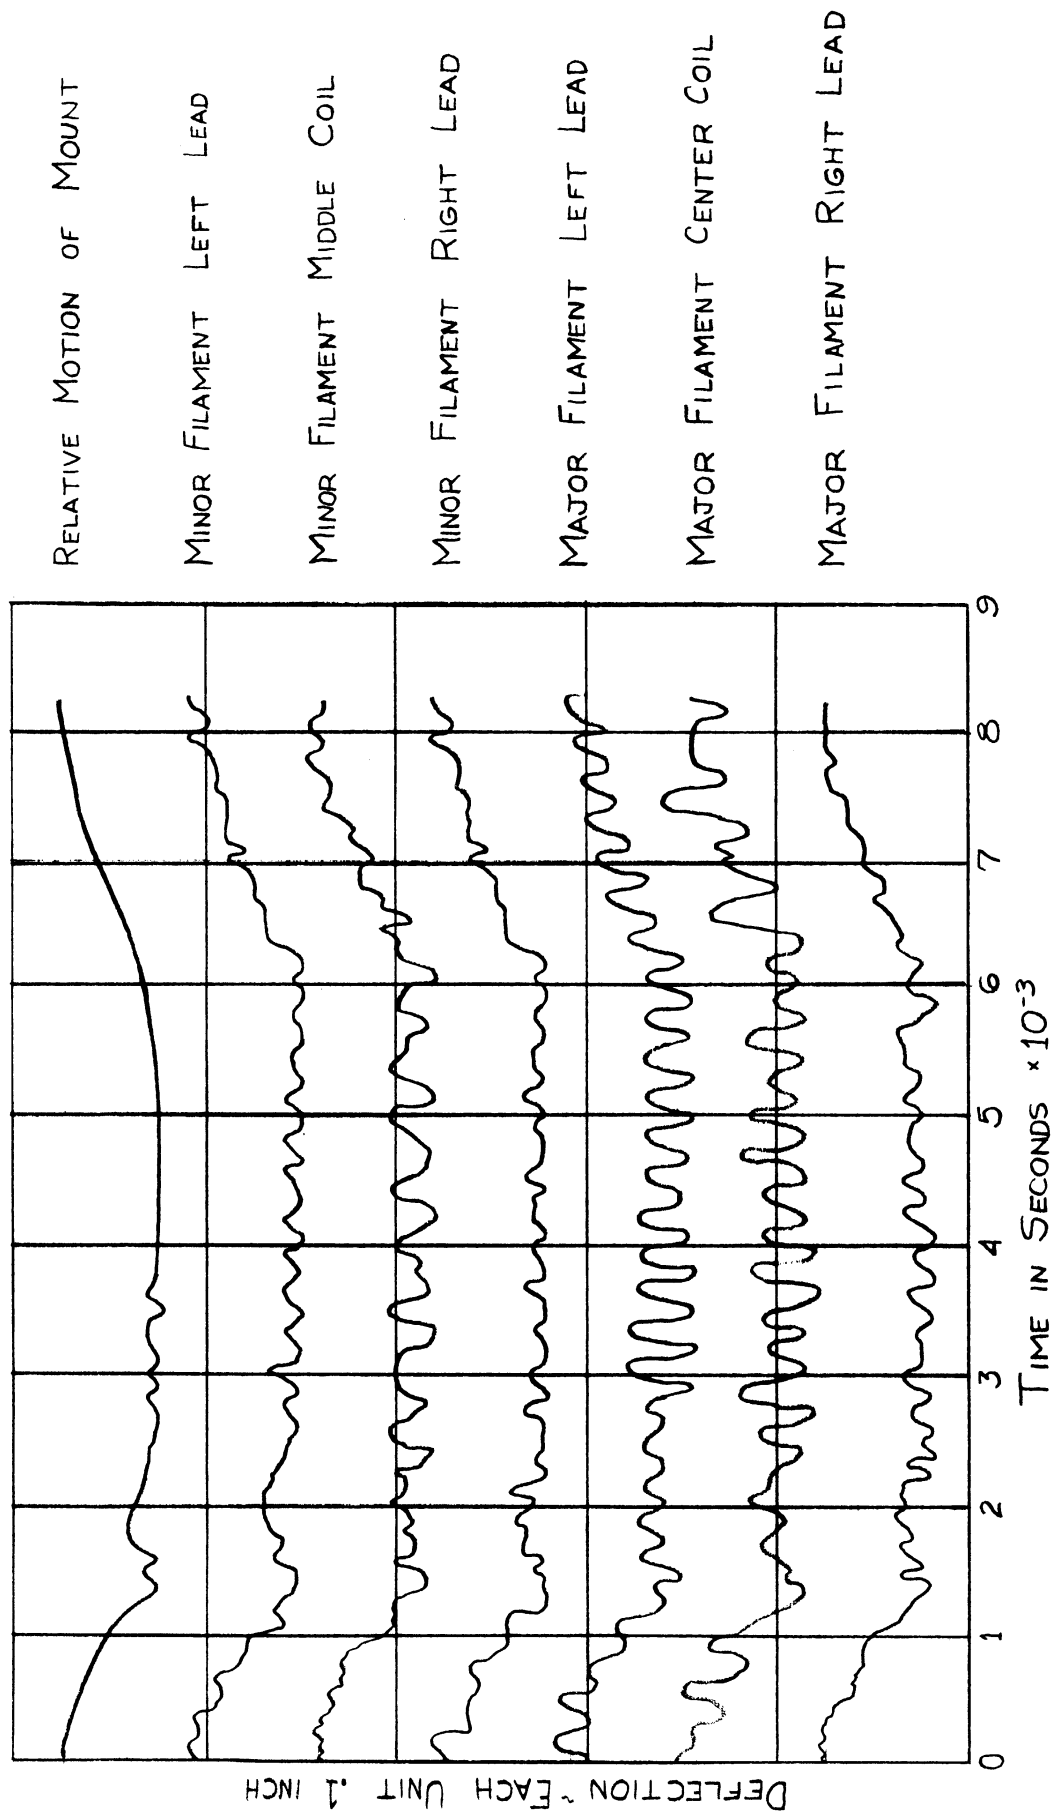
Fig. 25. The relative motion of various sections of the filament mount of an all-glass service drive lamp that was excited by impact.

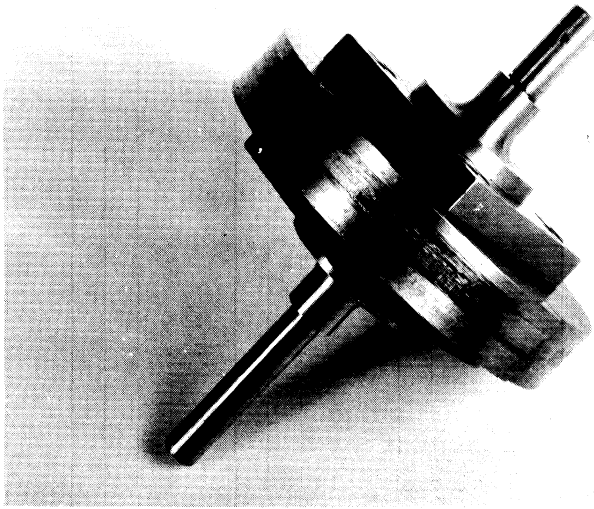
Fig. 26. The steel cam used for the PAR impact test.

1. the lamp did not follow the cam with a regular motion;
2. the lamp dented and scored the cam surface, (see Fig. 26), and
3. the glass envelope tended to grind away at the point of contact.

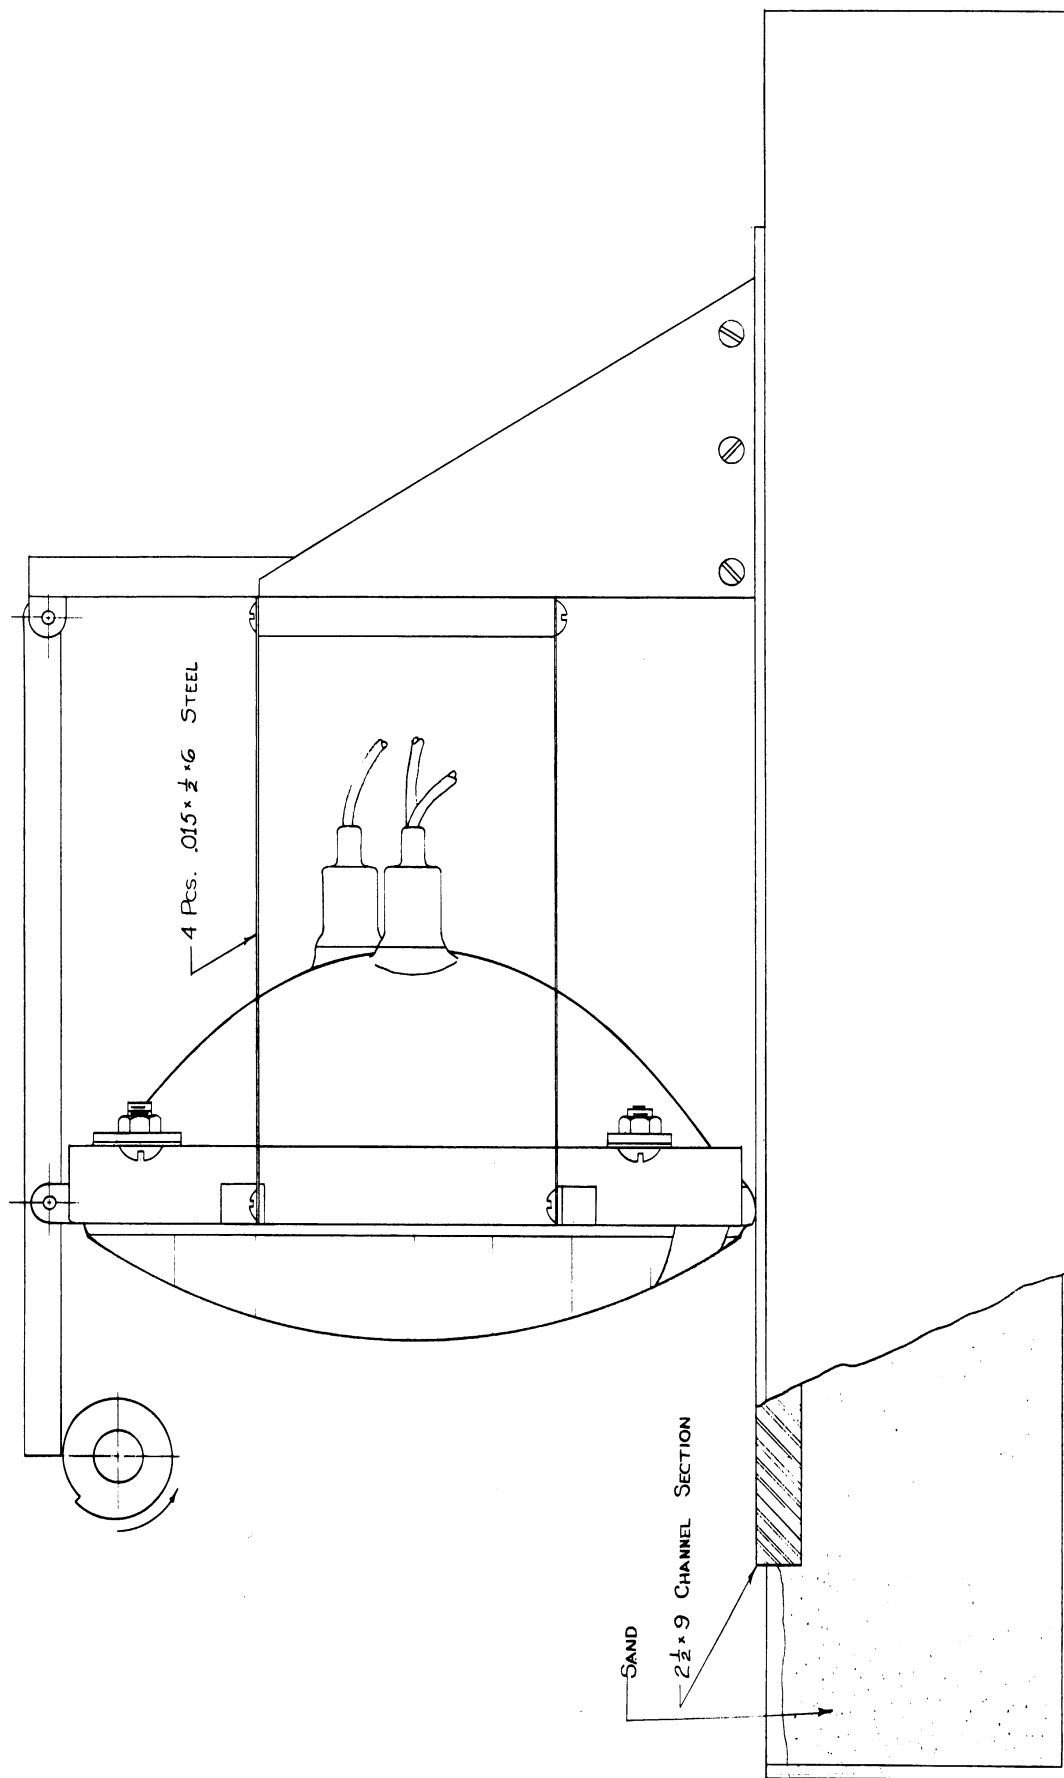
Fig. 27. General arrangement for a simplified impact tester for PAR type lamps.

1. The lamp must be suspended with the minimum amount of restraint in a position normal to its regular operation.
2. The lamp must be lifted repeatedly and allowed to fall so that the envelope strikes a relatively inelastic surface.
3. Means must be provided for adjustment of the drop height and the frequency of impact.
4. The device must be simple and compact to permit the building and operation of multiple test units.

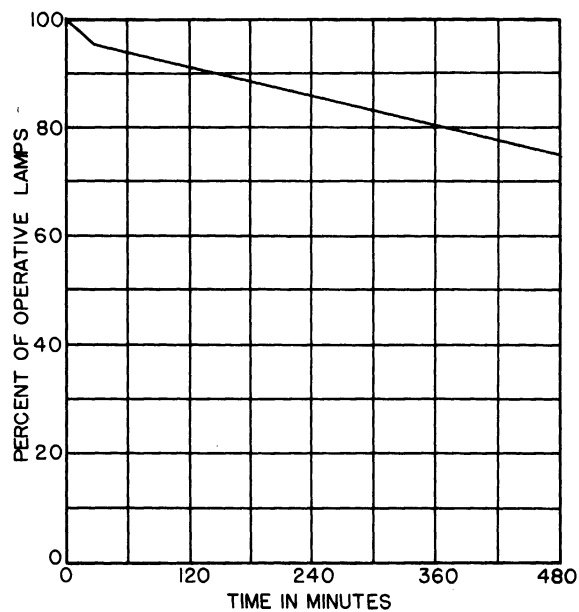
Fig. 28. Minimum mortality curve for lamps operated on the rotary-drum impact tester.
