THE UNIVERSITY OF MICHIGAN RESEARCH INSTITUTE  
ANN ARBOR, MICHIGAN

MACHINABILITY EVALUATIONS OF TEN LOTS  
OF  
2011-T3 ALLOY

UMRI Project 2575

REYNOLDS METALS COMPANY  
RICHMOND, VIRGINIA

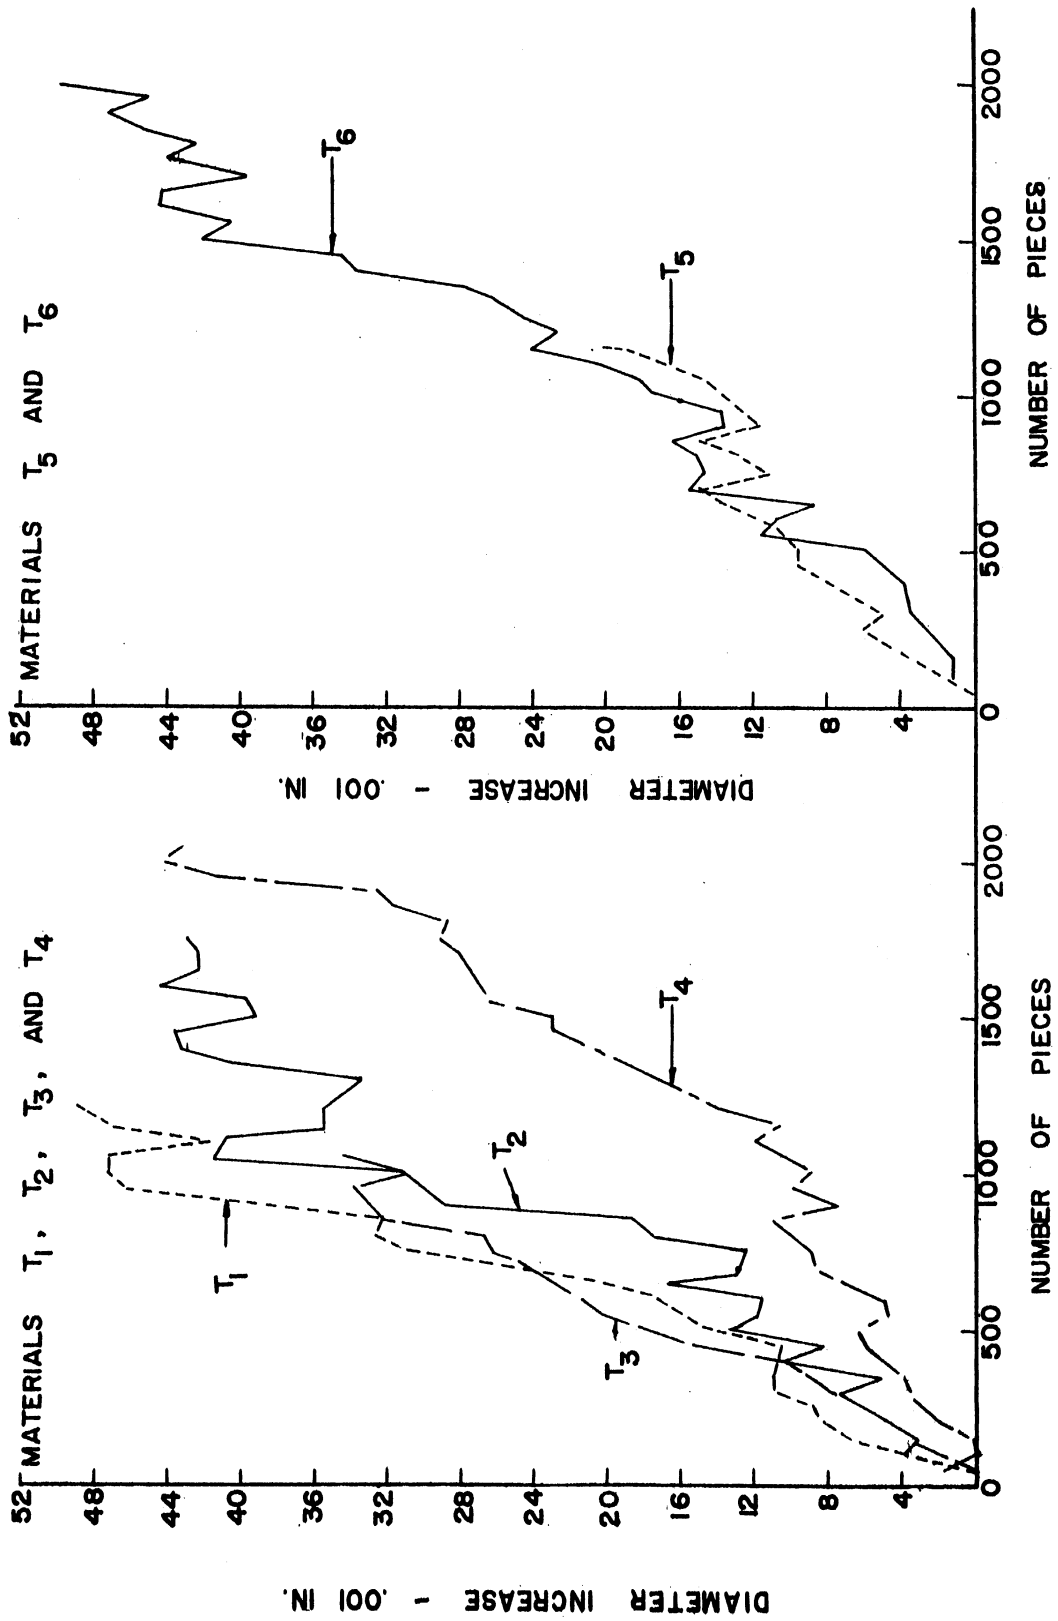
Fig. 9. Heavy-forming diameter variations vs. number of pieces.

Tool wear had much more effect upon dimensional stability and feeding forces. Figures 8 and 9, Figs. 15 and 16, and Tables II and III show these effects.

In general, the greater the tool wear the higher the feeding forces, and the greater the variations in formed diameter. There were, however, some differences in behavior among the various materials. For example, T<sub>6</sub> gave rise to .0084-in. wear on the form tool, requiring a maximum feeding force of 505 lb. Material A, however, required a maximum feeding force of only 180 lb for the same amount of wear, even though the initial (sharp tool) force was 45% higher than the initial force recorded for the T<sub>6</sub> material.

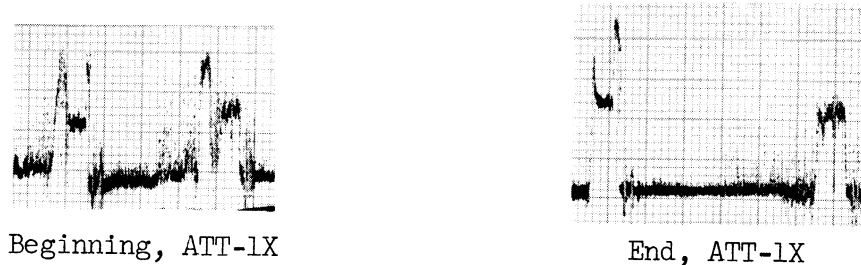
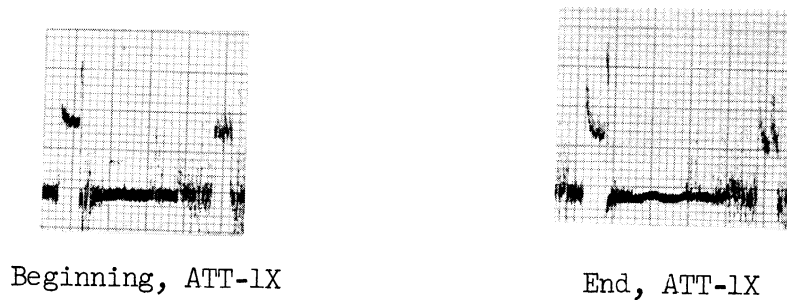
Fig. 25. Light-forming traces of feeding forces on oxide and inner surfaces. Forces are traced from left to right.

Figures 25, 26, and 27 show actual traces of the feeding forces on the turn and form tools, and drilling thrust. They serve to illustrate the changes that take place during a run, as well as the differences in behavior among the various materials. The effects of surface oxides can also be noted, particularly in the light-forming operation.

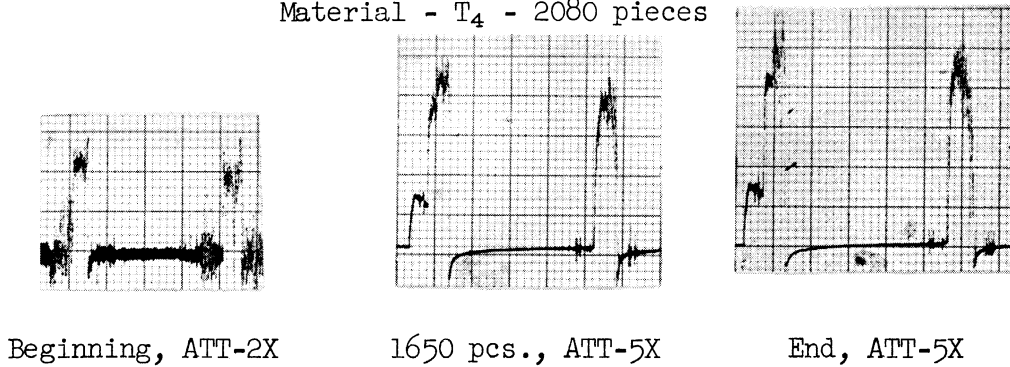
Fig. 26. Heavy-forming traces of feeding forces. Forces are traced from left to right.
