UMTRI-2007-4

**Vibration Transmission from Road Surface
Features – Vehicle Measurement and Detection**

Technical Report

**The University of Michigan
Transportation Research Institute (UMTRI)
2901 Baxter Road, Ann Arbor, MI 48109-2150**

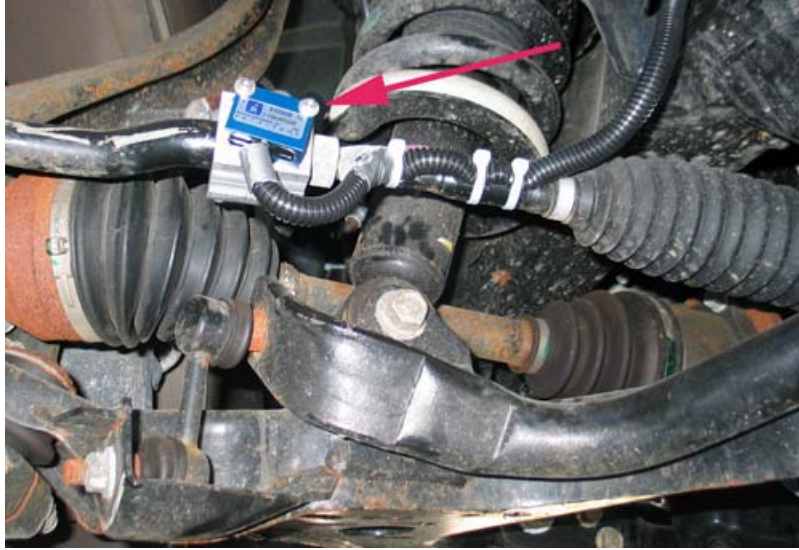
The intent behind installing these accelerometers was to record and analyze the extent of which the significantly different tire-road conditions (one side on the rumble strip while the other side on the pavement) affect steering vibrations. Figure 2.2 shows the accelerometer installation to the right-side of the steering tie rod.

Figure 2.2. Accelerometer installation at the right-side of the steering tie rod

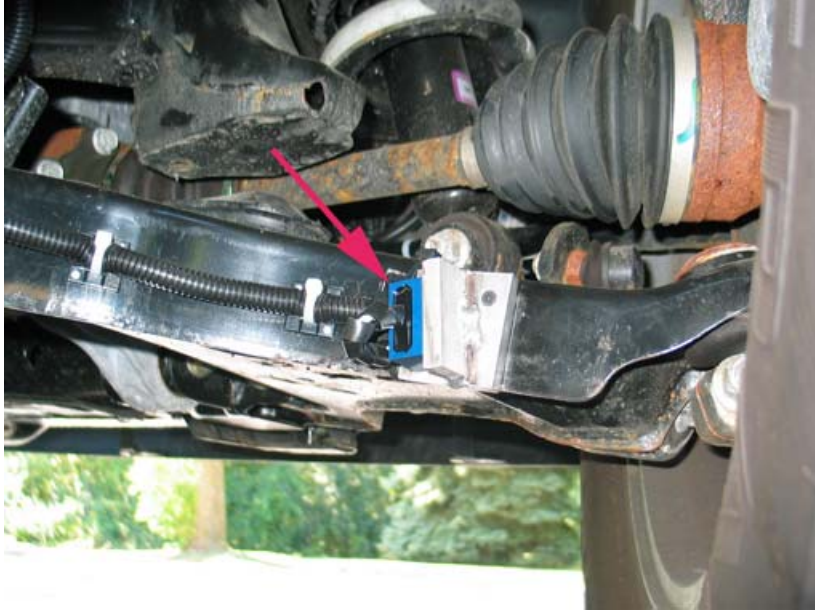
Figure 2.4. Right-front accelerometer installation (unsprung-mass data)

The figures on the following pages show typical installation of accelerometers for recording sprung- and unsprung-mass vibration data.

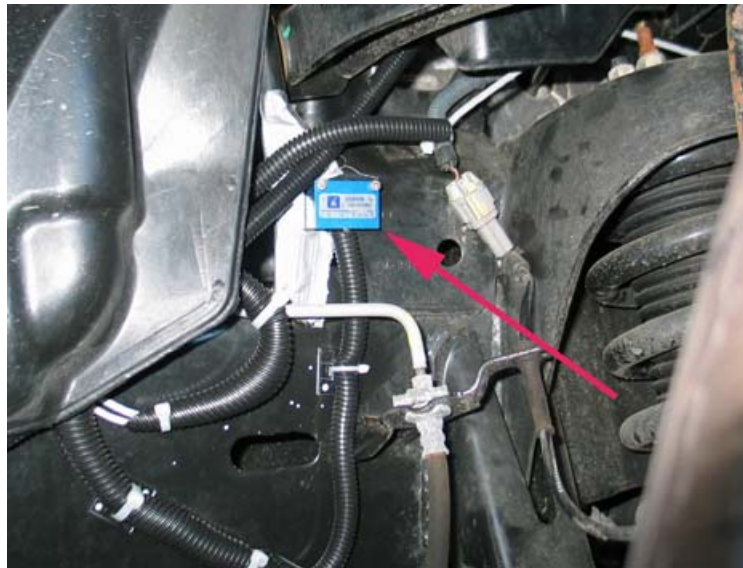
Figure 2.5. Right-front accelerometer installation (sprung-mass data)

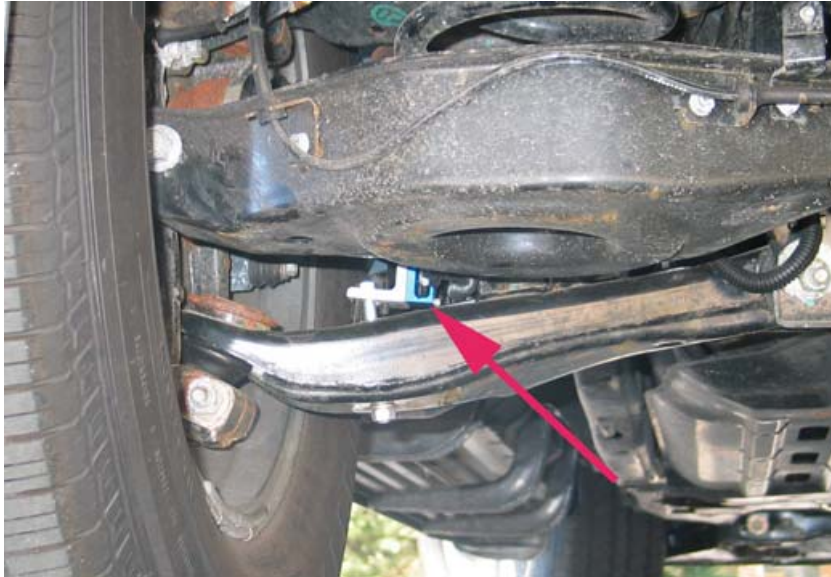
Figure 2.6. Left-rear accelerometer installation (unsprung-mass data)

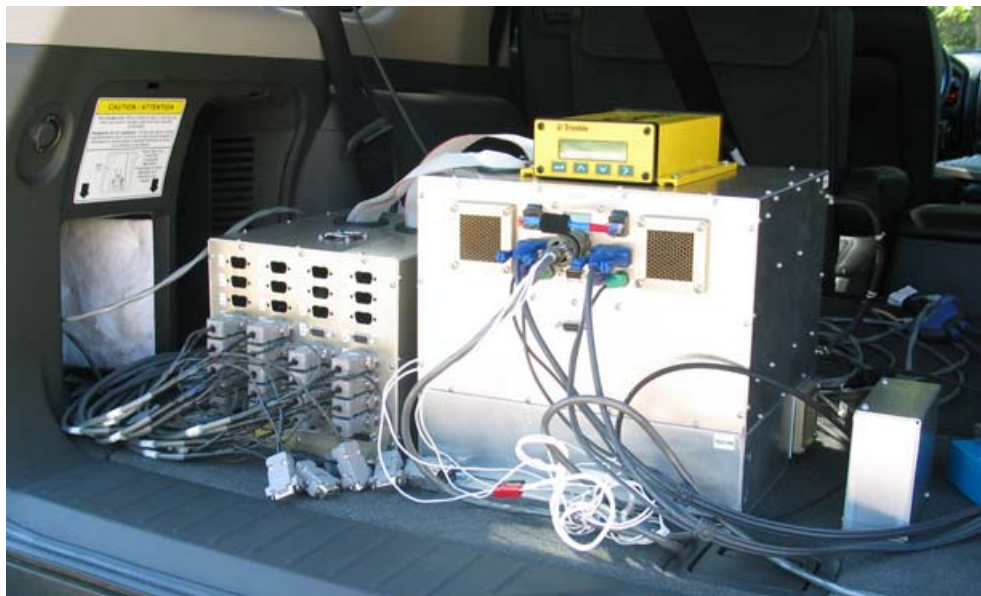
The ten accelerometers were wired to the Data Acquisition System (DAS), mounted at the rear of the vehicle (see figure 2.7). Accelerometers data were recorded at 1000 Hz.

Figure 2.7. Data acquisition system

- GPS data (speed, location, etc.) The GPS unit is shown in figure 2.7 (the yellow box on top of the DAS).

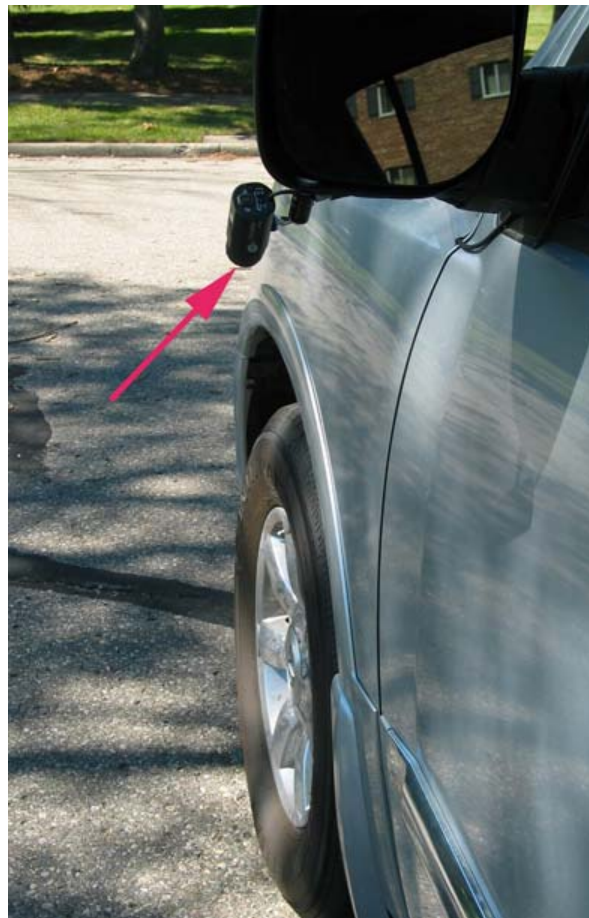
- vehicle longitudinal acceleration
- brake pedal state
- drive mode (4x4/4x2)
- Video –
 - Left- or right-side road camera looking at the contact area between the front wheel and the pavement (side is switched in preparation to each specific test, an image from a road camera is shown further down in this document). Figure 2.8 shows the left-side camera installation.

Figure 2.8. Left-side camera

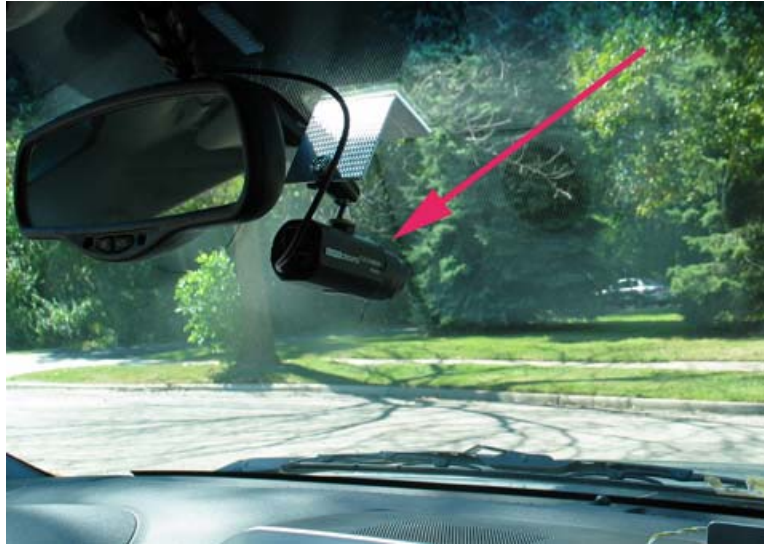
- Forward-looking camera to provide contextual information about the test (an image from this camera is shown further down in this document). Figure 2.9 shows the camera installation.

Figure 2.9. Forward-looking camera

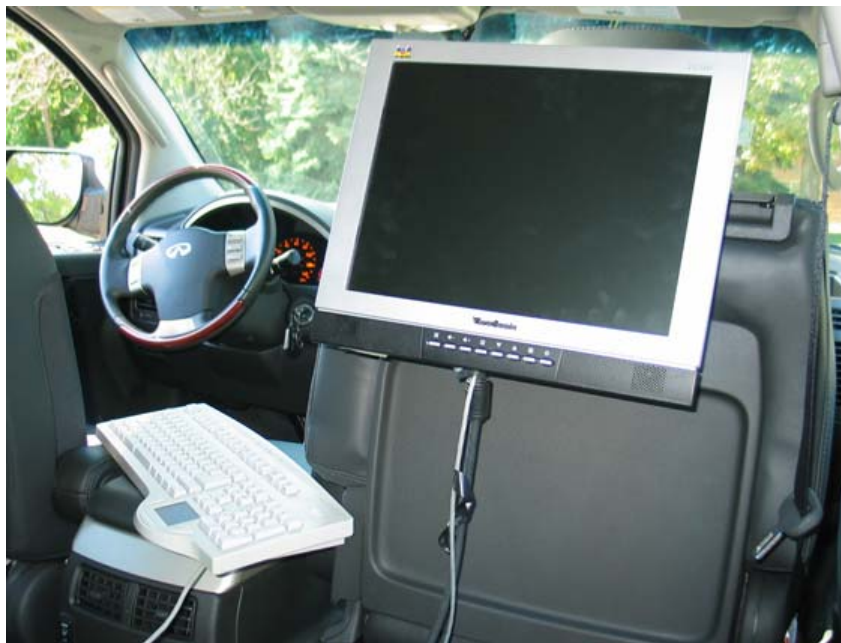
Controlling the test was done from a “command station” (see figure 2.10). This command station is comprised of a keyboard/mouse unit, and a monitor that is attached to the back of the passenger seat. The operator initializes and stops the data-collection process while seated in the back.

Figure 2.10. Command station and interface

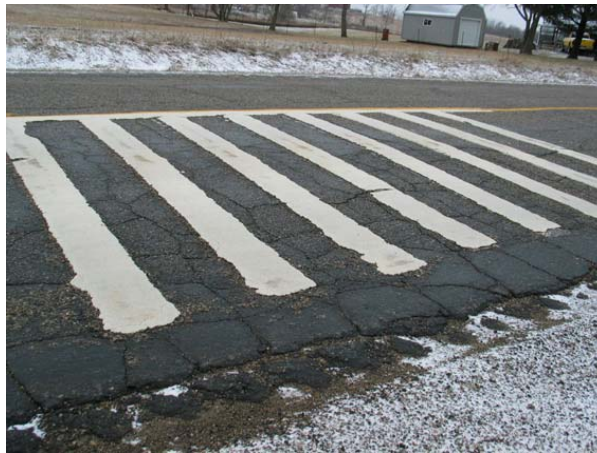
Raised-paint strips: commonly used across the lane as a warning to the driver of an approaching stop sign and/or intersection. It usually spans about 15 ft.

Figure 3.1. Raised-paint rumble strips

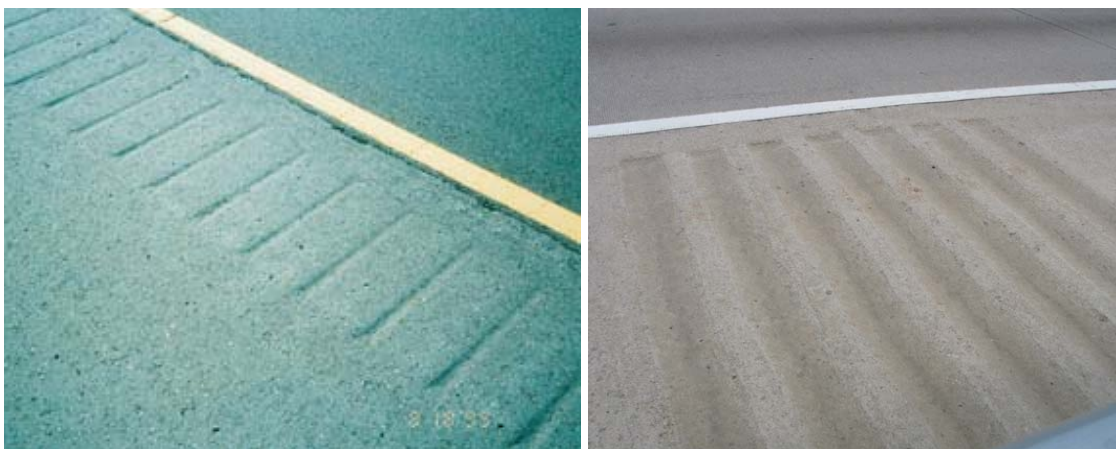
Rolled-in rumble strips: these rumble strips are typically generated by pressing depressions in hot asphalt shoulders or concrete during construction and reconstruction projects.

Figure 3.2. Rolled-in rumble strips (on the right: an intermittent type on concrete)

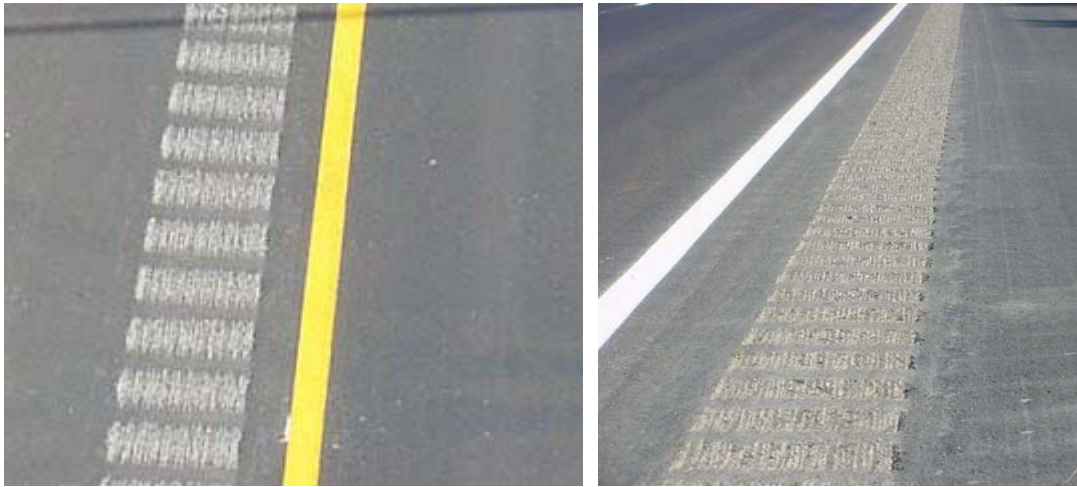
Milled-in rumble strips: the milled rumble strips are deeper and wider than rolled rumble strips, and they can be installed on new or existing pavements and on both asphalt or concrete shoulders.

Figure 3.3. Milled-in rumble strips

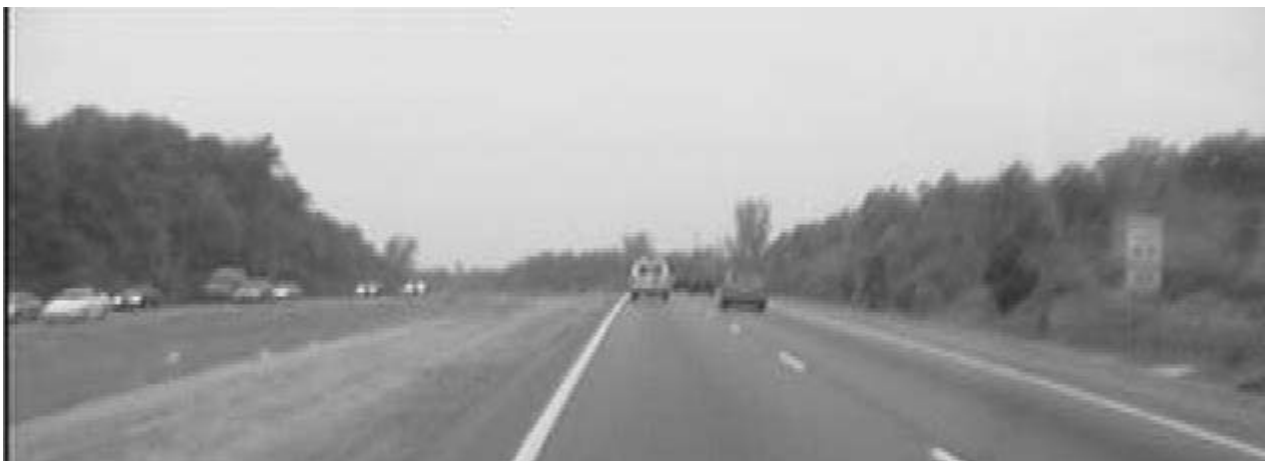
Figure 3.4 (a). Snapshot from forward-scene video

The complete list of all the tests that were performed is provided in Appendix A. This section provides a detailed description of an example test scenario and its results. Here the vehicle was driven in the left lane, and then steered off to the left past the lane marker and onto the rumble strip. Figure 3.4(a) is a snapshot image from the forward-scene video, and figure 3.4(b) is an image from the left-side road video, depicting the wheel as it crosses the lane marker and before it gets on the rumble strip.

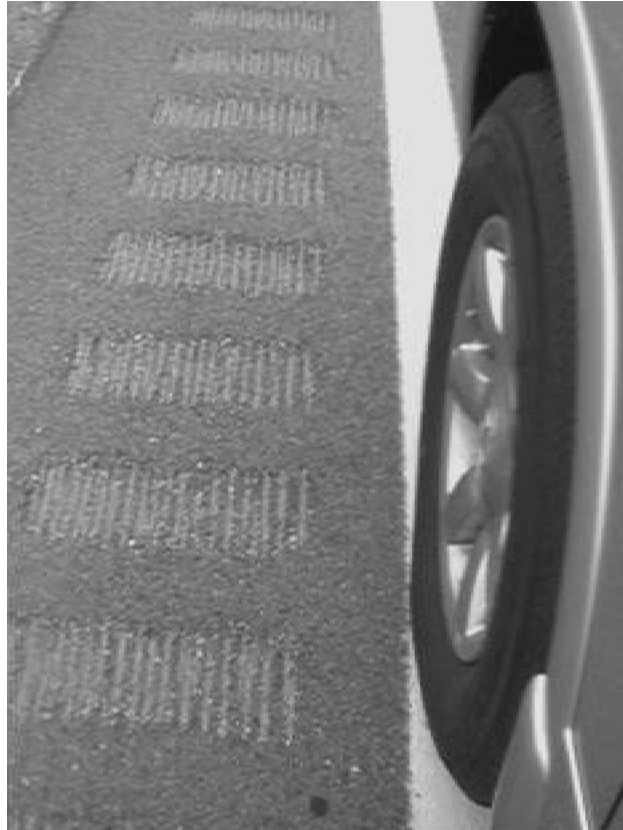
Figure 3.4 (b). Snapshot from the left-side road video

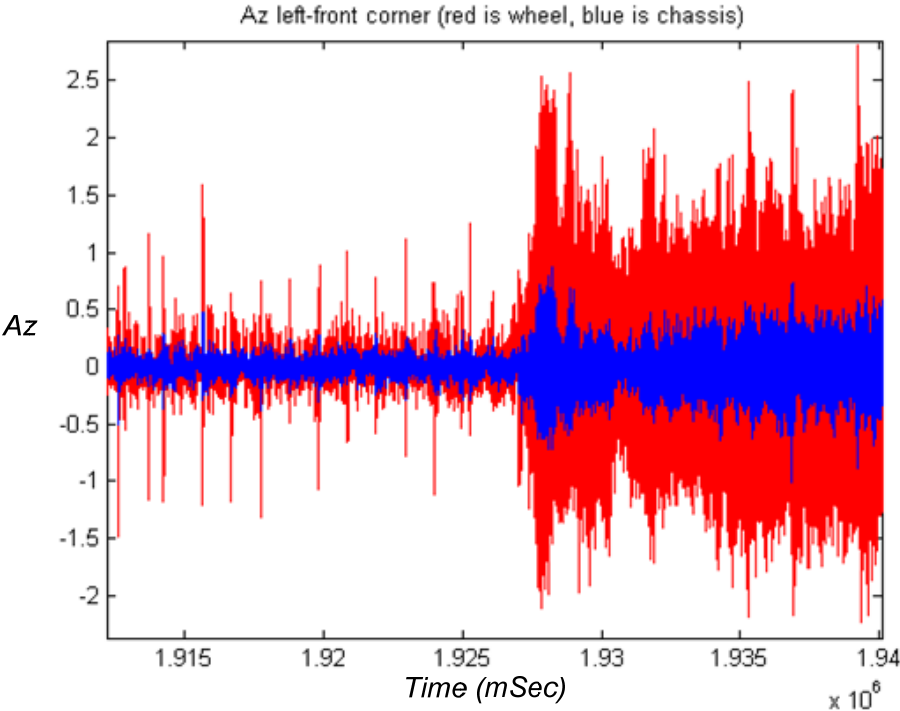
The effect of suspension dampening on the vertical acceleration is shown in the next figure. Again, this figure is zoomed around the time where the left wheel gets onto the rumble strip. The red line is the Az data from the left-front wheel (lower suspension arm), and the blue line depicts the data from the frame-mounted accelerometer located above that wheel.

Figure 3.8. Az data from the left-front wheel and chassis

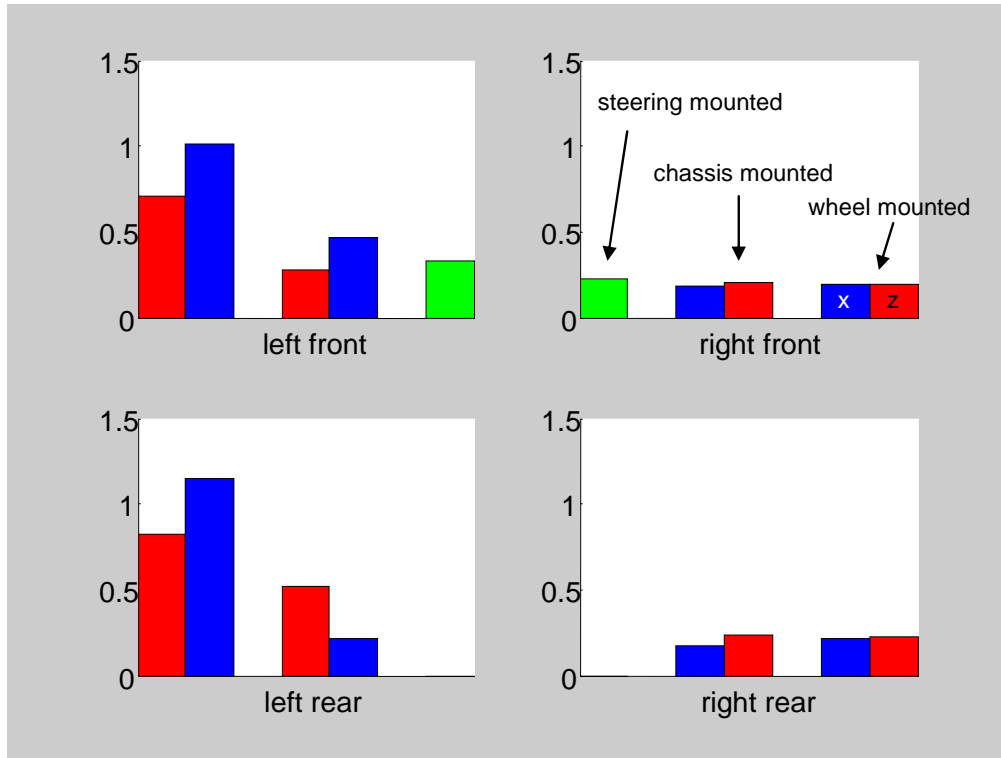
This analysis focused on the RMS values determined from each of the vibration sensors. Figure 5.4 shows a typical result, the bars presenting RMS accelerations averaged over all cases of interest, in this case averaged over all occasions where a left-side rumble strip (rolled or milled) was tested.

Figure 5.4. Mean RMS Values for all Left Side Rumble Strips

For consistency, and to avoid the effects of partial contact and varying times on the rumble strip, each ‘event’ analyzed was chosen to be the 10 second interval that generated the largest RMS value. In the following plots, each sub-plot corresponds one corner of the vehicle, red bars represent the vertical (Z) direction, blue bars are for longitudinal (X) and green bars (front only) display the lateral (Y) acceleration on the steering arm. The outer bars represent wheel hub responses, while the chassis mounted accelerometers are shown inboard –intended to be intuitively easy to study the plots. The amplitudes shown clearly represent an expected left-sided bias, though the amplitudes of the chassis mounted accelerometers show a relatively weak effect.

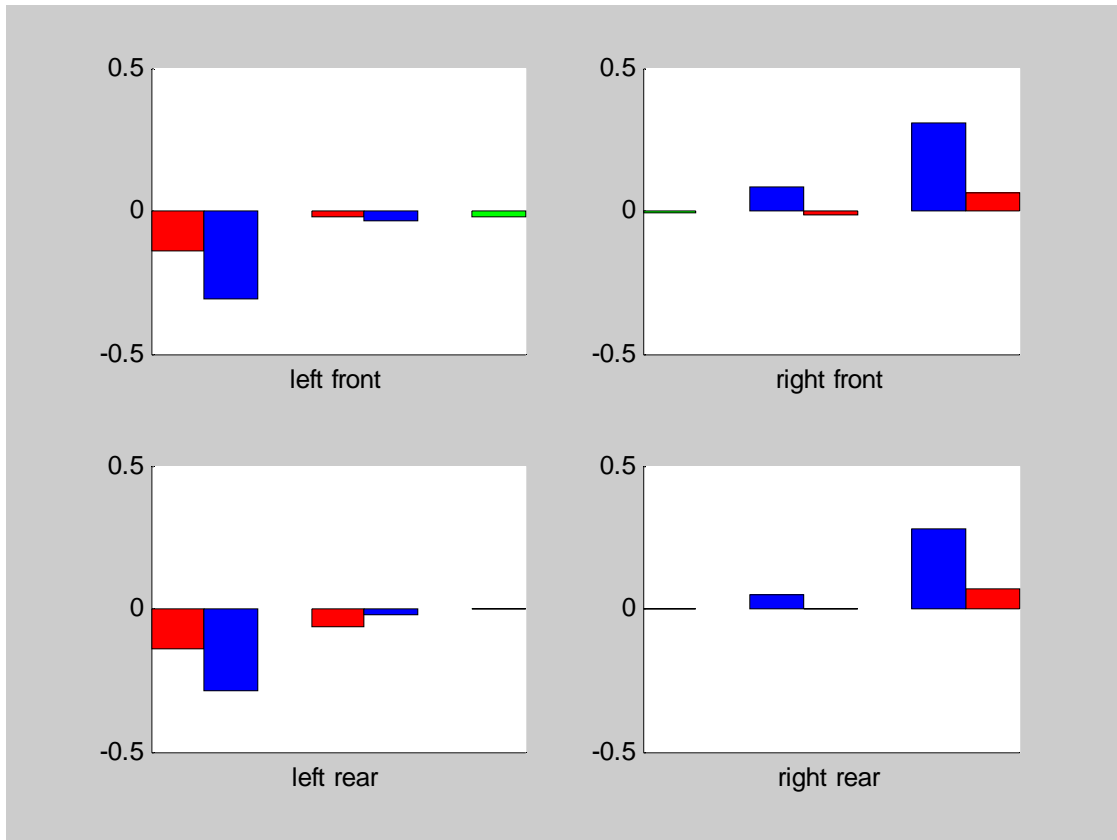
Comparing left and right rumble strip responses for the rolled-in case, Figure 5.8 shows the difference in response amplitude. While it might be possible to use relative phase or multivariable information to improve the detection, it is absolutely clear that the outboard (hub mounted) a_x accelerometer is the strongest signal and the best single sensor for detecting both the existence and location of the rumble strip.

Figure 5.8. Effect of Rumble-strip Location on Measured Response for Rolled-in Case (mean RMS differences, right minus left)

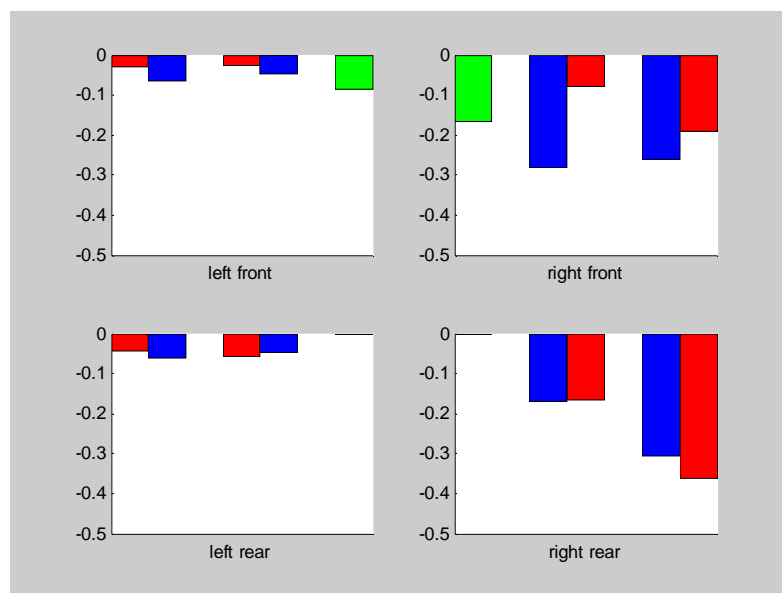
Figure 5.11 shows that selection of 4WD tends to reduce the response amplitude. The most obvious reason for this is the increase in effective inertia in the rotating wheel masses. This is interesting, because the vertical and longitudinal accelerations are similarly affected, while it might be presumed that the vertical accelerations would be influenced more directly by vertical tire stiffness, and would be relatively unaffected. This contradiction seems to imply that the rotational dynamics of the wheel are crucial to the response characteristics – for example a point follower tire model with bridging filter and vertical suspension dynamics would have difficulty predicting the vertical acceleration responses.

Figure 5.11. Effect of Transmission Selection on Response Amplitude (right side rumble strips, 4WD-2WD, 55mph only)

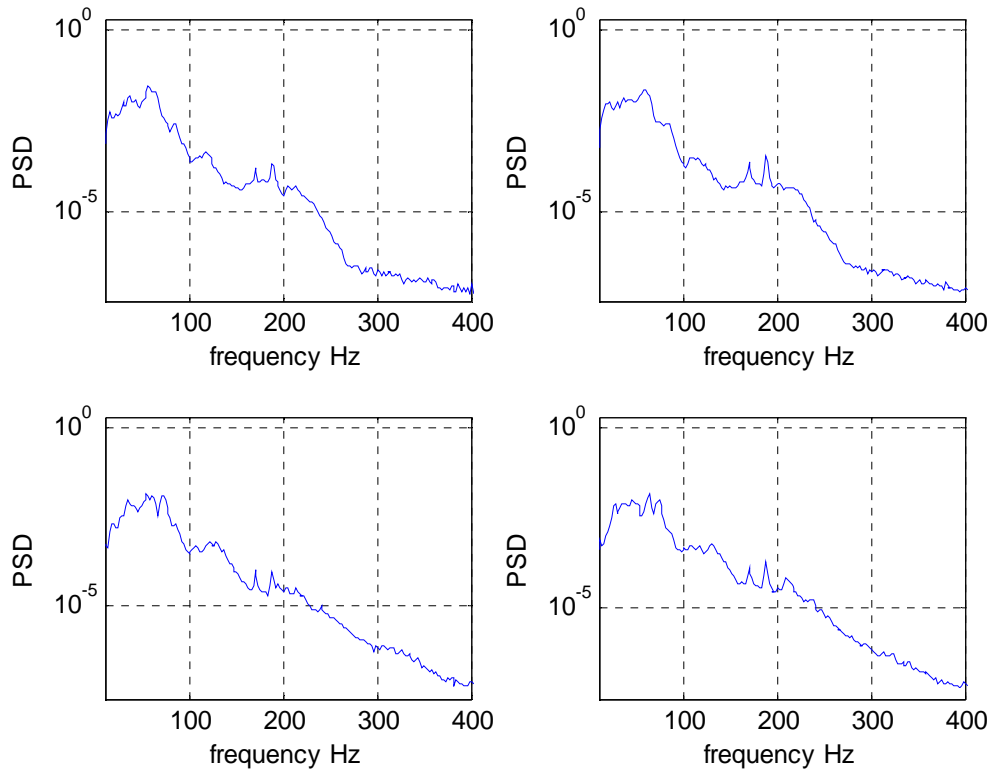
The following two plots (Figures 5.17 and 5.18) are on roads with no rumble strip contact, the first on a relatively smooth concrete road, the second on a relatively rough dirt road. Both show the same type of broad-band spectrum as was seen as background in the above plots, but neither shows a laterally biased pattern of harmonic peaks, or even any pattern of harmonic peaks at all. Thus it appears reasonable to hypothesize that a detection system could be based on (signal processing that extracts features equivalent to) this pattern of harmonic peaks, and it would not be triggered under normal driving conditions. Simply put, this type of vibration sensing, based on frequency, amplitude and lateral bias characteristics, seems to be able to extract the ‘signature’ of a rumble strip from the background disturbances from road roughness and indeed powertrain vibration.

Figure 5.18. Frequency analysis (PSD) for Run 40 (dirt road, semi-logarithmic plot)

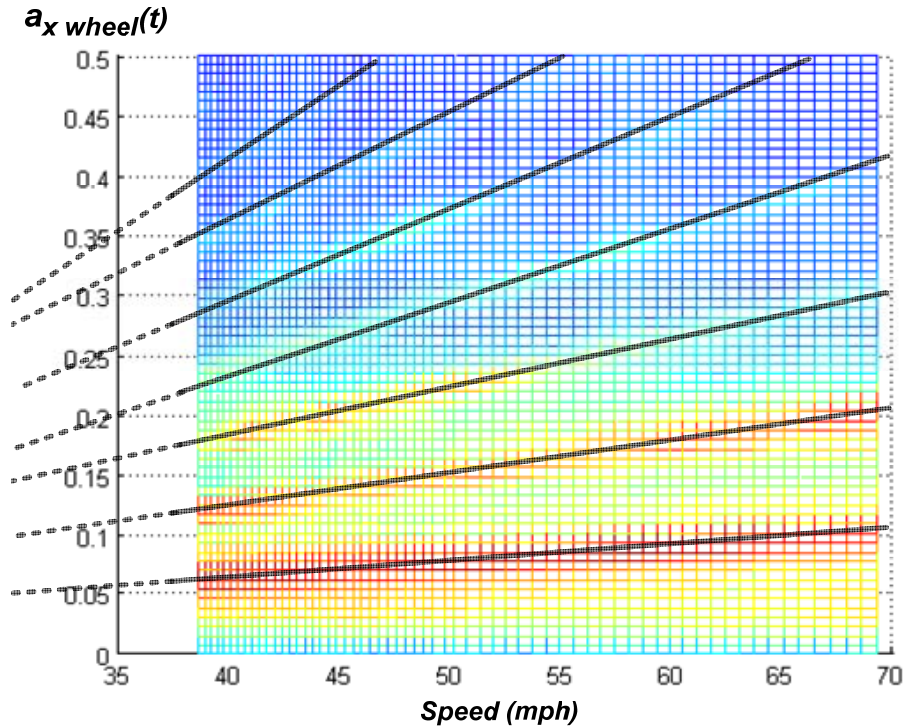
Figure 5.21. Harmonics in waterfall plot (of figure 5.20)

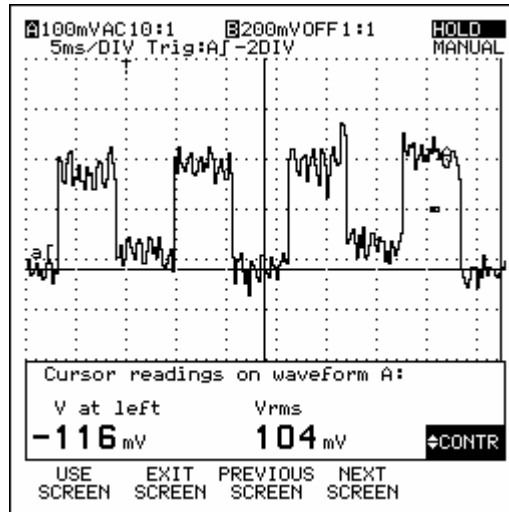
The wheel speed is measured by a series of voltage pulses, picked up by the 54 teeth mounted on each wheel. This pulse train provides timing triggers to the ABS system, which then computes a wheel-speed estimate for every control cycle – see Figure 6.1. To evaluate the likely validity of the wheel speed sensor for rumble strip detection we may look at time histories and amplitudes, but based on the analysis above it seems at least as appropriate to test whether the wheel speed is coherent with the reference signal $a_{xwheel}(t)$.

Figure 6.1. Direct analogue output measured on an oscilloscope from the existing wheel speed sensor.

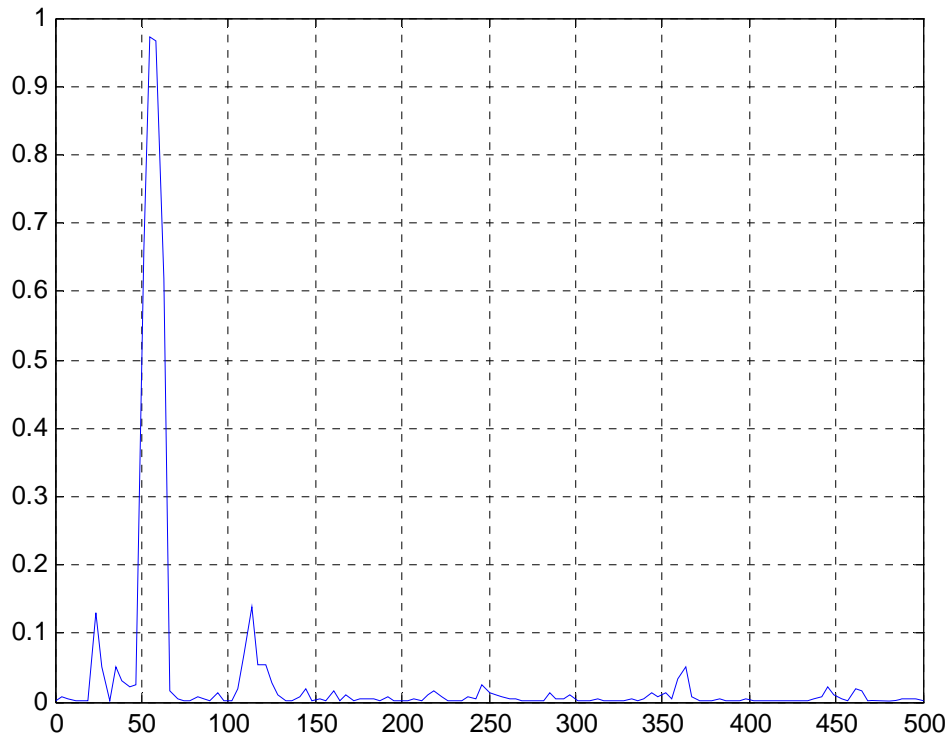
Figure 6.5 shows another example based now on a milled rumble strip – this was selected to provide a stronger signal, perhaps overcoming some of the quantization problems noted above. It was also a lower speed case, driven at 40mph rather than the “standard” 55mph of run90 in the above figures. In this case the coherency approaches its maximum value of 1 near the excitation fundamental frequency, which is at about 60Hz in this case (the rumble strip has a longer wavelength than above, and the vehicle speed is of course reduced). Note also that the localization problem seen with the steering mounted accelerometer is not an issue here. For the same case (Run 168) as Figure 6.5, the other wheel speed shows no significant coherency at all, which is completely in contrast to the steering acceleration.

Figure 6.5. Coherency function between wheel (a_x) and available wheel-speed sensor (rear right wheel, excitation from milled rumble strip, 40mph, Run 168)
