A Study of Mineral Density Surrounding Resorption Sites in Teeth

J. K. AVERY, R. A. MEYERS AND L. E. HALE

Department of Oral Biology, School of Dentistry and Department of Anatomy, Medical School, University of Michigan, Ann Arbor, Michigan

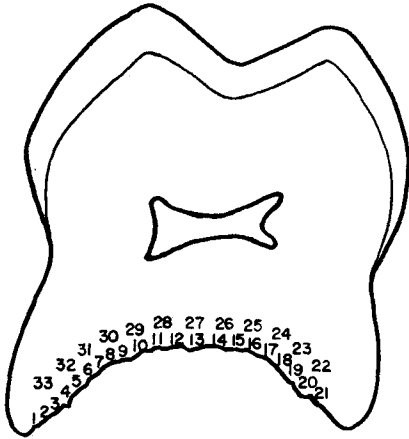
Figures 1 thru 4 are projection diagrams of sections of human teeth to show the location of the microhardness measurements. The area indicated by the lower series of numbers was taken within 10-40 μ from resorption sites as seen in figures 1, 2 and 3 and 10-40 μ from the surface of the normal appearing root in figure 4. The higher series of numbers were taken one-fourth to one-half millimeter from these areas. The figures are expressed as Knoop Hardness Numbers.

- 1 A primary molar undergoing external resorption probably related to the process of eruption of its permanent successor. Orig. Mag. \times 4.
- 2 A primary molar tooth undergoing external resorption of the lateral surface of only one root. Orig. Mag. \times 4.
- 3 A projection diagram of a human permanent tooth undergoing internal resorption. The superficial zone adjacent to the pulp has smaller Knoop Hardness Number indicating it is not as hard as the deeper dentin seen. Orig. Mag. \times 4.
- 4 A projection diagram of a normal appearing human tooth. In this case the peripheral zone of the root dentin immediately underlying the cementum was found to be softer than adjacent deeper root dentin. orig. Mag. \times 4.

1. 32.8	12. 33.3	23. 56.6
2. 47.6	13. 37.8	24. 56.6
3. 40.7	14. 37.3	25. 55.6
4. 40.1	15. 38.9	26. 56.6
5. 46.9	16. 37.8	27. 56.6
6. 37.3	17. 40.7	28. 61.9
7. 26.0	18. 45.4	29. 69.6
8. 39.5	19. 37.3	30. 68.2
9. 38.9	20. 36.2	31. 69.6
10. 39.5	21. 39.5	32. 69.2
11. 38.3	22. 53.7	33. 69.2

37.6 in primary teeth and 43.1 in permanent teeth or an average of 40.4 KHN for both series of teeth. The KHN of dentin 250 to 500 μ from these zones was found to be 52.8 in primary teeth and 56.1 in permanent teeth. It is observed that this is a difference of 15.2 KHN in primary teeth and 13.0 in permanent teeth between the areas of resorption and the areas deeper in dentin. An explanation of these findings is shown in figures 1, 2 and 3 and in tables 1 and 2.

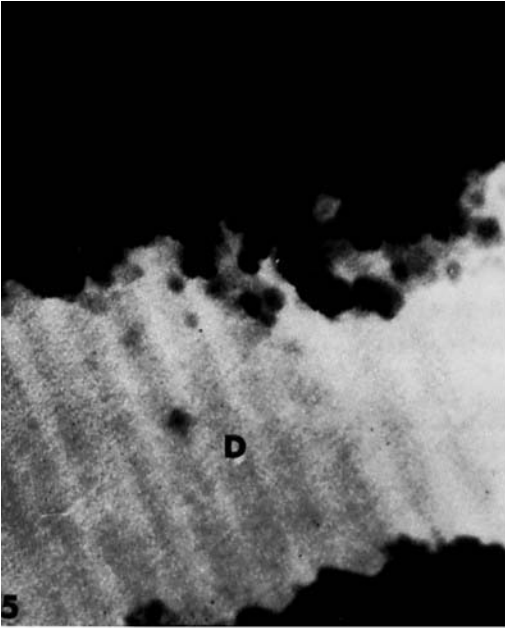
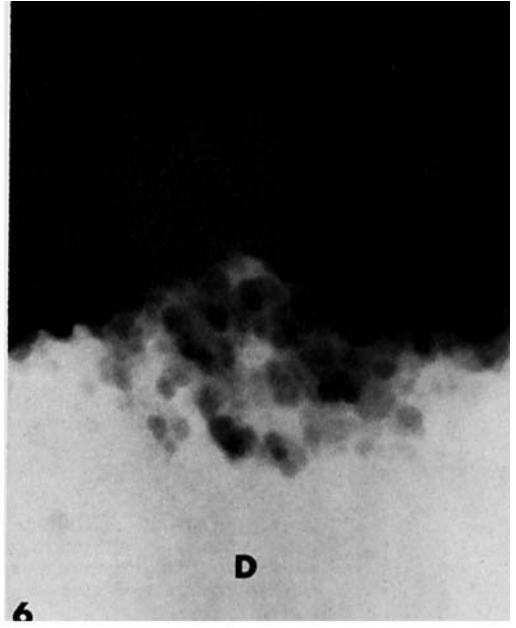
- 5-6 Microradiographs of areas of internal resorption of root dentin. These lesions were from areas of very little tissue destruction. It is noted that all of the resorption cavities are of similar size and not very large. The numerous radiolucent resorption cavities appear superimposed in those sections 70-100 μ in thickness. No distinct demineralization gradient appears around the sites. (D), Dentin. Orig. Mag. \times 450.

Microradiographs of the 70–100 μ thick dentin specimens revealed the oval shape of the resorption cavities and the interrelationship of large groups of these spaces (figs. 5, 6). It is of interest to observe that as many as 50 to 75 may be present in the thickness of a 70–100 μ slab. Many of the lacunae appear to range from 30 to 200 μ or more in size and in some cases a number of smaller ones appear in contact with a larger cavity (fig. 6). The larger cavity may be termed "primary" sites and the smaller lacunae associated with the larger areas "secondary" sites. The multilocular areas in figures 5 and 6 reveal how a number of lacunae may be grouped, many of them appear superimposed in the radiograph. No evidence appears of a gradient of mineral resorption around the sites. The resorption cavities shown in figures 5 and 6 were from a case where little tissue destruction had occurred. This could be considered a young active site. The lacunae appear smaller and more numerous than those of figures 7 and 8. The site shown in figure 7 is from an advanced case of internal resorption and much dentin was missing. This probably is an older site which has lost some of the spicules of dentin which helped define the smaller sites. As these sites expanded the spicules are eliminated resulting in the formation of larger sites. The edges of the resorption cavities appear equally as dense as the adjacent areas with the exception of the small area appearing in the center and upper left of figure 7. This area again may consist of a number of smaller sites, however, which are associated with the adjacent larger one. The microradiograph shown as figure 8 is of a

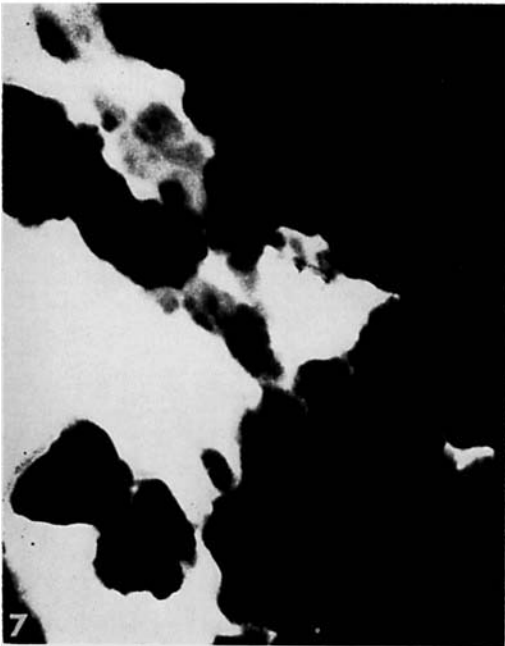
- 7 Microradiograph of an advanced area of internal resorption. In this case much of the root dentin was missing. Larger resorption cavities appear in the remaining dentin than in the cases shown in figures 5 and 6. The radiopacity is generally uniform except in the center of the picture where secondary sites are noted. Orig. Mag. \times 100.

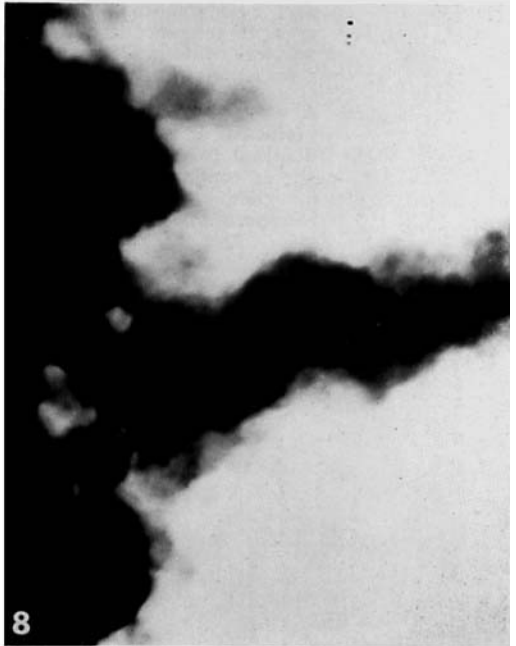
- 8 Microradiograph of an area of internal resorption located near the apical foramina. Numerous resorption cavities appear along the walls of this deep defect which may be an accessory root canal. Orig. Mag. \times 100.

deep, tunnel-type defect. This kind of defect was found in several of the teeth and is thought to be related to an accessory root canal. This theory is substantiated by the fact that this microradiograph was taken of an area near the apical canal. The boundaries of this space appear to be altered by numerous small lacunar sites. Many of the resorption fronts revealed areas of repair. Microradiographic appearance of areas of secondary deposition of bony or cementum-like substance on the root surface are shown in figures 9 and 10. Figure 9 is from an area of internal resorption and figure 10 from an external site. In a few areas, what appeared as a sub-surface demineralization front was observed (fig. 11). As this is from an area of internal resorption, it is possible that the less radiopaque area represents pre-dentin. A possible similar area can be seen in figure 13 where the resorption is in an early stage and some of the pre-dentin is still present. Pre-dentin is quite radiolucent and may appear as shown in figure 13. The diagram shown in figure 12 is an interpretation of the multilocular nature of the resorption sites and their various means of communication. All of the sites are connected with the surface of the advancing front and each site is usually connected with the smaller ones above, below and/or the one to the right and left of it. By this means a vast surface area is maintained and small islands of dentin are produced and efficiently eliminated.

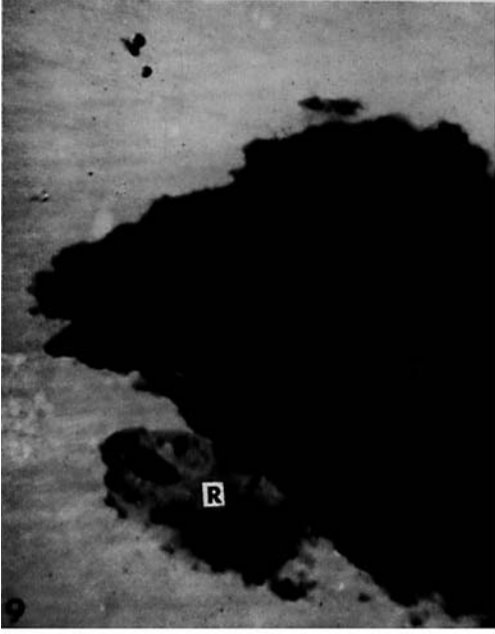
- 9 A resorption site which originated along the pulpal aspect of a human tooth. The dentinal tubules are visible as is the ragged edge of the resorption front. No mineralization gradient is seen. An area of bony repair can be seen partially filling a defect, (R), Repair. Orig. Mag. $\times 100$.

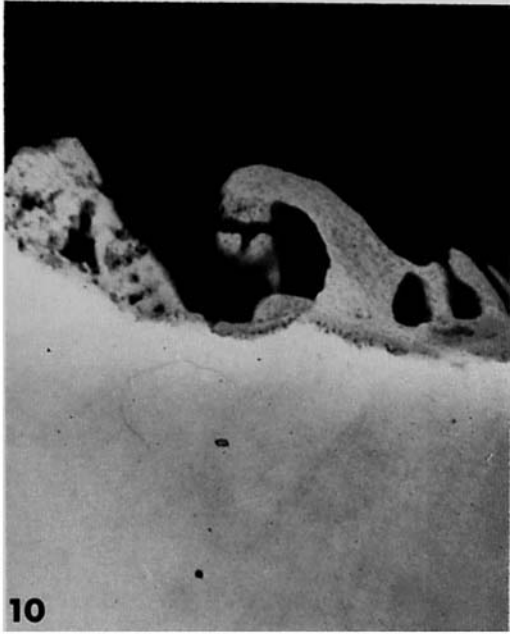
- 10 A resorption site located on the external aspect of a tooth. The areas of repair appear extensive. It is probable that this bone or cementum has also undergone some resorption with a cavity resulting in the central area of the secondary deposition. Orig. Mag. $\times 100$.

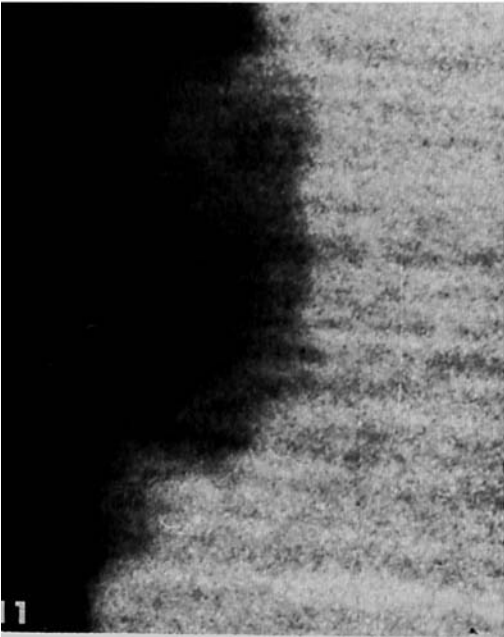
- 11 A microradiograph of a resorption site originating from the internal aspect of a tooth. The dentin tubules are faintly visible as is an area of radiolucent matrix. This appears as an area of decreased mineral content. Because of its location it is possible that this area represents pre-dentin. Orig. Mag. $\times 540$.

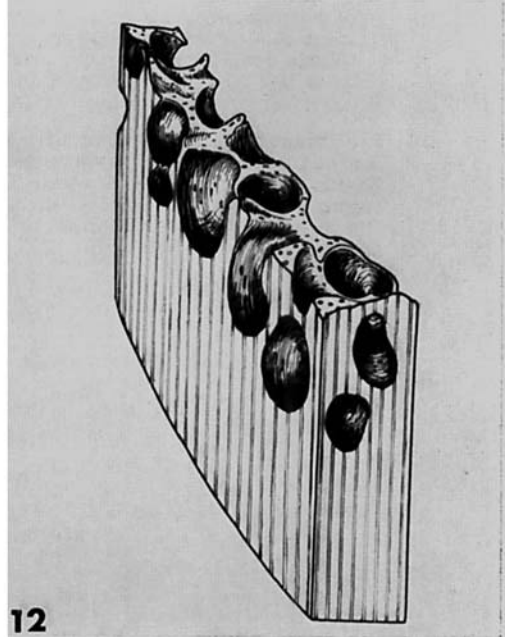
- 12 A diagram of a resorption front in dentin representing an interpretation of the microradiographic data. The relationship of the dentinal tubules and the numerous lacunar sites are shown. Each site is connected with another as well as to the surface of the primary site. As the oval shaped sites are expanded they isolate small islands of dentin which in turn are then finally resorbed.

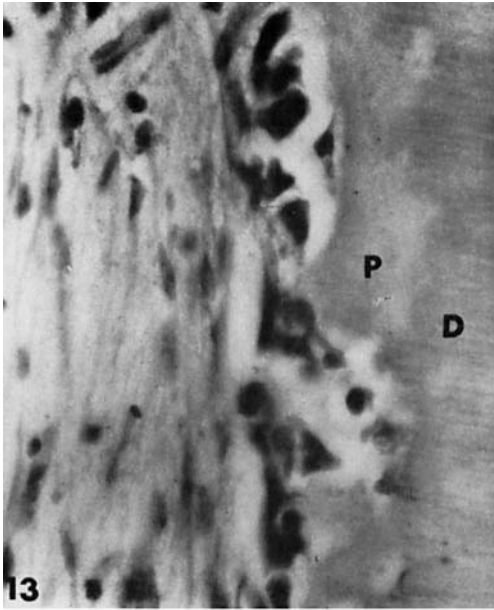
- 13 Photomicrograph of an initial or early site of internal resorption revealing a loss of some predentin. The odontoblasts have degenerated and the degenerative changes in the pulpal connective tissue can be seen. Some predentin, but not dentin, has already been destroyed. Vascular granulation tissue has invaded this area adjacent to a site of amputation of the pulp with calcium hydroxide. This amputation was done necessarily to remove a necrotic area of the pulp. (P), Predentin, (D), Dentin. Hematoxylin and eosin stain. Orig. Mag. $\times 450$.

The microscopic studies were of teeth some with internal and others with external resorption sites and the observations clarified some of the previous findings. Figure 13, as previously noted, was a primary site probably caused by chemical trauma on the pulp, $\text{Ca}(\text{OH})_2$. The initial stage of resorption is indicated by the degenerating odontoblasts and little loss of tissue at this time except the uncalcified pre-dentin. It also appears that pre-dentin deposition has ceased. Figure 14 illustrates a dense staining zone bordering a resorption site and may be indicative of such chemical changes as mineral loss to the depth of several microns. Functional dentin appears on the right with the proto-

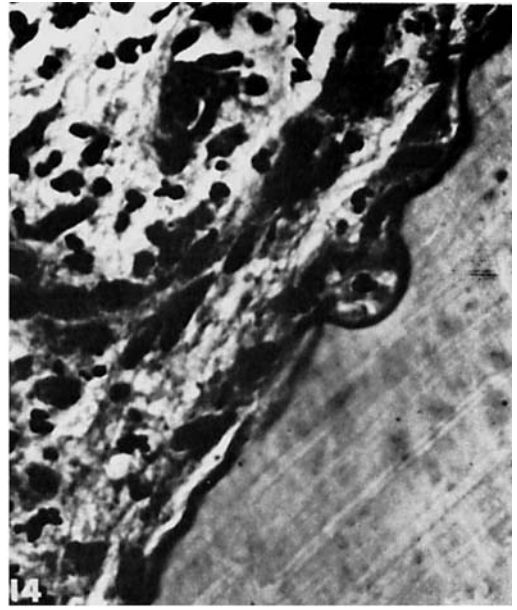
- 14 Photomicrograph of an area of internal resorption revealing a dense staining of the matrix immediately adjacent to the resorption front to a depth of several microns. This may be indicative of chemical changes related to the resorption process such as demineralization of the matrix. Mallory's connective tissue stain. Orig. Mag. $\times 450$.

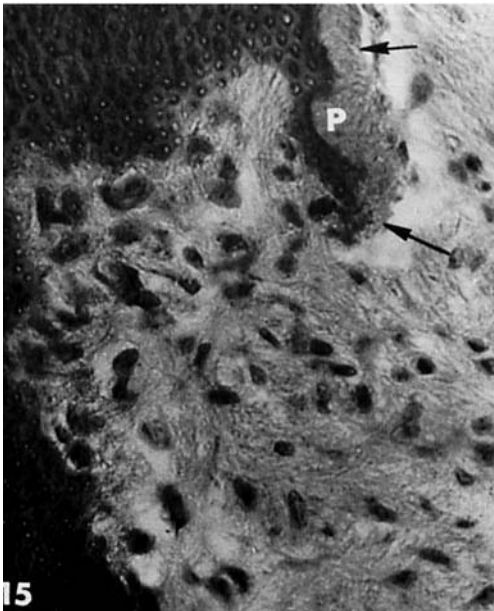
- 15 Photomicrograph of an area of internal resorption showing the dentinal tubules in cross section and a remaining spicule of dentin and attached predentin, (P), predentin and (arrows) indicating predentin. The normal architecture of the pulp is lost and some large multinucleated cells appear along the resorption front. Hematoxylin and eosin stain. Orig. Mag. $\times 450$.

plasmic processes of the odontoblasts still in the dentinal tubules. Figures 15 and 16 both are from early and acutely active resorption fronts. In both figures observe the area of pre-dentin (P) still present along the pulp border. It is apparent how this zone is bypassed along with an attached spicule of dentin as the front moves deep into the tissue. Close association of cells in the lacunae and the fibrous appearing substance in the background is evident. Finally, no definite subsurface alteration was revealed in the histologic study.

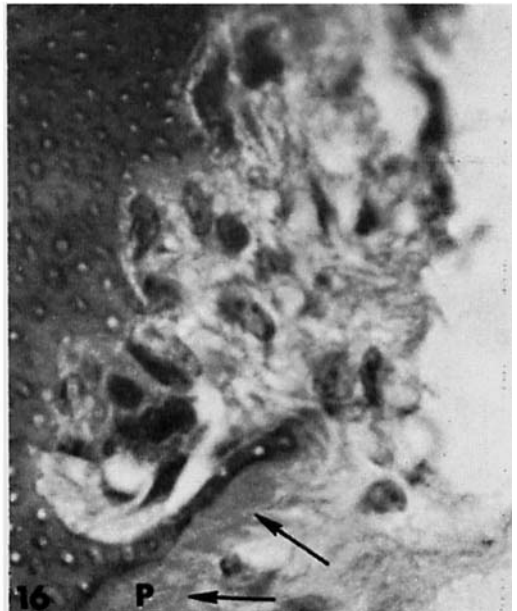
- 16 Photomicrograph of an area of active internal resorption. The cross sectioned dentin tubules and the lacunar resorption sites can be seen. Note the cells and fibrous appearing material within the lacunae. Below can be seen a spicule of dentin and adjacent attached predentin, (P), Predentin, and (arrows) indicating predentin. It would appear as if the resorption front is skirting this area. Hematoxylin and eosin stain. Orig. Mag. $\times 450$.
