# **PROFILE ANALYSIS OF THE LTPP SPS-1 SITE IN ARIZONA**

**STEVEN M. KARAMIHAS**

1. Report No. UMTRI-2007-16		2. Government Accession No.		3. Recipient's Catalog No.	
4. Title and Subtitle Profile Analysis of the LTPP SPS-1 Site in Arizona				5. Report Date May 2007

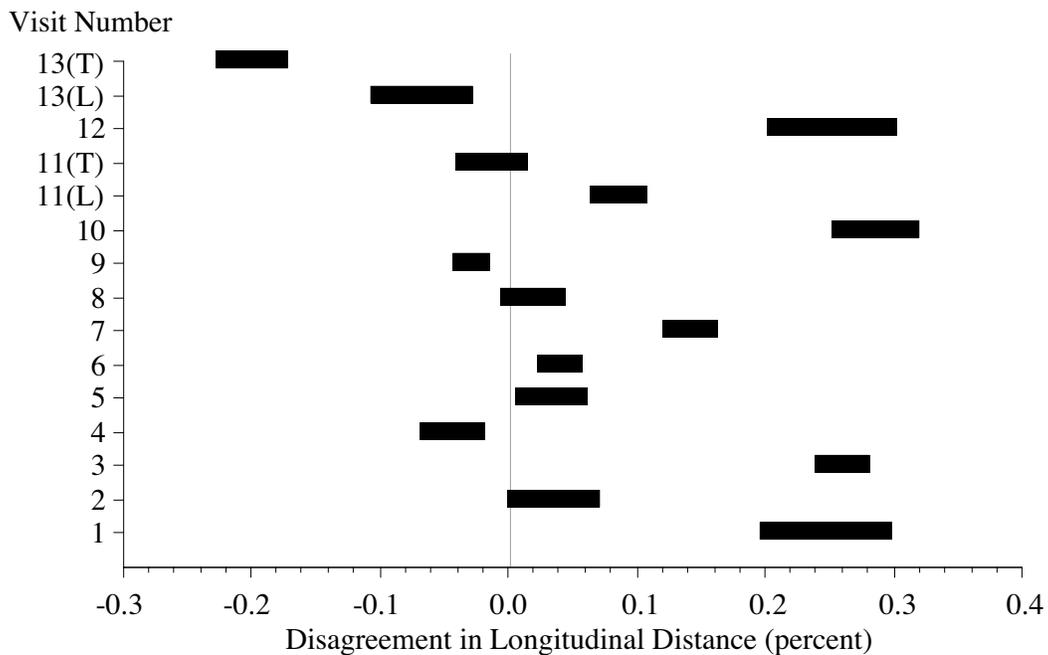
Figure 1 shows the disagreement in longitudinal distance measurement for each visit using the original basis set as a reference. In the figure, a range of disagreement for each visit exists because up to nine repeat profile measurements were made. The variation between repeat measurements within a visit appears as the width of each bar in the figure. Note that two separate bars are presented for visits 11 and 13. This is because the profile measurements from those visits covered the site in two parts. This included the first seven sections in a leading (L) set of measurements and the other nine in a trailing (T) set of measurements.

**Figure 1. Consistency in longitudinal distance measurement.**

Since the longitudinal distance measurement was based on the rotation of a drive wheel, the variations were most likely caused by variations in speed, lateral wander, and tire inflation pressure. (4) If tire inflation pressure were the dominant cause, the disagreement would grow more positive with each successive repeat measurement as the tire heated up and tire pressure increased. This is because the tire rolling radius would increase, and the profiler would register less wheel rotation for the same travel distance. This appeared to be the case for visits 03 through 08, but the effect was never greater than 0.05 percent of the overall distance. Note that the field procedures require the operator to warm up the tire prior to the measurements. That accounts for the high level of agreement within each of visits 03 through 11.

The variation between visits in Figure 1 is caused by differences in distance measurement instrument calibration. The longitudinal distance measured by a profiler is not true horizontal distance. It always includes some additional component because the profiler must travel up and down the undulations in the road. This component can be minimized by calibrating the profiler to true horizontal distance. However, if a profiler operates on a road with grade changes and roughness that are not similar to the site used for longitudinal distance measurement calibration, some error will exist. Tire inflation pressure and tread wear must also be close to the level that existed during calibration for consistent results.

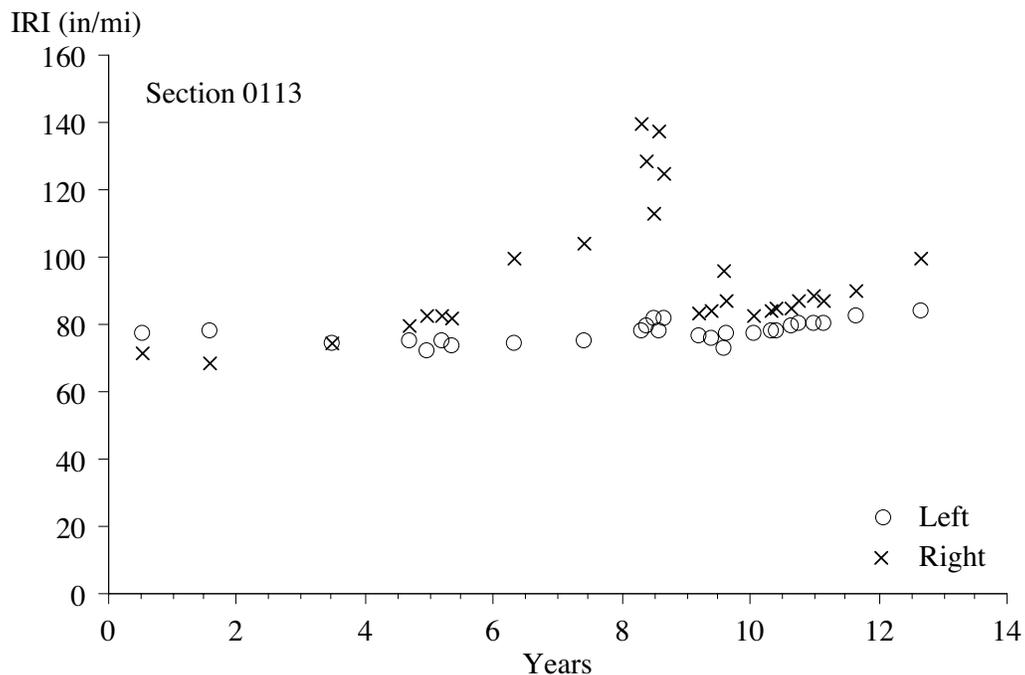
**Figure 2. IRI progression, section 0113.**

Figures 2 through 17 provide a snapshot of the roughness history of each pavement section. The remainder of this report is devoted to characterizing the profile content that made up the roughness, and explaining the profile features that contributed to roughness progression.

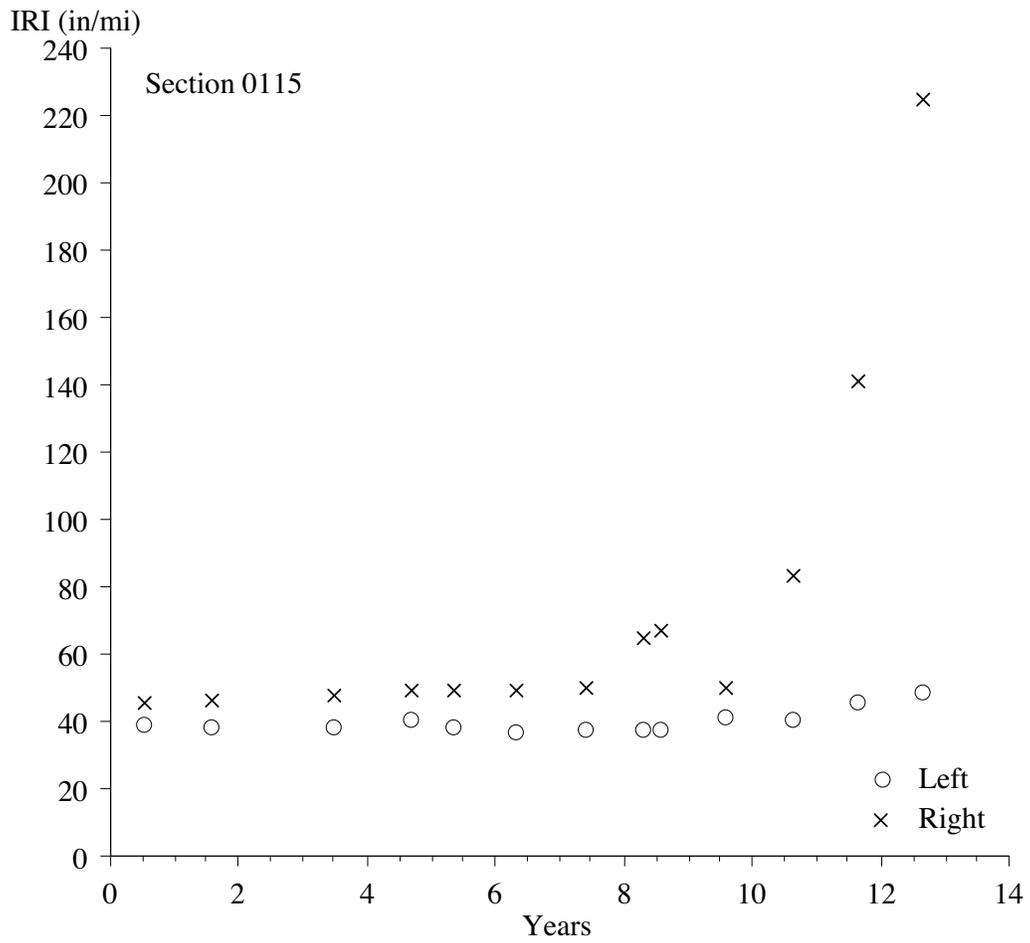
**Figure 3. IRI progression, section 0115.**

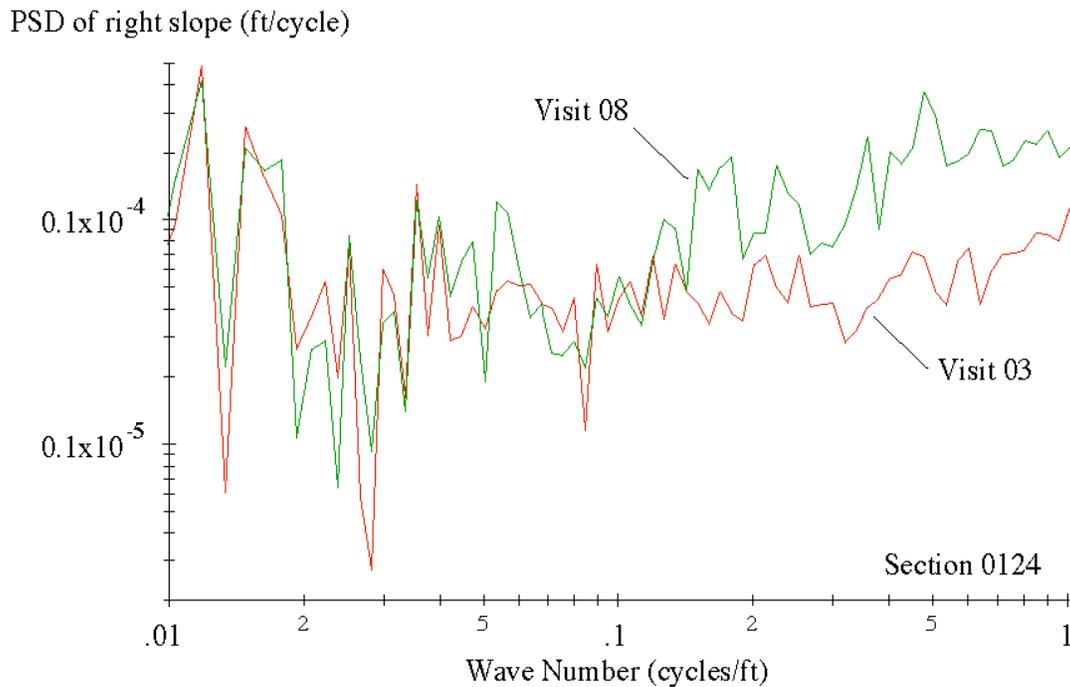
Figure 18 shows the PSD of the right profile for section 0124 during visits 03 and 08. This plot includes several noteworthy features:

**Figure 18. PSD of section 0124 profile, right side.**

- The plot shows the PSD of slope, rather than elevation. Thus, the vertical axis has units of  $\text{slope}^2/(\text{cycles}/\text{ft})$ , as opposed to  $\text{elevation}^2/(\text{cycles}/\text{ft})$ .

- The spectral content for wavelengths shorter than 10 ft increased between visits 03 and 08. In this case, the increase was caused by the presence of cracking in several areas of the section in visit 08. Several of the pavement sections behaved this way, and an increase in spectral content for shorter wavelengths often accompanied an increase in cracking.

- The spectral content differs for very long wavelengths (low wave numbers). This is not caused by a change in the shape of the section. Rather, it is the result of a change in profiler, and an associated change in the high-pass filtering methods. (6)

- The spectral content shows a decreasing trend at very short wavelengths (high wave numbers). This is an artifact of the low-pass filtering applied at the time of the measurement, which is a combination of digital filtering and height sensor footprint. (7)

- The PSD plot for visit 09 includes a spike at a wave number of about 2.2 cycles/ft, and at double that value. This is also an artifact of the measurement process, but the source is not clear. The spikes were present in all of the measurements made by this profiler, which includes all of the measurements made in visits 03 through 09. However, the spikes did not occur at the same wave number in each visit, or in each repeat measurement within a given visit. The wave number where the left-most spike occurred ranged from about 1.62 cycles/ft to 2.80 cycles/ft. A similar effect was present in the profile used in visits 01 and 02, and the spikes occurred from about 0.40 cycles/ft to 0.42 cycles/ft.

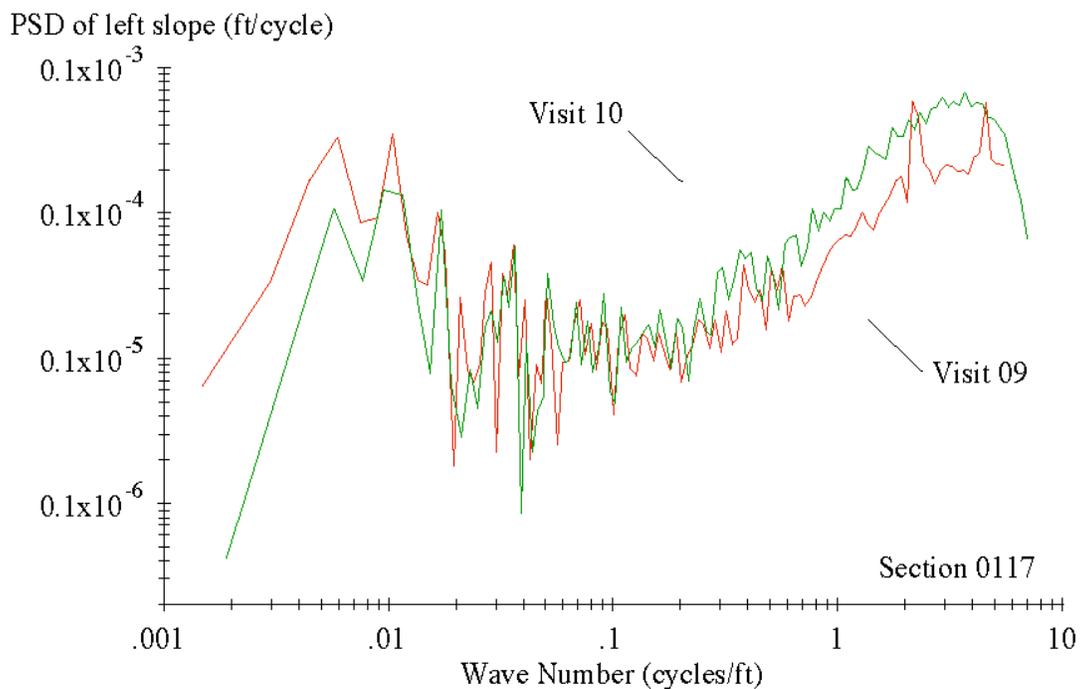
**Figure 19. PSD of section 0117 profile, left side.**

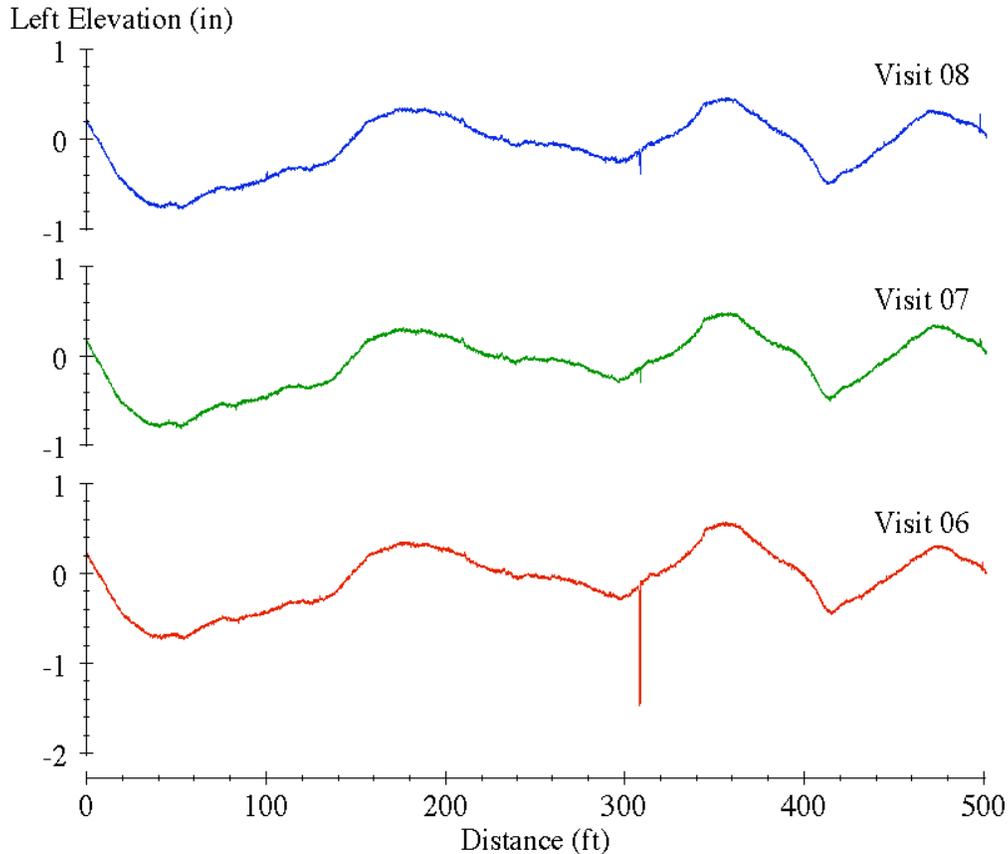
A simple way to learn about the type of roughness that exists within a profile is to view the trace. However, certain key details of the profile are often not as obvious in a raw profile trace as they may be after the profile is filtered. For example, Figure 20 shows the left raw profile trace for three visits of section 0122. The plot shows that the long wavelength content, or the trend, in each plot is quite consistent with time. However, a narrow dip appears about 309 ft from the start of the section which is much more severe in visit 06 because the profile tracked directly over it.

**Figure 20. Raw profiles of section 0122.**

Although the raw profile plots in Figure 20 provide very useful information about the nature of the roughness on section 0122, a filtered plot may provide a more detailed look at short-duration features of interest, such as the dip at 309 ft. Figure 21 shows a small segment of the profile after it has been high-pass filtered. In this case, a moving average (smoothing) filter with a baselength of 20 ft was applied to the profile, and the result was subtracted from the raw profile. Without the filter, the large changes in elevation along the profile may have masked the dip in visits 07 and 08, such that they may have been ignored. When the profile is filtered, the dip and its shape are much easier to evaluate.

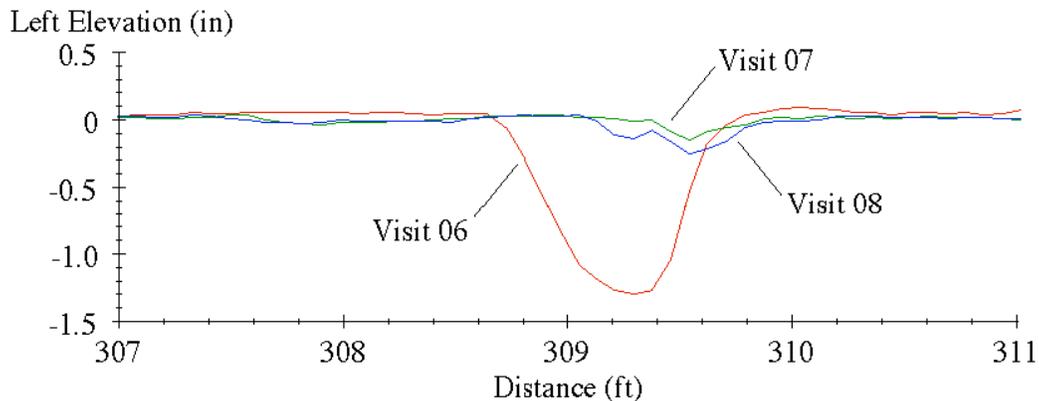
**Figure 21. Filtered profile of section 0122.**

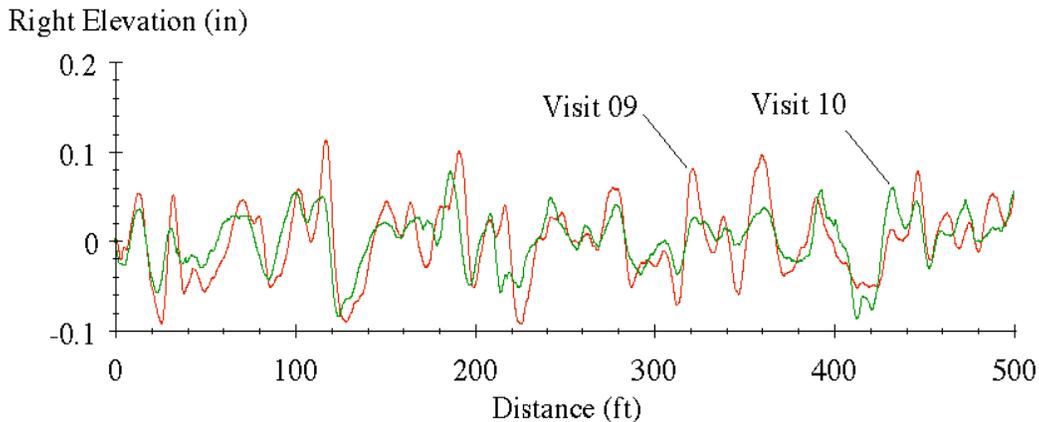
Filtered profile plots also helped to characterize the effects of maintenance operations. For example, a slurry seal was applied to nine of the sections on the SPS-1 site in May 2002 (between visit 09 and 10). In most cases, this caused a complete change to the short wavelength profile plots and a significant change to the medium wavelength profile plots. Figure 22 shows an example of the change in the medium wavelength content on section

0122. Local peaks and troughs occur in roughly the same place before and after the slurry seal, but the shape and severity of bumps and dips are heavily altered. This, and the submerging of narrow dips at cracks under the seal, is the source of the change in roughness that occurred after the slurry seal.

**Figure 22. Medium wavelength profiles of section 0122.**

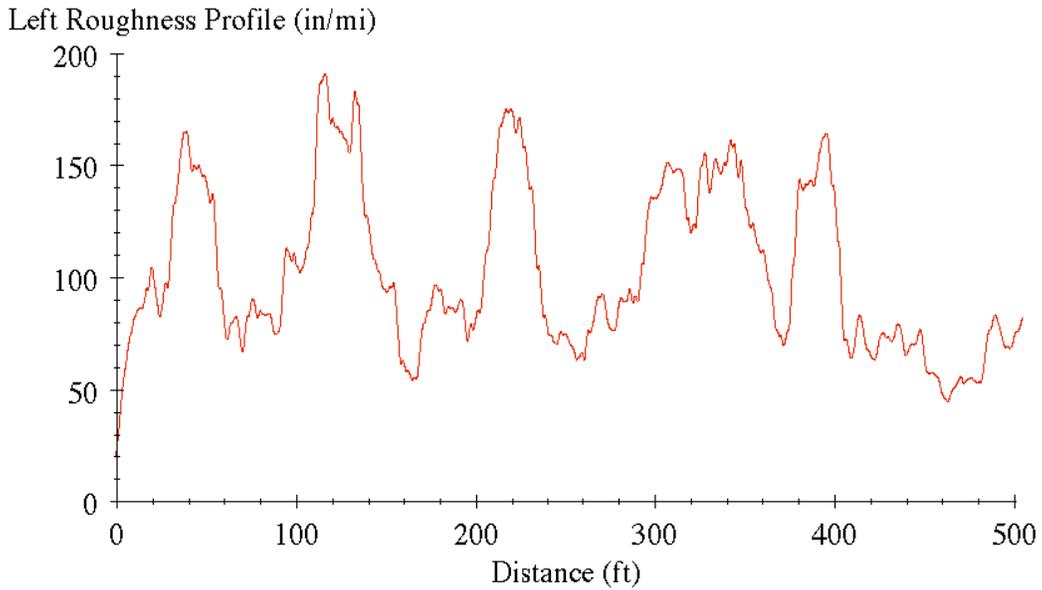
Figure 23 shows an example of a roughness profile for visit 08 of section 0160. The roughness profile was generated using a baselength of 25 ft. That means that every point in the plot shows the IRI of a 25-ft long segment of road, starting 12.5 ft upstream and ending 12.5 ft downstream. The plot shows several areas of elevated roughness over the first 400 ft. The smoothest 100 ft segment appears from 400 ft to 500 ft from the start of the section, but it is no smoother than the areas between isolated rough spots over the first 400 ft. Note that isolated roughness is absent over the last 100 ft of the section because it was diamond ground to smooth the section for an approach to a weigh-in-motion scale just downstream of the section.

**Figure 23. Roughness profile of section 0160, 25-ft baselength.**

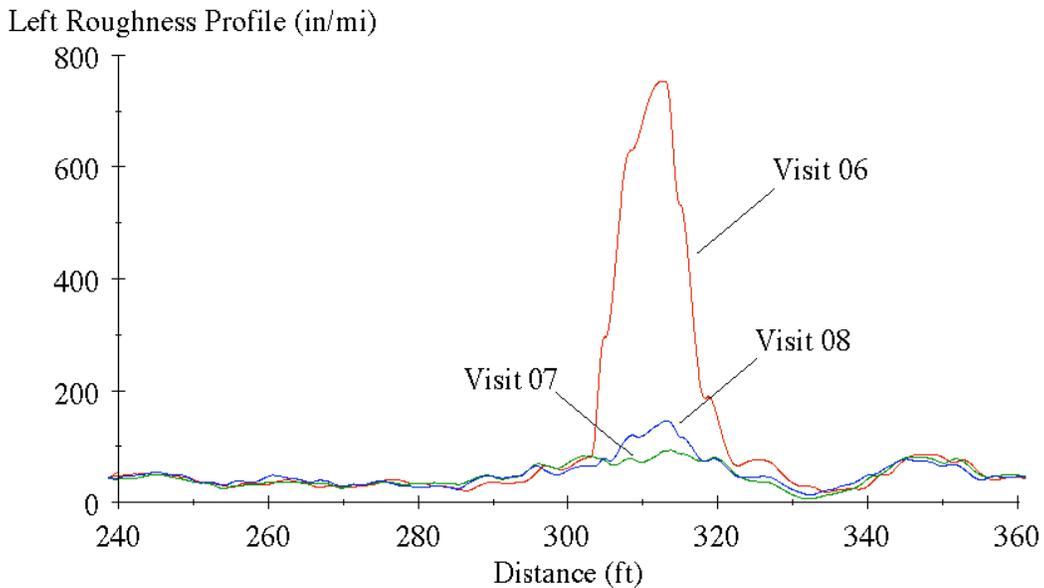
Figure 24 shows how a roughness profile can help find and quantify isolated roughness. The figure shows the roughness profile of section 0122 using a 10 ft baselength for visits 06, 07 and 08. With a 10 ft baselength, isolated roughness is easy to identify. In visit 06, the peak roughness at the dip is about 755 in/mi. In the same location, the roughness is 88 in/mi. This is a difference of 667 in/mi over 10 ft. Since that value represents the roughness over just one fiftieth of the segment, it suggests that the single dip contributes about 13 in/mi to the overall IRI of the section. This is most of the difference between the IRI in visits 06 and 07.

**Figure 24. Roughness profile of section 0122, 10-ft baselength.**

Section 0122: A deep, narrow dip was detected in the left side profiles in some visits (06, 08 and 09) at a pothole. In visit 06, it added up to 14 in/mi to the overall roughness of the section. It was patched in February 2001, and no localized roughness appeared there afterward. A bump appeared in the profiles 175 ft from the start of the section where the slurry seal operation was stopped then restarted in May 2002. The bump was severe enough to cause a peak in the roughness profile of 180 in/mi on the left side.

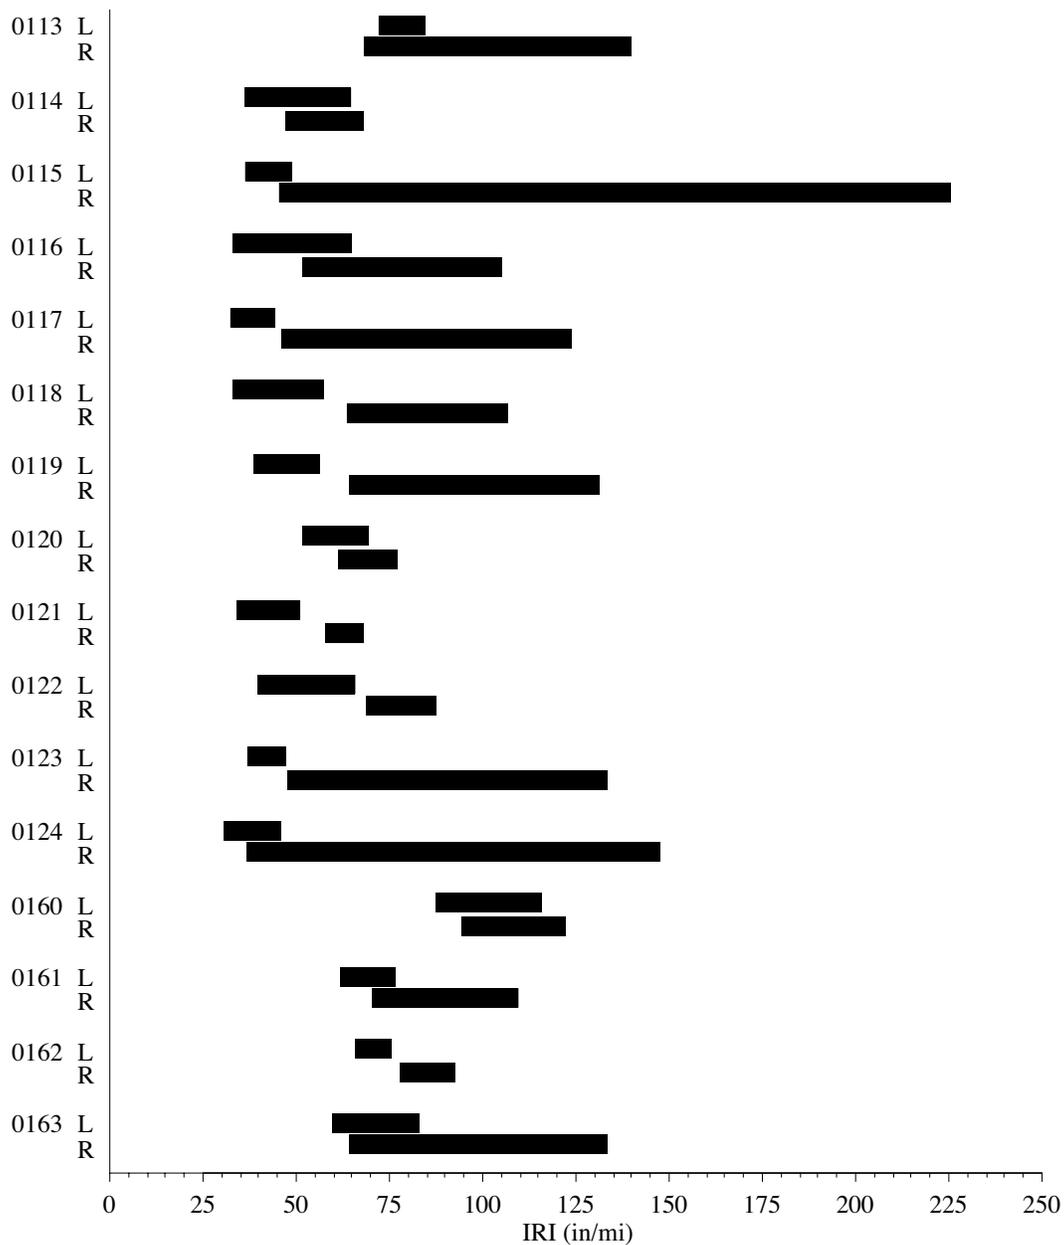
**Figure 25. Summary of IRI ranges.**

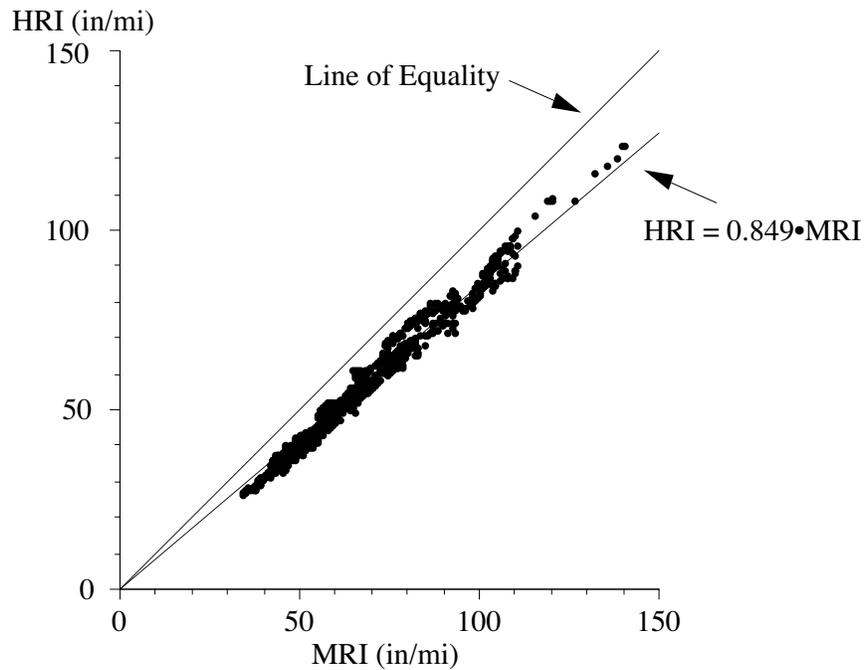
**Figure A-1. Comparison of HRI to MRI.**
