MICHIGAN PAVEMENT PERFORMANCE STUDY

FIVE YEAR SUMMARY

PAVEMENT PROFILE SURVEYS TO CORRELATE

MICHIGAN DESIGN PRACTICE WITH

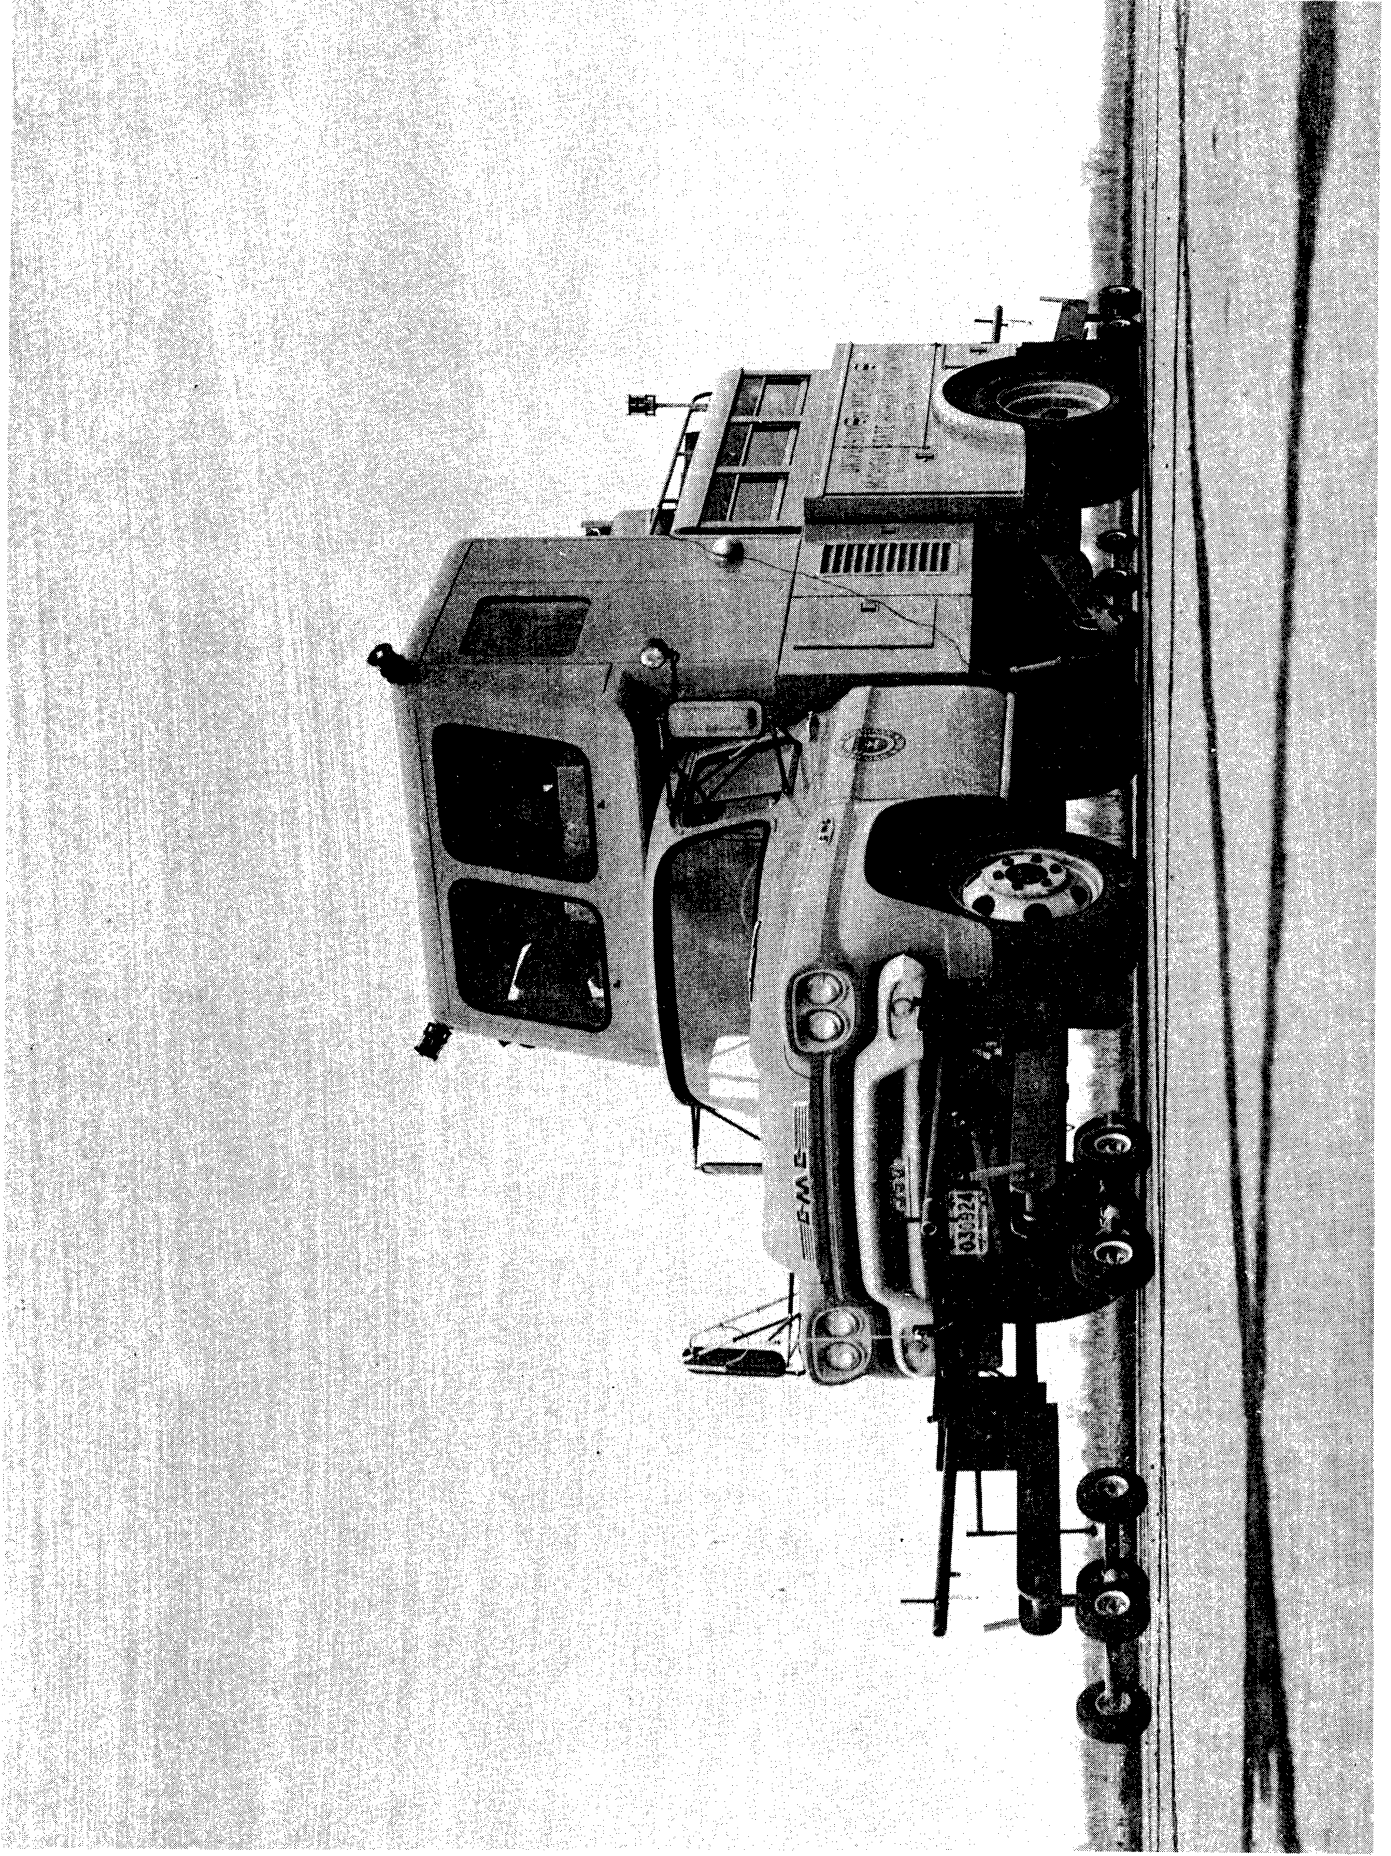
FIGURE-4 MICHIGAN TRUCK-MOUNTED PROFILOMETER

The University of Michigan equipment is modeled after that designed and used by the California State Highway Department. F. N. Hveem, Materials and Research Engineer for California, provided much useful information including plans and specifications for the design of their equipment and made California's experience available to the authors and their associates in designing and building the University of Michigan profile truck. In addition to recording the cumulative vertical displacement, equipment is provided for measuring and recording the location of cracks and joints, to provide a measure of the structural continuity of the pavement surface. Photographic equipment is also being developed to take a continuous film strip of the pavement coordinated with the recorded profile, but this has not been available for the surveys completed up to the present time. Means are also provided to measure and record the relative elevation in both wheel tracks, a device which is called a "roll indicator" with a recording pen in the center of the profile chart.

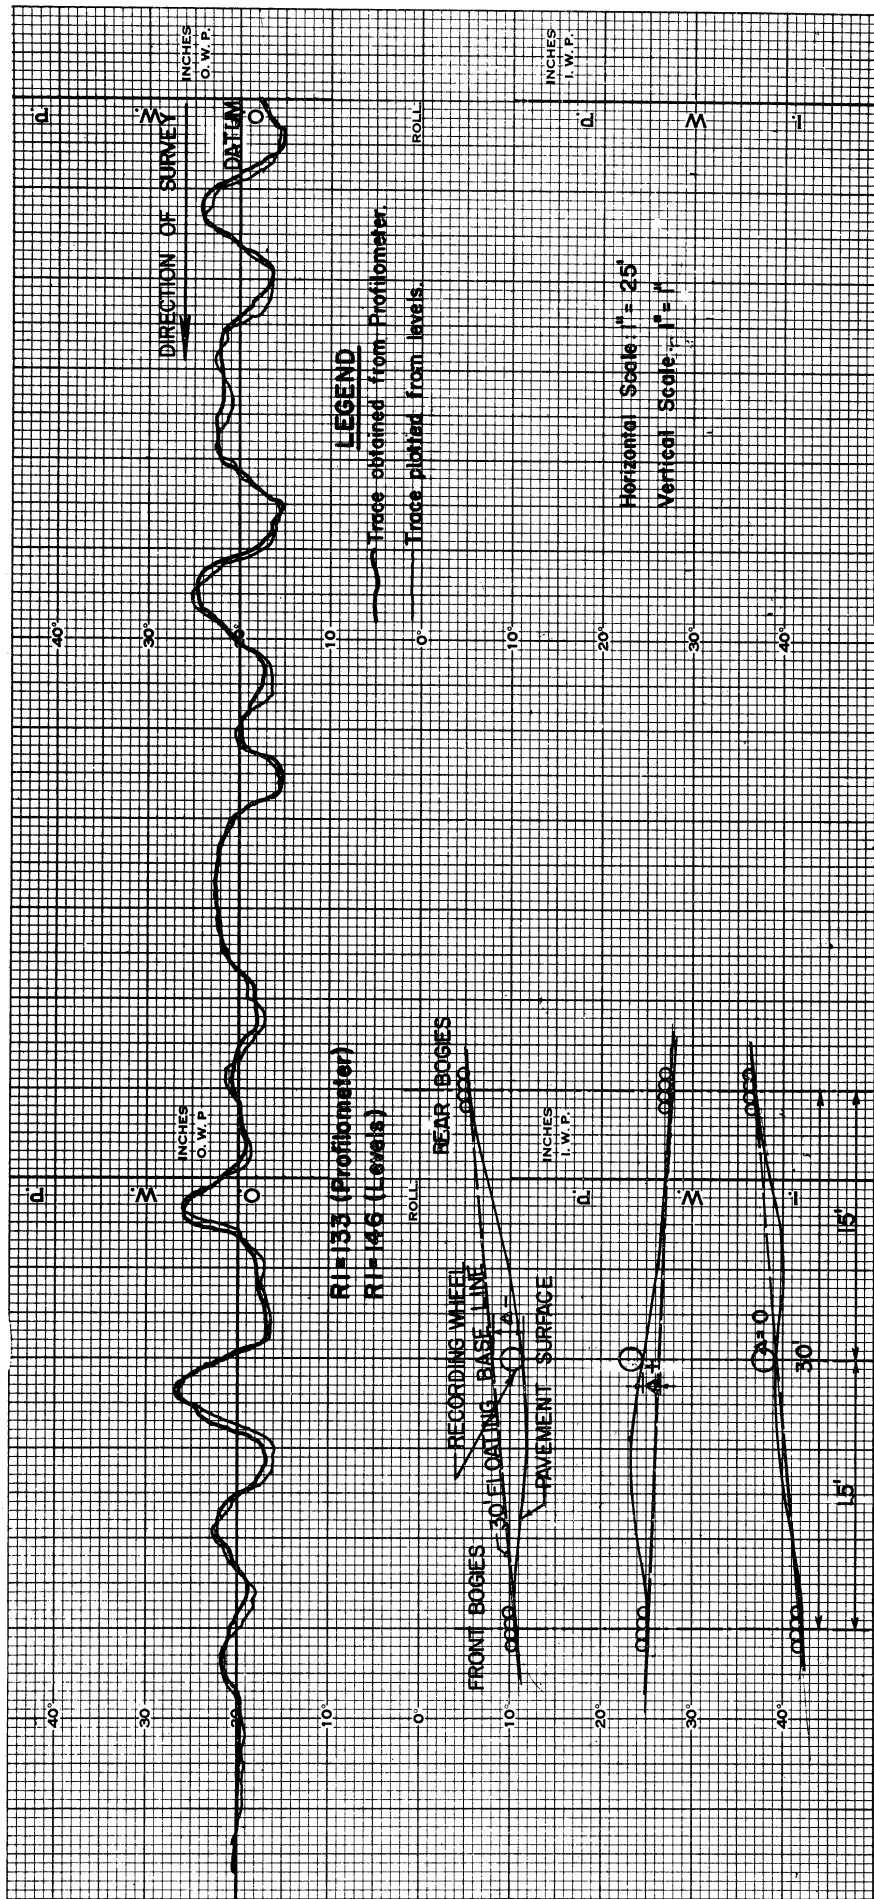
FIGURE-5
COMPARATIVE PAVEMENT PROFILE
ON TEST COURSE - WILLOW RUN AIRPORT

Up to the present time more than 1800 miles of pavement profiles have been accumulated covering some of the main traffic routes within the state and certain projects of special interest from the standpoint of research and design procedure. These data show that there is a wide variation in relative roughness on various roads throughout the state with differentials which appear to be great enough to serve as a means of identifying deficiencies in design or in the natural conditions to which the pavement is subjected. However, the use of a specific figure in terms of vertical inches of displacement per mile of pavement as a roughness index poses a somewhat different problem from relying upon the differential between two successive pavement profiles. In this connection it would be desirable to record actual vertical displacement that could be checked by precise level measurements or some other means so that it represents a definite physical condition rather than simply a relative roughness in empirical terms. Looking at it from this viewpoint, one of the first questions which arises in connection with the recorded pavement profiles is just what it is that the profile truck is measuring. The answer to this question depends primarily on the selection of a datum or zero elevation to which the measured vertical deflections may be referred. For the purpose of explanation, several pavement profiles taken on a test course at Willow Run Airport have been plotted for comparison in Fig. 5.

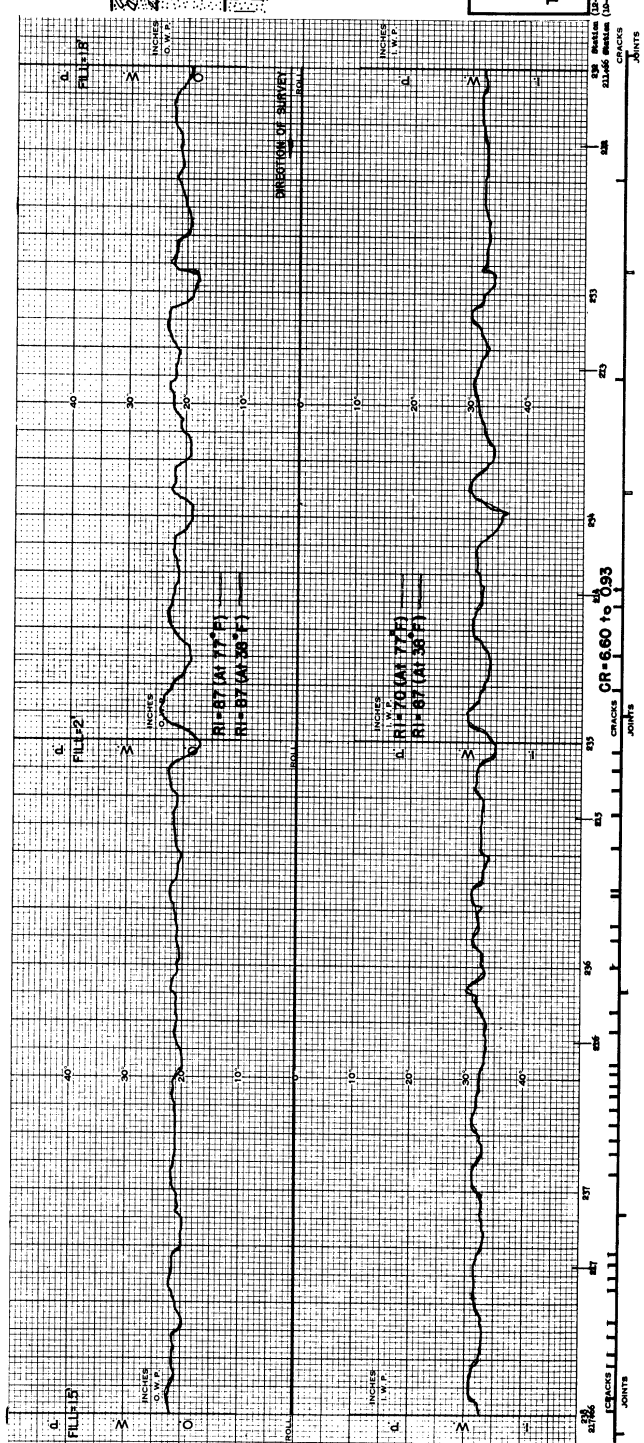
DRAINAGE: GOOD

FIGURE - 9 B
 CLASS - II RIGID
 M - 43, 1949 SERVICE 9 YEARS
 TRAFFIC: TOTAL 1500, COMMERCIAL 225, DHV 300
 DATE OF SURVEY: OCT. 7, 1958 & DEC. 4, 1958

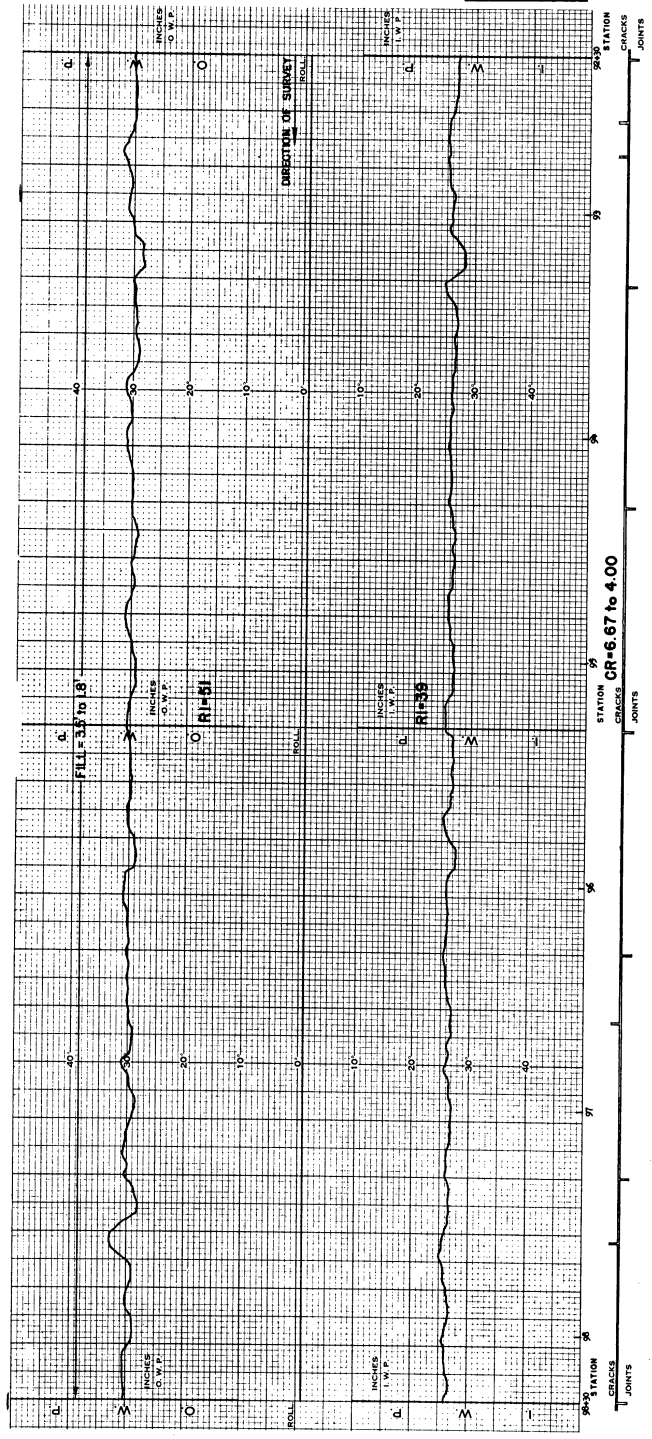
8" REIN. CONCRETE-1947
 12" SUBBASE: SAND
 SUBGRADE: SANDY CLAY
 DRAINAGE: GOOD

FIGURE -10 B
 CLASS-II RIGID
 M-43, 1947 SERVICE II YEARS
 TRAFFIC: TOTAL 1500-3300, COMMERCIAL 280, DHV 400
 DATE OF SURVEY: OCT. 7, 1958

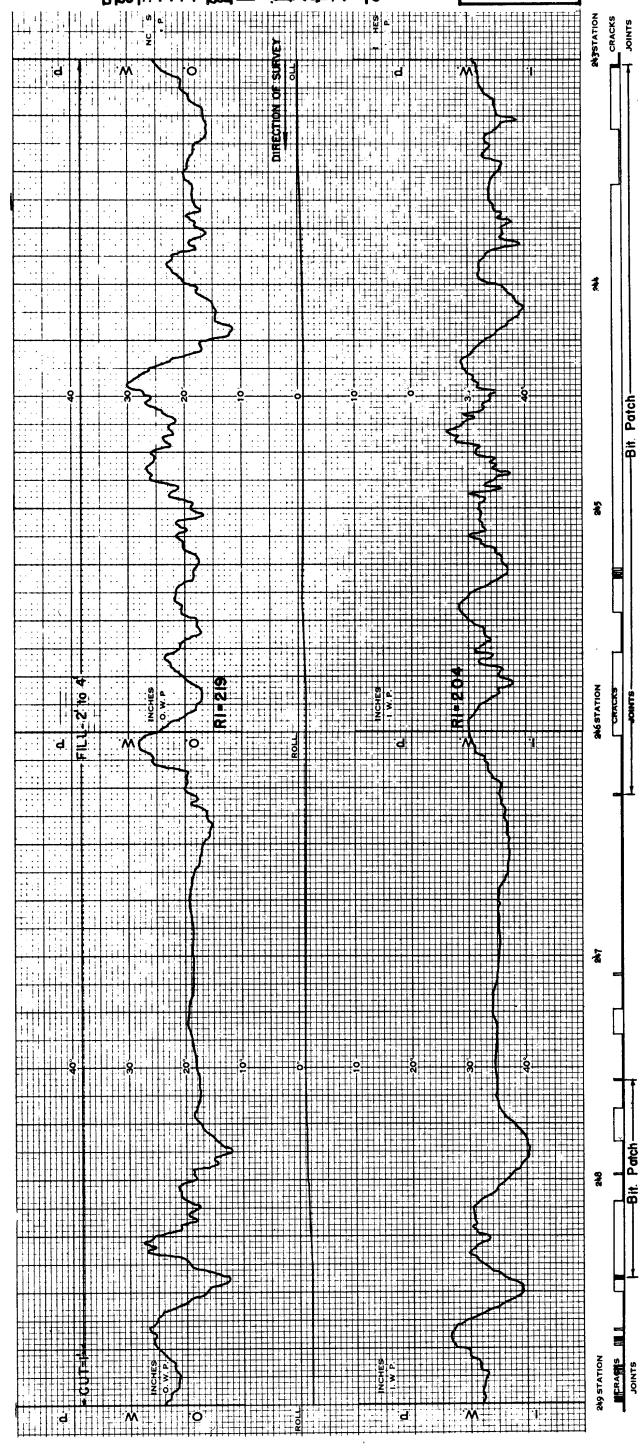
FIGURE-15 B
CLASS-III FLEXIBLE
M-100, 1953 SERVICE 5 YEARS
TRAFFIC: TOTAL 800, COMMERCIAL 160, DHV 200
DATE OF SURVEY: DEC. 4, 1958

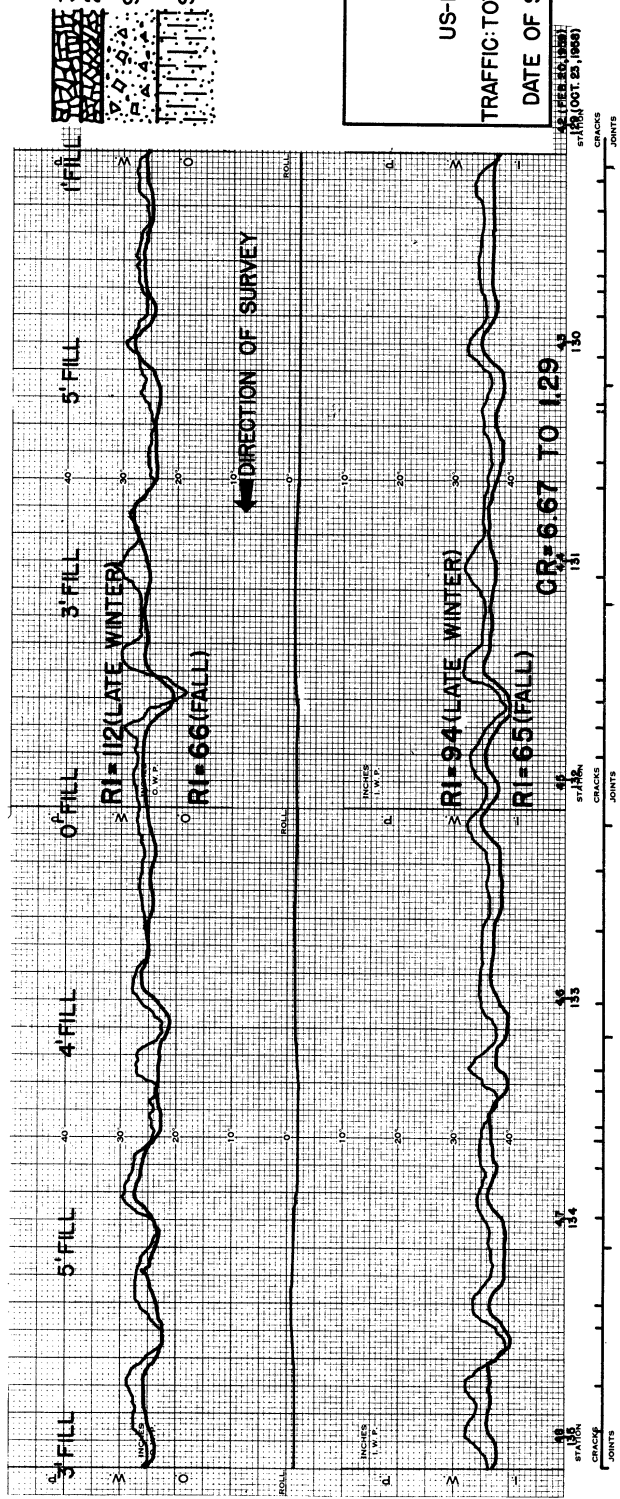
FIG. 14

3" BITUMINOUS CONCRETE - 1958
 2" BITUMINOUS CONCRETE - 1943
 9" 7"-9" PLAIN CONCRETE - 1926
 SUBGRADE: SANDY CLAY LOAM

DRAINAGE: POOR

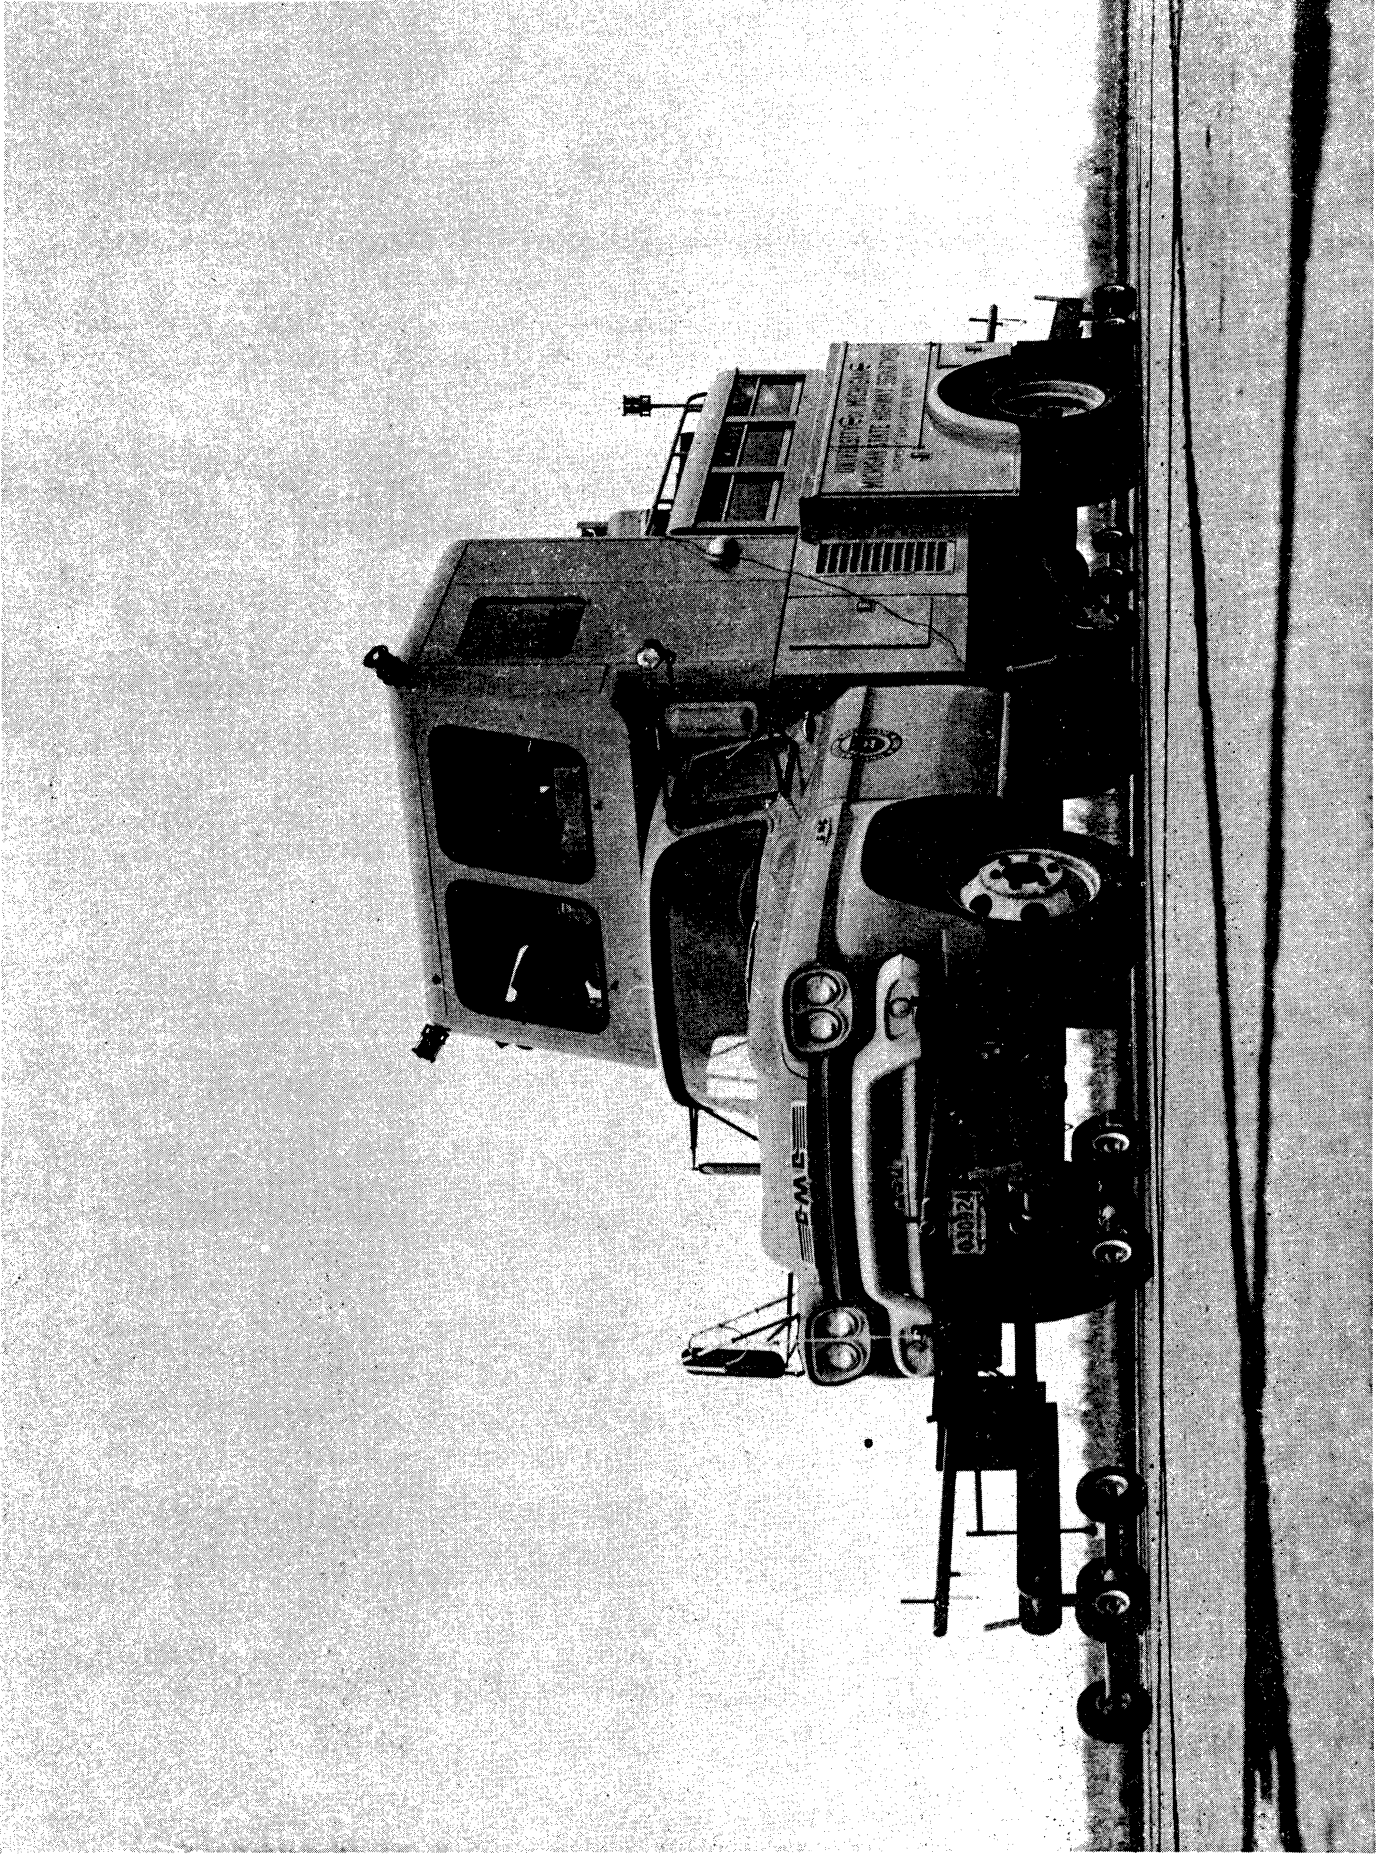
FIGURE - 4 MICHIGAN TRUCK - MOUNTED PROFILOMETER

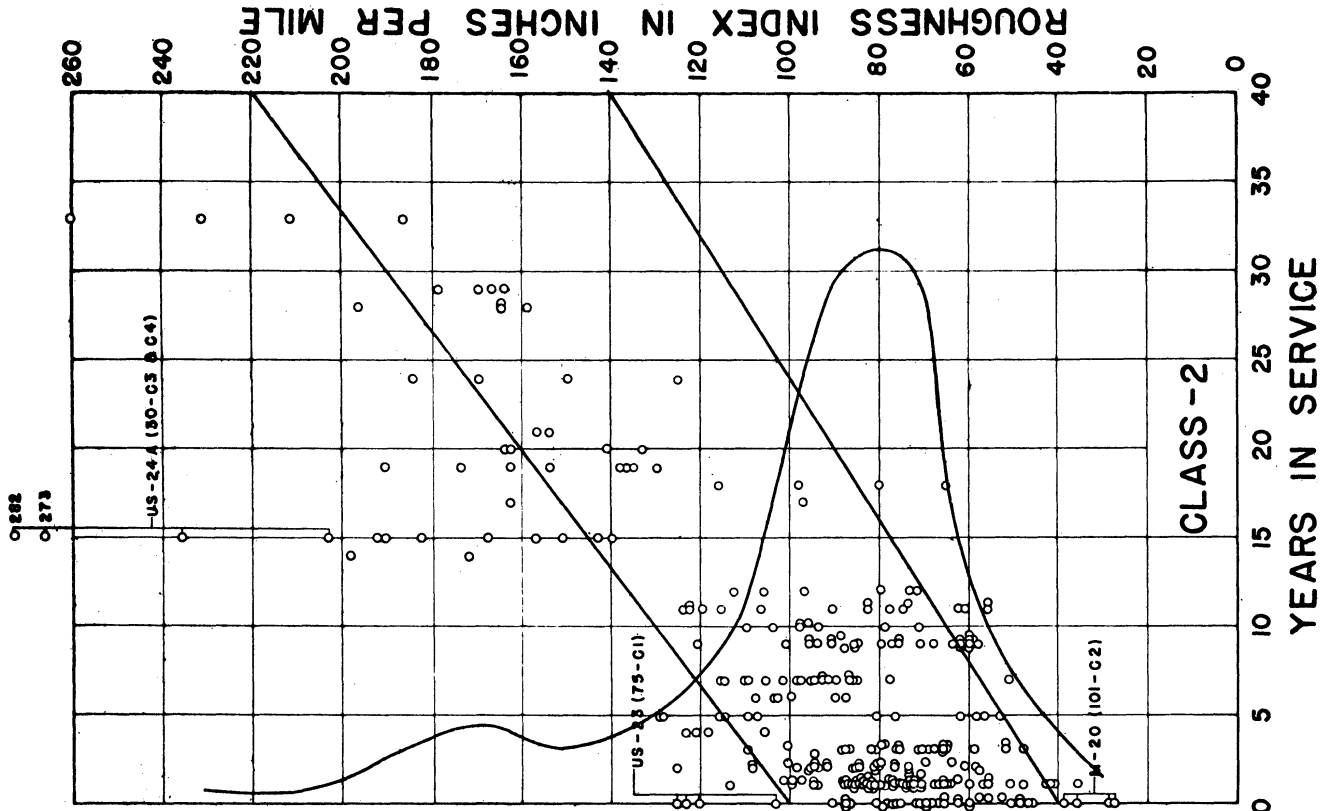
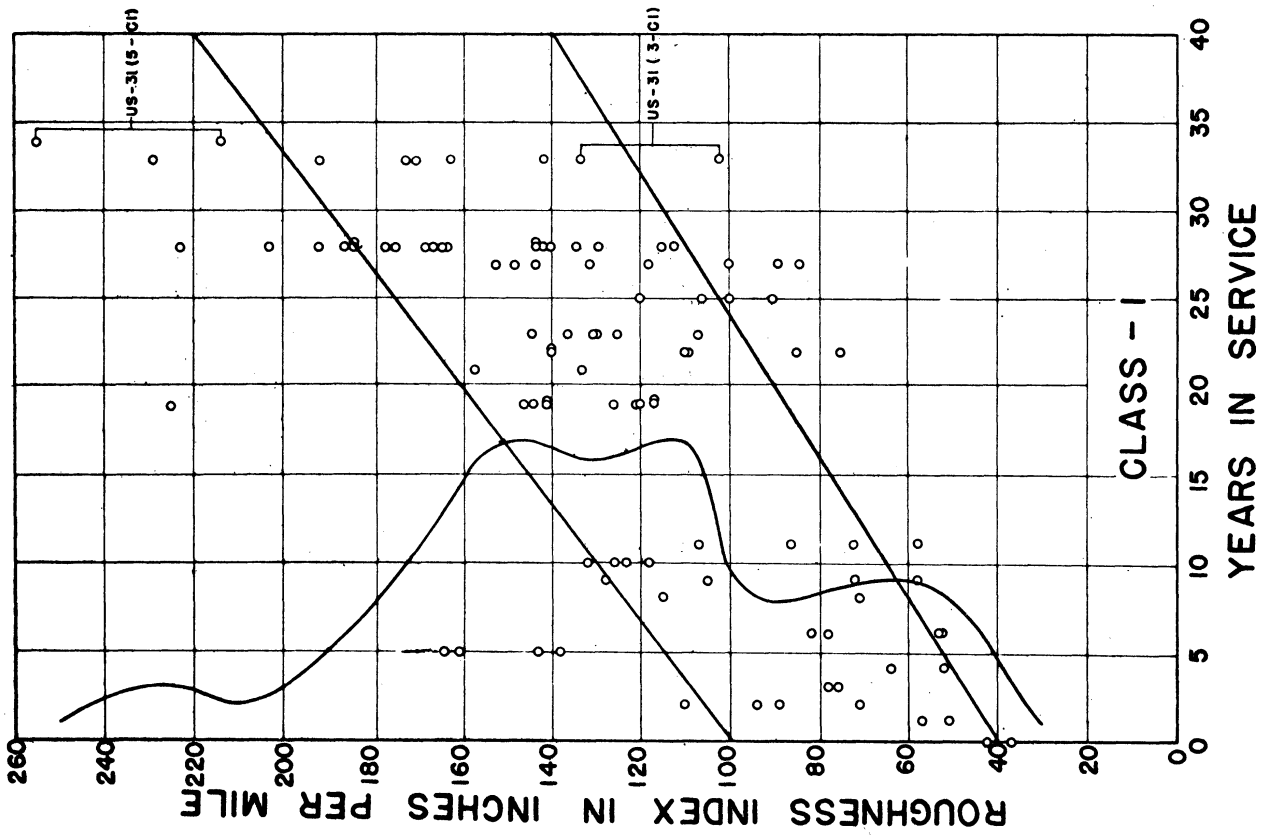
FIGURE - 15

ROUGHNESS VS. YEARS IN SERVICE
RIGID PAVEMENT
BASED ON 1958 SURVEY

In addition to the suggested band of normal behavior, two distribution curves have been sketched in on the two charts in Fig. 15 and these show quite a contrast in distribution of the pavement sections with respect to their roughness indexes. Class 1 pavements on the natural sand and gravel subgrades are spread out over a much wider range of roughness index than the Class 2 pavements, where there is a distinct grouping of points or peak in the curve at roughness indexes from 40 to 120. This suggests that the natural sand subgrades represent an uncontrolled condition insofar as compactness of the supporting subgrade is concerned, producing a much wider range of riding quality. Class 2 pavements, it may be recalled, are designed and built with sand subbases and granular base courses providing an opportunity for greater uniformity in texture and for improved compaction which has been practiced particularly in more recent years. The result, in terms of riding quality, is naturally enough much better and much more consistent, as should be expected under reasonably good construction control. As a matter of general observation and construction experience, road designers in the Michigan State Highway Department have come to the conclusion that it would be desirable to undercut the pavement structure itself and mix and compact the natural subgrade materials for a depth of some 18 inches in order to eliminate some of the variations due to nonuniformity in soil textures and soil densities. The data in Fig. 15 present positive evidence in support of such a construction procedure and it is being adopted by the Department.

In passing, it should be noted that there is a fairly uniform distribution in terms of years of service for the Class 1 pavements in Fig. 15; while, in the Class 2 pavements, the great majority of projects are concentrated in the first 15 years. This relates to the fact that the Department for the past 15 or 20 years has been correcting deficient subgrades to provide year-round service by the use of sand subbases and improved drainage. Prior to that time, there were very few Class 2 pavements built and they did not come up to present

Among the Class 2 pavements, three contracts have been selected for special comment. US-24A with roughness indexes which fall off the chart is the pavement of 20 foot, unreinforced concrete slabs without load transfer at the joints that has already been commented on in connection with Fig. 11. The other two projects, built in 1958, are M-20 and US-23. M-20 has an initial roughness index below 40, which would be rated as exceptionally smooth, and is the result of special care in placing and finishing the concrete slab. It too has already been commented on in connection with Fig. 12, and represents riding quality which can be produced under construction conditions when the effort is made to do so. The other section, US-23, represents a poorly built job with roughness index which would be rated only fair, and represents poor performance on the part of the contractor. When it is considered that riding quality is the basic commodity which is being purchased when a pavement is built, it seems fairly obvious that a large proportion of the investment has been lost by poor construction practice. "Built-in roughness" of this character is something that has not been given the attention it deserves, and one immediate benefit of the statewide recording of profiles has been to call attention to this deficiency in pavement construction practice and to provide a quantitative basis for correcting it.

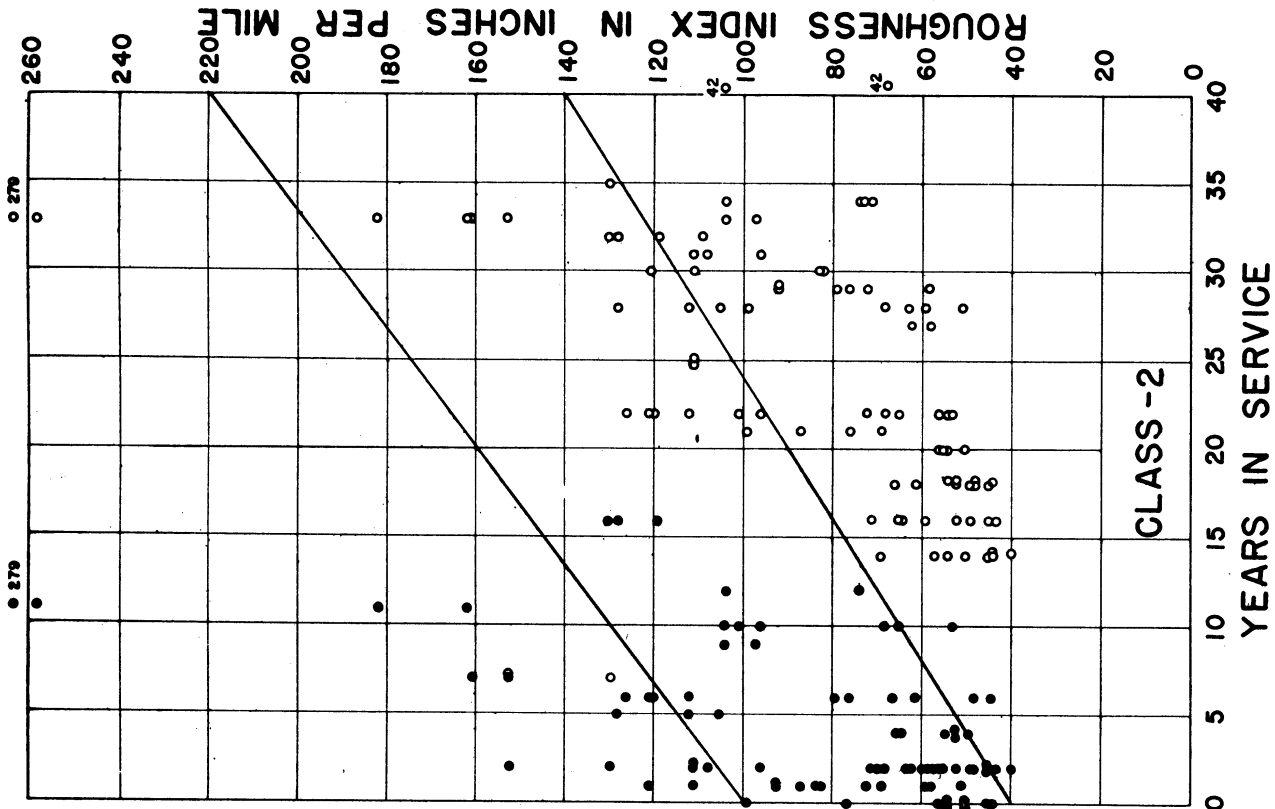
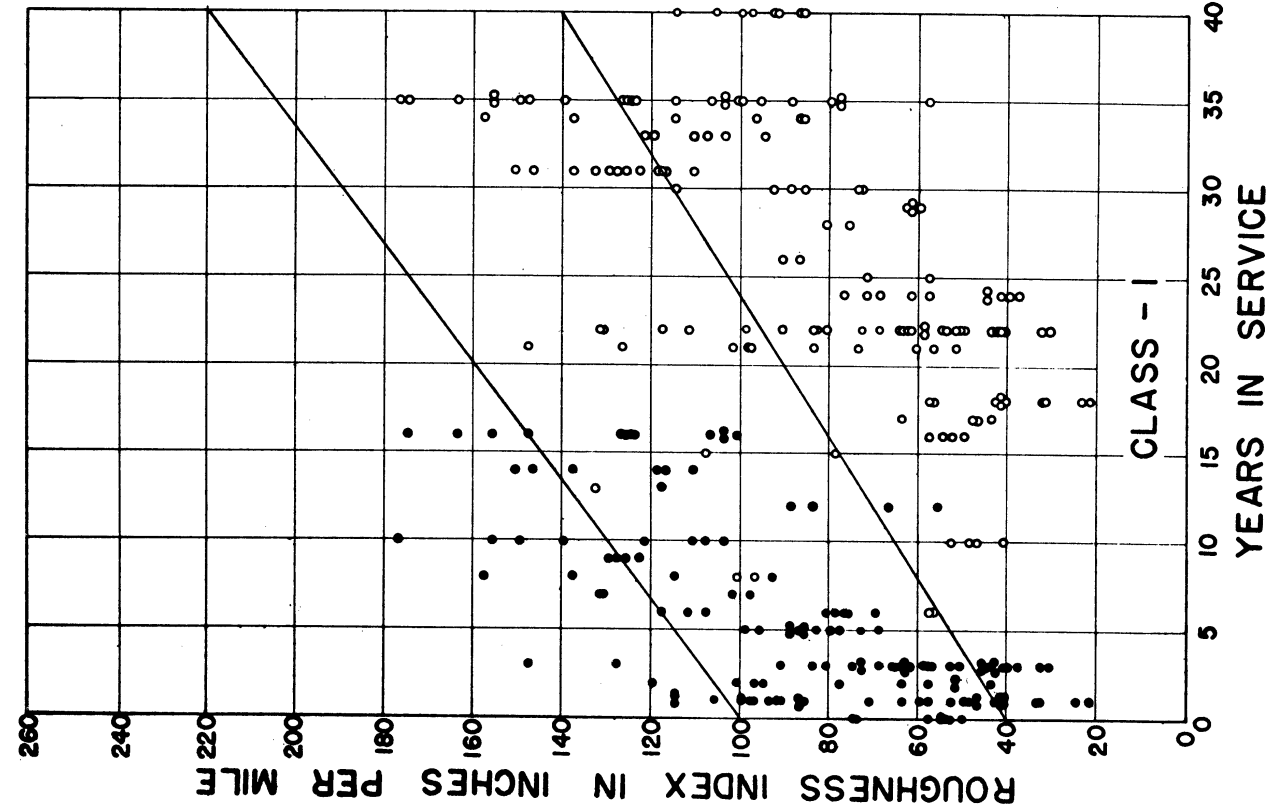
○ FROM YEAR BUILT
● FROM YEAR RESURFACED

In Fig. 16 are shown two similar charts comparing roughness index with years in service for older concrete pavements that have been recapped with a bituminous surface. The bands that have tentatively been used to represent normal behavior of structurally adequate pavements are shown on these charts largely for a basis of comparison. Roughness indexes for the pavement sections in question have been plotted against the years in service of the original concrete pavement and also in terms of years of service of the resurfacing. In this discussion, comment will be limited to the groups of points falling above and below the normal service band as they may provide the clue to the more important design conditions which are involved in service behavior.

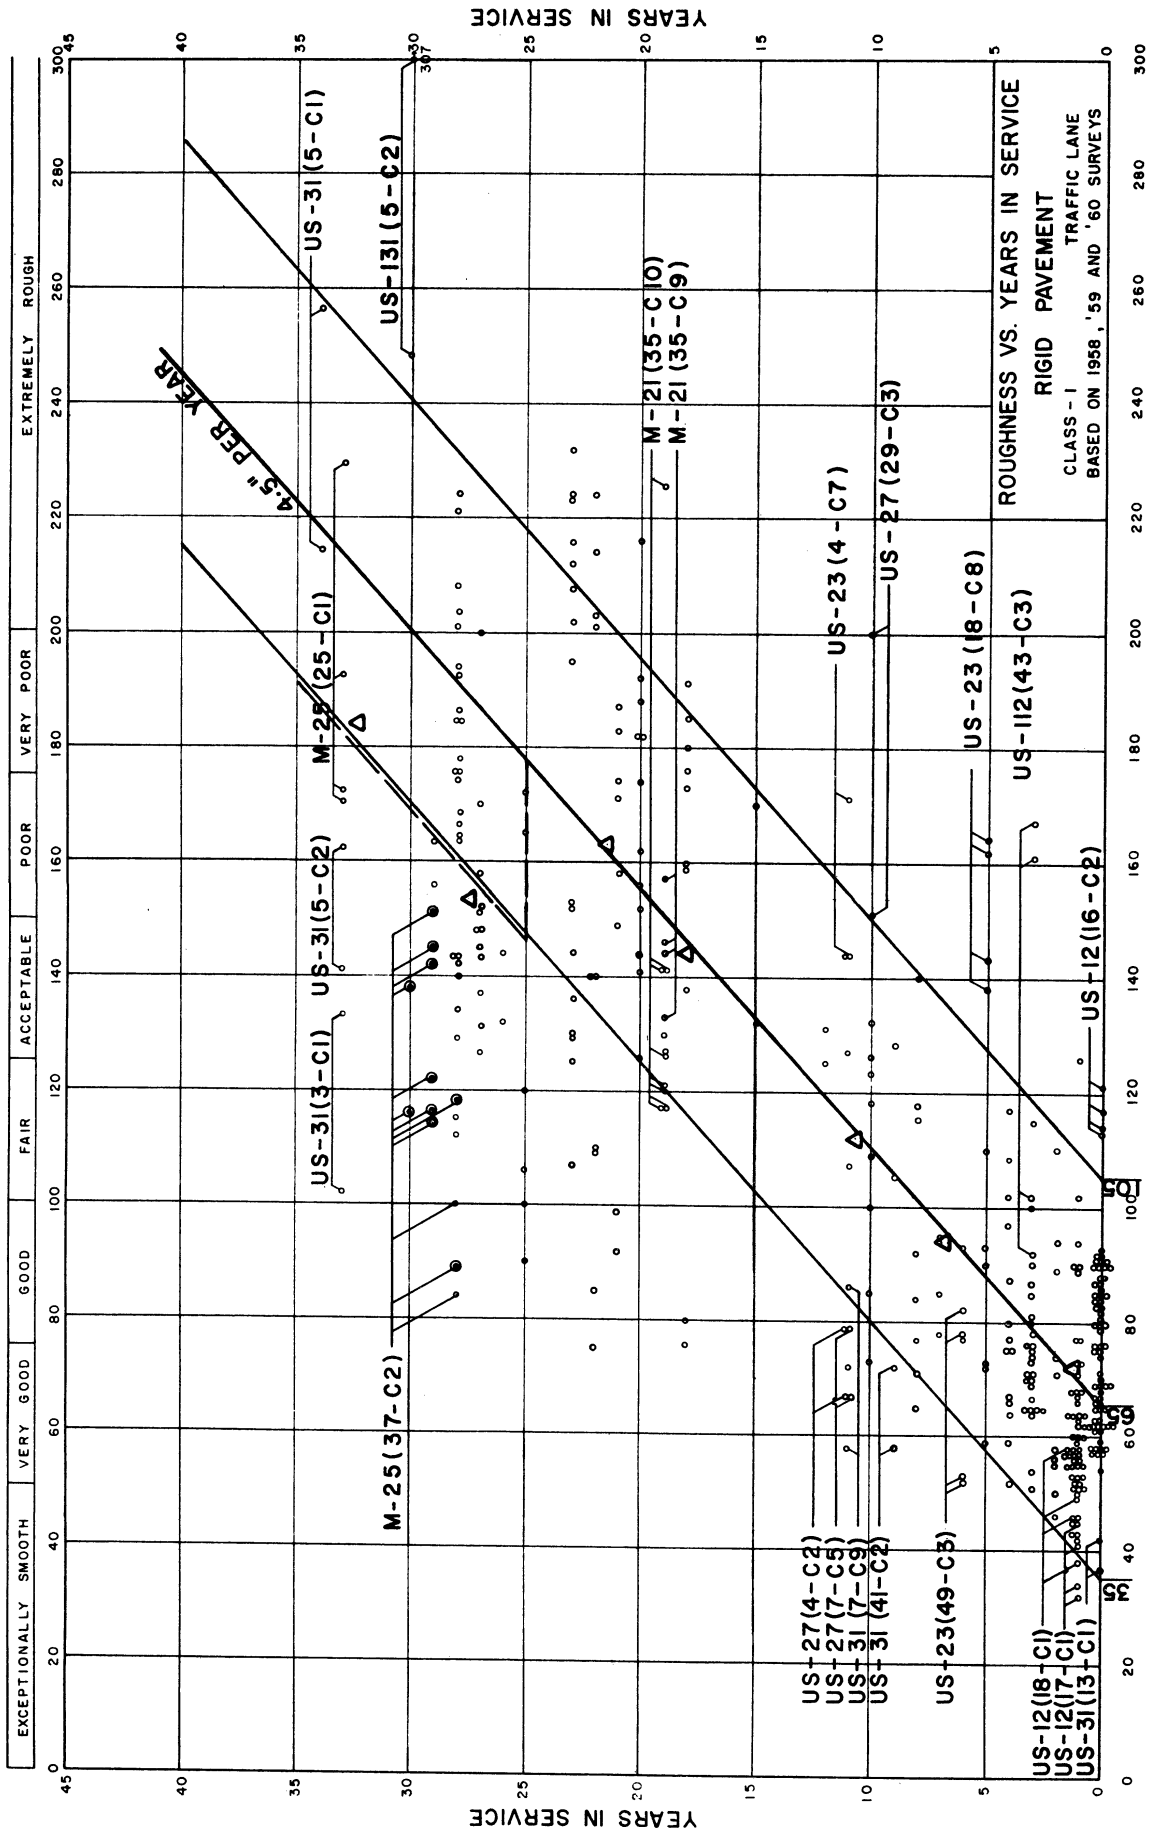
FIGURE - I

ROUGHNESS VS. YEARS IN SERVICE
 CLASS - I
 RIGID PAVEMENT
 TRAFFIC LANE
 BASED ON 1956, '59 AND '60 SURVEYS

ROUGHNESS INDEX IN INCHES OF VERTICAL DISPLACEMENT PER MILE (R.I.)

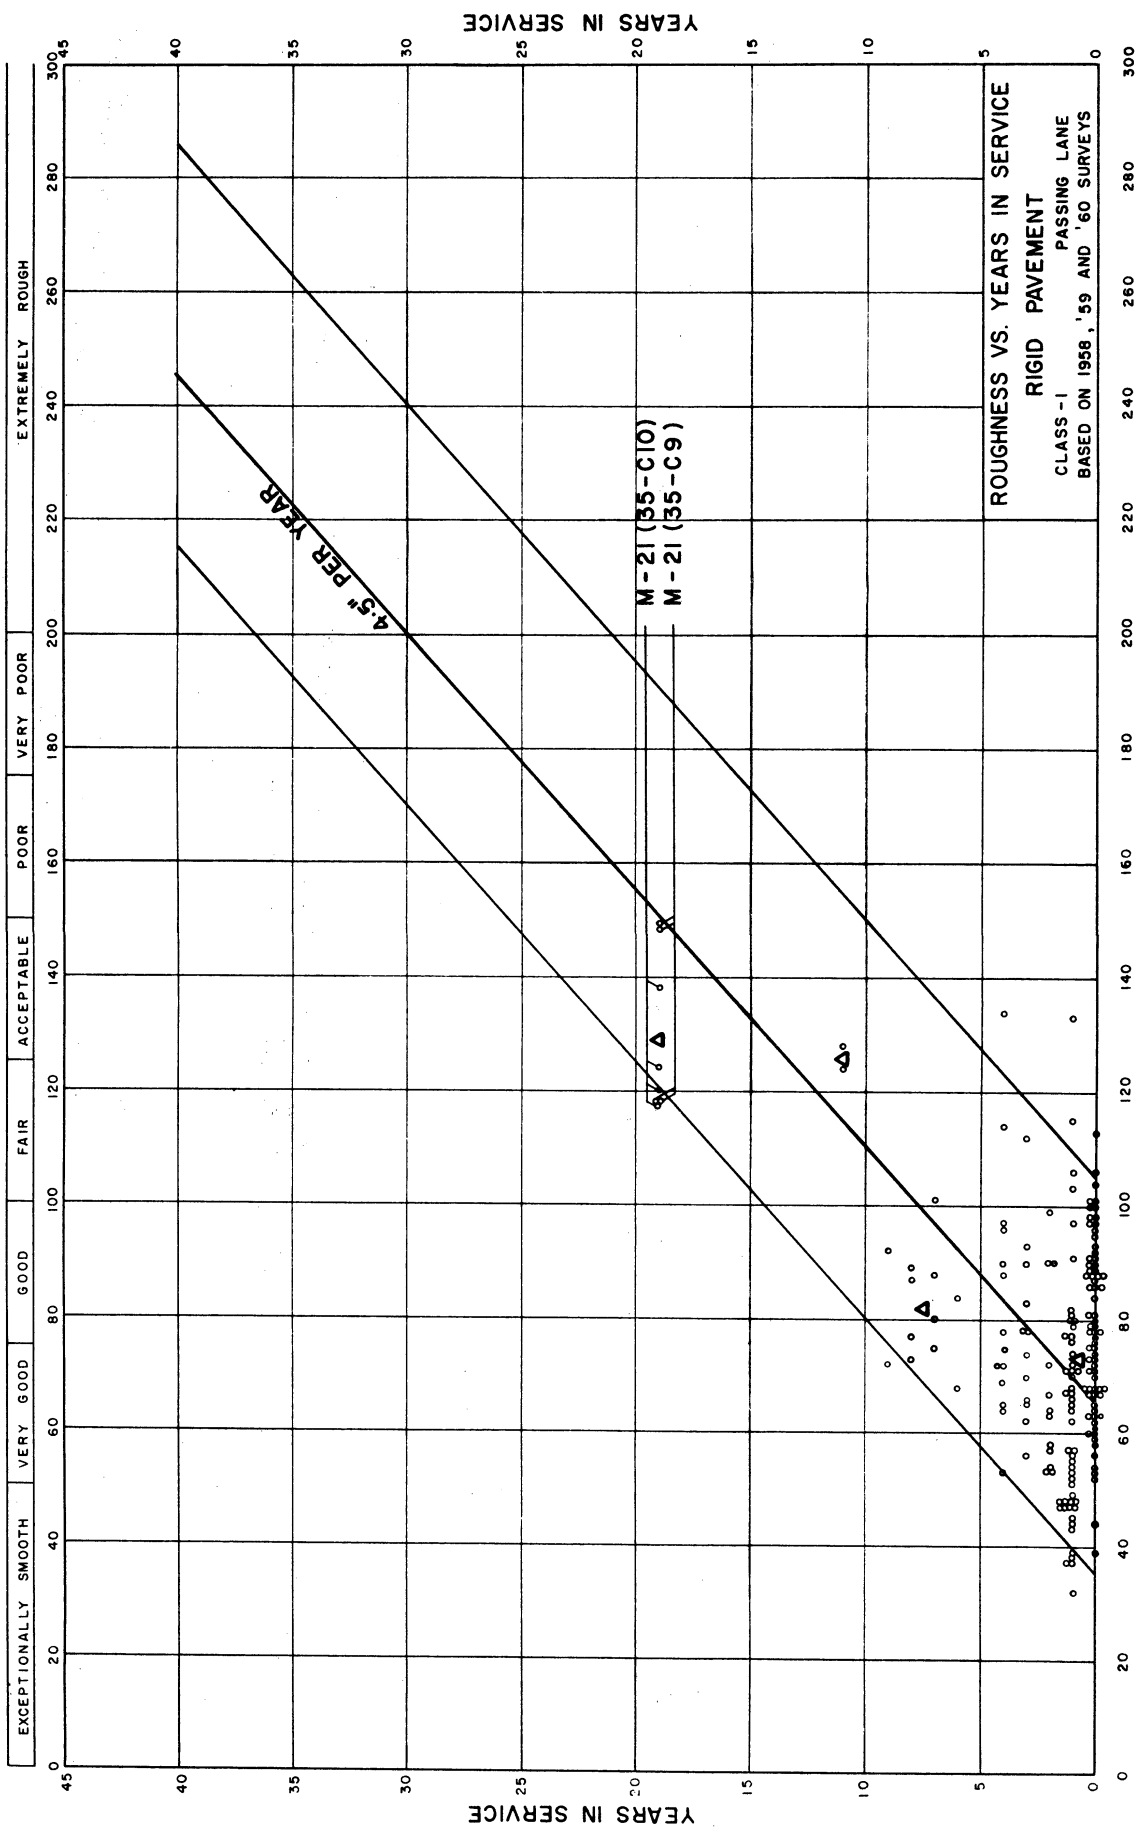
FIGURE - 3

ROUGHNESS VS. YEARS IN SERVICE
 RIGID PAVEMENT
 CLASS - I
 PASSING LANE
 BASED ON 1958, '59 AND '60 SURVEYS
