MICHIGAN PAVEMENT PERFORMANCE STUDY

FIVE YEAR SUMMARY

PAVEMENT PROFILE SURVEYS TO CORRELATE

MICHIGAN DESIGN PRACTICE WITH

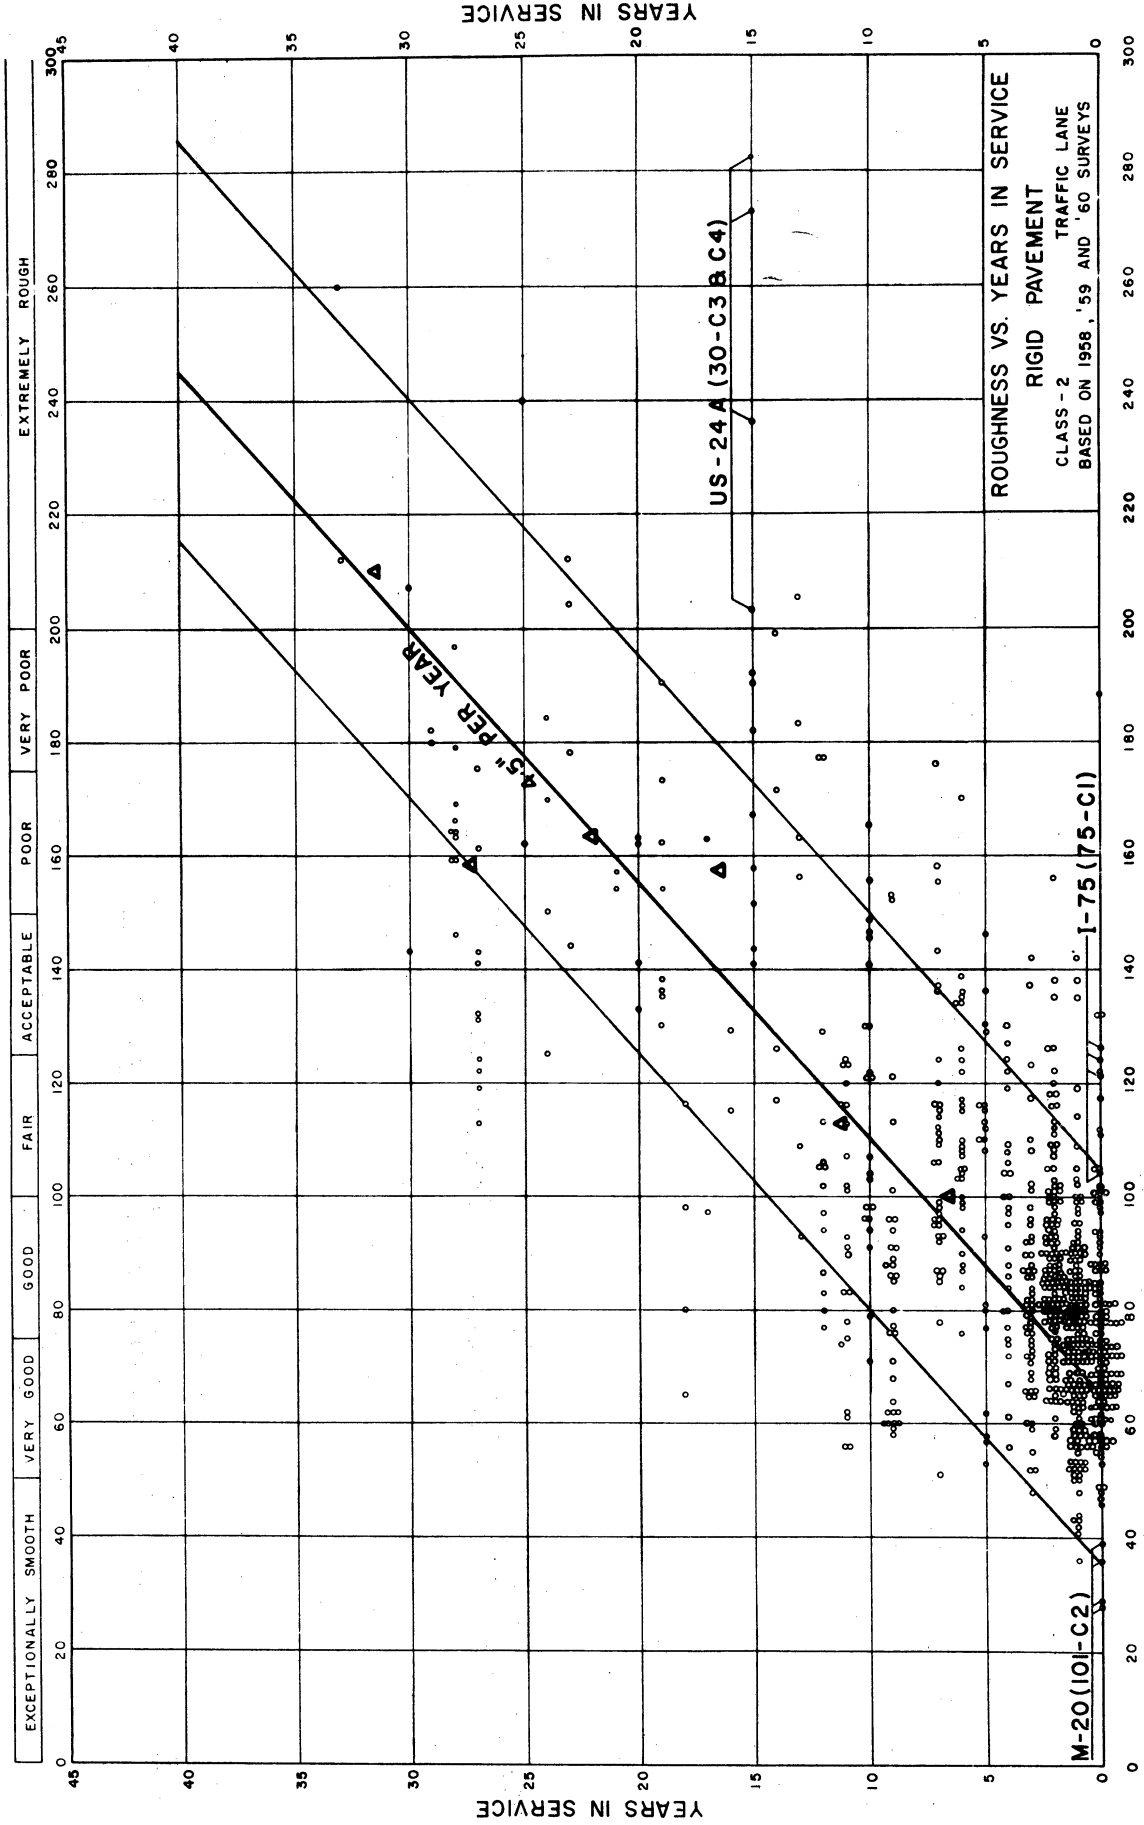
FIGURE - 4

ROUGHNESS VS. YEARS IN SERVICE RIGID PAVEMENT CLASS - 2 TRAFFIC LANE BASED ON 1958, '59 AND '60 SURVEYS

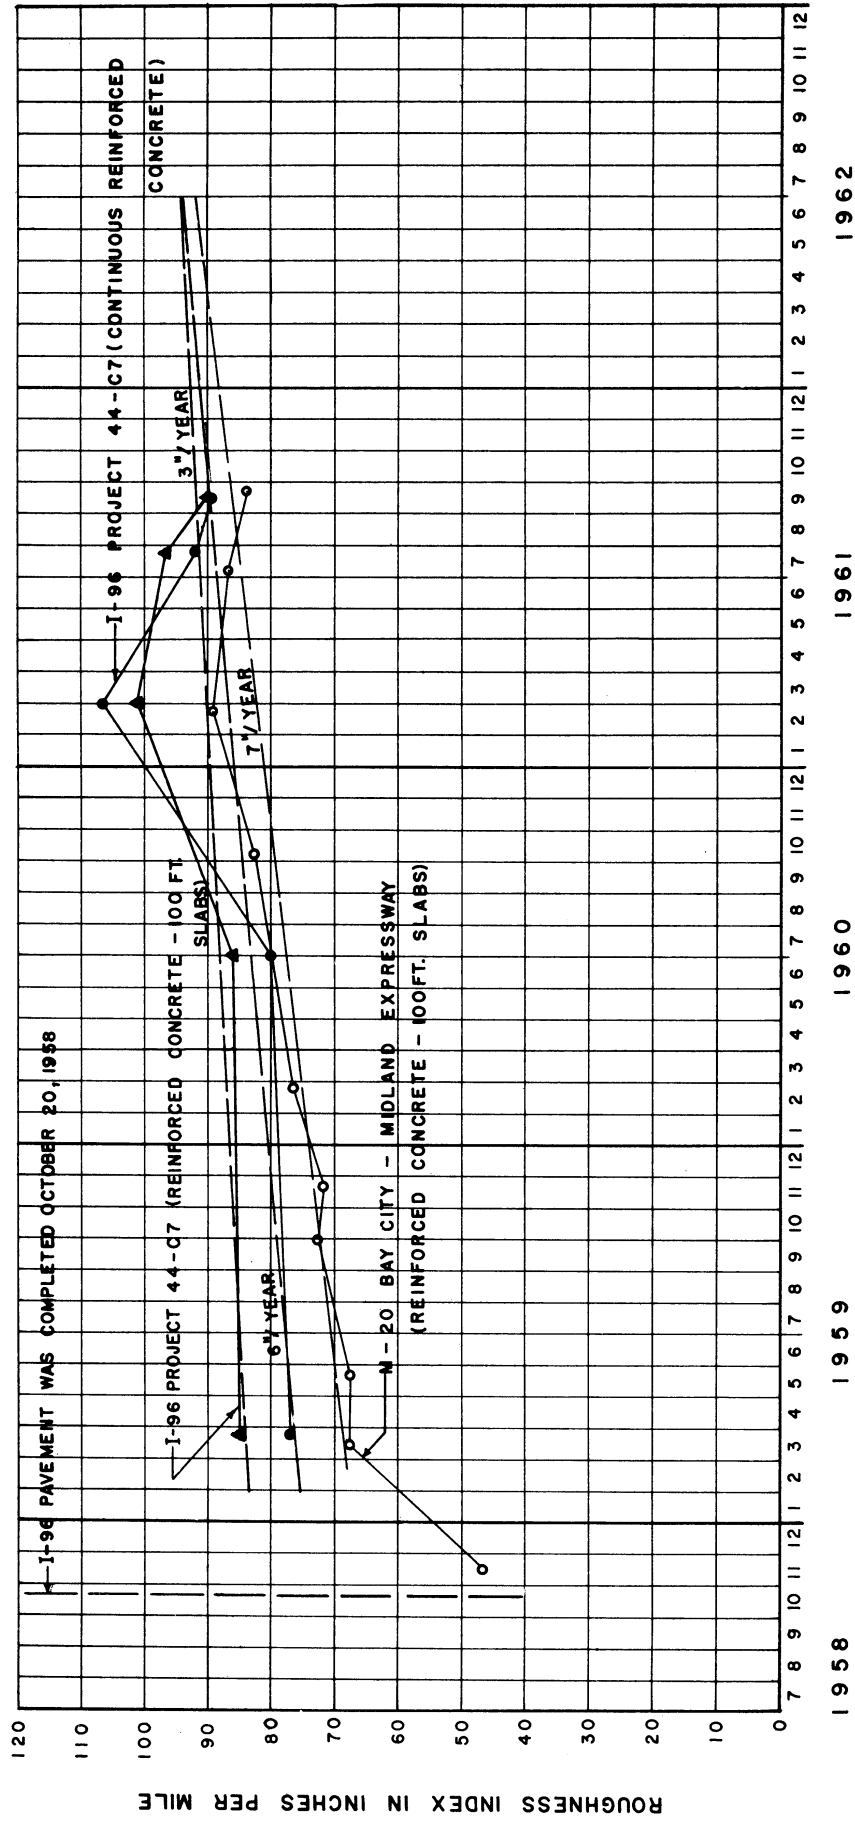
FIGURE - 9

CUMULATIVE CHANGE IN ROUGHNESS
ON SPECIFIC PROJECTS

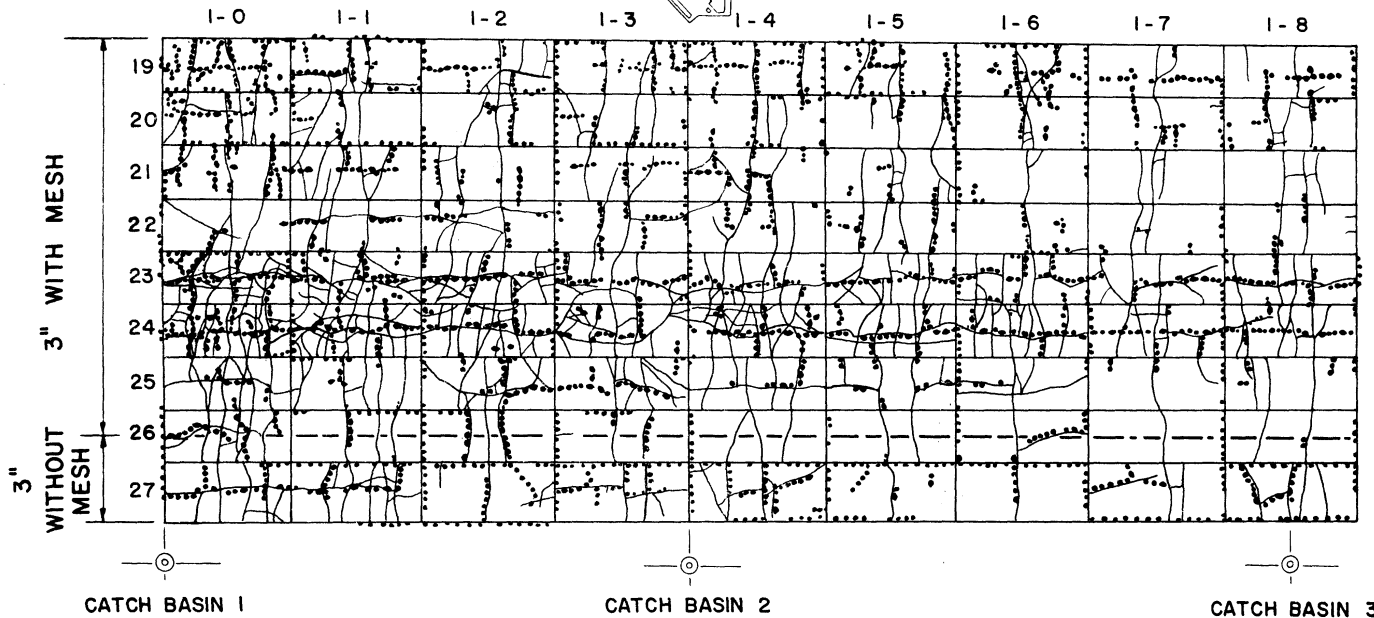
AREA A-l-m-a
REFLECTED CRACKING, 33% (38%)

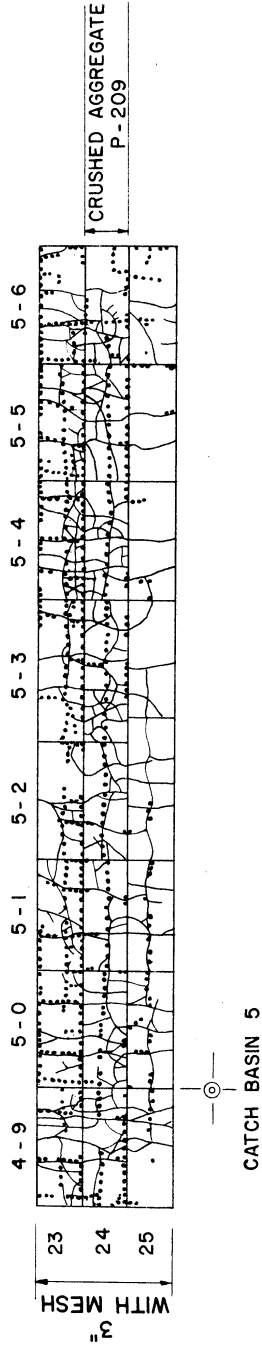
AREA A-2
 REFLECTED CRACKING
 LANE 23, 46% (51%)
 LANE 24, 32% (35%)
 LANE 25, 14% (17%)

SURVEYED ON 5-25-57
 SURFACED IN 1955

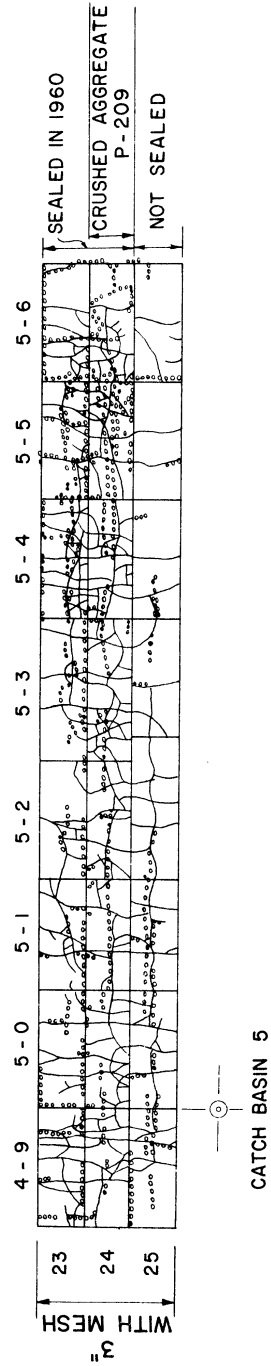
AREA A-2
 REFLECTED CRACKING
 LANE 23, 30% (32%)
 LANE 24, 32% (35%)
 LANE 25, 19% (22%)

SURVEYED ON 10-4-61
 SEALED IN 1960
 SURFACED IN 1955

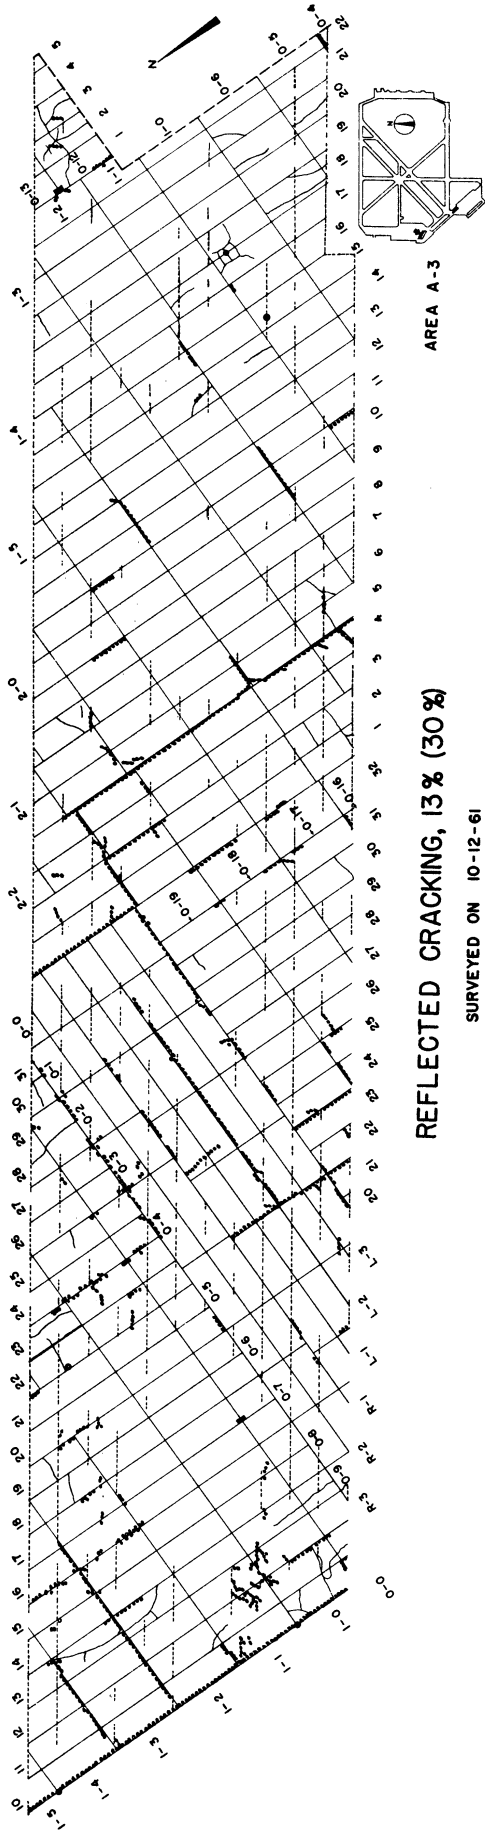
REFLECTED CRACKING, 13% (30%)

SURVEYED ON 10-12-61
EPON ASPHALTIC CONCRETE PLACED IN 1960

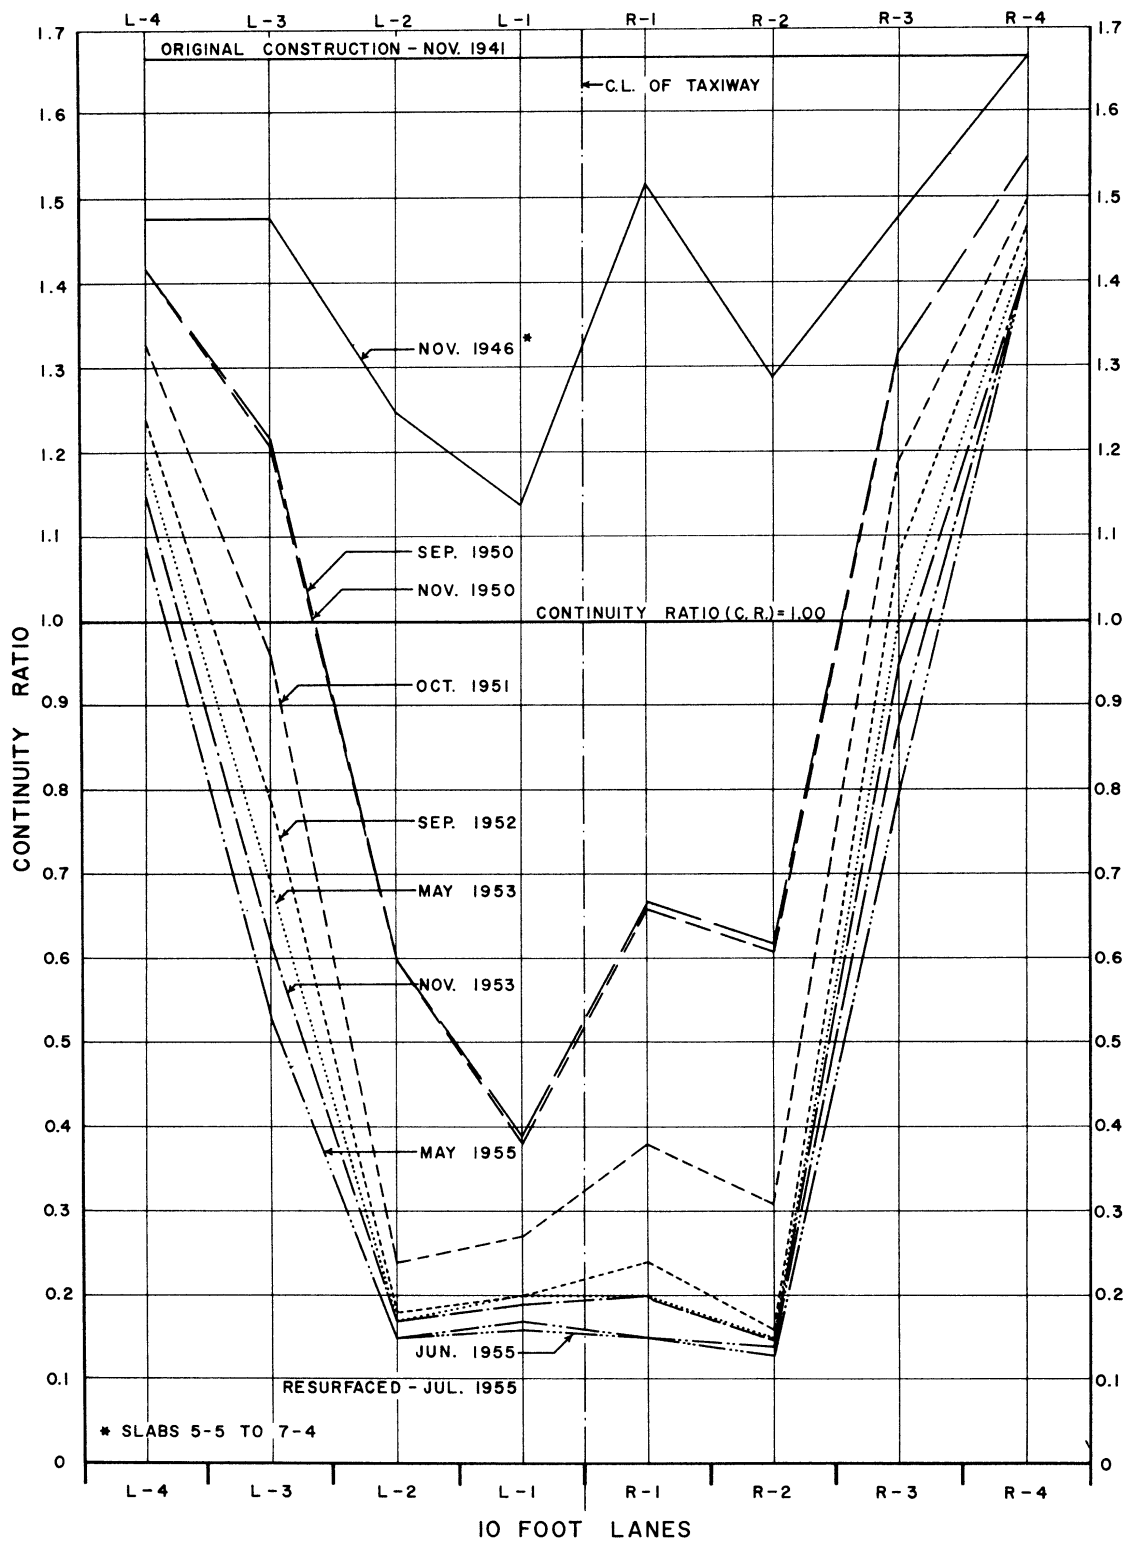
FIG. 4

CHANGE IN CONTINUITY RATIO BY LANES
 CENTER TAXIWAY - B - ORIGINAL PAVEMENT (SLABS 5-5 TO 8-6)

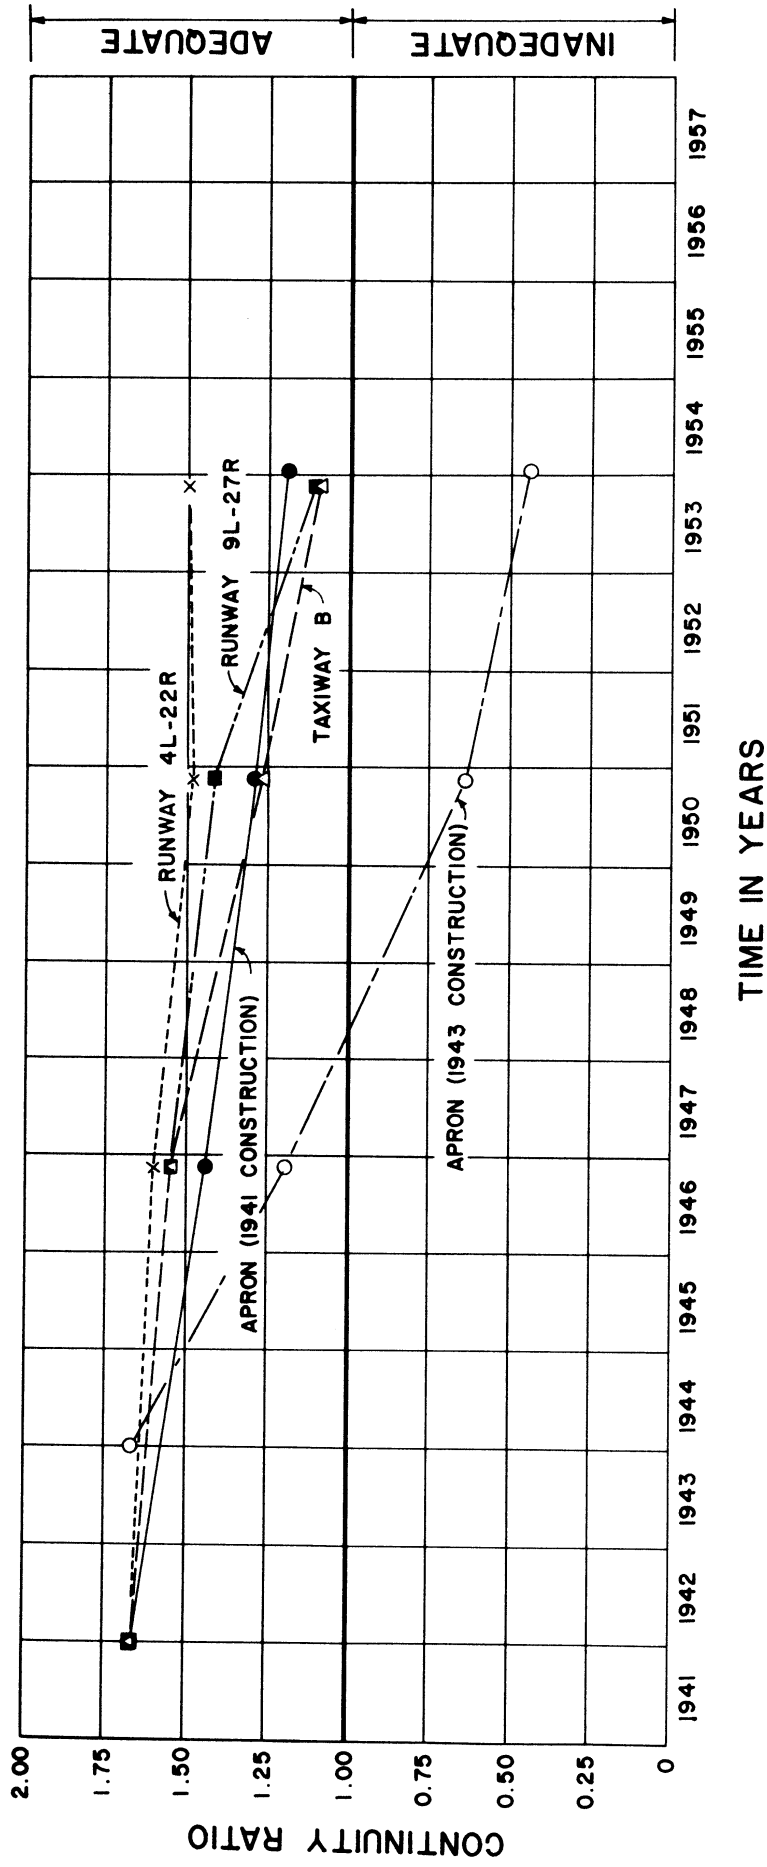
FIG. 5

CHANGE IN CONTINUITY RATIO - FIELD AVERAGE FOR TYPICAL PAVEMENT
WILLOW RUN AIRFIELD

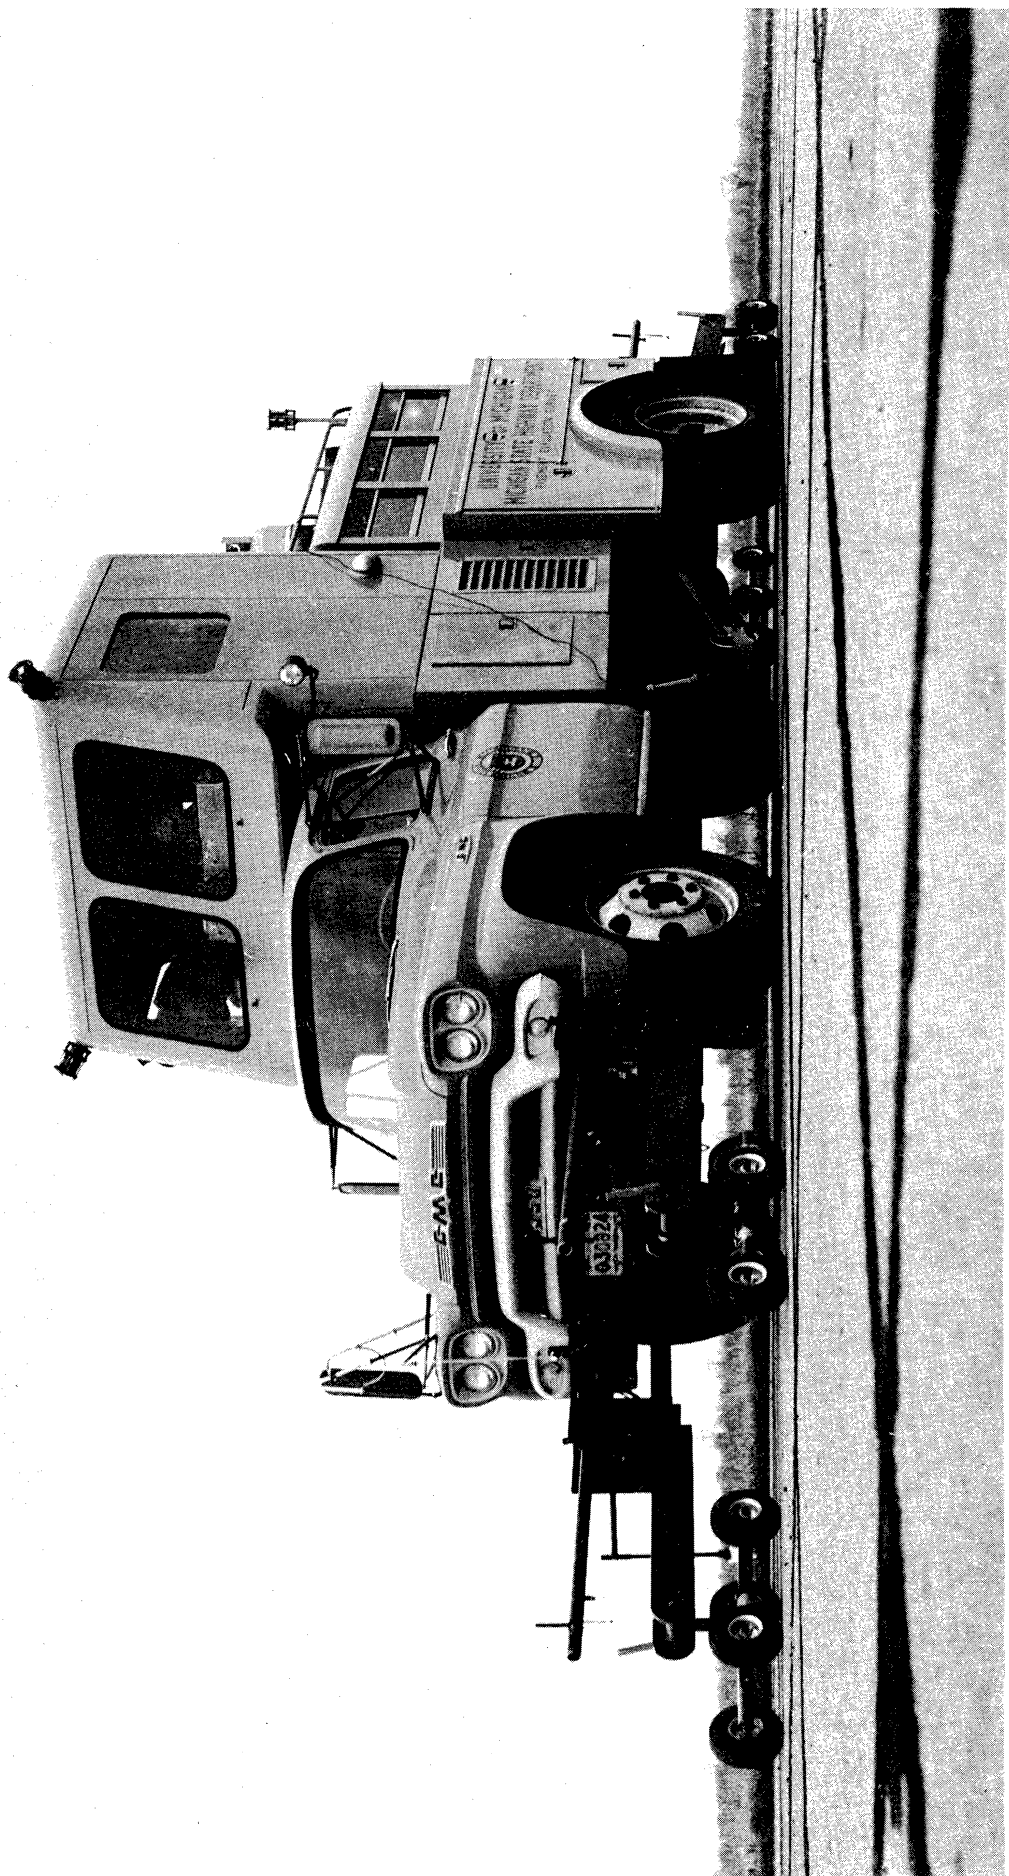
FIG. 6

MICHIGAN TRUCK - MOUNTED PROFILOMETER

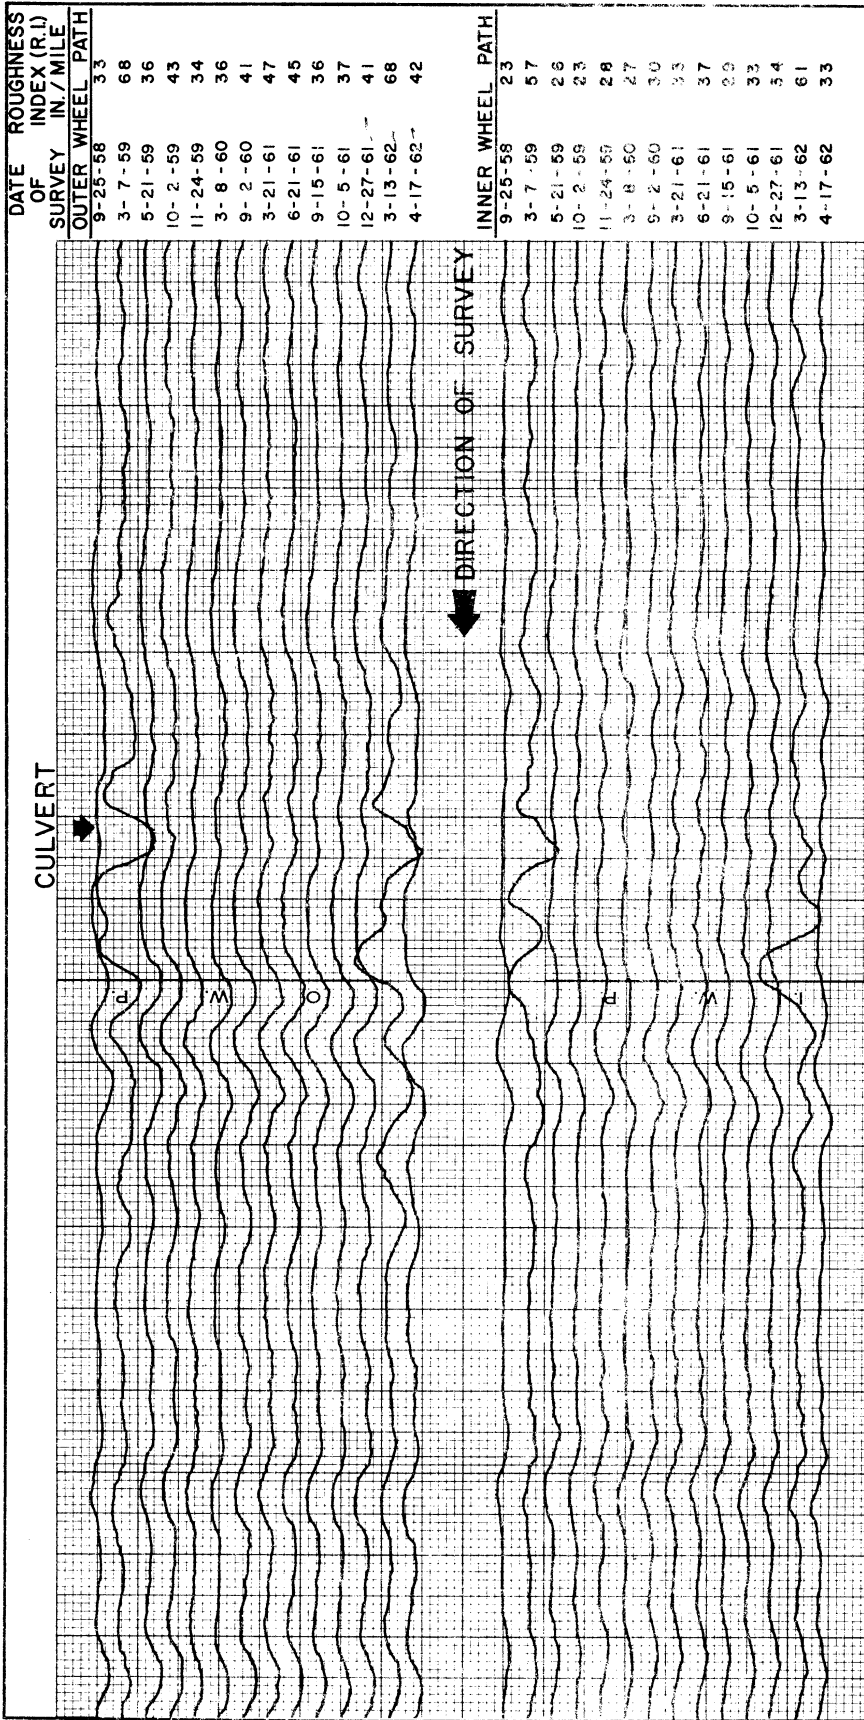
THE ABOVE ROUGHNESS INDICES ARE FOR THE PRESENTED SECTION, LOCATED BETWEEN 915' TO 465' SOUTH OF BERG ROAD.

4 1/2" BITUMINOUS CONCRETE
 4" AGGREGATE BASE (58% CRUSHED)
 4" AGGREGATE BASE (58% CRUSHED)] SPREAD IN ONE
 3" SELECTED AGGREGATE SUBBASE] OPERATION

CUMULATIVE CHANGES IN ROUGHNESS
 US-31 MUSKEGON - GRAND HAVEN EXPRESSWAY
 CLASS-1 FLEXIBLE PAVEMENT

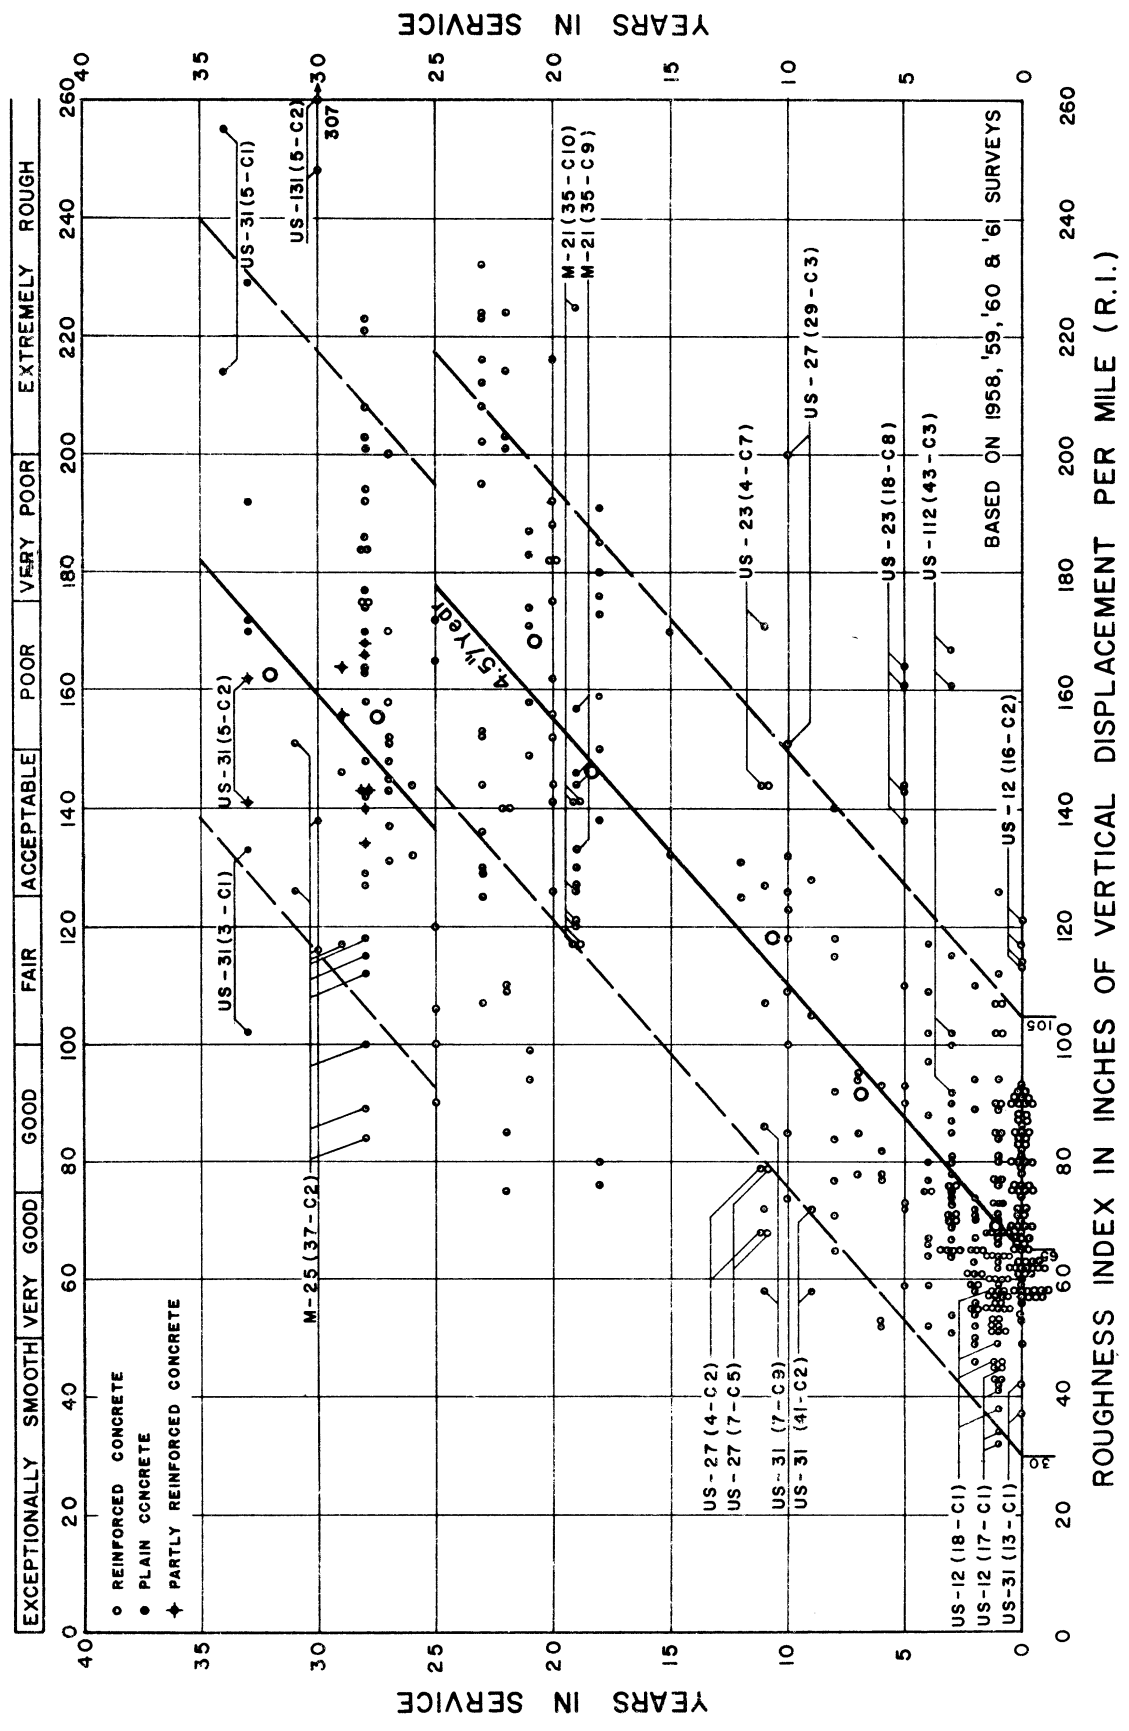
FIG. 17

CUMULATIVE CHANGES WITH AGE IN SERVICE

RIGID PAVEMENT - CLASS - I

TRAFFIC LANE

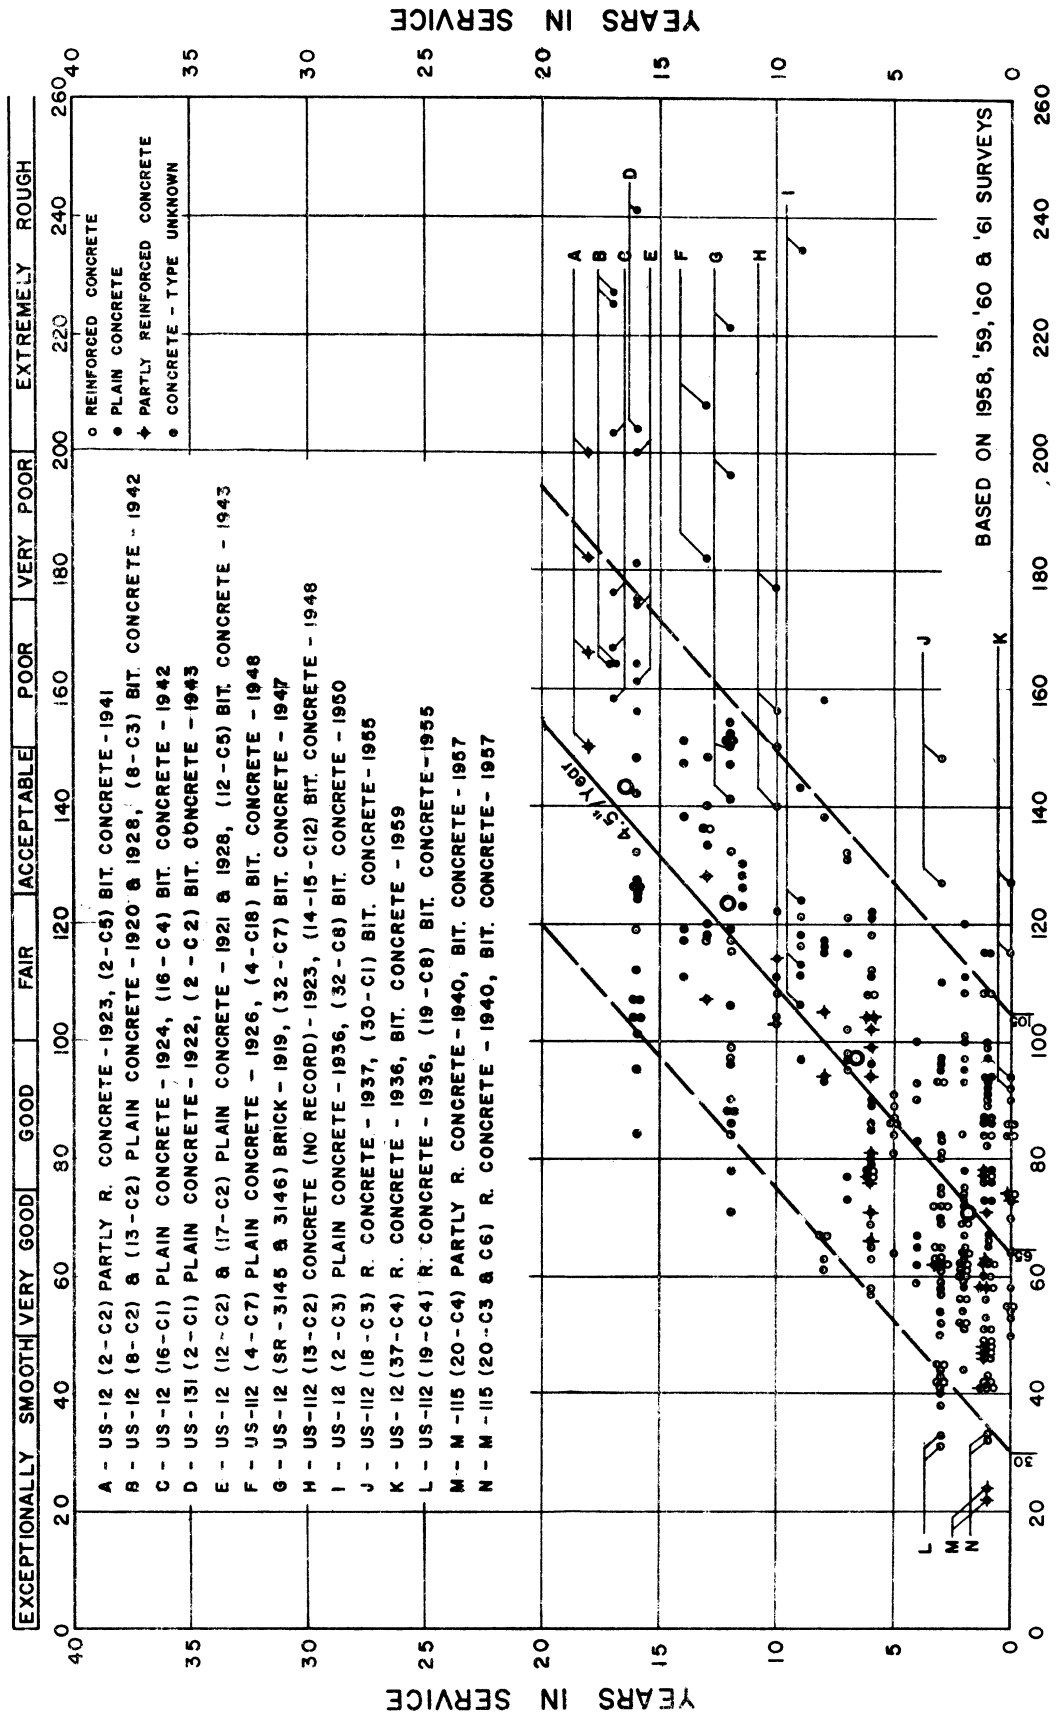
FIG. 18

CUMULATIVE CHANGES WITH AGE IN SERVICE
 RECAPPED CONCRETE PAVEMENT - CLASS - I

TRAFFIC LANE

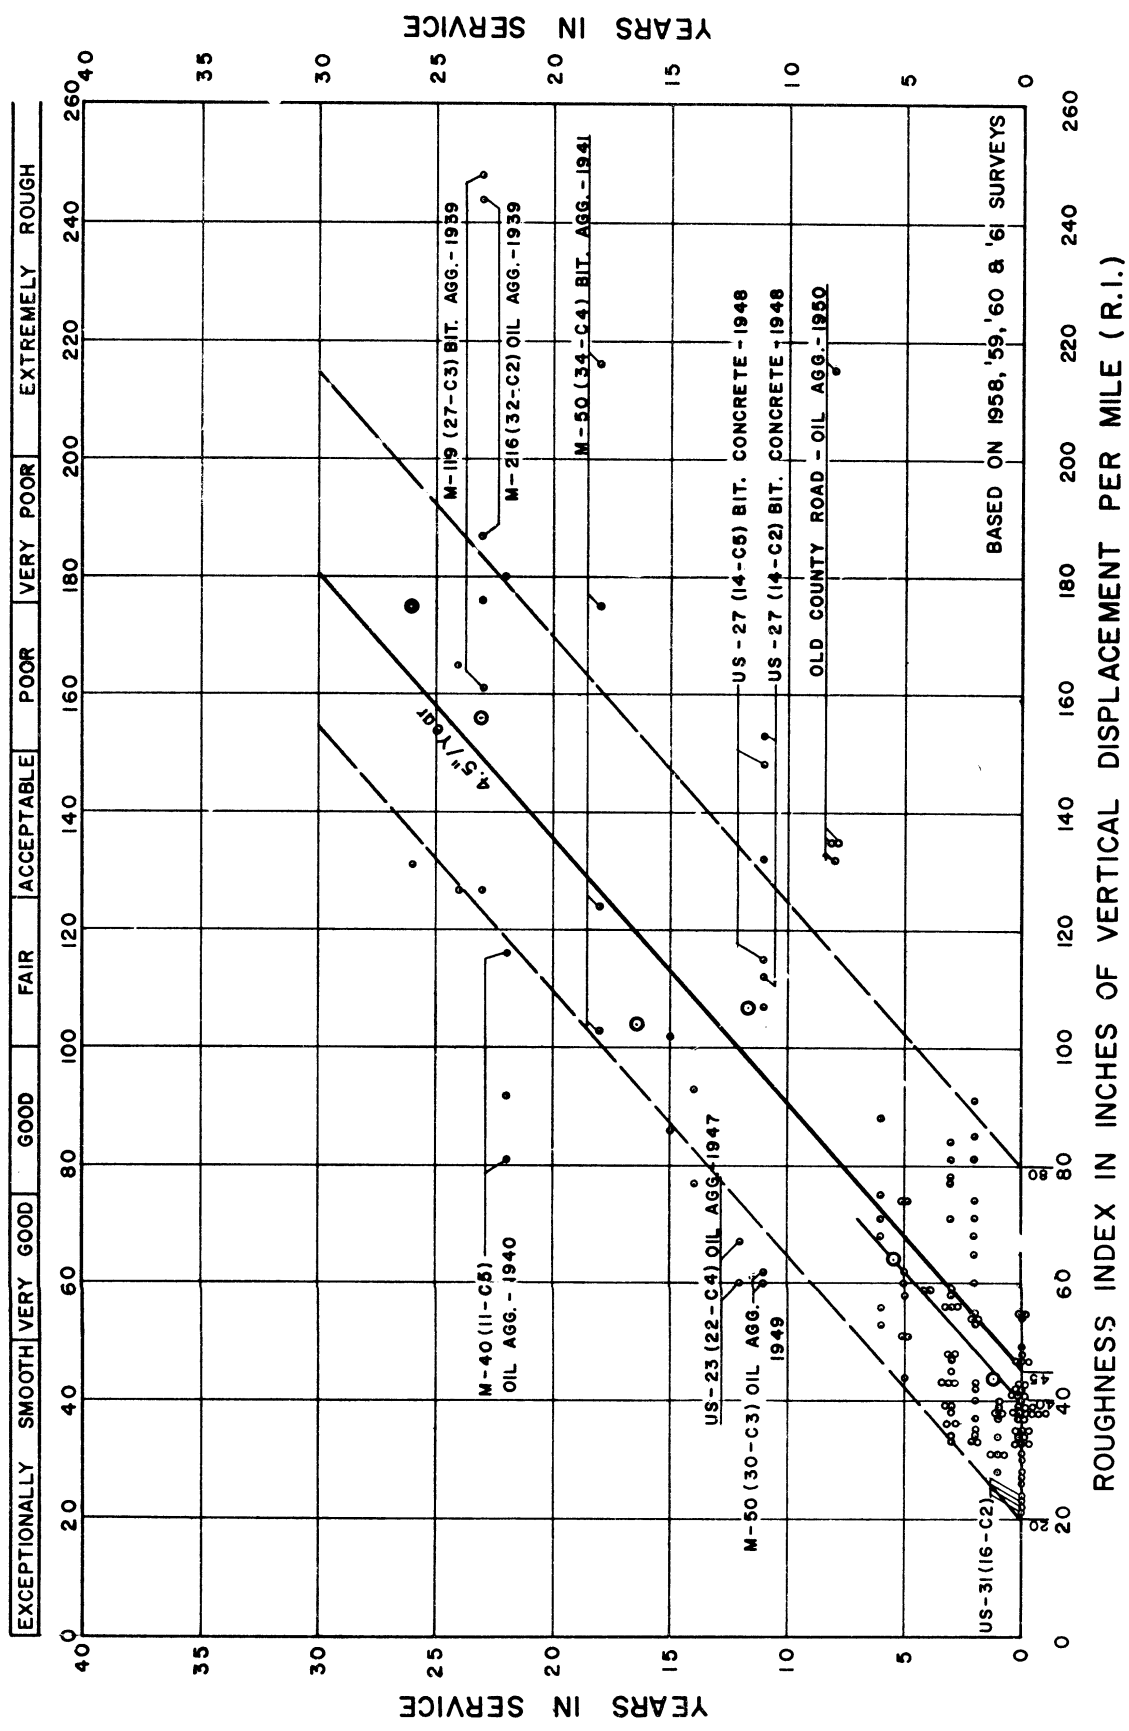
CUMULATIVE CHANGES WITH AGE IN SERVICE
 FLEXIBLE PAVEMENT - CLASS - I
 TRAFFIC LANE

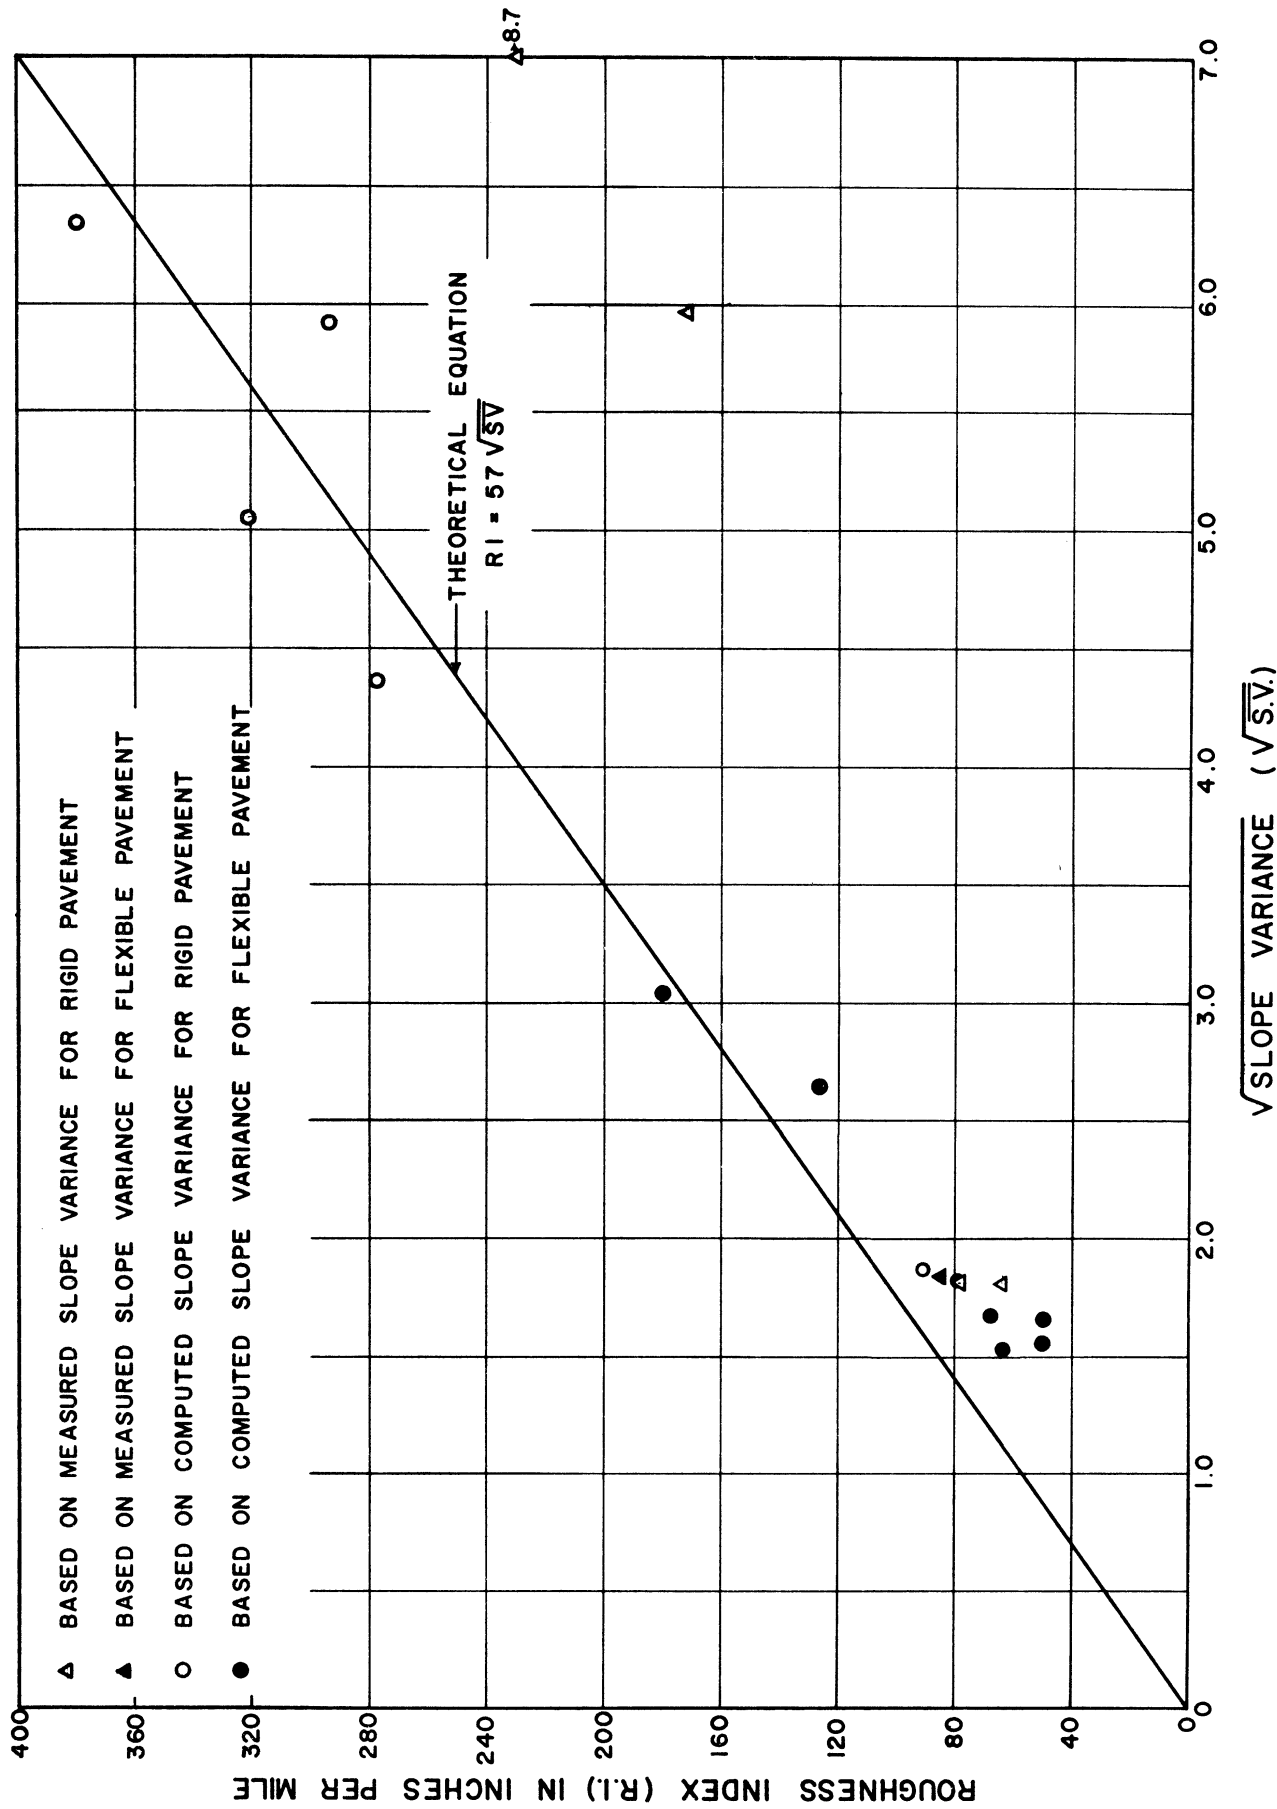
MICHIGAN ROUGHNESS INDEX
VS.
AASHO SLOPE VARIANCE

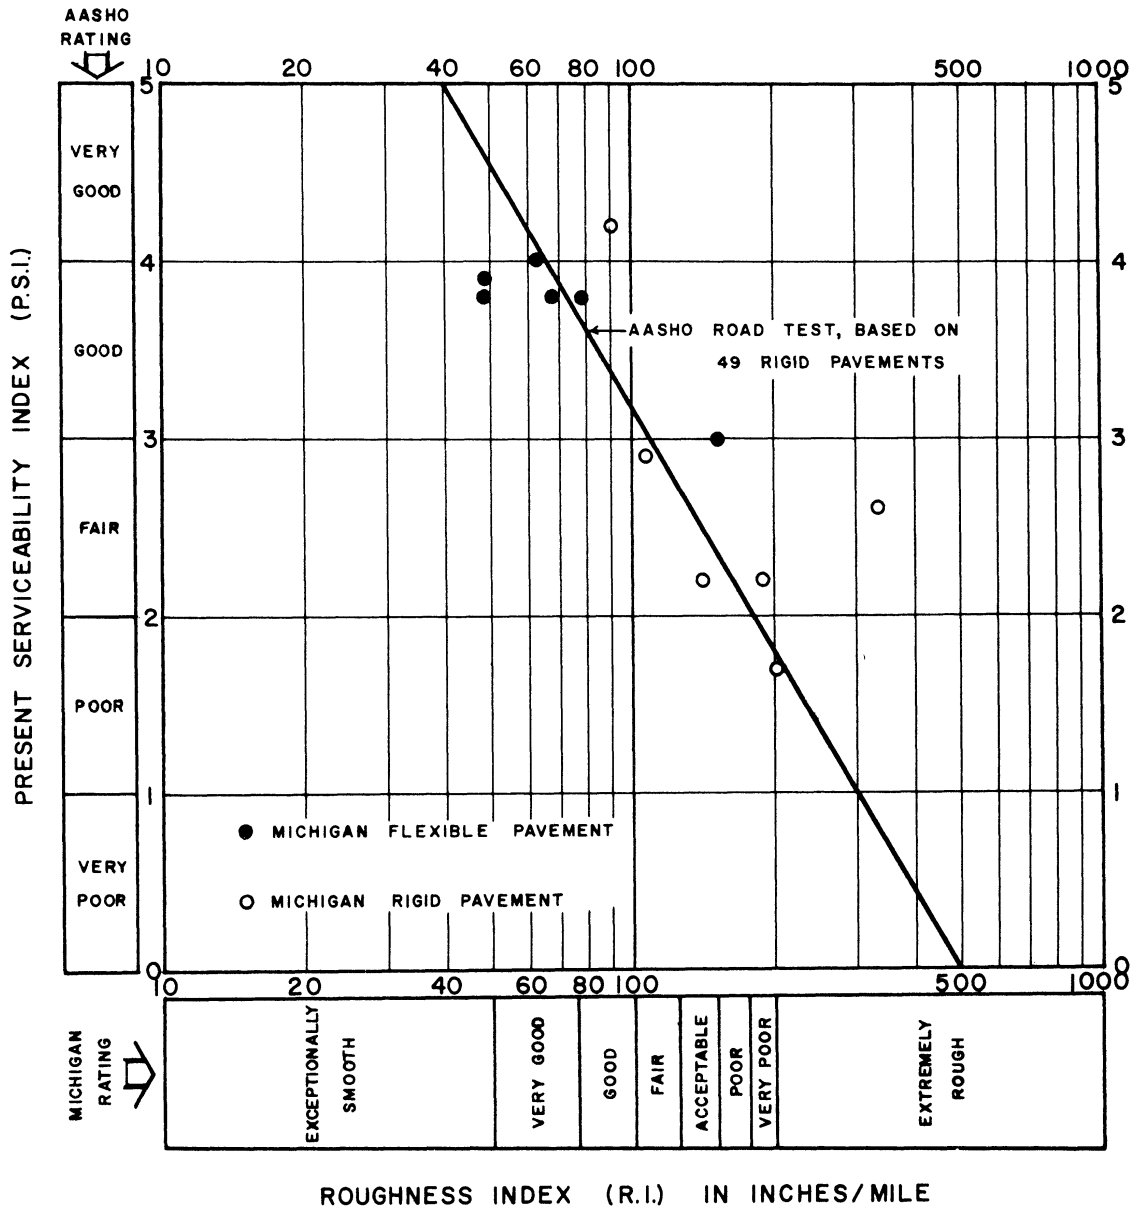
MICHIGAN ROUGHNESS INDEX
 VS.
 AASHO PRESENT SERVICEABILITY INDEX
 FIG. 21
