THE UNIVERSITY OF MICHIGAN

PRE-STRESS CONDITIONING AND ITS  
EFFECTS ON MATERIAL ATTRITION  
IN A CAVITATING ENVIRONMENT

A Dissertation Submitted  
in Partial Fulfillment of the Requirements  
for the Degree of Nuclear Engineer  
at the University of Michigan

1969

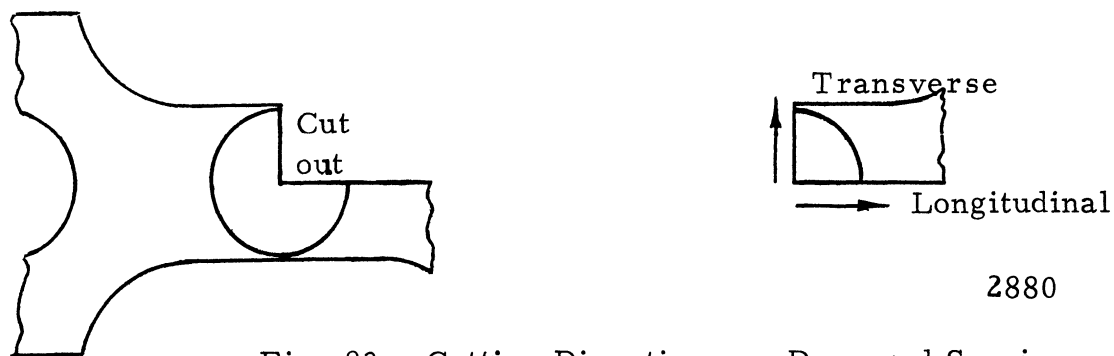
Fig. 83. Cutting Directions on Damaged Specimen.
