Full-Scale Rollover Testing of Commercial Cargo-Tank Vehicles

Christopher B. Winkler

Abstract

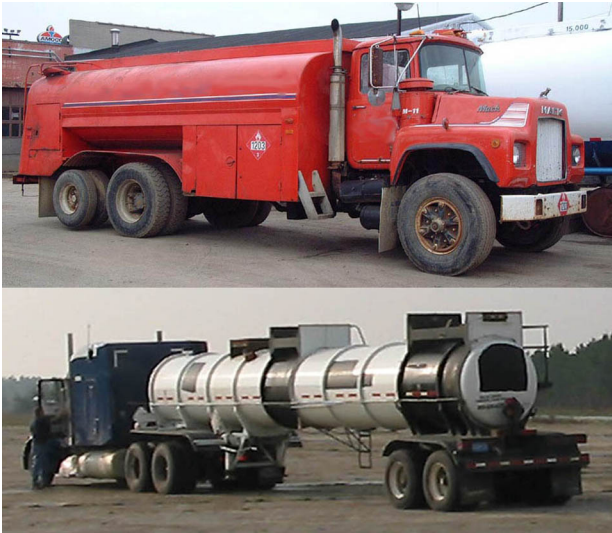
Fig. 1: The test vehicles

The two test vehicles appear in figure 1. The three-axle unit truck was designed for urban de-

livery of petroleum fuels. The centre of its three axles is the drive axle equipped with dual tyres. The third axle is an air-lift tag axle, also with dual tyres. The tractor-semitrailer combination has the typical North American configuration of a 6x4 tractor pulling a two-axle semitrailer. All axles other than the tractor's steer axle use dual tyres. The experimental design called for rolling the unit truck several times, replicating up to five of the simulated rollovers. Hence, this vehicle was armoured with very sturdy roll bars, front and rear, that closely matched the profile of the tank, the topside protection rails, and the cab, figure 2¹. The tank of the unit truck contained five separate compartments, the centre three of which were filled with water for testing while the front and rear were left empty. This, along with the extra mass of the roll bars resulted in a total mass (16 406 kg), centre of gravity (cg) position, and moments of inertia very similar to the unmodified vehicle with a full load of petroleum fuel.

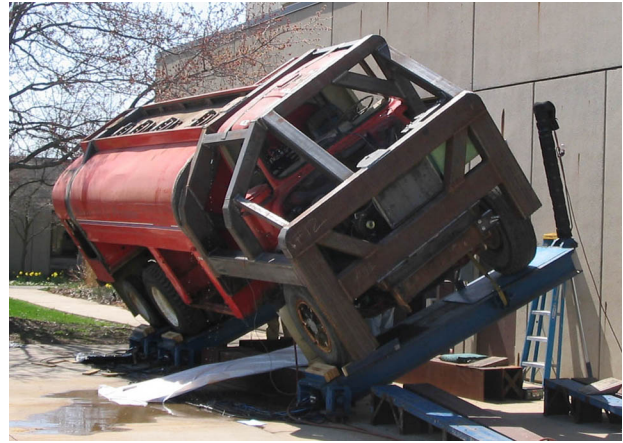
Fig. 2: The unit truck with roll bars on the UMTRI tilt table

Both vehicles were subject to tilt-table testing, figure 2, that established their static rollover thresholds as 0.48 g lateral acceleration for the unit truck and 0.40 g for the combination vehicle².

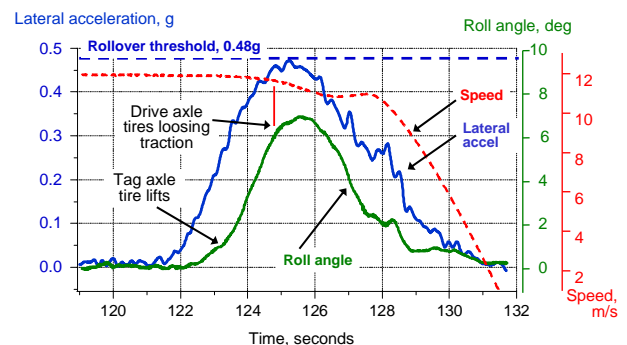
Fig. 4: Motion data – preliminary run of the unit truck

12.0 m/s would, in theory, generate 0.48 g lateral acceleration. The preliminary run was conducted with an initial speed of 12.1 m/s (43.5 km/h). Time histories of lateral acceleration, roll angle, and speed from this run appear in figure 4. The reference lateral acceleration of 0.48 g is also shown. The data show that, as the vehicle transitions from straight travel onto the curve, lateral acceleration rises toward the rollover threshold and the vehicle roll angle develops, as expected, slightly lagged with respect to acceleration.

The light-side tyres of the non-driving, tag axle lift from the road surface at a roll angle of about 1° . At a roll angle of slightly more than 6° , the tyres of the drive axle are so lightly loaded that they lose drive traction. This, along with the drag associated with hard cornering, causes the speed to fall off before lateral acceleration reaches the rollover threshold. At this point, the cruise control releases the throttle to avoid over speeding the engine, and lateral acceleration and

roll angle decline. Shortly afterwards (at about 128 s), the run is aborted and the brakes are applied.

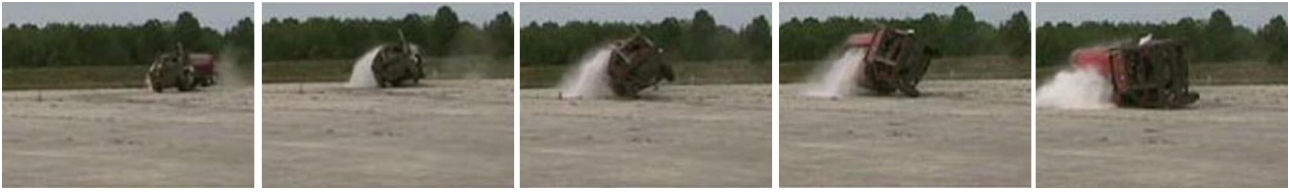
Fig. 5: The first rollover of the unit truck

In order to provide sufficient momentum to achieve the rollover threshold after drive thrust was lost, the next run (i. e., the first rollover run) was conducted at an initial speed of 13.9 m/s (49.9 km/h. Figure 5 shows the vehicle as it was rolling over in this test. In the first picture to the left, the light-side tyres of both rear axles have lifted from the road. Hence, at this time, lateral acceleration has already risen to the rollover threshold, and full rollover is virtually inevitable [6].

In the second picture, the tyre of the steer axle has also lifted. In the third, the vehicle’s cg is very near the apex height it attained during

the rollover. In the fourth photo, the vehicle is “falling” toward the ground and is close to striking the ground. Note that all of the heavy-side tyres remained on the ground. This is a characteristic of only the mildest of rollover manoeuvres [3]. In the last photo, the vehicle has struck the ground and has rolled to slightly more than 90°.

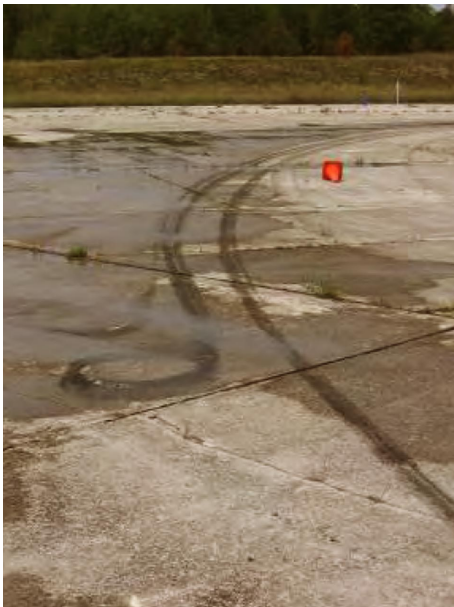
Fig. 6: Skid marks from the first rollover of the unit truck

Figure 6 shows the tyre skid marks made during this event, including the clear imprint of the drive-axle wheel where it struck the ground. Note in particular, that the mark from the drive axle tyre comes right up to the point of drive-wheel strike. Moreover, the mark of the steer axle tyre passes the wheel-strike mark and, although not in the picture, this mark ends at a distance ahead of the wheel mark that is virtually equal to the wheelbase. Clearly the tyres are marking the ground even as they approach a 90° inclination angle. All of this is clear evidence of a minimal rollover event.

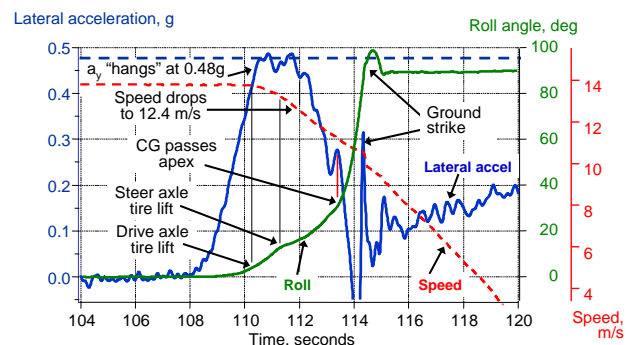
Fig. 7: First rollover of the unit truck – motion data

Time histories of acceleration, roll, and speed from this rollover appear in figure 7. The data show that, as the manoeuvre began, lateral acceleration rose to the rollover threshold of 0.48 g

while speed remained slightly above 13 m/s. The vehicle rolled gradually during this period. The drive-axle tyres lifted from the ground at about 6° of roll, and the steer-axle tyre lifted 0.75 s later at a roll angle of about 13° . During this period, the lateral acceleration of the cg of the vehicle dwelled near the static rollover threshold until the roll angle increased to the vicinity of 20° .

At this point, the cg had risen significantly and at the same time was starting to accelerate rather significantly outboard relative to the wheelbase, i. e., opposite the lateral acceleration of the turn. Hence, lateral acceleration at the cg began to fall significantly. Shortly thereafter, the vehicle had rolled to more than 30° and the cg passed its apex height.

The cg then fell under the influence of gravity; lateral acceleration declined at a faster rate and even went negative. Upon striking the ground at almost exactly 90° of roll, lateral acceleration, of course, spiked back onto the graph. The vehicle briefly rolled a few degrees more and then settled back to 90° ³.

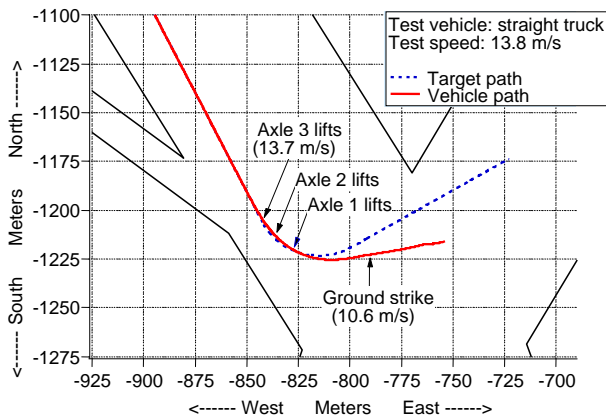
Fig. 8: First rollover of the unit truck – path

Figure 8 shows a scale drawing of the target path and the path of the vehicle's cg during this rollover. The vehicle had changed heading only about 5.5° from its original path when the drive axle lifted and eventual rollover was established. Yet, by the time ground strike took place, the vehicle track had rotated an additional 54.5° and the vehicle had travelled about 50 m. The horizontal speed at the time of ground strike was 10.6 m/s or 3.1 m/s slower than the speed on entry to the turn.

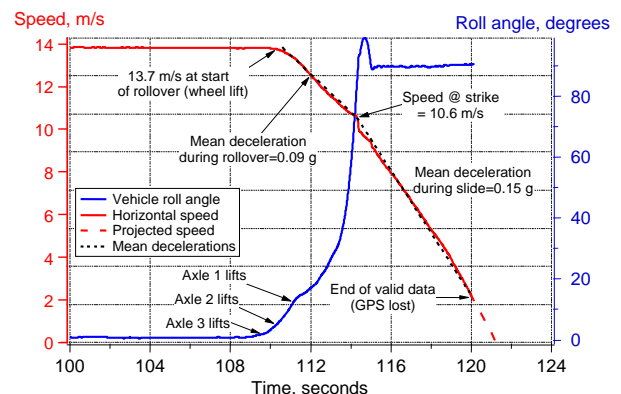
Fig. 9: First rollover of the unit truck – speed and roll

Figure 9 shows time histories of horizontal speed and roll that reveal more detail about the vehicle's deceleration. The vehicle entered the 0.48 g turn at 13.7 m/s. During the turn, the vehicle decelerated at an average 0.09 g. At the moment of impact with the ground, speed briefly dropped precipitously. For this brief period, the normal force between the vehicle and road surface far exceeded the weight of the vehicle so that frictional drag was, momentarily, very high. (Recall that this vehicle was armoured with very

stout roll bars and there was virtually no crush involved in this event. Hence, the event was both briefer and more intense than it would have been had the vehicle deformed.) After the impact event, the normal force between vehicle and road returned essentially to the weight of the vehicle. While sliding on the Portland cement concrete surface, the vehicle decelerated at an average of 0.15 g.

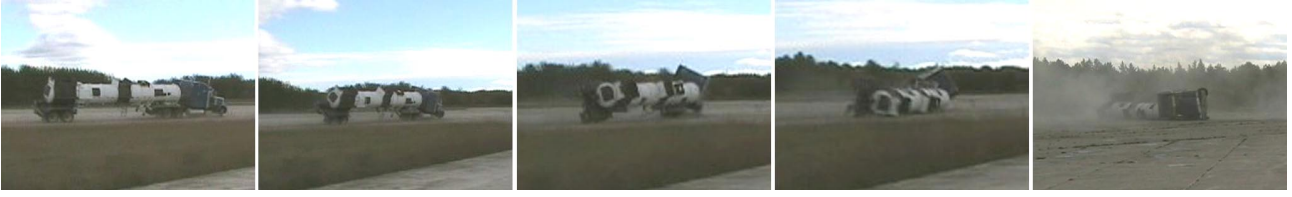
Fig. 10: Rollover of the tractor-semitrailer

Figure 10 shows the rollover of the tractor-semitrailer. Starting from the left, the vehicle was just beginning to roll; light-side tyres on both the trailer and the tractor drive axles have lifted from the ground. As the trailer tyres are considerably higher off the ground, it is apparent that the trailer axles lifted first, as is typical in tractor-semitrailer rollovers [6].

In the second photo, the cg of the trailer was passing through its apex, and in the third photo, the trailer was falling toward the ground. From this photo it becomes apparent that the trailer had rolled sooner and farther than the tractor cab. This is typical of tractor-semitrailer rollover and happens because

Hence, it is typical that the trailer, sitting on the tractor drive axles and its own axles, rolls over “first” and then “drags” the forward section of the tractor over after “winding up” the tractor frame. In the final picture of figure 10, the vehicle has come to rest. Note that the rotational momentum developed in the very beginning of the turn caused the vehicle to rotated nearly 270° anti-clockwise in the plan view.

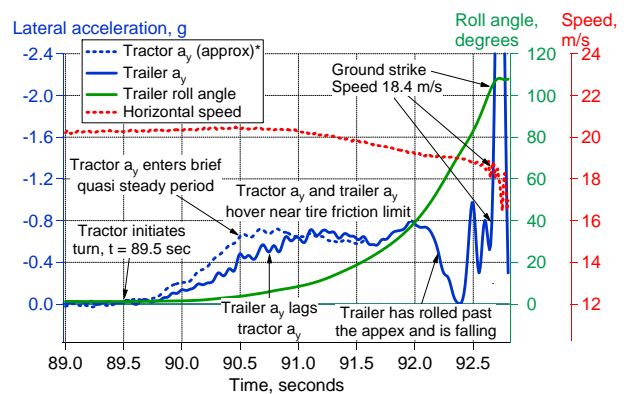
Fig. 11: Rollover of the tractor-semitrailer – motion data

Figure 11 presents the time histories of lateral acceleration of the tractor and the trailer, and roll angle and speed of the trailer. Except for lateral acceleration of the tractor, these data derive directly from the inertial navigation system. Lateral acceleration of the tractor, however, is only estimated from the product of speed and trac-

tor yaw rate. This estimated value is truncated at the point where tractor behaviour becomes highly dynamic and tractor roll angle begins to increase rapidly.

At the beginning of the manoeuvre, the data show the lateral acceleration of the tractor leading that of the trailer as they both rose to a nominal level of about 0.70 – 0.72 g where they dwelled for a bit longer than a full second. During the same period, the trailer was rolling to about 25°. During this portion of the manoeuvre, the lateral acceleration of the vehicle was being limited by the maximum tyre/road friction coefficient.

Under these conditions, a friction coefficient in the range of 0.72 is about all that can be expected. After the cg of the trailer passed through its apex, lateral acceleration of the trailer fell rapidly. From about 92.3s until the time of ground strike, there was a good deal of “confusion” in the lateral acceleration signal as the trailer is influenced by the “windup” and “release” of the tractor frame.

Note that at the time of ground strike, the trailer had rolled well past 90° – up to 104°. This was partly because of the narrow profile of this tank, but also because, in severe rollovers, the heavy-side tyres on the tractor drive and trailer axles often leave the ground late in the process as, in a manner of speaking, the trailer spins in roll faster than the cg falls toward Earth [3, 7]. This entire rollover event took place much more rapidly than the rollover of the unit truck: in this case, ground strike took place about 3.2s after the initiation of the turn. Nevertheless, because of the high drag of the severe turn, the vehicle still lost 2.0 m/s of speed before hitting the ground at a speed of 18.4 m/s.

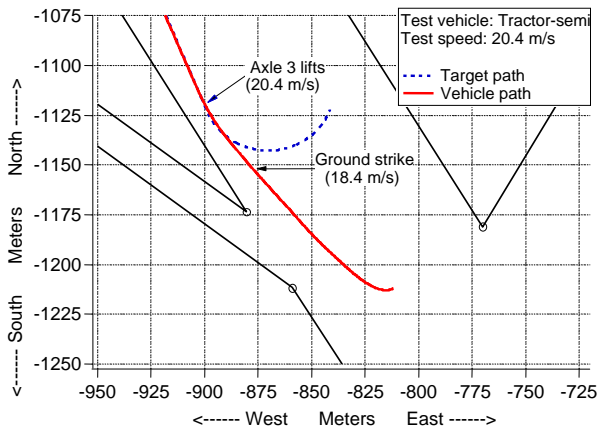
Fig. 12: Rollover of the tractor-semitrailer – path

Figure 12 presents the track of the trailer cg during the rollover. The rollover was so severe and rapid that the track angle changed only slightly from the initial path. The small hook in the path near its end resulted from the fact that the horizontal speed of the vehicle was rapidly approaching zero, but the vehicle was continuing to rotate in the plan view as it slid, and the cg of the trailer was not at the centre of this rotation.

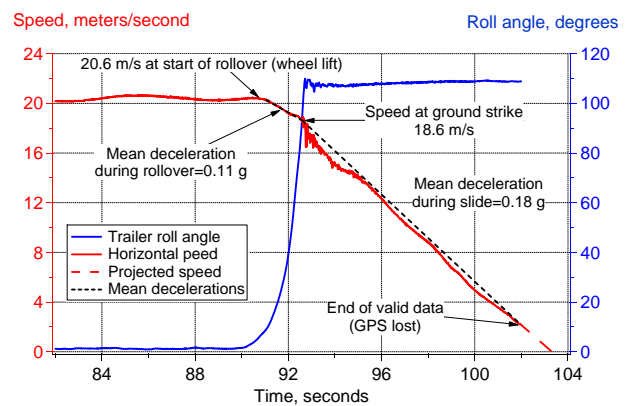
Fig. 13: Rollover of the tractor-semitrailer – speed and roll

Figure 13 presents time histories of roll and speed for this rollover. During the turn, prior to ground strike, the average longitudinal deceleration was about 0.11 g. This was higher than the 0.09 g observed for the unit truck, but of course, this turn was far more severe. Once again, a precipitous drop in horizontal speed took place

at the moment of ground strike. The tractor-semitrailer was a normal vehicle that did not have the very stiff, protective roll bars like the unit truck had. Hence, a good deal of crush took place on impact and the disturbance in speed due to ground strike was drawn out longer in time. The average deceleration during the sliding portion of the event was 0.18 g.
