Final Report
CARBURIZED FINAL-DRIVE PINION GEARS

Project 2171

DETROIT ARSENAL, DEPARTMENT OF THE ARMY
CONTRACT NO. DA-20-089-ORD-36692
CENTER LINE, MICHIGAN

June 1955

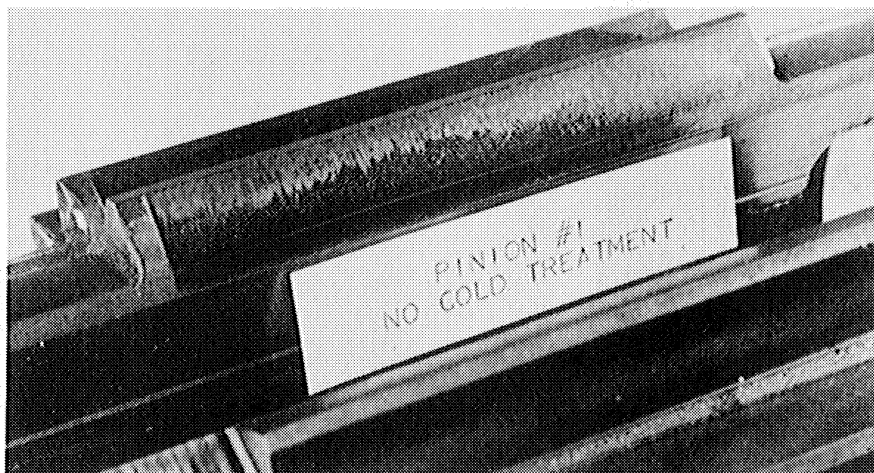
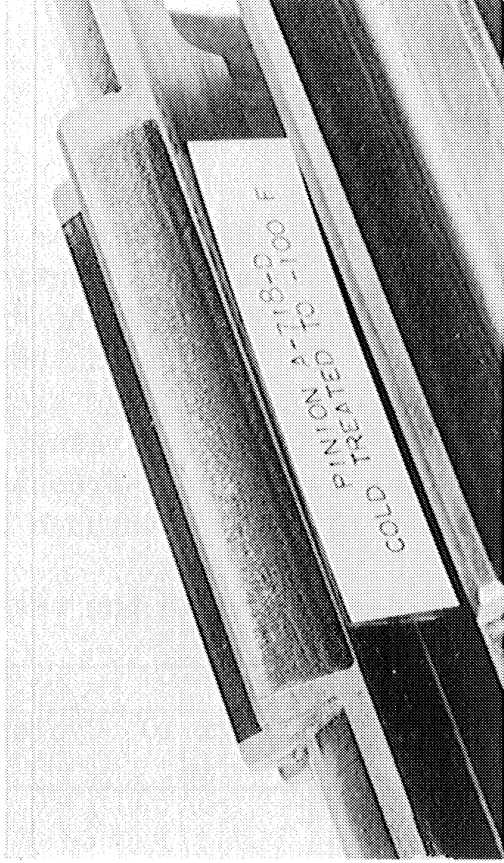
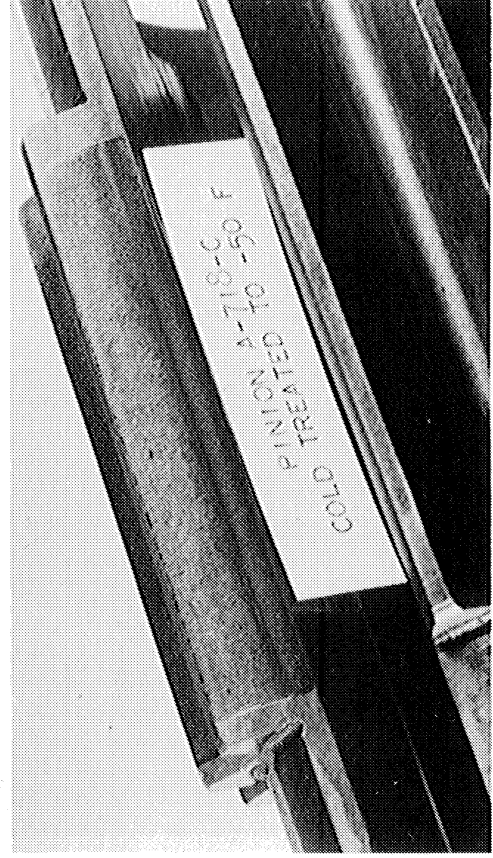
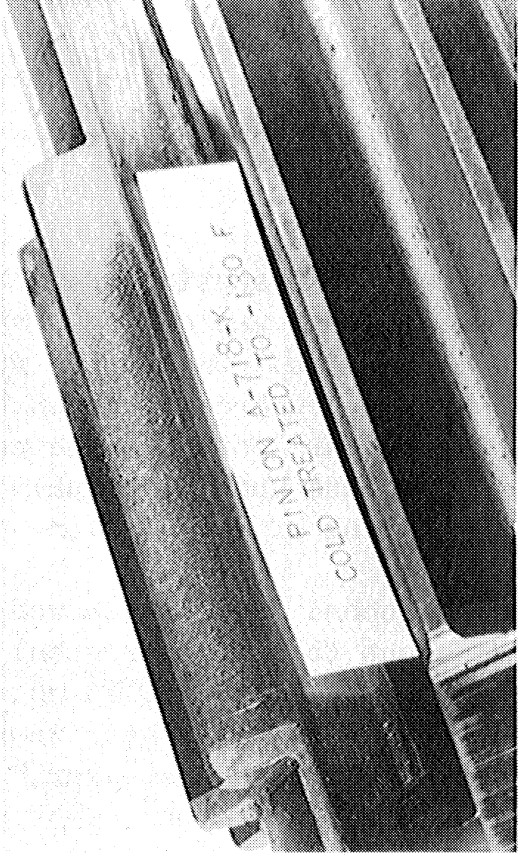
Fig. 5. Wear pattern after 10^6 cycles.

Fig. 6. Wear pattern after 10^6 cycles.

Fig. 8. Wear pattern after 10^6 cycles.

Fig. 7. Wear pattern after 10^6 cycles.

Fig. 9. Wear pattern after 2×10^6 cycles.

Fig. 10. Wear pattern after 10^6 cycles.

Fig. 12. Wear pattern after 10^6 cycles.

Fig. 11. Wear pattern after 10^6 cycles.

Fig. 13. Wear pattern after 2×10^6 cycles.

Inspections after the low torque runs disclosed that the wear pattern was evenly distributed across the face of the gear teeth. Inspections after the high torque runs disclosed a wear pattern shifted toward the side of the large gear on which the bearings were located. This shift of the wear pattern is caused by deflection of the shaft on which the large gear is mounted. This deflection prevents proper meshing of the gears resulting in wear which is influenced more by the mounting than by the deep-freezing treatment. The wear patterns of the gears are shown in Figs. 5 through 13.

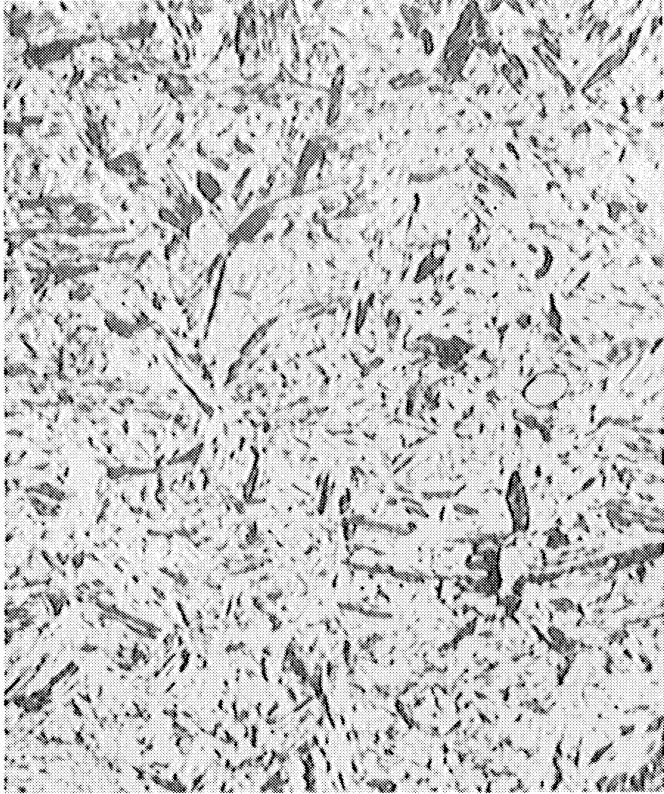
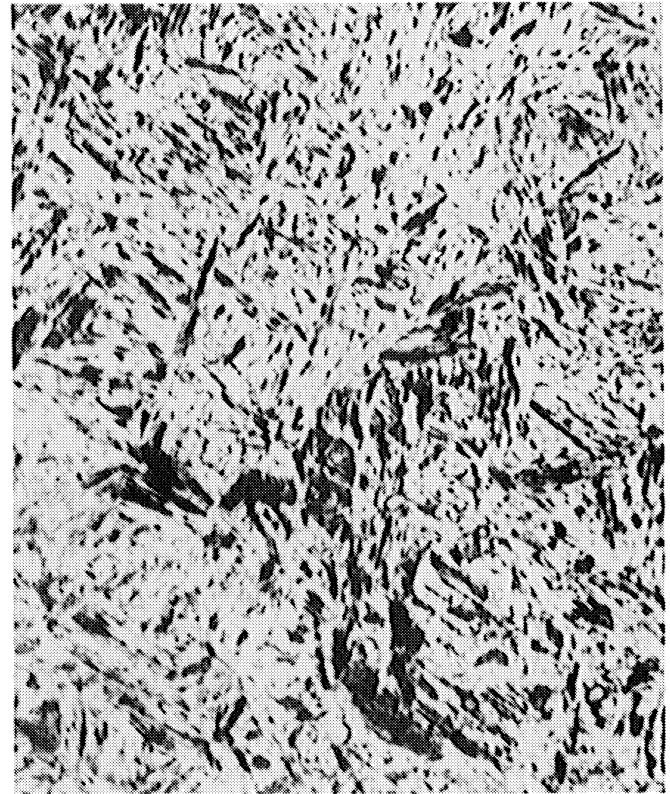
Figs. 16-19. Typical microstructures for hardened section of gear teeth from gears A, B, C, and D. All sections are located at .0025 to .0030 inch below tooth face. Gears 1 and B were not subjected to sub-zero temperature treatments. Gears C and D were treated at -50 and -100°F.

The examination of the etched section failed to reveal any marked differences in microstructure. Representative microstructures as found at 0.003 to 0.004 inch below the surface are shown in Figs. 16 through 24.

Coarseness or fineness or variations in grain size (though limited) appear to be about the only observable differences. 1(std) and B(std) differ slightly in grain size and in fineness of the martensite pattern. C(-50°F), the first of the sub-zero-treated steels, shows a slightly smaller grain size with a coarser martensite pattern than 1(std) or B(std). The pattern reverses again with D(-100°F). The small grain size variations can only be accounted for on the basis of the oil-quench treatment or the original hardening. It will be observed that E(-120°F), F(-120°F), H(-130°F), and K(-130°F) sub-zero treatments at -120 and -130°F again show small grain size variations and fineness or coarseness of martensite pattern. L(-150°F) shows a well developed martensite pattern not unlike D(-100°F). These small variations show no direct correlation with the wear losses.

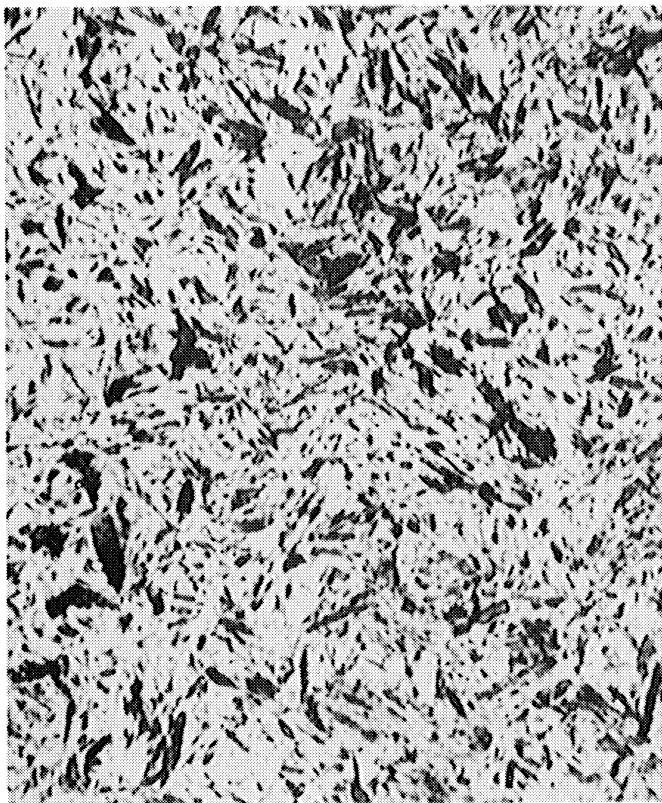
Figs. 20-23. Typical microstructures for hardened section of gear teeth from gears E, F, H, and K. All sections are located 0.0025 to 0.0030 inch below tooth face. Gears E and F were subjected to sub-zero temperature treatments at -120°F , H and K at -130°F .

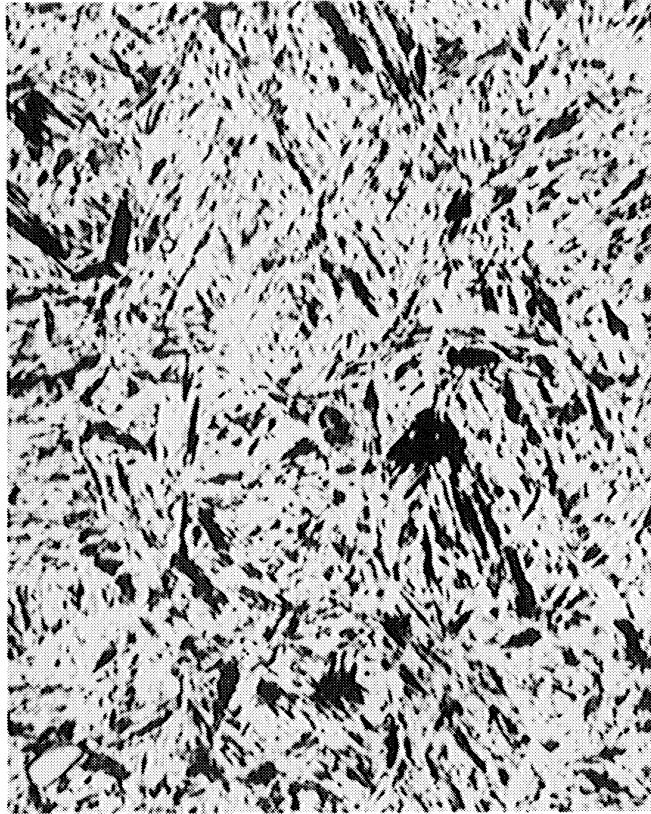
Fig. 24. Typical microstructure for hardened section of tooth from gear L section located 0.0025 to 0.0030 inch below tooth face. L was subjected to sub-zero temperature treatments at -150°F .
