SINGLE RUPTURE TESTS ON FIVE BETHLEHEM STEELS AT 1000°F.

Project Number M317
Report Number 2

Bethlehem Steel Company

May 8, 1942

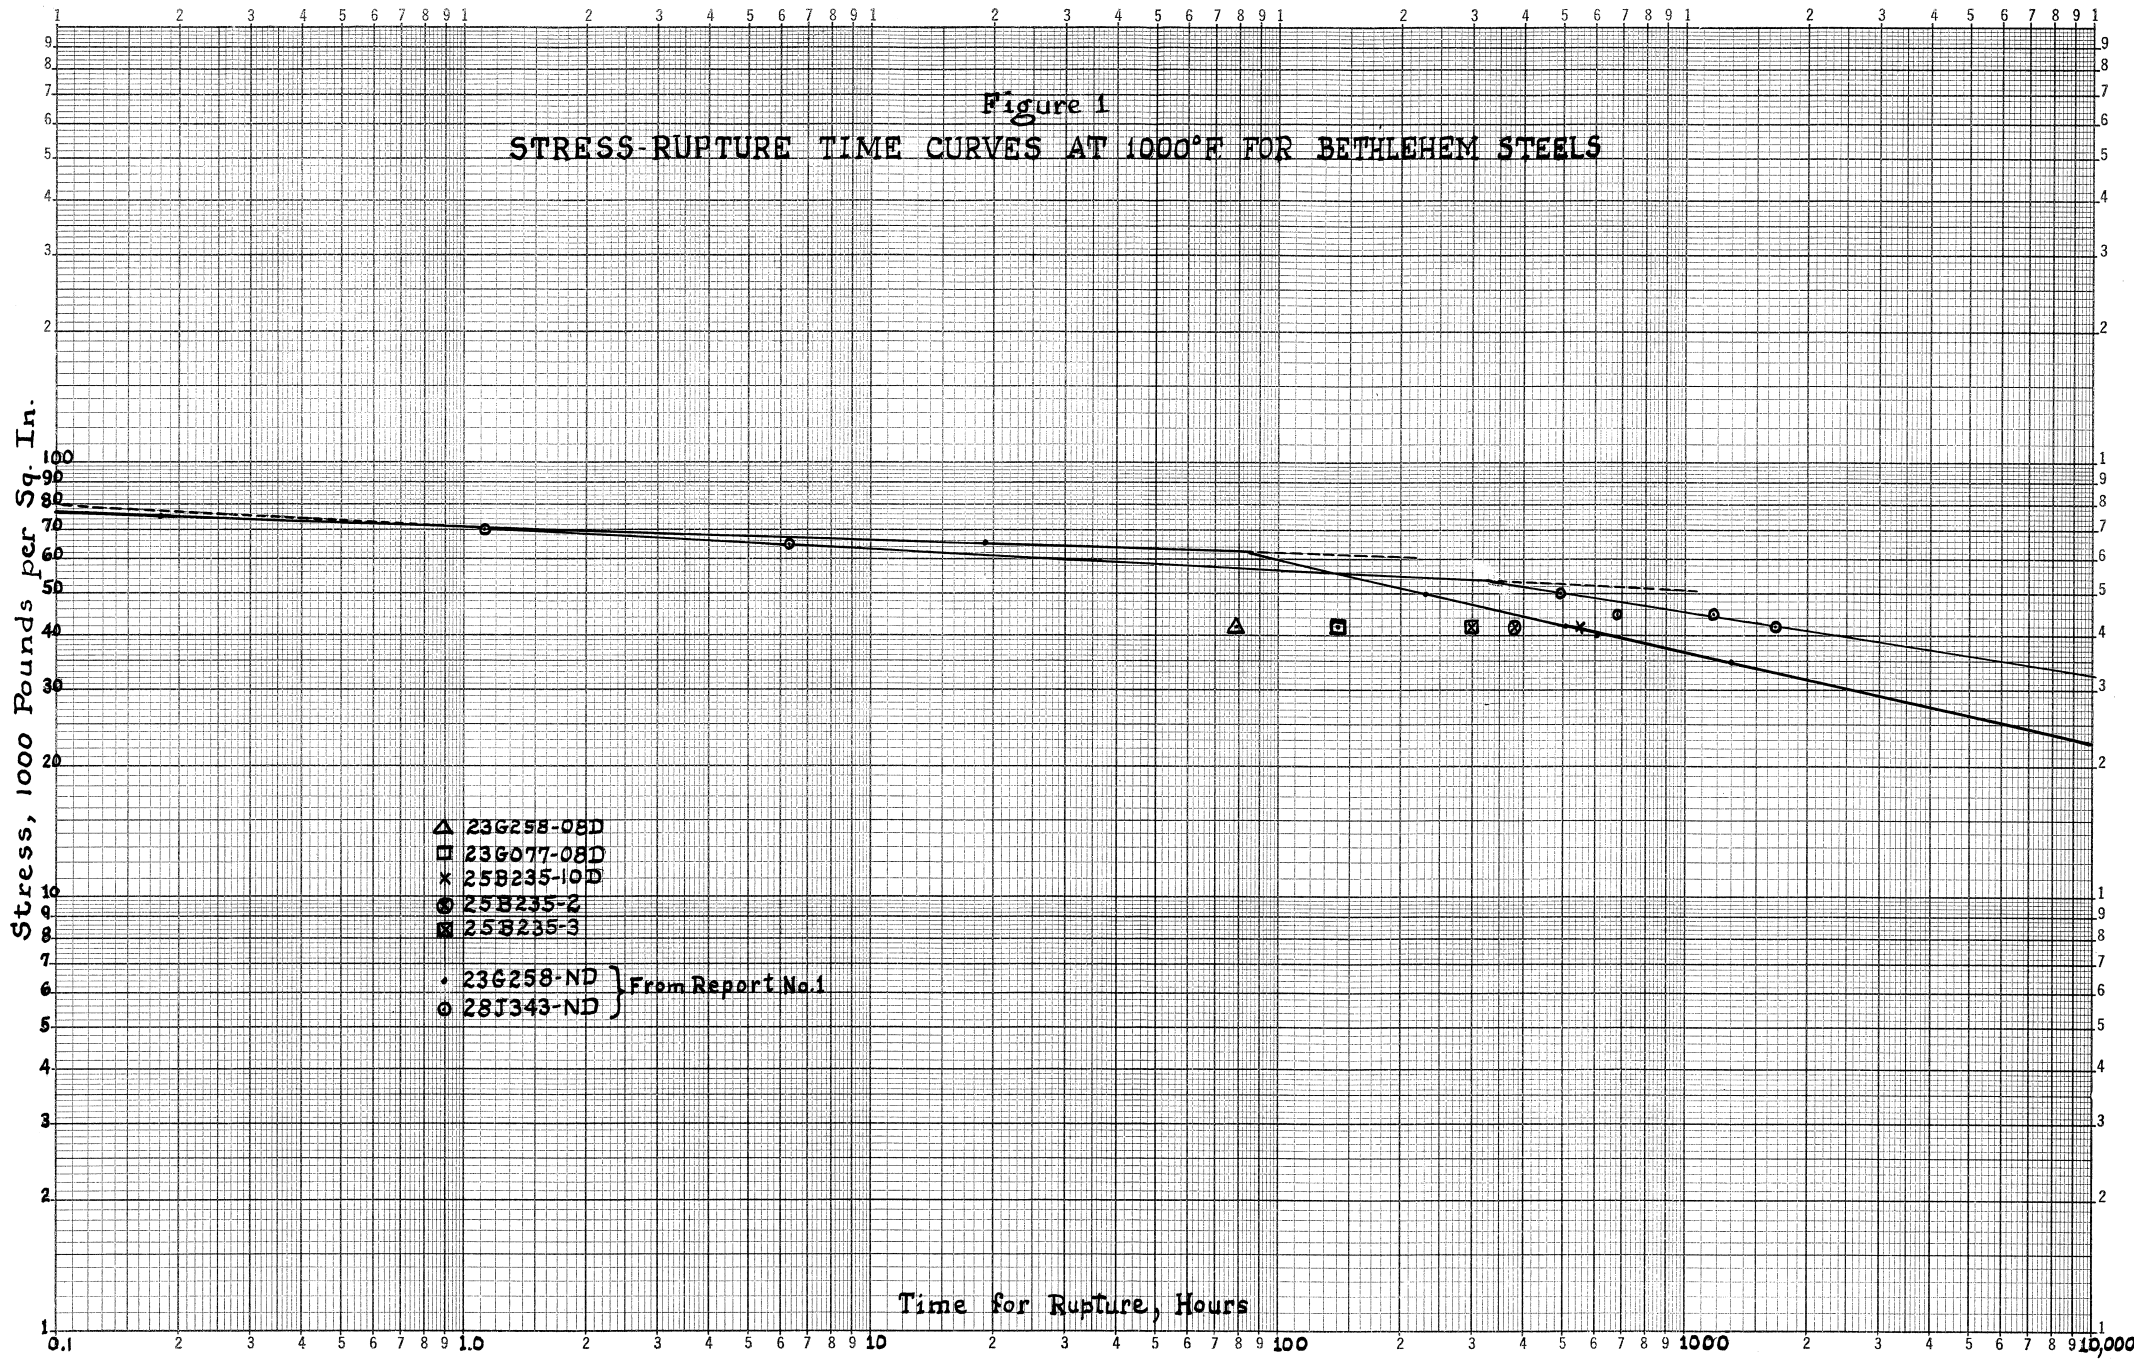
Figure 1
STRESS-RUPTURE TIME CURVES AT 1000°F FOR BETHLEHEM STEELS

The stresses and corresponding rupture time periods have been plotted to logarithmic coordinates in Figure 1. For comparative purposes the curves from Report Number 1 have been included.

- △ 23G258-08D
- 23G077-08D
- × 25B235-10D
- 25B235-2
- 25B235-3
- 23G258-ND } From Report No.1
- 28J343-ND }

On the basis of comparative times for rupture at 1000°F. under a stress of 42,000 pounds, material 25B235-10D possessed the best load carrying ability of the five materials considered. Likewise it was about equal to the 23G258-ND material of Report Number 1. The other four materials were all weaker with the rupture time periods varying from 79 hours for 23G258-08D to the 552 hours for 25B235-10D.

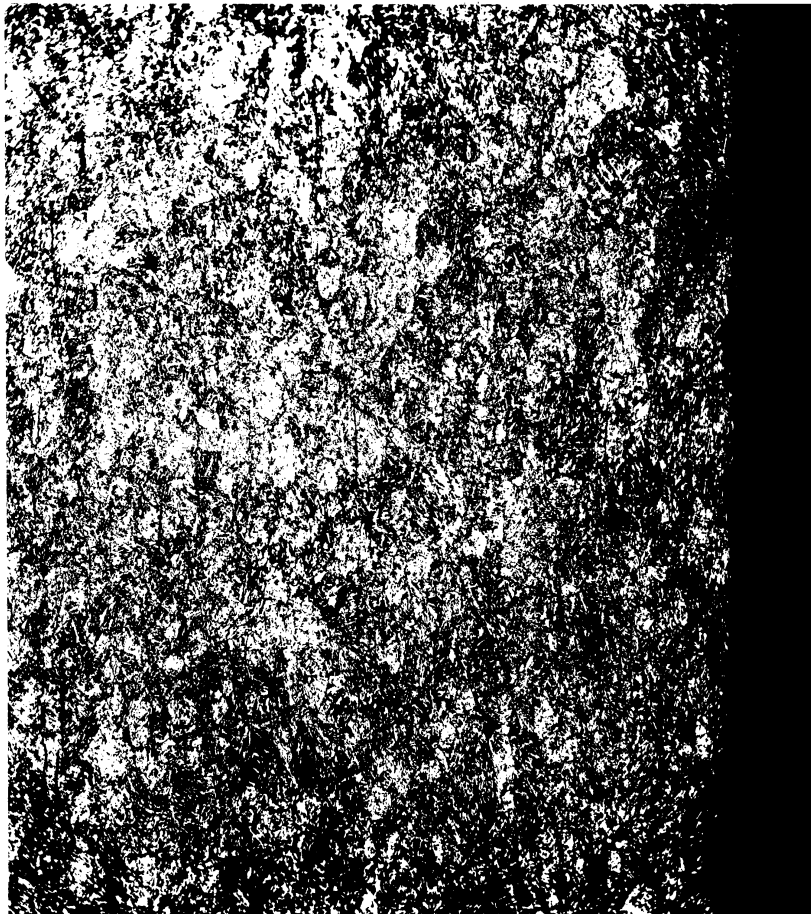
Chart 1
Microstructure of Bethlehem 23G258-08D Steel Rupture Test Specimen
79 Hours for Rupture at 1000°F. Under a Stress of 42,000 Pounds

Fracture - X100D

Surface - X100D

The longitudinal sections at the fracture of the completed rupture test specimens were examined metallographically. The photomicrographs of Charts 1 through 5 were taken at the fracture and at the surface of the specimen about one-half inch from the fracture. The photomicrograph at the fracture illustrates the type of failure and the surface position shows the amount of cracking adjacent to the point of failure.

Charts 1 and 2 show that, in accordance with the ductility values, materials 23G258-08D and 23G077-08D failed with considerable distortion and very little cracking. Numerous fine intergranular cracks, which were filled with oxide near the surface, were present in specimens 25B235-10D and 25B235-2.

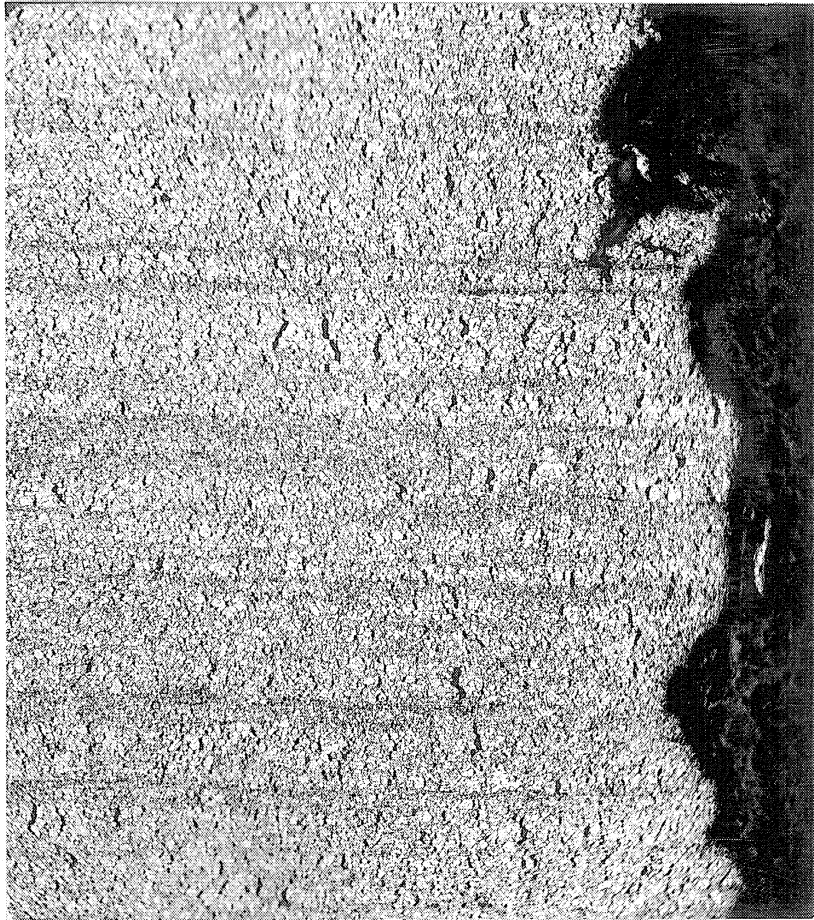
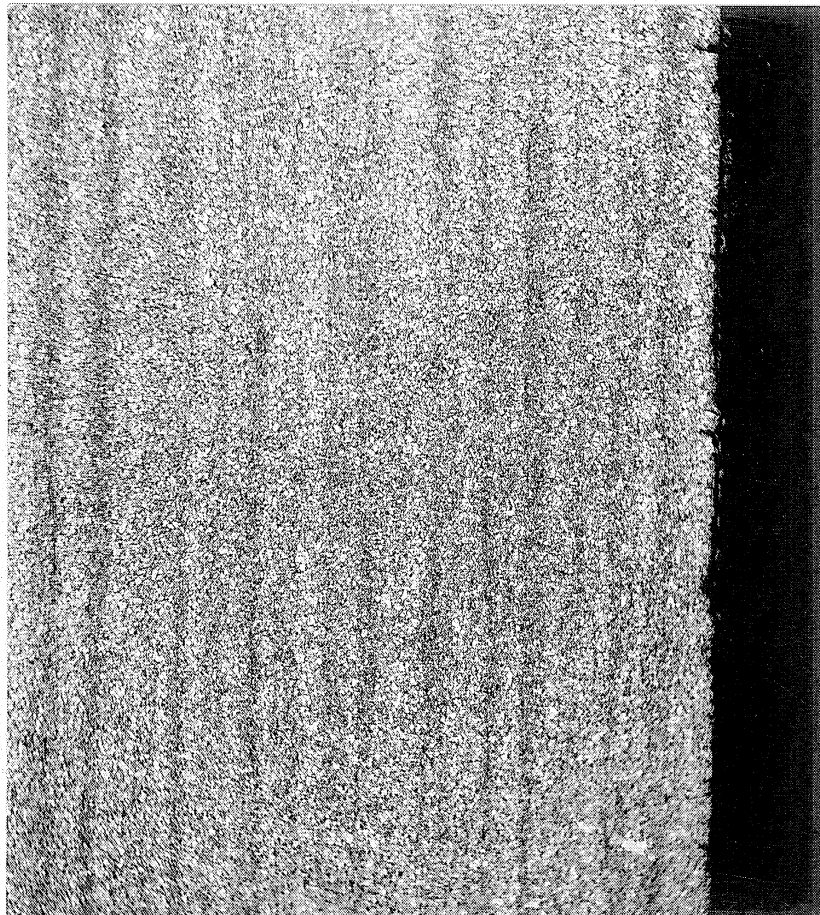
Chart 3
Microstructure of Bethlehem 25B235-10D Steel Rupture Test Specimen
552 Hours for Rupture at 1000°F. Under a Stress of 42,000 Pounds

Fracture - X100D

Surface - X100D

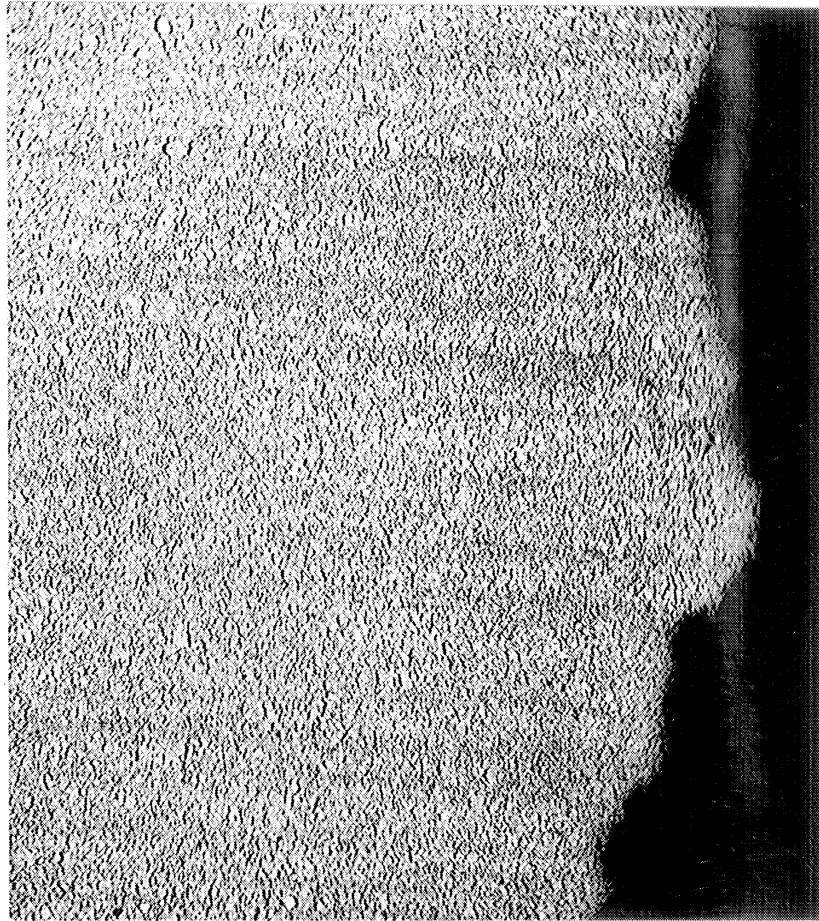
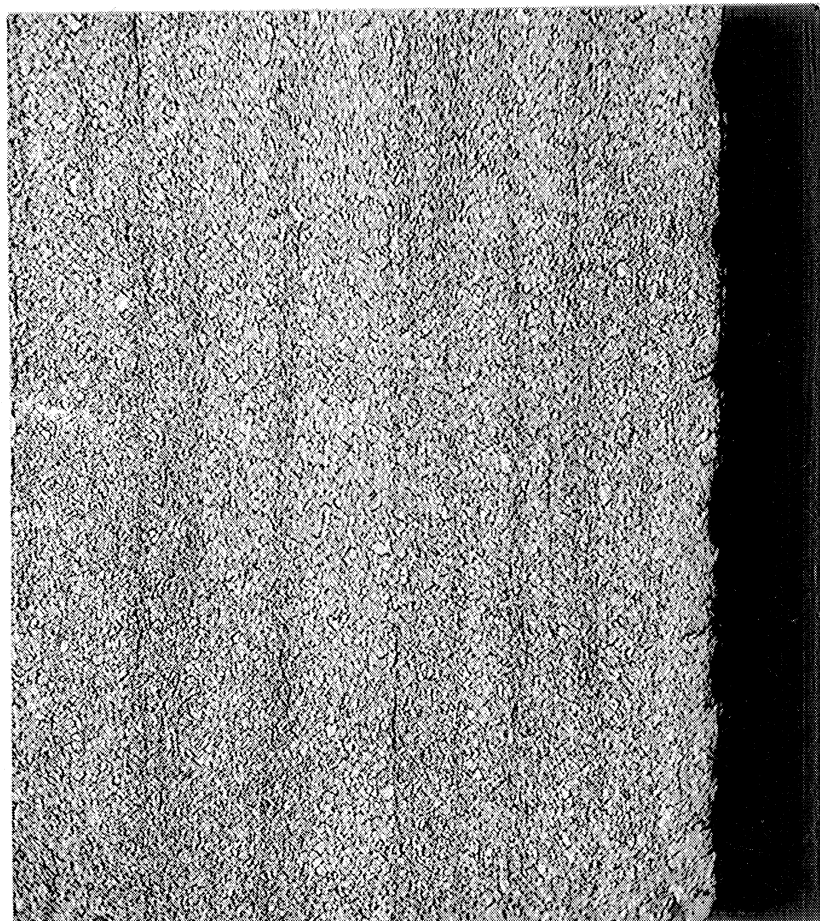
Chart 4
Microstructure of Bethlehem 25B235-2 Steel Rupture Test Specimen
381 Hours for Rupture at 1000°F. Under a Stress of 42,000 Pounds

Fracture - X100D

Surface - X100D

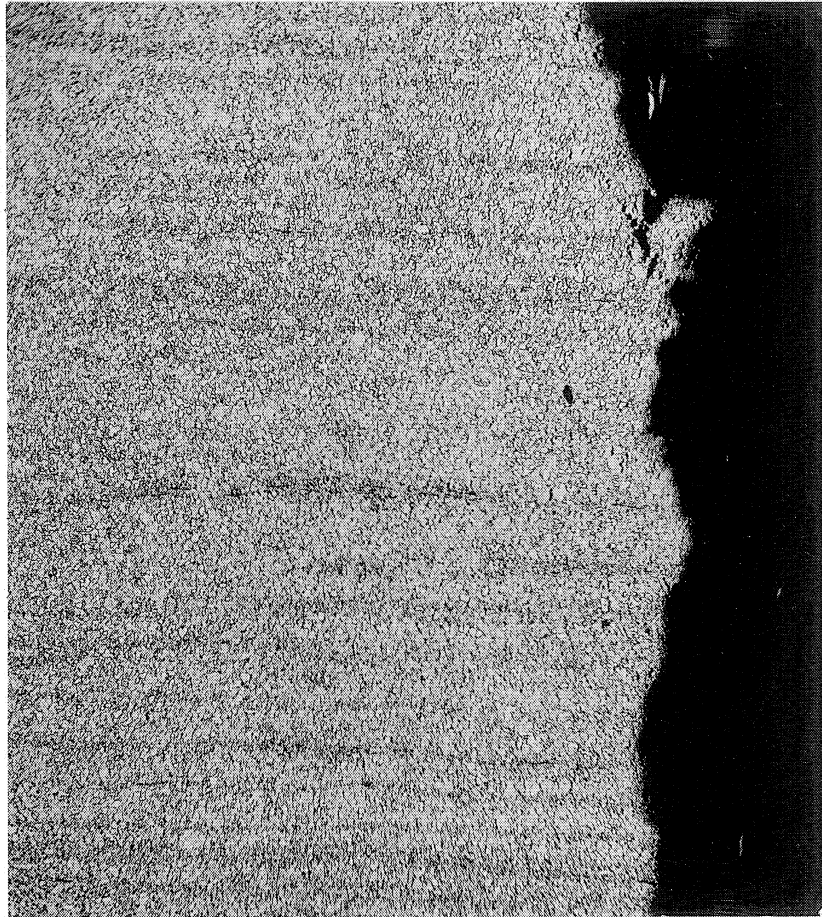
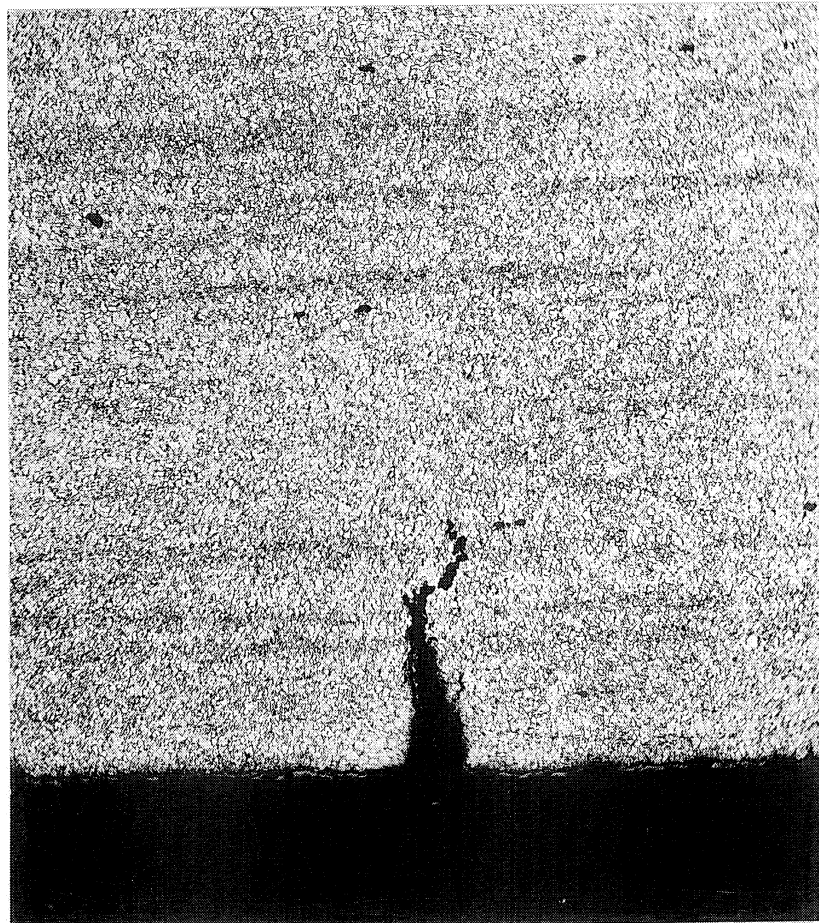
Chart 5
Microstructure of Bethlehem 25B235-3 Steel Rupture Test Specimen
299 Hours for Rupture at 1000°F. Under a Stress of 42,000 Pounds

Fracture - X100D

Surface - X100D

There were not as many fine cracks present in the 25B235-3 sample but the presence of larger cracks suggests that the material is more subject to crack propagation once one starts than the others.
