EARTHQUAKE HAZARD ANALYSIS FOR COMMERCIAL BUILDINGS IN MEMPHIS

A Report of Research Sponsored by
U.S. Geological Survey
Contract No. 14-08-0001-19829

SUMMARY

The report deals with the evaluation of seismic risk for commercial buildings in Memphis, Tennessee.

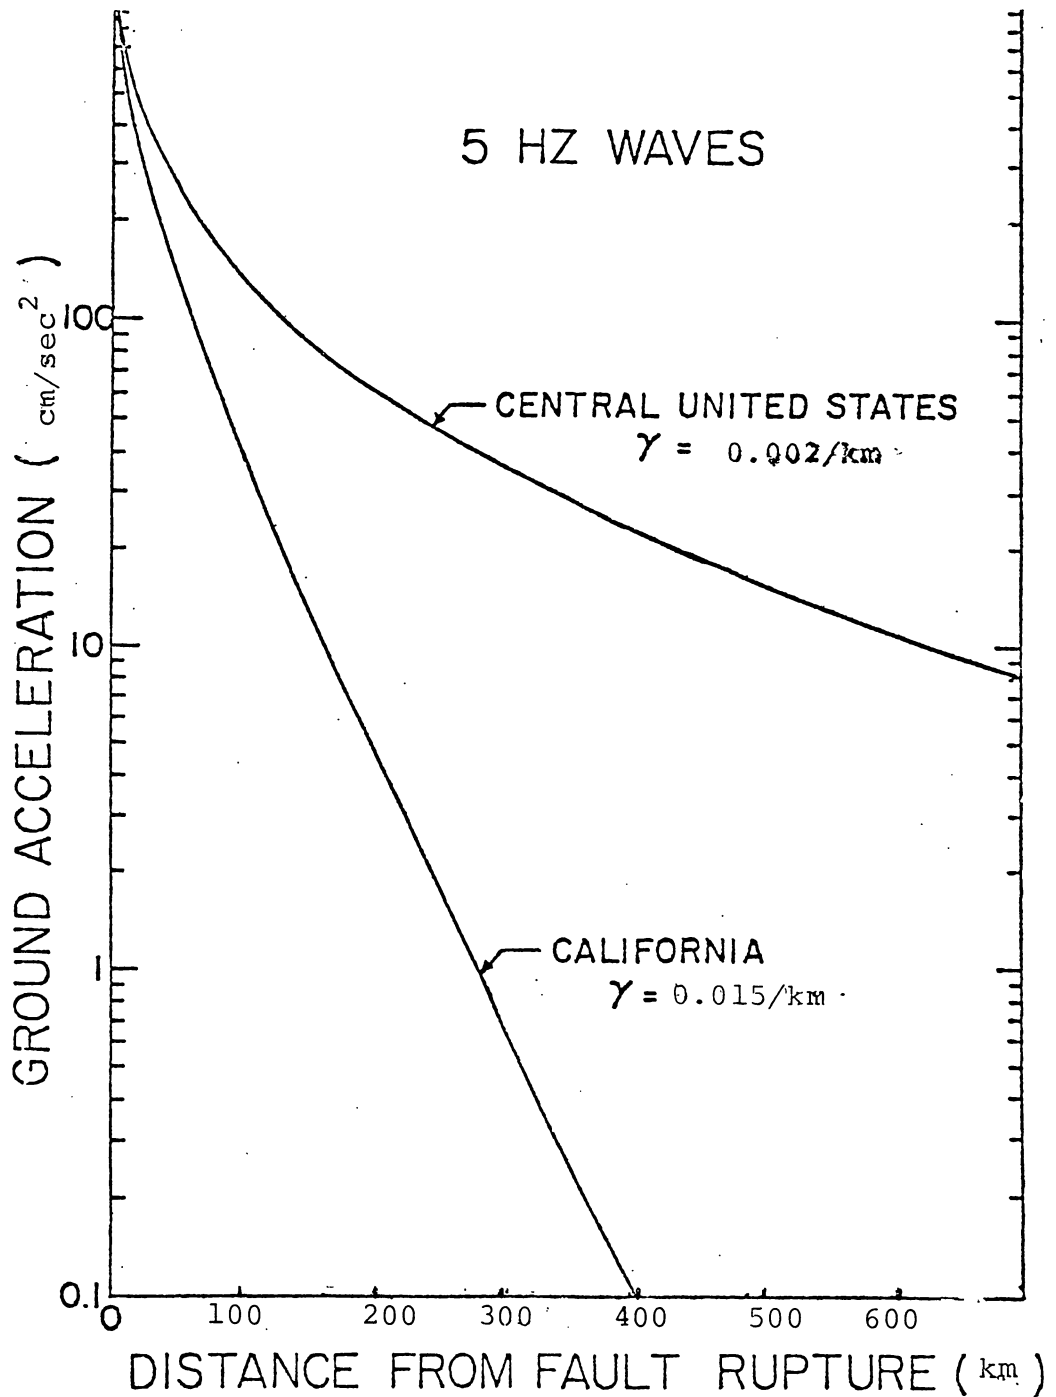
Fig. 2.14 Ground Acceleration vs Distance from Fault Rupture for California and the Central US, 5-Hz Wave (From ref. 33)

attenuates. Figure 2.14 compares the attenuation of the ground acceleration for 5-Hz waves in California and in the central United States. At approximately 125 miles (200 km) from the epicenter, the central U.S. attenuation of acceleration is about 1/10th as great as for California. At 220 miles (350 km), there is a difference of two orders of magnitude. Similar curves for 1-Hz waves are shown in Figure 2.15. Waves of this frequency tend to be most damaging to very long or high-rise structures (ten stories or more).

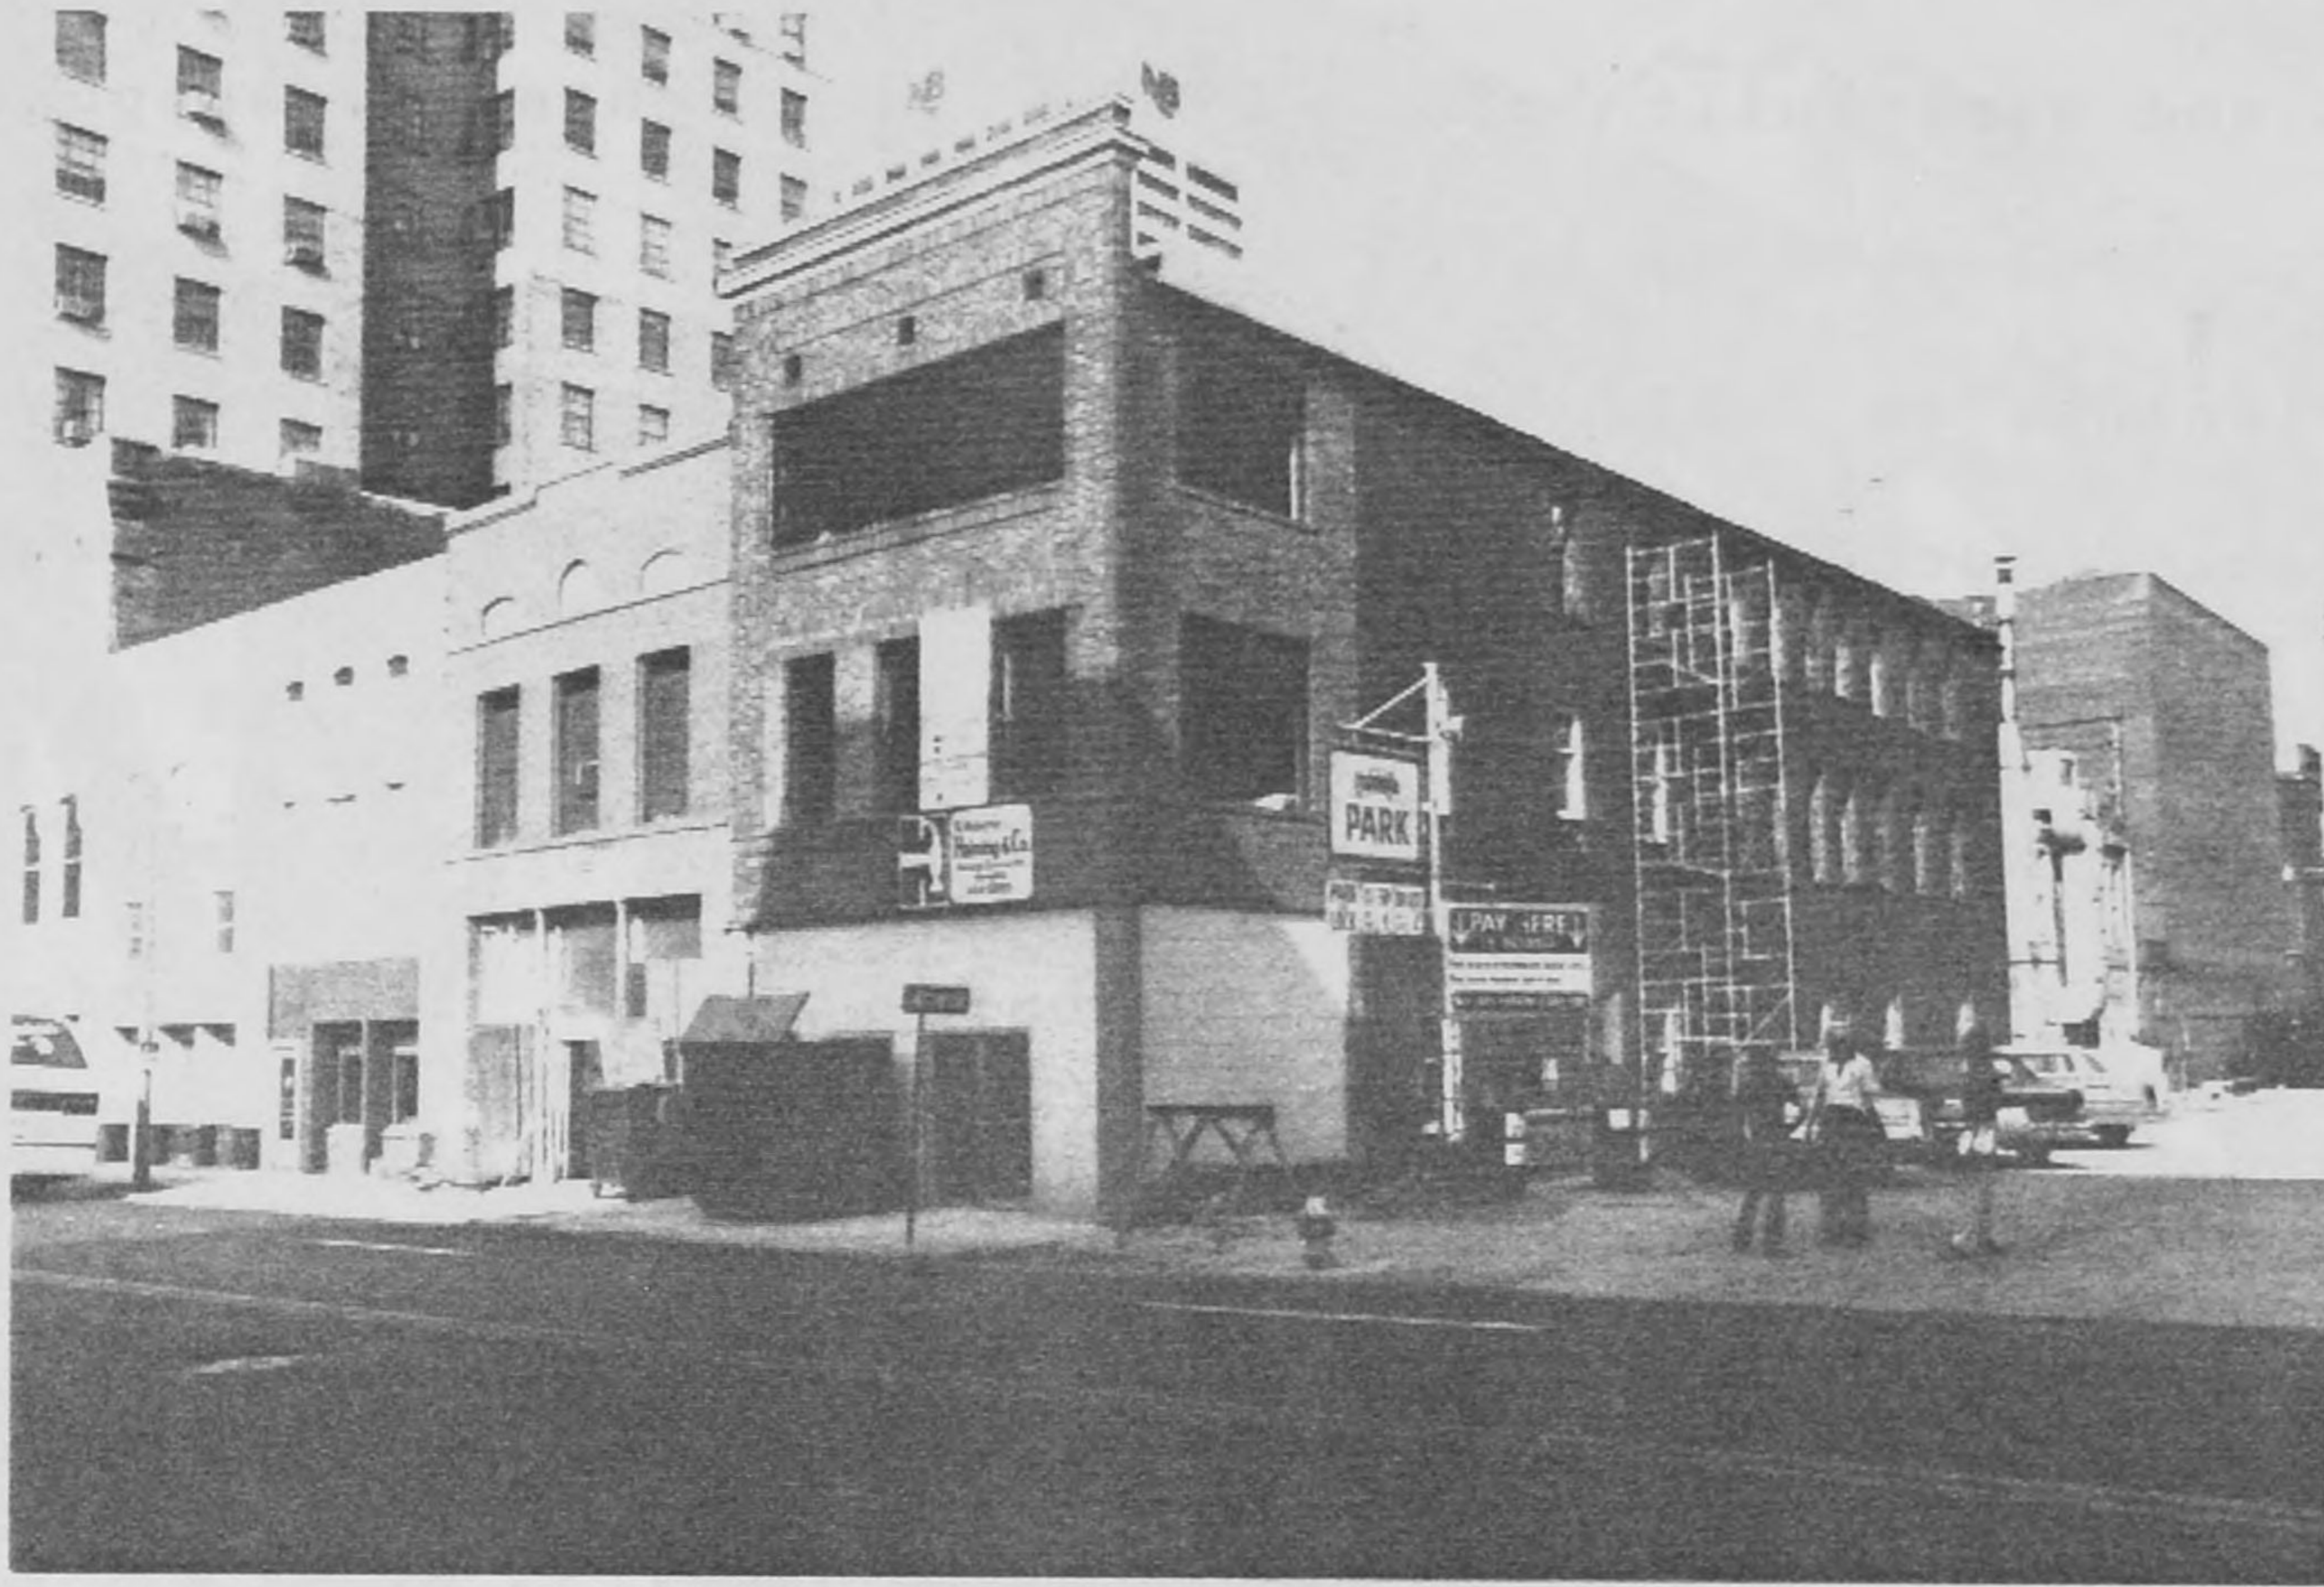
Fig. 6.1 Building A

Building A is a typical representative of low-rise masonry bearing wall structures, Fig. 6.1. It was built around 1867 and has 3 stories, unreinforced brick walls, wood joists, and wood floors and roof. Its weakest feature is the lack of shear walls in the narrow direction. Heavy damage can be expected despite the lightweight floors and roof.

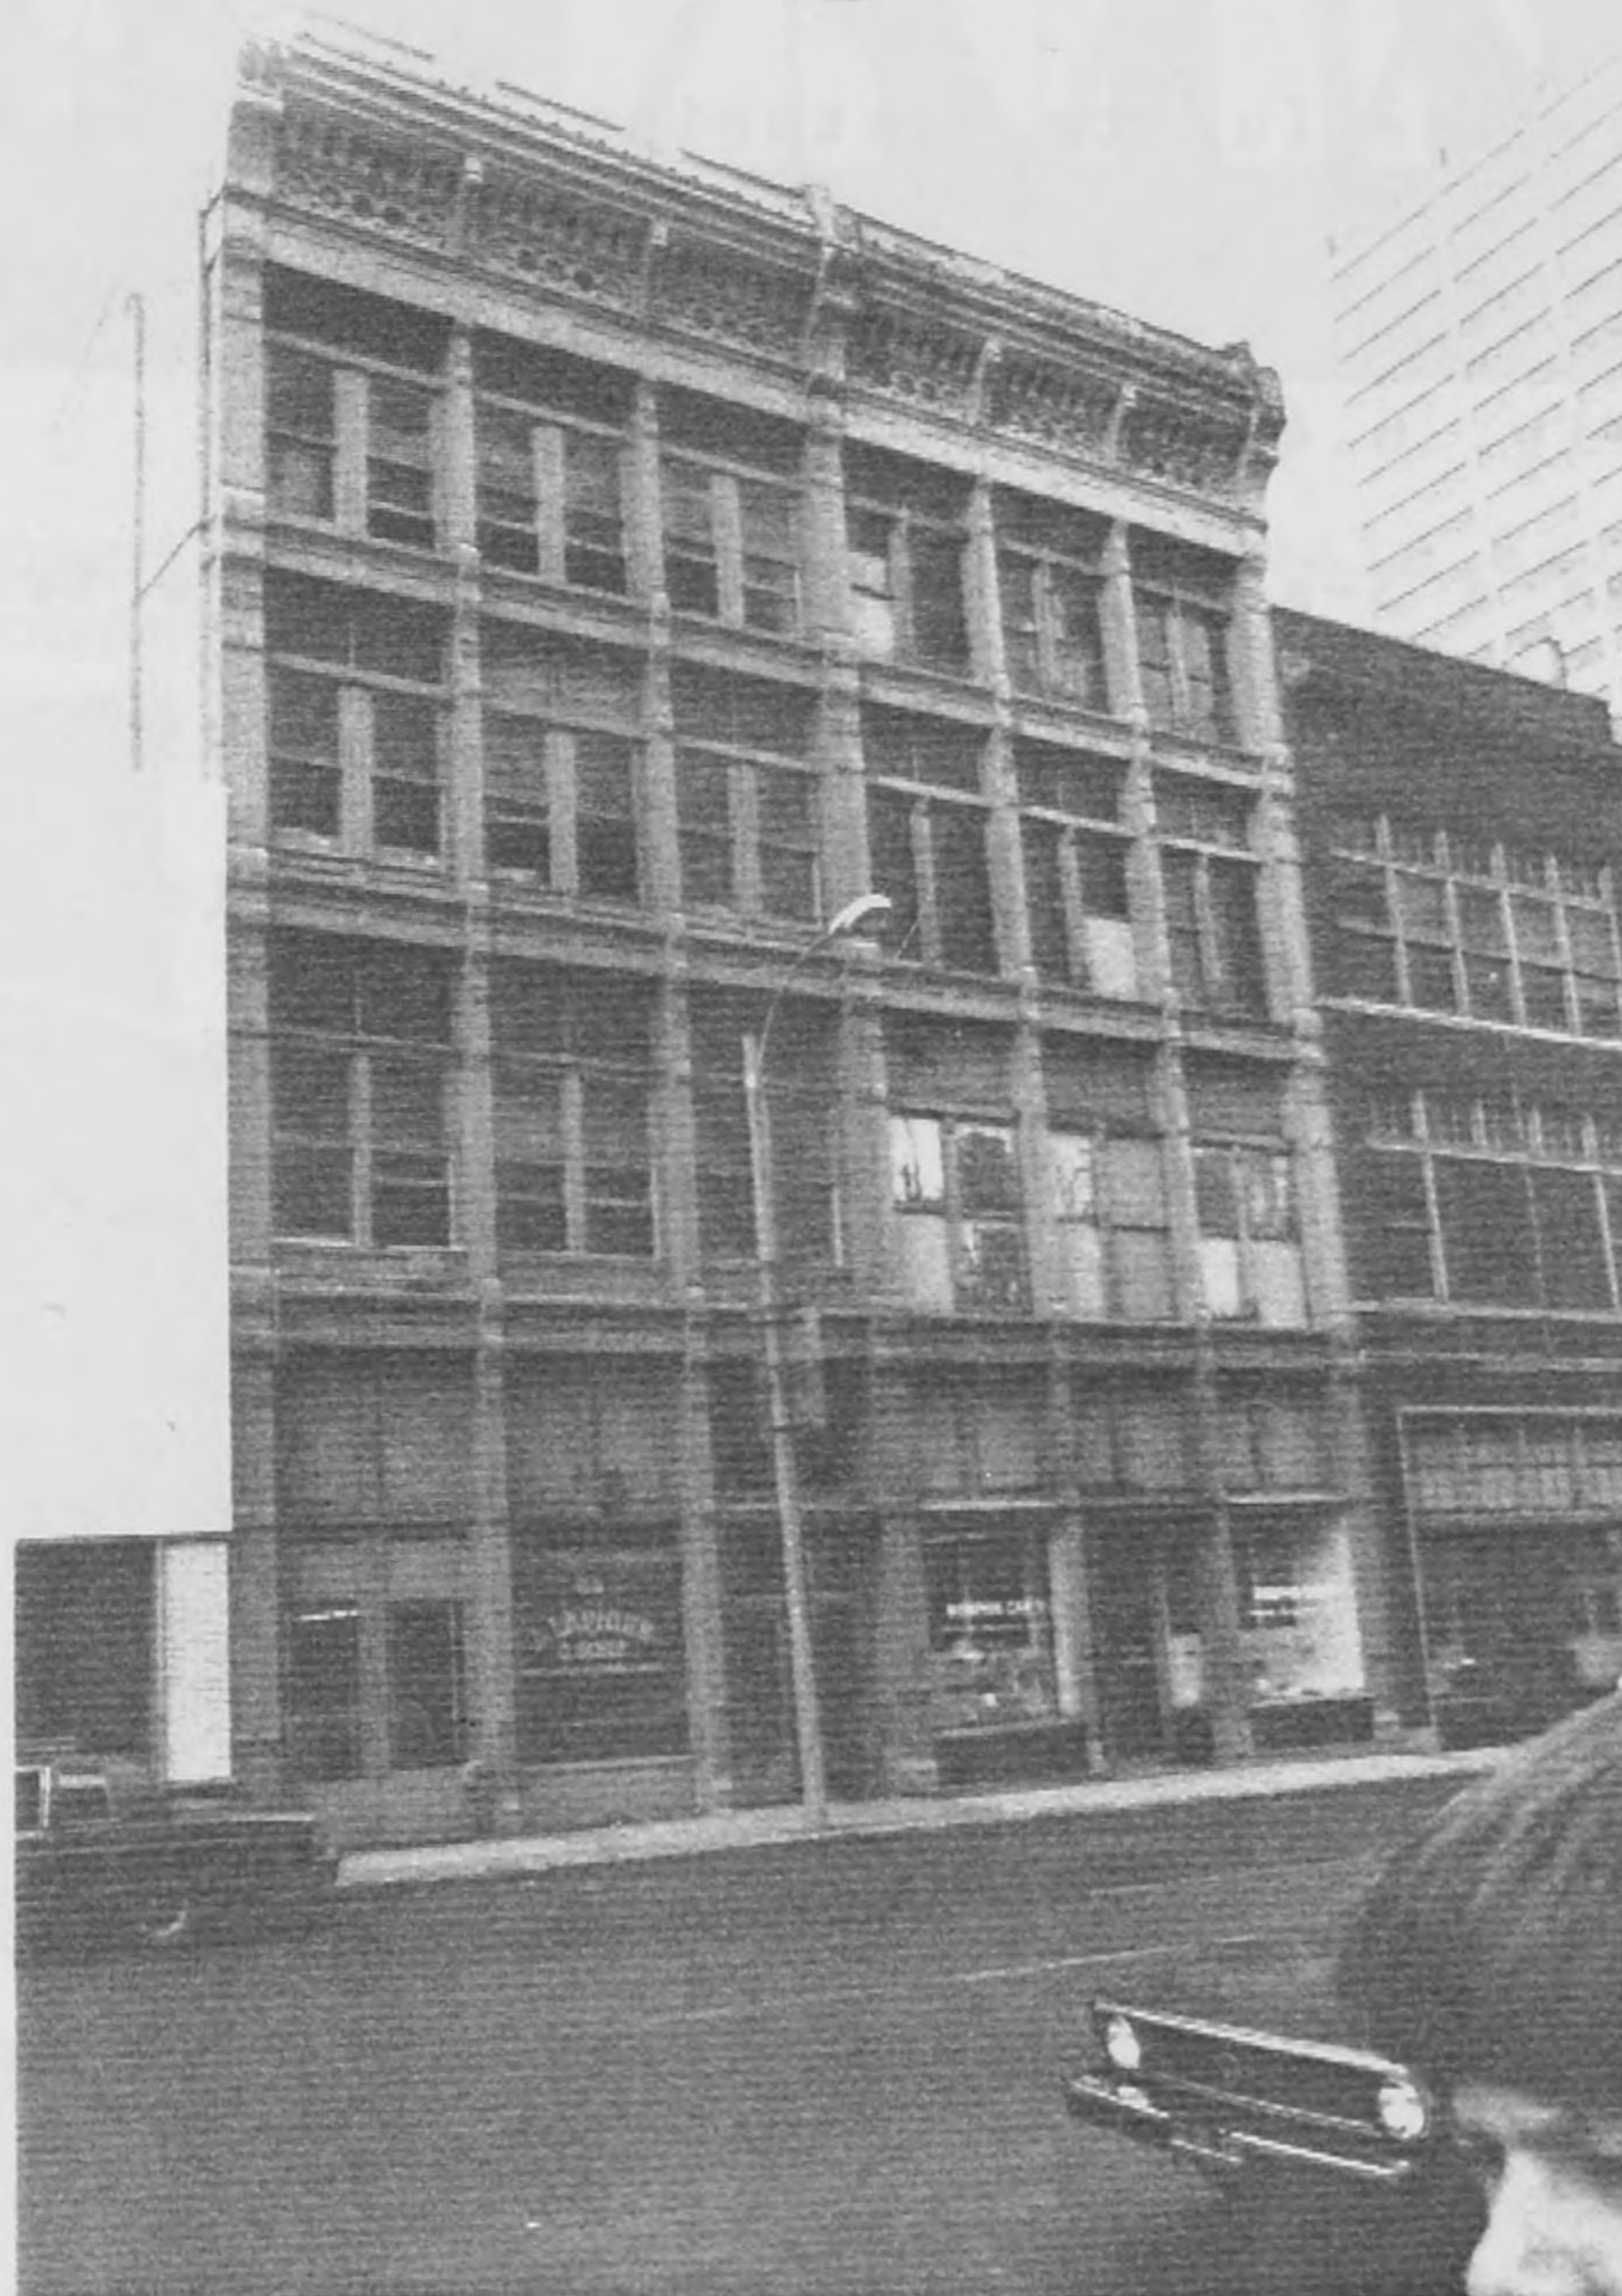
Fig. 6.2 Building B

Buildings B, also with masonry bearing walls, have four stories and were built before 1900. The fronts are supported by cast iron frames, Fig. 6.2.

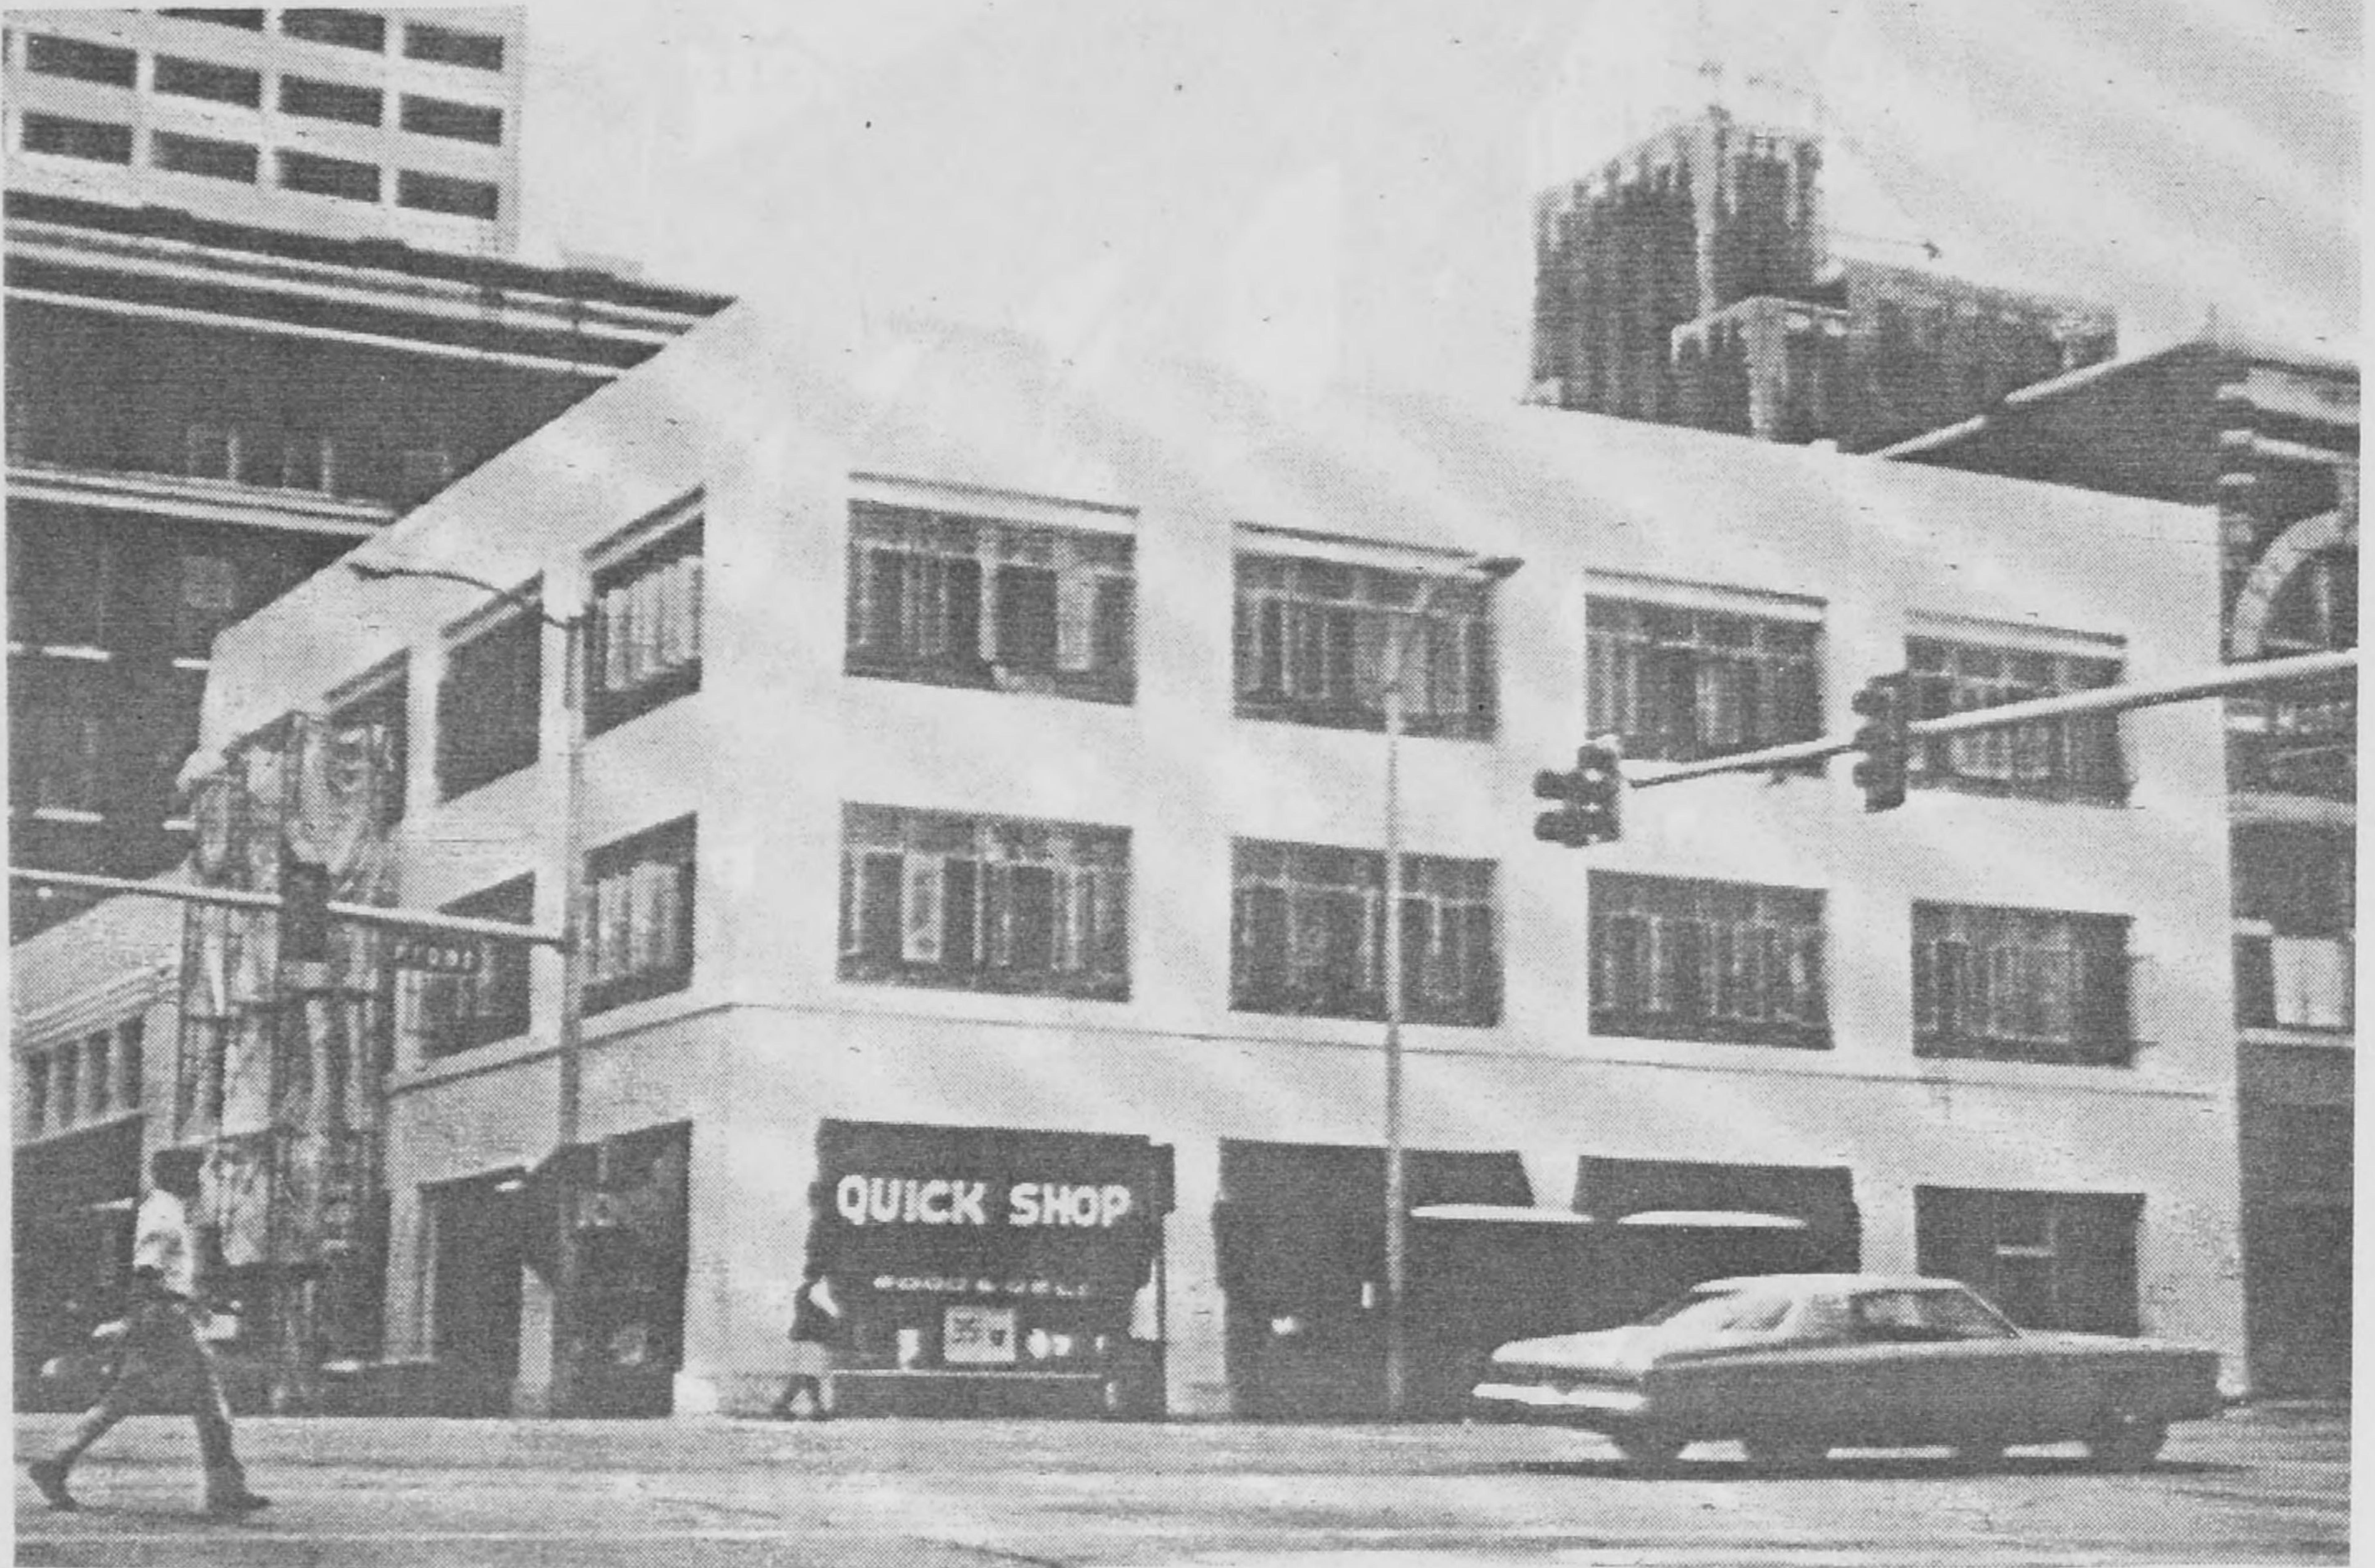
Fig. 6.5 Building C

Building C is a 3-story reinforced concrete frame building with concrete floors and roof, built in the 1930's, Fig. 6.5. It is a doubly symmetric, rectangular building with few partitions. Typical cross sections of beams and columns are shown in Fig. 6.6. There is little potential for architectural damage, except for some plaster repair and glass replacement that might be required. Judging from a comparison of this structure to others of comparable size that have survived or failed in destructive earthquakes, one would expect structural damage to be minimal.

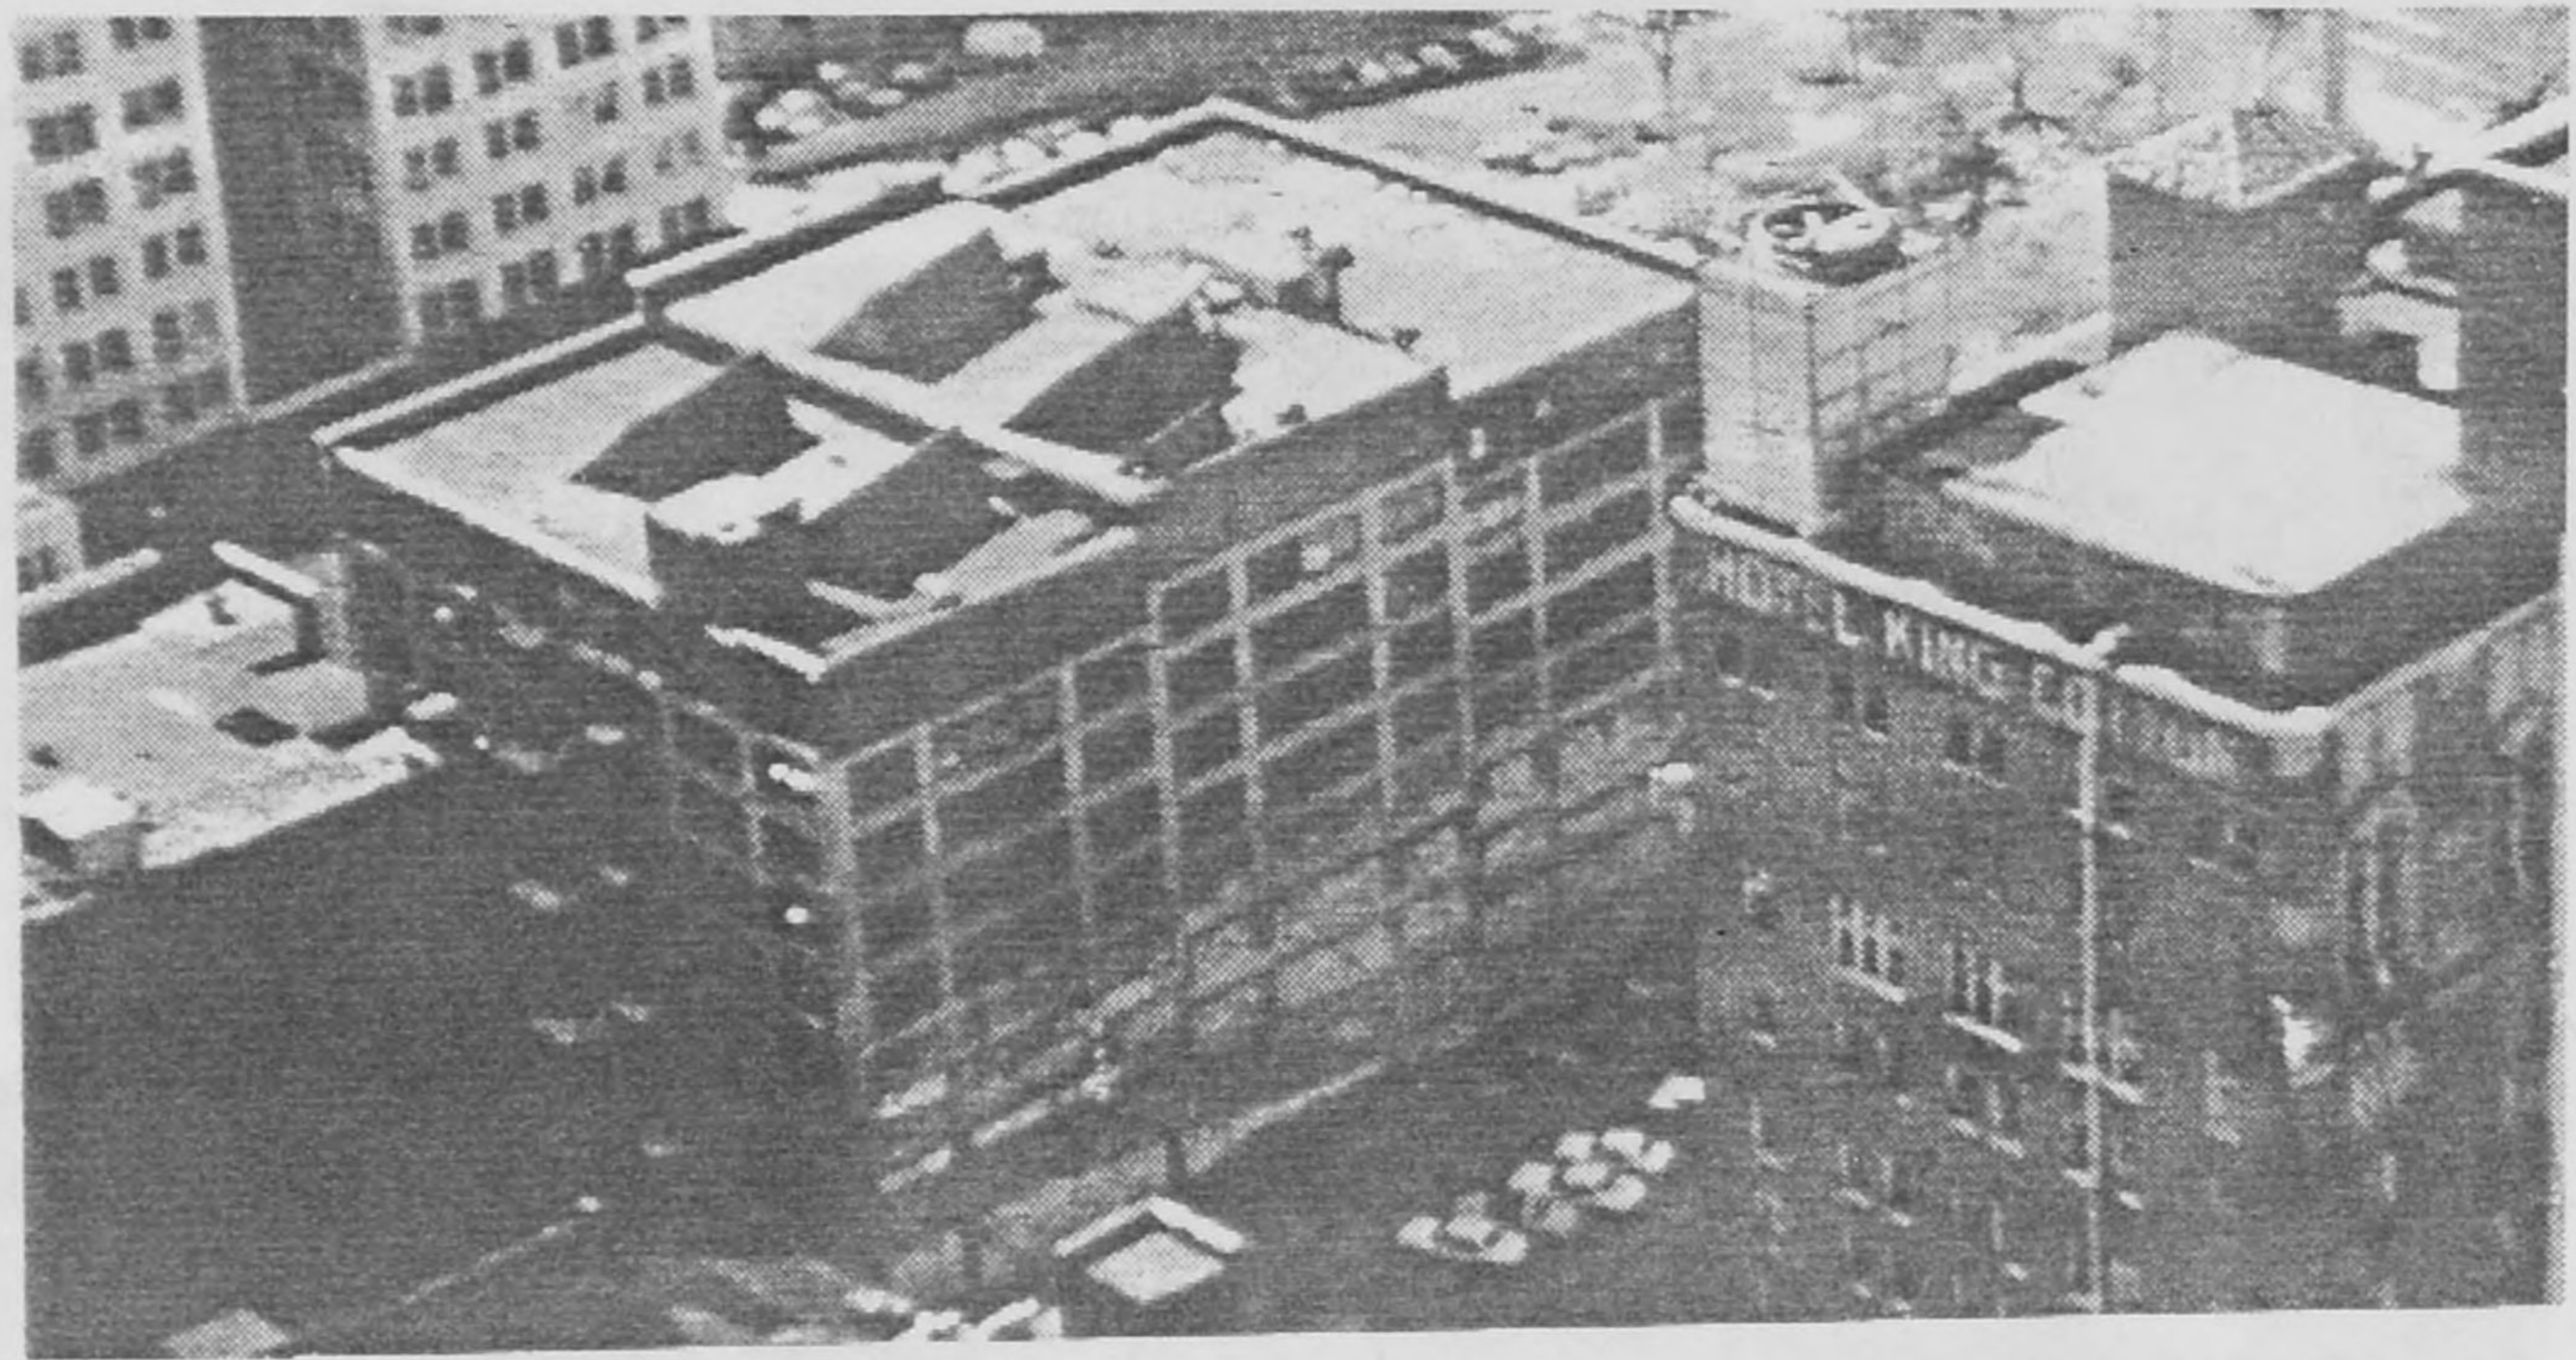
Fig. 6.12 Building G

Building G is 9 stories high. It is featured with an irregular steel frame with brick walls, Fig. 6.12, wood floors and roof, and is presently undergoing extensive remodelling. It was

built in 1906 and remodelled several times since then. Some parts of the building have been flooded in the past, causing a deterioration of wood floors and rusting of steel beams.
