EARTHQUAKE HAZARD ANALYSIS FOR COMMERCIAL BUILDINGS IN MEMPHIS

A Report of Research Sponsored by
U.S. Geological Survey
Contract No. 14-08-0001-19829

SUMMARY

The report deals with the evaluation of seismic risk for commercial buildings in Memphis, Tennessee.

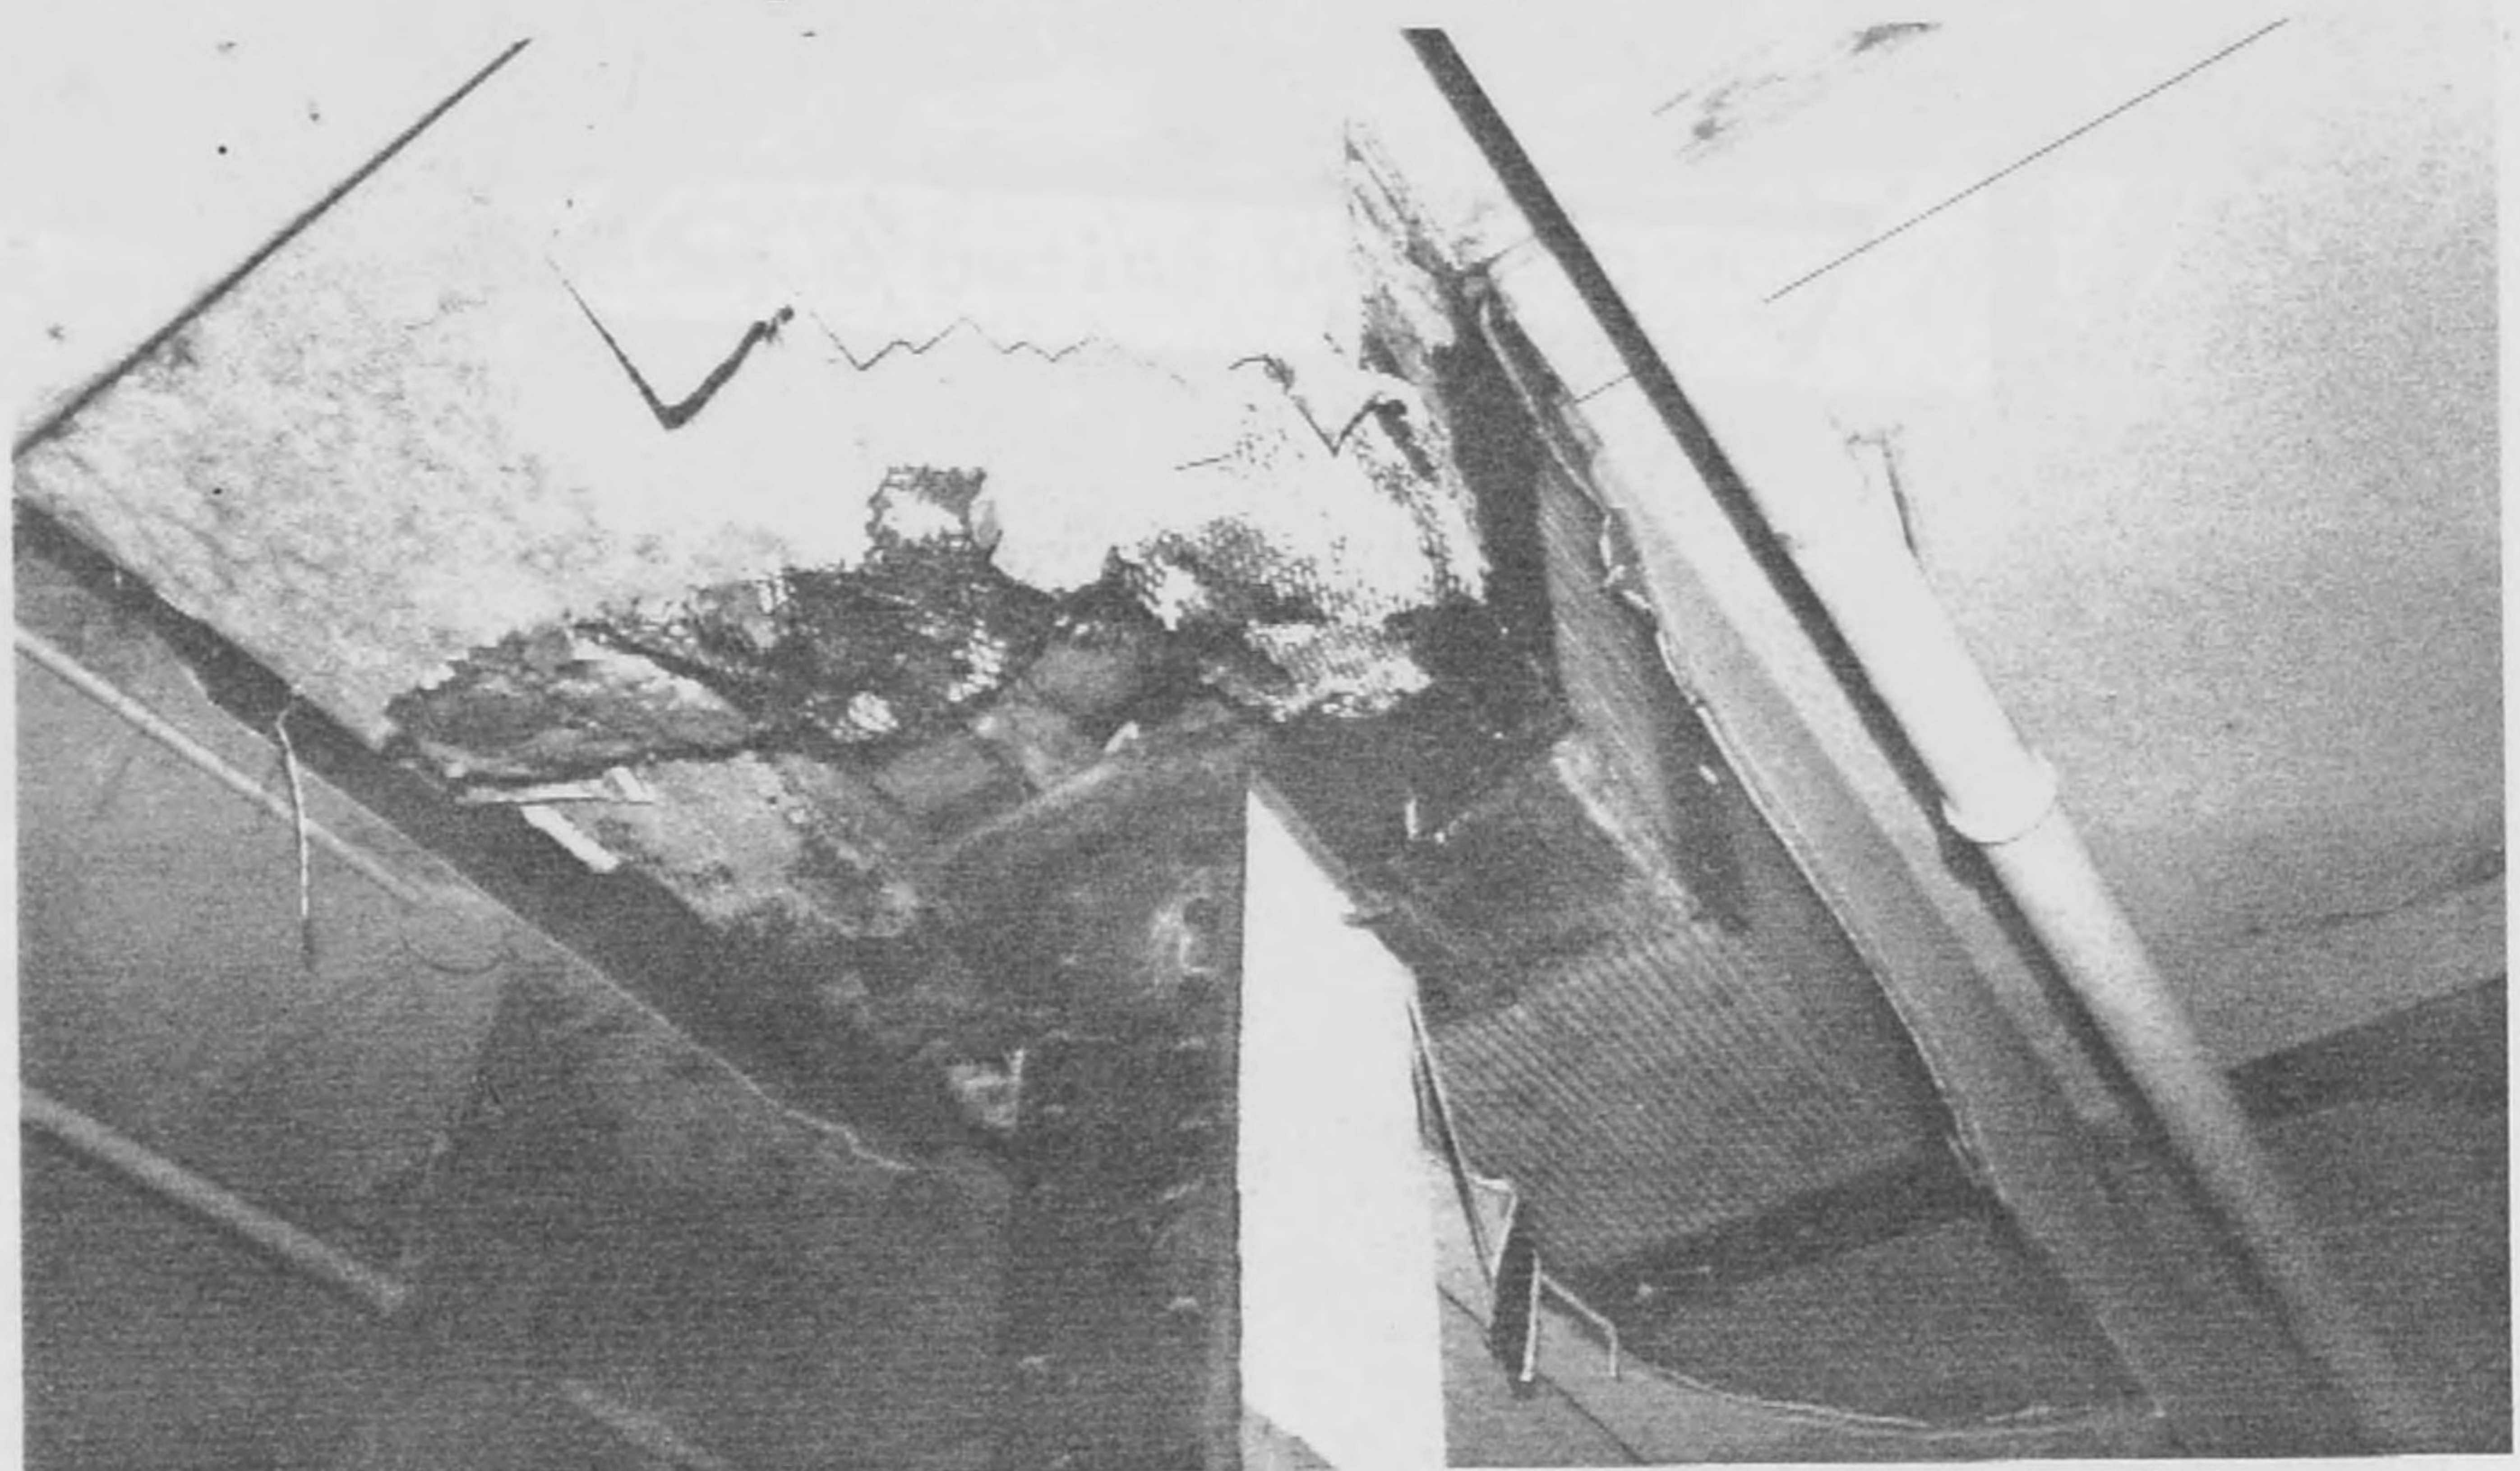
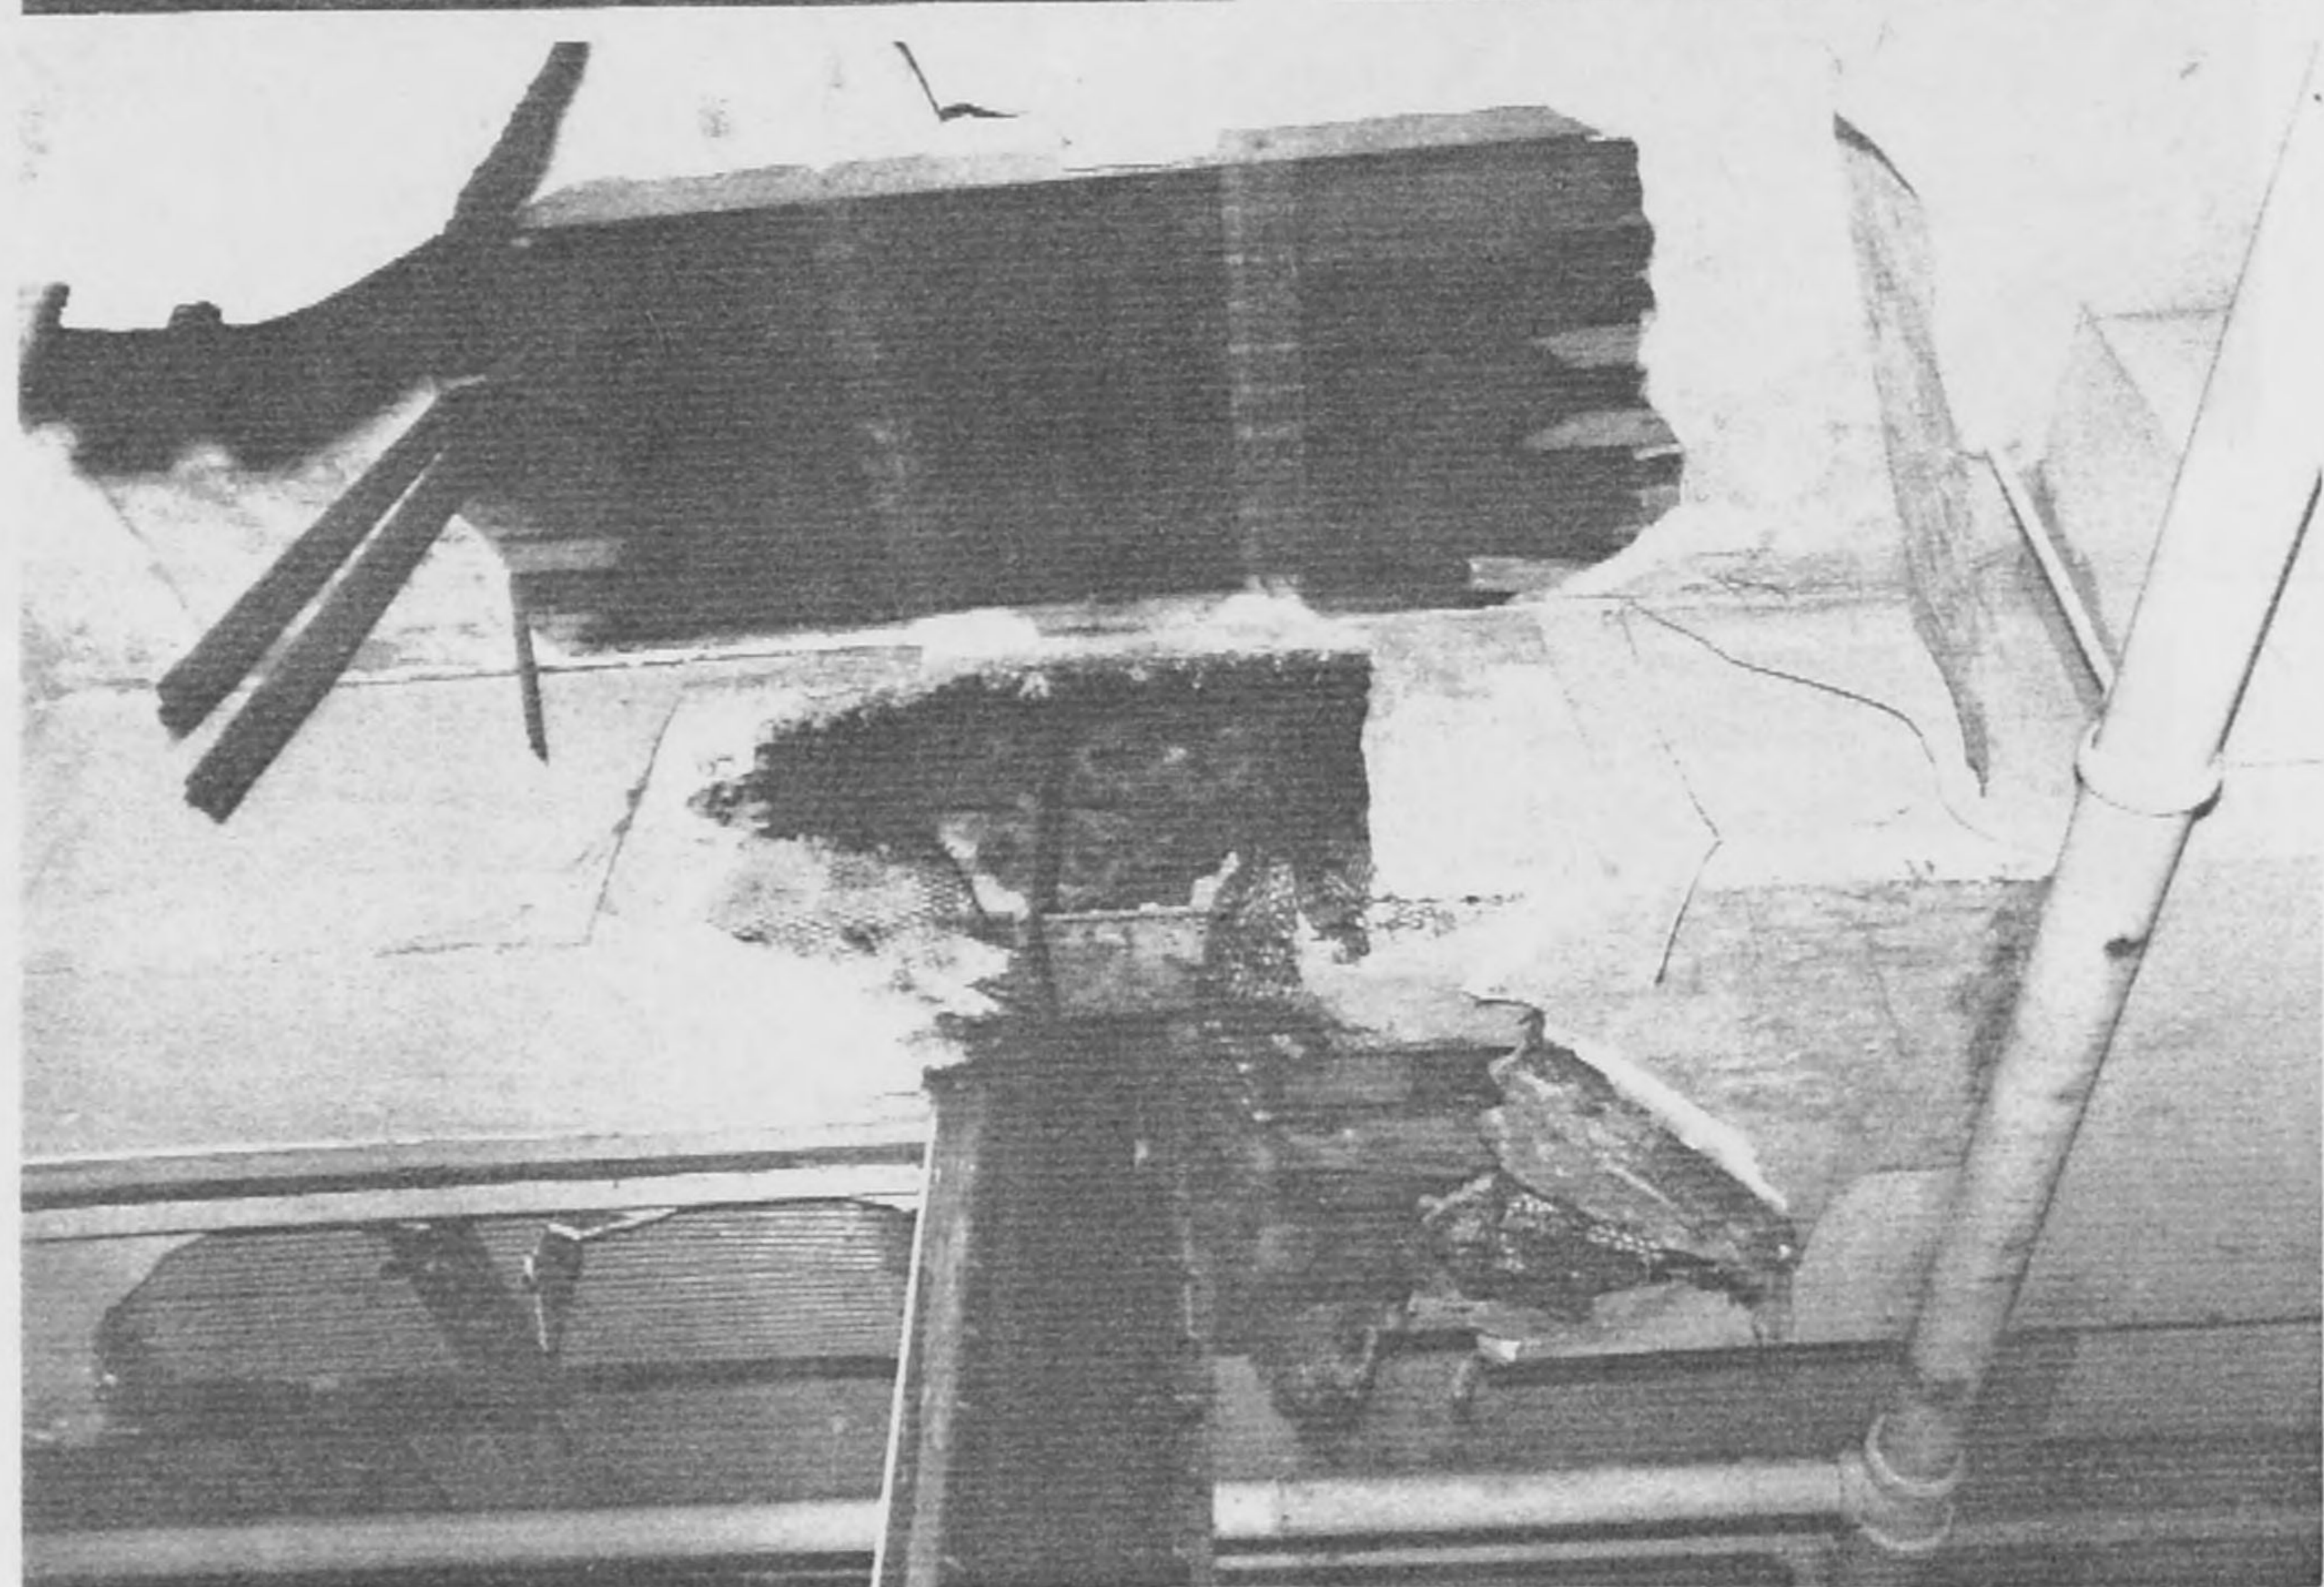
Fig. 6.13 Details of Steel Frame in Building G

Structural details are shown in Fig. 6.13. The light weight floors and roof are the redeeming features of this structure. One would expect some shattered brick walls and considerable glass breakage, but no collapse. However, the damage could make the building more costly to repair than to replace.

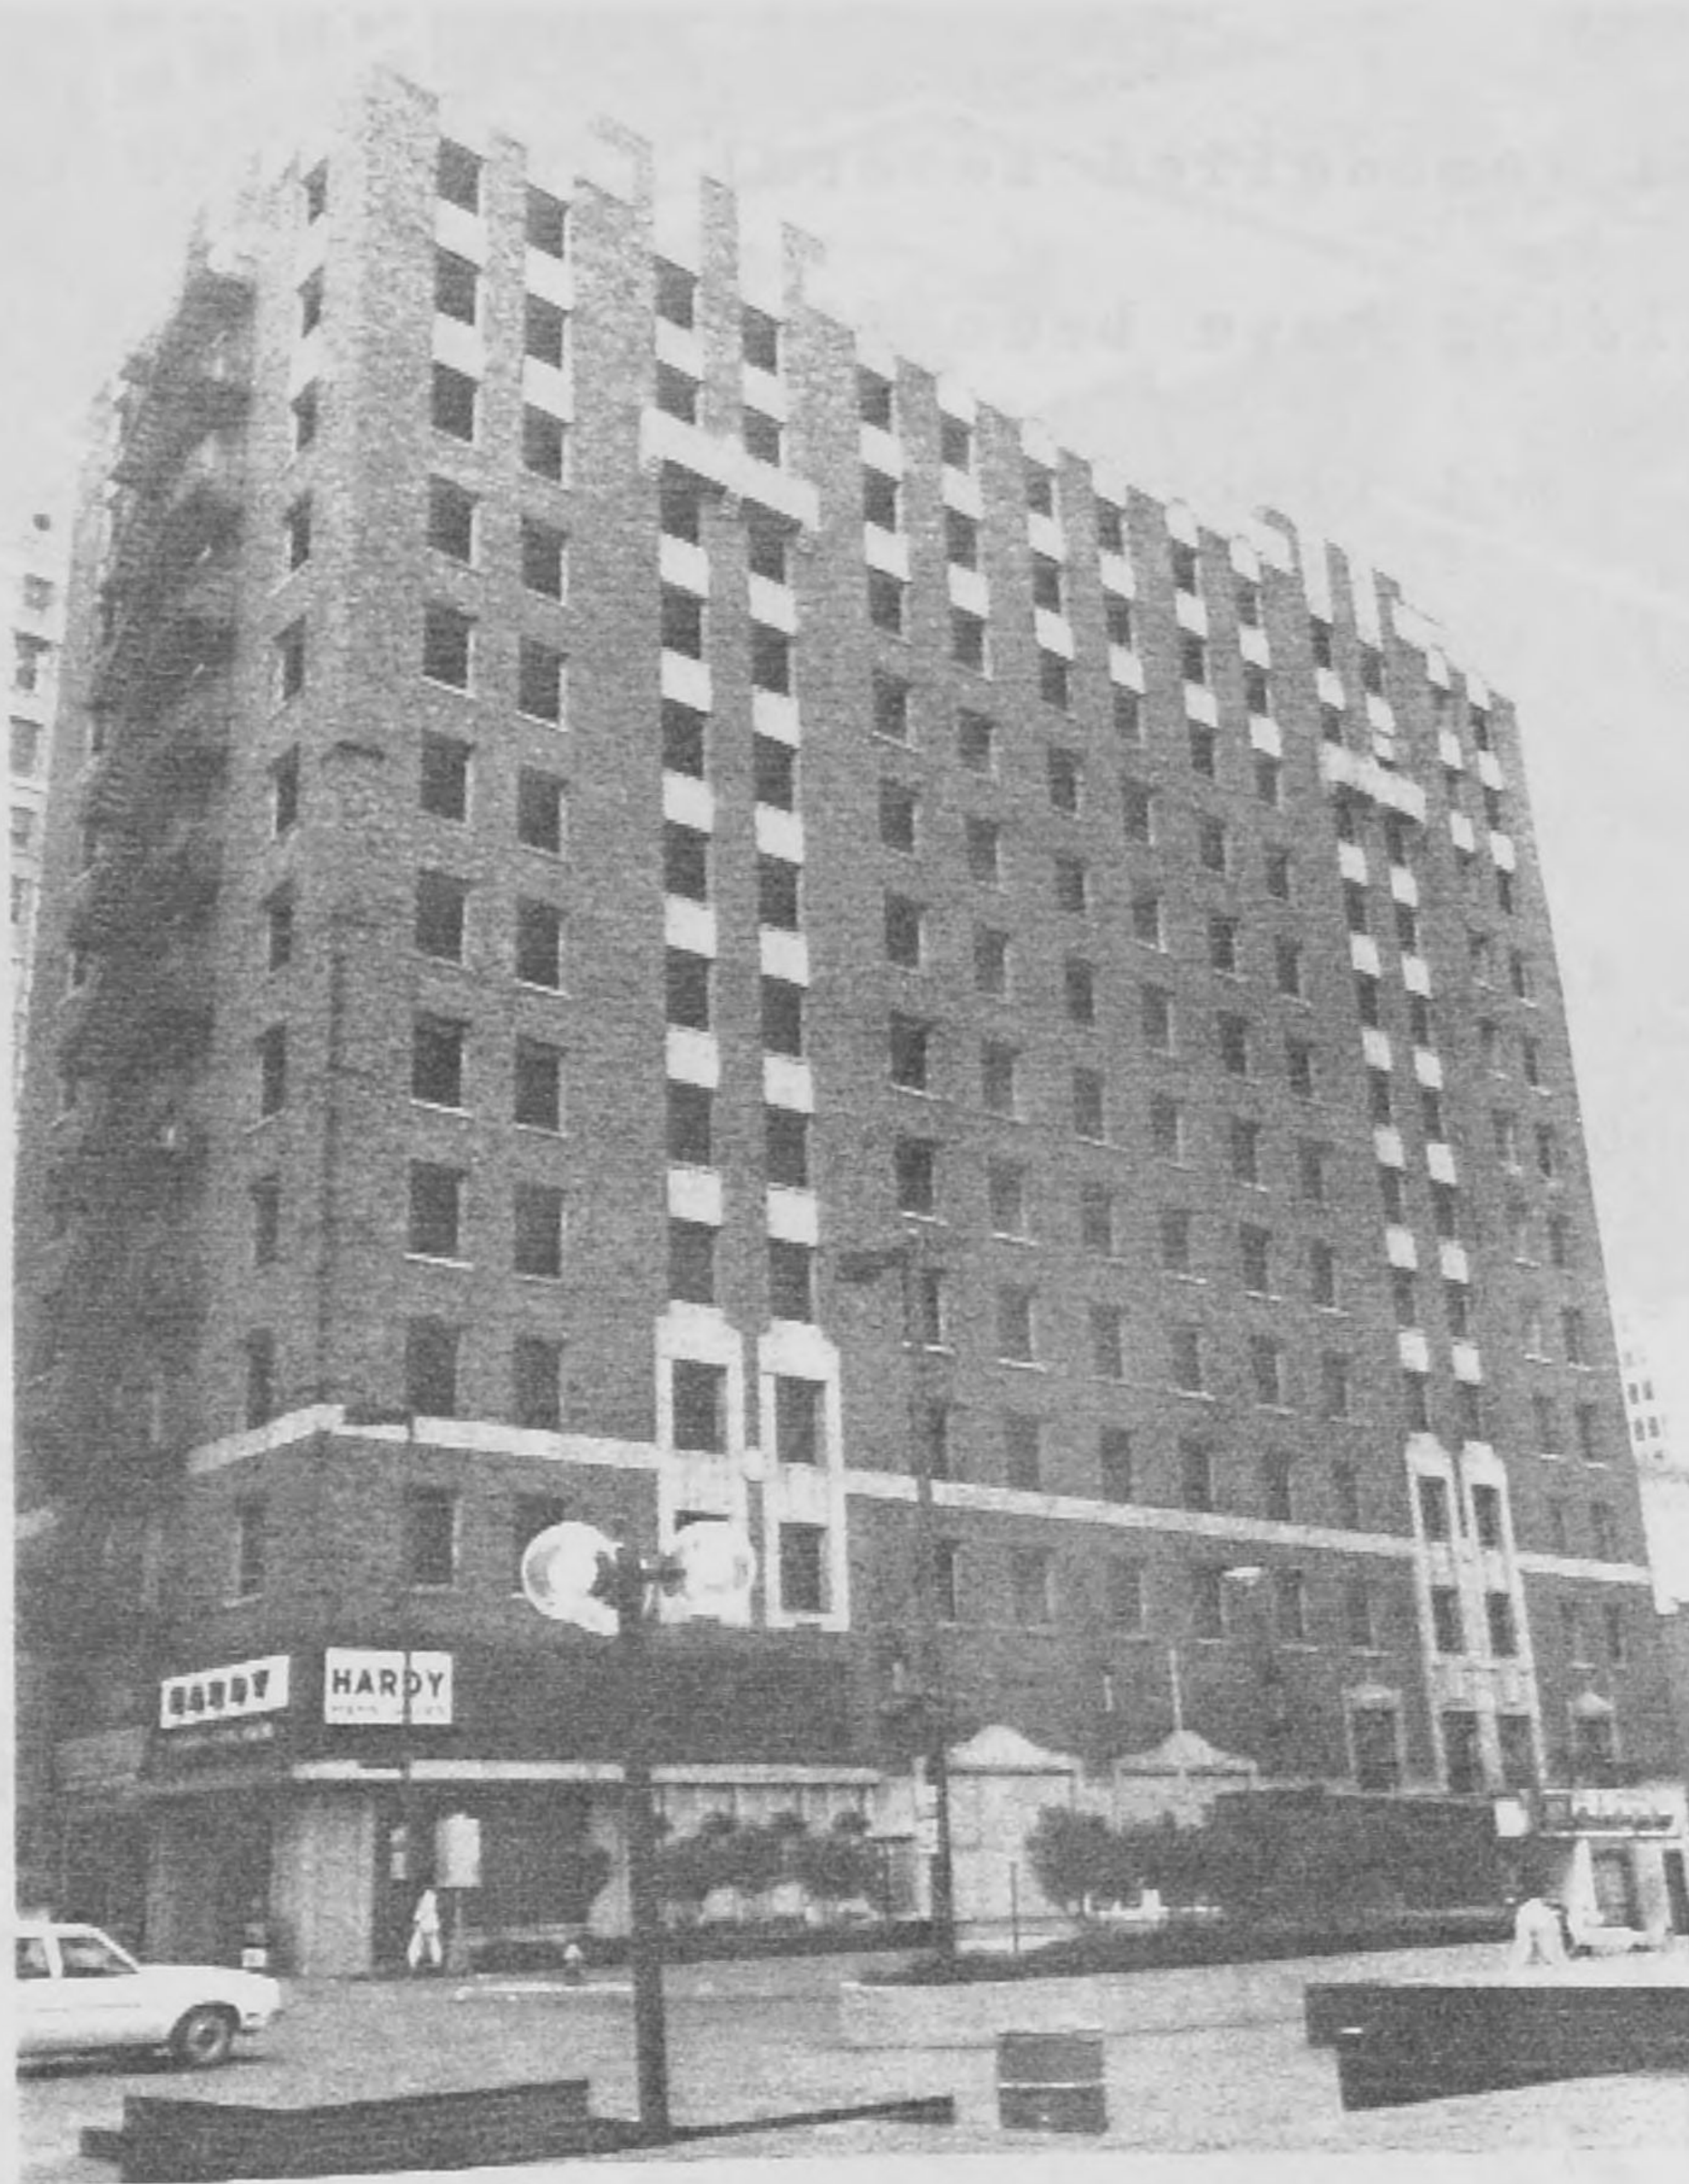
Fig. 6.14 Building H

Building H is a 12-story reinforced concrete frame building, Fig. 6.14, with concrete floors and roof, built in the 1930's. This is a regular building, rectangular in plan, with numerous shear walls: exterior and interior, longitudinal and transverse. A typical floor is shown in Fig. 6.15, and typical cross sections of columns, beams, and floor slabs are shown in Fig. 6.16. Again, comparing this building with similar buildings subjected to previous earthquakes, one would expect no structural damage of any significance, and not a great deal of architectural damage.

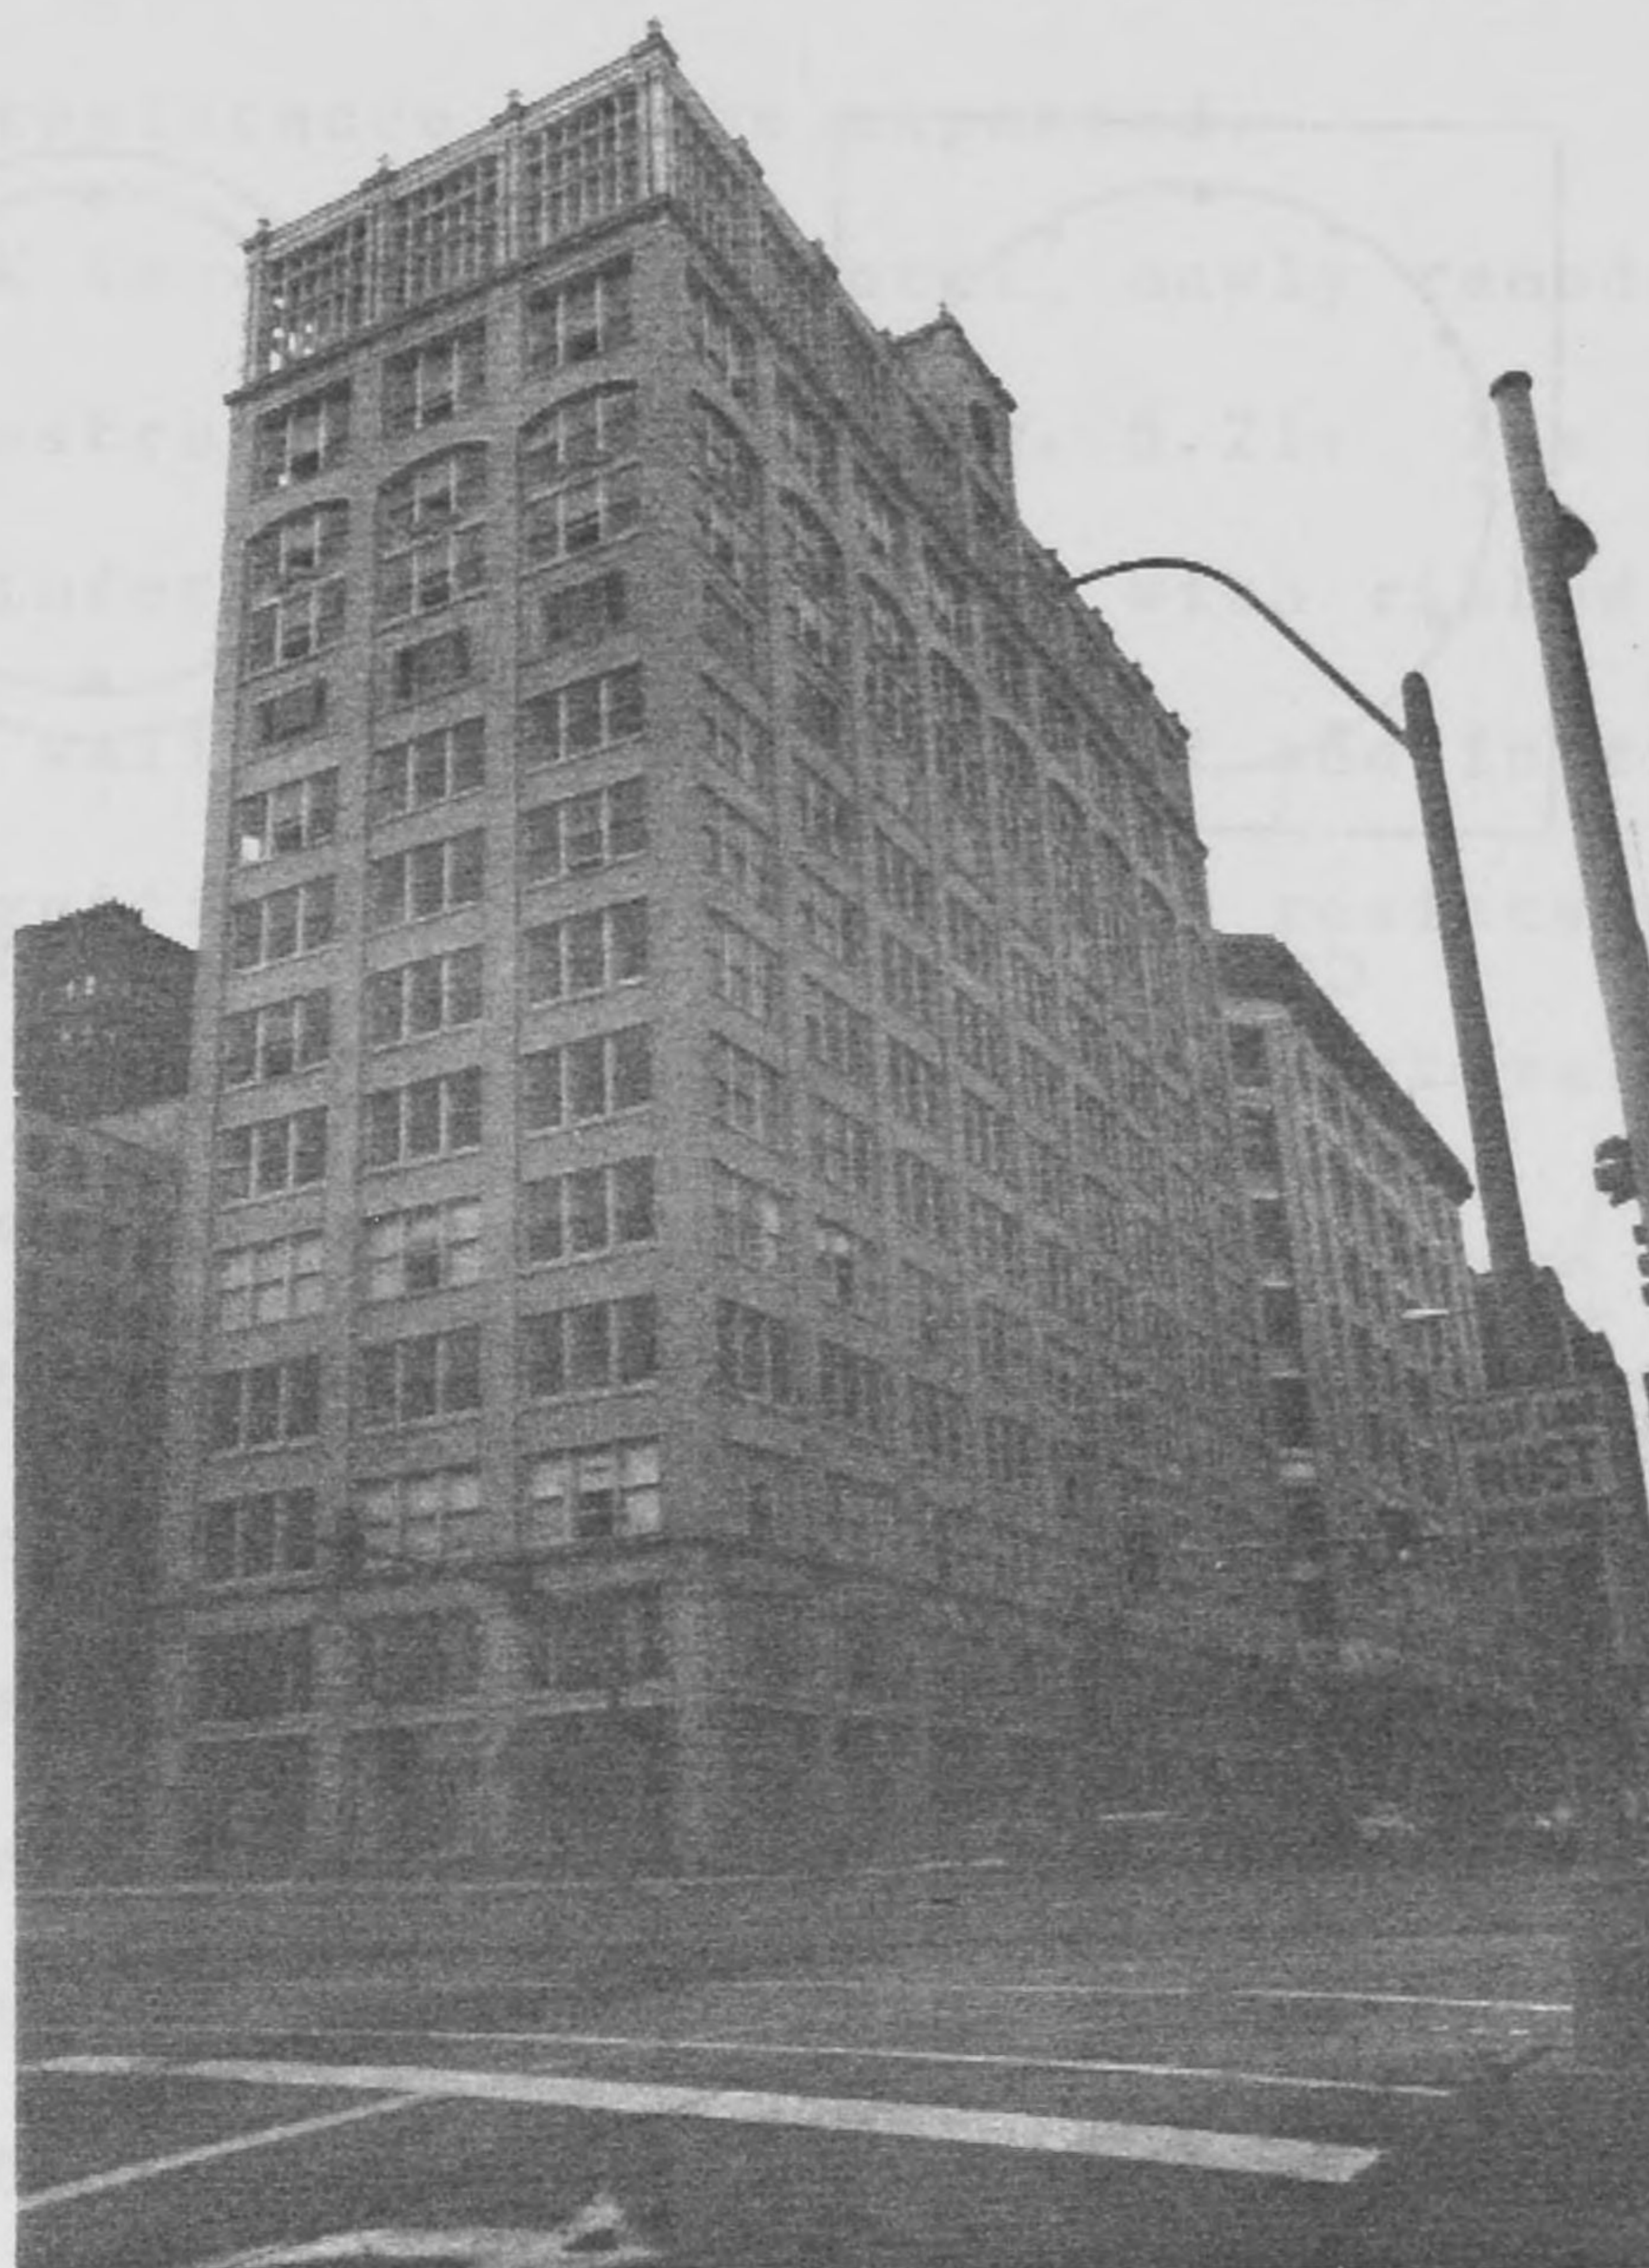
Fig. 6.17 Building I

Building I, with 13 stories, Fig. 6.17, was built in 1923. It has a steel frame, brick walls, and concrete floors and roof. Typical sections of beams and their connections are shown in Fig. 6.18. Numerous exterior and interior walls (partitions) may contribute significantly to the lateral strength of the building. No serious damage can be expected.

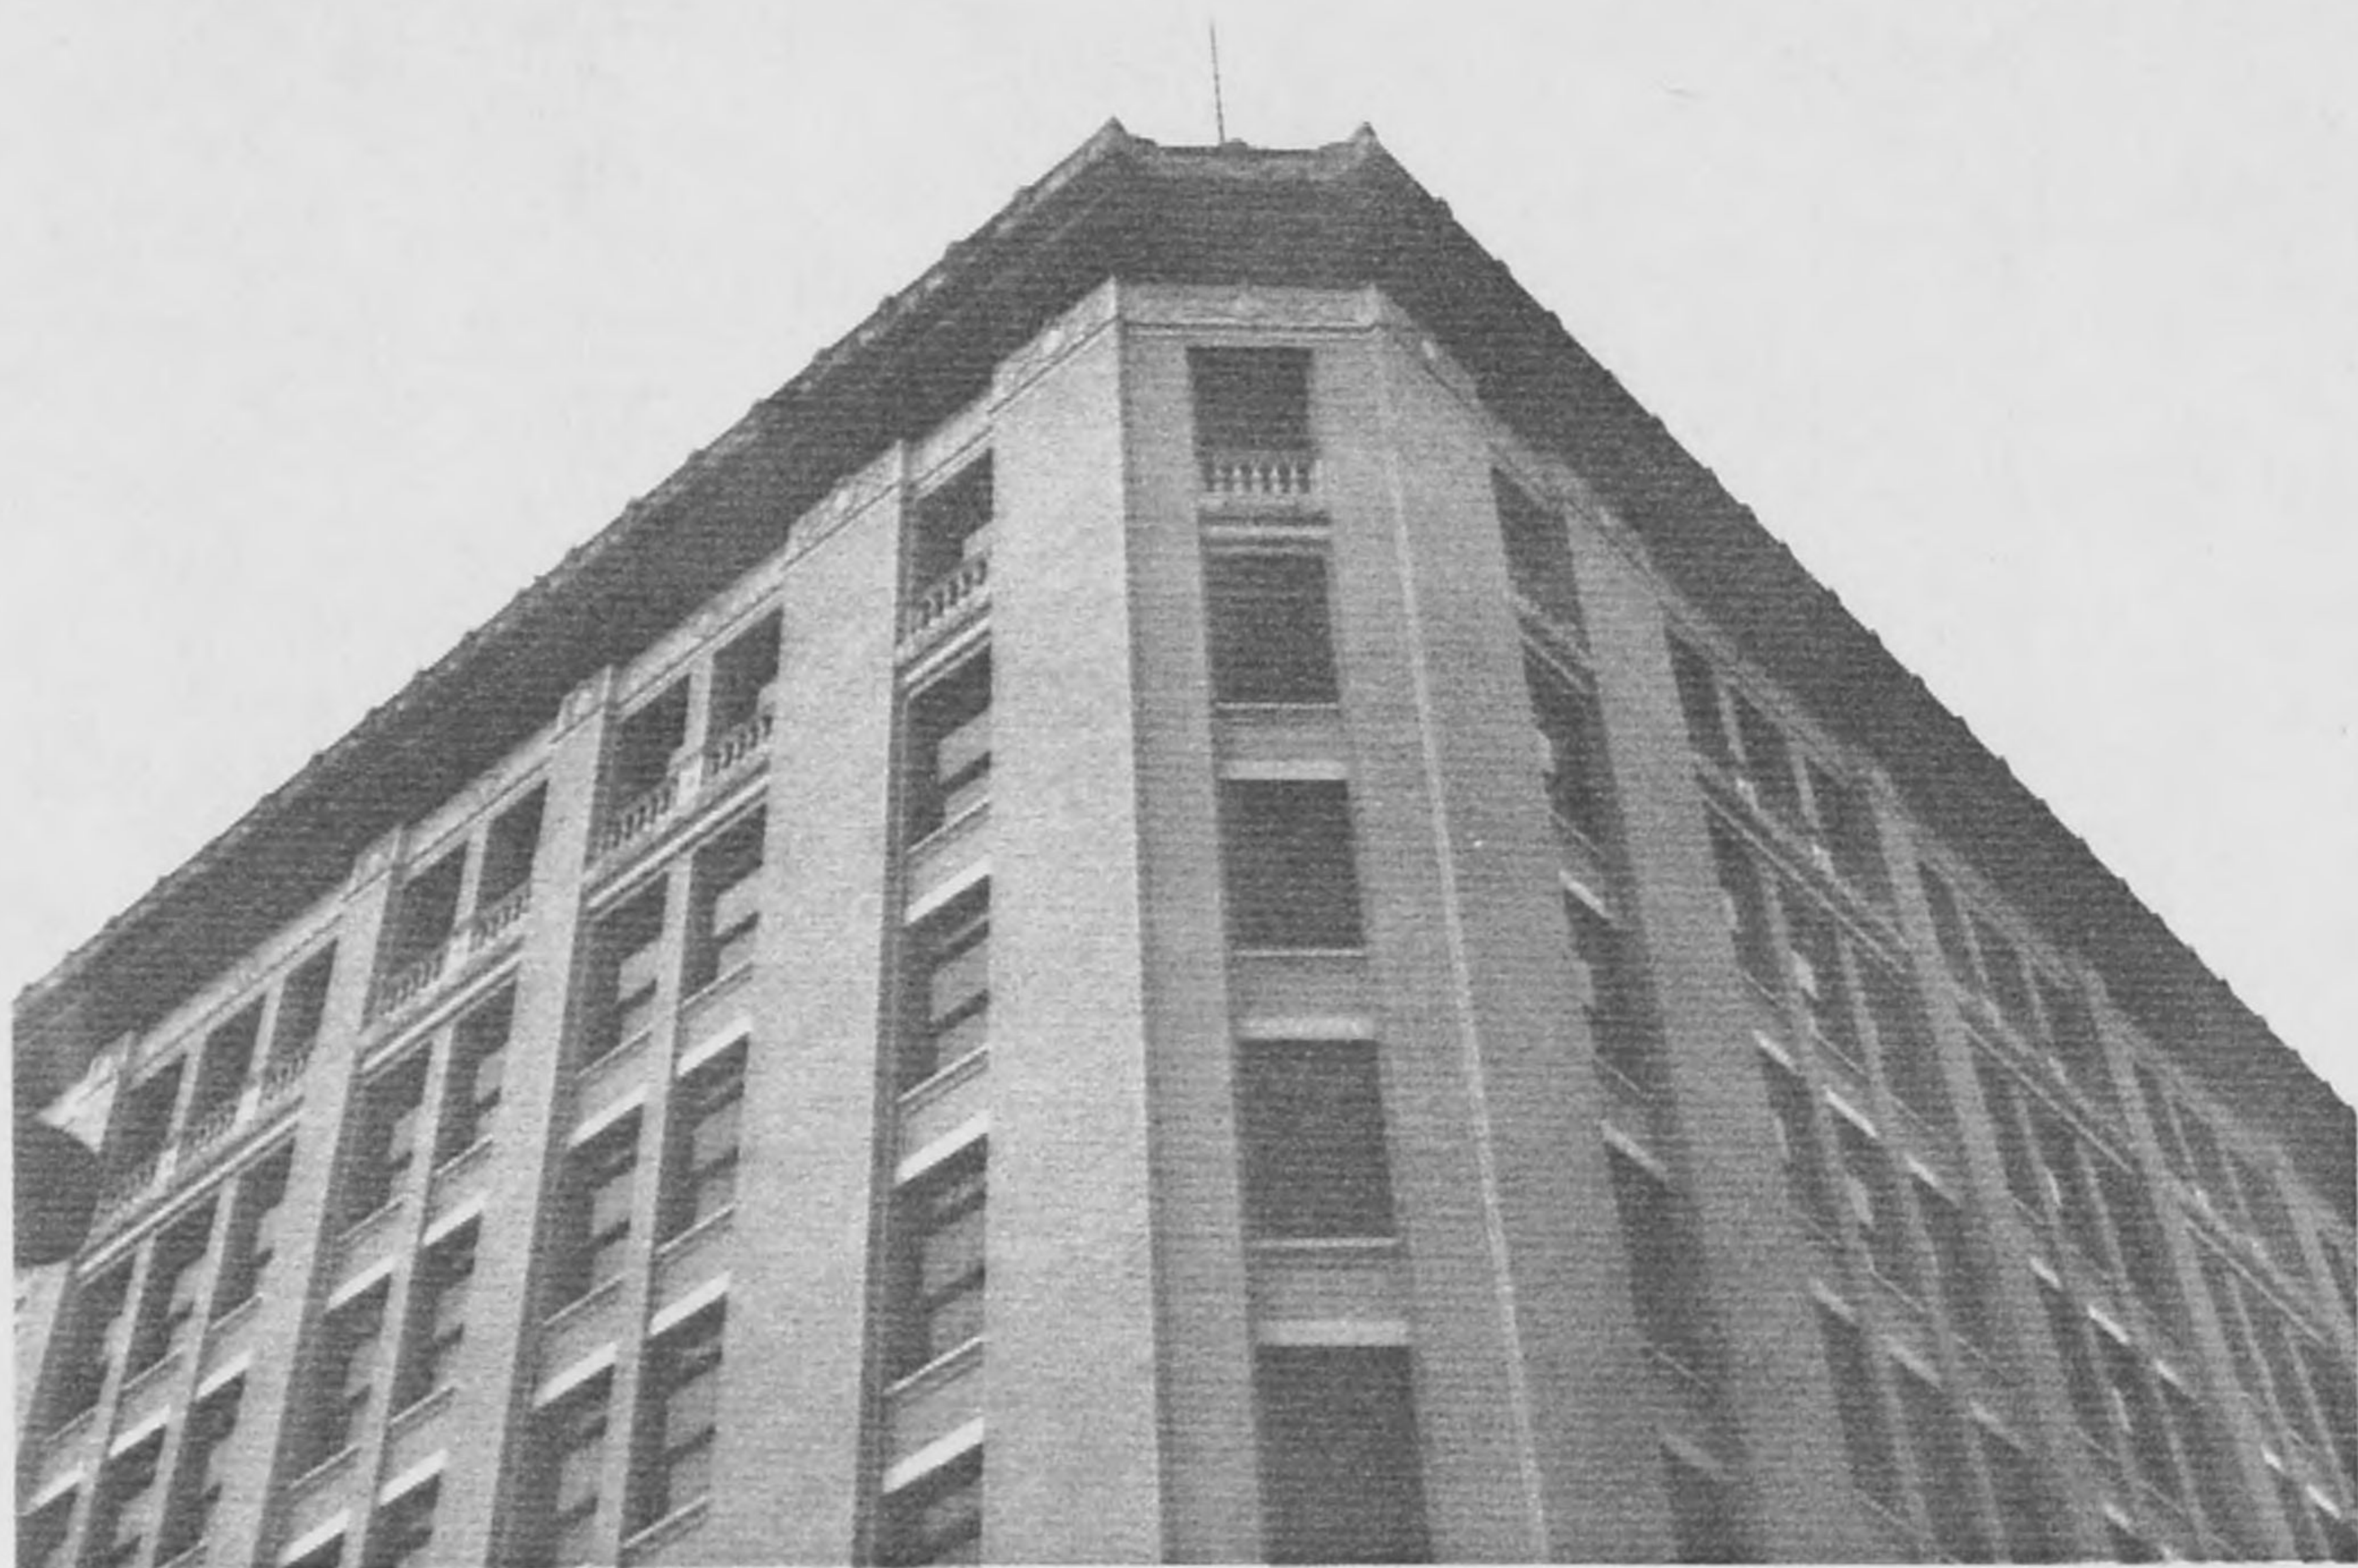
Fig. 6.20 Parapet of Building J

and the building is heavily ornamented (Fig. 6.20). A rather good seismic resistance can be expected.

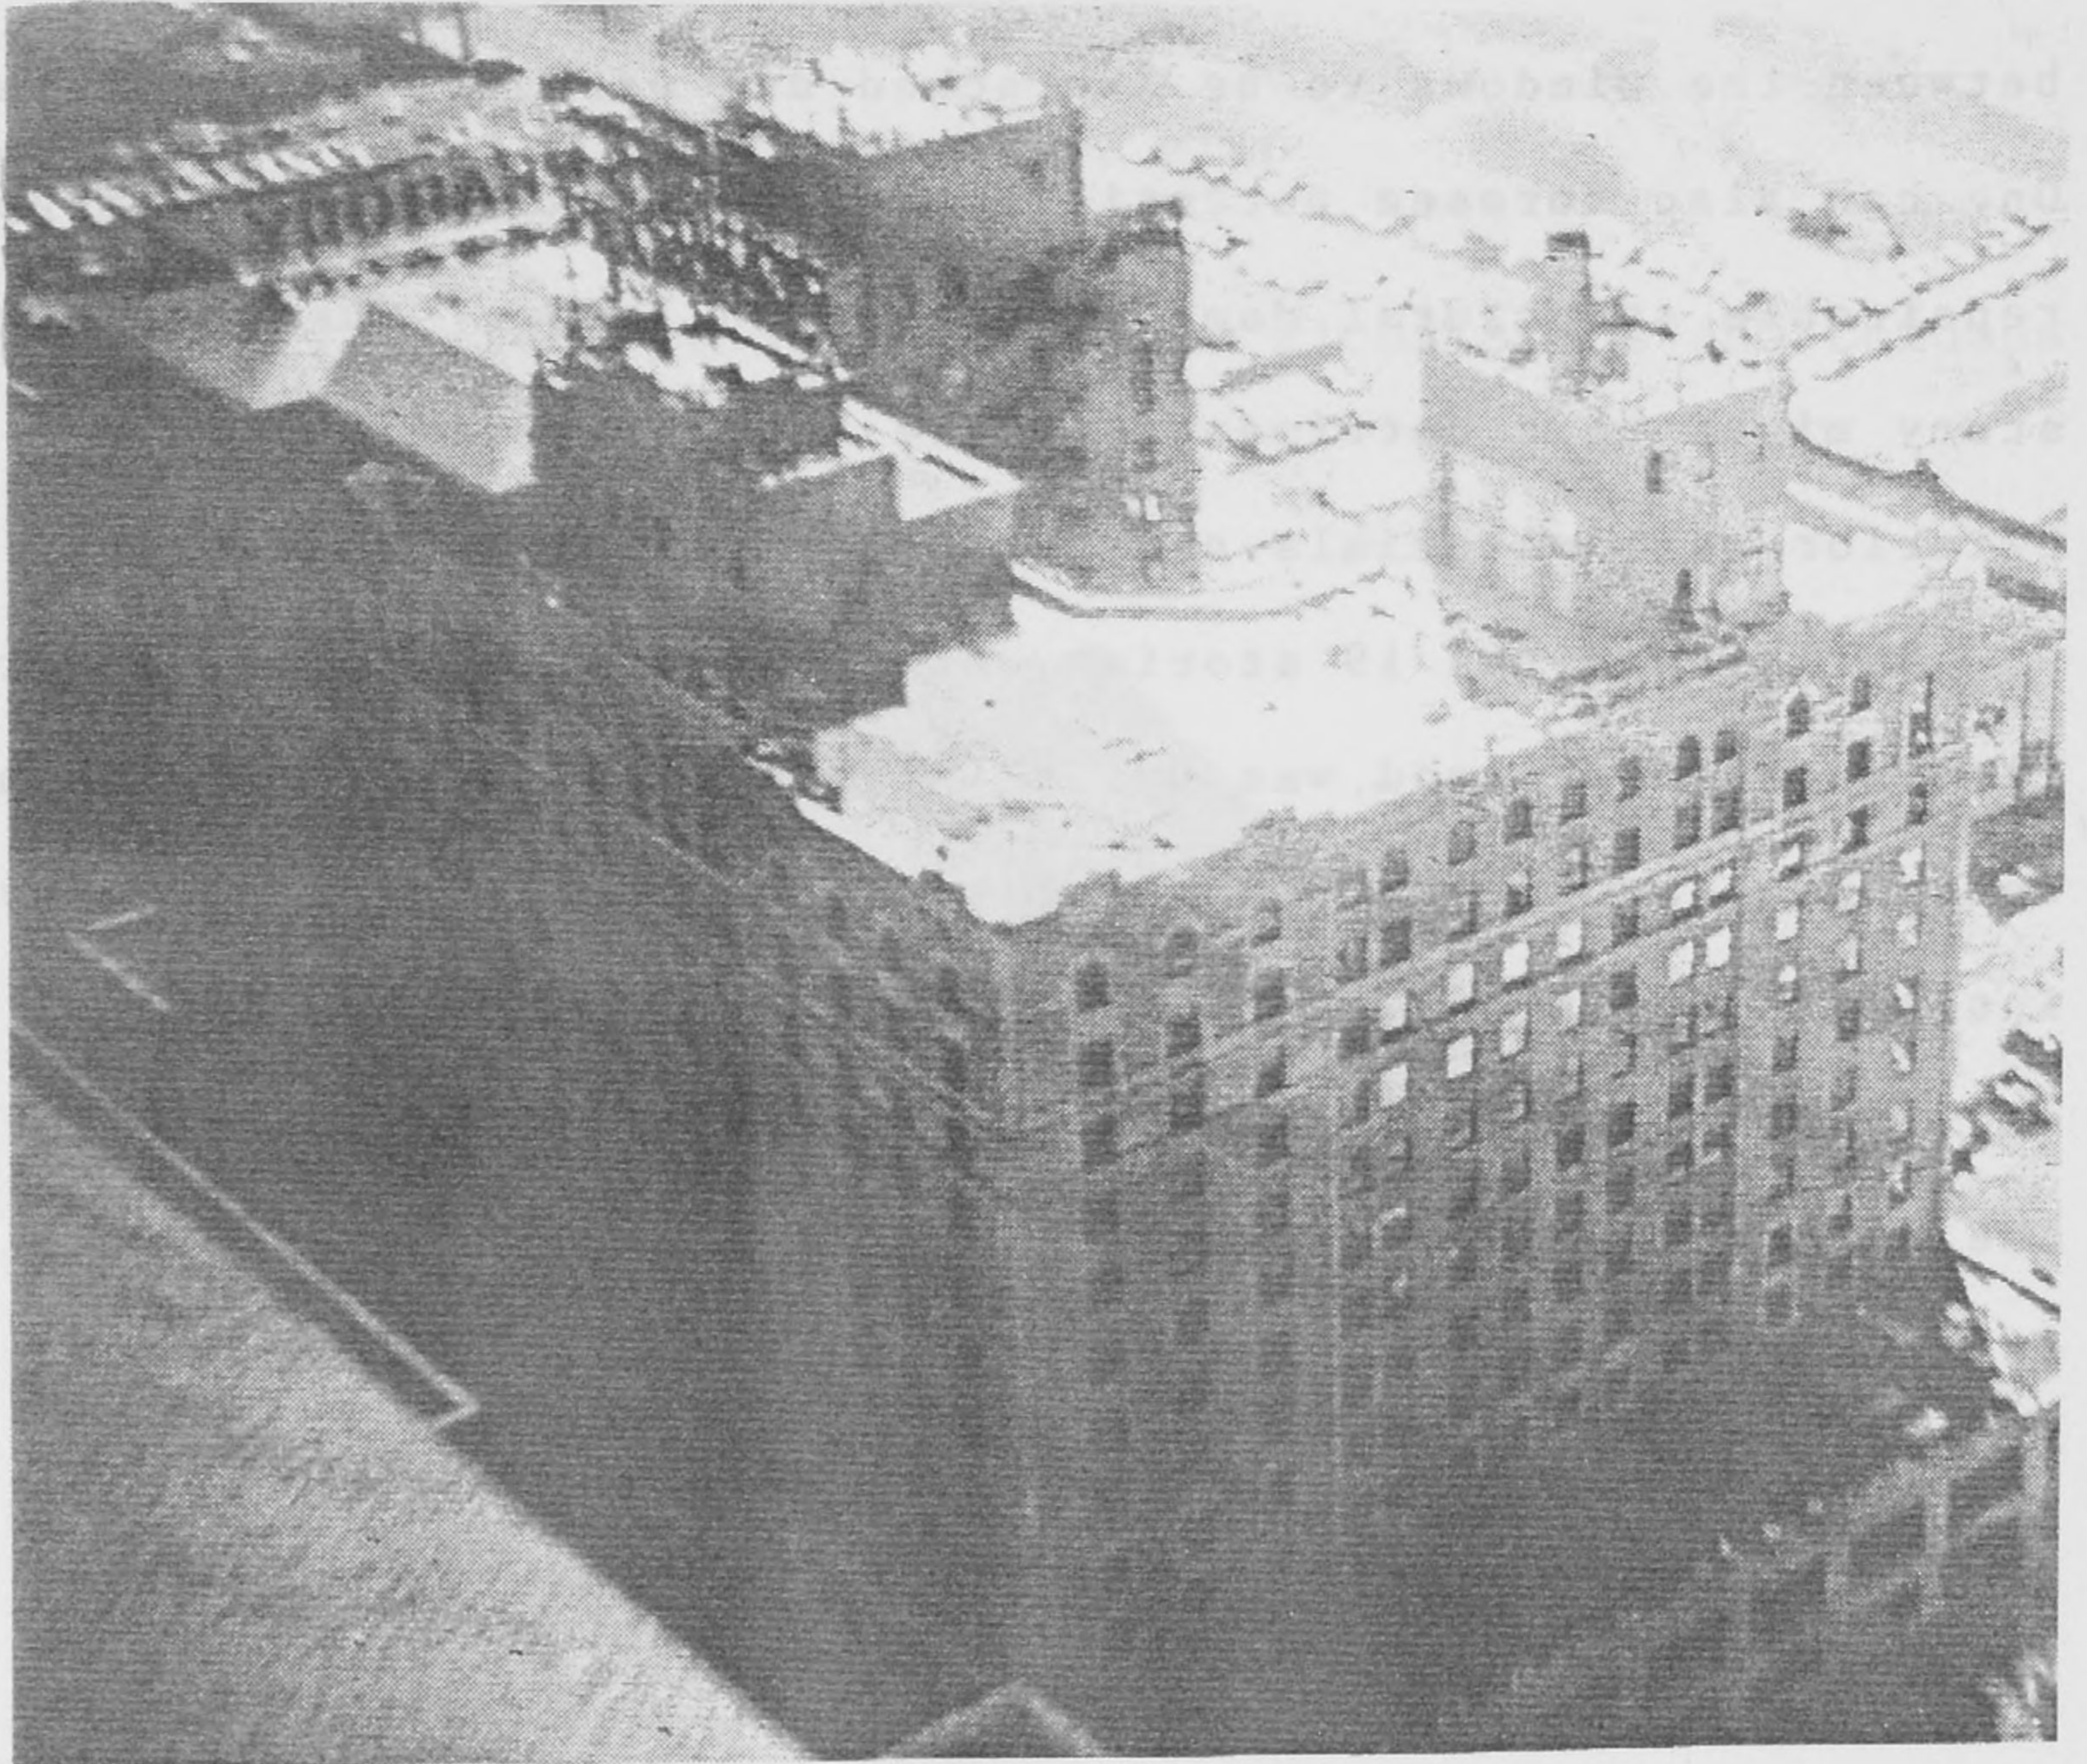
Fig. 6.21 Building K

Building K is an 11-story hotel, newly remodelled, which was originally constructed in 1921, Fig. 6.21. Its structure consists of a reinforced concrete frame with ribbed floor slabs and brick outside walls. Numerous exterior and interior walls contribute significantly to the seismic resistance of the building. In case of an earthquake, a relatively good performance can be expected.
