EARTHQUAKE HAZARD ANALYSIS FOR COMMERCIAL BUILDINGS IN MEMPHIS

A Report of Research Sponsored by
U.S. Geological Survey
Contract No. 14-08-0001-19829

SUMMARY

The report deals with the evaluation of seismic risk for commercial buildings in Memphis, Tennessee.

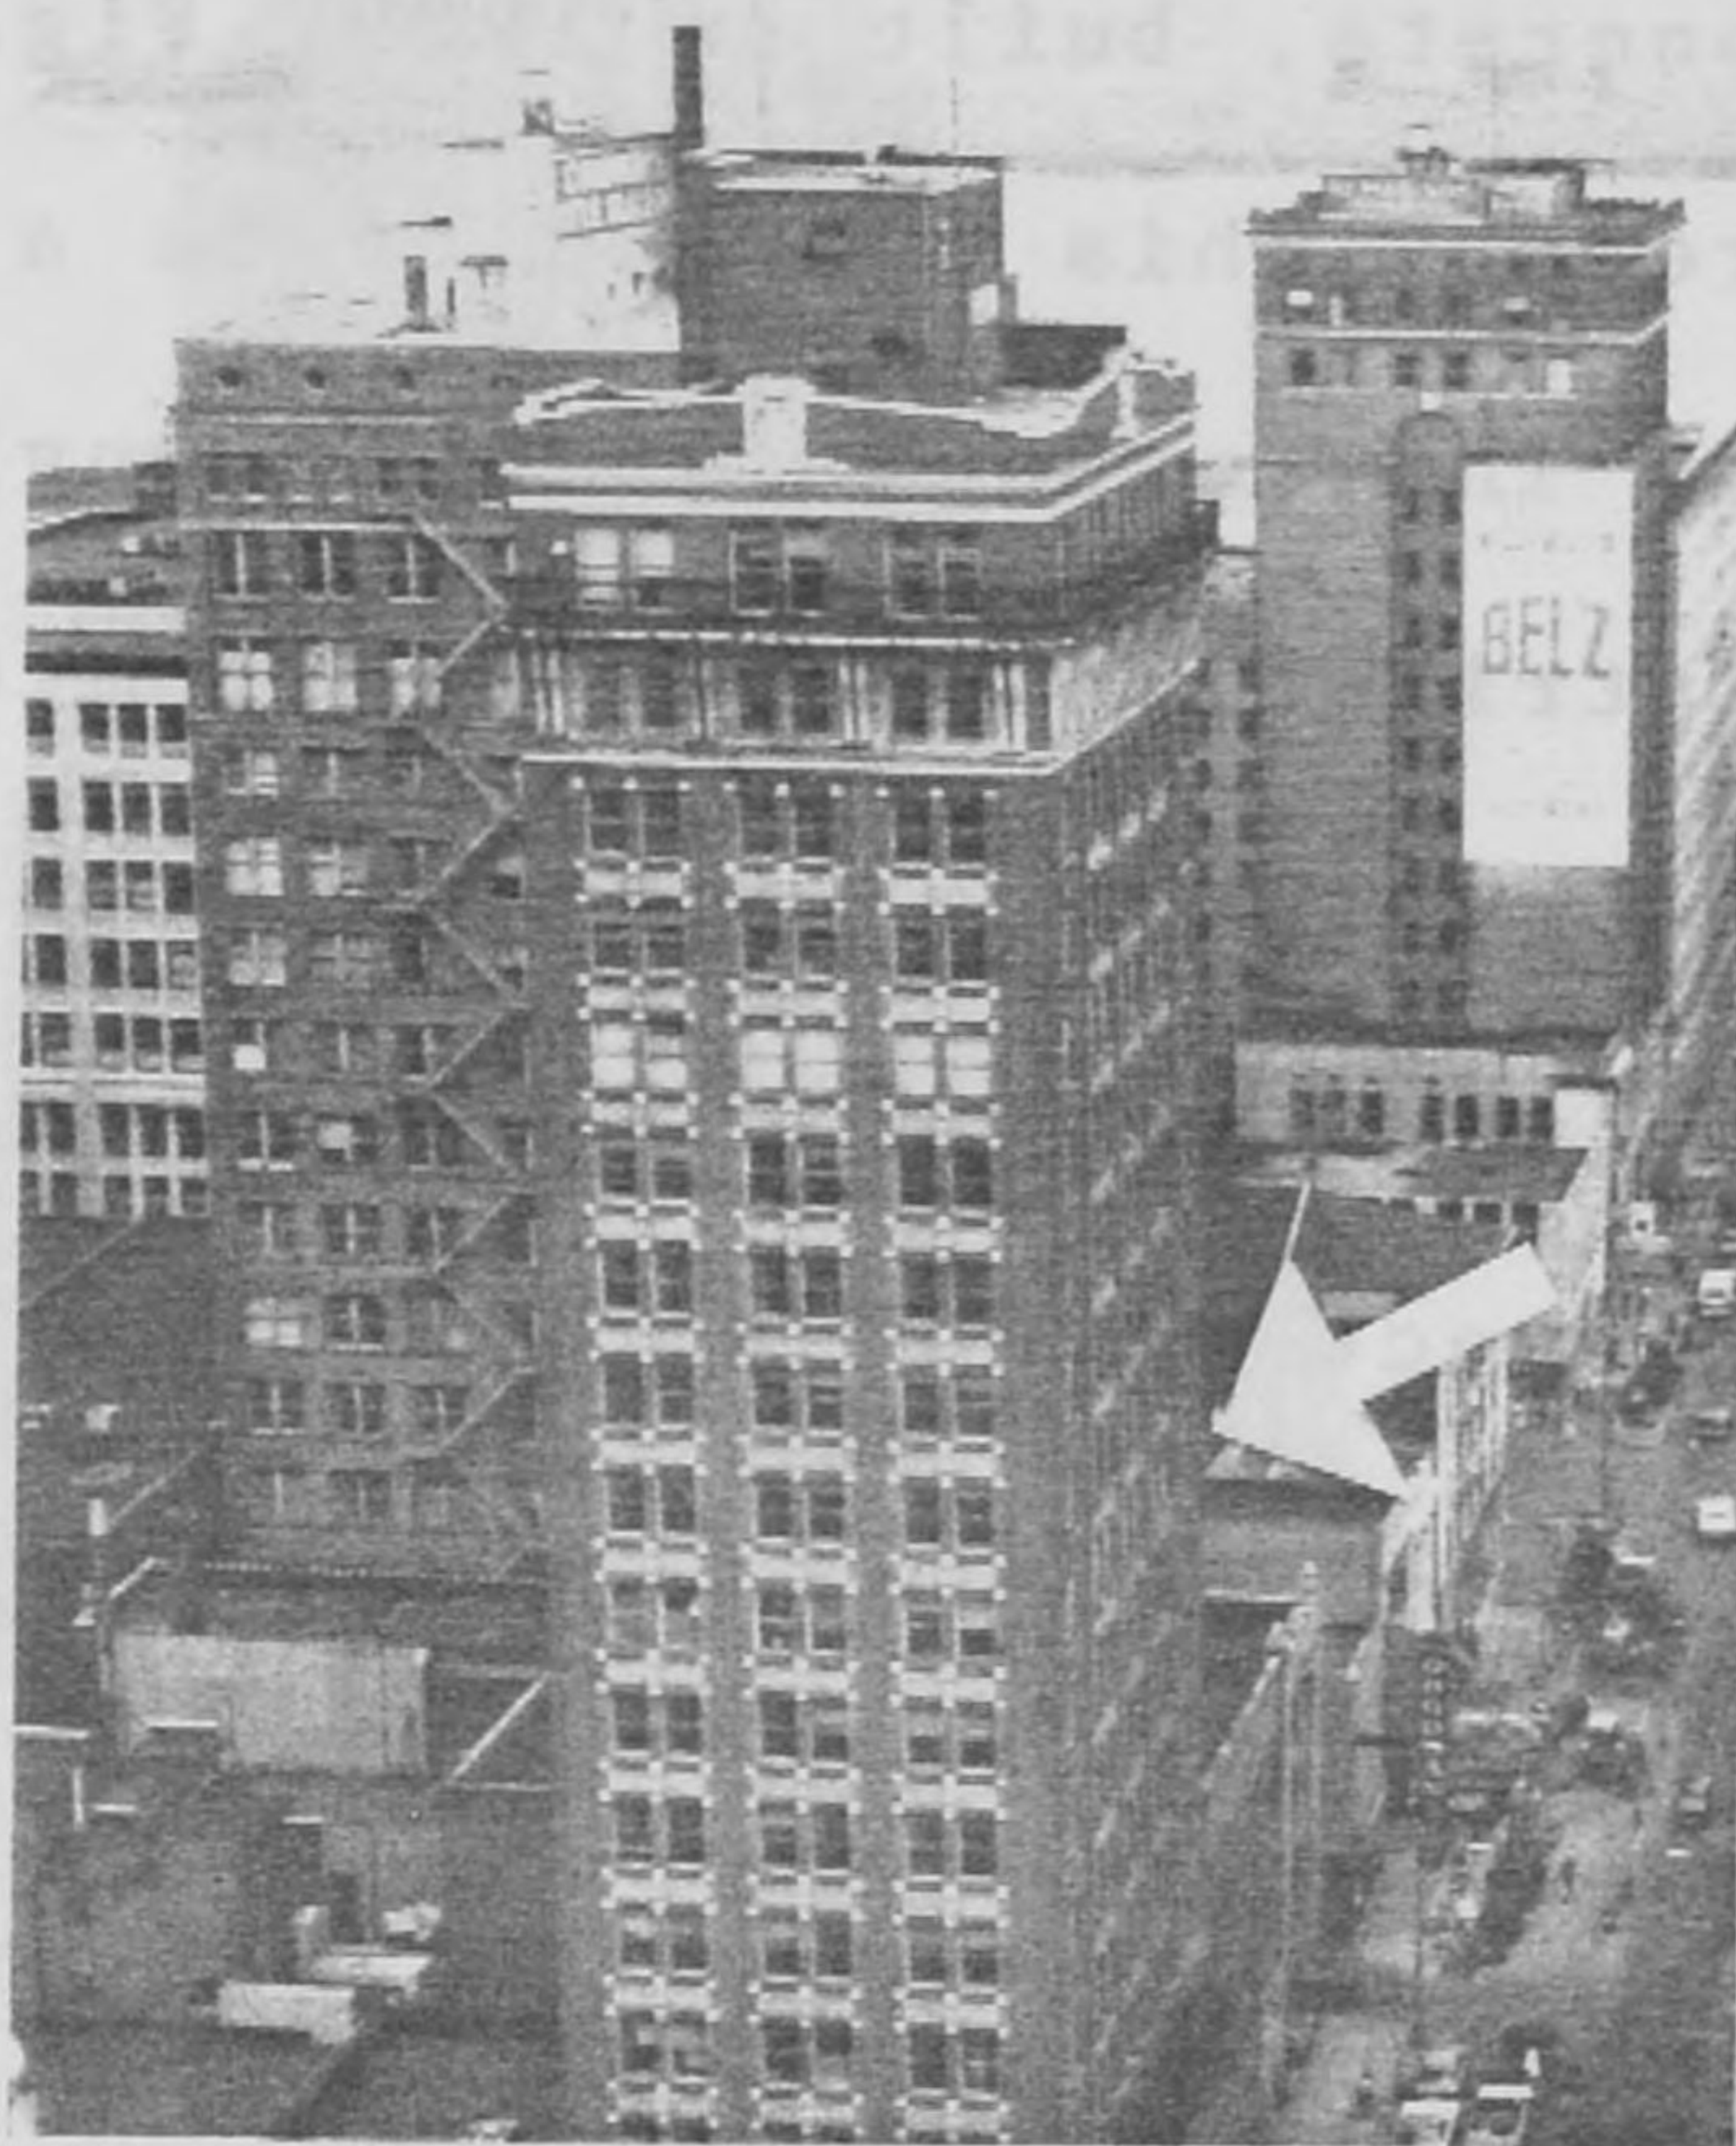
Fig. 6.22 Building L

Building L, an 18-story steel frame structure with concrete floors and roof, was built in 1901 and extended in 1937, Fig. 6.22. Windows make up a large fraction of the exterior wall length. In case of an earthquake, one can expect the brick piers between the windows to be X-cracked and perhaps badly shattered. One can also foresee potentially severe architectural damage, repairable structural damage, but no collapse. The soft ground story might be a detriment. There would be some hazard due to exterior wall materials and parapets falling to the street.

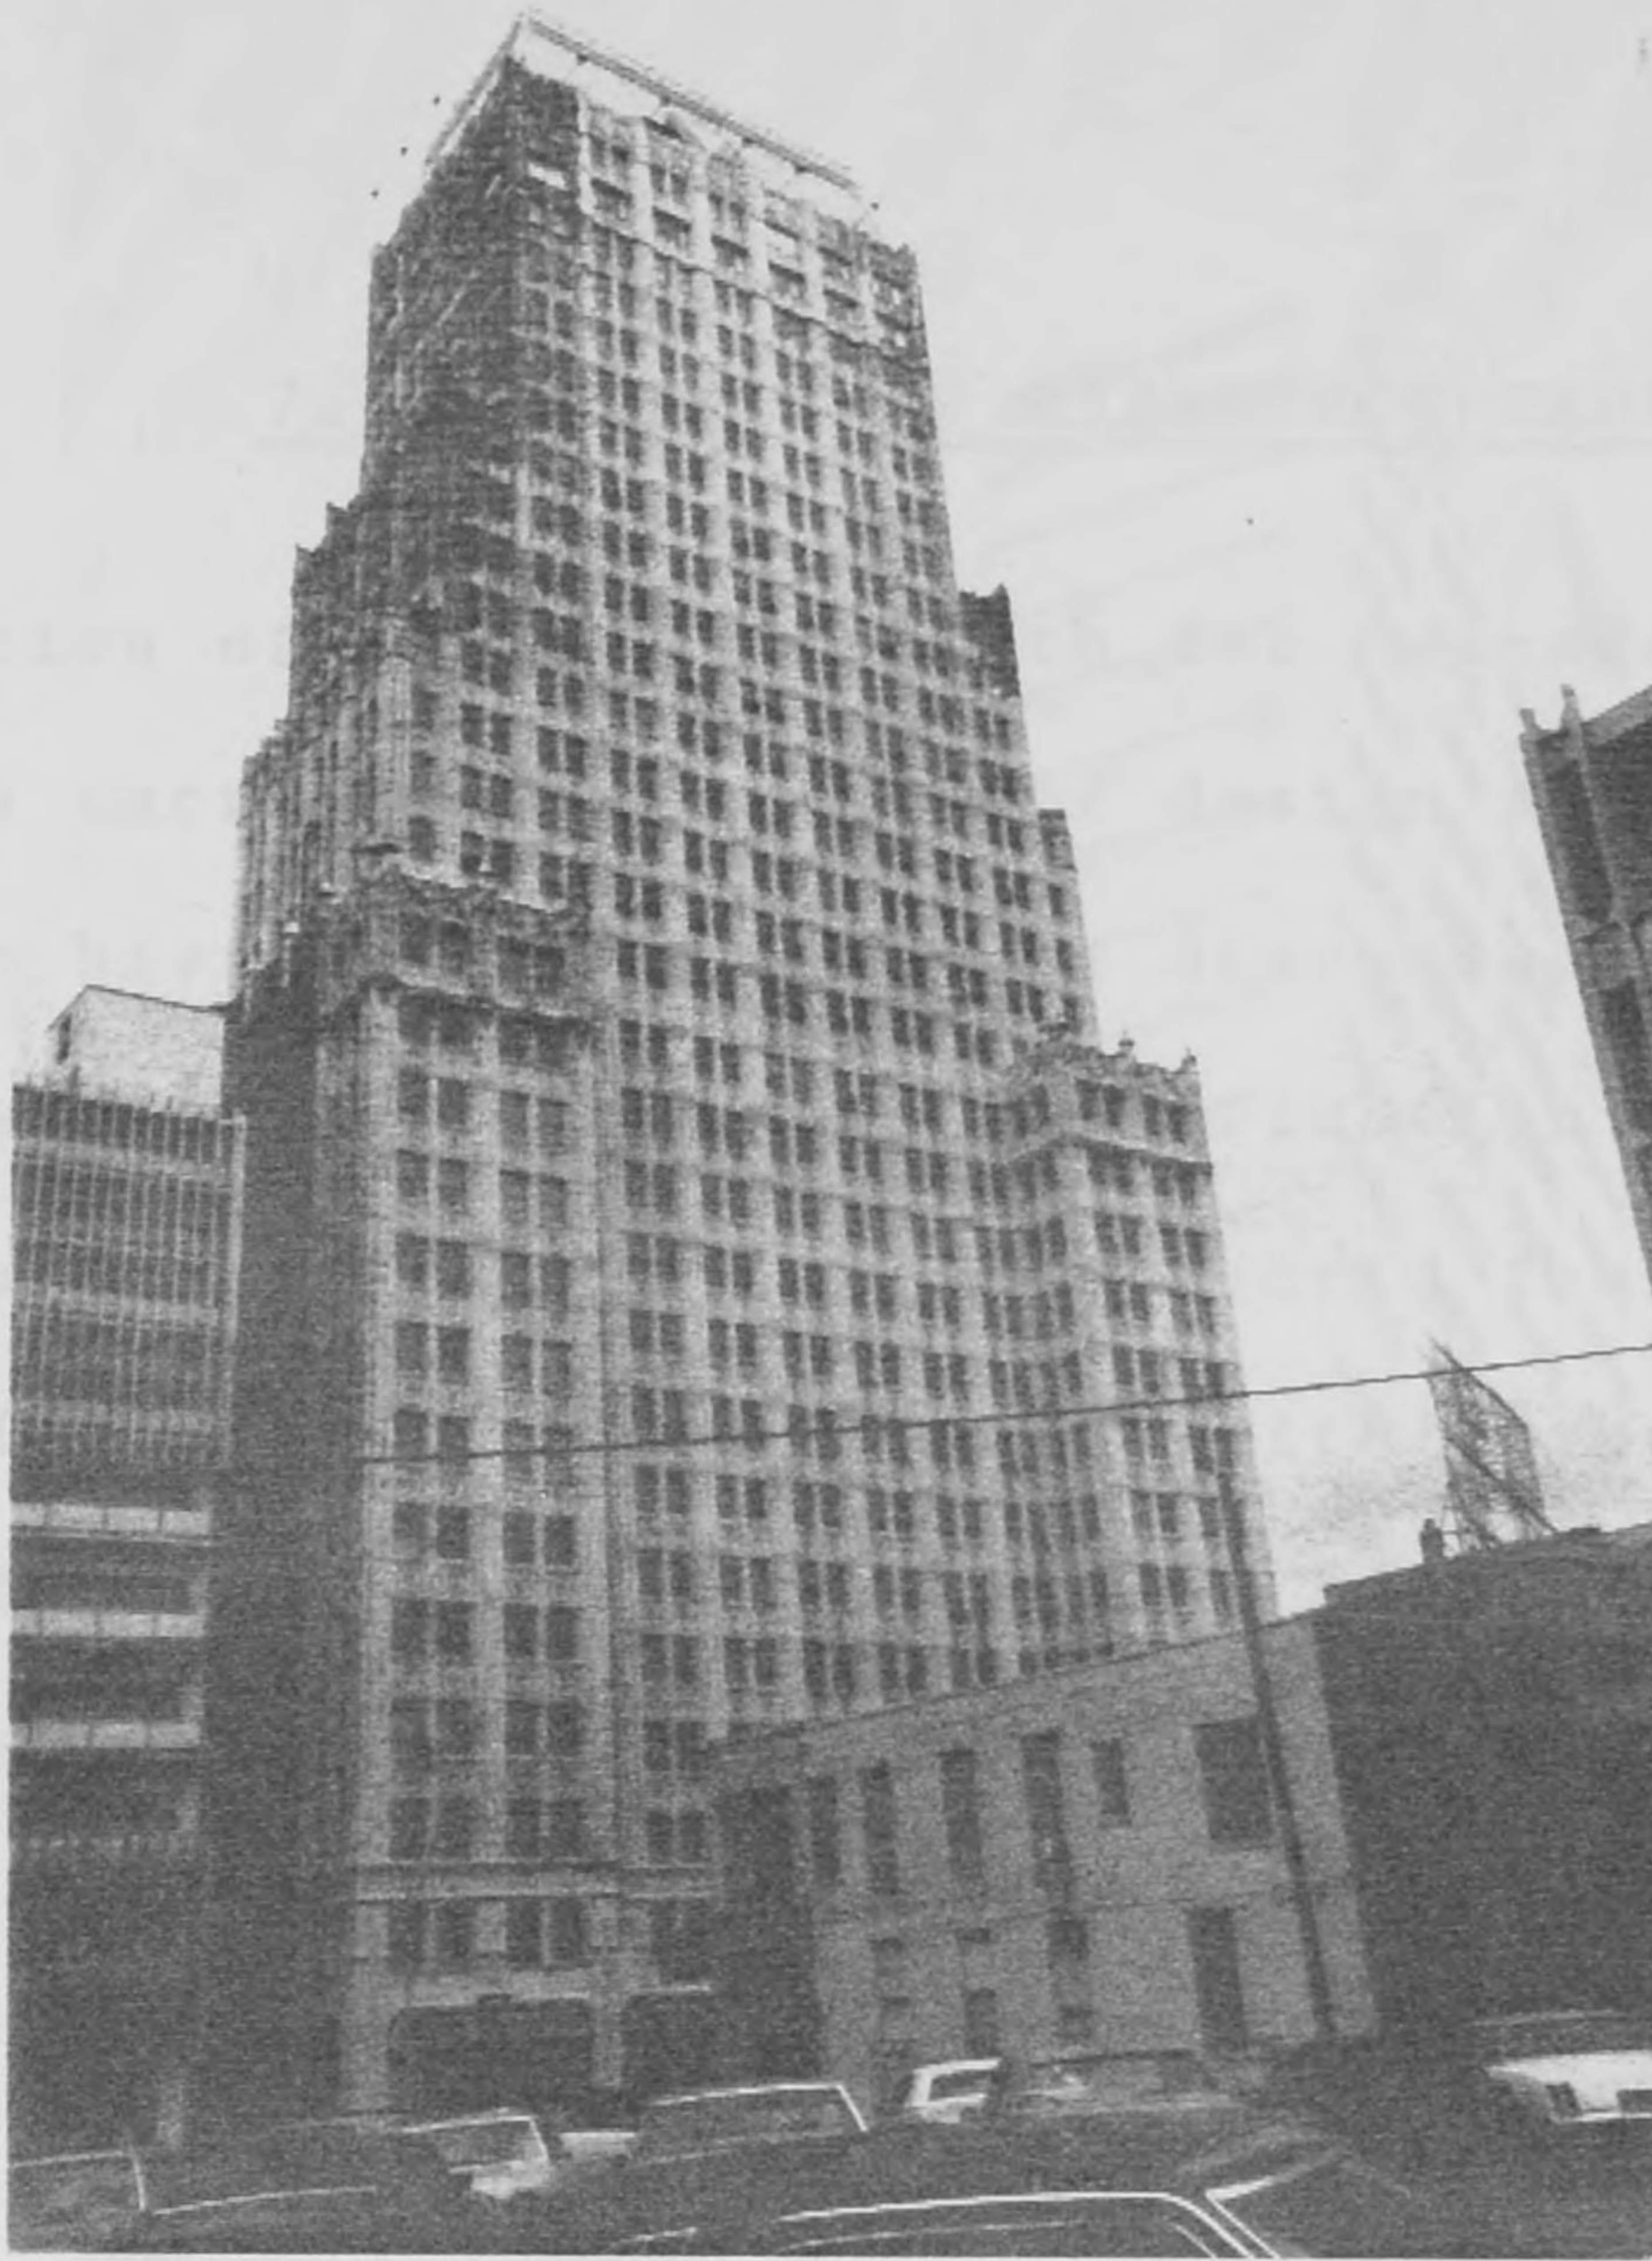
Fig. 6.24 Building N

steel frame encased in concrete, built in 1929, Fig. 6.24. The floors and roof are concrete. This appears to be a well-designed and well-built structure. The setbacks in the longitudinal direction might enhance the distribution of lateral forces, but they would also generate a reentrant corner problem. The two effects might be offsetting. The lower part of the building is U-shaped, Fig. 6.25, and one could expect structural difficulty at those corners. An earthquake may be expected to cause architectural damage, but only moderate structural damage.

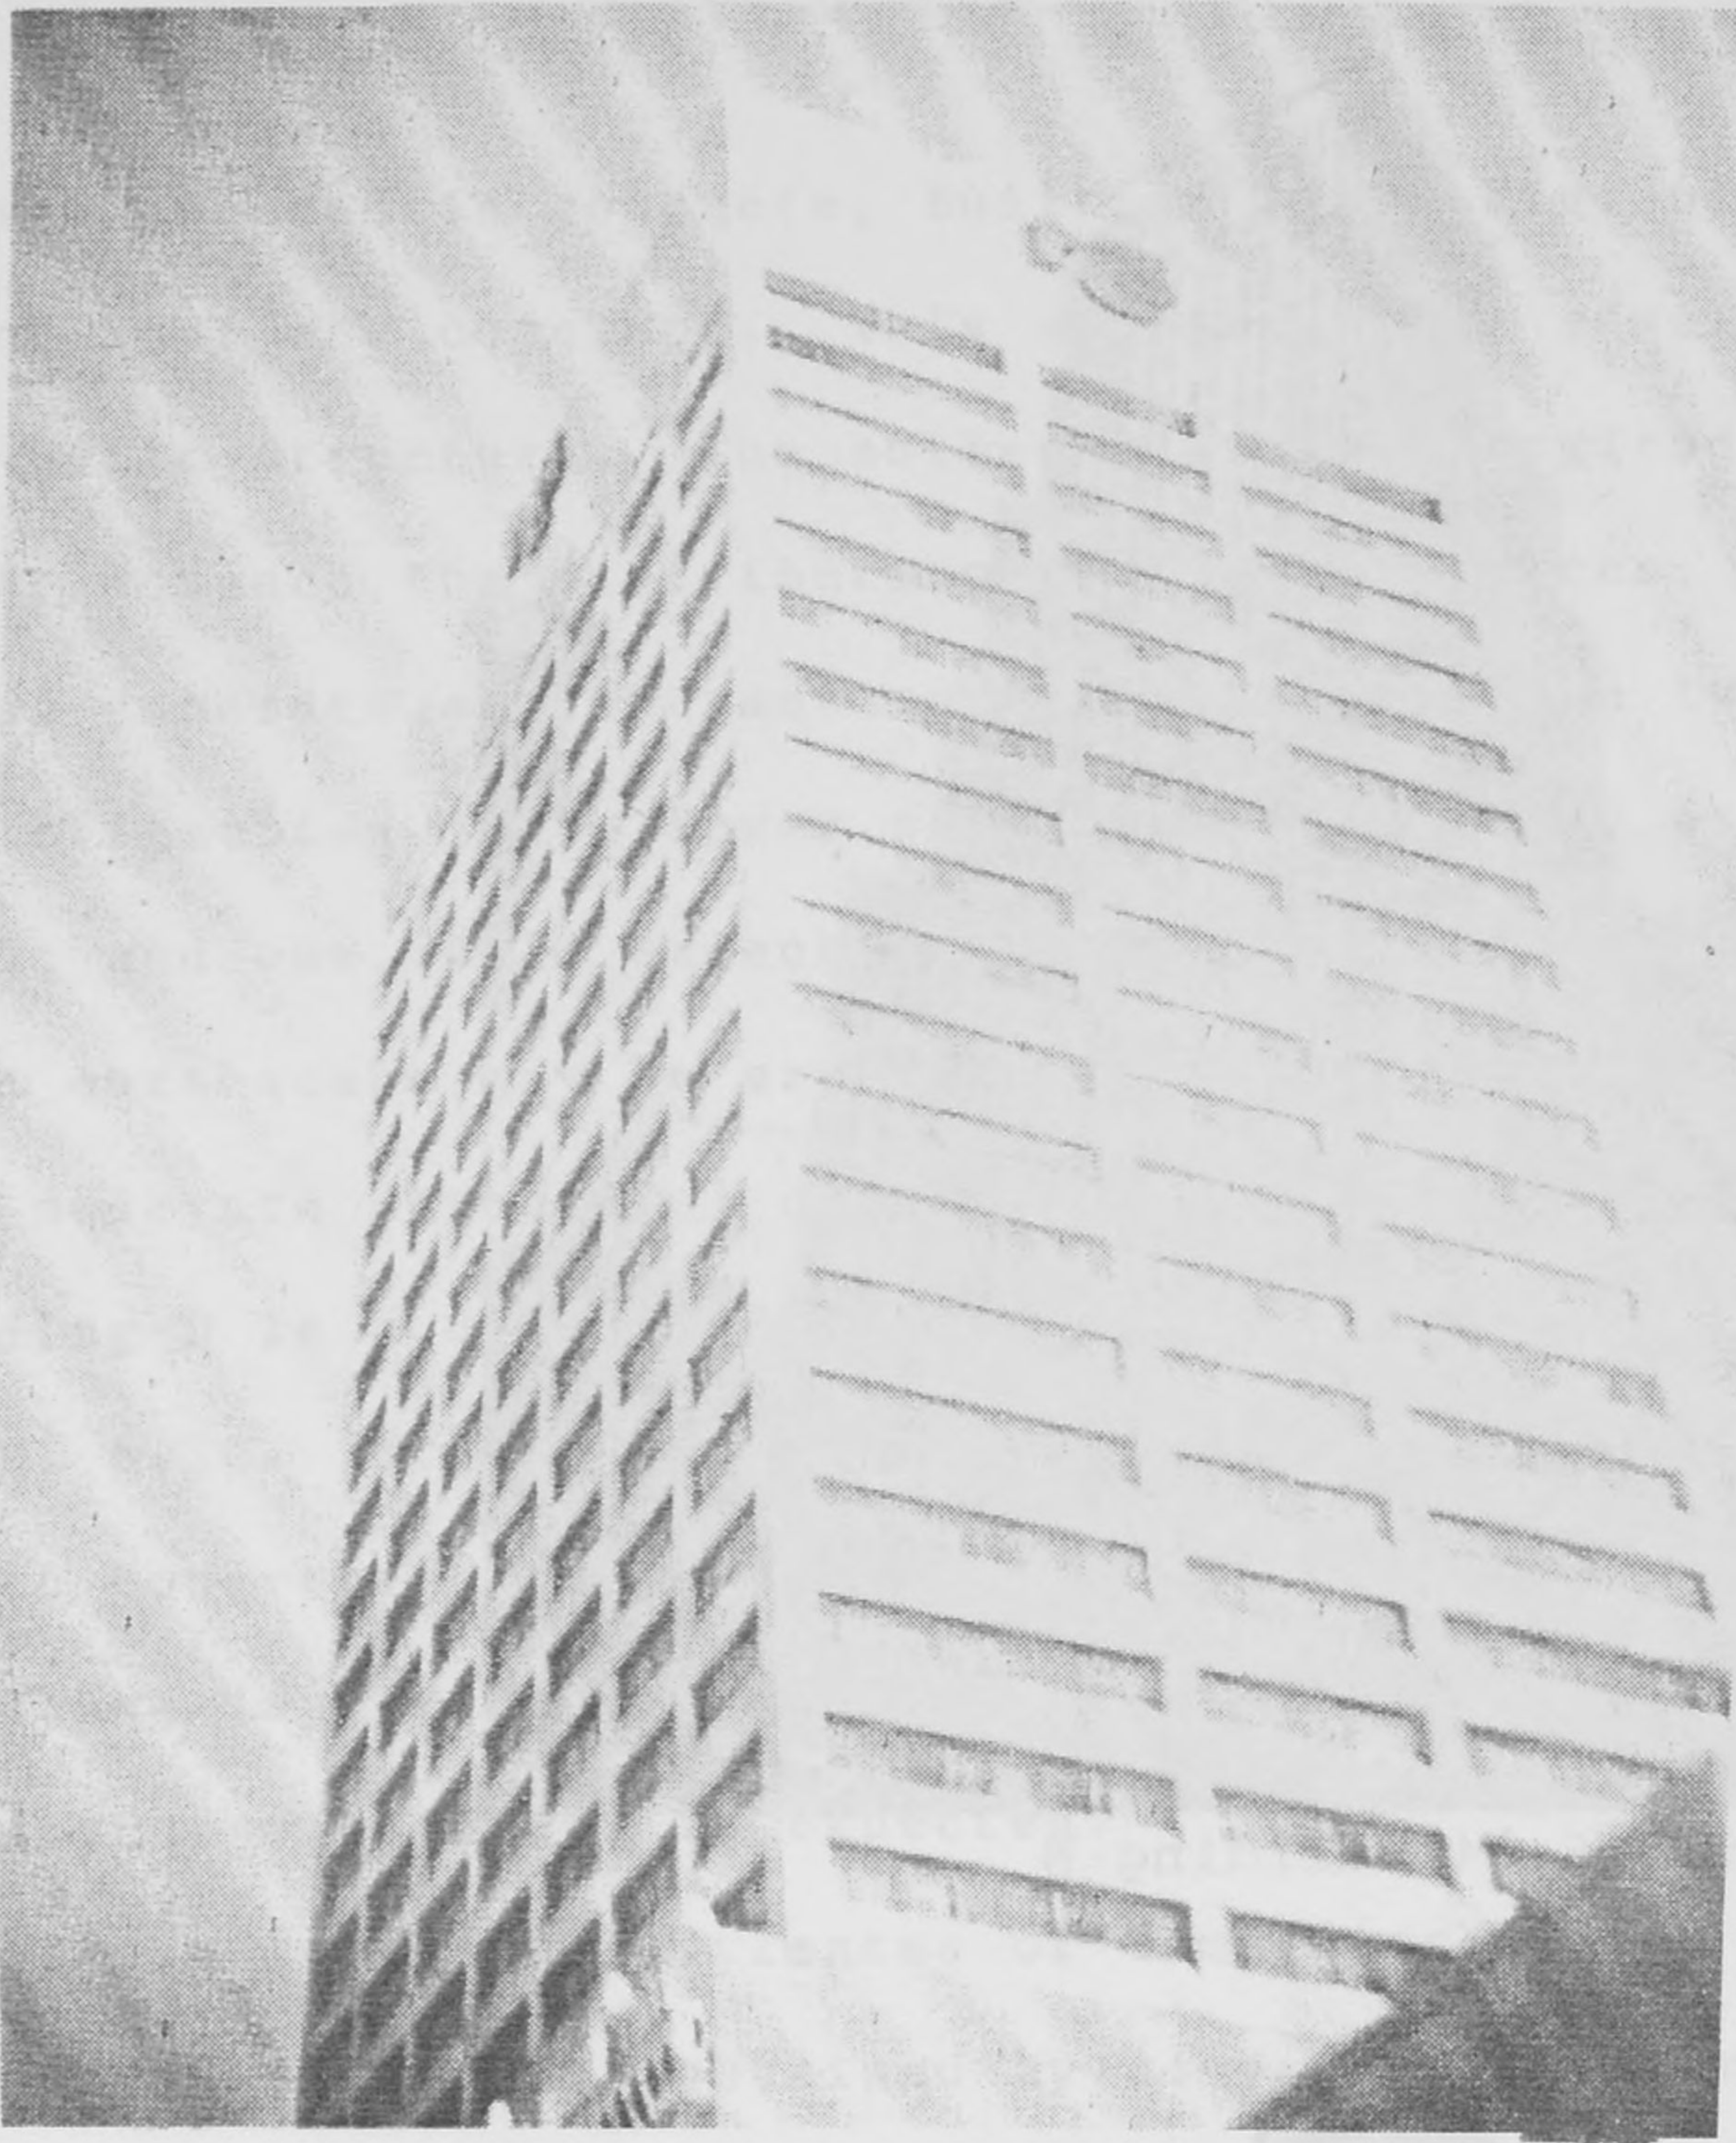
Fig. 6.26 Building O

Building O is a 32-story office building, constructed in 1969, Fig. 6.26. Its structure is a regular rectangular steel frame with concrete floor slabs. The framework during construction is shown in Fig. 6.27. In the case of an earthquake, no serious structural damage is expected.
