**EFFECT OF COPING DESIGN ON FRACTURE
RESISTANCE OF ZIRCONIA CORE CERAMICS**

A thesis submitted in partial fulfillment of the requirements for the degree of Master of
Science in Restorative Dentistry

Horace H. Rackham School of Graduate Studies
The University of Michigan, Ann Arbor, Michigan

2007

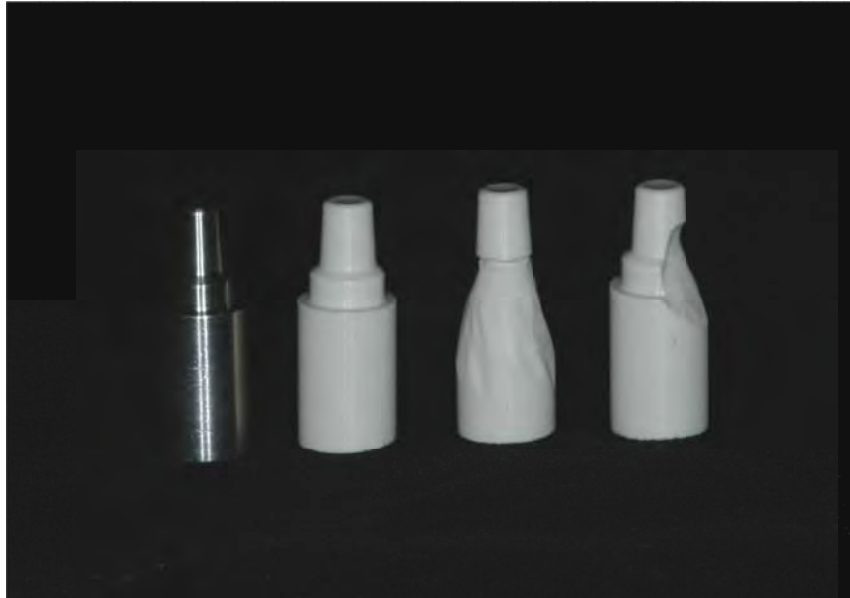
Thirty-six replicated dies were divided into three groups of 12 each within the three coping designs (Table 2). The control group had ceramic copings extended to the finishing line of the preparation as recommended by manufacturer (Figure 4). In the second group the entire zirconia ceramic coping was cut back to the axial cervical line angle (Figure 5). The third group was designed to have a full coping shoulder on the lingual and a cut-back to the middle of the axial wall on the facial (Figure 6).

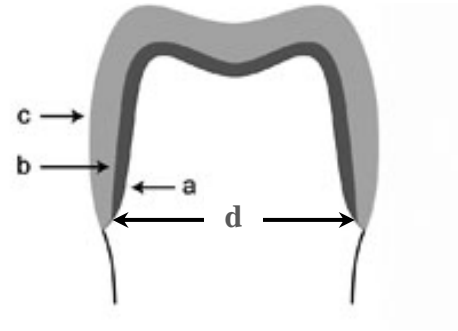
Figure 5. Shoulder-free zirconia coping

- a - crown die
- b - modified zirconia coping
- c - veneering porcelain
- d - shoulder cut back

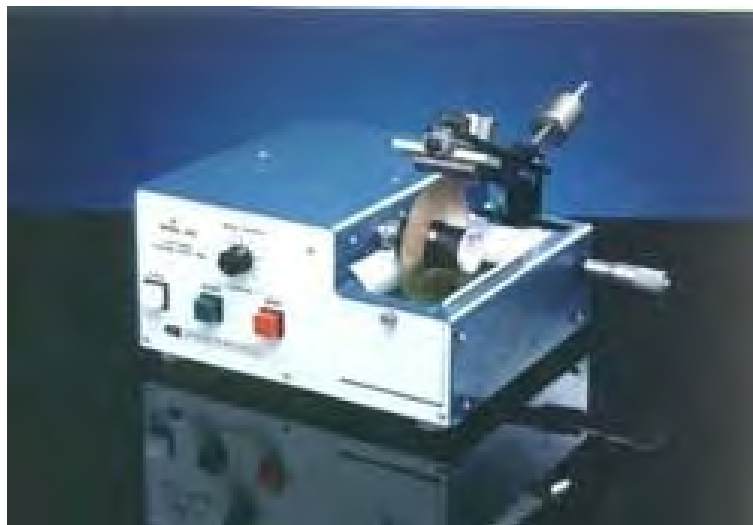
Figure 9. Diamond saw

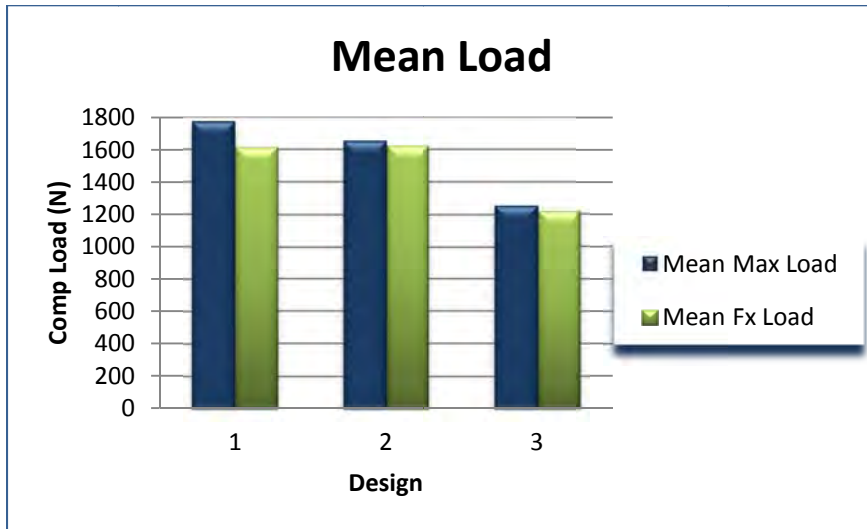
Figure 11 is a graphic illustration of the mean values for maximum and fracture load in Designs 1, 2, and 3. The distribution of the maximum load and fracture load (Figure 12-17) for the individual specimens within Designs 1, 2, and 3 can be seen in Figures 12-14 and Figures 15-17 respectively.

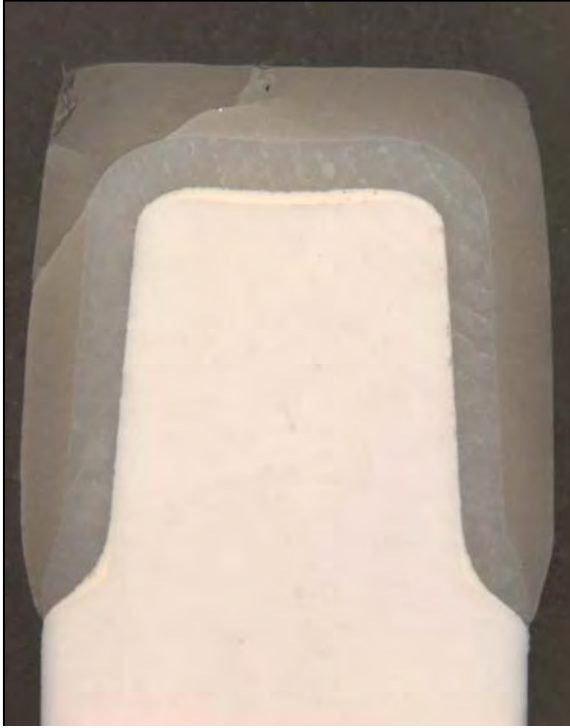
Figure 20. Sectioned crown (Design 1) at 10X magnification

Figures 20-29 are representative of the three selected samples from each of the three designs examined under an optical microscope. Visually the largest gap between the coping and the die was seen in Design 1 and Design 3, where the thickest cement film was noticed on occlusal surfaces, while the axial wall cement film was thinner. Design 3 had the largest cement space within the occlusal surface and facial axial wall. All of the designs had a thick cement

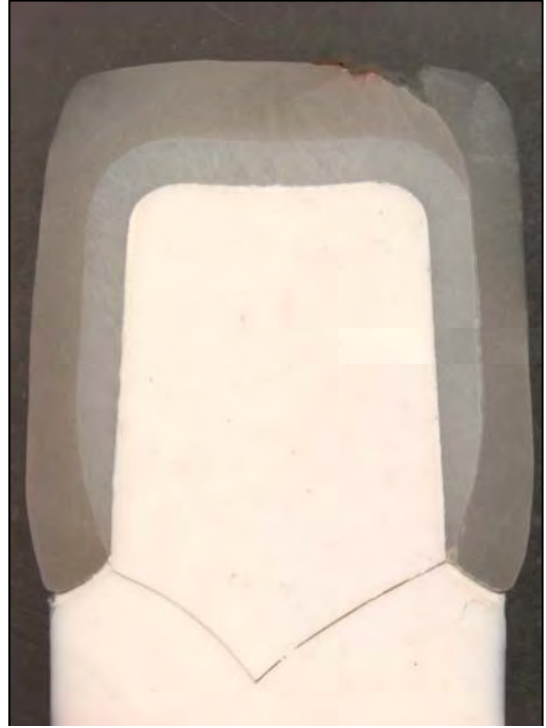
Figure 21. Sectioned crown (Design 2) at 10X magnification

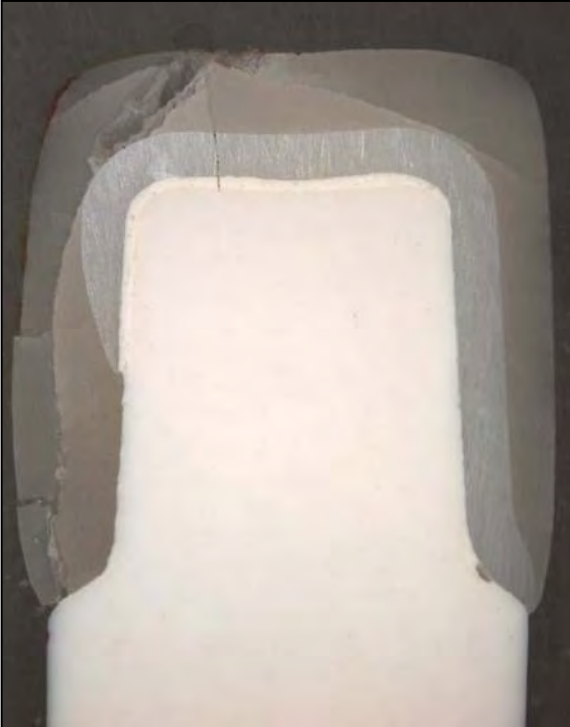
Figure 22 Sectioned crown (Design 3) at 10X magnification

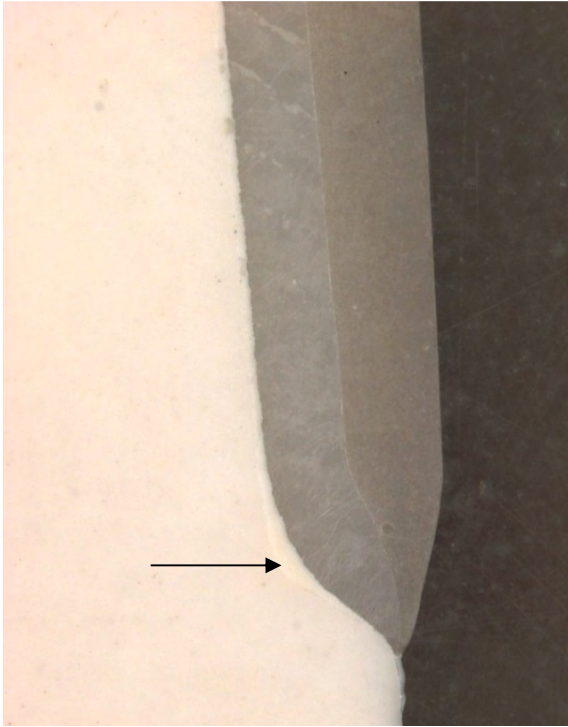
Figure 23. Sectioned crown (Design 1) at 20X magnification

space at the cervical margin. Figures 23-26 show the marginal gap in each selected sample at 20X magnification. Figures 27-29 demonstrate the occluso-axial surfaces and coping adaptation to the cemented dies at magnification of 20X. It is clearly observed that the axio-cervical line angle had the poorest coping adaptation to the die, whereas the axial surface of the coping is well adapted and further cement space appears to be significantly thinner. The cement space on the facial axial surface of the Design 3 is more evident than on the lingual axial surface (Figures 25, 26).

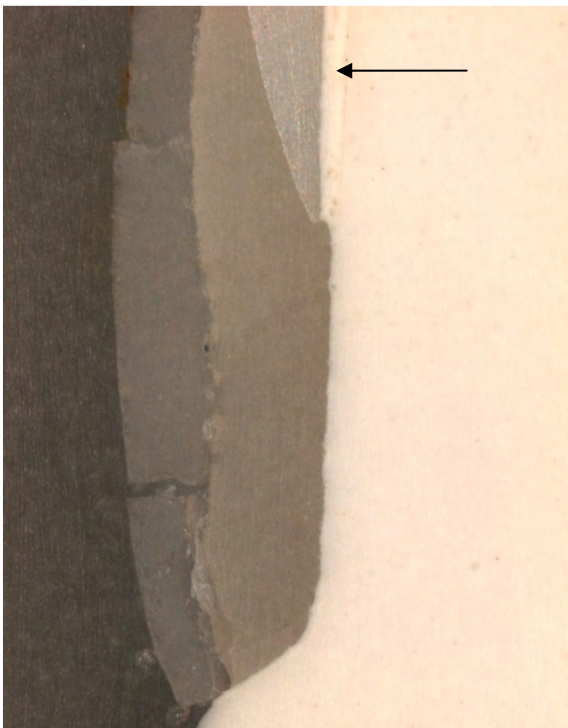
Figure 25. Sectioned crown (Design 3 - facial surface) at 20X magnification

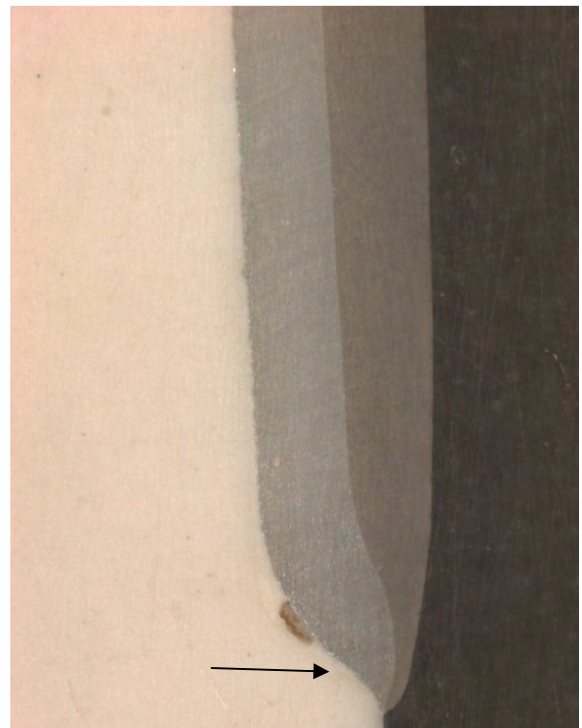
Figure 26. Sectioned crown (Design 3 - lingual surface) at 20X magnification

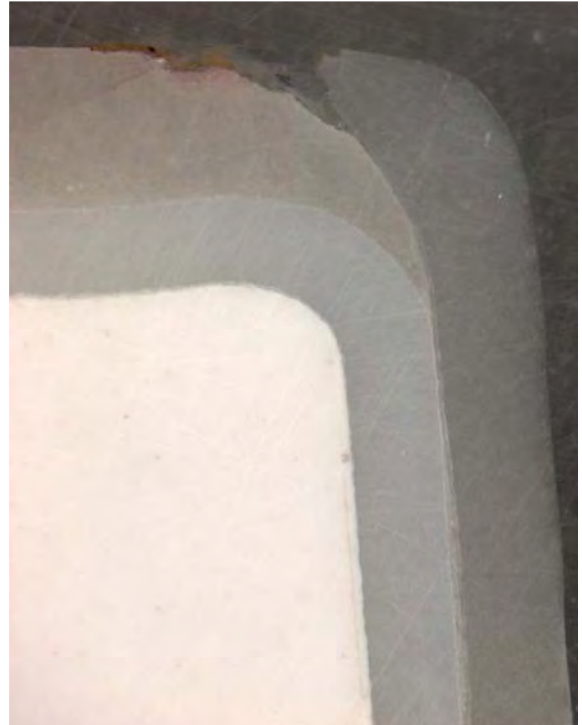
Figure 28. Sectioned crown (Design 2 - axio-occlusal surface) at 20X magnification

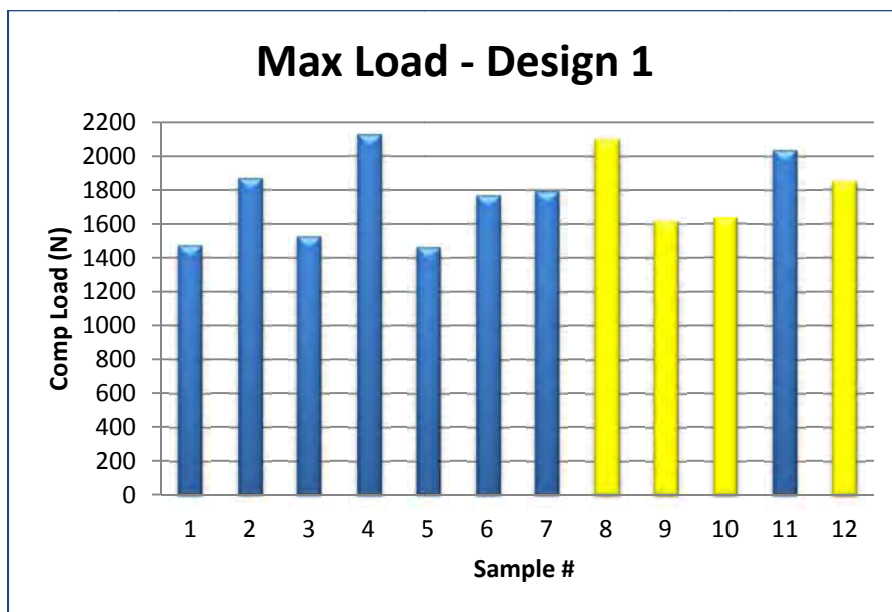
ceramic samples ($D1-1773.13 \pm 235.05$, $D2-1653.08 \pm 380.63$, and $D3-1256.71 \pm 190.78$) provides evidence that it is the ceramics that is carrying most of the stress and is supporting as well as preventing the die from fracture (Figure 30-32).

The investigation of the relationship between the die fracture resistance and overall fracture values of restorations within Design 1, 2 and 3 did not demonstrate any trend (Figure 30-32). Bars presented in yellow color represent dies that fractured in Class I (horizontally). Bars that are colored in red represent dies that fractured in Class III (combination of vertical/horizontal). The remaining blue colored bars had no evidence of fracture in dies. The porcelain fractures did not seem to be related to the die fractures and loss of support as the test strength increased.
