INFLUENCE OF COMBINED HIGHWAY GRADE
AND HORIZONTAL ALIGNMENT
ON SKIDDING

FINAL REPORT

VOLUME 2 OF 2

SEPTEMBER 1974

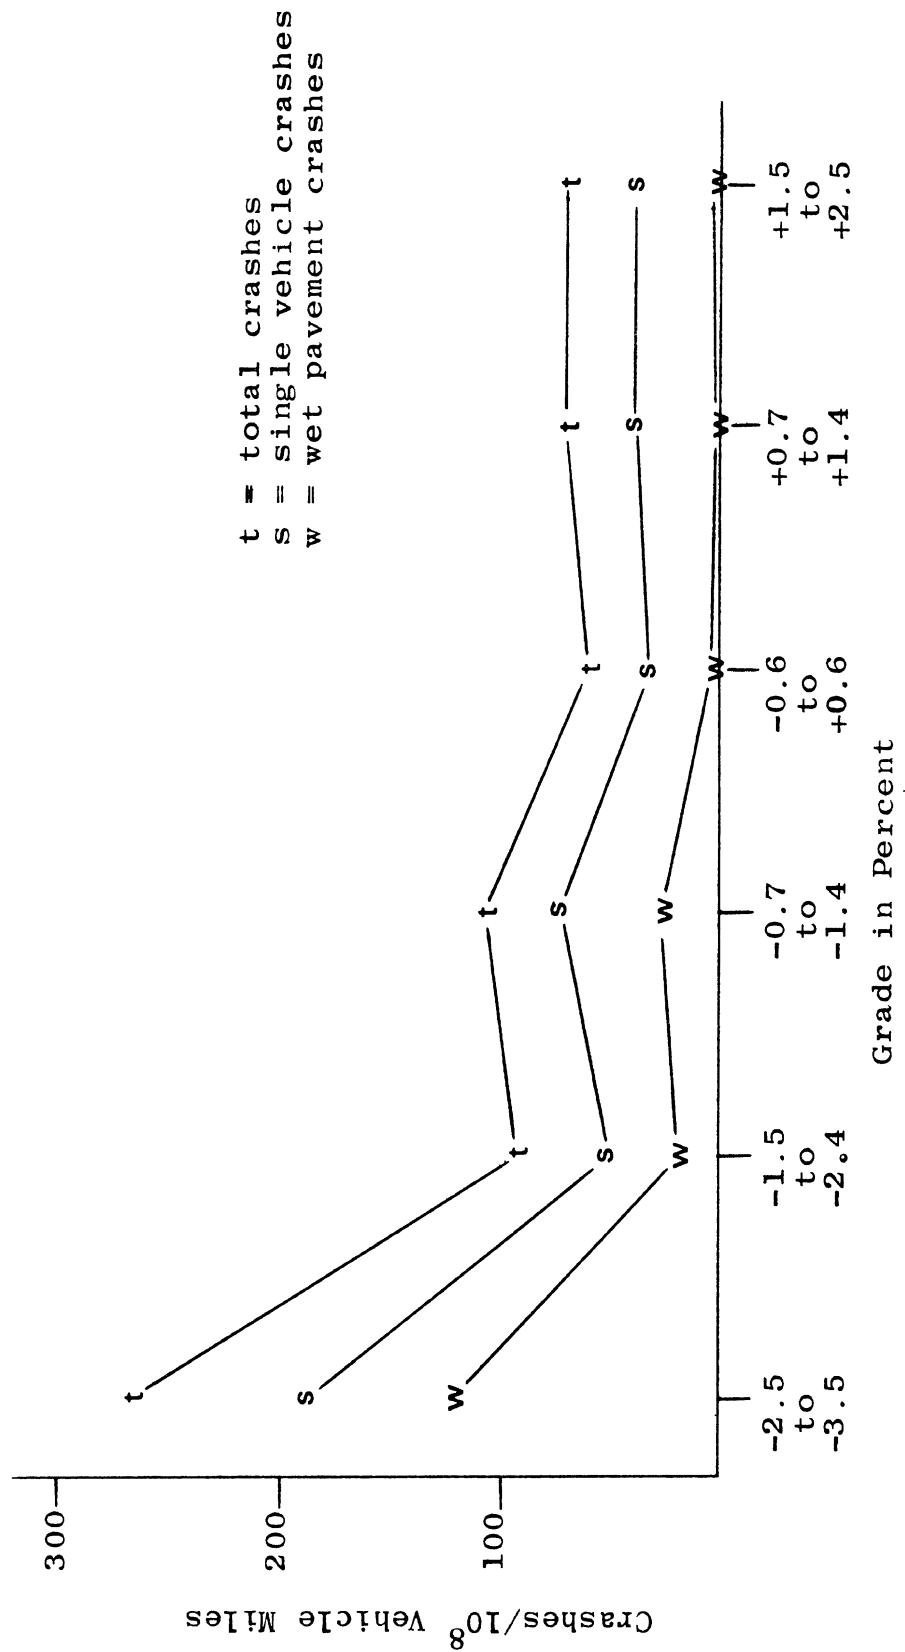
Figure A-2
 Curvature Model
 Expected Relationship Between Grade and Crash
 Rate using Ohio Turnpike Data

The results of the regression for wet pavement are given in Tables A-7, A-10, and A-13, while the tables of observed, expected, residual rates, and 95% confidence intervals are given in Tables A-28, A-31, and A-34. Plots of the expected rates for wet road are indicated by "w" in Figures A-1 through A-6.

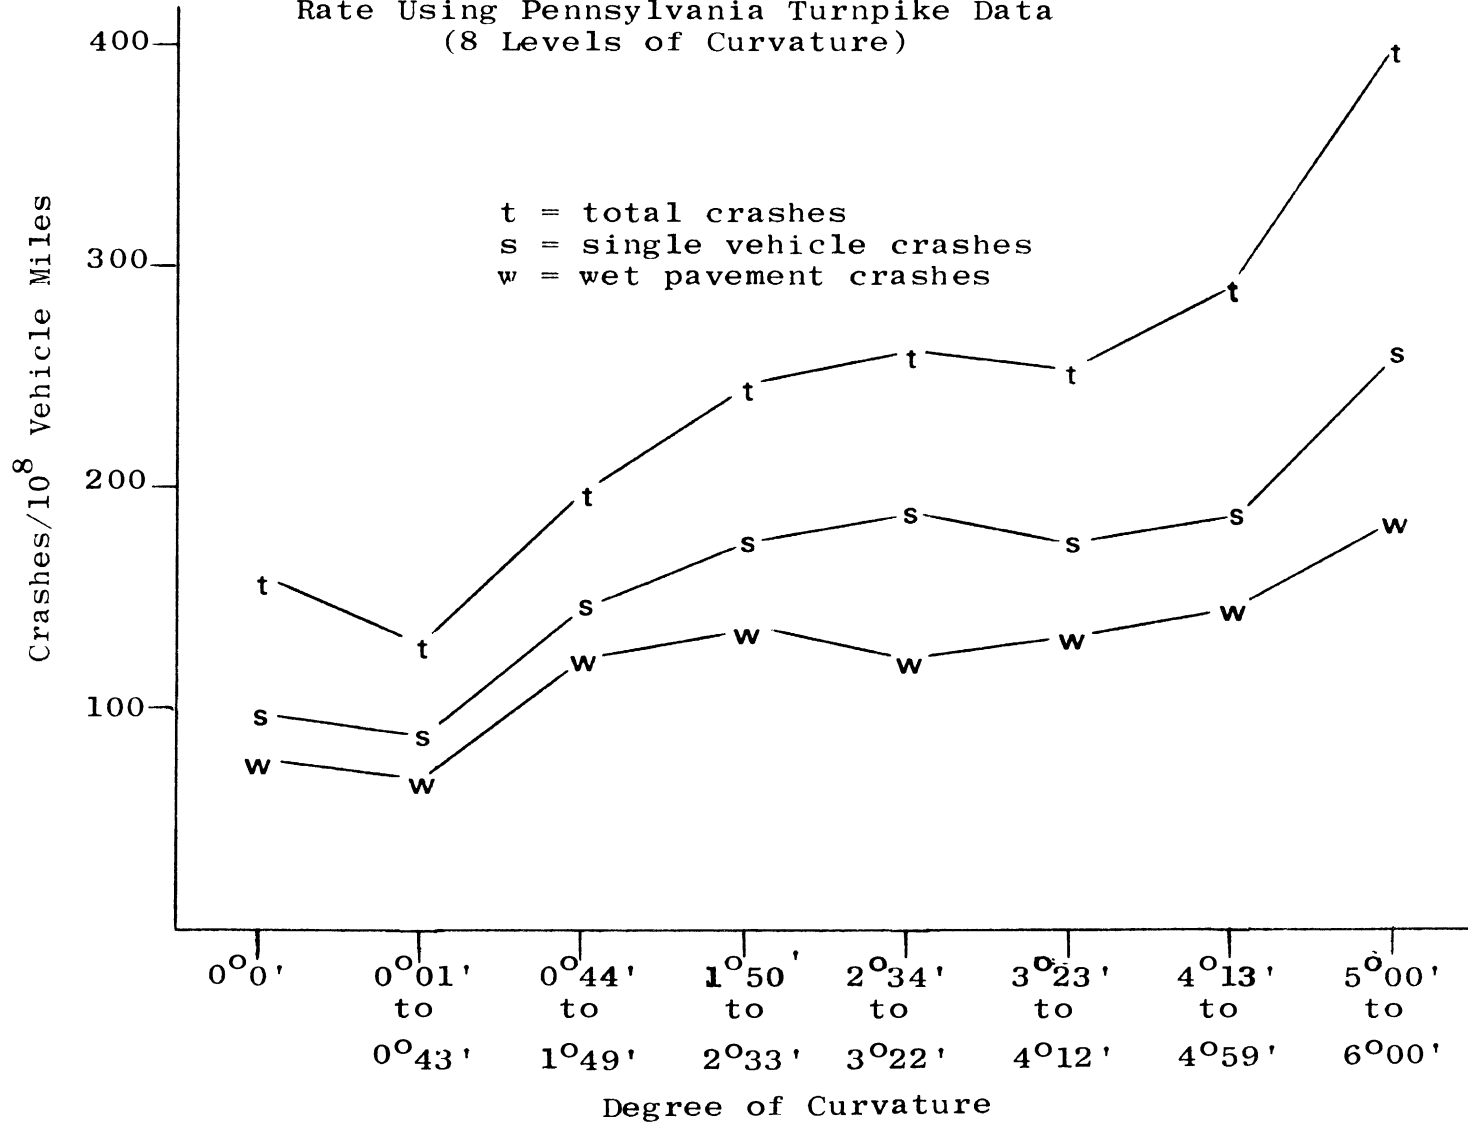
Figure A-3
 Curvature Model
 Expected Relationship Between Curvature and Crash
 Rate Using Pennsylvania Turnpike Data
 (8 Levels of Curvature)

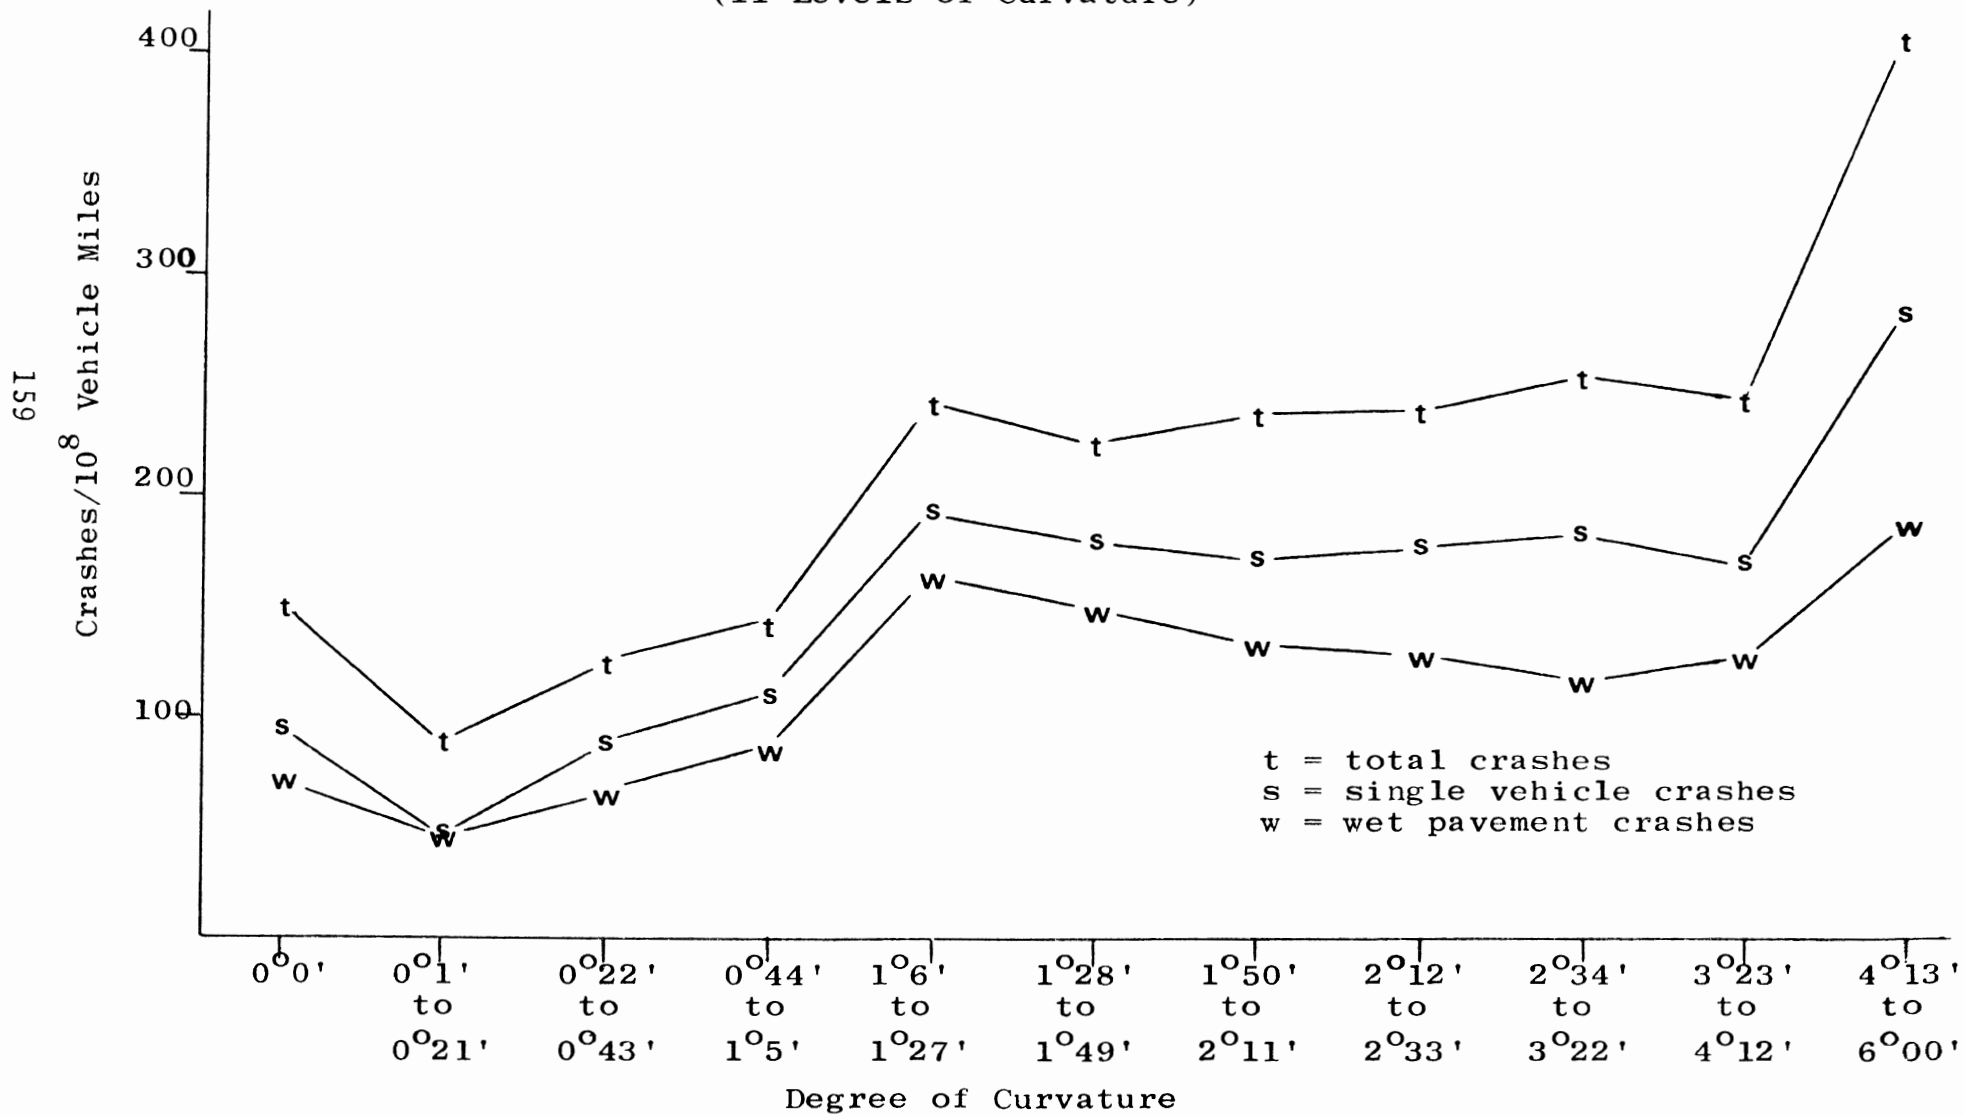
Figure A-5
 Curvature Model
 Expected Relationship Between Curvature and Crash
 Rate using Pennsylvania Turnpike Data
 (11 Levels of Curvature)

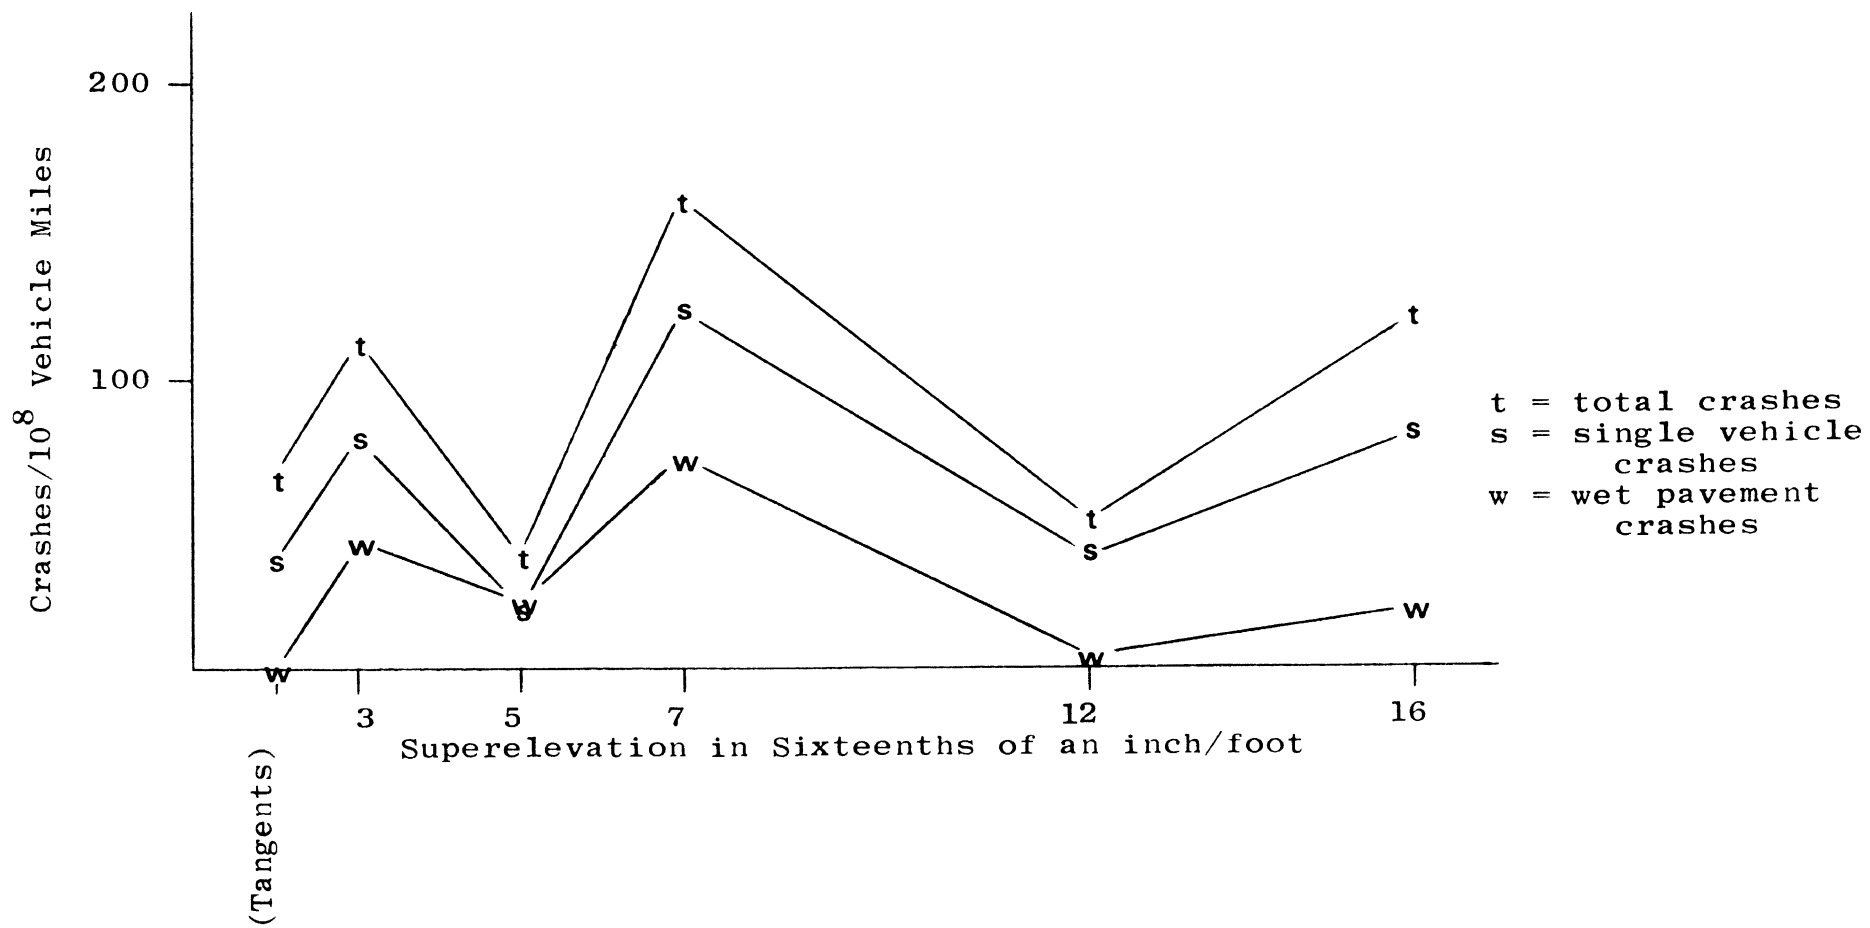
Superelevation Model
Expected Relationship Between Superelevation and
Crash Rate Using Ohio Turnpike Data

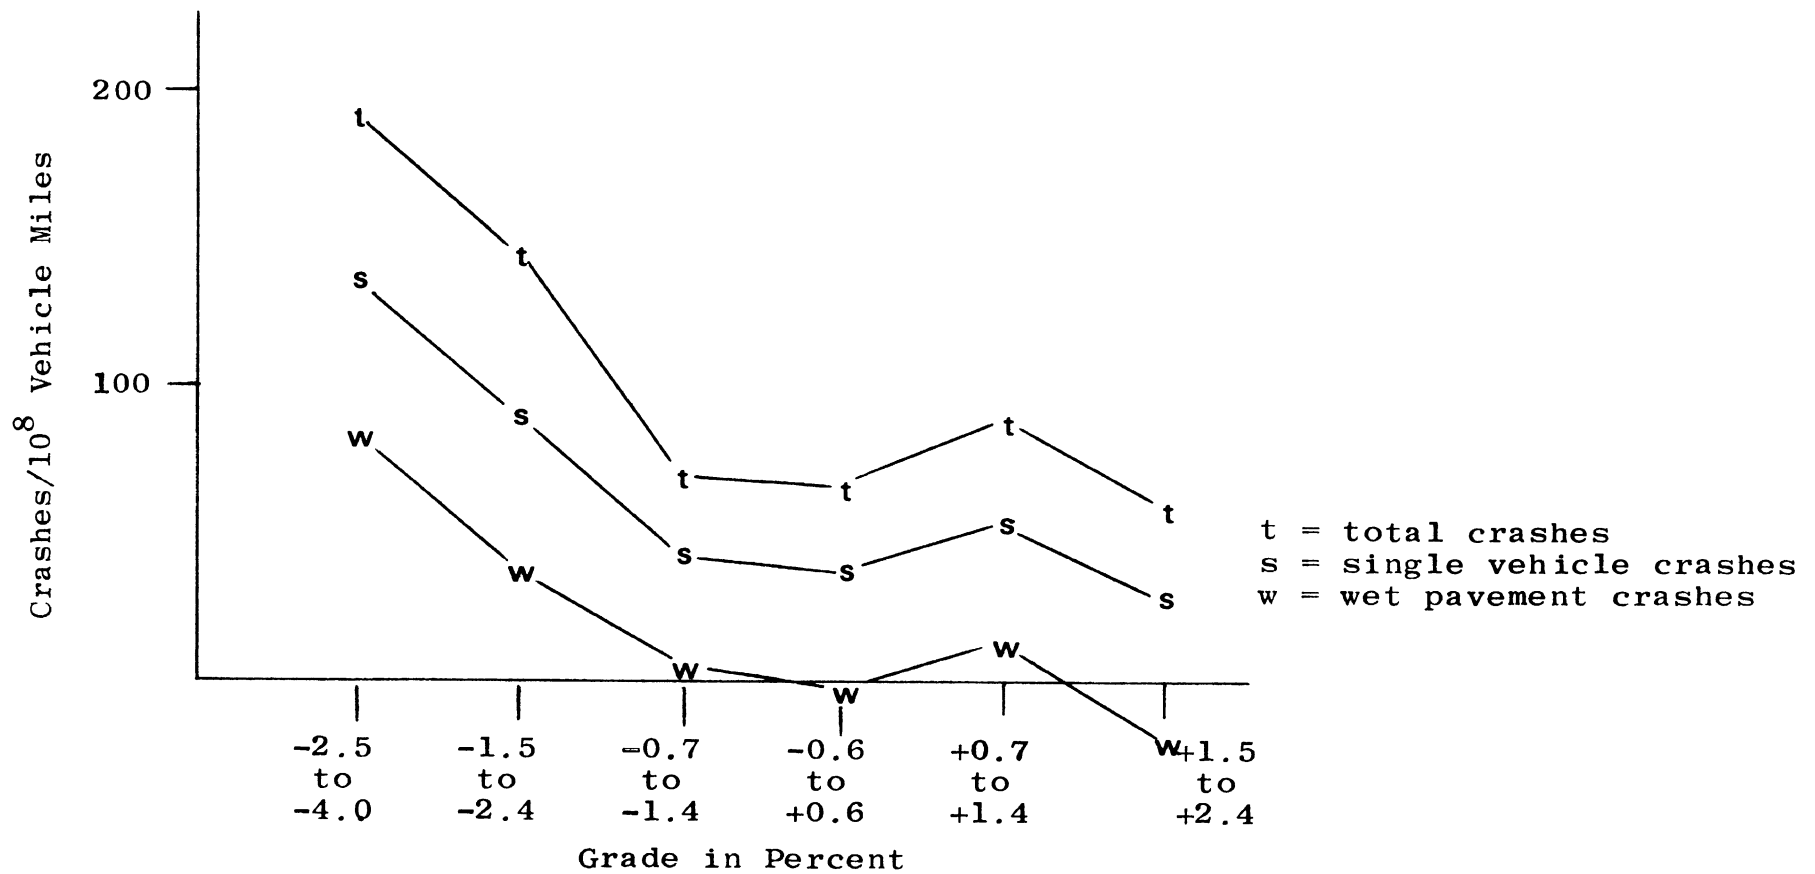
Figure A-8
 Superelevation Model
 Expected Relationship Between Grade and
 Crash Rate Using Ohio Turnpike Data

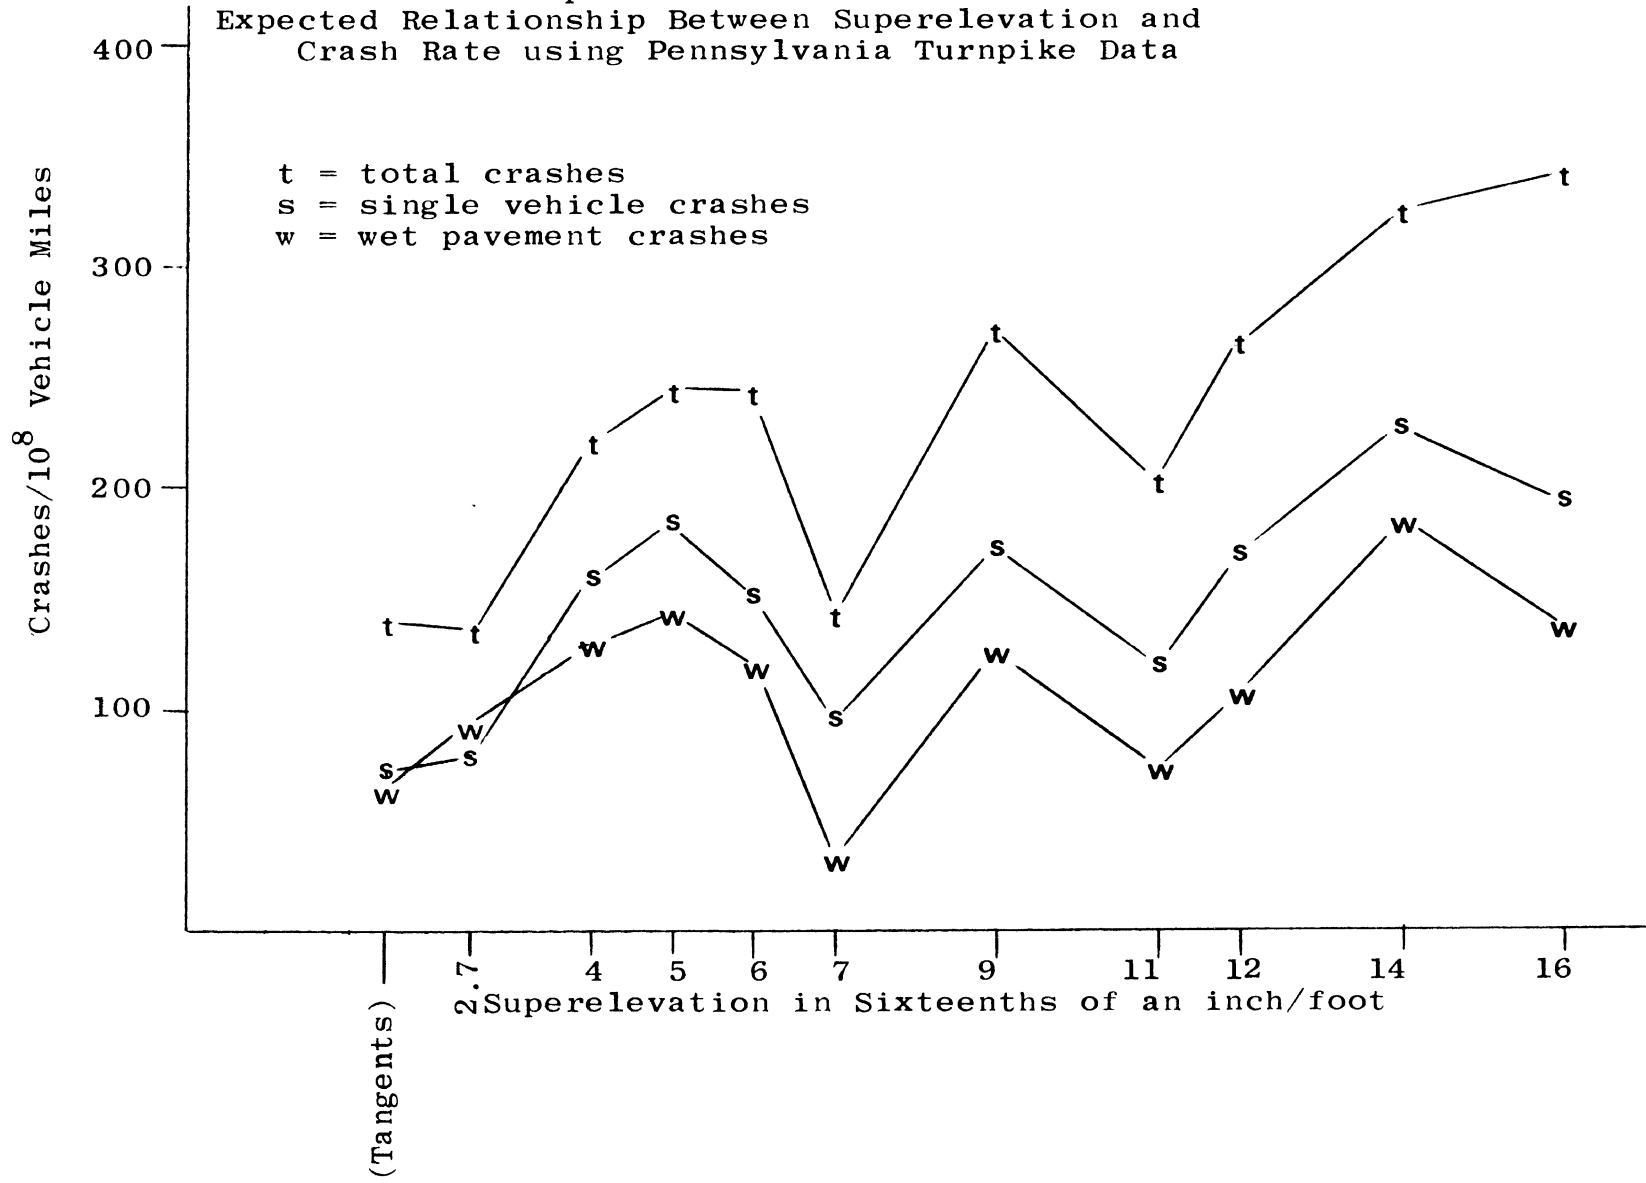
Figure A-9

Superelevation Model
Expected Relationship Between Superelevation and
Crash Rate using Pennsylvania Turnpike Data

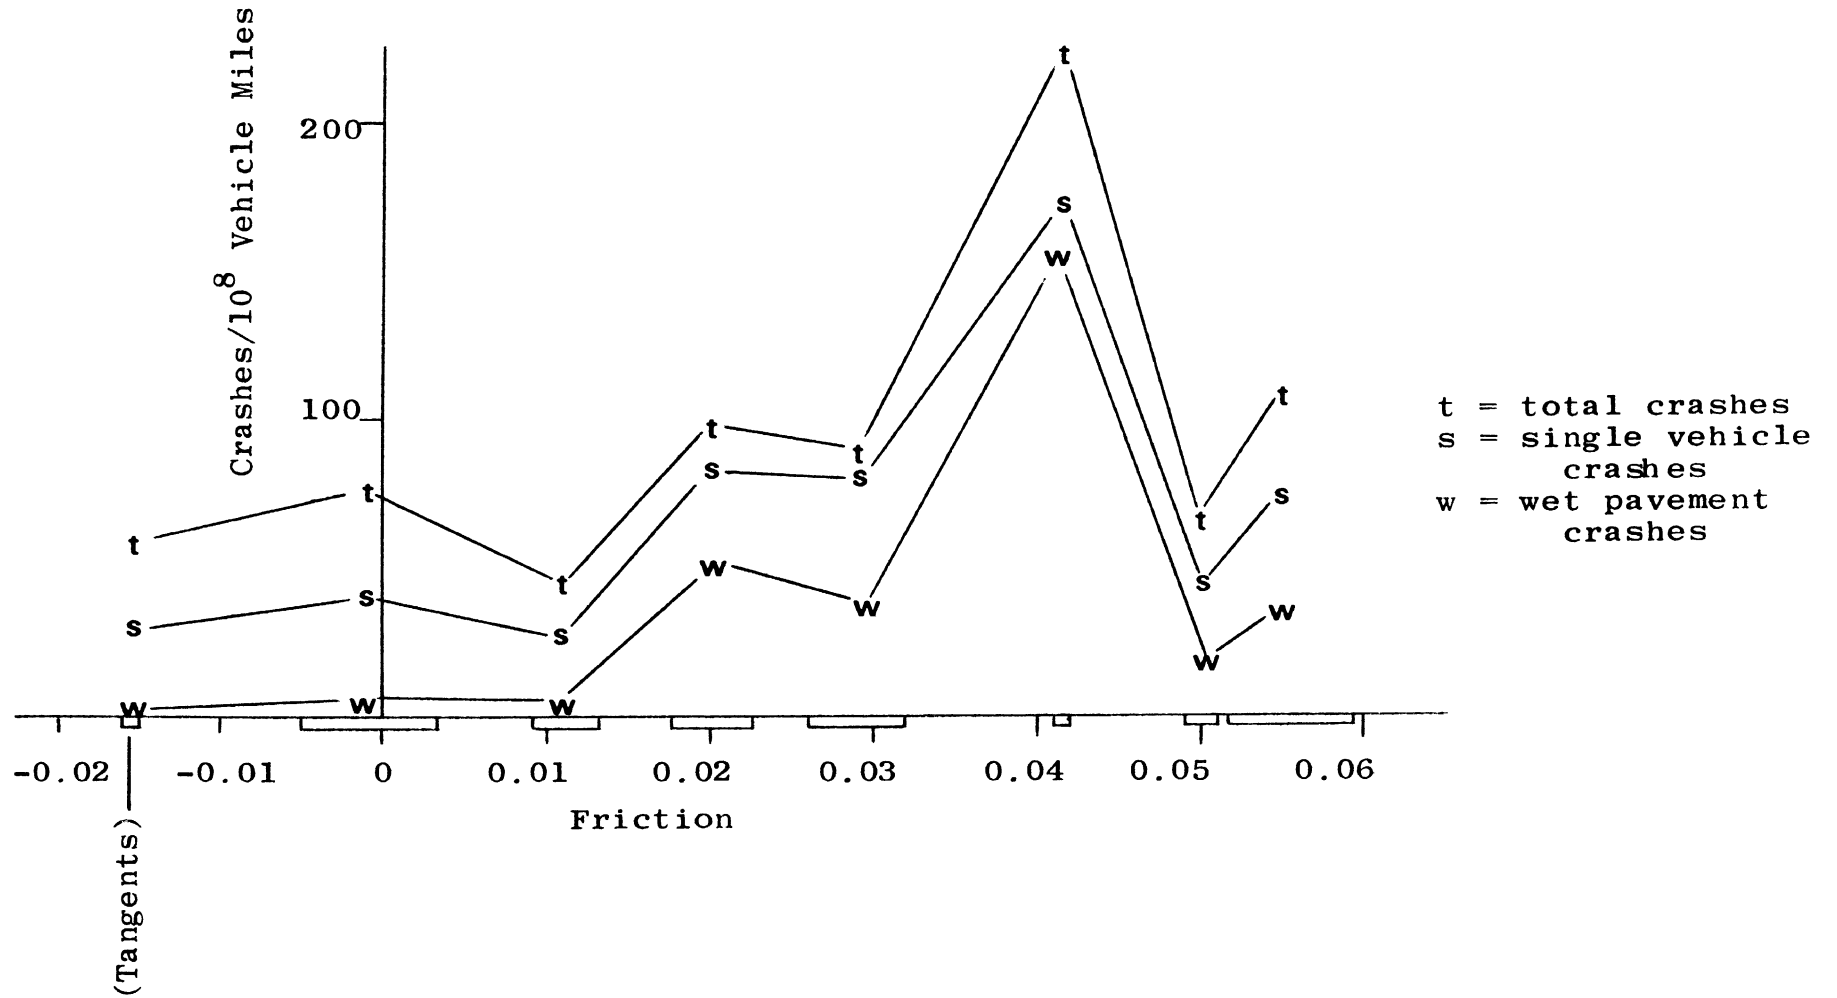
Figure A-11
 Side Force Factor Model
 Expected Relationship Between Friction and
 Crash Rate Using Ohio Turnpike Data

side force curves and tables for Ohio. The peak with side force is at $f = 0.04139$, which occurs on 1° curves and is thus the same peak observed in the curvature model. The Pennsylvania data does not indicate a dependence on grade, but does have an increasing accident rate with increasing f .

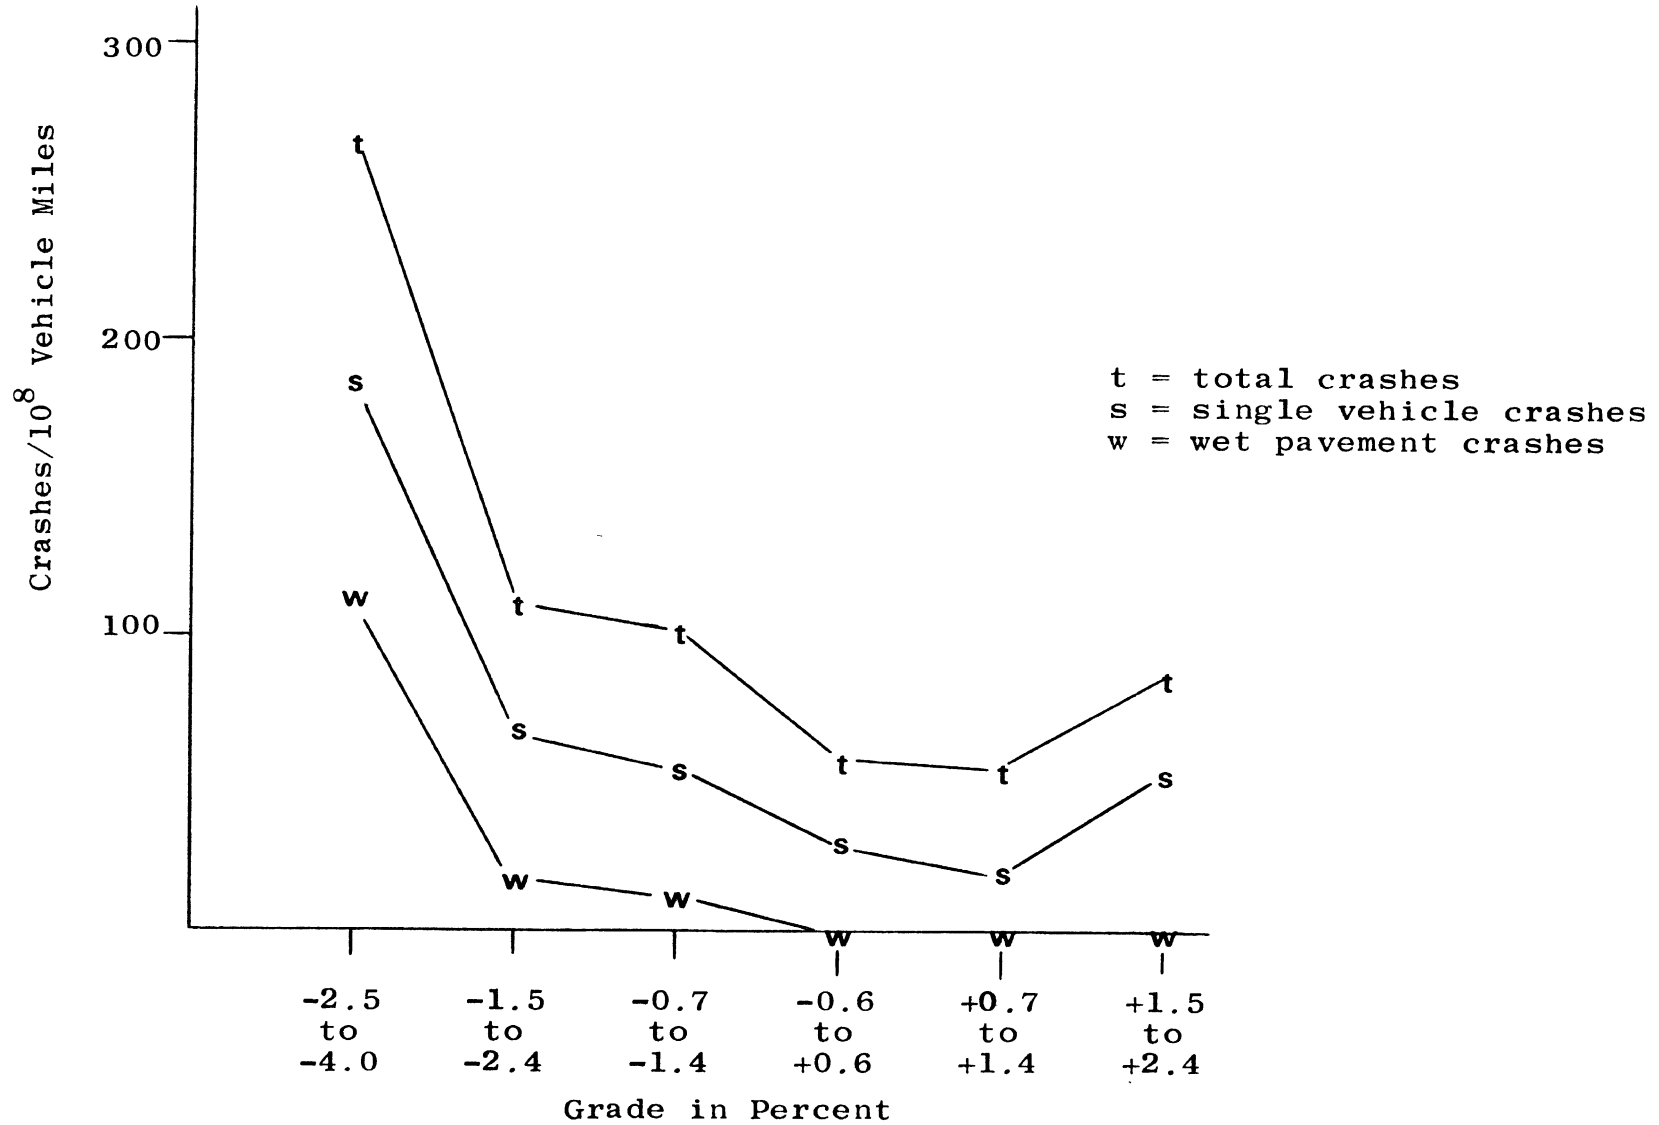
Figure A-12
 Side Force Factor Model
 Expected Relationship Between Grade and
 Crash Rate Using Ohio Turnpike Data

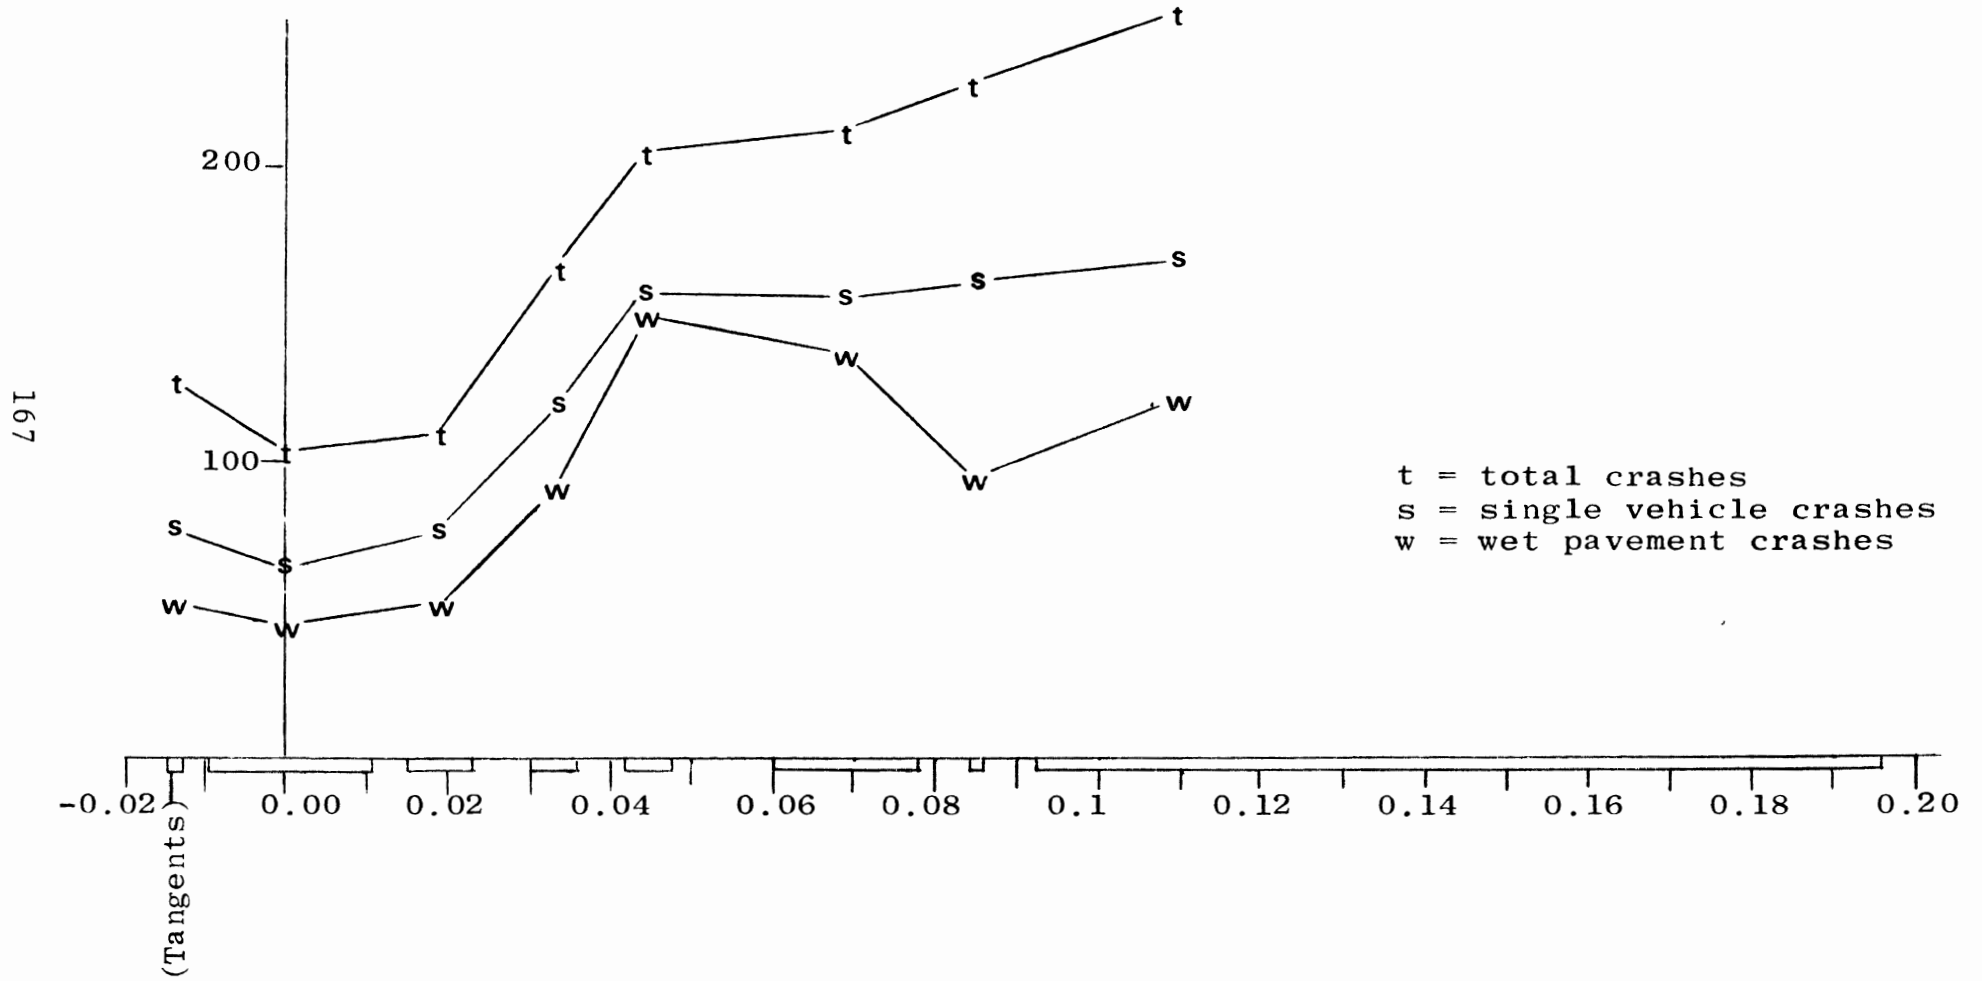
Figure A-13
 Side Force Factor Model
 Expected Relationship Between Friction and
 Crash Rate Using Pennsylvania Turnpike Data

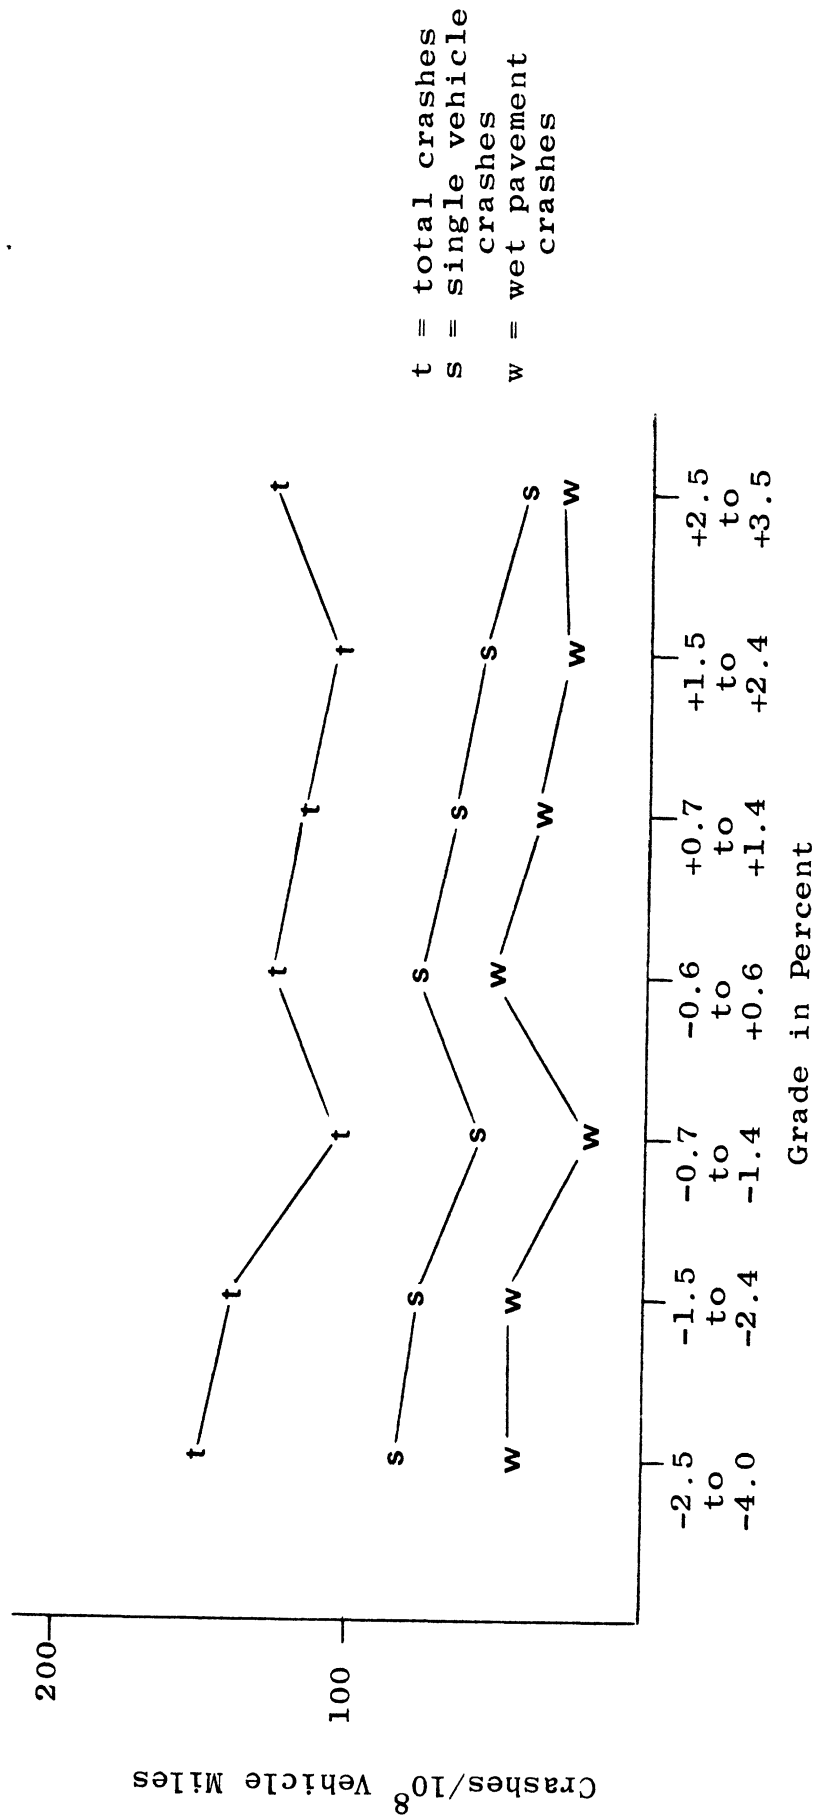
Figure A-14
 Side Force Factor Model
 Expected Relationship Between Grade and
 Crash Rate Using Pennsylvania Turnpike Data

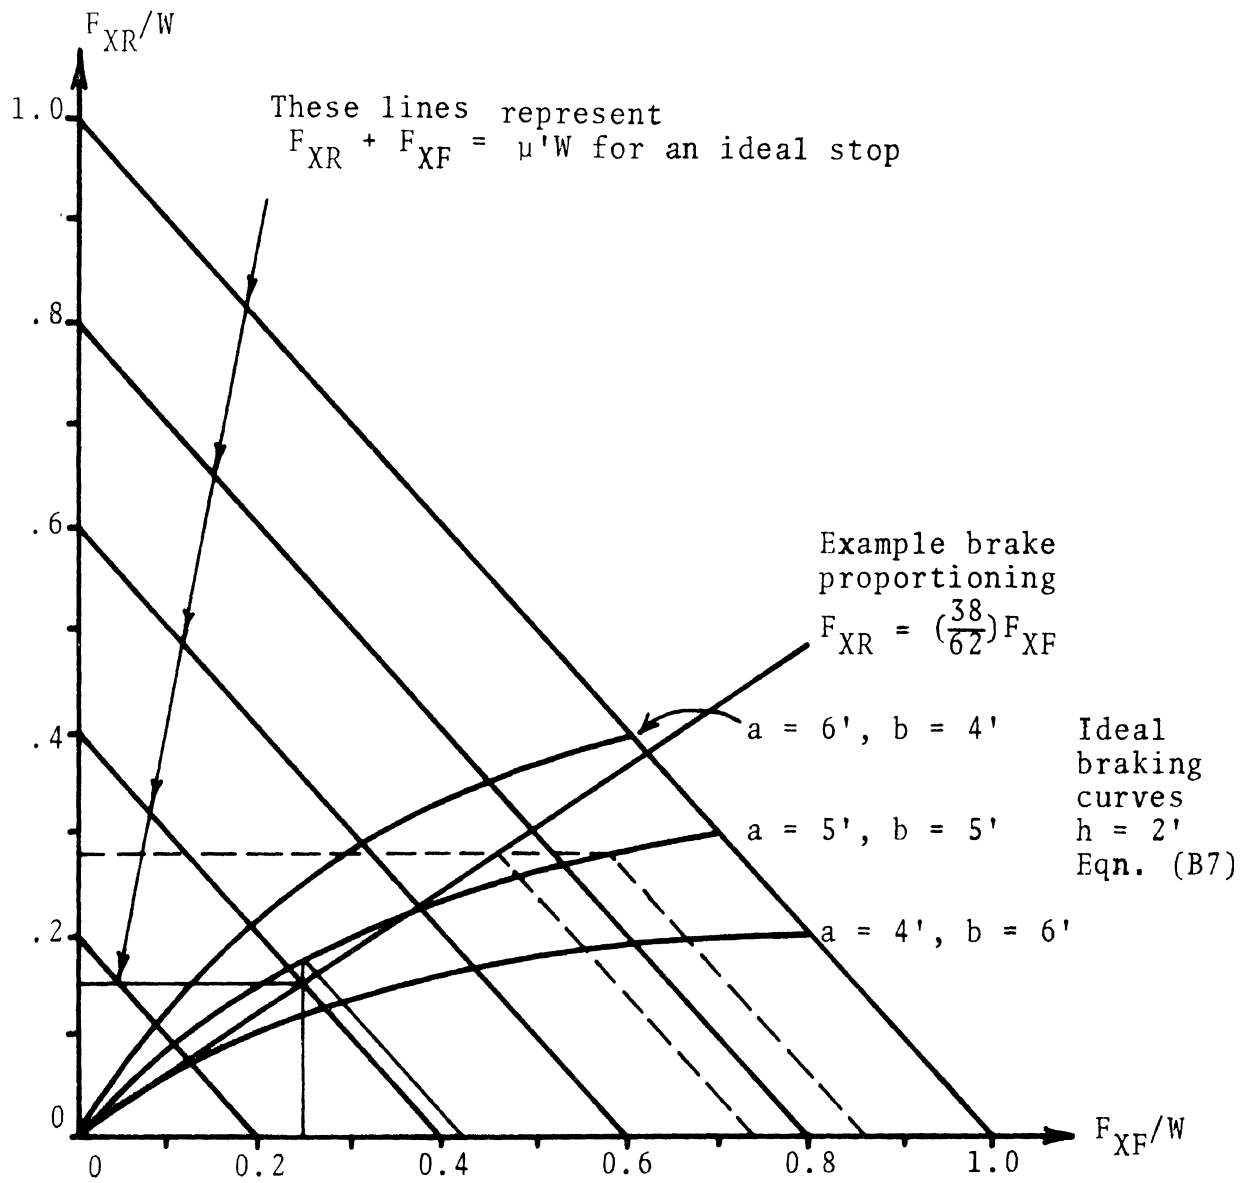
Below $\mu' = 0.6$, the front-tire braking force reaches a maximum before the rear-tire braking force. An example of this is shown in the figure. For $F_{XR}/W = .15$, the

Figure B-2. The Effect of Brake Proportioning on Braking Performance.

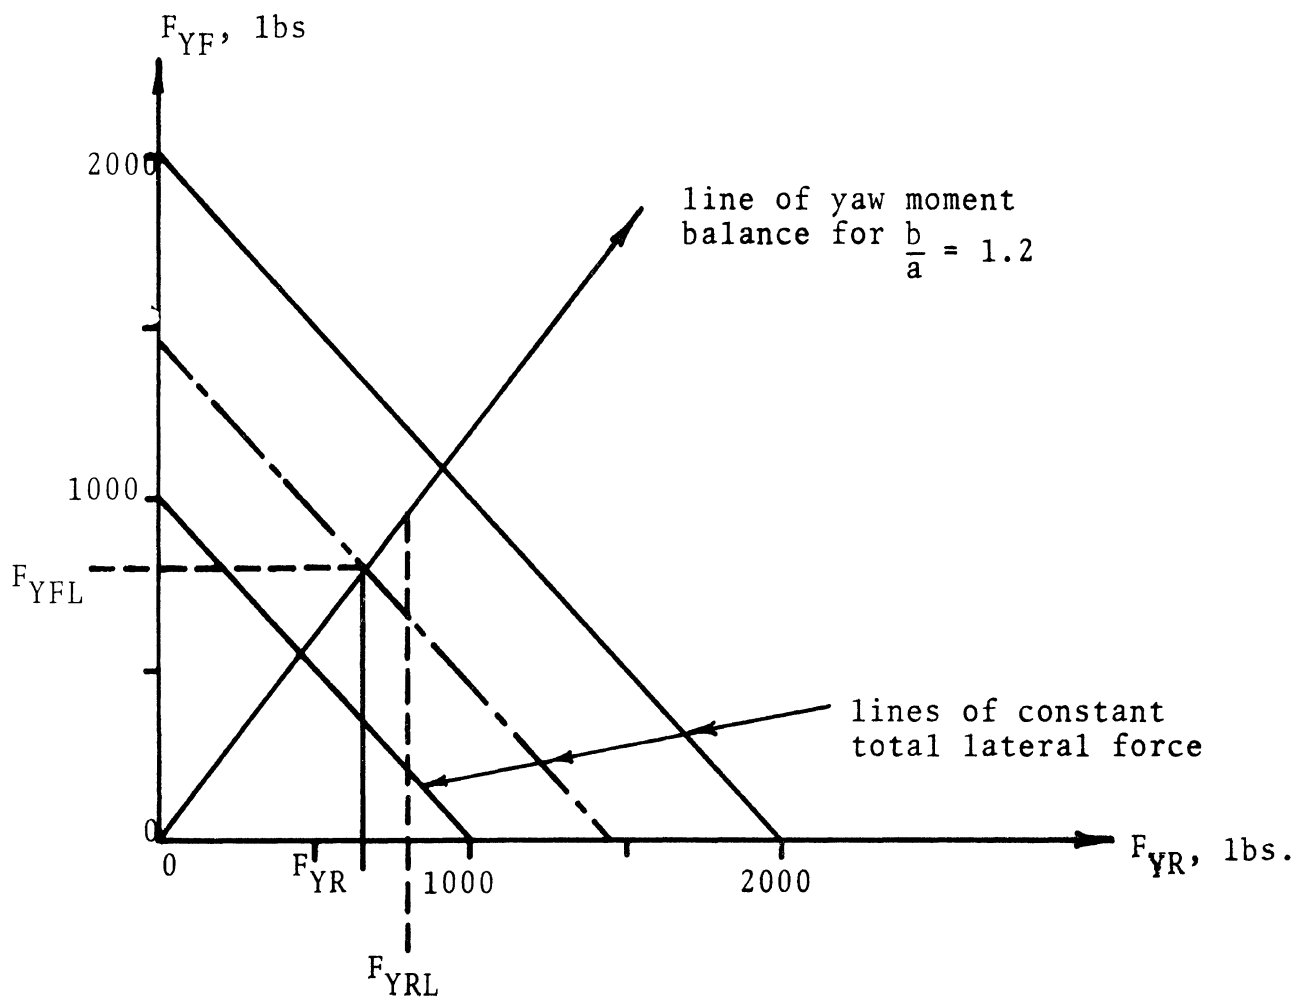
In the plow-out example of Figure B-5 it is assumed that the maximum lateral force, F_{YFL} , from both front tires is 800 lbs. and, due to tire differences or other factors, F_{YFL} is equal to the maximum available lateral force from the rear tires (F_{YRL}), even though the center of gravity is closer to the front wheels than to the rear wheels (i.e., $b > a$). Points satisfying the yaw moment balance lie along a radial line drawn through the origin with slope, b/a , in Figure B-5. Lines of constant total lateral force have a negative slope equal to unity. These lines represent Equation (B.19) for various steady turning conditions. The point where loss of control occurs can be found by proceeding out the yaw moment balance line

Figure B-5. Front-Tire Saturation (Plow-Out)

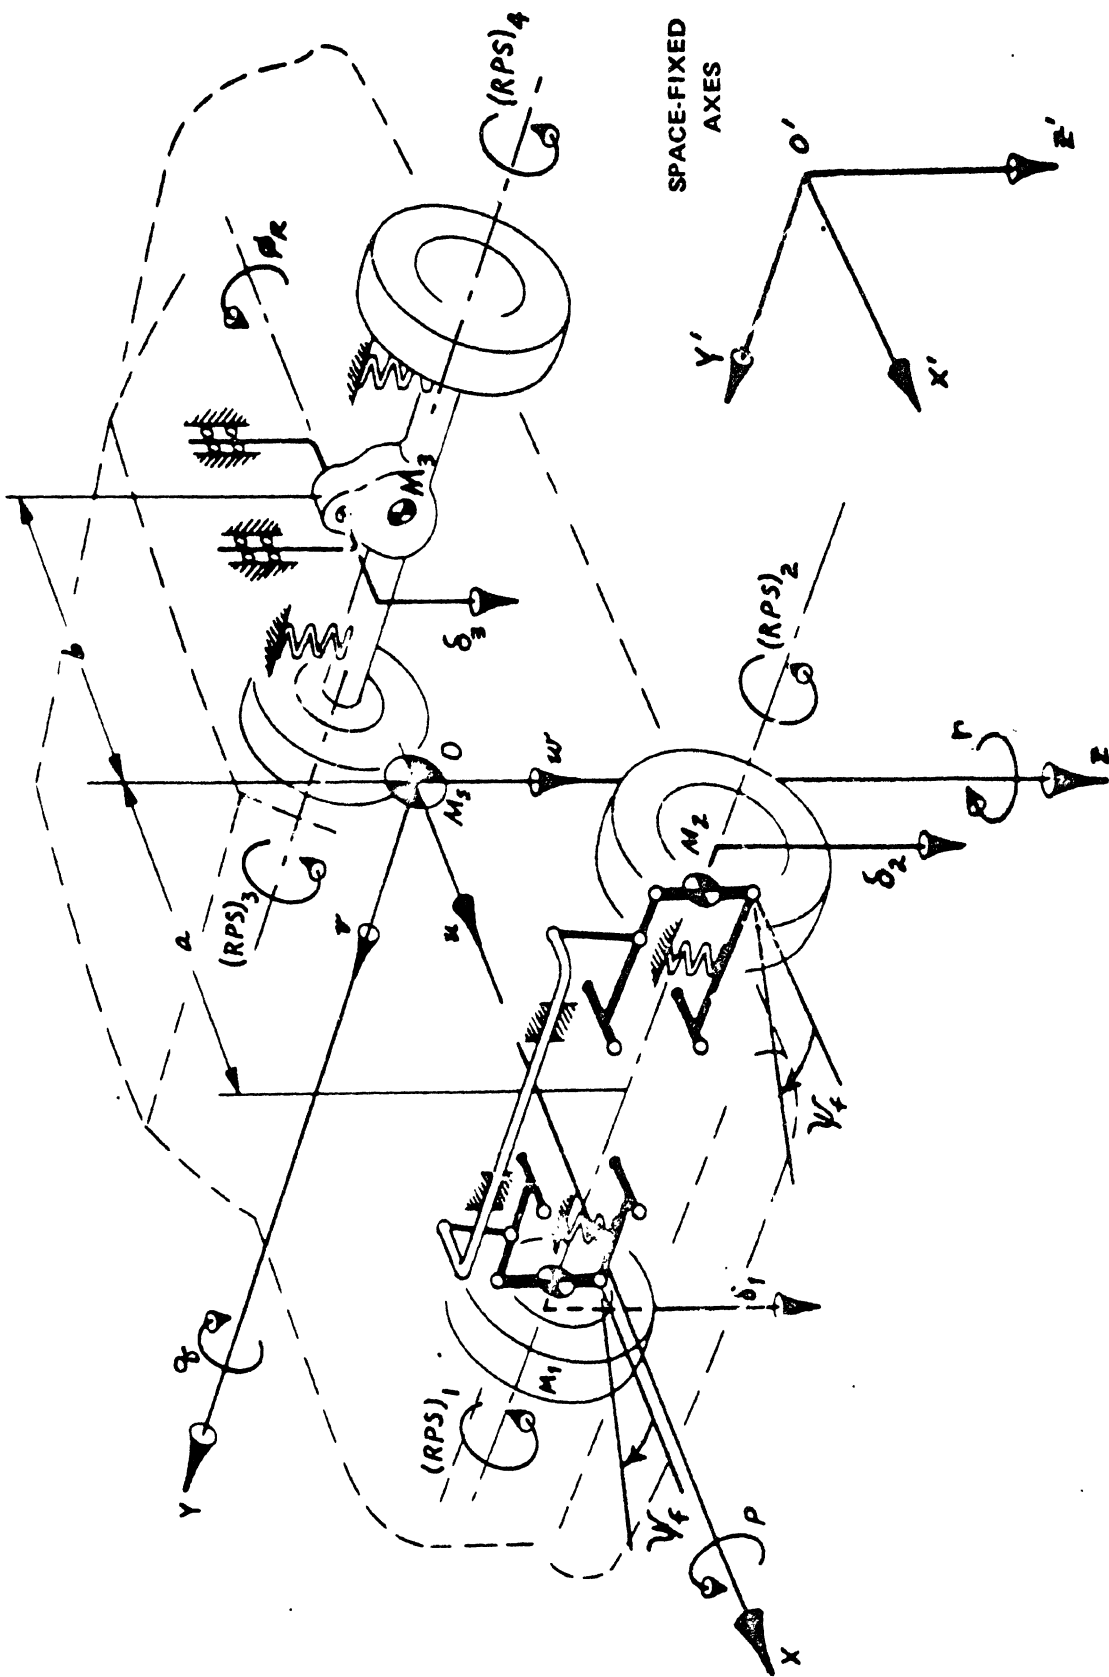
Figure B-8. HVOSM—Vehicle Model
