INFLUENCE OF COMBINED HIGHWAY GRADE
AND HORIZONTAL ALIGNMENT
ON SKIDDING

FINAL REPORT

VOLUME 2 OF 2

SEPTEMBER 1974

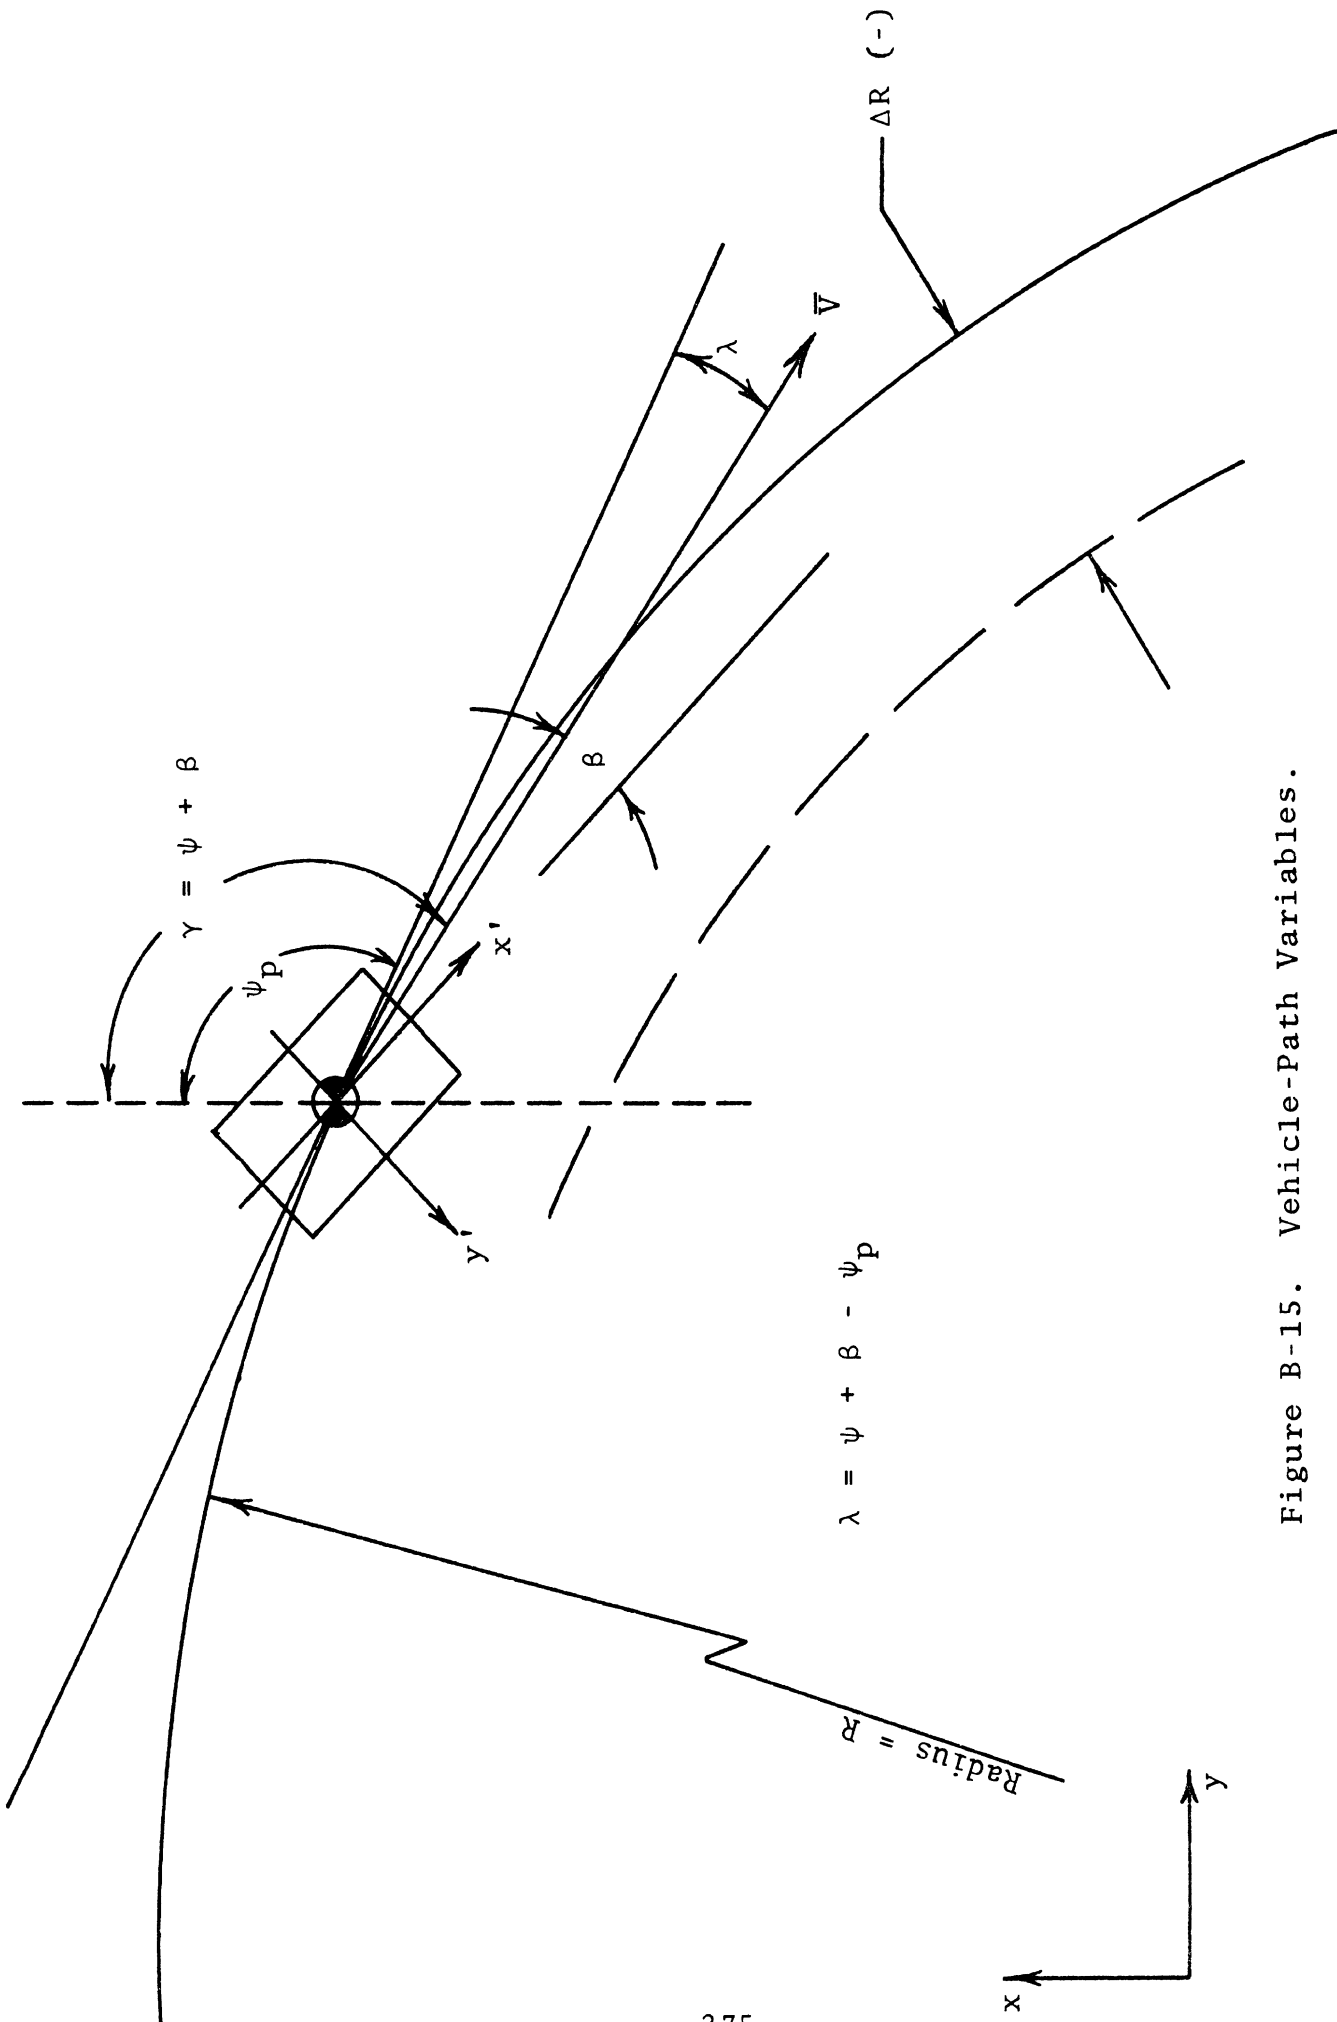
Figure B-15. Vehicle-Path Variables.

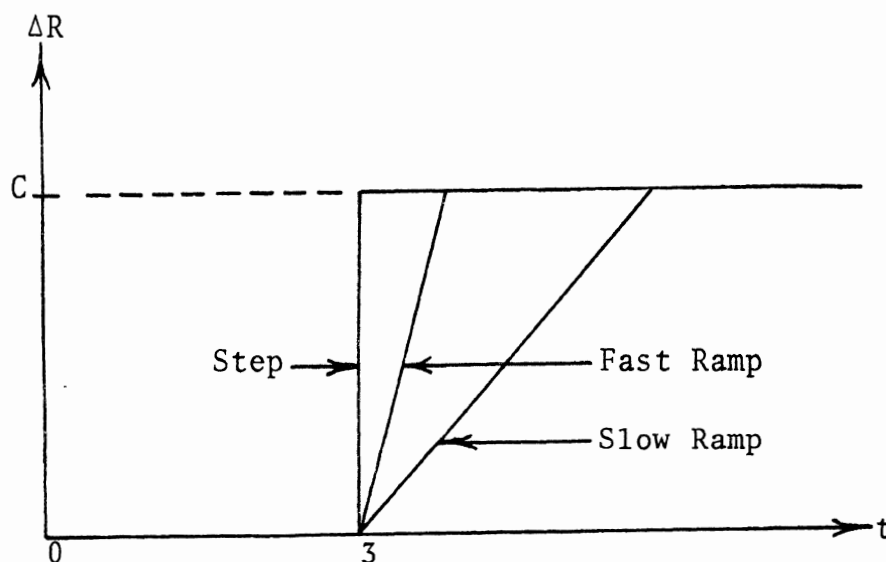
Figure B-16

where C is a constant equivalent to a 12-foot lane change. Note that this step form of ΔR can cause an abrupt change in steering to occur. Varying degrees of steering path response can be obtained by ramping ΔR from 0 to C at the desired rate, as shown in Figure B-16.

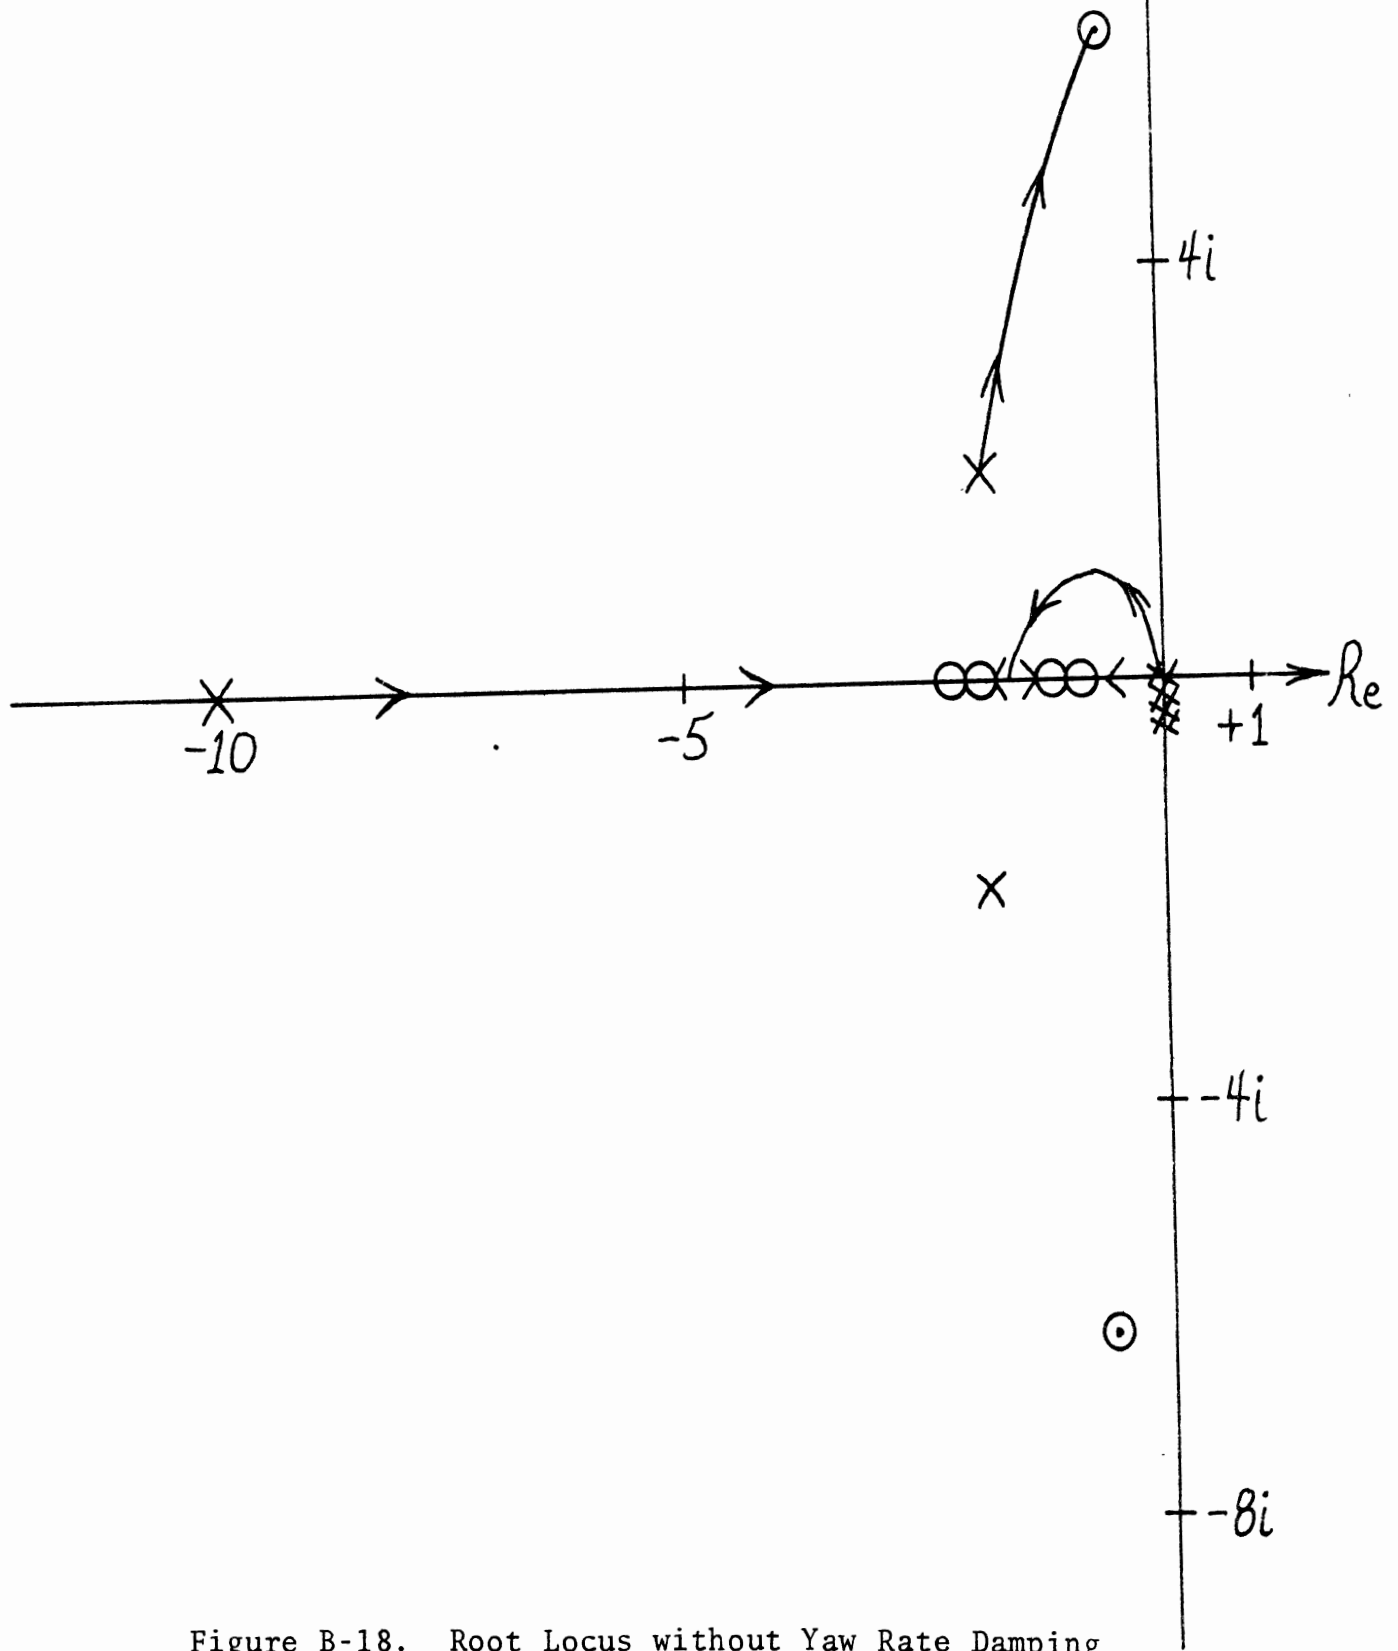
$$H(P) = \frac{.9K_1(P^2 + 1.1P + 38)(P+1)^2(P+2)^2}{P^3(P^2 + 3.6P + 7.3)(P+10)}$$

Figure B-18. Root Locus without Yaw Rate Damping
283

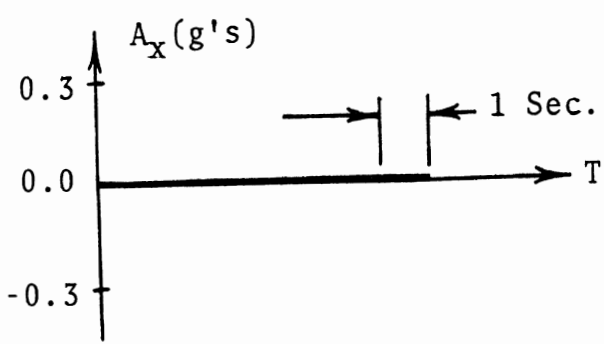
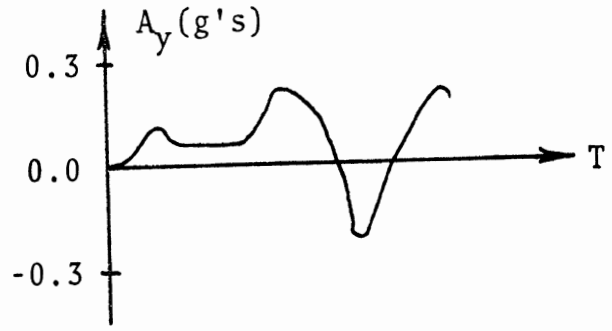
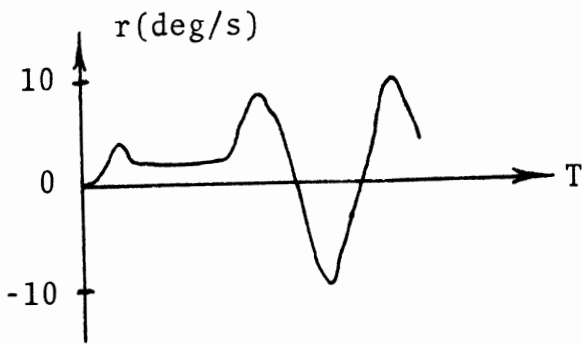
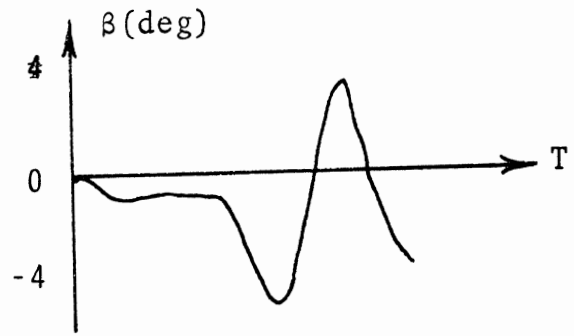
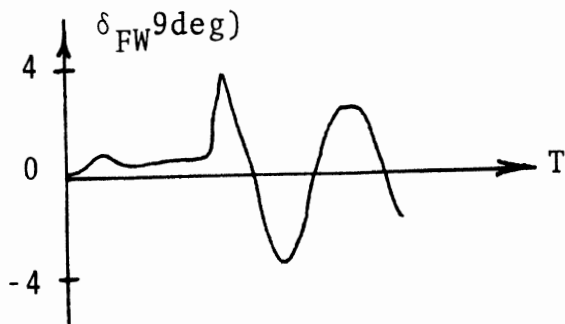
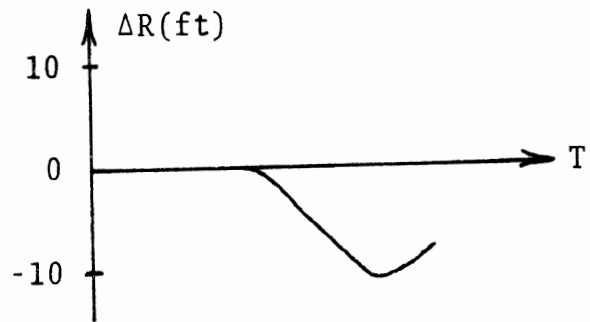
Figure B-26. V_{LC} - Directional Instability During Lane Change

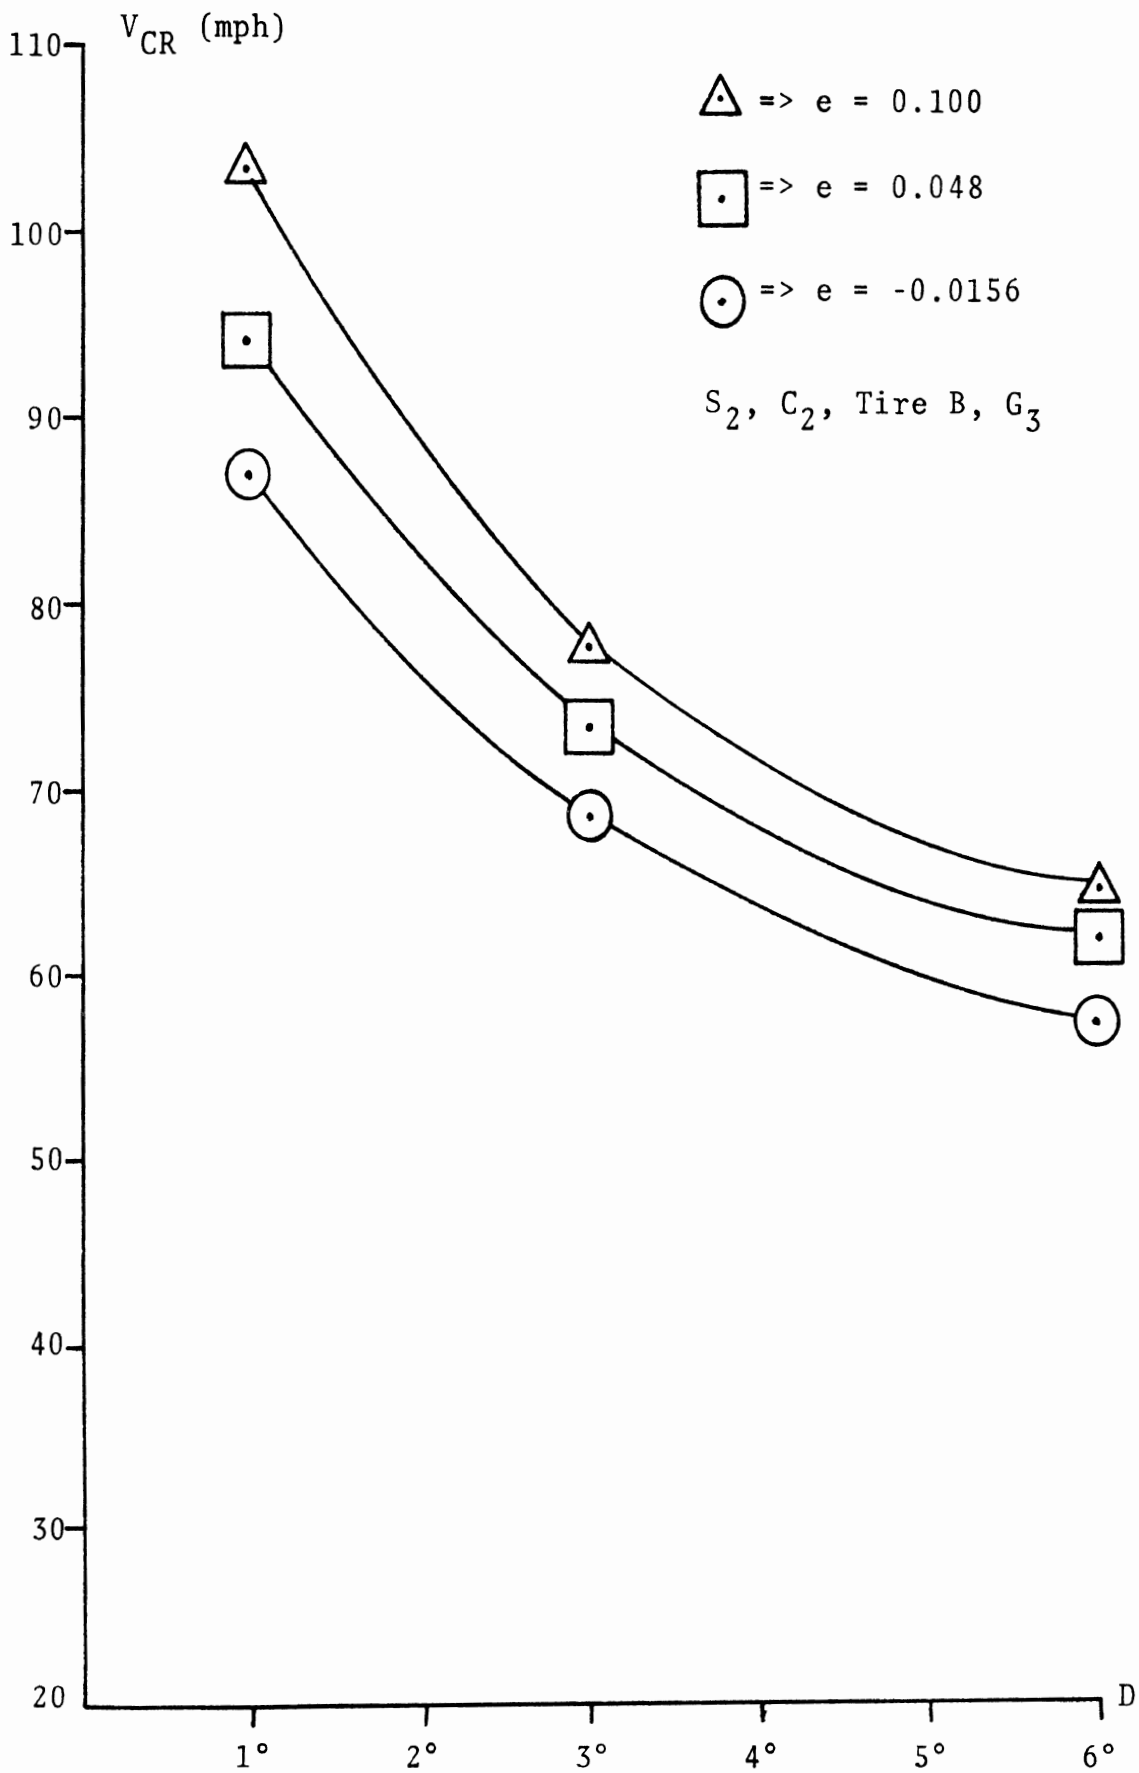
Figure B-29. Effect of Superelevation on V_{CR}

Figures B-29 through B-31 show the effects of super-elevation, surfaces, and tires on V_{CR} at different curvatures. Likewise, Figures B-32 through B-34 and Figures B-35 through B-37 demonstrate these same effects but for V_{LC} and V_{LOC} , respectively. Figure B-38 shows the effect grade has on V_{LOC} . The notation used in the plots is also defined in Table B-6.

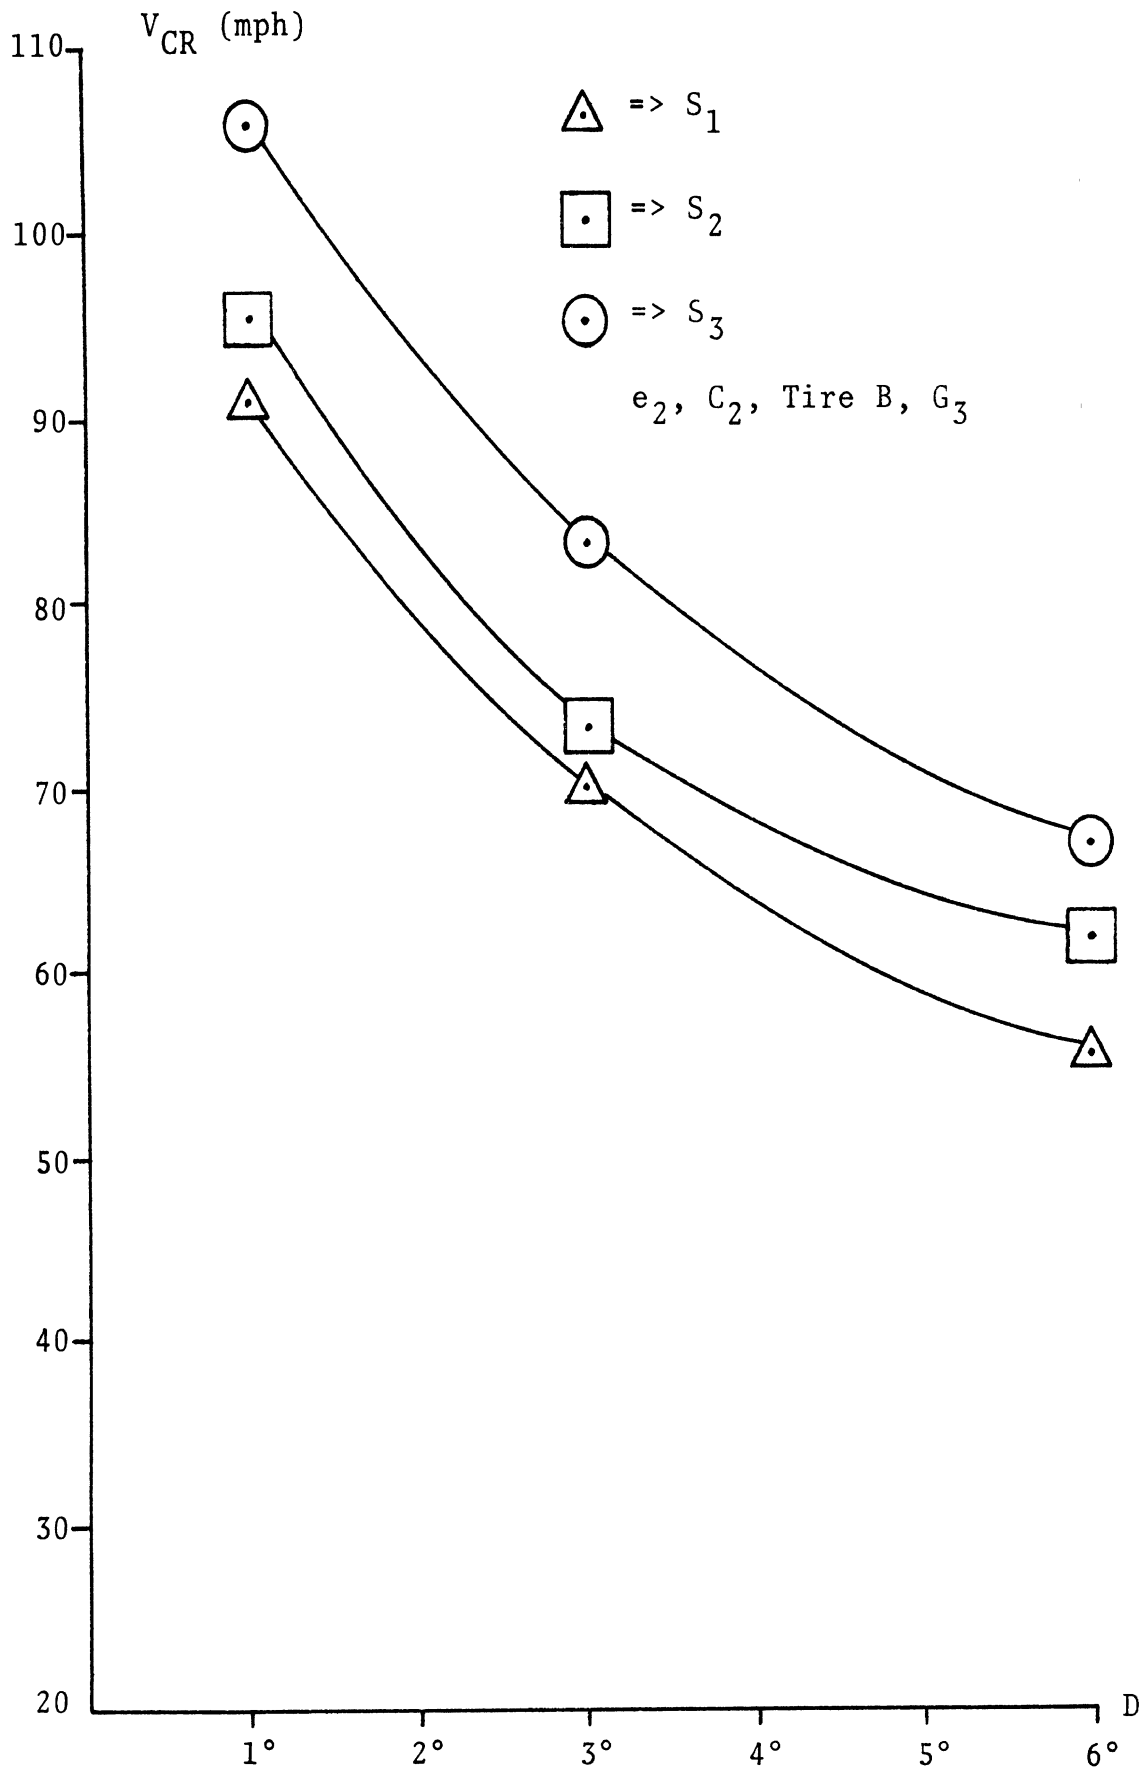
Figure B-30. Effect of Surface on V_{CR}

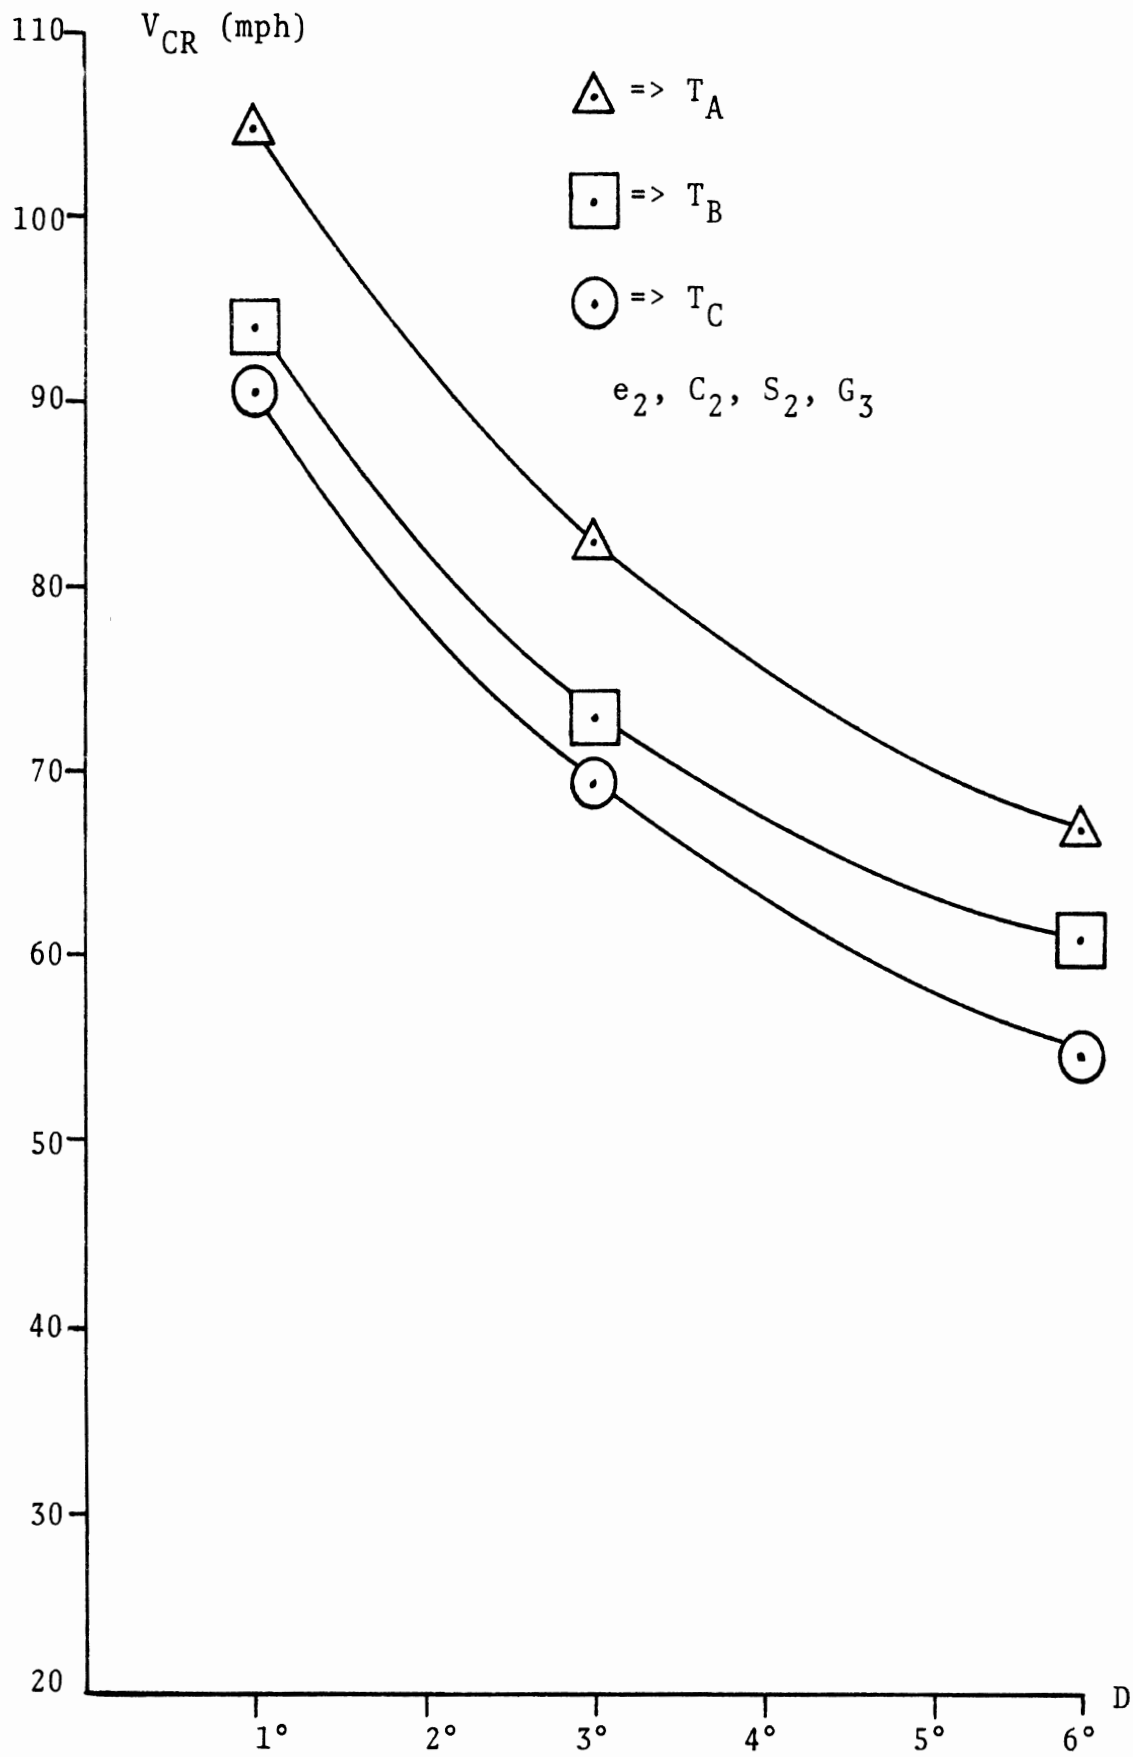
Figure B-31. Effect of Tire Wear on V_{CR}

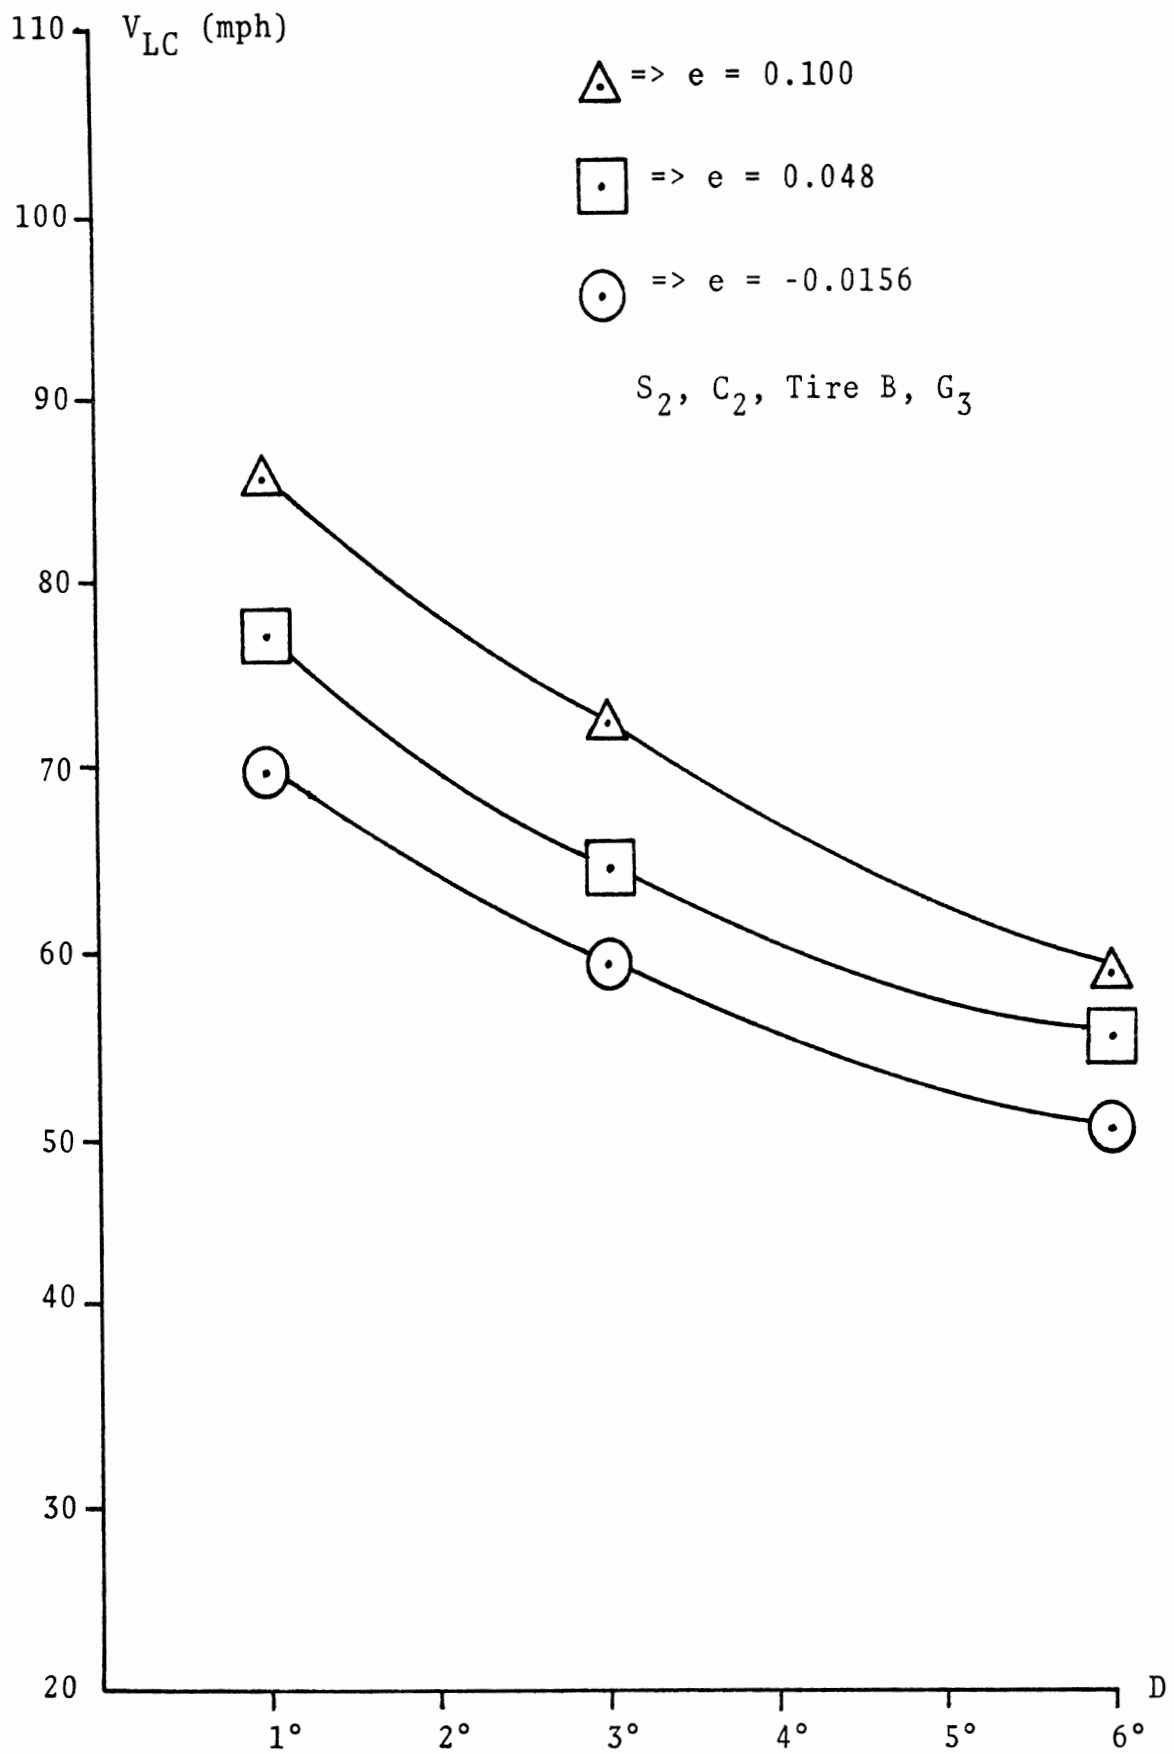
Figure B-32. Effect of Superelevation on V_{LC}

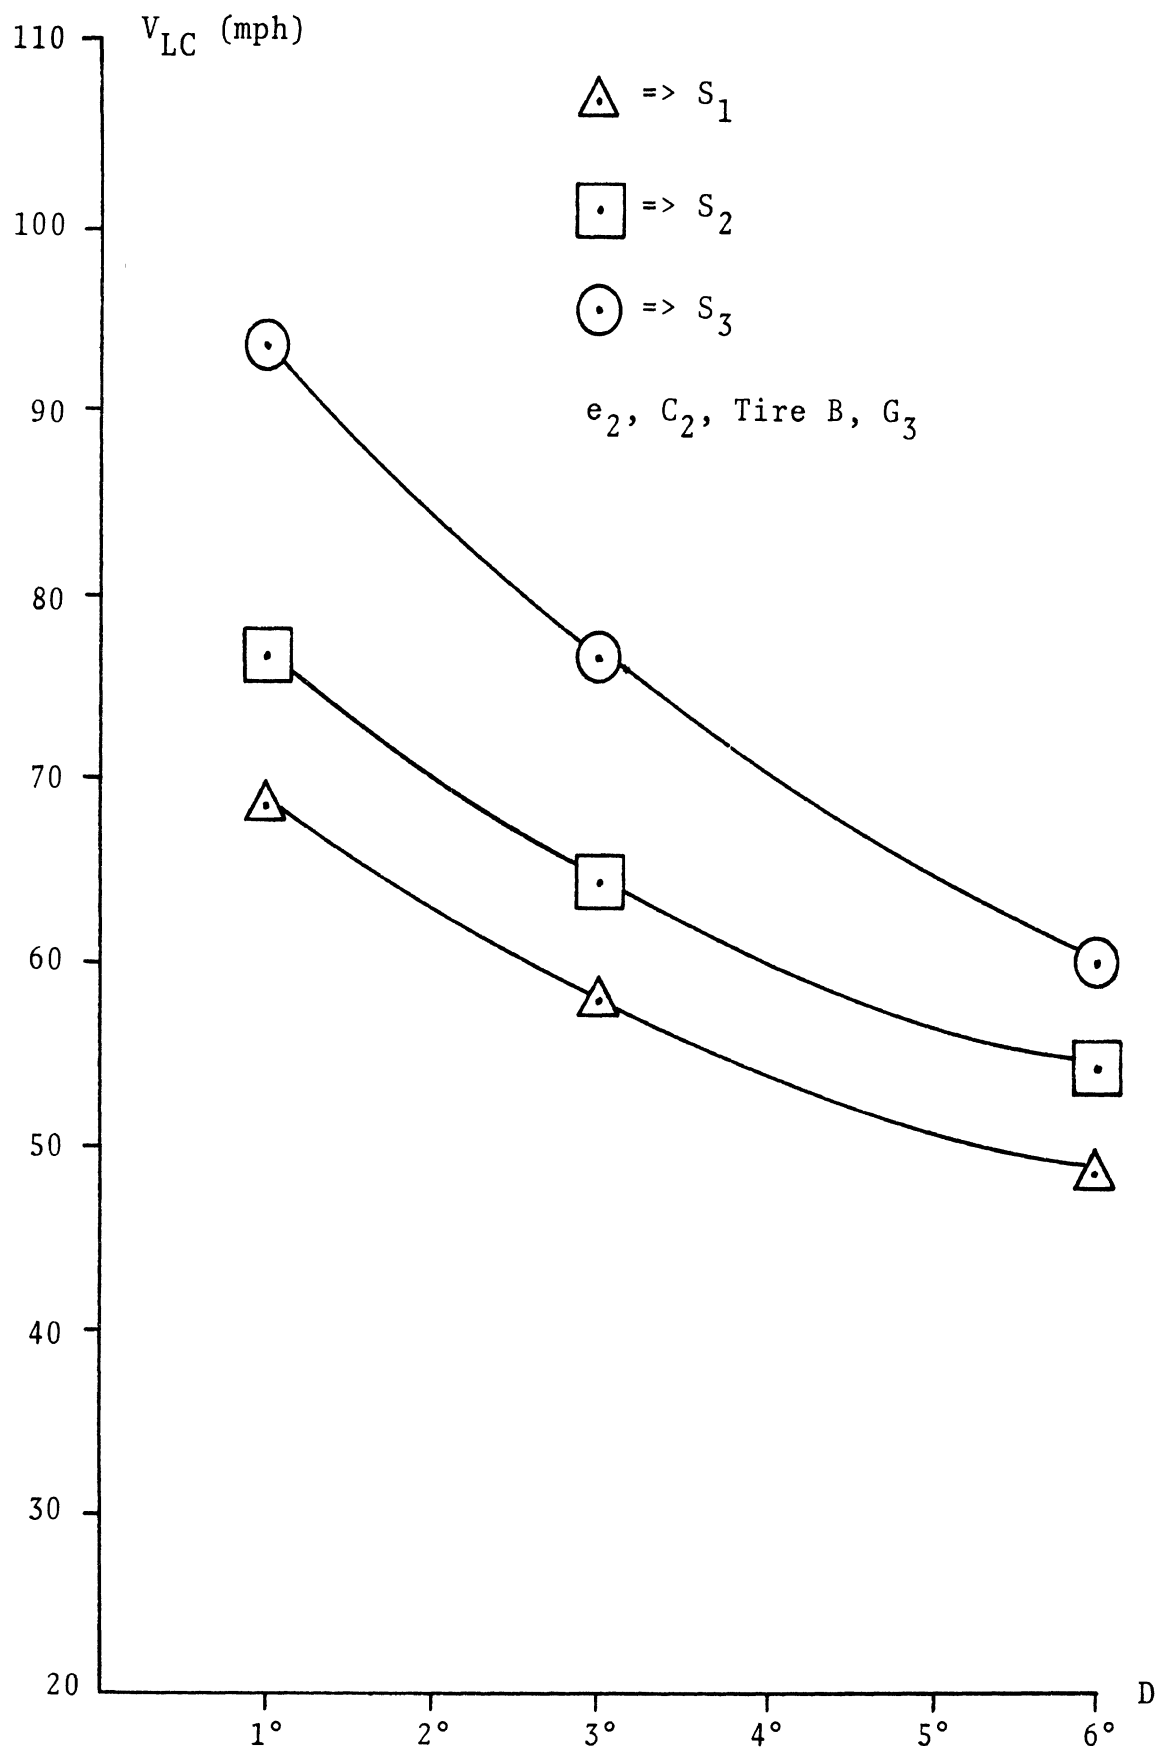
Figure B-33. Effect of Surface on V_{LC}

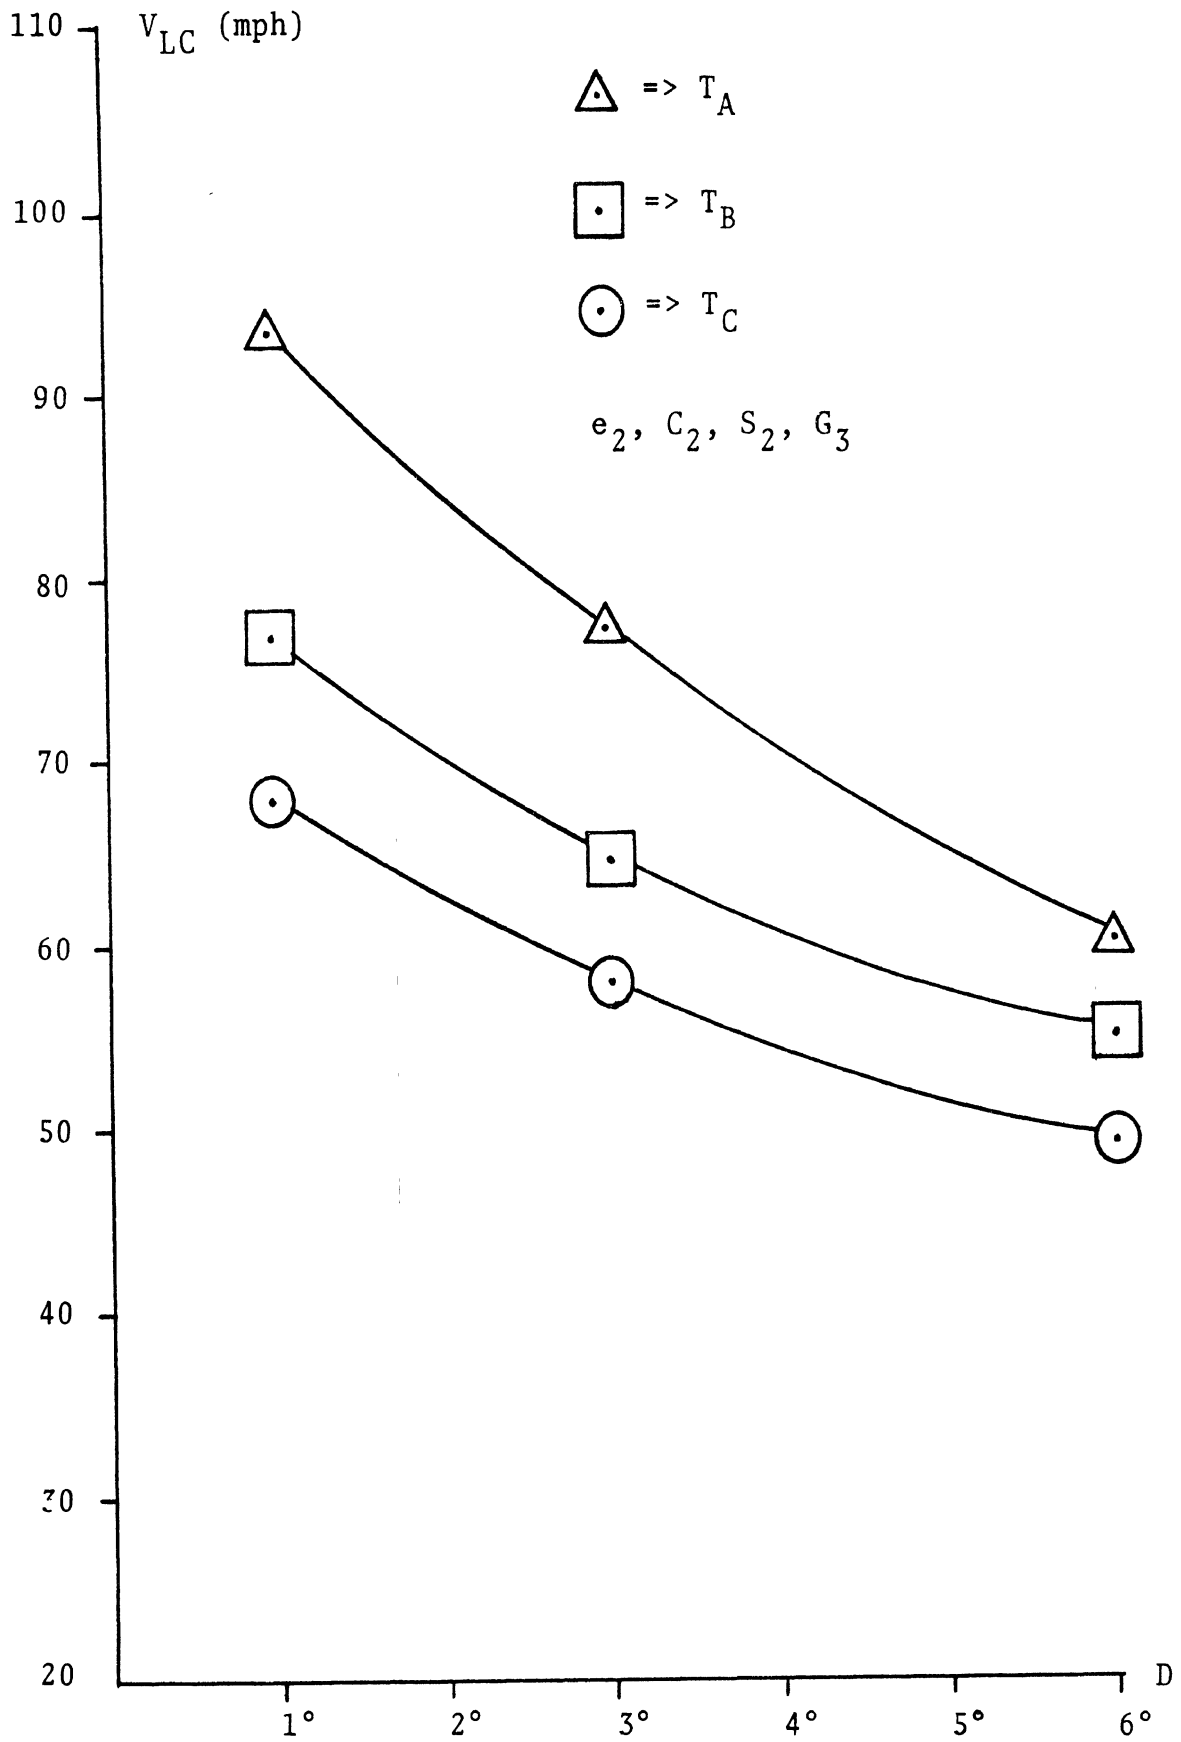
Figure B-34. Effect of Tire Wear on V_{LC}

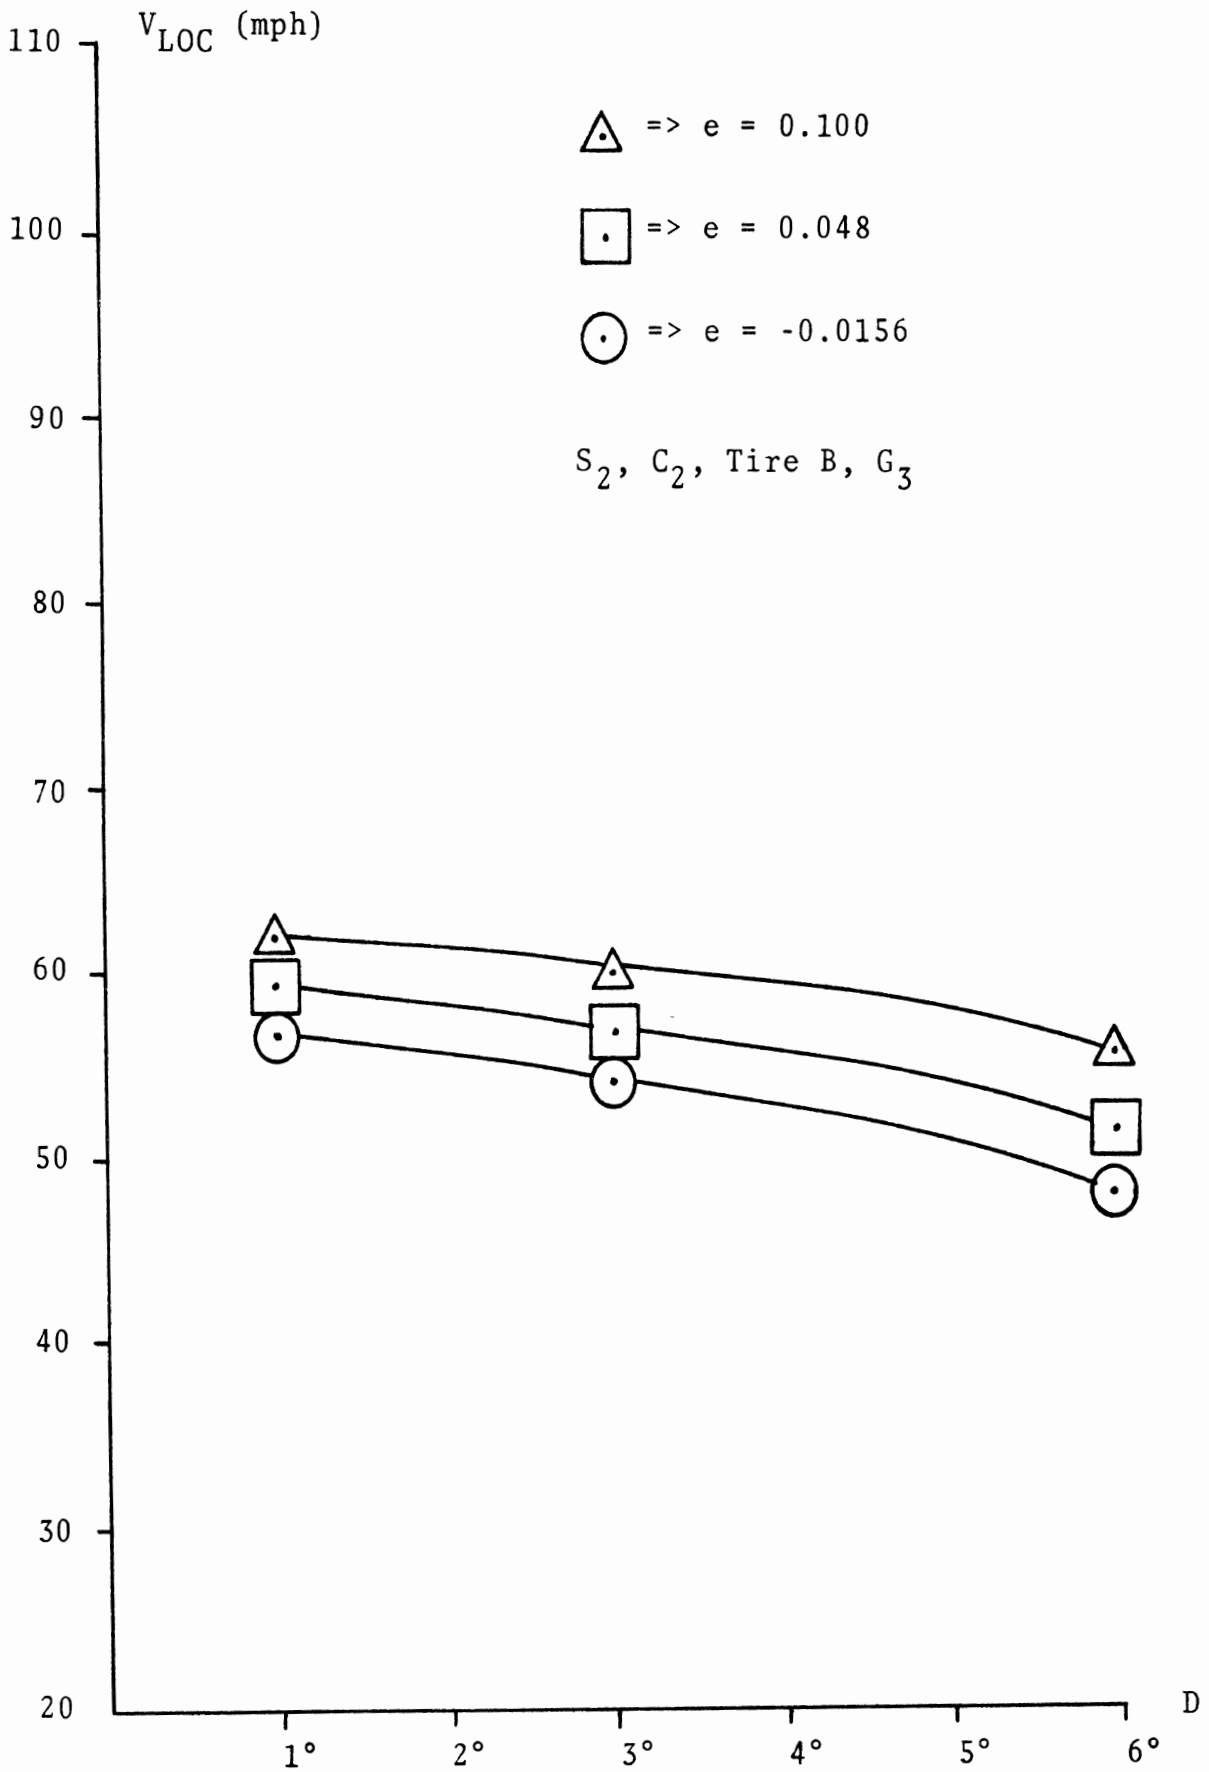
Figure B-35. Effect of Superelevation on V_{LOC}
