INFLUENCE OF COMBINED HIGHWAY GRADE
AND HORIZONTAL ALIGNMENT
ON SKIDDING

FINAL REPORT

VOLUME 2 OF 2

SEPTEMBER 1974

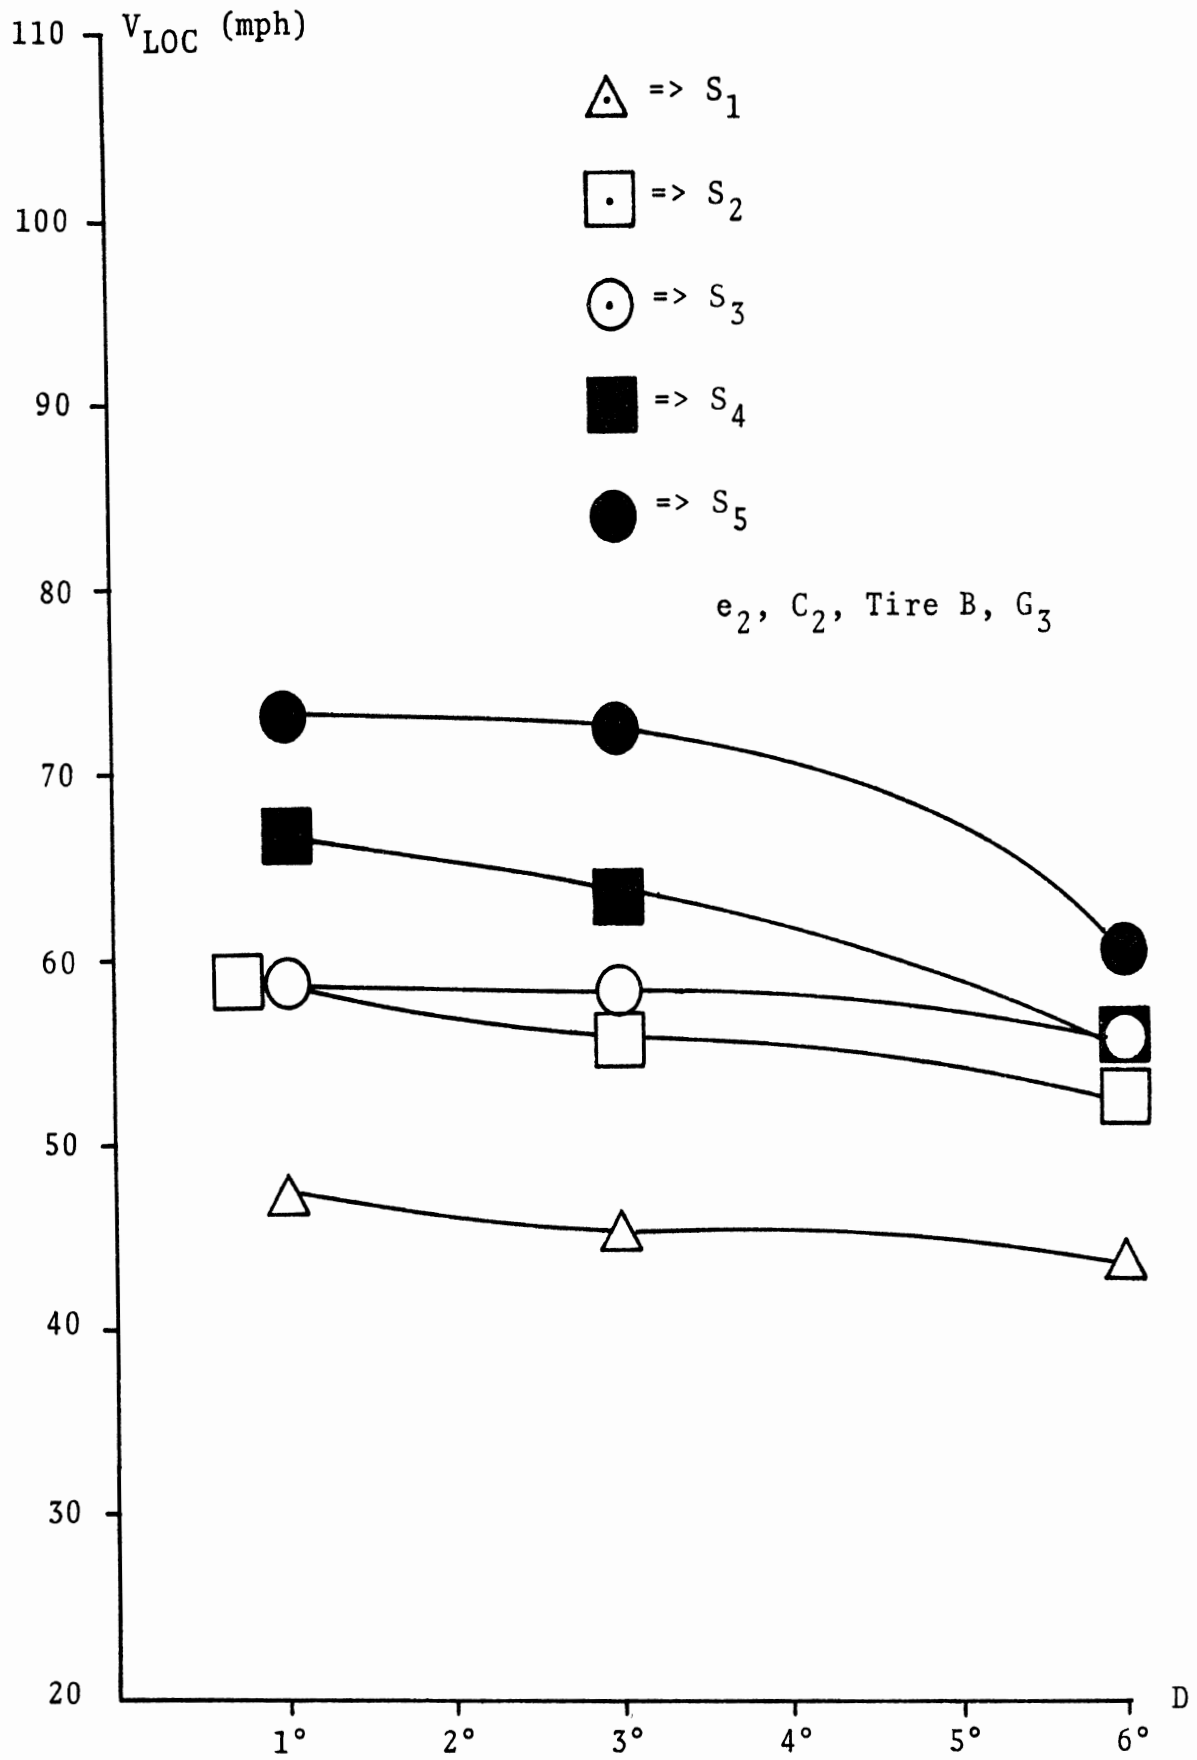
Figure B-36. Effect of Surface on V_{LOC}

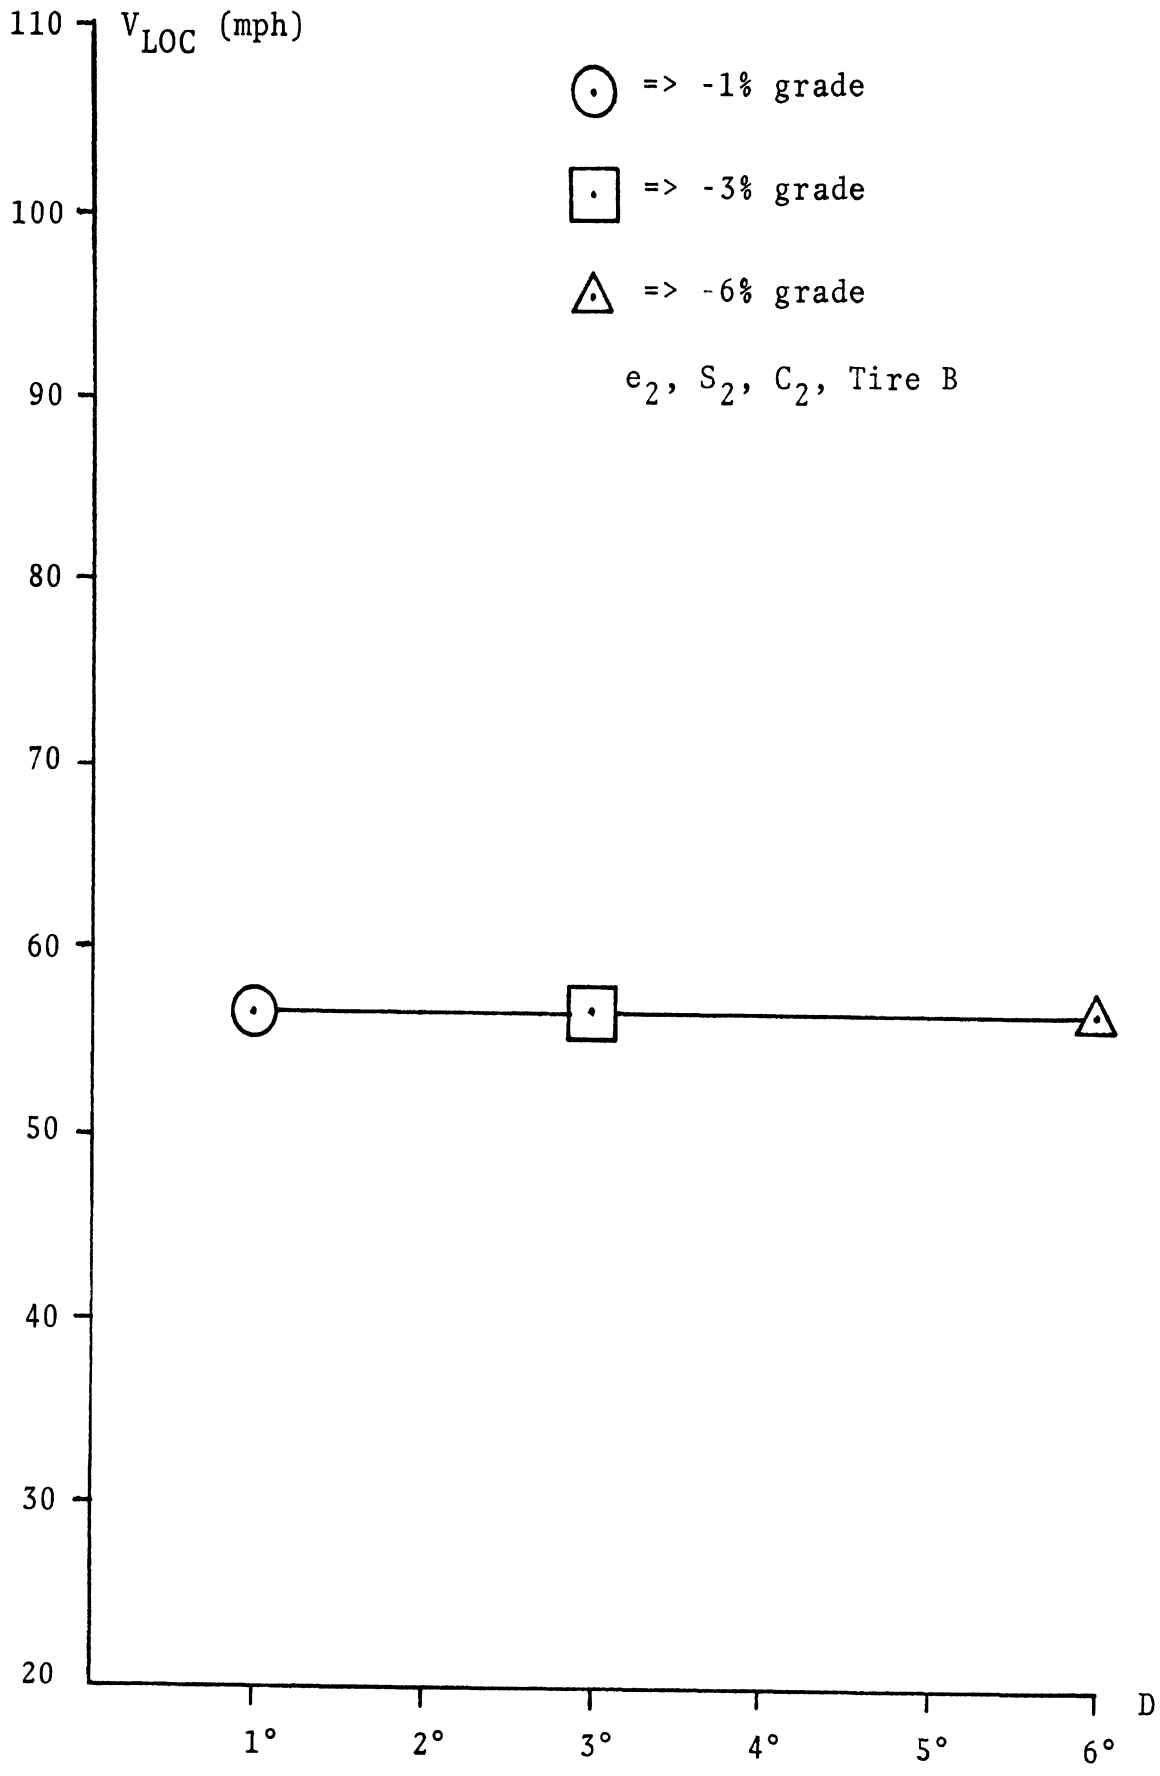
Figure B-38. Effect of Grade on V_{LOC}

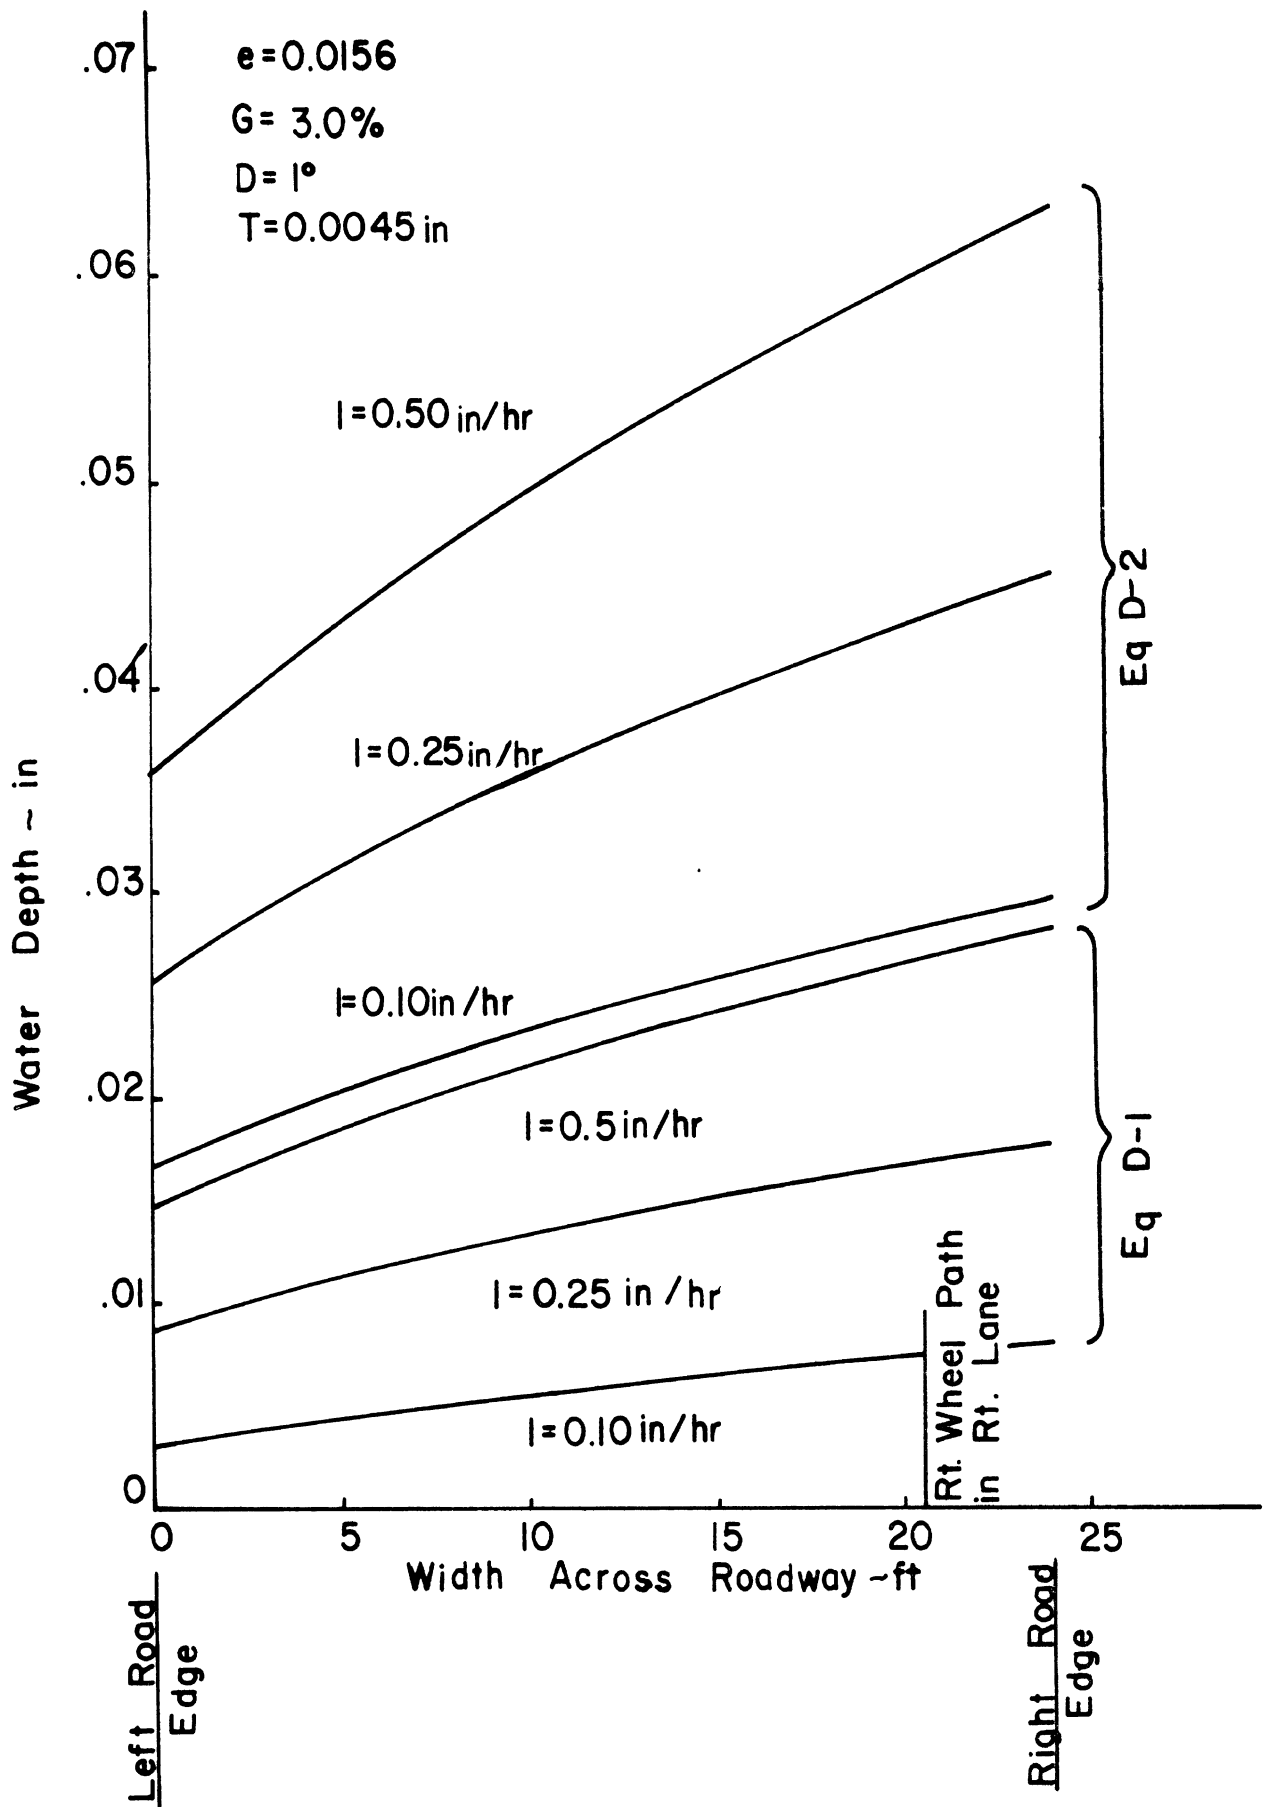
Equations (D.1) and (D.2) are plotted on Figure D-3 in terms of water depth versus road width. Separate curves are shown for rainfall intensities of 0.10, 0.25, and 0.50 in/hr. These values were chosen to reflect the hourly rainfall accumulations recorded at Cleveland Hopkins Airport and to account for higher rainfall rates that undoubtedly occur for shorter periods than would be reflected in an average hourly rate. (For example, on

Figure D-3. Water Depth vs. Road Width for Various Rainfall Rates Between M.P. 166.4-166.6 on Existing Westbound Ohio Turnpike.

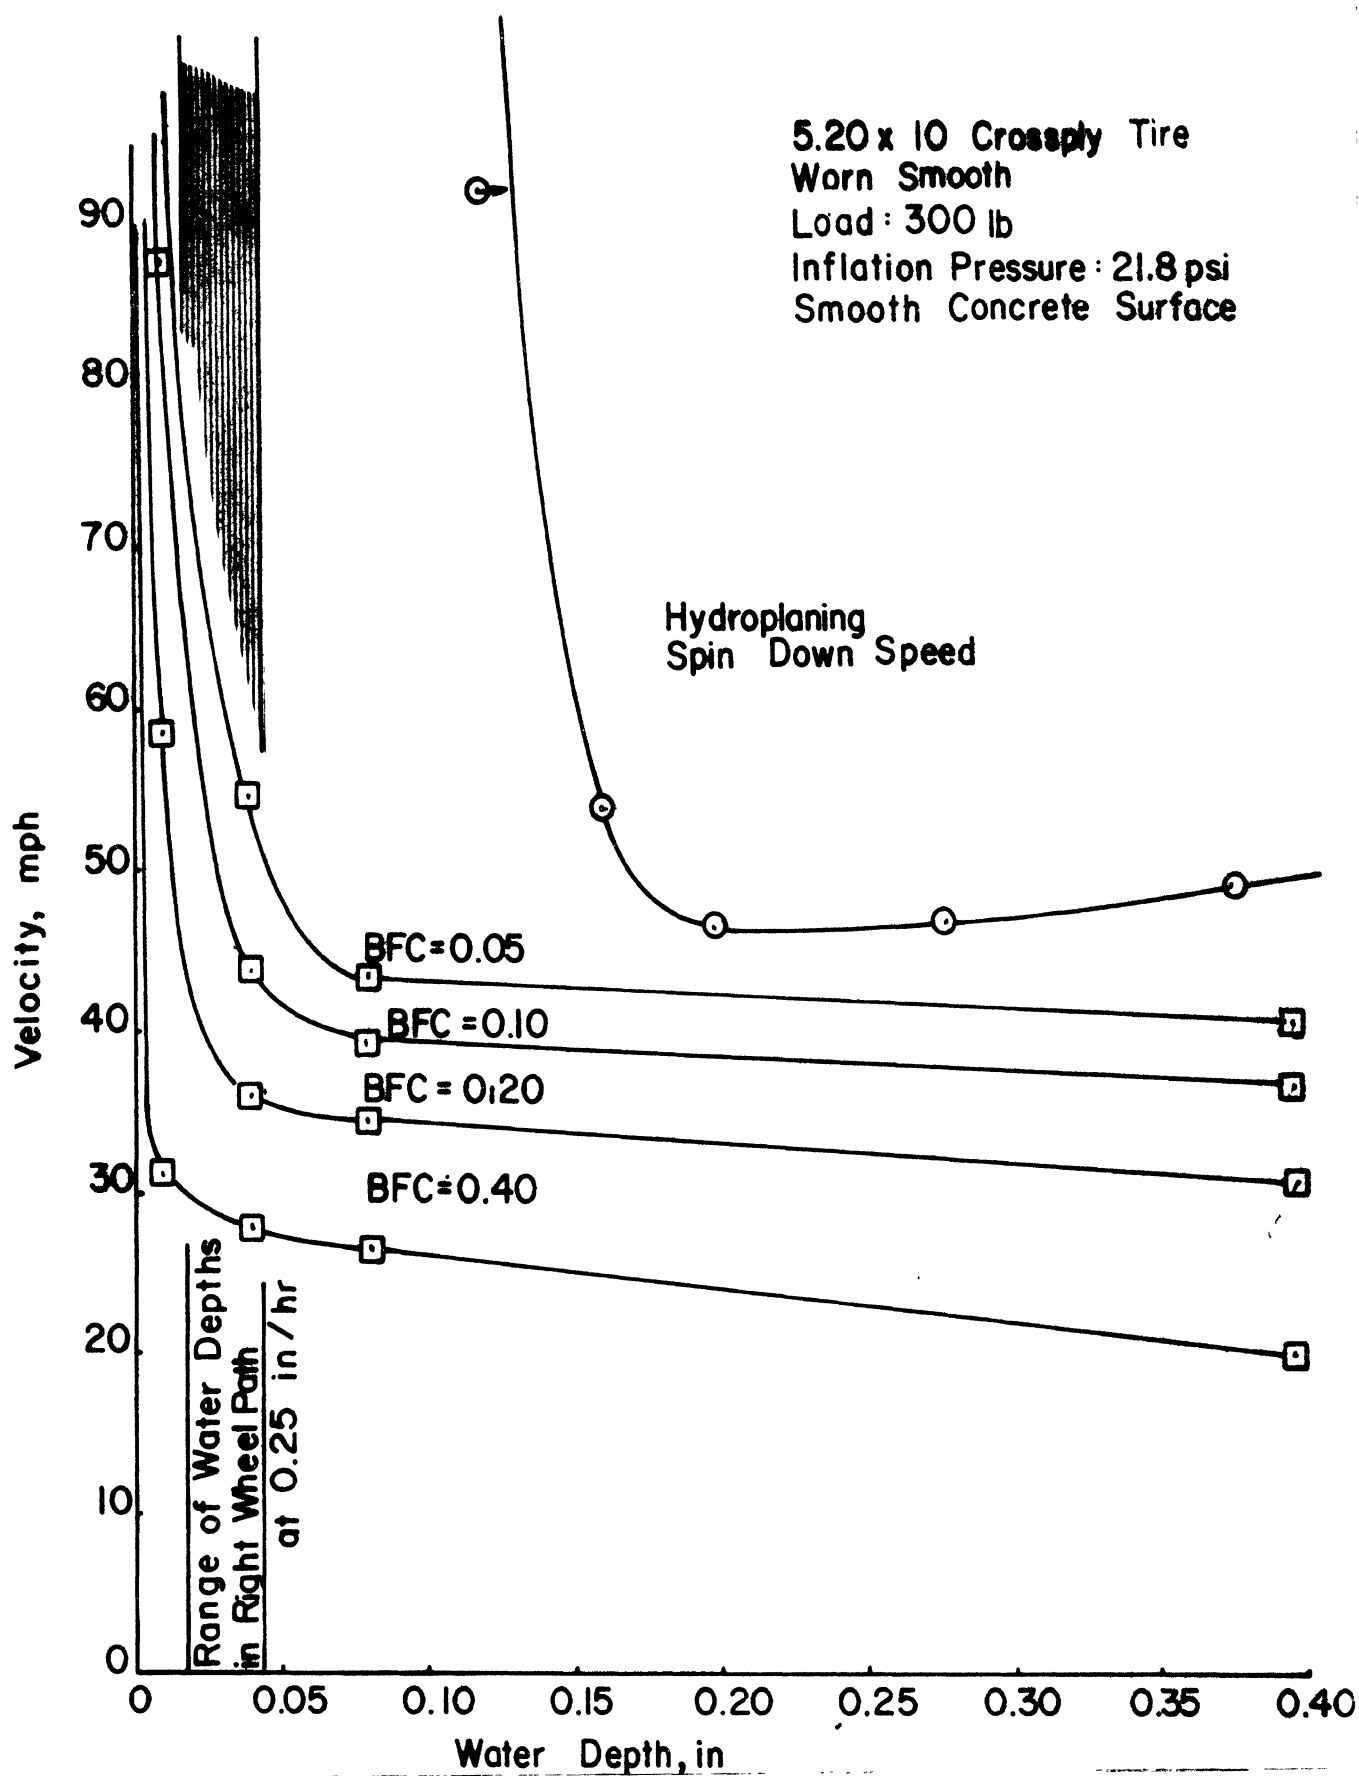
D.4.2.1.3 Pavement traction characteristics in wet weather. Figure D-4 consists of several curves of velocity versus water depth for fixed values of brake force coefficient, BFC (5). The data are for a 5.20 x 10 cross-ply tire which has been worn smooth and for a "smooth" concrete surface. In terms of surface texture, the surface is very much like that at the subject site. The curve at the upper right represents the hydroplaning characteristics of the tire on the surface. Note that complete hydroplaning—the situation where the tire lifts off the surface and spins down (i.e., stops rotation)—does not occur for water depths of less than about 0.13 inch at typical highway speeds. At 60 mph, however, the water depth need only be 0.02 inch to produce a BFC of 0.10—a value well below that which is needed for safe driving. To produce a BFC of 0.4, the water depth must

Figure D-4. Smooth Tire Traction Characteristics

The effect that the predicted water depths have on tire traction can be examined by referring to Figures D-4, D-5, D-6, and D-7. (The data plotted on these figures are not necessarily applicable to grooved pavement. No data for grooved pavement, of the type shown on these figures, are known to exist. Inasmuch as the water expulsion properties of grooved surfaces are better than that of ungrooved, smooth concrete, the conclusions derived through the use of the smooth pavement data will be conservative in terms of predicting degraded tire

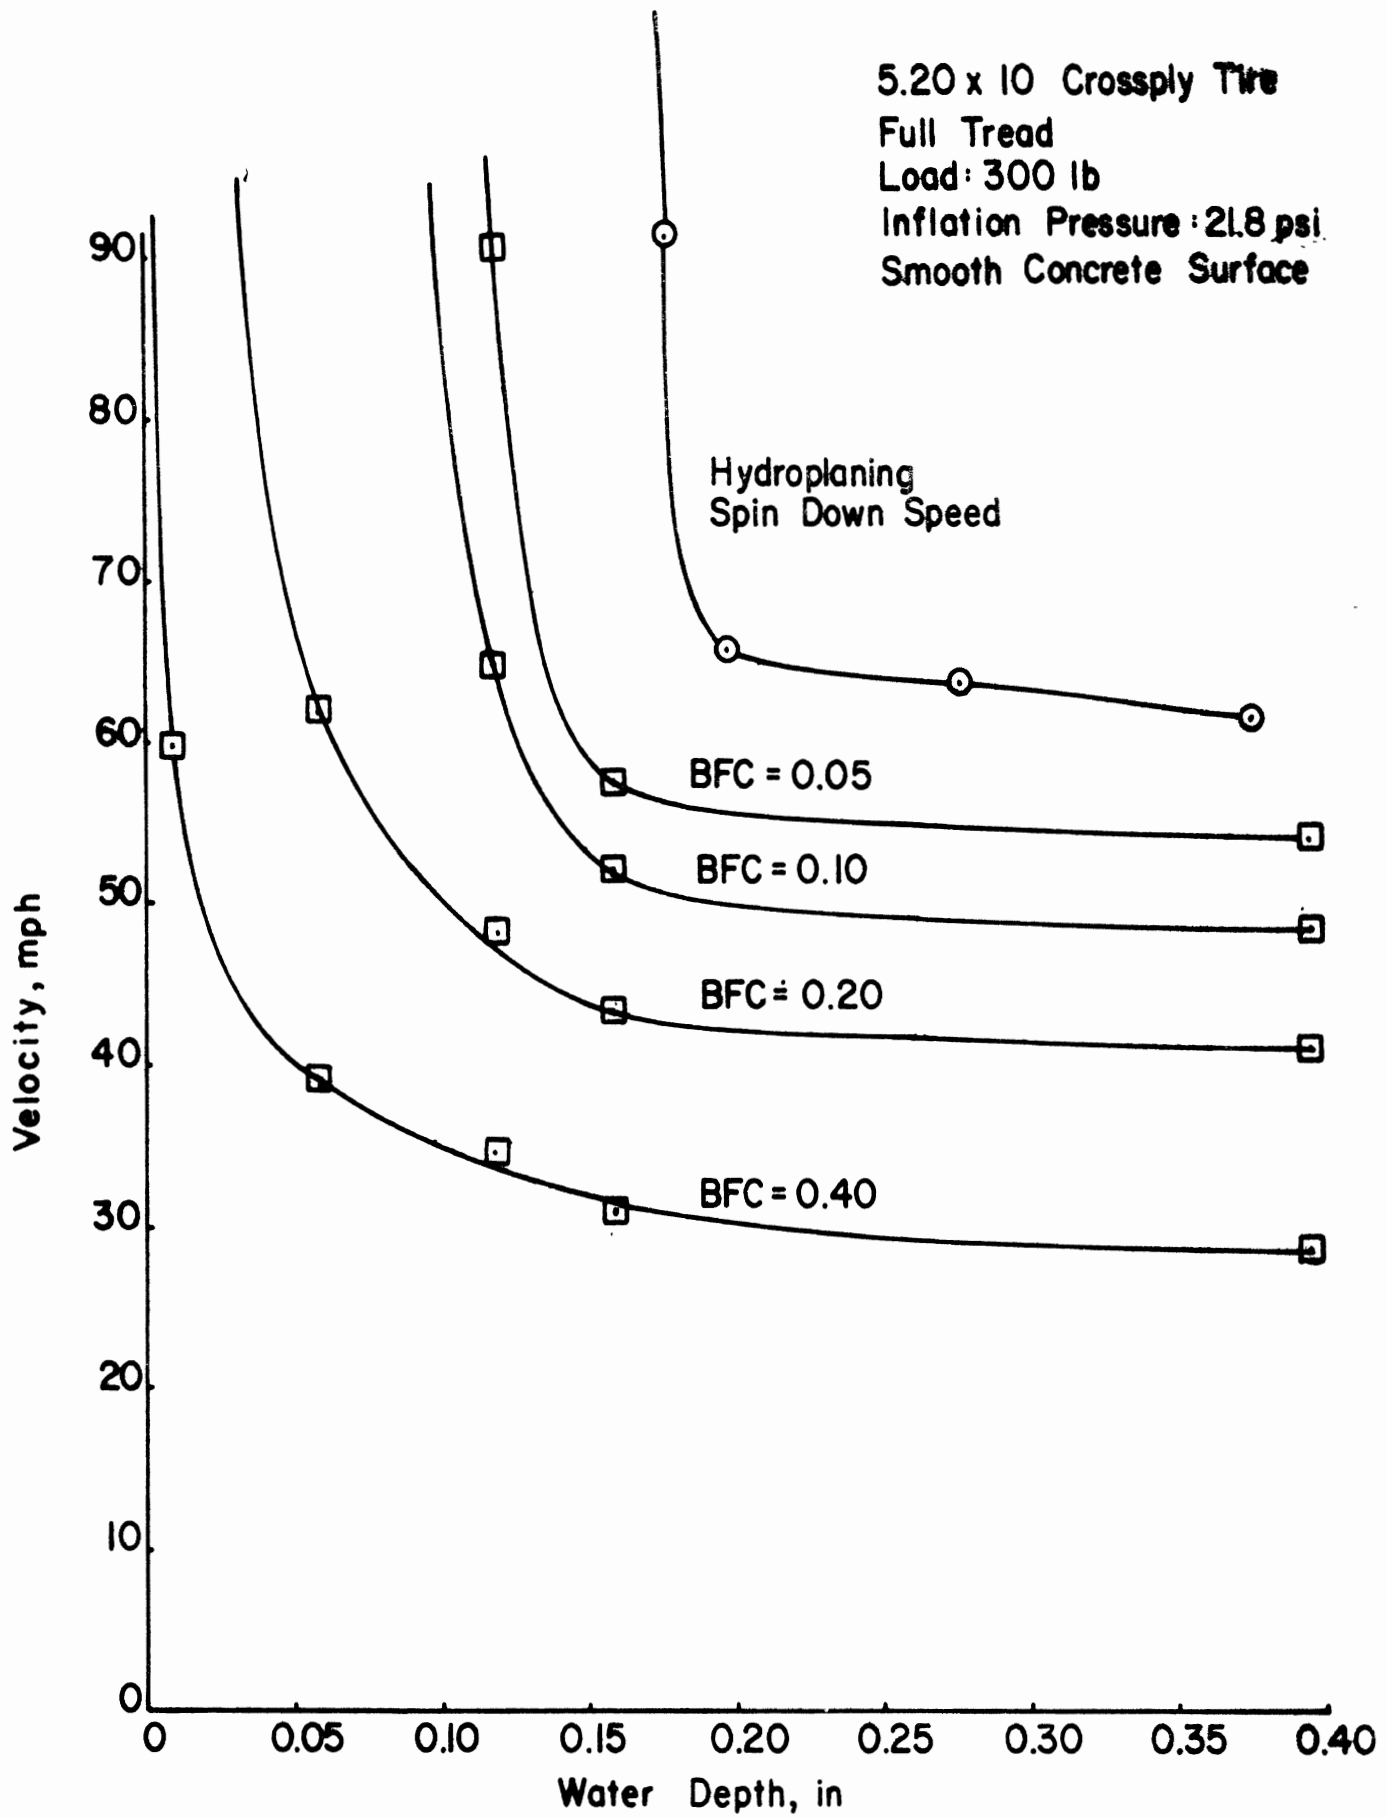
Figure D-5. Full-Tread Tire Traction Characteristics

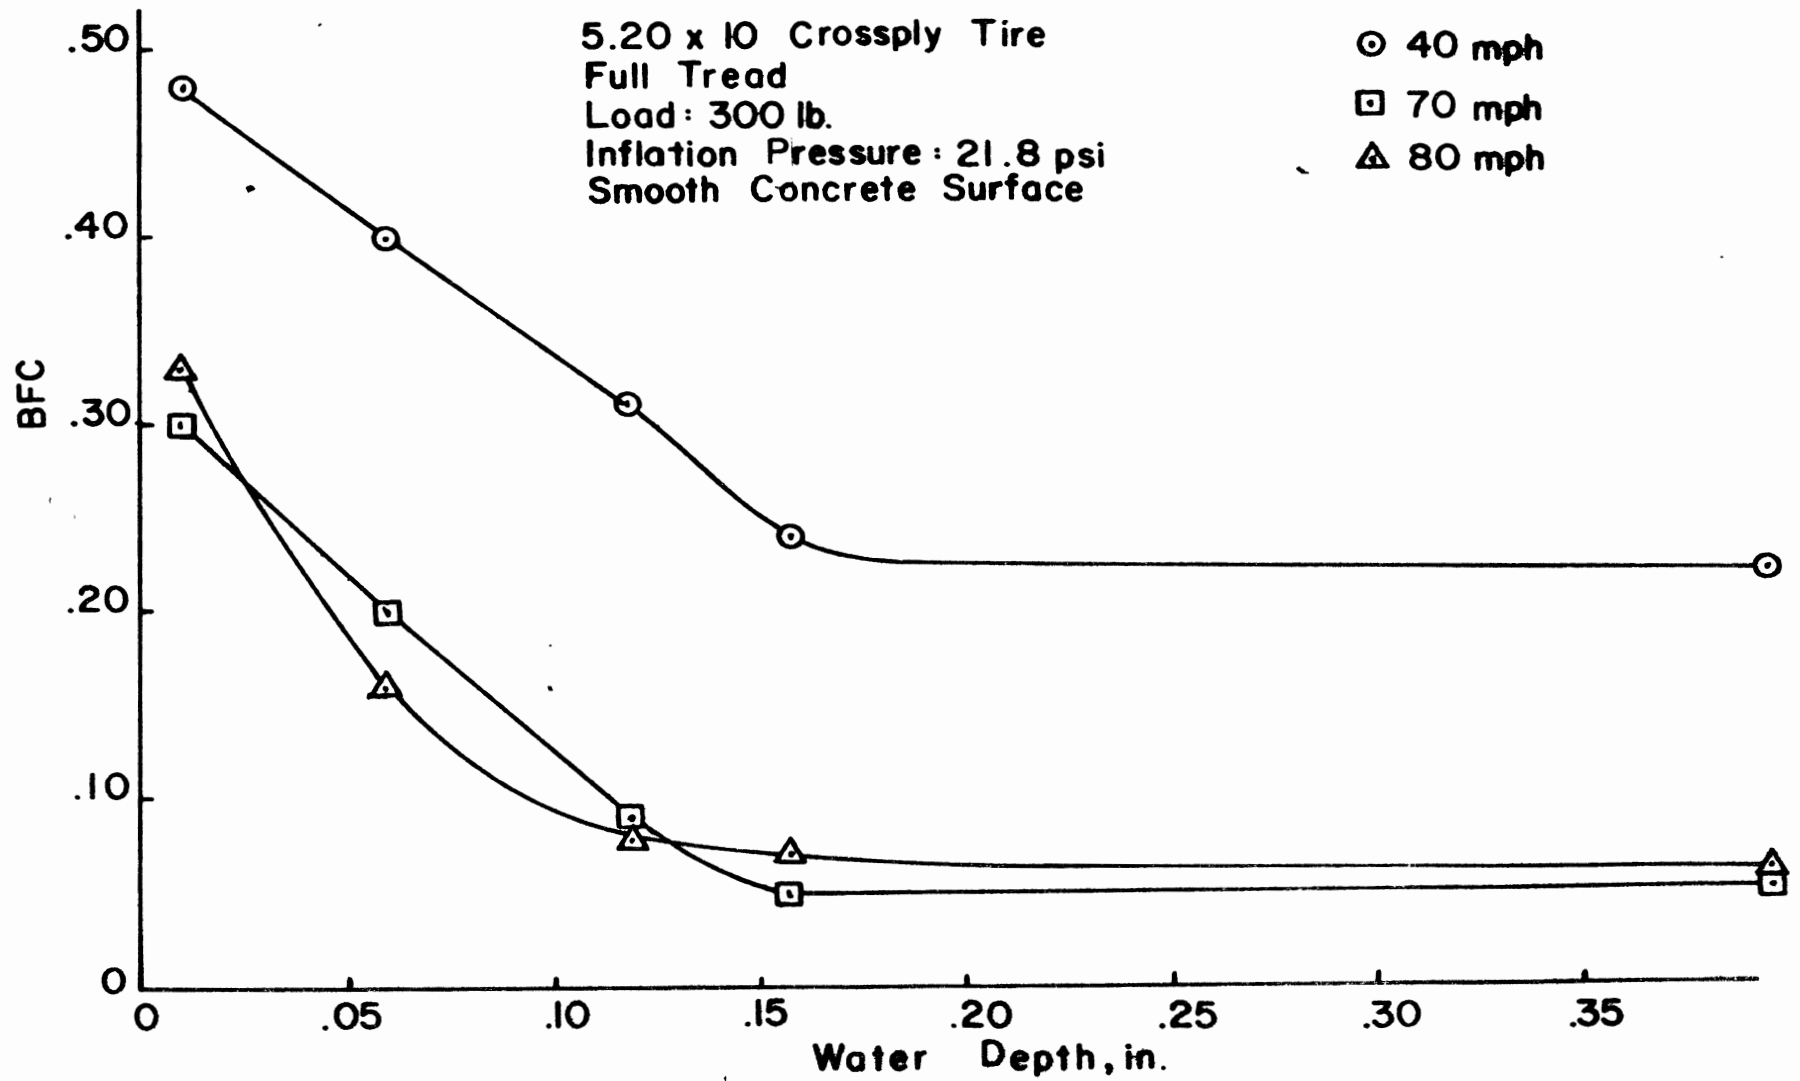
Figure D-6. Brake Force Coefficient as a Function of Water Depth - Fully Treaded Tires

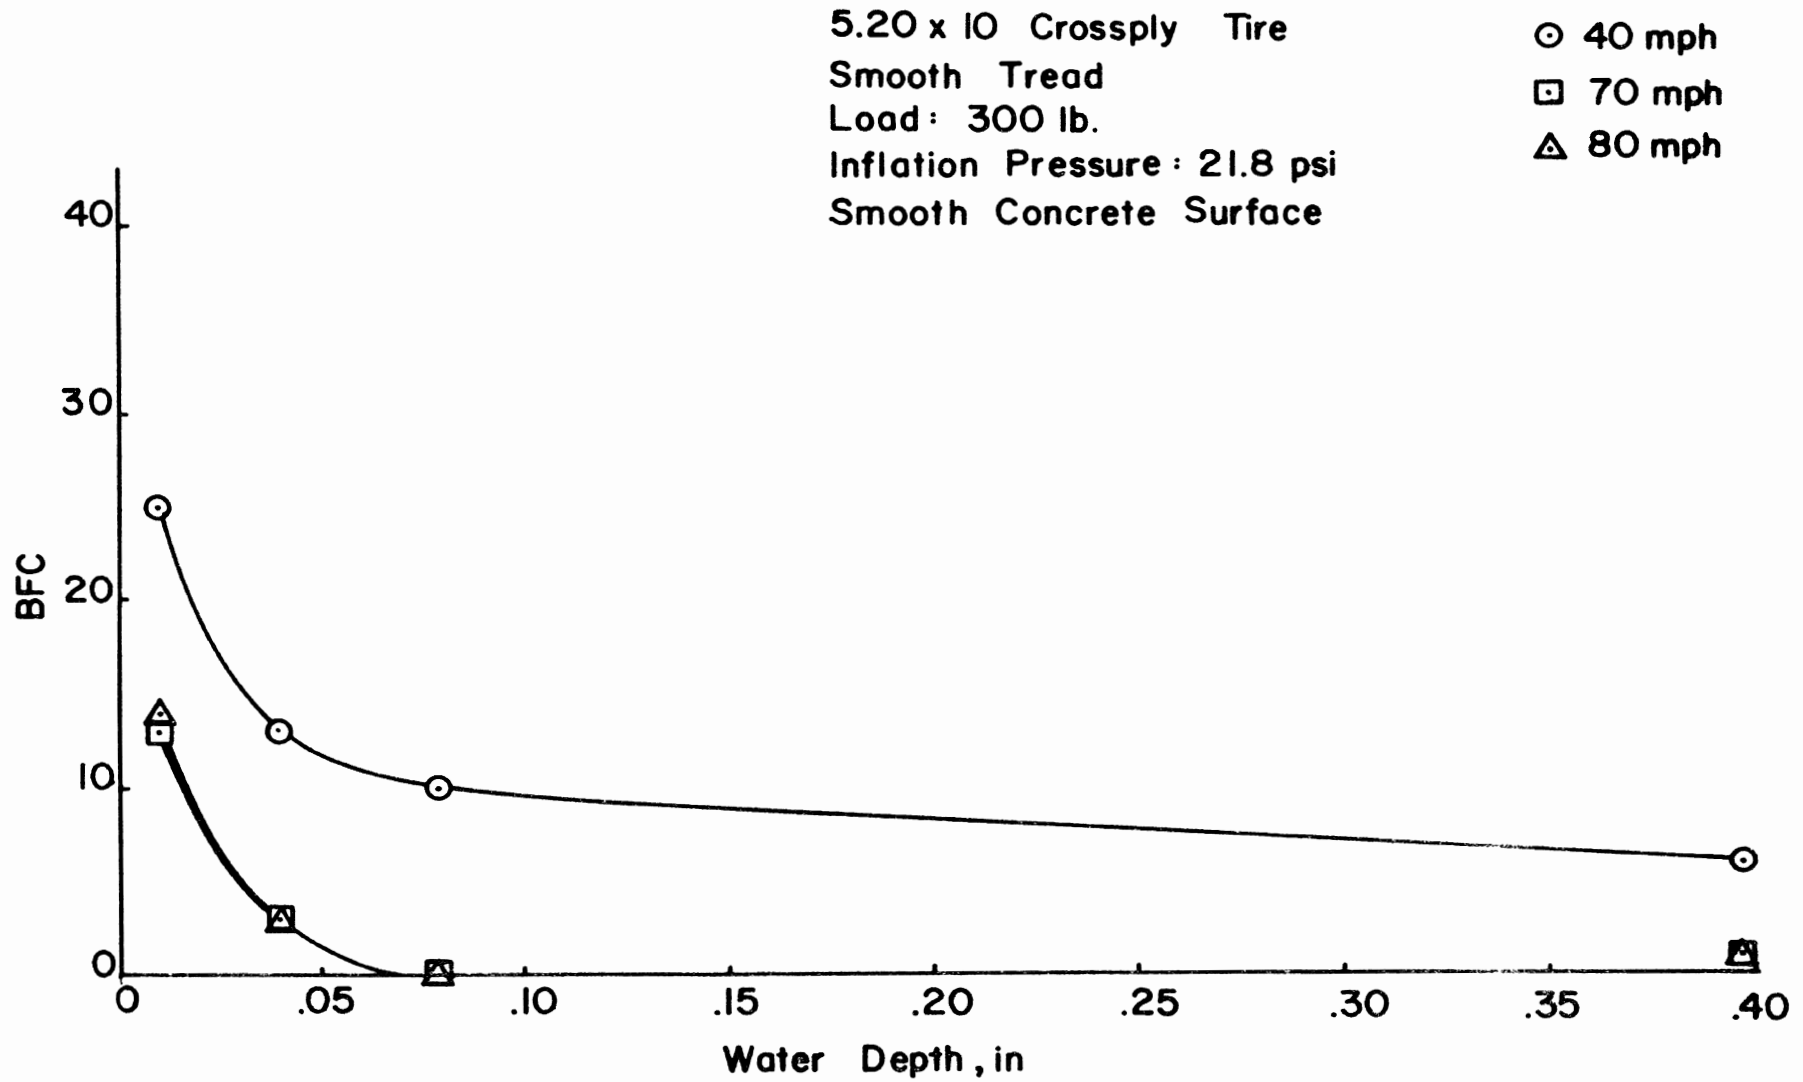
Figure D-7. Brake Force Coefficient as a Function of Water Depth -
Smooth Treaded Tires

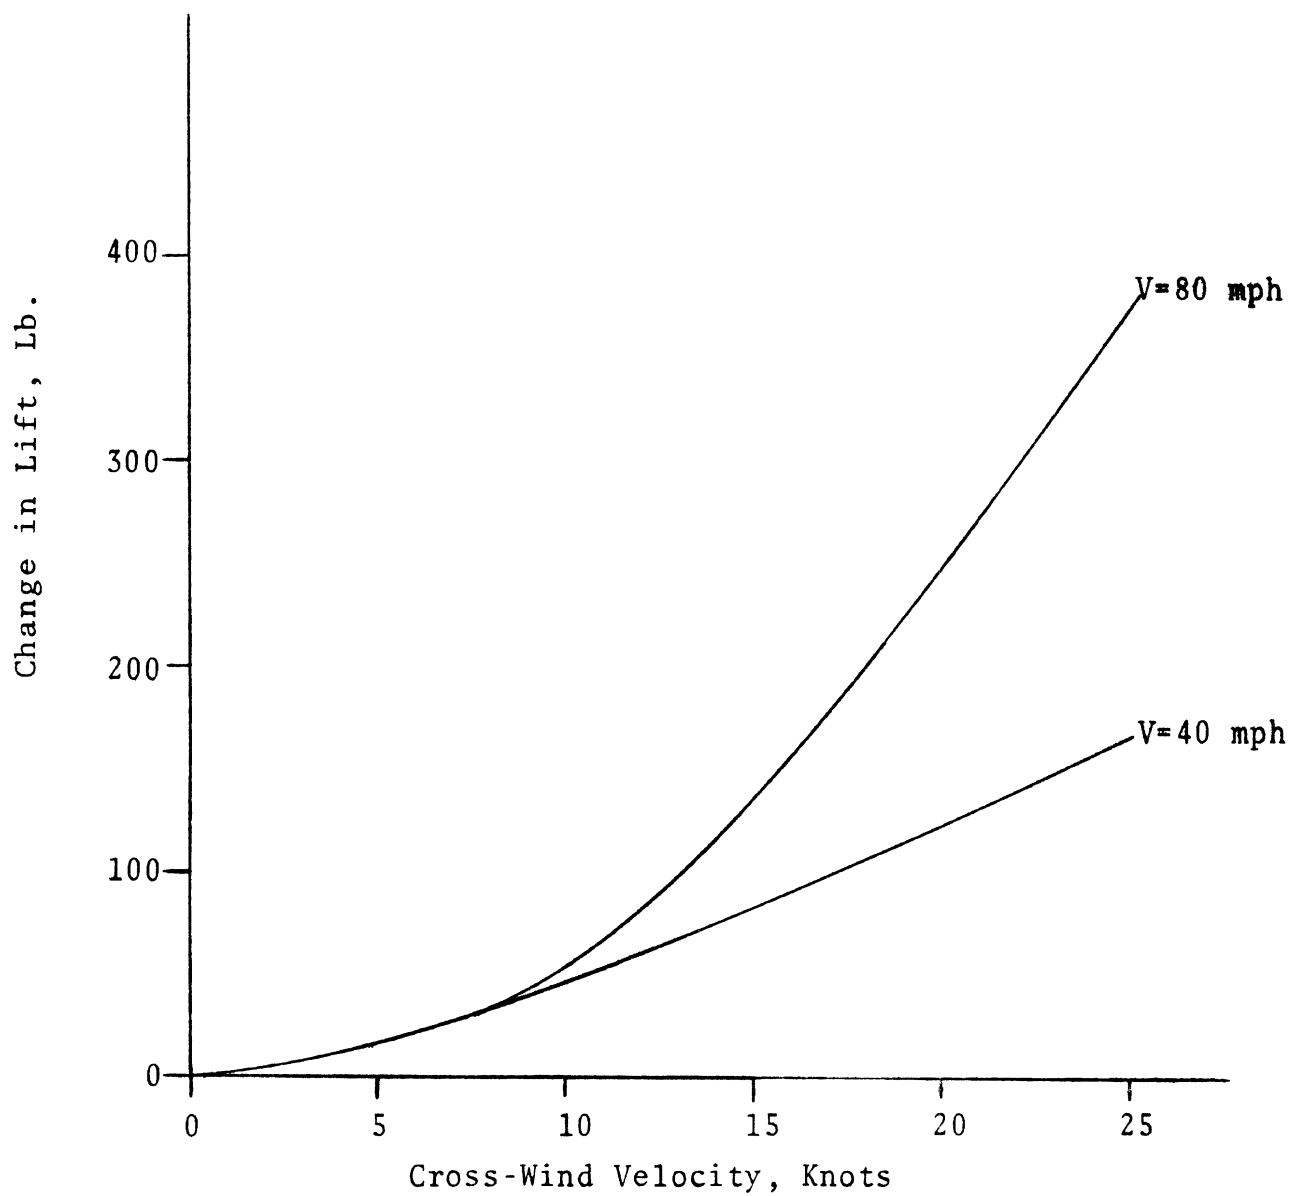
Figure D-9. The Influence of Cross-Wind on Aerodynamic Lift

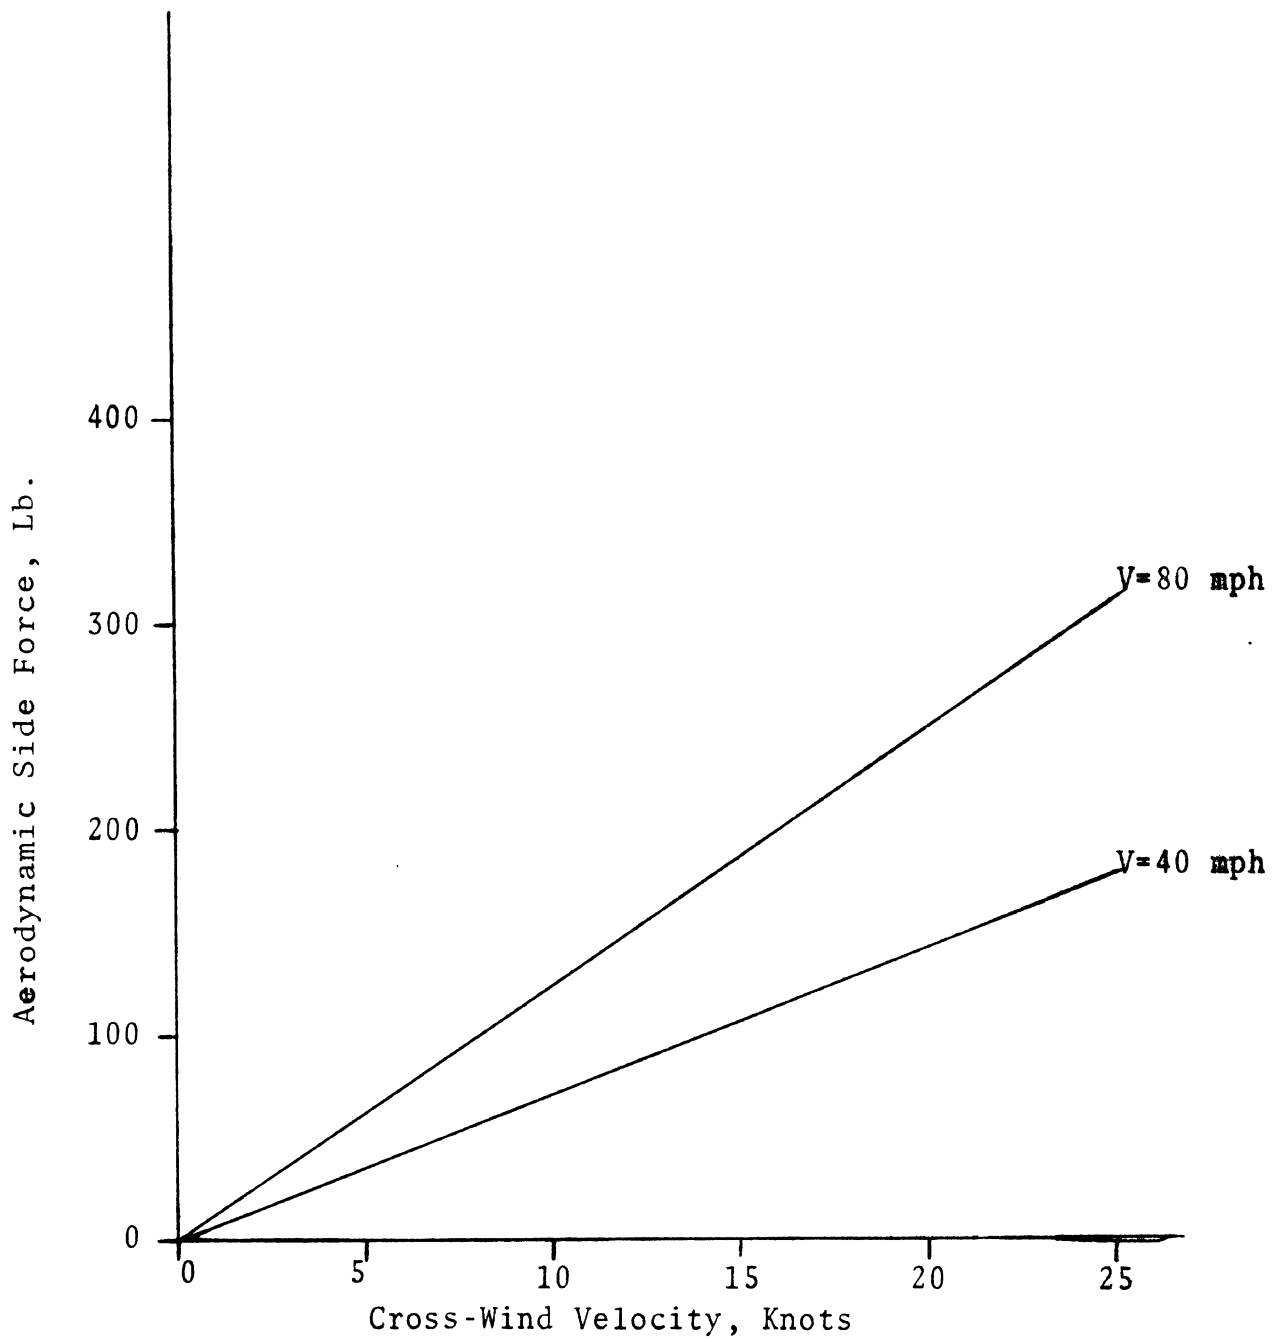
Figure D-11. The Influence of Cross-Wind on Aerodynamic Side Force

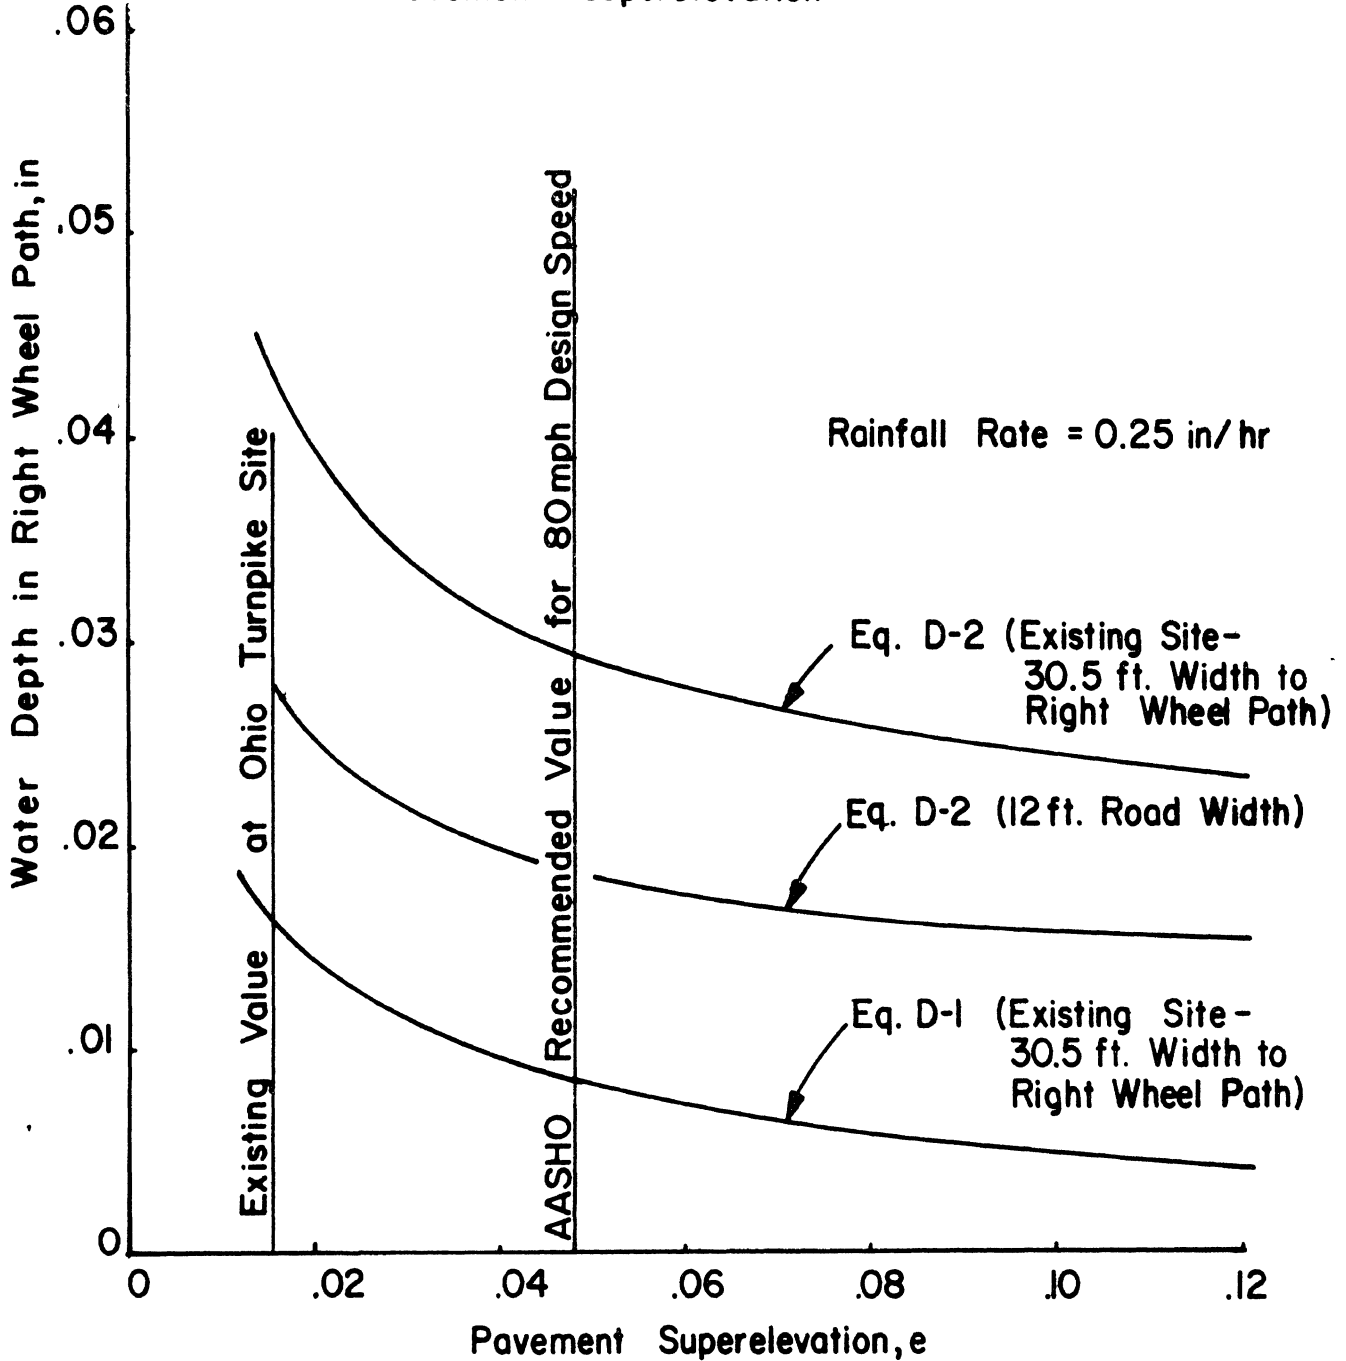
Figure D-12. The Variation in Water Depth with Superelevation
