INFLUENCE OF COMBINED HIGHWAY GRADE
AND HORIZONTAL ALIGNMENT
ON SKIDDING

FINAL REPORT

VOLUME 2 OF 2

SEPTEMBER 1974

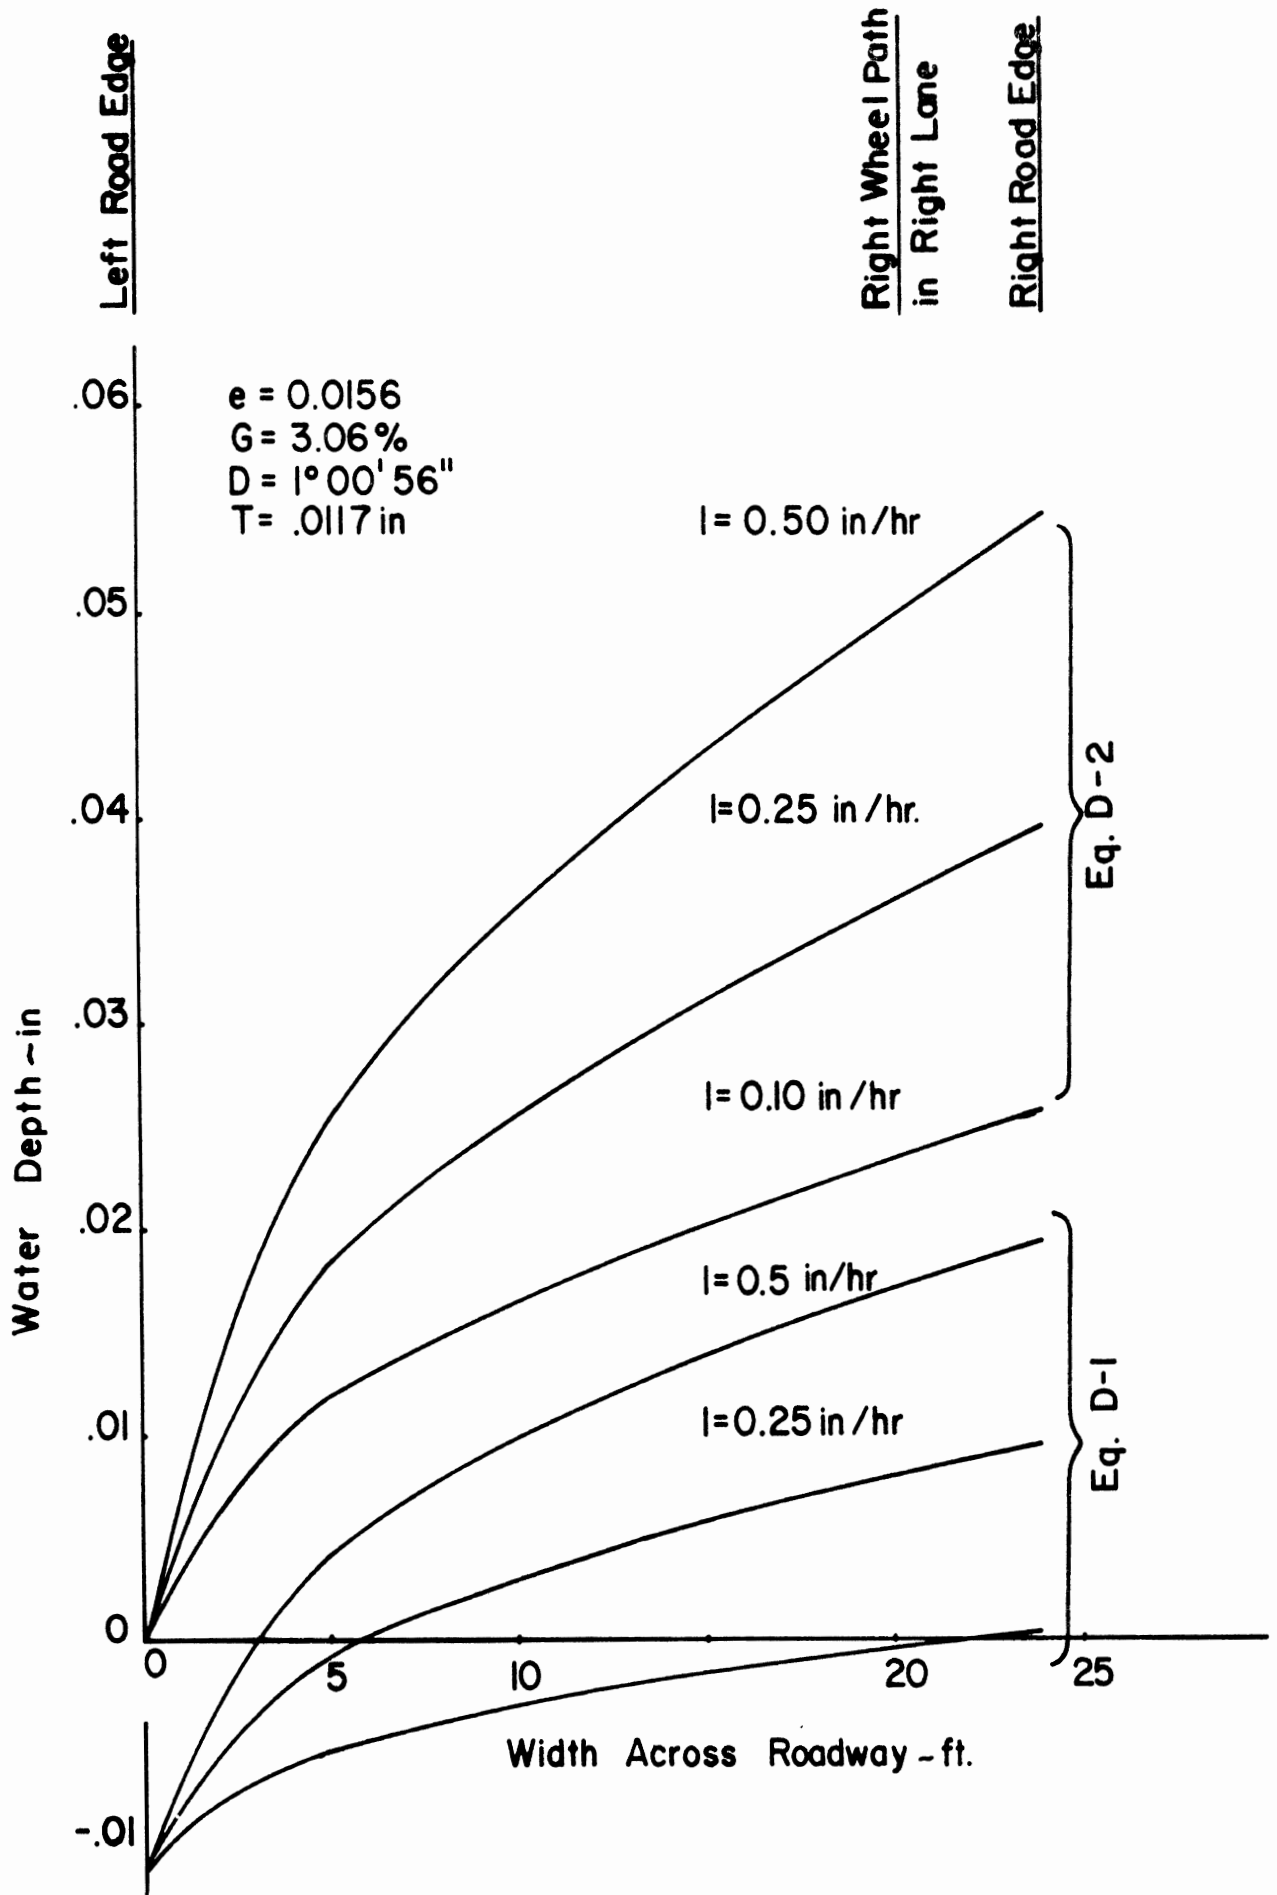
Figure D-15. Water Depth vs. Road Width for Various Rainfall Rates for Southbound I-95 at Interchange with U.S. 1. 404

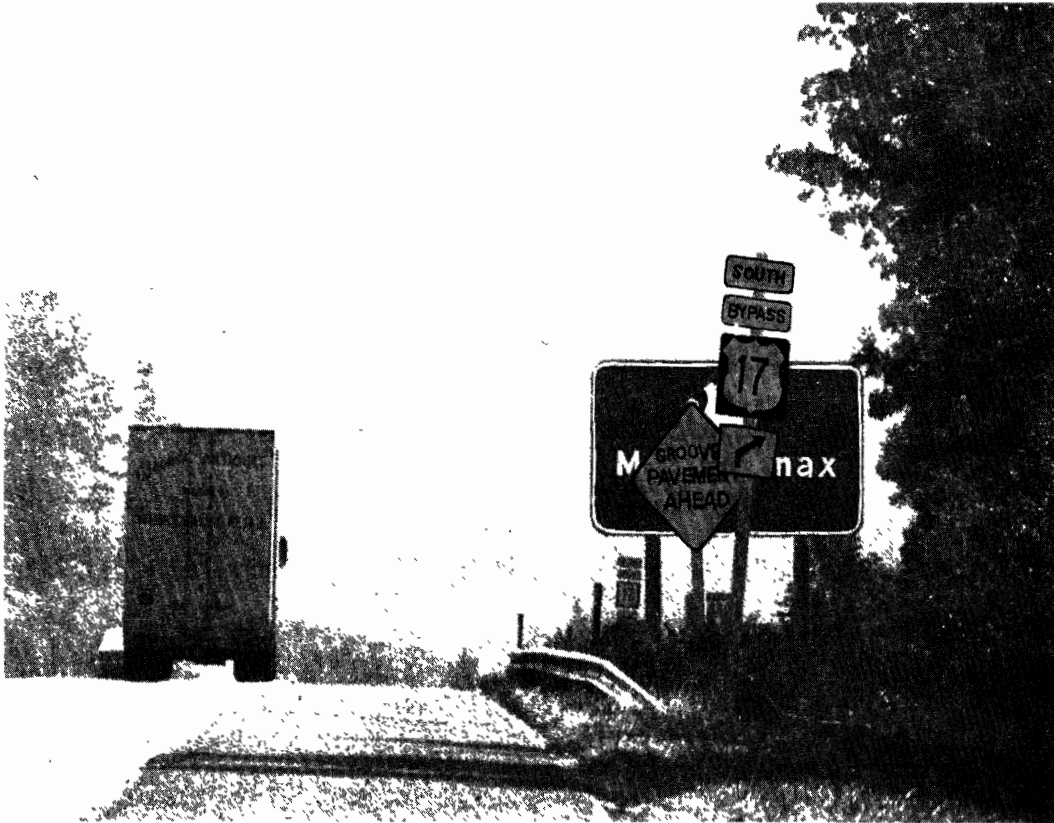
Figure D-16. An Obscured View of the U.S. 1/
Massaponax Sign.

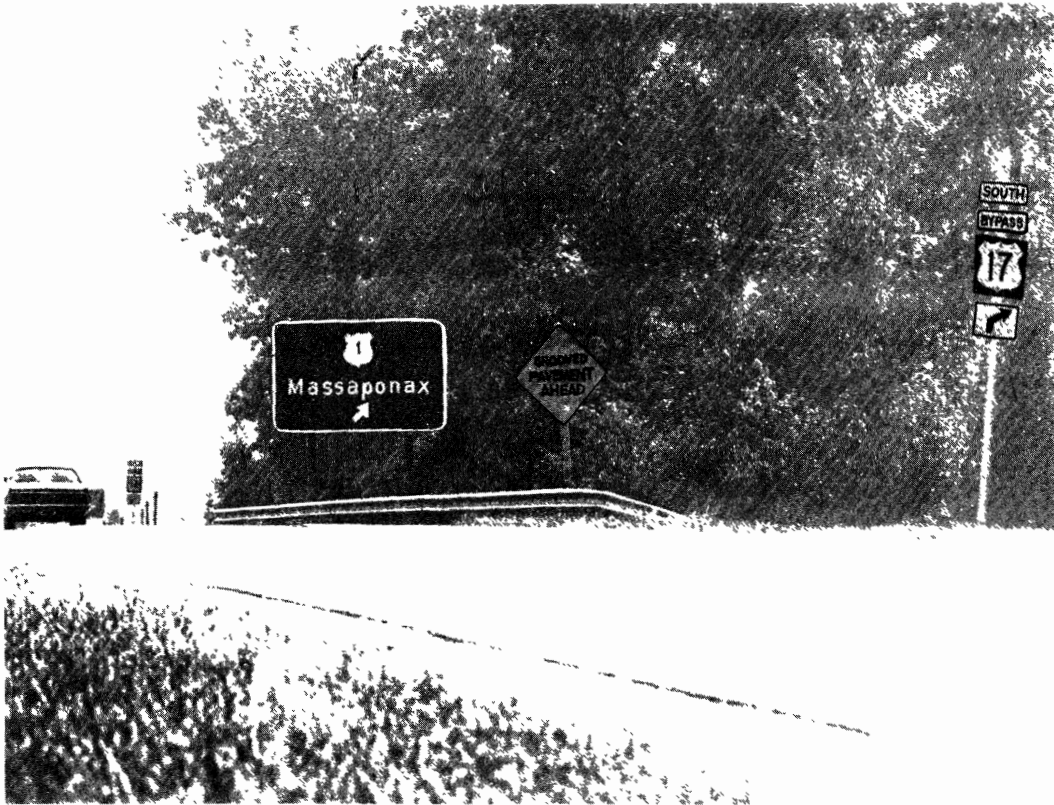
Figure D-17. An Open View of the Sign

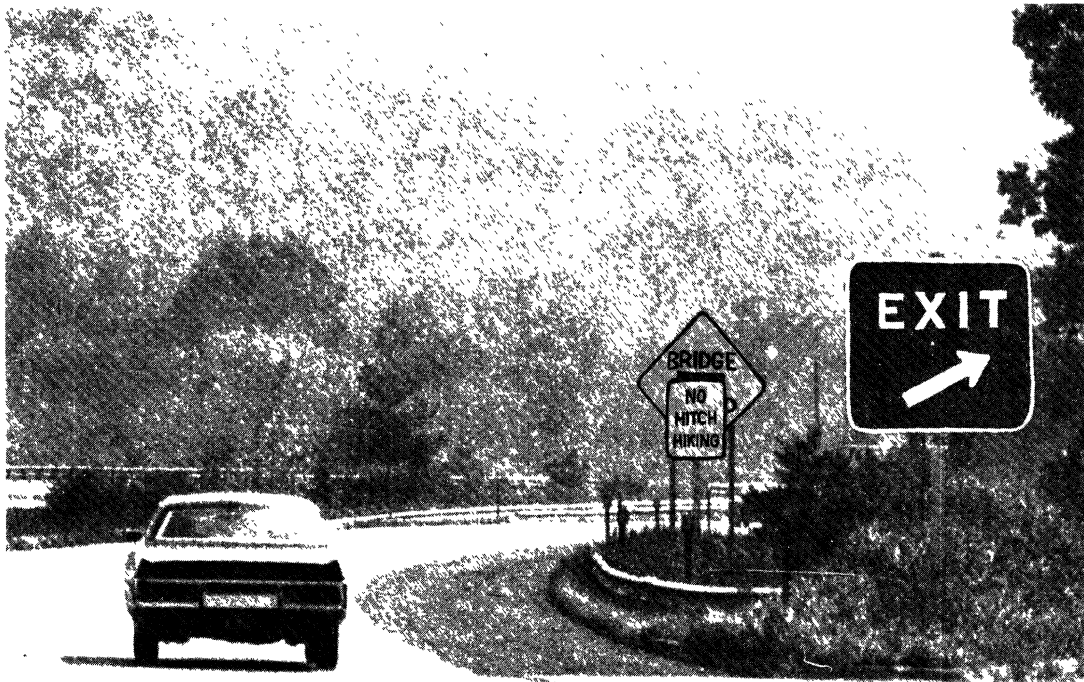
It can also be noted on these photographs that the high embankment and vegetation on the inside of the curve hide the bridge from oncoming motorists. The situation is probably most acute when traffic is heavy, since the traffic itself contributes to loss of visibility (see Figure D-19).

Figure D-18. An Obscured View of the Icy Bridge Sign.

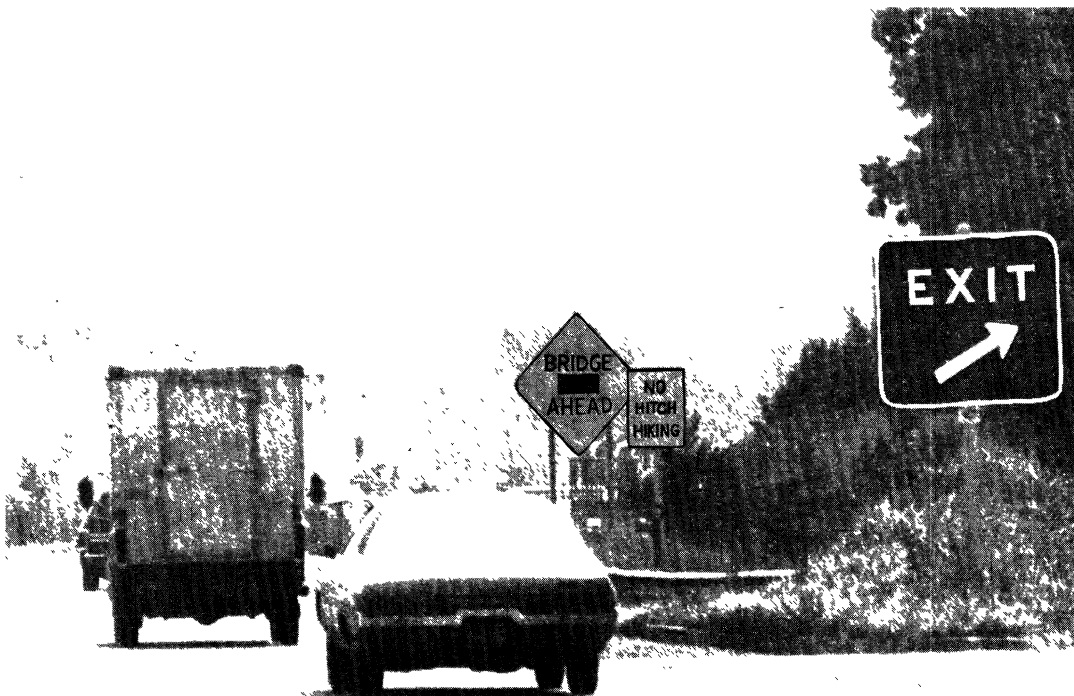
Figure D-19. An Open View of the Sign.

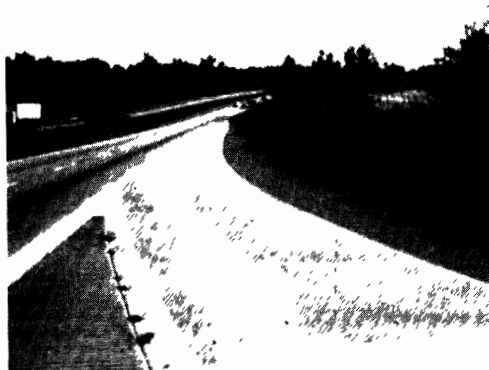
Figure D-22. Three Views of the Entrance Ramp as a Vehicle Proceeds Up the Ramp to the Acceleration Lane.

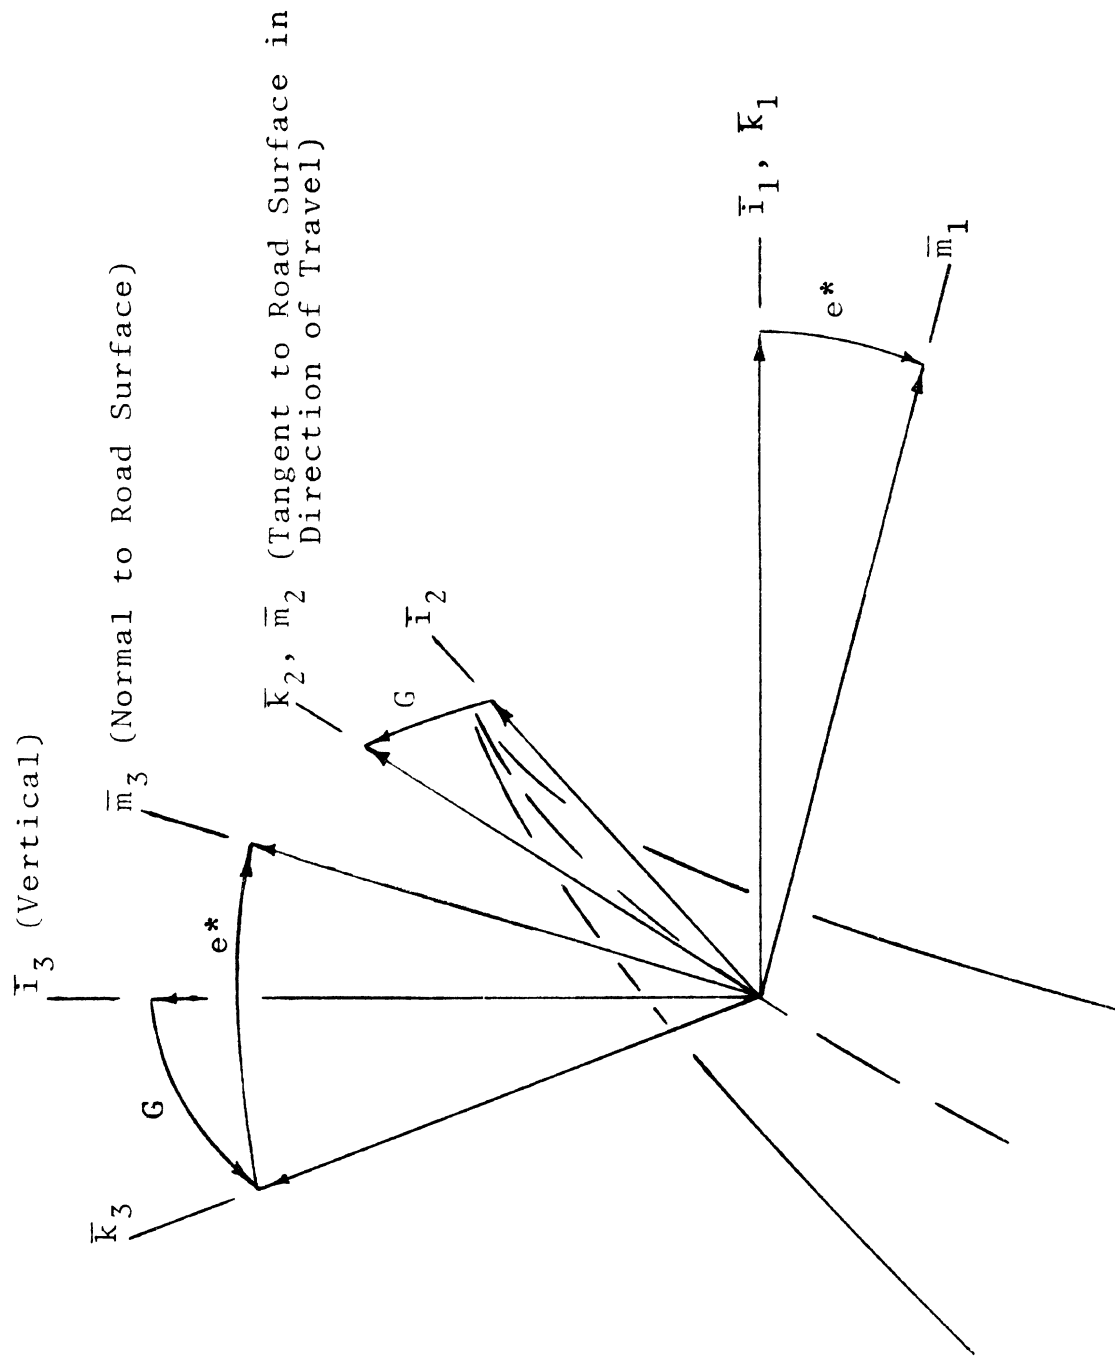
The *k* coordinate system is defined by rotating the *i* system through an angle *G* about the \bar{i}_1 axis. *G* is the grade of the roadway (+ for upgrade). The *m* coordinate system is defined by rotating the *k* system through an angle e^*

Figure E-1. Coordinate Conventions

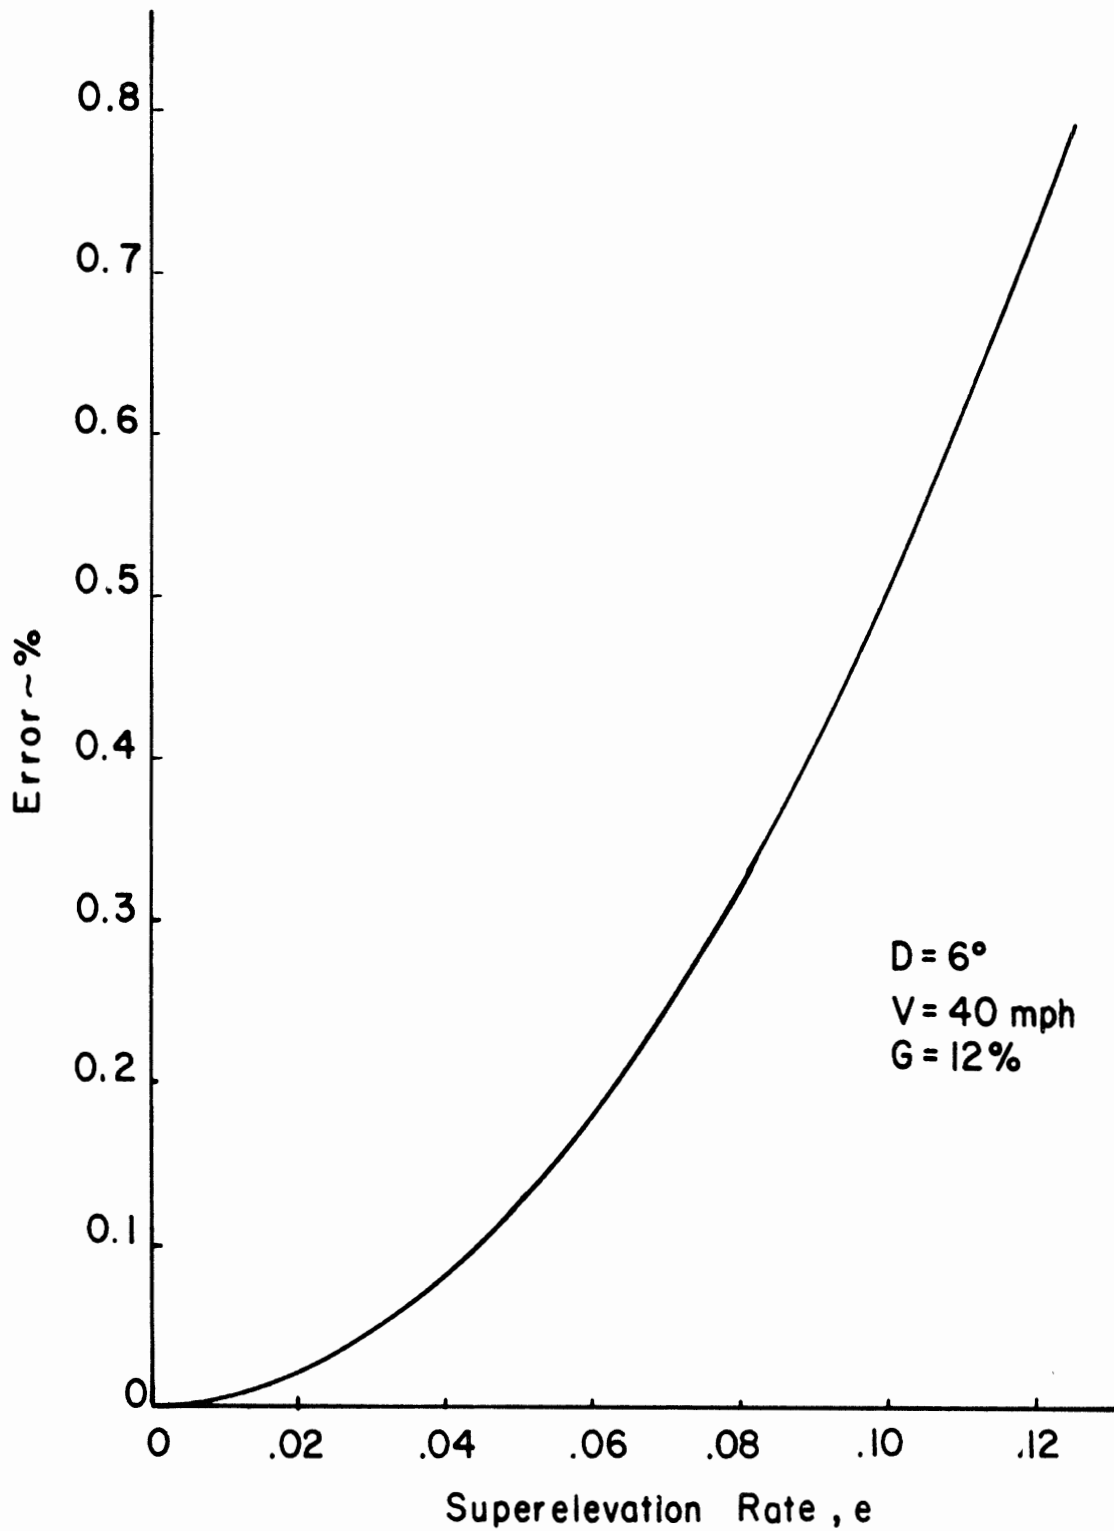
The expression is plotted on Figure E-3 as a function of superelevation rate for fixed values of velocity, grade, and curvature. It can be noted that the maximum error is 0.73%, and that this error occurs at a superelevation rate of 0.12. Additional plots of the error expression (Equation (E.9)) are shown on Figure E-4. These plots show the variation in error as a function of curvature, velocity, and grade near maximum error conditions.

Figure E-3. Error Versus Superelevation Rate

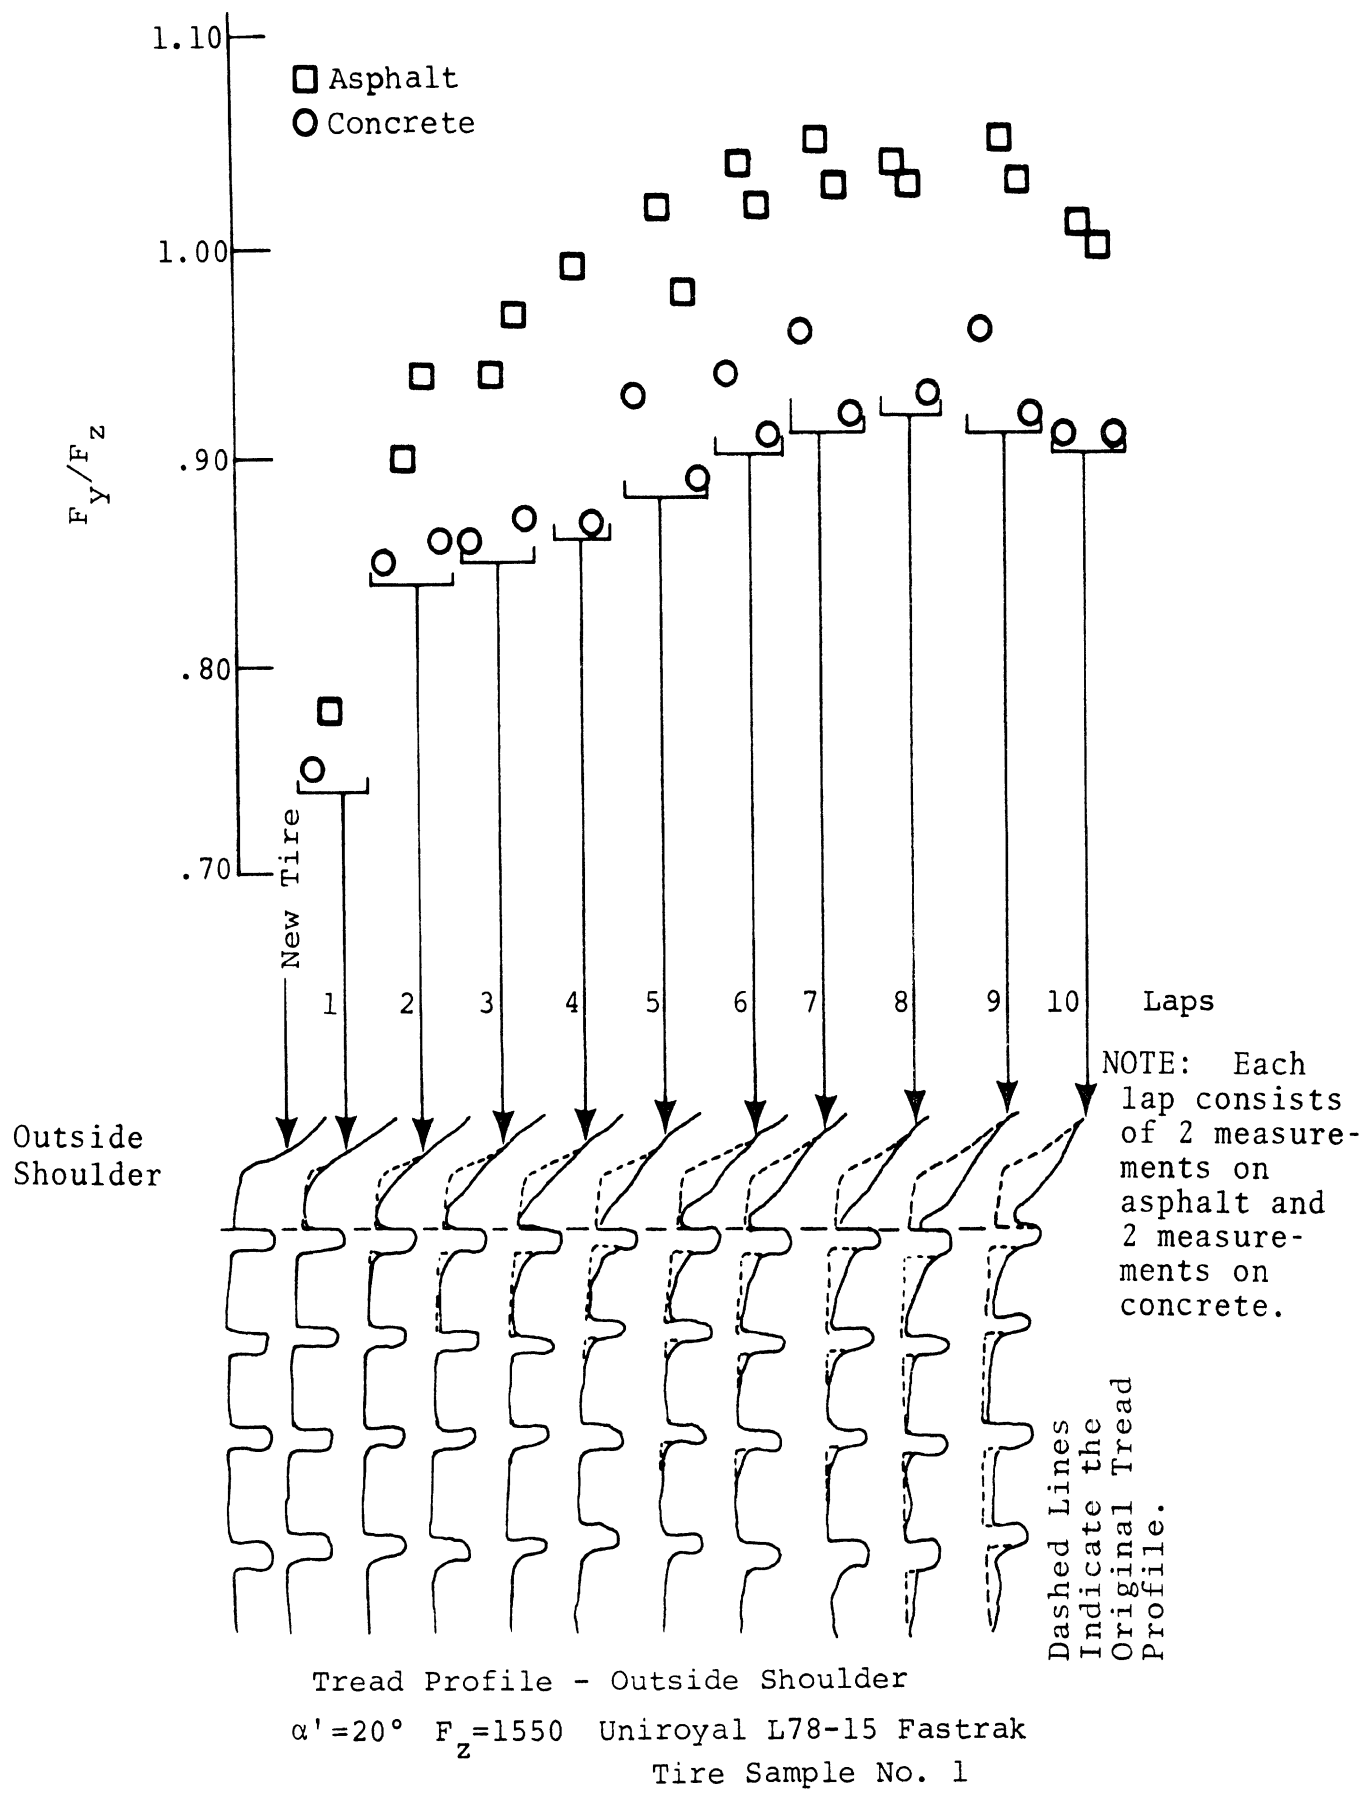
A limited number of tire tests (42, 43) have indicated that a small amount of shoulder wear can cause a significant increase in the peak lateral force that can be generated by pneumatic tires on dry surfaces. Figure G-1 shows test results that have been obtained with an L78-15 tire. These data were procured with the HSRI mobile tire tester, a device that serves to (1) provide, in a controlled fashion, a vertical load and slip angle to the tire such that it is worn in a manner analogous to the wear produced in vehicle testing and (2) gather side force data concurrent with the wearing process. The wear

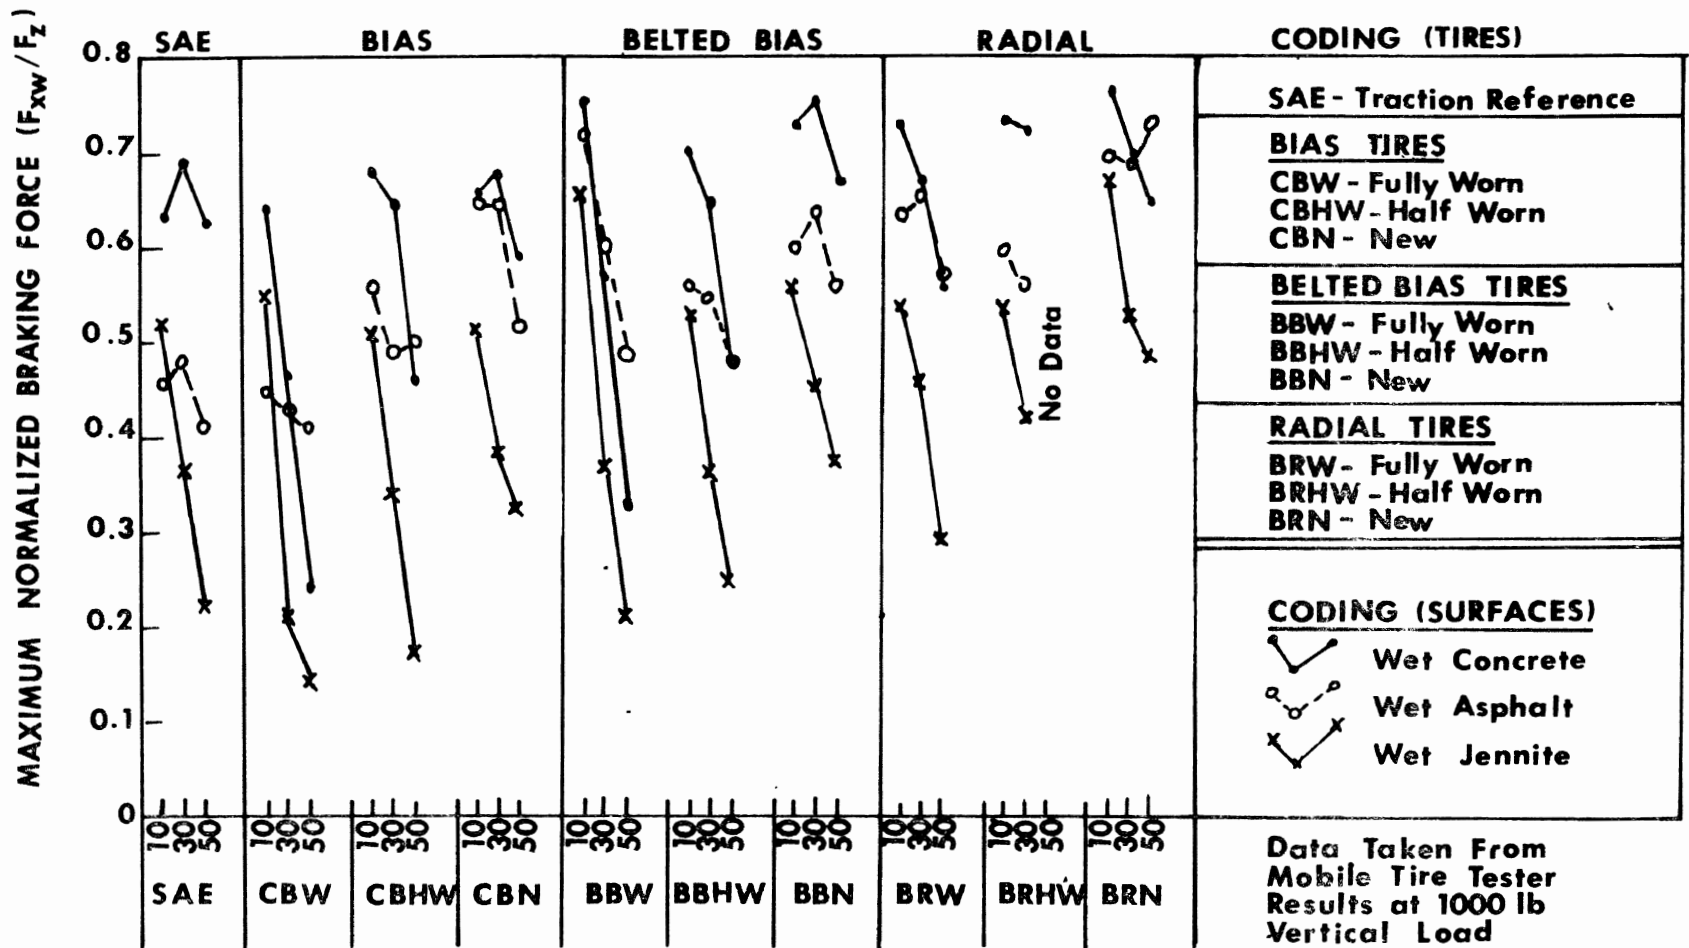
Tire tests have shown that, in general, a decrease in tread depth results in larger lateral forces being produced on dry surfaces. However, the opposite is true on wet surfaces. Clearly, tire-shear-force capability on wet road surfaces is a critical safety item wherein tread depth is very important. Figure G-2 shows the influence of the state of tread wear on the peak braking force obtained for three tire constructions (bias, belted bias, and radial ply) (44). The influence of the type of surface and the velocity of the test is also shown in Figure G-2. These data show that the new tires produce higher braking forces on wet surfaces than the worn tires. The data also show that the velocity at which the test is performed is a highly significant variable, particularly on the concrete and jennite surfaces. (The asphalt surface used in these tests had a coarse macrotexture. If, however, tests had been performed on an asphalt surface with a smooth macrotexture, then, in all likelihood, the

Figure G-2. Influence of Tread Wear at 3 Velocities (10, 30, and 50 mph) on 3 Surfaces for 3 Types of Tire Construction

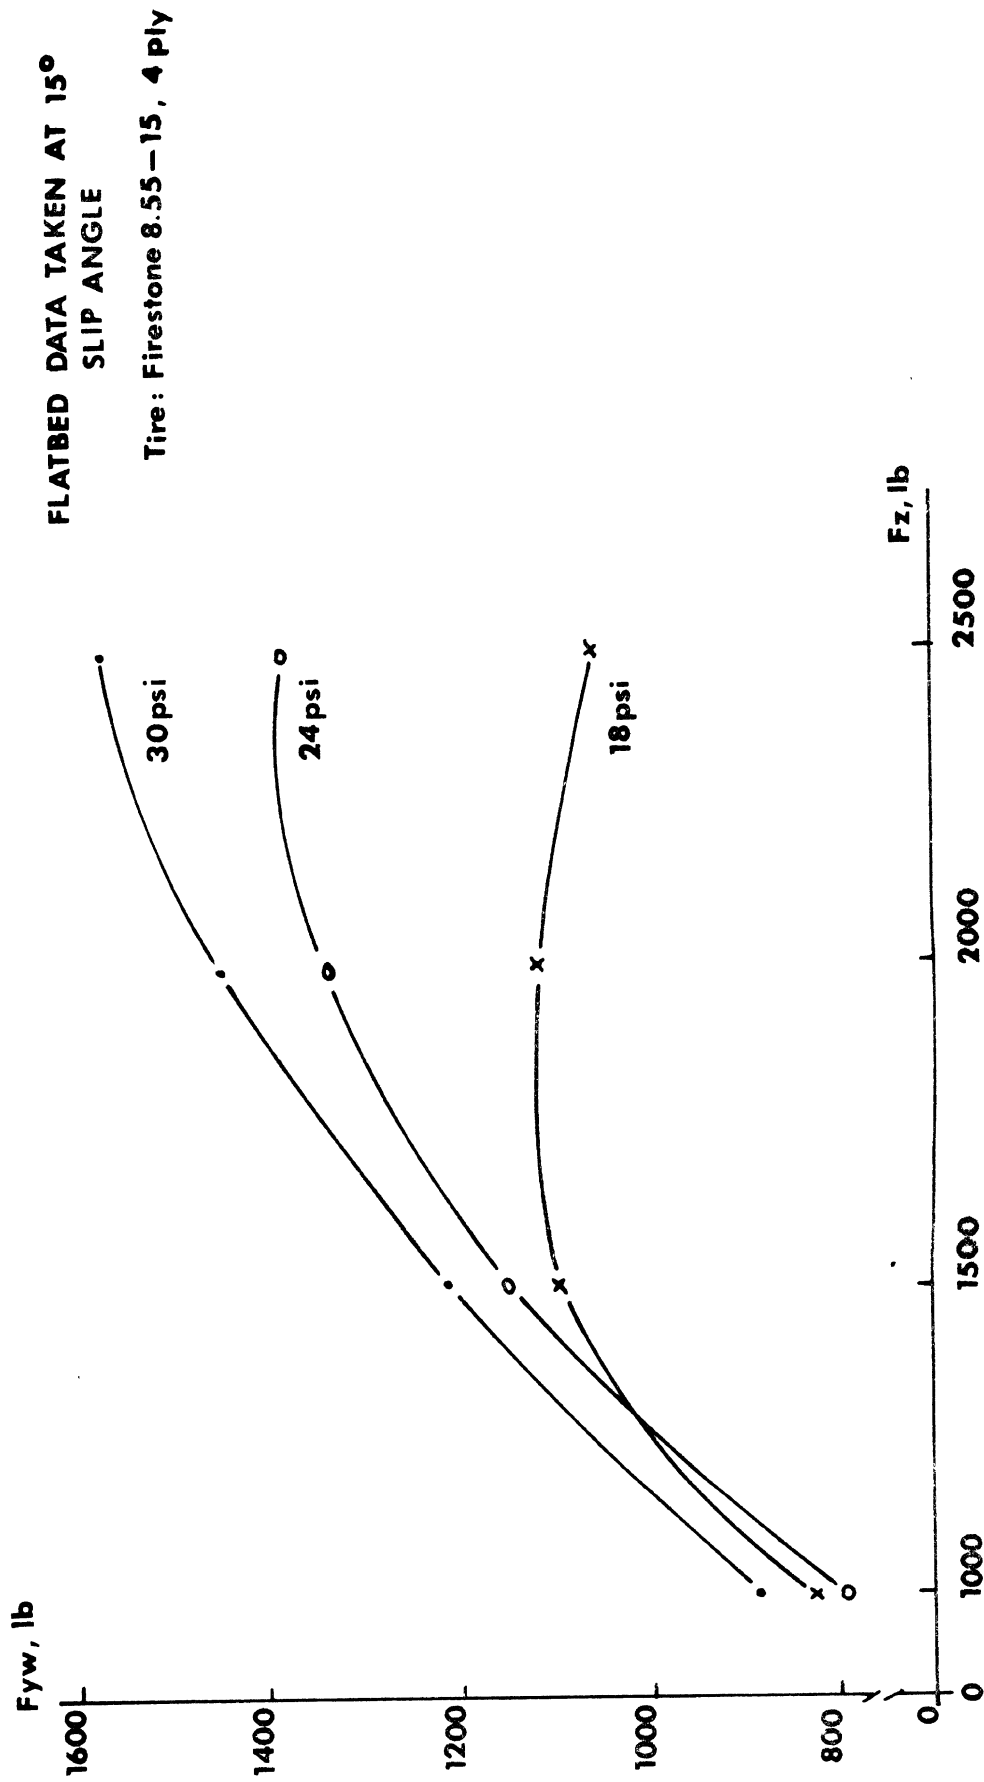
In a recent HSRI study (47) measurements were made to compare (a) the peak longitudinal force, (b) the locked-wheel longitudinal force, and (c) the lateral force produced at eight degrees of slip and for the same type of tire with a highway tread, a snow tread, and a studded snow tread. The measurements were made on a wet concrete surface. For this particular tire, it can be seen (see

Figure G-3. The Influence of Inflation Pressure on Maximum Lateral Force at 15° Slip Angle
