Assessment of the greenbelt at Michigan Department of
Natural Resource Boat Launches in Cheboygan and Emmitt
County, Michigan

University of Michigan Biological Station

Biology 482: Limnology

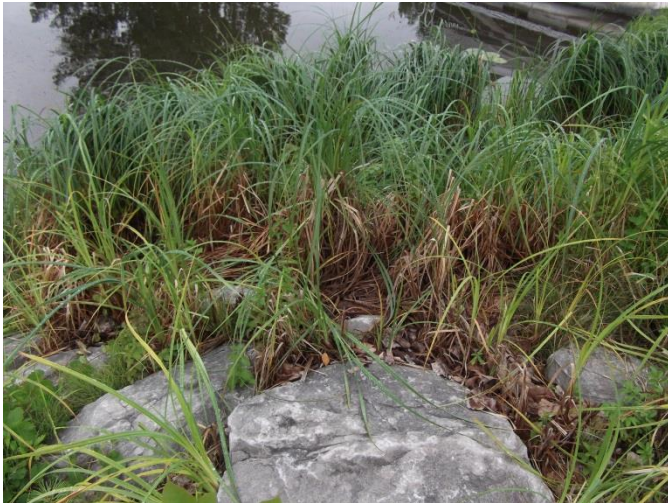
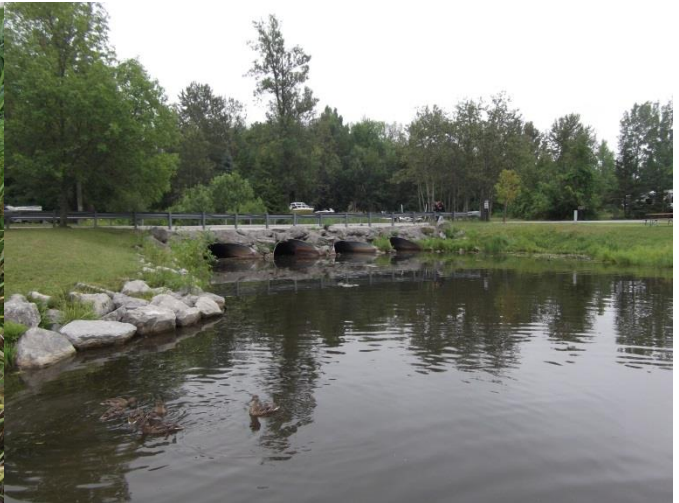
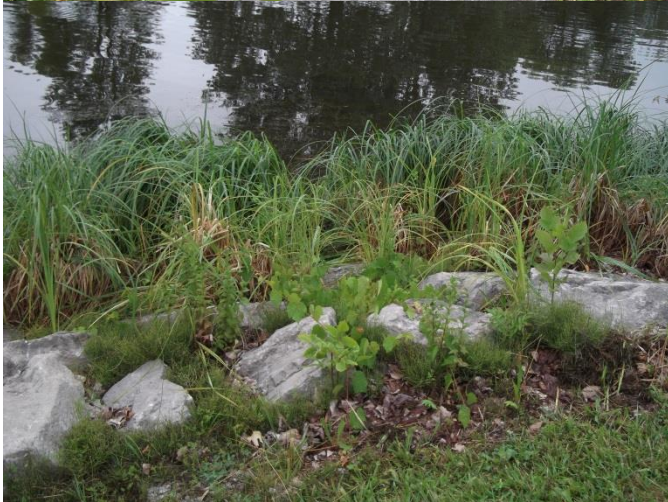
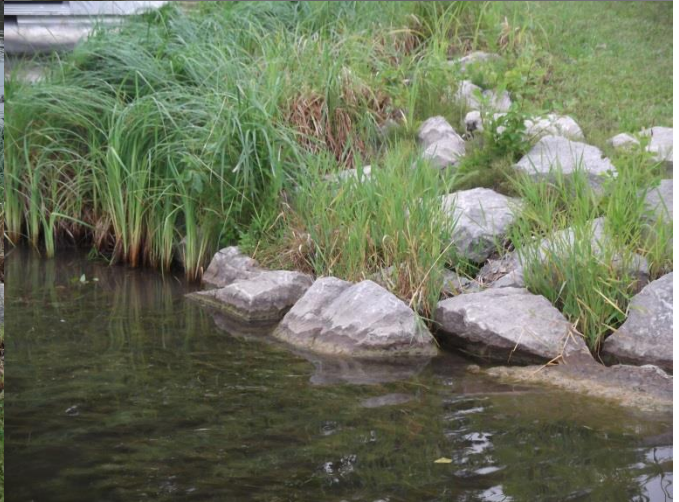
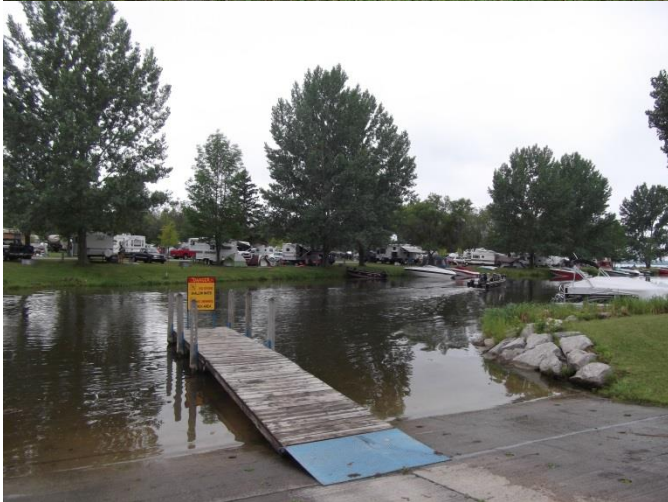
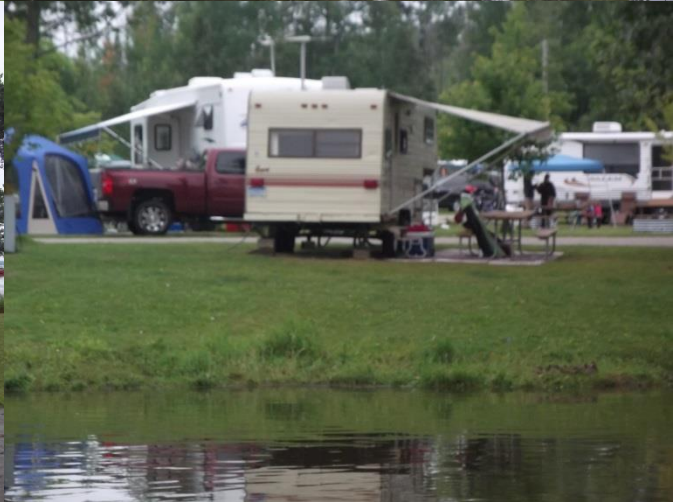
Aloha State Park – Burt Lake

Visual cues and water chemistry data indicated that the launch at Aloha State Park is especially at risk from outside contamination. Phosphorus and total nitrogen levels were by far the highest of all the sites. Phosphorus levels were elevated so that nitrogen is limiting primary productivity in the region around the boat launch, whereas phosphorus is typically the limiting nutrient for freshwater systems in the region (Schindler 1977). These elevated nutrient levels are probably a result of human input from both the

surrounding campsites and the storm drain that empties into the inlet. The excess primary productivity as a result of these nutrients could result in eutrophication of this area. Although the greenbelt at this site received an adequate score of seven, establishing a strong vegetative buffer in this region is paramount because of these elevated nutrient levels. This can be easily achieved through no mow practices from the campground to the shoreline. When maintaining this buffer, herbaceous species should be emphasized, as these are especially efficient at buffering phosphorous (Kim *et al.* 2001); however, as nitrate levels are highly elevated, the presence of woody species is critical as well. Additionally, maintaining a strong greenbelt at a well-visited site like Aloha State Park is especially important as a healthy greenbelt demonstrates proper shoreline management techniques to the general public.

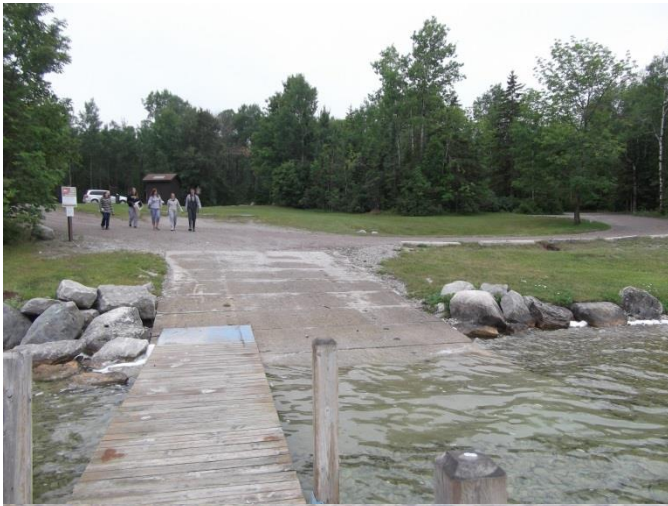
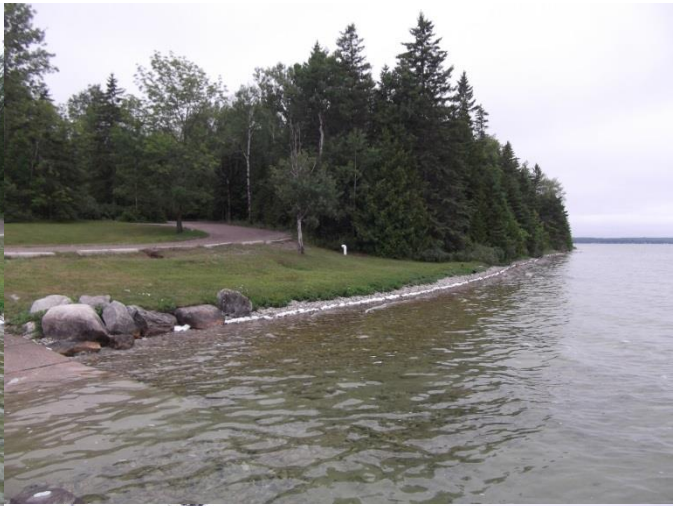
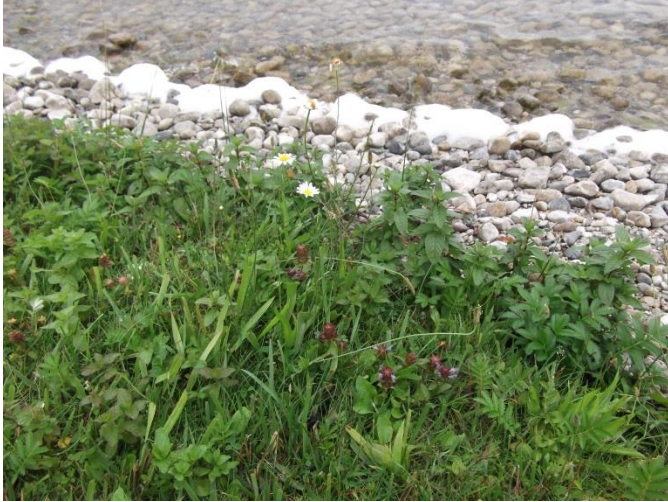
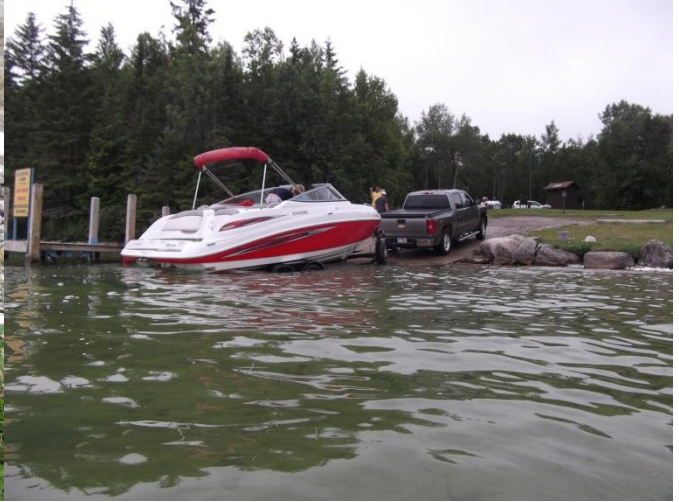
Jewell Road - Mullett Lake

This site received an overall score of zero. The primary species of vegetation is turfgrass. The species diversity increases roughly one meter from the shoreline, but this area is still being maintained and shows little overstory growth. Riprap covers approximately five to ten percent of the shoreline, directly on either side of the launch itself. If no mow practices were utilized, this small area of riprap would not be necessary as a form of erosion control, as a successful greenbelt is more effective than riprap (Fongers and Fulcher 2002). No mow practices should be utilized at this site, as the area that is being maintained serves no recreational purpose.

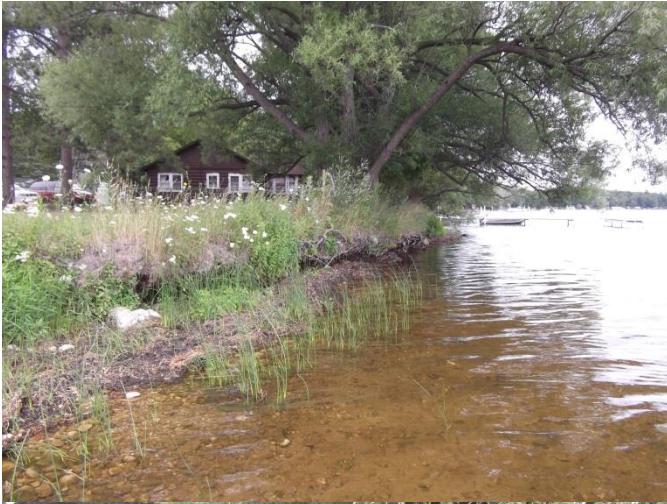
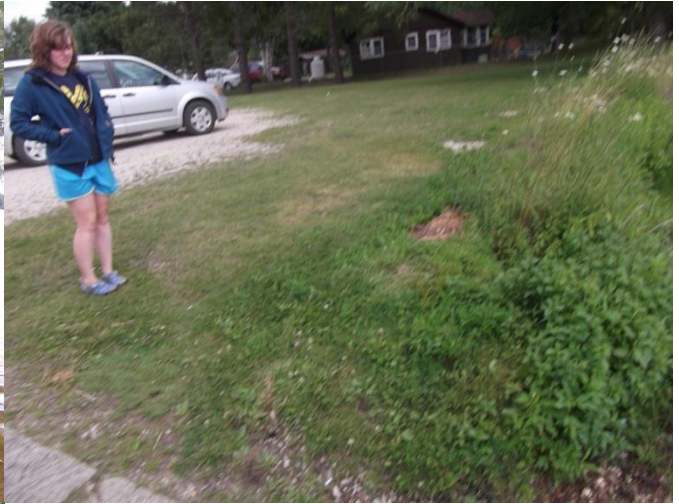
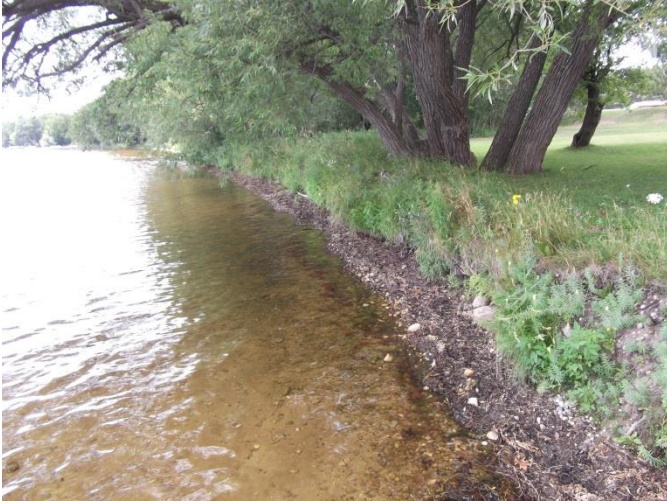
Previous surveys conducted by the Tip of the Mitt identified Paradise Lake MDNR boat launch as a problem site lacking a greenbelt and effective maintenance practices. Restoration work has been done by the MDNR to improve the green belt and health of the launch. Since June 2013, a boat washing station has been added to the site. The beginnings of a greenbelt were established along the shoreline previously dominated by turfgrass. Although lacking slightly in width and diversity, the Paradise Lake site generally demonstrated an exceptional greenbelt. Current groundcover is being allowed to develop into understory and overstory herbaceous and woody growth. Dense, diverse vegetation includes emergent species. Zebra mussels and resultant chlodophera were found, but invasive knapweed was not. With an increased greenbelt depth and width and a no mow policy from shore to road, this site could present an effective and exemplary greenbelt.
