**CHARACTERIZATION OF THE CYCLIC BEHAVIOR OF CORRODED STEEL
BRIDGE BEARINGS AND THEIR INFLUENCE ON SEISMIC BRIDGE
PERFORMANCE**

A dissertation submitted in partial fulfillment
of the requirements for the degree of
Doctor of Philosophy
(Civil Engineering)
in the University of Michigan
2014

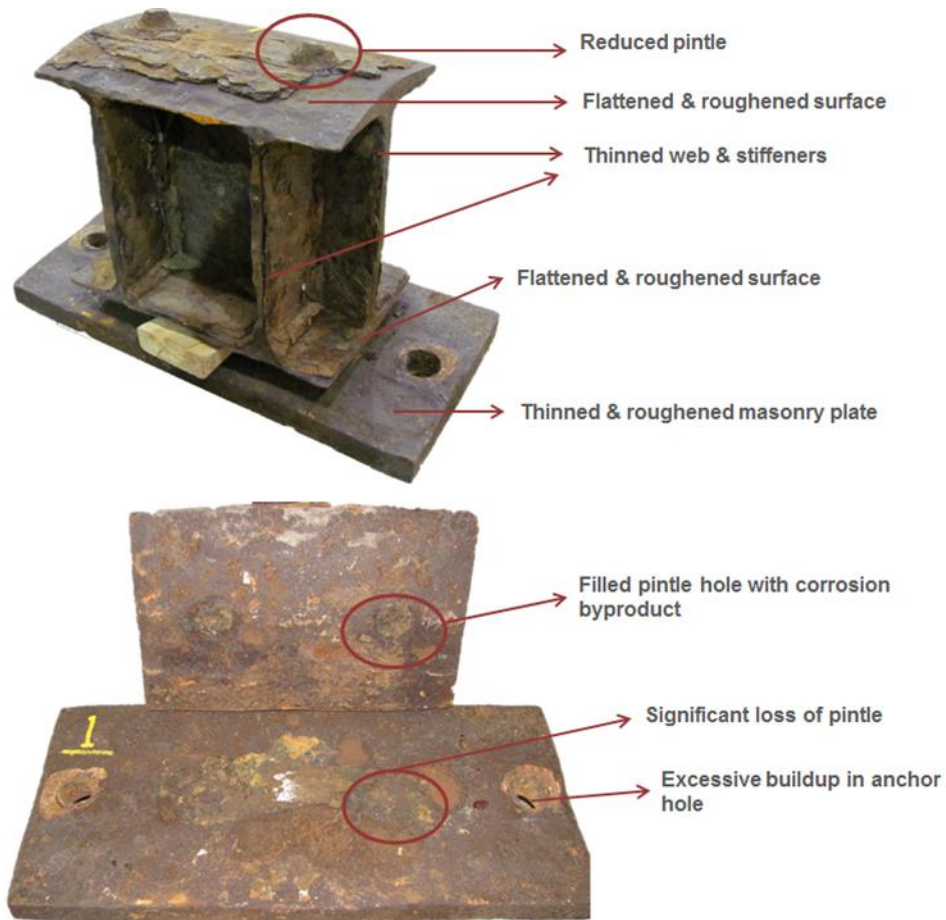
Figure 5.1 Illustration of various corrosion locations and effects on a steel rocker bearing salvaged from an abutment

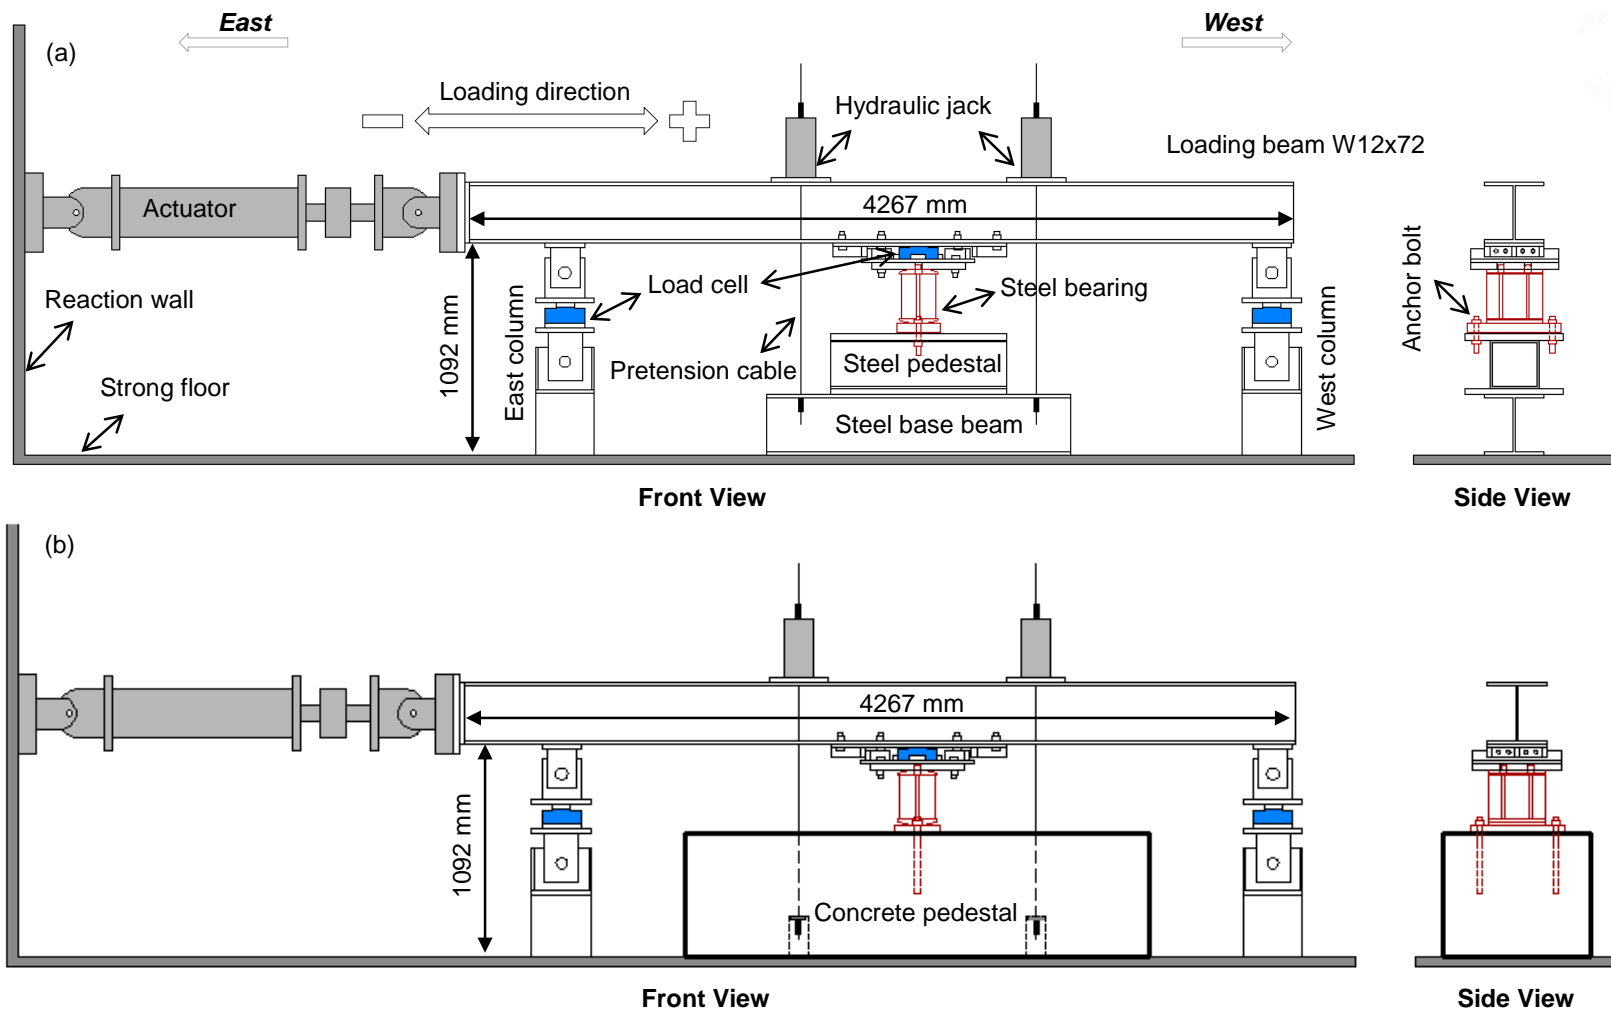
Figure 6.1 Experimental test setup with (a) a steel pedestal and (b) a concrete pedestal

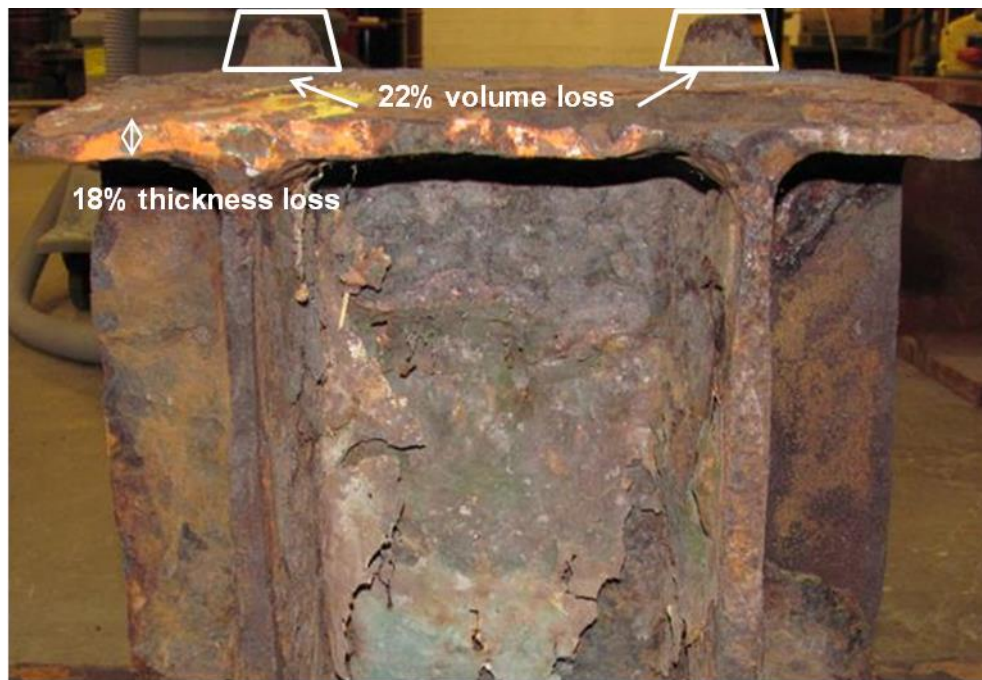
Figure 6.19 Top cylindrical contact surface of AR25 before rust removal

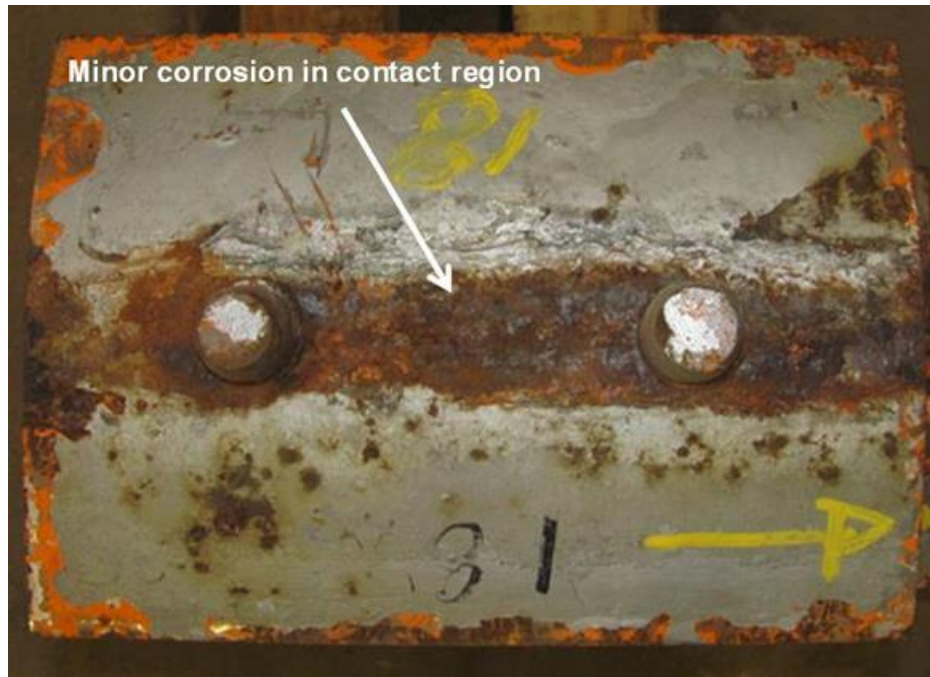
Figure 6.27 Top cylindrical contact surface of Bearing PR18

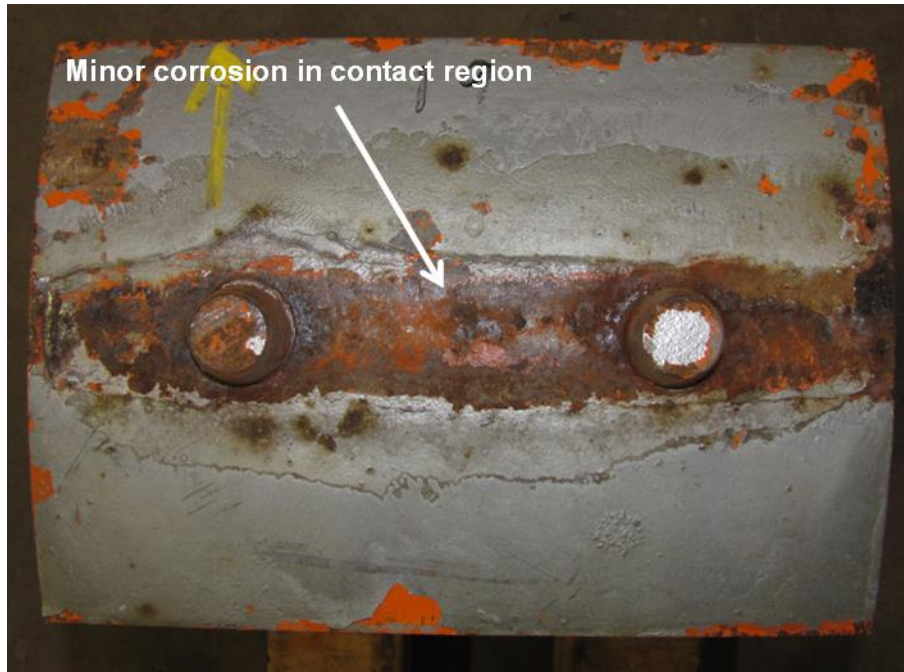
Figure 6.32 Top cylindrical contact surface of Bearing PR19

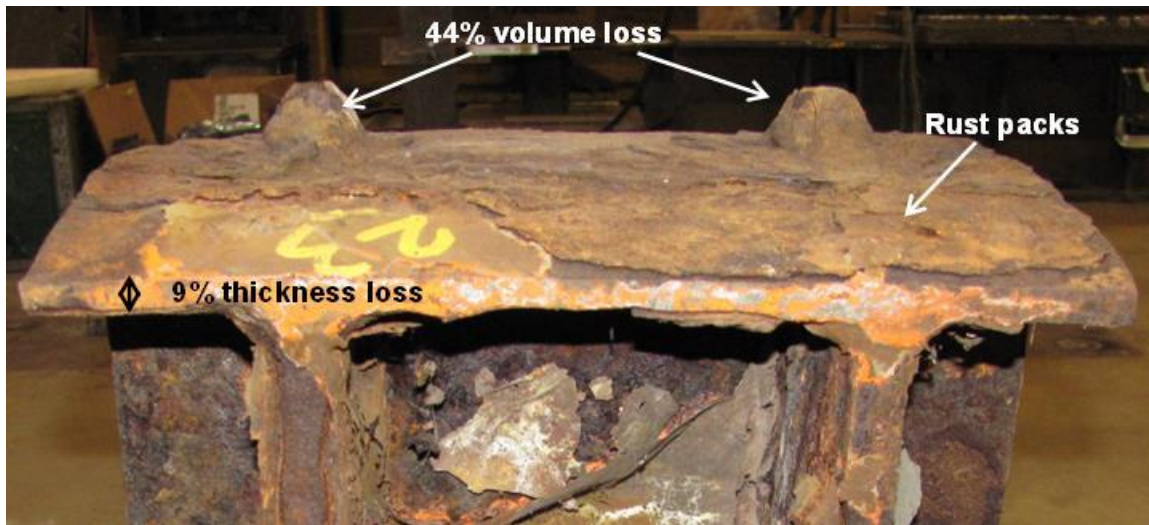
Figure 6.54 Top cylindrical surface of Bearing AR23 in the as-received condition

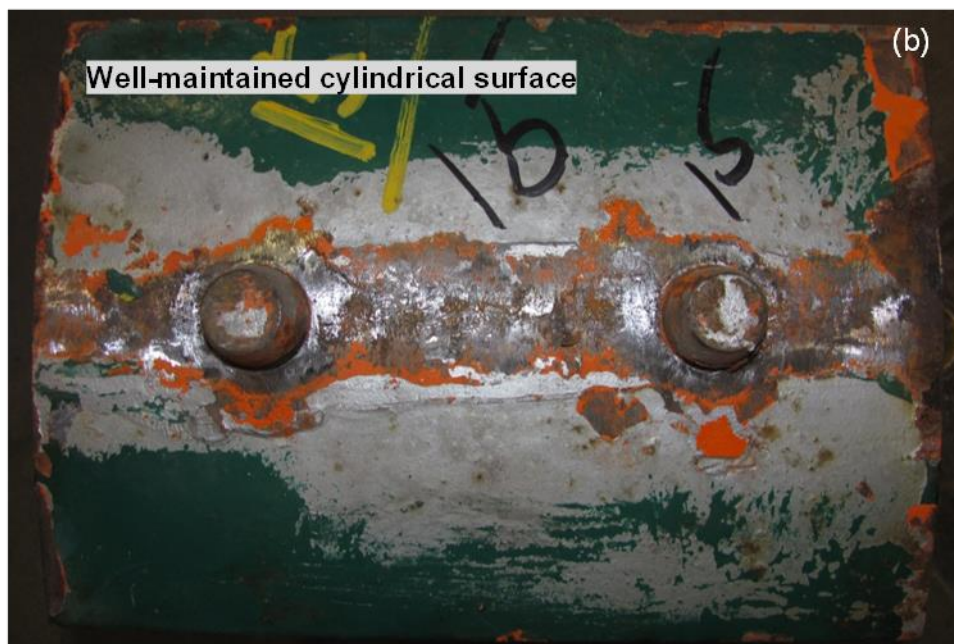
Figure 6.79 Pier bolster bearing #15 (PB15) in the as-received condition

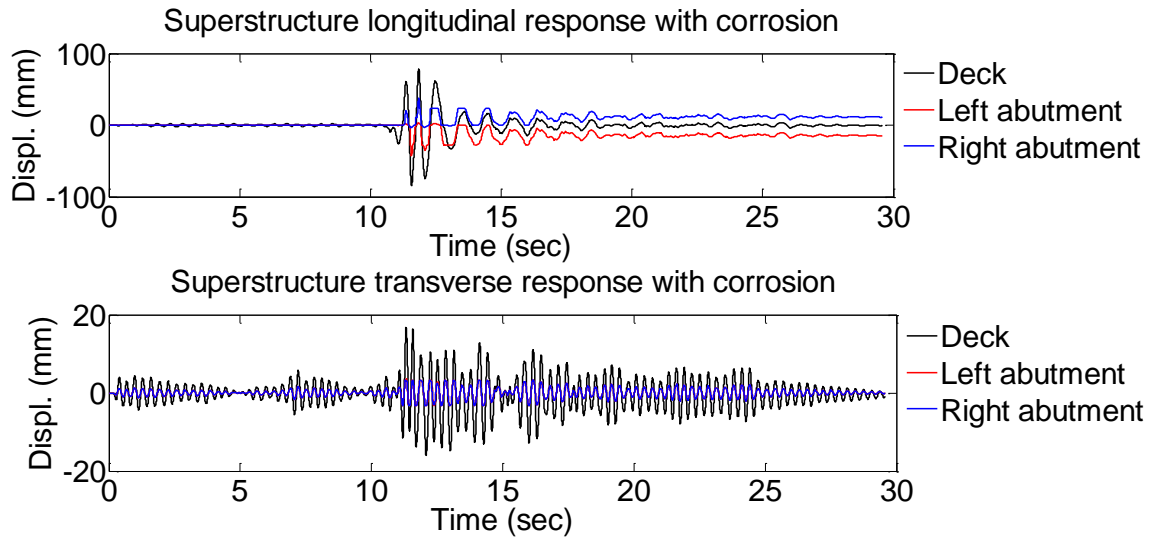
Figure 7.42 Superstructure and abutments displacement time histories of *Bridge C* under bidirectional 2in50 motion pair of bo35 and bo36
