A Predictive Framework for Thermomechanical Fatigue Life of High Silicon Molybdenum Ductile Cast Iron Based on Considerations of Strain Energy Dissipation

A dissertation submitted in partial fulfillment
of the requirements for the degree of
Doctor of Philosophy
(Mechanical Engineering)
in The University of Michigan
2016

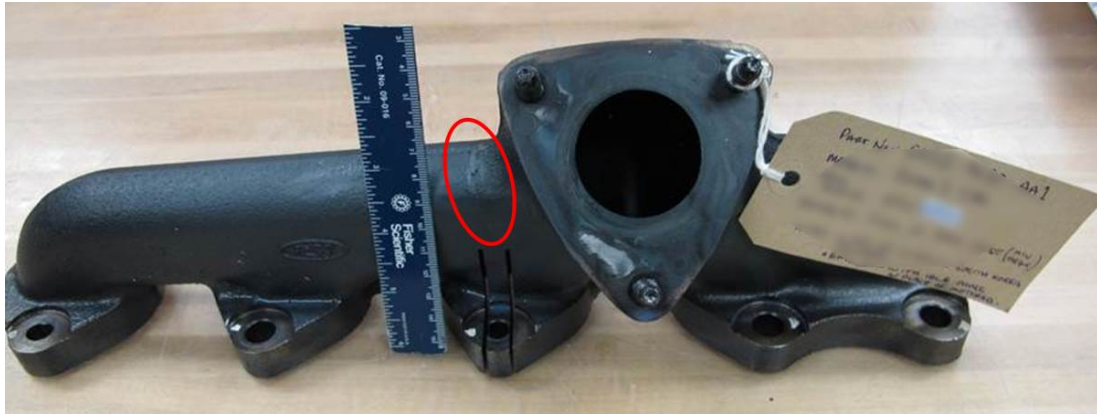
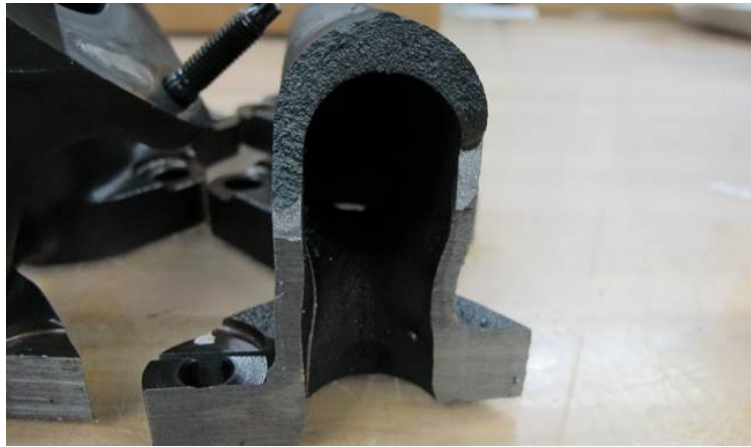
Figure 1.1: Cast iron manifold subjected to severe thermal cycles during a dynamometer tests that resulted in (a) a large crack that propagated (b) through the thickness of the manifold wall.

The coupled thermal and mechanical loads which are characteristic of TMF have shown to have a prominent effect on the durability of the exhaust manifold. Figure 1.1a shows a manifold which has undergone component-level validation testing under conditions of severe thermal cycling in an accelerated dynamometer test for component validation. The transient thermal gradients generated a mechanical strain due to the constraint of hot material by the surrounding cooler material, and the manifold experienced a through-crack at the location denoted in Figure 1.1a within a short number of cycles. The fracture surface of the crack is shown in Figure 1.1b. The crack propagated quickly and allowed exhaust gas to escape, which led to the detection of the crack. Upon further examination, additional cracks were detected at additional locations on the outer surface of the manifold. It is therefore imperative to understand the durability of high temperature engine components undergoing TMF to achieve a reliable design.

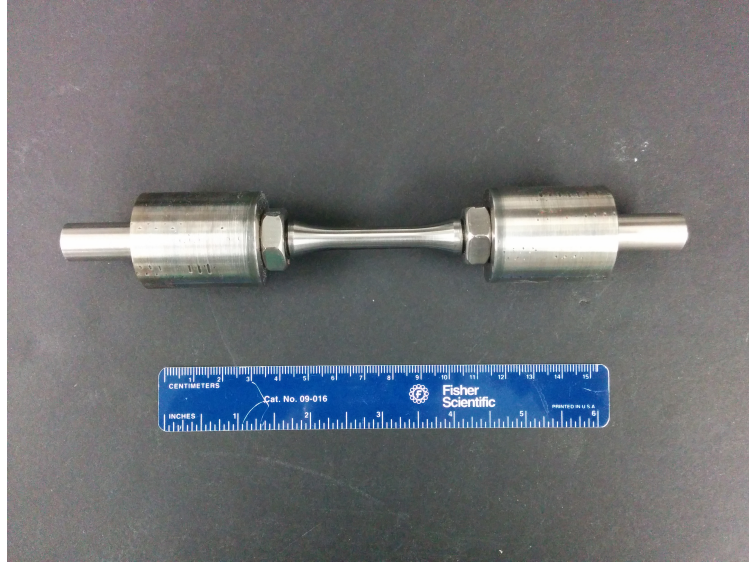
Figure 2.3: Assembled tensile and TMF specimen and superalloy extensions.

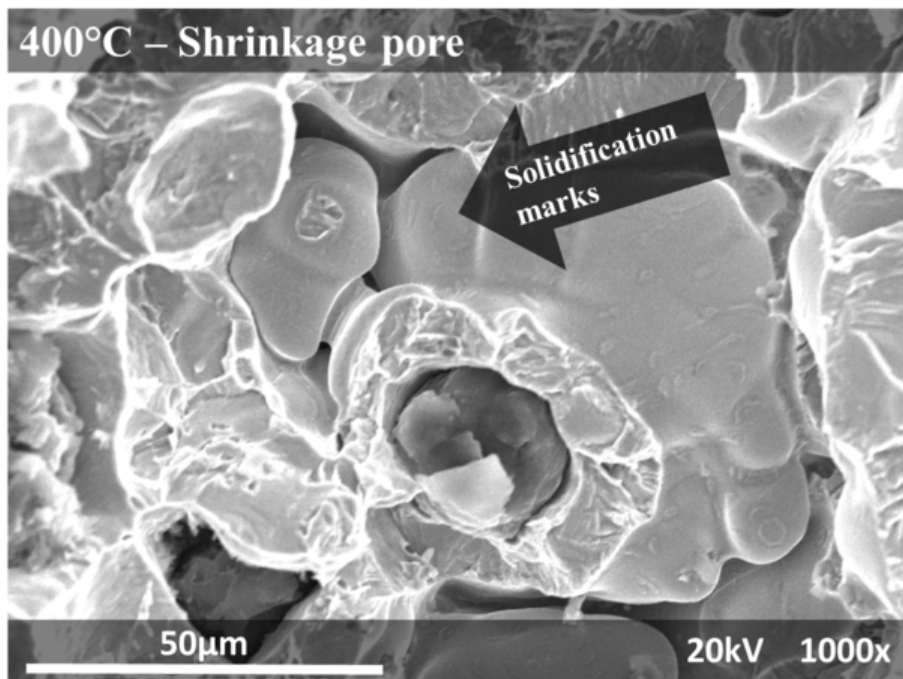
Figure 2.10: SEM images of (a) the fracture surface in a specimen tested under quasi-static conditions at 400 °C and (b) brittle intergranular fracture. Continued on next page, SEM image of (c) shrinkage pore identified by solidification marks.

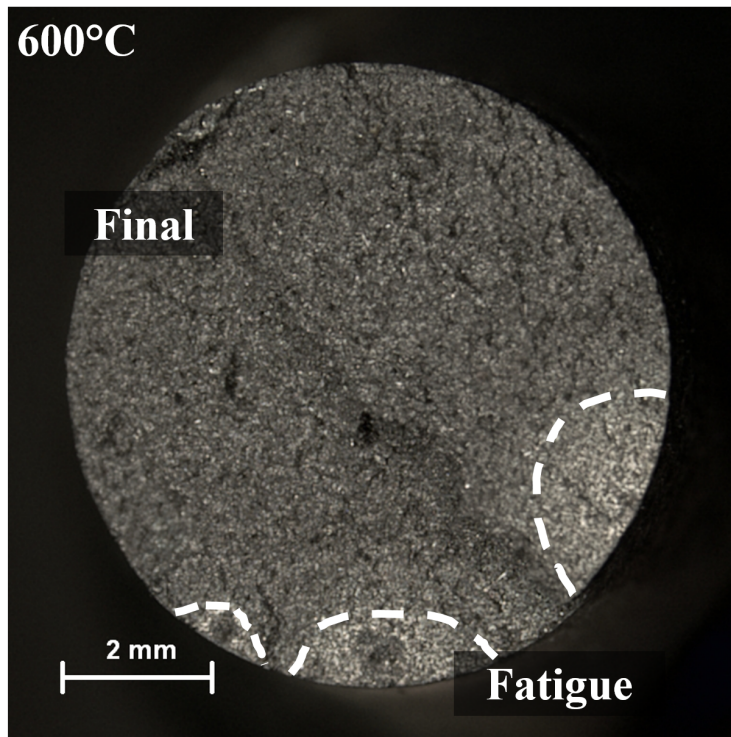
Figure 2.18: Optical microscope images of the fracture surfaces obtained from LCF tests at a low strain range at (a) room temperature and (b) 200 °C. Continued on next page, (c) 400 °C, (d) 600 °C, (e) 720 °C and (f) 800 °C.

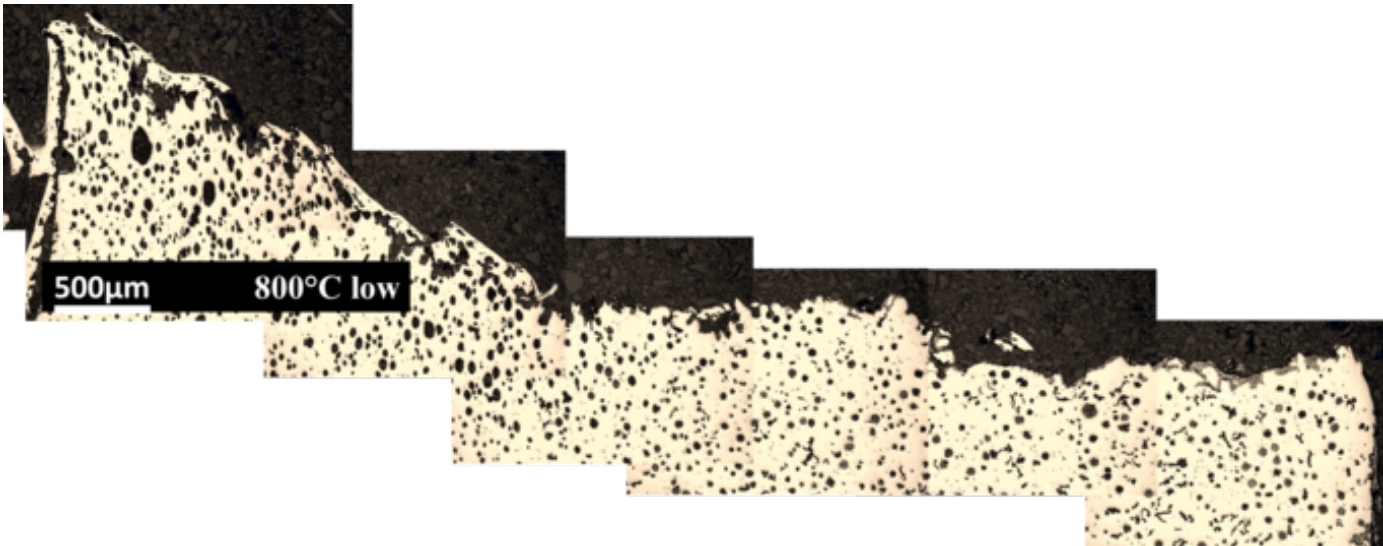
Figure 2.25: Optical micrographs of longitudinal cross-sections through the fracture surface in specimens tested at a low strain range under low cycle fatigue at (a) room temperature and (b) 200 °C. Continued on next page, (c) 400 °C, (d) 600 °C, (e) 720 °C and (f) 800 °C.
