UMTRI-2016-8

Wheelchair Occupant Studies

Final Report

The Biosciences Group
University of Michigan
Transportation Research Institute

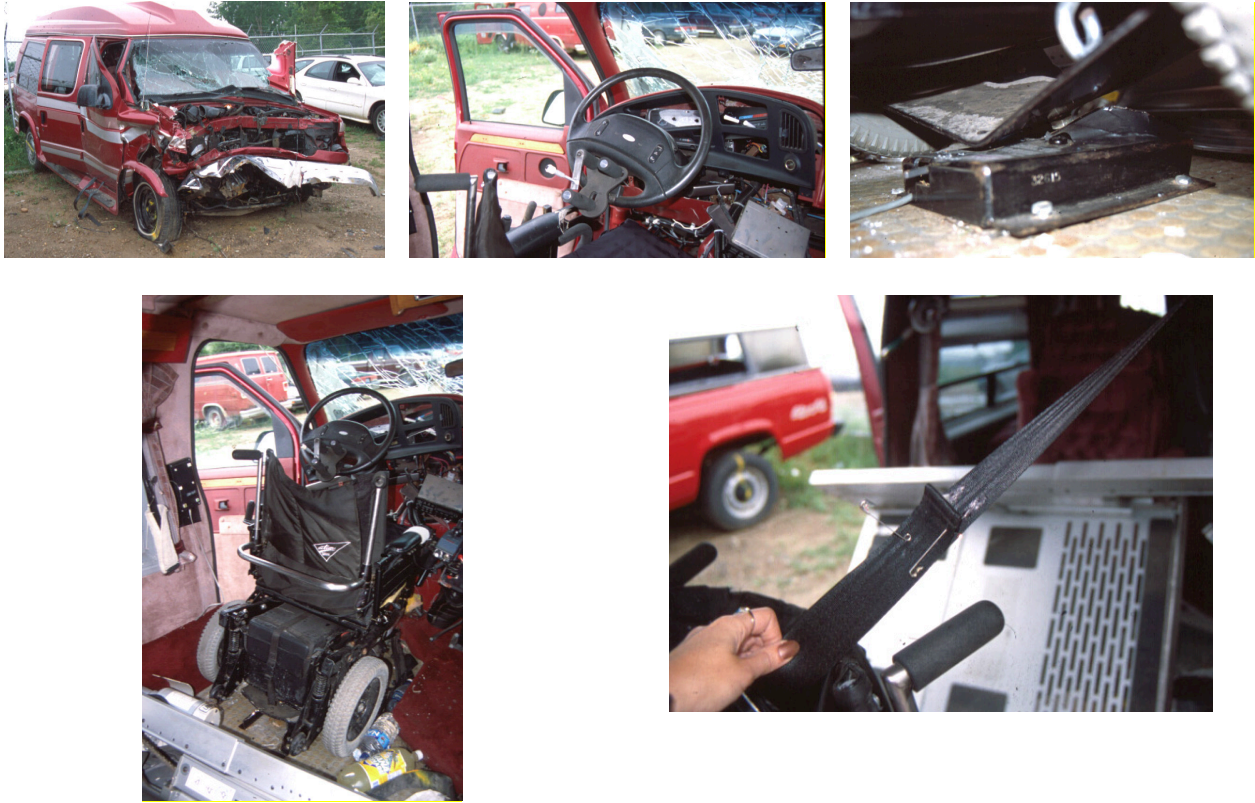
Figure 1.2 - Exterior and interior photos of a full-size van operated by a driver seated in a power wheelchair who sustained fatal chest and abdomen injuries in a severe frontal crash

Although this was a severe frontal crash, there was no evidence of driver contact with the steering wheel or assistive steering device. It is therefore believed that the fatal chest and abdominal injuries, including lung lacerations and contusions plus liver lacerations, were caused primarily by chest and abdomen loading by the loosely worn two-point shoulder belt. Injury to the spleen may also have been caused by contact with the tri-pin steering assist device even though there was no evidence of contact with the tri-pin. The lack of a frontal-impact air bag, significant deformation of the docking-securement device, and use of only a user-modified loosely worn shoulder belt rather than a properly fitted lap/shoulder belt, are likely contributors to the fatal chest and abdominal injuries to this driver.

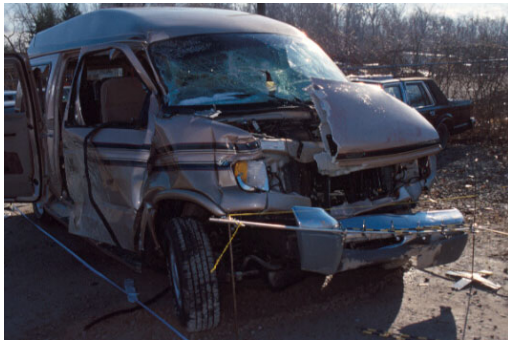
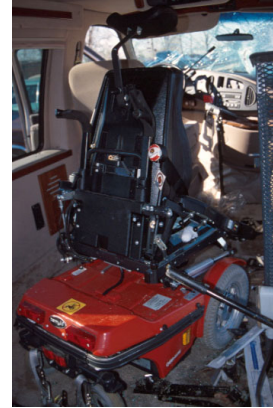
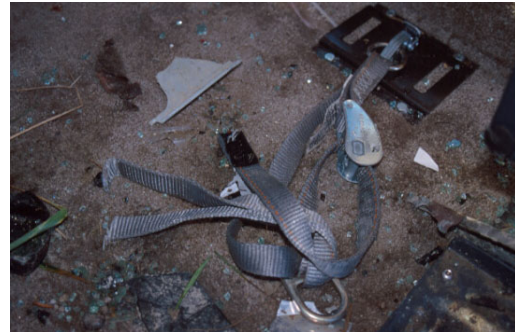
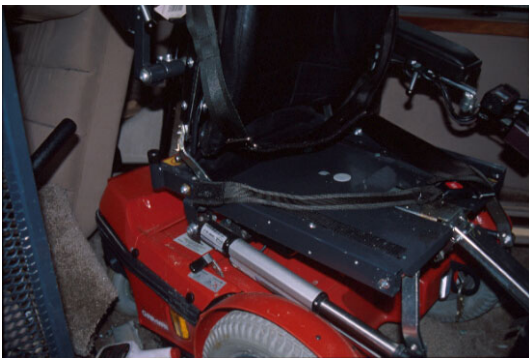
Figure 1.4 - Exterior and interior photos of a van driven by a male driver seated in a power wheelchair that was involved in a frontal crash into the side of the cab and box of a dump truck at a four-leg intersection

During the frontal collision, one side of the postural lap belt and one side of the postural chest belt tore free from the wheelchair (grommets tore through webbing), which allowed the passenger to come out of the wheelchair near the end of the frontal-crash deceleration. He sustained a laceration to the back of his head, a contusion to the spleen, a fracture to the second finger on his right hand, and lost consciousness for less than an hour.

After the crash, an aftermarket lap/shoulder belt restraint system was found hanging on the side of the vehicle. The driver and the wheelchair passenger reported that they thought that the postural belts provided a sufficient vehicle restraint system and therefore they did not think it was necessary to use the available vehicle-anchored seat belt. Although this passenger in a wheelchair was not seriously injured, in part because he was using a crash-tested power wheelchair that was properly and effectively secured during this moderate frontal collision, it is likely that he would have been much more seriously injured had the crash been more severe.

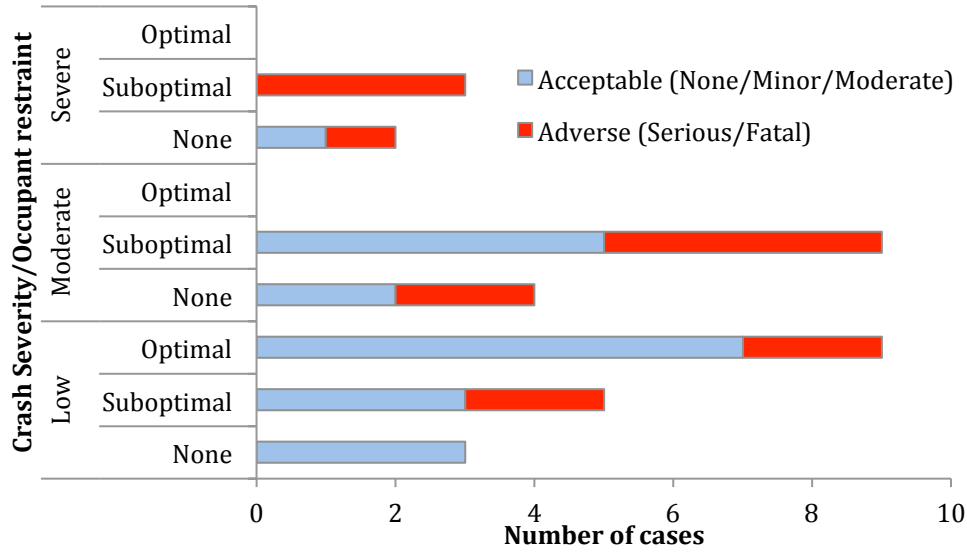
Figure 1.5 - Distribution of wheelchair-occupant cases by crash severity, occupant restraint, and injury outcome

The distribution of cases by crash severity, occupant restraint condition, and injury outcome for the wheelchair-occupant dataset is shown in Figure 1.5. For this plot, crash severity was categorized into three levels of low, moderate, and severe based on Delta Vs of less than 25 kph, between 25 and 42 kph, and greater than 42 kph, respectively. Six of seven combinations of crash severity and restraint condition resulted in an adverse injury outcome, which includes serious-to-fatal injuries. Of the five occupants involved in severe frontal crashes, none were

In the 13 moderate frontal crashes, none of the occupants were considered to have had optimal restraint and 6 of these 13 occupants sustained serious-to-fatal (i.e., adverse) injuries. In the 17 low-severity crashes, four occupants sustained serious-to-fatal injuries. Two of these were among the 9 occupants considered to have had optimal restraint, while two others were among five occupants for which the restraint condition was classified as suboptimal.

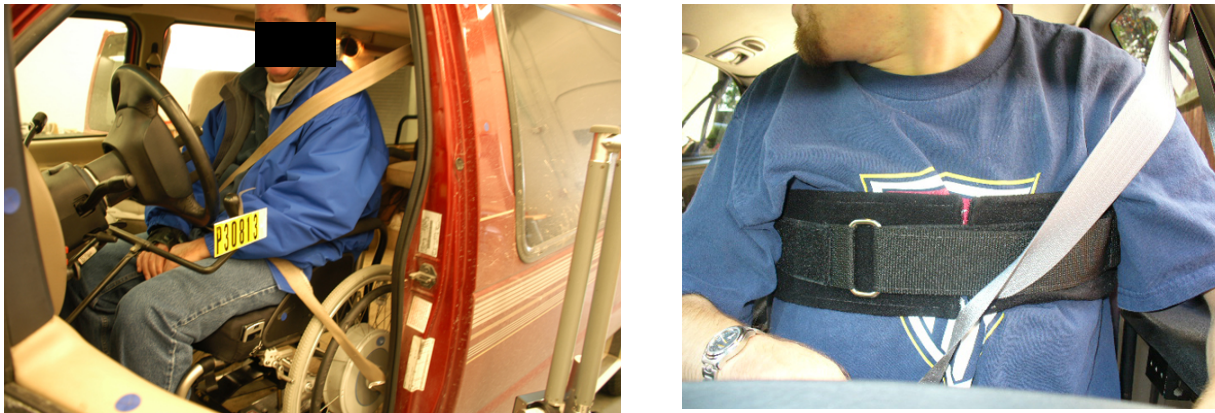
Figure 2.13 - Photos showing typical positioning of the shoulder belt nearly off (left) or completely off (right) the driver’s outboard shoulder

Poor positioning of the shoulder belt was often the result of the wheelchair’s width, which caused the driver to be shifted more inboard than a driver using the OEM vehicle seat. The average lateral distance from the center of the driver’s shoulder belt (measured at the height of the top of the shoulder) to the center of the subject’s shoulder (measured at the acromion) was 95.0 mm (\pm 85.9 mm).

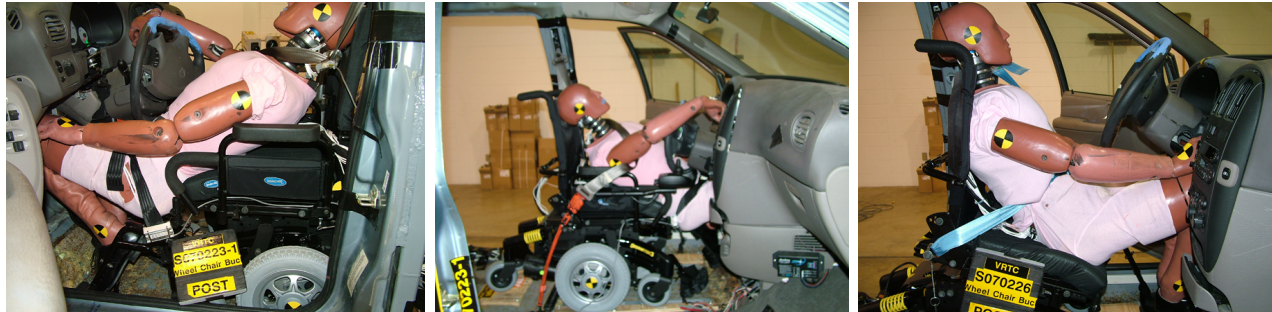
Figure 2.19 - Typical post-test positions of the ATD following TRC wheelchair-driver sled tests

In this regard, one observation from these sled tests was that locating the single securement bolt more rearward under the wheelchair reduces forward pitching of the wheelchair and therefore helps to reduce ATD submarining. This is especially the case when the lap belt is anchored to the back of the wheelchair rather than to the vehicle floor. However, while locating the securement bolt more rearward may be beneficial in frontal crashes, it has a potentially negative effect in rear impacts where the wheelchair will tend to rotate rearward such that the front of the wheelchair rises up off the floor.

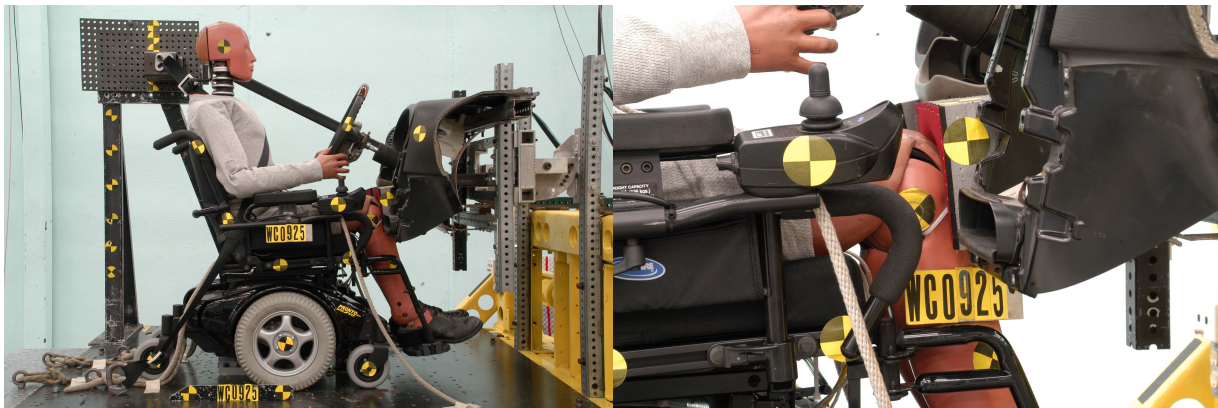
Figure 2.36 - Photos of the setup for frontal-impact sled test of the close-proximity knee restraint with no airbag and a two-point vehicle-anchored shoulder belt

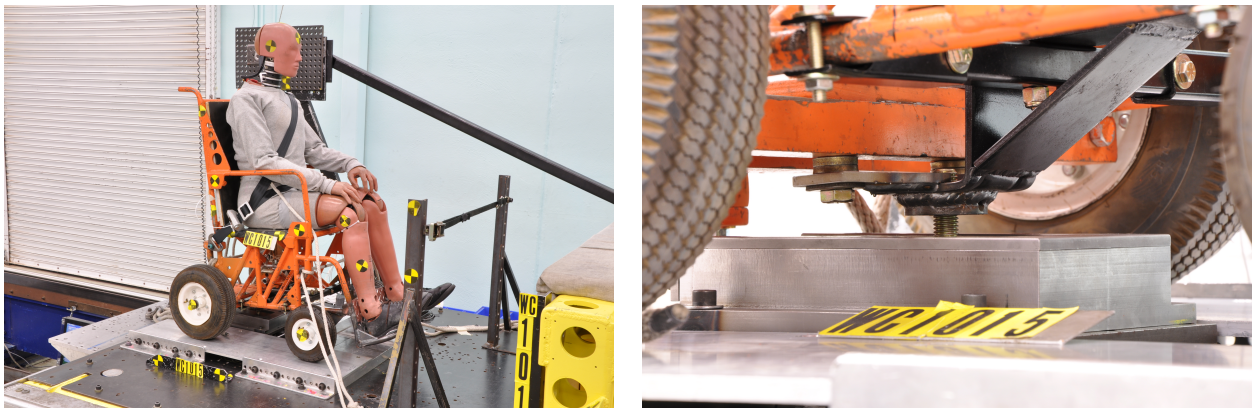
Figure 2.44 - Setup photos for a test of the surrogate docking-securement device (SDSD) with a 7.94-mm (5/16") thick hot-rolled steel plate used to secure the surrogate wheelchair (SWC) loaded with the midsize-male Hybrid III ATD restrained by a surrogate lap/shoulder belt and SWC-anchored lap belt

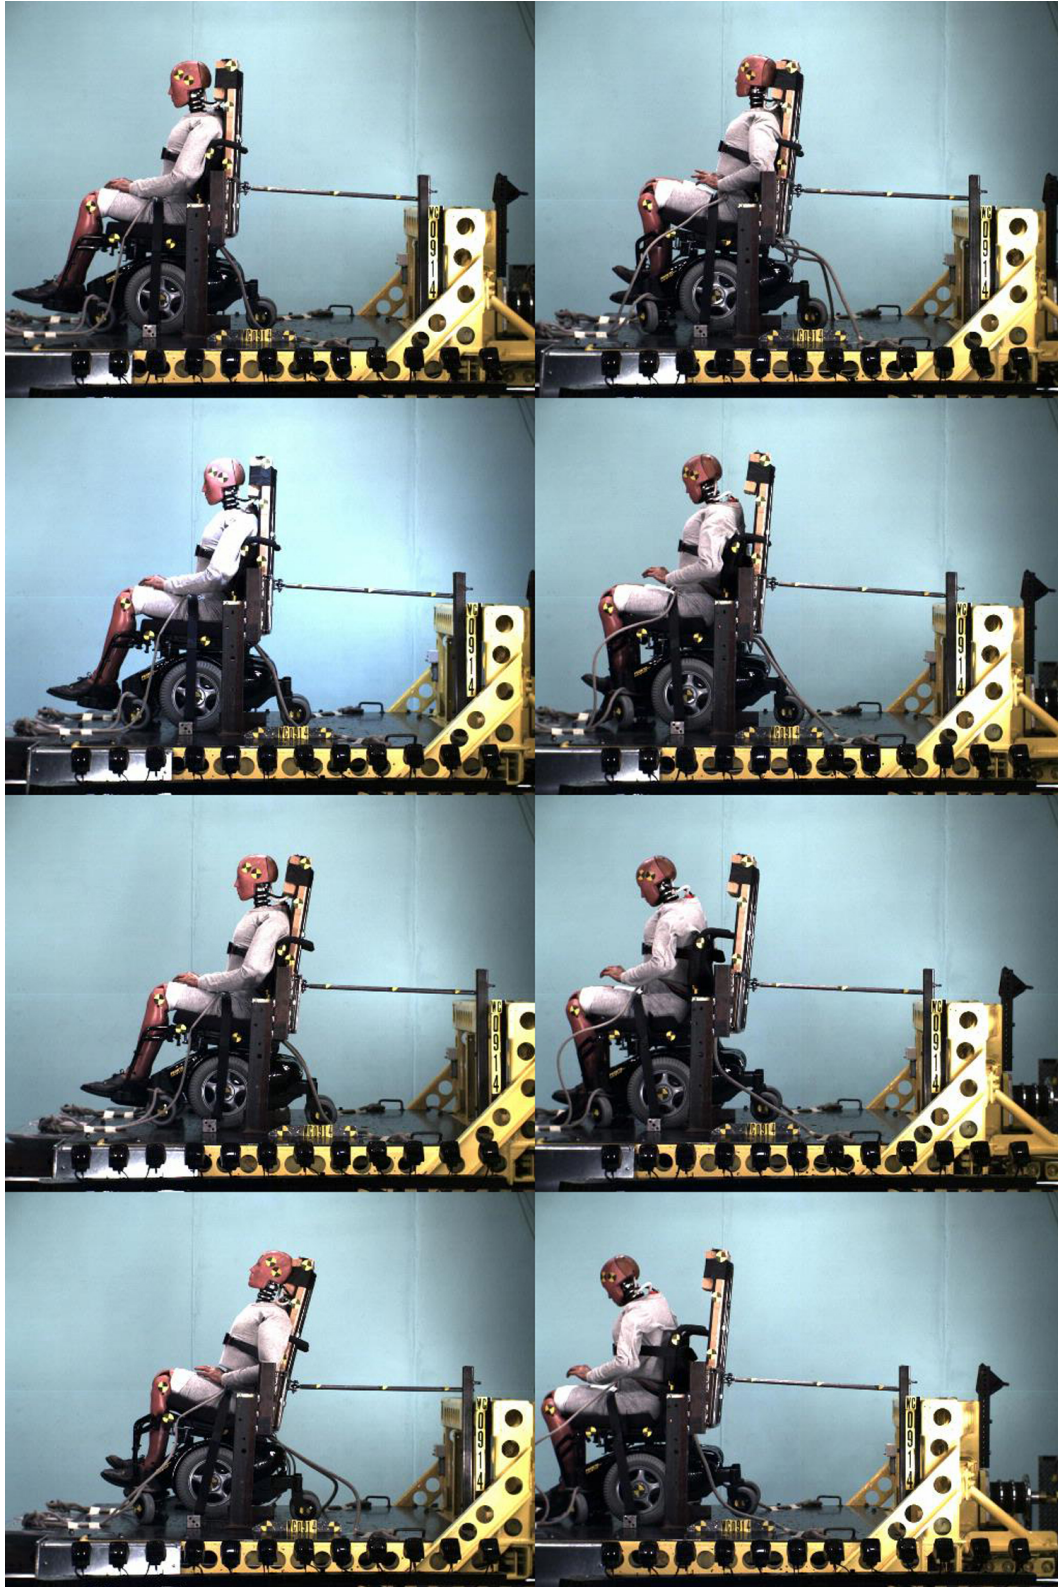
Figure 2.62 – Time-sequence frames from the side-view high-speed digital video of the second rear-impact sled test of the BME student-designed vehicle-mounted head-and-back restraint

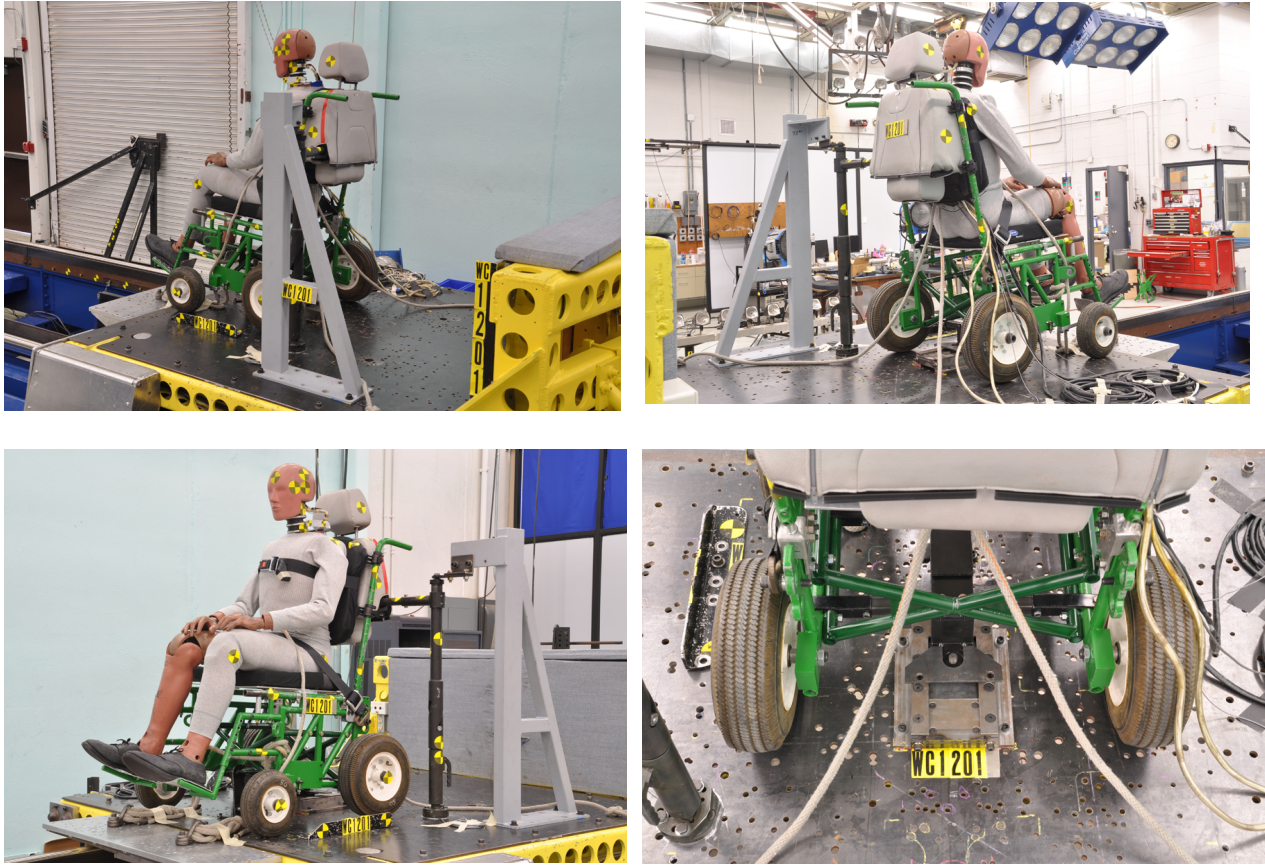
Figure 2.64 - Photos showing the setup of SWCF and midsize-male ATD for the first rear-impact sled test of the deployable Swedish head-and-back restraint system

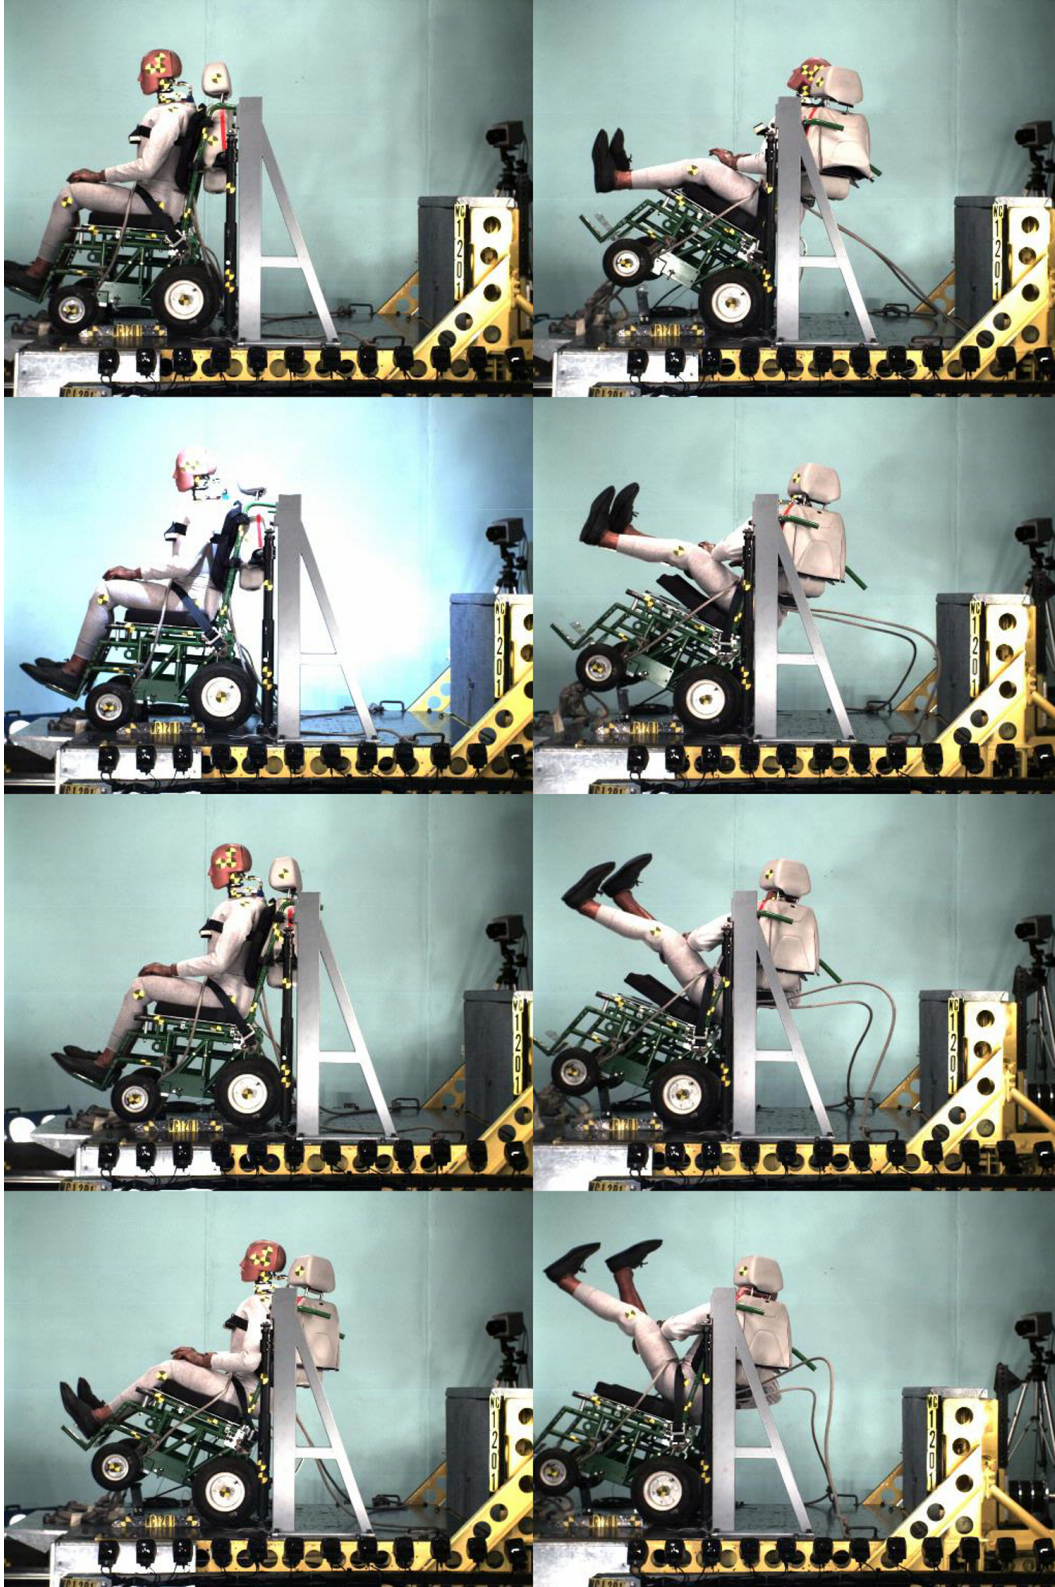
Figure 2.66 – Time-sequence photos from the side-view high-speed digital video of the first rear-impact sled test of the deployable Swedish vehicle-anchored head-and-back restraint system – note the rearward rotation of the SWCF

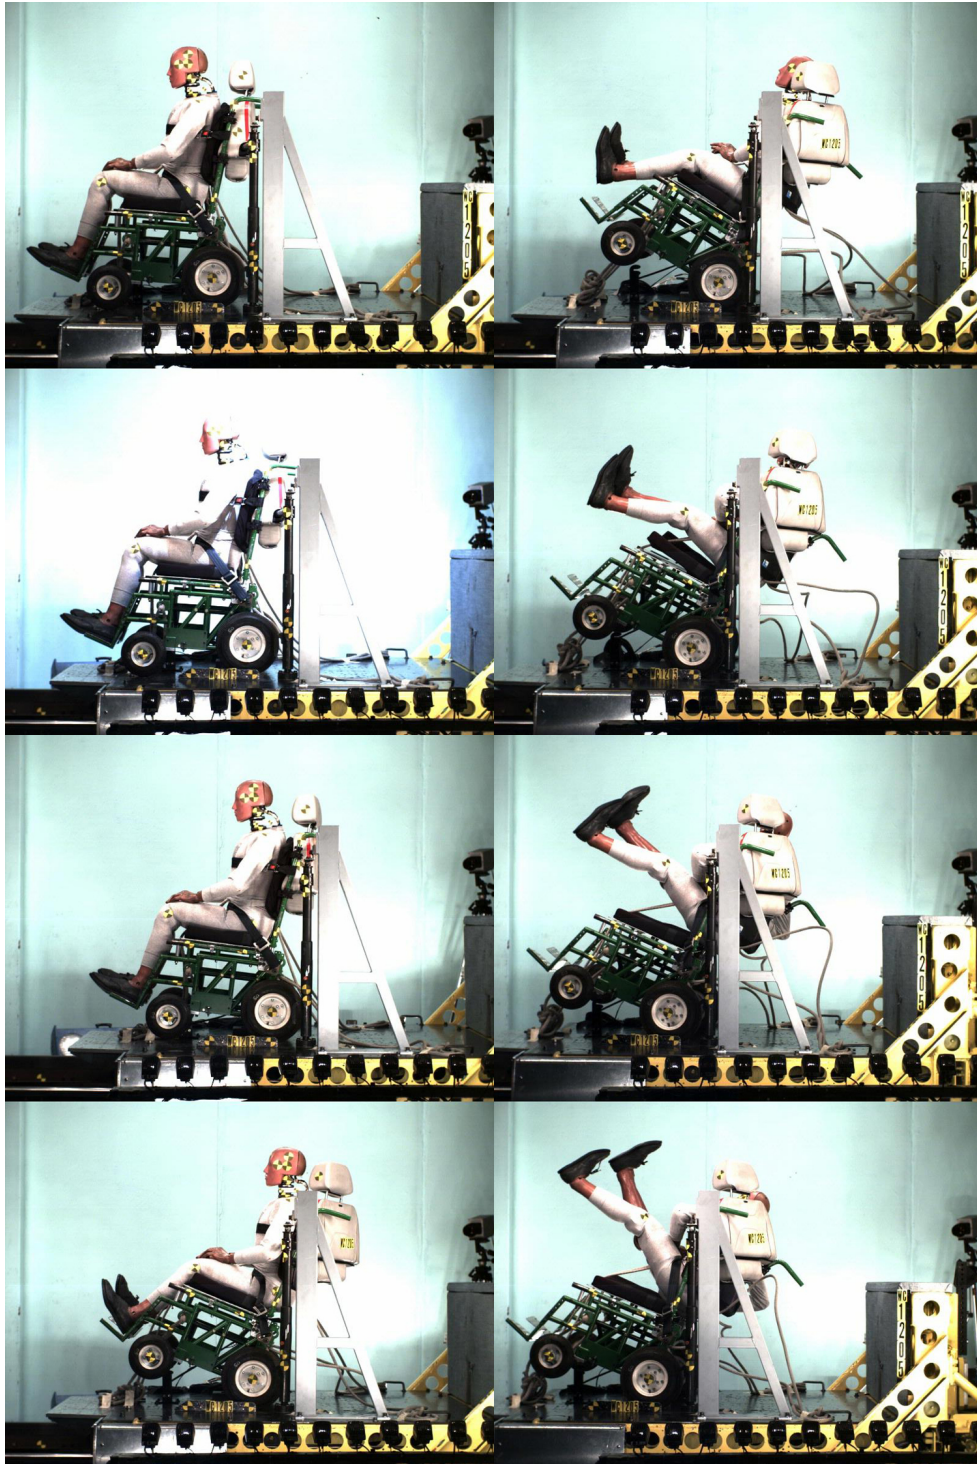
Figure 2.68 – Time-sequence frames from the side-view high-speed digital video of the second rear-impact sled test of the Swedish deployable vehicle-anchored head-and-back restraint system – note the rearward rotation of the SWCF

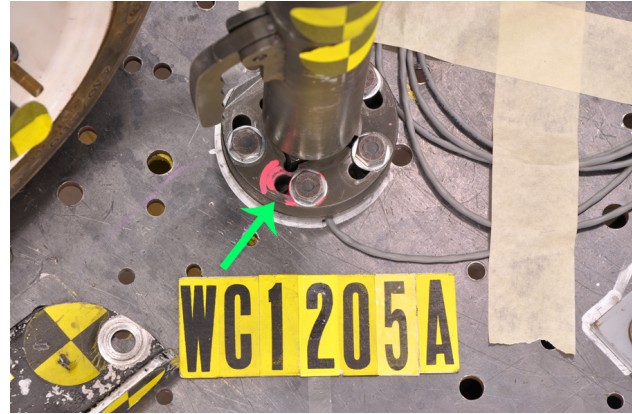
Figure 2.70 - Broken plastic drive nut (upper part of photo on left) on screw-motor actuator and slippage in curved slots at the base of the Swedish head-and-back restraint post (right) that were significant contributors to the poor performance of the Swedish deployable vehicle-anchored head-and-back restraint system in the second sled test

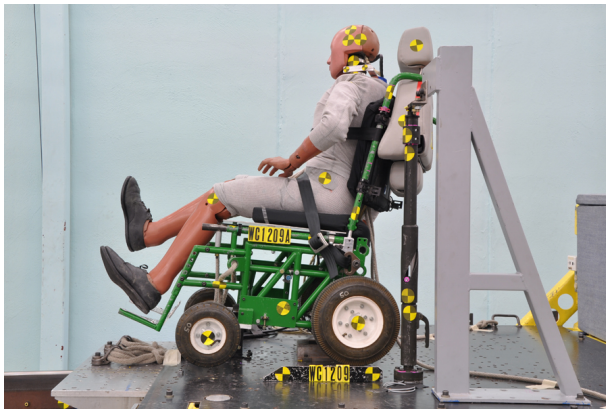
Figure 2.71 - Post-test photos from the third rear-impact test of the modified Swedish deployable vehicle-anchored head-and-back restraint system

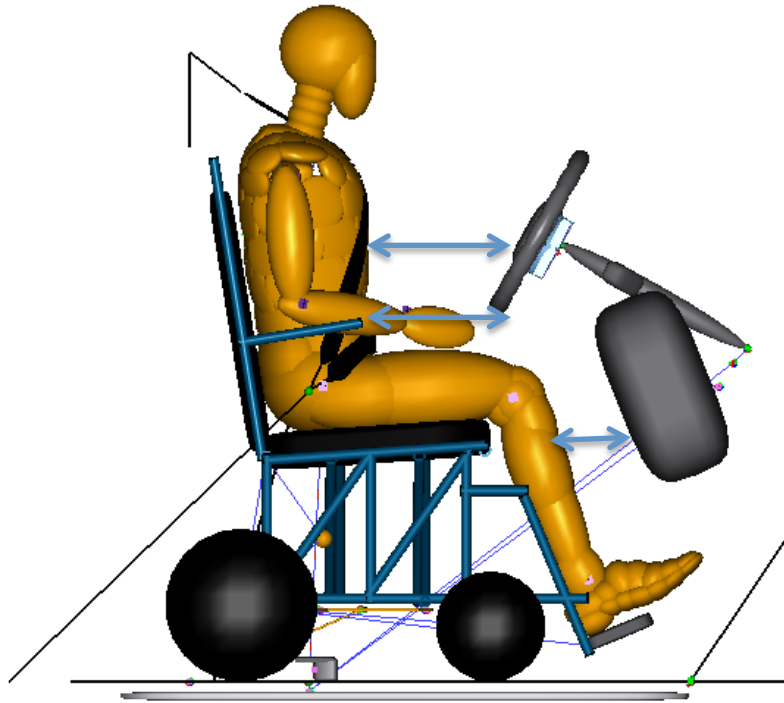
Figure 3.1 -Illustration of measurements used to position the midsize-male and small-female ATDs relative to the steering-wheel air-bag module and the knee restraint on the UMTRI sled

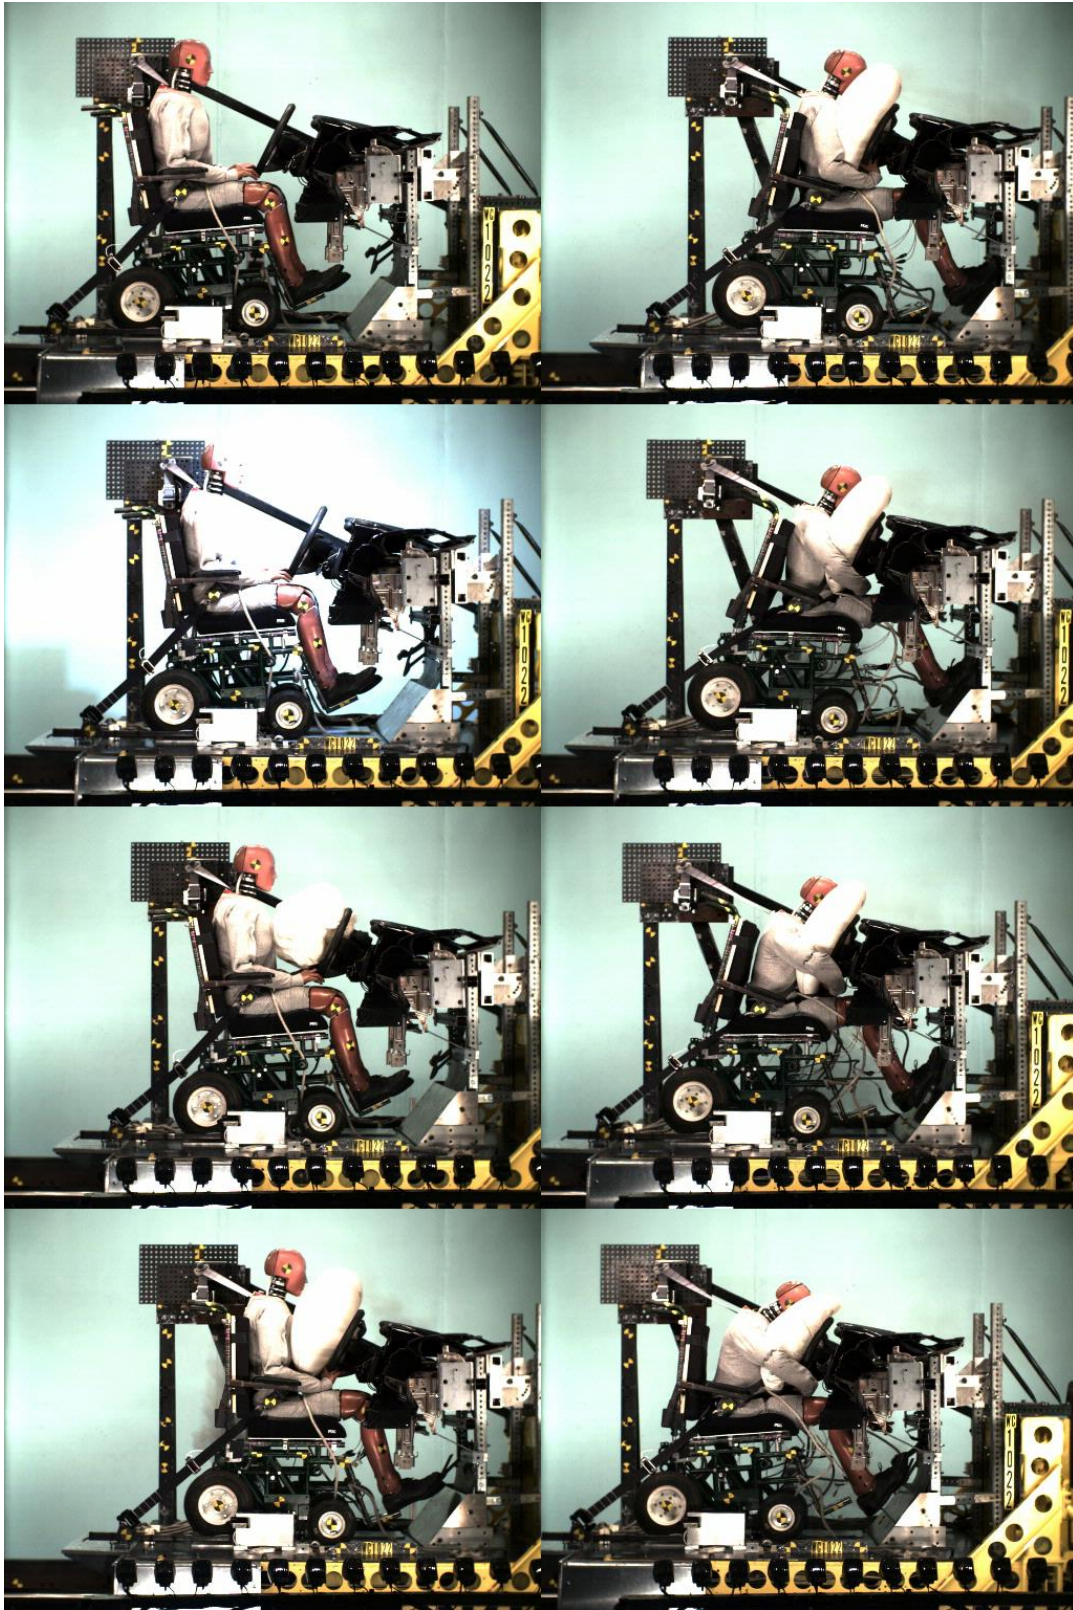
Figure 3.4 – Time-sequence frames from the side-view high-speed video from Test No. WC1022 with good belt fit and 12-ms air-bag deployment time, showing midsize-male ATD kinematics and interaction with the air bag

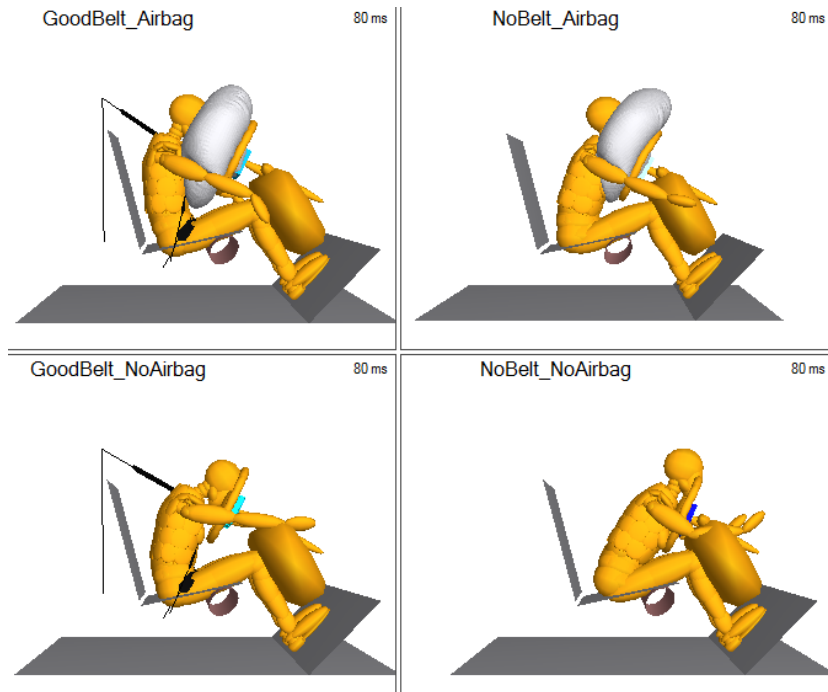
Figure 3.13 - Positions of the small-female ATD seated in an OEM minivan seat relative to the steering wheel, air bag, and knee bolster at 80 ms during a computer-simulated 48-kph, 20-g frontal impact – simulations are for good seat-belt fit (left) and no seat belt (right), and for air-bag deployment at 12 ms (upper) and no air bag
