REINFORCED CONCRETE INFILLED SHEAR WALLS  
FOR ASEISMIC STRENGTHENING

Report on Research Conducted under Grant  
No. GI-39123 from the National Science Foundation

Report UMEE 76S1  
Department of Civil Engineering  
The University of Michigan  
Ann Arbor, MI 48109

January 1976

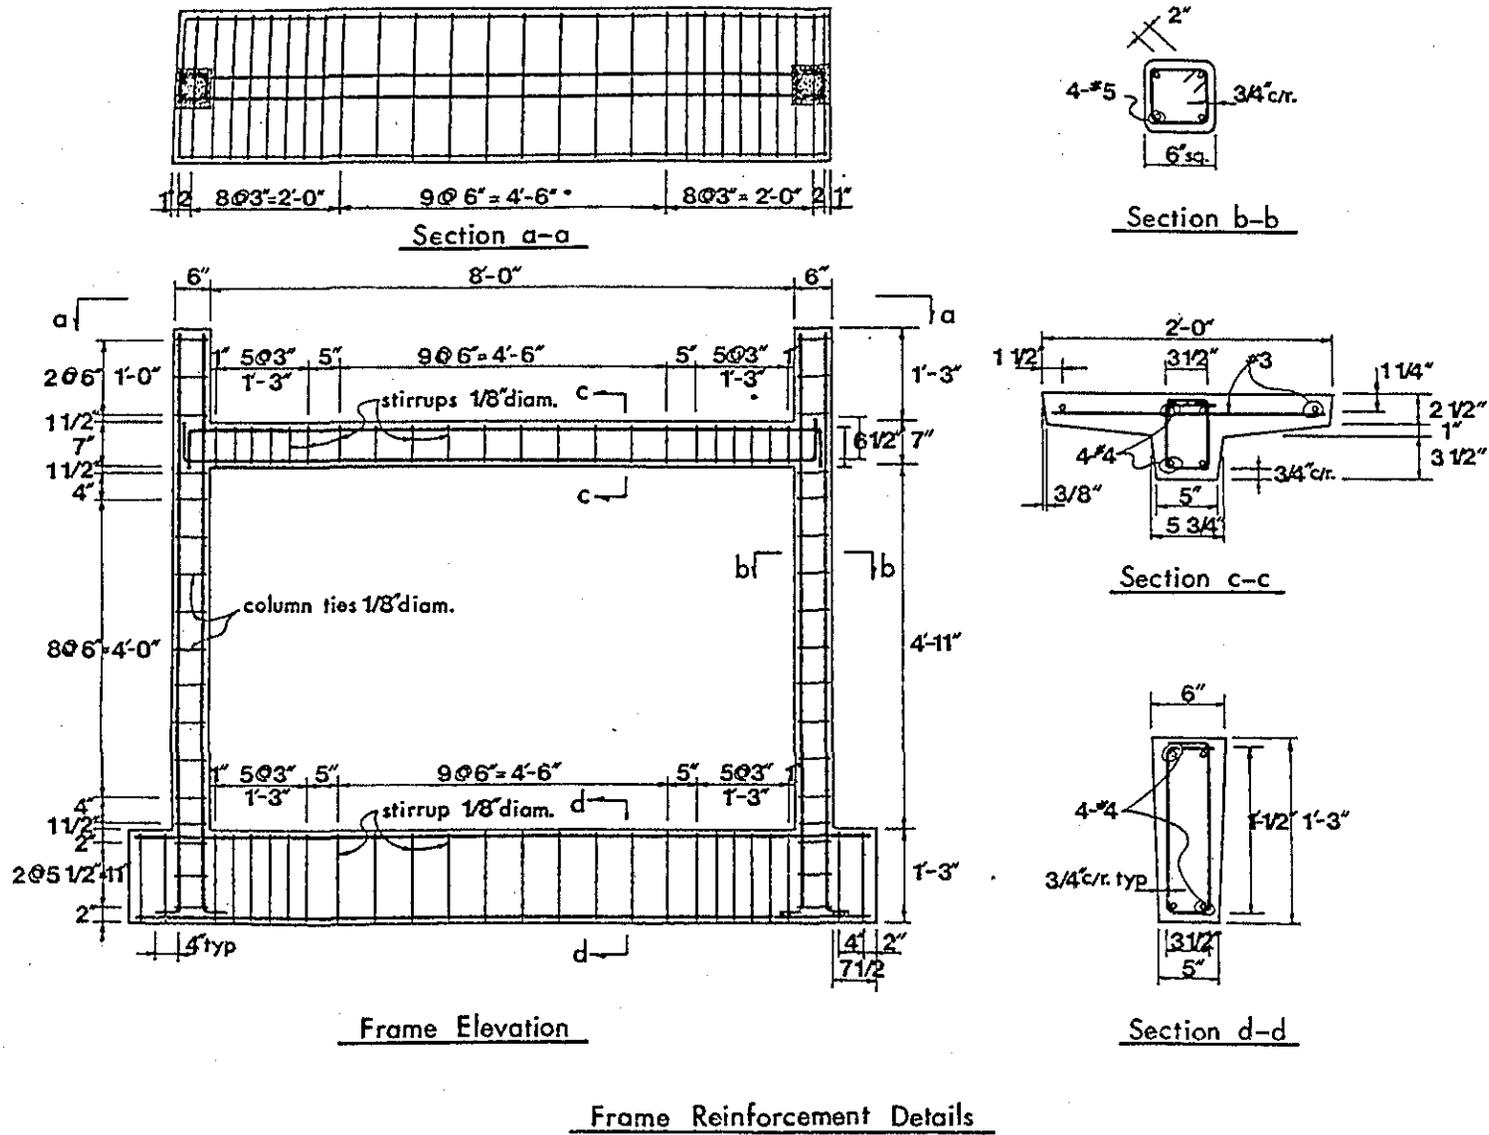
Figure 2. Reinforcement diagram for frame.

Frame. The reinforced concrete frame design was identical for the five specimens; it was a geometrical one-half scale model of one story of the representative frame except for the base beam and foundation blocks as described above and as detailed in Appendix B. Concrete and reinforcing steel were ordered to match the properties used for the design of the representative frame. Because of changes in criteria by the CRSI (28), the steel supplier (Bethlehem Steel Corporation) bent the bars to slightly larger radii than designed. Figure 2 presents the frame specimen design.

Reinforcement was placed and tied as designed (Figure 2). Figure 9 shows #5 column bars being tied into the foundation block; as shown, cardboard tubes were used to form holes for the hold-down bolts. After the base and columns had been cast, beam and slab reinforcement was placed as shown in Figure 10; beam steel was squeezed together about 1/4 in. to 1/2 in. to fit within the column bars.

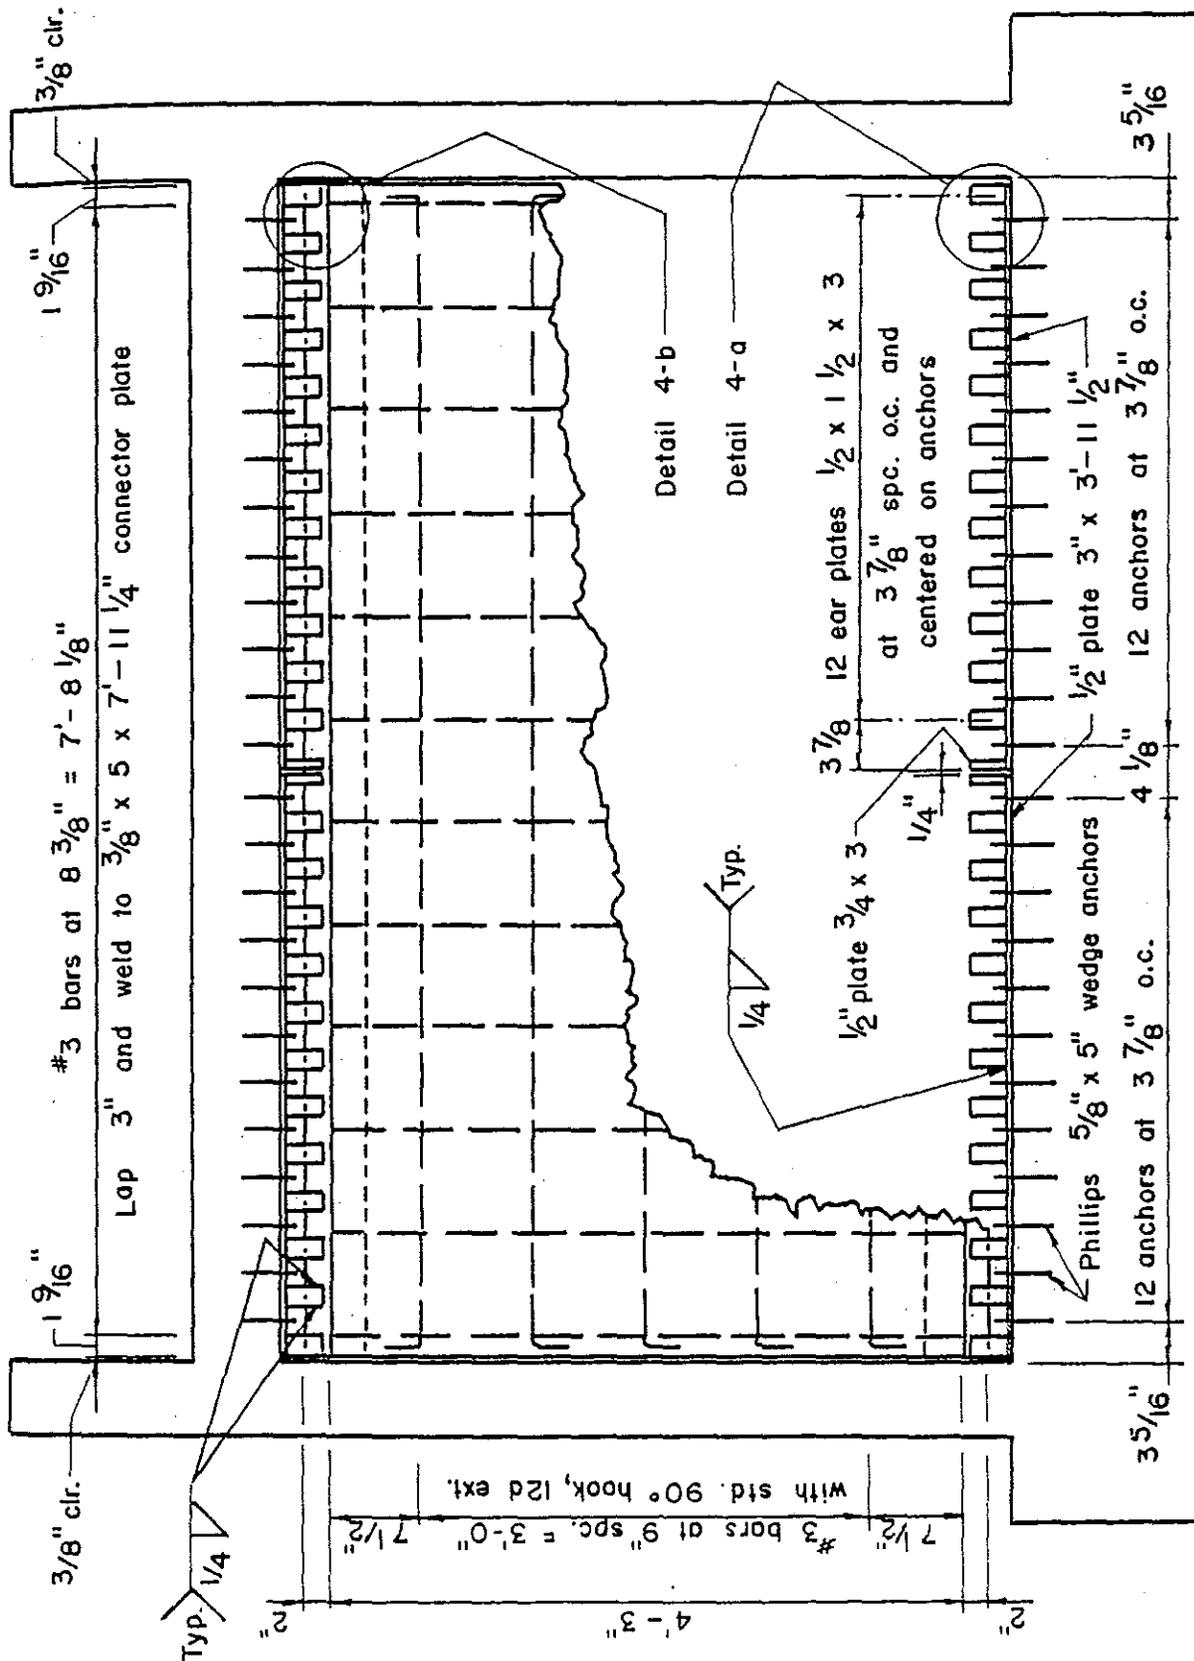
Figure 5. Single precast wall panel reinforcing and connecting detail.

The panel-to-frame connector was designed in two parts. One was a plate which was welded to vertical reinforcing bars and embedded within the panel. The other was called the ear plate connector which was T-shaped with 1/2 in. x 1-1/2 in. x 3 in. ear plates welded to a 1/2 in. x 3 in. x 47-1/2 in. base plate (Figure 6). The base plates were attached to the top and bottom beams using Phillips 5/8 in. x 5 in. wedge anchors, which were installed in

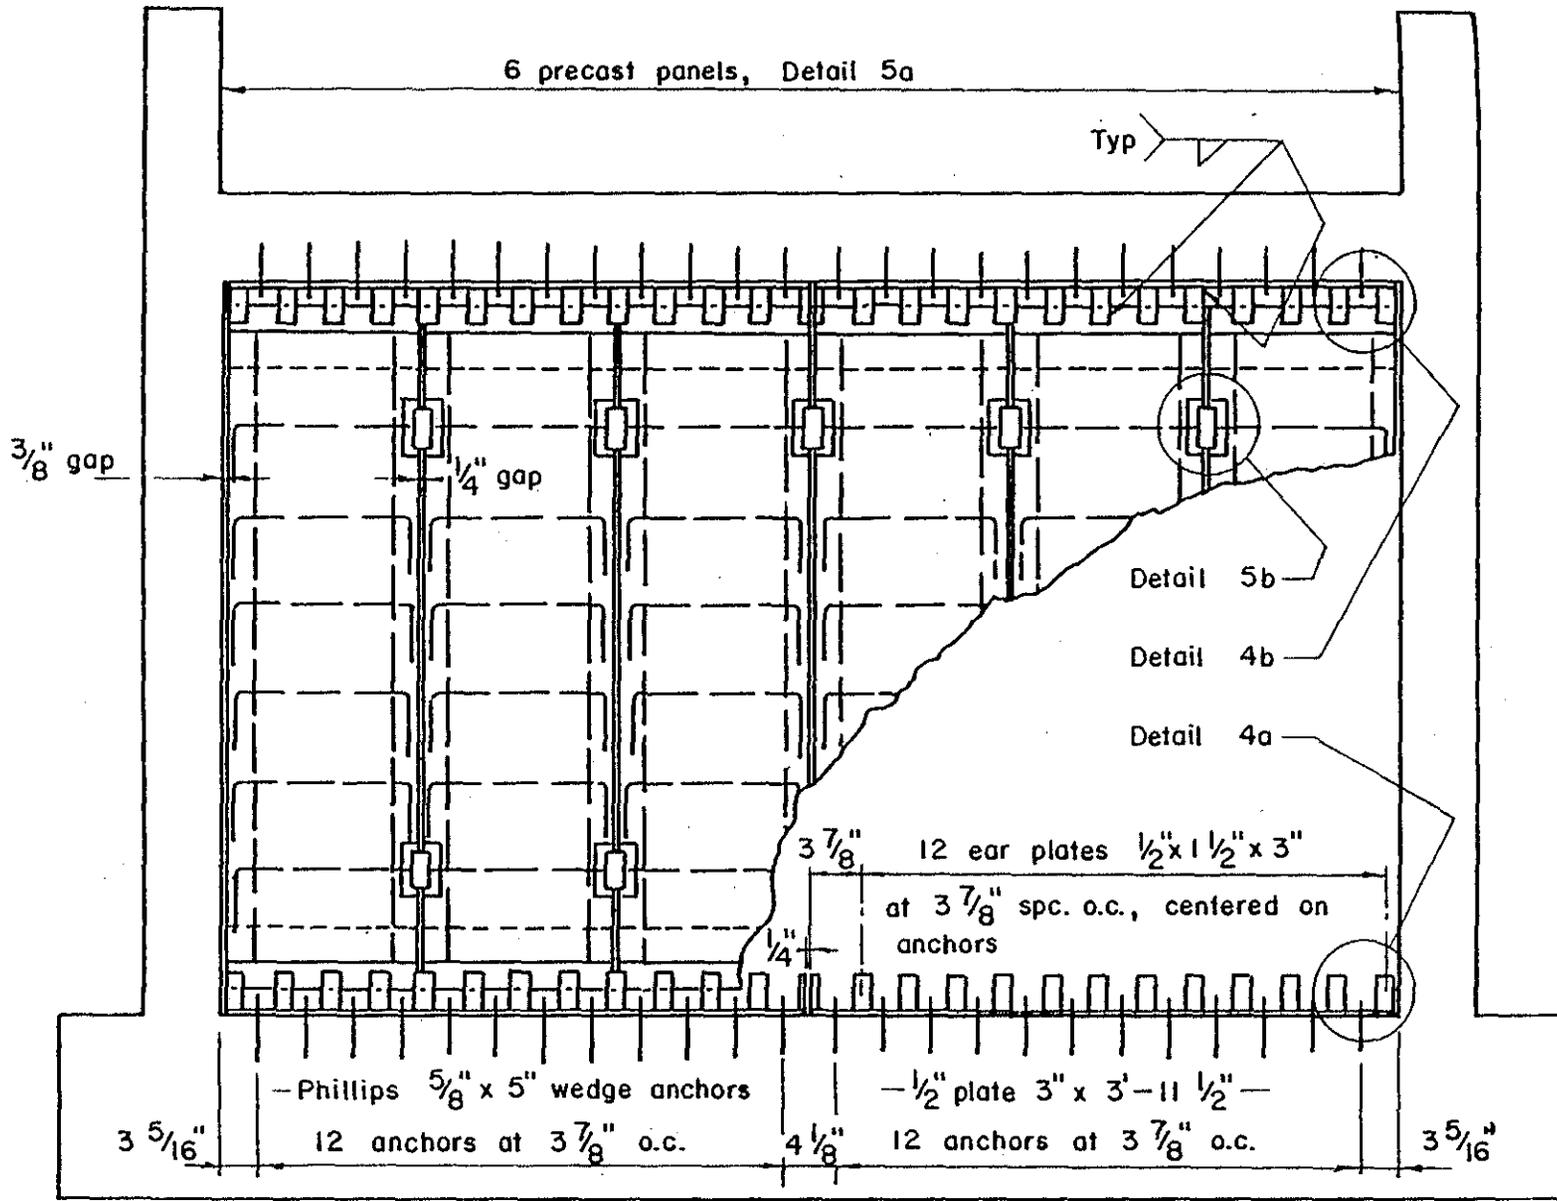
Figure 7. Multiple precast panel reinforcing and connecting detail.

joined together by lap welding steel plates which were embedded in each panel and attached to horizontal and auxiliary reinforcement. These horizontal connections were designed to transmit shear forces from one panel to another and to restrain end rotation of the panel. The design of the panel and the connections were based on current design techniques (47, 48, 49).

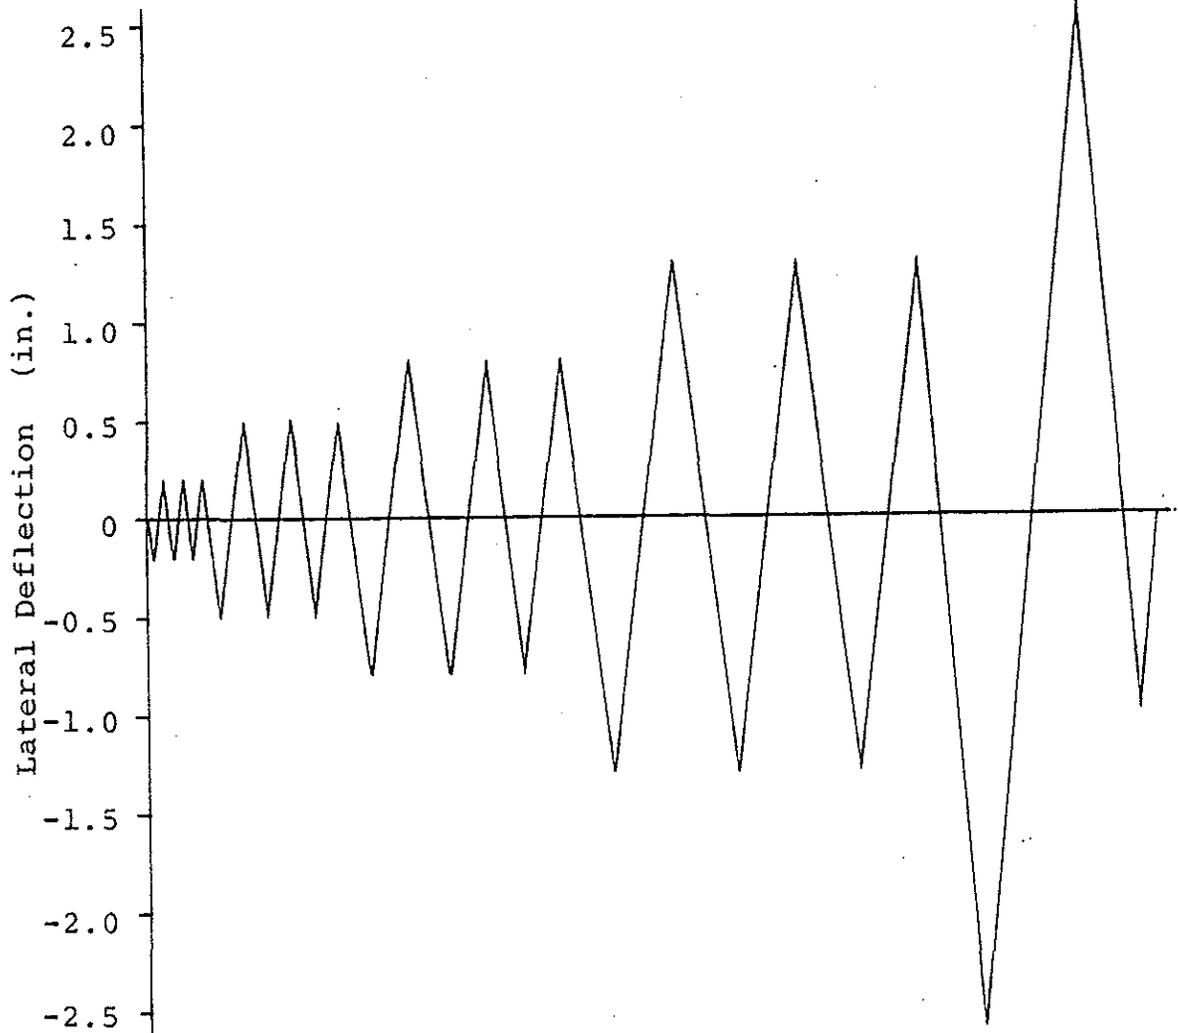
Figure 8. Reversed cycle deflection sequence.

The five specimens were subjected to similar sequences of reversed cycle deflections as illustrated in Figure 8. The deflection sequence was designed to study the structural characteristics of the various infilled walls rather than to correspond to an actual earthquake condition; although such increasing deflection cycles would represent a "worst case" seismic condition (18). Specimens were deflected three times to each deflection level. The levels were based on the calculated and

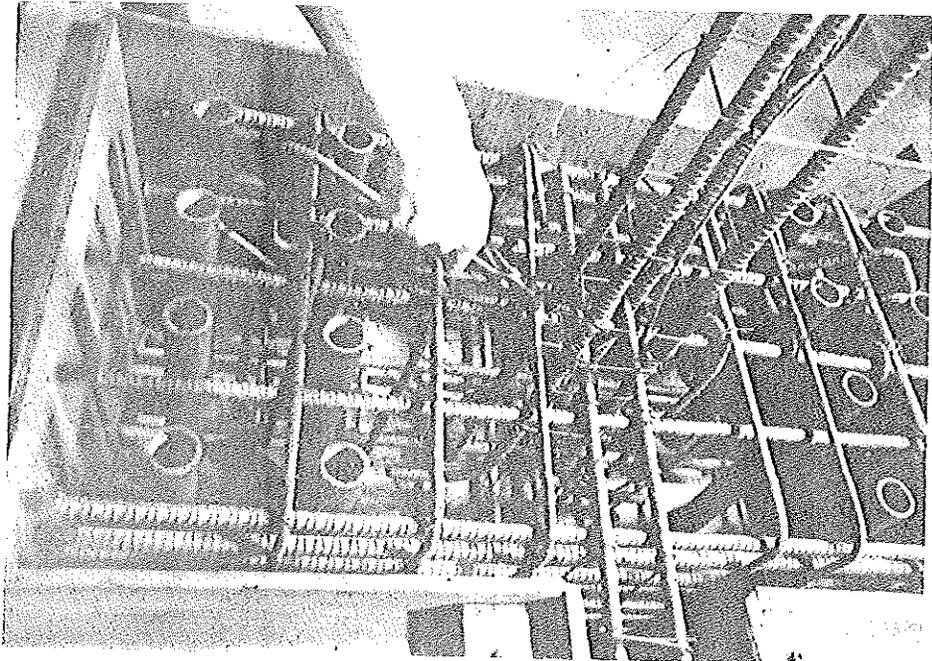
Figure 9. Column and base reinforcement in plywood forms.

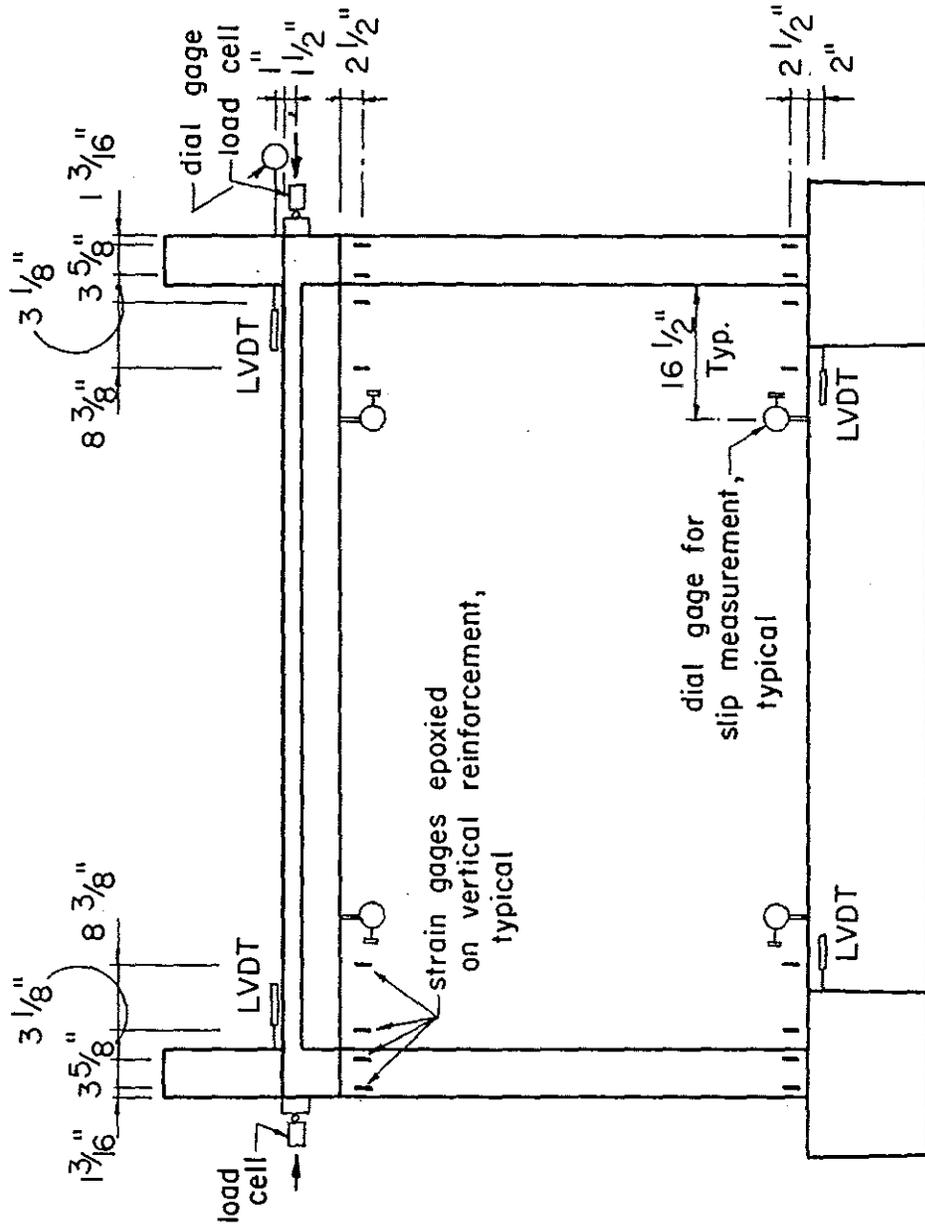
Figure 20. Instrumentation set-up.

one inch above the slab using LVDTs (Linearly Variable Displacement Transducers) and dial gages, all accurate to 0.001 in.

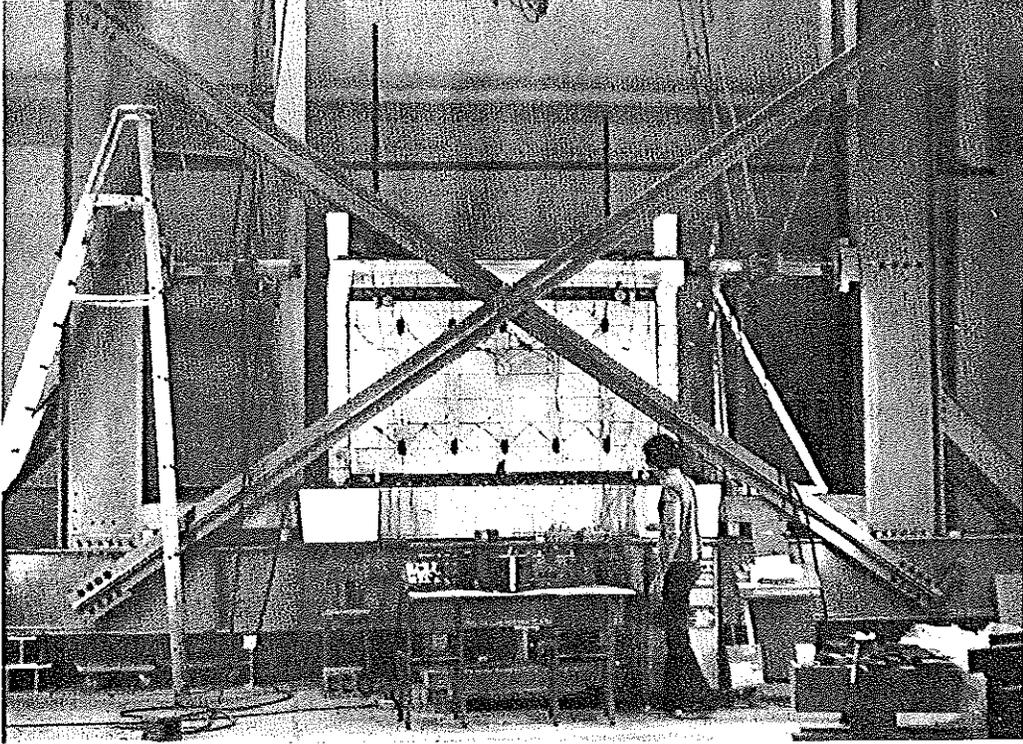
Figure 21. Test set-up for Specimen 5.

The specimens were held in position by thirty-two 1-1/4 in. diameter hold down bolts; 16 fit vertically down through holes in each foundation block and fastened to the bottom steel beams.

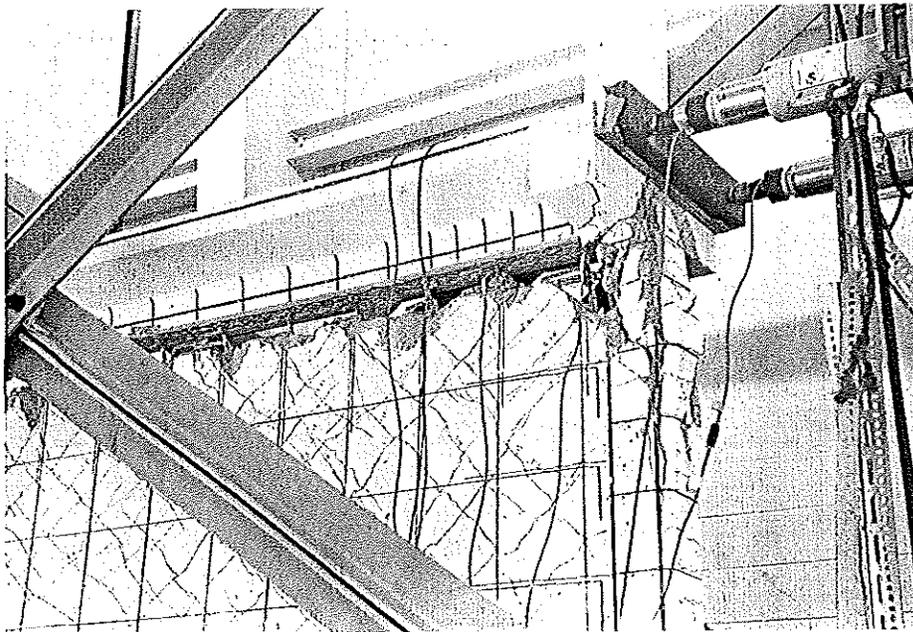
Figure 22. Two jack load system. Specimen 3 shown deflected to -1.3 in.

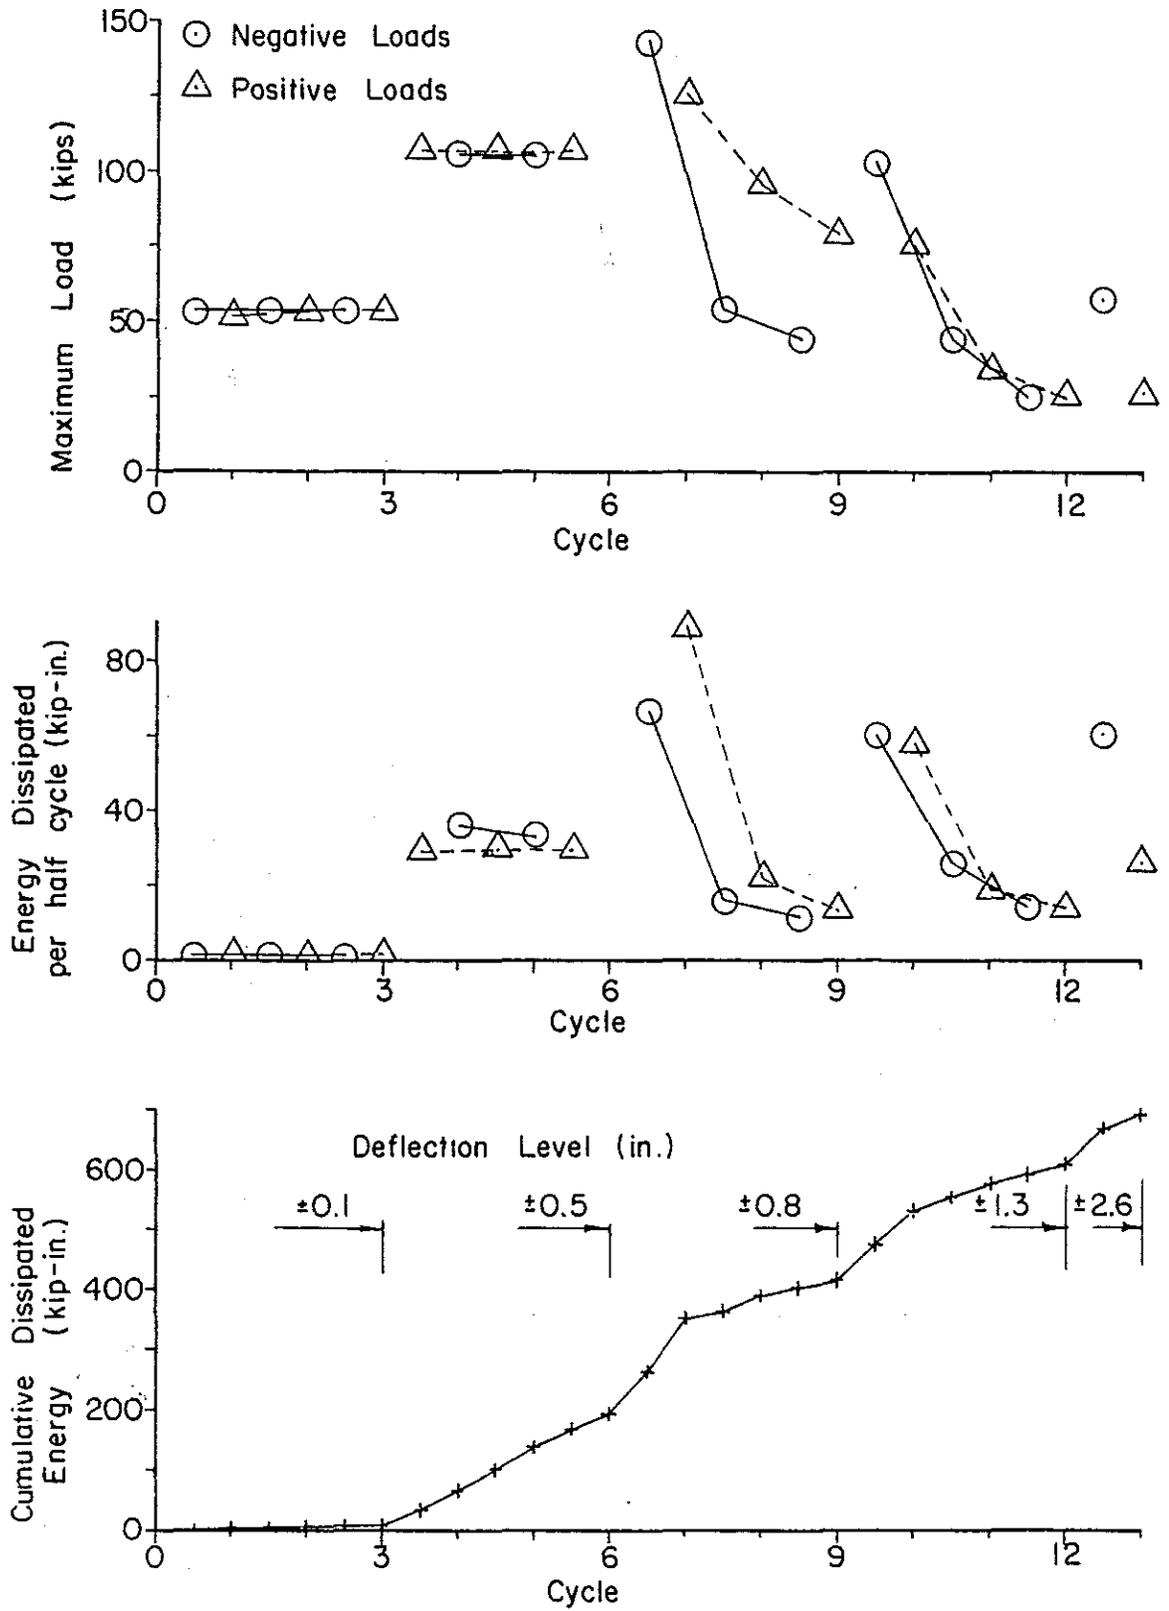
Figure 28. Specimen 1, summary of maximum load and energy dissipation data.

nor the energy dissipated decreased with succeeding cycles. First yield of the column reinforcement occurred in the base of the negative column at cycle 3-1/2 with a load of 106.9 kips and +0.51 in. deflection. The first six cycles were at or below the yield load.

Energy Dissipation. The energy dissipated in each half cycle for the five specimens has been shown in Figures 28, 32, 34, 37 and 41. Within the three cycles of any deflection level the energy dissipated per half cycle decreased with succeeding cycles at a rate greater than that at which maximum load capacity decreased. Decreased energy dissipation primarily resulted because the load-deflection hysteresis curves degenerated to the shear-slip type; the loops became more narrow (Figures 23 through 27).

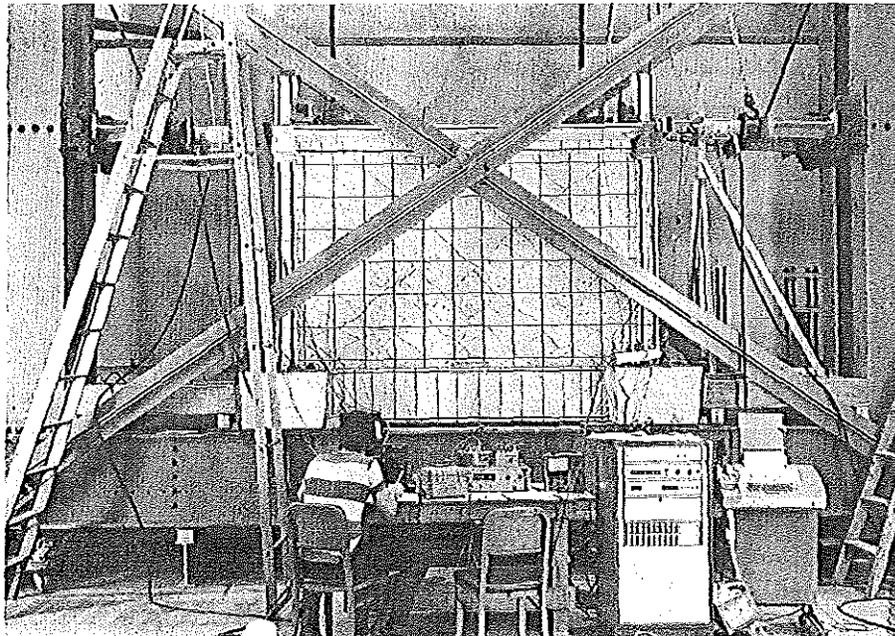
Figure 29. Specimen 1, after three cycles to  $+0.8$  in.

With continued cycles to  $+0.8$  in. the base of the wall cracked extensively, and a compression-diagonal shear failure developed at the base of the positive column (Figure 29). Maximum load in each half cycle degraded greatly.

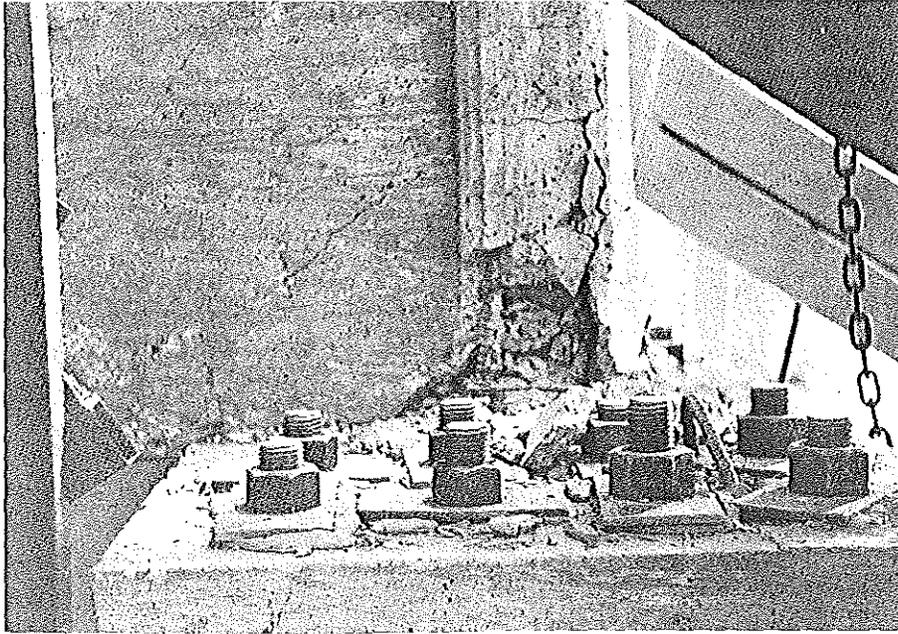
Figure 30. Specimen 1, base of positive column after cycles to  $\pm 1.3$  in.

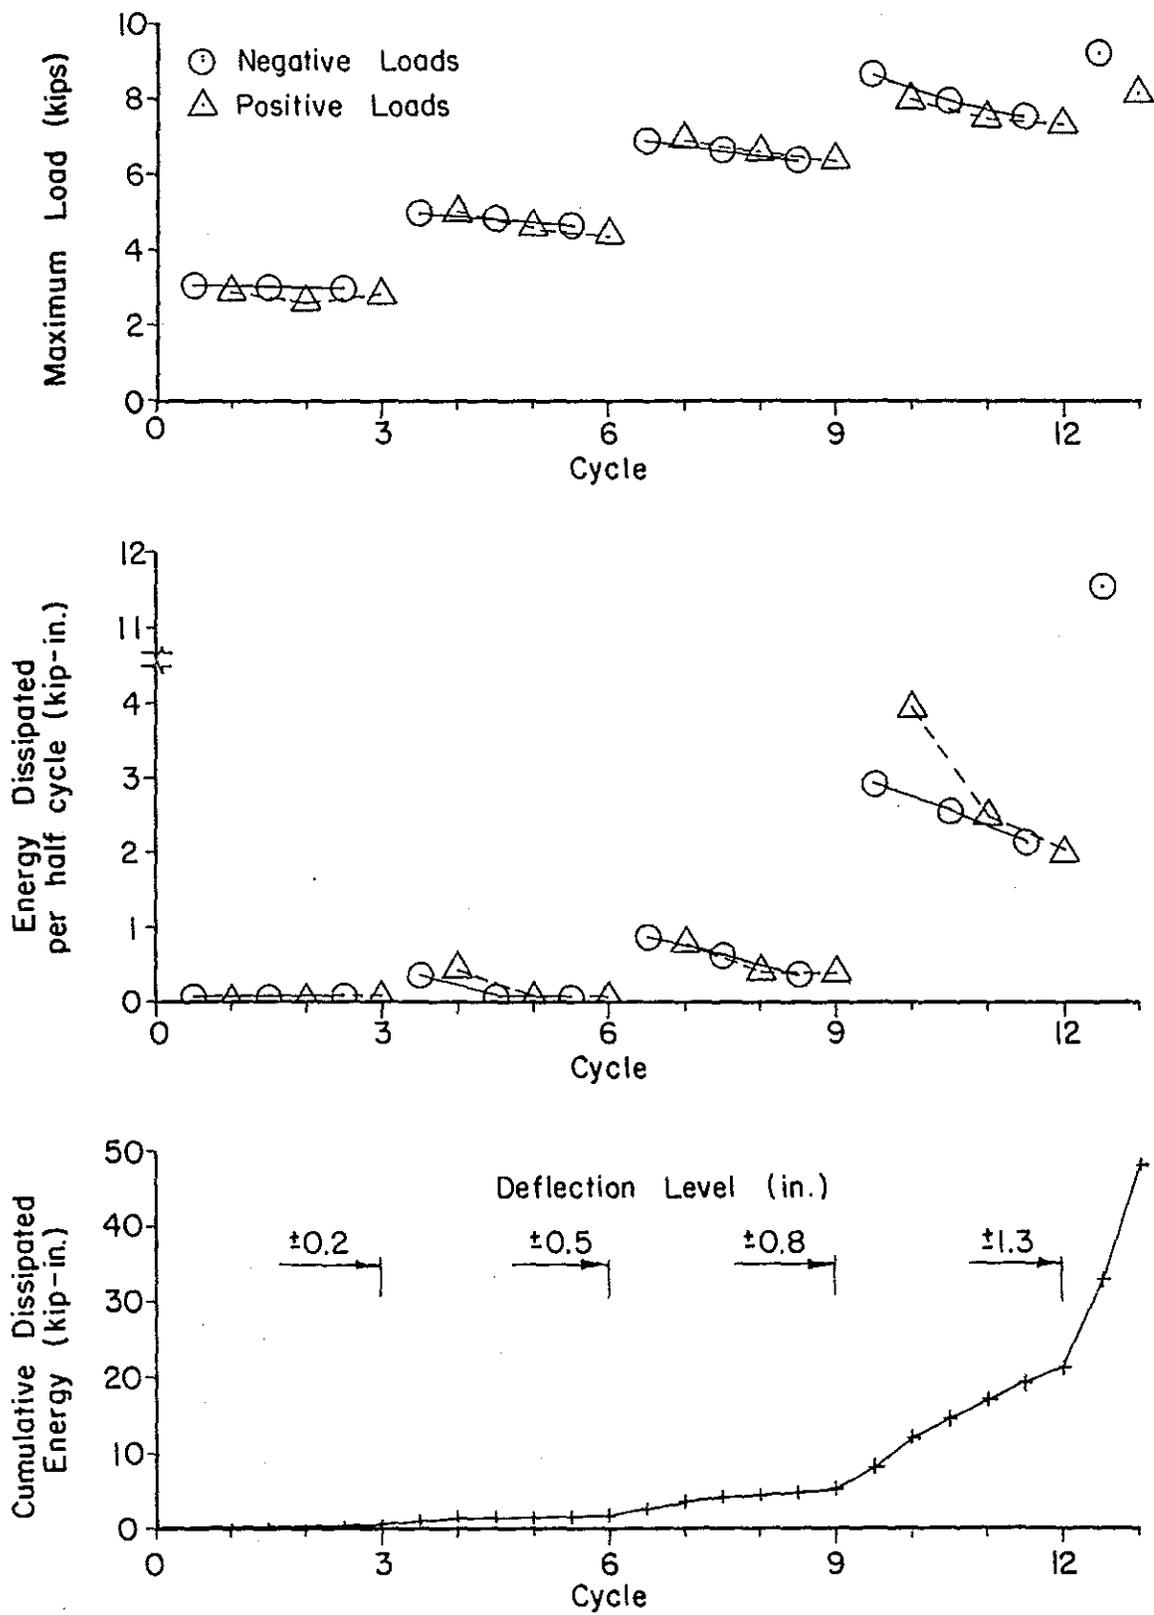
Figure 32. Specimen 2, summary of maximum load and energy dissipation data.

Figure 32 presents the data summary for Specimen 2. Column reinforcement first yielded in tension at a deflection of  $-0.80$  in. and  $-6.4$  kips during cycle 6-1/2. The data show that before and after yielding the maximum load degraded little, only 12 percent at the  $\pm 1.3$  in. deflection level. The load-deflection hysteresis

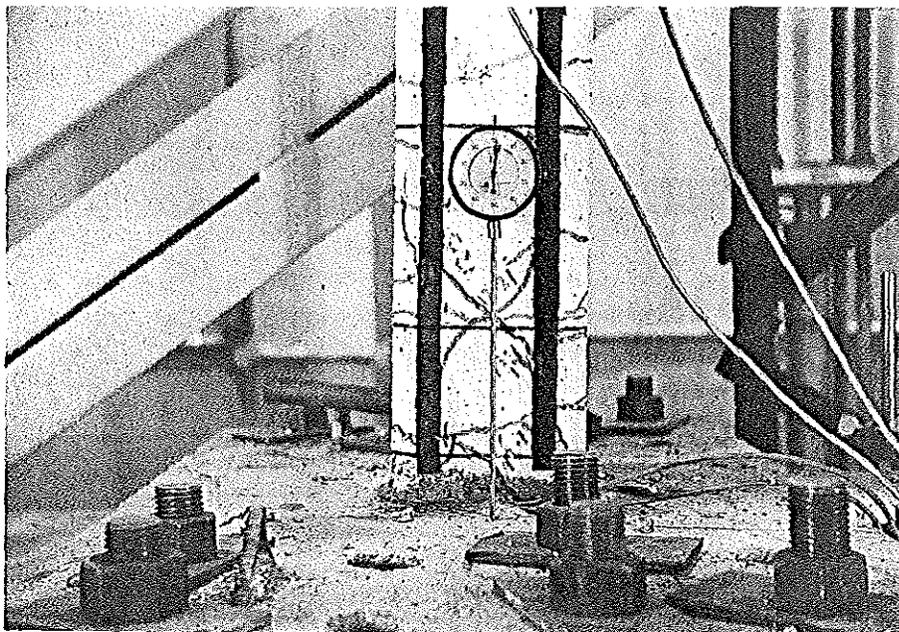
Figure 33. Specimen 2, negative column after completed test.

curves did degenerate to a shear-slip type with increased cycles as each column elongated at its base (an average strain of 0.003 in./in. over a 10 in. gage length after twelve cycles).

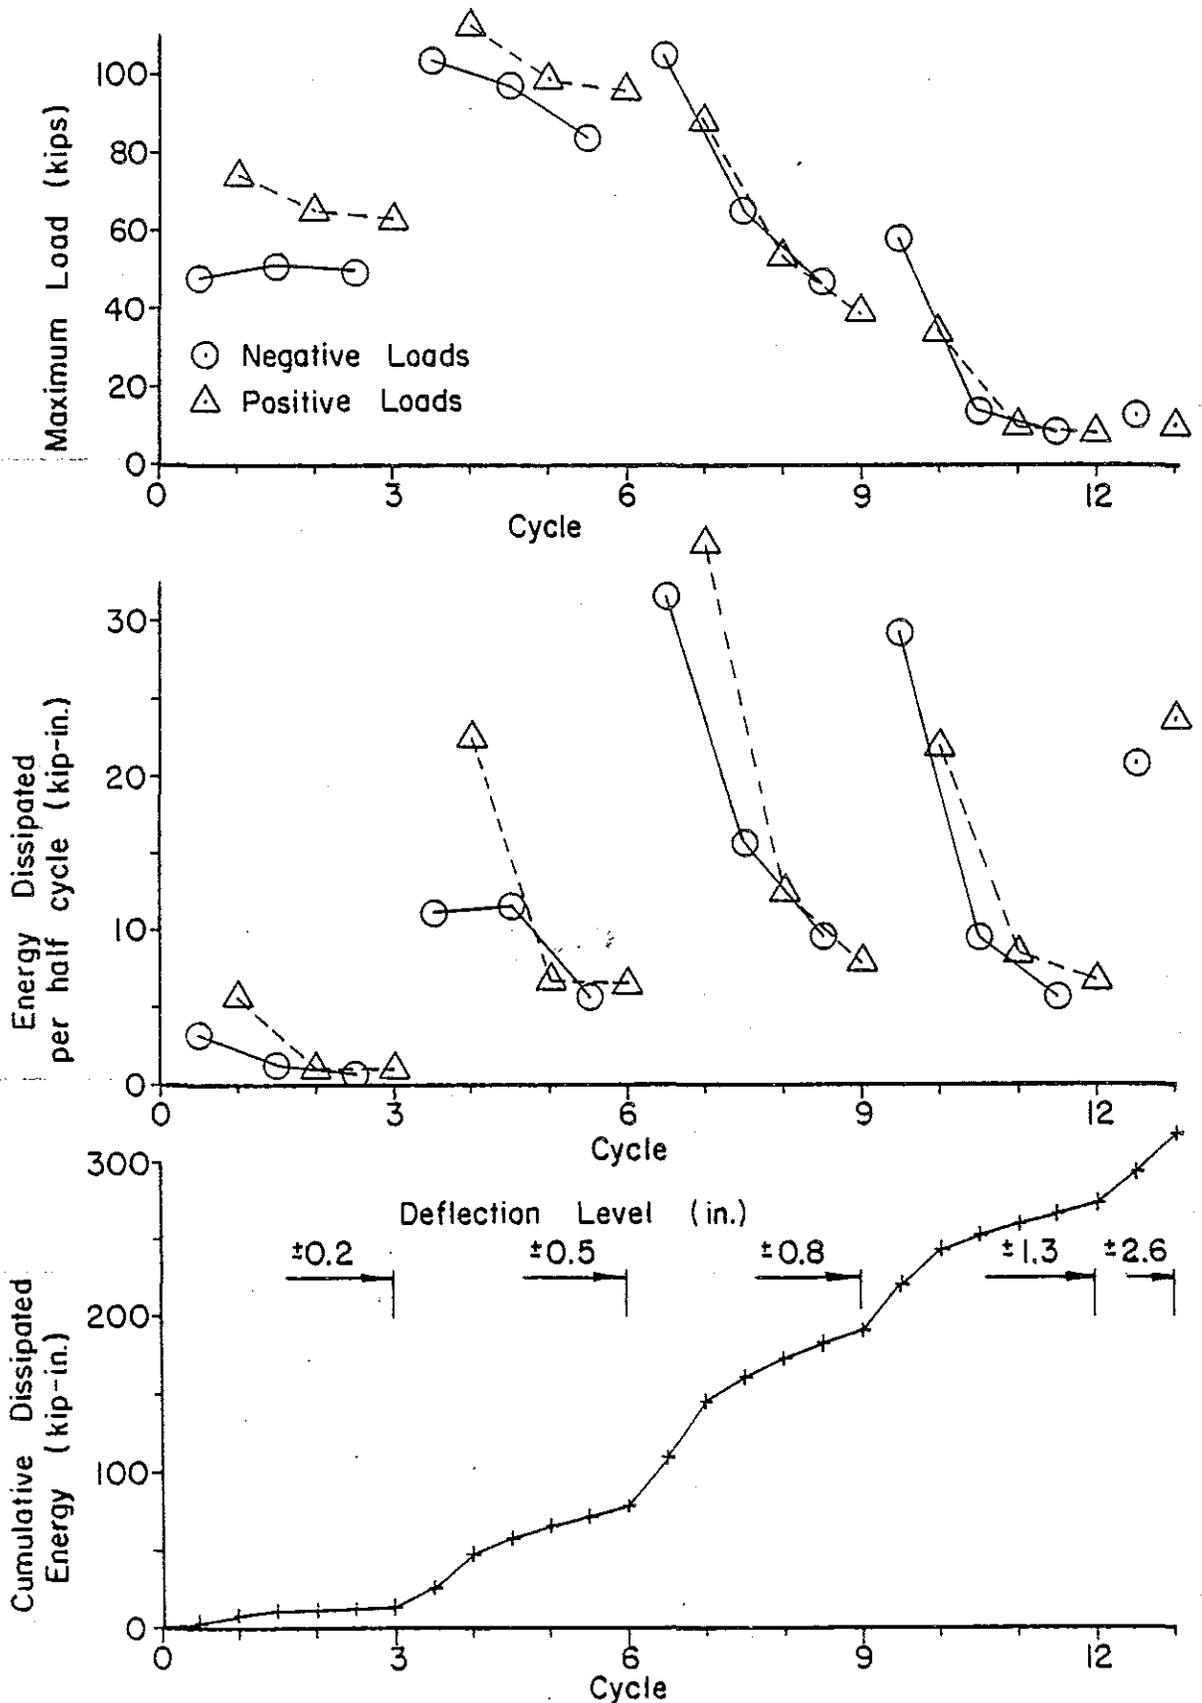
Figure 34. Specimen 3, summary of maximum load and energy dissipation data.

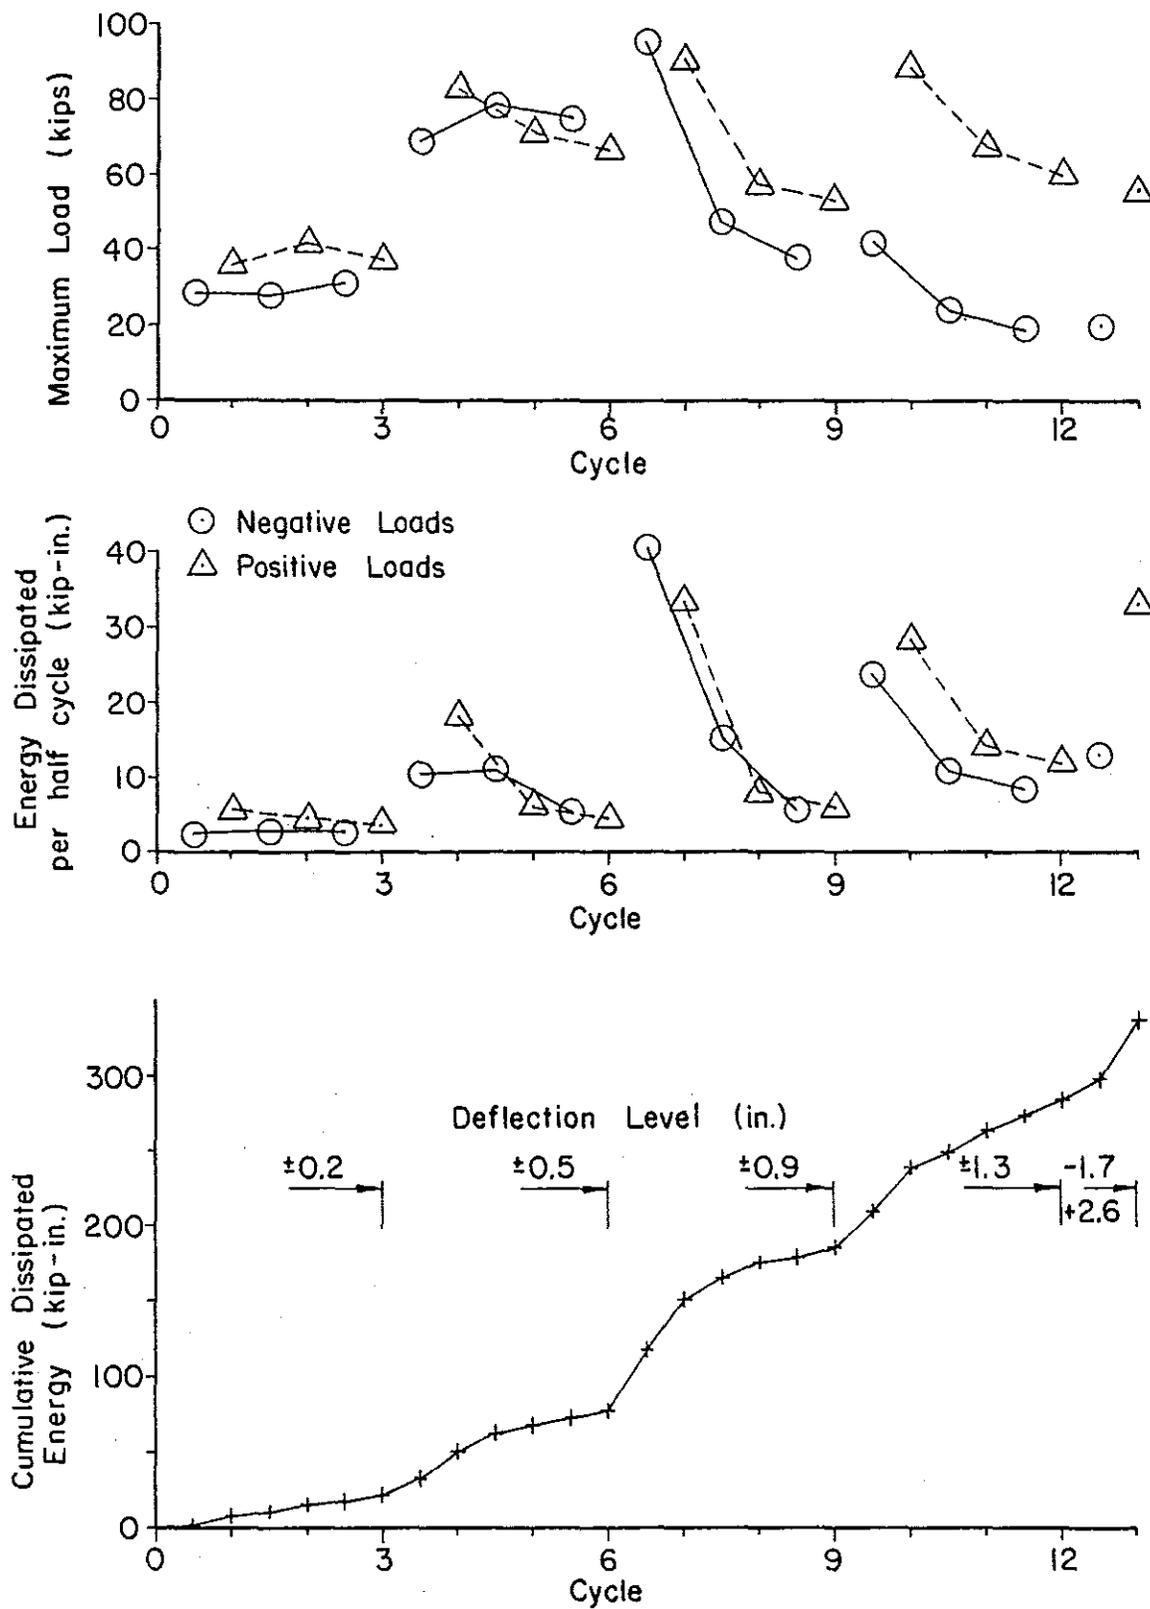
Figure 37. Specimen 4, summary of maximum load and energy dissipation data.

Cracking and strain data indicated that the structure responded with a combined frame and shear wall behavior. Columns were subjected to flexure plus net tension or compression. The wall strains showed a compression zone from the top loaded corner diagonally down to the opposite base corner. Relative slip movement between the panel and the frame equaled about one-half the total lateral deflection.

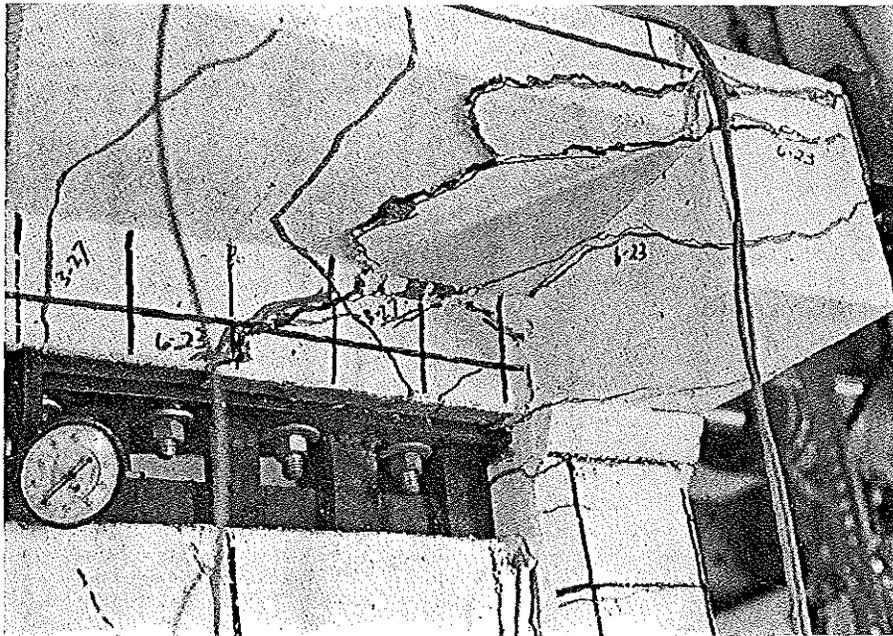
Figure 38. Specimen 4, shear failure of top beam.

During cycle 6-1/2 at -0.78 in. deflection and -95.5 kips, the top beam failed in diagonal tension-shear as shown in Figure 38. The failure was precipitated by failure of welds connecting the ear plates to the embedded panel plate in the upper positive corner and by the pullout of the anchor bolts in the lower positive corner. With failure of the connection between the wall and top beam, the beam's shear span increased from about 1 in. to 1 ft.; and diagonal tension-shear failure resulted. Reversed loading did not cause similar weld failure, anchor pullout, or beam failure at the negative side of the specimen.

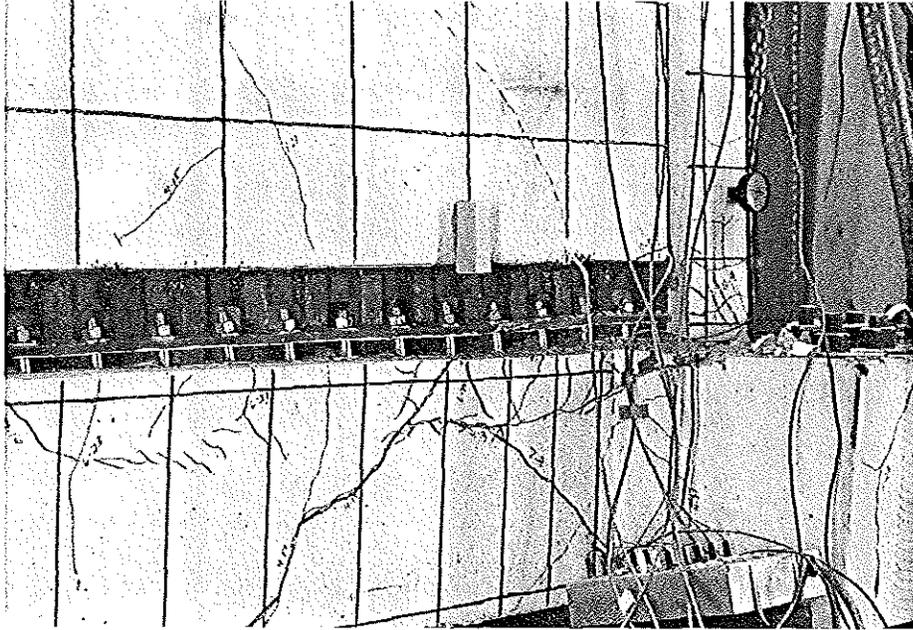
Figure 39. Specimen 4, anchor bolts pulled out at positive end of base beam at  $-1.68$  in.
