REINFORCED CONCRETE INFILLED SHEAR WALLS  
FOR ASEISMIC STRENGTHENING

Report on Research Conducted under Grant  
No. GI-39123 from the National Science Foundation

Report UMEE 76S1  
Department of Civil Engineering  
The University of Michigan  
Ann Arbor, MI 48109

January 1976

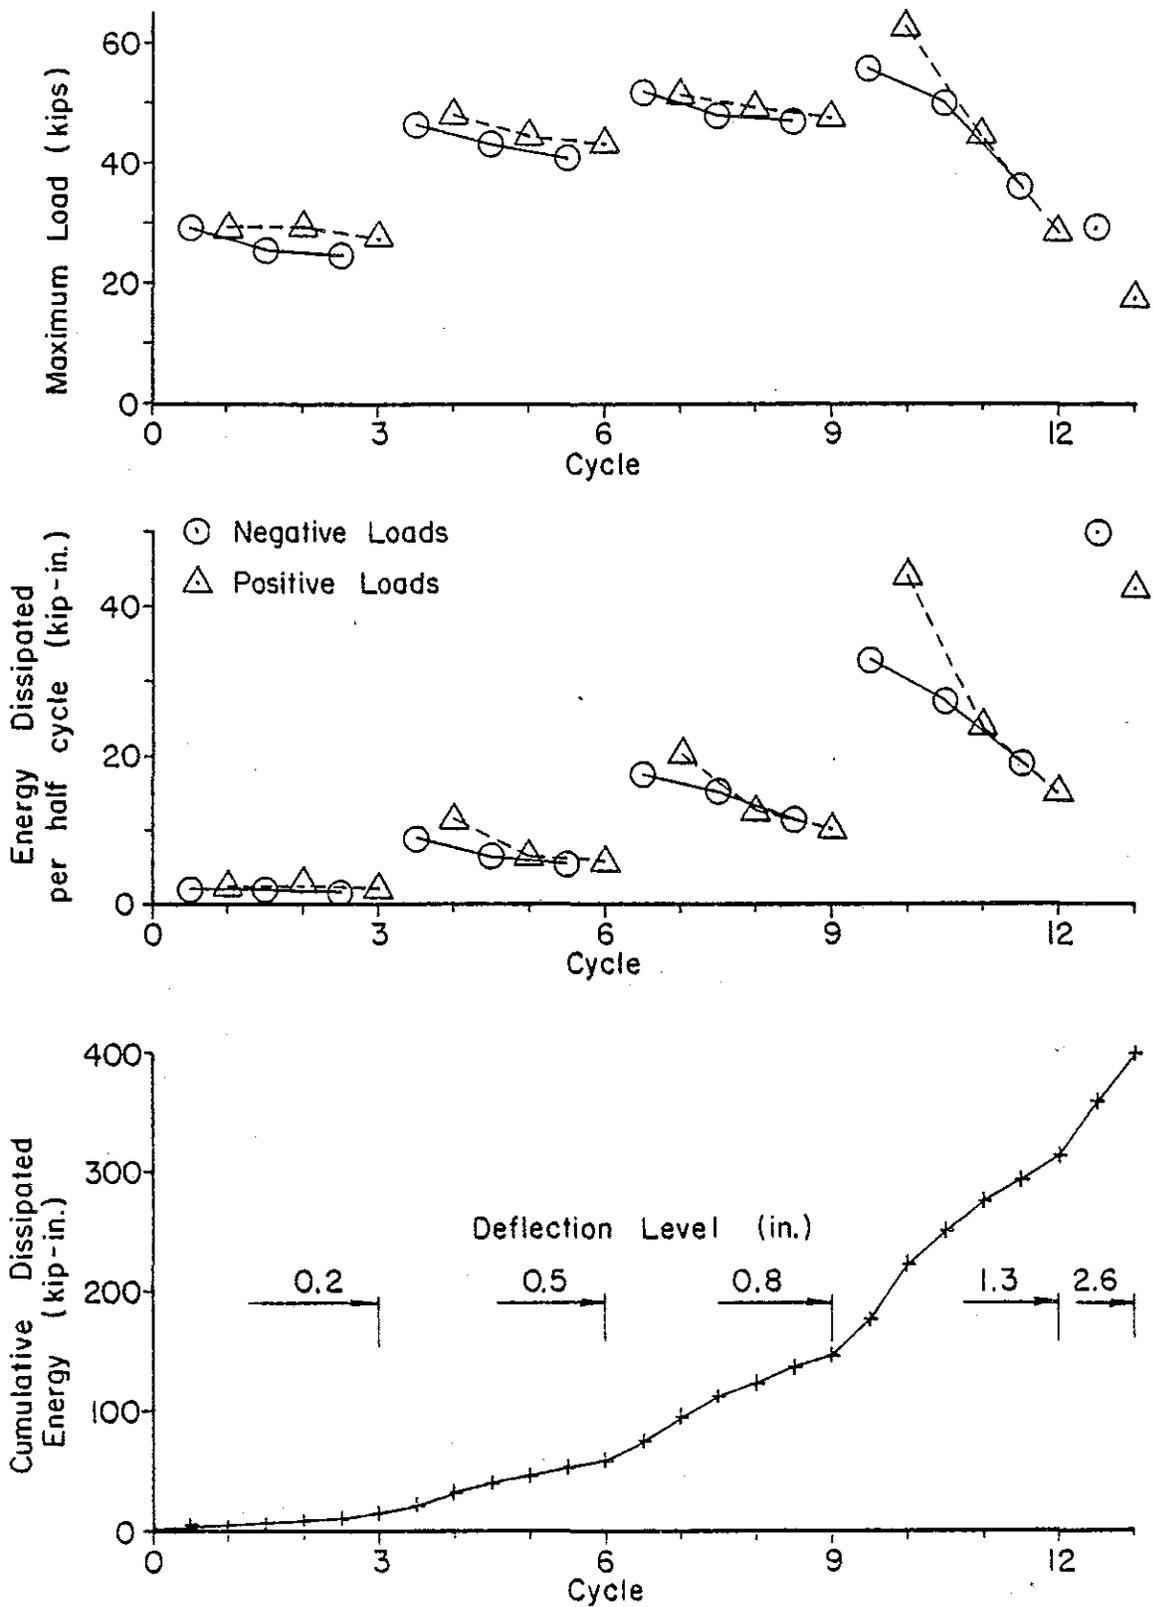
Figure 41. Specimen 5, summary of maximum load and energy dissipation data.

Energy Dissipation. The energy dissipated in each half cycle for the five specimens has been shown in Figures 28, 32, 34, 37 and 41. Within the three cycles of any deflection level the energy dissipated per half cycle decreased with succeeding cycles at a rate greater than that at which maximum load capacity decreased. Decreased energy dissipation primarily resulted because the load-deflection hysteresis curves degenerated to the shear-slip type; the loops became more narrow (Figures 23 through 27).

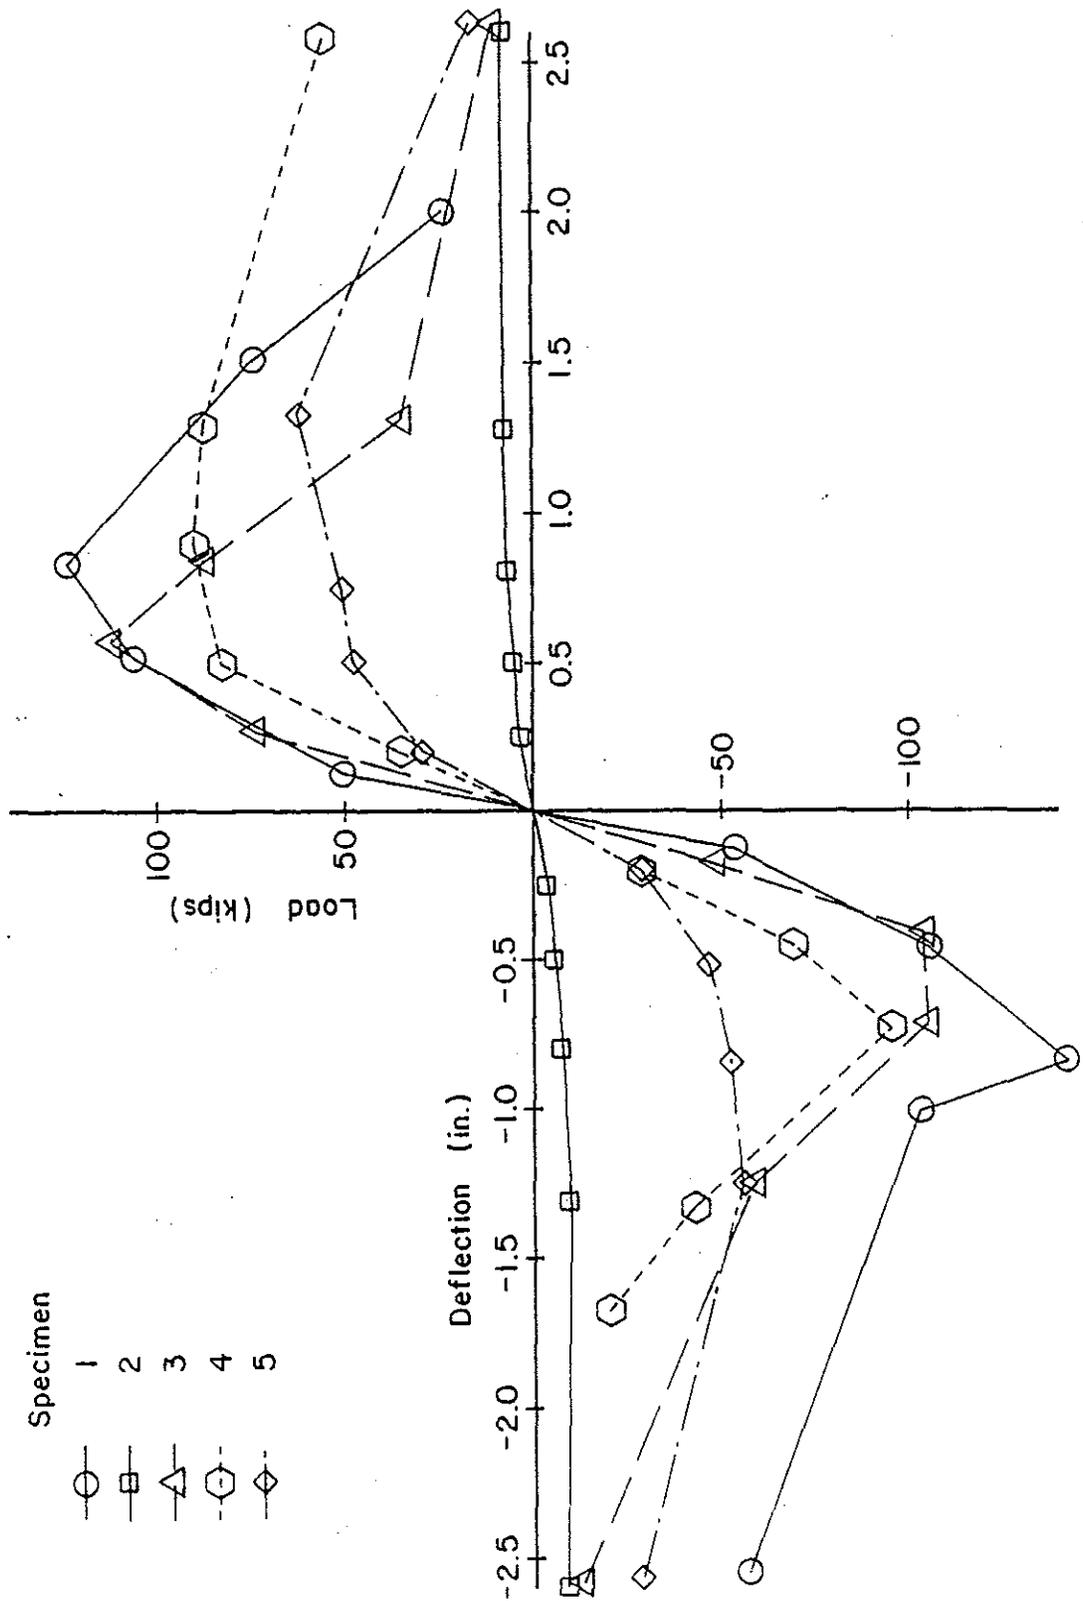
Figure 45. Maximum load-deflection envelope for the five specimens.

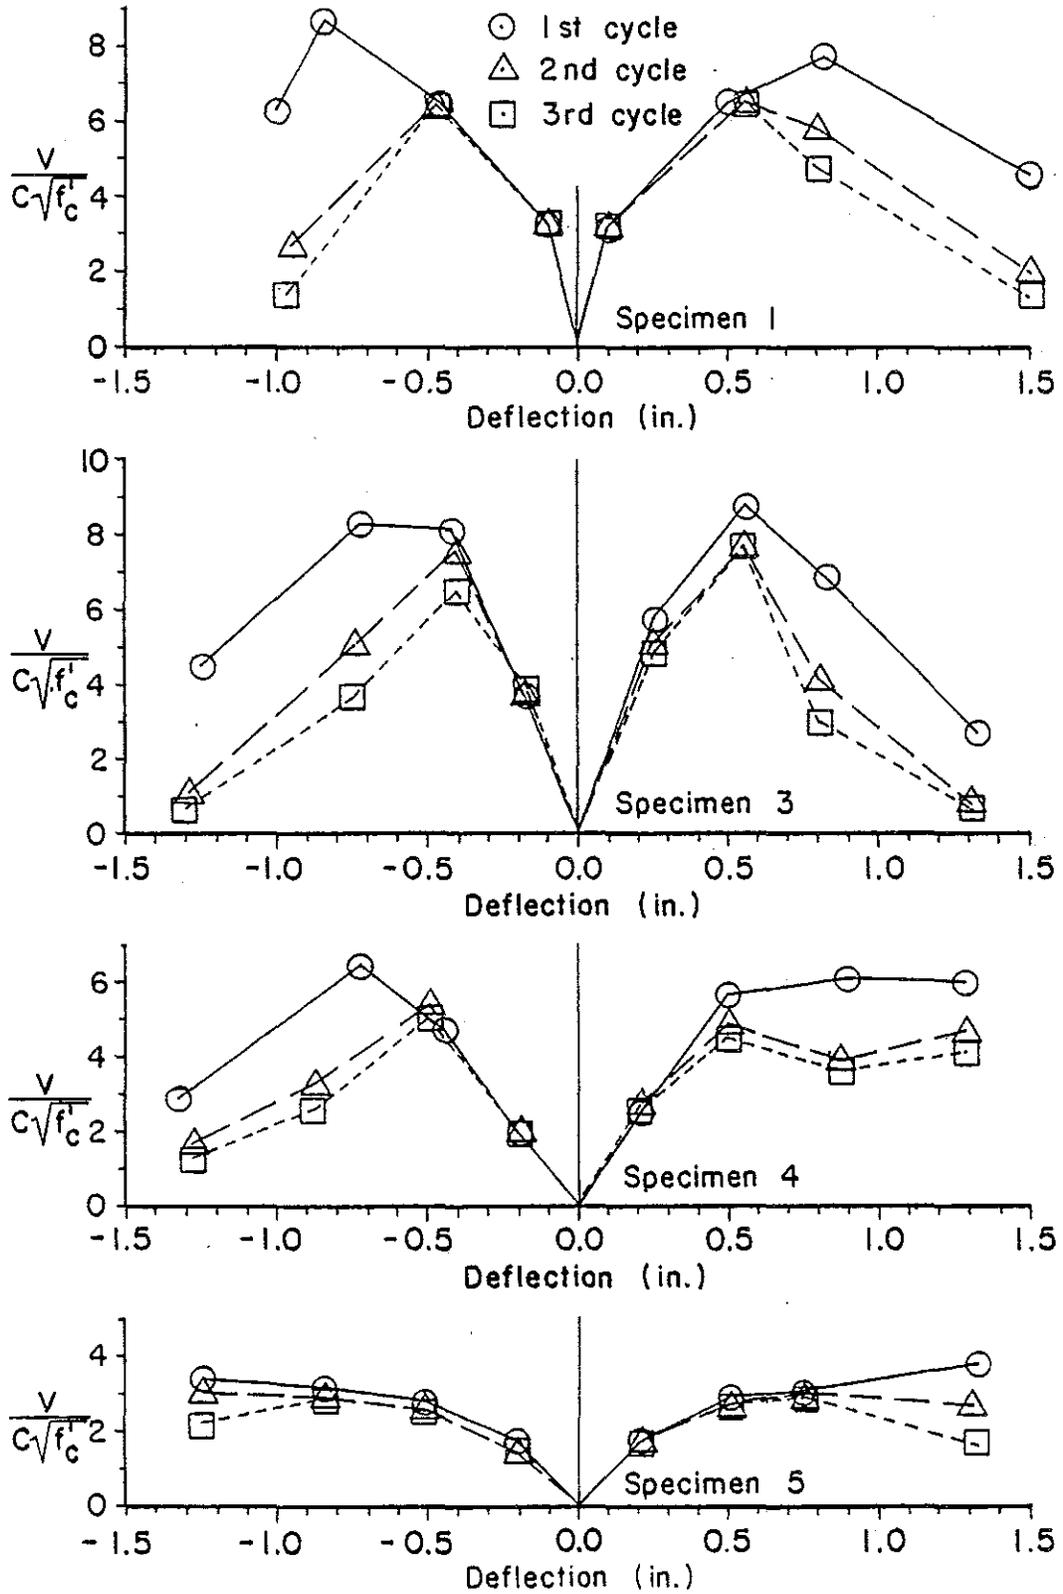
Figure 47. First, second and third cycle coefficient envelopes for Specimens 1, 3, 4 and 5 from top to bottom, respectively.

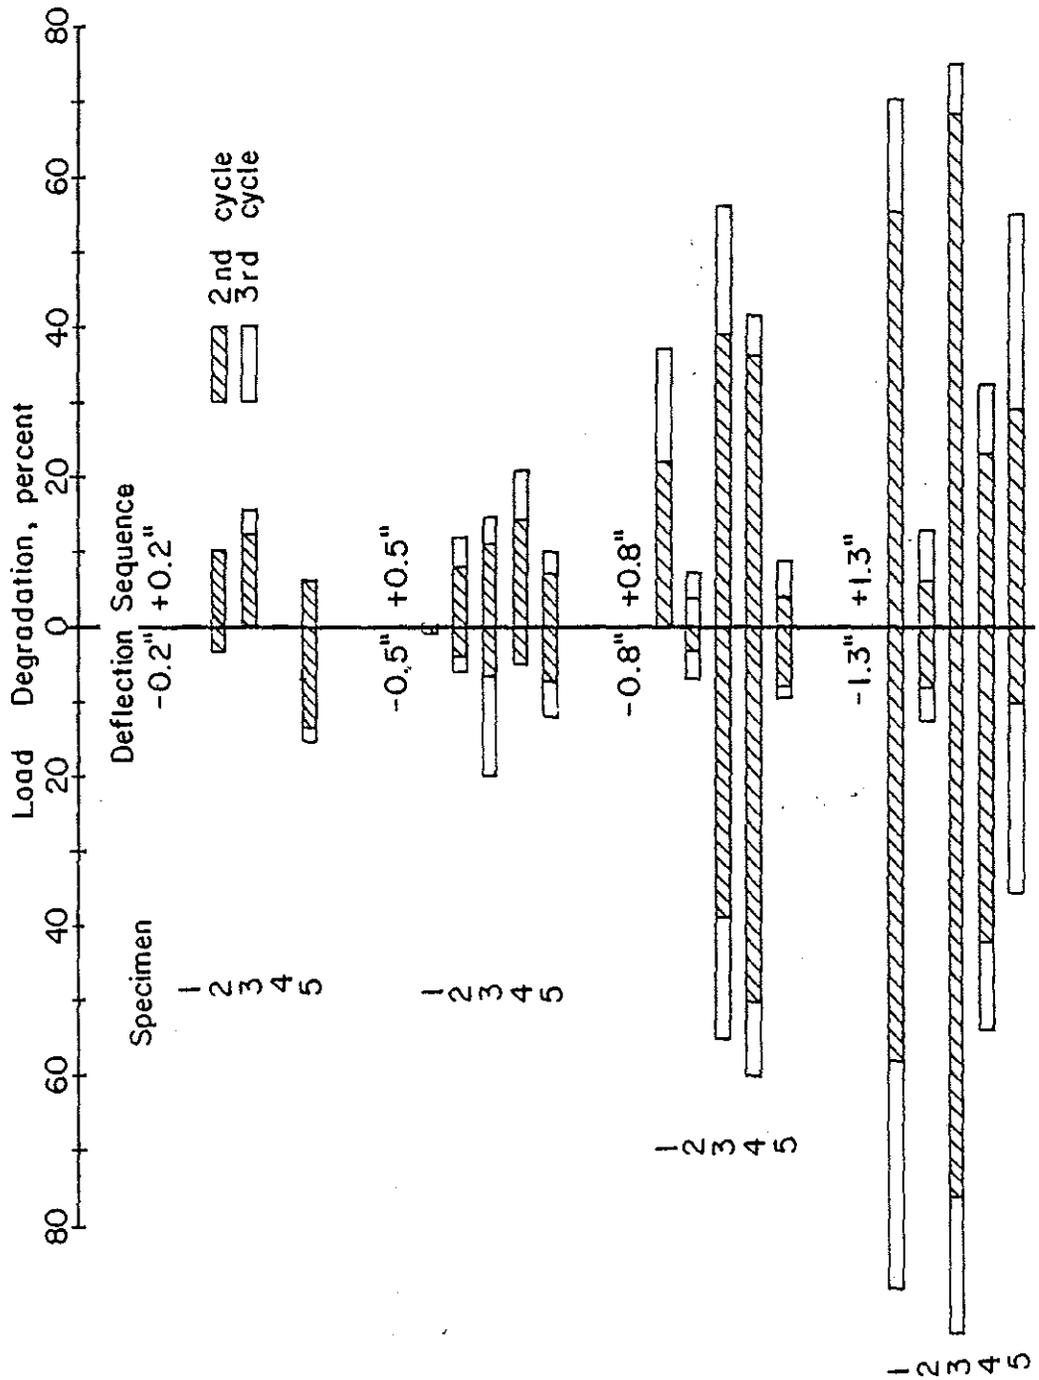
Figure 48. Load degradation as a function of deflection amplitude.

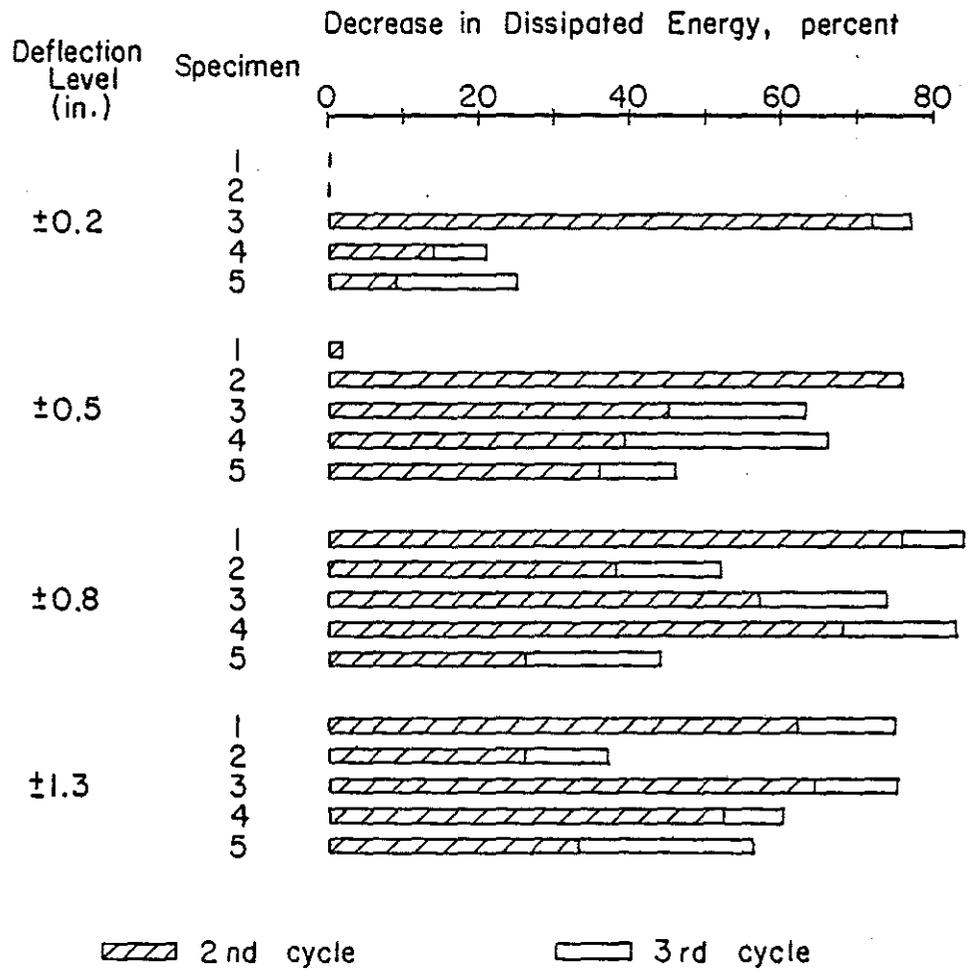
Figure 49. Decrease in energy dissipated per cycle.

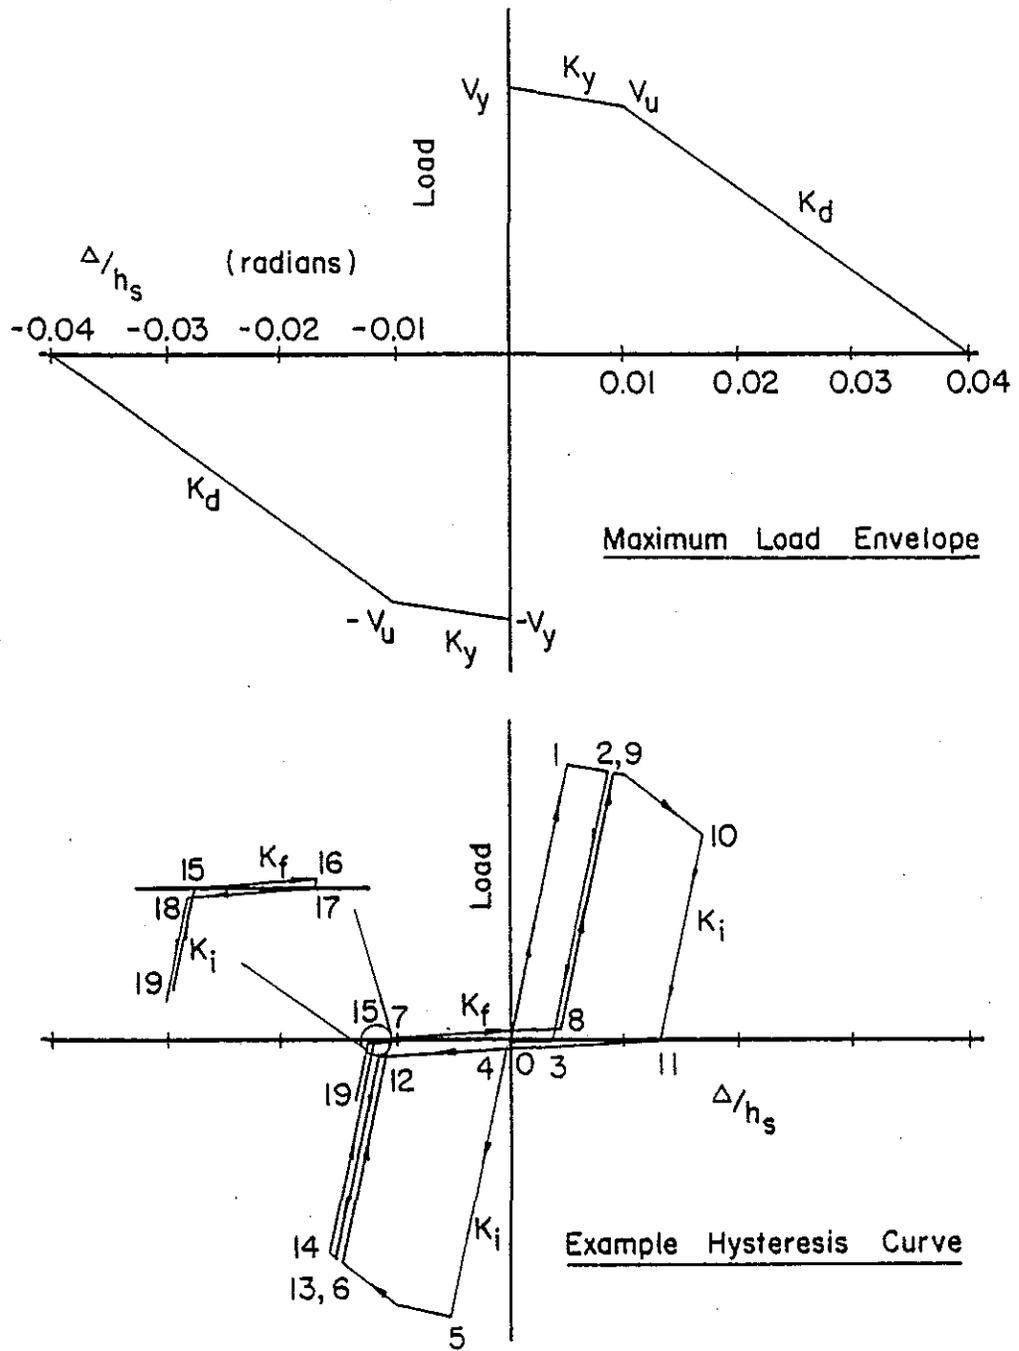
Figure 51. Load-deflection hysteresis model for infilled shear walls.

Lateral deflection is given in terms of relative story deflection,  $\Delta/h_s$ , where  $\Delta$  is the lateral deflection and  $h_s$  is

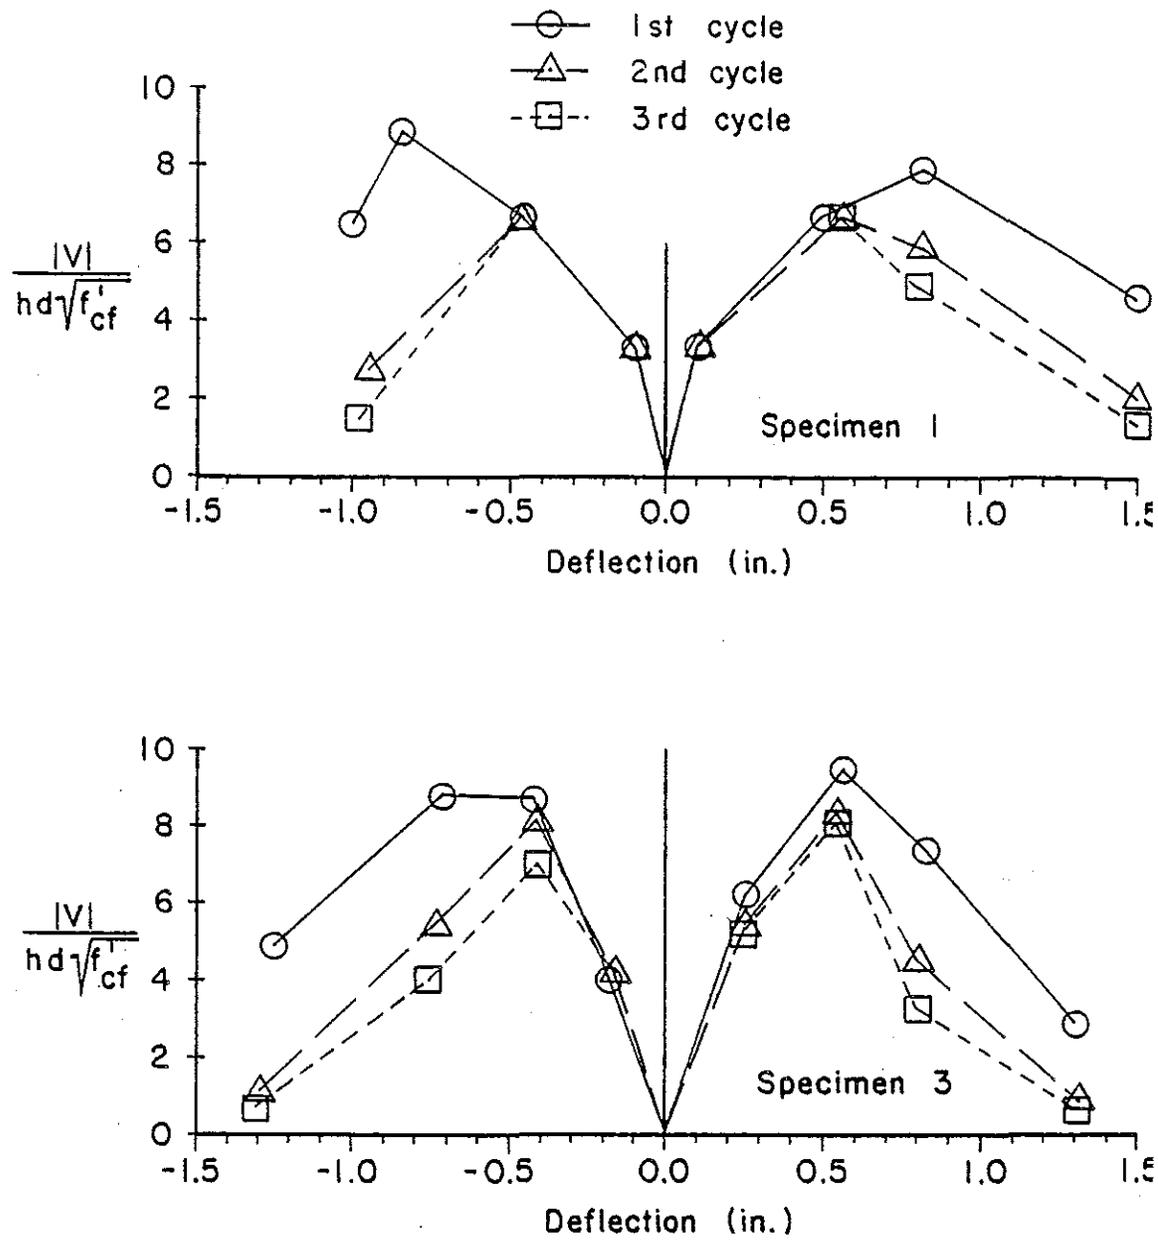
Figure 52. Modified stress coefficient envelopes for Specimens 1 and 3.

First, second and third cycle envelopes of the modified stress coefficients are given in Figure 52 for Specimens 1 and 3 and in

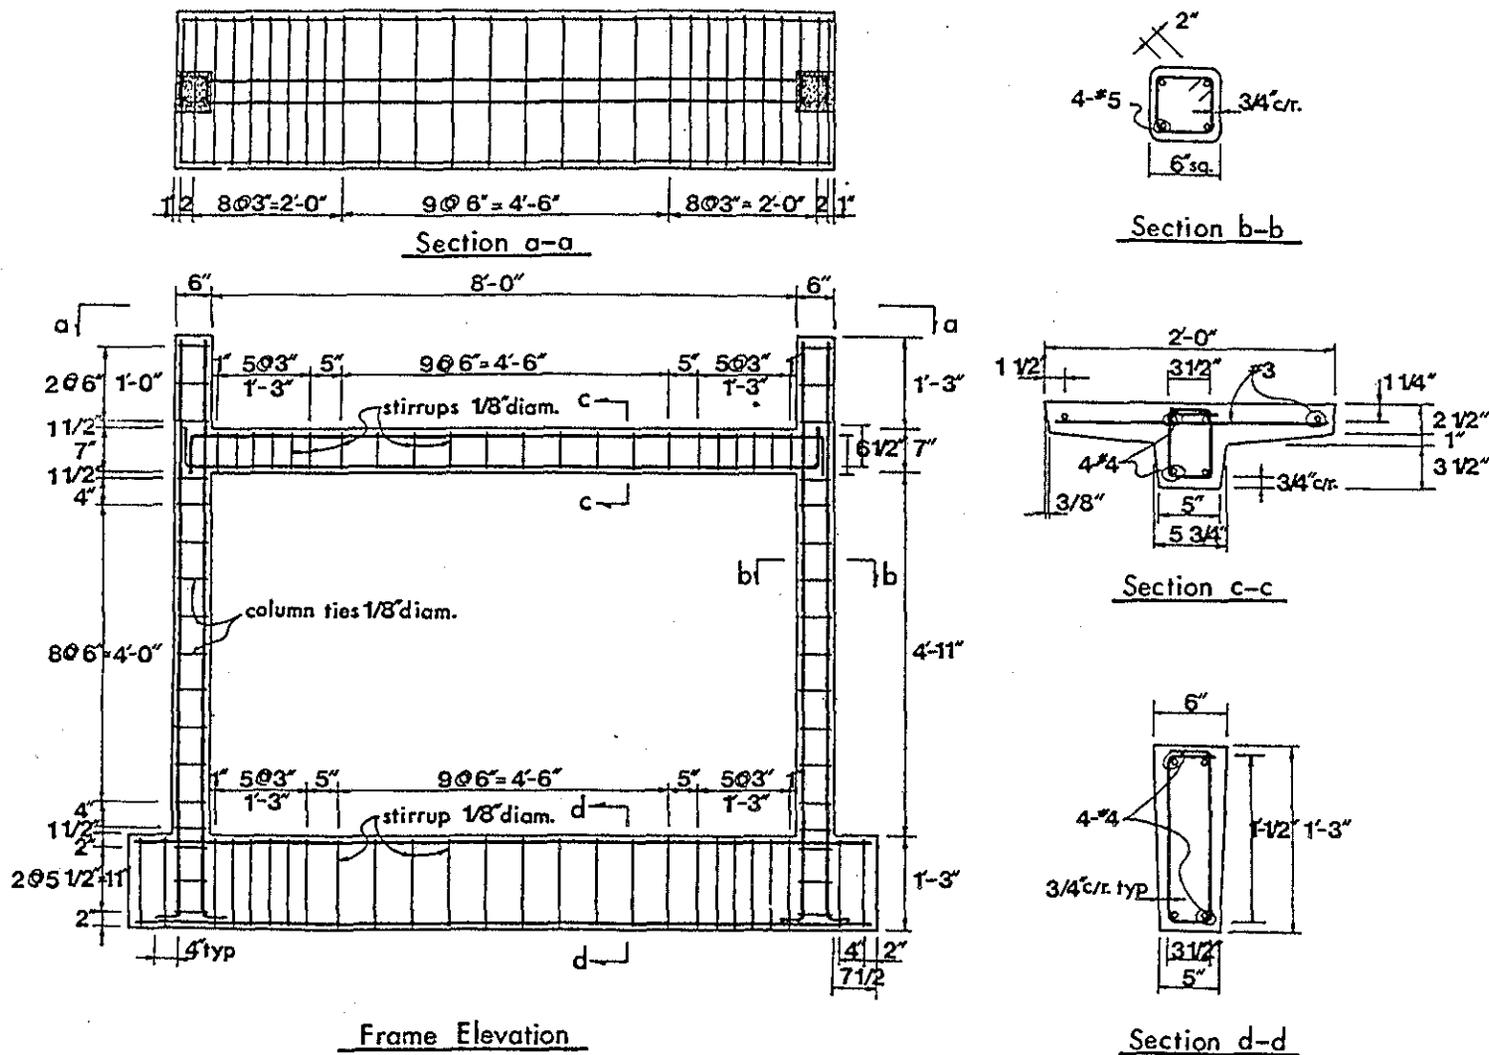
Figure B-1. Design of model frame, Specimen 2.

Frame Reinforcement Details

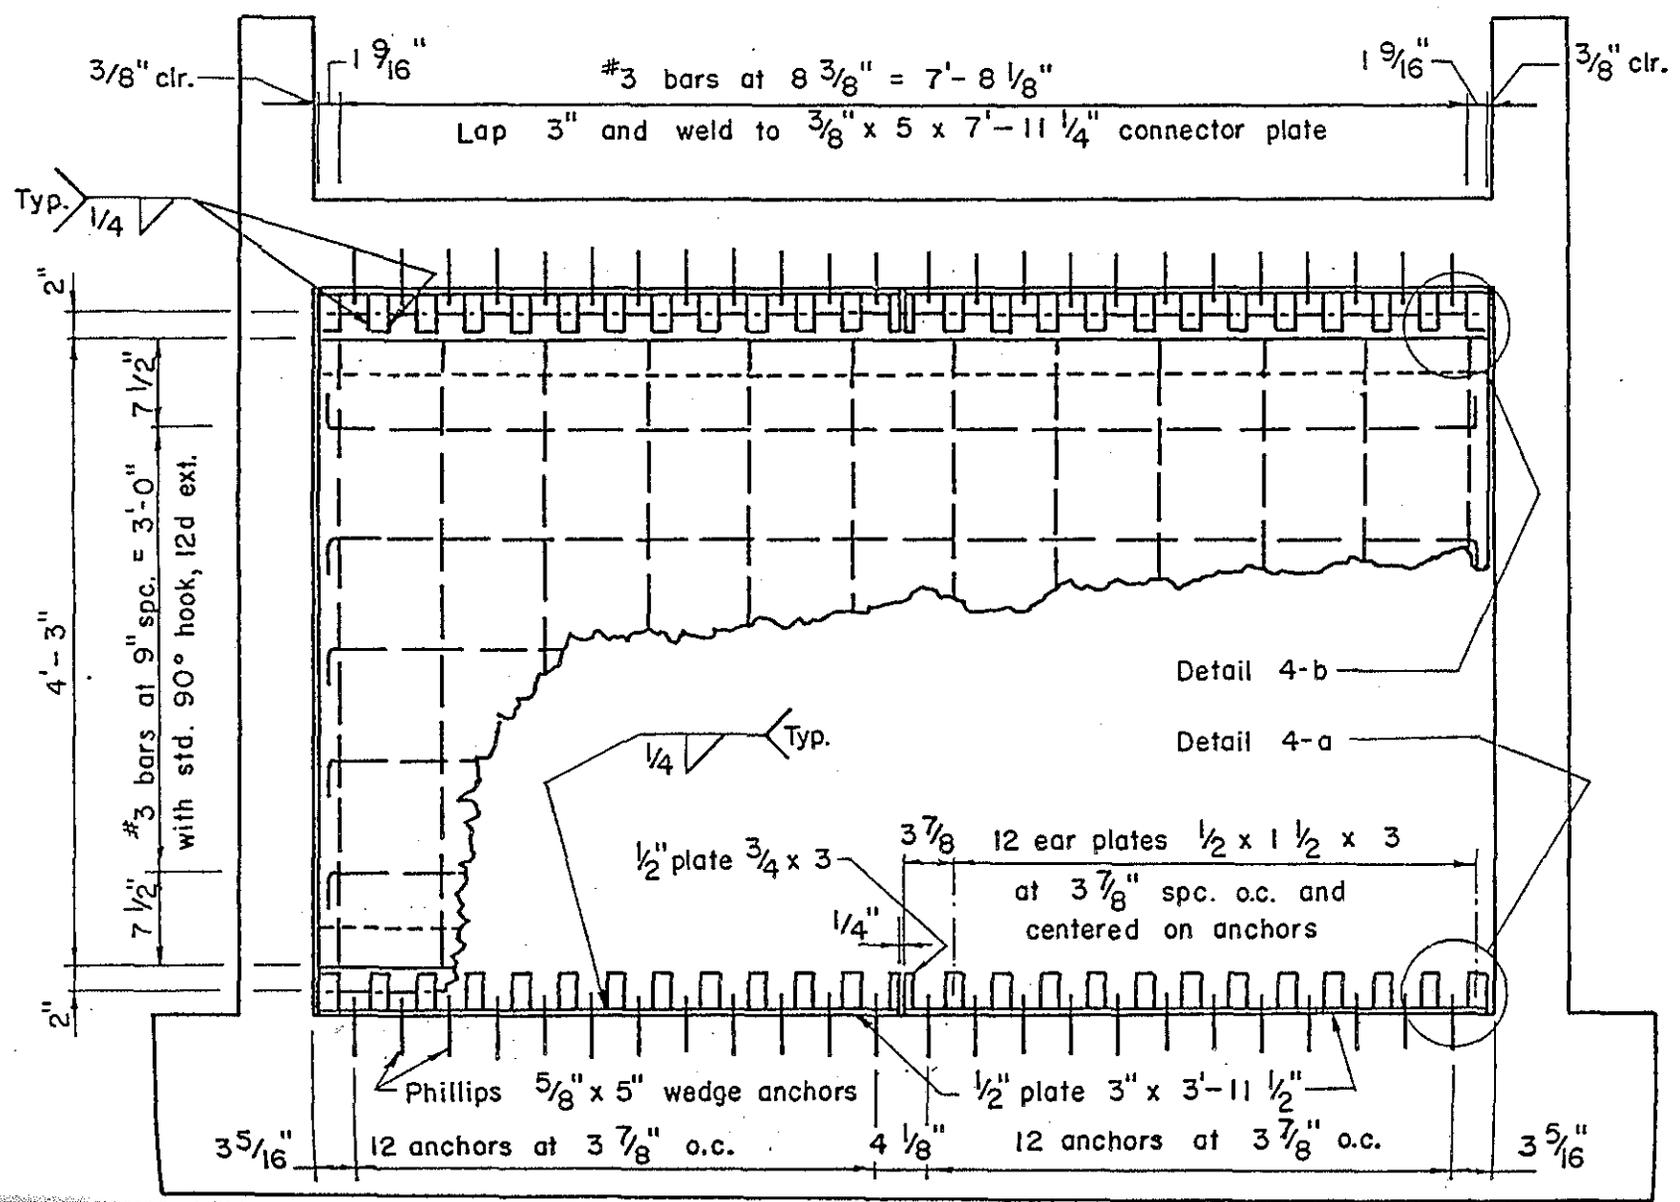
Figure B-5. Design of single precast panel wall, Specimen 4.

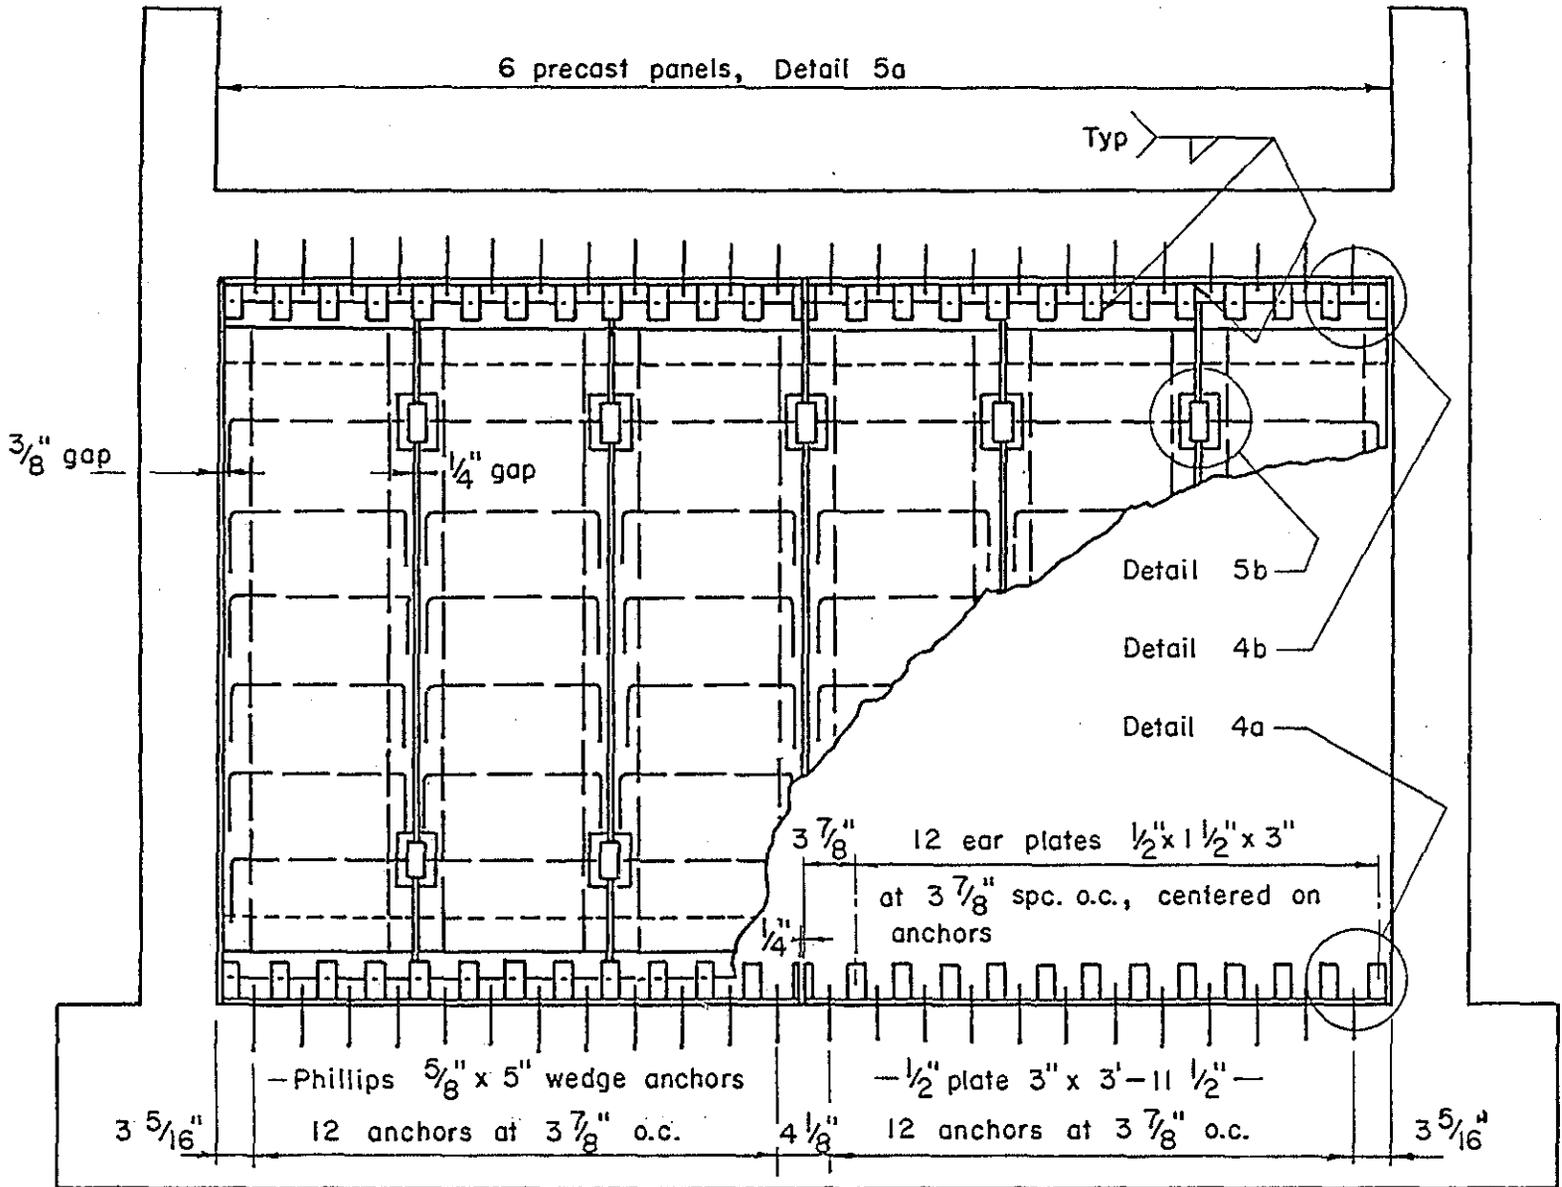
Figure B-8. Design of multiple precast panel wall, Specimen 5.

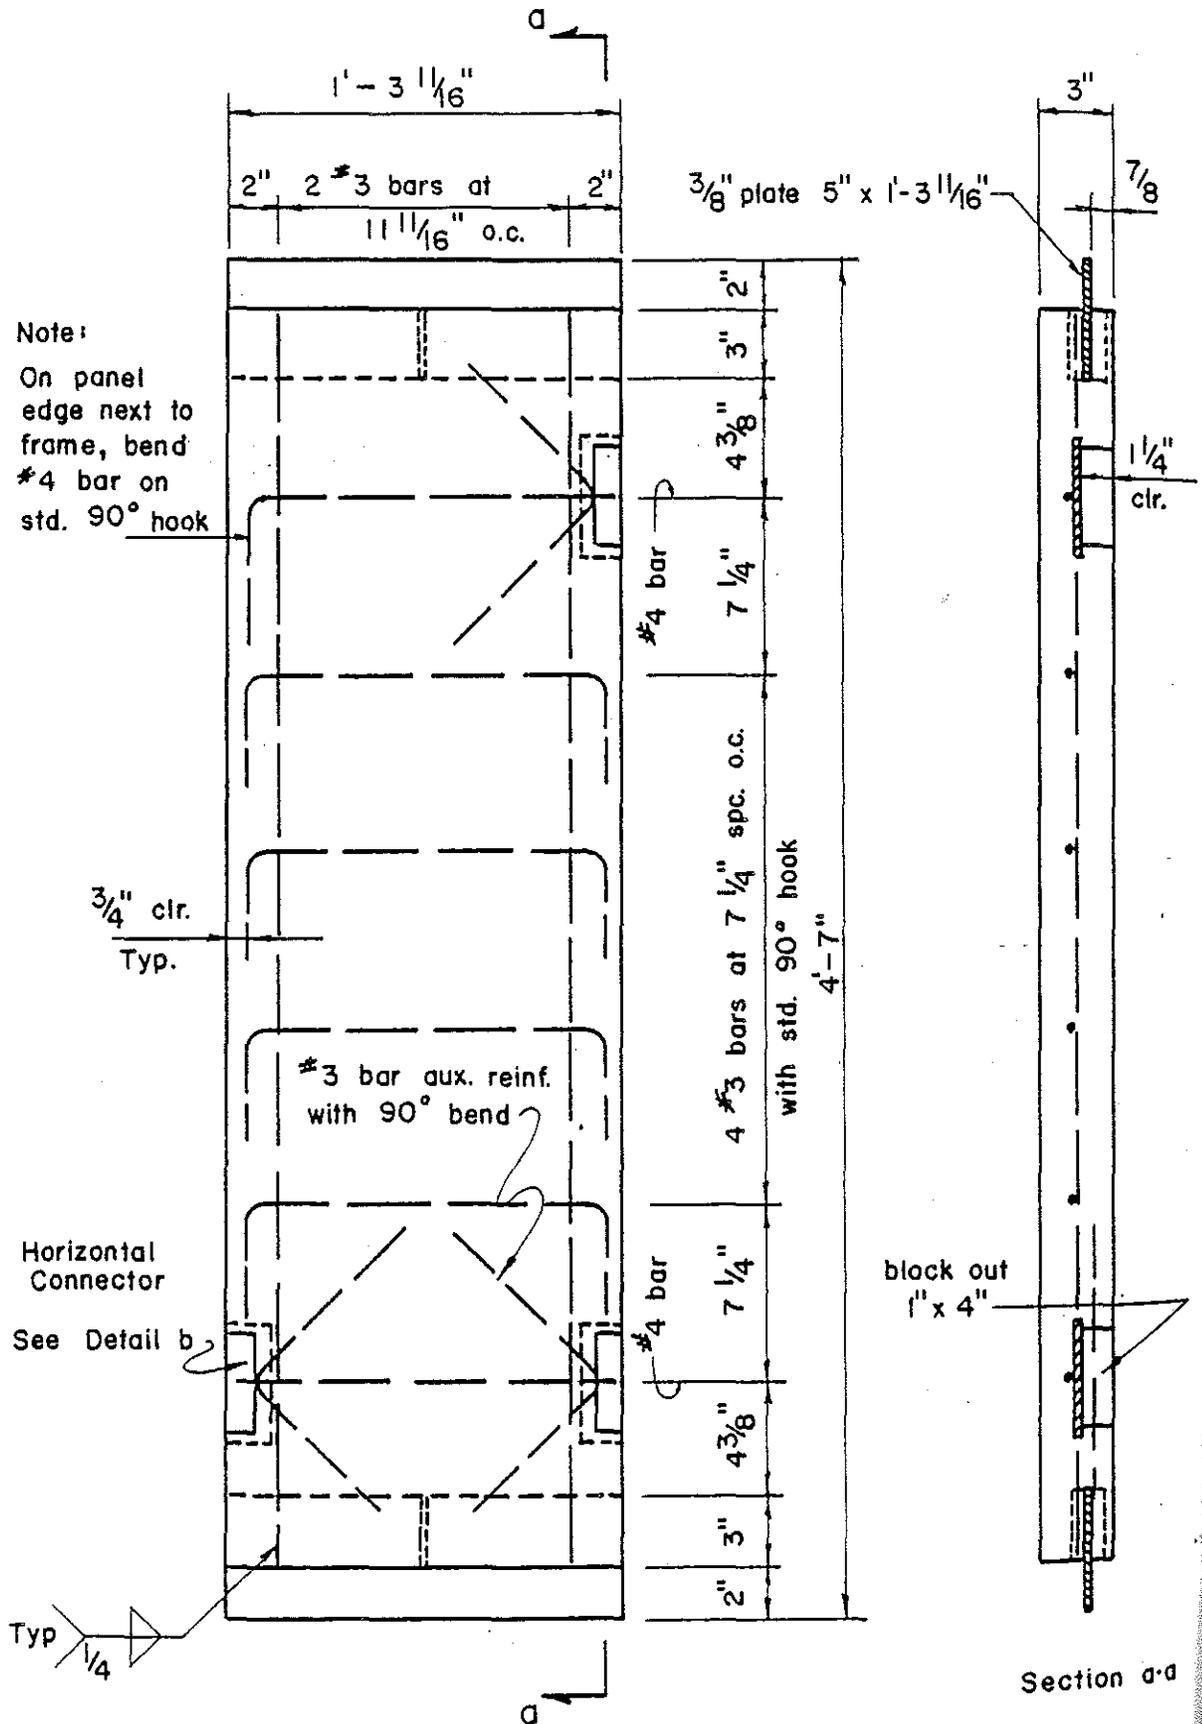
Figure B-9. Detail design of a multiple precast panel unit.

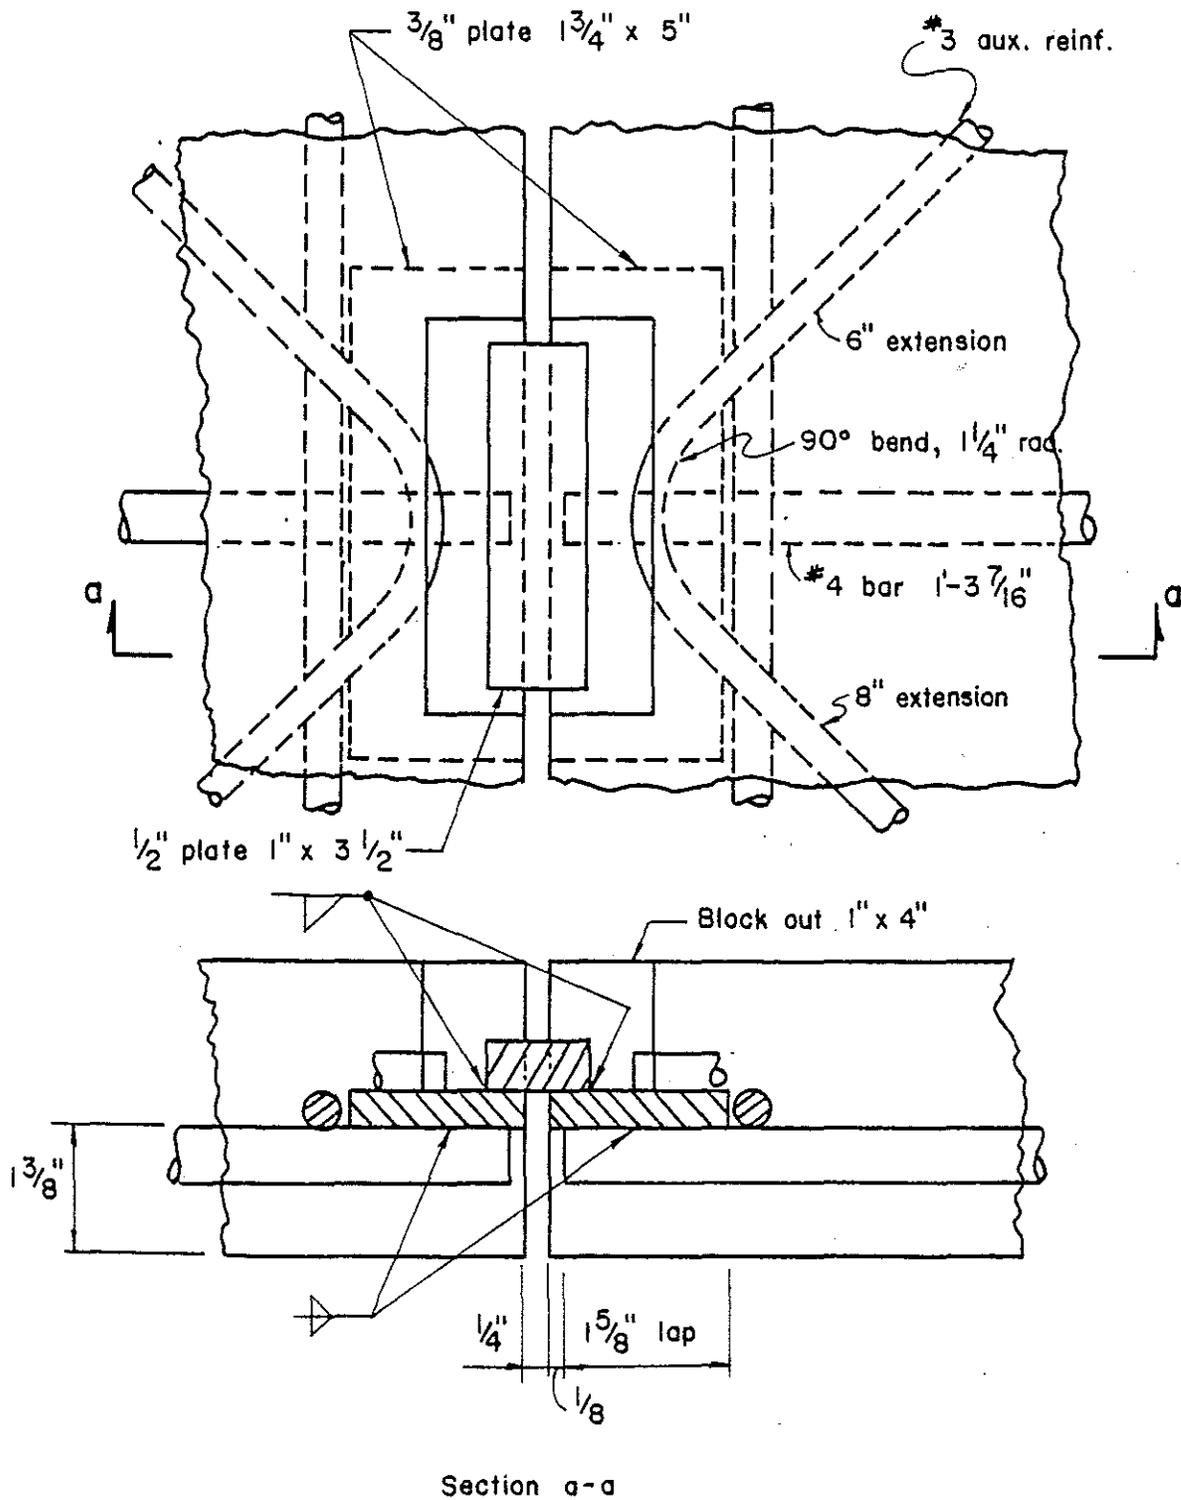
Figure B-10. Detail of panel-to-panel connection.

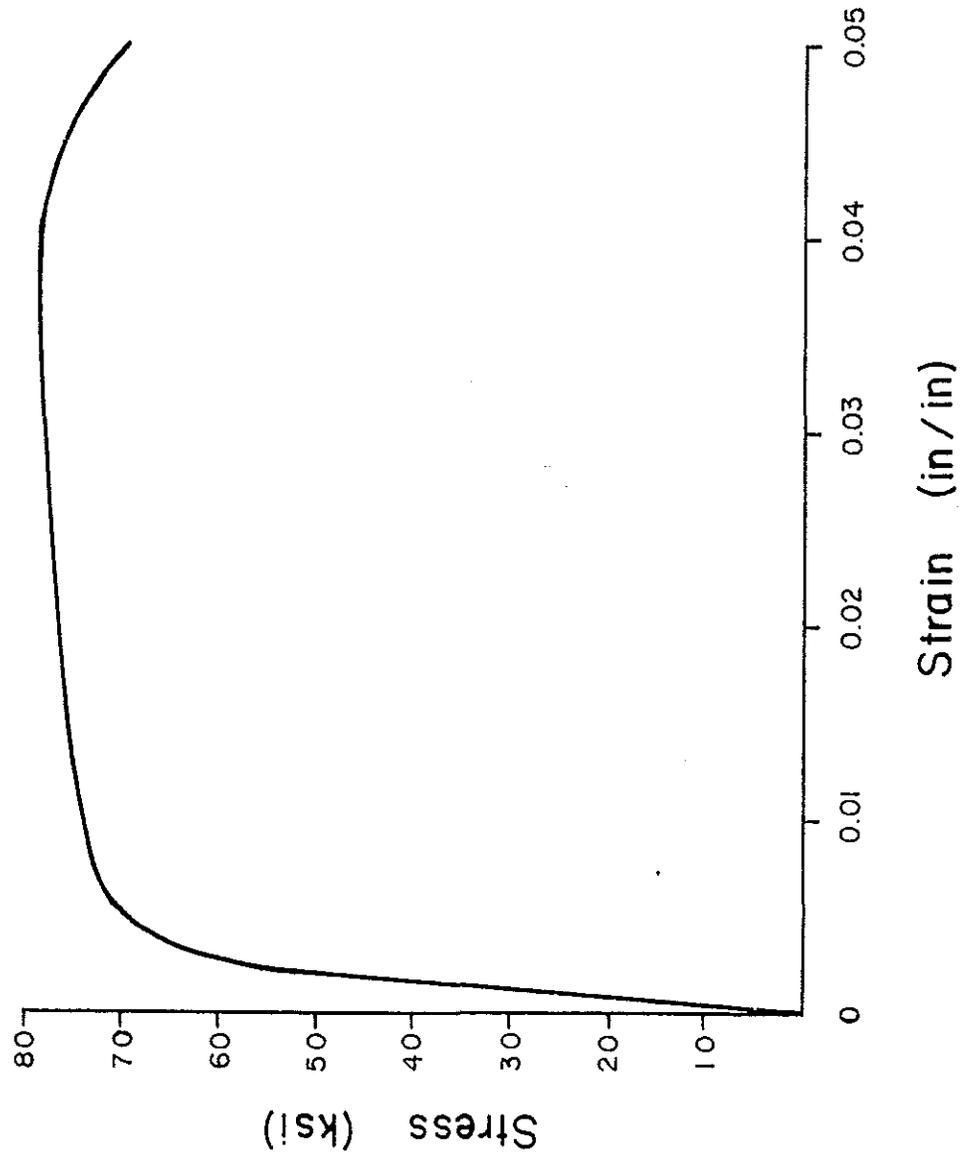
Figure C-1. Average stress-strain behavior of "as delivered" 11 gage plain steel bar.

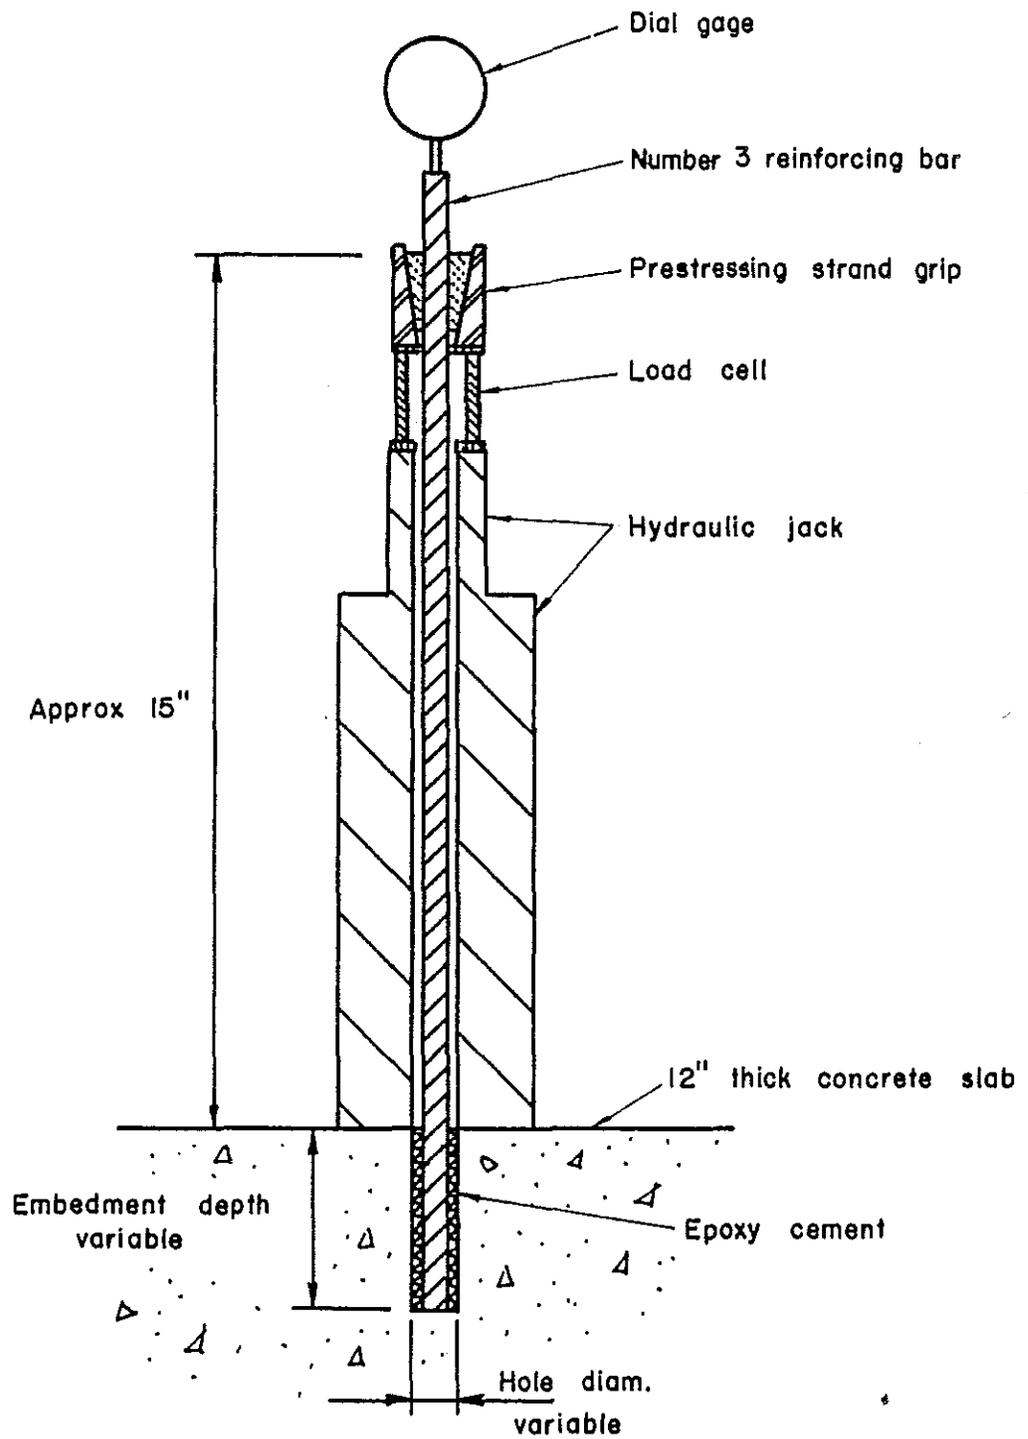
Figure E-1. Schematic diagram of pullout tests.

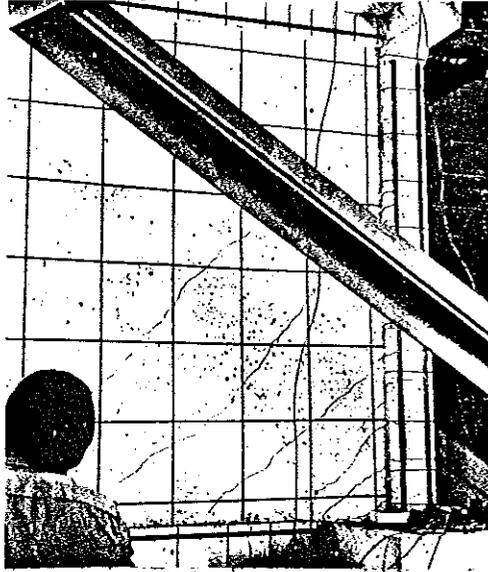
Figure F-7. Specimen 1, cracking at +53.4 kips load level.
