REINFORCED CONCRETE INFILLED SHEAR WALLS  
FOR ASEISMIC STRENGTHENING

Report on Research Conducted under Grant  
No. GI-39123 from the National Science Foundation

Report UMEE 76S1  
Department of Civil Engineering  
The University of Michigan  
Ann Arbor, MI 48109

January 1976

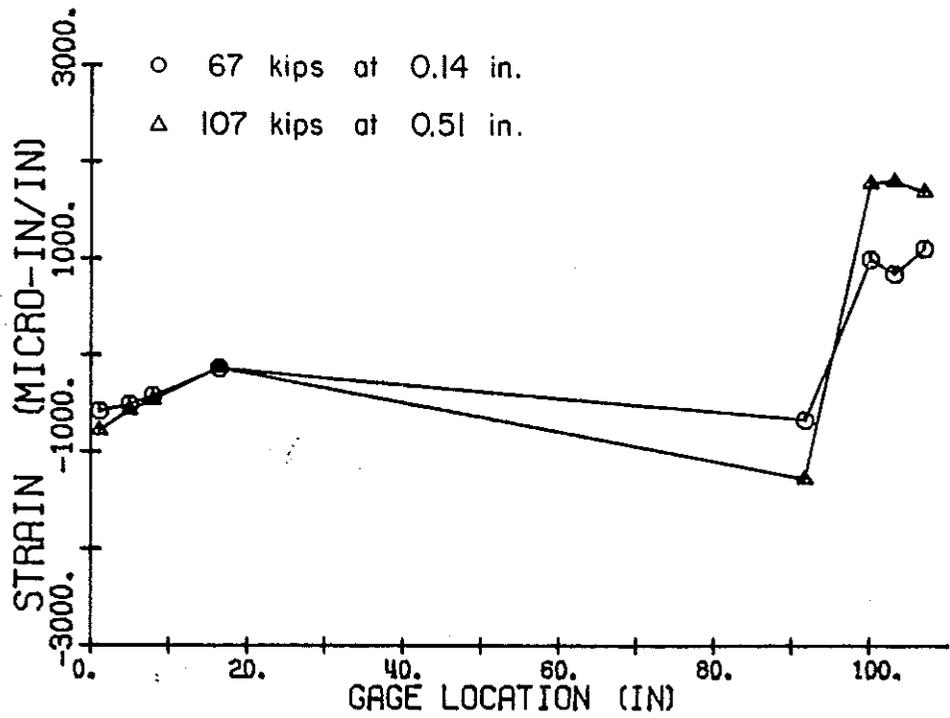
Figure F-8. Specimen 1, strain pattern at bottom of wall during first load cycled to +107 kips.

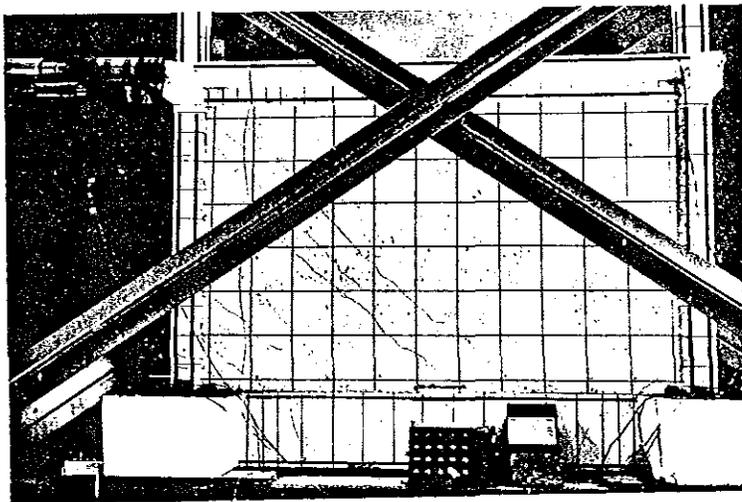
Figure F-12. Specimen 1, crack pattern after cycles to +107 kips.

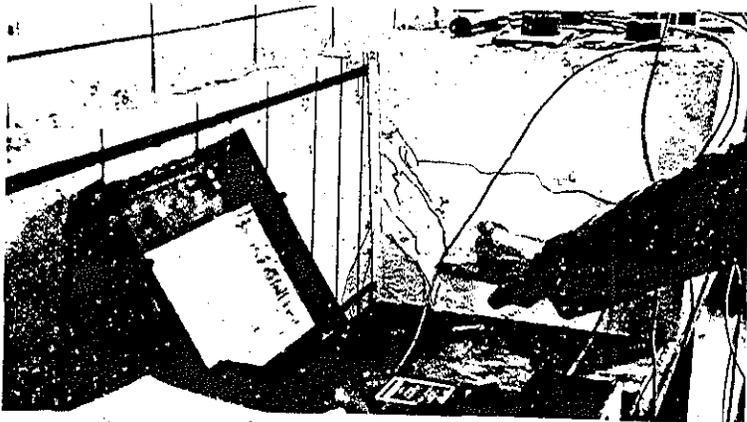
Figure F-13. Specimen 1, cracking of foundation.

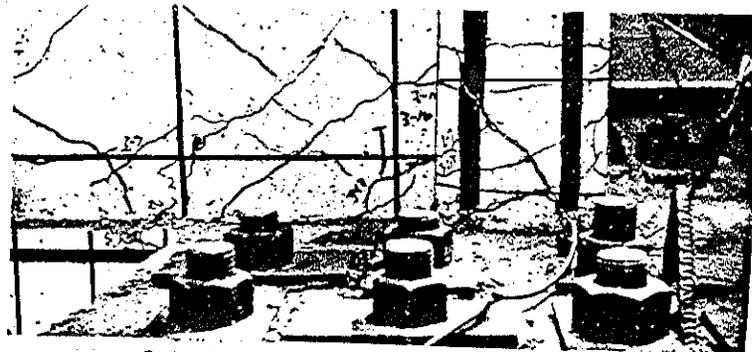
Figure F-16. Specimen 1, compression column at load of +125.7 kips.

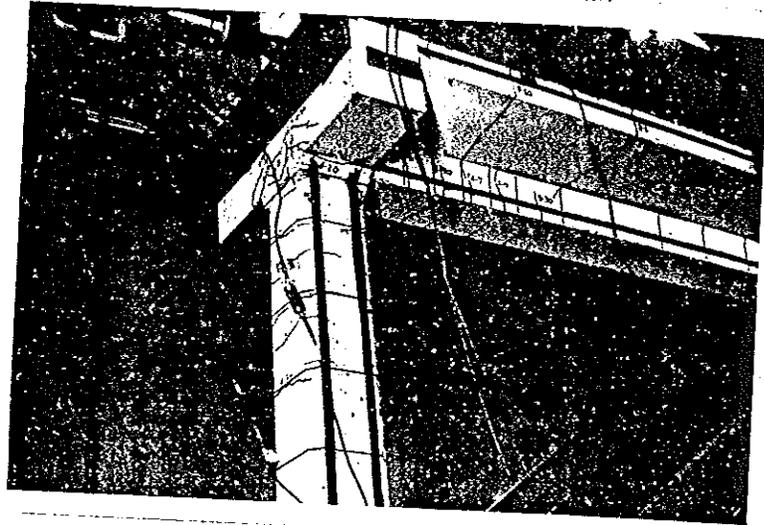
Figure F-35. Specimen 2, beam-column cracking at +1.3 in. deflection.

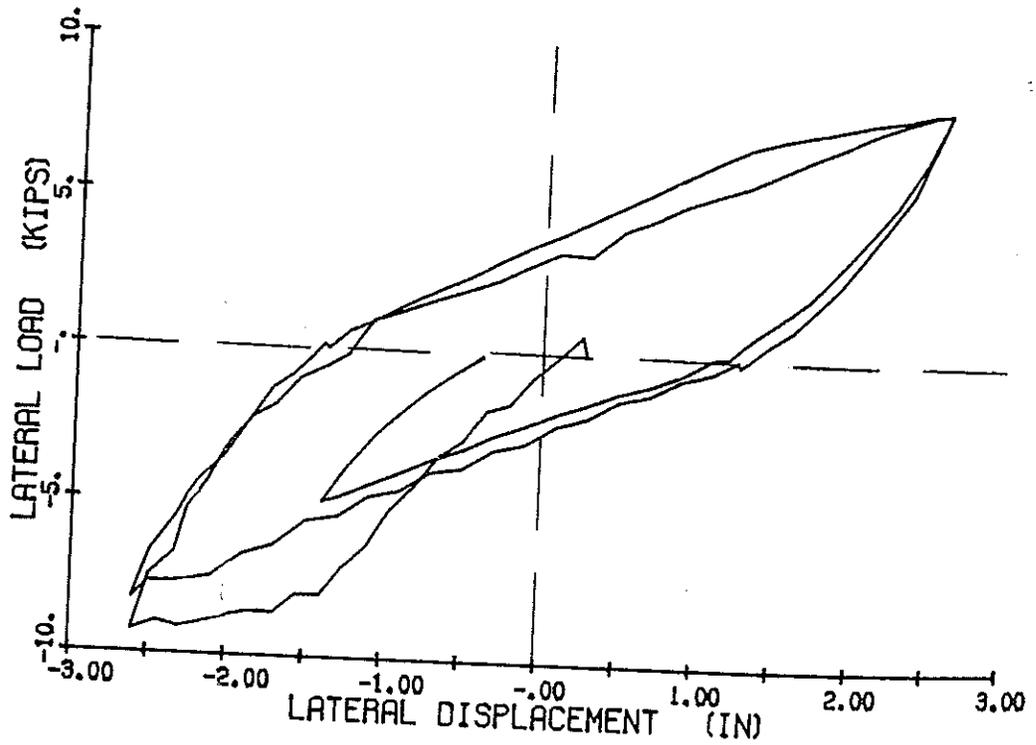
Figure F-36. Specimen 2, load-deflection curve for two cycles to +2.6 in.

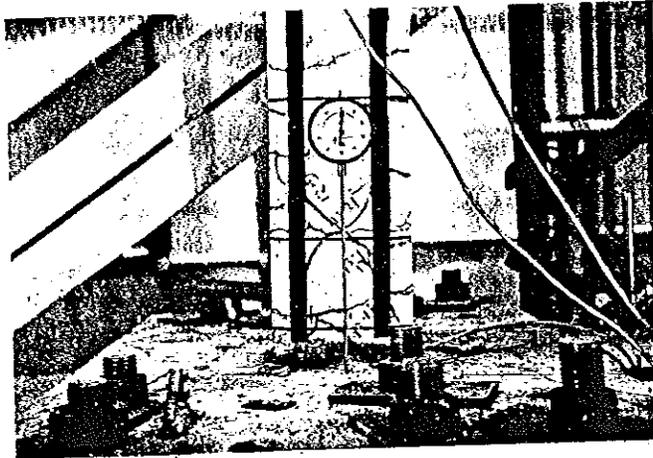
Figure F-38. Specimen 2, diagonal cracking in north column.

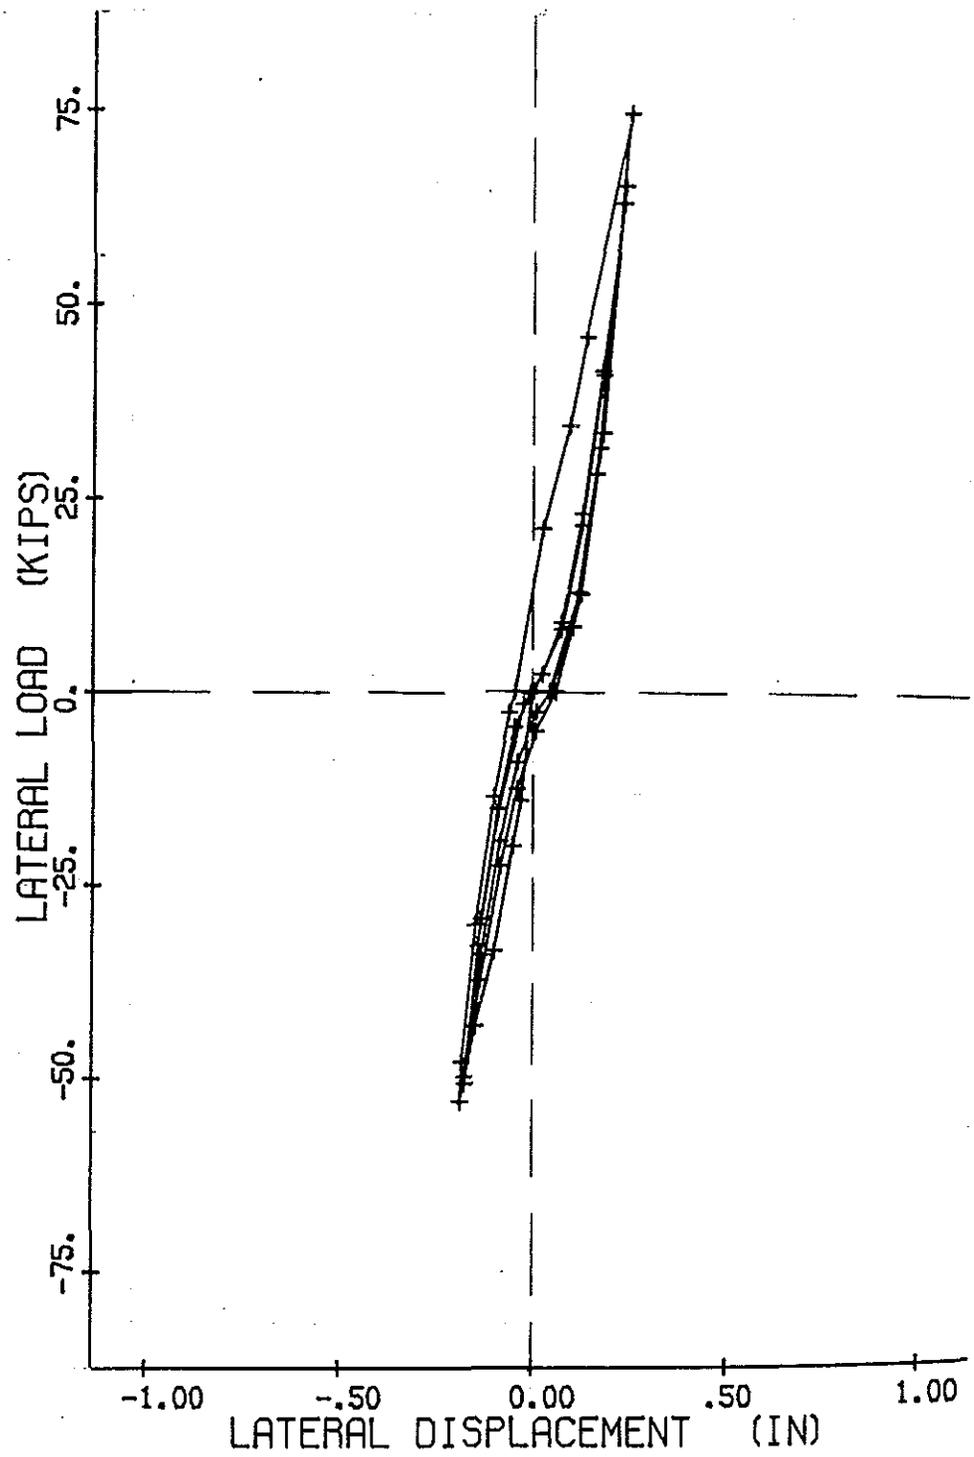
Figure F-39. Specimen 3, load-deflection curve for +0.1 in. cycles.

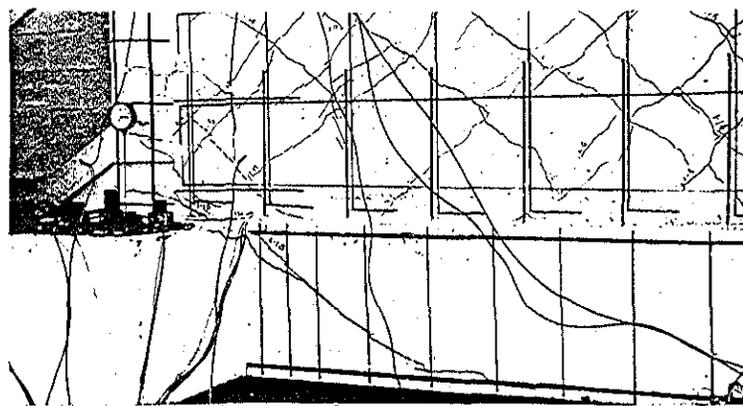
Figure F-42. Specimen 3, diagonal crack through north column and base beam during second half cycle to  $+0.56$  in.

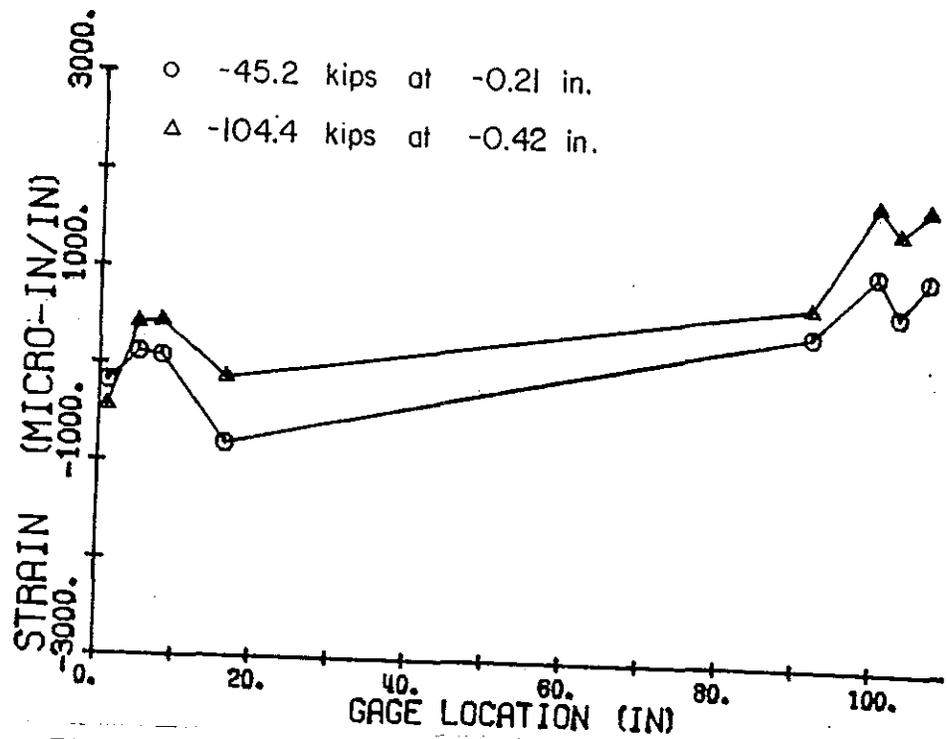
Figure F-43. Specimen 3, strain pattern, bottom gages first half cycle to -0.5 in.

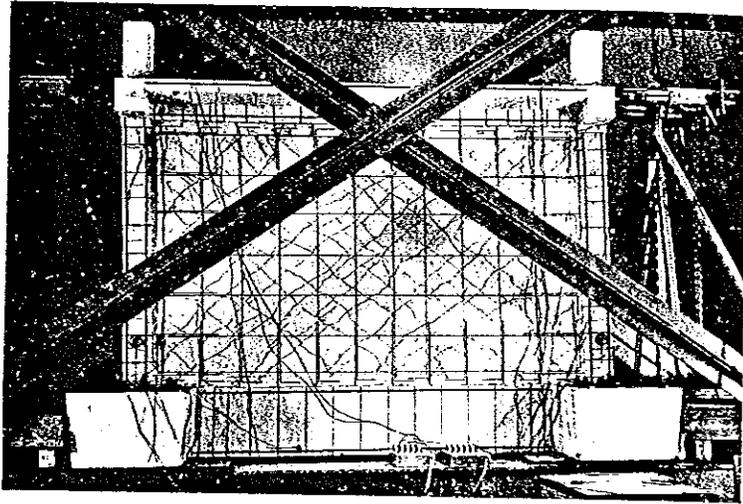
Figure F-47. Specimen 3, extensive diagonal cracking after  $\pm 0.5$  in cycle.

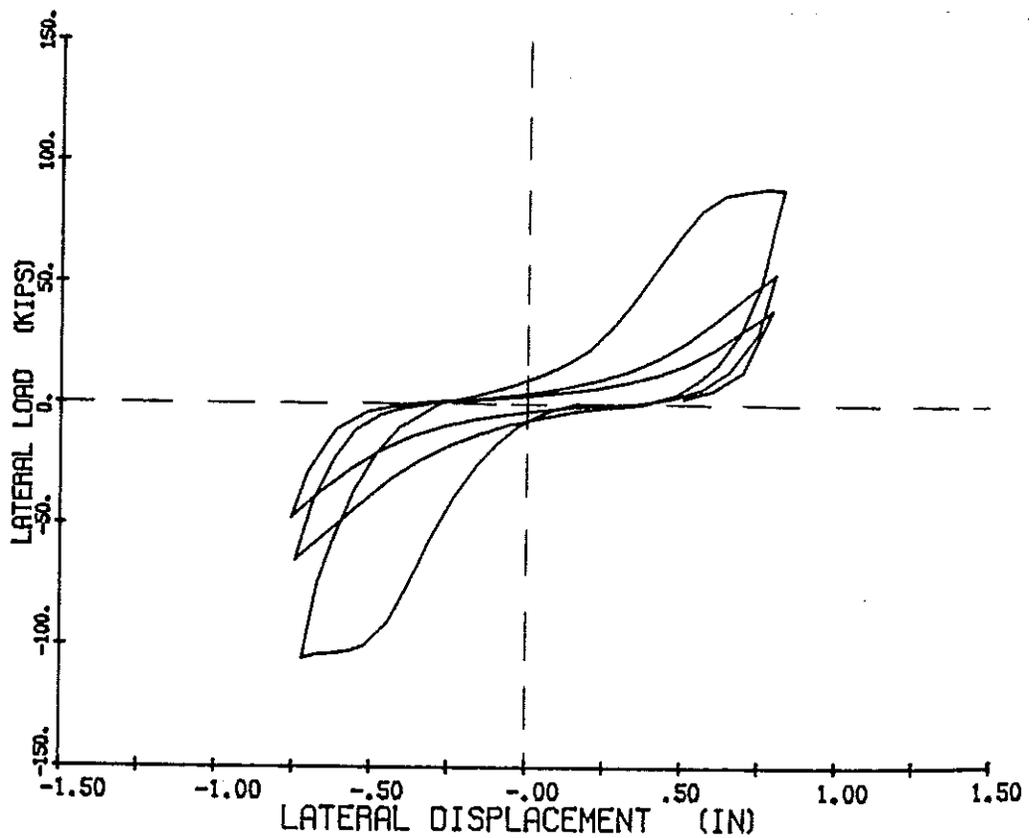
Figure F-48. Specimen 3, load-deflection curve  $\pm 0.8$  in. deflection.

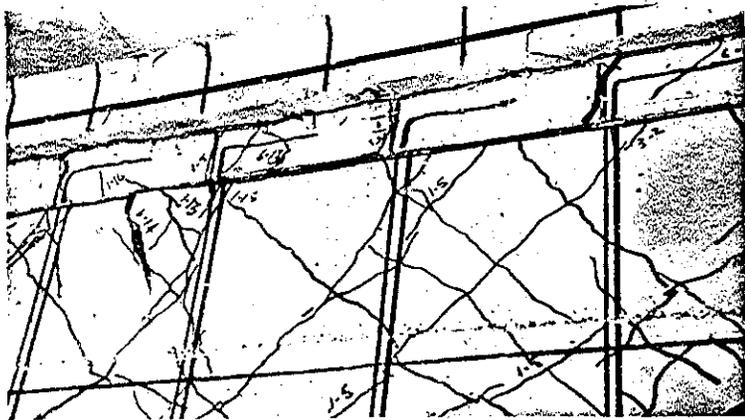
Figure F-51. Specimen 3, joint slip and drypack crack, -0.72 in. deflection.

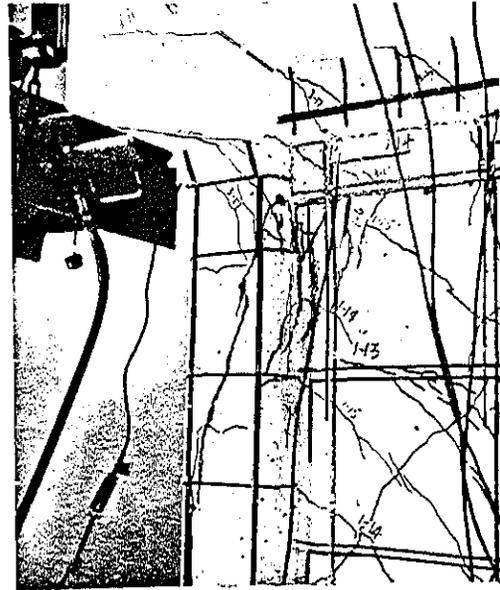
Figure F-50. Specimen 3, diagonal crack in north column, -0.72 in. deflection.

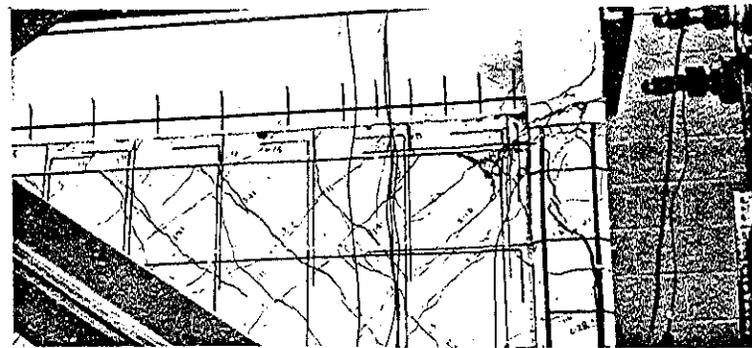
Figure F-52. Specimen 3, crushing in CIP wall and south column diagonal crack, +0.83 in.

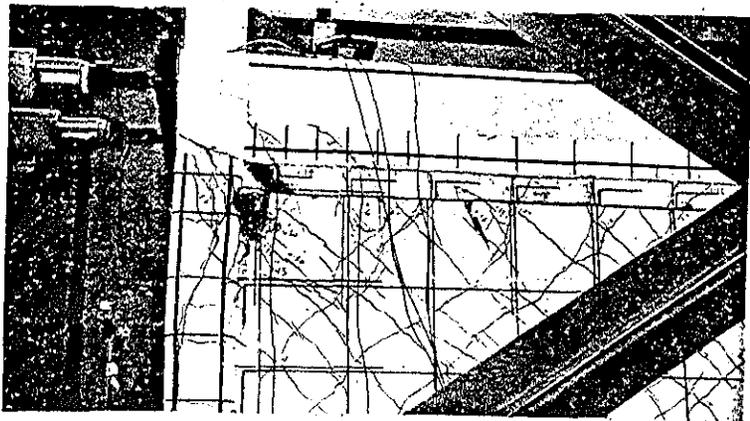
Figure F-53. Specimen 3, crushing in drypack and CIP top north corner, +0.83 in.

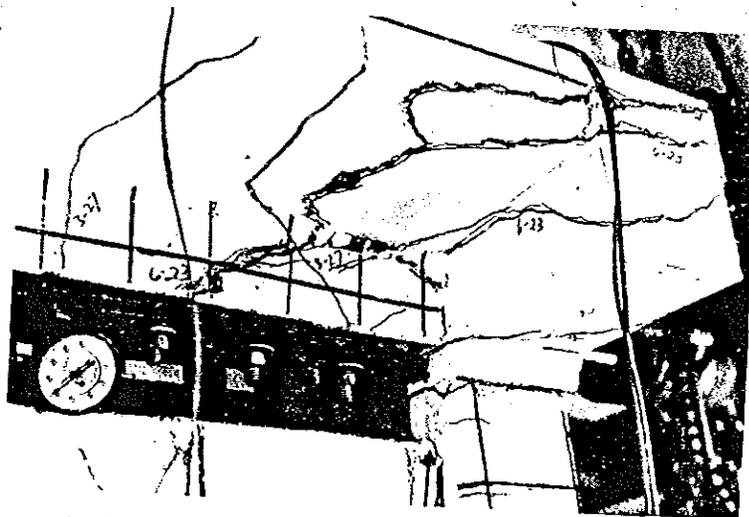
Figure F-76. Specimen 4, diagonal shear failure to top beam, -95.5 kips.

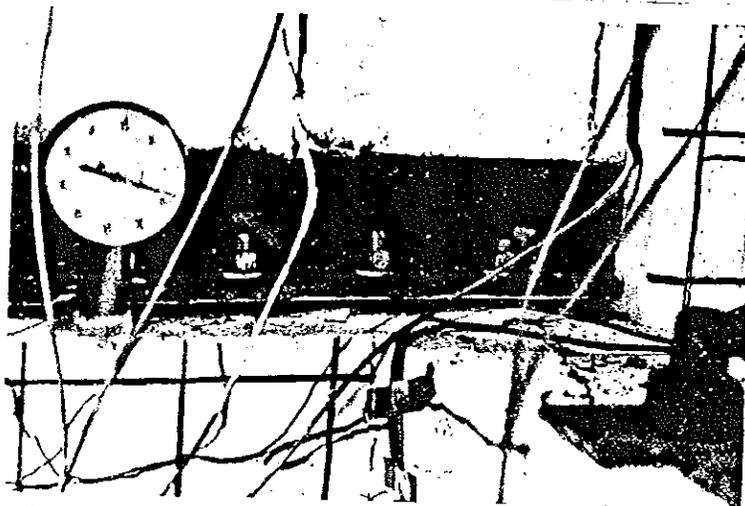
Figure F-77. Specimen 4, pullout of anchors after first half cycle to -0.89 in.

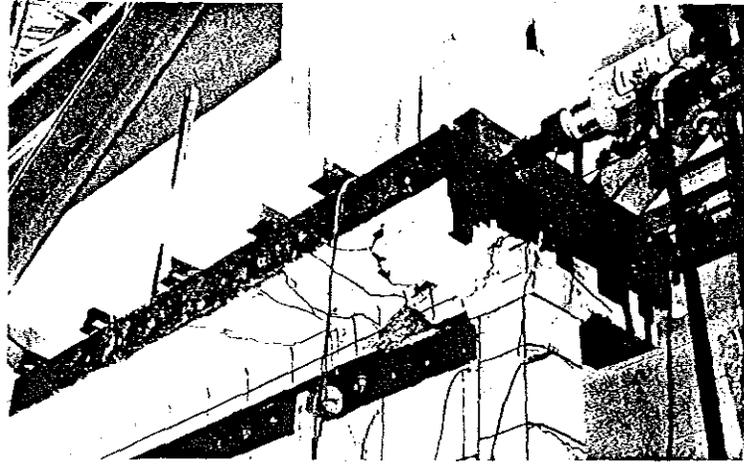
Figure F-80. Specimen 4, top beam showing repair using steel angles.

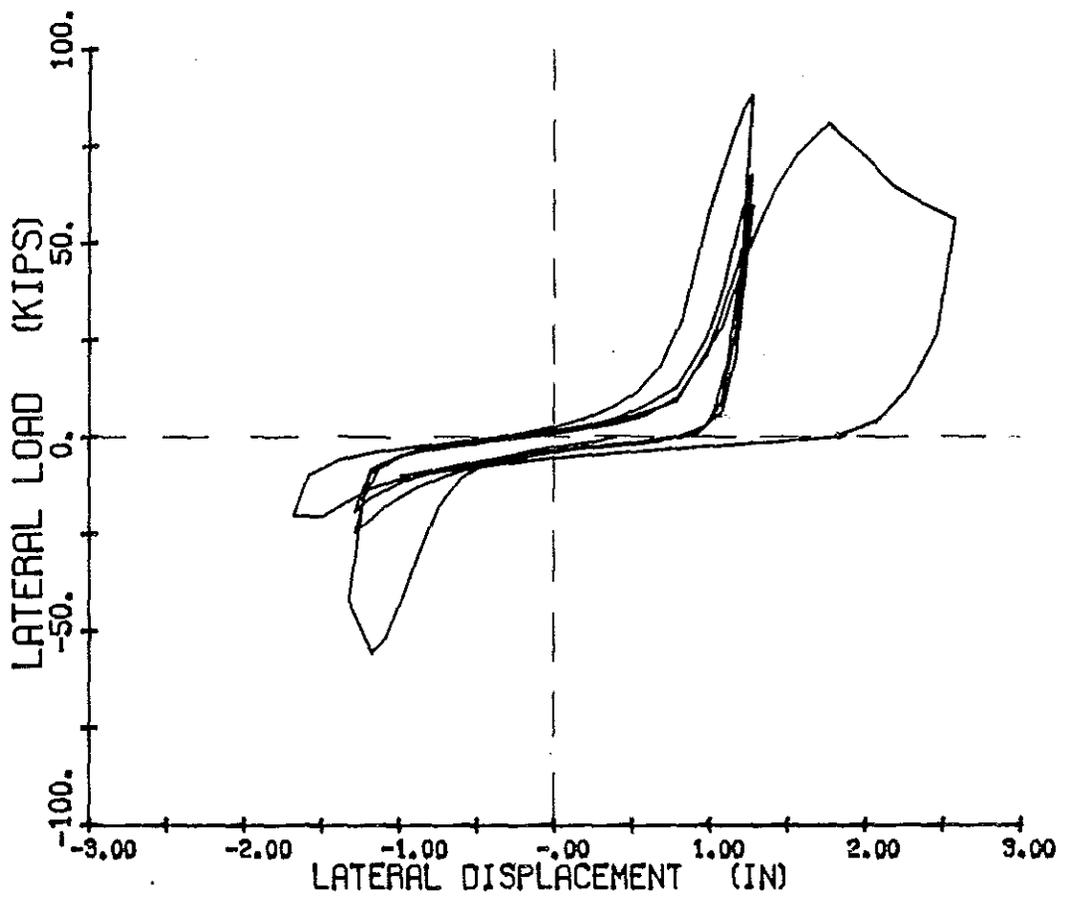
Figure F-81. Specimen 4, load-deflection curve for three cycles +1.3 in. and one cycle -1.7 in., +2.6 in.

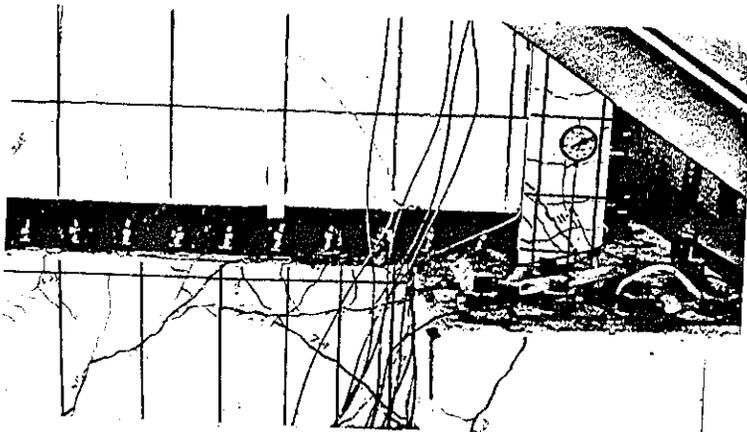
Figure F-84. Specimen 4, diagonal shear crack in column resulting from wall bearing on column.

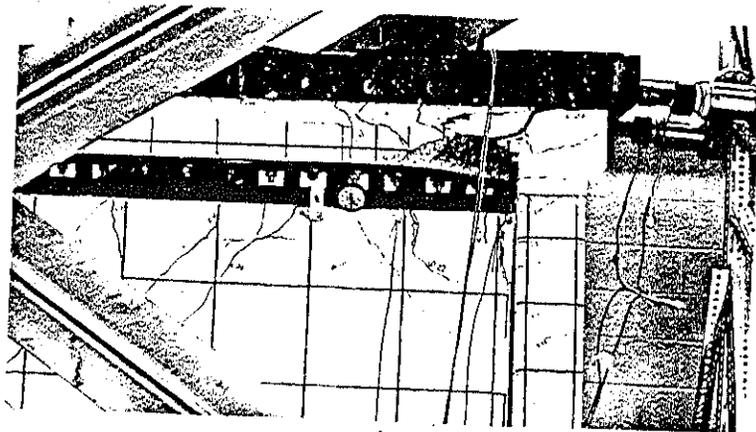
Figure F-85. Specimen 4, maximum negative deflection -1.68 in.

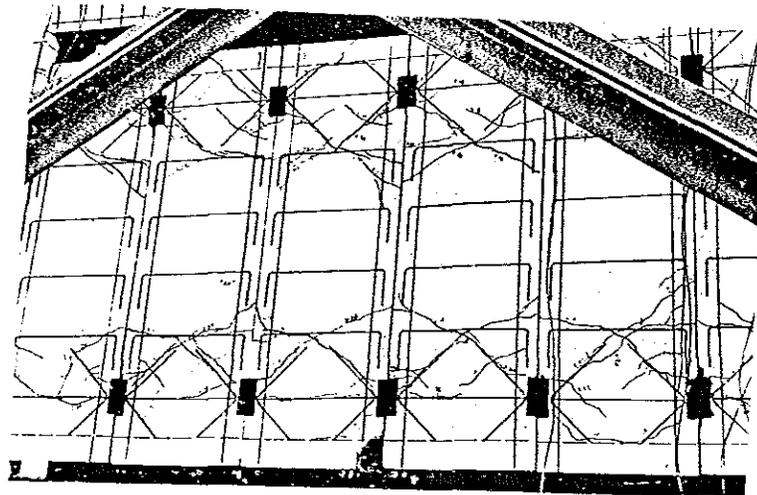
Figure F-92. Specimen 5, panels after first cycle  $+0.5$  in. showing diagonal shear cracks.

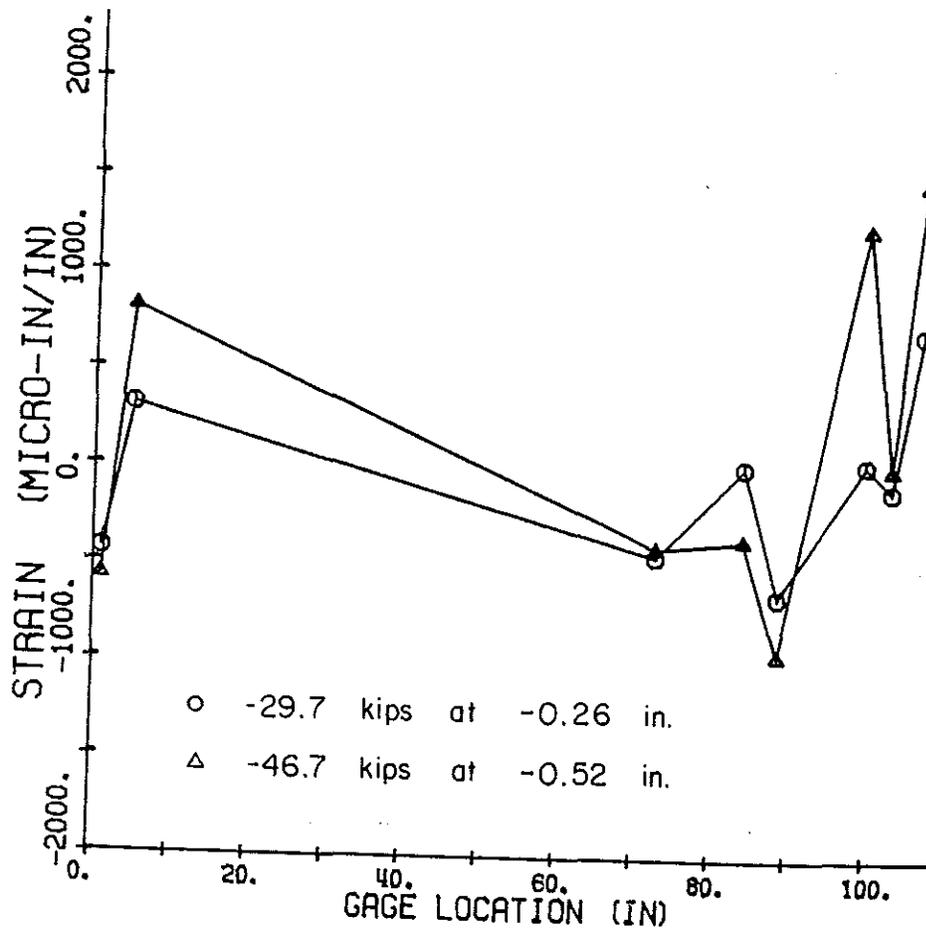
Figure F-93. Specimen 5, bottom strain pattern for first half cycle to  $-0.52$  in.

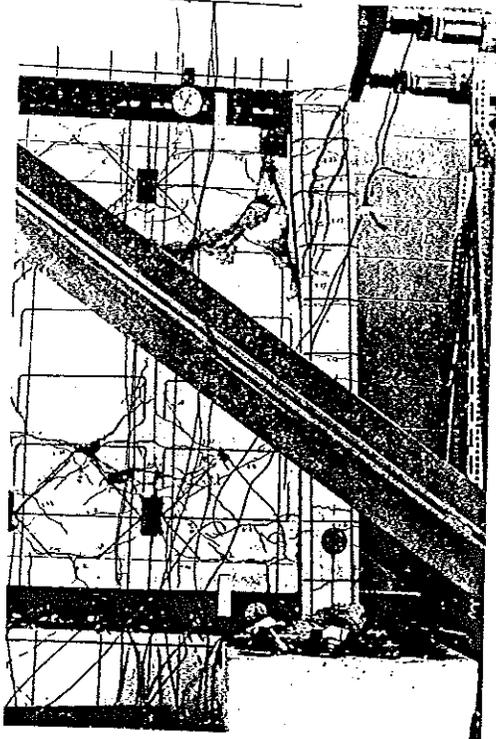
Figure F-108. Specimen 5, shear failure at south column at -2.59 in.

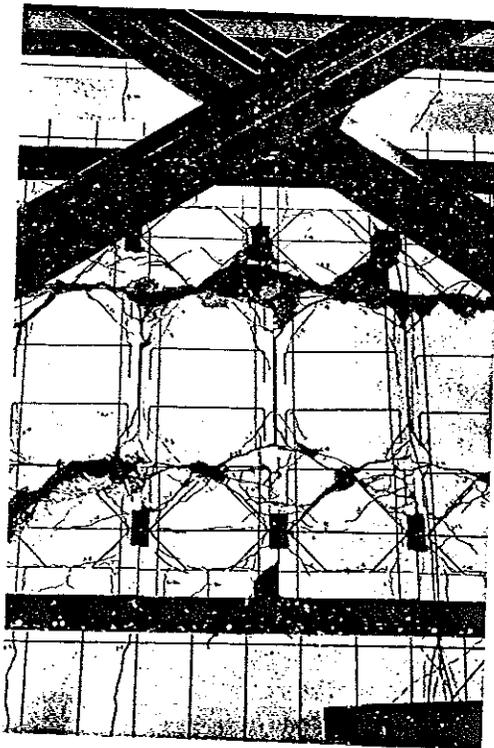
Figure F-110. Specimen 5, from left to right, panels #2 through #5 at -2.59 in.

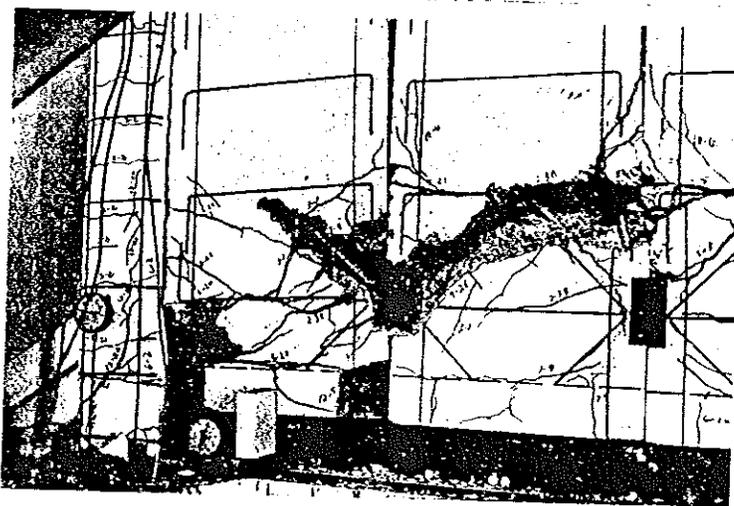
Figure F-109. Specimen 5, shear failure at base of north column at -2.59 in.

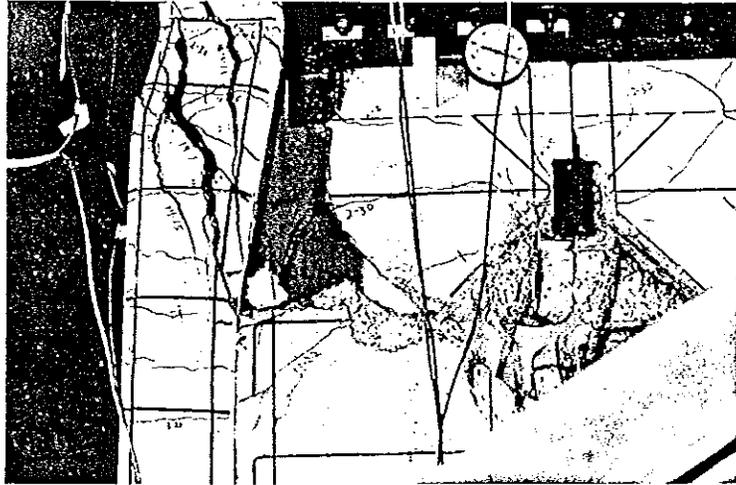
Figure F-111. Specimen 5, shear failure at top of north column at +2.68 in.

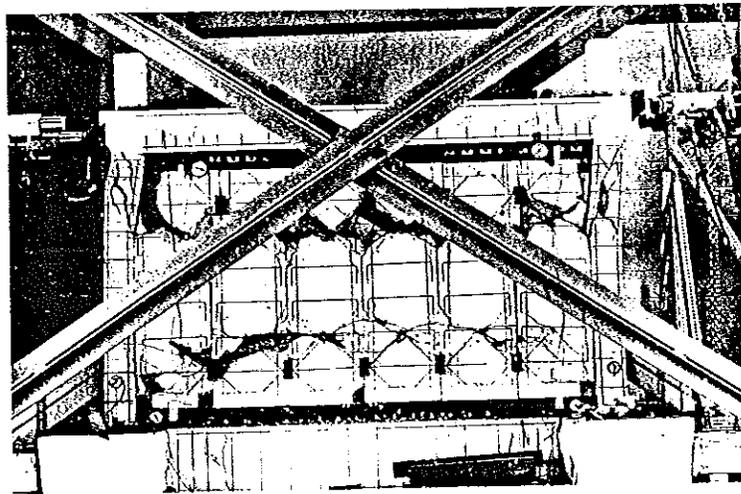
Figure F-112. Specimen 5, shear deflection at top of panels at +2.68 in.
