Final Report: Investigation into the Loss of the *H.L. Hunley*

ONR Grants # N00014-14-1-0179, N00014-15-1-2031

MSDL Report Number: 2017-001

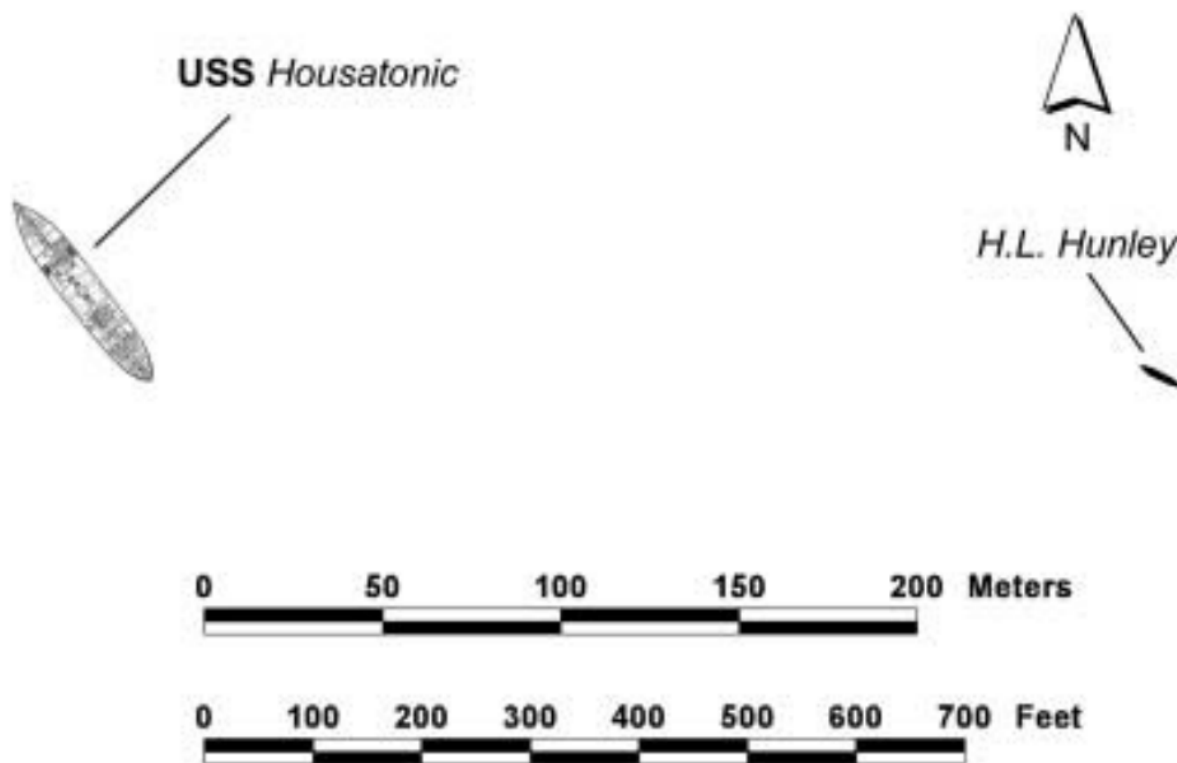
The pre-disturbance survey completed before recovering the *Hunley* presents important information about the location and orientation of the submarine. The vessel was sitting in approximately 30 feet of water orientated with the bow at 297 degrees relative to magnetic north, which points it almost directly at Sullivan's Island. The *Hunley* was located about 4 nautical miles from the coast of Sullivan's Island, under three feet of sediment. The vessel was canted about 45 degrees starboard. This location is presented in Figure 2.

Figure 2: Relative location and orientation of the *Housatonic* and *Hunley*

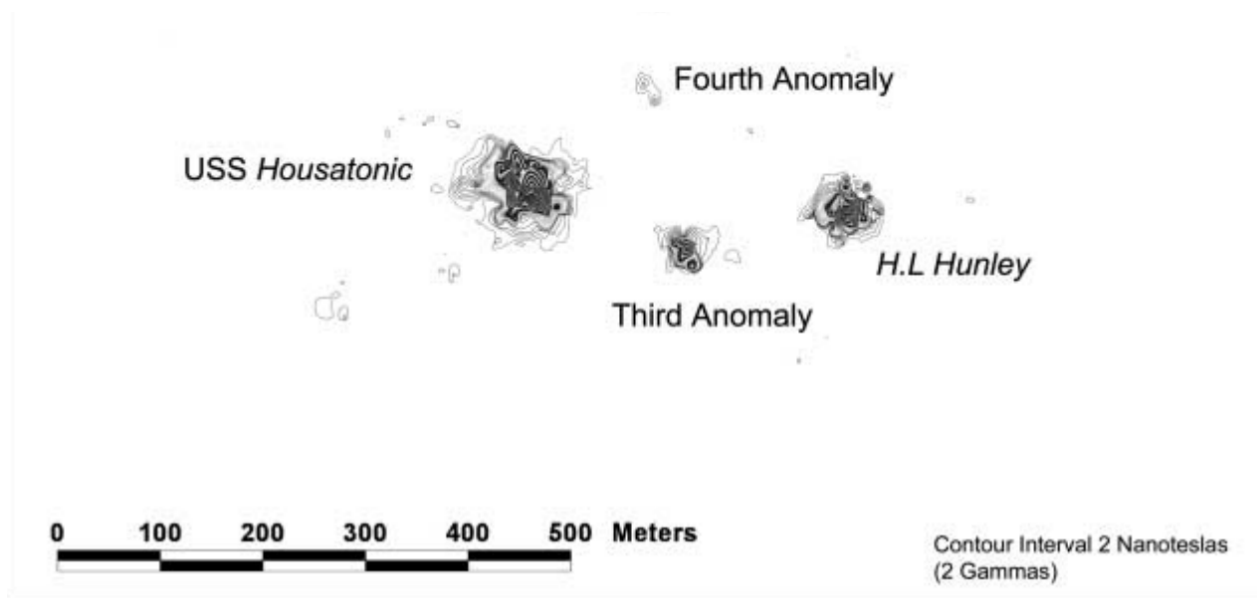
In addition to the pre-disturbance survey, a site map was completed to help layout the battlefield and how it changed over time. This survey produced four objects: The *Housatonic*, the *Hunley*, the third anomaly which is a buoy, and a fourth anomaly which is an anchor and chain. Figure 3 below presents the layout of objects based on a magnetometer reading.

Figure 3: Magnetometer reading of the battle site completed in 1998.

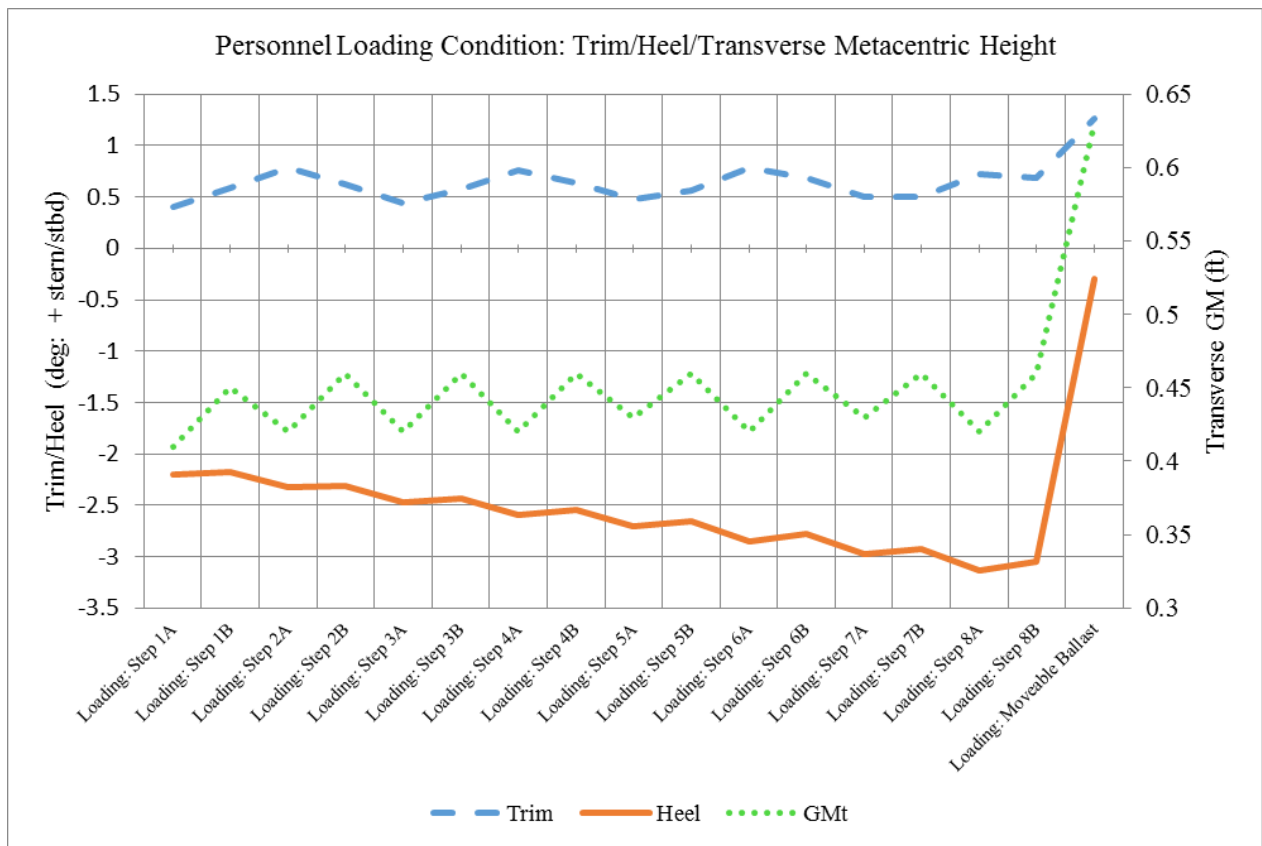
The personnel loading condition consists of a series of 17 discrete steps simulating one possible process for the crew to safely embark and load the remaining solid ballast blocks. The process simulates the progressive addition of weight to the pier-side loading condition assuming the crew embarked starting from the middle seats and alternating between the forward and aft hatches. The process starts with the pier-side loading condition and simulates the progressive addition of each member of the crew entering from alternating hatches along the centerline of the vessel and shifting amidships and off-centerline to port to simulate each member of the crew taking their final position at their assigned locations on the bench. In Figure 14, odd numbers enter through the forward hatch, even through the aft hatch; Step A is entering the vessel, step B is the final location in the vessel. The remaining solid ballast blocks were the last weights added to complete the personnel loading condition. Note that in operation, it is unlikely that the solid ballast blocks were re-loaded with each mission, once adjusted they could be left in the vessel. Given their low VCG, they would only improve the stability throughout the loading process from what was presented here. Interestingly, the locations of the weights as they were discovered during excavation results in a very reasonable 1.26 degree trim by the stern and effectively negligible 0.3 degree port heel. This suggests that the weights did not likely shift considerably during *Hunley's* attack or sinking. The effect of loading on the hydrostatic properties of the vessel at each step of the loading sequence is graphically shown in Figure 14.

Figure 14: Hydrostatic property progression with personnel loading sequence

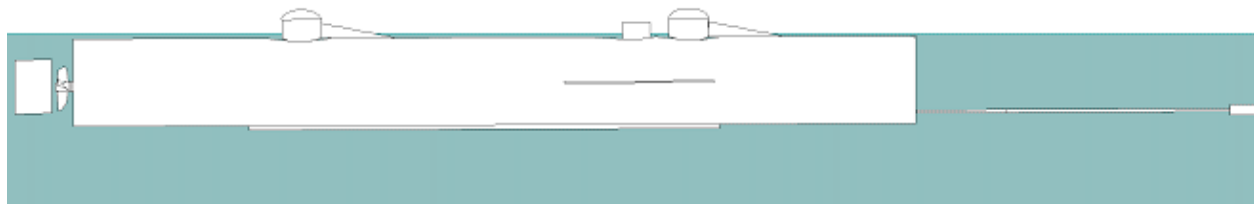
For the second attack condition, the ballasting was adjusted to fill the forward ballast tank to 80 percent of its maximum capacity and the aft tank to 50 percent of its capacity. This ballasting configuration results in the *Hunley* submerging to a point where the deck was fully submerged and only the conning towers and snorkel box pierced the surface. The distinction between these two pre-weapon deployment conditions is characterized by the difference in longitudinal stiffness due to changes in waterplane area. The deck awash pre-weapon deployment condition has the larger waterplane area, giving the vessel greater longitudinal stiffness and consequently making the vessel less sensitive to trimming moments applied by longitudinal weight shifts or fore and aft impulse loading. The deck submerged case is expected to be more sensitive to shifts of weight. The pre-weapon deployment with the deck submerged is presented in Table 8, Deck submerged pre-weapon deployment hydrostatic properties. The vessel orientation is presented in Figure 17, Deck submerged pre-weapon deployment vessel orientation.

Figure 17: Deck submerged pre-weapon deployment vessel orientation

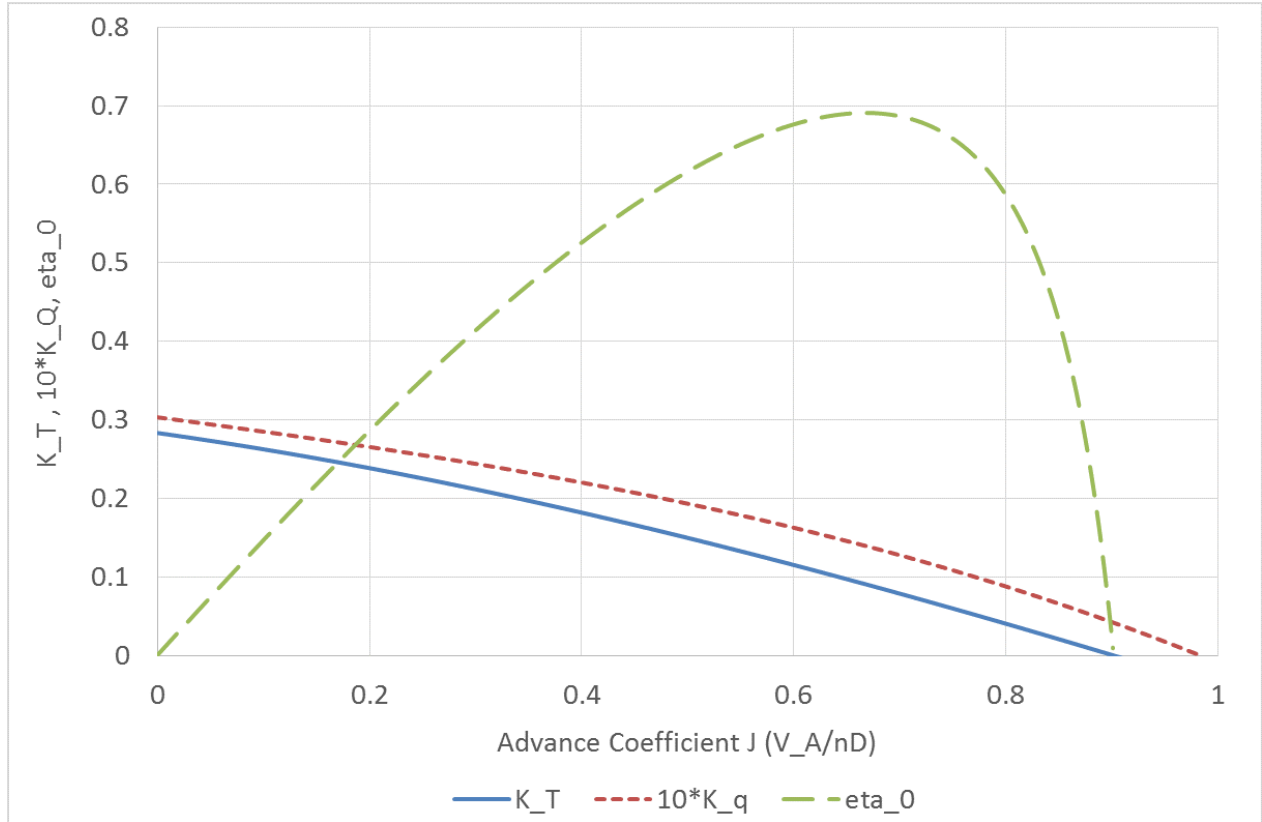
Using the values above, the propeller was approximated as a Wageningen B Series propeller. The B Series approach represents a more modern propeller and is again an initial rough estimate. However, in the absence of propeller section shape data from a de-concreted propeller, it is a reasonable starting point. A Matlab script was used to develop the thrust and torque coefficients for the propeller. This program used a polynomial fit for the required coefficients based on experimentally tested propellers parameterized by the propeller geometry. The thrust coefficient, torque coefficient, and open water efficiency for various forward speeds are presented in Figure 20.

Figure 20: Propeller characteristic curve.

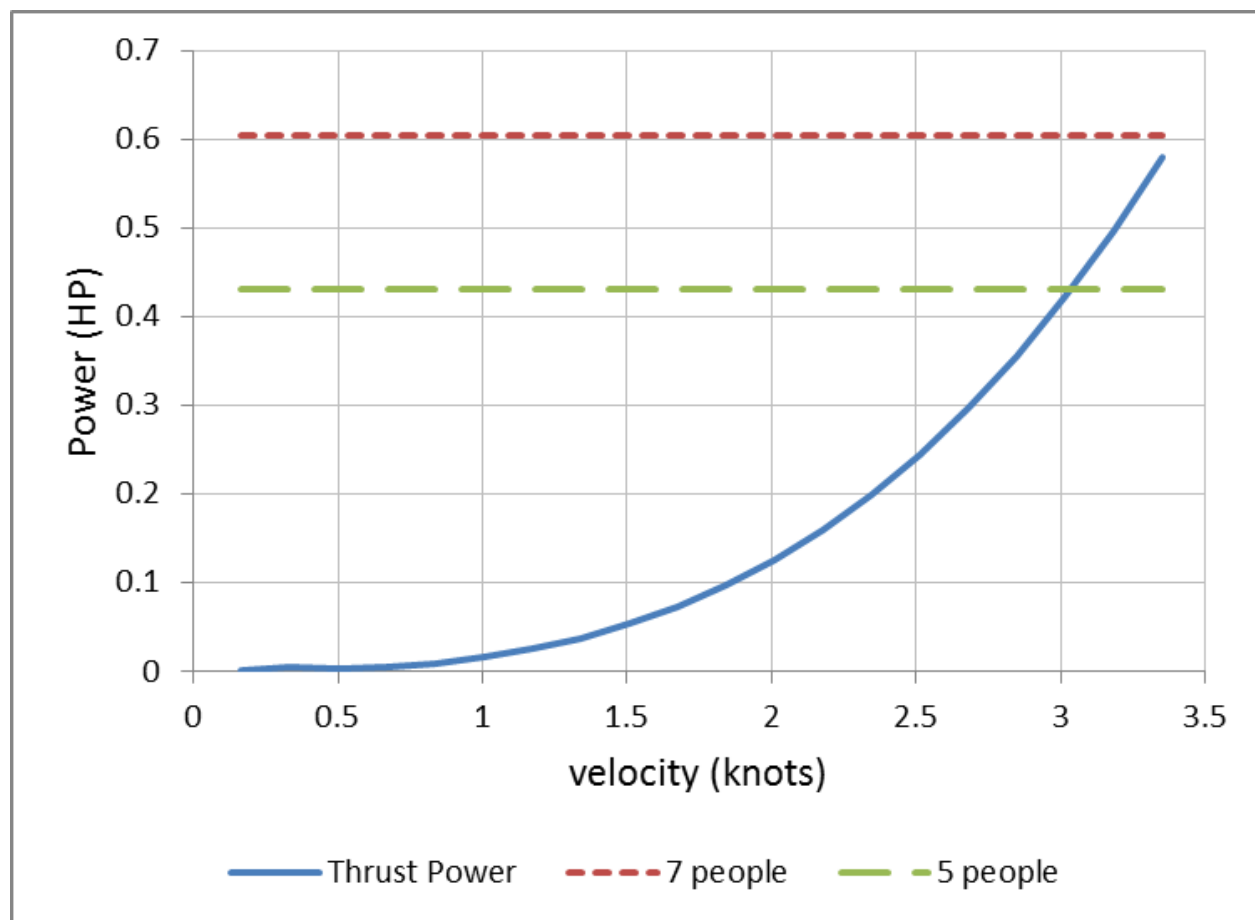
Completing these calculations, the human RPM was varied from 5 to 100 RPM, the forward velocity was calculated based on matching the required power to the power produced by the crew at that RPM. These values were determined to be close enough if the thrust was within five percent over the resistance of the hull. This could be further improved with more refinement in the propeller curve. The results of the propeller matching are presented in Figure 21.

Figure 21: Power required over velocity curve

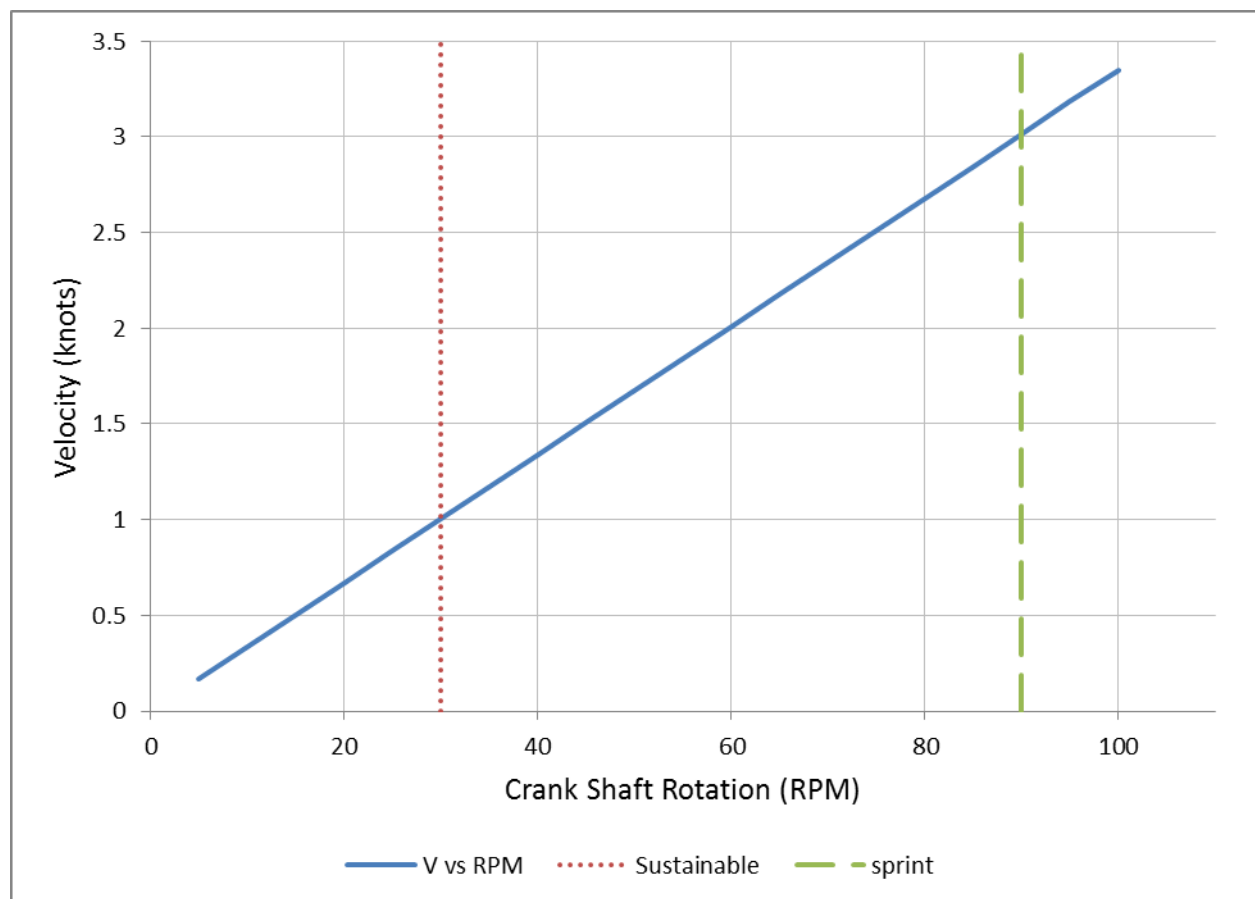
An RPM to velocity comparison graph was developed to see the maximum speed that would be obtainable under different assumed crankshaft rotation rates. The results are presented in Figure 22.

Figure 22: Velocity over RPM graph with RPM bounds

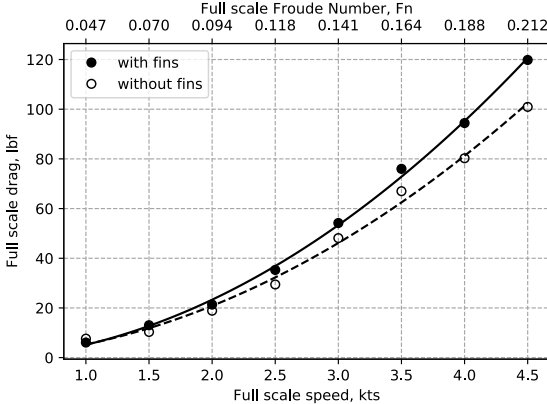
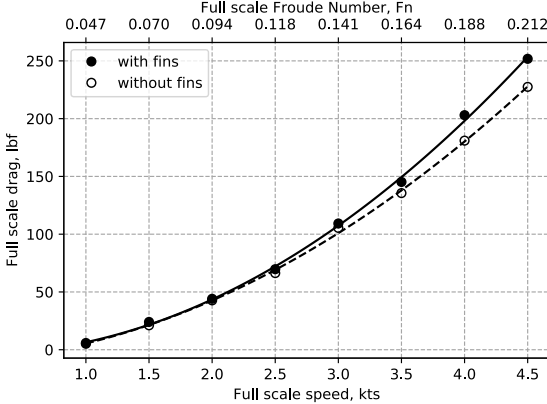
(a) Resistance Curves for Cases A and B

(b) Resistance Curves for Cases C and D

(c) Resistance Curves for Cases E and F

Figure 23: Resistance Curves and Quadratic Fit over Range 1-4 kts

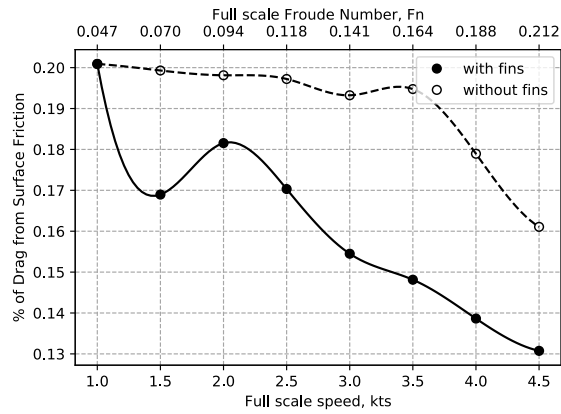
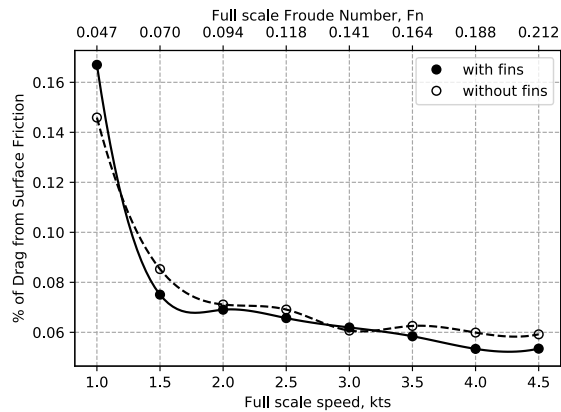
To further understand the resistance characteristics of each model, the total model drag was separated into the components used in the 1957 ITTC resistance scaling procedure: frictional surface drag and residuary resistance. For the submarine in this test, the residuary resistance will include wave making drag as well as flow separation and form drag from the hullform as a 1+k approach similar to the 1978 ITTC was not taken. The percentage of total drag attributable to frictional surface drag is shown in Figure 25. For the slower speeds, the relative contribution of skin friction is higher as expected. The low value of friction for the initial point tested in Case D is believed to be a measurement issue, the total drag at this speed is only on the order of 1 Newton for the model. However, even at three knots, in any of the surfaced conditions, frictional drag contributes more than 50% to the total drag. At lower speeds, the contribution ranges from 60% to 90%.

(a) Resistance Fractions for Cases A and B

(b) Resistance Fractions for Cases C and D

(c) Resistance Fractions for Cases E and F

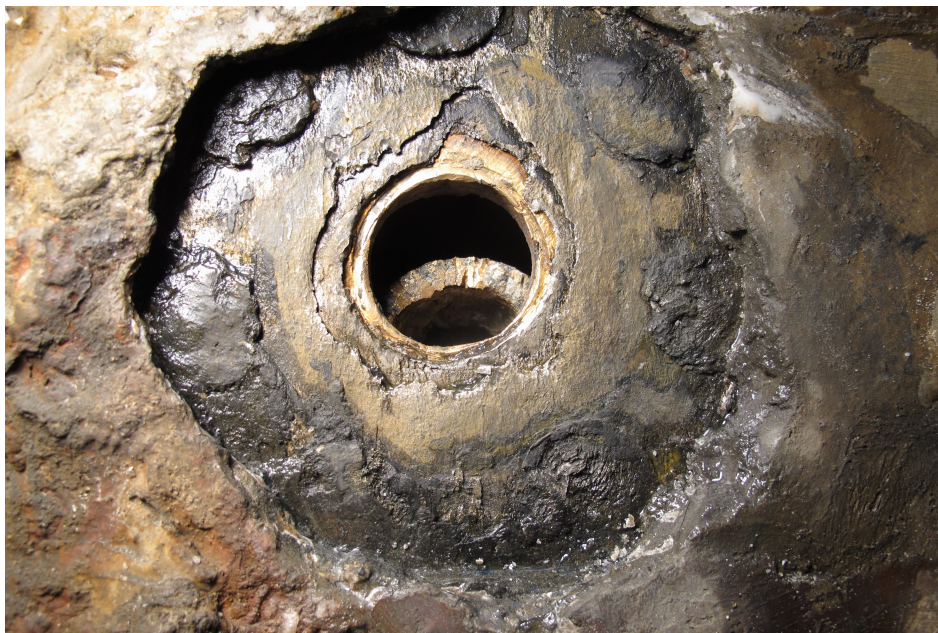
ered that the forward ballast tank fill pipe had fractured where it meets the submarine’s outer hull (Figure 27). This fracture would allow seawater to directly enter the crew compartment, roughly below the forward conning tower. The stability results show that only 50-75 gallons of flooding water are necessary to sink the vessel when the vessel is floating with the deck awash. Thus, if the ballast pipe sheared off as a result of the weapon firing, it is possible that the vessel foundered owing to the water that would be let in. However, it is not clear how long it would take for such damage to sink the vessel. Thus, understanding the flow rate through the sheared pipe is critical. This work was done in three phases. First, a simple model was built to get a rough estimate of the time to sink through the flooded connection. Then, detailed CFD and a model experiment were used to validate this finding.

The first step was to complete a rapid model using basic Bernoulli equations to obtain a rough estimate of the flooding time. The hole geometry is an irregular shape due to the sheared pipe blocking a portion of the circular opening. The geometry was developed in AutoCAD using the image shown in Figure 27 and known dimensions. The opening of the hole was traced in AutoCAD using two circles which were then scaled to the proper dimensions. The diameter of the hole in the outer hull is 1.54 inches, and the thickness of the pipe is 0.314 inches; It was assumed that the interior diameter of the pipe is the same size as the hole. AutoCAD was used to calculate the area of the hole which came to be 1.016 square inches. This opening area was used in the initial model to calculate the volumetric flow rate.

Figure 27: Geometry of sheared pipe opening

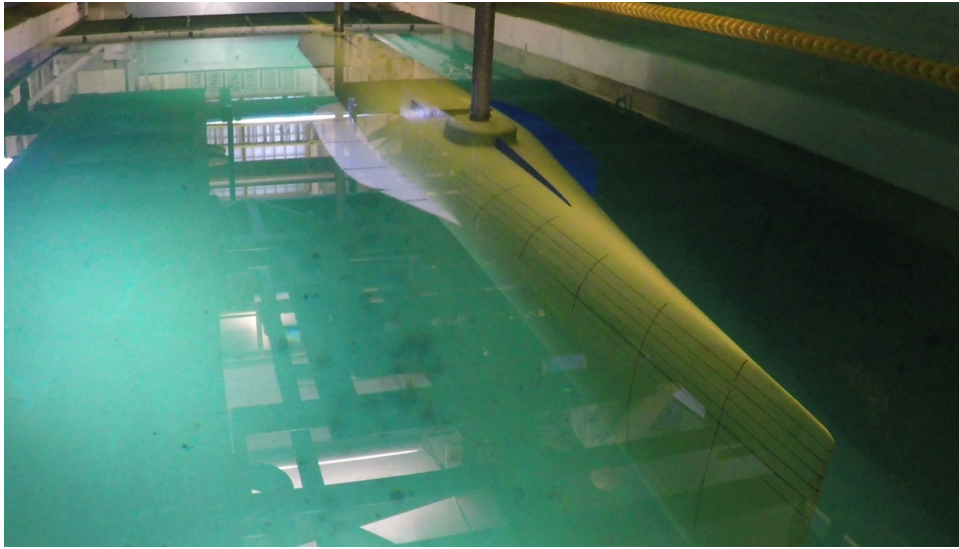
Figure 4: CSS Hunley model at static completely submerged condition (test cases 3 and 4)
