# Understanding Nonpoint Source Pollution and Public Perceptions: A Study of the Black Lake Watershed

University of Michigan School for Environment & Sustainability Master's Students

**Client: Tip of the Mitt Watershed Council**

**Spring 2024**

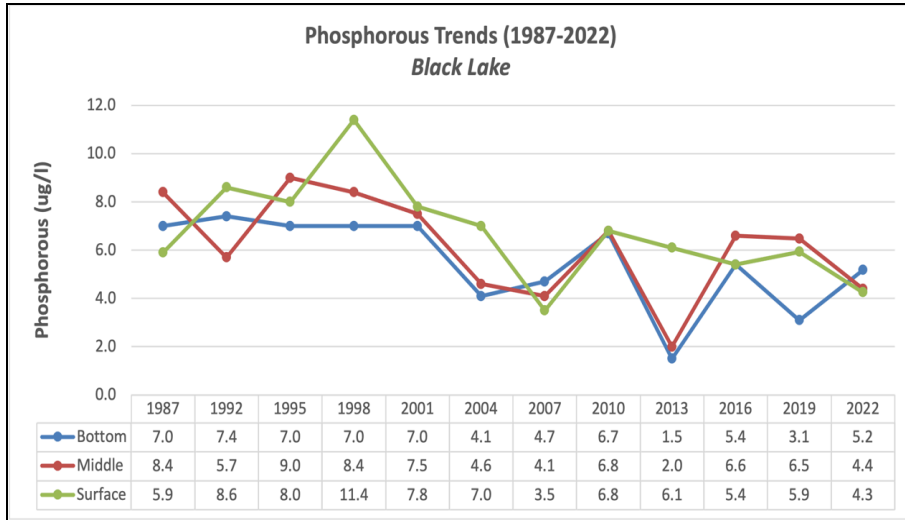
Figure 1.3. Black Lake Phosphorous Trends from 1987-2022<sup>26</sup>

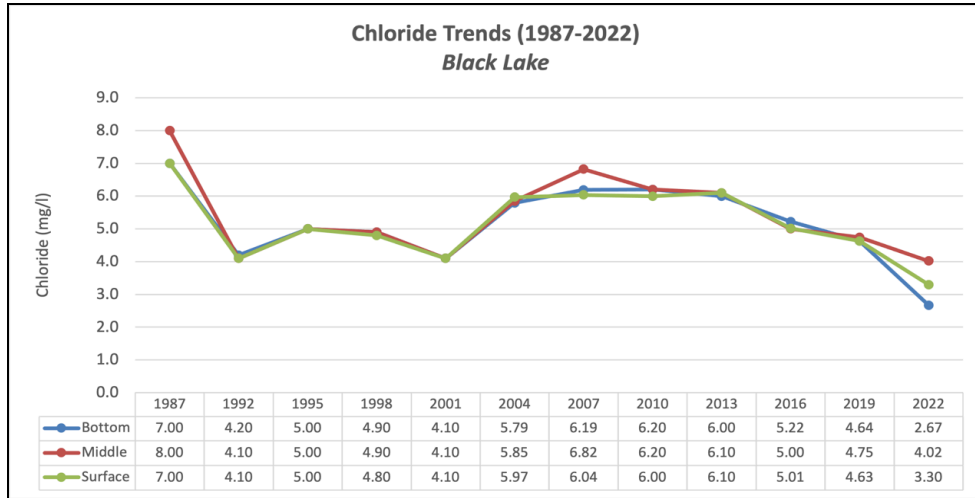
Chloride can be seen on a downward trend in 2007 going from a middle reading of 6.82mg/L to 4.02mg/L in 2022 (Figure 1.6).

Figure 1.5. Black Lake Chloride Trends from 1987-2022<sup>26</sup>

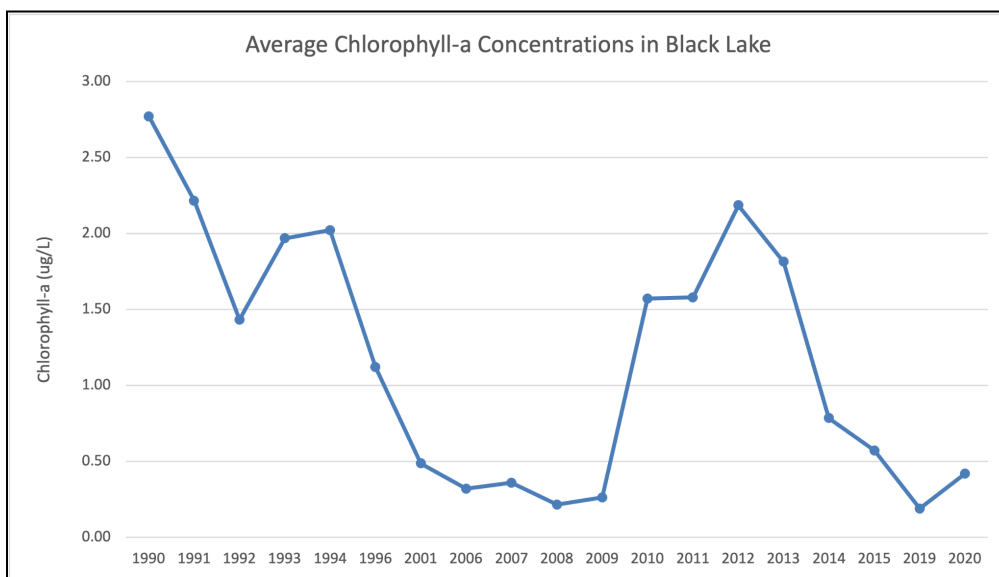
Black Lake measured the highest Chlorophyll-a concentration in 1990 with an average of 2.77ug/L and again in 2012 with an average of 2.19ug/L. From 2001 to 2009 and 2014 to 2020, concentrations were the lowest with the most recent measurement being 0.37ug/L (Figure 1.7). Overall, the low concentrations are not a cause for concern, however, it raises the question of why these HABs are forming if chlorophyll-a concentrations are not reflecting the outbreaks.

Figure 1.6. Average Chlorophyll-a concentrations in Black Lake 1990-2020 collected by Black Lake volunteers<sup>29</sup>

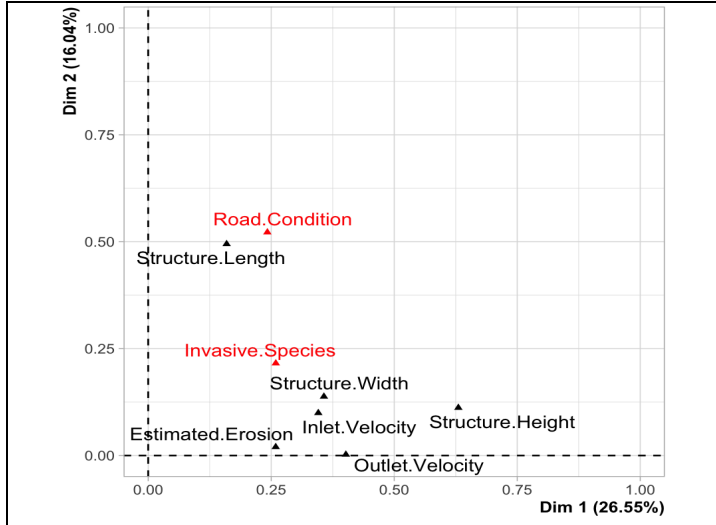
Figure 4.5 displays all of the variables, both categorical and continuous. It can be seen that Structure.Height contributes the most to Dim 1 and Road.Condition contributes the most to Dim 2. When a variable “contributes” to a dimension, it is explaining how much it accounts for the variation within the data. Invasive.Species appears to contribute nearly the same to Dim 1 as it does Dim 2, meaning there are possible relationships between both dimensions.

Figure 4.5. Graph of categorical (red: road condition and invasive species abundance) and continuous (black: structure length, width, height, estimated erosion, and inlet/outlet velocity) variables.

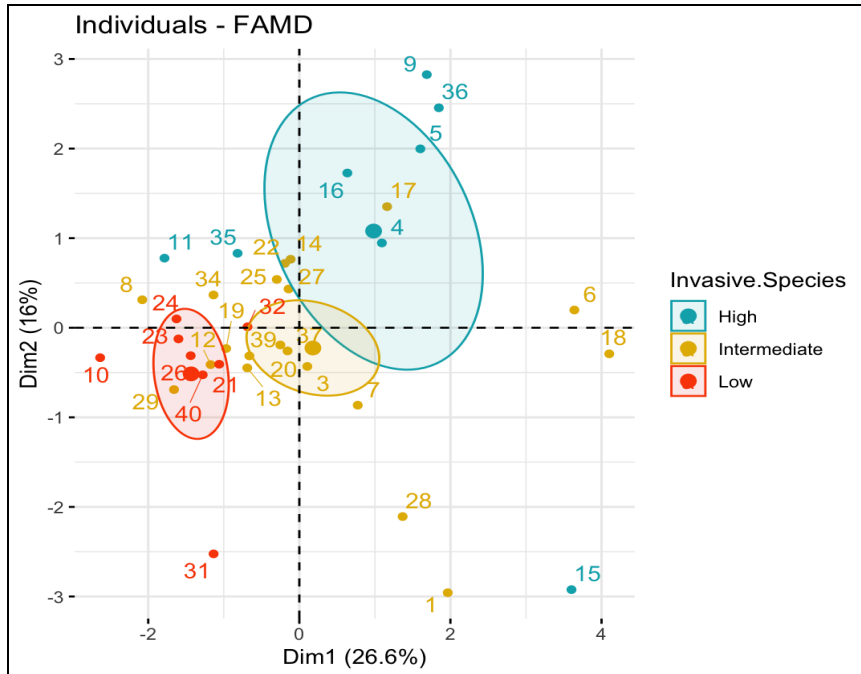
The final figure (Figure 4.7) depicts the species abundance for each site. Clusters are based on invasive species abundance. Outliers exist for all clusters, but appear to be relatively close to their respective grouping. This graph represents the information depicted in Figure 4.6 but displays how the individual data points are positioned in respect to their invasive species abundance. “High” invasive species clusters contribute positively to Dim 1 as do “Intermediate” invasive species; however, “Low” invasive species contribute the most to Dim 2 (negatively to both Dim 2 and Dim 1). To conclude the analysis, it is apparent that the sites that were revisited have more characteristics in common than what someone would expect from reading the raw data (based on the created clusters), and that there is an obvious trend of similarity regarding invasive species abundance and other variables at RSX sites. This analysis helped determine that there may be an underlying pattern to invasive species abundance given that there are clusters of data formed in relation to the other documented characteristics of RSX sites (road condition, structure height, width, estimated erosion, etc.). The FAMD analysis was not necessary for our project, however it was completed for a previous course.

Figure 4.7. Individual data in respect to invasive species abundance

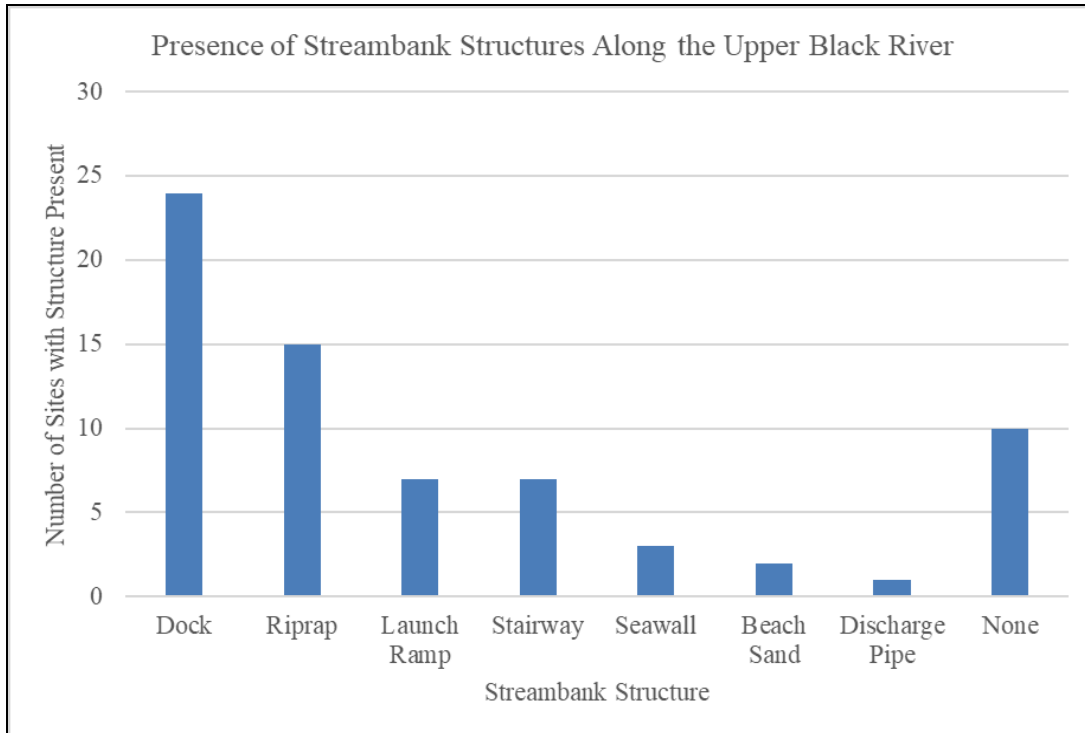
Figure 4.12. Presence of streambank structures at erosion sites along the Upper Black River

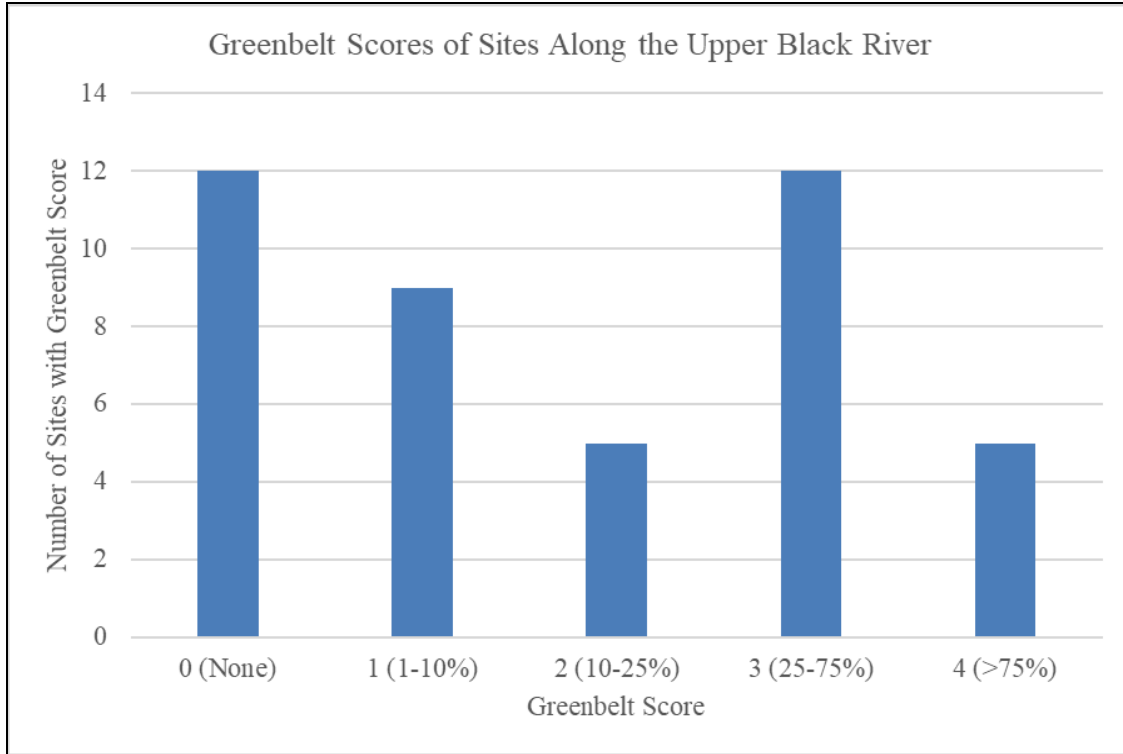
Greenbelt scores were given to all sites based on what percentage of the shoreline the greenbelt covered. For the purpose of this inventory, greenbelts were defined as a buffer of vegetation along the streambank between the water and shoreline development. The two most common scores were 0 (no greenbelt present) and 3 (extends 25-75% of shoreline) which 12 sites had (Figure 4.13).

Figure 4.13. Greenbelt scores based upon the percentage of the shoreline the greenbelt extends for sites along the Upper Black River

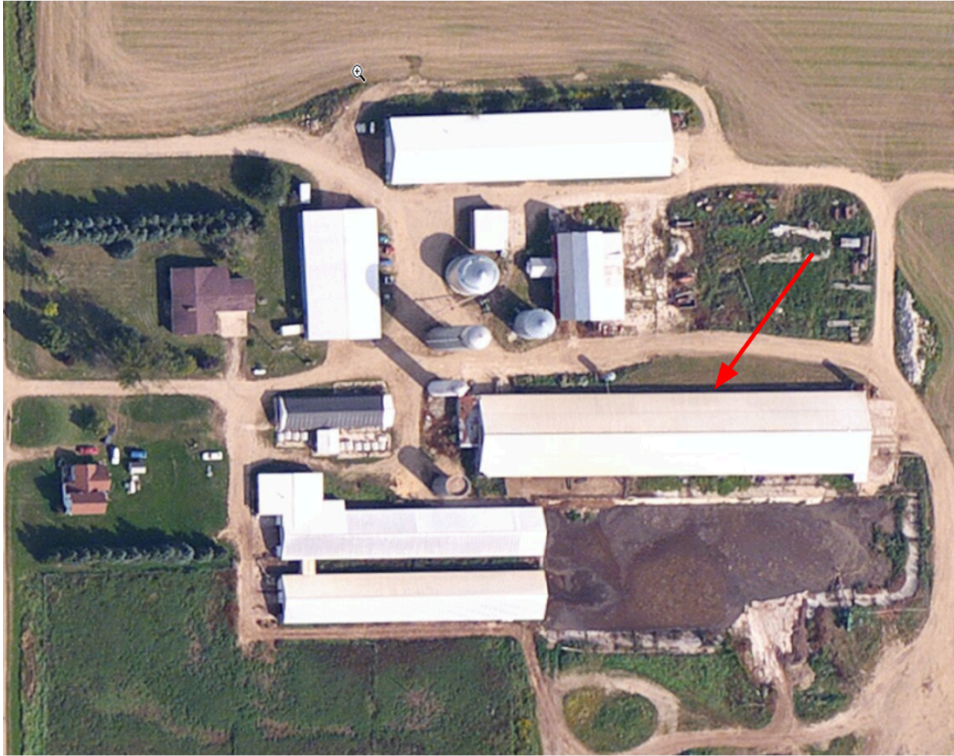
AFOs are typically long linear white buildings of varying sizes, depending on the number of animals they are housing. Figure 3 shows a larger AFO. It is also important to consider the kind of animal that may be present. The presence of the ring in Figure 4 indicates that horses are likely kept at this facility.

Figure 3. Larger operation with typical white structures of an AFO.

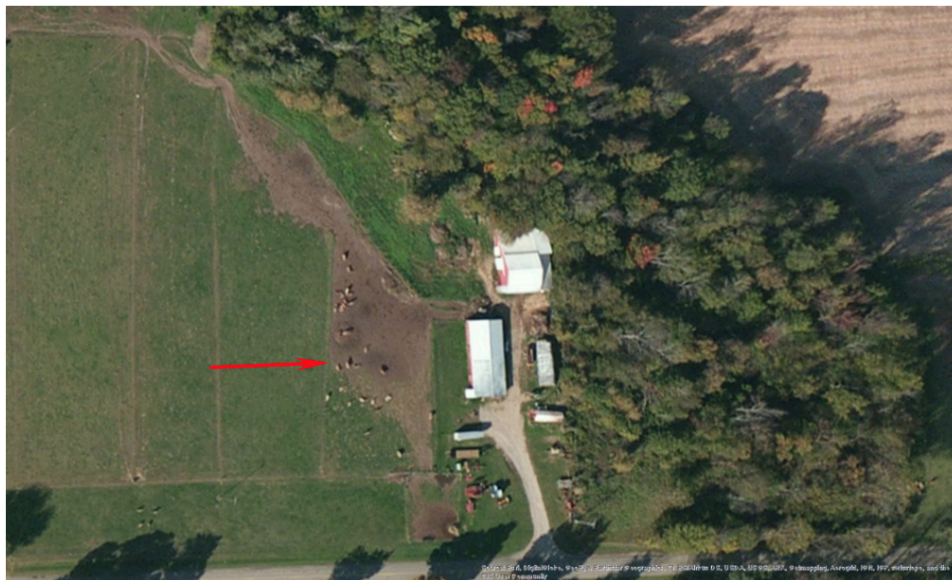
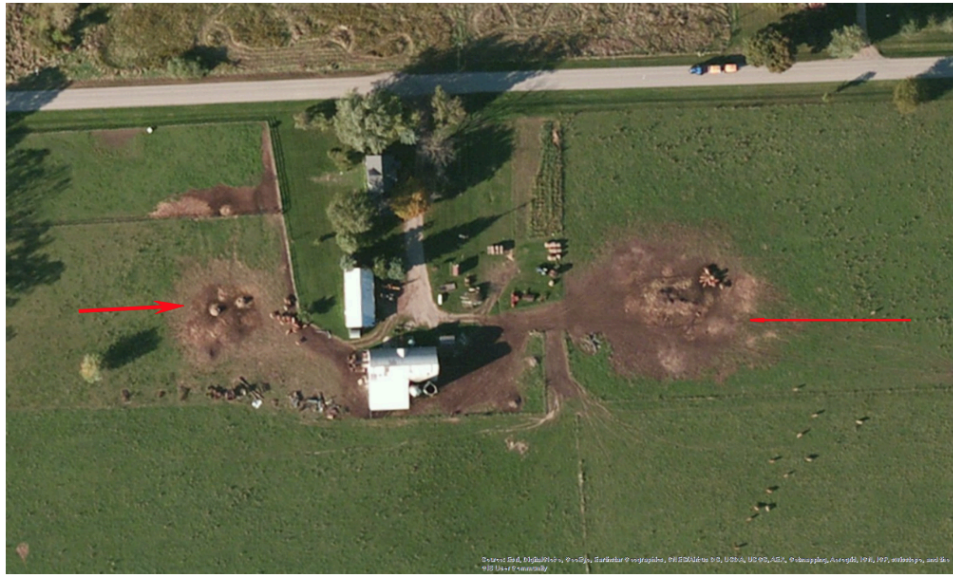
The presence of animals can result in the loss of ground vegetation. Patches of bare earth are a characteristic of AFOs (Figures 5 and 6).

Figure 5. Patches of bare earth.

Figure 6. Patches of bare earth area associated with AFO.

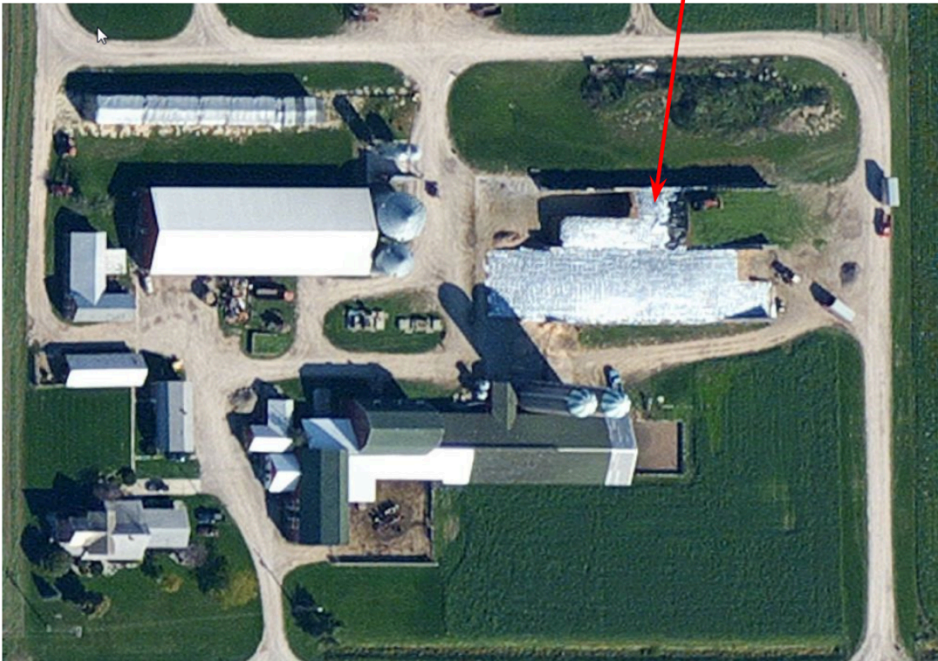
Figure 8. Example of the foil like appearance of a silage bunker.

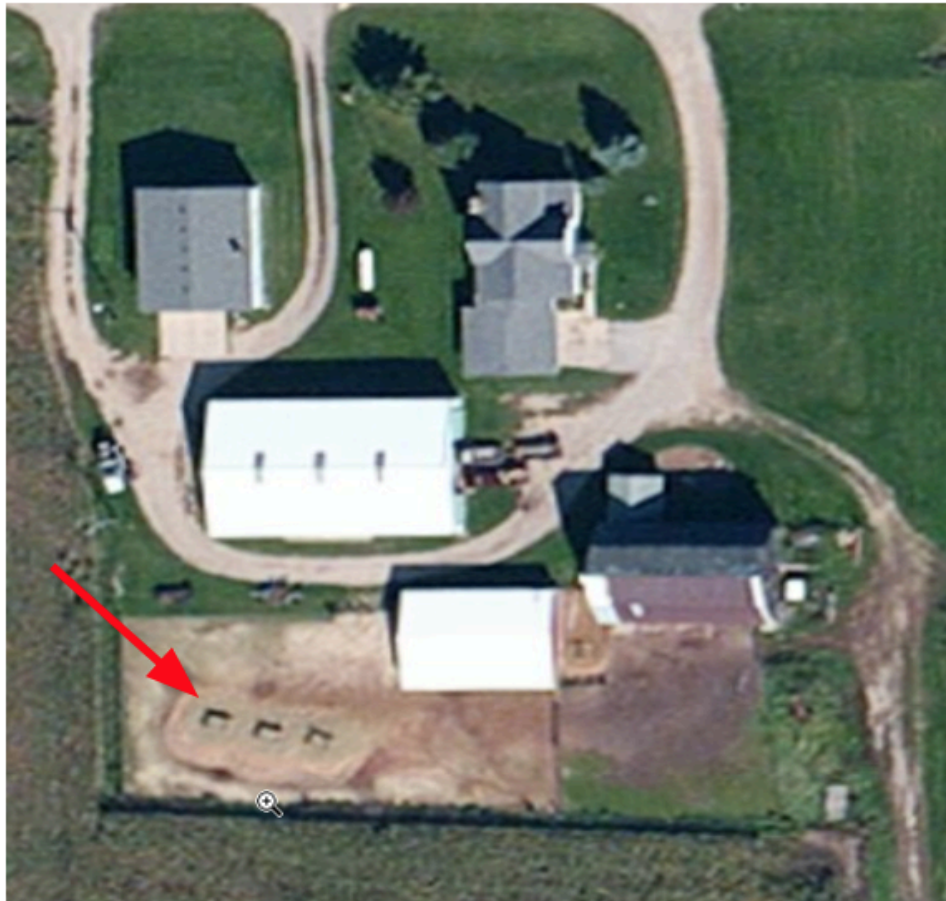
Feed for animals are often placed in feeder stations. Figure 9 shows several feeder stations out in a feedlot. An indicator typically associated with feeder stations is patches of bare earth. In a pasture setting, feeder stations are often moved around, and the bare earth areas have a distinct circular and/or rectangular pattern (Figure 10).

Figure 9. Feeder stations in feedlot

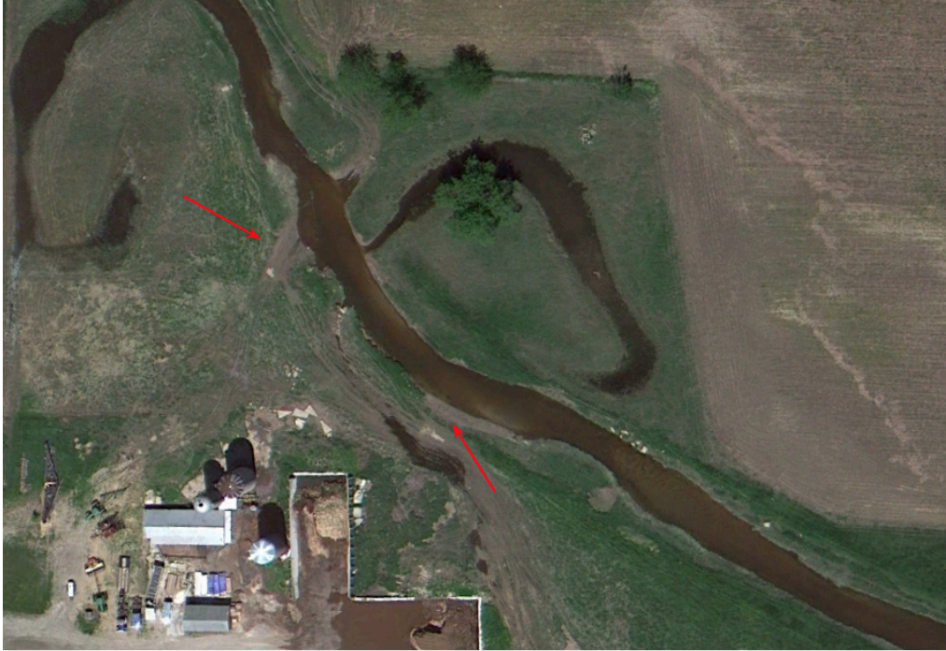
Figure 11: Arrows indicate areas of bare soil where animals may have access to the stream. Banks appear disturbed.

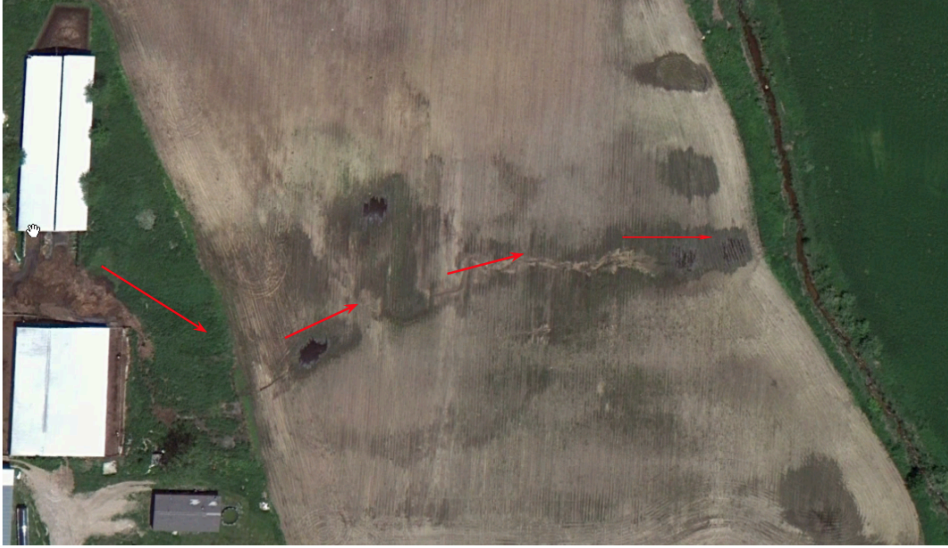
Figure 12: Arrows indicate natural drainage path from a feedlot area through a field to surface water.

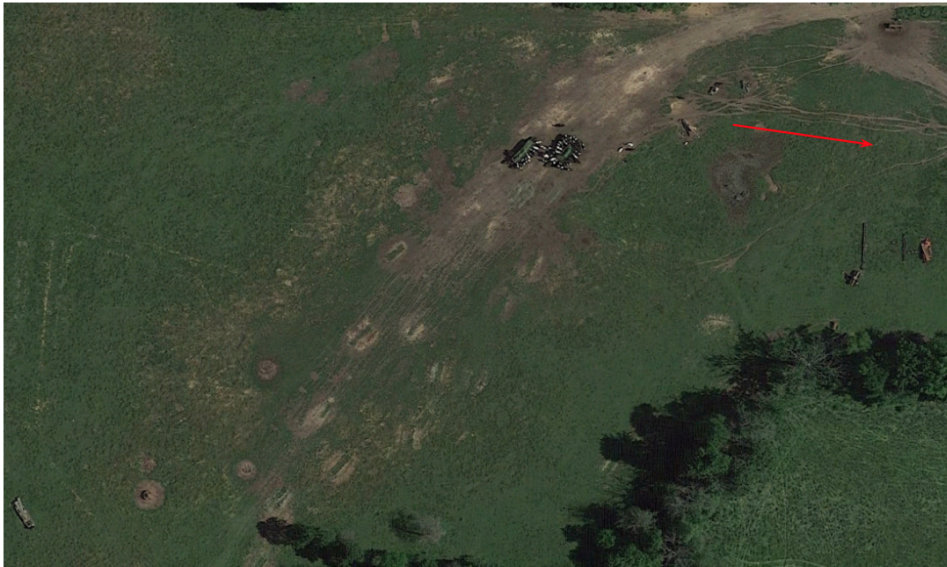
Figure 13: Disturbed areas show temporary locations for animal feeding. Arrow indicates drainage flow path from feeding area, potentially transporting nutrients and pathogens to surface water.

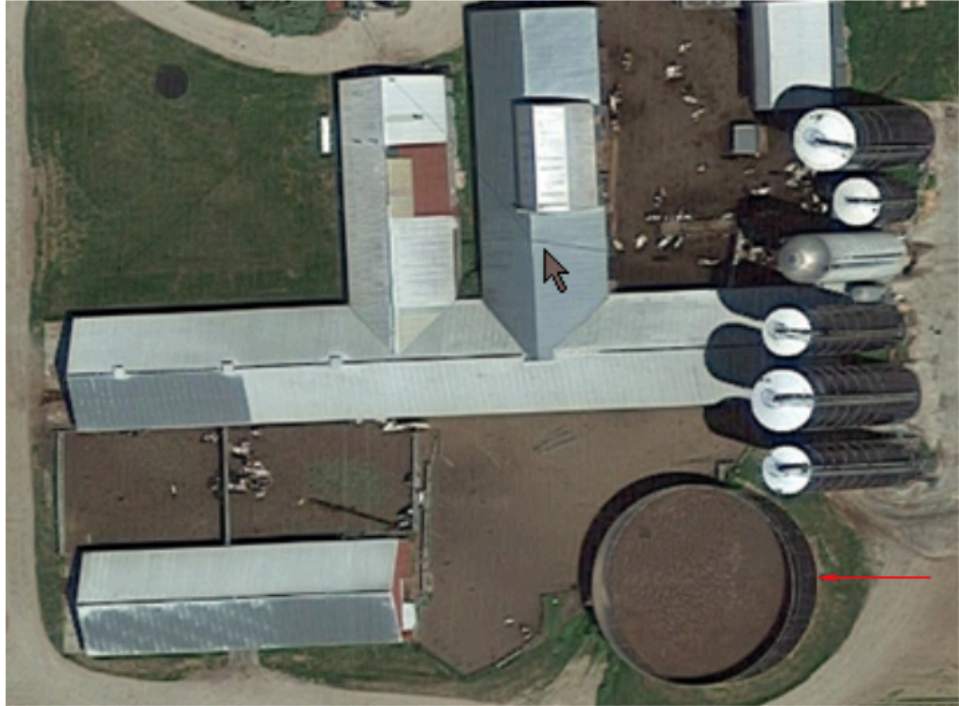
Figure 14: Arrow indicates above ground manure storage structure.

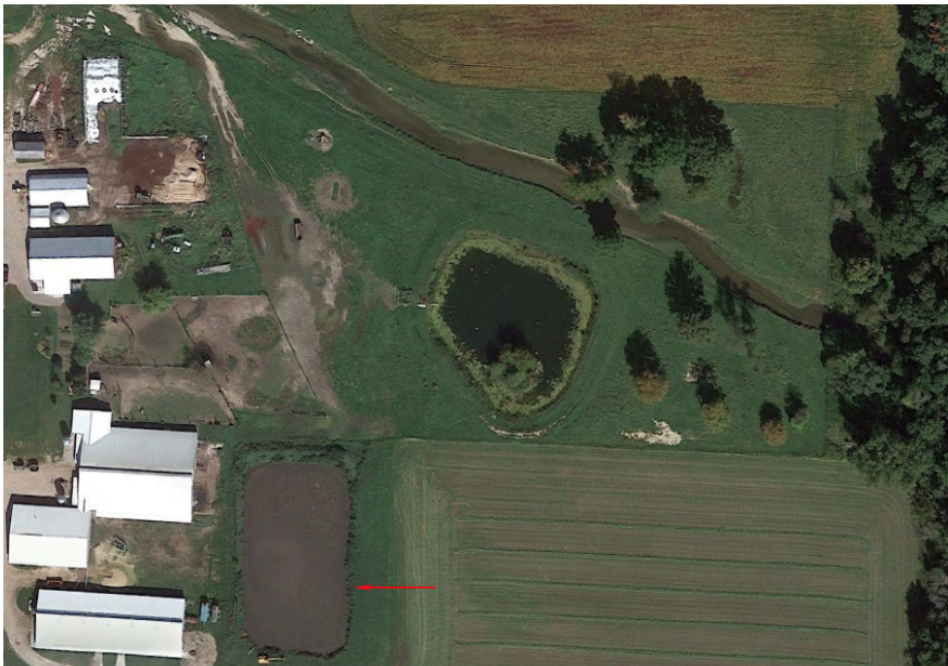
- Earthen manure storage structure are lined, pond-like structures. Are they located close to surface water bodies?

Figure 15: Arrow indicates earthen manure storage structure.

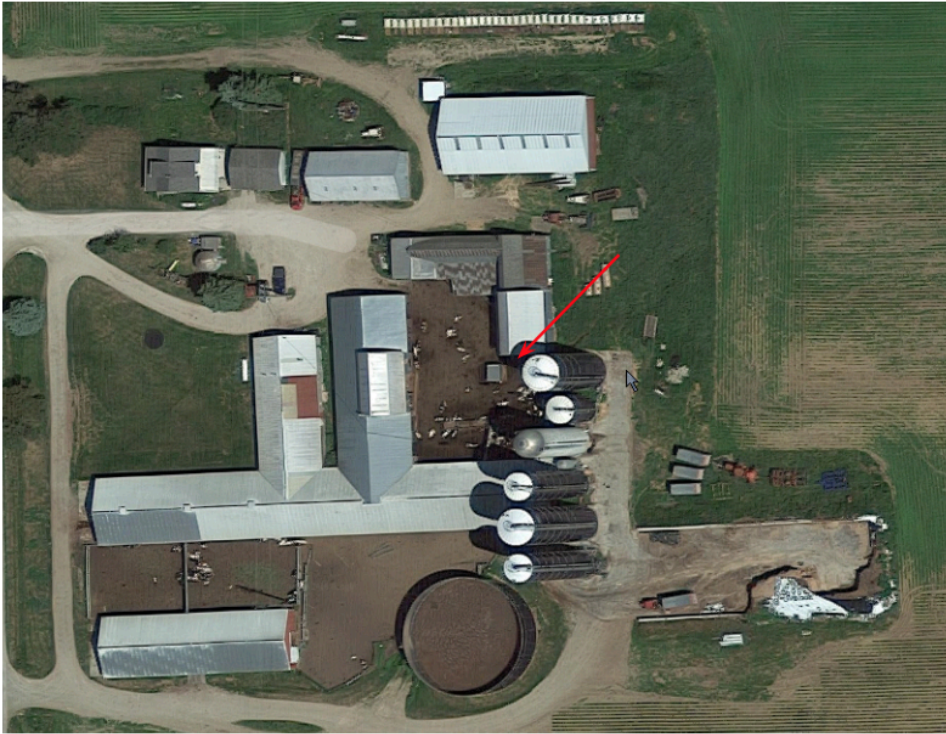
Figure 16: Arrow indicates silos, potential sources of nutrients

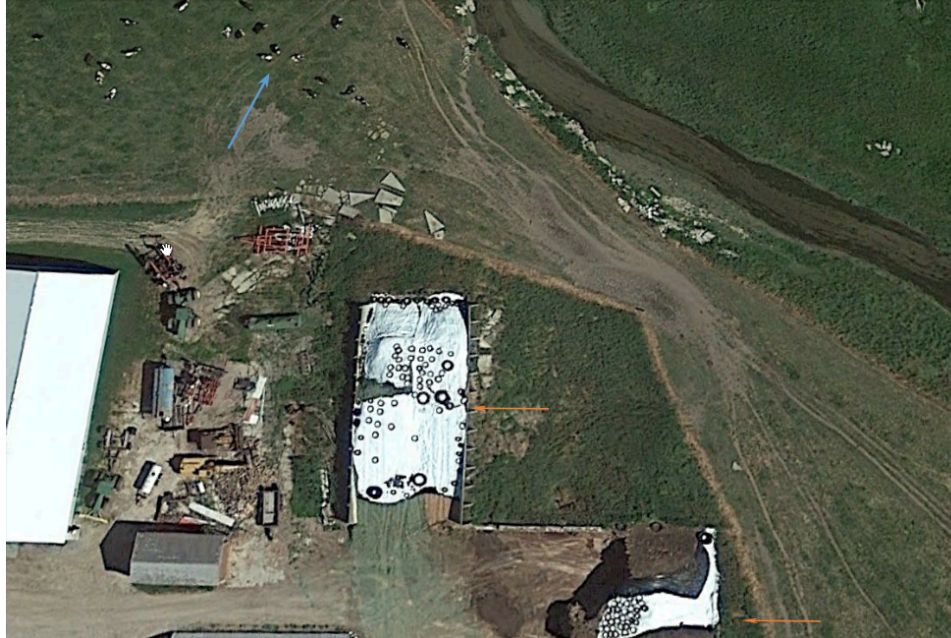
Figure 17: Orange arrows indicate silage storage bunkers. Blue arrows show cows in close proximity to stream.

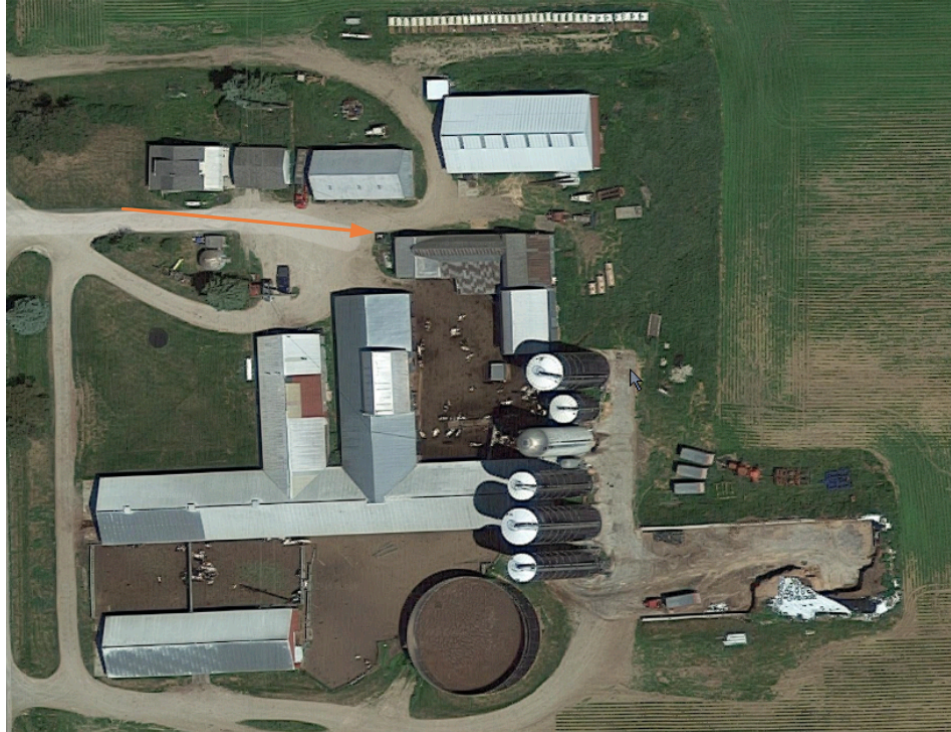
Figure 18: Dairy operation

- Presence of a circular storage structure for liquid manure
  - Silos for storing feed
  - Red arrow indicates milking parlor structure with direct road access for trucks
  - Top of the image shows hutches for calves
  - Limited pasture area
  - \*Based on the size and number of structures, this operation is categorized as “Medium”
- Beef

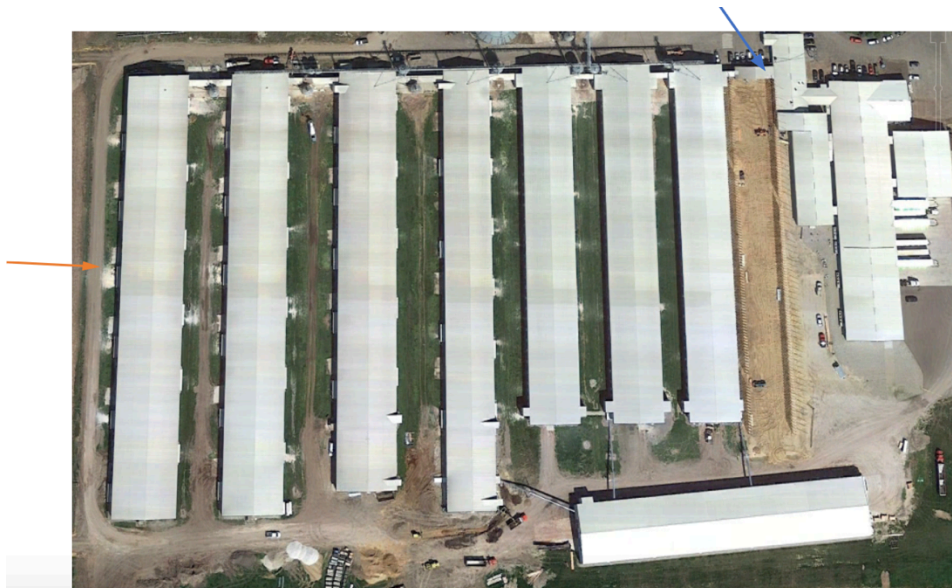
Figure 20: Poultry operation

- Fans lining the outside of long building with nearby dust/feather piles (see red arrow)
  - Long buildings are connected to a more central building for processing. Easy road access as well (see blue arrow)
  - \*Based on the size and number of structures present this operation would be categorized as “Large”
- Swine

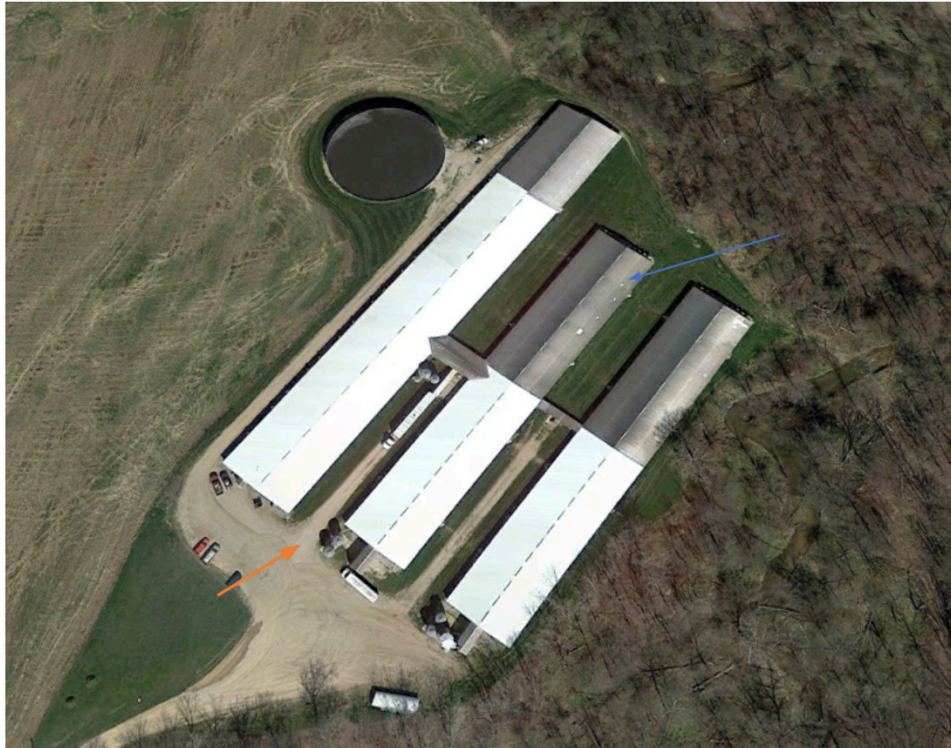
Figure 21: Swine operation (with visible manure storage structure)
