UMTRI-83-46

DOWNSIZING OF HEAVY TRUCK WHEELS DUE  
TO EXTREME OVERINFLATION

Technical Report Documentation Page

16. Abstract A series of experiments was performed in which heavy truck tires were inflated up to failure. The purpose of the experiments was to examine the alterations in rim dimensions which derive from the explosive failure of the tire. It was found that radial tires, in size 11-24.5/G, failed in a manner which resulted in the tire bead dismounting over the flange of the single-piece rim. This type of failure caused the bead seat circumference to decrease by approximately 5/8 inch. If such a tire failure was to occur in the field, and the rim downsizing dimension remain unnoticed, a hazard may exist since new tires mounted on such down-sized rims will explosively dismount at much lower pressure values than would apply in the case of new, full-sized rims.

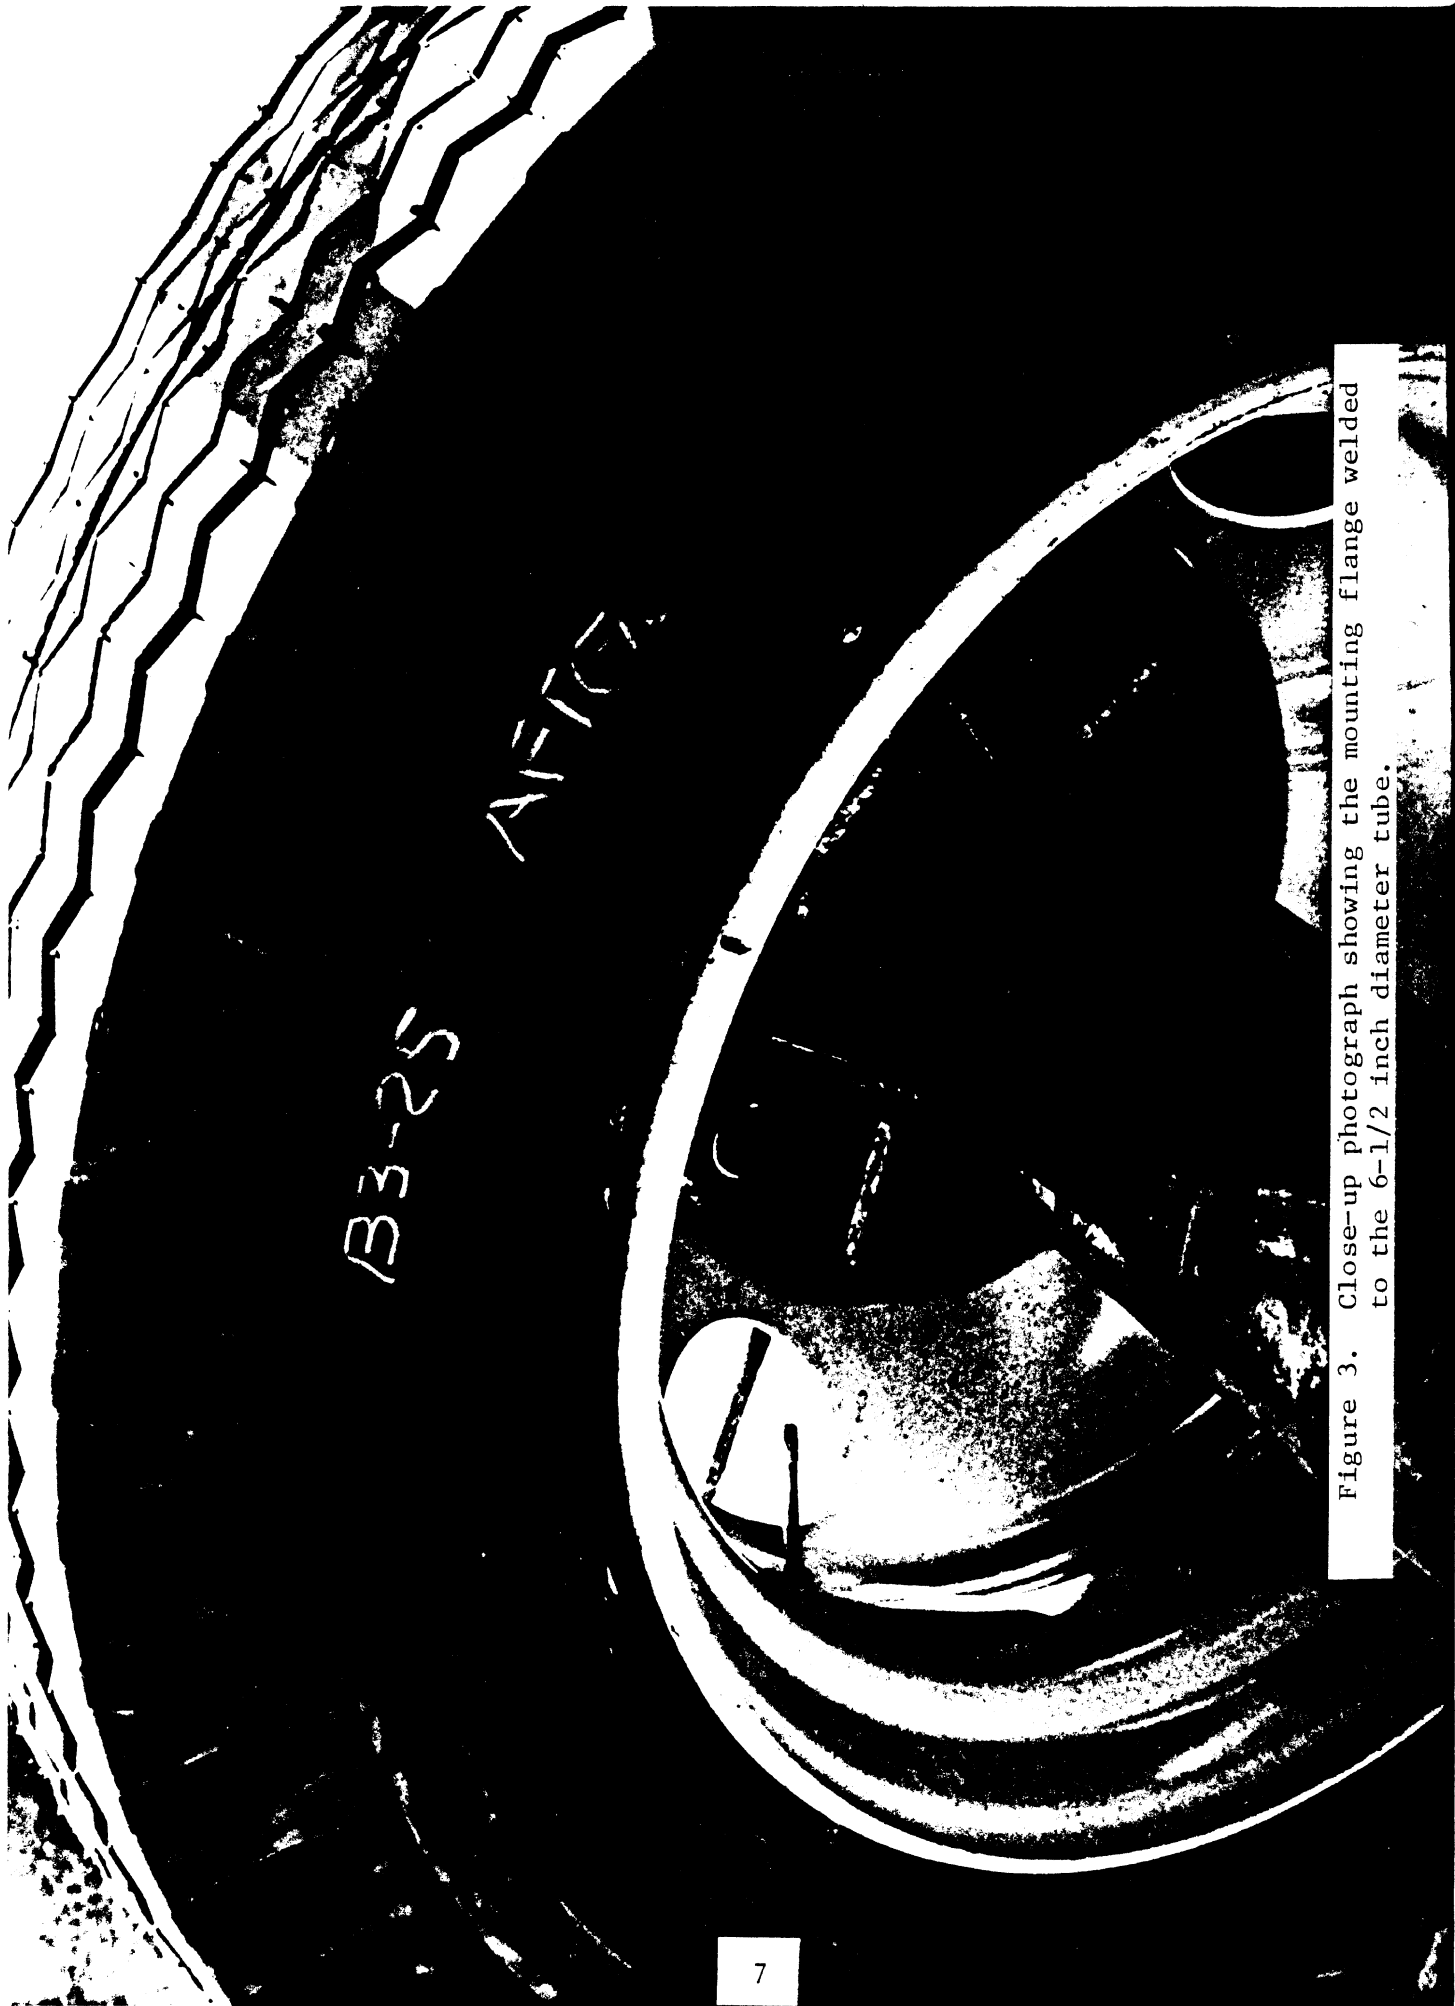
Figure 3. Close-up photograph showing the mounting flange welded to the 6-1/2 inch diameter tube.

The mounting fixture and the test pit are shown in Figures 2, 3, and 4. The wheel was bolted to a flange which was welded to a section of 6-1/2-inch steel pipe such that the tire was centered between 2 steel end plates supporting the pipe. The mounting fixture was configured to suspend the test sample in the containment pit so that the exploding tire could not contact any rigid support structure. Thus clearance of approximately 16 inches was provided between the sidewalls of the mounted tire and the end plates shown in Figure 2.

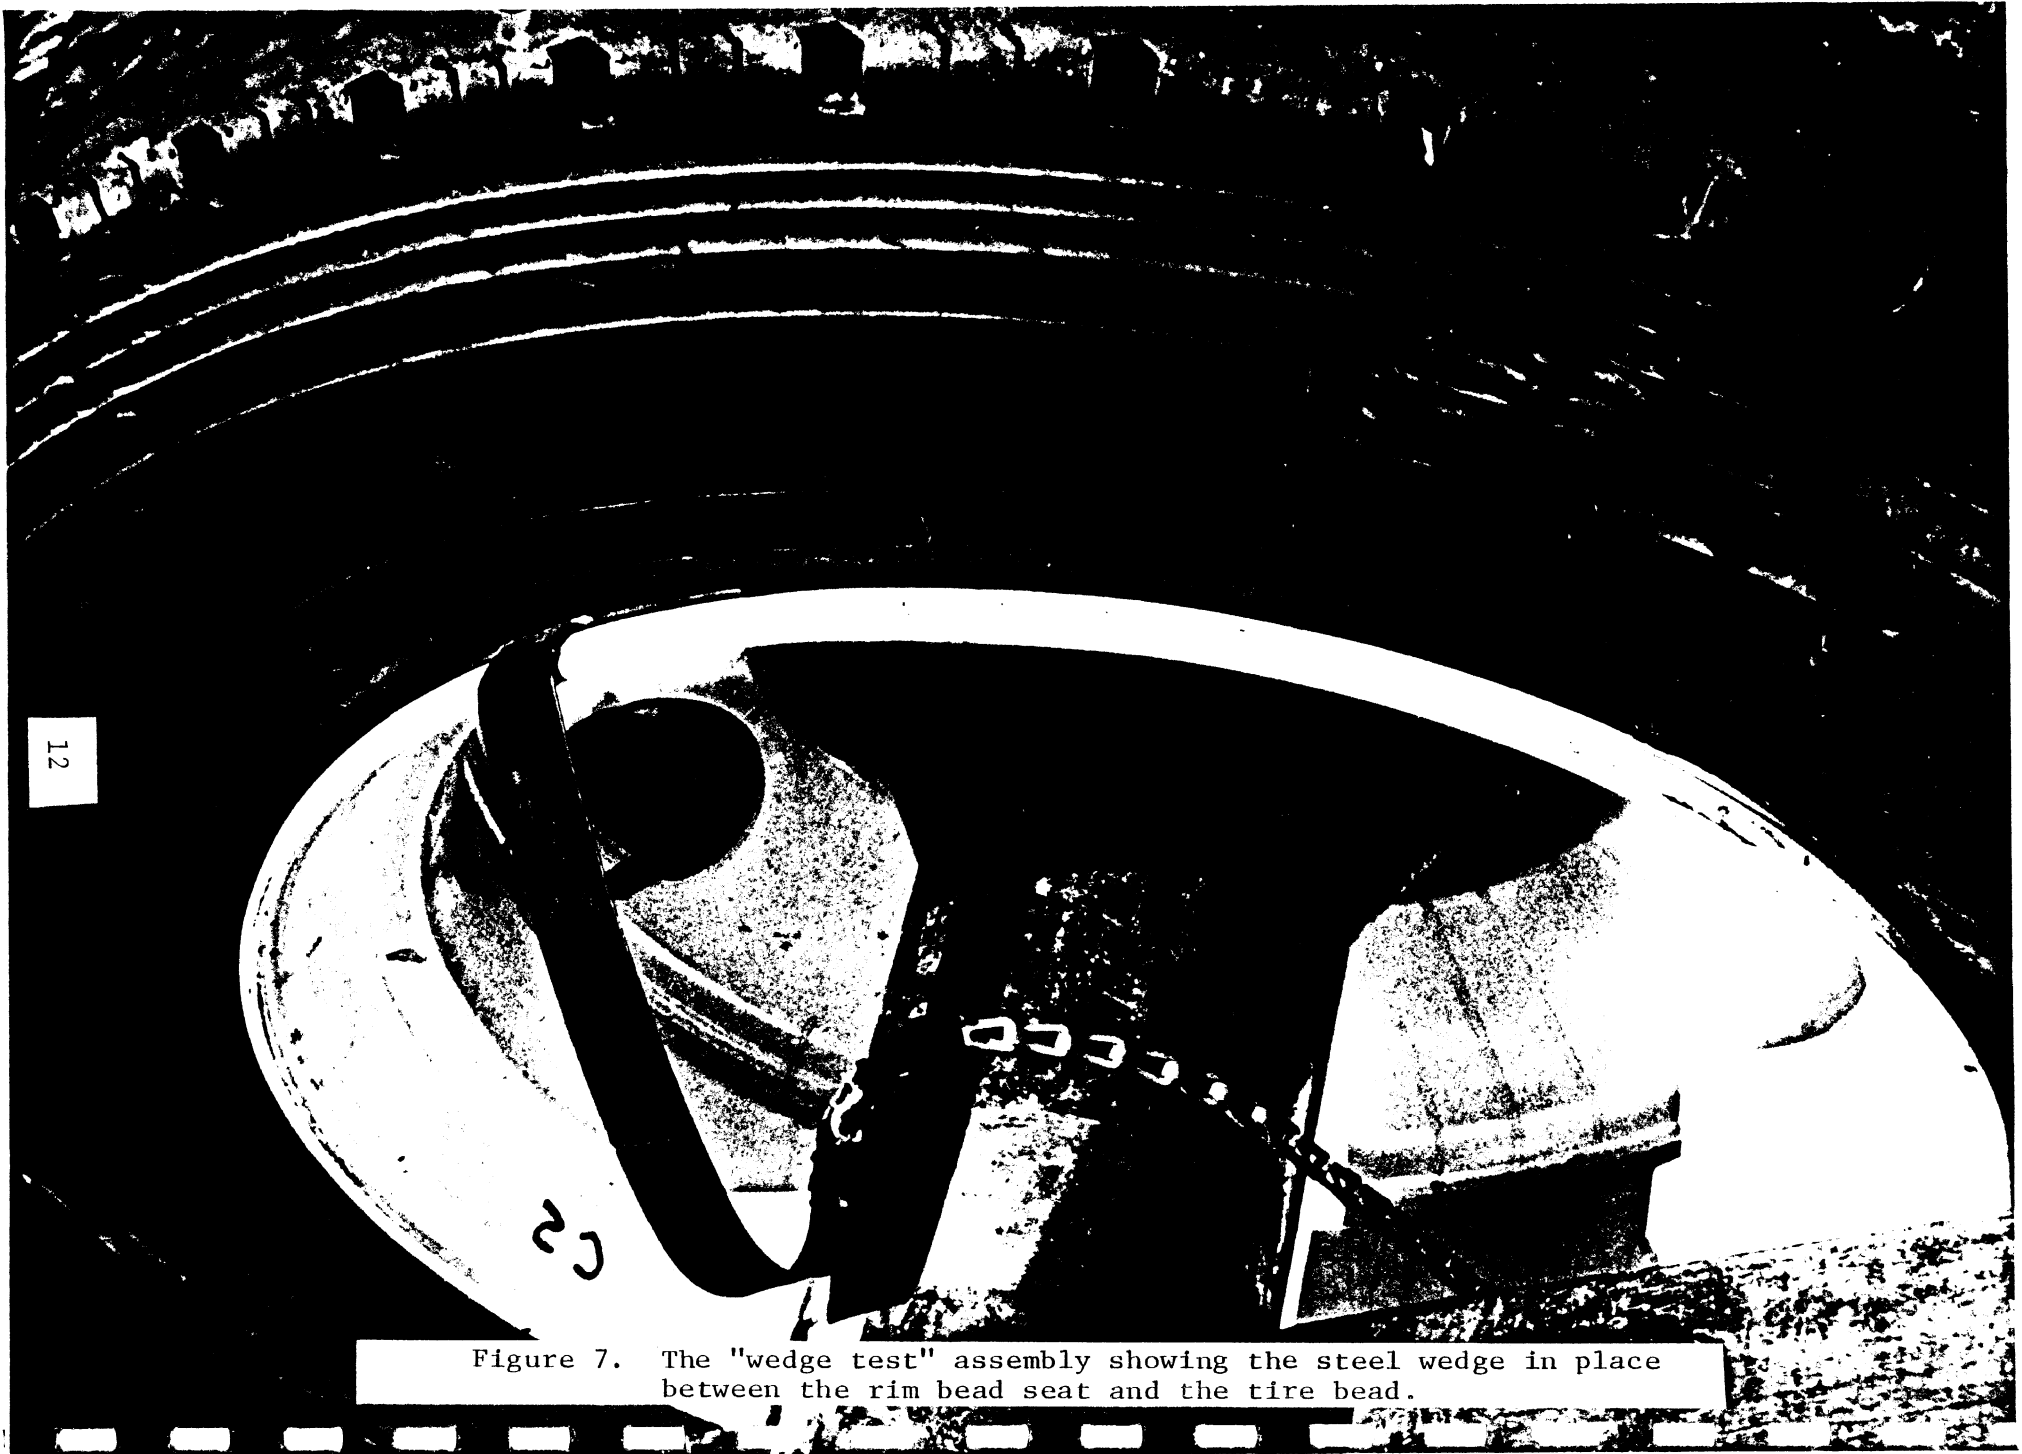
Figure 7. The "wedge test" assembly showing the steel wedge in place between the rim bead seat and the tire bead.

Figure 1 shows photographs of the wedge device which was used in an attempt to simulate a bead hang-up and, thus, to induce a lower burst pressure. The wedge was 6-1/2 inches long and 3/8-inch thick and was contoured to fit both the bead seat circle and the fillet radius at the flange. The "nose" of the wedge was tapered so as to achieve tire contact tending to retain it against the wheel flange. The photograph in Figure 7 shows the wedge installed in a tire/wheel assembly and strapped to the test fixture.

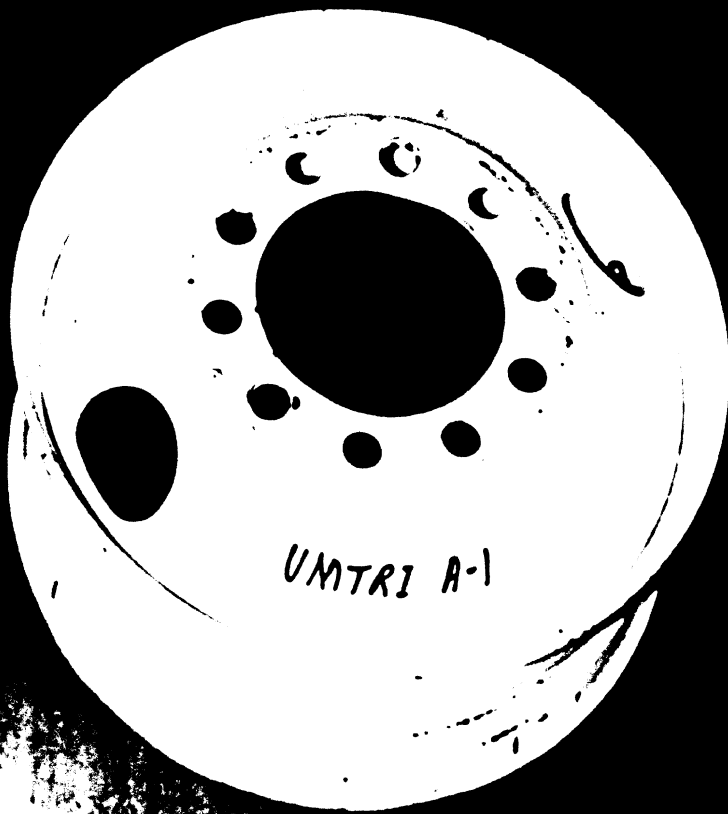
Figure 11. A typical down-sized rim showing slight distortion of the inside flange.

In the test of new tires mounted on downsized rims, all tires (radial and bias) dismounted over the downsized flange at pressures ranging from 160 psi to 240 psi for the radial tires and from 135 psi to 165 psi for the bias tires, while producing little or no additional downsizing of the bead seat. Downsizing of the rims resulted in only slight visible distortion of the wheel flange and no visible distortion of the bead seat. A typical downsized rim is shown in Figure 11. Slight distortion of the inside flange (the flange nearest to the backdrop) can be seen in the photograph. The distortion consists primarily of localized flattening of the flange.
