1. Report No. UMTRI-84-9	2. Government Accession No.	3. Recipient's Catalog No.	
4. Title and Subtitle Dynamic Testing of Vest Restraint System (VRS). Phase II. Final Report.		5. Report Date March 1984	6. Performing Organization Code

15. Supplementary Notes Evaluation of Vest Restraint System (VRS). Phase I. Interim Report. November 30, 1982. Richard G. Snyder and John W. Melvin	
16. Abstract Seven tests of the Bureau of Mines proposed vest restraint system were conducted at UMTRI as the phase II or development program. The factors that were found to provide good performance of the vest restraint were the elimination of sliding motion between belt webbing in the vest, common slots in the anchor hardware for the two tether belts on each side, and anchors positioned rearward to provide a 45-degree tether angle. It was recommended that the vest restraints be sized to the torso height of the wearer to preclude abdominal intrusion by the lap belt segment and that upper torso restraint be added to protect against frontal impact, significantly reducing head excursions and associated injuries.

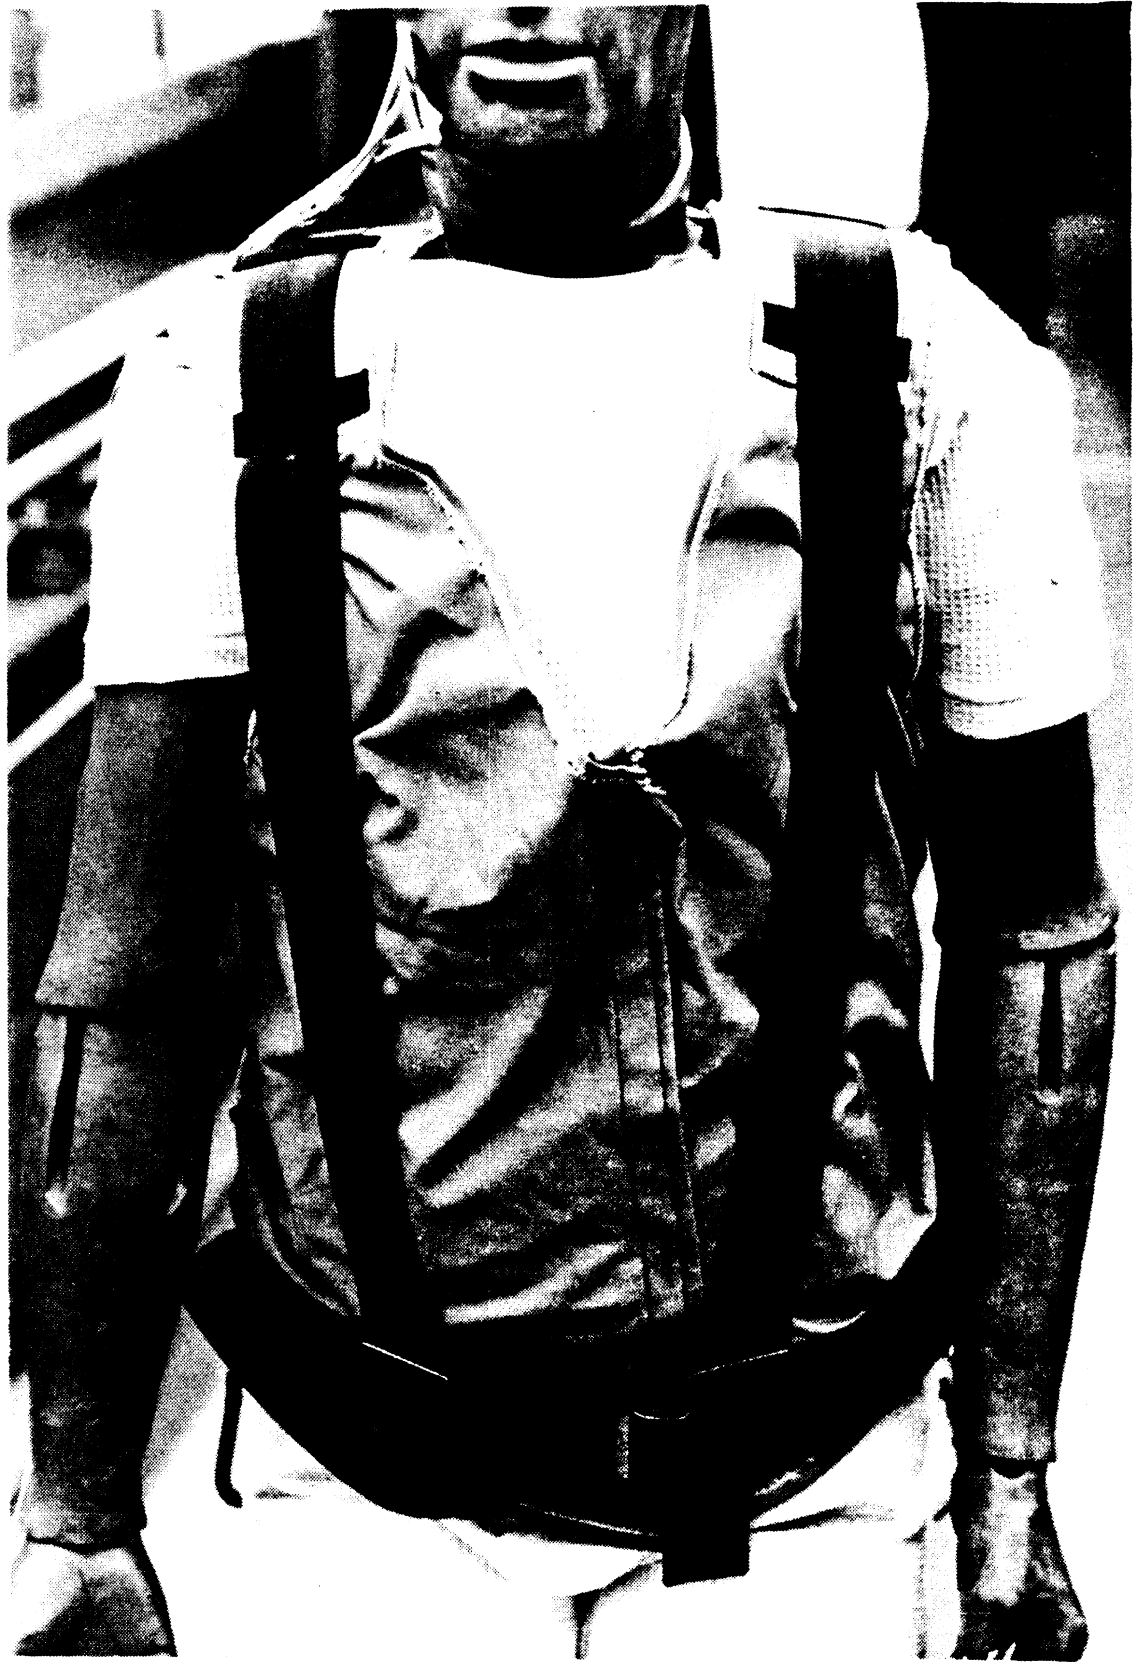
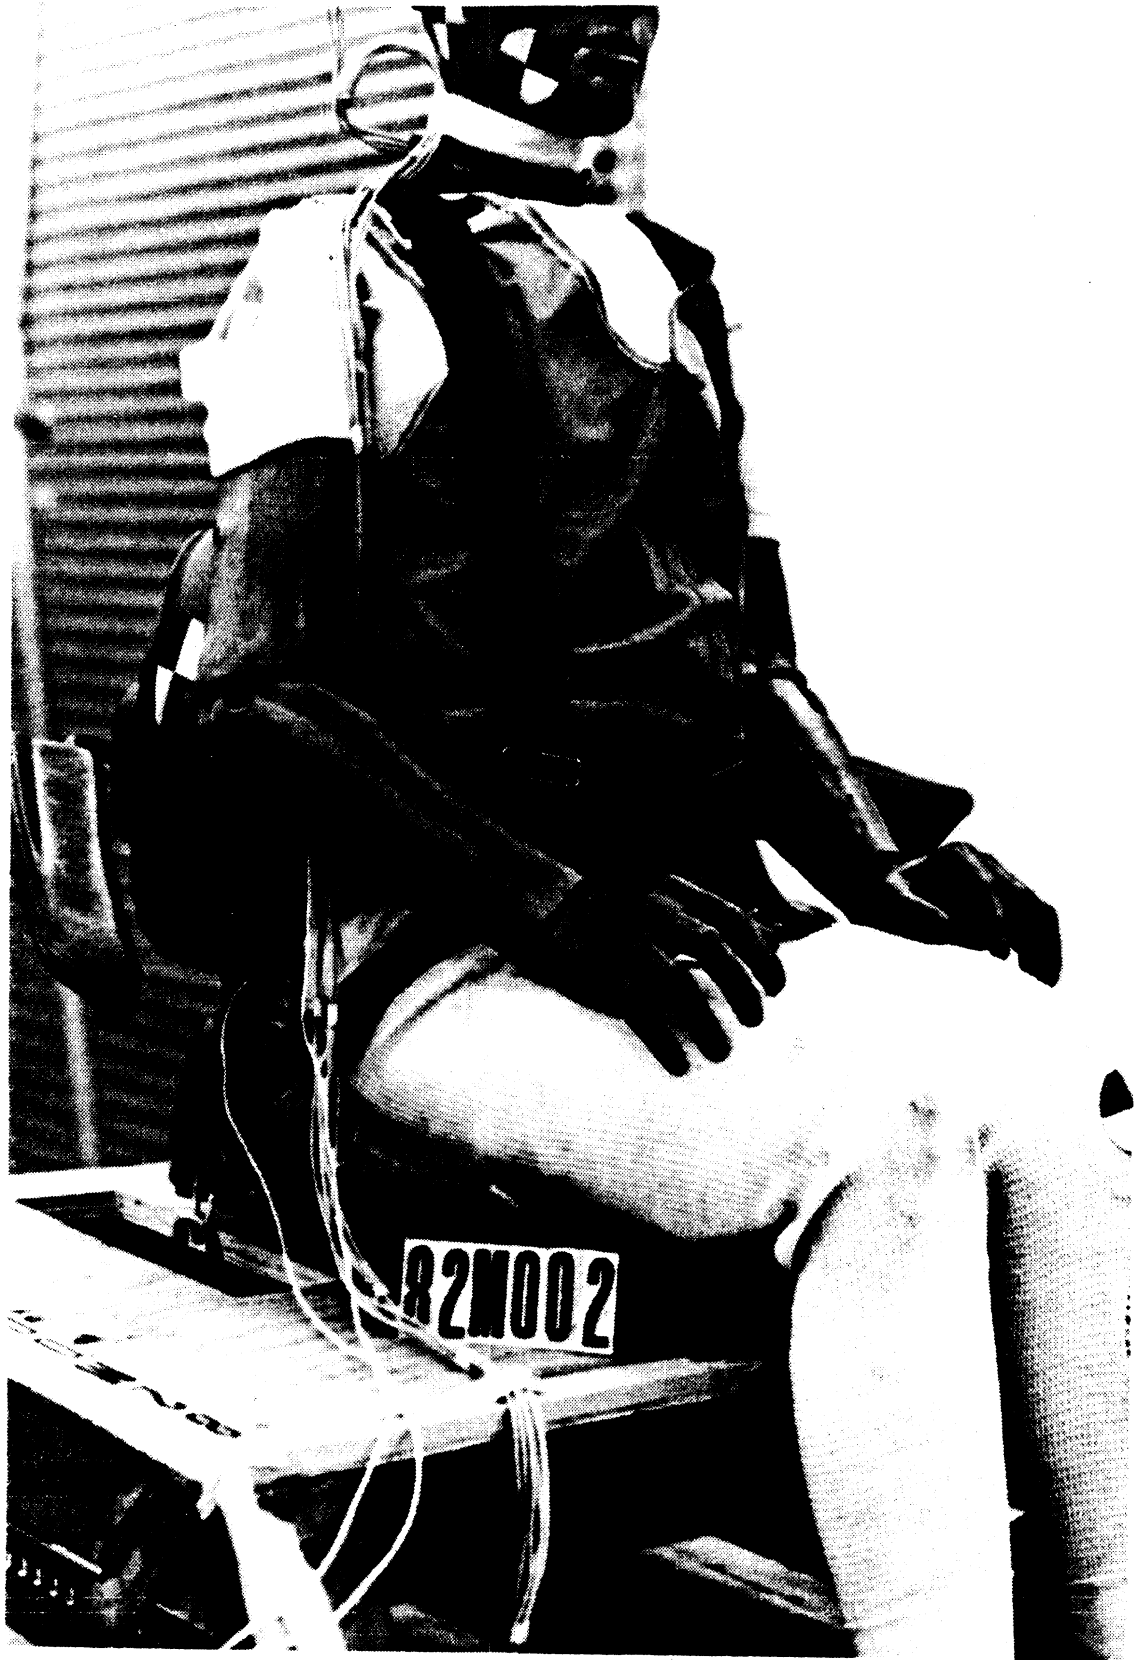
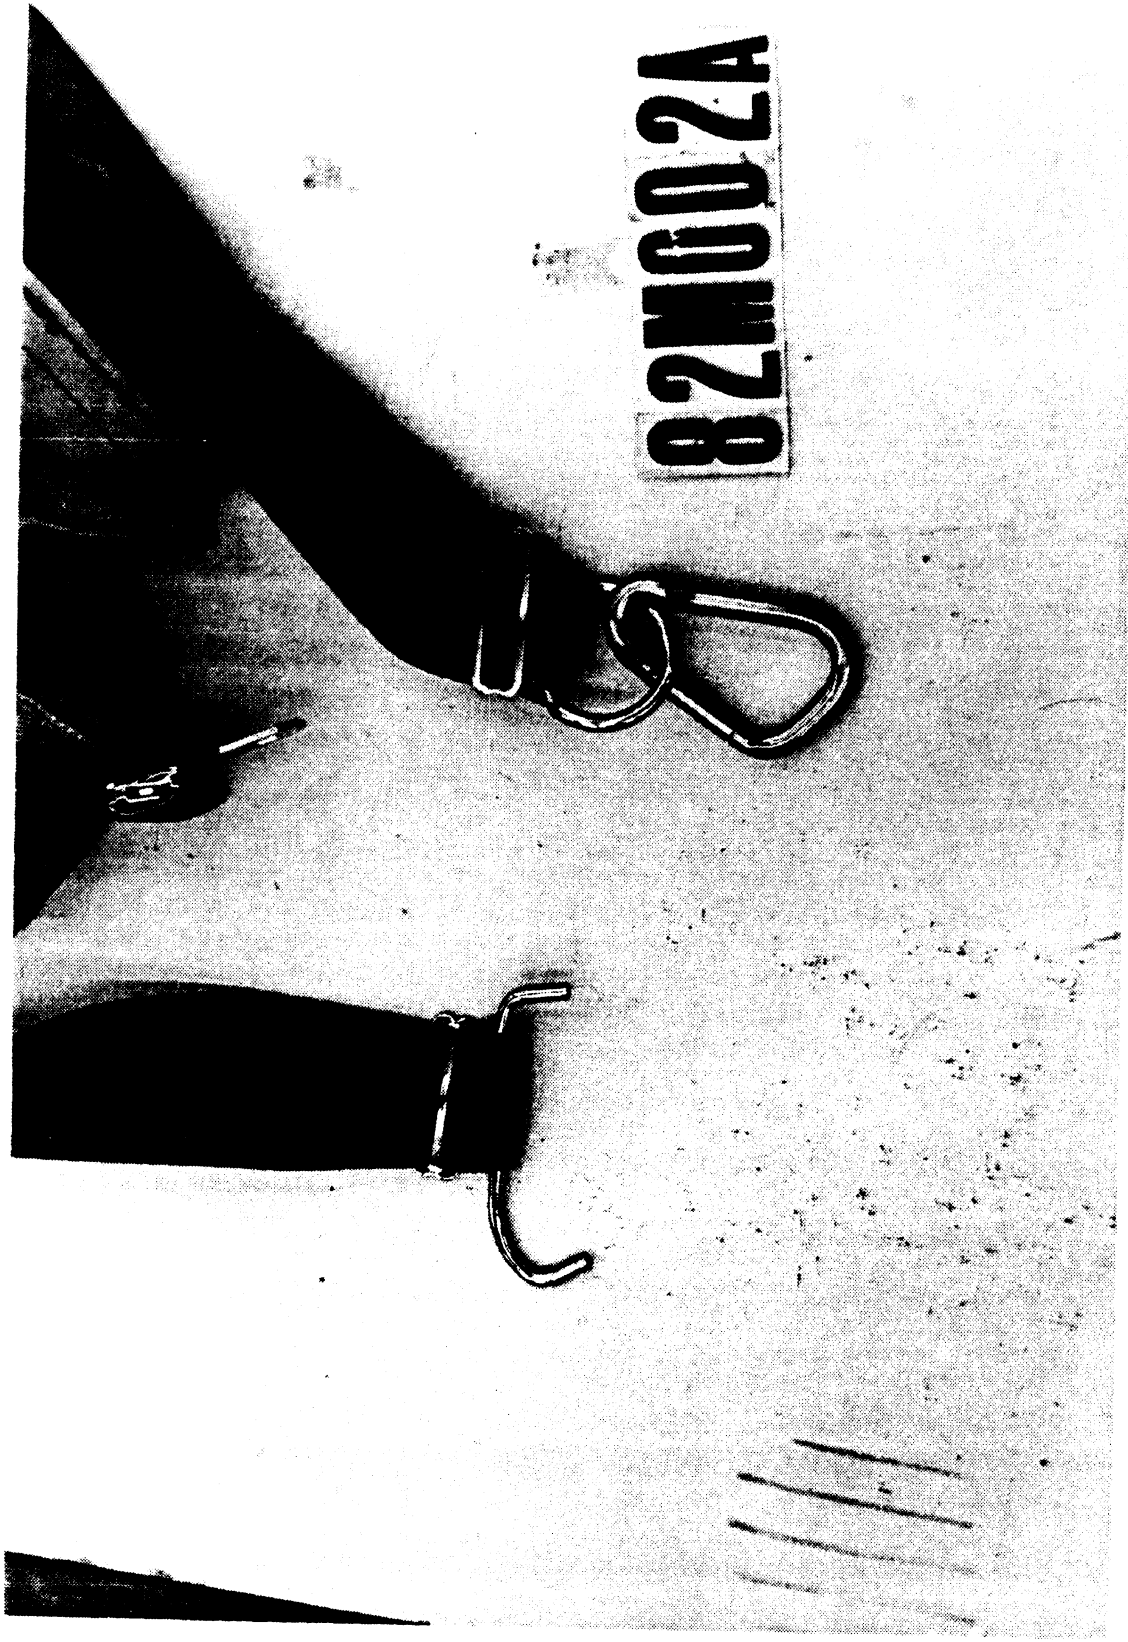
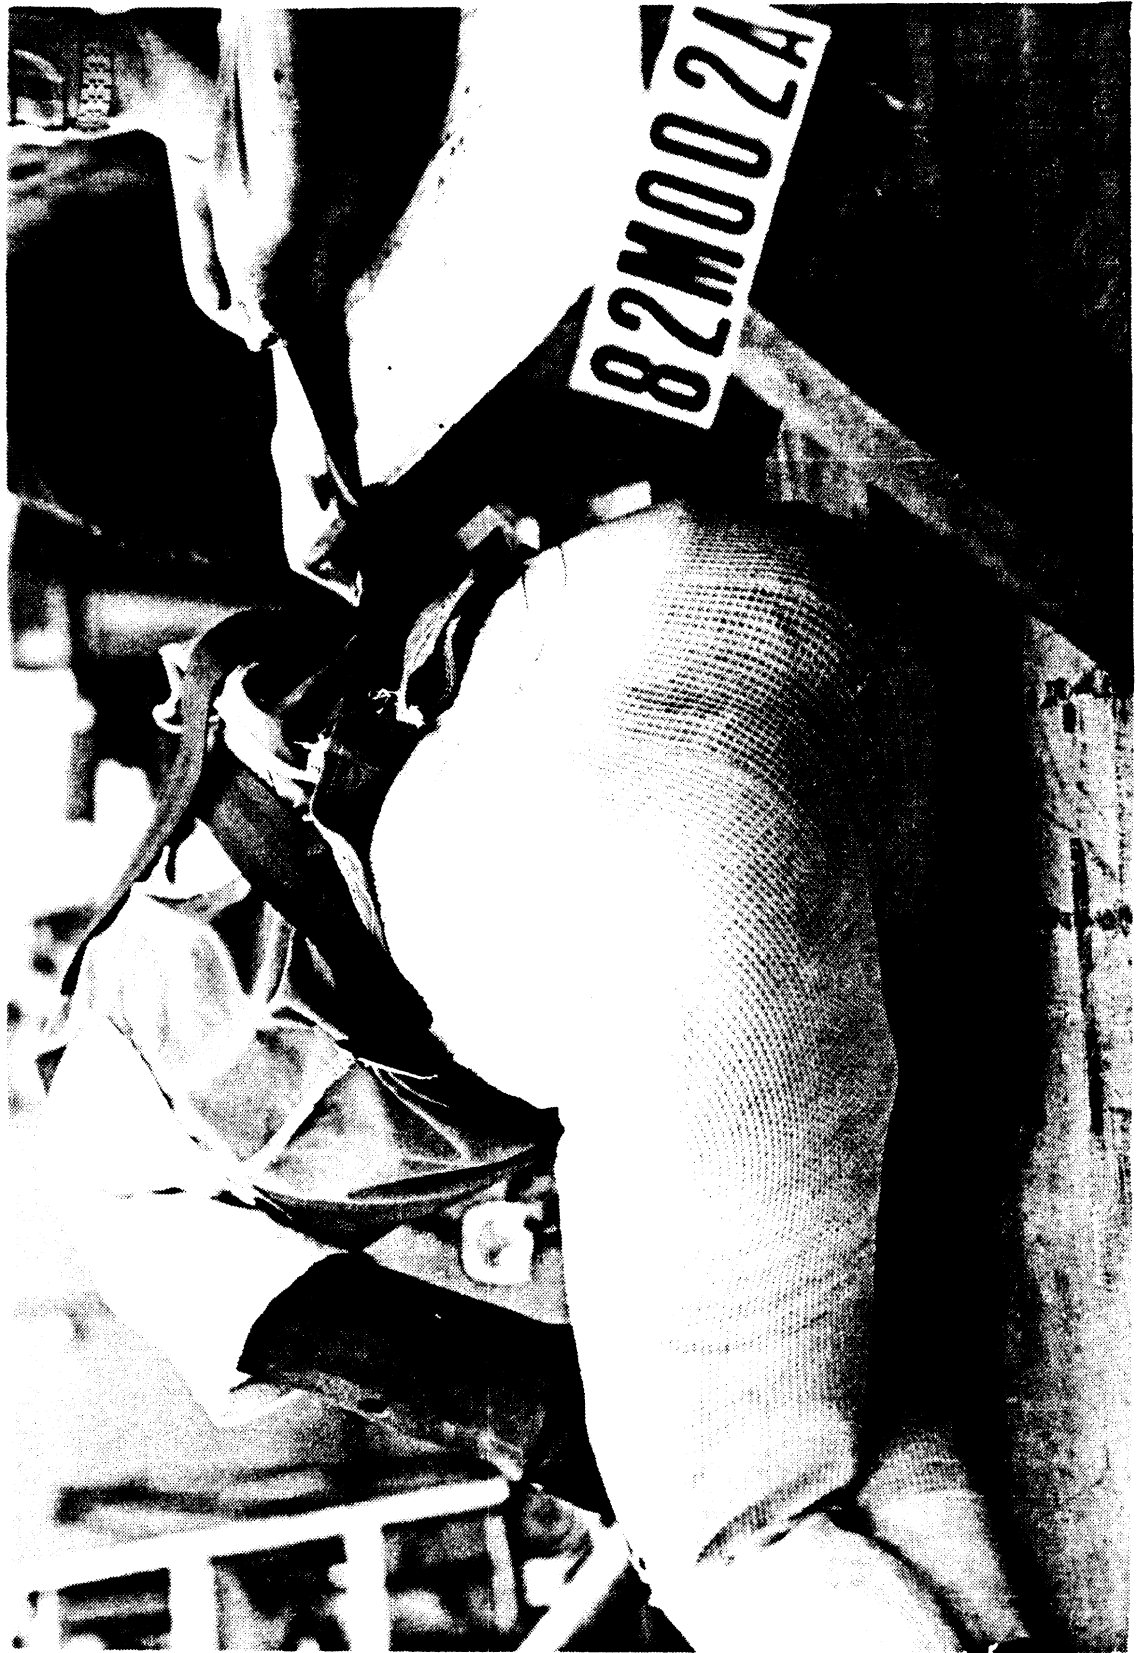
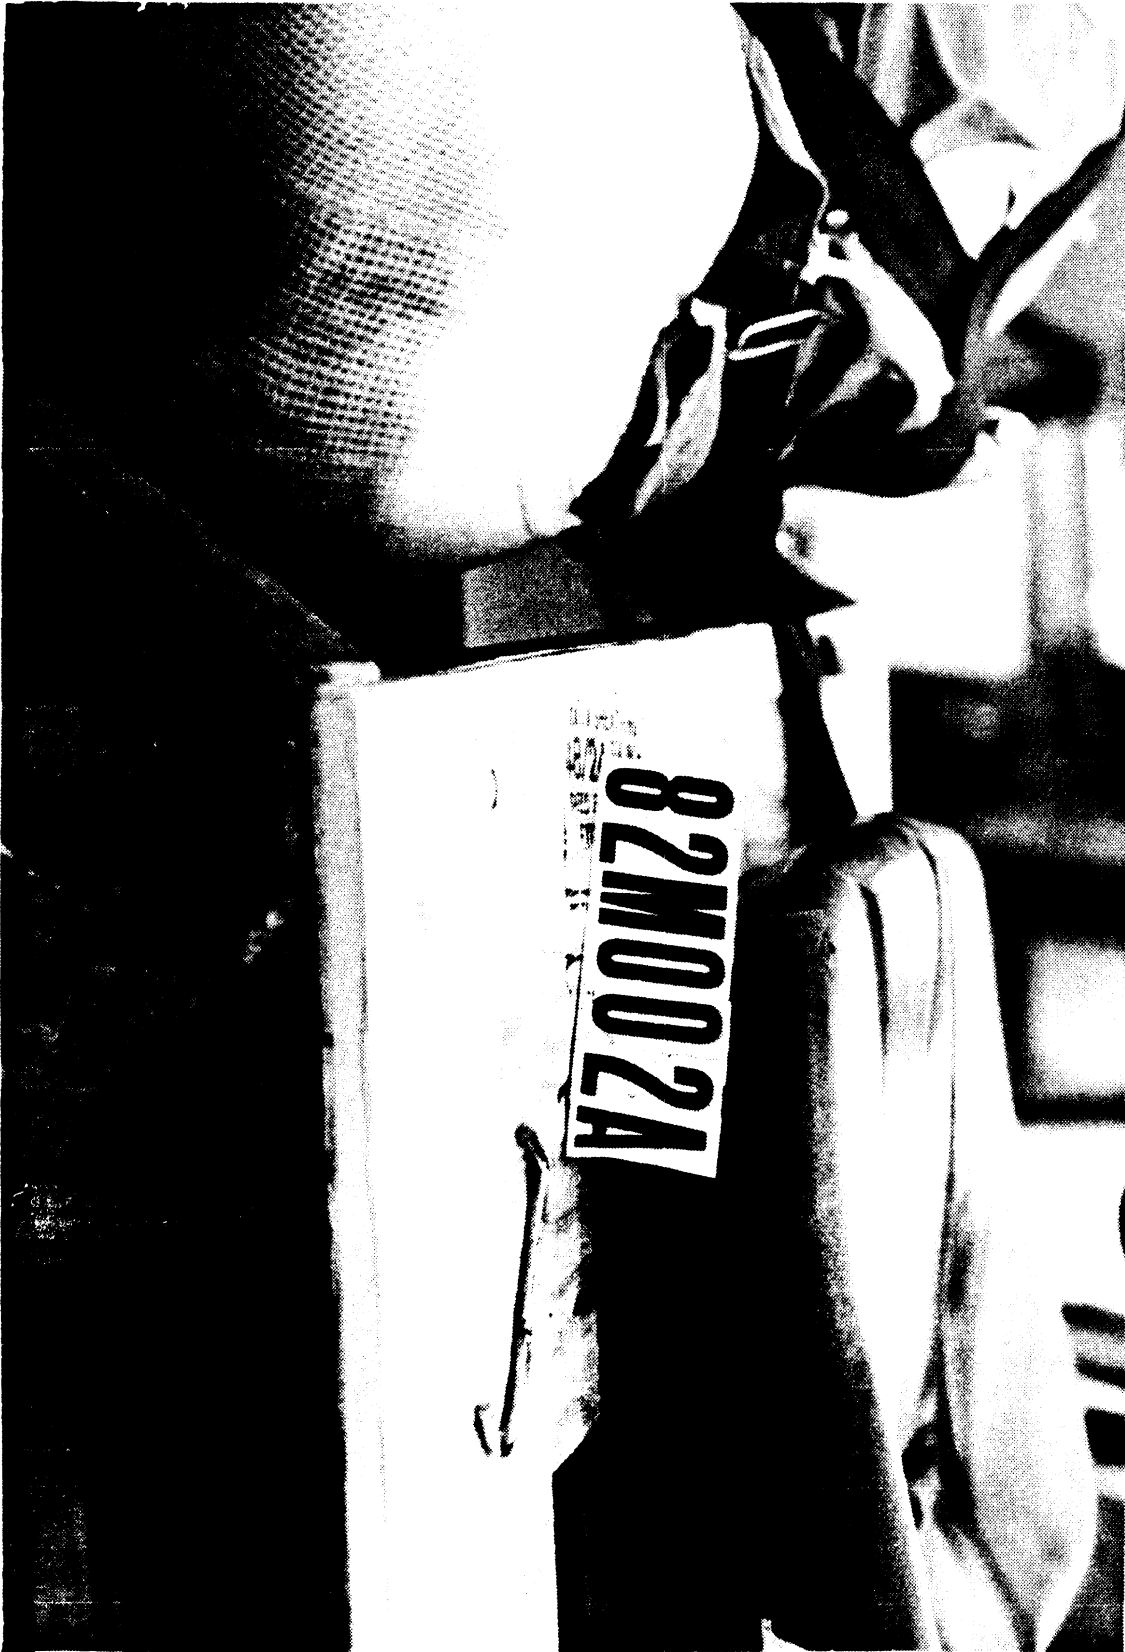
82M002

A vest restraint with improved stitching was then provided and evaluated in 82M002, the first test of this program's second phase. During impact, the left side tether strap "D"-ring weld failed, and the "D"-ring pulled open and released the tether belts. The dummy was not restrained and impacted against the front of the sled.

OBSERVATIONS: Left side tether "D"-ring failed, releasing dummy during impact.

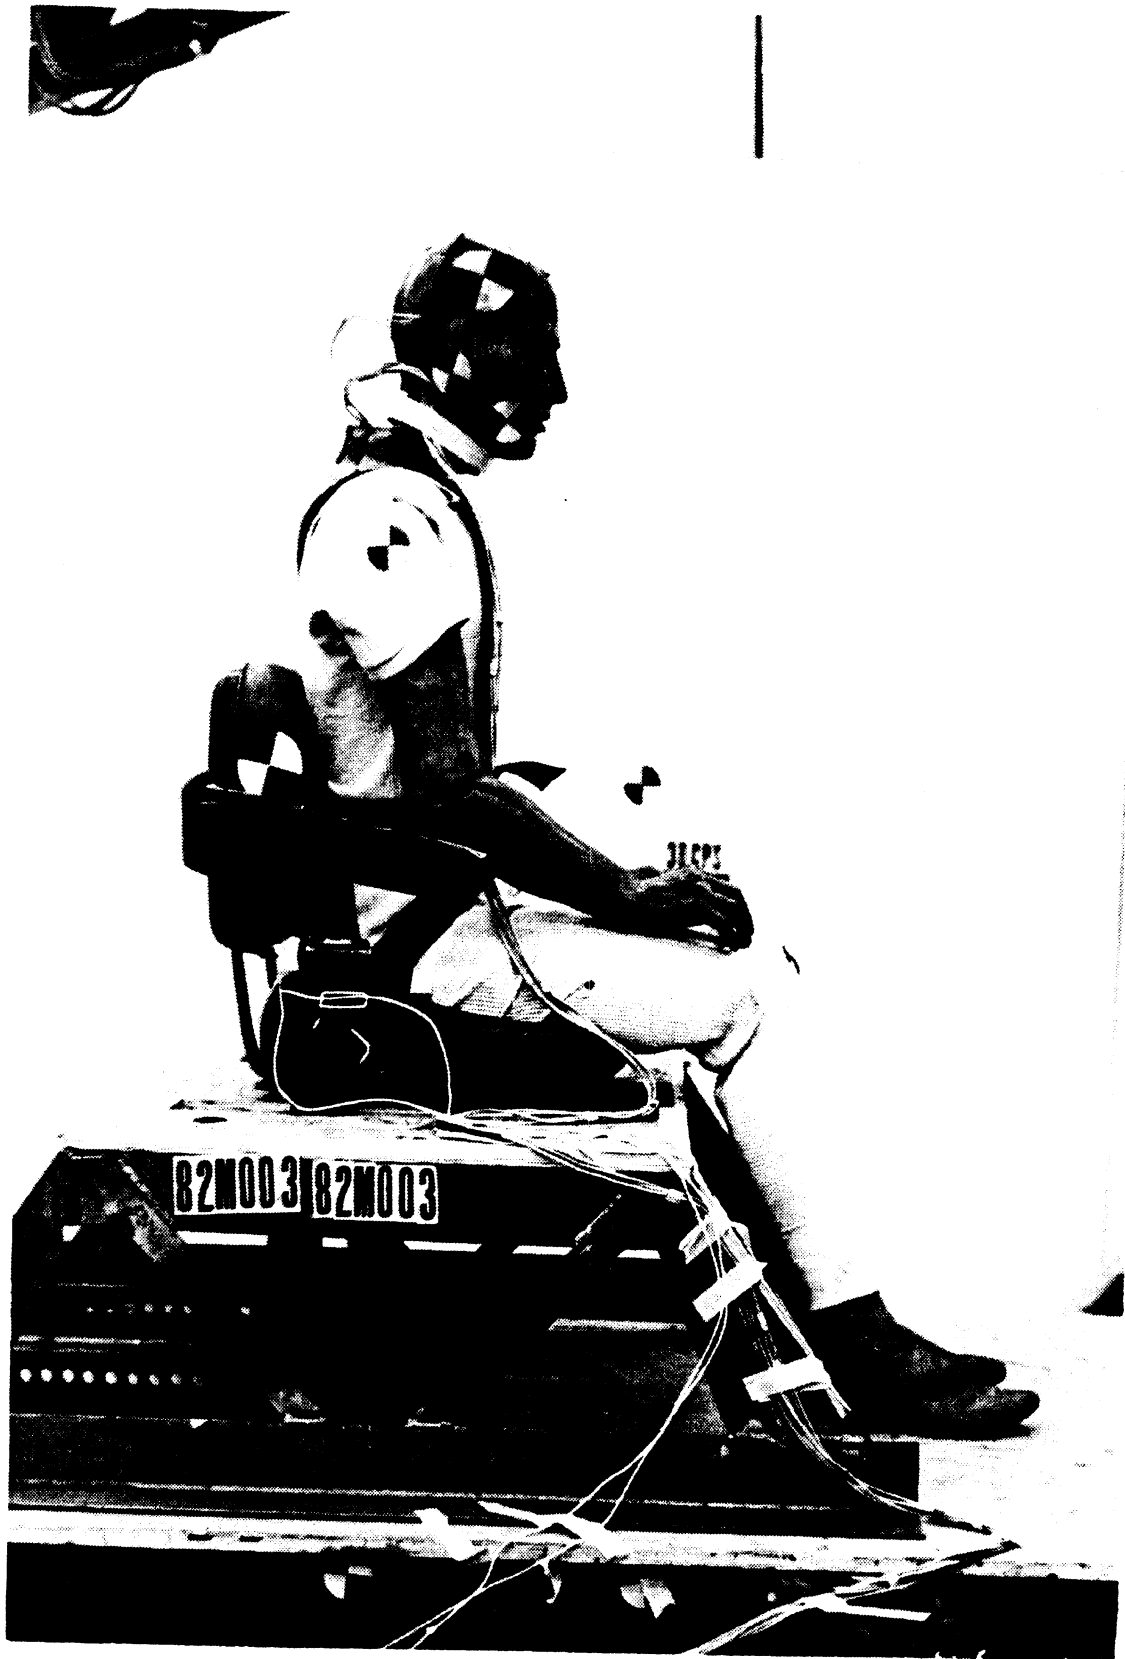
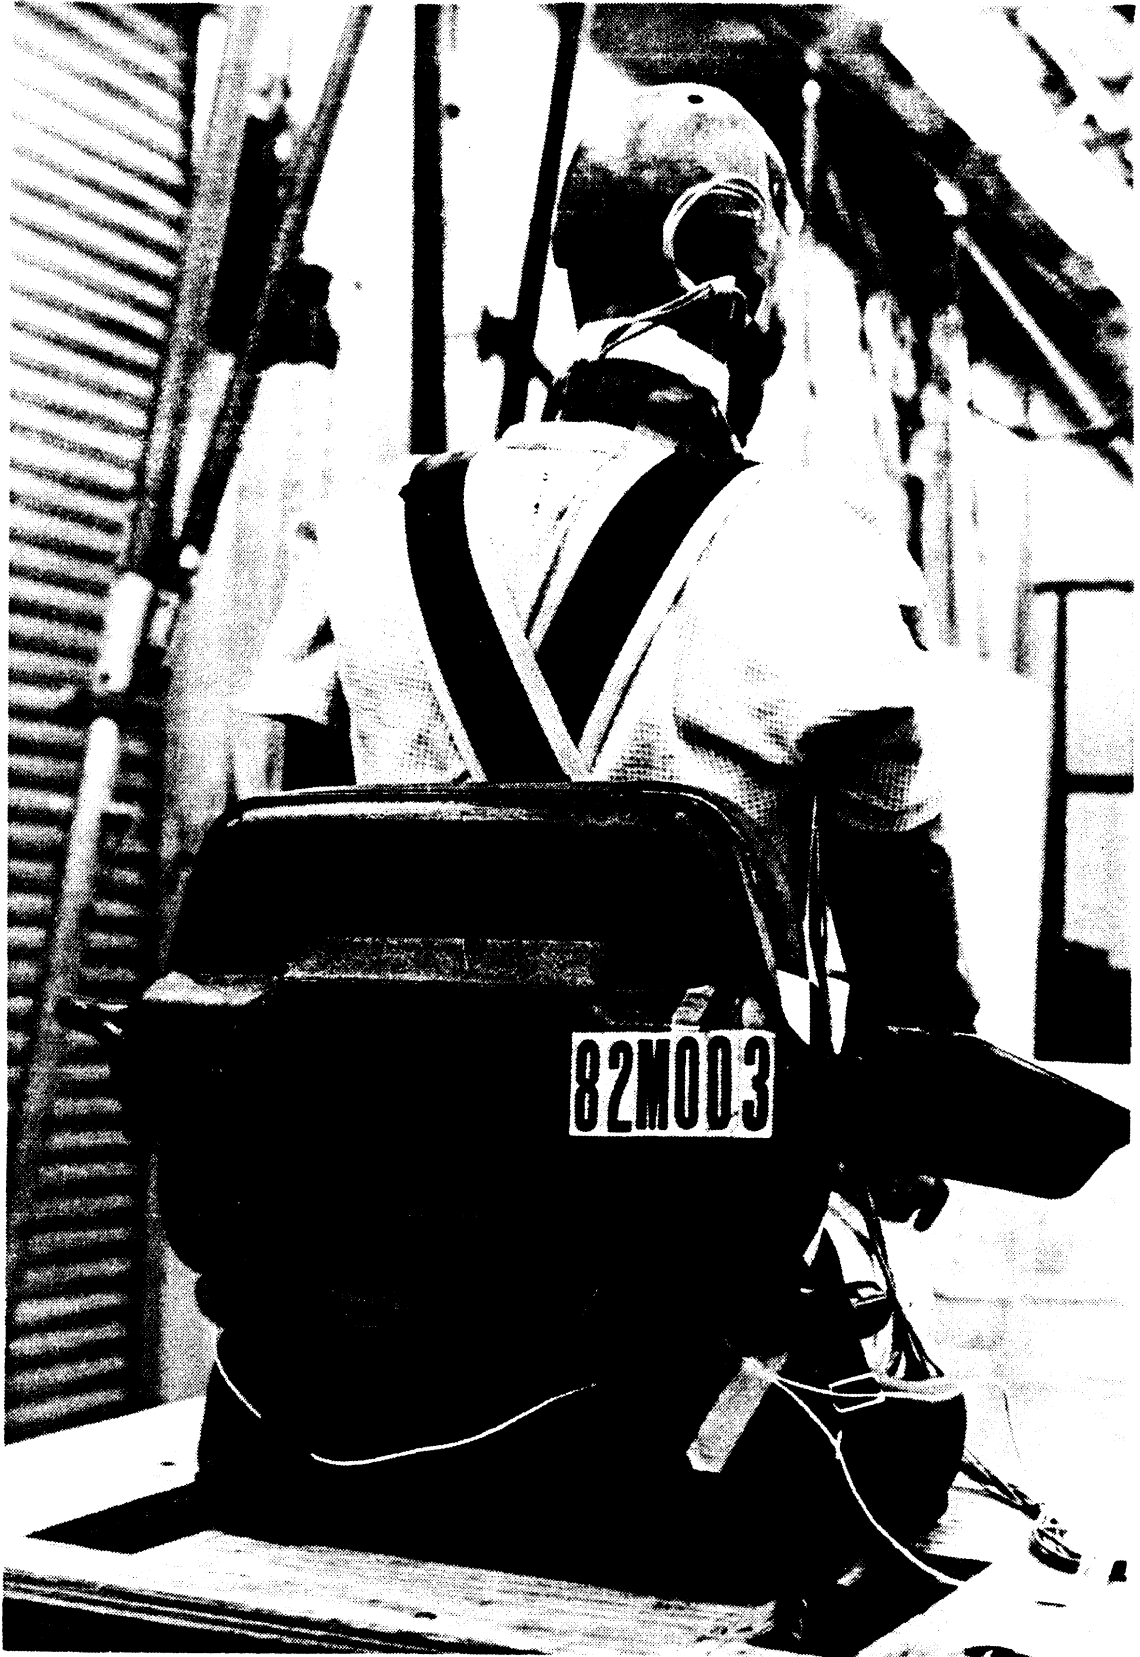
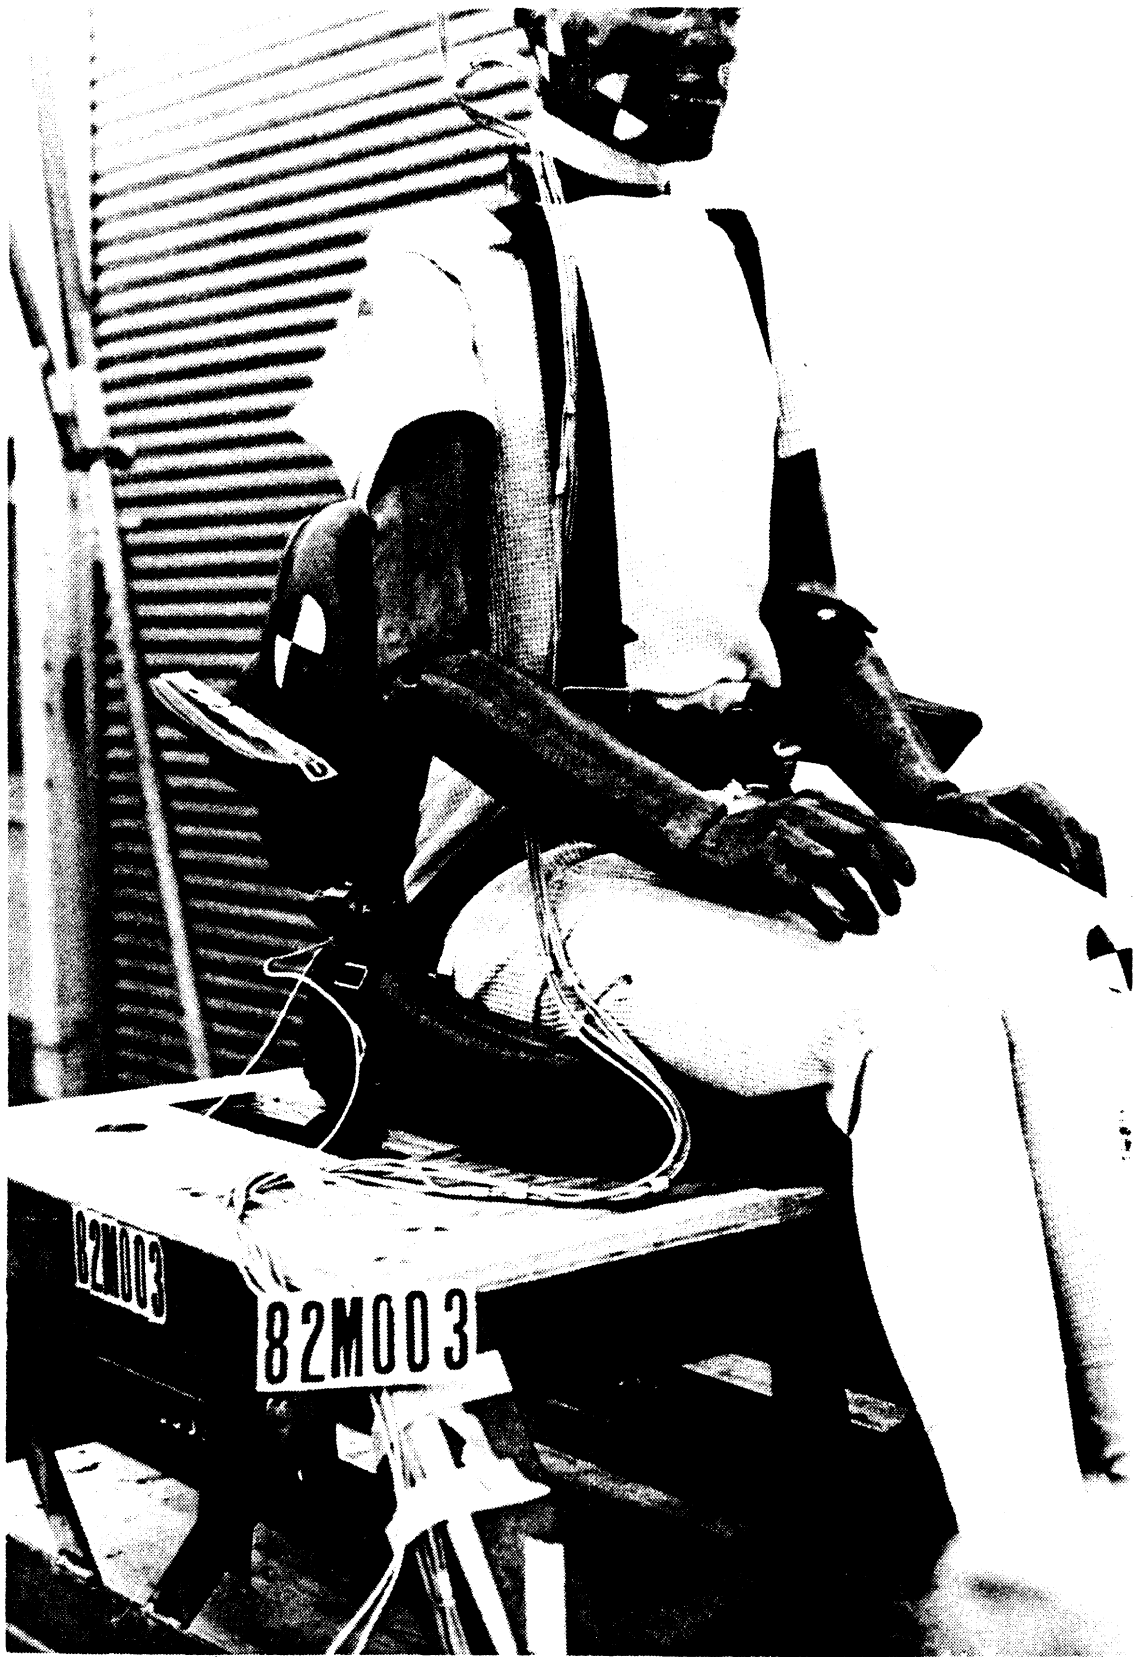
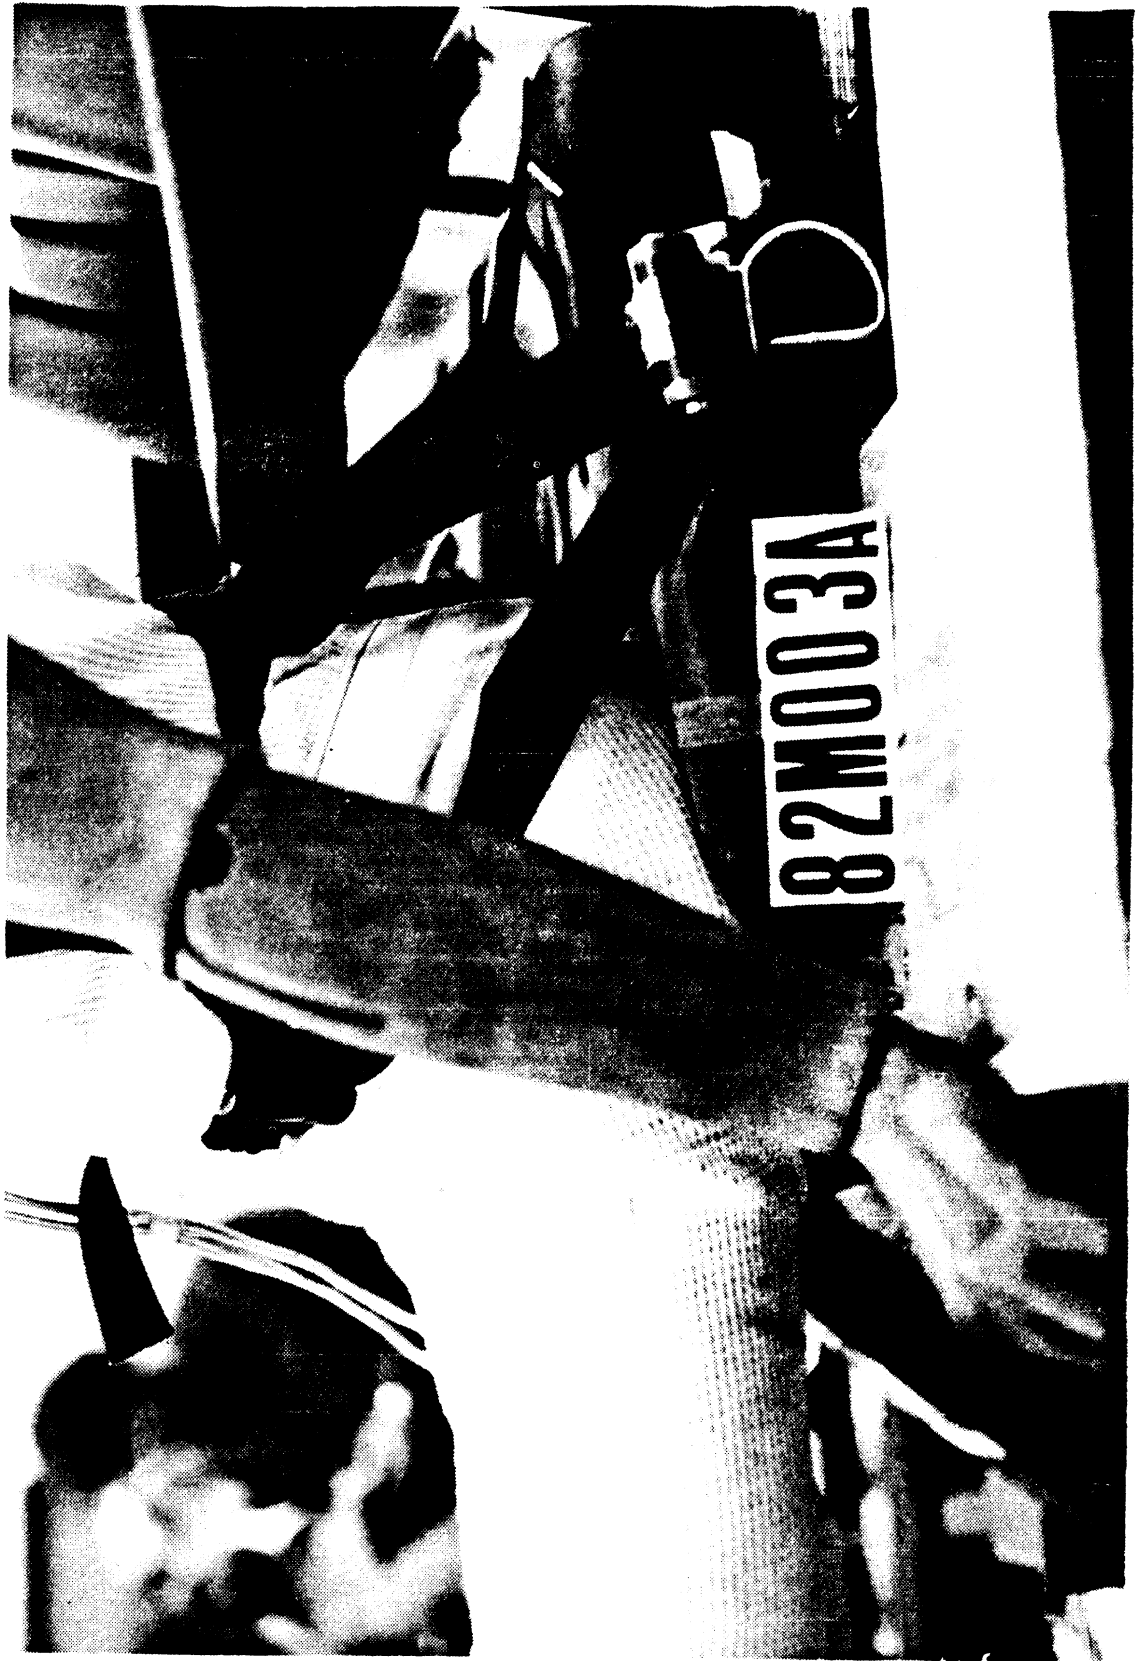
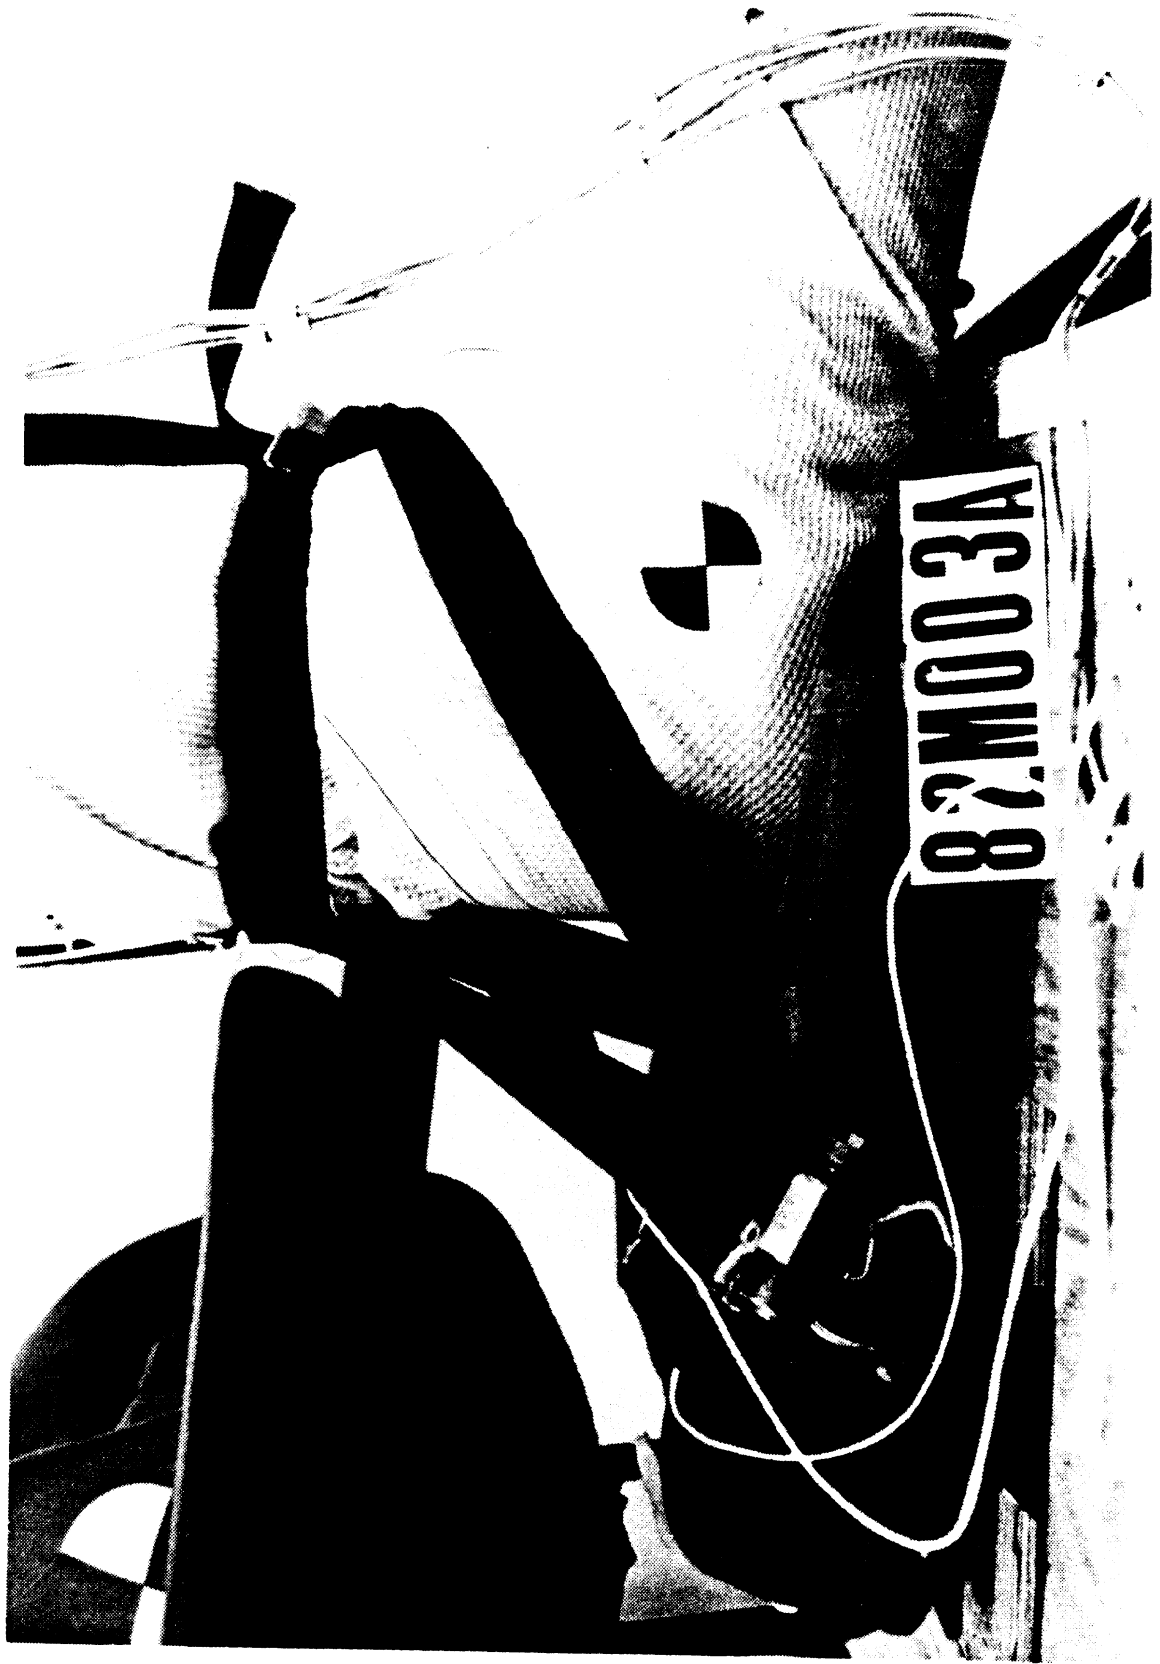
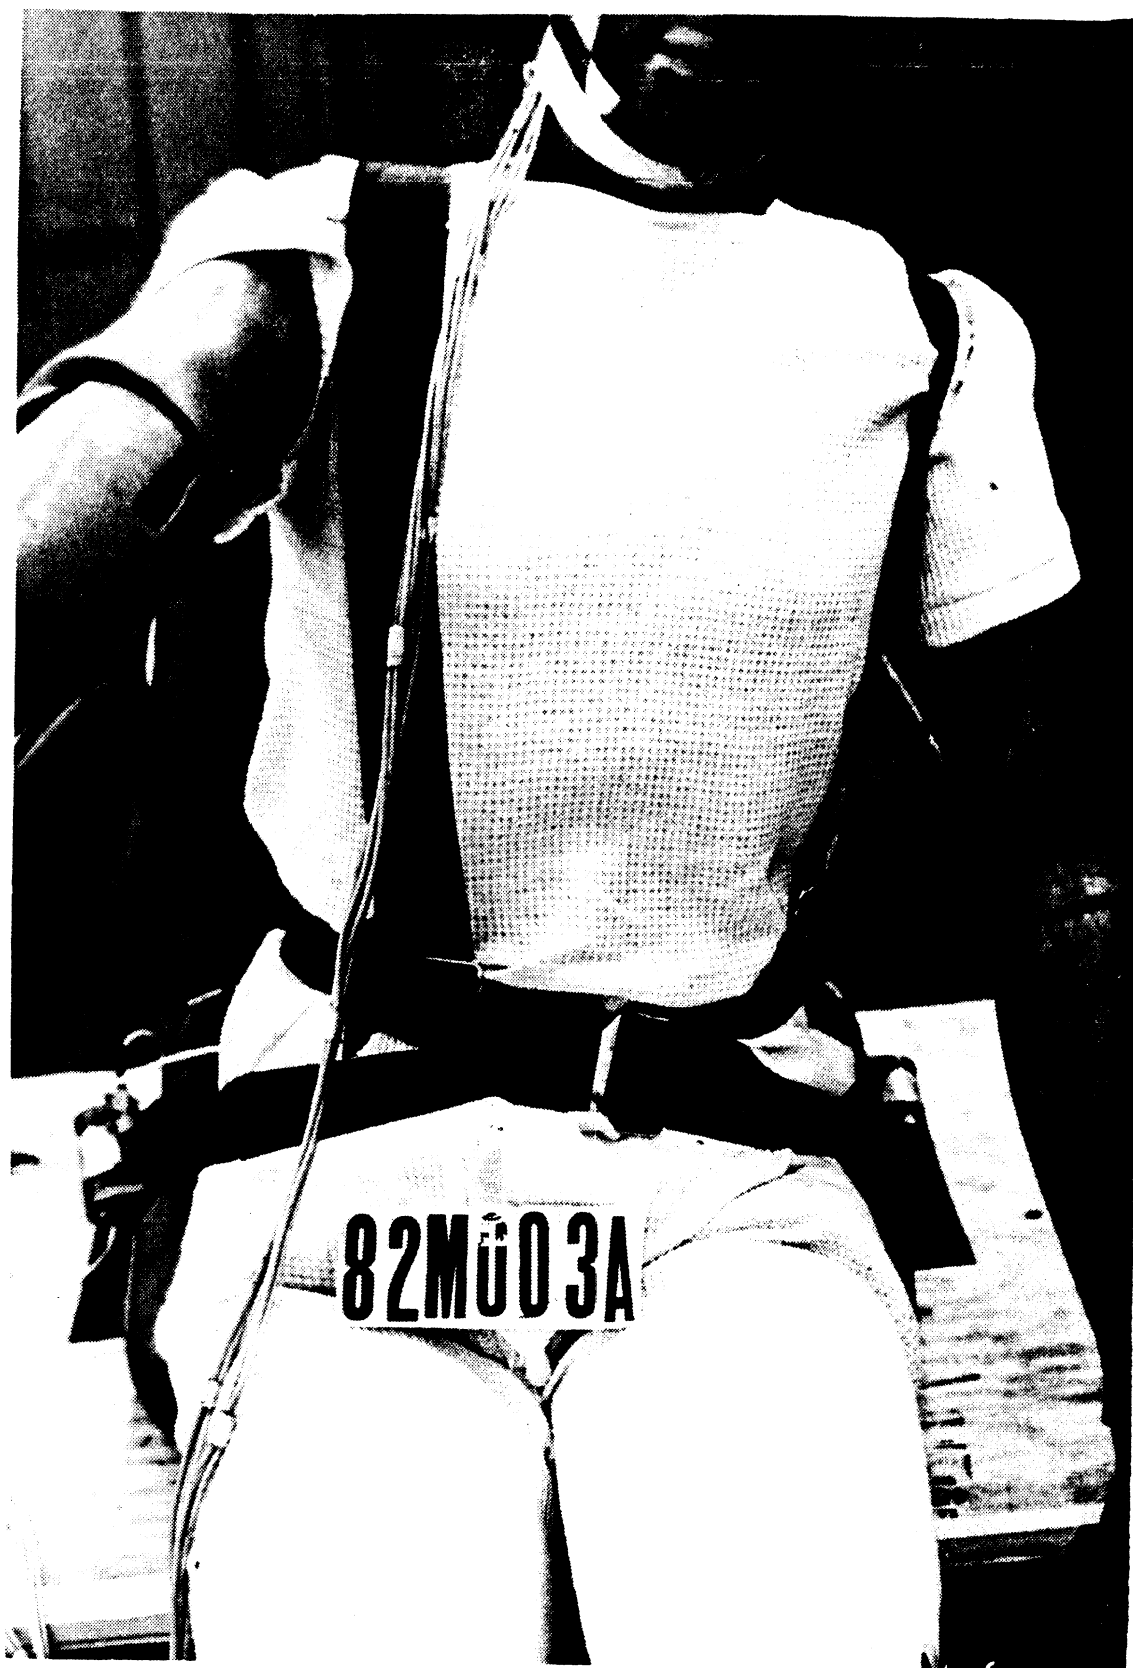
82M003

To reduce fabrication time for revised vest restraints, the next three tests were conducted using only the belt webbing portion and eliminating the vest fabric. In test 82M003, this bare harness was anchored to the test platform using conventional seat belt hardware for attaching the tether belt ends. Both the front and rear tethers on each side were routed through the same belt anchor. This configuration withstood the impact forces and restrained the dummy on the seat, although the dummy's forward excursion was excessive and almost allowed the dummy to ride over the front edge of the seat. Although abdominal intrusion was not indicated, the lap belt portion of the harness could still be slightly lower to obtain good pelvic retention and preclude submarining.

OBSERVATIONS: Belt harness did not fail, but dummy experienced excessive excursion to the forward edge of the seat as well as possible abdominal intrusion from the lap belt portion of the harness.

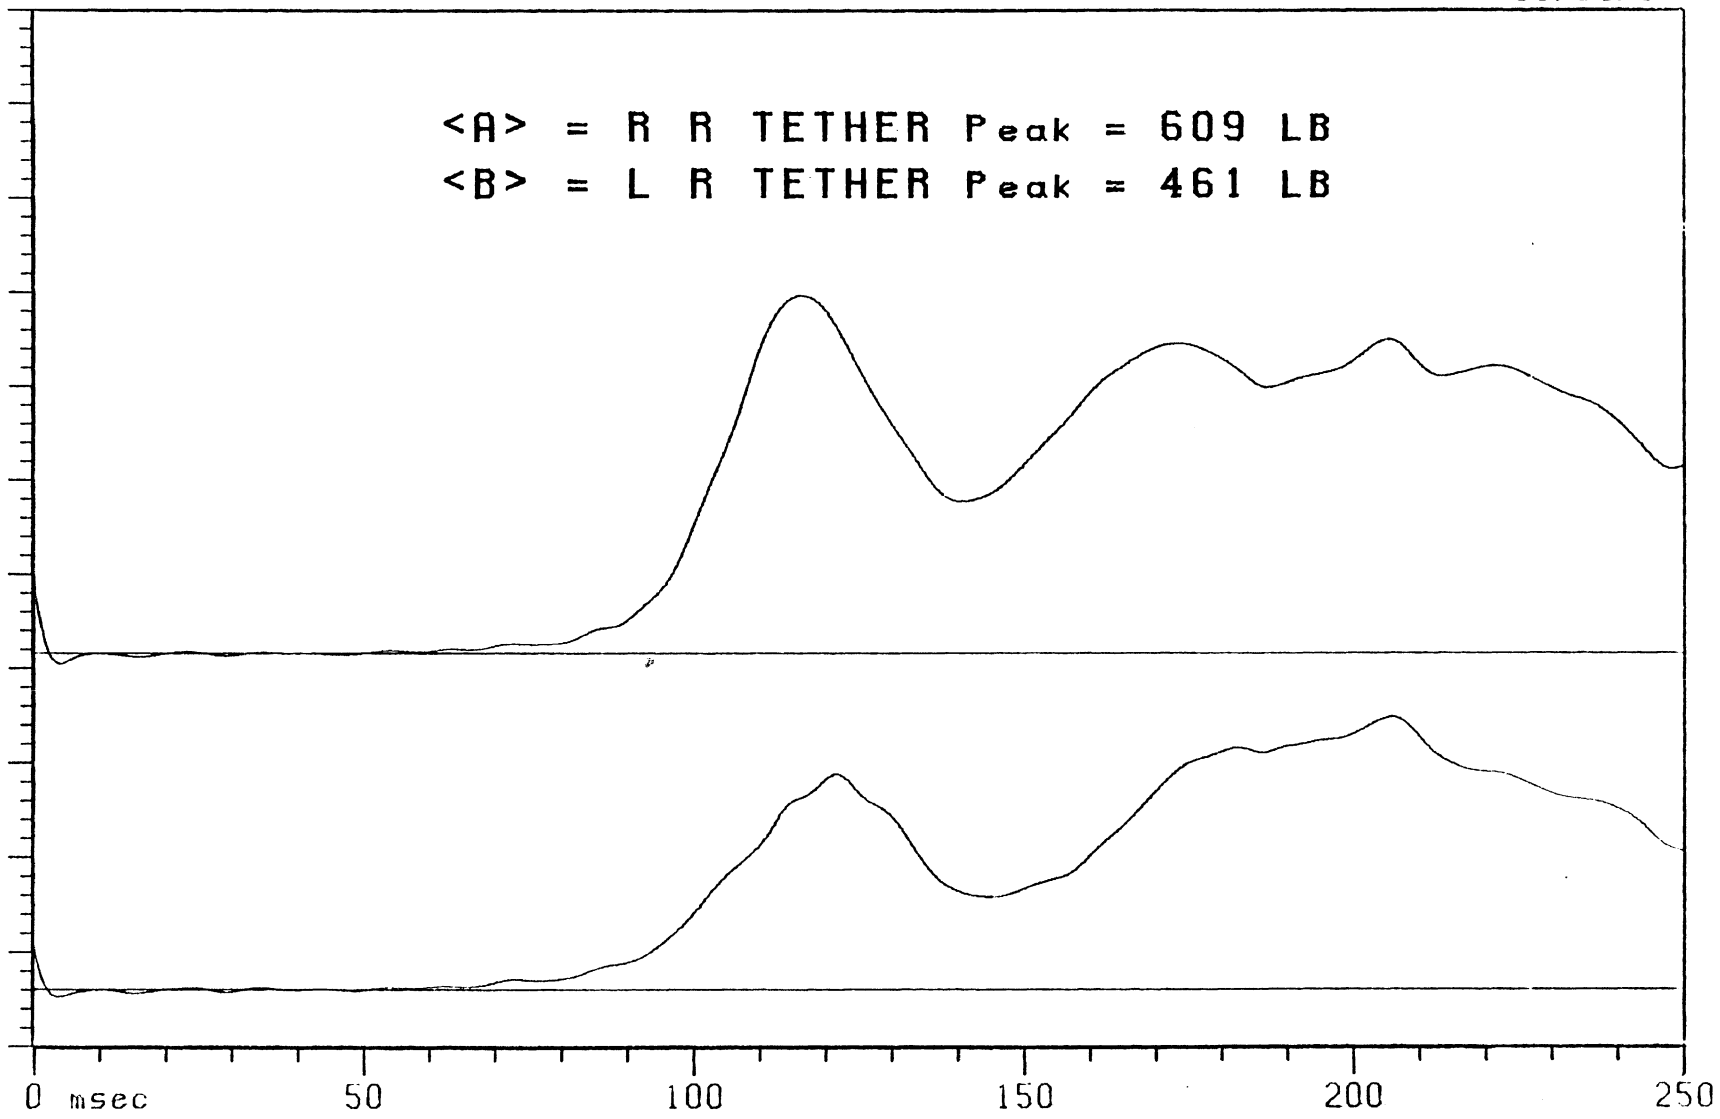
82M 003.

<A> = R R TETHER Peak = 609 LB
 = L R TETHER Peak = 461 LB

BELT LOADS
