1. Report No. UMTRI-84-9	2. Government Accession No.	3. Recipient's Catalog No.	
4. Title and Subtitle Dynamic Testing of Vest Restraint System (VRS). Phase II. Final Report.		5. Report Date March 1984	6. Performing Organization Code

15. Supplementary Notes Evaluation of Vest Restraint System (VRS). Phase I. Interim Report. November 30, 1982. Richard G. Snyder and John W. Melvin	
16. Abstract Seven tests of the Bureau of Mines proposed vest restraint system were conducted at UMTRI as the phase II or development program. The factors that were found to provide good performance of the vest restraint were the elimination of sliding motion between belt webbing in the vest, common slots in the anchor hardware for the two tether belts on each side, and anchors positioned rearward to provide a 45-degree tether angle. It was recommended that the vest restraints be sized to the torso height of the wearer to preclude abdominal intrusion by the lap belt segment and that upper torso restraint be added to protect against frontal impact, significantly reducing head excursions and associated injuries.

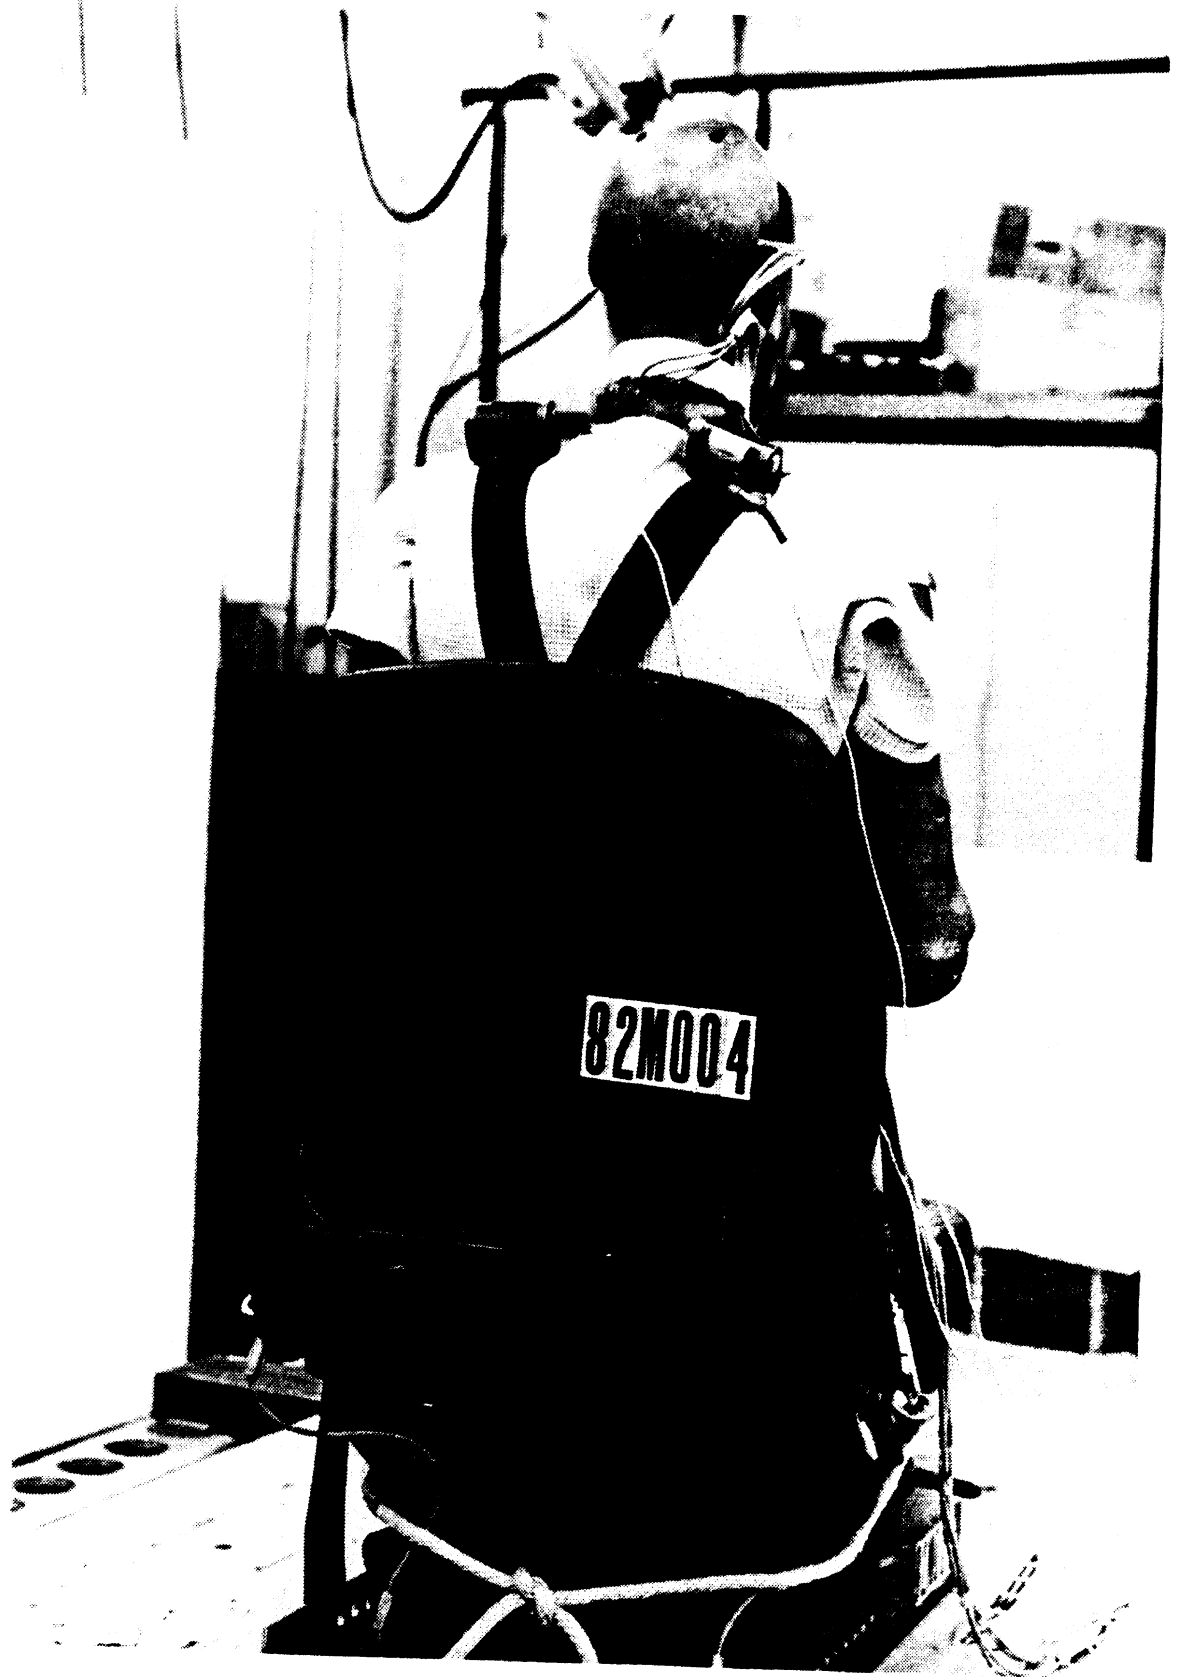
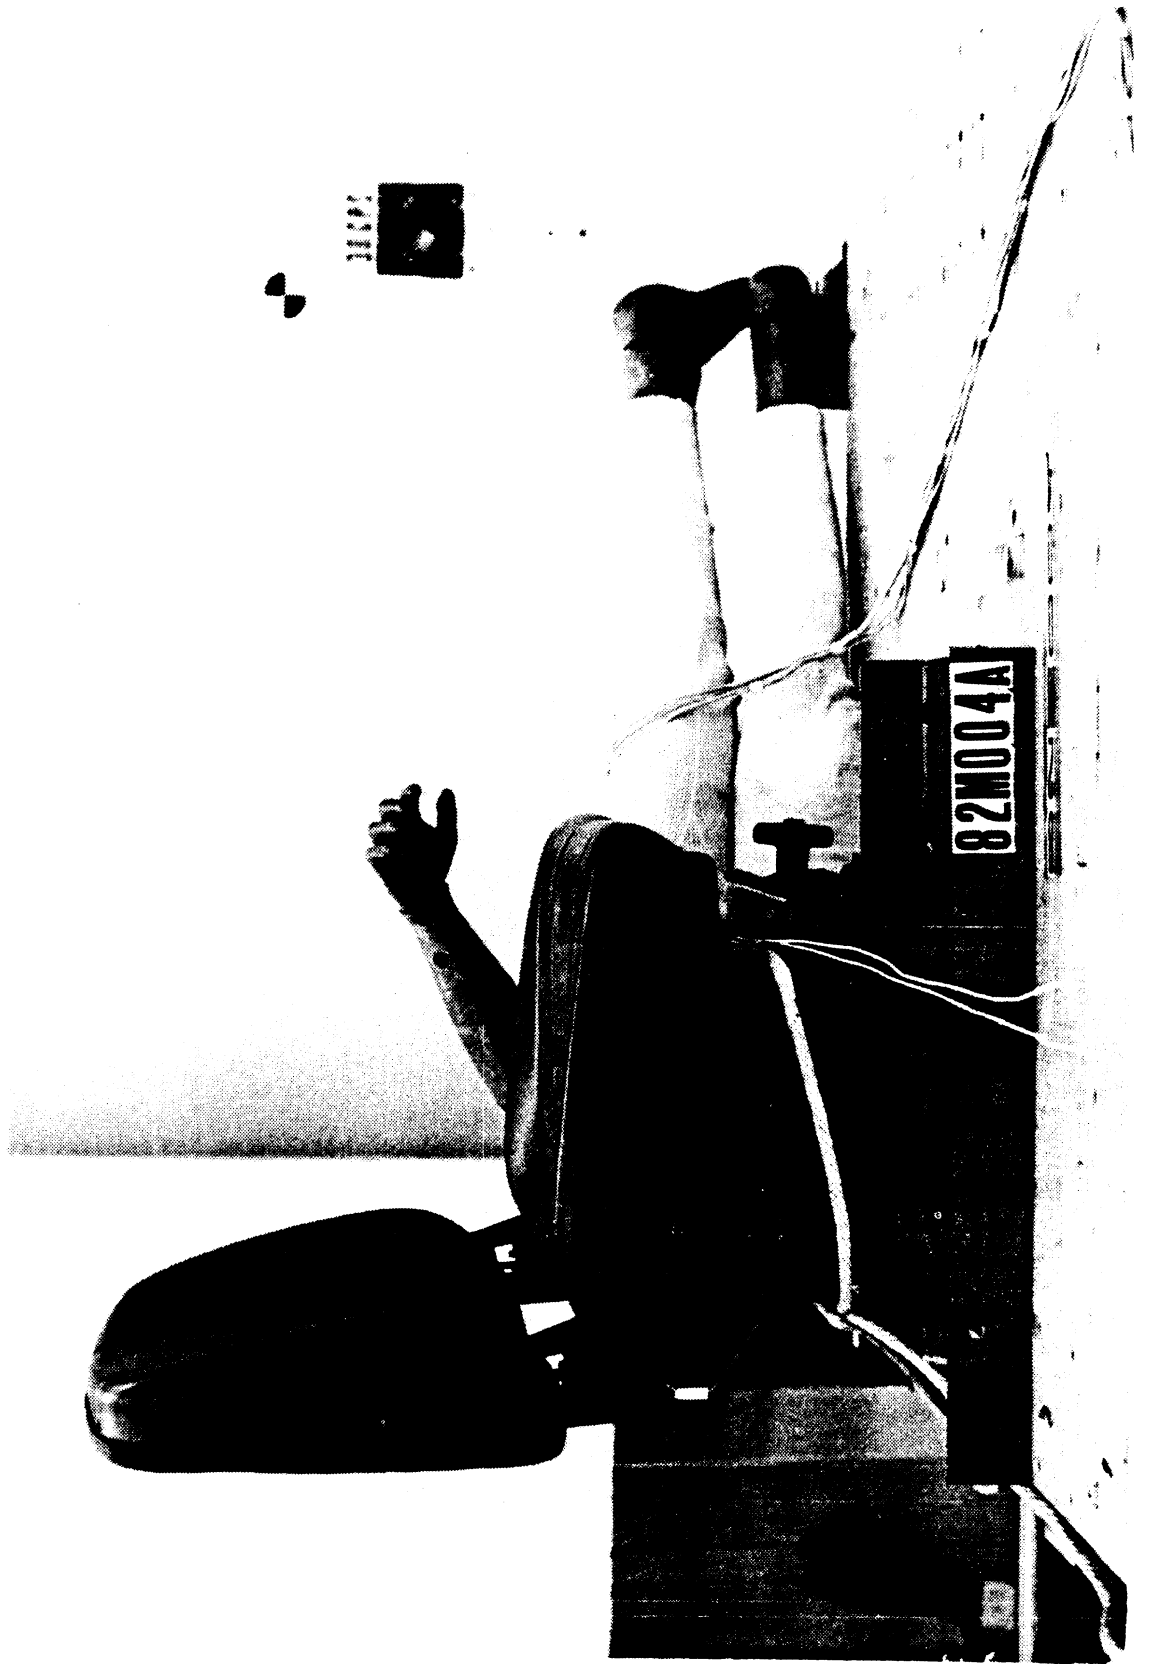
82M004

The next test, 82M004, used a similar belt harness as the previous test, but a suspension-type seat was substituted for the rigid forklift seat. Locking-loop tether end clips were used to facilitate attachment to the eyelets supplied on the seat frame. During impact, the right side eyelet pulled out of the seat frame because of insufficient thread engagement with its retaining nut, and the dummy was not restrained.

OBSERVATIONS: Right tether anchor pulled out, releasing the dummy during impact.

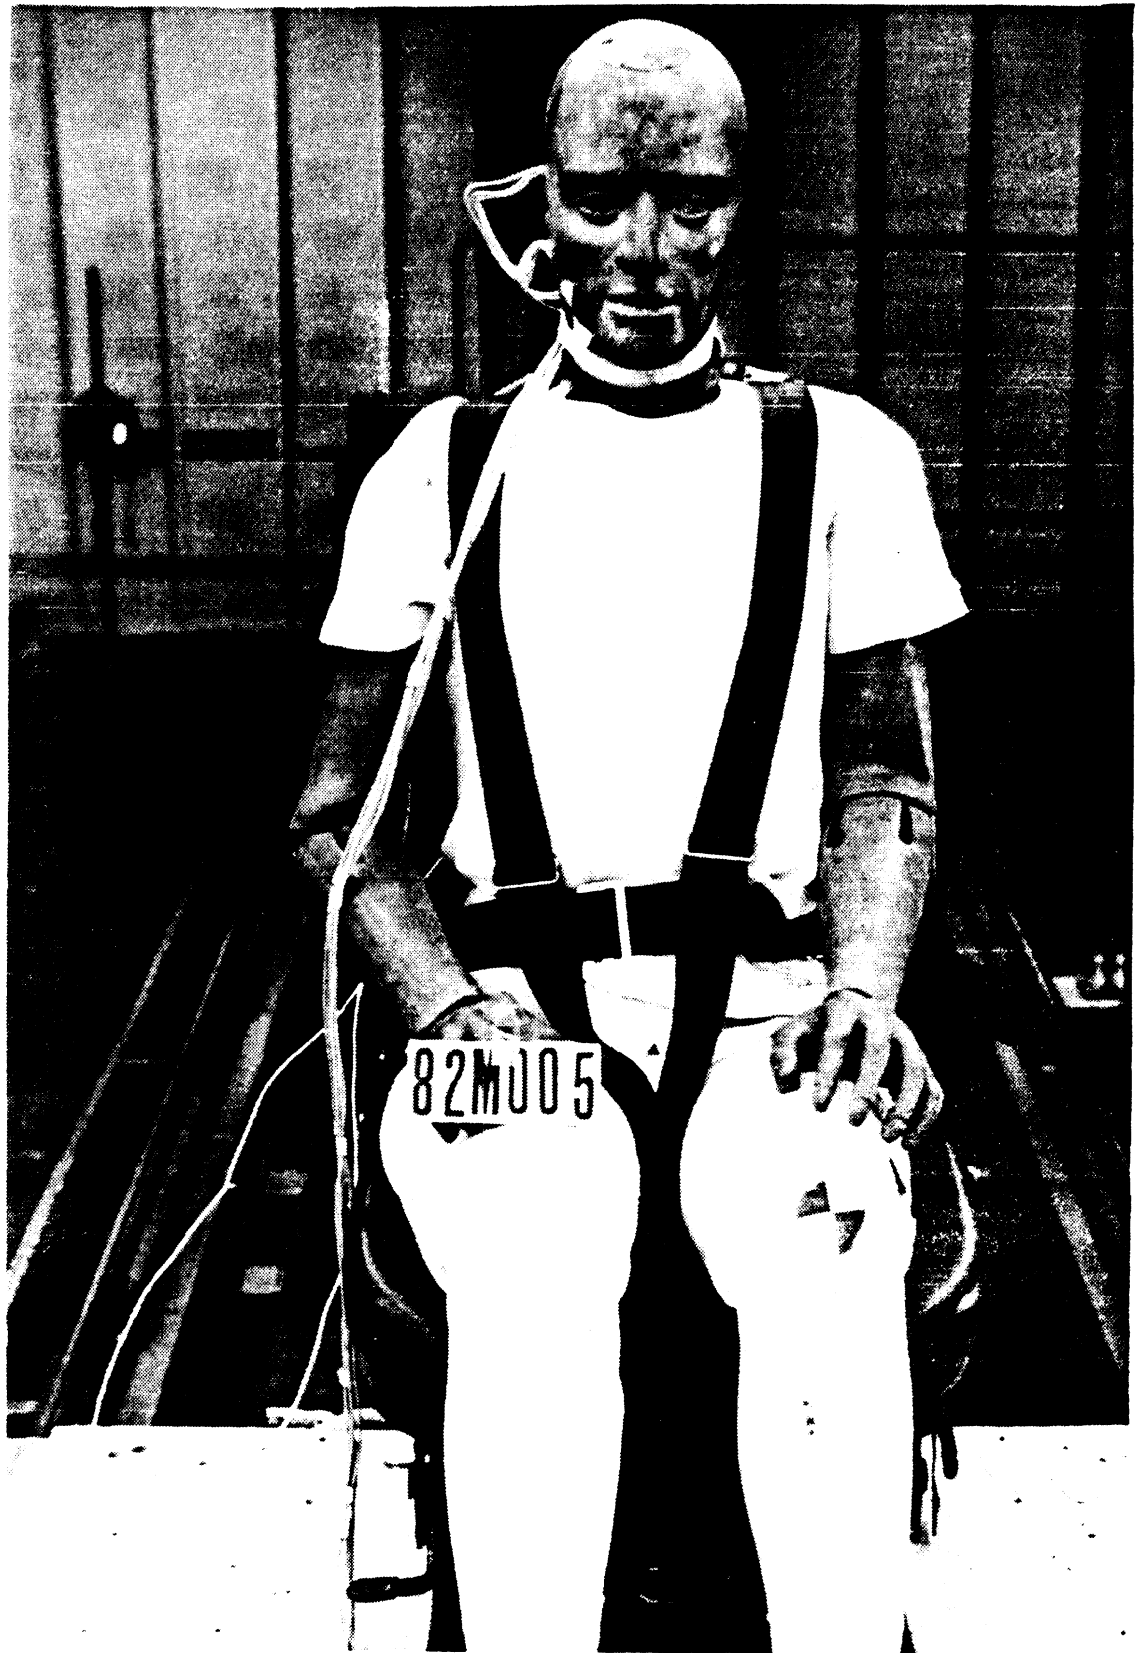
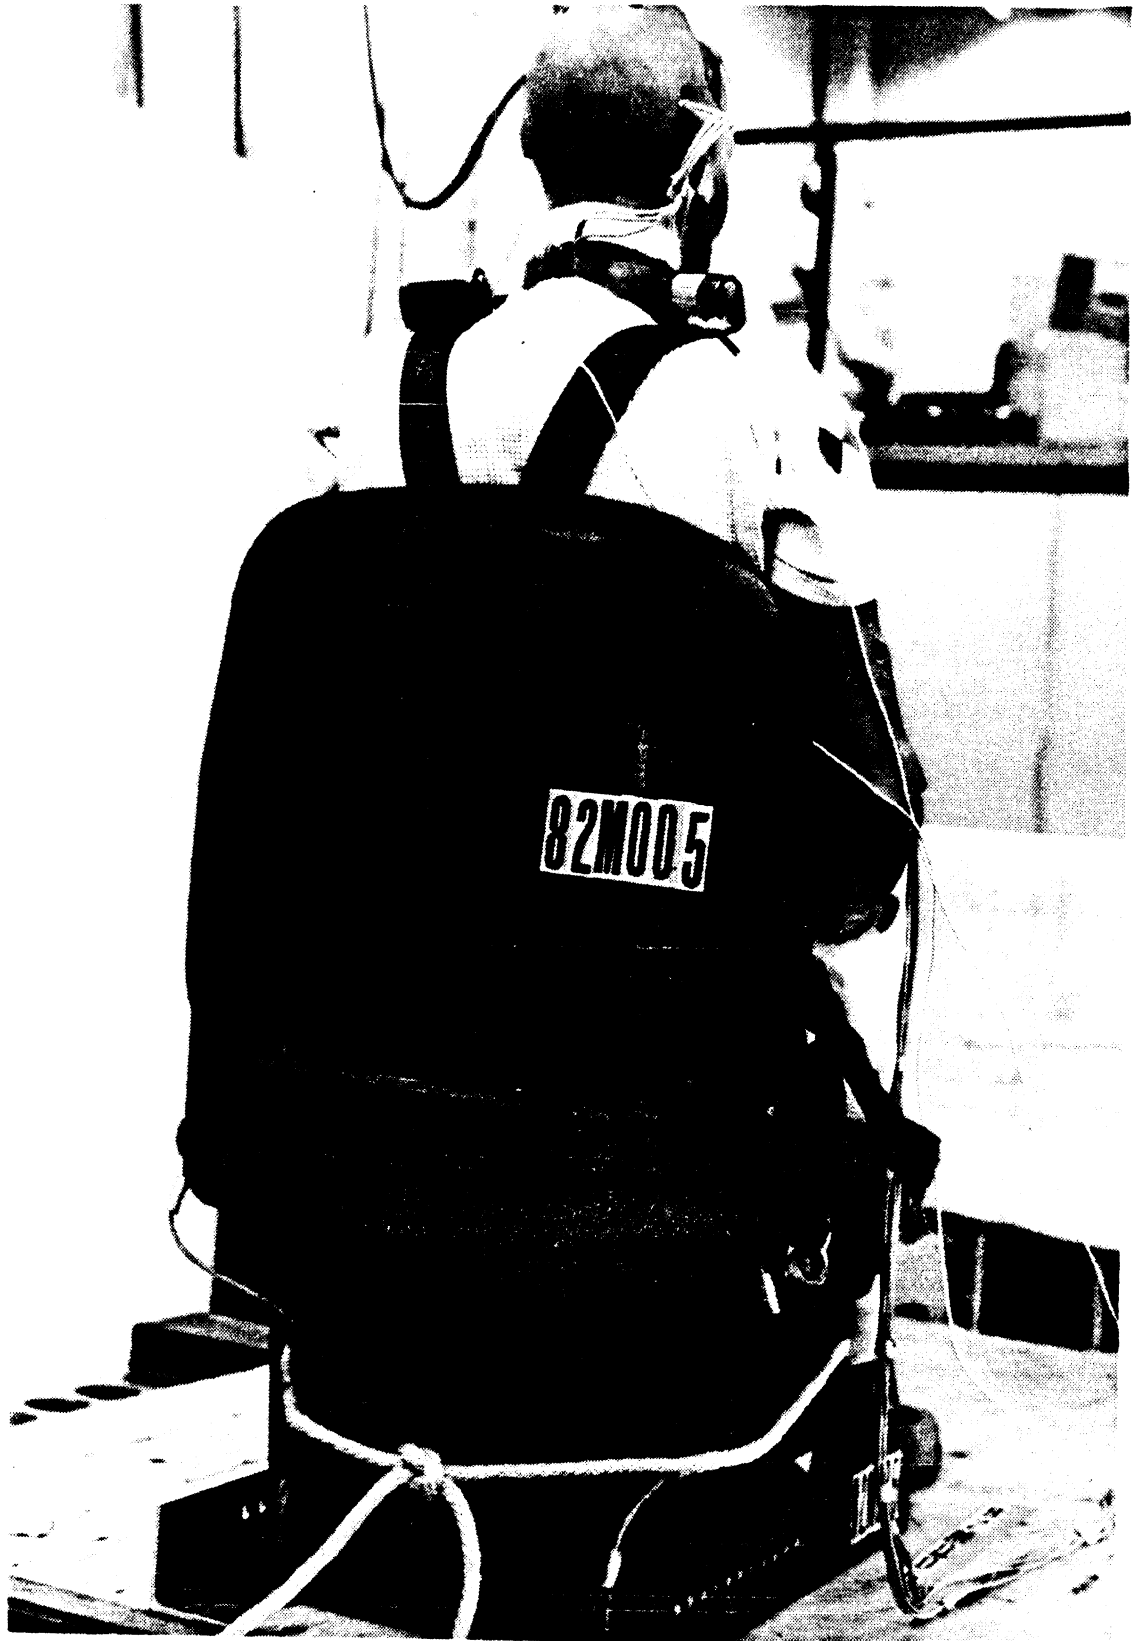
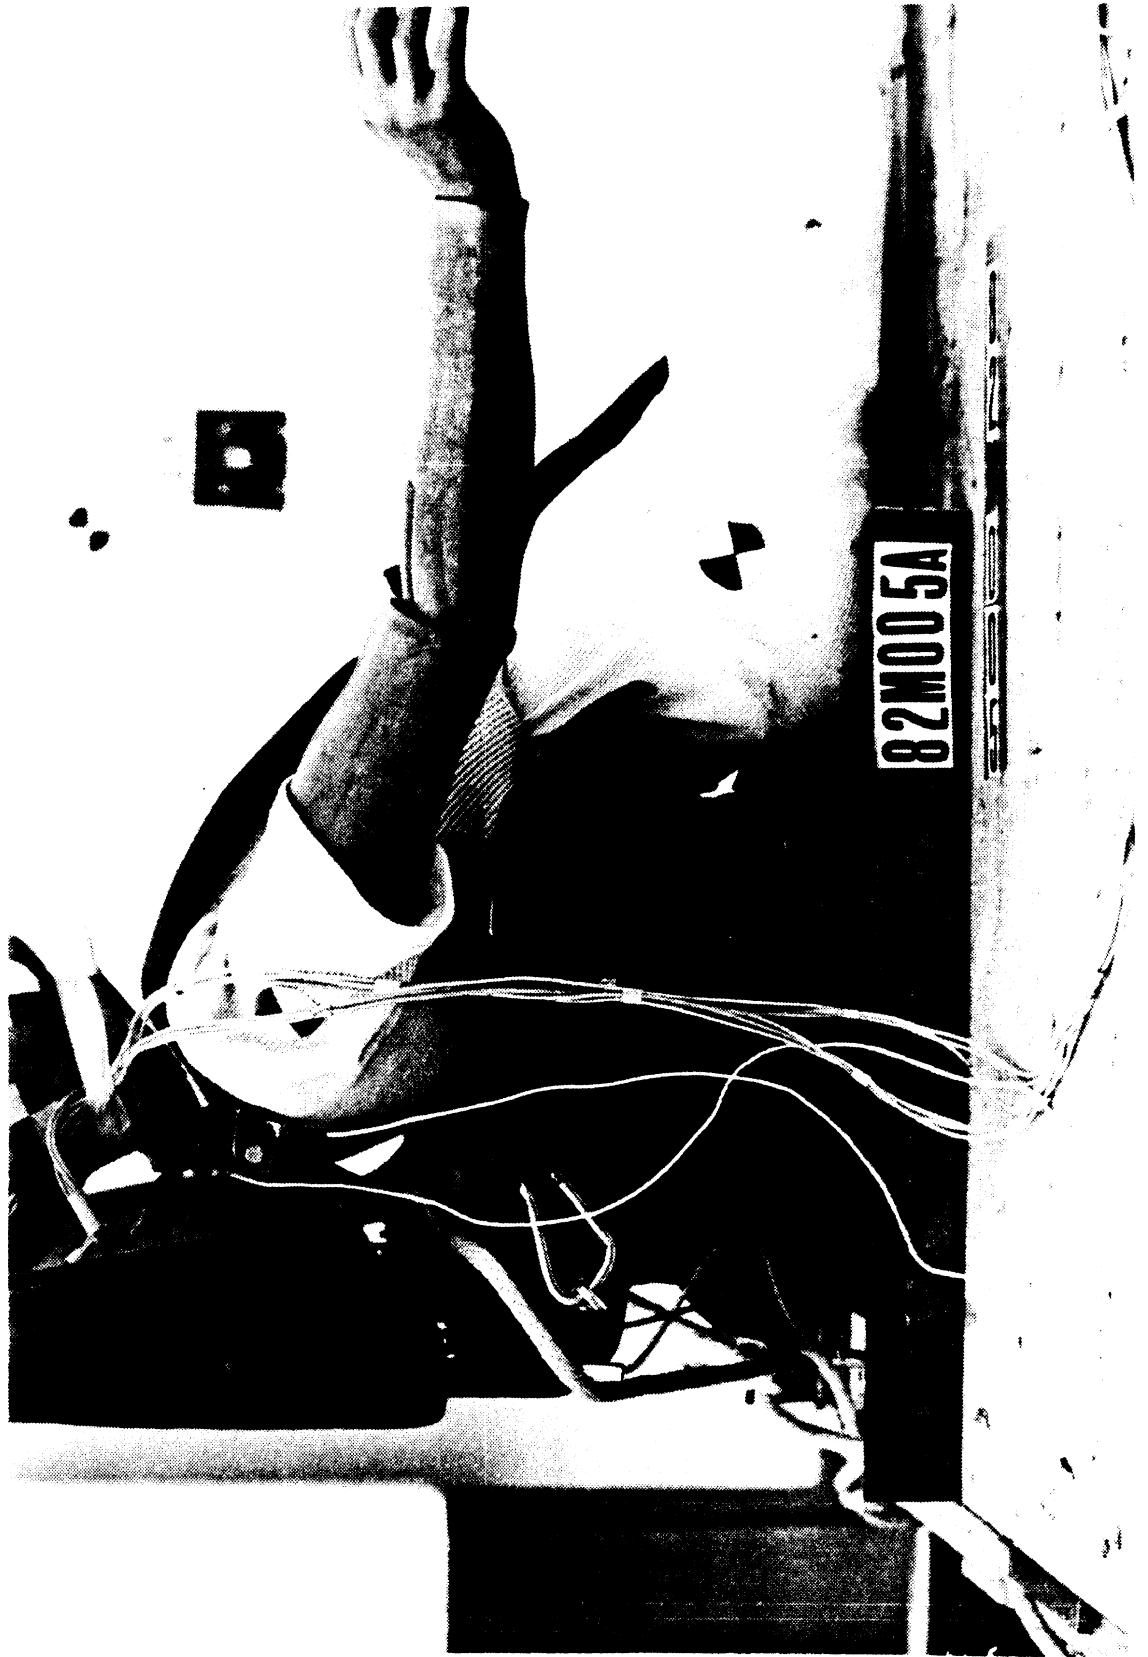
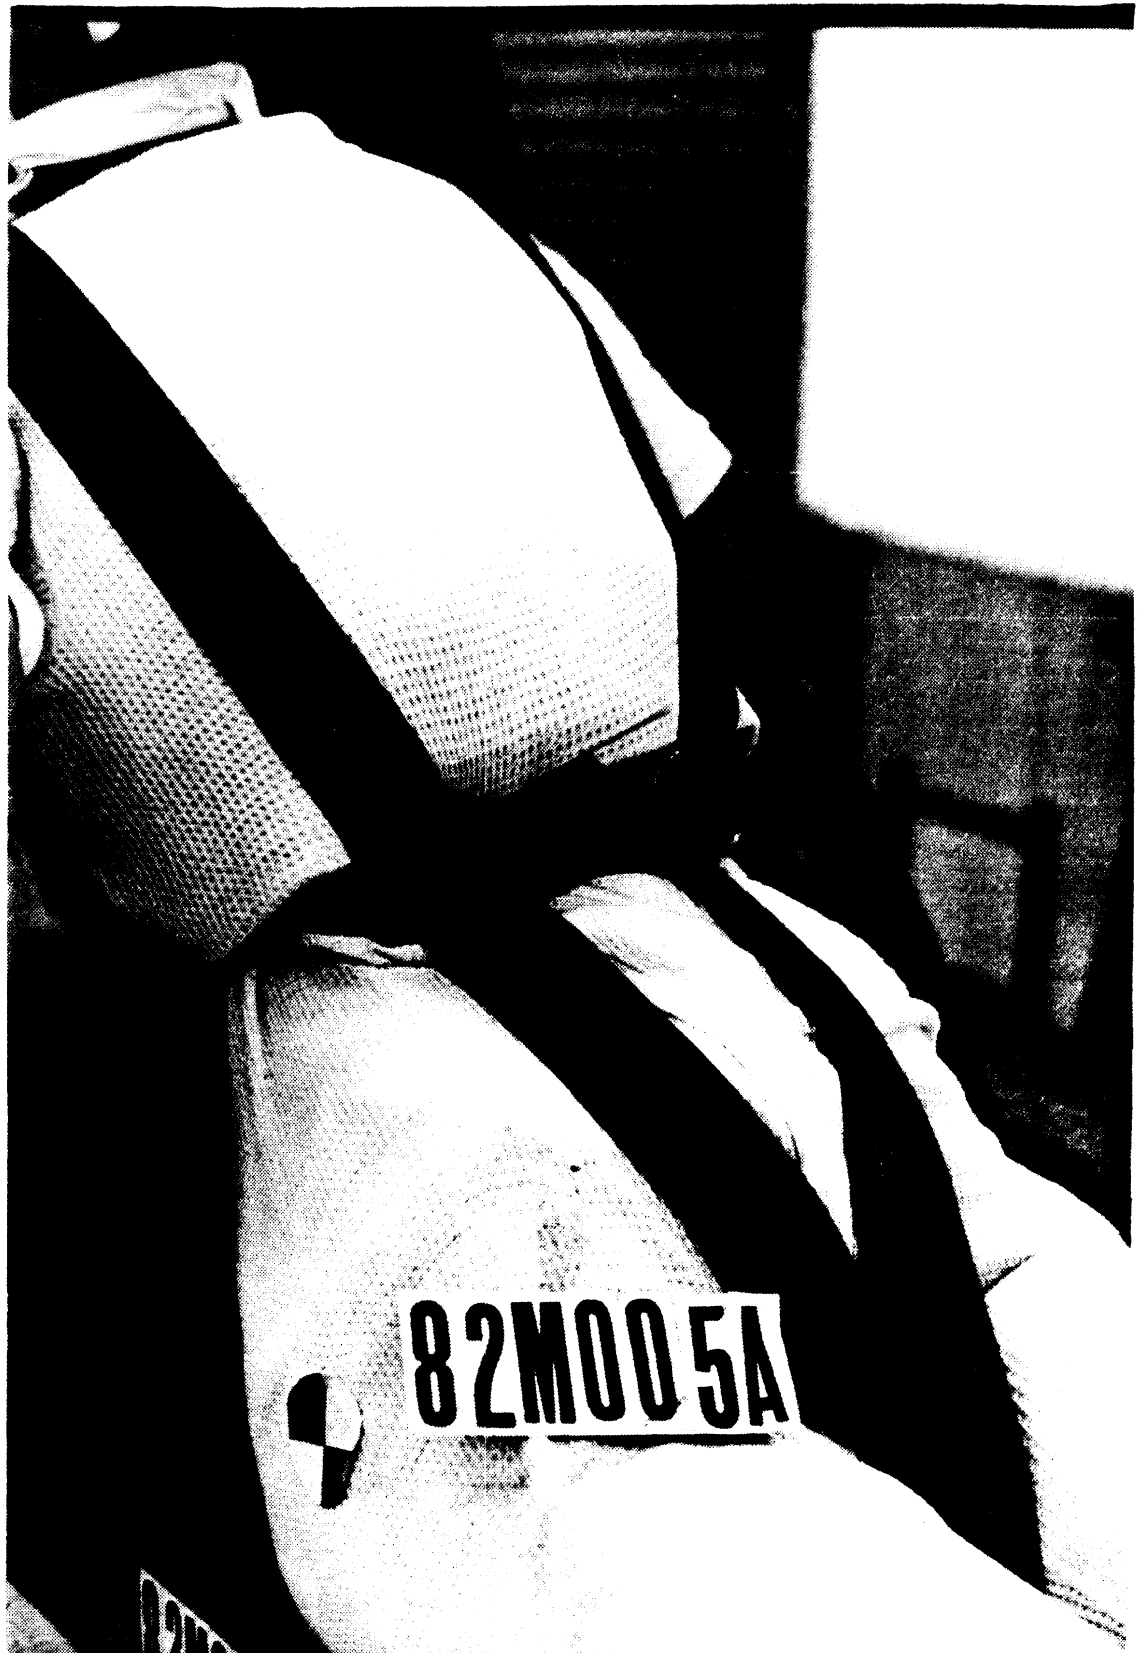
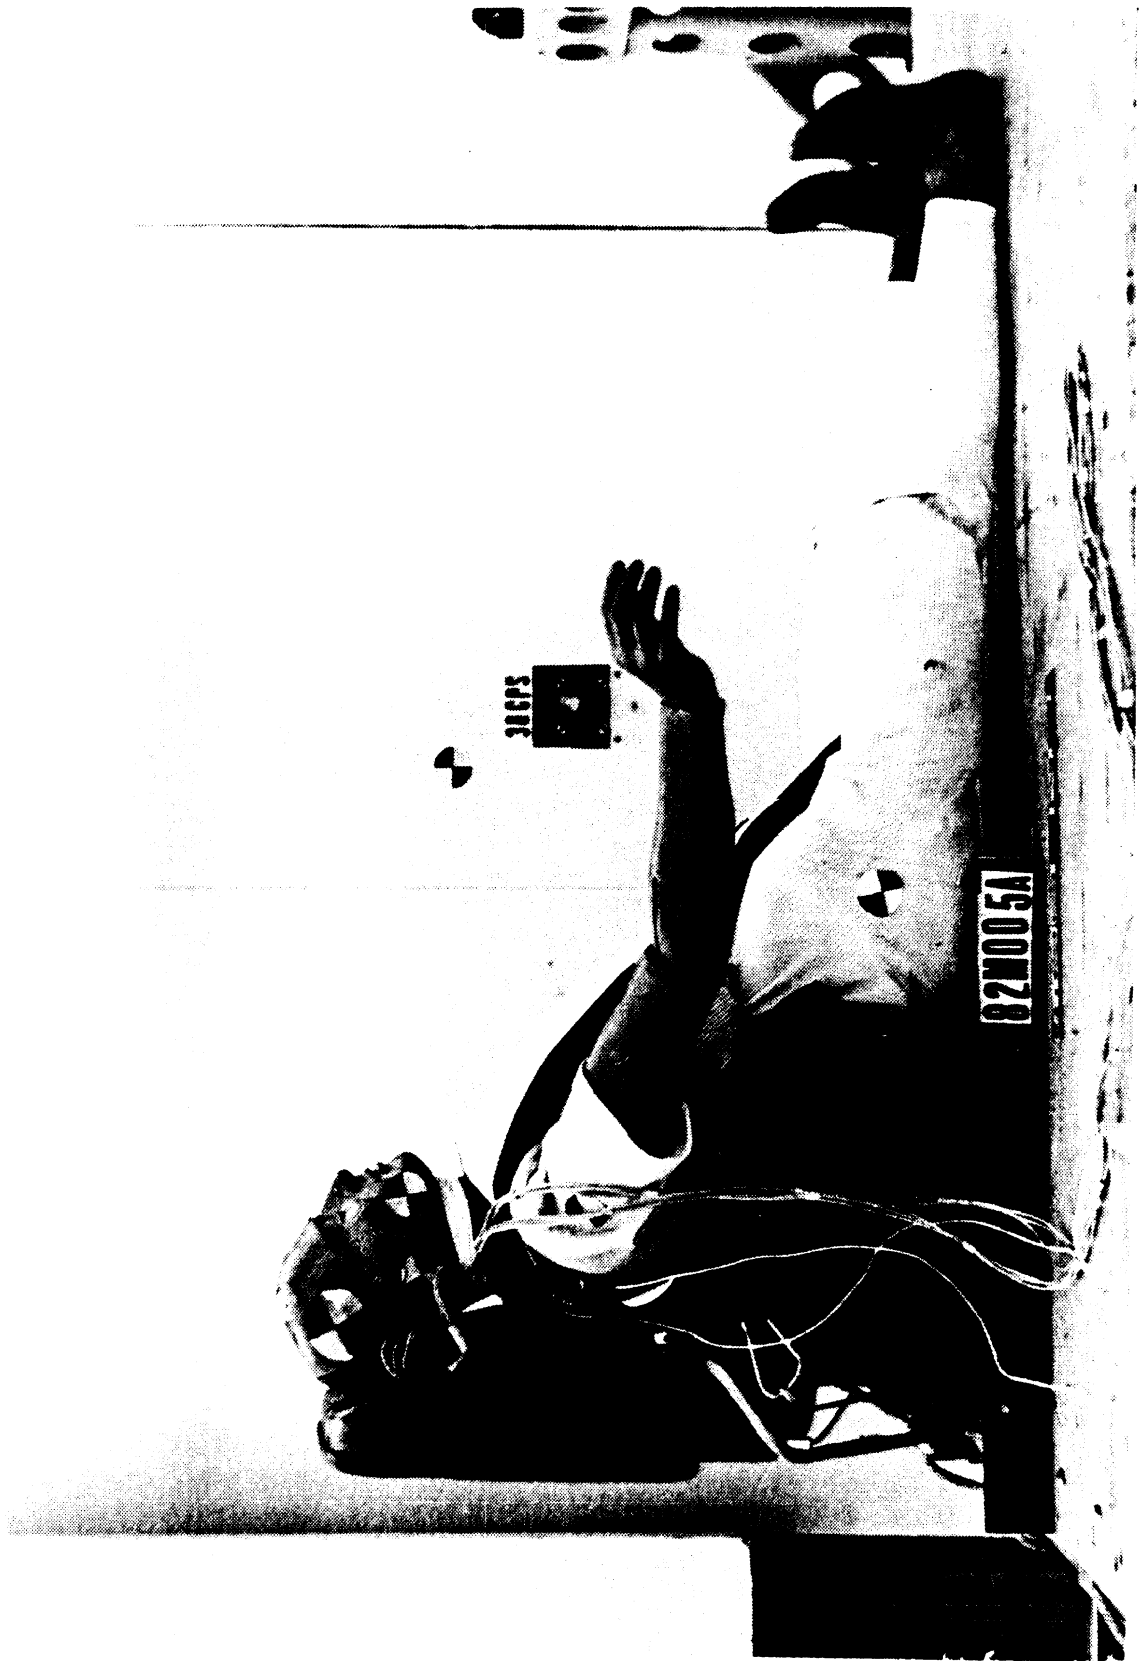
Test 82M005 was then conducted as a rerun of the conditions of the previous test, but with the tether eyelets securely installed in the seat frame. During impact, the harness did not fail, but the suspension seat pitched forward and the dummy slid off the forward edge. As in previous

tests when the dummy ramped off of the seat, very severe abdominal intrusion by the harness was observed, and this condition is quite obvious in the post-test photos.

OBSERVATIONS: Suspension seat pitched forward, ramping the dummy off the forward edge and producing severe abdominal belt intrusion.

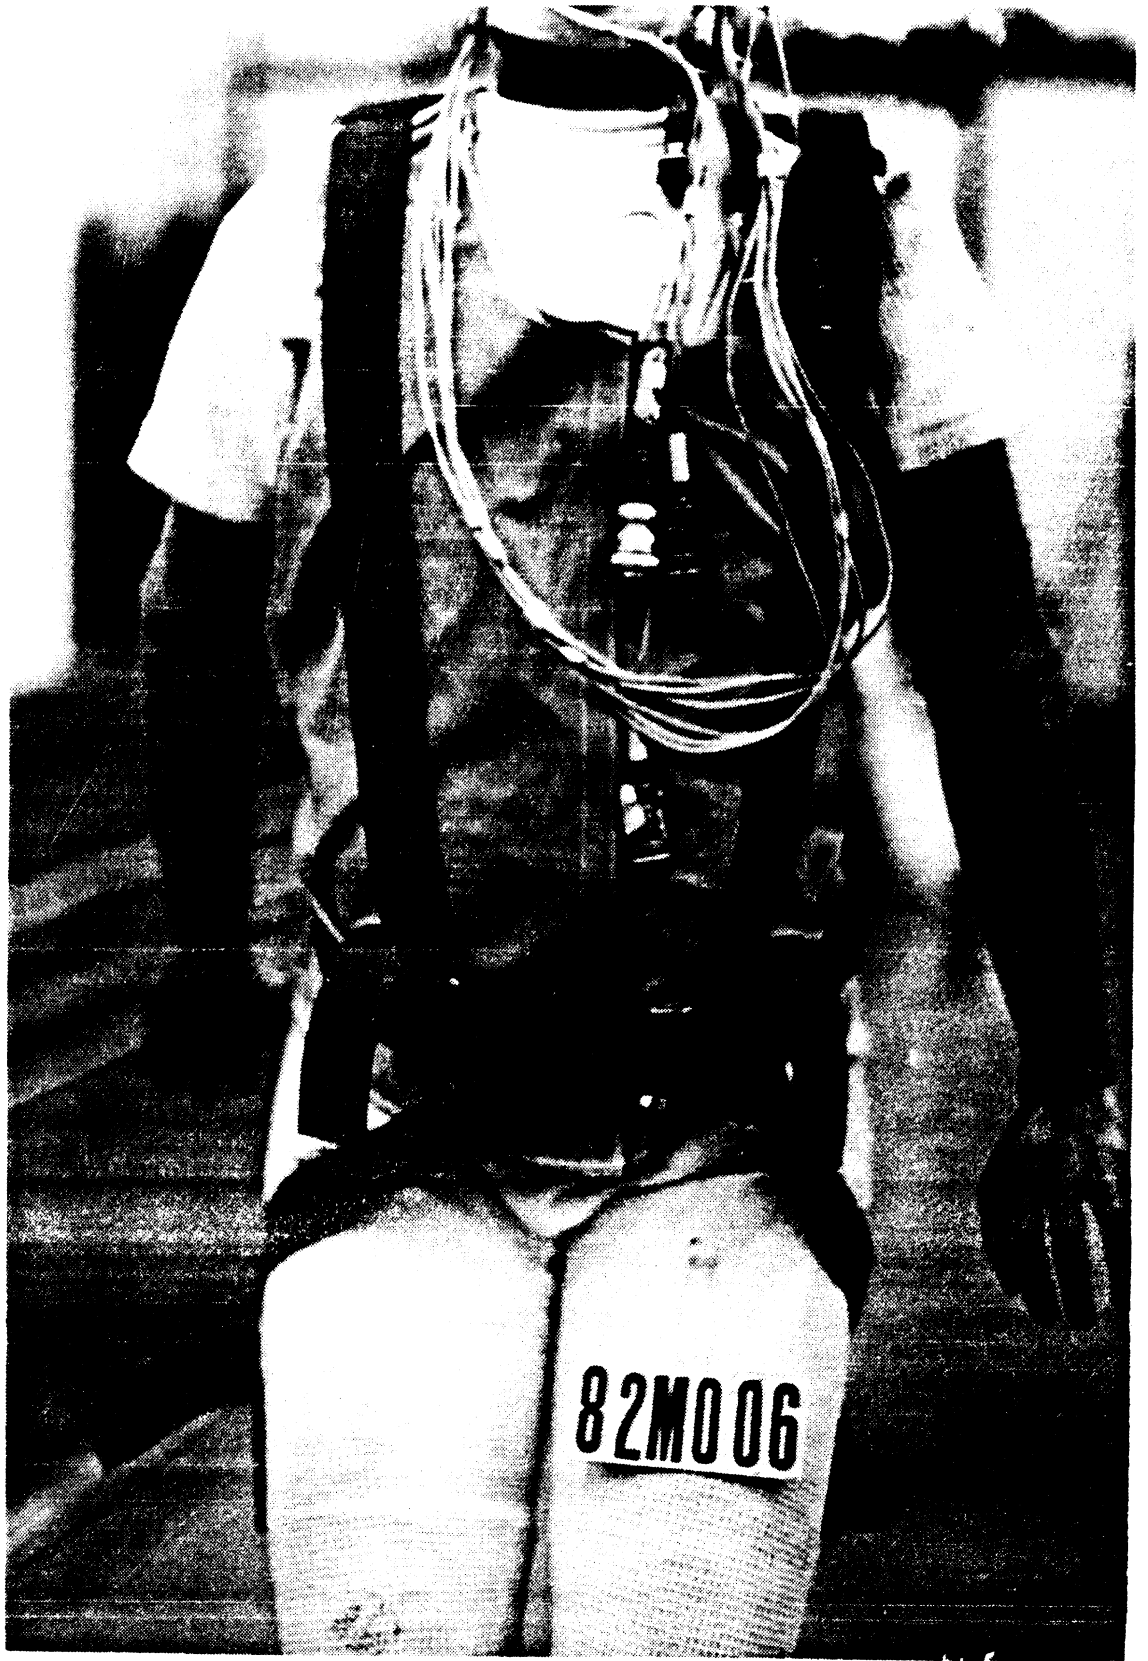
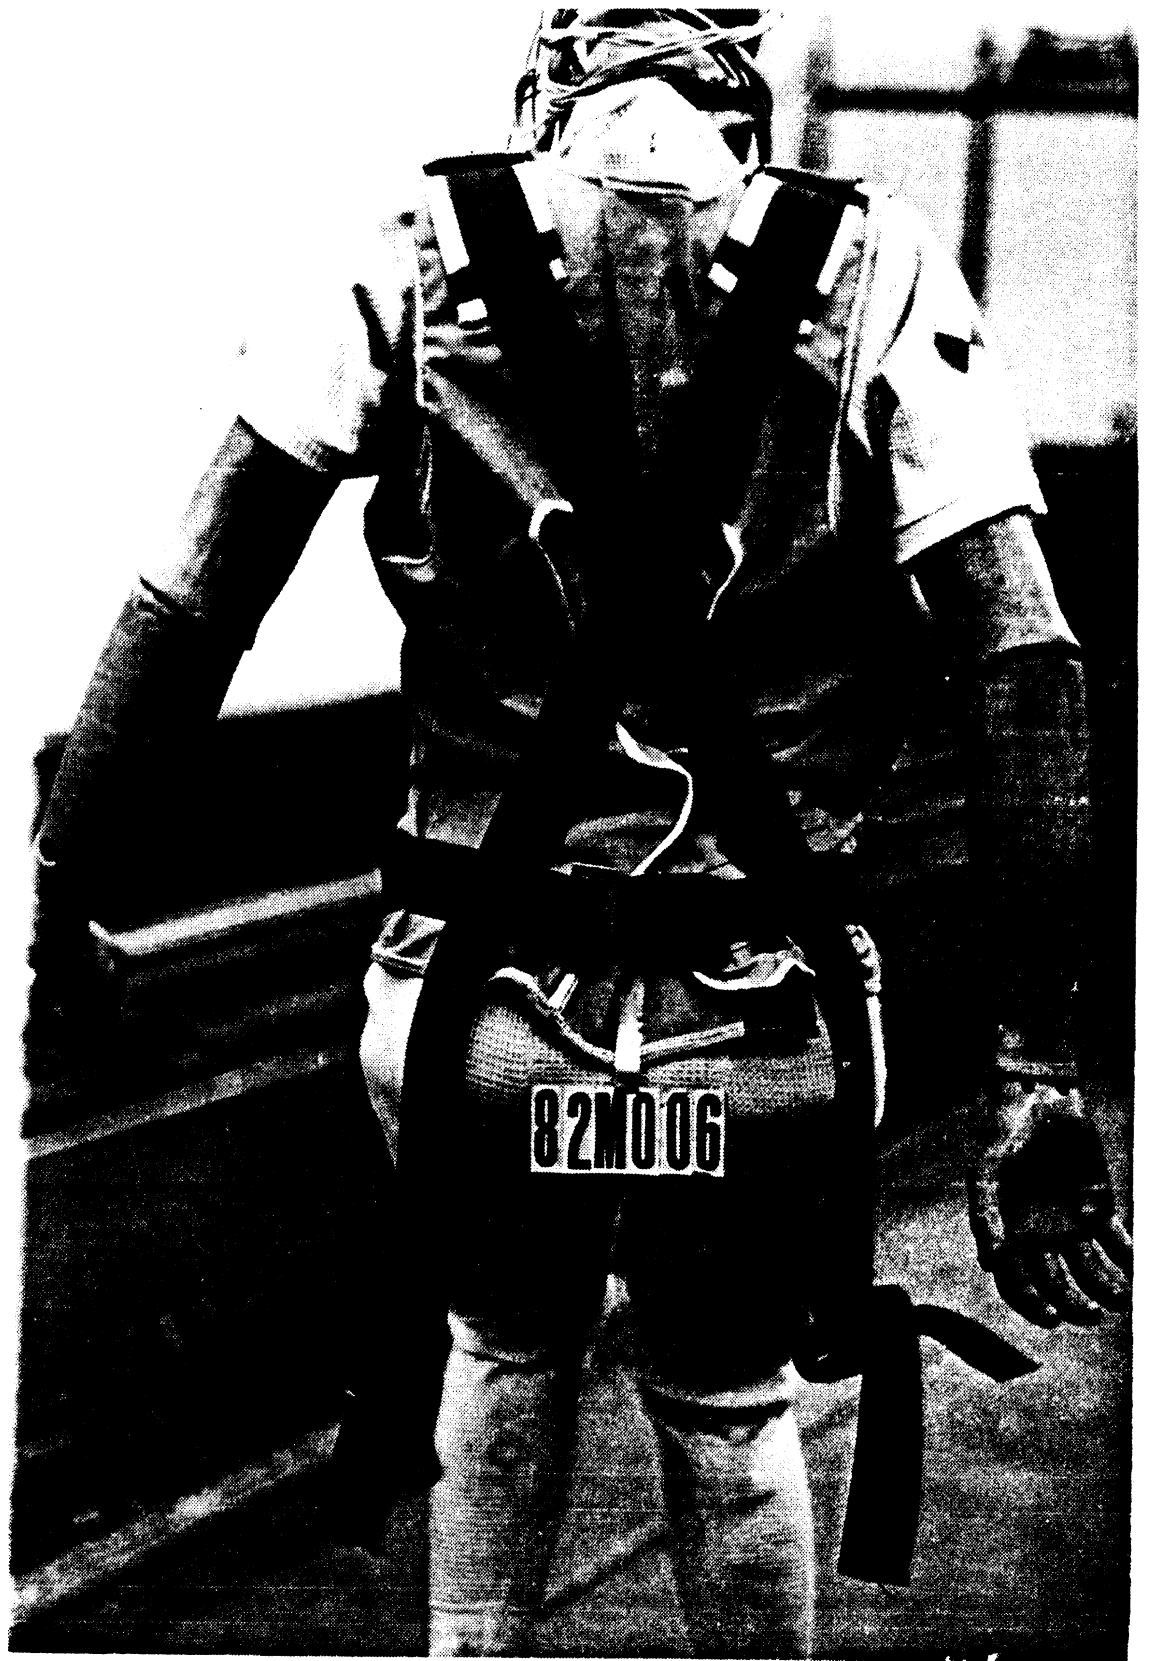
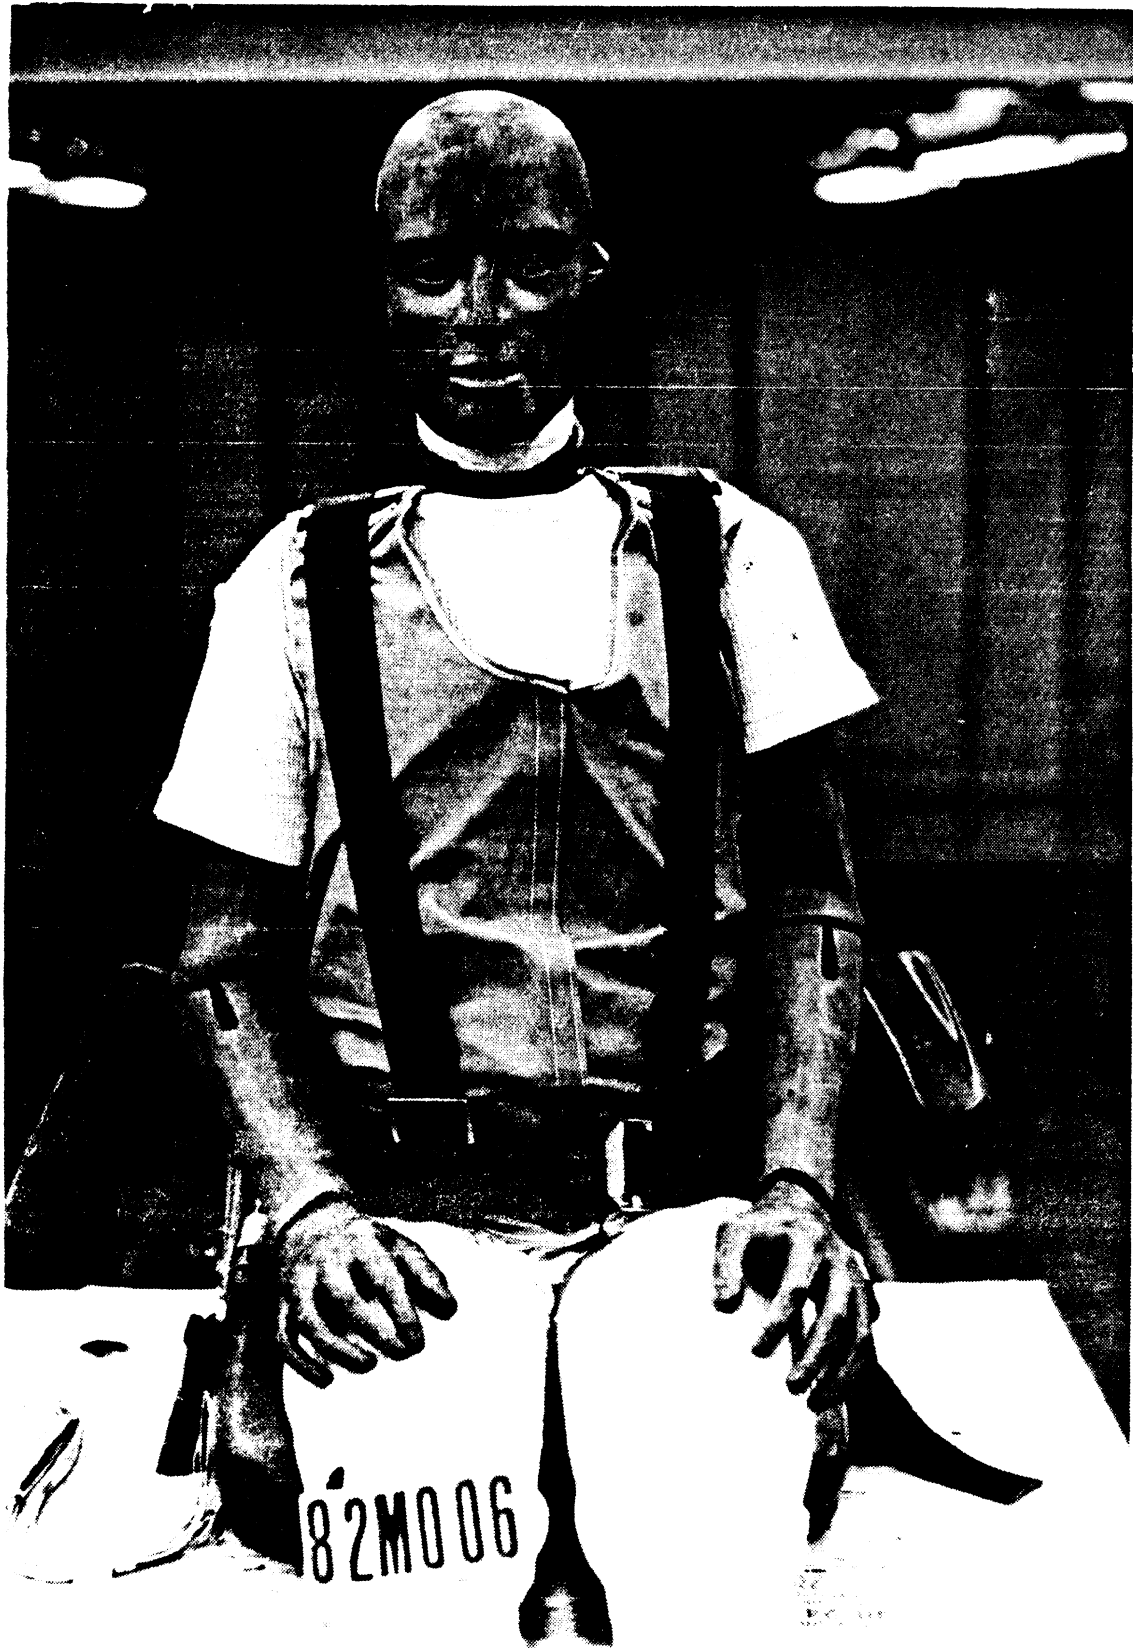
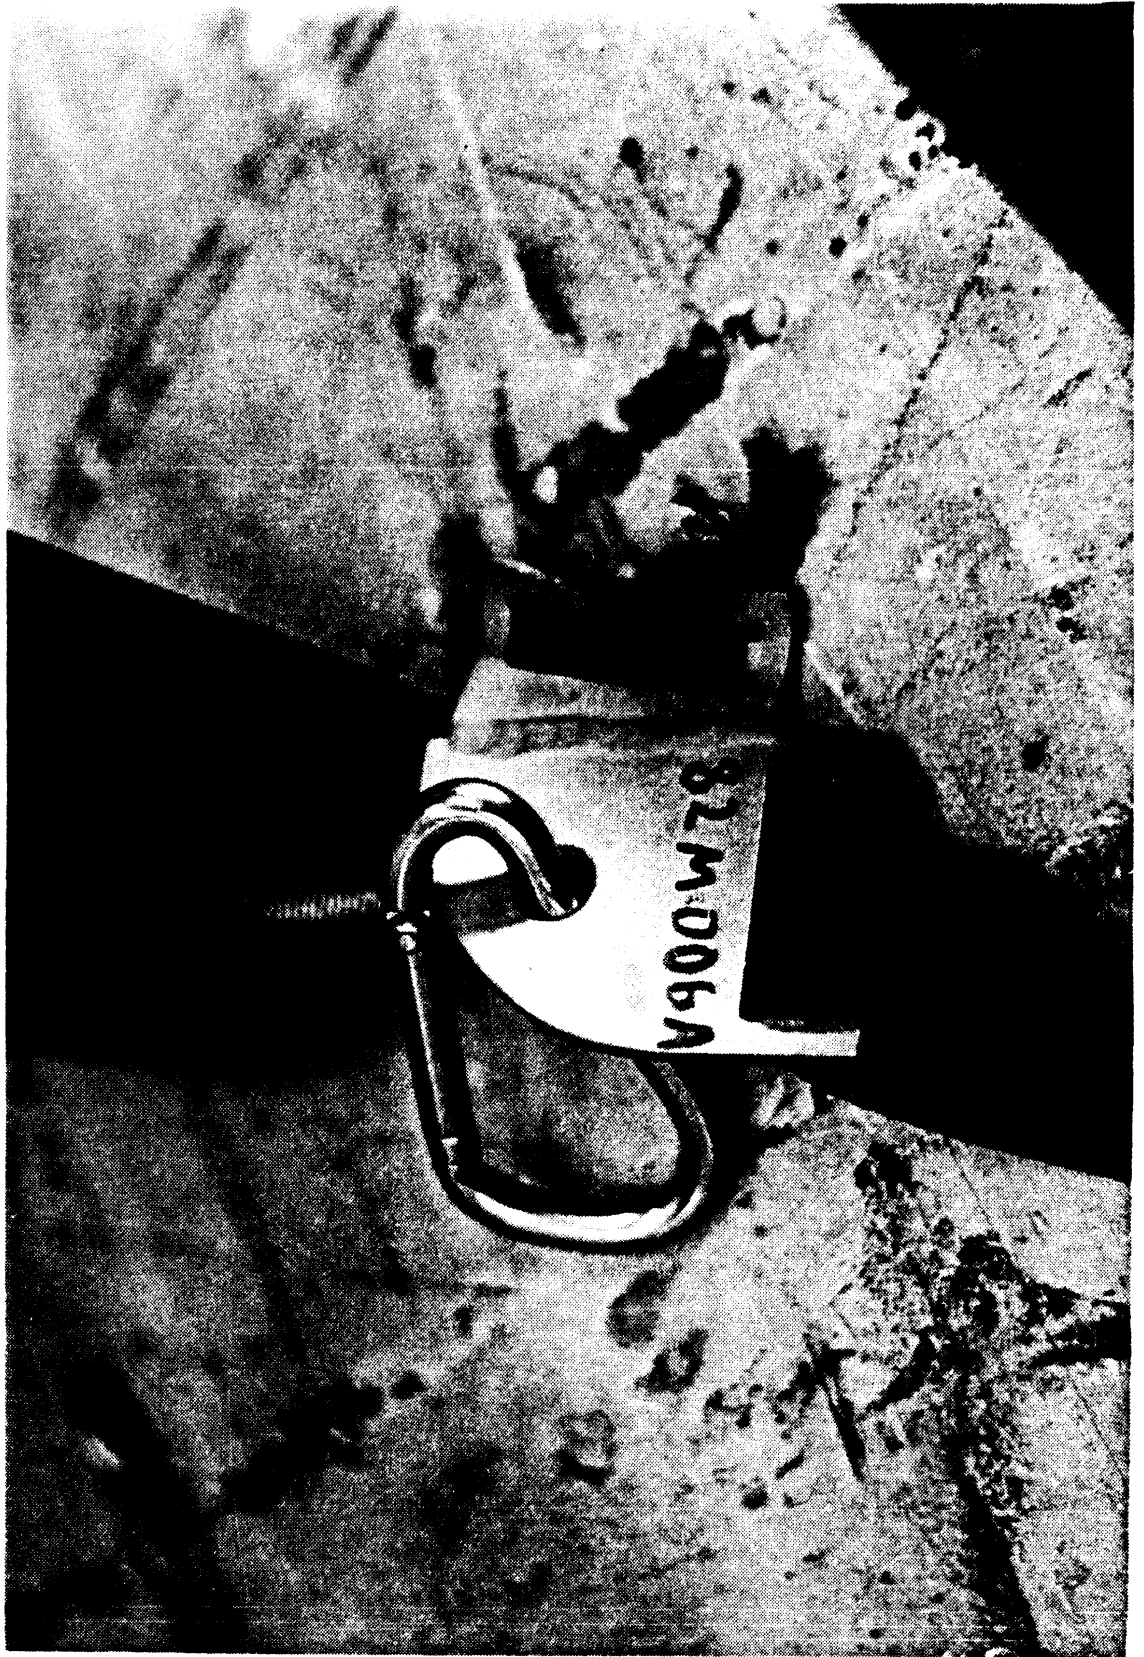
Test 82M006 was conducted to evaluate a revised vest restraint system with new tether anchors and revised belt routing and securement in the harness. A flat-plate tether anchor with separate feed-through slots for the front and rear tether was used on each side. However, it provided too large an angle between the front and rear sets of slots, and it proved very difficult to adjust. The belts of the harness had been stitched together at all intersections to prevent any available belt slack from being pulled into the tether straps and increasing the dummy's excursion. During impact, the belt slots in the tether anchor distorted badly and cut the belt on the left side, releasing the dummy. A similar belt-cutting failure had also been initiated at the right side anchor plate.

OBSERVATIONS: Left tether anchor bracket distorted and tore the belt webbing, releasing the dummy during impact.
