1. Report No. UMTRI-84-9	2. Government Accession No.	3. Recipient's Catalog No.	
4. Title and Subtitle Dynamic Testing of Vest Restraint System (VRS). Phase II. Final Report.		5. Report Date March 1984	6. Performing Organization Code

15. Supplementary Notes Evaluation of Vest Restraint System (VRS). Phase I. Interim Report. November 30, 1982. Richard G. Snyder and John W. Melvin	
16. Abstract Seven tests of the Bureau of Mines proposed vest restraint system were conducted at UMTRI as the phase II or development program. The factors that were found to provide good performance of the vest restraint were the elimination of sliding motion between belt webbing in the vest, common slots in the anchor hardware for the two tether belts on each side, and anchors positioned rearward to provide a 45-degree tether angle. It was recommended that the vest restraints be sized to the torso height of the wearer to preclude abdominal intrusion by the lap belt segment and that upper torso restraint be added to protect against frontal impact, significantly reducing head excursions and associated injuries.

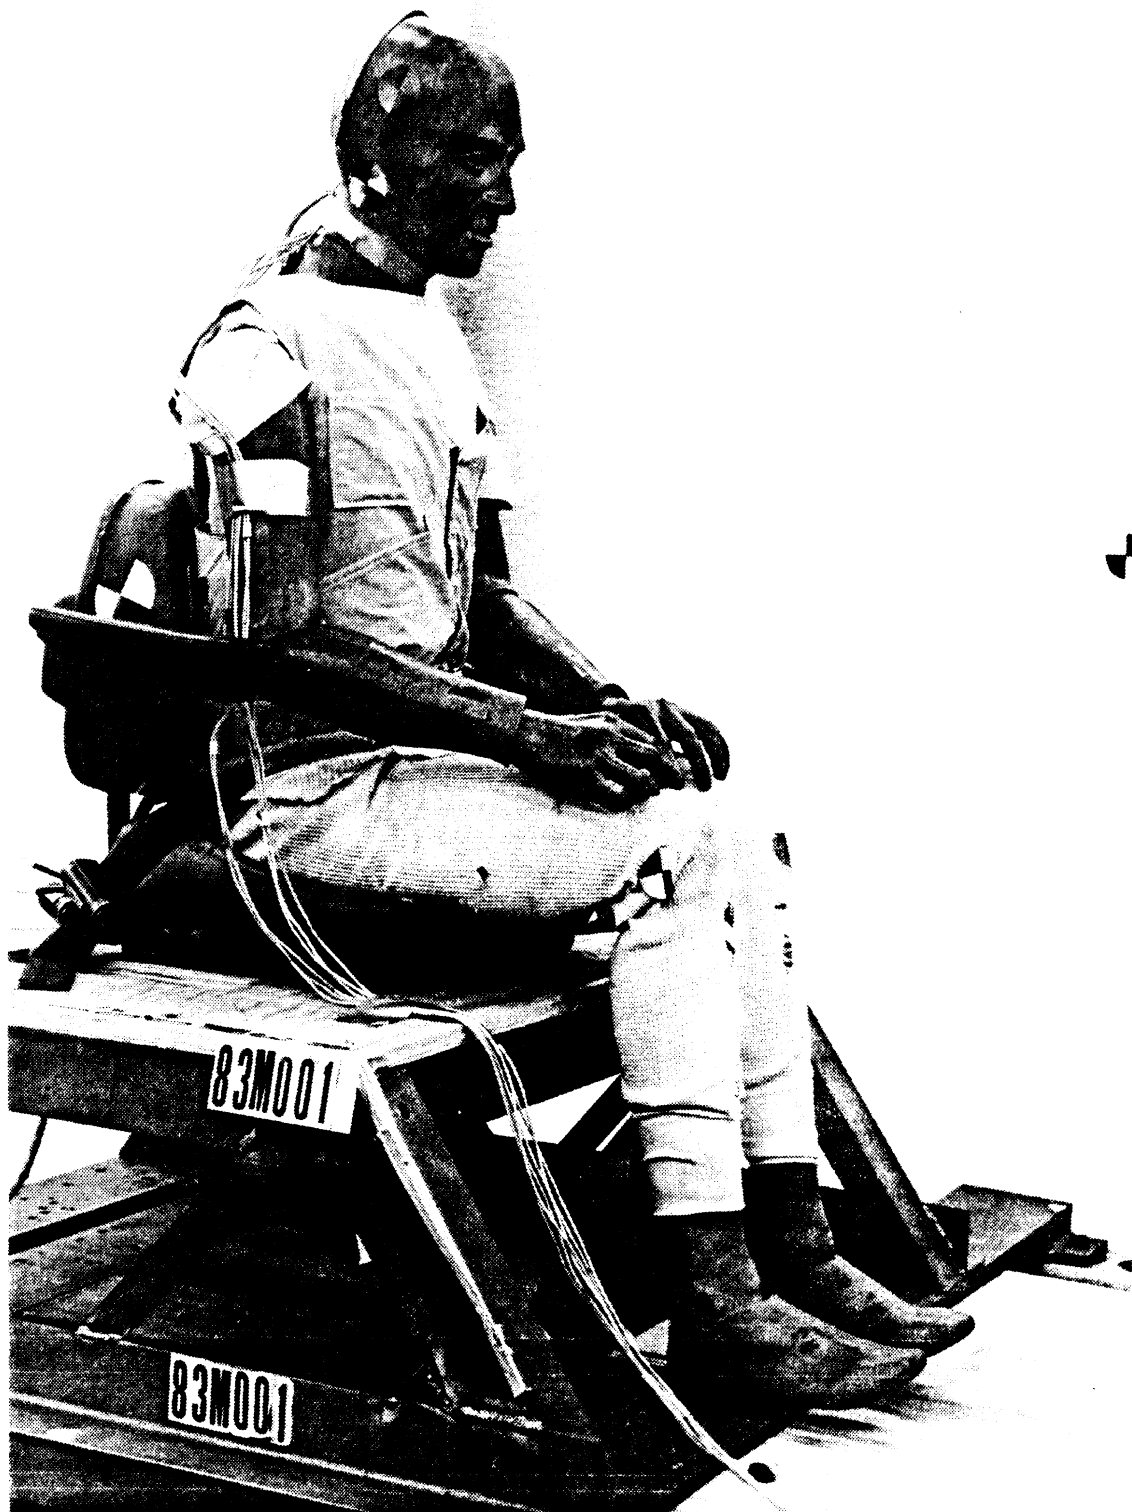
The last test, 83M001, was a repetition of the previous configuration vest restraint and anchoring, but using improved feed-through tether anchor plates to replace the seat belt anchors that had been improvised for the last test. However, during the impact, the stitching tore at several junctions in the harness, and the vest fabric was also torn as the belt webbing shifted. Subsequently, it was reported that an incorrect thread had been used in the harness fabrication. Further testing was discontinued at this point at the request of the sponsor.

OBSERVATIONS: Harness stitching failed, allowing the dummy to slide off the front edge of the seat and producing abdominal belt intrusion.

- * The vest harness should be based on the most recent design tested that restricts relative motion of the belts and has a common attachment for the tether belts on each side.
- * The tether belt anchor points should be selected to provide the most forward tether straps with an angle of approximately 45 degrees to horizontal to minimize forward excursion.
- * The vest restraint should be sized to the torso height of the wearer to prevent abdominal intrusion by the lap-belt portion of the harness during an impact.
- * Upper torso restraint to protect against frontal impact would significantly reduce operator head excursion and exposure to injury and should be seriously considered as a future upgrade to the vest restraint system.
