WEAR OF AGED DENTAL COMPOSITES

P. L. FAN and J. M. POWERS

School of Dentistry, The University of Michigan, Ann Arbor, MI 48109 (U.S.A.)

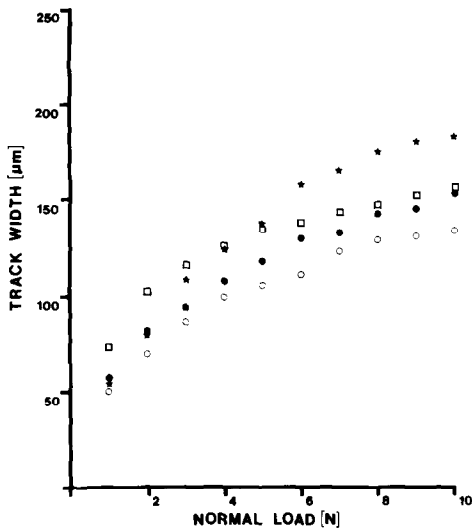
Fig. 1. Wear track widths of PR vs. normal load: ★, 0 h; ○, 300 h; ●, 600 h; □, 900 h.

Figures 1 - 4 show the average wear track widths at various normal loads for aged and unaged specimens of PR, FN, I and SI respectively.

The wear track widths of the two conventional composites C and PR decreased after 300 and 600 h of aging. After 900 h of aging the wear tracks were wider at lower normal loads but narrower at higher normal loads than those of the unaged samples.

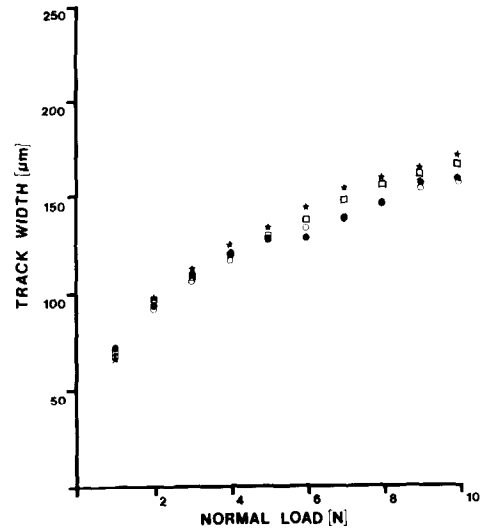
Fig. 2. Wear track widths of FN vs. normal load: ★, 0 h; ○, 300 h; ●, 600 h; □, 900 h.

The microfilled composites showed an initial decrease in wear track width on aging and then the track widths approached those of the unaged samples on further aging. There were differences in the wear track widths between each aged and unaged microfilled composite and between the microfilled composites.

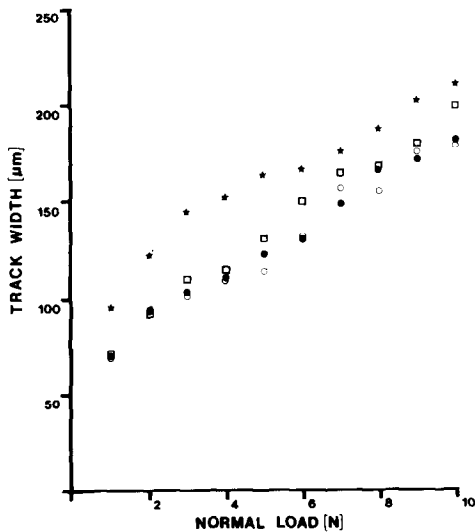
Fig. 3. Wear track widths of I vs. normal load: ★, 0 h; ○, 300 h; ●, 600 h; □, 900 h.

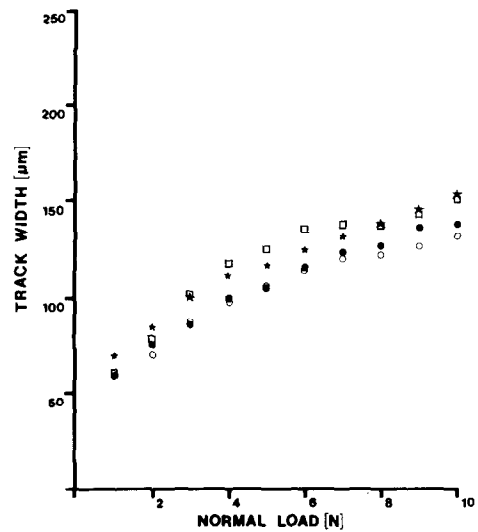
Fig. 4. Wear track widths of SI vs. normal load: ★, 0 h; ○, 300 h; ●, 600 h; □, 900 h.
